PLANS FOR REDUCTION OF SHOALING  
AT THE ENTRANCE TO  
UMPQUA RIVER, OREGON

MODEL INVESTIGATION

TECHNICAL MEMORANDUM NO. 2-277

WATERWAYS EXPERIMENT STATION

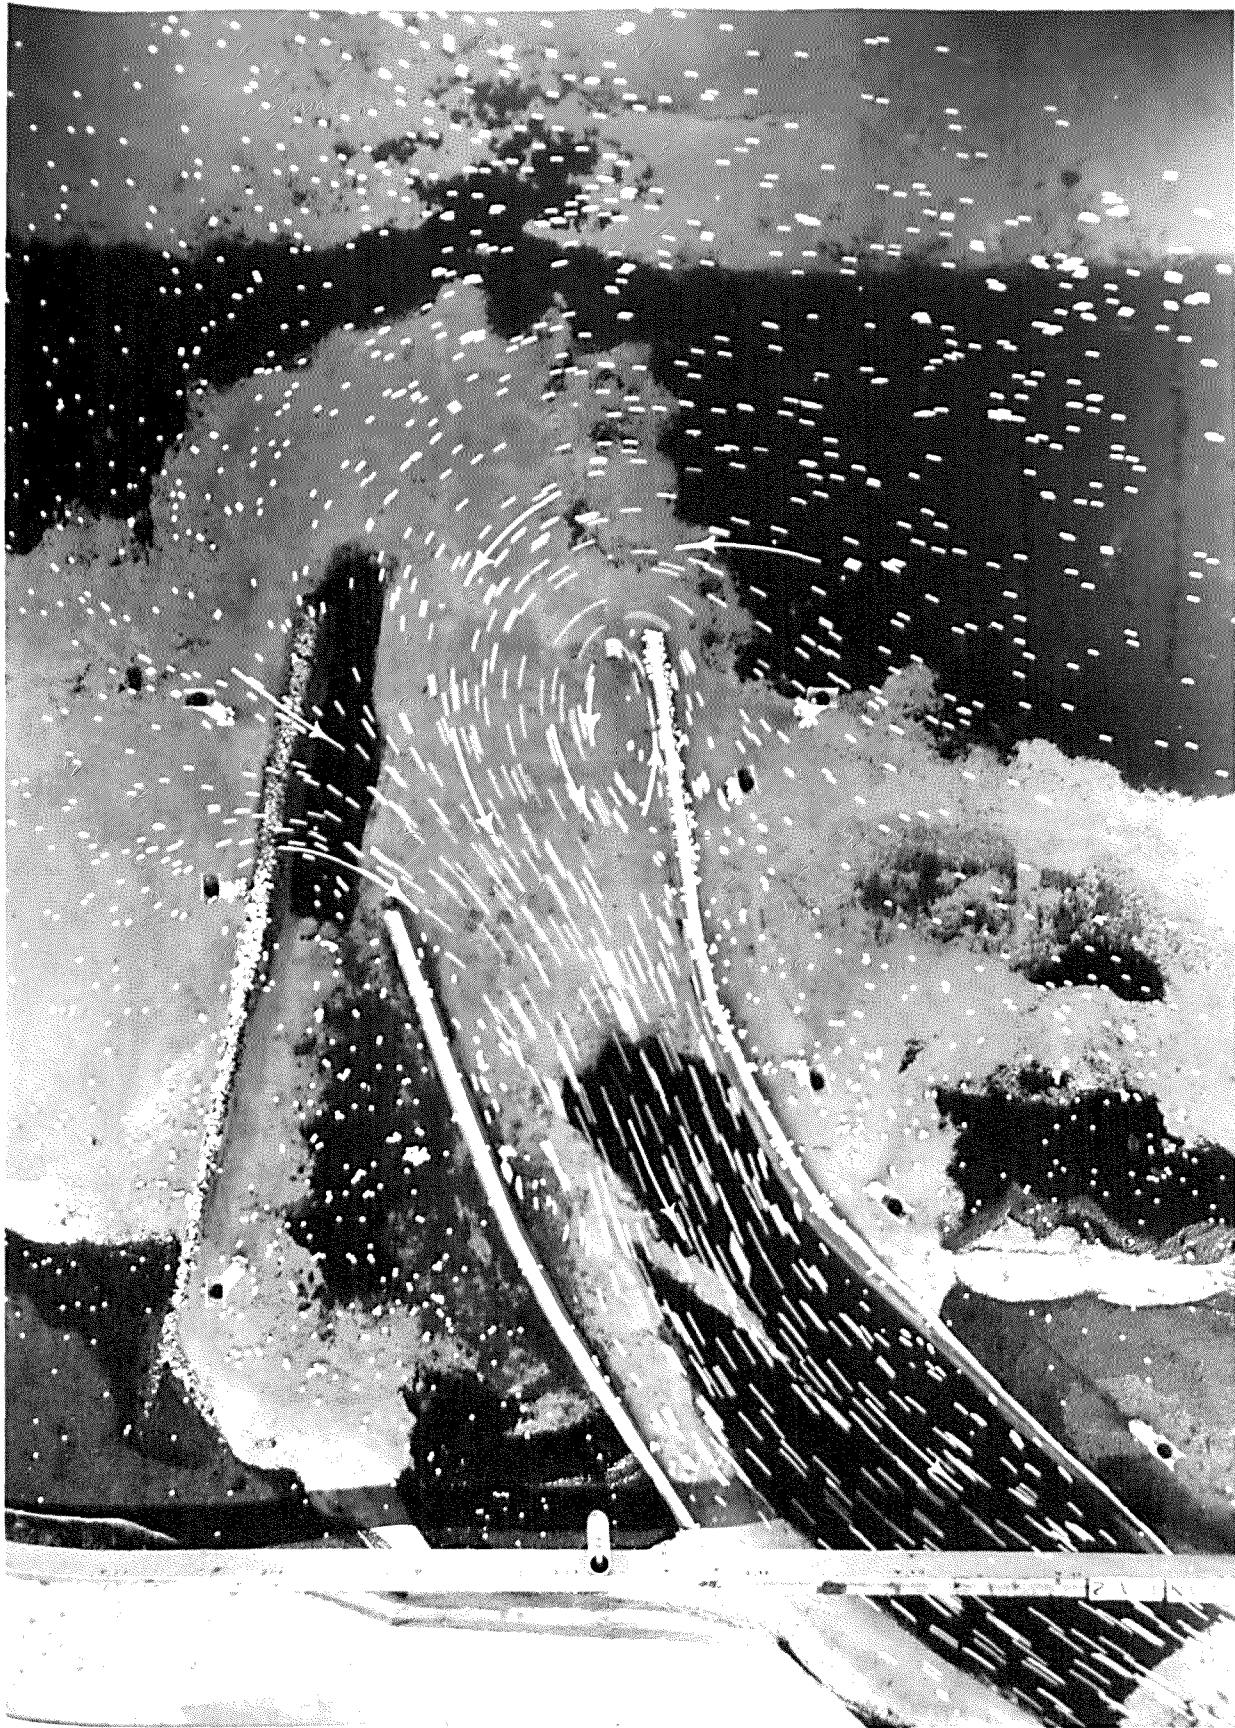
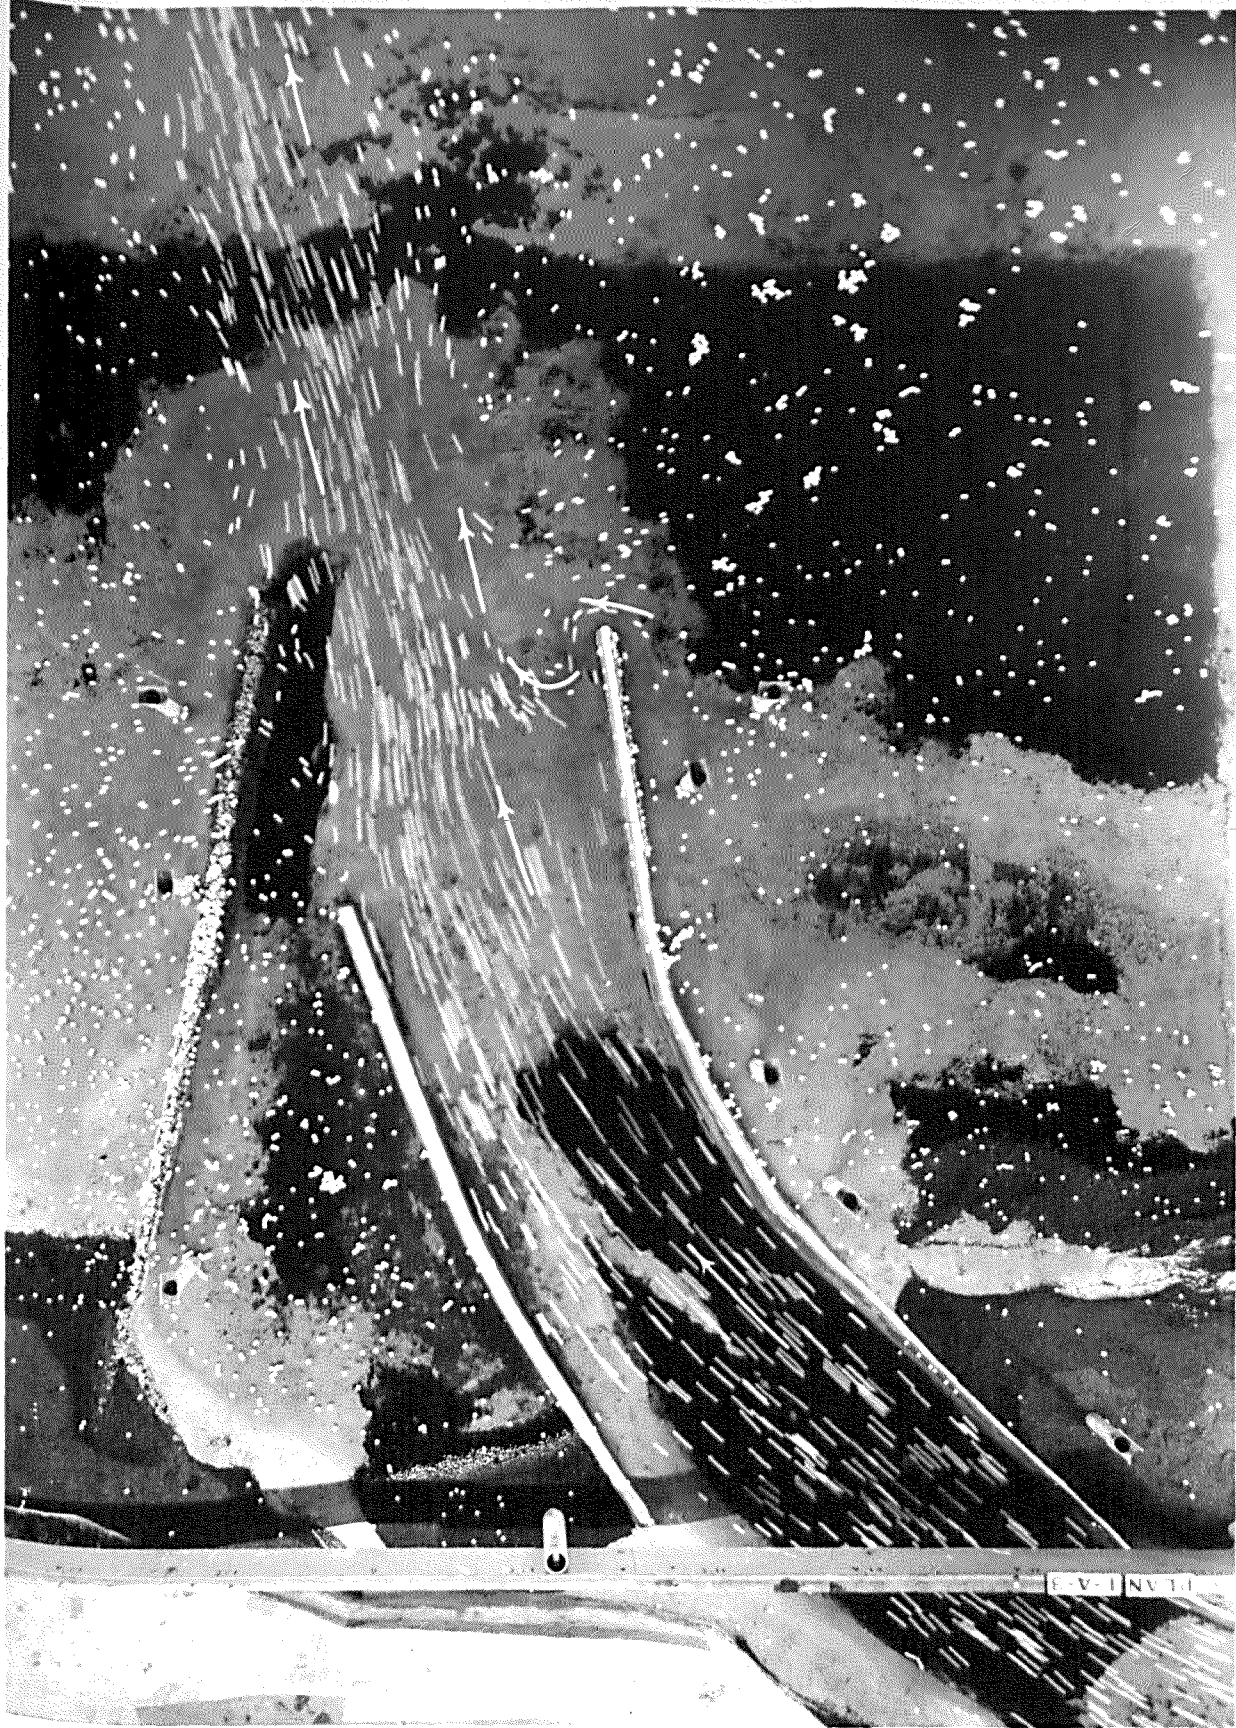
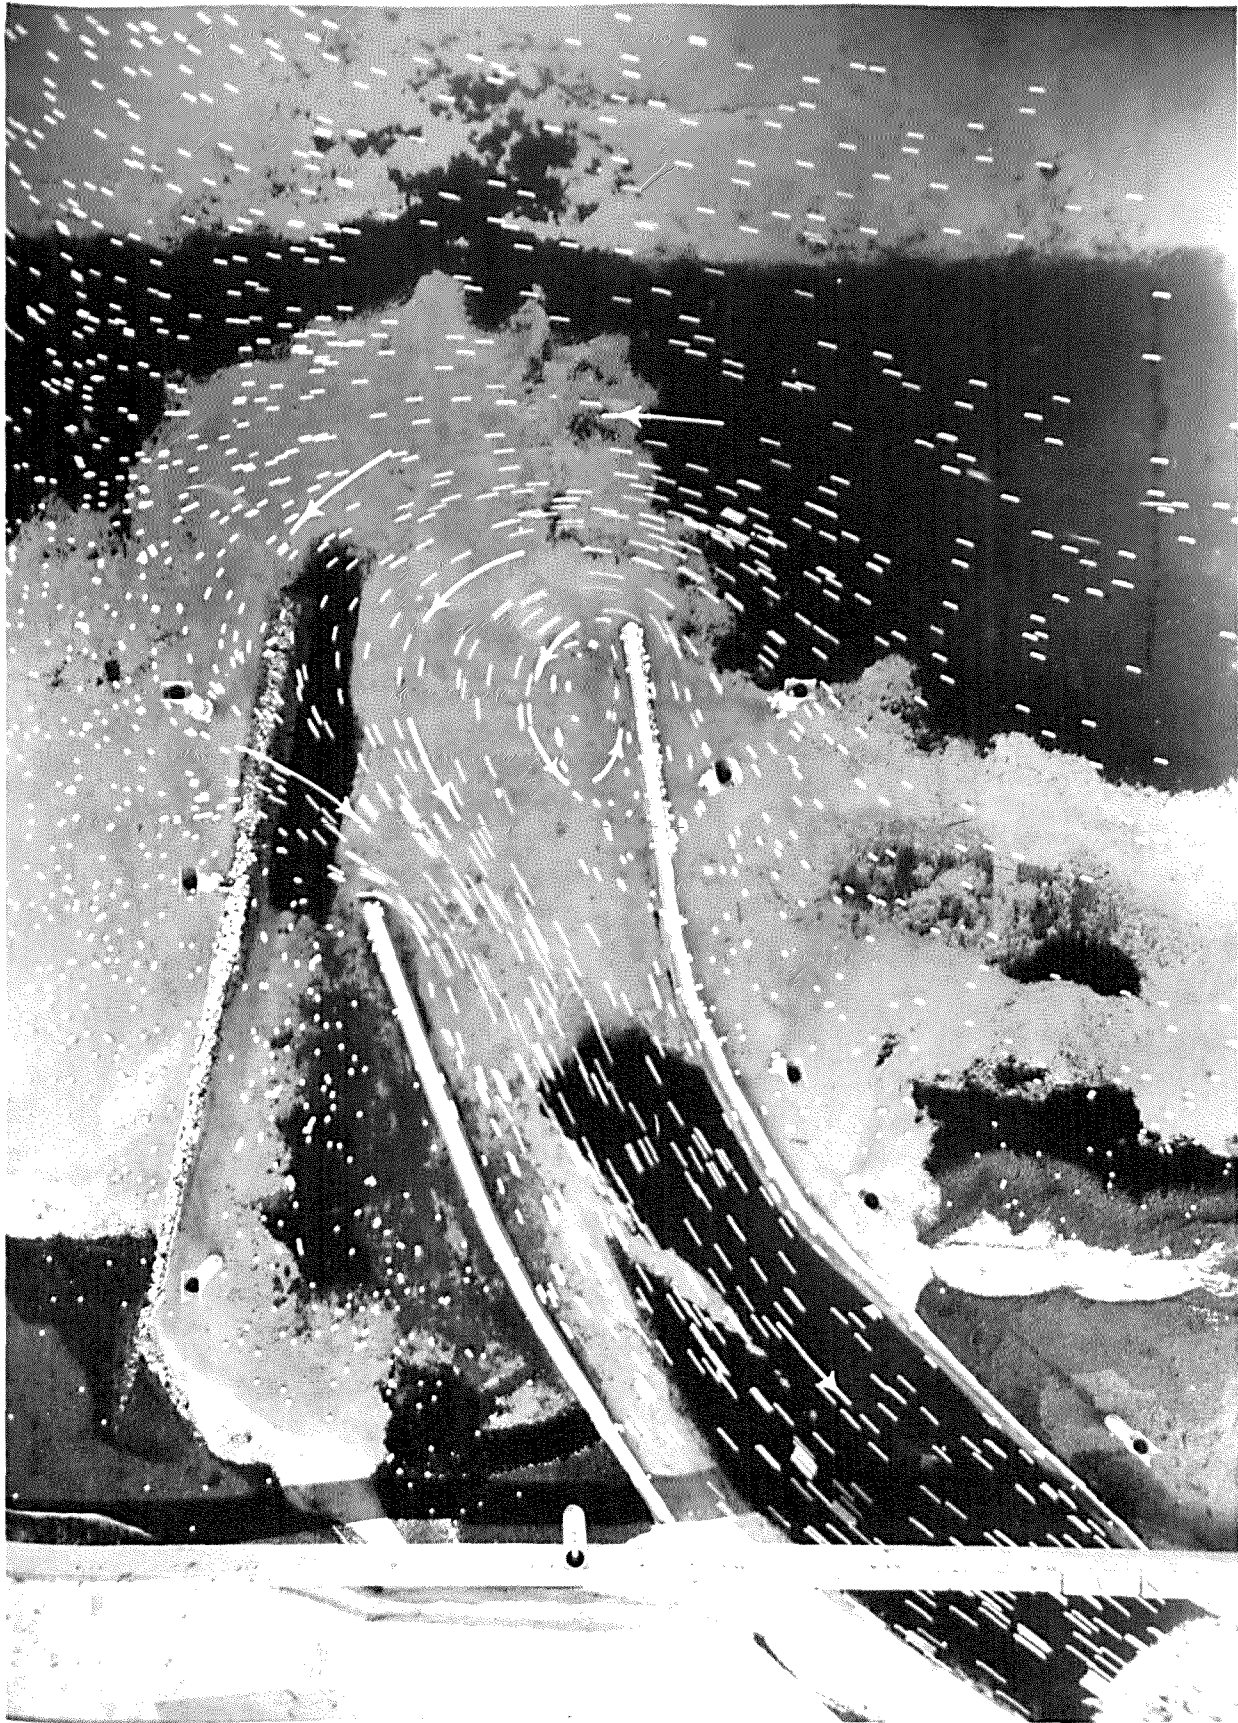
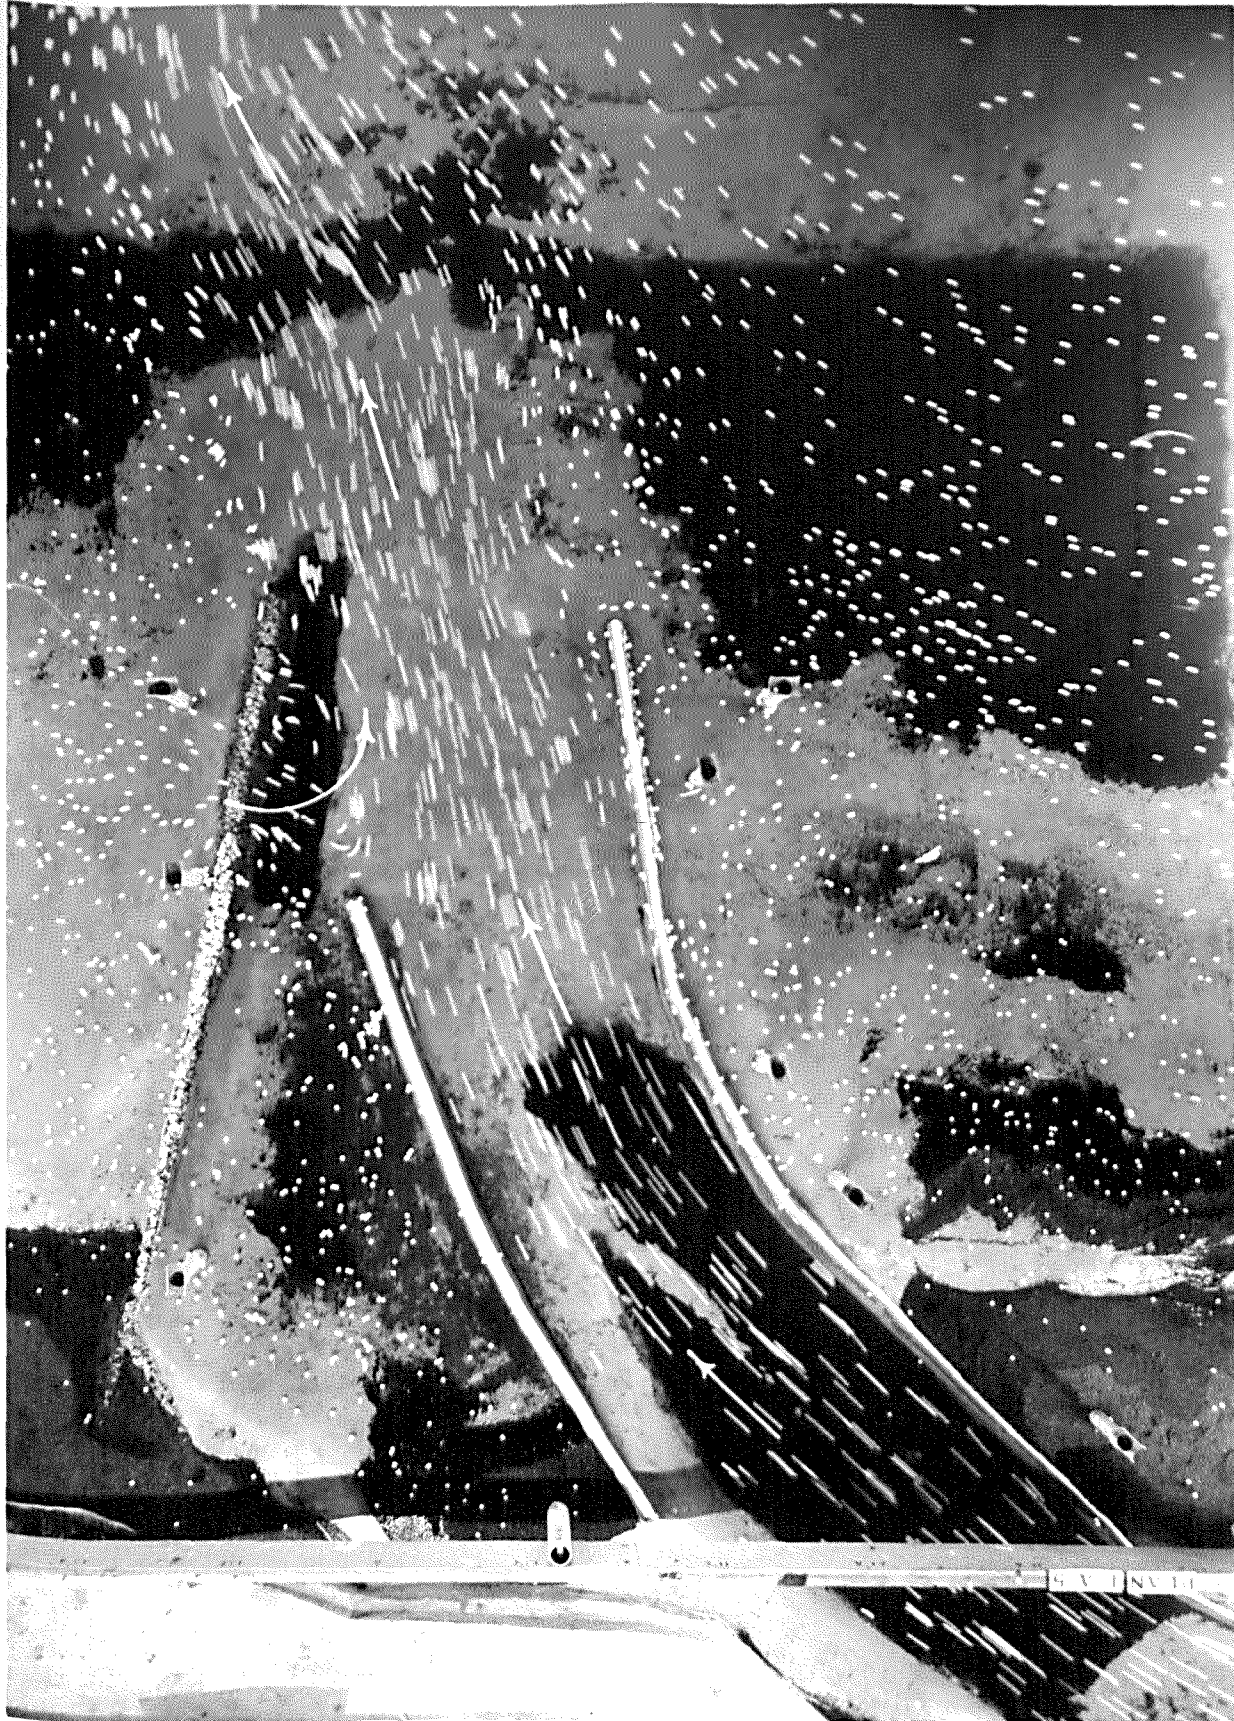
PHOTOGRAPH 14. Plan 1-A - Current directions at strength of flood before HHW (hr. 10.5)

PHOTOGRAPH 15. Plan 1-A - Current directions at strength of ebb after HHW (hr 16.5)

PHOTOGRAPH 16. Plan 1-A - Current directions at strength of flood before LHW (hr. 23.0)

PHOTOGRAPH 17. Plan 1-A - Current directions at strength of ebb after LHW (hr. 4.0)

18. The scour and fill effected by plan 1-A are shown on plate 2 and photograph 3; surface current directions at strengths of flood and ebb are shown on photographs 14-17; and current velocity observations with the plan installed are shown on plates 9 and 10 and in table 2. The scour and fill pattern at the end of the test of plan 1-A was substantially the same as that at the end of the base test. Some local scour occurred along the north side of the plan 1-A jetty, and a considerable deposit of material formed on the south side of the jetty in the angle between the jetty and the shore. There were general increases in maximum flood velocities and general decreases in maximum ebb velocities from those of the base test. When compared to the velocities observed during the test of the dredging plan, however, plan 1-A indicated general increases in both maximum flood and maximum ebb velocities (see table 4). The jetty of plan 1-A shifted the main current away from the outer end of the existing south jetty, thus bringing the current alignment closer to that of the navigation channel. A small eddy formed just south of the outer end of the existing north jetty during the flood period, but was not noticeable during the ebb. There was no current or eddy action in the

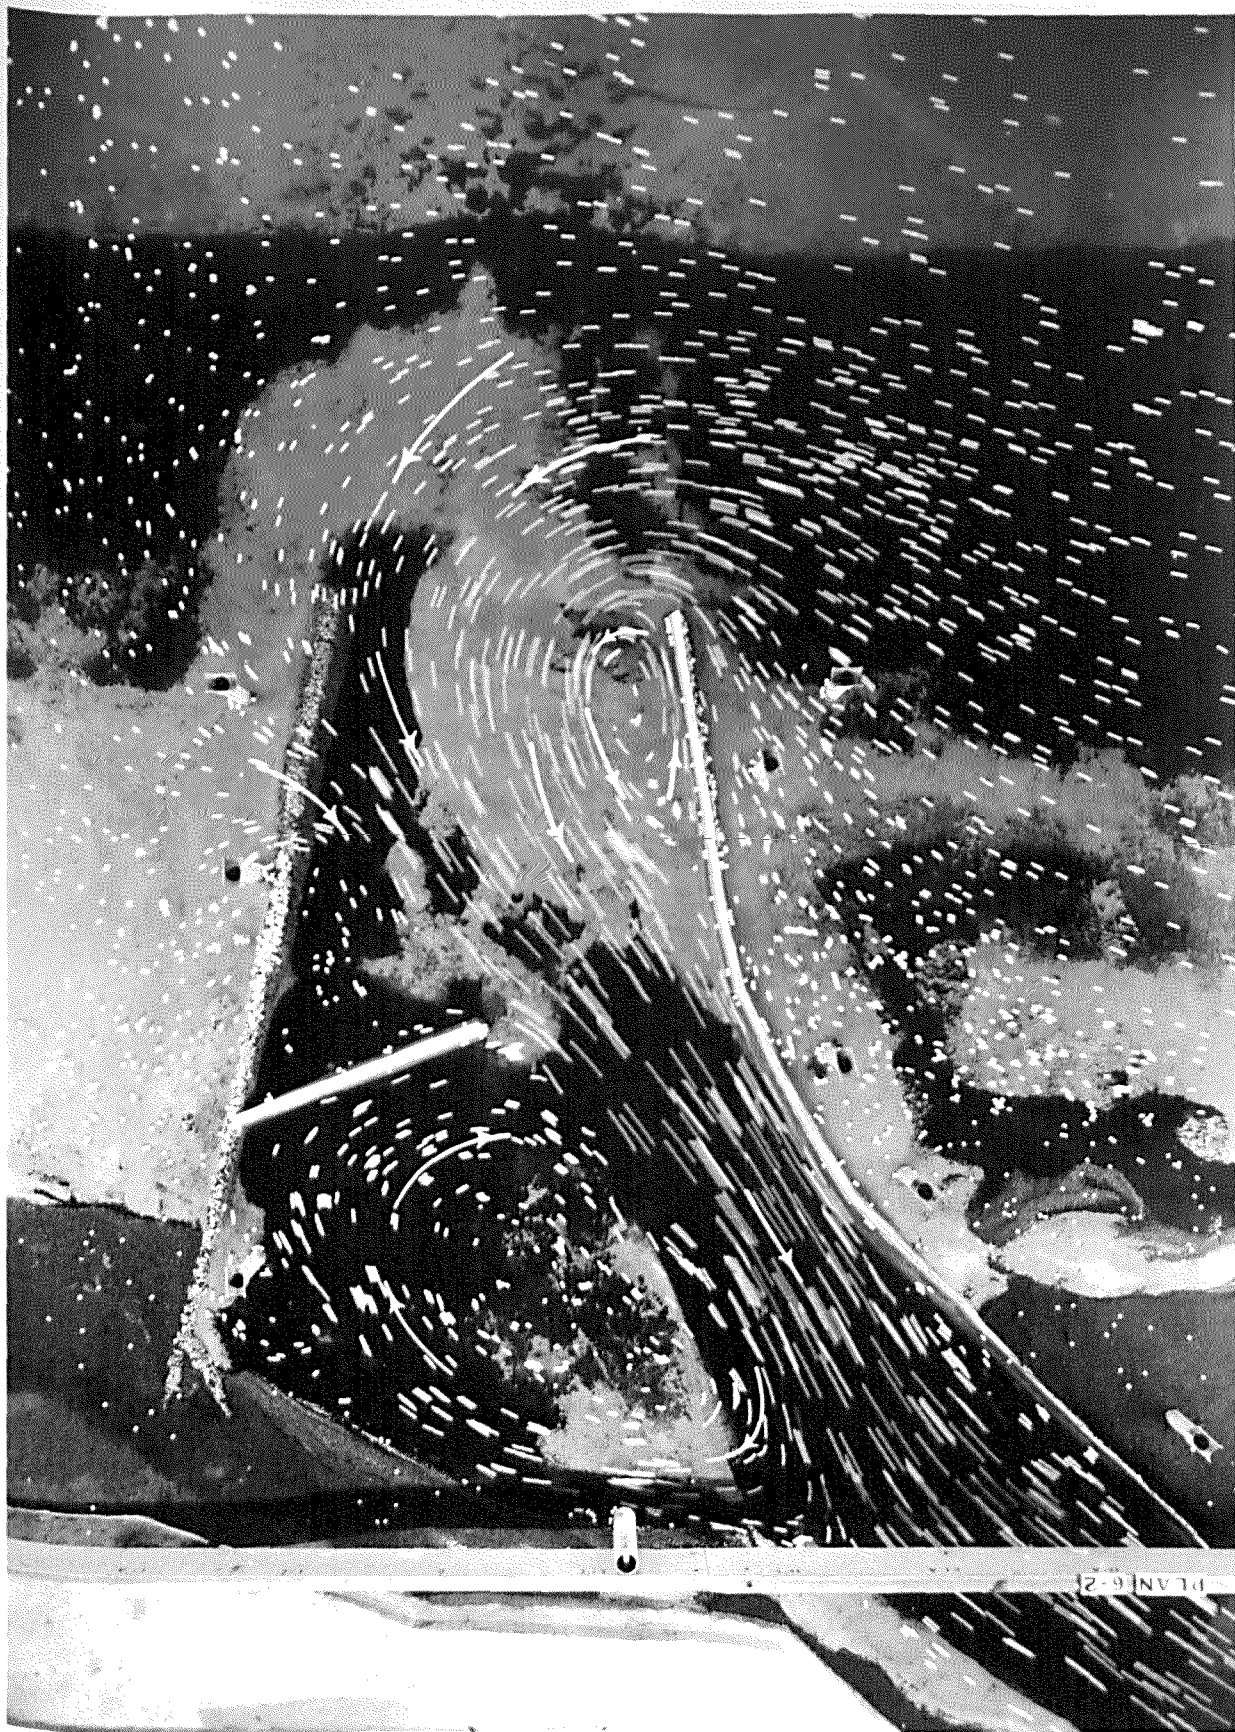
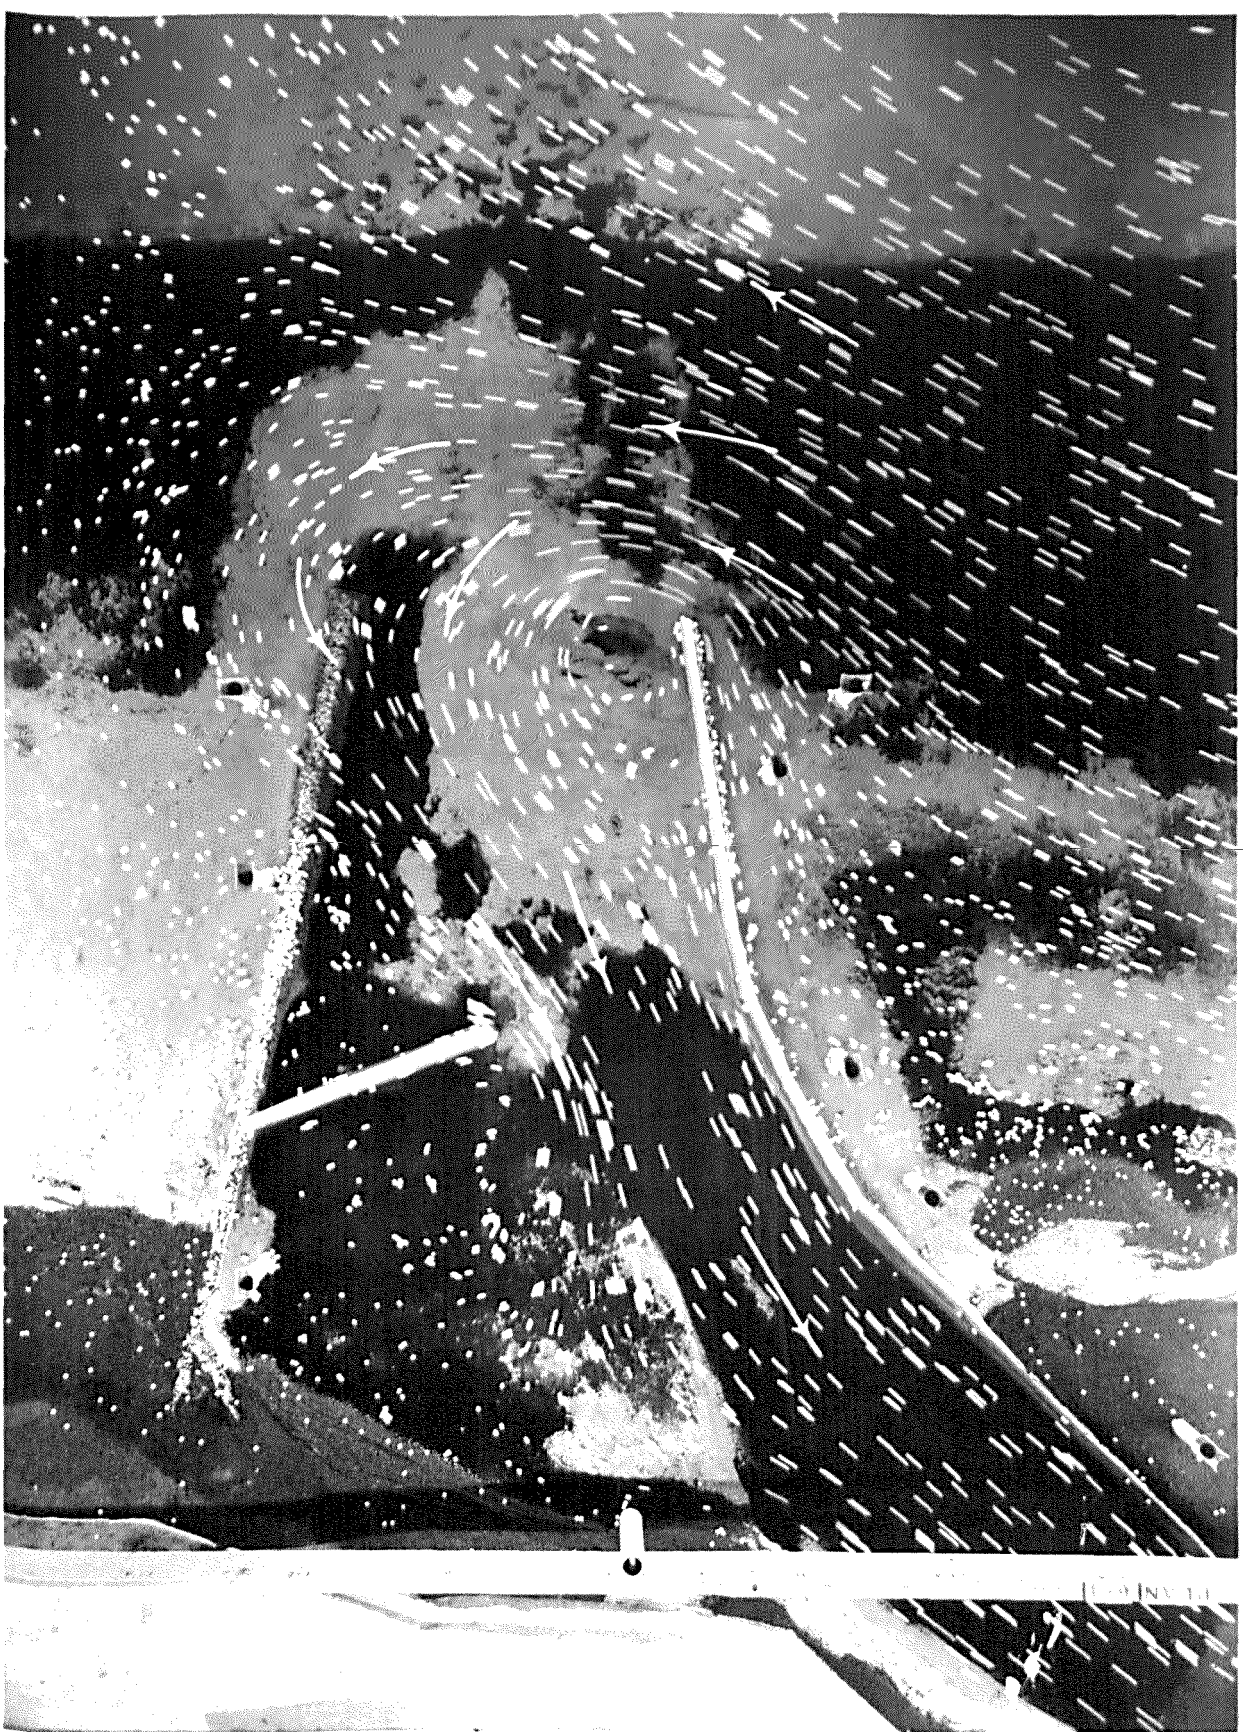
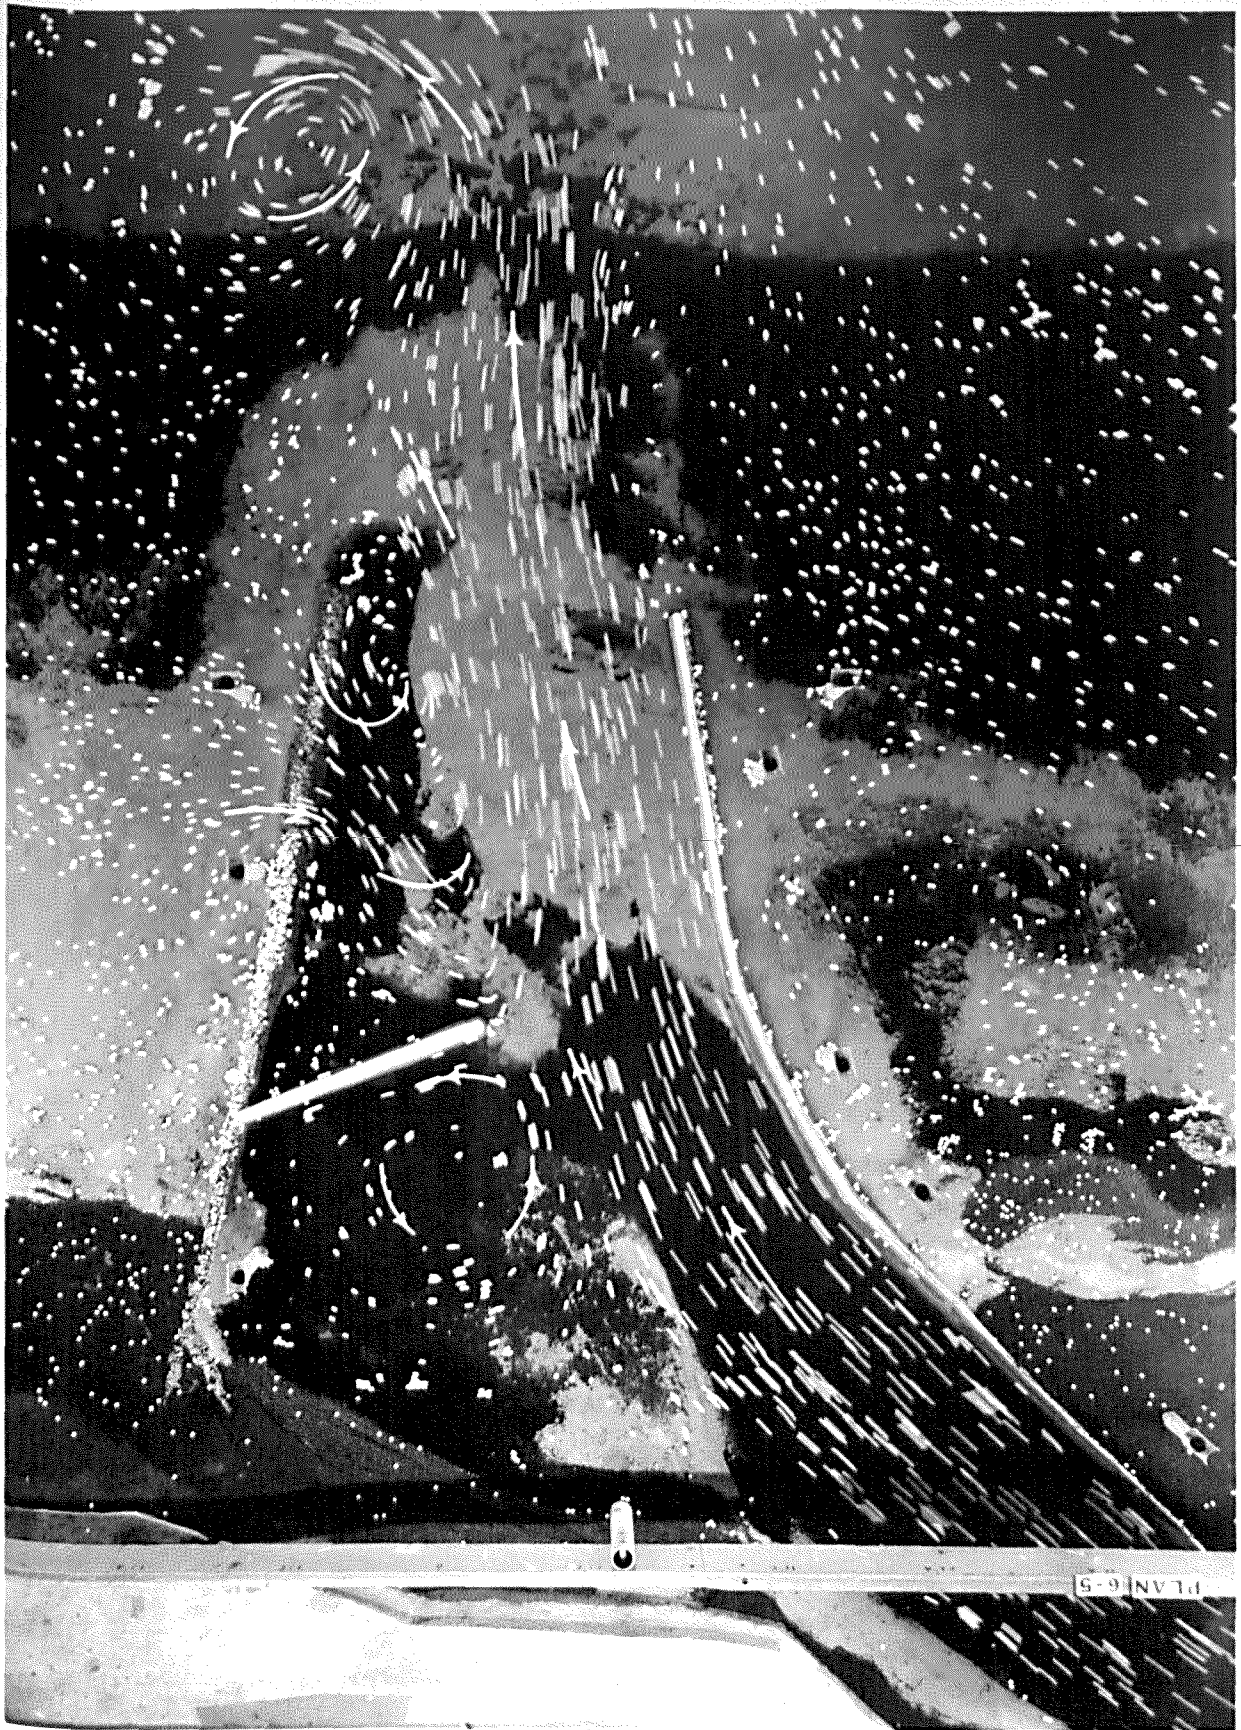
PHOTOGRAPH 18. Plan 6 - Current directions at strength of flood before  
HHW (hr. 10.5)

PHOTOGRAPH 19. Plan 6 - Current directions at strength of ebb after  
HHW (hr. 16.5)

PHOTOGRAPH 20. Plan 6 - Current directions at strength of flood before LHW (hr. 23.0)

PHOTOGRAPH 21. Plan 6 - Current directions at strength of ebb after LHW (hr. 4.0)

20. The scour and fill patterns for plan 6 are shown on plate 3 and photograph 4; current directions at strengths of flood and ebb are shown on photographs 18-21; and current velocity measurements are shown on plates 11 and 12 and in table 2. The pattern of scour and fill over the problem area was generally similar to that which occurred during the base test; however, the extent of scour in the area between the existing jetties was less than that which occurred during the base test or during tests of plans 1 and 1-A. The plan-6 jetty was subjected to heavy broad-side wave action for all wave directions reproduced. Current velocities in the channel were generally reduced from those of the base test, but were about the same or slightly higher than those measured during the test of the dredging plan (see table 4). The plan-6 jetty caused a considerable northward shift in the alignments of flood and ebb currents in the jetty channel; however, there were changes in the alignments of both flood and ebb currents in the vicinity of the structure. During the flood period, eddies formed in the jetty channel just south of the outer end of the north jetty and in the area between the plan-6 jetty

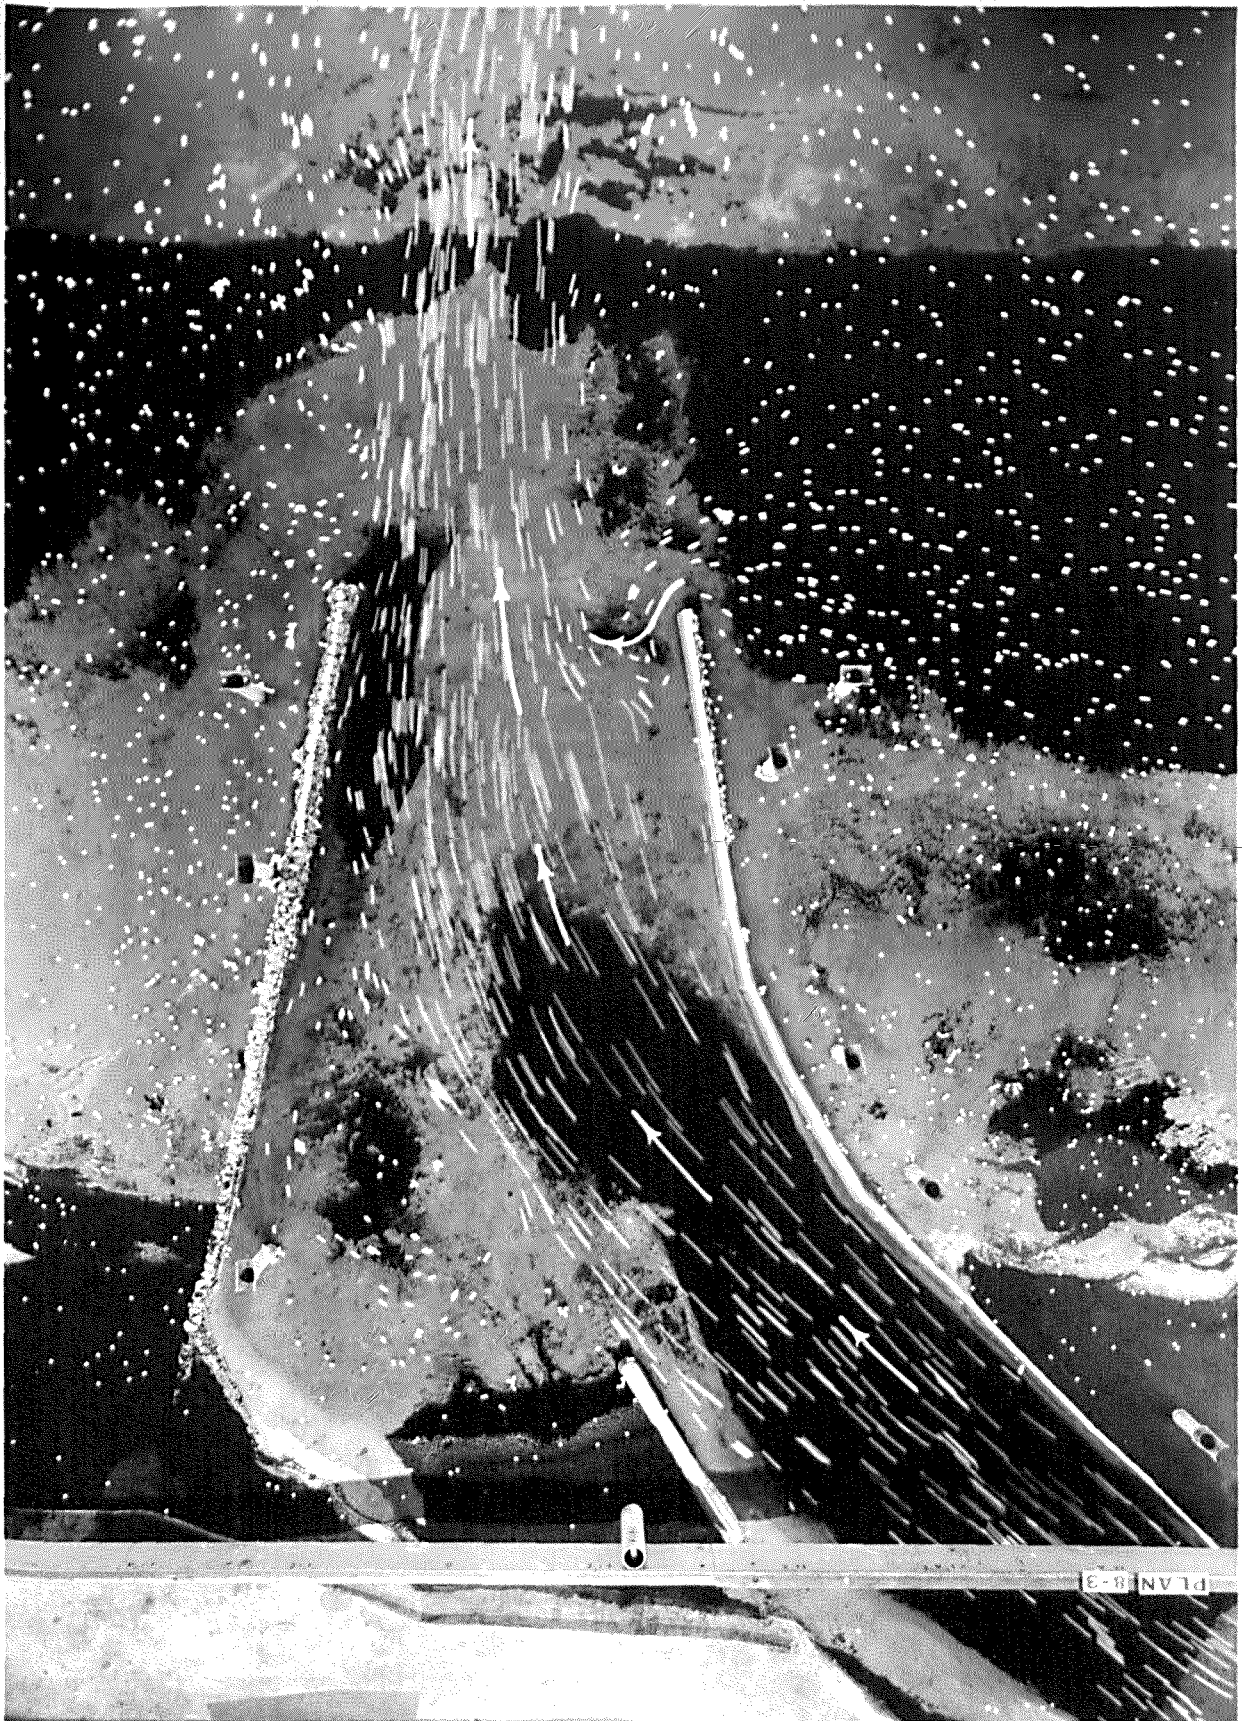
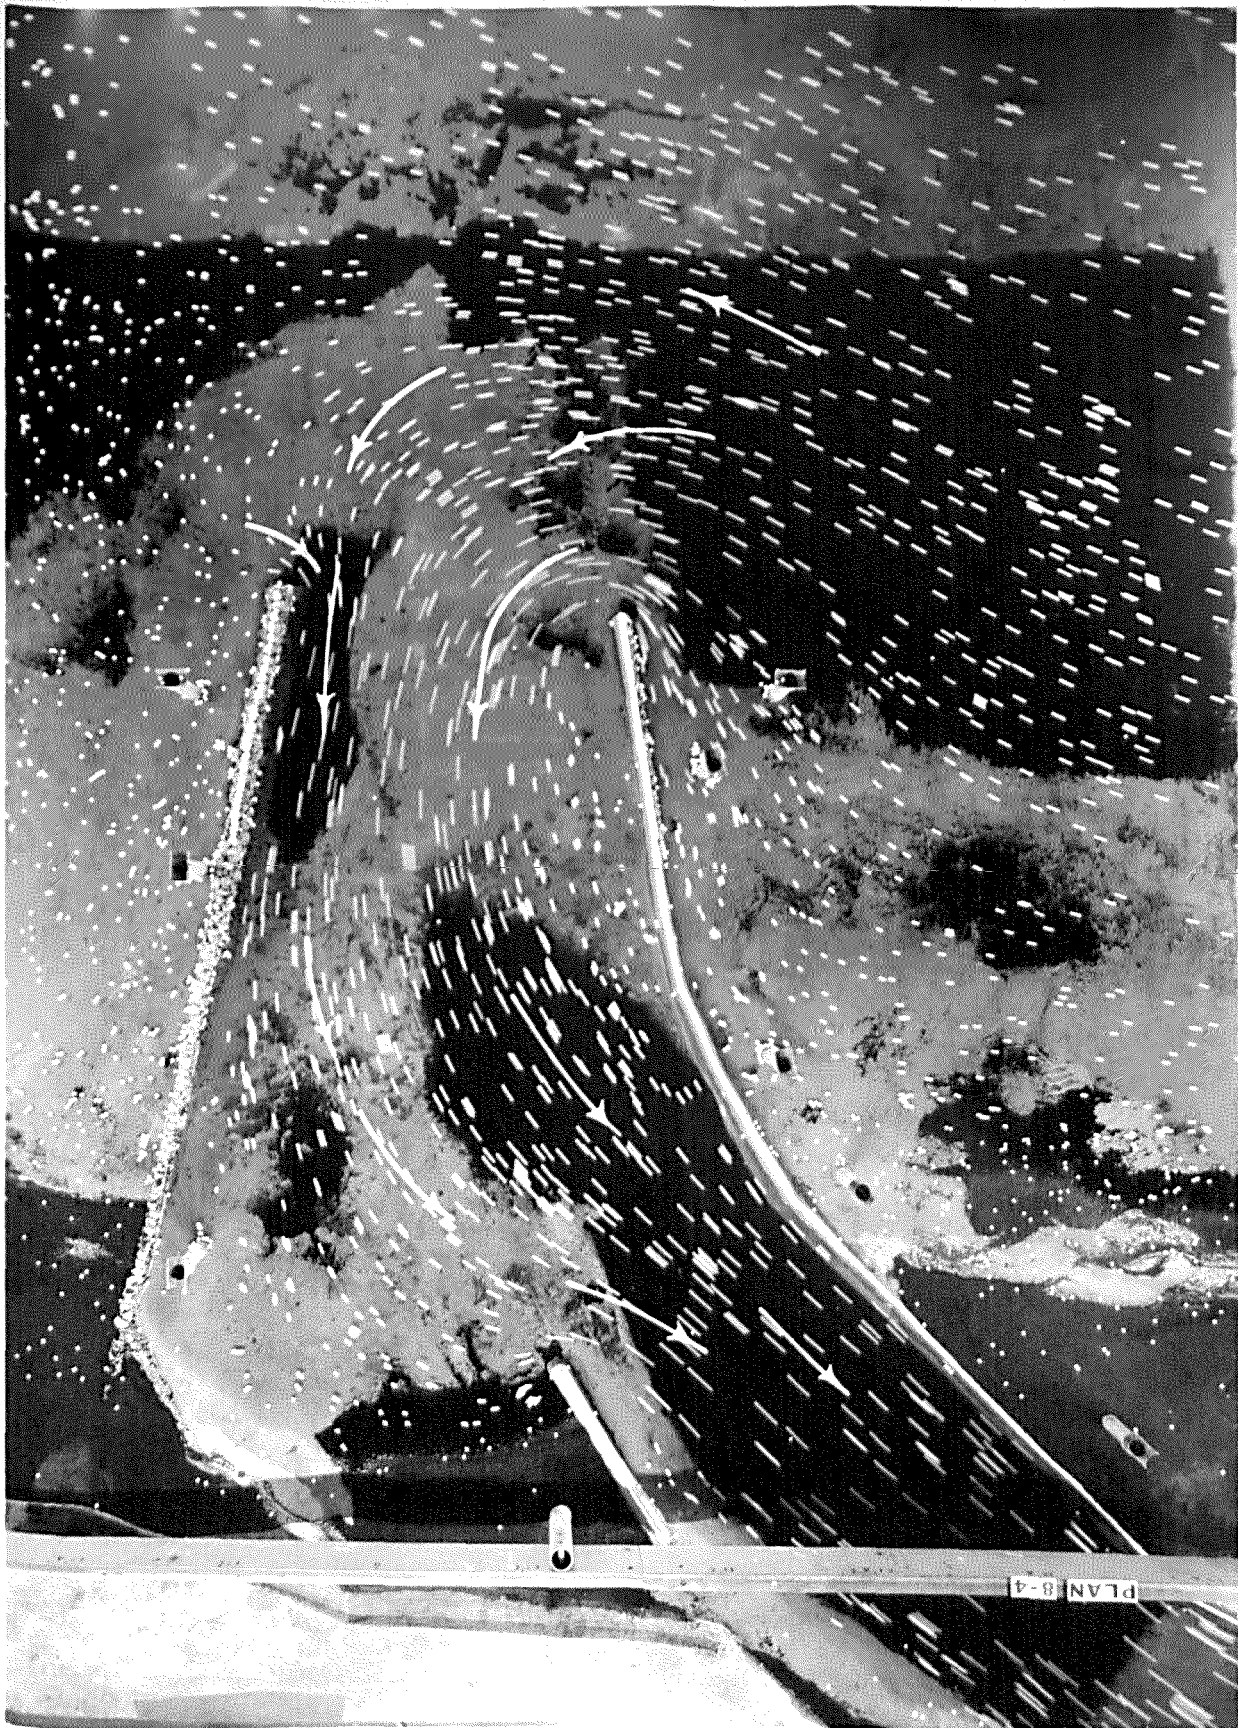
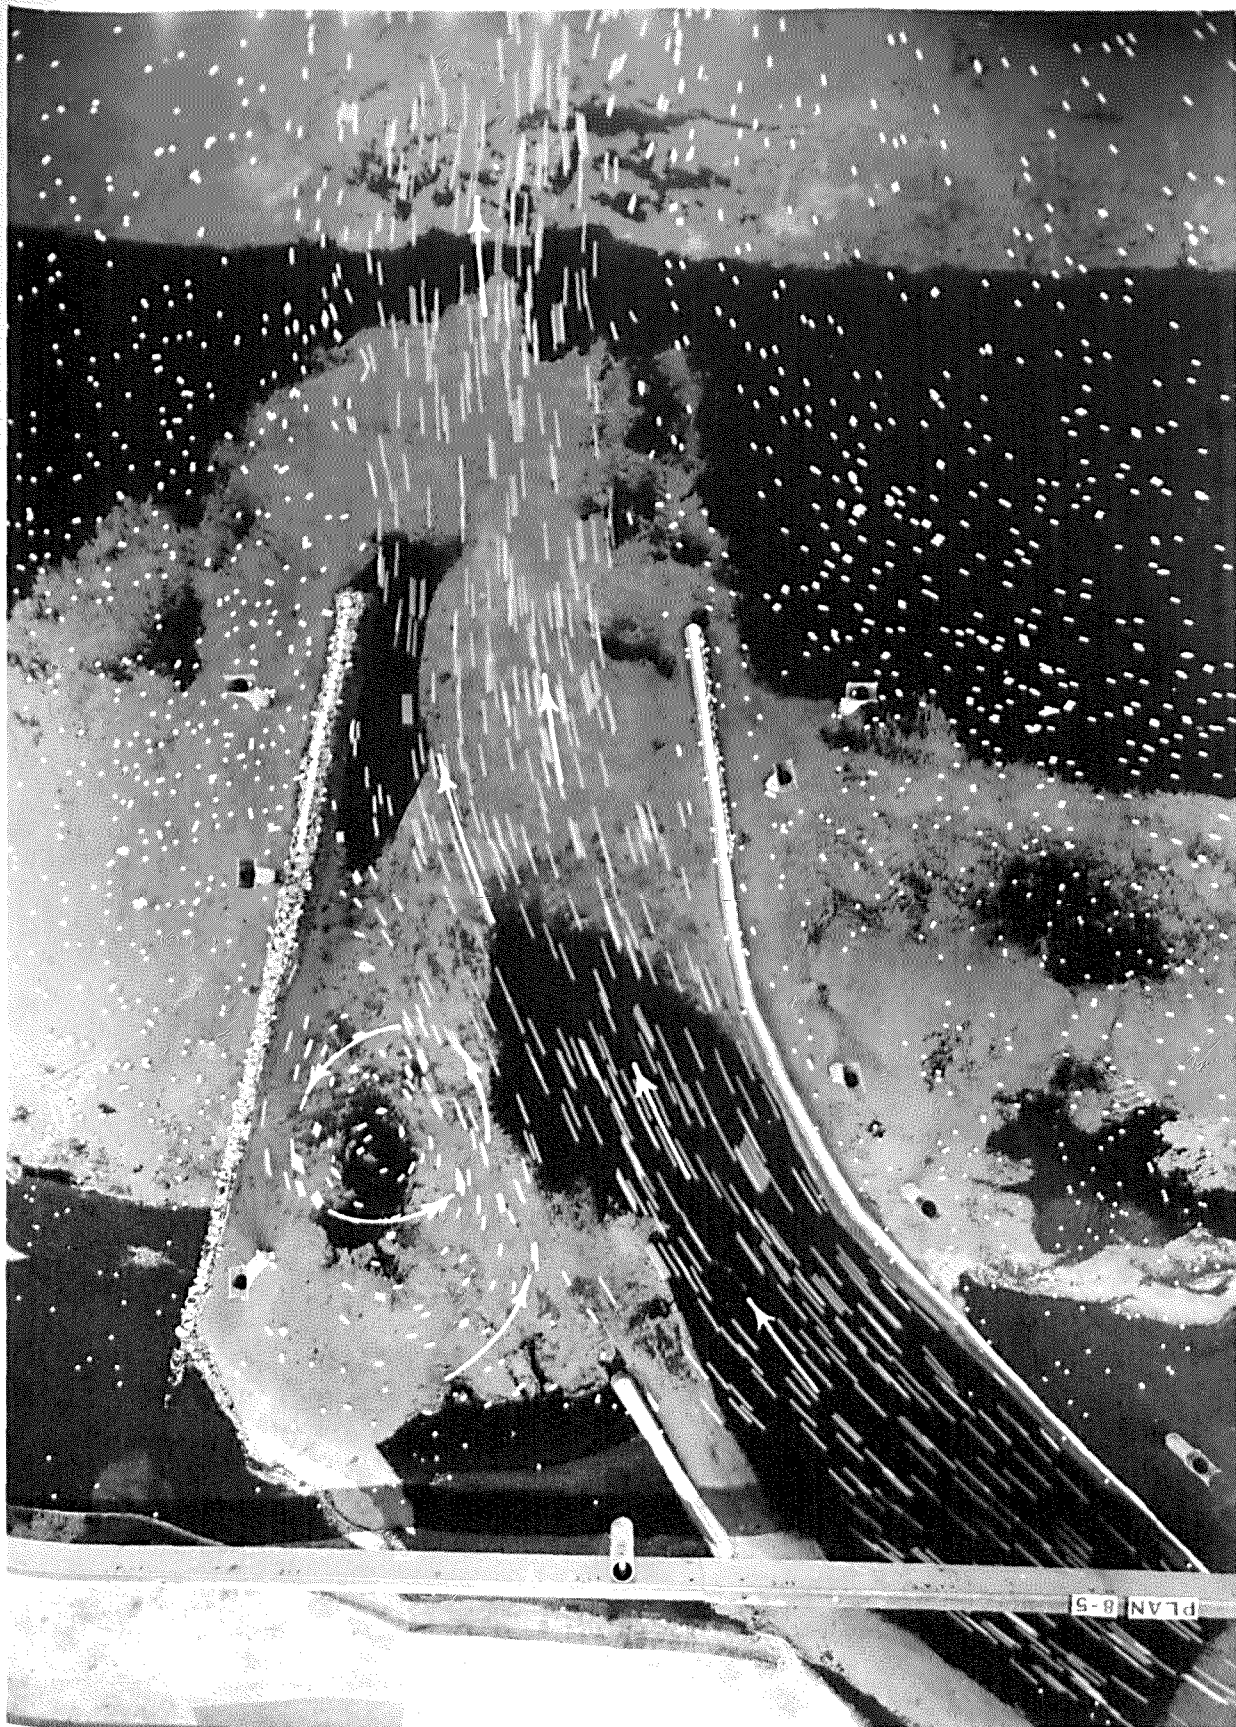
PHOTOGRAPH 22. Plan 8 - Current directions at strength of flood before HHW (hr. 10.5)

PHOTOGRAPH 23. Plan 8 - Current directions at strength of ebb after  
HHW (hr. 16.5)

PHOTOGRAPH 24. Plan 8 - Current directions at strength of flood before  
LHW (hr. 23.0)

PHOTOGRAPH 25. Plan 8 - Current directions at strength of ebb after LHW (hr. 4.0)

22. The scour and fill pattern for the test of plan 8 is shown on plate 3 and photograph 5; current directions at strengths of flood and ebb are shown on photographs 22-25; and current velocity measurements are shown on plates 13 and 14 and in table 2. The scour and fill pattern for the test of plan 8 was almost identical to that of the base test, the only difference being that slightly less scour occurred in the outer portion of the jetty channel. The plan effected general decreases in maximum flood velocities from those of the base test, and general increases in maximum velocities from those of the dredging plan. The alignments of flood and ebb currents were shifted northward an appreciable distance, bringing the current alignments closer to that of the navigation channel. During the flood tide period, a large eddy formed in the jetty channel just south of the outer end of the existing north jetty, and a smaller eddy formed between the plan-8 jetty and the existing south jetty. No eddies of appreciable size were noted during the ebb tide period.
