TECHNICAL MEMORANDUM NO. 6-412

TENSILE CRACK EXPOSURE TESTS

LABORATORY EVALUATION OF SERIES "A" BEAMS WITH RESULTS FROM 1951 TO 1975

January 1980

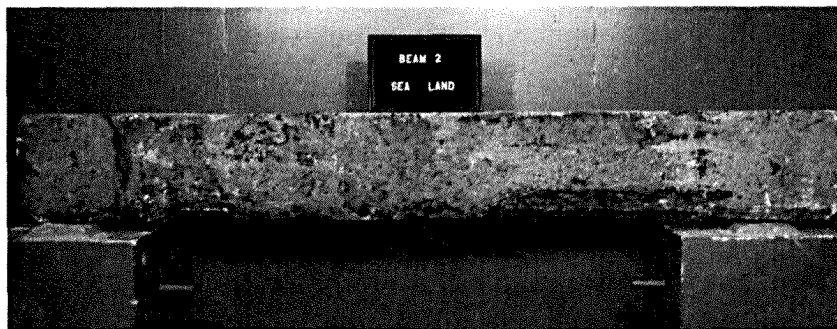
31. Photographs 3-22 show the "as received" condition of ten of the beams. The surfaces of the beams were still moist with sea-water when they were taken from the bituminous membrane, and they had not been subjected to any drying in transit. As can be seen in the photographs there was considerable spalling of the cover over the reinforcement. The spalled areas range in length from 1-1/2 in. long, where no reinforcement had been exposed to nearly the entire length of the beam, exposing the major amount of reinforcement. The spalls were deep enough to expose at least half of the bar and generally occurred in the area of the flexural cracks, although some spalls did occur at the ends of the beam away from the flexural areas.

Photo 3. "As received" condition of beam 1 looking west

Photo 4. "As received" condition of beam 1 looking east

Photo 5. "As received" condition of beam 2 looking west

Photo 6. "As received" condition of beam 2 looking east

Photo 7. "As received" condition of beam 5 looking west

Photo 8. "As received" condition of beam 5 looking east

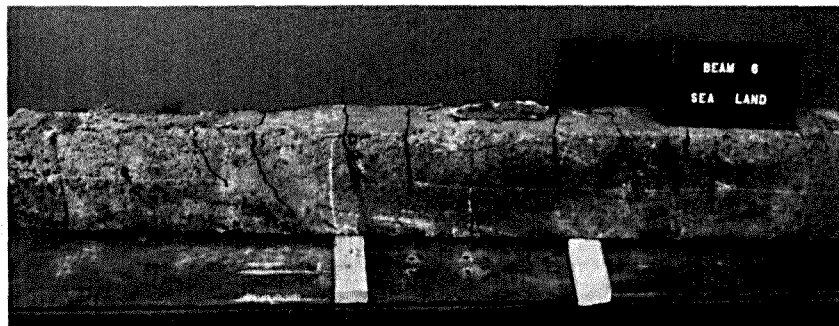
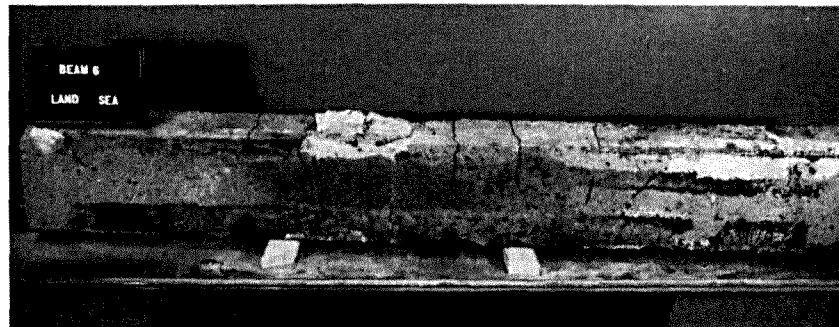
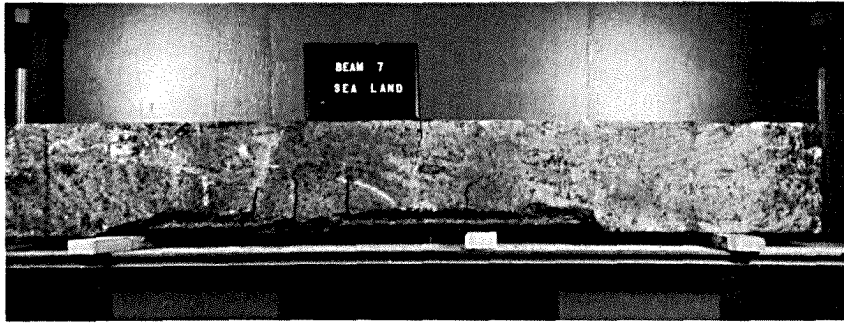
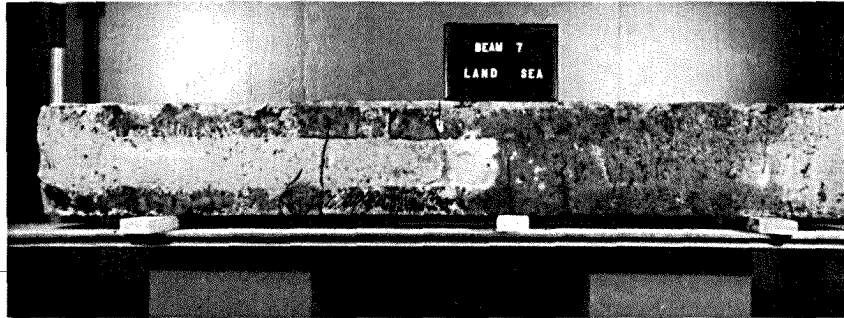
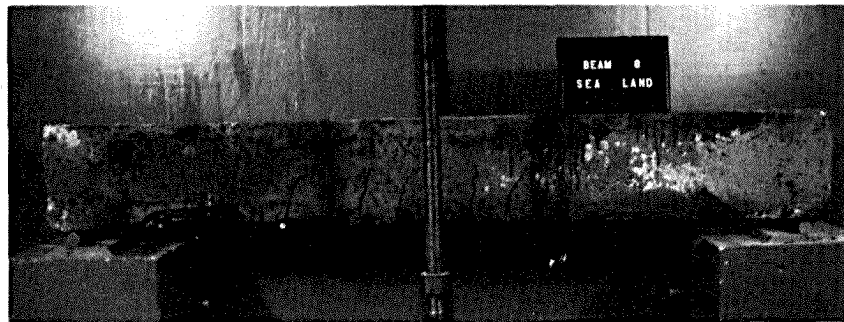
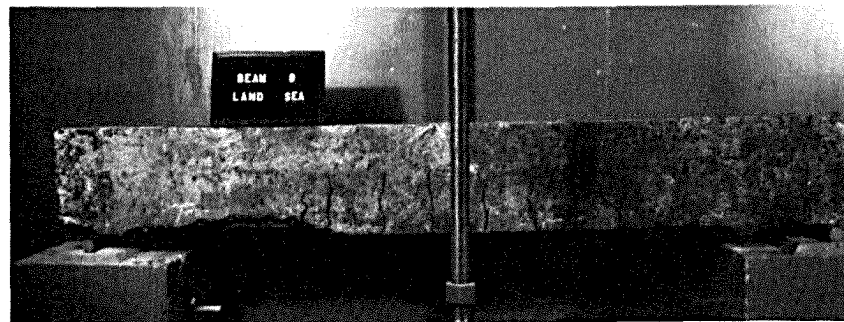
Photo 9. "As received" condition of beam 6 looking west

Photo 10. "As received" condition of beam 6 looking east

Photo 11. "As received" condition of beam 7 looking west

Photo 12. "As received" condition of beam 7 looking east

Photo 13. "As received" condition of beam 8 looking west

Photo 14. "As received" condition of beam 8 looking east

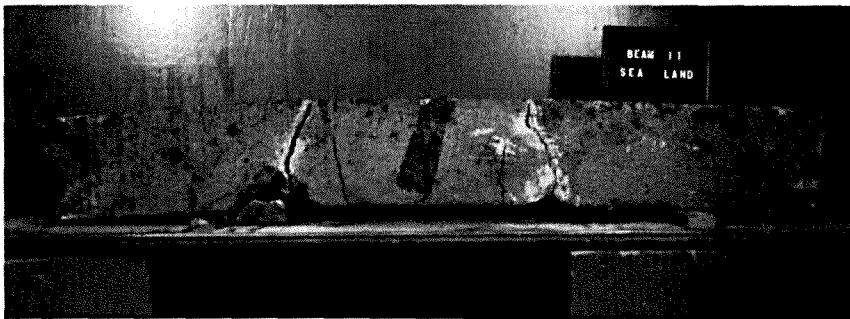
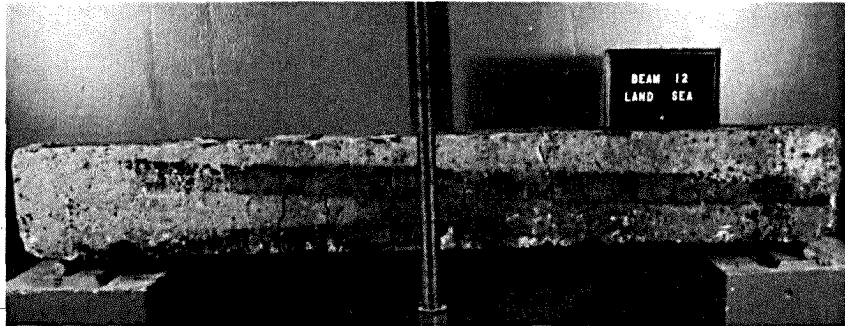
Photo 15. "As received" condition of beam 10 looking west

Photo 16. "As received" condition of beam 10 looking east

Photo 17. "As received" condition of beam 11 looking west

Photo 18. "As received" condition of beam 11 looking east

Photo 19. "As received" condition of beam 12 looking west

Photo 20. "As received" condition of beam 12 looking east

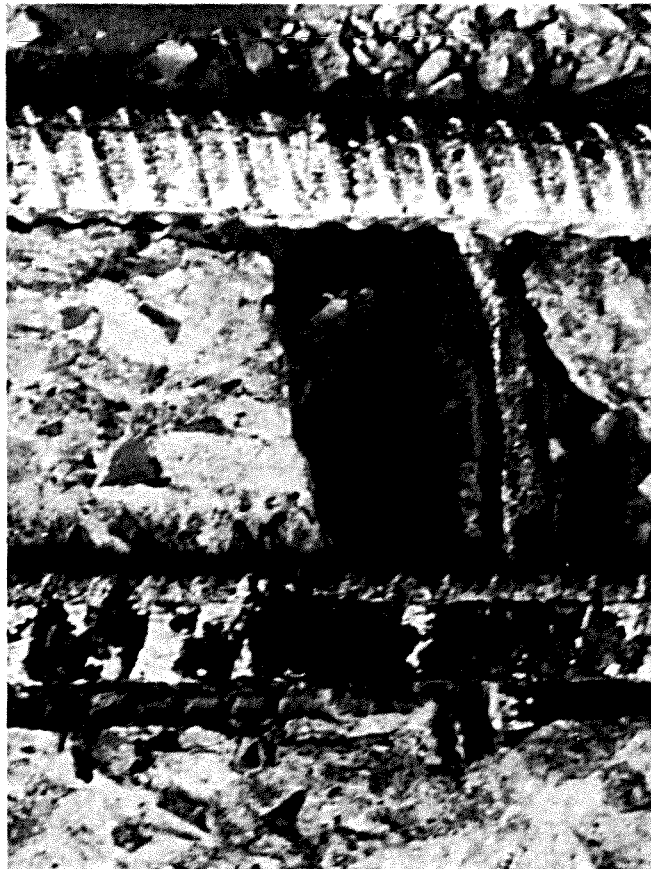
43. Each beam was broken open to expose the reinforcement that was still protected by cover. In general, the steel beneath the 3/4-in. cover was not corroded. There were areas beneath the concrete that did receive corrosion. The tips of the reinforcing bars were generally rusted, and the areas of the bars where they were welded to the other

bar in the beam were generally corroded (Photo 30); but on the whole the bars that were not exposed to direct attack by oxygen and seawater remained only lightly rusted.

Photo 30. Corrosion on reinforcement adjacent to weld

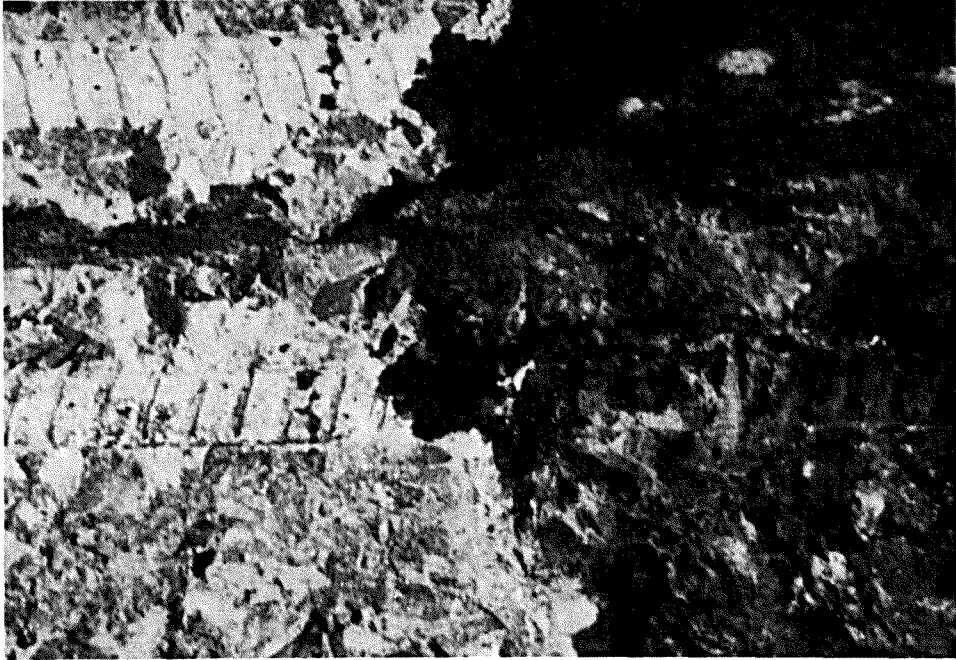
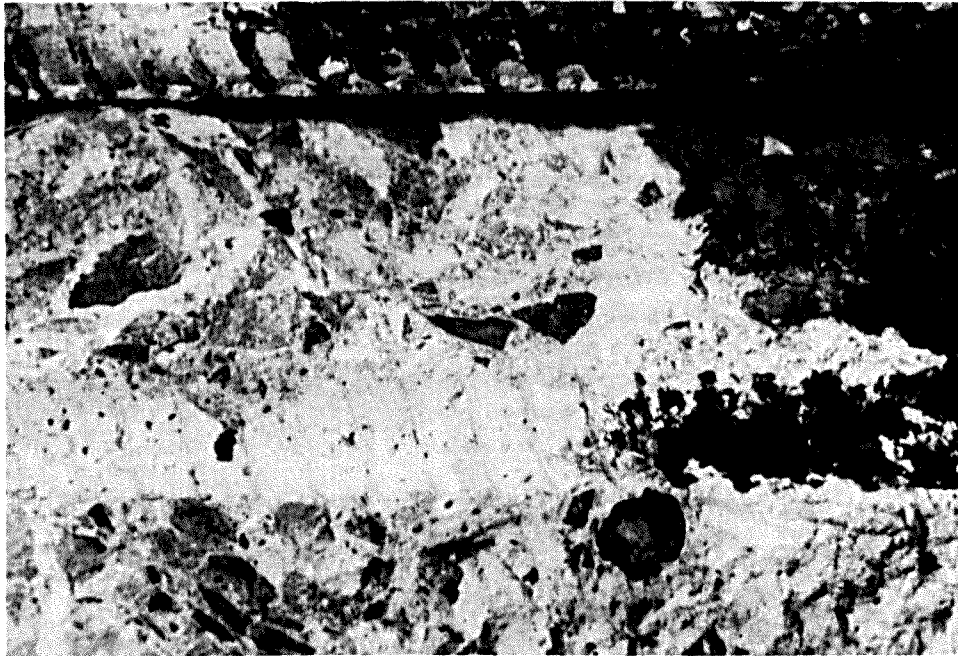
44. Photos 31 and 32 show the extent of corrosion directly adjacent to a spalled area. In both photographs, the darkened concrete area in the right of the pictures are areas where concrete had spalled away from the rest of the beam while at Treat Island, exposing the steel to water and oxygen. The lighter areas of each photograph show concrete and steel surfaces that were exposed in the laboratory by autopsy and reveal that the corrosion did not penetrate from the spalled area into the sound portion of the beam. Similarly, most of the steel areas that remained covered were unrusted. Photos 33-37 show areas of the steel from unspalled areas of various beams. The corrosion shown varies from moderately rusted (Photo 33) to unrusted (Photos 36 and 37) and is representative of the corrosion that appeared beneath the sound concrete cover.

Photo 31. Corrosion on reinforcement at spalled area

Photo 32. Corrosion on reinforcing bar adjacent to spalled area

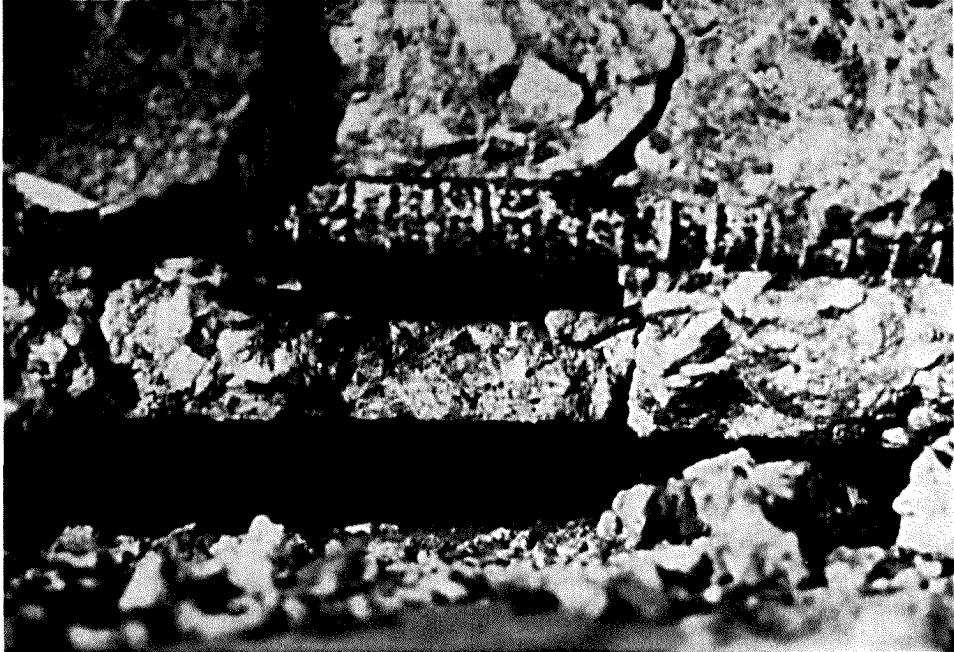
Photo 33. Moderate amounts of corrosion on reinforcement

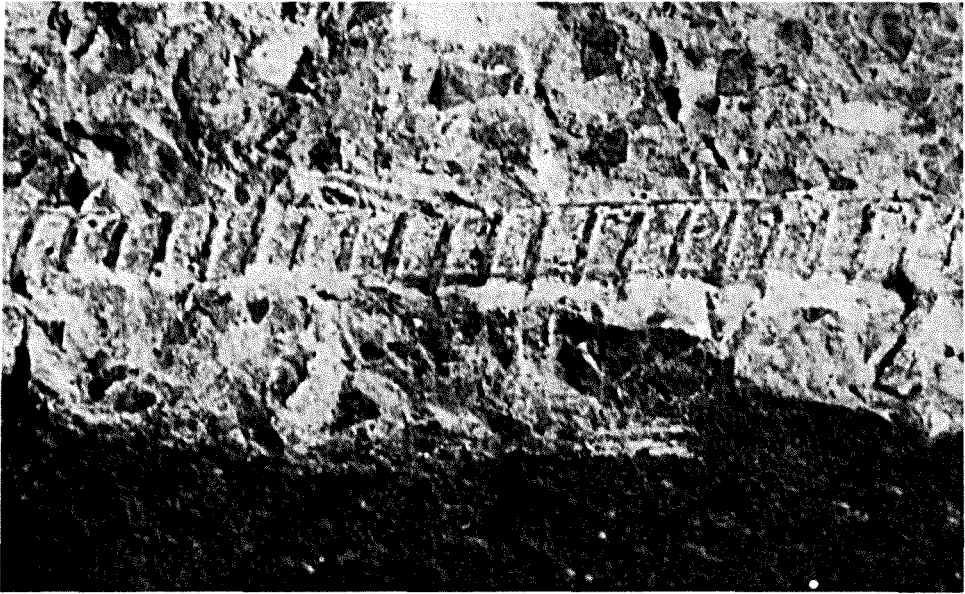
Photo 37. Uncorroded condition of reinforcement bar beneath unspalled concrete
