# An Investigation of Corrosion Mitigation Strategies for Aging Post-Tensioned Cables

Ernest L. Miller, Barry C. White, Richard W. Haskins,  
Robert M. Ebeling, and James A. Evans

January 2017

Final report

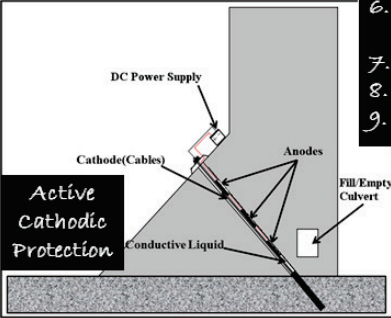
**Active Cathodic Protection**

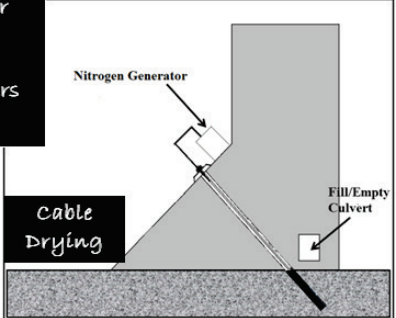
**Cable Drying**

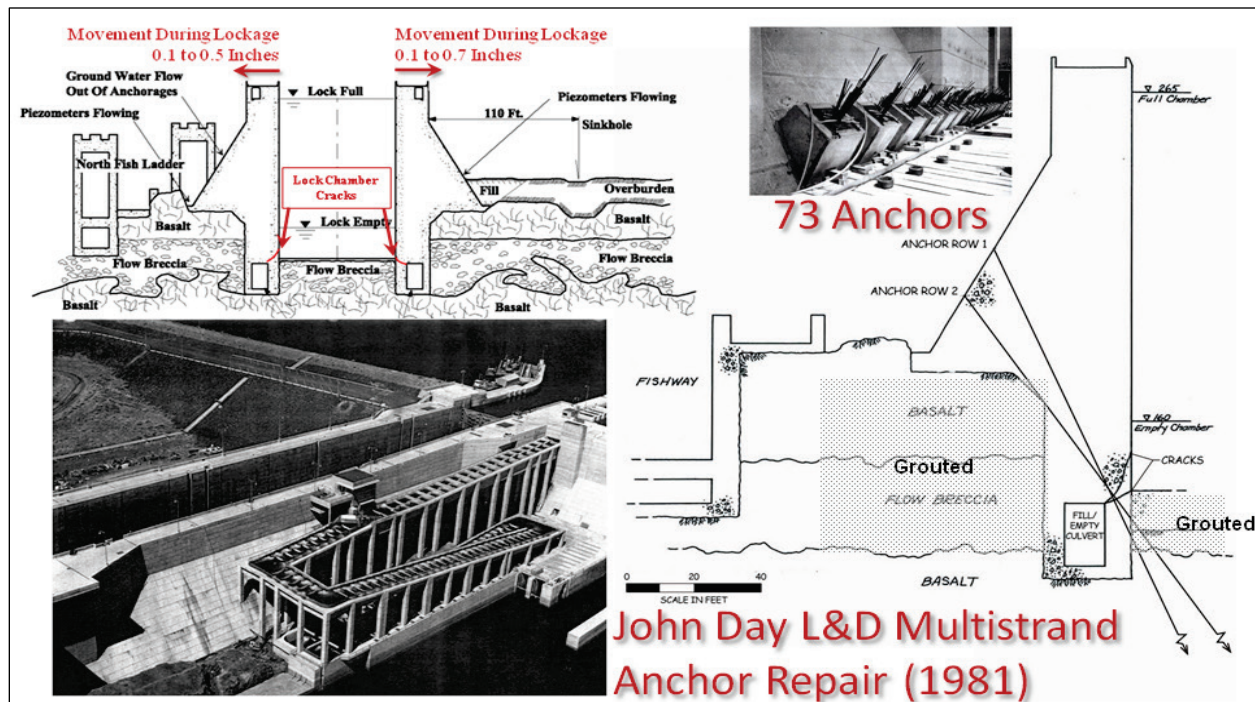
Figure 1.1. Post-tensioned anchorage system remediation of John Day Lock in 1981 using 73 tie-down anchors.

Excessive lock wall movement during filling and emptying of the lock at the John Day Lock in 1979 led to the discovery of cracking. A structural remediation investigation effort at John Day proposed the addition of post-tensioned anchors for long-term structural repairs. In 1981, these

repairs began. The Portland District installed 73 post-tensioned anchors; each anchor consisted of 37 seven-strand cables of 0.6 in. diameter that were oriented to pass through the cracked concrete between the lock wall chamber and the fill/empty culvert wall on the locking chamber side of the culvert (lower left figure in Figure 1.2). A schematic diagram of the anchorage installed at John Day Lock is shown in the upper left of Figure 1.2. This post-tensioned anchor consists of five zones; the anchor head region, the anchor pedestal, the free stressing length, an inflatable packer, and the tension bond length. The free stressing length consists of greased, sheathed cables. Portland District engineers designed the John Day anchors for infrequent post-tensioning with time, as deemed necessary. A process of three-stage grouting was used over the tendon bond length. Individual sheaths were placed around each strand in which the load transfer (to the surrounding concrete monolith in which it is encased) does not take place. Inspections between 1981 and 1995 showed no broken strands; therefore, inspections were halted in 1995. Between 2001 and 2004, John Day Lock's foundation was again inspected and was given the recommendation that various anchors be tested to confirm load capacity. In 2003 and again in 2008, all of the anchors were visually inspected, tested, and determined to be good, although broken strands were discovered. However, it was discovered that between 2003 and 2008 there was an 11% increase of anchors with visible damage. In 2011, the John Day Lock Multistrand Anchor Meeting was held at Portland District Headquarters, where these anchors and research plans were discussed to determine capacity and the effects of corrosion (Ebeling et al. 2012).

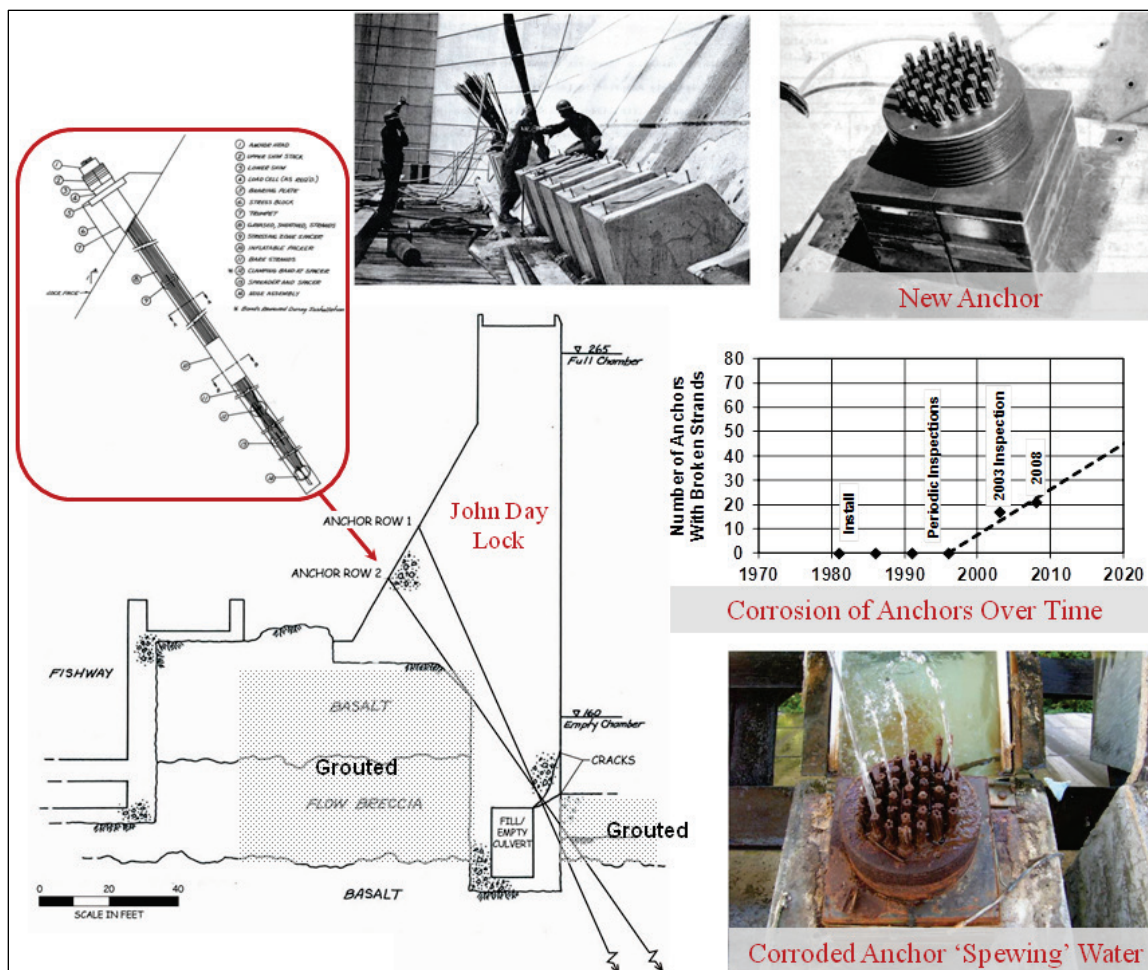
Figure 1.2. The installation of a post-tensioned anchor system at John Day Lock, pictures of its (then) new anchor head and its (current) corroded anchor head spewing water, and rate of anchor loss with time (due to corrosion).

In the middle right of Figure 1.2, Portland District's assessment of the number of anchors with broken strands over time is shown. The data indicates that more corroded strands will break over time. This observation is supported by the fact that inspections have shown that the number of anchors with visibly damaged strands increased by 11% between 2003 and 2008. Cornforth Consultants (2009) interpretation of 2008 John Day Lock data suggests that each year that passes would result in a 3-5% increase in the number of anchors with damaged strands. Heslin et al. (2009) observes that lift-off tests in 2008 had lift-off loads that were roughly 5% lower than the same anchors tested in 2003.

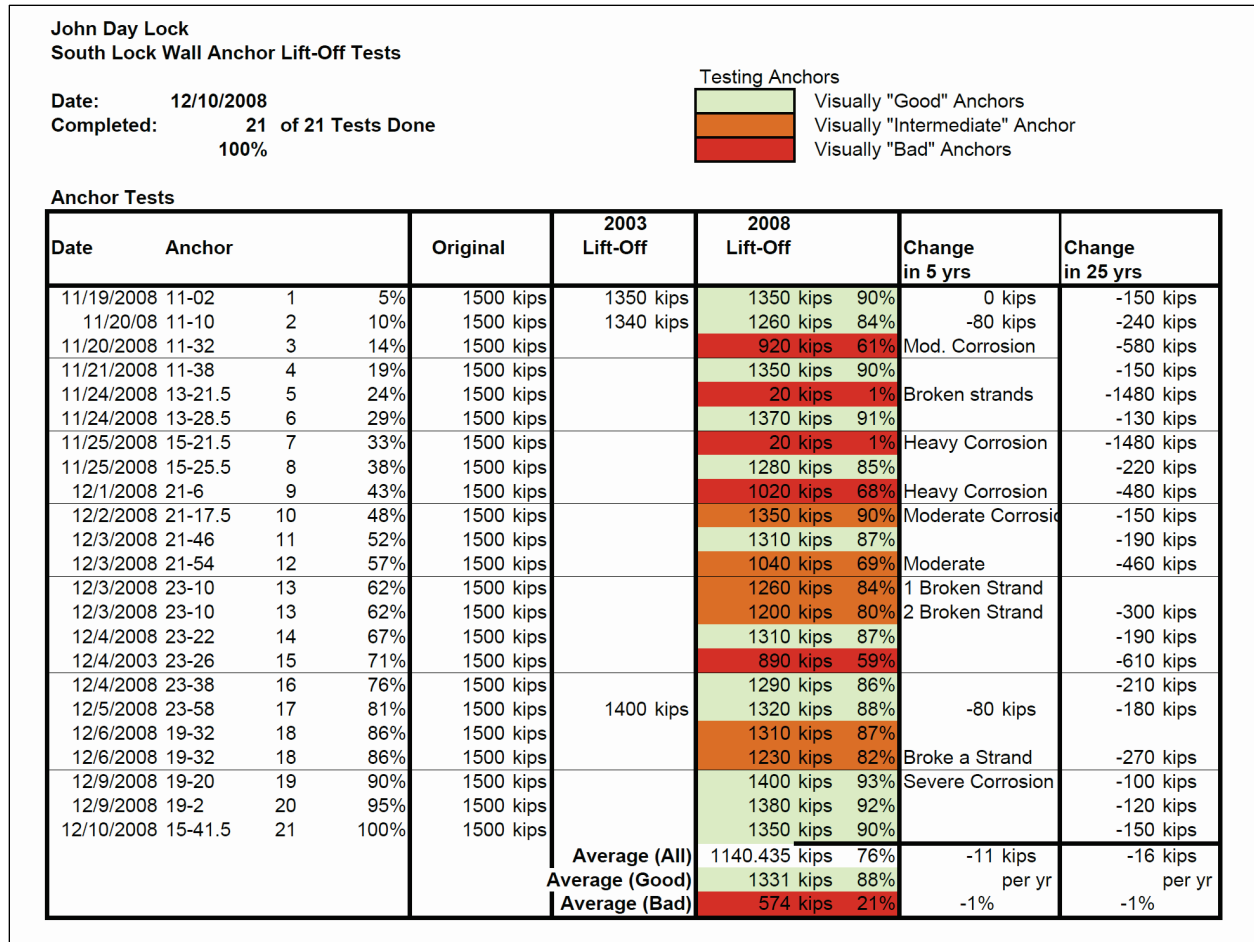
Figure 1.3. Inspection results for lift-off tests at the south lock wall at John Day Lock.

Cornforth Consultants (2009) and Heslin et al. (2009) observed that the anchors could be grouped into damaged and undamaged tendons using a combination of visual inspections and interpreted results of lift-off tests. For the anchors with undamaged tendons, the John Day lift-off loads were 85-90% of the values at installation due to stress relaxation. The damaged tendons had a significant reduction in PT from the PT value at installation. The anchor measurements, which are highlighted in red and orange, can be seen in Figure 1.3.

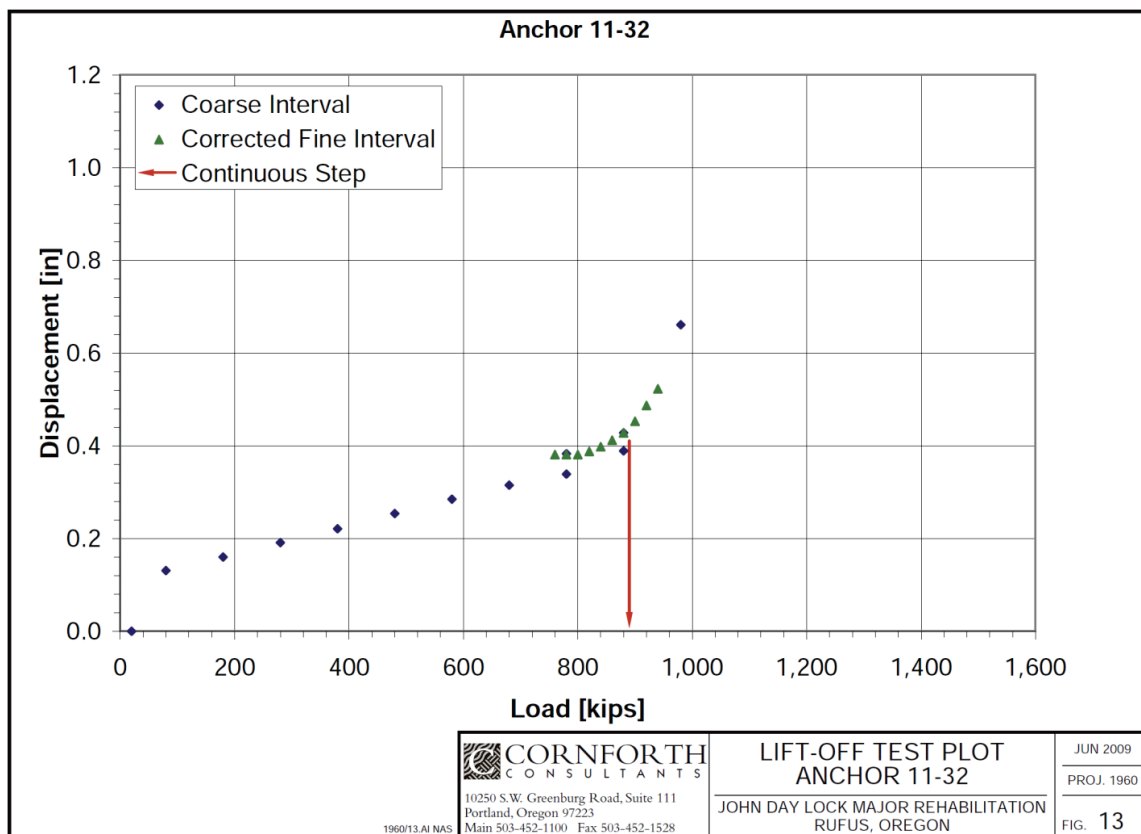
Figure 1.4. Example of a lift-off test for anchor 11-32 at the south lock wall at John Day Lock.

Cornforth Consultants (2009) and Heslin et al. (2009) discuss the three-stage, lift-off testing method. Figure 1.4 shows a typical lift-off test for the corroded anchor 11-32 that exhibits a reduced PT value of 920 kips.

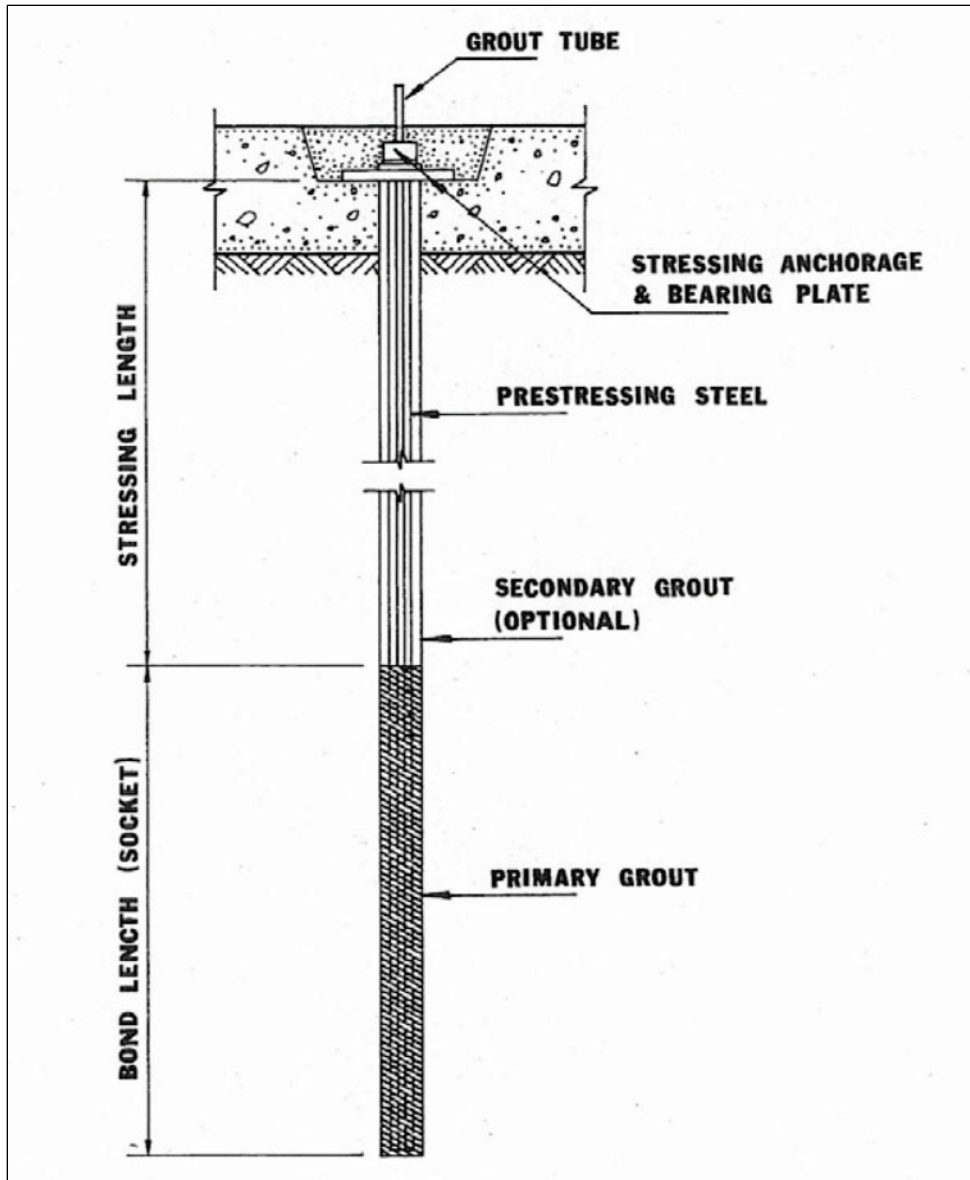
Figure 1.5. Post-tensioned anchor recommendations (PCI 1974).

By 1980, grouting was the number one corrosion mitigator for the bond length (Figure 1.5). Permanent protection was defined as 18 months or more. Sheathing was considered corrosion protection as well as separation of cable and grout. Plastic corrugated sheathing and epoxy were permitted if it extended at least two feet down the free length. Free length was to have sheath with grout or grease inside (PTI Recommendations 1980).

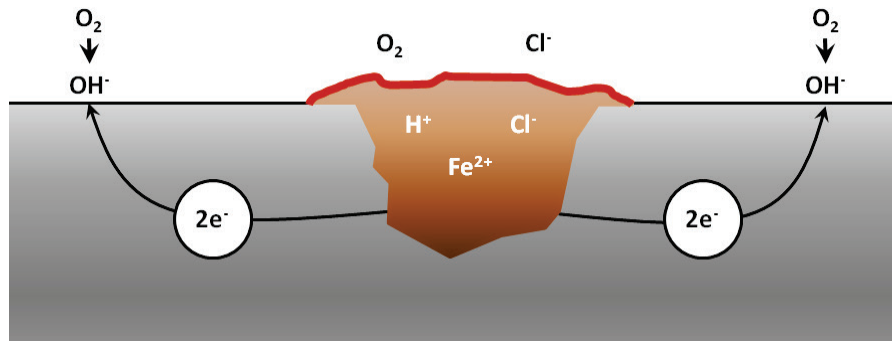
Figure 2.1. The process of pitting corrosion (Lee and Zielske 2014).

Pitting corrosion is the mechanism cited most often in the technical literature on post-tension cable deterioration. Most of these studies are concerned with corrosion of anchorages on bridges, which have different geometries from mass concrete and are often exposed to de-icing salts. Pits can significantly reduce the capacity of post-tensioned cables by reducing the cross-section area and the inertial properties of the cross-section area of the cable. Observed pit depths of over 1 mm have been cited (Charng and Lansing 1982). Pits can also lead to stress corrosion cracking in post-tensioned anchorage, causing branching of pits, which lead to more concentrations of corrosion (Hopwood and Havens 1984). The electro-chemical mechanics behind pitting corrosion are well described in Lee and Zielske (2014), and that process is described visually in Figure 2.1. For steel structures in a wet environment, corrosion occurs when the oxygen concentration and chloride concentration in the water exceed a certain value. The chlorides act as a catalyst to bind oxygen to the iron atoms in the steel structure, forming iron oxide (or rust). This releases electrons, which move away from the corrosion to another part of the steel structure. The low resistance of the water outside of the steel allows this electrical process to continue. The corroded material can expand from two to six times the original material size (Broomfield 1997).

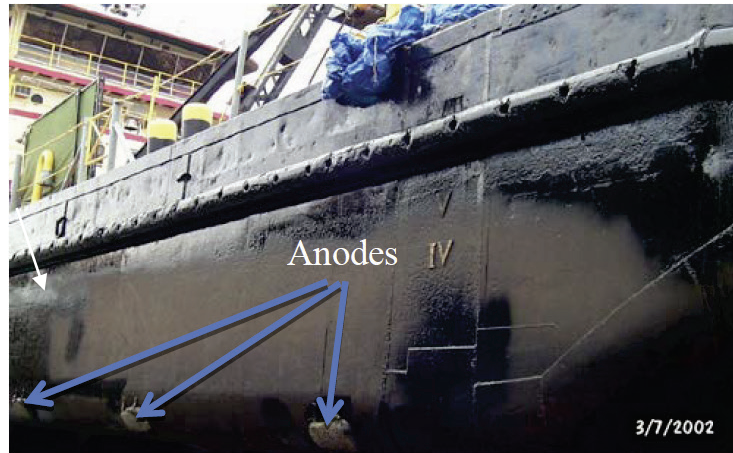
Figure 2.3. Example of anode protecting ship's hull (cathode). This is the U.S. Army Corps of Engineers Dredge Jadwin in dry dock. The anodes are the metal bars welded to the hull of the ship.

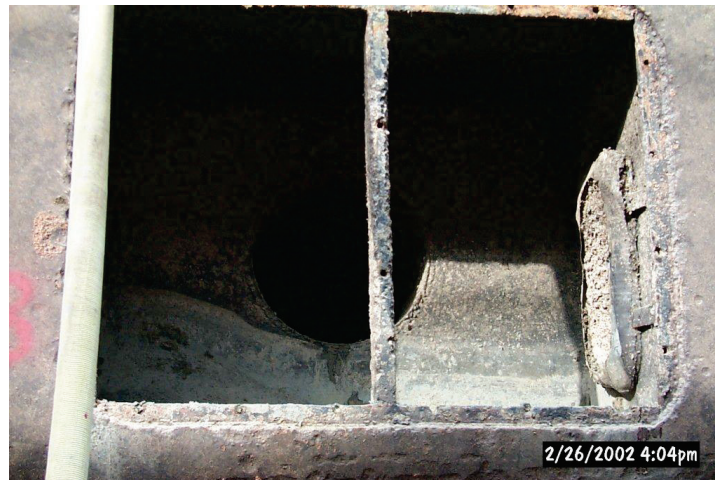
Figure 2.4. Example of anode protecting ship's hull (cathode). This is the U.S. Army Corps of Engineers Dredge Jadwin in dry dock. Note the partially consumed anode (to the right) at the entrance of the engine cooling water intake.

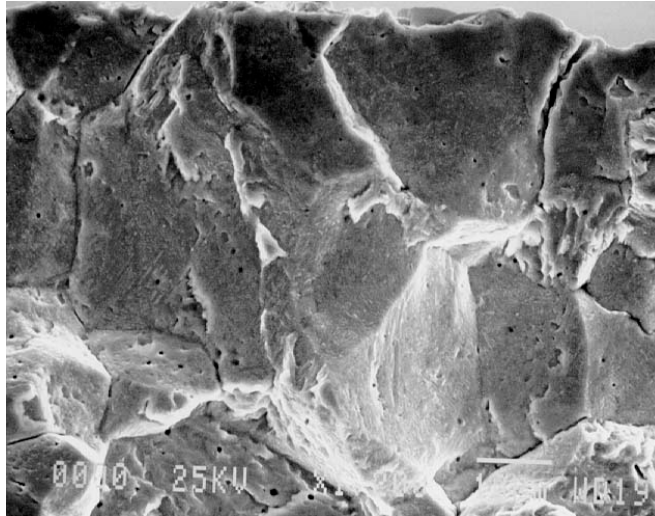
Figure 2.5. Electron microscope view of hydrogen embrittlement (photo courtesy of NASA Corrosion Technology Laboratory).

Hydrogen embrittlement is detrimental to a metal since hydrogen is absorbed into the metal. This would disrupt the crystalline structure of the metal that would then create fractures or cracks (Figure 2.5), which reduces the flexibility of the metal. High strength steels, such as those used in post tensioning, are especially susceptible to this effect. According to EM 1110-2-2704 (USACE 2004) citing NACE RP0169-2002, the system should be properly optimized by adjusting the rectifier until 90% of the potential falls within the range of polarized (cathodic) potential of between negative 850 mV and negative 1200 mV, or 100-mV polarization. The multiple micro-fractures caused by hydrogen embrittlement contained within a small region of the surface metal can be seen in Figure 2.5. This type of damage can come from over-voltage of an active cathodic protection system.

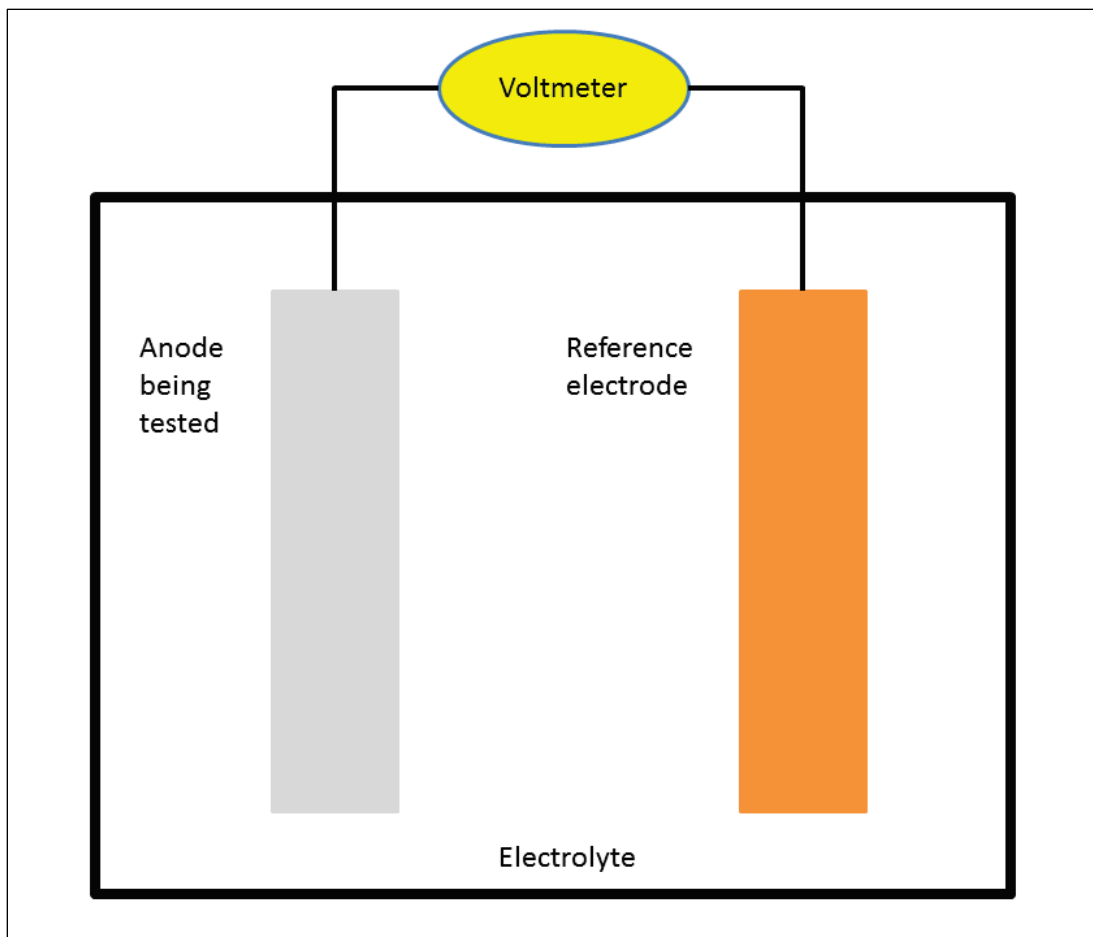
Figure 2.6. Depiction of potential measurement between anode and reference electrode (Chess and Gronvold 1996).

When measuring the voltage of an anode, a reference electrode is used for calibration purposes, which will always have the same electrical potential at any temperature. This reveals the electrical potential of the anode being tested in comparison with the stable reference electrode. Figure 2.6 describes how to measure potential difference with a reference electrode.

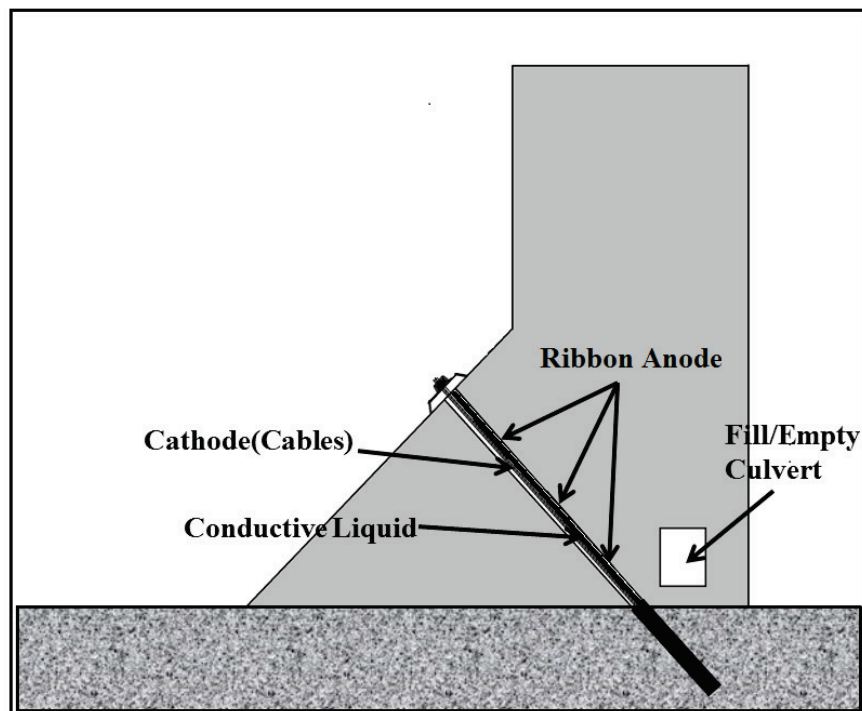
Figure 2.7. Idealization of passive (sacrificial anode) cathodic protection as applied to the cables of a lock wall remediated by using post-tensioned anchorage.

The passive cathodic protection system application shown in Figure 2.7 primarily differs from the Figure 2.2 active cathodic protection system by not having an external D.C. power supply and by not having wires connected directly to the anodes and cathodes. Once the protective current has been calculated, use Appendix A.1, Design Sequence for Cathodic Protection Systems flow chart to determine between galvanic or impressed current protective systems. If the conditions at the site are not clear, the choice is based on the current density required. At less than 1 mA/ft<sup>2</sup>, passive (i.e., galvanic) system is used; if the current density requirement is above 1 mA/ft<sup>2</sup>, then the active (i.e., impressed) current system should be used (see Chapter 2-3 USACE 2005).

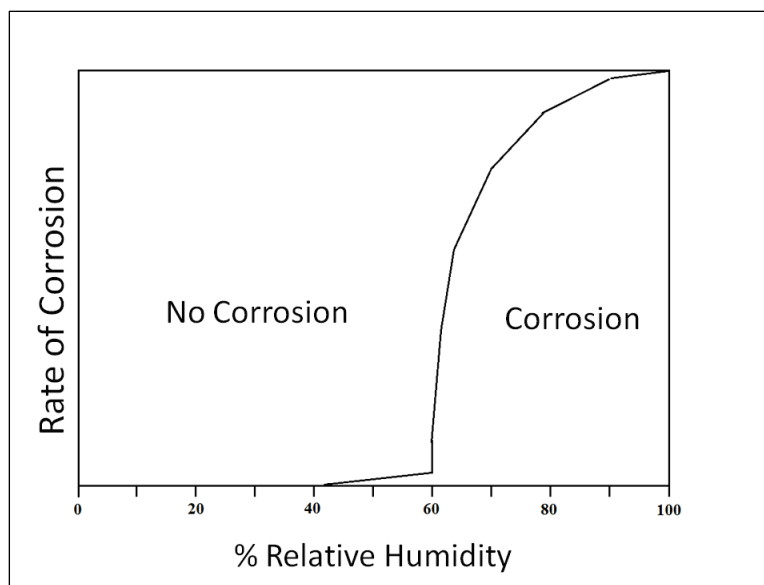
Figure 2.8. Relationship between relative humidity and the rate of corrosion of iron in air with 0.01% sulfur dioxide (Uhlig 1948).

Moisture acts as an electrolyte (a medium by which electrons can flow) and is an essential environmental condition of the corrosion process. H. H. Uhlig (1948) researched the fact that if the local atmosphere has a relative humidity (RH) of more than 60%, corrosion increases, but as it lessens to 40% local atmosphere, it decreases to a very low (an almost nominal) rate, as can be seen in Figure 2.8.

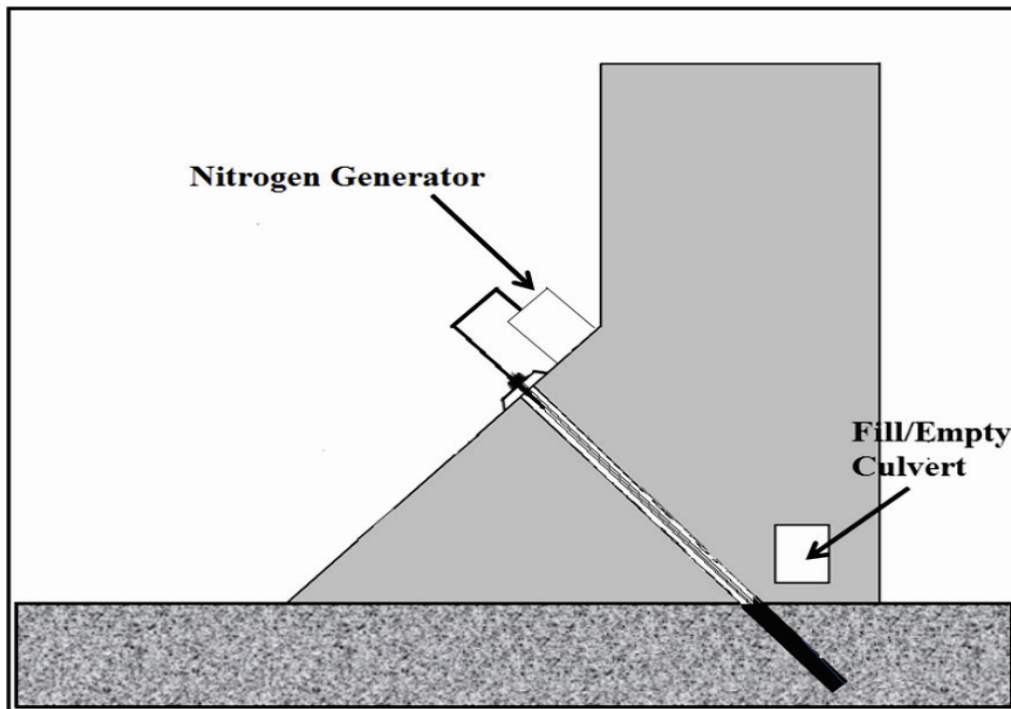
Figure 2.9. Illustration of a possible cable drying system as applied to the cables of a lock wall remediated by using post-tensioned anchorage.

Figure 2.9 shows a possible cable-drying system that can maintain a positive pressure of nitrogen to a duct. Unfortunately, if several leaks exist in the duct pipe containing the cables, the gas pressure can dissipate before reaching the end of the cable. The gas is dissipated through three different mechanisms in the grout and/or mass concrete: the porosity of the material, cracks in the material, and voids that may have been

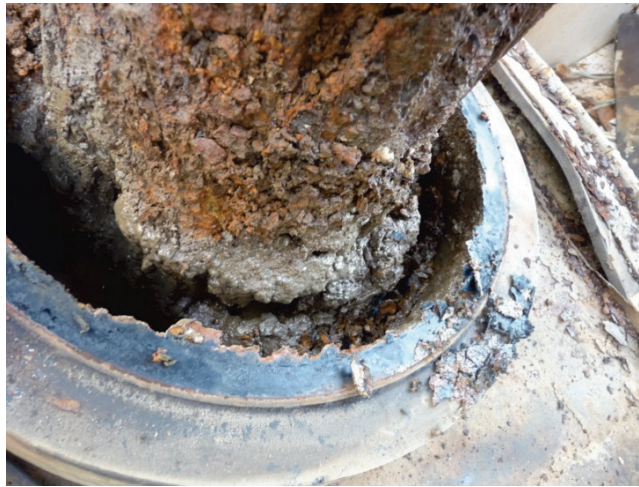
**Figure 2.10. Example of accelerated corrosion due to biological agents in existing grease (Ebeling et al. 2013).**

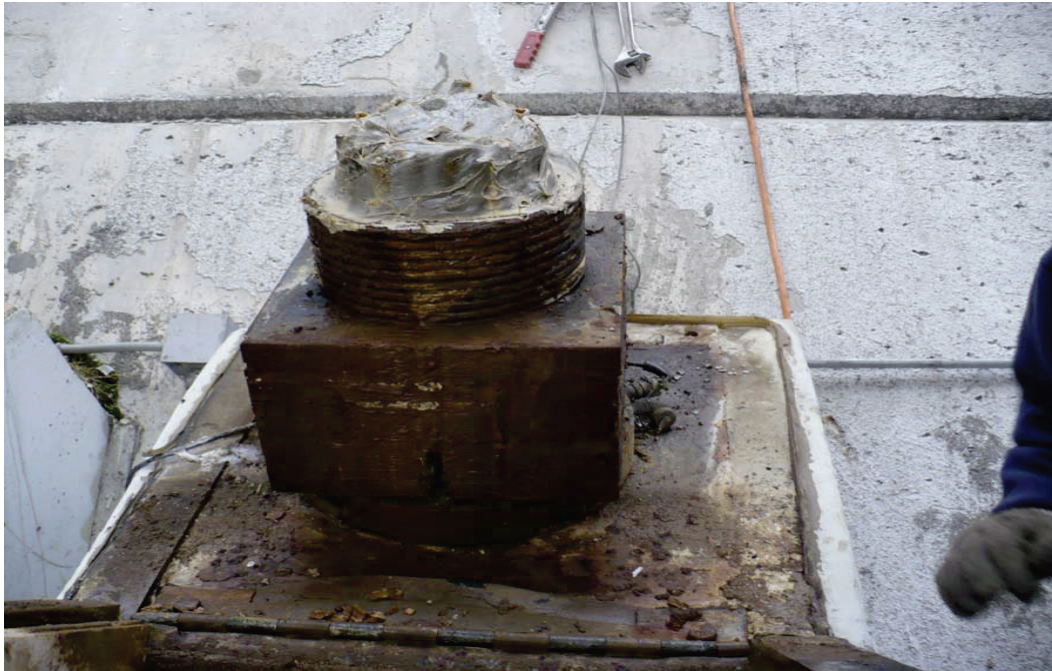
**Figure 2.11. Freshly greased anchor head (Cornforth Consultants 2009).**

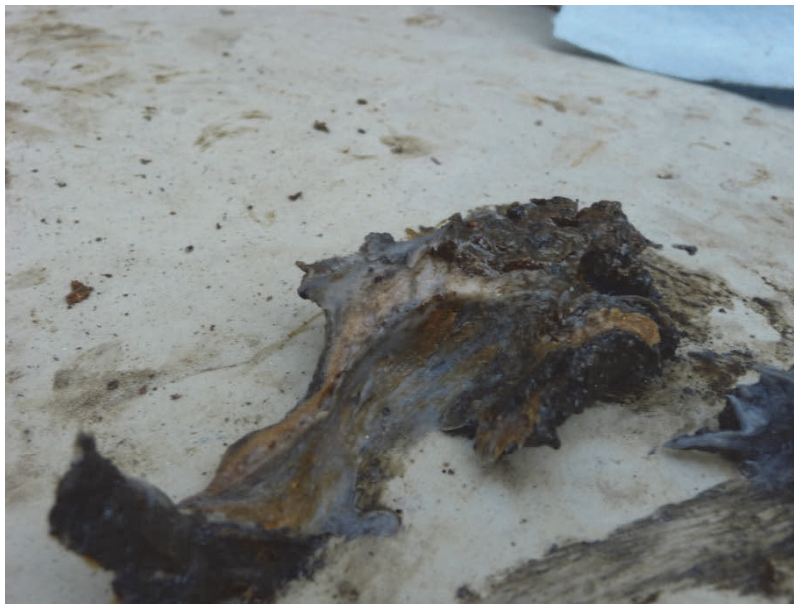
Figure 2.12. Grease with biological growth at John Day lock when anchor head was removed (Ebeling et al. 2013).

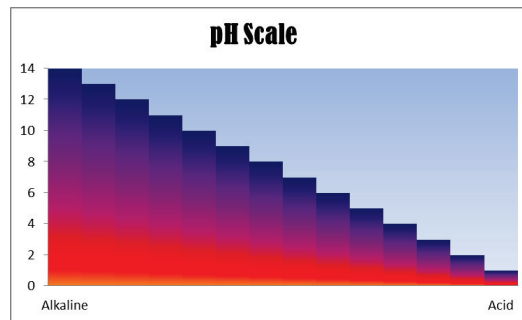
Figure 2.13. Simple scale of alkaline-acid to pH number.

Acidity has a significant effect on corrosion. Acidity and alkalinity are measured on the pH scale, which is a scale of 1 to 14, with 1 being the most acidic and 14 being the most alkaline (Figure 2.13). A number expressing the acidity or alkalinity of something on a logarithmic scale is called pH. Seven is neutral, lower values are more acidic, and higher values are more alkaline. The pH is equal to  $-\log_{10} c$ , where  $c$  is the hydrogen ion concentration in moles per liter. According to Baboian and Treseder (2002) citing Romanoff (1957), after an environment surpasses a pH of 7.5, acidic corrosion does not occur. This is not to say that corrosion does not occur, but that the acidity has little effect. Uhlig (1948) reveals that when the pH of an environment drops below 4 pH, the corrosion of steel greatly accelerates (Figure 2.14).

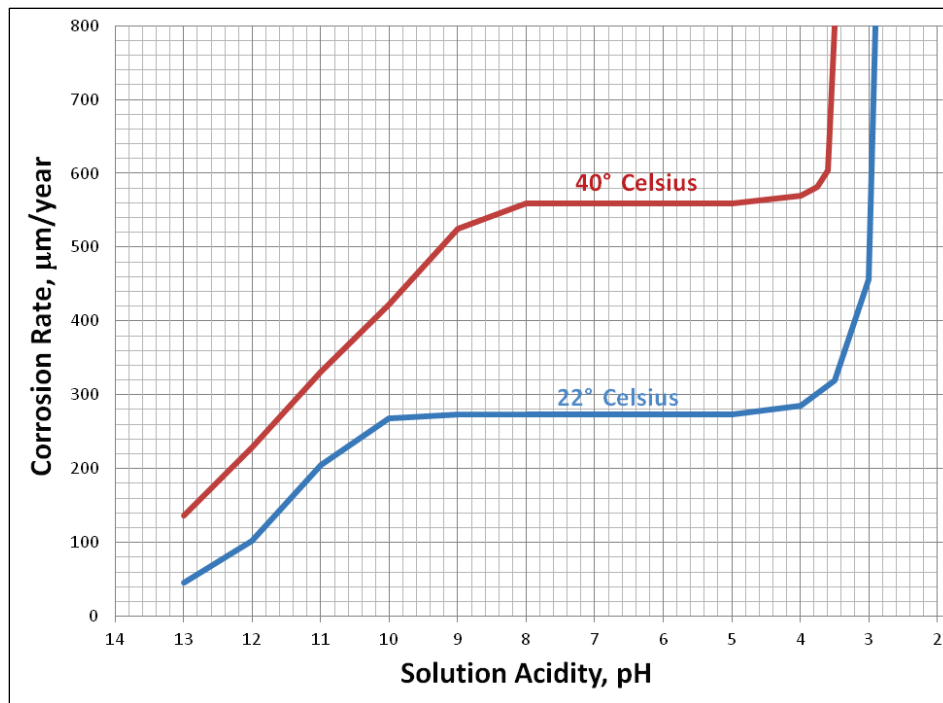
Figure 2.14. The effect of pH on corrosion (Uhlig 1948).

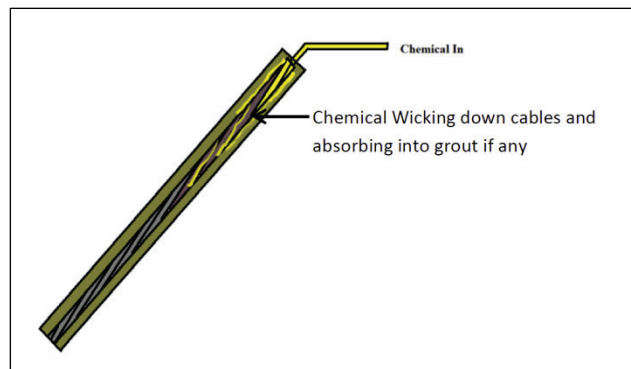
Figure 2.15. Representation of chemical impregnation of multistranded cables and surrounding grout.

The chemical used in this corrosion mitigation technique has penetrating properties allowing it to wick evenly into the cured grout surrounding the cables. After the impregnation chemical has cured (typically within 24 hrs), it forms an impenetrable boundary that is relatively impervious with the exception of harsh chemicals (methylene chloride, etc.).

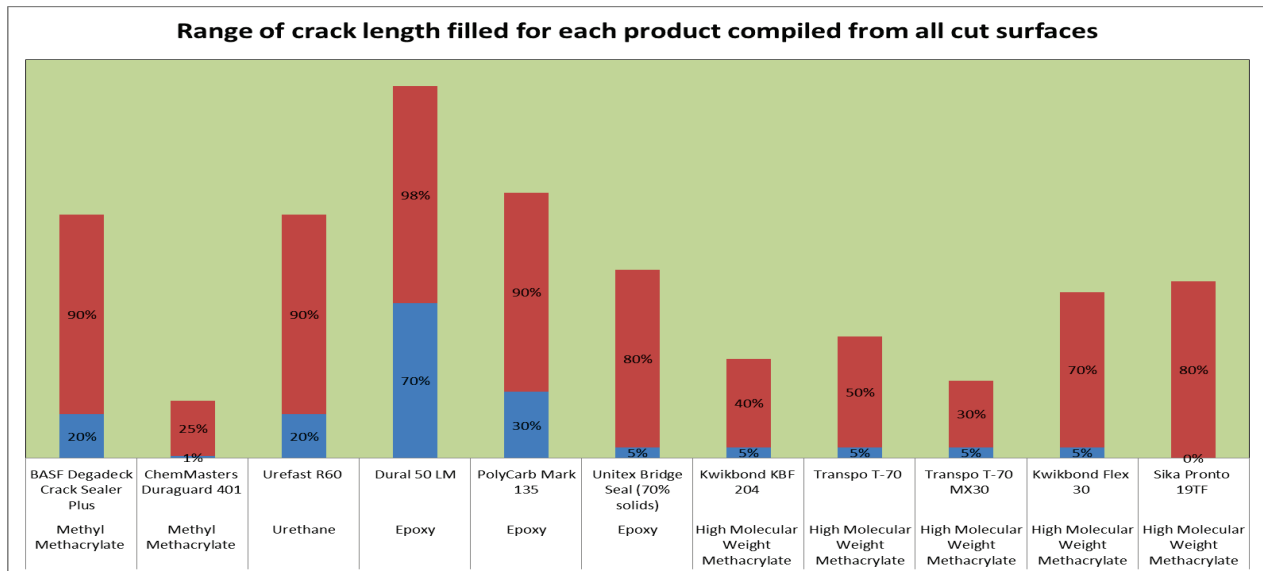
Figure 2.16. Products used in evaluation of healer/sealers study (Soltesz 2010).

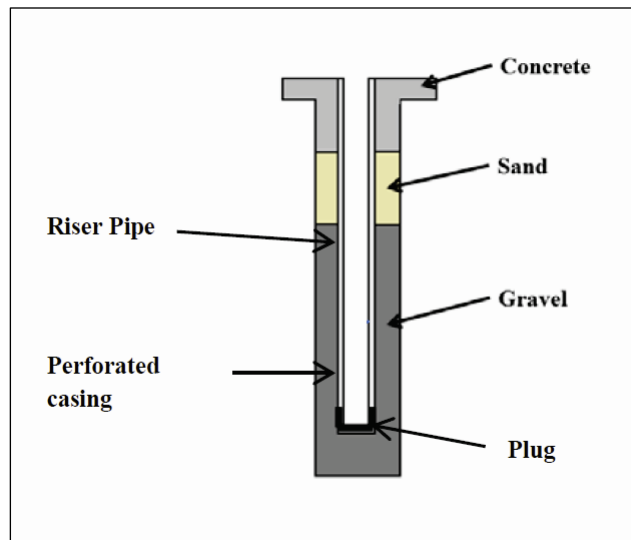
Figure 2.17. Illustration representing relief well (HQUSACE 1992).

If hydrostatic pressure is increased when the lock gates are opening or closing, wells can be strategically placed to relieve this pressure by diverting it through the wells. Any water source previously ejecting water through the ducts and up through the anchor cables could be redirected away from the anchor ducts with relief wells.

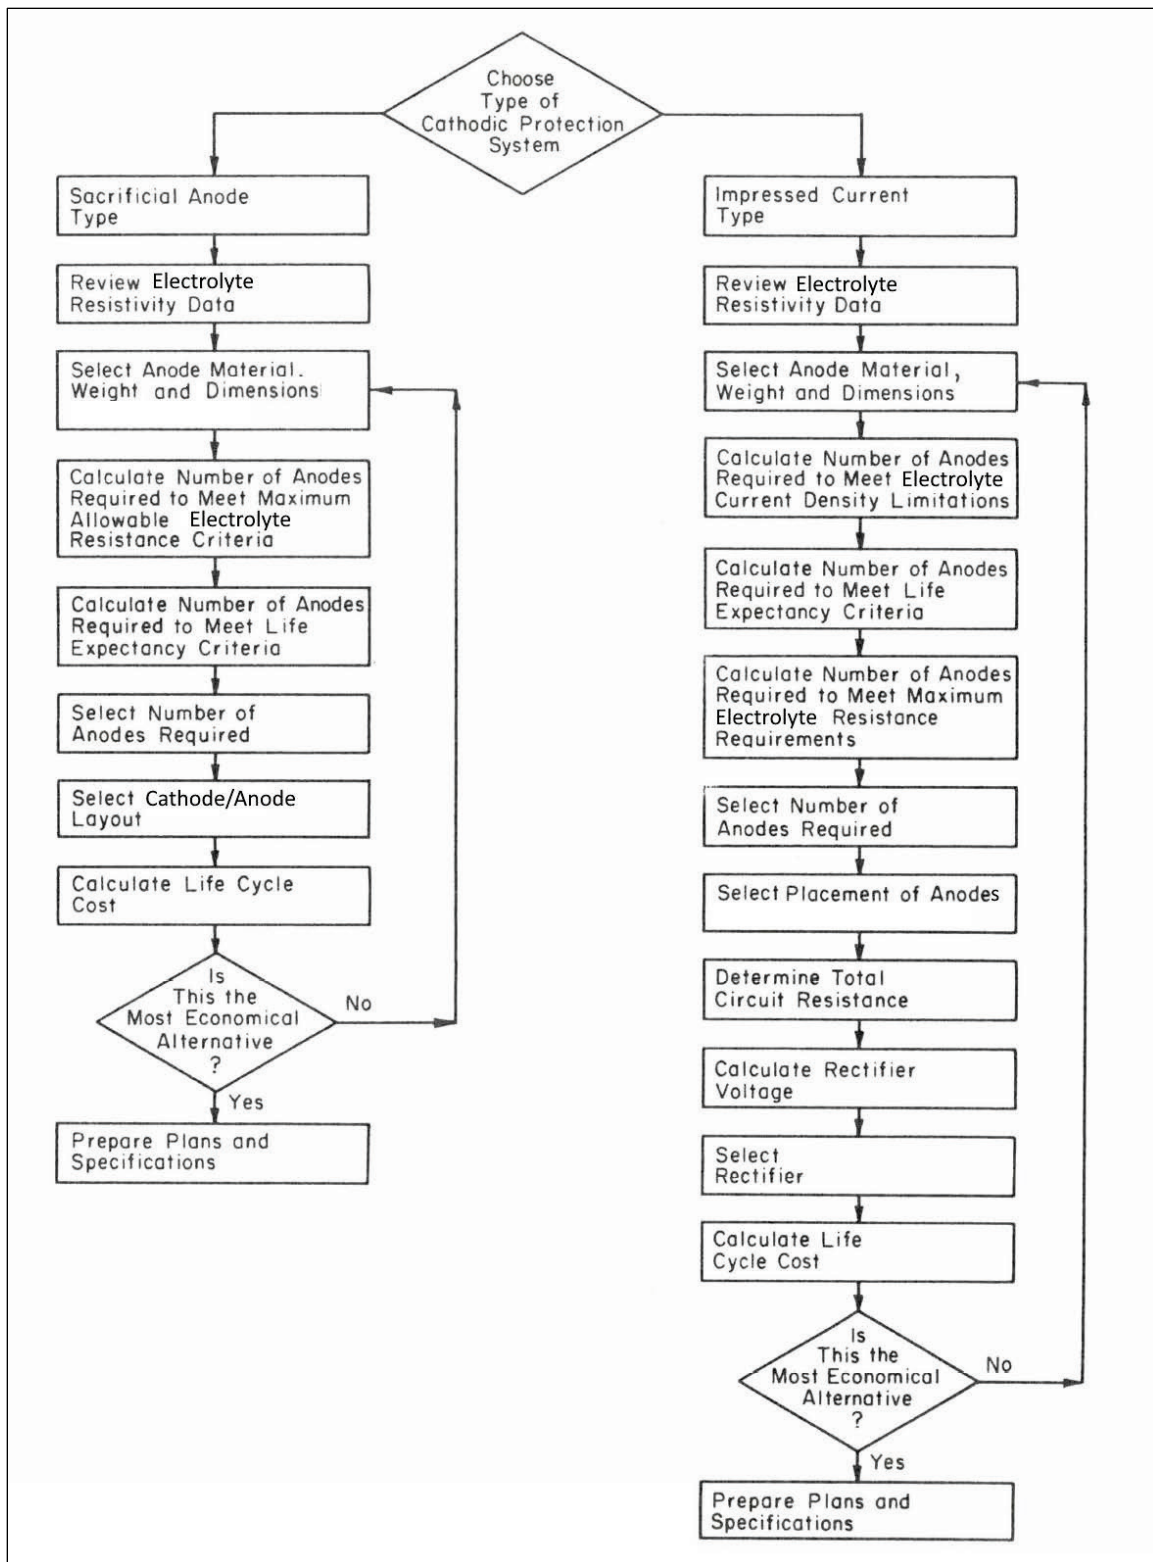
Figure A.1. Flowchart of decision-making process between implementing active and passive cathodic protection, after HQUSACE 2005 p.2-3.
