## **Comparison of Original MO-Mat and Prototype Replicas for Expeditionary Roads**

Timothy W. Rushing and James F. Rowland

April 2012

Final report

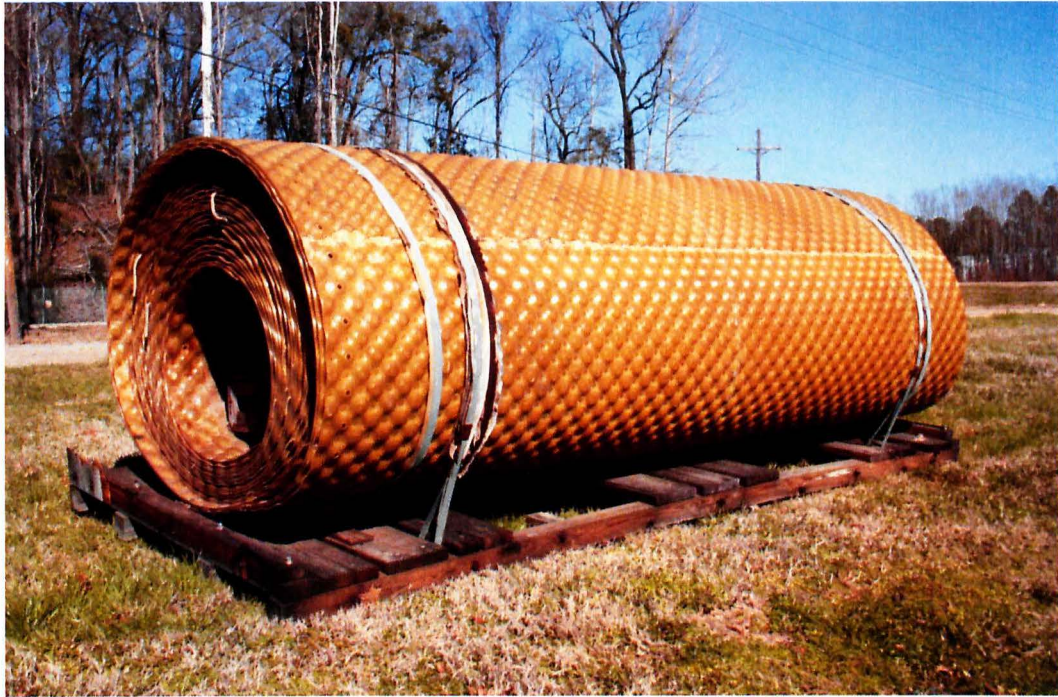
Figure 1. MO-Mat kit as delivered to the ERDC.

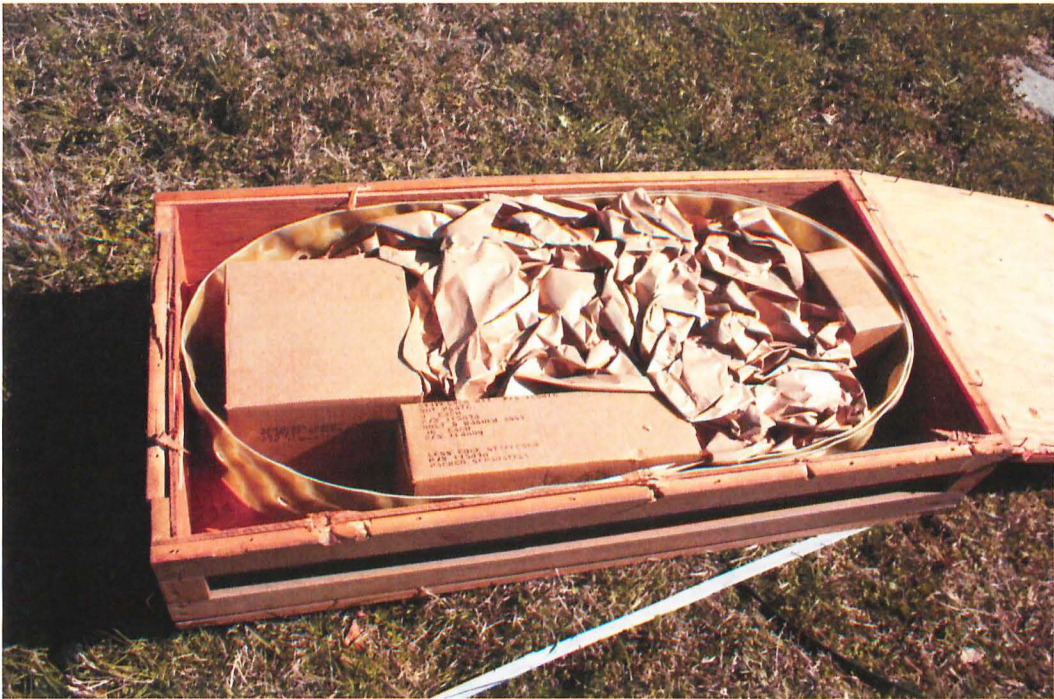
Figure 2. Contents of original MO-Mat installation kit.

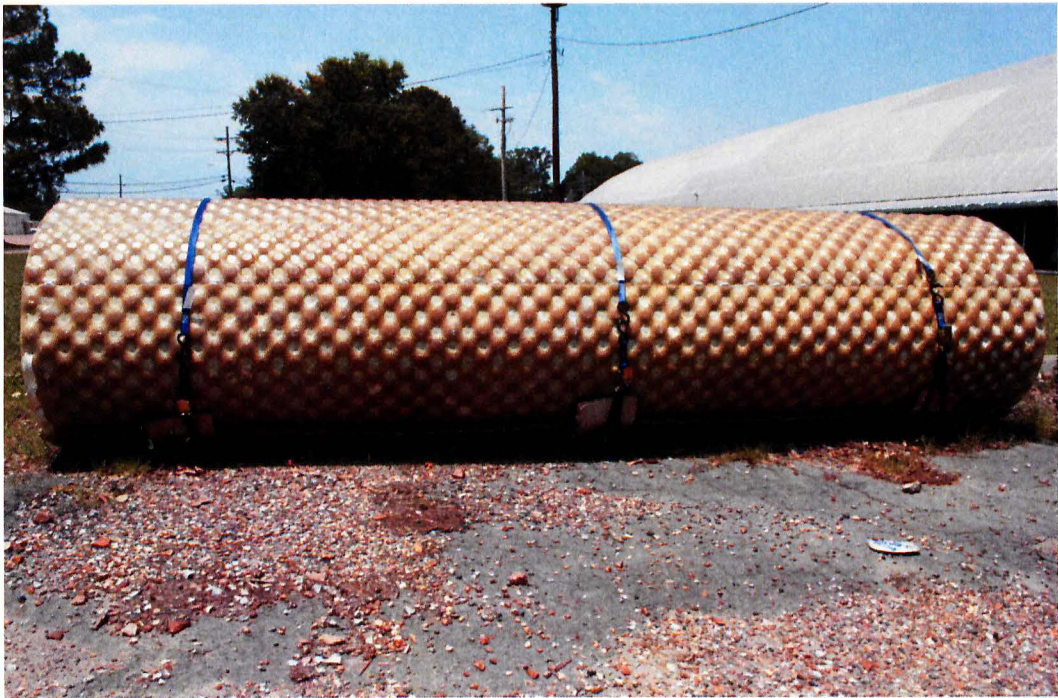
Figure 4. GFI, Inc. 922 replica MO-Mat.

the E-Glass in the molds. A vacuum system was used to remove air from the mold and ensure proper panel shape. Two mat panels of each resin material were delivered for laboratory and full-scale traffic testing. The delivered panels measured approximately 12-ft wide by 36-ft long. Projected production cost for each of the prototype panels was \$12.5/ft<sup>2</sup>. Photos of the 922 and 8101 systems are shown in Figures 4 and 5.

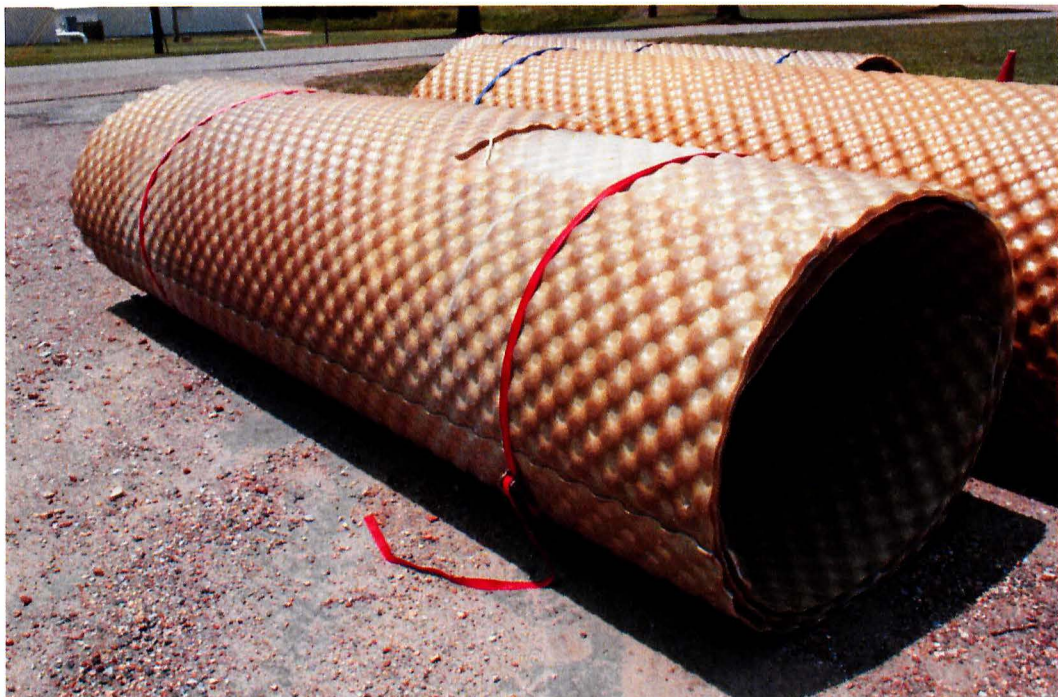
Figure 5. GFI, Inc. 8101 replica MO-Mat.

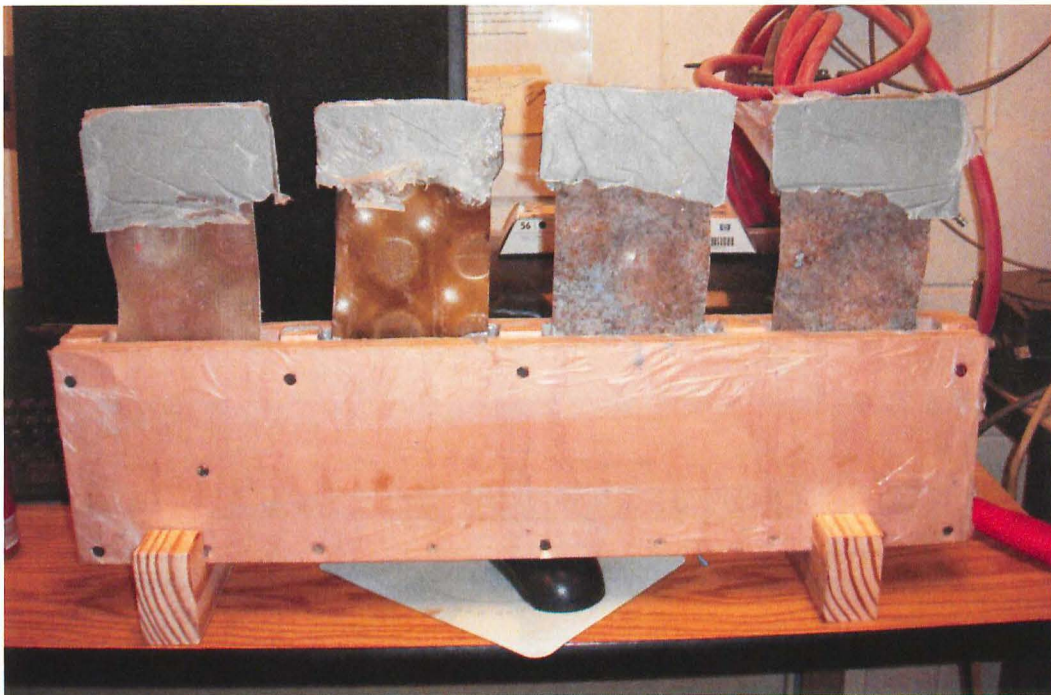
Figure 6. Tensile specimens with Sikadur® grip surfaces.

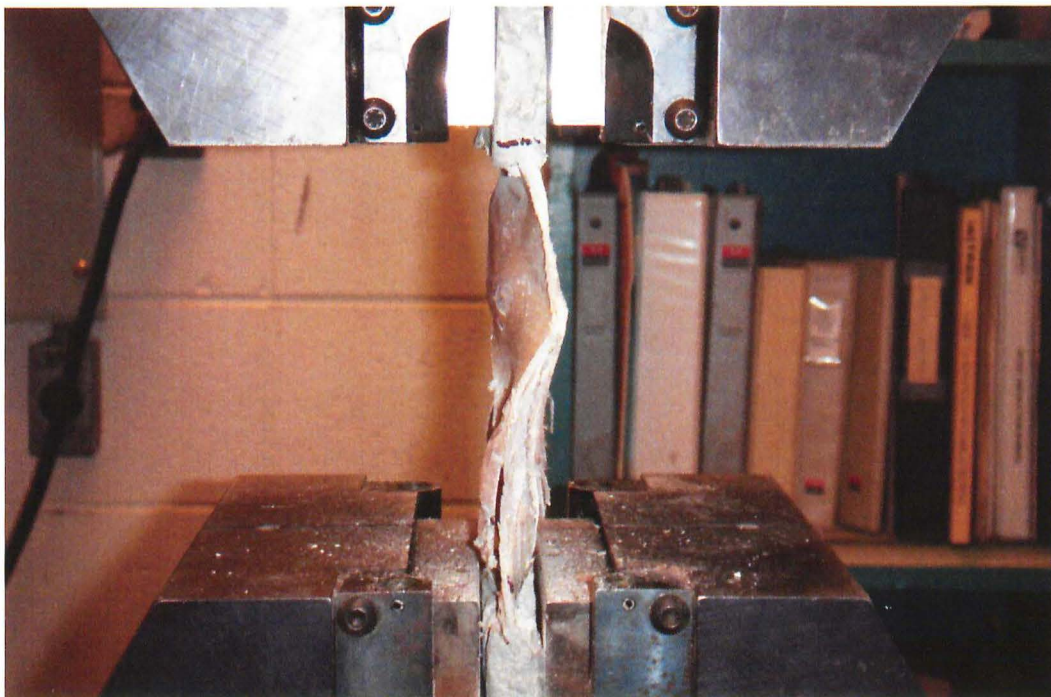
Figure 7. Typical tensile testing of MO-Mat sample.

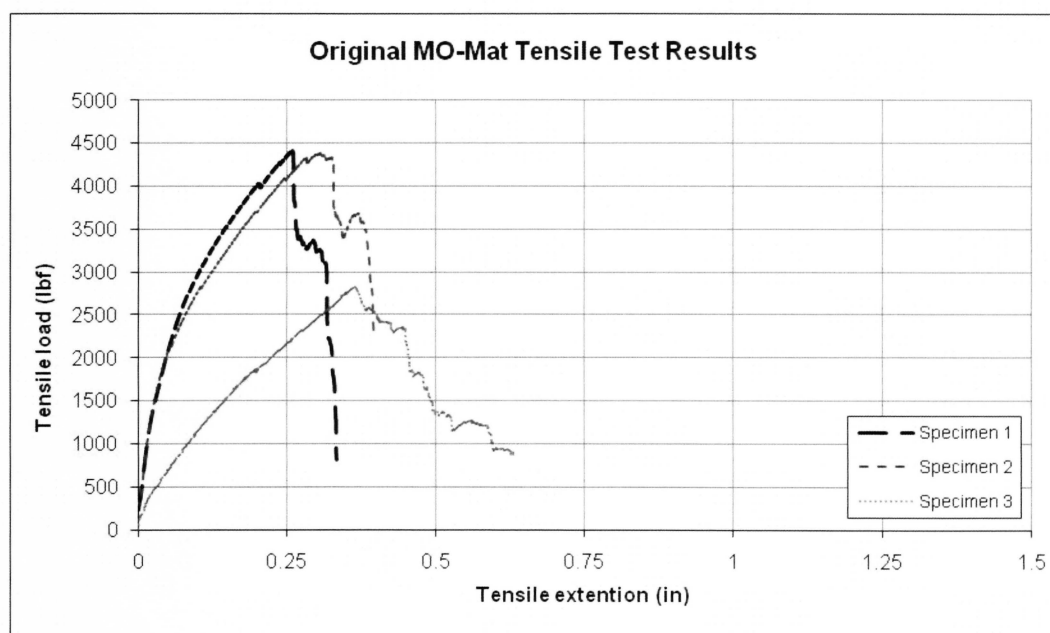
Figure 8. Original MO-Mat tensile test results.

Plots of the tensile test results are shown in Figures 8 through 10. Table 1 lists values of maximum load, extension at maximum load, statistical values for both series, and changes in values with respect to the original MO-Mat. Results from the original MO-Mat test for Specimens 1 and 2 indicated maximum tensile strengths for both samples of approximately 4,400 lbf. Specimen 3 yielded after approximately 2,800 lbf was applied. The cause of the large discrepancy in tensile results from samples was unknown; however, the mean value of the three specimens was determined to be conservative and was therefore used for system comparison. Extension values for the original MO-Mat at maximum load were approximately 0.3 in.

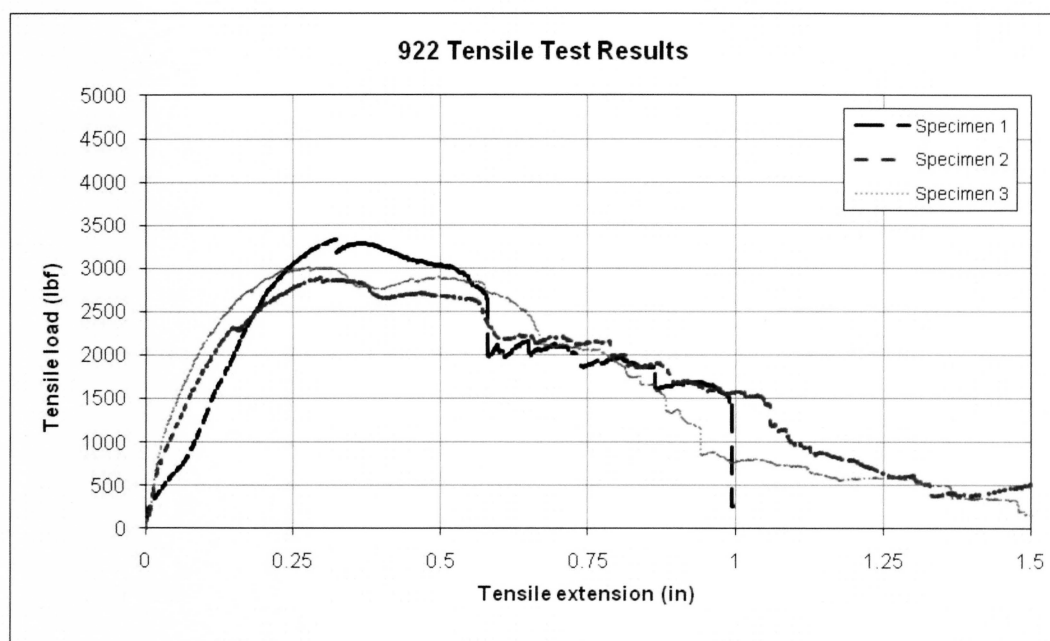
Figure 9. GFI, Inc. 922 tensile test results.

The maximum tensile capacities and extensions at the maximum loads of the three 922 specimens were all approximately 3,000 lbf and 0.3 in., respectively. When compared to the original MO-Mat, 922 had a 20 percent reduced tensile capacity. The extension at failure was 0.3 in., nearly equal for the two systems. The results indicate that, although the two systems fail at the same extension, the 922 prototype is only able to carry about 80 percent of the applied tensile load when compared to the original system.

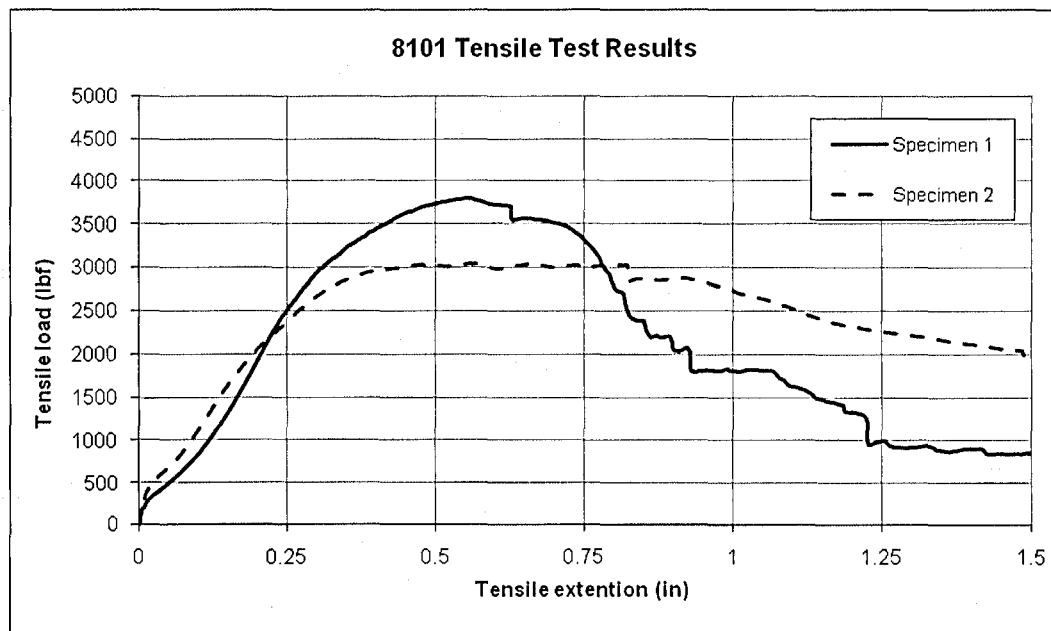
Figure 10. GFI, Inc. 8101 tensile test results.

For the 8101 system, the maximum tensile capacities and extensions at maximum loads averaged approximately 3,400 lbf and 0.6 in., respectively. When compared to the original MO-Mat, 8101 had a 12 percent reduced tensile capacity, but the extension at failure was double at 0.6 in. The results indicate that the 8101 system is slightly weaker, but is much more flexible under load. The increased flexibility may reduce the mats ability to transfer load to the subgrade underneath which may allow an increase in rate of permanent subgrade deformation.

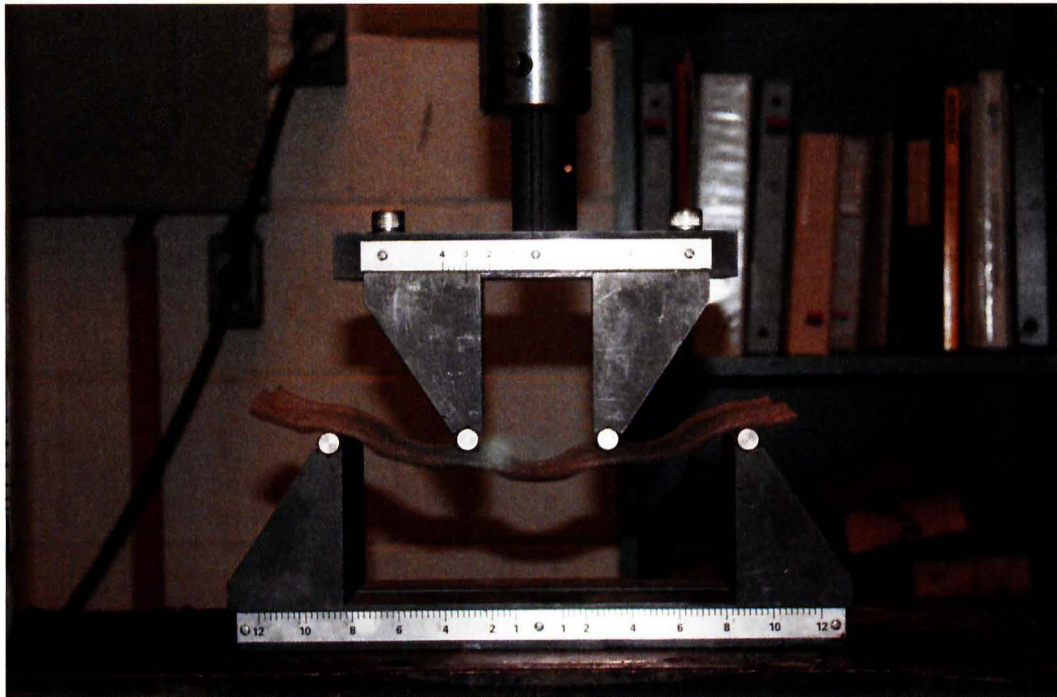
Figure 11. Typical 4-point bend testing of MO-Mat sample.

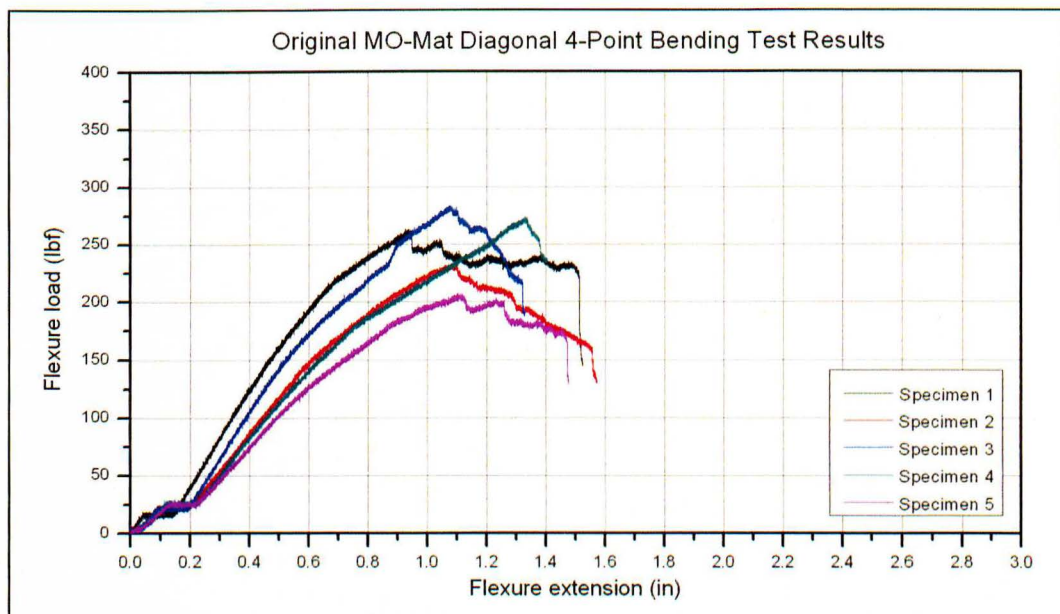
Figure 12. Original MO-Mat diagonal 4-point bending test results.

Plots of the bending test results are shown in Figures 12 through 17. Table 2 lists values of maximum load, extension at maximum load, statistical values for each series, and changes in values with respect to the original MO-Mat. Upon inspection of the results, the strength differences in the longitudinal and diagonal directions are clearly evident. For example, the mean value of

maximum bending strength for the original MO-Mat in the diagonal direction was 252 lbf compared to 144 lbf in the longitudinal direction. From this data, the original MO-Mat system is 1.75 times stronger in the diagonal direction than the longitudinal and transverse directions, thus allowing the mat to be rolled into a reasonably tight spiral. The stiffness of

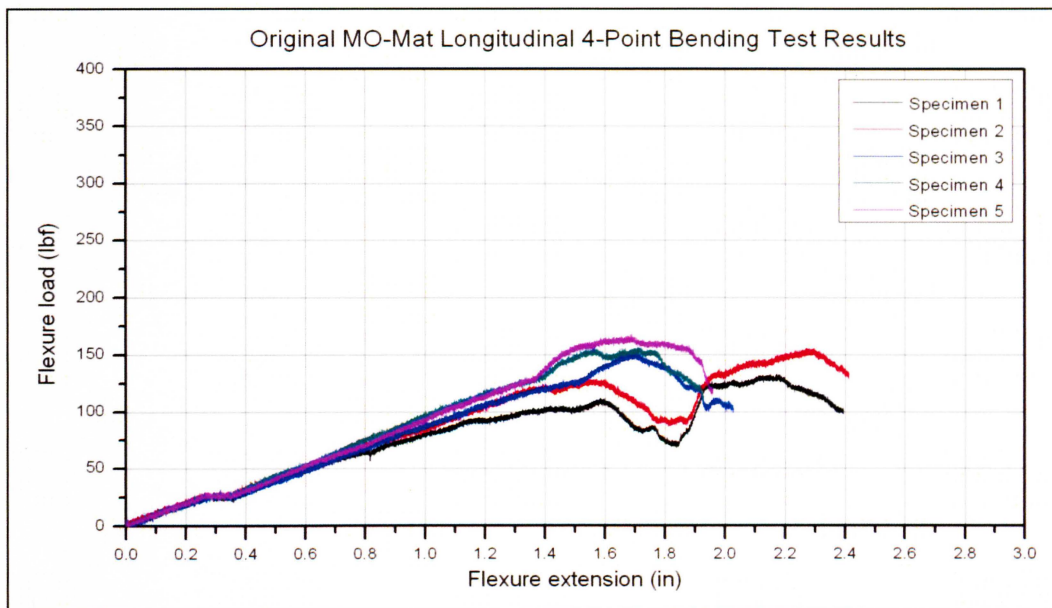
Figure 13. Original MO-Mat longitudinal 4-point bending test results.

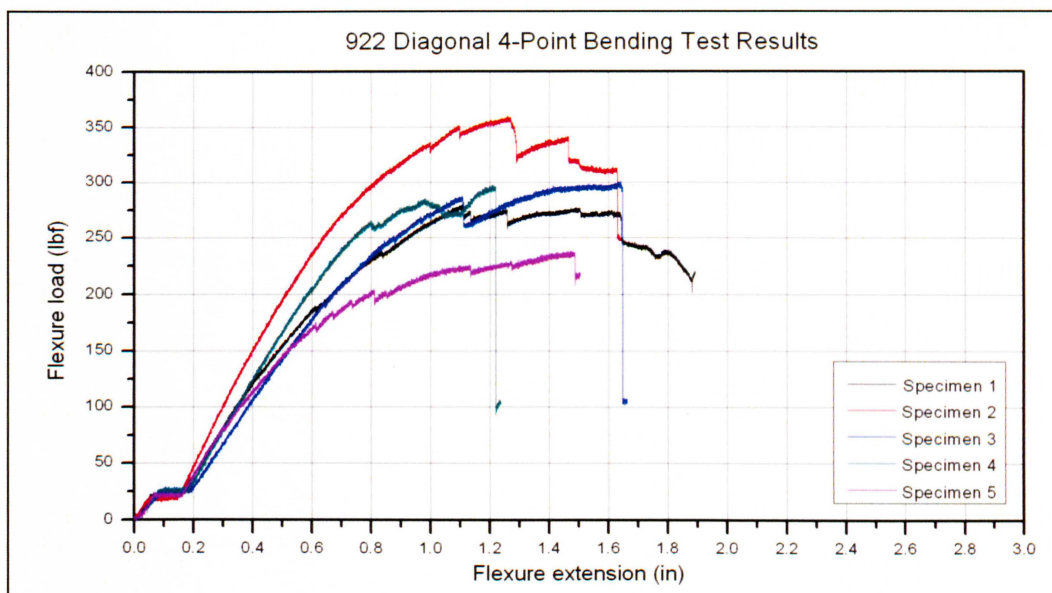
Figure 14. 922 diagonal 4-point bending test results.

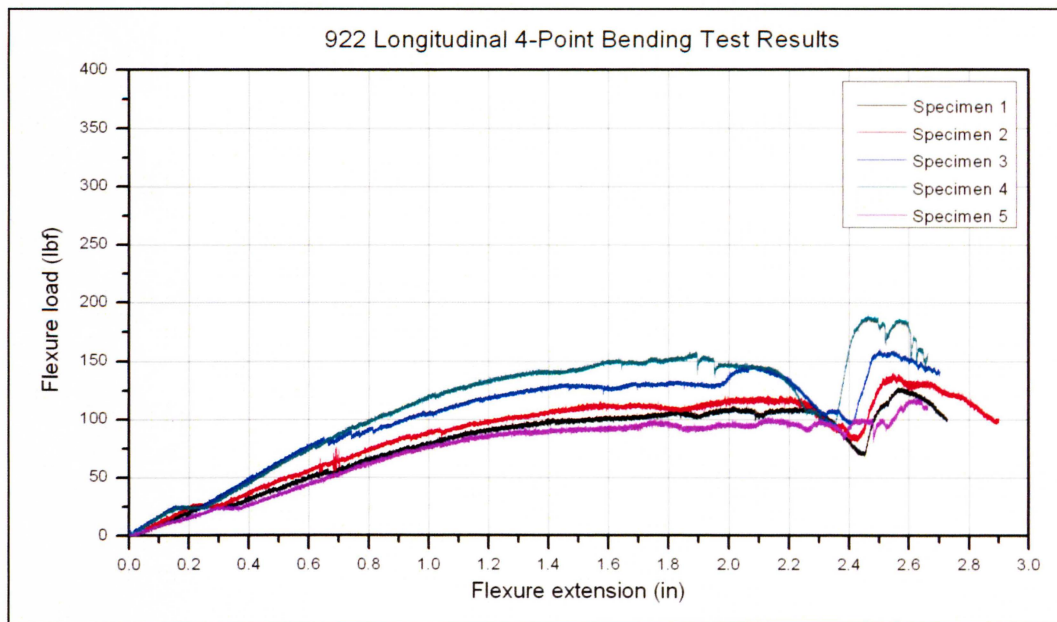
Figure 15. 922 longitudinal 4-point bending test results.

Significant differences were noted when comparing results from the longitudinal directions. The 922 system yielded at 90 percent of the load of the original MO-Mat system and at an extension 0.5 in. greater. These values indicate that the 922 resin system is more flexible than the original system and should be easier to roll and require a reduced volume for shipping and storage while retaining similar strength in the diagonal direction. The maximum bending stress for the 8101 system was 1.8 times that of the original MO-Mat and the extension at the yield point was 0.8 in. greater. In this case, the comparison is not quite as straight forward. The system appears more flexible, but requires more force to achieve the flexibility. To compare the systems, Figure 17 should be evaluated for extension when the maximum bending strength of 144 lbf for original MO-Mat is considered. An average extension of approximately 0.9 in. is inferred from the 8101 results at 144 lbf of applied load in comparison to 1.6 in. for the original MO-Mat. Therefore, when the same load is applied to the 8101 system as the original MO-Mat, the system responds with just over half of the extension. From this analysis the 8101 system is determined to be significantly stiffer than the original MO-Mat system in the longitudinal and transverse directions and would be more difficult to roll into a spiral for transportation and storage.

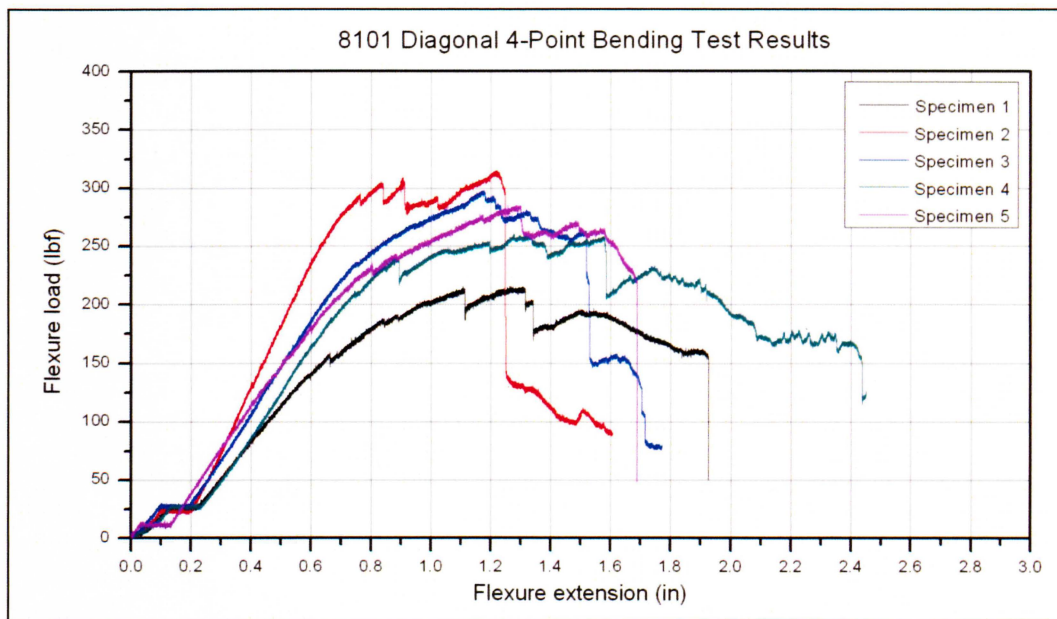
Figure 16. 8101 diagonal 4-point bending test results.

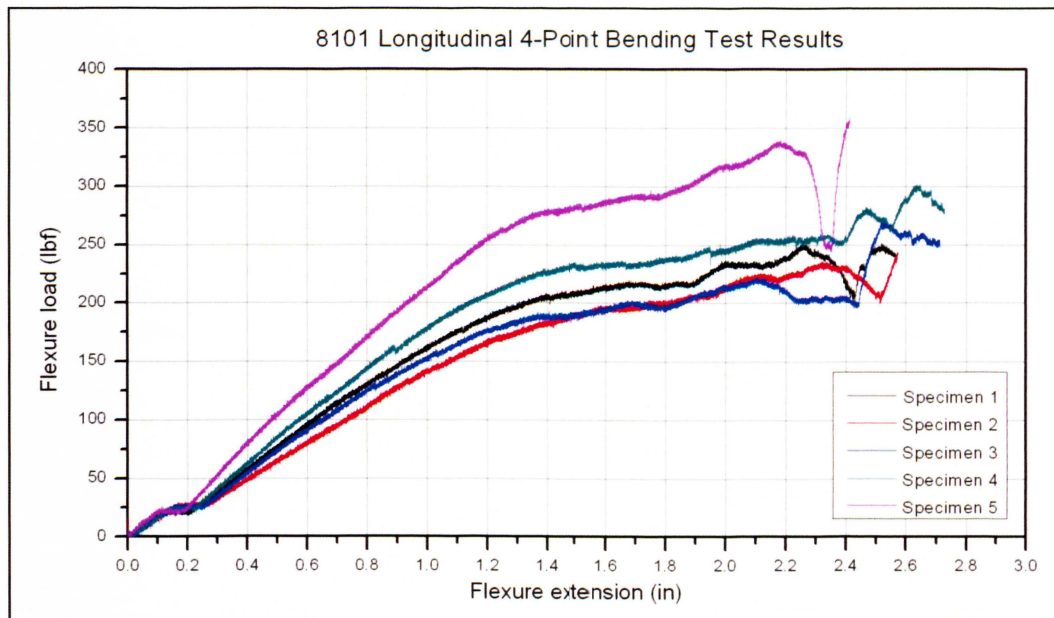
Figure 17. 8101 longitudinal 4-point bending test results.

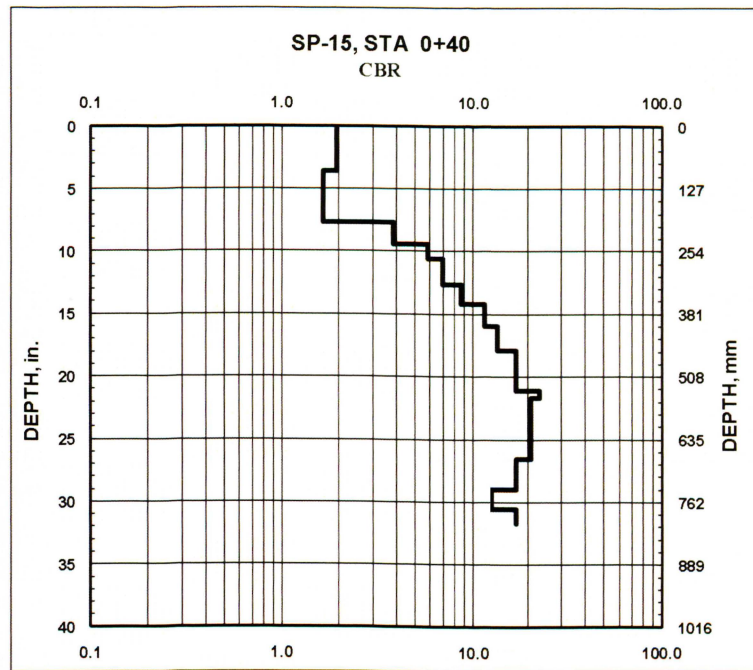
Figure 18. Representative profile of the DCP data for the SP-15 test section.

The SP-15 section was constructed on the ERDC, Vicksburg, Mississippi, installation. The SP material was procured from a local source in Vicksburg and delivered to the testing area in 2006. The material was placed in a single 24-in. thick lift that was unconfined and was approximately 24-ft wide and 320-ft long to accommodate the installation of nine roadway matting systems for a previous matting system test (Rushing et al. 2007). Once the SP material was placed, it was compacted with three complete coverages of a 12-ton vibratory roller to settle the material and to achieve a 15 CBR subgrade strength. A Dynamic Cone Penetrometer (DCP) with a 10-lb hammer was used to characterize the bearing capacity of the completed test roadway according to ASTM D 6951 and Webster et al. (1992). A typical profile of the DCP data for the SP-15 section is shown in Figure 18. As shown in Figure 18, the true strength of a clean granular sand is not reflected until enough overburden pressure is applied to effectively confine the sand. In this case, about 15 to 20 in. of overburden was required for the effective strength to be measured by the DCP. Crushed limestone was placed on each end of the SP-15 section to connect the section to an existing gravel road to enable the construction equipment and the traffic vehicle to enter and exit the test section without becoming immobilized. A photo of SP-15 construction is shown in Figure 19.

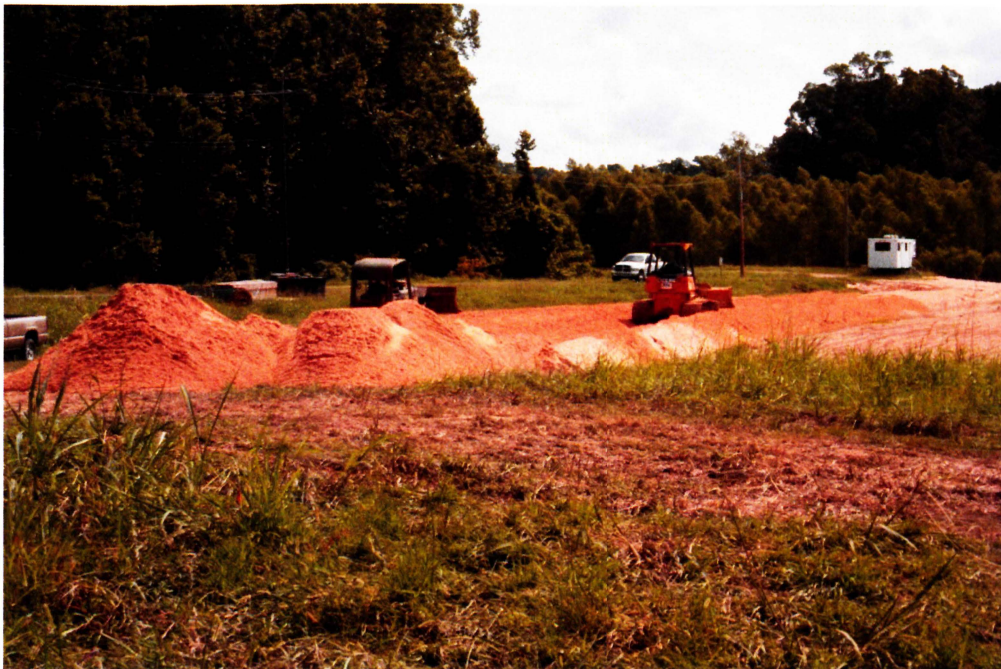
Figure 19. SP-15 test section construction in 2006.

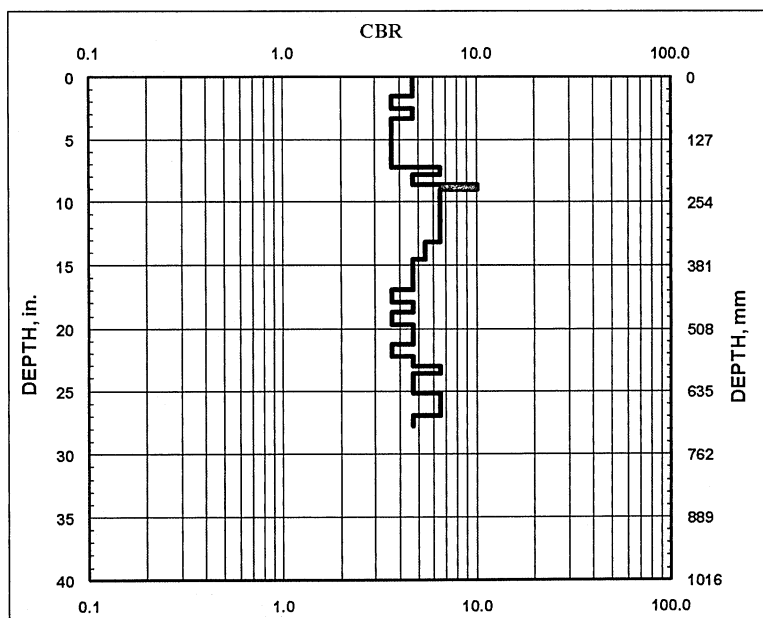
Figure 20. Typical profile of the DCP data for the ML-5 test section.

by 150-ft long area with a rotary mixer and bulldozer. The bearing capacity of the in-situ ML-CL subgrade had a CBR of approximately 5 percent when measured with the DCP; therefore, no additional preparation was required. A typical profile plot is shown in Figure 20.

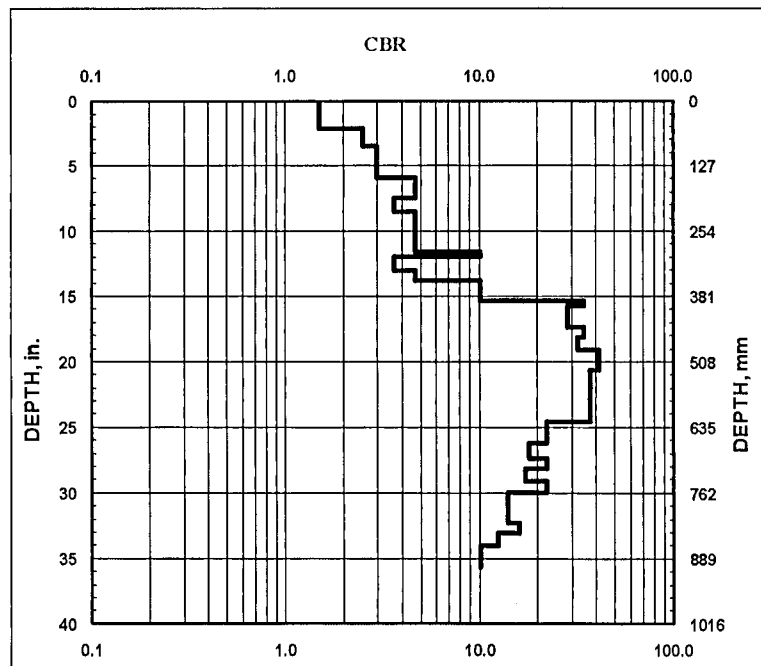
Figure 21. Typical profile of the DCP data for the SM-5/80 test section for passes 1-140.

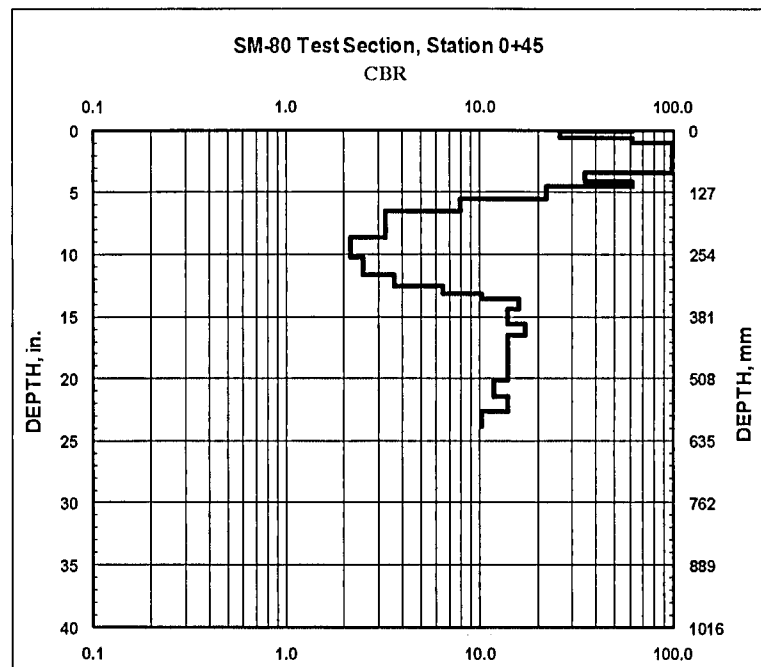
Figure 22. Typical profile of the DCP data for the SM-5/80 section for passes 141-2,000.

Prior to resuming the traffic evaluation, the subgrade was allowed to freeze for an additional 60 hours. DCP measurements, shown in Figure 22, immediately prior to trafficking indicated that the subgrade was completely frozen to a depth of 6 to 8 inches and the effective bearing capacity was a CBR of 80 percent. The ambient air temperature at the time of testing was 8 °F. Temperatures ranged from -2 °F to 22 °F for passes 141-2,000 of the evaluation.

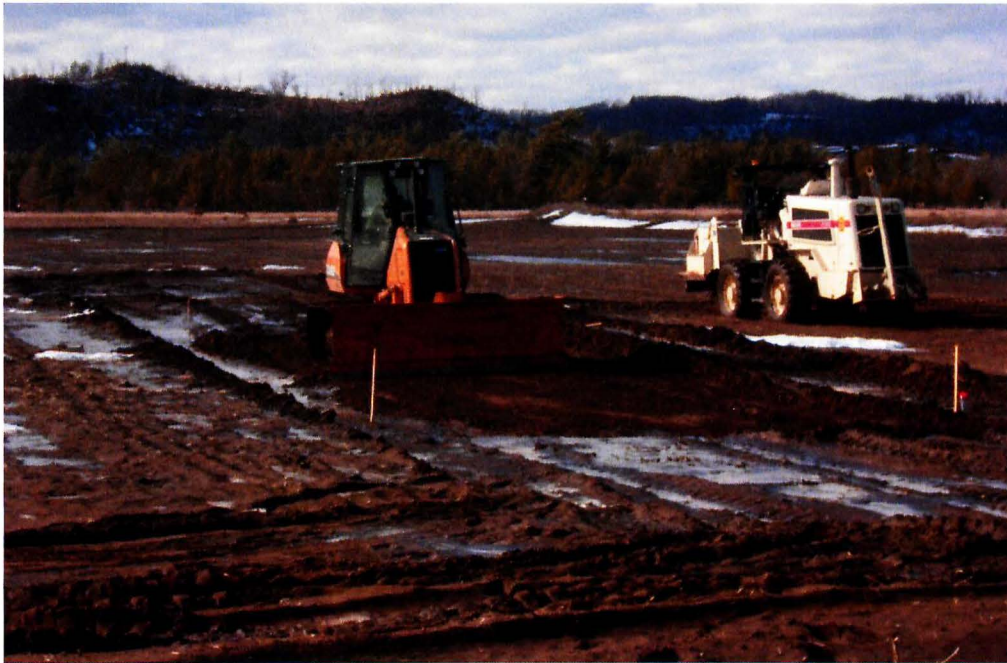
Figure 23. SM-5/80 test section construction.

The SM-5/80 section was constructed at Engineer Dig Site 09 at Fort McCoy, WI in 2009. The subgrade was prepared by tilling a section of existing subgrade 20-ft wide by 300-ft long to a depth of 16 in. with a rotary mixer and back-blading it with a bulldozer for smoothness. A standard DCP with a 10-lb hammer was used to verify the subgrade strength. Typical profile plots from DCP measurements of the sections are shown in Figures 21 and 22. The difference in subgrade strength was a function of the depth of frozen subgrade in the test section. The first 140 passes of the load vehicle were made when the subgrade of the test section was frozen to a depth of approximately 2 in. Further testing was postponed until the subgrade was frozen to a depth of approximately 6 in. with an effective CBR of 80 percent. Since temperatures were greater than 30 °F initially and then dropped further below freezing during later stages of the evaluation, the depth of the frozen layer increased during testing. A photo of the SM-5/80 construction is shown in Figure 23.

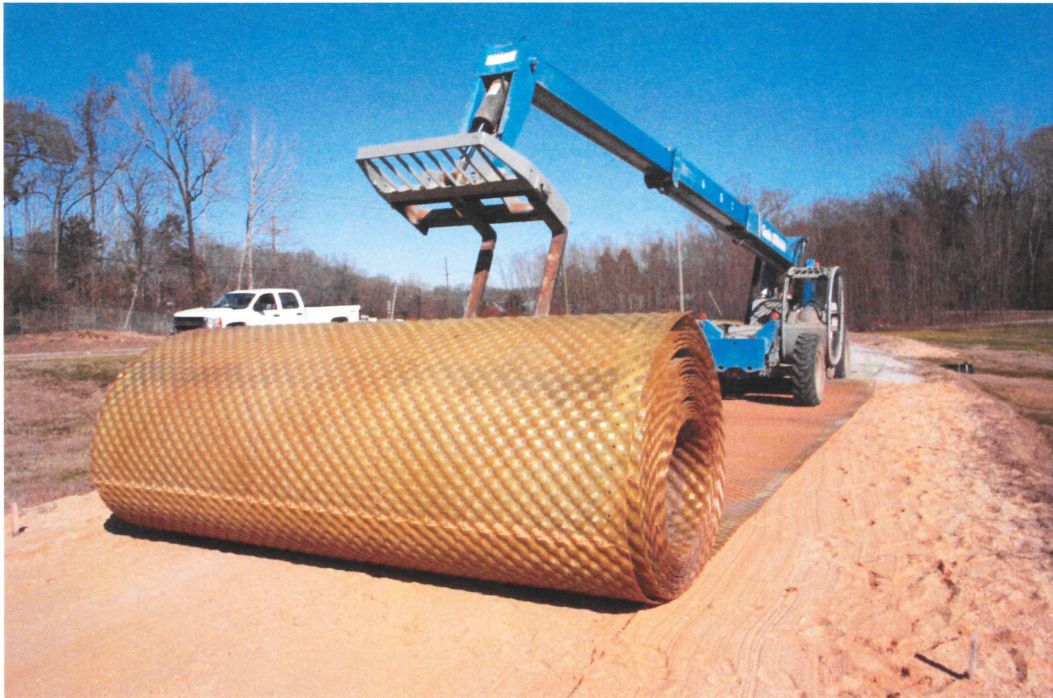
Figure 24. Unrolling original MO-Mat on SP-15 test section.

The MO-Mat and replica systems were installed by rolling out the mat panels and anchoring the ends and edges by driving T-stakes so that the top flange overlapped the mat and anchored the system to the subgrade, as shown in Figures 24 and 25. To determine the installation rate of original MO-Mat, stakes and strings were installed to mark the centerline of the test section prior to mat system installation. The mat system was lined up along the centerline and rolled in one direction until the entire section was complete. Since the system required staking to hold the mat flat on the subgrade, time was recorded until all stakes were installed. Photos showing completed mat installations prior to trafficking for the original MO-Mat and replica systems are shown in Figures 26 and 27.

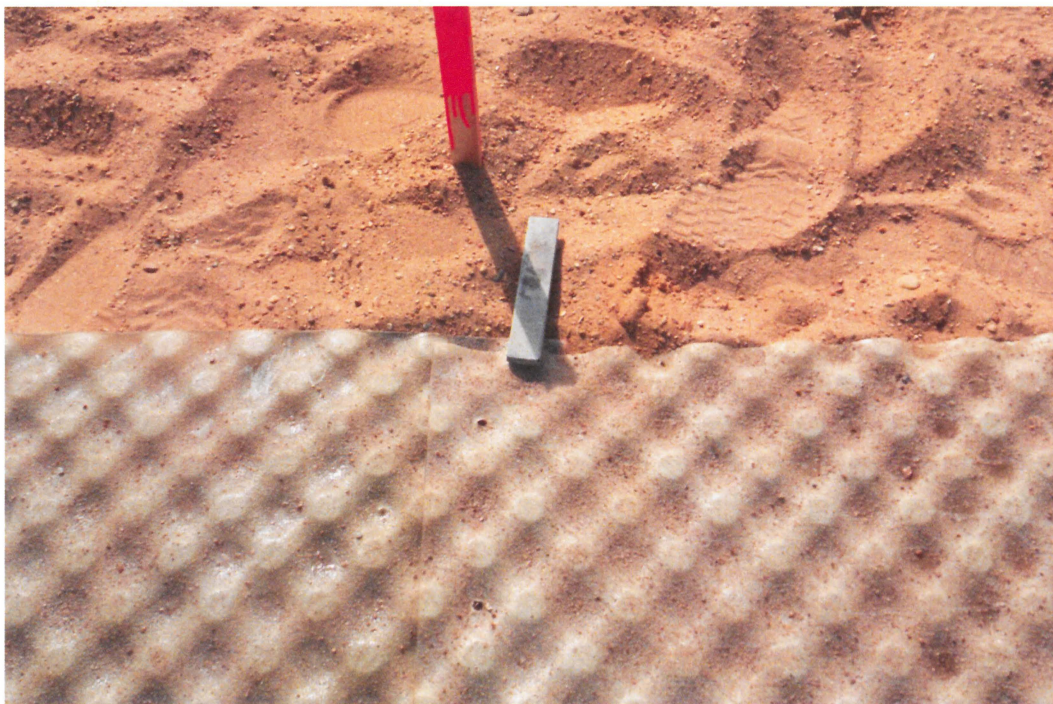
Figure 25. T-stake installation along edge of 8101 system on SP-15 subgrade.

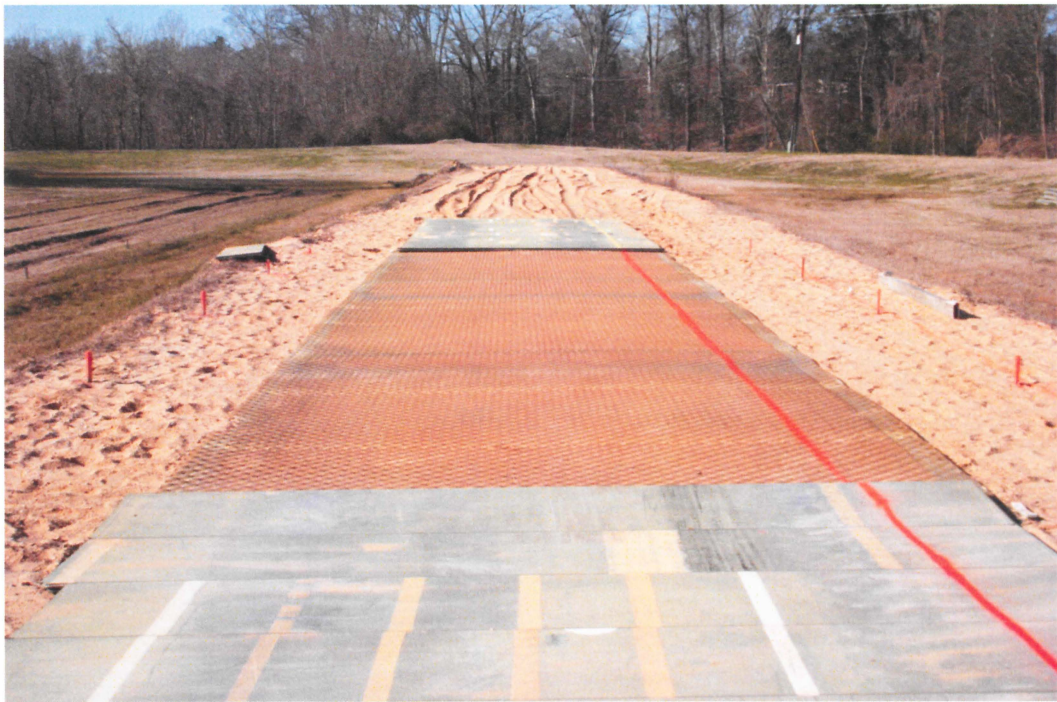
Figure 26. Completed installation of original MO-Mat system on SP-15 subgrade.

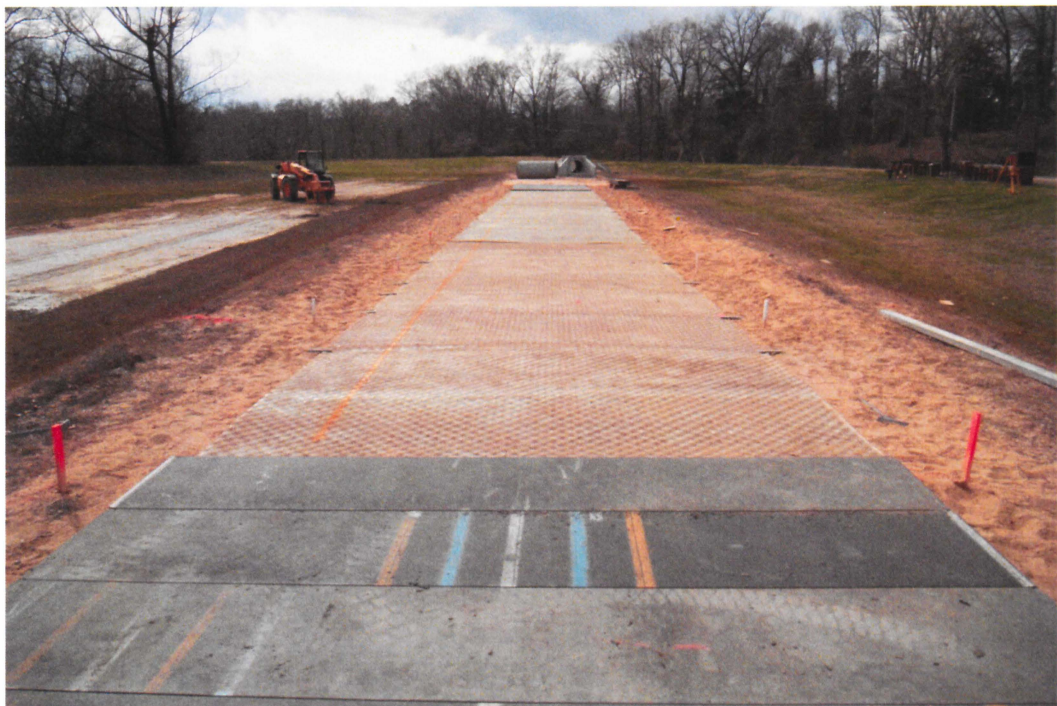
Figure 27. Completed installation of 922 and 8101 systems on SP-15 subgrade.

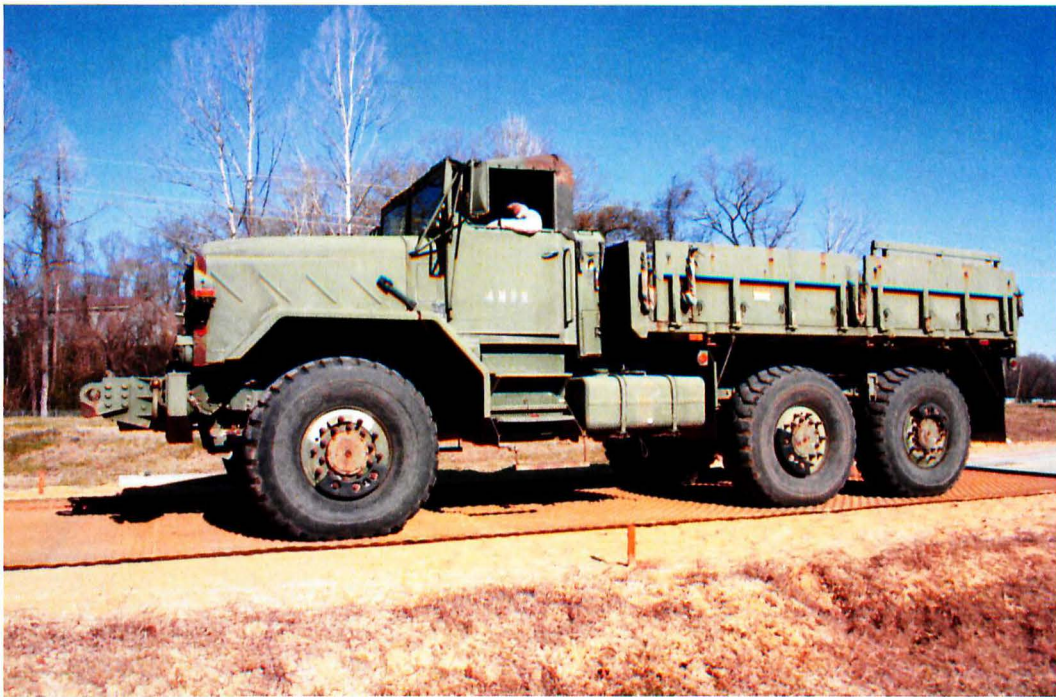
Figure 28. Seven-ton test vehicle on the SP-15 test section.

A key constant in all roadway matting system evaluations described in this report was the testing vehicle. Each section was trafficked with the same 7-ton USMC transport vehicle loaded to maximum capacity with 7-tons of lead and steel blocks secured in the truck bed, centered above the rear axles. The truck was designed with six wheels, two drive wheels in the front and two load wheels on each side of the rear. Tire pressures were adjusted to the recommended “cross-country” driving conditions with 28 lb/in.<sup>2</sup> in the front and 35 lb/in.<sup>2</sup> in the rear. According to the load distribution plate located inside the test vehicle, the front axles weighed 15,290 lb and the two rear axles combined weighed 29,310 lb when loaded to its 7-ton maximum capacity. Channelized traffic was applied to each test section by driving the test vehicle forward and then backward in the same wheel paths at 5 to 10 mph until the test was complete. Acceleration and deceleration of the test vehicle occurred on end ramps at either end of each test section. A photo of the test vehicle is shown in Figure 28.

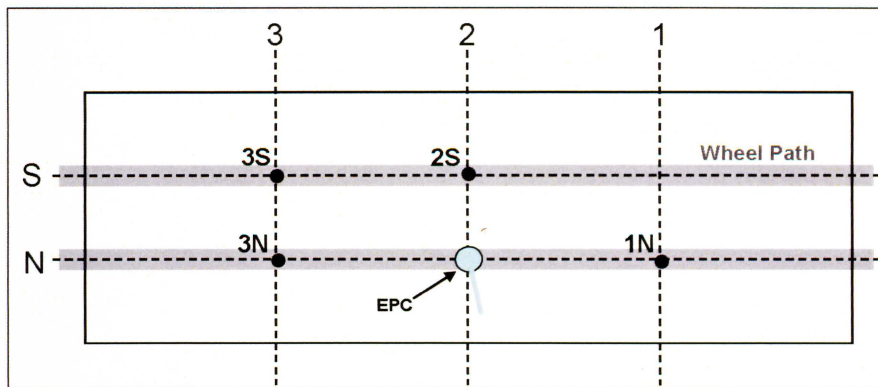
**Figure 29. Example of data collection locations.**

serve as reference points for data collection before, during, and after trafficking. Data were not collected at the mat ends because effects of the test vehicle's entering and leaving the matted section can in many instances skew results, especially when monitoring rut depths. A benchmark was established for each test section outside of the trafficked area as a reference point for rod and level measurements. A measuring tape was stretched between quarter point stakes on opposite sides of the test area, and rod and level measurements were recorded at 1-ft intervals to establish baseline cross-sectional surface elevations. DCP measurements were recorded at each quarter point location to characterize the bearing capacity of each test subgrade. Moisture and density measurements were also taken at these points for most test sections using a Troxler 3430 nuclear gauge according to ASTM D 3017 and ASTM D 5195, respectively. An example of data collection locations of the original MO-Mat section is shown in Figure 29.

After the mat systems were installed, the north wheel path was marked by painting a line along a taut string. The wheel path was used to mark locations for profile measurements. Mat surface profiles were determined by stretching a measuring tape from beginning to end of the matted section and reading rod and level elevation measurements at 1-ft intervals along the

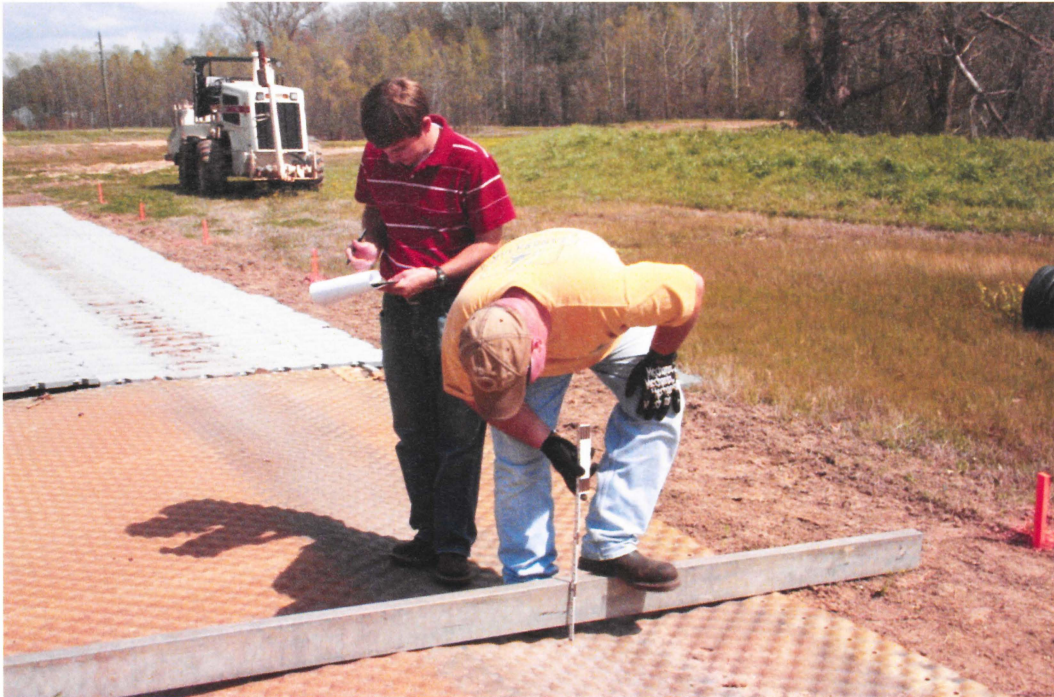
Figure 30. Typical rut depth measurement.

1. Each mat surface was visually inspected for damage or fatigue.
2. Rut depths were measured along the marked wheel path with a folding ruler while pressing the mat to contact the subgrade, as shown in Figure 30.
3. Rod and level cross-section measurements were recorded at each data collection location, as shown in Figure 31.
