## **Comparison of Original MO-Mat and Prototype Replicas for Expeditionary Roads**

Timothy W. Rushing and James F. Rowland

April 2012

Final report

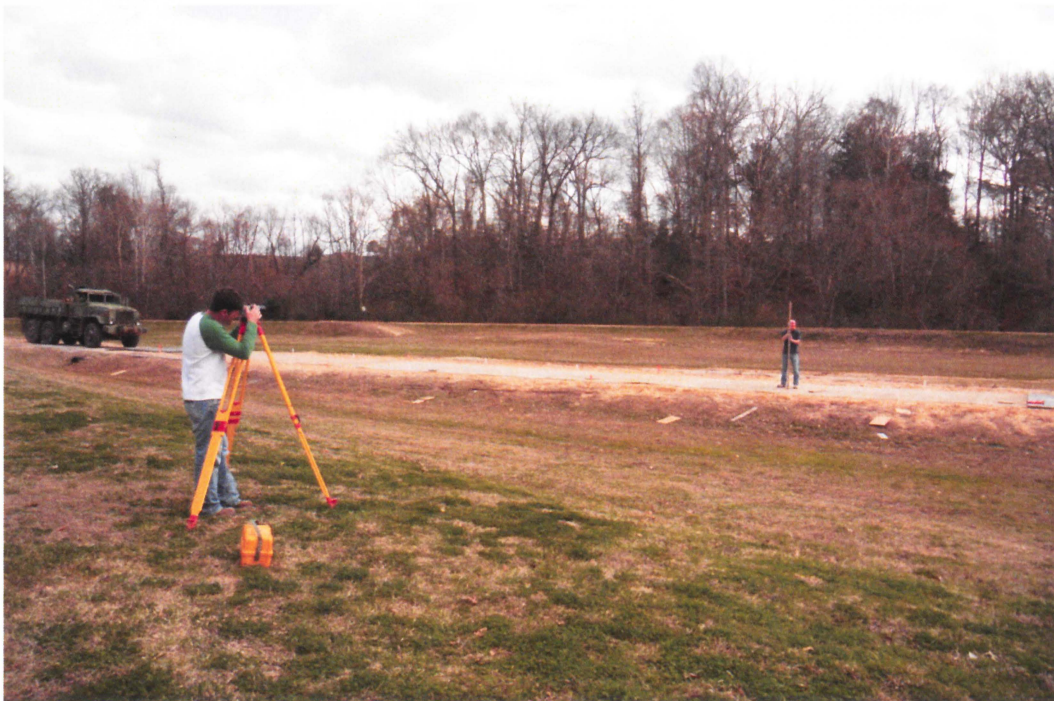
Figure 31. Typical rod and level cross-section measurement.

1. Each mat surface was visually inspected for damage or fatigue.
2. Rut depths were measured along the marked wheel path with a folding ruler while pressing the mat to contact the subgrade, as shown in Figure 30.
3. Rod and level cross-section measurements were recorded at each data collection location, as shown in Figure 31.

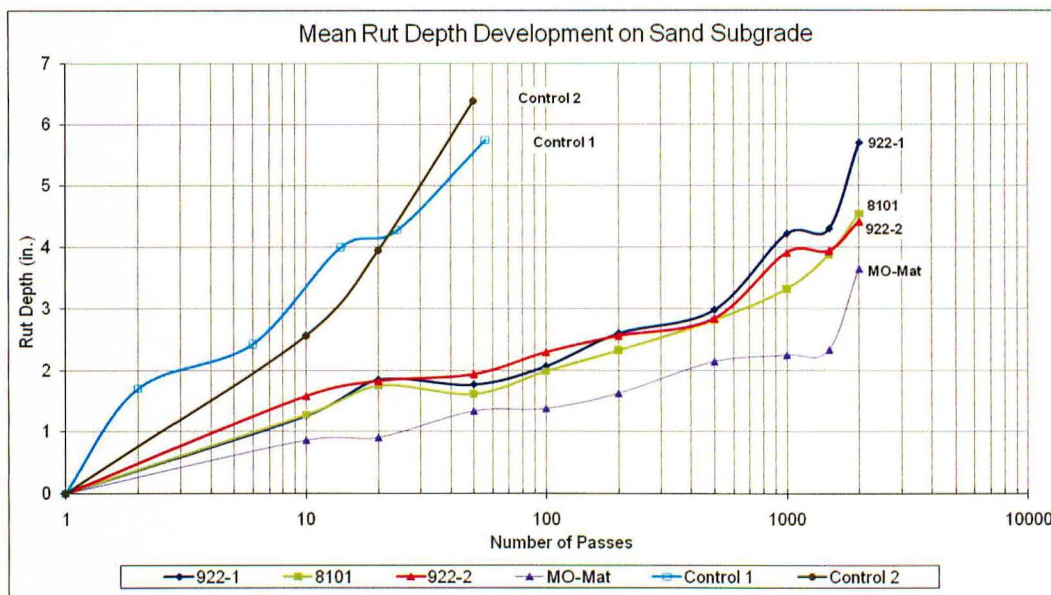
Figure 32. Average rut depths for mat systems on the SP-15 test section.

Each of the three mat systems was evaluated over the SP-15 subgrade, and results are reported in this section. Figure 32 shows the rut depths for each mat system. Each data point is the average of three readings taken at quarter points in one of the wheel paths. In Figure 32, the X-axis is scaled logarithmically, since the rut developed rapidly and then slowed its progression as the number of passes increased. The sand at the surface was loose at the beginning of the test and moved outward to areas with less stress when the vehicle load was applied. The sand continued to move until all voids were filled, and it became confined underneath the mat. Once a state of confinement was reached, the bearing capacity of the sand increased, and the rate of rut formation was greatly reduced. All mat system and control section rut depths are included on one plot for comparison.

allowing rut formation to increase throughout trafficking. Rut depths are shown in Figure 32, cross-section development is shown in Figure 36, and the final condition is shown in Figure 37.

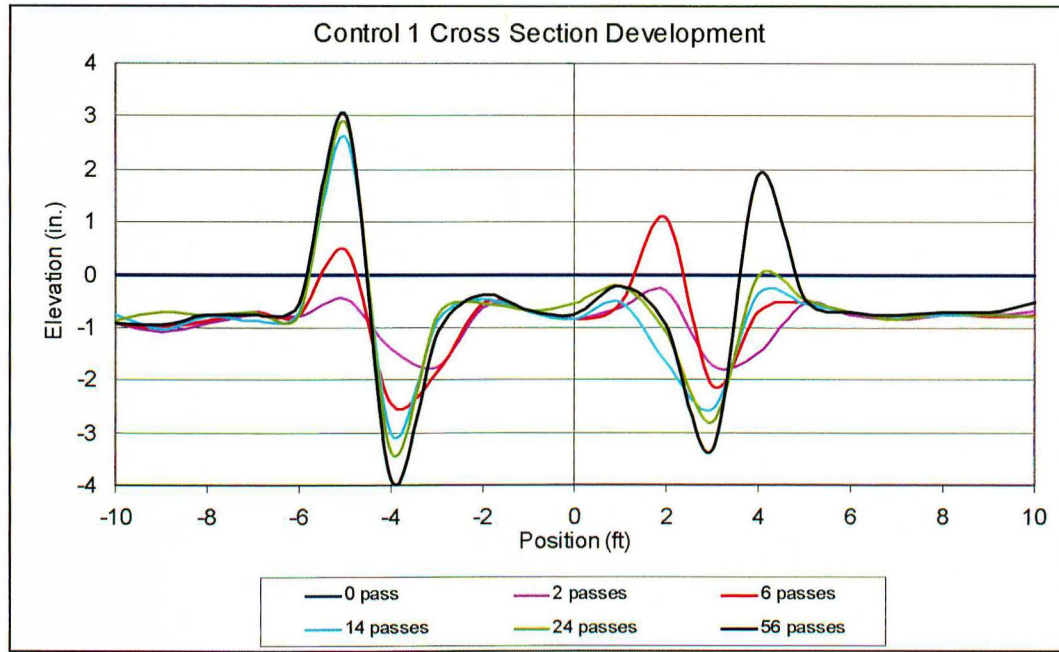
Figure 33. SP-15 control 1 cross-section development.

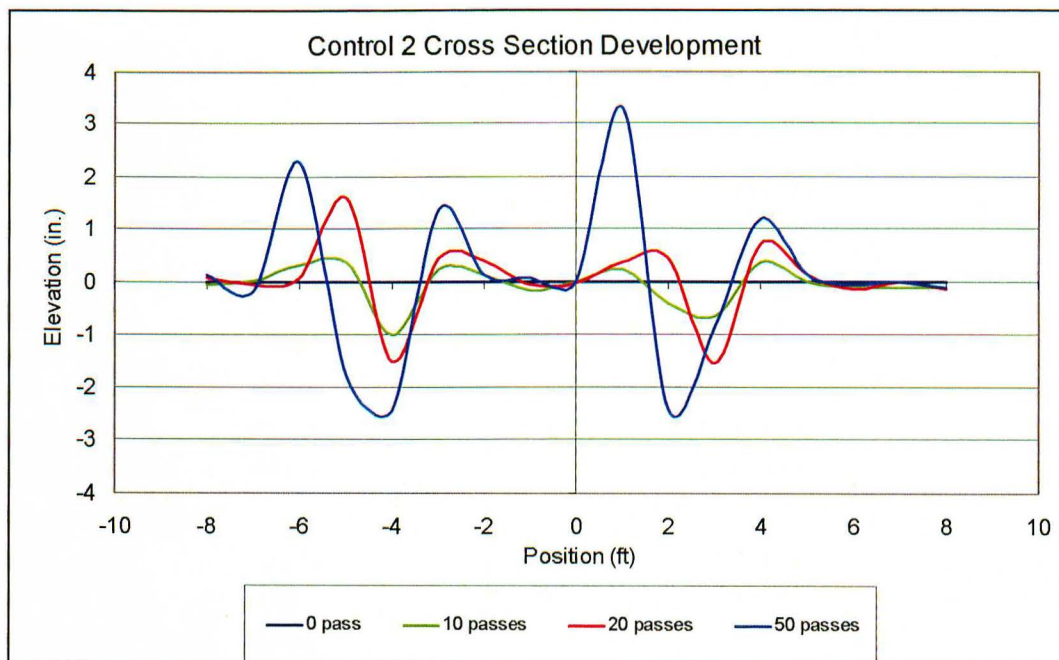
Figure 34. SP-15 control 2 cross-section development.

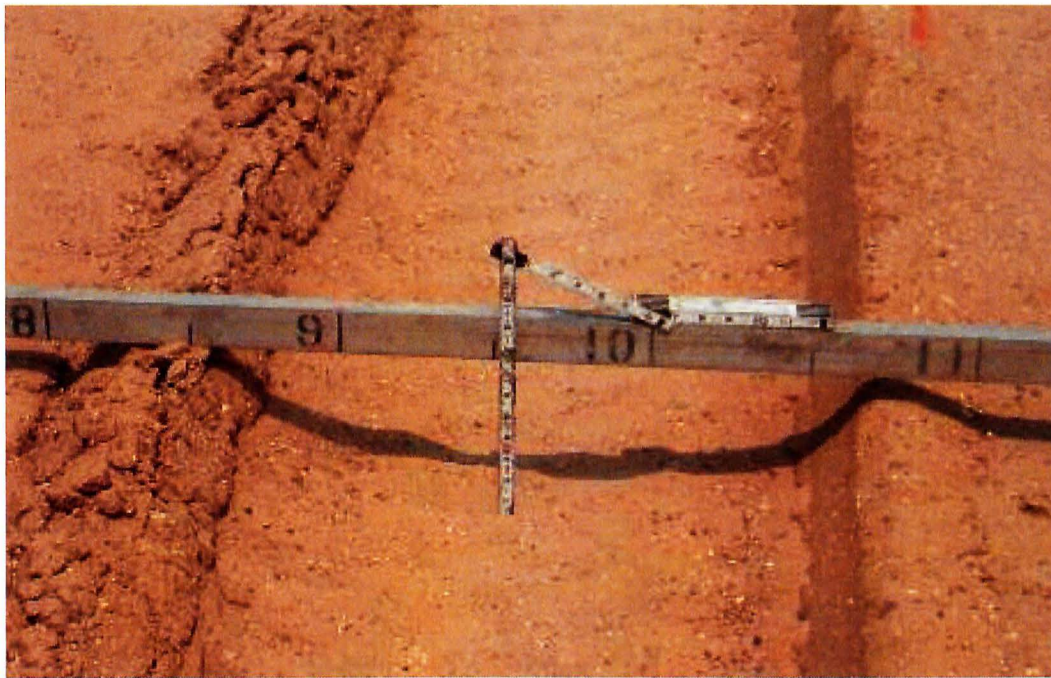
Figure 35. Control 1 after 56 passes over SP-15.

100-ft long section of the sand was smoothed with a front end loader, staked to mark off a 60-ft test area, and subdivided into 15-ft long quarter points for data collection. For the first control, data were collected after 2, 6, 14, 24, and 56 passes. For the second control, data were collected after 10, 20, and 50 passes. Similar results were recorded for each of the control sections indicating that little change in subgrade condition occurred during the mat evaluations. Results from rut depth measurements indicated that a rut depth of 3 in. was reached after approximately 10 passes, and a 6-in. rut was reached after 50 passes. Plots of the rut depths are shown in Figure 32, rod and level cross-section measurements are shown in Figures 33 and 34, and the final condition of the control section is shown in Figure 35.

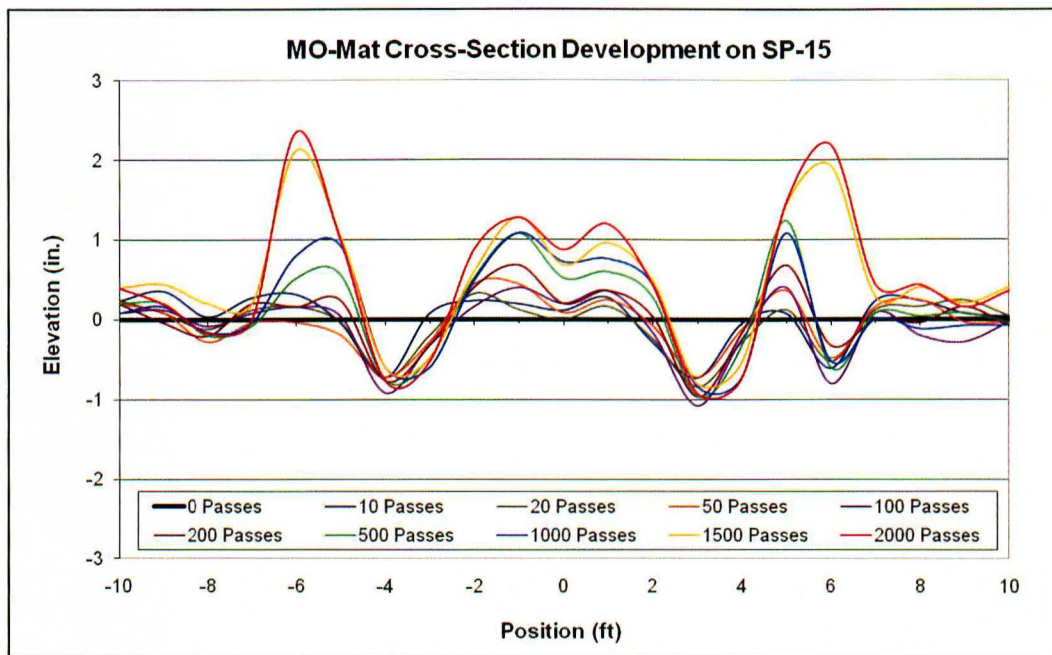
Figure 36. MO-Mat cross-section development on SP-15.

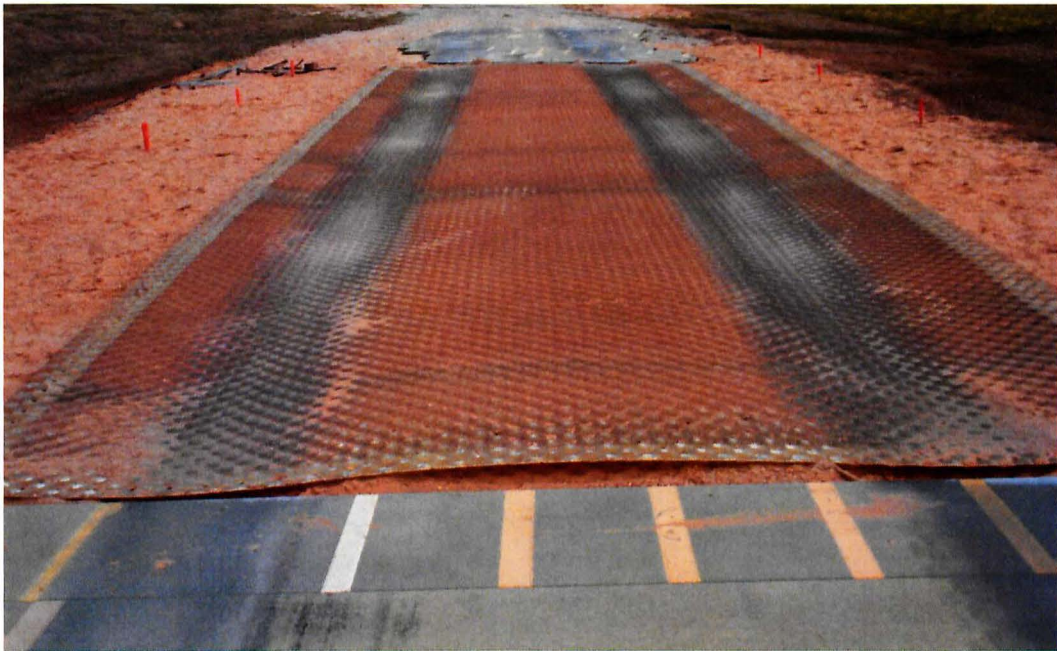
Figure 37. MO-Mat after 2000 passes on SP-15.

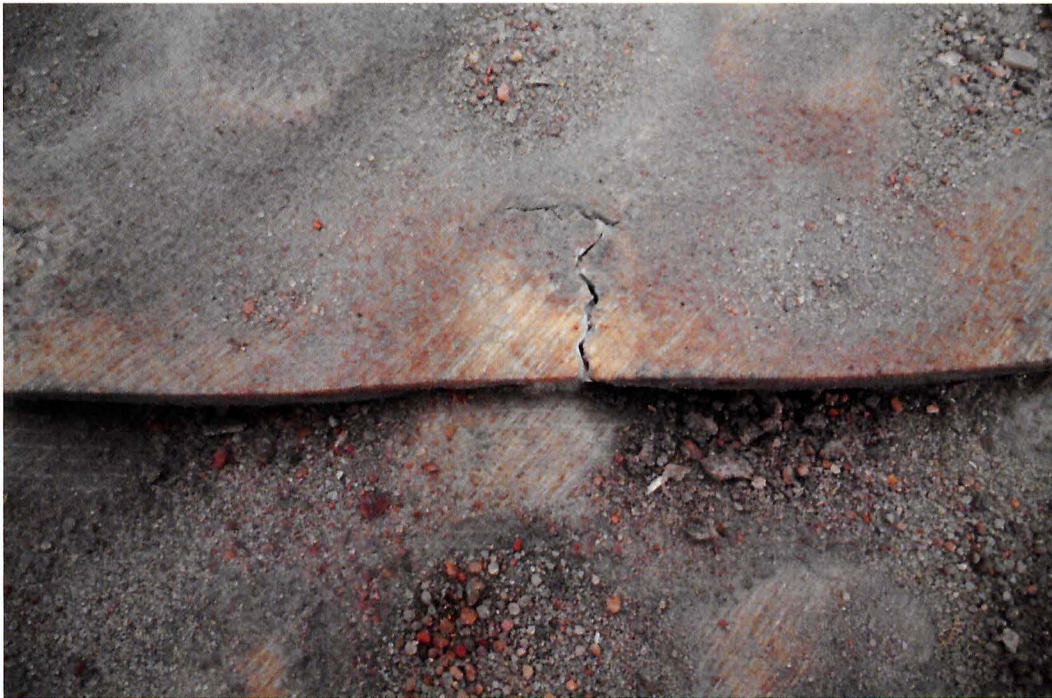
Figure 38. Crack formed from tire impact after 1000 passes on 922.

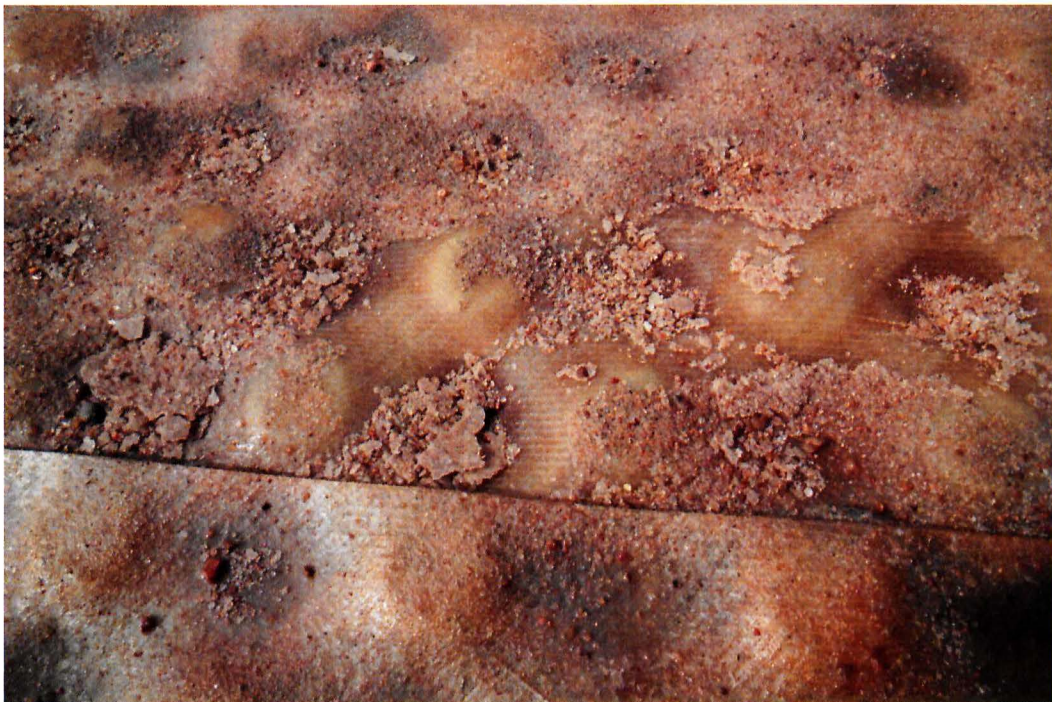
Figure 39. Debonded nonskid material after 1,000 passes on 922.

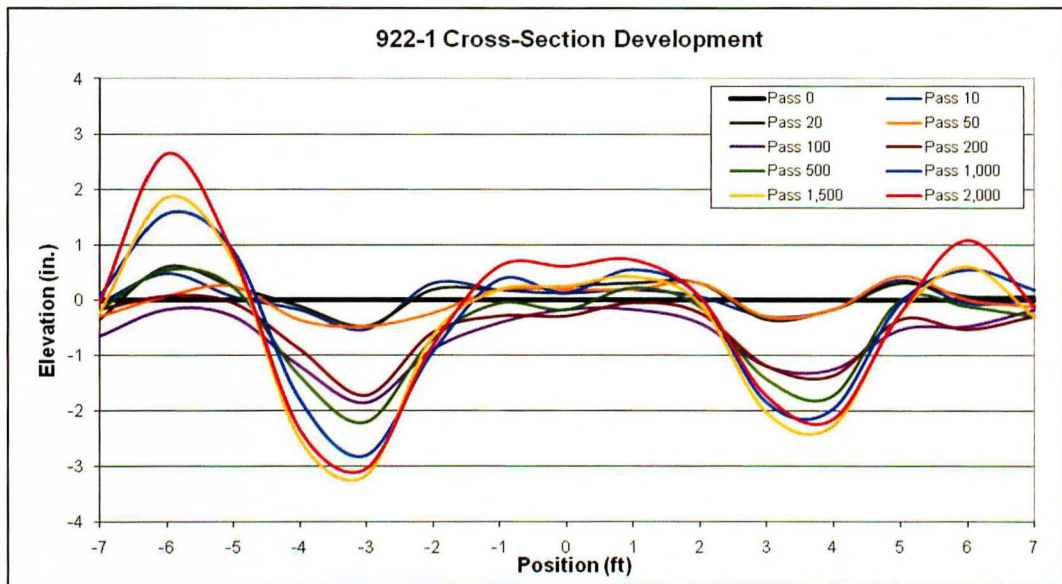
Figure 40. 922-1 cross-section development on SP-15.

Two individual rolls of the 922 replica system were delivered for evaluation. One of the rolls, labeled 922-1, was manufactured using three unique adhesives to determine which had the best performance. The other roll, labeled 922-2, utilized only one adhesive type. Since one of the rolls contained experimental adhesives, both were included in the traffic evaluation. The 922 panels were delivered to the SP-15 test roadway by a forklift and unrolled by three workers. T-stakes were driven along the panel edges approximately every 6 ft to hold the system flat on the subgrade. After 1,000 passes, cracks were noted in the panels where two individual sheets of material were bonded together with an adhesive. The cracks were located in areas that were not completely filled with adhesive. The lack of adhesive caused the area to remain unsupported and was damaged by tire impact as shown in Figure 38. The damage was minor and did not affect mat performance. Additionally, some of the nonskid material had begun to de-bond from the mat, as shown in Figure 39; however, the majority of the nonskid material remained intact. After 2,000 passes no additional damage was noted to the mat system, but rut depths measured 5.7 in. and 4.4 in. for the 922-1 and 922-2 panels, respectively. Therefore, the system was durable enough to resist breaking but was somewhat flexible, allowing rut formation to increase throughout trafficking. Rut depths are shown in Figure 32, cross-section development is shown in Figures 40 and 41, and the final condition is shown in Figure 42.

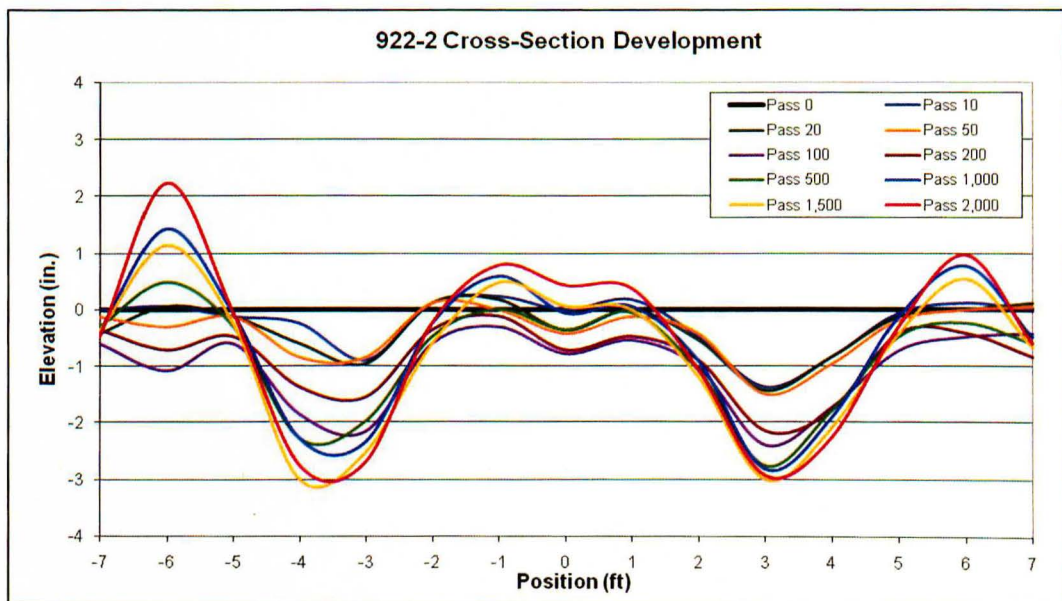
Figure 41. 922-2 cross-section development on SP-15.

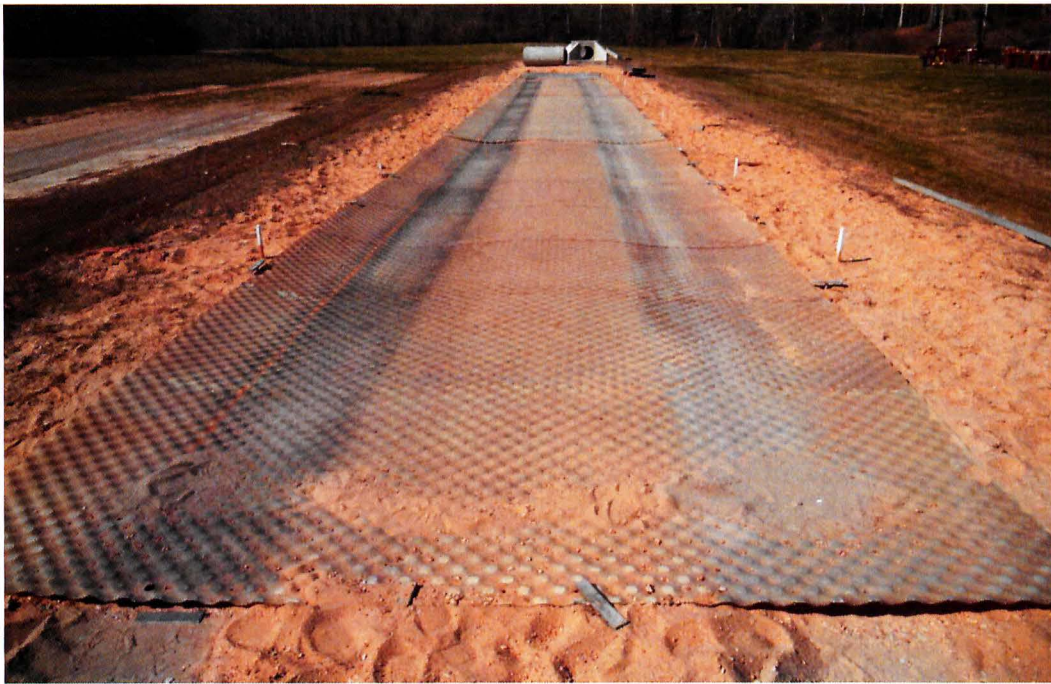
Figure 42. 922-1, 8101, and 922-2 after 2,000 passes on SP-15.

Two rolls of the 8101 system were delivered for trafficking. Both rolls were identical, so only one was used in the evaluation. The 8101 panels were delivered to the SP-15 test roadway by a forklift and unrolled by three workers. T-stakes were driven along the panel edges approximately every 6 ft to hold the system flat on the subgrade. After 1,000 passes, cracks were noted in the panels where two individual sheets of material were bonded together with an adhesive. The cracks were located in areas that were not completely filled with adhesive. The lack of adhesive caused the area to remain unsupported and was damaged by tire impact, as shown in Figure 43. The damage was minor and did not affect mat performance. Additionally, some of the nonskid material had begun to de-bond from the mat, as shown in Figure 44; however, the majority of the nonskid material remained intact. After 2,000 passes no additional damage was noted to the mat system, but rut depths measured 4.5 in. Therefore, the system was durable enough to resist breaking but was somewhat flexible, allowing rut formation to increase throughout trafficking. Rut depths are shown in Figure 32, cross-section development is shown in Figure 45, and final condition is shown in Figure 42.

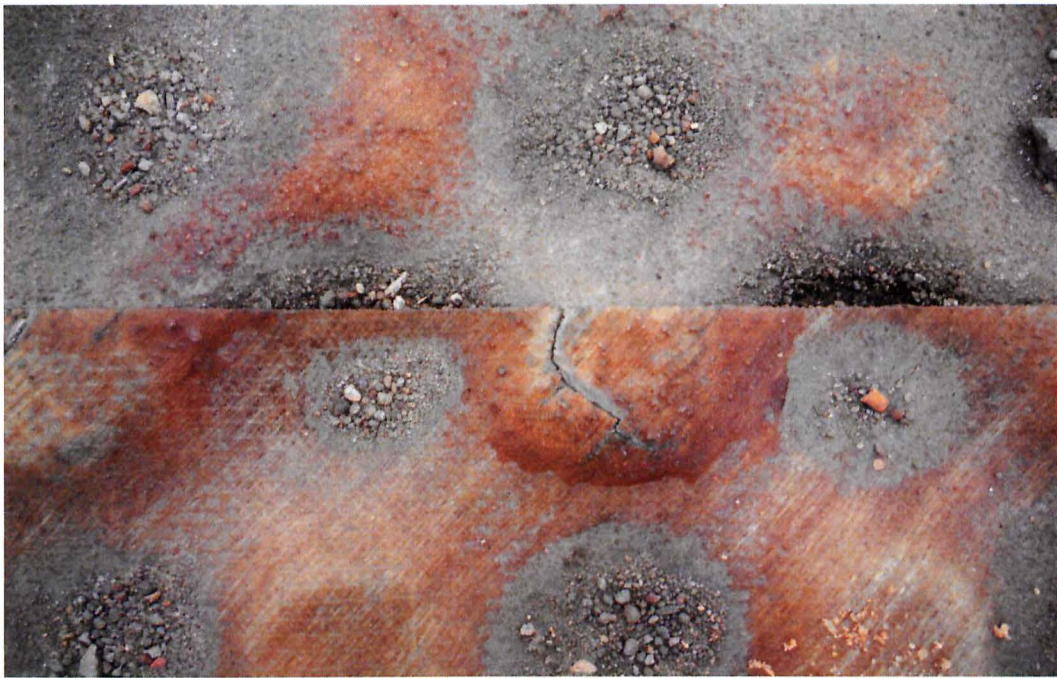
Figure 43. Crack formed from tire impact after 1,000 passes on 8101.

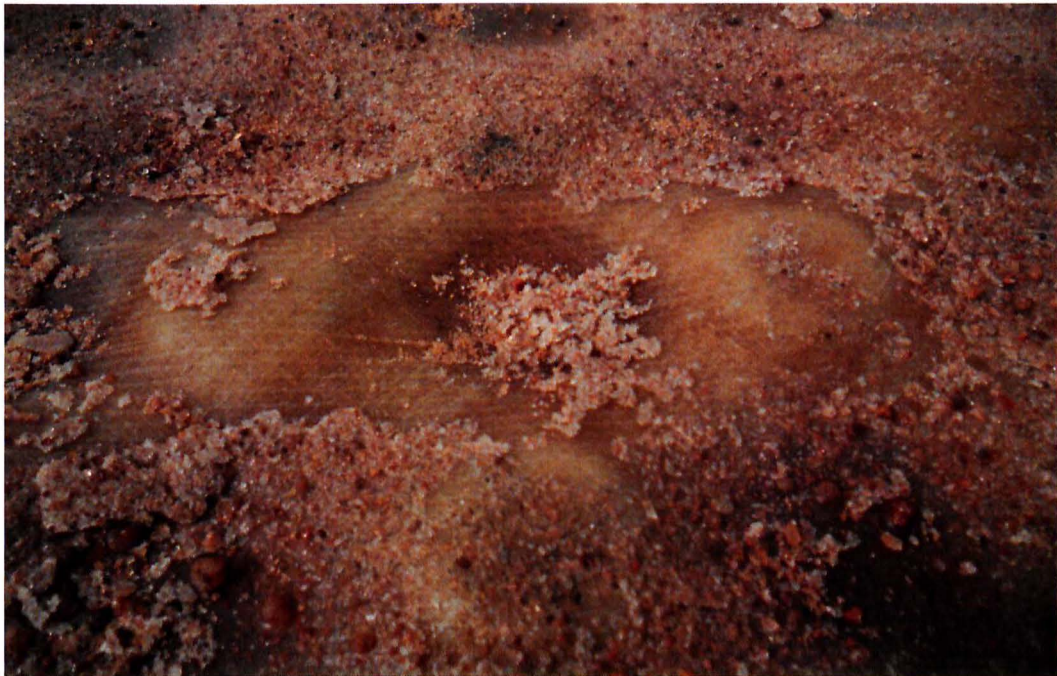
Figure 44. Debonded nonskid material after 1,000 passes on 8101.

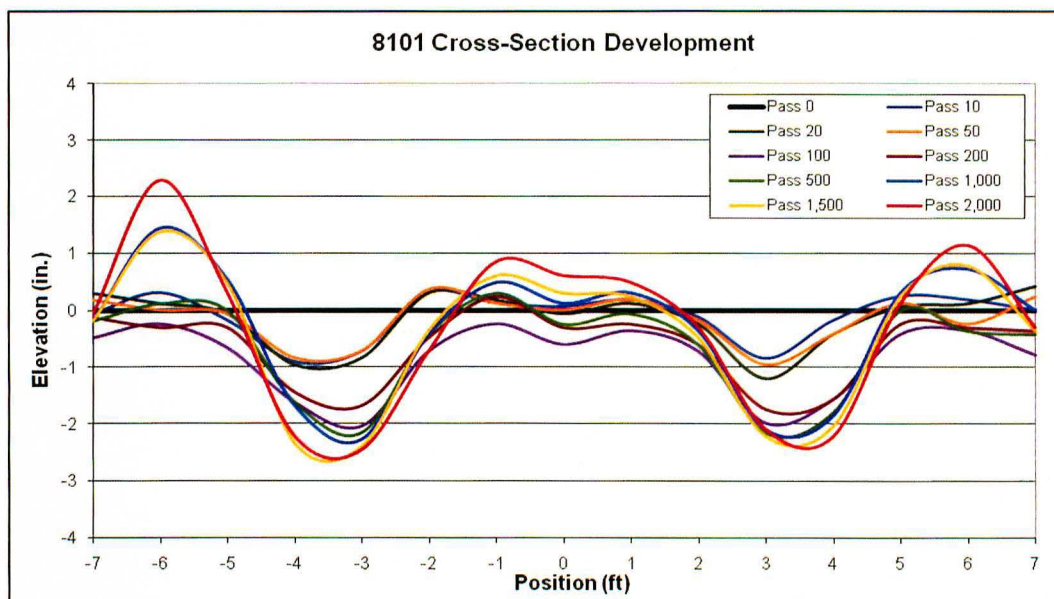
Figure 45. 8101 cross-section development on SP-15.

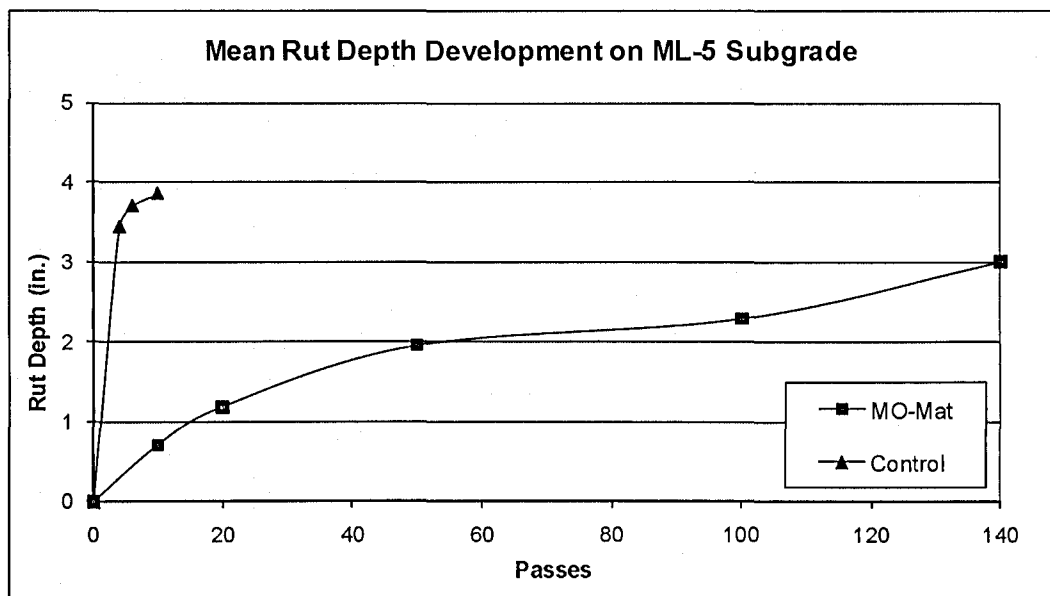
Figure 46. Average rut depth for mat systems on the ML-5 test section.

Only the original MO-Mat mat system was evaluated over the ML-5 test section. Results from evaluation of a control test section and the MO-Mat system are reported in this section. Figure 46 shows the rut depths measured with a straightedge and a ruler in one wheel path of the test vehicle. Each data point is the average of three readings taken at quarter points in one wheel path. The ML-5 subgrade did not exhibit the confining effects of the sand subgrade. Because of the limited bearing capacity of the material, failure was a function of densification and shear, or a function of outward movement of particles away from the applied stress. Densification occurred when voids were compressed in the material and water was forced from the voids. Shear failure was observed in the upheaval of material between the two wheel paths. Since the ML-5 subgrade was relatively weak, only a limited amount of data was collected prior to system failure.

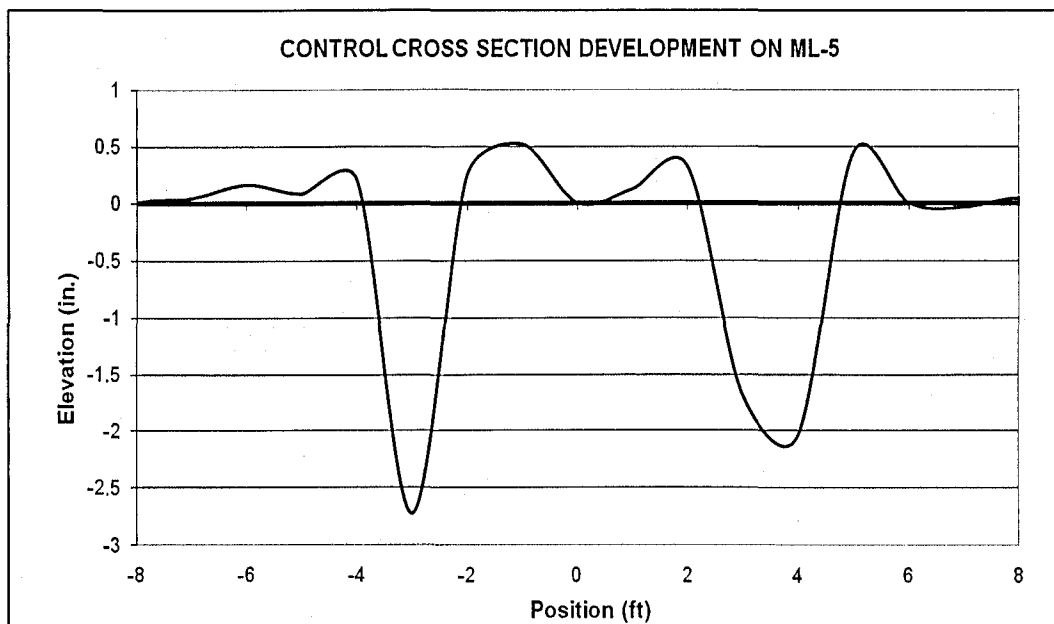
Figure 47. ML-5 control cross-section development after 10 truck passes.

A 100-ft-long, undisturbed section of the ML-5 test section was prepared for a control test. After four truck passes, the rut depth on the section measured 3.4 in. After 10 passes, the rut depth had increased to 3.9 in., and traffic was concluded because the 3-in. minimum rut depth failure had been exceeded. Rut depths are shown in Figure 46, cross-section development is shown in Figure 47, and the final condition is shown in Figure 48.

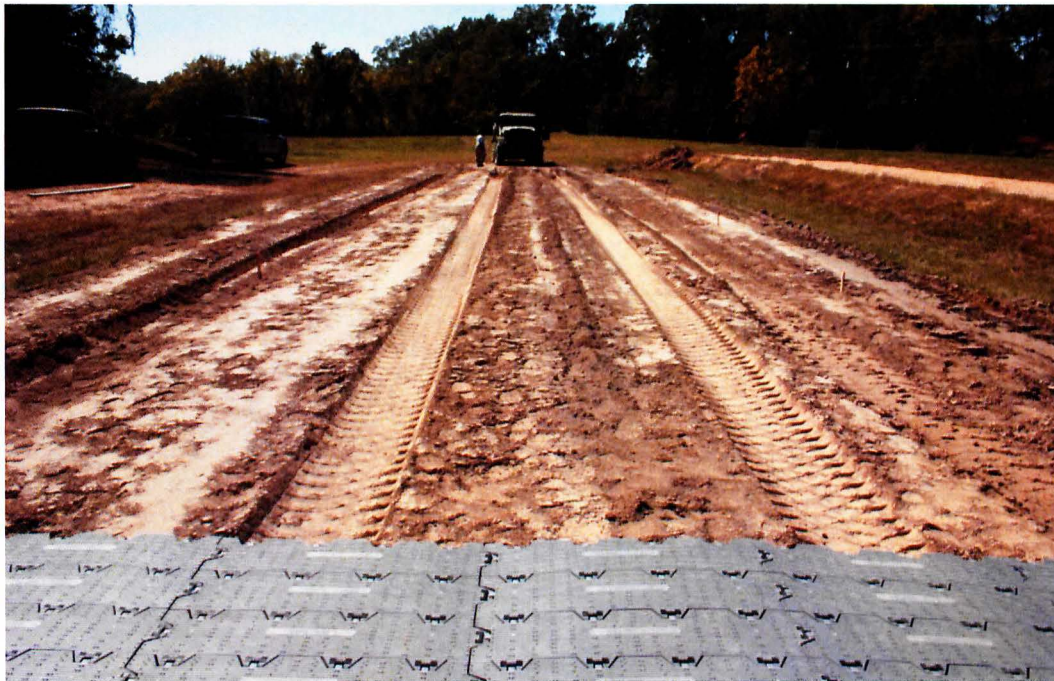
Figure 48. ML-5 control after 10 passes.

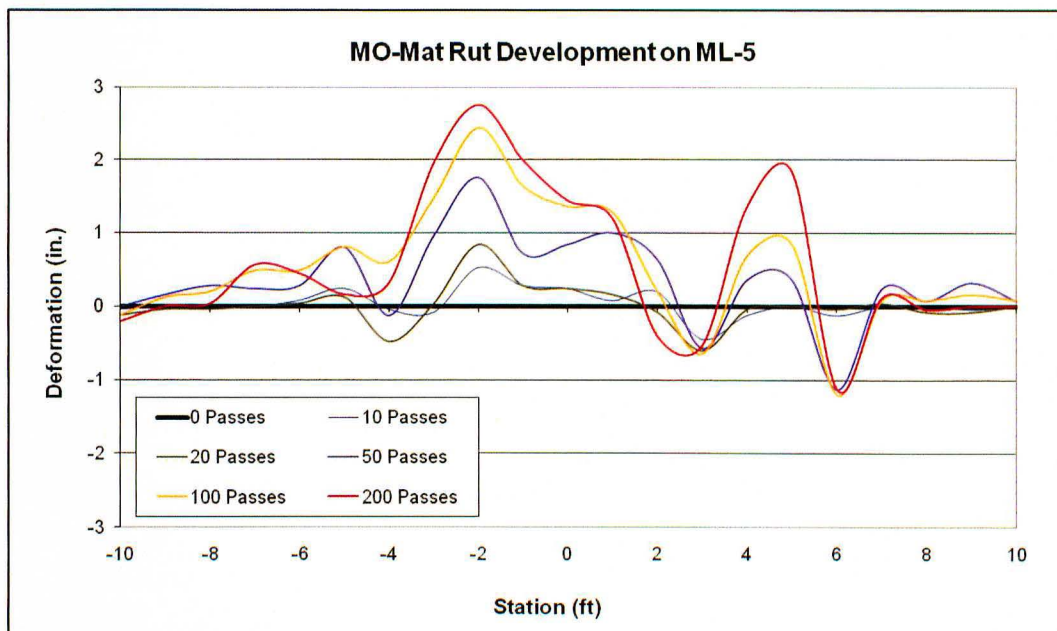
Figure 49. MO-Mat cross-section development on ML-5.

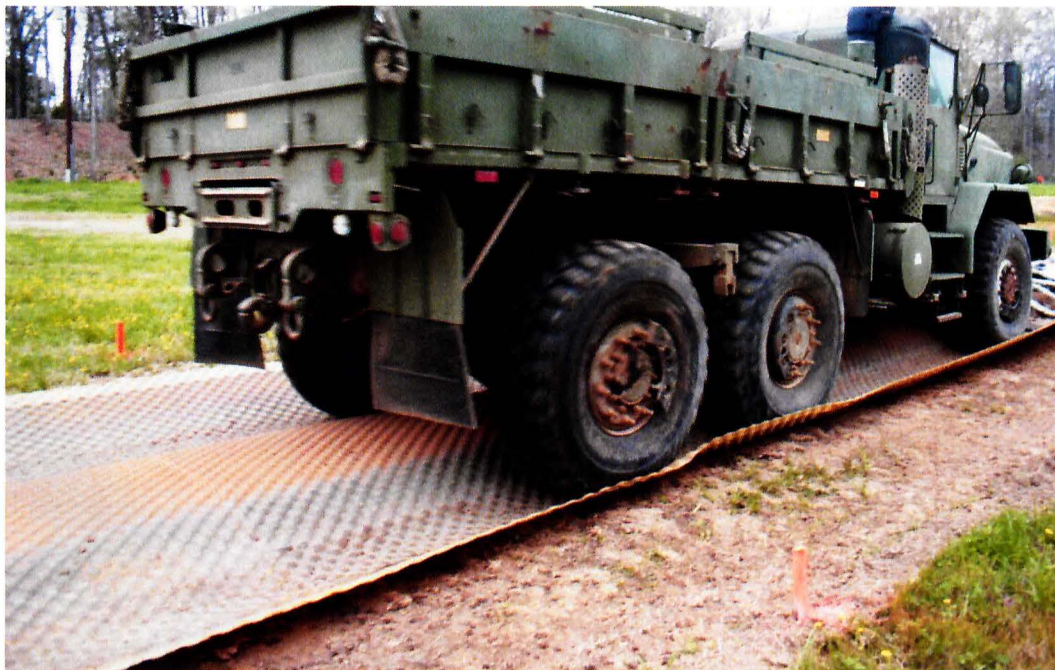
Figure 50. MO-Mat after 140 passes on ML-5.

A single MO-Mat panel was installed in the ML-5 test section and staked in all four corners with T-stakes. After 140 vehicle passes, only minor damage occurred to one end of the mat panel where the test vehicle's axle impacted the end. The impact occurred at the transition between the matted onramp and MO-Mat section. The damage consisted of two mat tears approximately 12-in. long and did not cause any trafficking difficulty. The rut depth, however, had reached 3.0 in. after 140 passes, and traffic was concluded because of rut failure. The flexible fiberglass system was unable to distribute the load of the trafficking vehicle over a sufficient area to reduce rutting. The system was durable enough to resist breaking and offered a good riding surface, even though the rut depths were significant. Rut depths are shown in Figure 46, cross-section development shown in Figure 49, and final condition is shown in Figure 50. Usable information from the cross section development in Figure 49 is difficult to discern. Because of the large amount of upheaval between the two wheel paths and bridging of the ruts by the mat, an accurate depiction of the rut formation could only be obtained by collecting similar data on the subgrade after removal of the mat system. Figure 51 shows a plot of the average cross sections measured on the subgrade surface at three quarter points at the conclusion of trafficking. Based on the information presented in Figure 51, the final rut depth on the MO-Mat system was closer to 4.0 in.

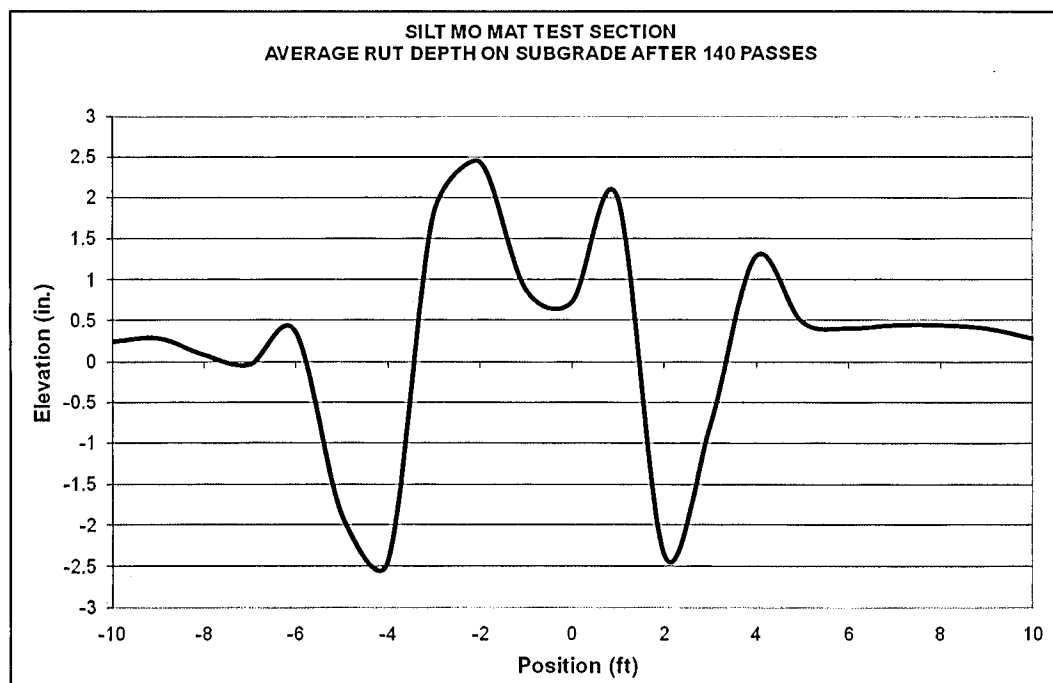
Figure 51. Mo-Mat subgrade average cross-section after 140 passes.

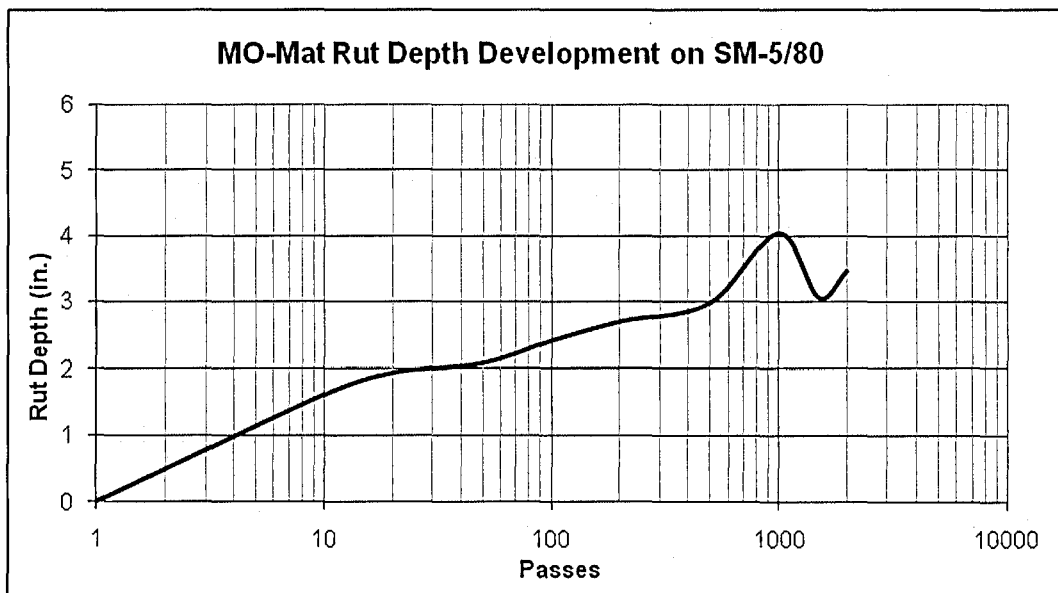
Figure 52. Average rut depth on MO-Mat system on the SM-5/80 subgrade.

Figure 52 shows the rut depths measured with a straightedge and a ruler in one wheel path of the test vehicle. As in previous sections, each data point represents the average of three readings taken at quarter points in one wheel path. As described for the ML-5 test section, the SM-5/80 subgrade did not exhibit the confining effects of the sand subgrade and failed from a combination of densification of voids and shear. After 1,000 passes, snow began to accumulate on and around the mat, and the subgrade continued to freeze. The rut depth measurements decreased because of the packing and refreezing of snow on the mat surface and hardening of the subgrade underneath the mat.

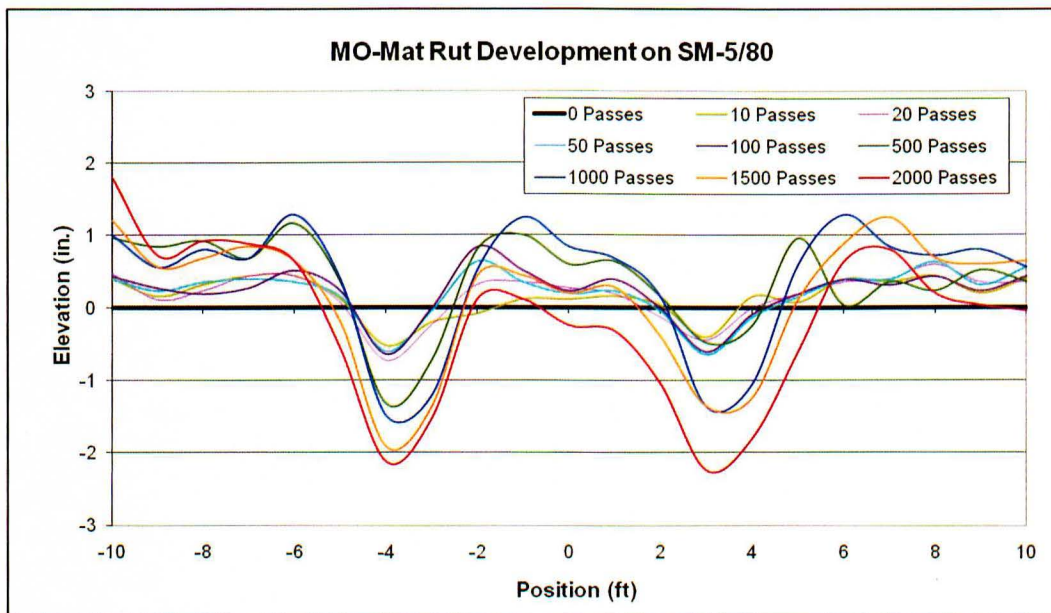
Figure 53. MO-Mat cross-section development on SM-5/80.

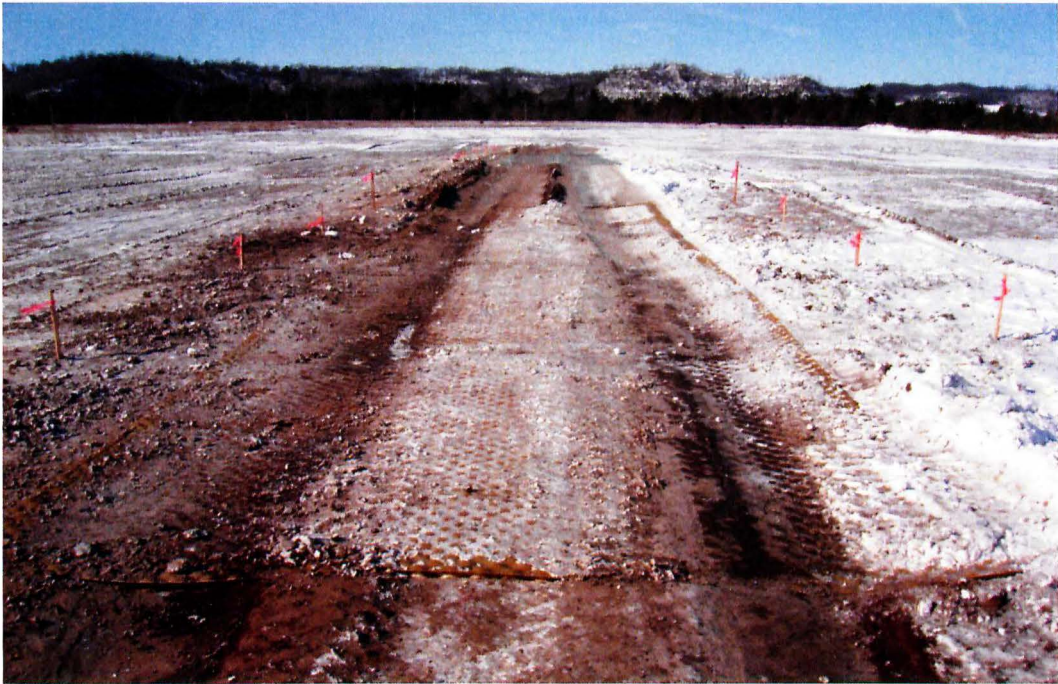
Figure 54. MO-Mat after 2,000 passes on SM-5/80.

A 48-ft long roll of MO-Mat was installed over the SM-5/80 subgrade for evaluation. As described previously, the mat acted to insulate the subgrade and prevent freezing of the upper surface; however, a thin sheet of ice covered the mat when trafficking began. No damage was noted to the MO-Mat system when traffic was concluded after 2,000 passes. However, the average rut depth reached 3.0 in. after 500 passes and increased to 4.0 in. after 1,000 passes. The fiberglass system was unable to distribute the load of the test vehicle over a sufficient area to reduce rutting, but it was durable enough to resist breaking and offered a good riding surface, even though the rut depths were significant. Rut depths are shown in Figure 52 and cross-section development is shown in Figure 53. At the conclusion of trafficking, the panel was hooked to a tow strap, pulled off the test section by a forklift, turned over to remove the snow and ice, re-rolled by three workers, strapped to a truck, and remained in usable condition. The final condition of the mat on the SM-5/80 test section is shown in Figure 54.

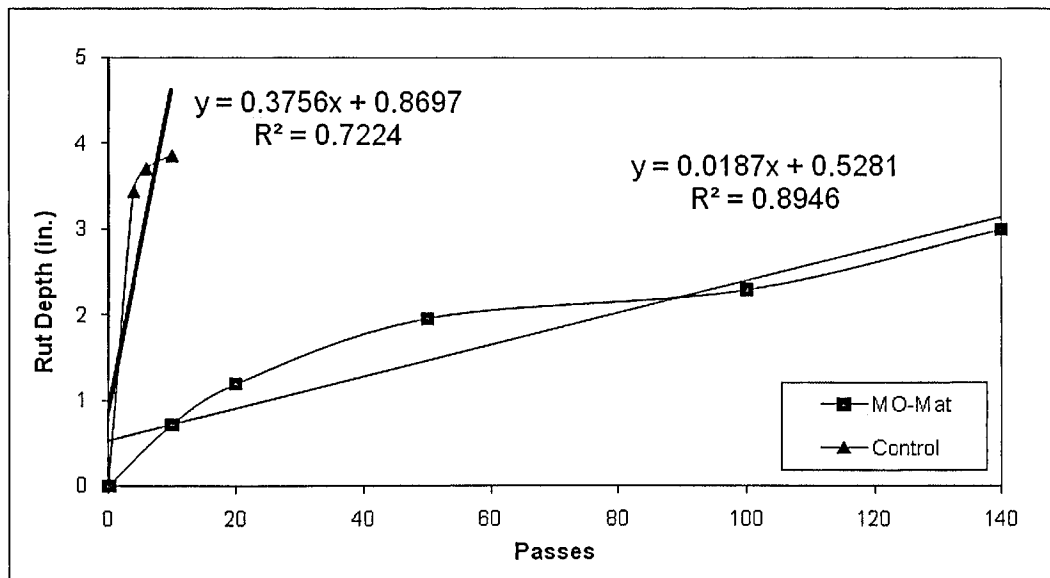
Figure 55. Example of linear regressions used for performance prediction.

resulting values were less conservative and poorer predictions were derived. Therefore, when using Equations 1 and 2, a positive rut value will occur for zero passes, although intuition should reveal no rutting has occurred. The regression coefficients presented in Table 3 can be used in their respective equations, Equation 1 or Equation 2, for rut prediction.
