# **Building Envelope and Infrastructure Assessment Using an Integrated Thermal Imaging and Lidar Scanning System**

Amundsen-Scott South Pole Station, Antarctica

June 2018

Final Report

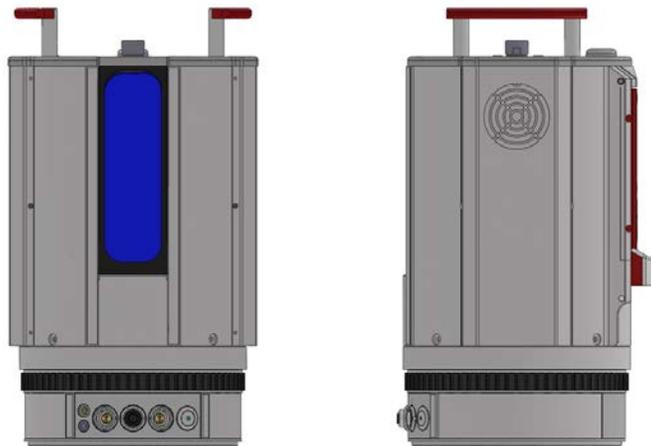
Figure 1. Riegl VZ-1000 TLS lidar scanner (front and side views) used in the lidar/TIR system. The sensor is portable and light enough for one person to carry and setup in the field.

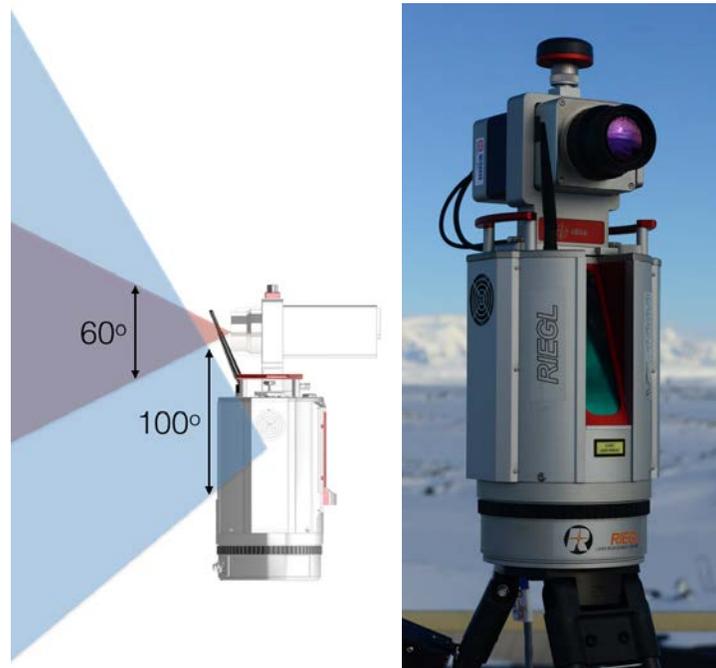
Figure 2. *Left:* Field-of-view of the lidar sensor (*blue shaded area*) compared with the FOV of the TIR (*red shaded area*). While the lidar sensor has a wider FOV, the typical setup of the system places the focus object (building) within the narrower TIR FOV, providing full coverage from both sensors. *Right:* Lidar/TIR system in use.

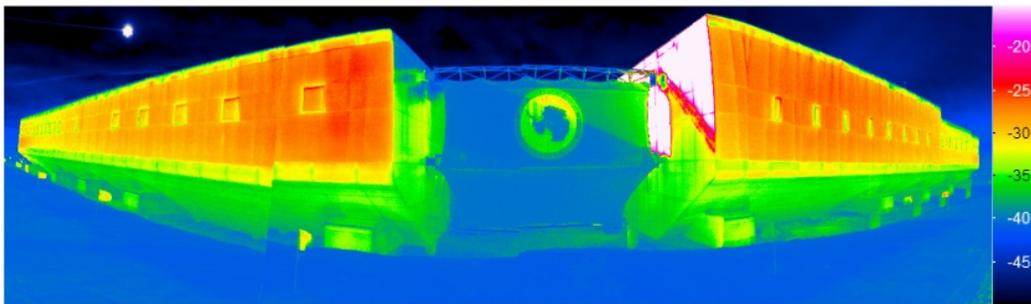
Figure 3. Panoramic thermal image, colored by temperature ( $-50^{\circ}\text{C}$  to  $-15^{\circ}\text{C}$ ), of the South Pole Elevated Station taken from Scan Position 3. The image is composed from five individual images collected by the TIR camera. The image captures consistent temperature values on similarly oriented building surfaces. The breezeway cover (with USAP logo) and right side of the building show the influence of direct solar exposure on radiometric readings through high temperature measurements, shown as white surfaces.

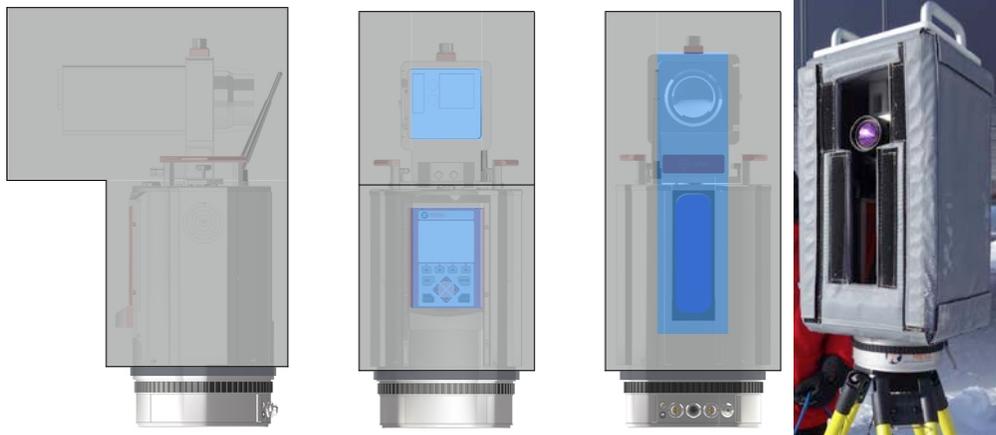
Figure 4. *Left*: CAD (computer-aided design) model of the thermal jacket design concept for the lidar/TIR system. *Gray* panels represent permanent surfaces when installed while *blue* panels are removable for system operation. *Right*: Final thermal jacket system deployed at South Pole Station. The front panels are removed for data acquisition, and the nylon plate on the top of the jacket provided structural rigidity and handles for transport.

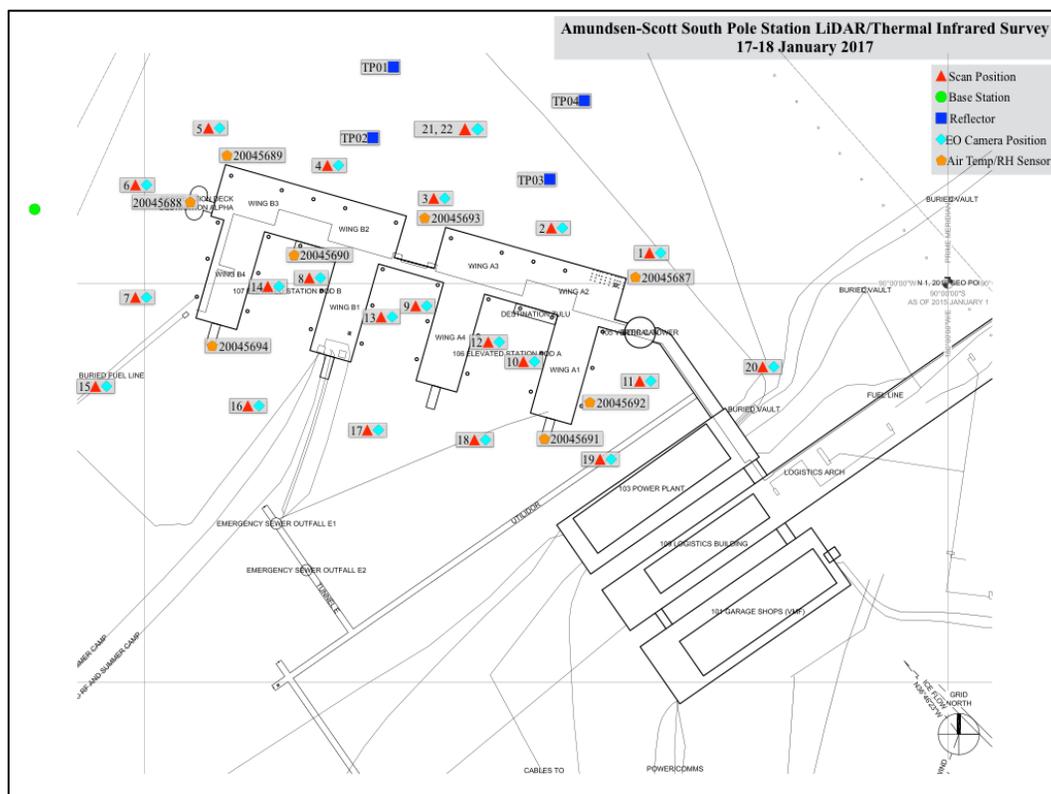
Figure 5. Survey map indicating the location of scan positions (*red triangles*), GNSS base station and reflectors (*green circle* and *blue squares*, respectively), electro-optical image acquisition positions (*aqua diamonds*), and external air temperature sensor placement (*orange pentagons*).

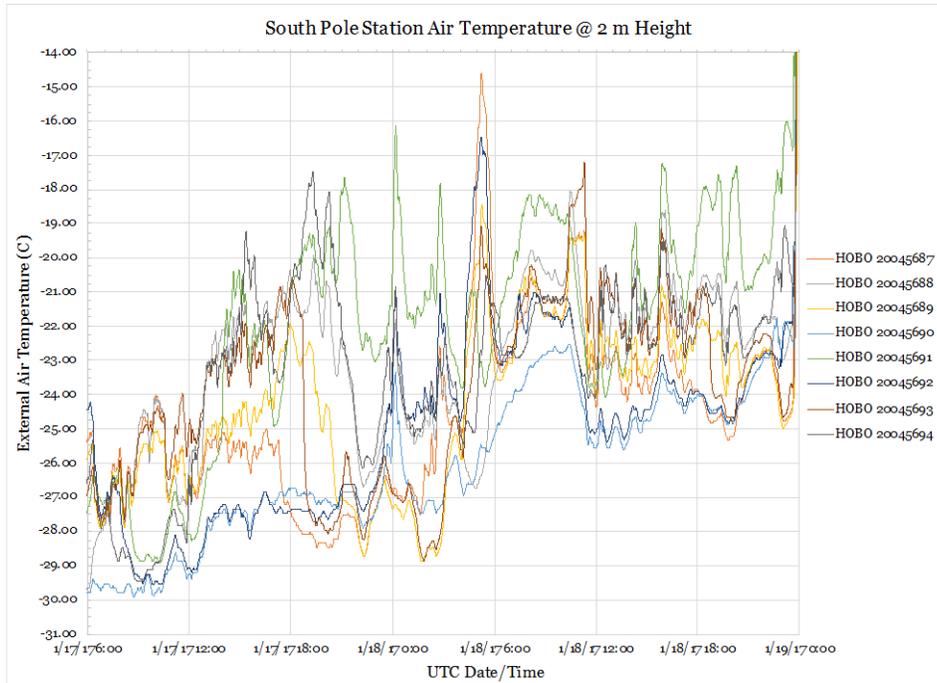
Figure 6 shows a plot of all external air temperature measurements during the survey period. Variations in temperature measurements are due to different conditions at each location, including aspect, solar exposure, wind, and proximity to warmer objects (e.g., building surfaces, vehicles, and infrastructure). These measurements are referenced when assessing the 3-D thermal model, providing in situ data for comparing and validating TIR measurements and thermal-deficiency findings.

Figure 6. Air temperature measurements from eight sensors temporarily installed around the exterior of the South Pole Elevated Station during the lidar/TIR survey. See Appendix B for placement locations. Variation in temperatures is due to sensor location and the effects of solar exposure and winds.

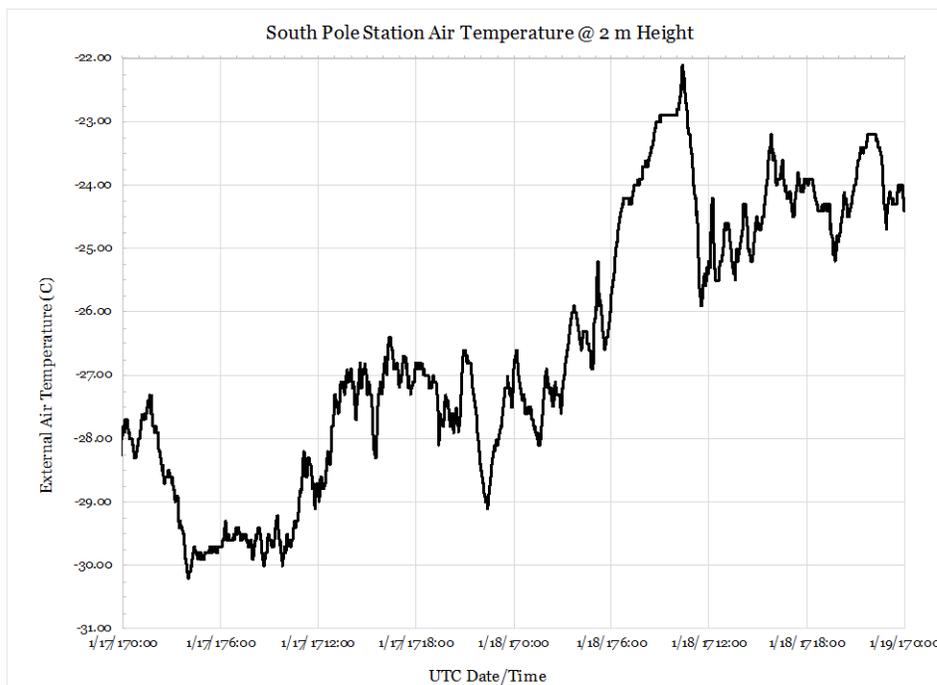
Figure 7. Plot of air temperature measurements for 17–19 January 2017 from the South Pole Observatory meteorological station, taken from 2 m above the snow surface. A minimum temperature of  $-30.2^{\circ}\text{C}$  occurred in the early morning of 17 January, and a maximum temperature of  $-22.1^{\circ}\text{C}$  occurred mid-morning on 18 January.

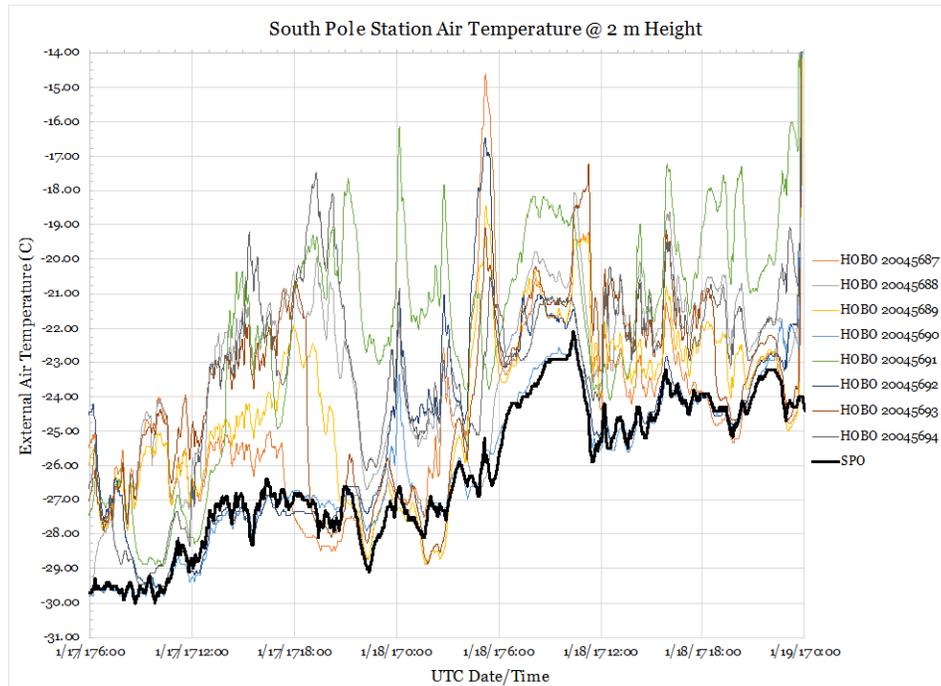
Figure 8 compares the temporary air temperature sensor measurements with the SPO data. The SPO data agree well with nearby HOBO air temperature sensors.

Figure 8. Plot of air temperature measurements for 17–19 January 2017 from all HOBO air temperature sensors (*color lines*) and the South Pole Observatory meteorological station (*black line*). Variations occur likely due to differences in location and thus atmospheric conditions.

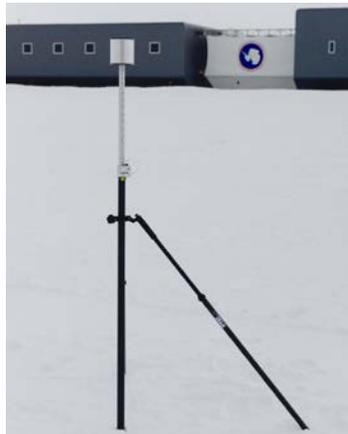
Figure 10. A 10 cm cylinder reflector setup during the South Pole lidar/TIR survey. The reflectors, with 10 cm height/diameter dimensions, provide reference coordinates used to tie the 3-D model to a global coordinate system.

A single RTK survey was completed for the South Pole survey as it is necessary to have only one lidar scan with the reflectors visible to georeference the entire dataset. The reflectors are 10 cm height/diameter cylinders covered in a reflective tape that is easily identified within a reflectance-colored point cloud. Four reflectors were distributed around scan position 22 and were surveyed on 19 January 2017 and had a height offset of the GNSS antenna applied to log the centroid of each reflector cylinder (Figure 11). Reference Figure 5 and Appendix B for scan position 22, GNSS base station, and reflector locations. We then collected high-resolution "tiepoint scans" during the lidar/TIR data acquisition procedure for scan position 22 and used them to precisely fit the point cloud to the UPS South coordinate system.

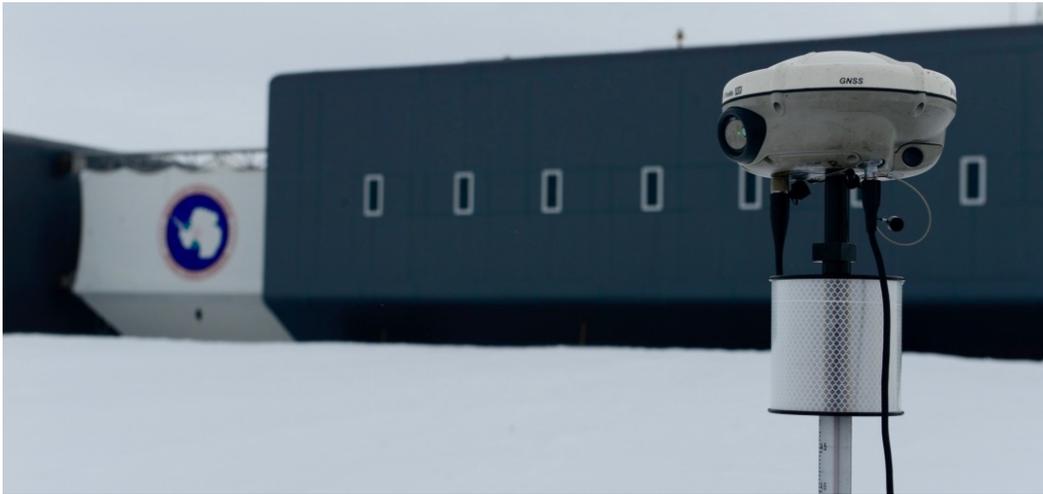
Figure 11. A 10 cm reflector cylinder with Trimble R8 antenna setup, highlighting the need to apply a height offset from the antenna measurement point to the cylinder centroid.

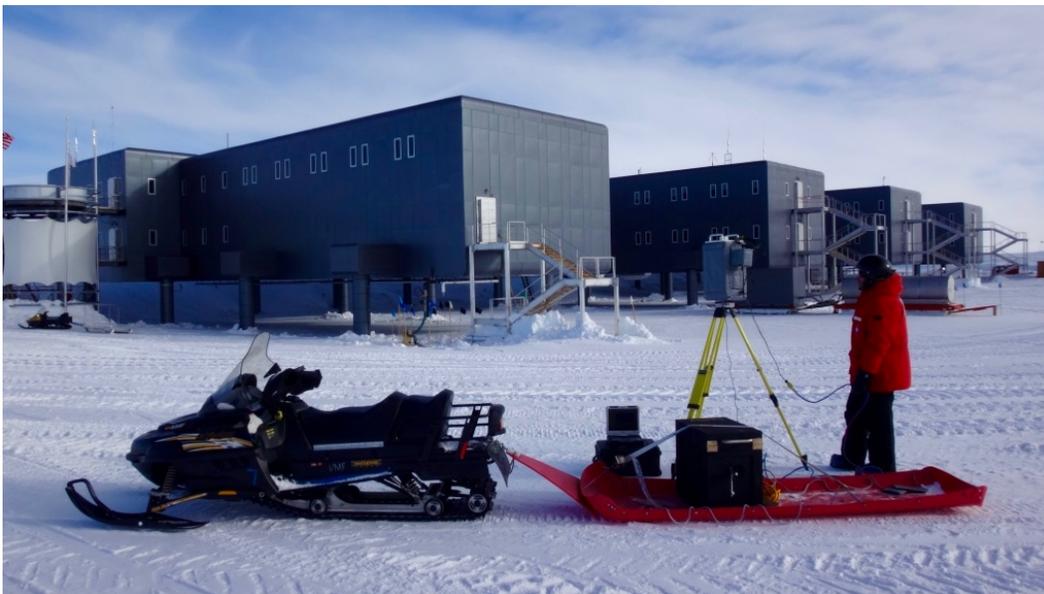
Figure 13. Author David Finnegan operating CRREL's lidar/TIR system at the South Pole Station. The thermal jacket was designed specifically for this survey, maintaining the minimum operating temperatures for both sensors. A generator, housed in the enclosure located on the snowmobile sled, provides power to both the system and the thermal jacket.

The lidar/TIR system includes a Riegl VZ-1000 laser scanner; InfraTec VarioCAM HD thermal infrared camera; and for extreme cold temperature operations, a custom thermal jacket to maintain minimum operating temperatures for the lidar and TIR sensors (Figure 13). The system was mounted to a fiberglass survey tripod, which is both lightweight and less prone to thermal expansion/contraction compared to similar metal tripods. External batteries typically used for powering the system would have experienced dramatically reduced performance due to cold temperatures at the South Pole. Additionally, the thermal jacket requires 110VAC power; therefore, a portable generator (Honda EU2000) supplied by Station management was used to power both the lidar/TIR system and the thermal jacket (Figure 13). The generator, housed inside an insulated enclosure to retain heat, was towed behind a snowmobile between each scan position. Both lidar and TIR sensors were controlled by a ruggedized PC. The lidar sensor uses wireless communication while the TIR was connected via Ethernet cable to the PC. The PC was kept inside the operator's jacket between scan positions to maintain operating temperatures.

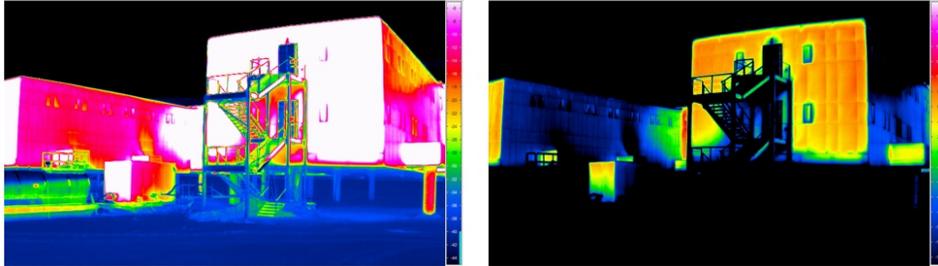
Figure 19. A thermal image of wing B1 taken from scan position 17. Because of direct solar exposure on the end wall, the thermal values are elevated, reducing the level of detail visible across a wider temperature scale of  $-45^{\circ}\text{C}$  to  $-5^{\circ}\text{C}$  (*left*). By altering the temperature scale of the thermal image ( $-15^{\circ}\text{C}$  to  $20^{\circ}\text{C}$ ) to optimize detail in the solar-exposed sections, relative thermal differences are apparent (*right*). Conversely, lower temperatures (snow and shaded surfaces) lose definition with the solar-exposed temperature scale.

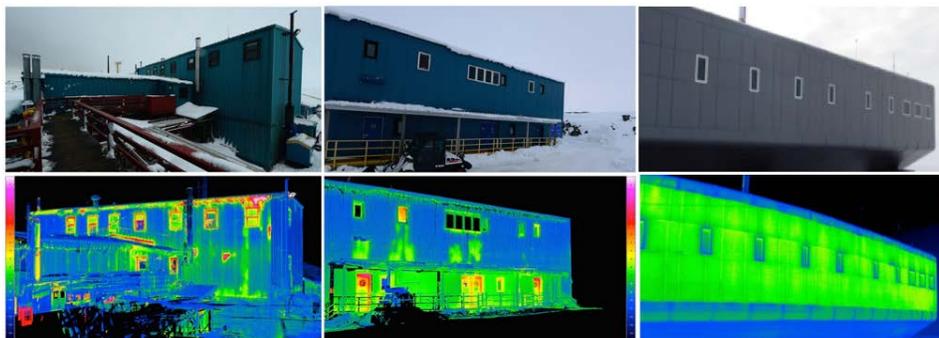
Figure 20. Comparison of Palmer Station and South Pole Station lidar/TIR results. *Left*: Palmer Station Biolab,  $5^{\circ}\text{C}$  to  $-15^{\circ}\text{C}$  scale. *Middle*: Palmer Station GWR (garage, warehouse, and recreation) building,  $5^{\circ}\text{C}$  to  $-15^{\circ}\text{C}$  scale. *Right*: South Pole Station Wing B3 North,  $5^{\circ}\text{C}$  to  $-45^{\circ}\text{C}$  scale. While the temperature scales are different due to differences in air temperature from each survey, the thermal deficiencies in the Palmer Station buildings are obvious while South Pole Station displays a significantly more uniform temperature scale.

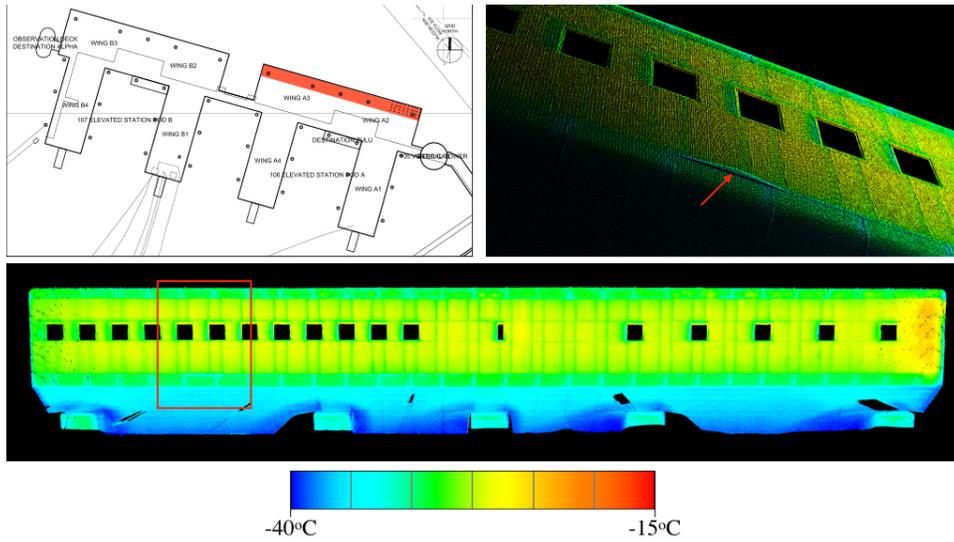
Figure 21. A 3-D thermal model of Wings A2/A3. Overall the exterior surface on the north side of Wings A2 and A3 is at a consistent temperature with little heat loss emanating from the windows. Structural insulated panels (SIP) and trim are easily identified by the consistent lower temperature of the trim. A detached piece of trim was identified by its lower temperature compared to adjacent, attached trim. The overhanging, down-facing exterior portion of the Pod A subfloor is consistently lower in temperature, likely due to unused crawl space and proximity to the snow surface. *Top left:* Focus section highlighted in red on the Elevated Station map. *Bottom:* North side of Wings A2 and A3,  $-40^{\circ}\text{C}$  to  $-15^{\circ}\text{C}$  scale. Temperature differences between SIP and trim are visible. The section with detached trim is outlined in red. *Top right:* Underside view of a piece of detached trim identified initially by its lower temperature.

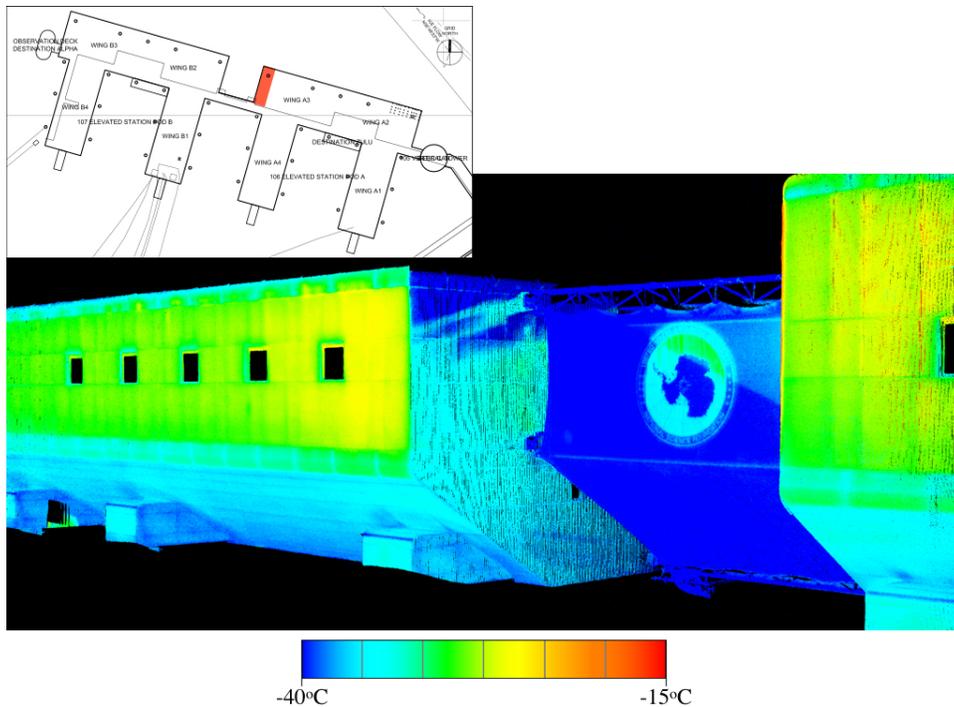
Figure 22. A 3-D thermal model of Wing A3 West. *Top left:* Focus section highlighted in red on the Elevated Station map. *Bottom:* Wing A3 West at a  $-40^{\circ}\text{C}$  to  $-15^{\circ}\text{C}$  scale.

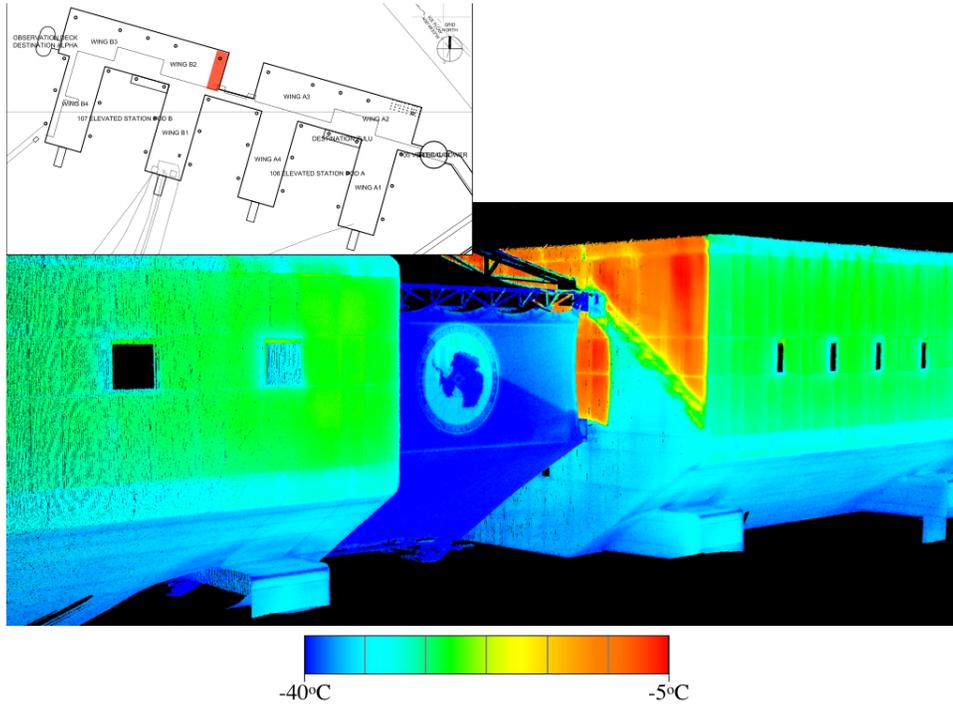
Figure 23. A 3-D thermal model of Wing B2 East. While the north facing sides of Wing A3 and B2 display consistent temperatures, the East face of Wing B2 is partially exposed to direct sunlight, causing an area of higher temperatures. Differences between SIP and trim are still observable. *Top left:* Focus section highlighted in red on the Elevated Station map. *Bottom:* Wing B2 East at a  $-40^{\circ}\text{C}$  to  $-5^{\circ}\text{C}$  scale. Solar-exposed surfaces on the upper right side of Wing B2 East result in significantly higher radiometric measurements with the TIR camera (red/orange sections).

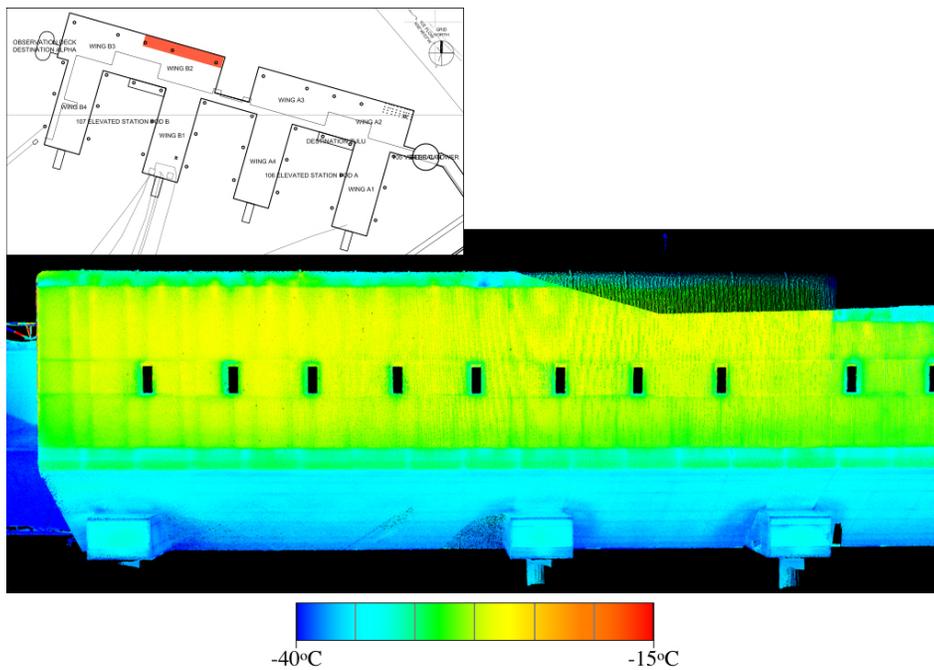
Figure 24. A 3-D thermal model of Wing B2 North. *Top left:* Focus section highlighted in red on the Elevated Station map. *Bottom:* Wing B2 North at a  $-40^{\circ}\text{C}$  to  $-15^{\circ}\text{C}$  scale.

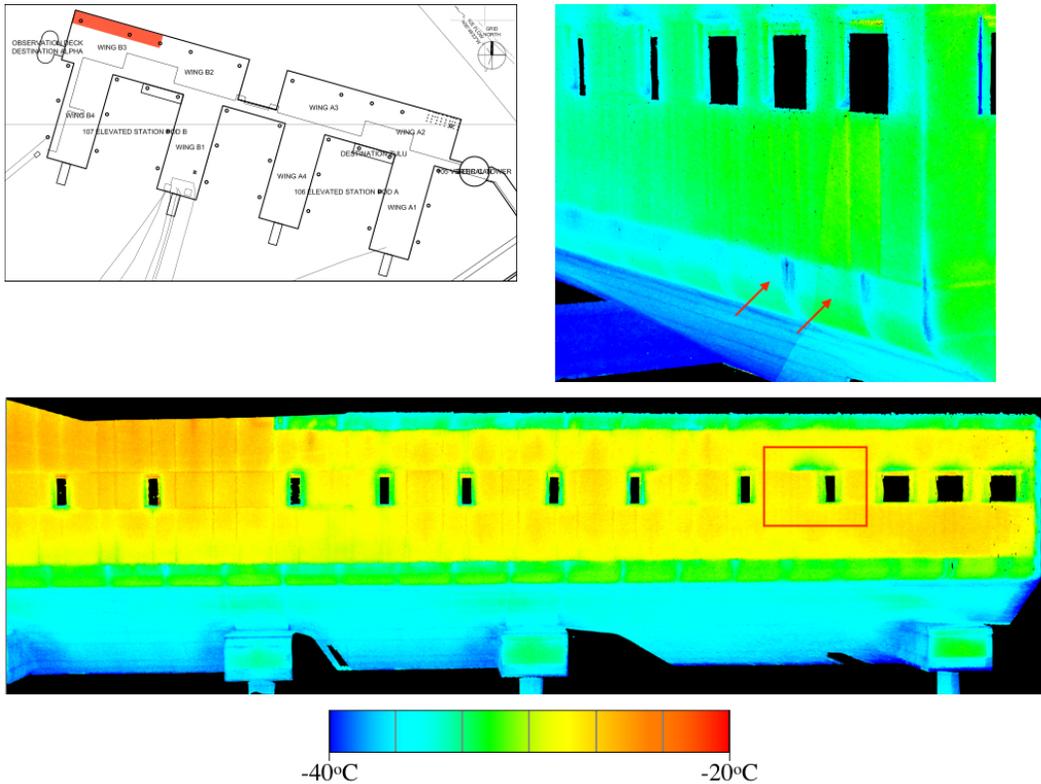
Figure 25. A 3-D thermal model of Wing B3 North. On Wing B3 North, two areas of interest were identified by using the thermal values in combination with the 3-D point cloud. First, an area of slightly detached SIP trim is visible above and to the left of the fourth window from the right. Fig. 26 shows an electro-optical image of this area. Likewise, two pieces of vertical trim towards the right side of the wall are detached, as noticed through lower temperatures. *Top left*: Focus section highlighted in red on the Elevated Station map. *Bottom*: Wing B3 North at a  $-40^{\circ}\text{C}$  to  $-20^{\circ}\text{C}$  scale. Trim detachment was identified on the fourth window from the right (*red square*) and on two vertical trim pieces (*top right*).

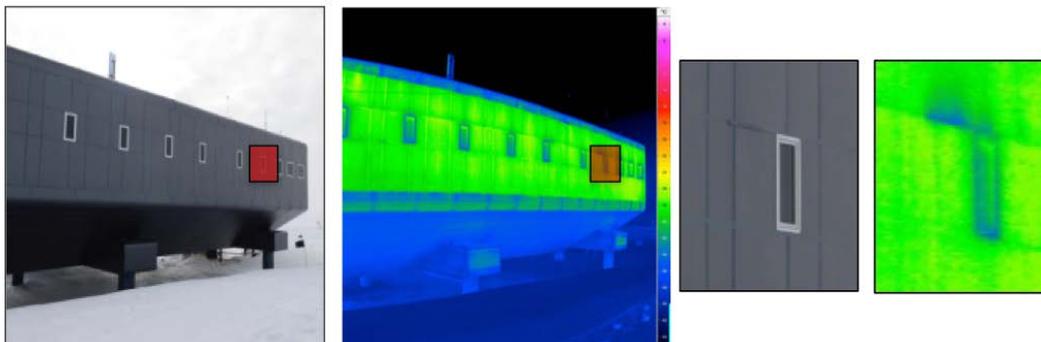
Figure 26. Wing B3 North SIP trim detachment. Temperature variation at SIP trim, allowing identification of trim fit issues and/or damage. The electro-optical image confirms the trim piece in question is dislodged from the SIPs.

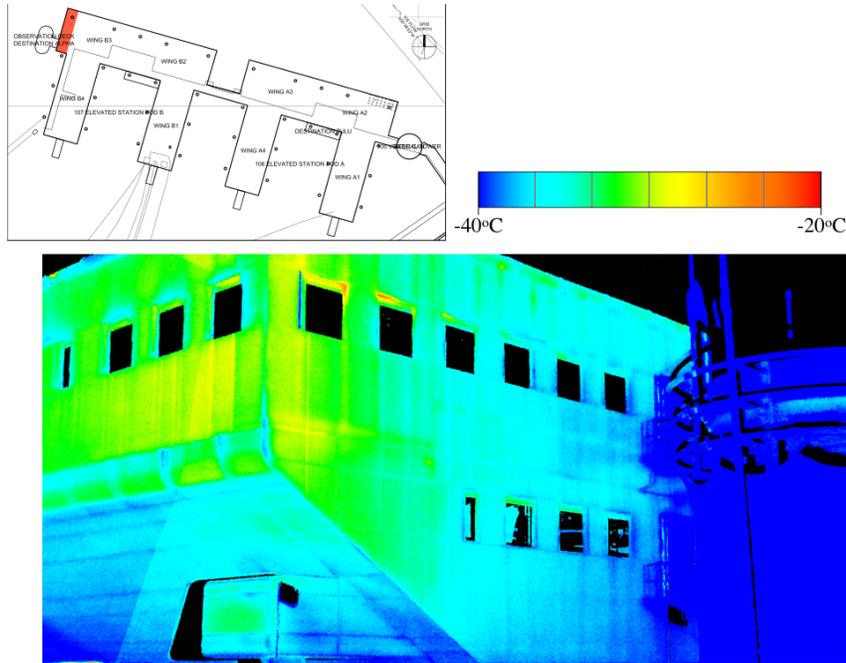
Figure 27. A 3-D thermal model of Wing B3 West and portion of Observation Deck Destination Alpha. *Top left:* Focus section highlighted in red on the Elevated Station map. *Bottom:* Wing B3 West at a  $-40^{\circ}\text{C}$  to  $-20^{\circ}\text{C}$  scale.

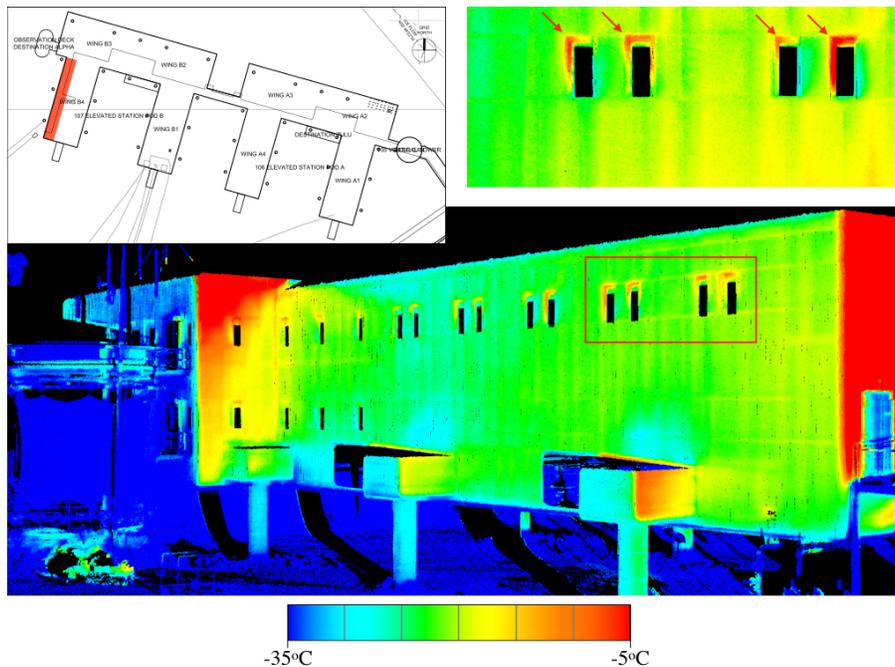
Figure 28. A 3-D thermal model of Wing B4 West. The second floor windows on Wing B4 West show signs of significant temperature differences. The interior temperatures of this section (the gymnasium) fluctuate between  $18^{\circ}\text{C}$  and  $20^{\circ}\text{C}$  throughout the lidar/TIR survey, so it is possible there was heat loss occurring from these windows. *Top left:* Focus section highlighted in red on the Elevated Station map. *Bottom:* Wing B4 West at a  $-35^{\circ}\text{C}$  to  $-5^{\circ}\text{C}$  scale. The red box indicates windows with high thermal gradients above and along the sides of the frames. *Top right:* Detail view of the windows in questions.

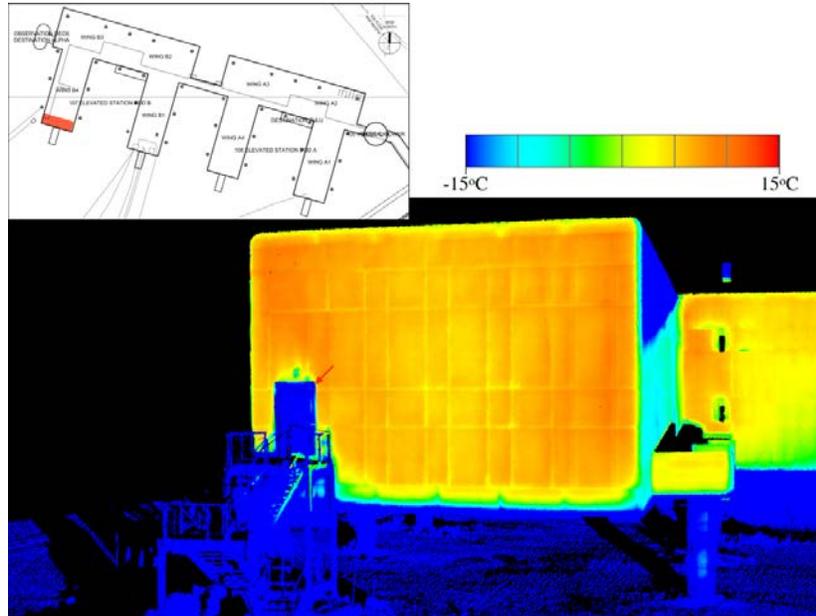
Figure 29. A 3-D thermal model of Wing B4 South. Because of direct solar exposure on the Wing B4 South external surface throughout our entire time on station, the TIR measurements are significantly higher than the unexposed sections. Increasing the color scale temperature values better shows relative temperature differences. Of note is the lack of any substantial heat loss from the first floor door, indicating that the doors, designed for industrial freezers, are performing well. *Top left:* Focus section highlighted in *red* on the Elevated Station map. *Bottom:* Wing B4 South at a  $-15^{\circ}\text{C}$  to  $15^{\circ}\text{C}$  scale. Because of direct solar exposure, all south-facing surfaces must be displayed with higher color scale temperatures to reveal relative surface-temperature differences. The *red arrow* highlights almost no heat loss emanating from the doorway.

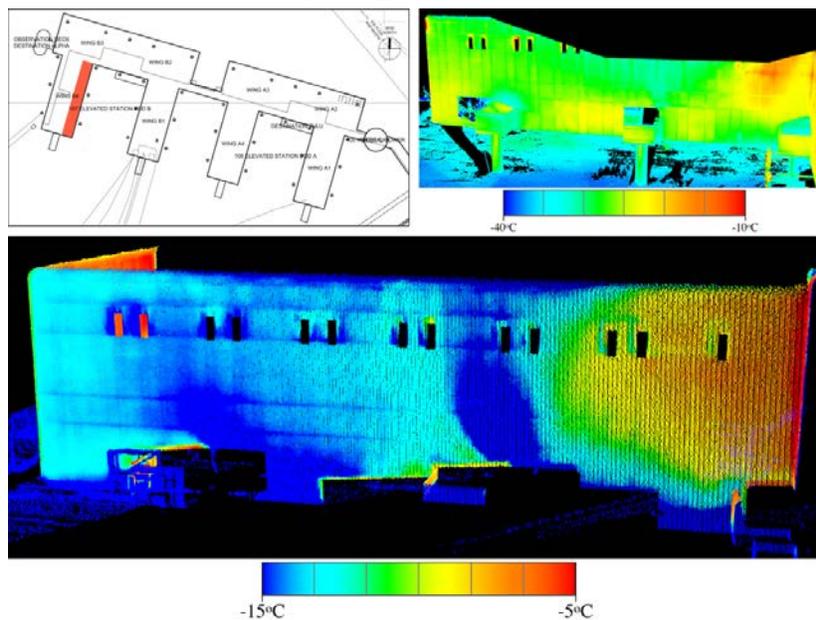
Figure 30. A 3-D thermal model of Wing B4 East. *Top left:* Focus section highlighted in *red* on the Elevated Station map. *Bottom:* Wing B4 South at a  $-15^{\circ}\text{C}$  to  $-5^{\circ}\text{C}$  scale. *Top:* Wing B4 South at a  $-40^{\circ}\text{C}$  to  $-10^{\circ}\text{C}$  scale

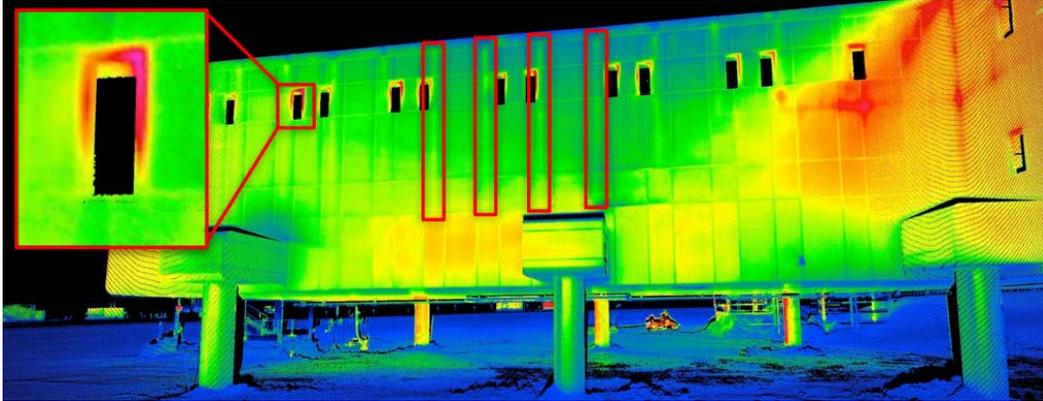
Figure 31. Wing B4 East. The four *red vertical rectangles* encompass areas of thermal bridging from the building frame structure, with measurements of up to 4 °C difference across the bridging sections. The enlarged window (*inset image*) identifies an area of heat loss of up to 20 °C difference (−29 °C to −9 °C). The windows located on Wing B4 West (Fig. 28), directly across from the highlighted window below, also show heat loss.

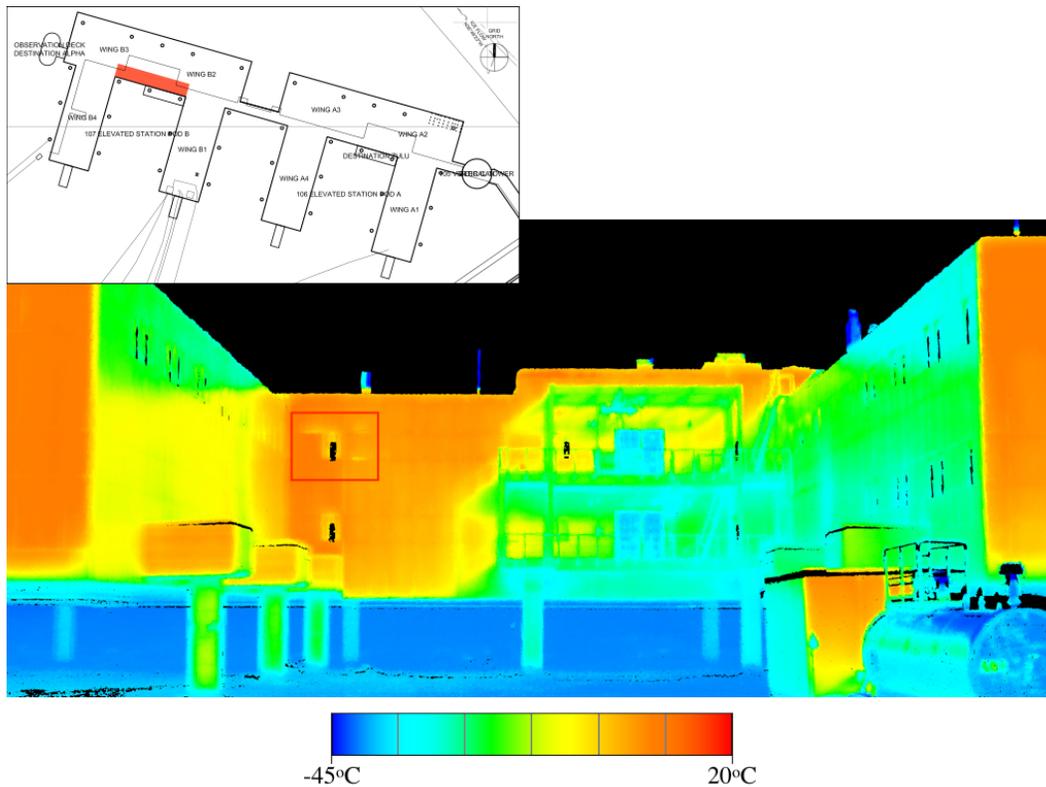
Figure 32. A 3-D thermal model of Wing B2/B3 South. *Top left:* Focus section highlighted in *red* on the Elevated Station map. *Bottom:* Wing B2/B3 South at a −45 °C to 20 °C scale. The temperature scale is wide due to areas of both exposed and unexposed to direct sunlight. A potential trim detachment was observed adjacent to the second floor left window on the B2/B3 South face, highlighted by the *red box*.

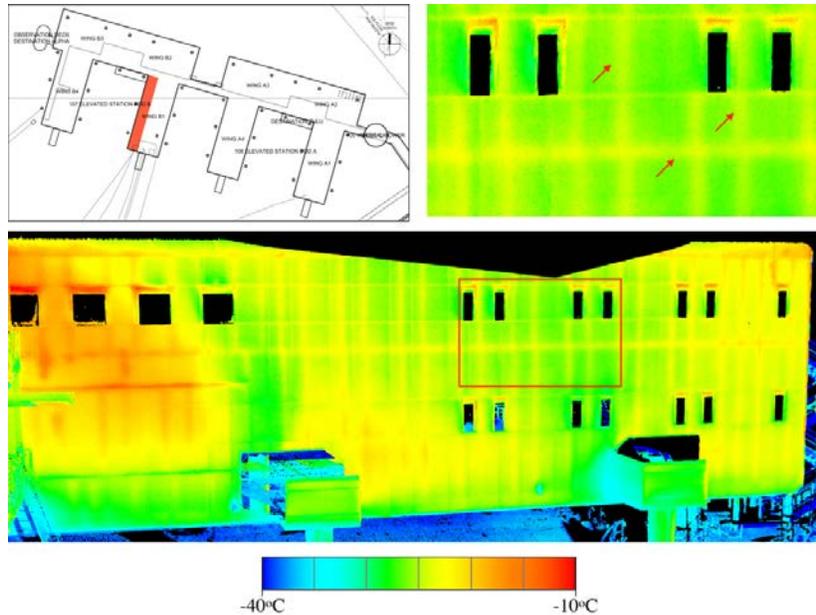
Figure 33. A 3-D thermal model of Wing B1 West. Significant thermal bridging, or a path of least resistance for heat to escape from the interior of the building, was observed and measured on most of the East and West faces of Wings A1, A4, B1, and B4. We posit that the thermal bridging is occurring from the building's internal frame and could potentially be avoided in future designs by ensuring there is overlapping insulation where the frame abuts the exterior walls. *Top left:* Focus section highlighted in *red* on the Elevated Station map. *Bottom:* Wing B1 West at a  $-40^{\circ}\text{C}$  to  $-10^{\circ}\text{C}$  scale. Significant thermal bridged was measured across the entire face, with a section highlighted by the *red box* and expanded for detail (*top right*). Note that these do not correlate with the SIP trim locations.

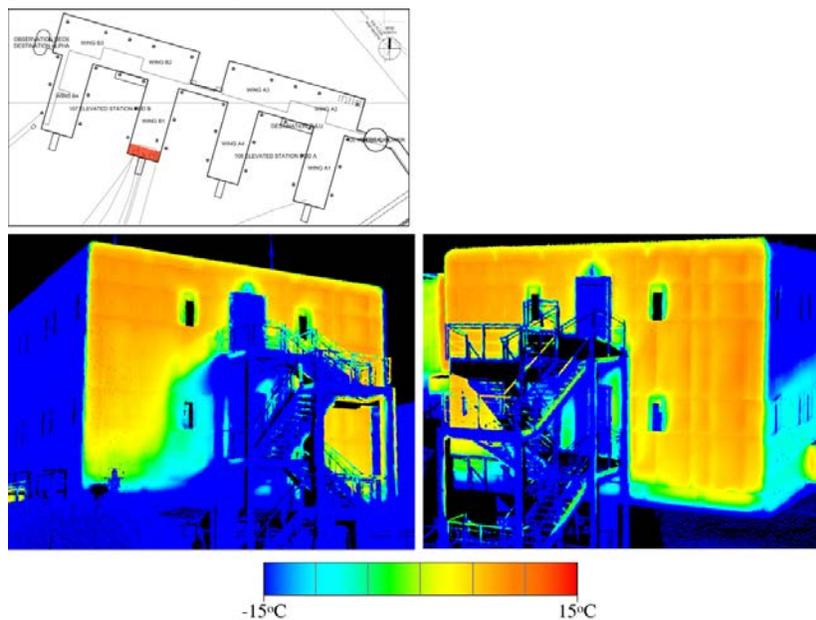
Figure 34. A 3-D thermal model of Wing B1 South. *Top left:* Focus section highlighted in *red* on the Elevated Station map. *Bottom:* Left and right views of Wing B4 South at a  $-15^{\circ}\text{C}$  to  $15^{\circ}\text{C}$  scale. Because of direct solar exposure, all south-facing surfaces must be displayed with higher color scale temperatures to reveal relative surface temperature differences.

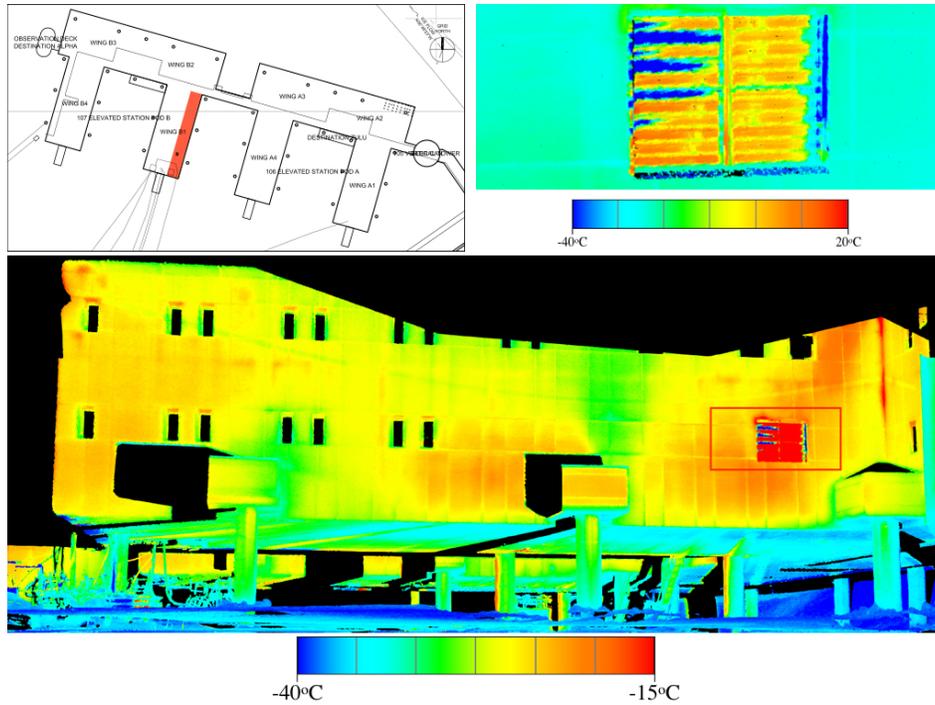
Figure 35. A 3-D thermal model of Wing B1 East. *Top left:* Focus section highlighted in red on the Elevated Station map. *Bottom:* Wing B1 East at a  $-40^{\circ}\text{C}$  to  $-15^{\circ}\text{C}$  scale. *Top right:* Detail of a generator exhaust vent at a  $-40^{\circ}\text{C}$  to  $20^{\circ}\text{C}$  scale.

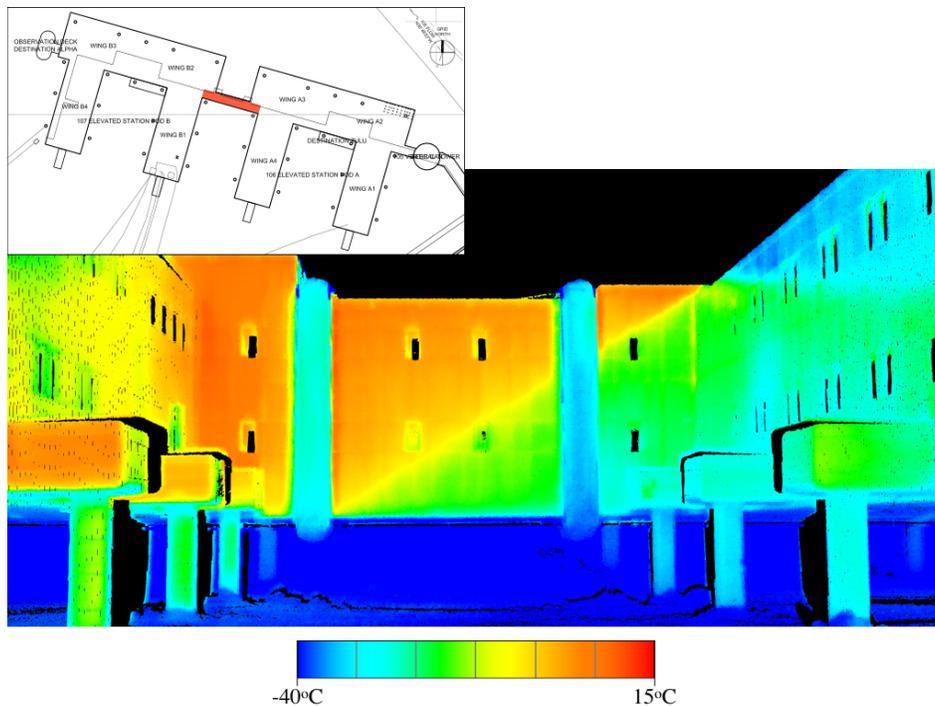
Figure 36. A 3-D thermal model of Pod A/B Connector South. *Top left:* Focus section highlighted in red on the Elevated Station map. *Bottom:* Pod A/B Connector South at a  $-40^{\circ}\text{C}$  to  $15^{\circ}\text{C}$  scale. No significant heat loss observed along the pod connection points.

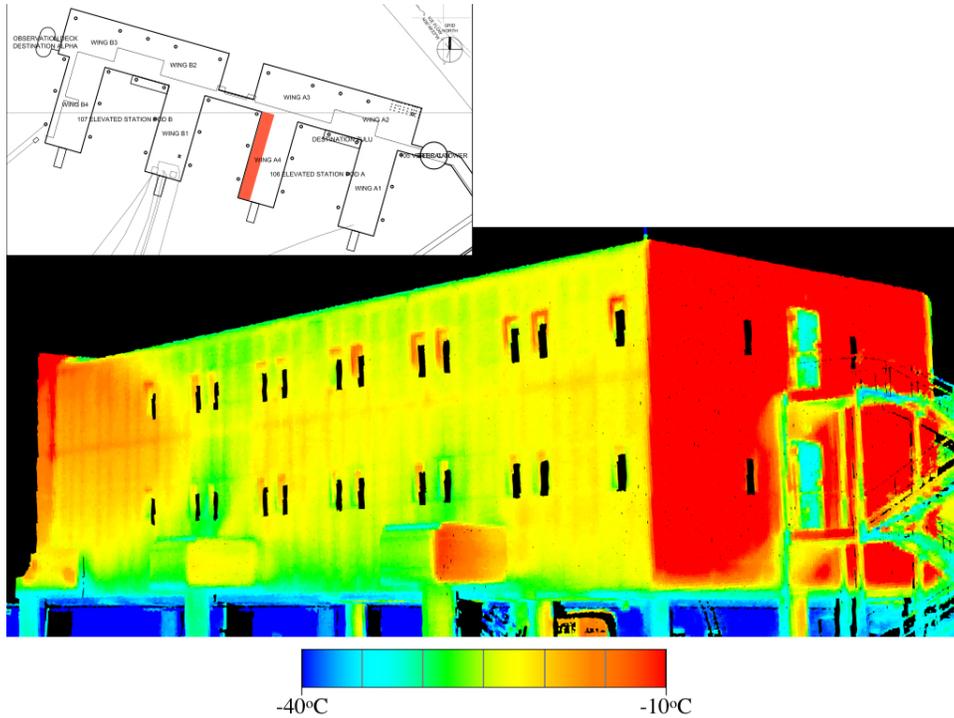
Figure 37. A 3-D thermal model of Wing A4 West. *Top left:* Focus section highlighted in red on the Elevated Station map. *Bottom:* Wing A4 West at a  $-40^{\circ}\text{C}$  to  $-10^{\circ}\text{C}$  scale. Thermal bridging and higher thermal gradients along the top windows are apparent.

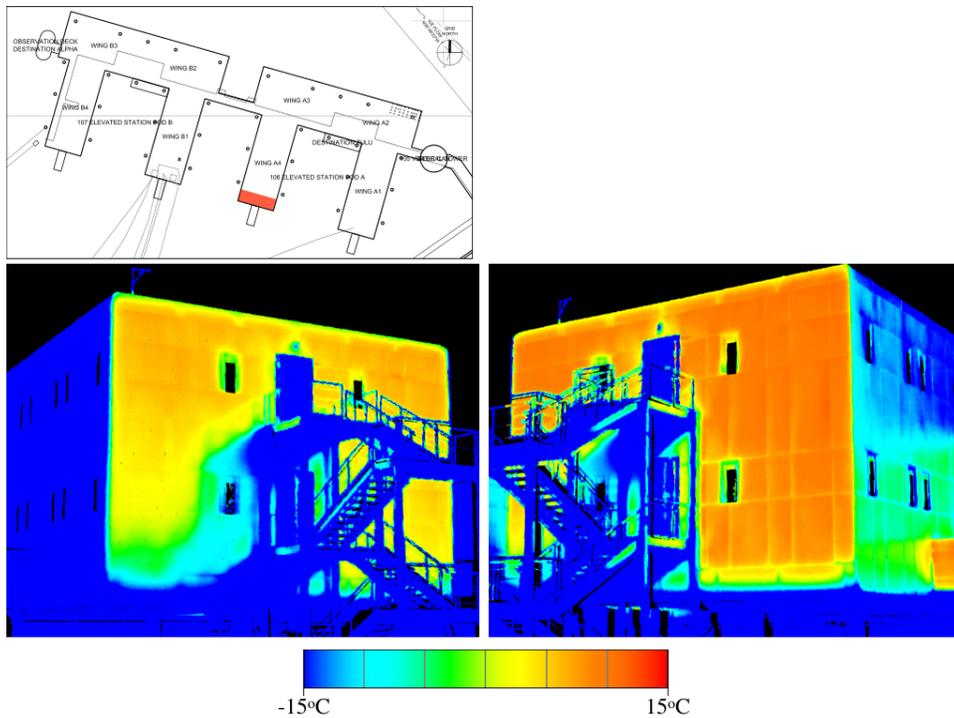
Figure 38. A 3-D thermal model of Wing A4 South. *Top left:* Focus section highlighted in red on the Elevated Station map. *Bottom:* Left and right views of Wing A4 South at a  $-15^{\circ}\text{C}$  to  $15^{\circ}\text{C}$  scale.

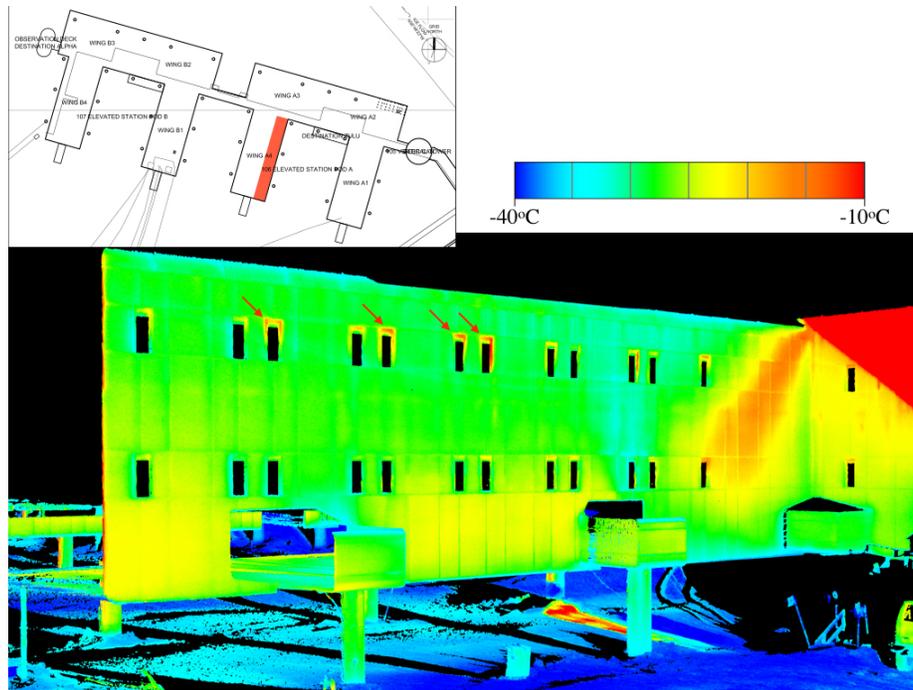
Figure 39. A 3-D thermal model of Wing A4 East. *Top left:* Focus section highlighted in *red* on the Elevated Station map. *Bottom:* Wing B1 East at a  $-40^{\circ}\text{C}$  to  $-10^{\circ}\text{C}$  scale. Areas of heat loss from windows are indicated by *red arrows*.

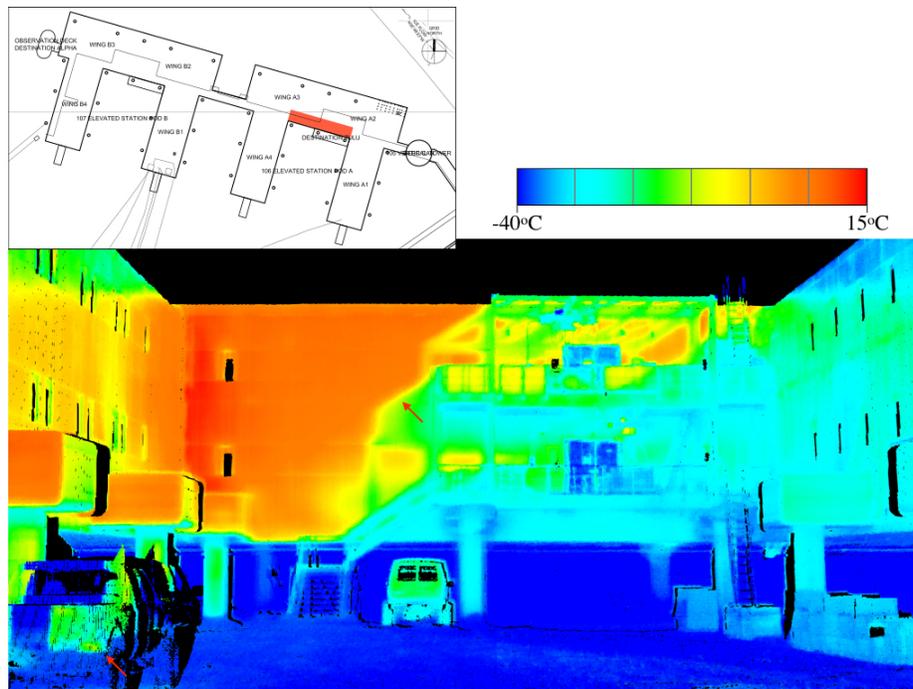
Figure 40. A 3-D thermal model of Wing A2/A3 South and Destination Zulu. *Top left:* Focus section highlighted in *red* on the Elevated Station map. *Bottom:* Wing A2/A3 South at a  $-40^{\circ}\text{C}$  to  $-15^{\circ}\text{C}$  scale. The transition line from the solar-exposed to non-exposed surface is indicated by the *red arrow*. In addition, the vehicle in the bottom left (*red arrow*) moved out of the FOV after the lidar scanner collection but before the TIR collection. This is shown by the overlay of column temperature values on the truck 3-D point cloud.
