# **Building Envelope and Infrastructure Assessment Using an Integrated Thermal Imaging and Lidar Scanning System**

Amundsen-Scott South Pole Station, Antarctica

June 2018

Final Report

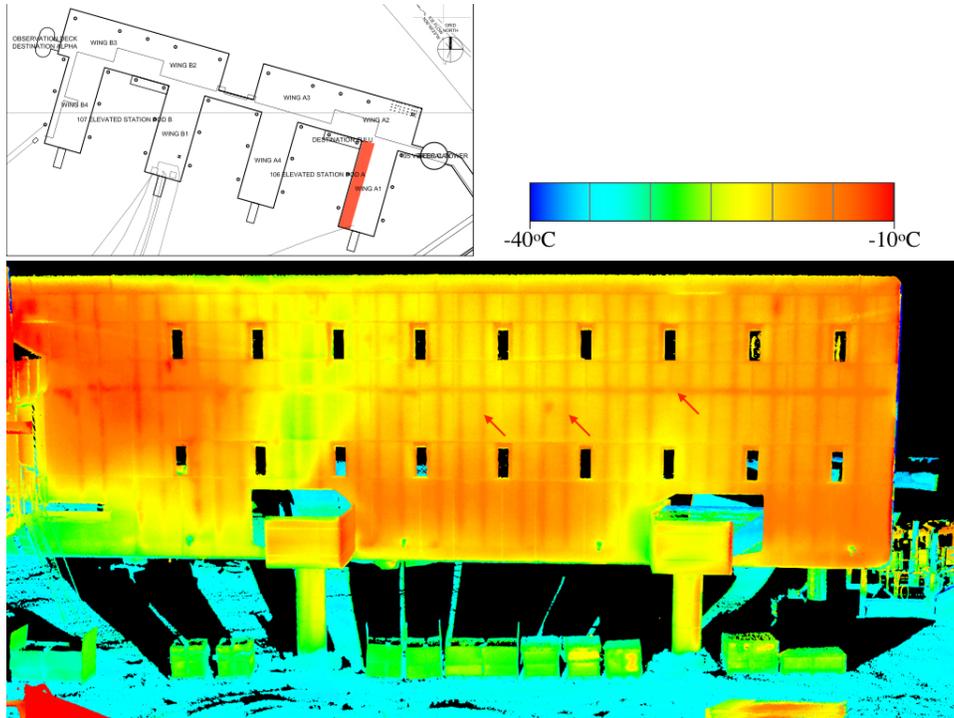
Figure 41. A 3-D thermal model of Wing A1 West. *Top left:* Focus section highlighted in *red* on the Elevated Station map. *Bottom:* Wing A1 West at a  $-40^{\circ}\text{C}$  to  $-10^{\circ}\text{C}$  scale. Thermal bridging is indicated by *red arrows* and is measured across the entire wall.

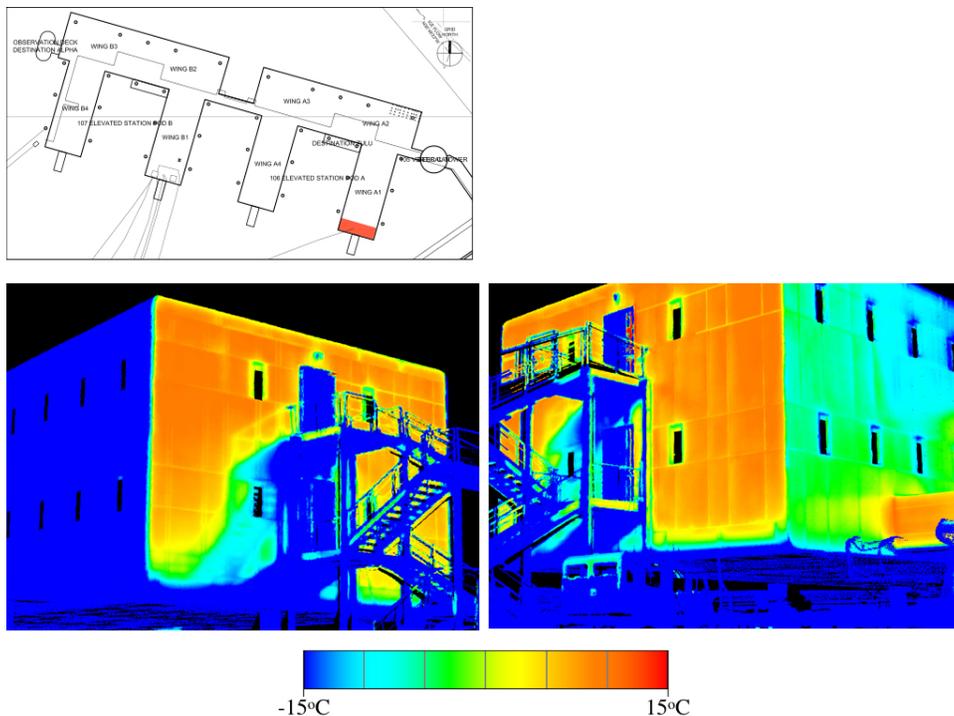
Figure 42. A 3-D thermal model of Wing A1 South. *Top left:* Focus section highlighted in *red* on the Elevated Station map. *Bottom:* Left and right views of Wing A1 South at a  $-15^{\circ}\text{C}$  to  $15^{\circ}\text{C}$  scale. Shadowing from direct solar exposure is visible in the bottom left image, below and left of the exterior stairwell.

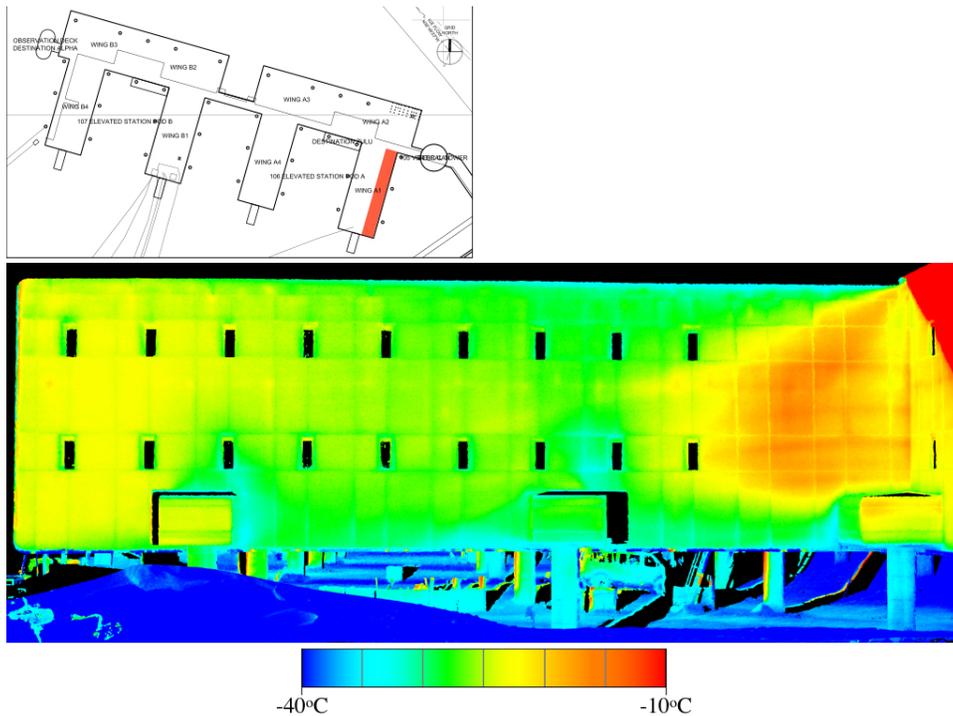
Figure 43. A 3-D thermal model of Wing A1 East. *Top left:* Focus section highlighted in red on the Elevated Station map. *Bottom:* Wing B1 East at a  $-40^{\circ}\text{C}$  to  $-10^{\circ}\text{C}$  scale.

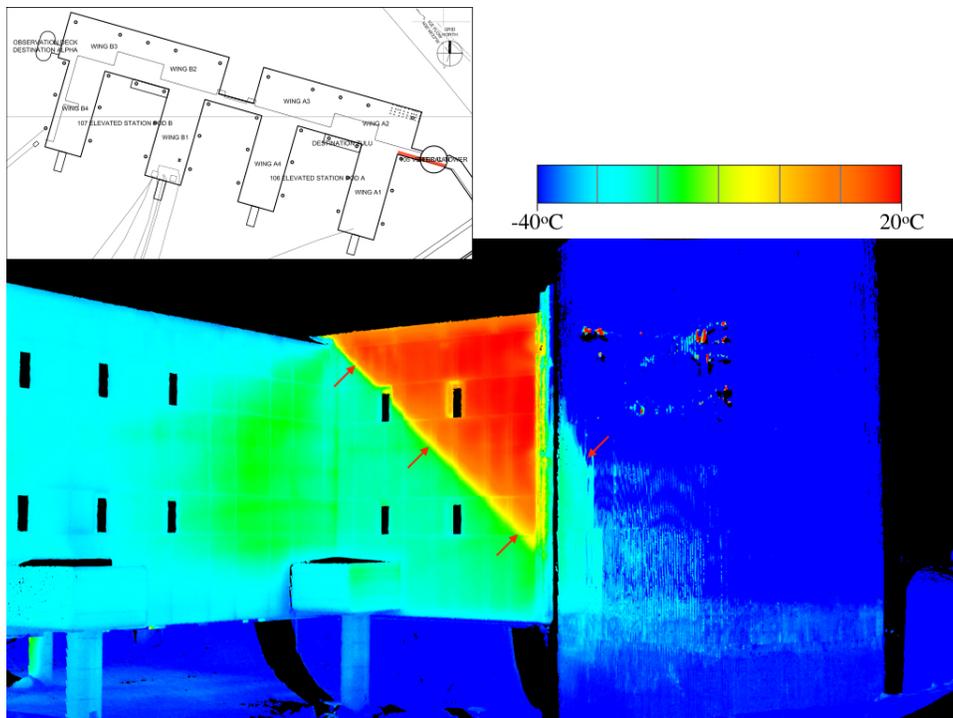
Figure 44. A 3-D thermal model of the Vertical Tower South. *Top left:* Focus section highlighted in red on the Elevated Station map. *Bottom:* Vertical Tower South at a  $-40^{\circ}\text{C}$  to  $20^{\circ}\text{C}$  scale. The transition line between solar-exposed and unexposed surfaces is indicated by red arrows. The Vertical Tower, made of corrugated metal, is highly reflective and therefore reflects the adjacent building surface temperatures.

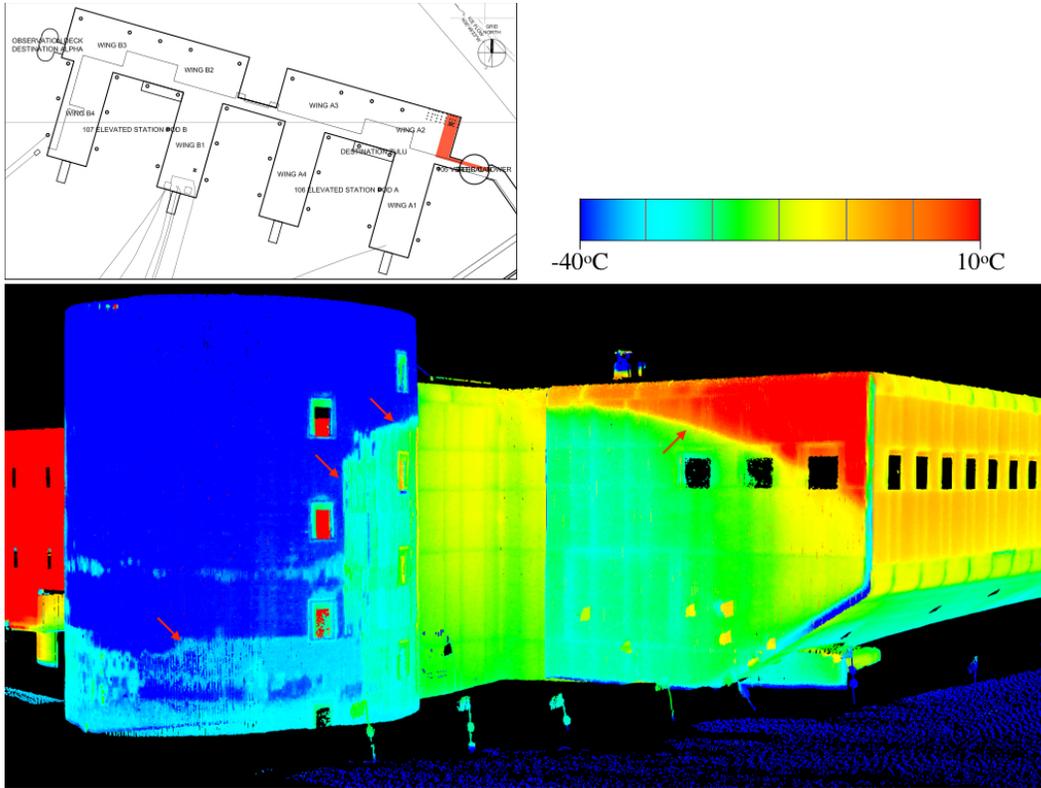
Figure 45. A 3-D thermal model of the Vertical Tower North and Wing A2 East. *Top left:* Focus section highlighted in *red* on the Elevated Station map. *Bottom:* Vertical Tower North and Wing A2 East at a  $-40^{\circ}\text{C}$  to  $10^{\circ}\text{C}$  scale. The transition line between solar exposed and unexposed surfaces is indicated by *red arrows*.

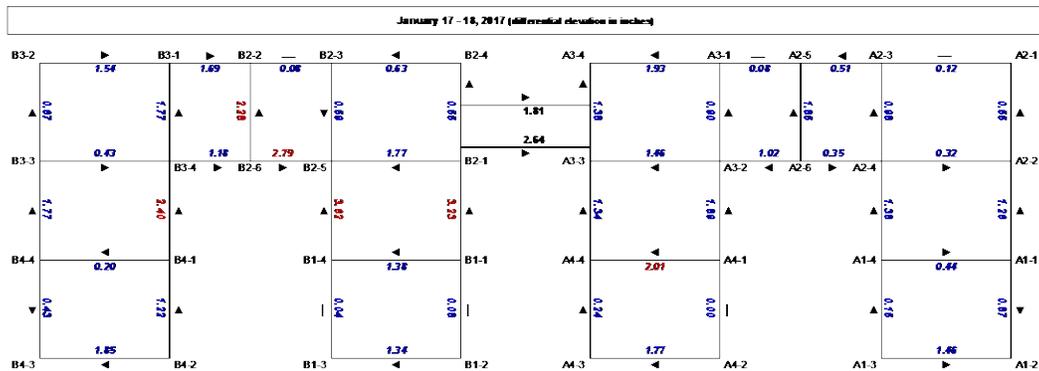
Figure 48. Measured height differences between adjacent support columns of the South Pole Elevated Station from the 17–18 January 2017 lidar survey. The number values indicate the amount of height difference (*red* is greater than a 2 in. change, and *blue* is less than a 2 in. change) while the *arrows* indicate the down-sloping direction. See appendix Fig. 2 for large format.
