U.S. Air Force Airfield Damage Repair (ADR) Modernization Program

Moisture Detection of Stored Rapid-Setting Cementitious Materials

July 2018

Final report

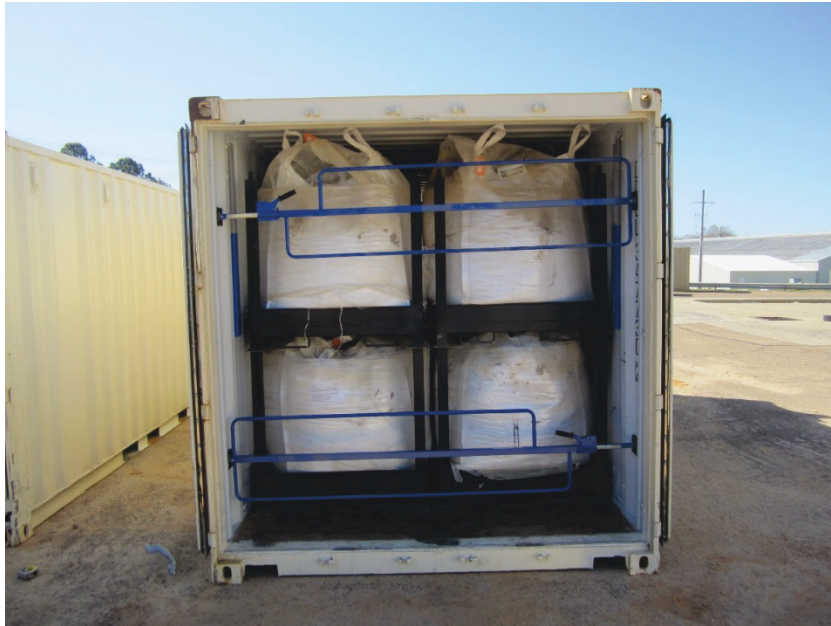
Figure 1. Conex container with Super Sacks in racks.

In order to assess the feasibility of long-term storage in a conex environment, a study was conducted to measure the internal temperature and humidity of the conex containers. Internal properties of four conex containers were measured over an approximate 3-month period. Of the four containers, three were fitted with moisture deterrent systems with a single container serving as a control. The four containers and moisture deterrents are listed in Table 1. Air temperature outside of the containers and rainfall data were also collected during the same time period. Illustrations of each of the moisture deterrents are shown in Figures 2 through 4.

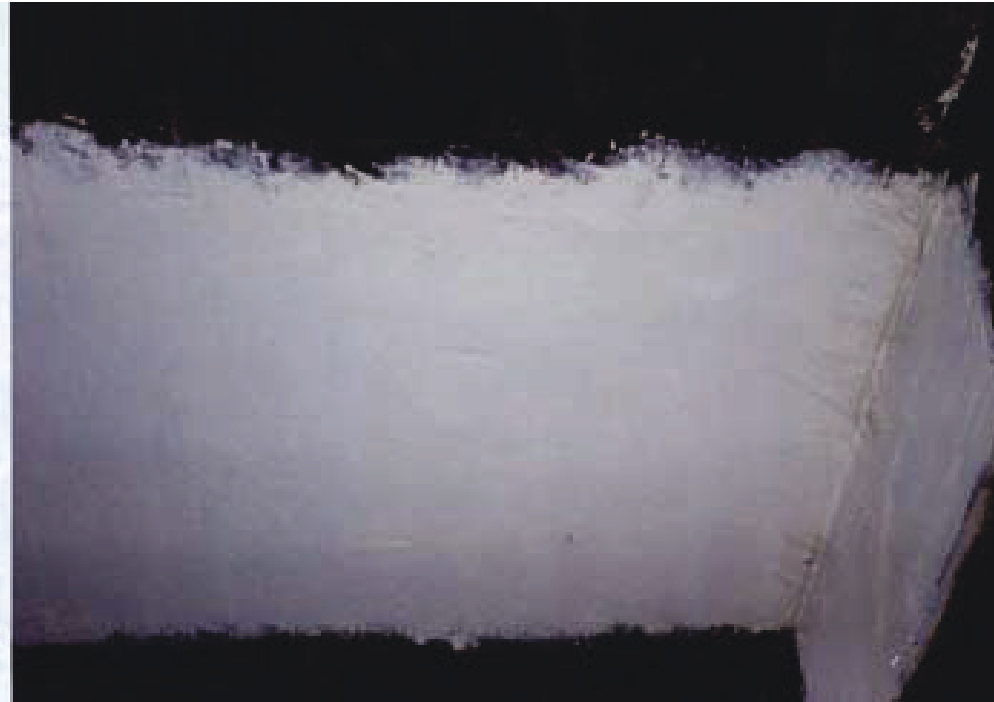
Figure 2. Kefa Airless 8125.

Kefa Airless 8125 is a water-based coating designed to store moisture during high humidity periods and release the moisture to be evaporated into the air during low humidity periods. This material can be applied by painting or spraying, is mold resistant, and was previously used by U.S. Army, Navy, and Coast Guard vessels.

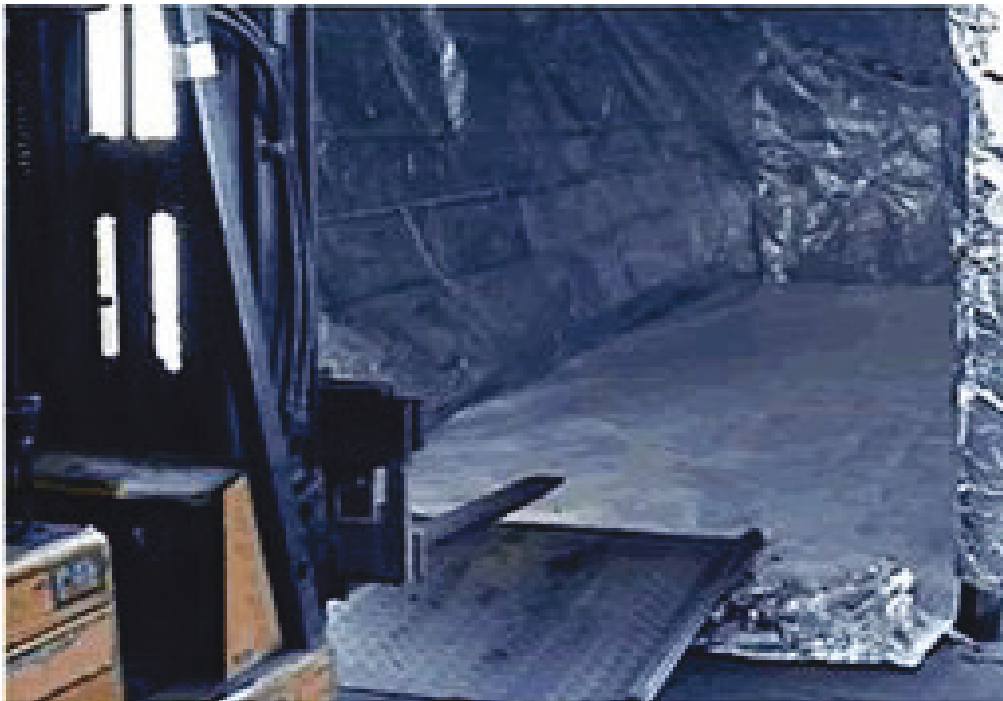
Figure 3. CorrPakBPS liner.

The aluminum foil liner is a reflective barrier material designed to create a temperature- and humidity-controlled environment. The liner is attached to the interior of the conex and can be completely closed after the material is loaded. Absorpole is a calcium chloride desiccant that can absorb up to 2 liters of moisture and is designed for conex containers.

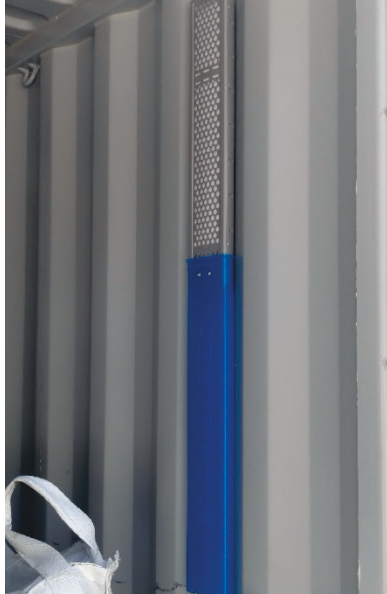
Figure 4. Absorpole.

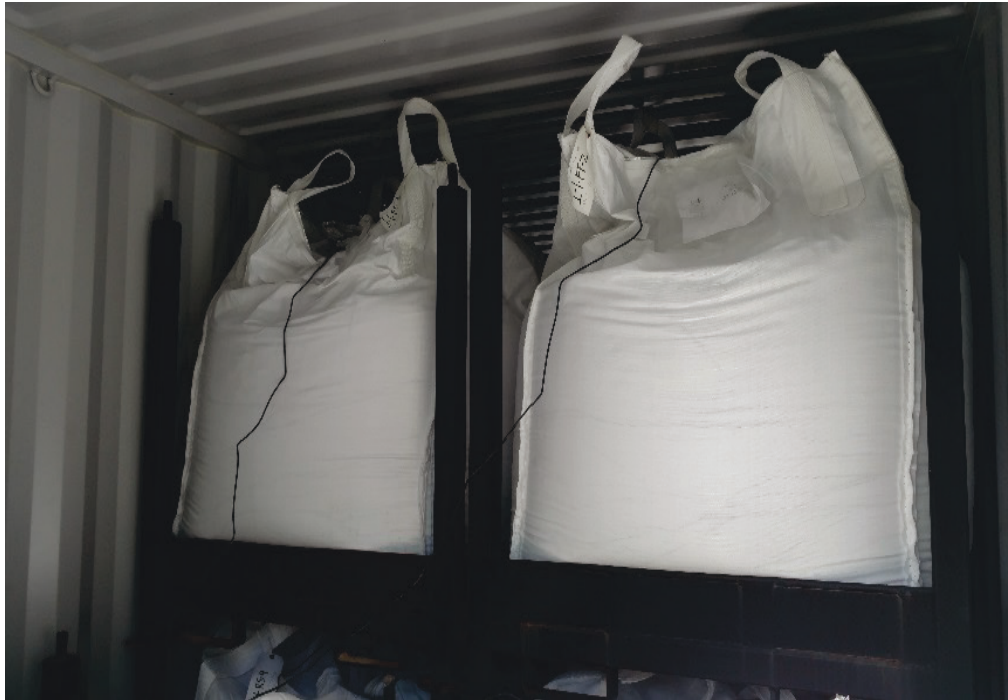
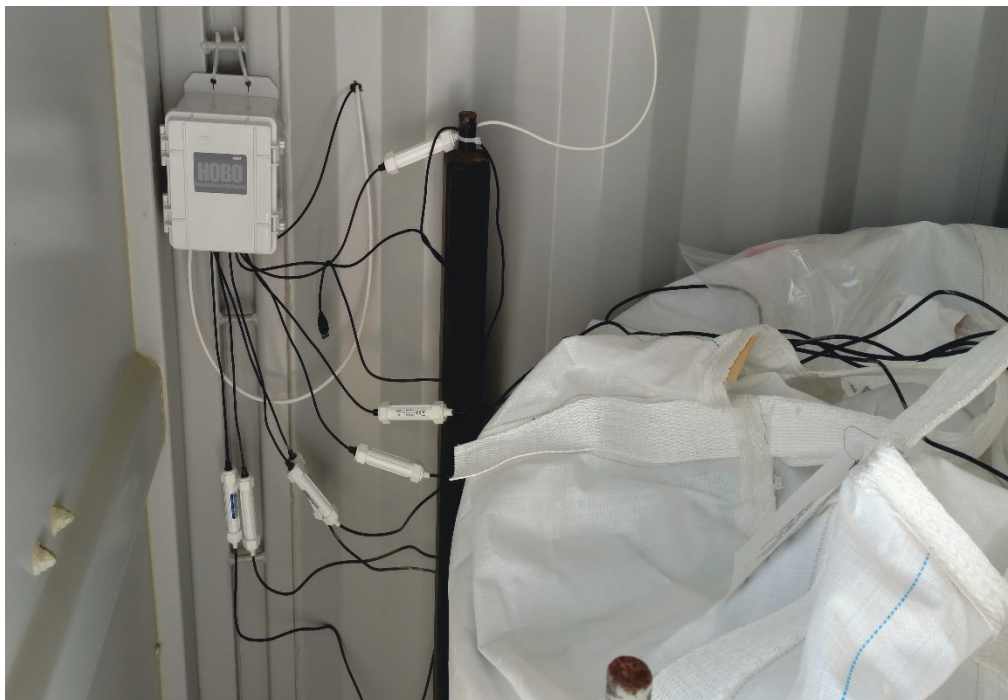
Figure 5. Sensor 1.

a. Sensor 1 embedded in Super Sacks.

b. Cabling attached to logger device at end of conex.

Two different types of sensors were used: a typical soil moisture sensor and an RFID moisture sensor. The typical soil moisture sensor (hereafter referred to as sensor 1) was an Onset soil moisture probe connected to a HOBO data logger. This type of sensor must be physically connected to a data collection device in order to function. To read the data, a computer must then be attached to the data collection device. Onset soil moisture probe sensors and the data logger are shown in Figure 5.

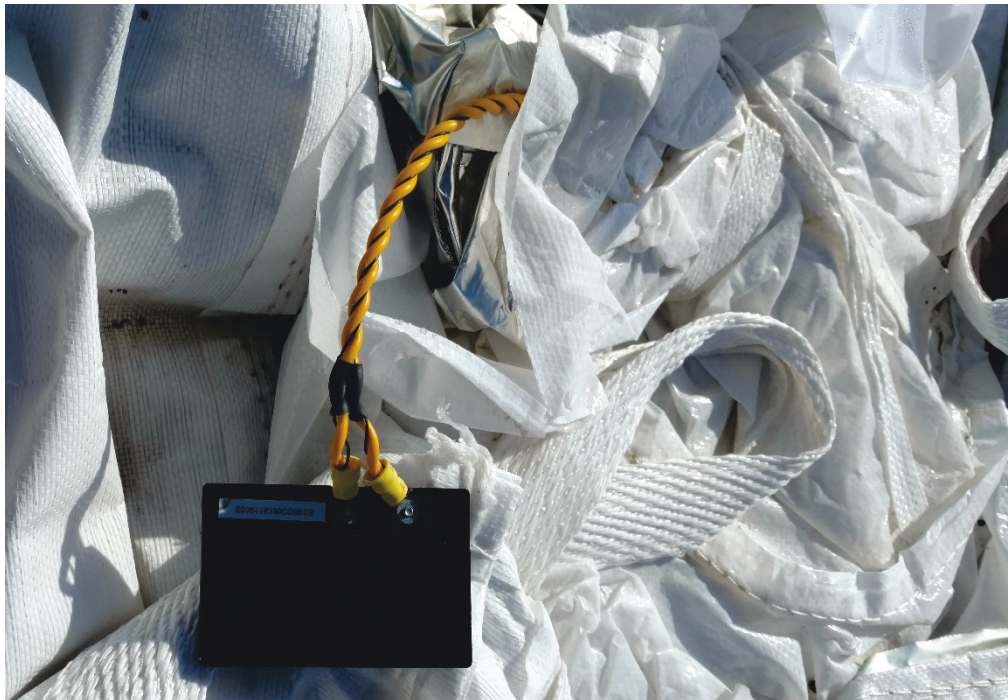
Figure 6. Sensor 2 with RFID transmitter.

The second type of sensor (hereafter referred to as sensor 2) is an RFID-type sensor that does not need to be physically connected to a logger in order to collect data. These sensors feature a leak-sense cable that can detect moisture throughout the length of the cable and an RFID transmitter. Cables were manufactured by Phase IV Engineering. The RFID transmitter allows the sensor to remain in the Super Sack, which can be moved freely, and measurements can be obtained by using a handheld or permanent stationed receiver.

Due to the nature of sensor 2, measurements consist of a true/false output that indicates whether a certain moisture threshold has been crossed at the time of measurement. Sensor 2 does not actually measure the amount of moisture present. Since the sensor is not connected physically, it has an internal built-in battery, which on longer tested regimens would have to be replaced periodically. The number of measurements obtained in a given time period significantly affects battery life. A sensor 2 cable with an RFID transmitter installed in a Super Sack is shown in Figure 6.

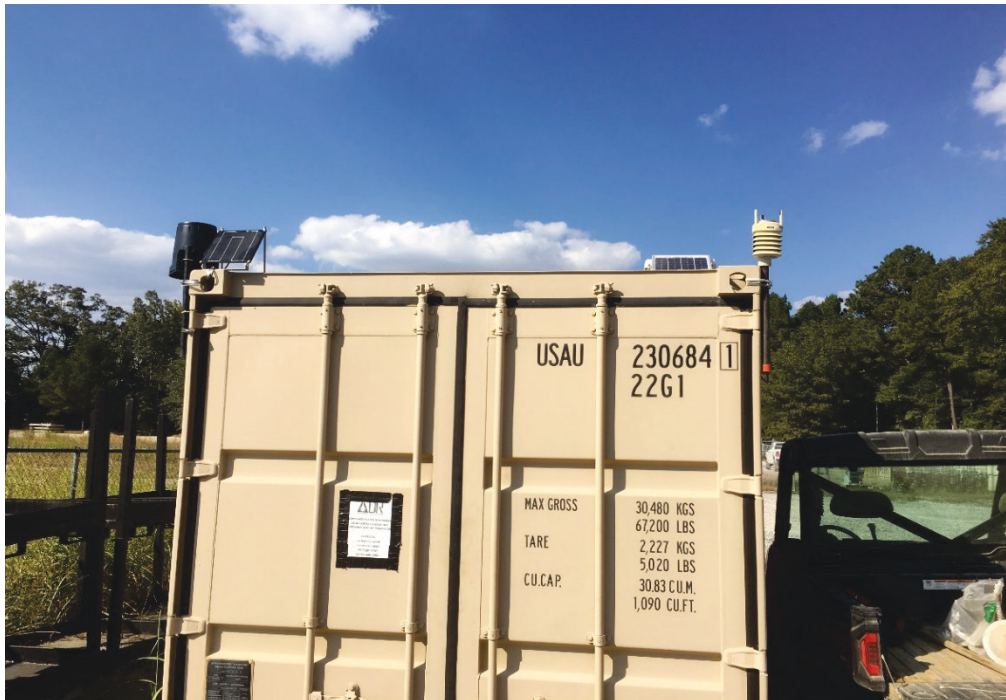
Figure 7. Conex closed with external weather monitoring devices attached.

identification (ID) was given based on four factors: inside conex or external (I or E), sensor type (1 or 2), material (RS or FF), and replicate number (1-3). Figure 7 shows the closed container with weather, temperature, and humidity monitoring devices attached.

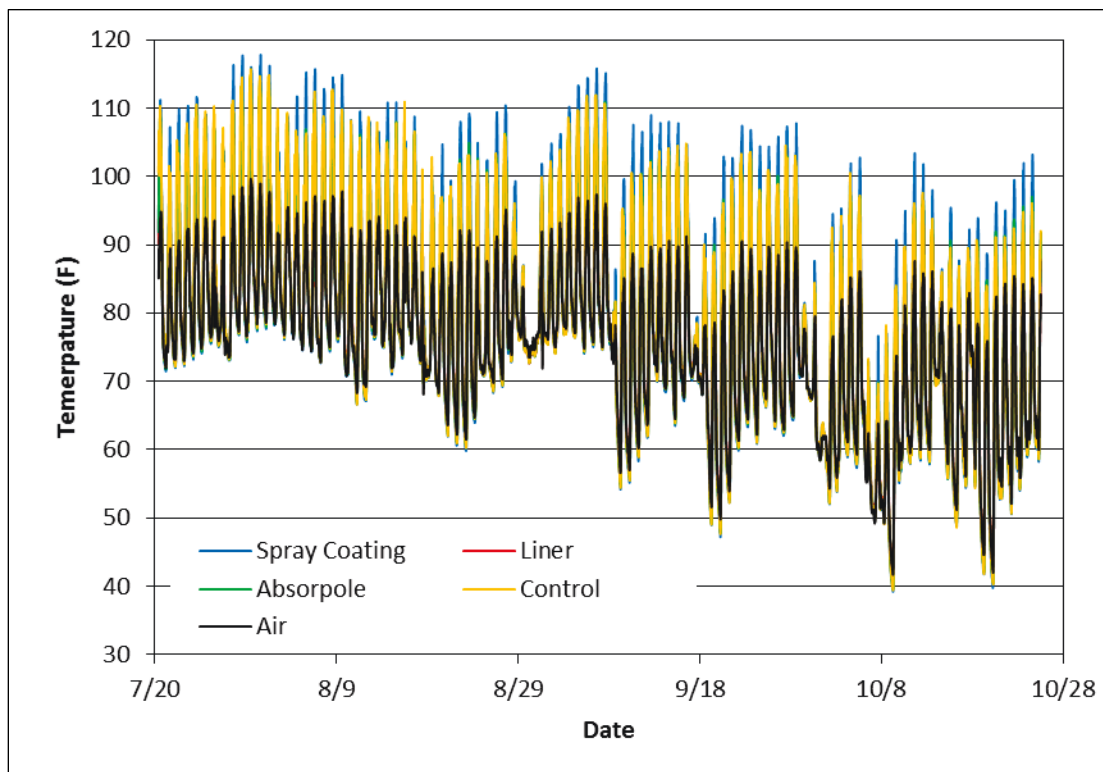
Figure 8. Temperature data from container storage.

Temperature results from the four conex containers and the ambient air temperature are shown in Figure 8. Humidity and rainfall data during the same time period are shown in Figure 9. Day and night temperature cycles are clearly visible, with the temperature in all of the containers exhibiting higher peaks during the day than the ambient air temperature. During the approximately 3 months of data collection, the average ambient temperature and relative humidity were 75.4°F and 73.1 percent, respectively.

The control conex had a 3.6°F higher average temperature than ambient, but 3.7 percent lower average humidity. All three containers with moisture deterrents recorded lower average temperatures than the control container by 0.6 to 1.5°F. This was not seen as a meaningful difference. Table 4 contains average temperature and humidity data with comparisons. The container with the aluminum foil liner exhibited an increased relative humidity compared to ambient, while the spray coating and Absorpole containers exhibited lower relative humidity by 1.3 percent and 8.4 percent, respectively. Only the container with the Absorpole had a lower average relative humidity than the control container. Neither the spray coating nor the liner were more effective at reducing humidity than the control container.

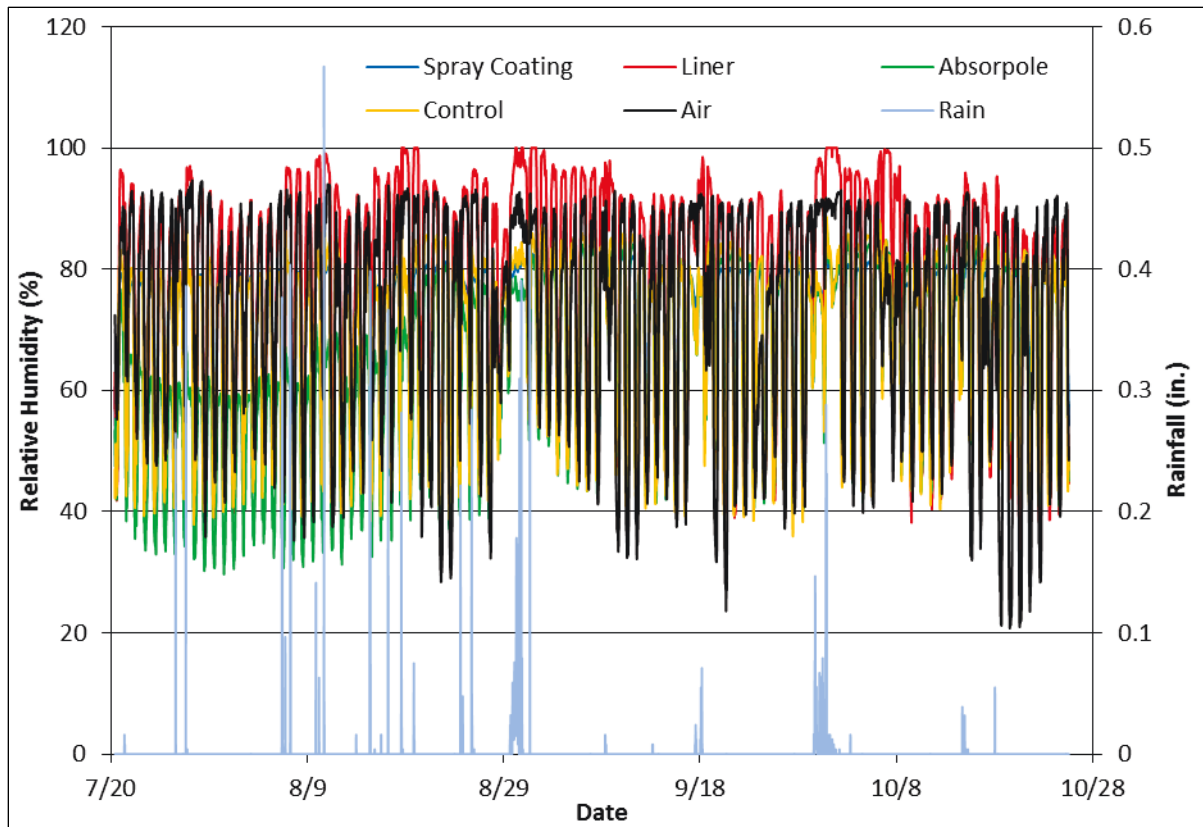
Figure 9. Humidity data for container storage.

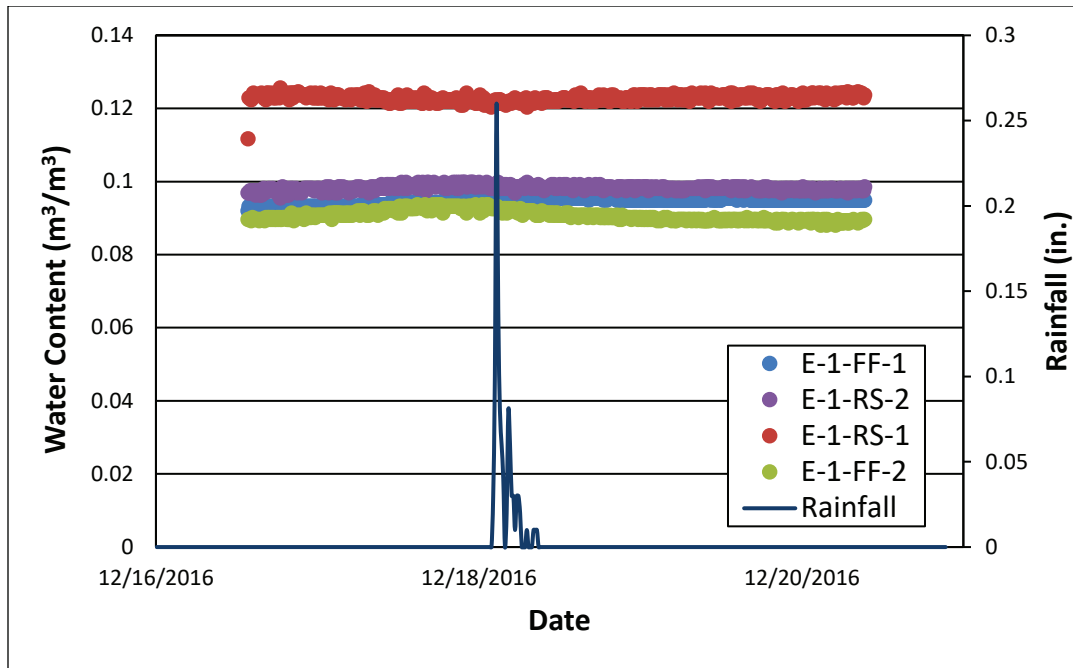
Figure 12. Sensor 1 outside conex (single rainfall event).

A section of data deemed reliable in Figure 11 is highlighted in Figure 12. As seen in the figure, even when the sensors appeared to be functioning correctly, no moisture changes in the Super Sack were measured during the rainfall event. Based on physical appearance after rainfall events, it was apparent that moisture was entering the Super Sack; but in the limited amount of reliable data, no moisture increases in the Super Sacks were measured.

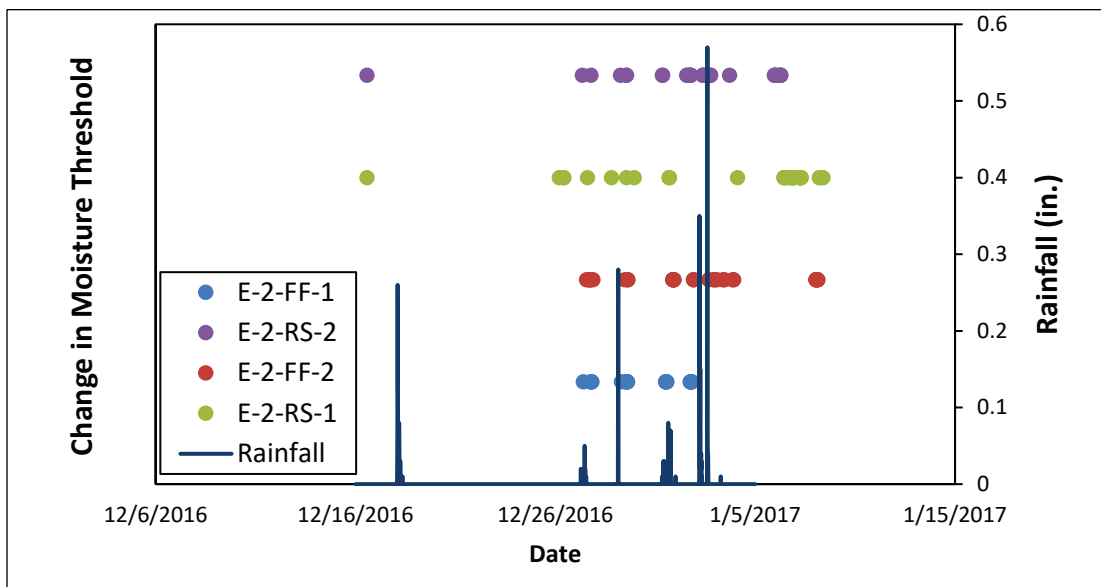
Figure 13. Sensor 2 outside conex.

Sensor 2 data is shown in Figure 13. Because sensor 2 measures only changes in moisture, there are no values for the moisture measurement; instead, data points on the figure indicate whether there was a change in moisture present. Sensors in all four Super Sacks recorded a change in moisture content on major rainfall events. However, sensors also measured change in moisture content on nonrainfall events.

Additional measurements not associated with rainfall events could be due to excessive dew or humidity, as the sensor is capable of picking up small moisture changes. This appears likely considering multiple sensors recorded a “wet” event not associated with rainfall. Sensor type 2 also registers a measurement when the sensor changes from a “wet” reading to a “dry” reading, and this may account for multiple readings from a single rainfall event.

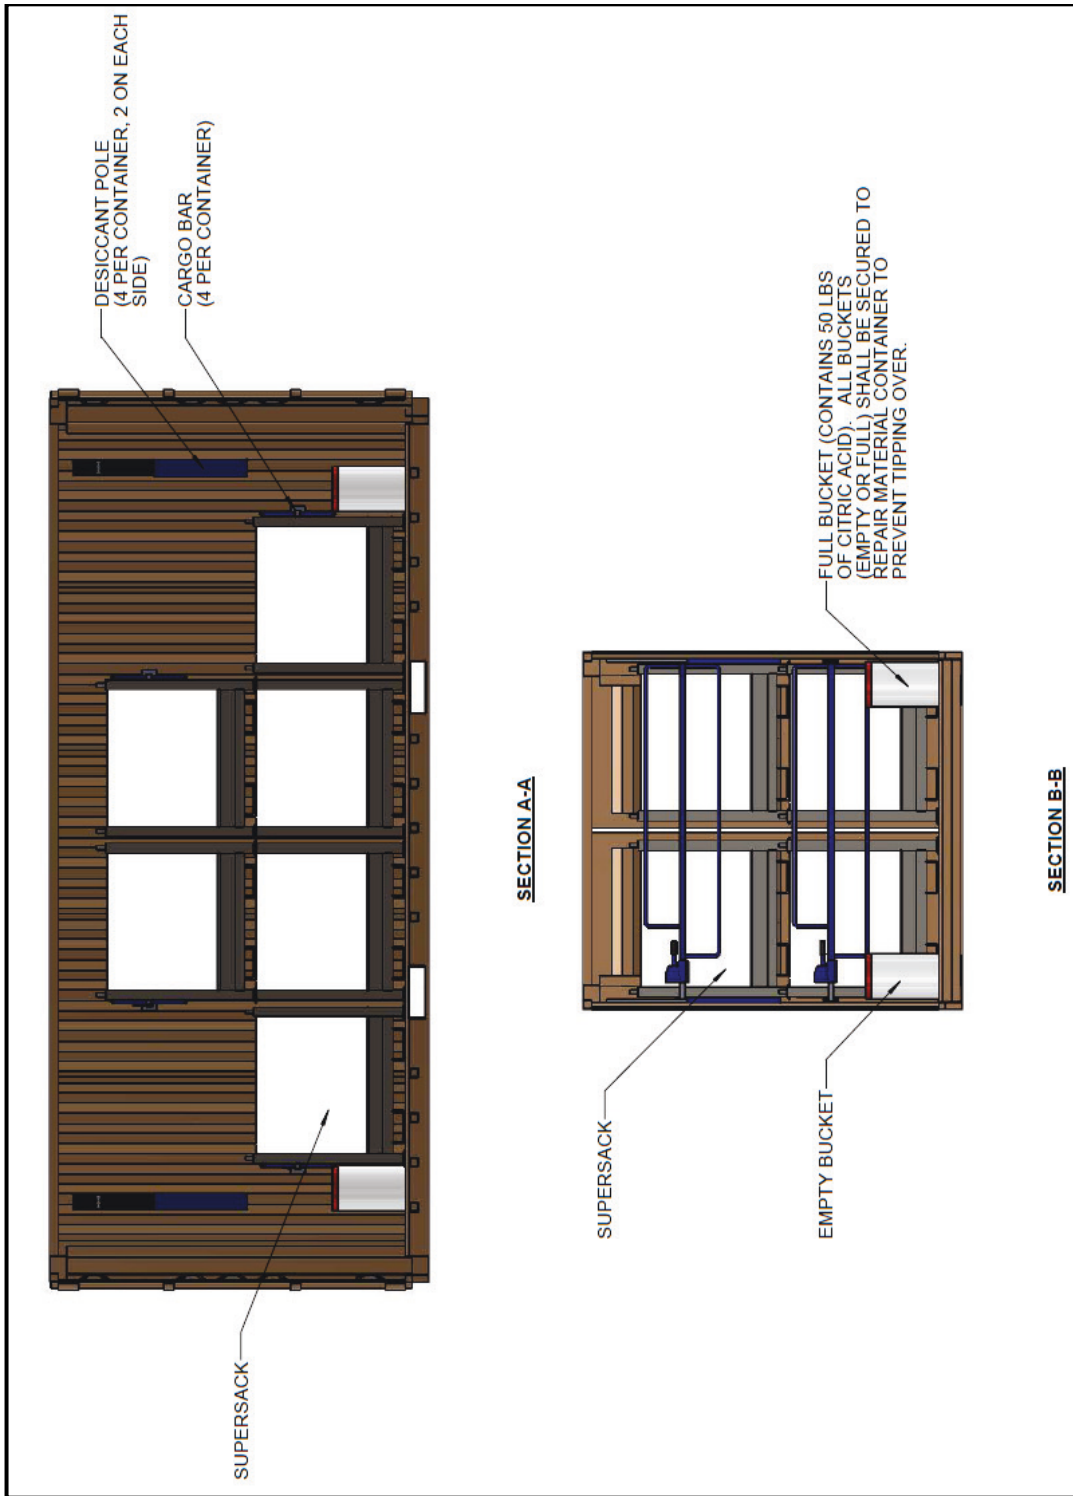
Figure A3. Material container drawing section view.
