U.S. Air Force Rapid Airfield Damage Repair (RADR) Program

Camouflet Repair Alternatives

Ben C. Cox and Thomas A. Carr

August 2018

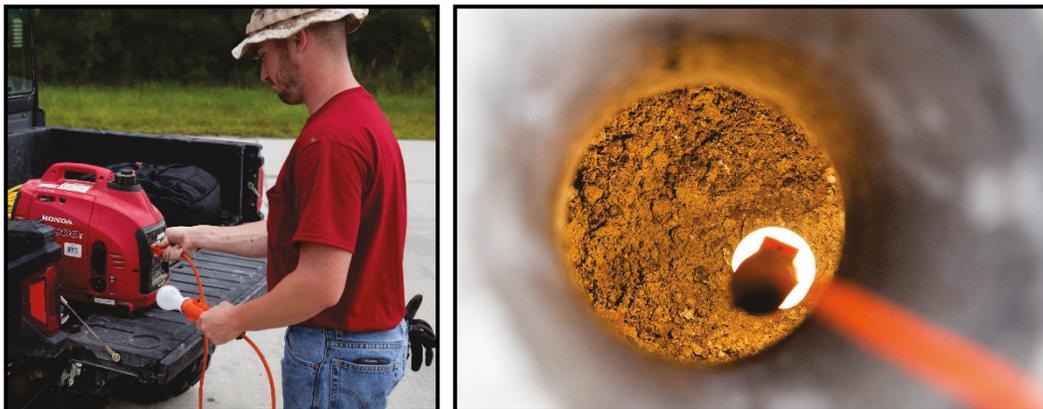
Figure 3.11. Supplementary light source used to illuminate camouflets for MC1.

Preliminary laboratory testing in the camouflet model indicated the MC1's lighting was insufficient to illuminate the inside of the camouflet. This was not unexpected since its use in this project differed considerably from its typical applications (i.e., small spaces, close-up viewing). In order to still use the MC1, a supplementary light source was utilized. A simple hanging work light with the protective guard removed (Figure 3.11) was chosen as a quick solution. While this would not be the ideal solution in everyday use, it was adequate for this project.

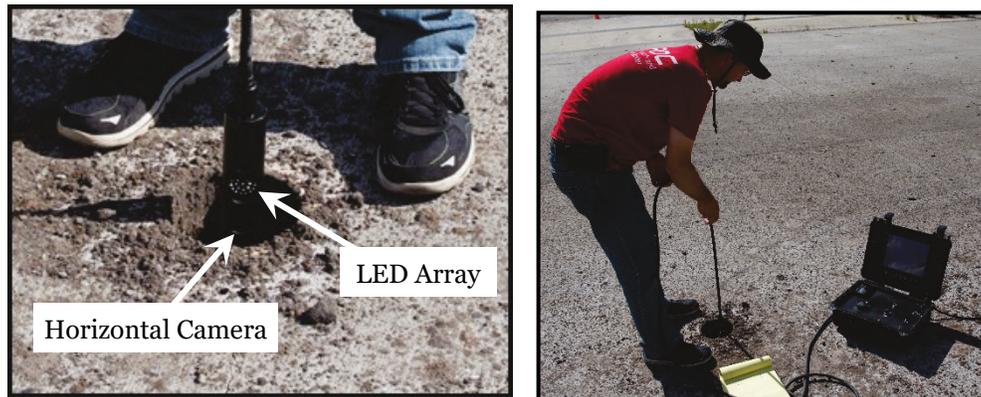
Figure 3.12. SVS camera photographs.

The general process was to suspend the camera near a camouflet OPE, begin the video recording, and then slowly lower the camera to the bottom of the camouflet. Then, the camera was raised to the camouflet OPE again, rotated slightly, and lowered again. This process was repeated until overlapping up-and-down shots had been obtained for the entire camouflet (i.e., full coverage of the interior of the camouflet). Approximately 2 min were required to fully record the interior of a camouflet.

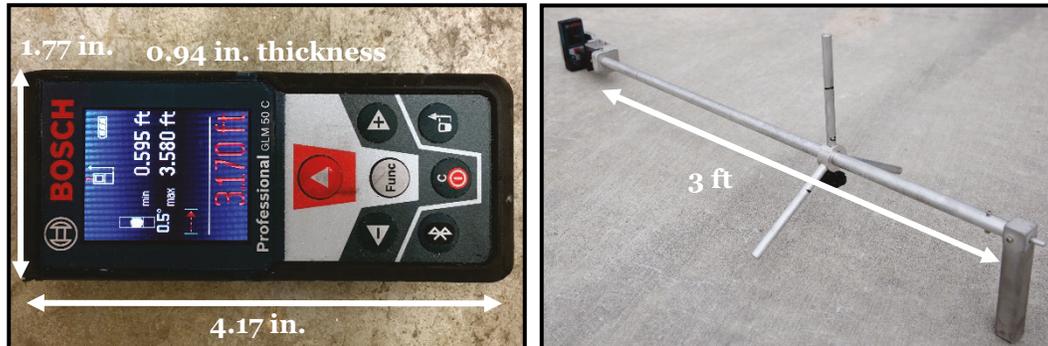
Figure 3.13. MLRF overview.

90° (horizontal), 45°, or 0° (vertical) as shown in Figure 3.14c to Figure 3.14e, respectively. Together, this system is referred to herein as the modified laser range finder (MLRF). It was evaluated both in the laboratory model camouflet and in full-scale camouflets at Silver Flag. Appendix C provides detailed drawings for the MLRF for reproduction.

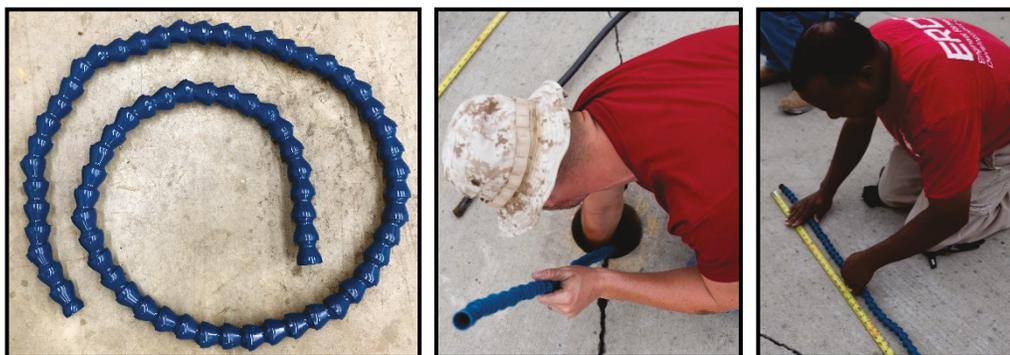
A 5-ft section of modular plastic Loc-Line tubing (Figure 3.17) manufactured by Lockwood Products Inc. was used to measure camouflet depth and approximate diameter similar to the Uniprise tubing. The tubing was specified by inner diameter, which was 0.50-in. inner diameter. It is referred to as the Loc-Line tubing in this report and was evaluated in the laboratory camouflet model as well as full-scale camouflets at Silver Flag.

Figure 3.17. Photographs of Loc-Line tubing and its use.

The Loc-Line tubing was selected for similar reasons as the Uniprise tubing in that it could be bent and then maintain its shape. The procedure used to measure camouflets was similar to the Uniprise tubing. It was

partially inserted into a camouflet, gradually worked into a near 90° bend, and further inserted to the camouflet side wall. The tubing was then grasped at the interface of the concrete and base, removed, and measured as illustrated in Figure 3.17. Depth was also measured.

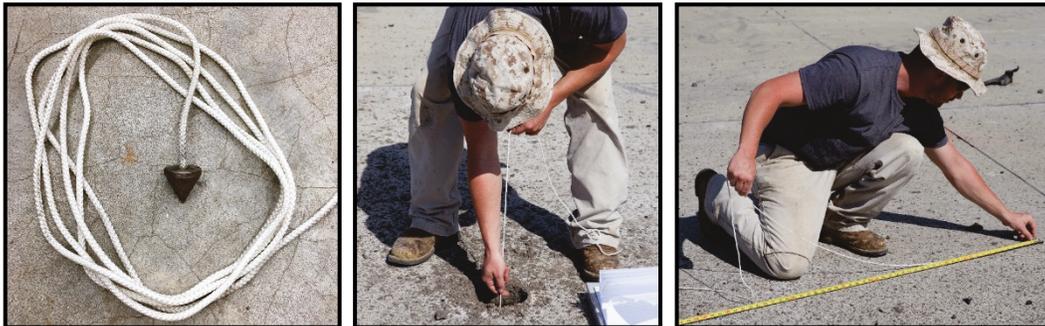
Figure 3.18 illustrates the process of measuring depth with the plumb bob. It was lowered into a camouflet until it contacted the bottom of the camouflet. The plumb bob string was grasped level with the pavement surface and then measured. Concrete thickness was then subtracted to obtain the camouflet height.

Figure 3.18. Photographs of the plumb bob and its use.

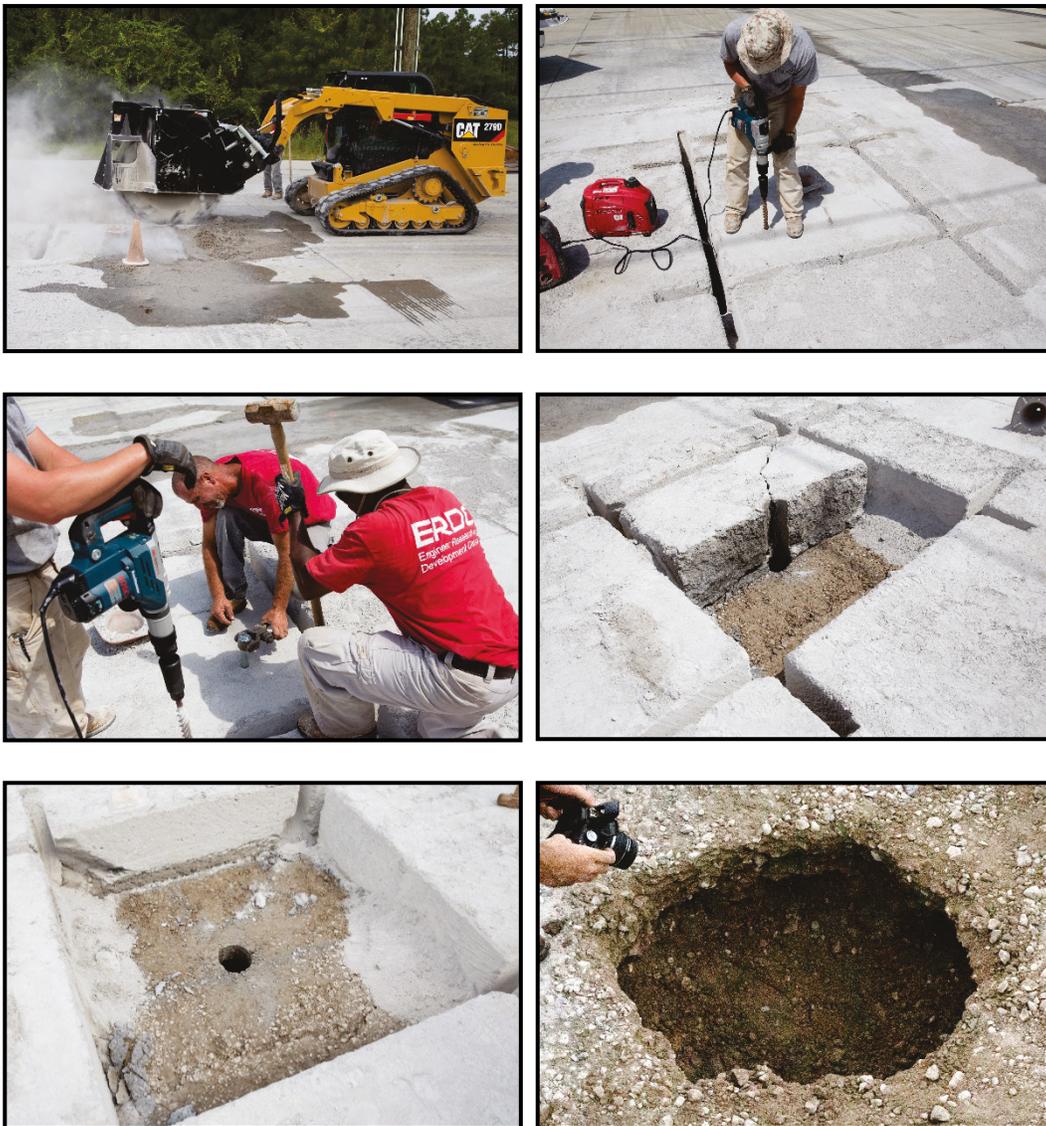
Figure 3.20. Unearthing camouflet for destructive void characterization.

After the camouflet was evaluated using all void characterization techniques, a 5-ft by 5-ft section of concrete centered over the camouflet OPE was removed. A Caterpillar 279D compact track loader (CTL) outfitted with a Caterpillar SW60 wheel saw (60-in. diameter) was used to cut through the approximately 16-in.-thick slab. The cuts were originally attempted with an SW45 wheel saw (45-in. diameter), but it was not large enough to cut through the entire thickness of the slab.

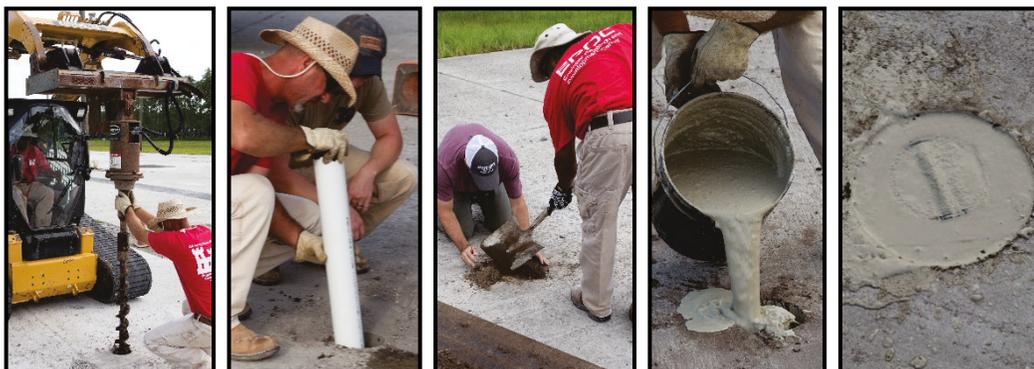
To prepare a slab for a camouflet (Figure 3.23), a 6-in.-diameter core was first cut and removed from the center of a slab. Then, a 4-in.-diameter CTL auger attachment was used to auger approximately 4 ft deep. A section of 4-in.-diameter schedule 40 PVC pipe was cut to 43.5 in., capped on one end with a PVC end cap, and inserted (capped end first) into the auger hole until flush with the surrounding slab. The upper open end was covered temporarily with duct tape to prevent debris from falling into the PVC pipe. Sand and base material were swept back into the hole to fill most of it, and grout was used to fill the remainder (approximately the final few inches) as shown in Figure 3.24a. For blasting, the duct tape was removed, and one 1.25-lb block of C-4 (initially) was inserted and detonated. This produced little to no cracking within the slab and was the method typically used for other camouflet blasting exercises at Silver Flag.

Figure 3.23. Slab preparation process for camouflet blasting.

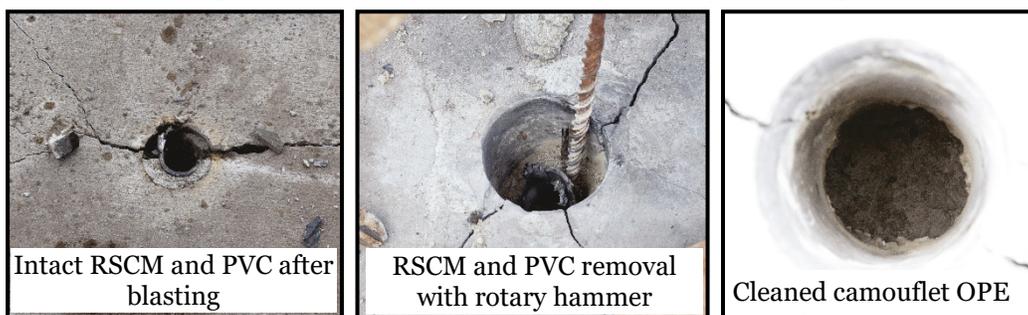
Figure 3.25. Removal of RSCM and PVC after blasting.

Also for the second round of blasts, C-4 charges were varied in order to determine the charge size that would create the largest camouflet possible without causing significant slab damage. An iterative approach was taken to select the final C-4 charge in which 2 to 4 blocks of C-4 were considered. Ultimately, 2 blocks of C-4 were used for all camouflets that remained after the trial-and-error testing with various C-4 charges. The test plan discussed in Section 3.5.1 provides details regarding specific charge sizes for each camouflet.

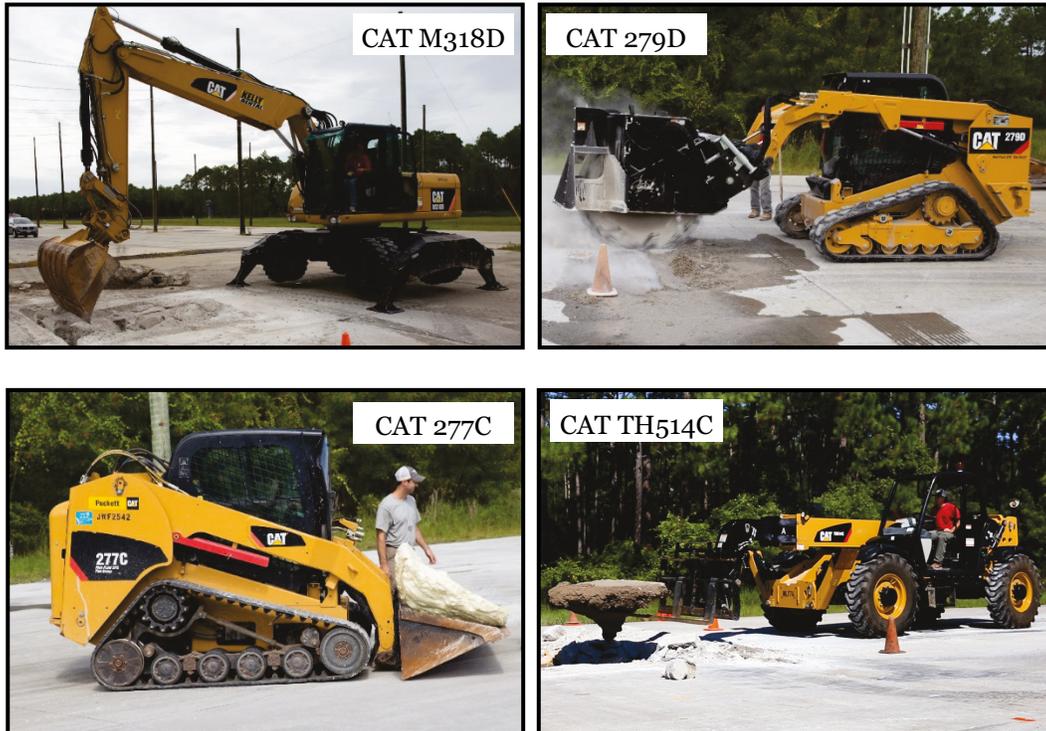
Numerous pieces of heavy equipment were used during the field testing at Silver Flag. Figure 3.26 shows examples of the types of equipment used, including a Caterpillar M318D wheeled excavator, a Caterpillar 279D CTL, a Caterpillar 277C CTL, a Caterpillar TH514C telehandler, and a 4,000-gal water truck. Most equipment was rented for general use material moving and handling. The 277C CTL was shipped from ERDC Vicksburg to Silver Flag for the work alongside multiple attachments: a set of pallet forks, a power broom, an SW45 wheel saw, and a bucket. Relative to other heavy equipment used in this project, CTLs and telehandlers were utilized specifically during actual camouflet repair processes.

Figure 3.26. Examples of general equipment used at Silver Flag.

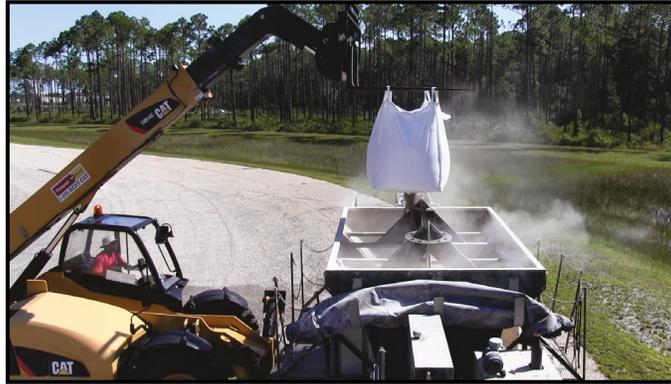
A Caterpillar TH514C telehandler, or extendable boom forklift, was used to move the 3,000-lb supersacks of pre-blended cementitious materials as well as totes containing FI-10S components. It was primarily used to load supersacks of material into the simplified volumetric mixer, as shown in Figure 3.27, since the CTLs were not capable of doing so. The TH514C has a rated load capacity of 11,000 lb with a maximum forward reach of approximately 30 ft.

Figure 3.27. Telehandler loading supersack into SVM.

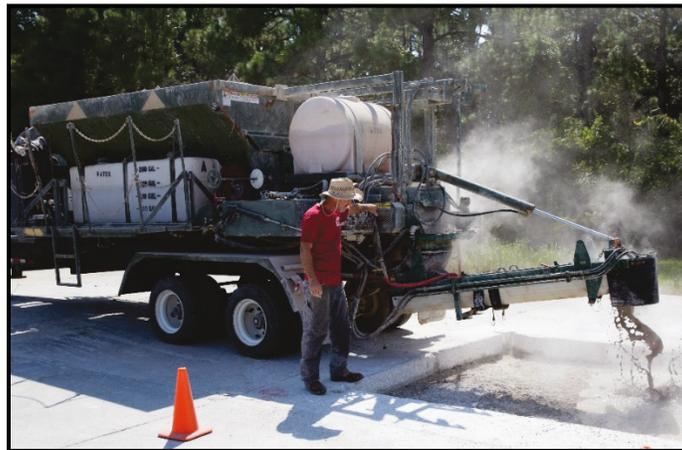
Figure 3.28. Simplified volumetric mixer.

The simplified volumetric mixer (SVM) that was discussed in Chapter 2 was used for the camouflet repairs in this project. The SVM, shown in Figure 3.28, is a tow-behind mixer designed by CemenTech Inc. with input from ERDC and used in the modernized ADR program. It is pre-calibrated for both rapid-setting flowable fill and rapid-setting concrete.

The SVM is towed with a vehicle capable of pulling at least 20 tons (typically a dump truck). Key components of the SVM are a single dry material hopper (approximately 7-yd³ capacity), a conveyor belt feed

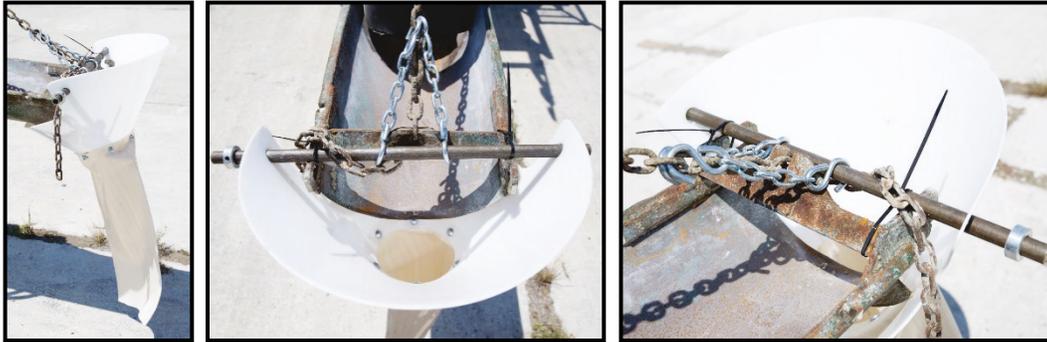
Figure 3.29 provides photographs of the mini concrete tremie hopper (referred to hereafter as the mini hopper) purchased from Deslauriers Inc. (part number TREMH-6) for approximately \$100. It consists of a high-density polyethylene hopper with an attached 8-in.-diameter elephant trunk. The mini hopper was shipped with a 6-ft elephant trunk, which was shortened to 2 to 3 ft for the camouflet project. It also included a steel rod and chains for hanging from the end of a concrete chute as shown in Figure 3.29 (zip ties were also used for extra measure).

Figure 3.29. Photographs of the mini concrete hopper.

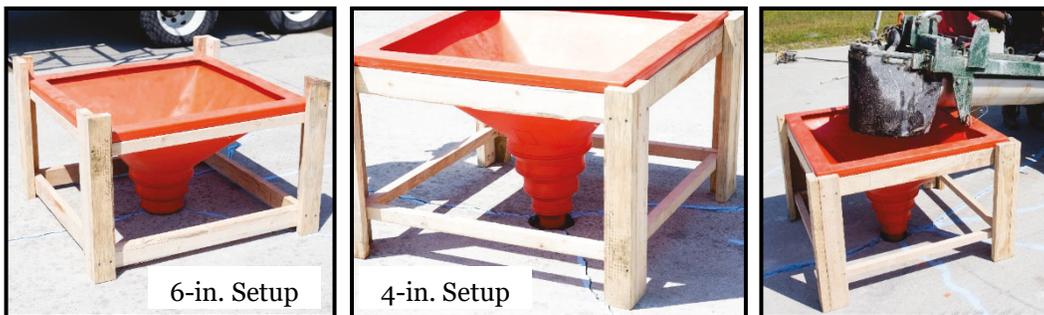
Figure 3.30. Photographs of the tremie funnel and support frame.

Superchute Ltd. also sells support frames designed specifically to pair with the tremie funnel; however, these were too large for the camouflet repairs. Alternatively, a similar wooden frame was built out of pine framing lumber for the camouflet project. It was built as a two-sided frame that held the funnel at two height positions: a greater height for using the 4-in. diameter outlet and a lower height for using the 6-in. outlet in the event flow through the 4-in. outlet was insufficient. The discharge boom on the SVM was backed over the top of the funnel and lowered to minimize splattering to the extent possible.

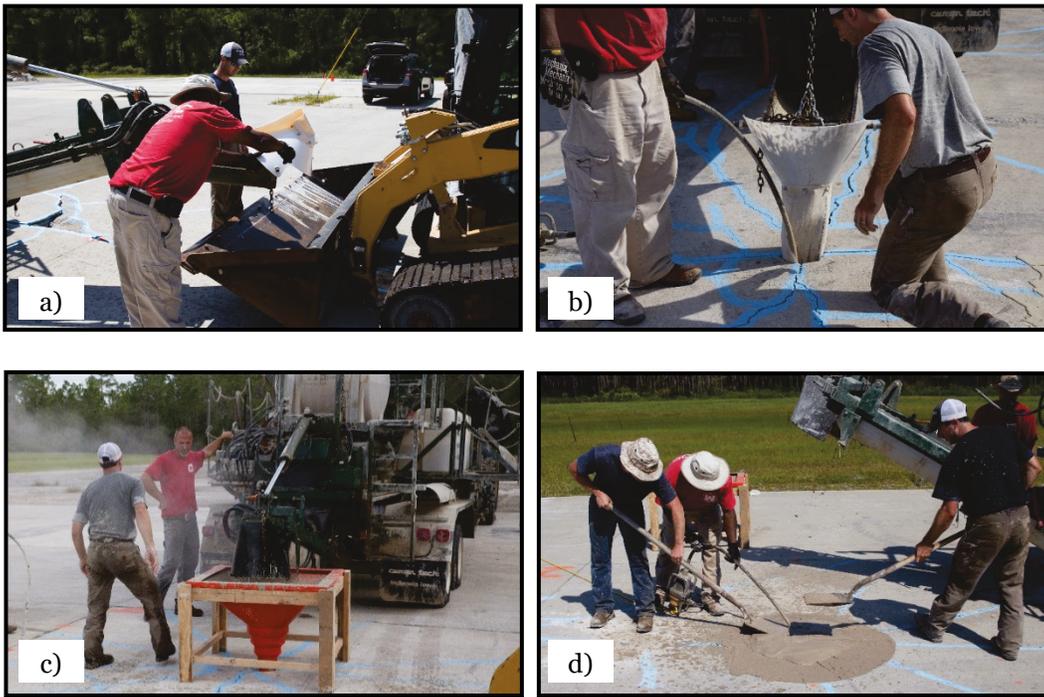
Figure 3.31b and Figure 3.31c illustrate the use of the mini hopper and tremie funnel during placement. In both cases, the discharge boom was lowered to an angle of 10 to 15°. Rapid-setting flowable fill or rapid-setting concrete was produced until each camouflet was filled. Tracking the fill level within the camouflet as it rose was not straightforward. The simplest, yet relatively effective, means of tracking fill level was for an engineer or technician to insert his hand into the camouflet OPE alongside the mini hopper or tremie funnel and feel for material as the level rose. This was the most effective (although maybe not the most practical long-term) solution to determine when to stop SVM production with minimal overflow.

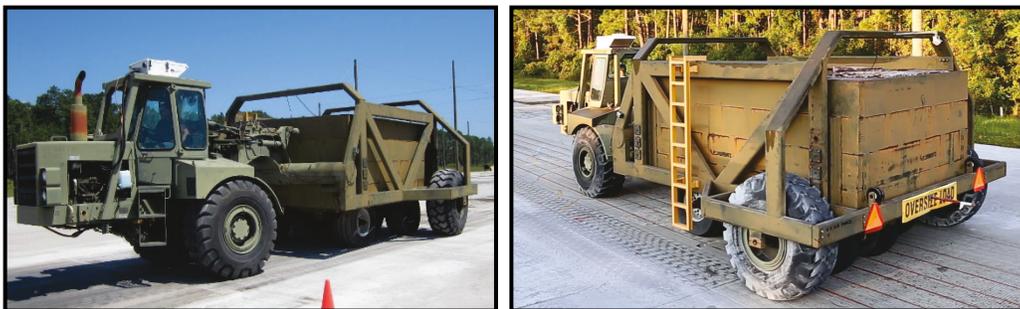
A multiple wheel C-17 load cart (Figure 3.34) was designed to match the geometry and loading of one half of the main gear of a C-17 fully loaded to its maximum takeoff weight of approximately 586,000 lb. The weight of the load cart itself was approximately 269,560 lb; individual wheel loads were approximately 44,930 lb. The load cart contained six wheels arranged in a triple-wheel tandem configuration. The gear used 50-in.-diameter, 21-in.-wide, 20-ply tires maintained at a normal operating pressure of 138 to 144 psi.

Figure 3.34. C-17 load cart.

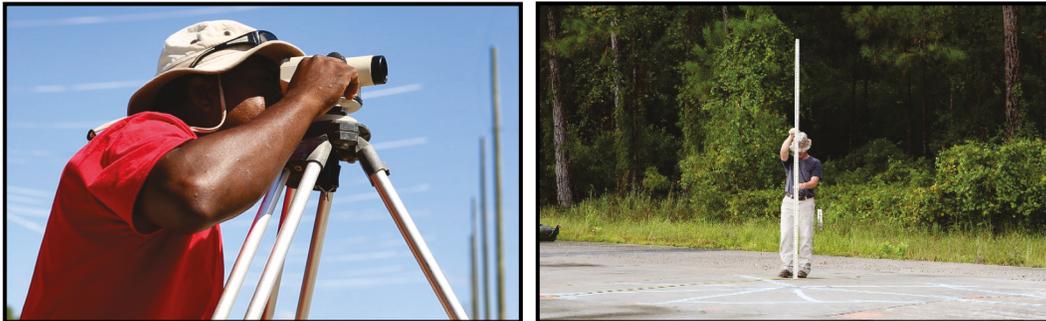
Rod and level surveys were conducted (Figure 3.37) to measure elevation changes (upheaval, settlement, etc.) during field testing and trafficking. The roughness specification for fighter aircraft such as the F-15 is ± 0.75 in. or less to ensure acceptable aircraft gear loads. This value was used as a benchmark value for analyzing camouflet upheaval due to blasting and settlement due to trafficking.

Figure 3.37. Conducting rod and level surveys.

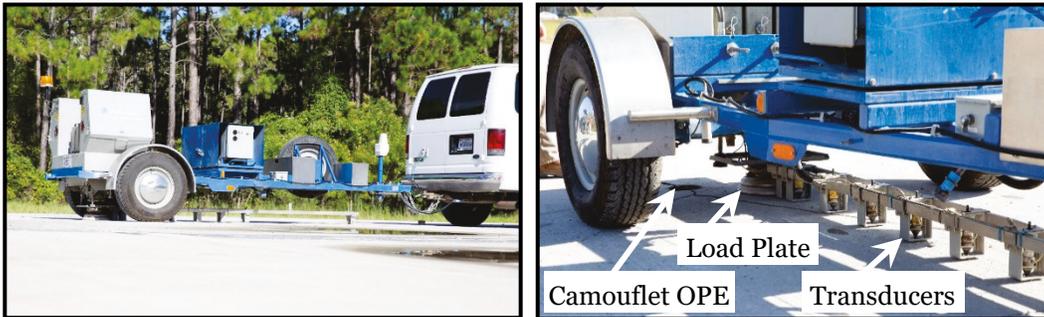
The heavy-weight deflectometer (HWD) shown in Figure 3.39 was used to assess the structural support of each camouflet slab at various points throughout testing. Measurements were taken prior to blasting, after blasting but before repair, after repair and curing but before trafficking (0 passes), and at the same pass intervals as visual assessments (112, 560, 1,008, 1,192, and 1,568 passes).

Figure 3.39. Heavyweight deflectometer.

The HWD consists primarily of an 11.8-in. diameter load plate to which an impulse load is applied and seven transducers that measure the corresponding deflections (D_s) at seven locations (D_1 to D_7). D_1 to D_7 locations relative to the center of the load plate were 0, 12, 24, 36, 48, 60, and 72 in., respectively. At each test location, the HWD was dropped, without relocation, 4 to 7 times at a range of loads depending on the general stiffness of the pavement. Loadings ranged from approximately 15 to 55 kips resulting in contact pressures of approximately 150 to 550 psi. Consecutive tests at various points throughout the field work occurred at essentially the same locations approximately 1 ft beside the camouflet OPE.

Camouflet characteristics were not well-suited for traditional HWD assessment. For example, slabs were considerably cracked, which would affect the stress transfer throughout the slab (and consequently affect deflection measurements). It is also important to note several other factors that could influence HWD measurements. All other factors being equal, (1) deflections would be expected to decrease (or perhaps remain approximately the same) as the camouflet repair gained strength over time, and (2) deflections would be expected to increase (or perhaps remain approximately the same) as trafficking continued (e.g., degradation of the repair, further cracking of the slab). Strength gain over time and traffic effects could not be decoupled since no un-trafficked control camouflet was repaired for comparison. Thus, HWD data was primarily useful for analysis of general trends rather than advanced characterization.

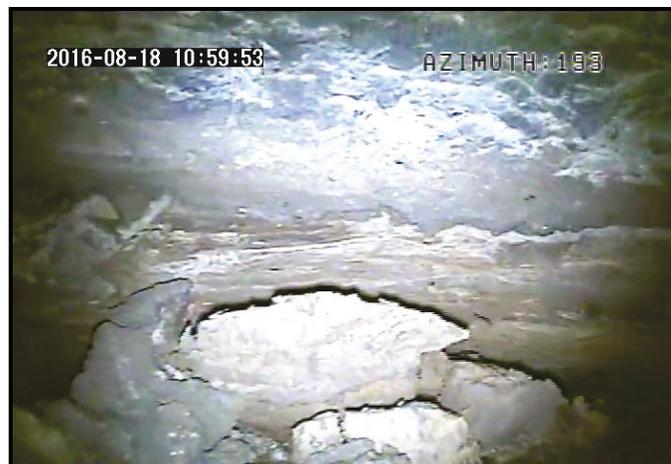
The SVS camera was evaluated only on Camouflets 2 and 12. Based on preliminary field tests, it did not appear promising and was tested in a limited manner similar to the MC1 borescope. Figure 5.22 illustrates a fair quality photo extracted from SVS video files. In comparison to the MC1 borescope, there was much greater definition, and the onboard light source was much better although it only illuminated part of the frame well. However, the overall SVS video quality was marginal, so most of the extracted images were blurred. SVS images were analyzed with PhotoScan identically to MC1 images.

Figure 5.22. SVS camera photo of Camouflet 2.

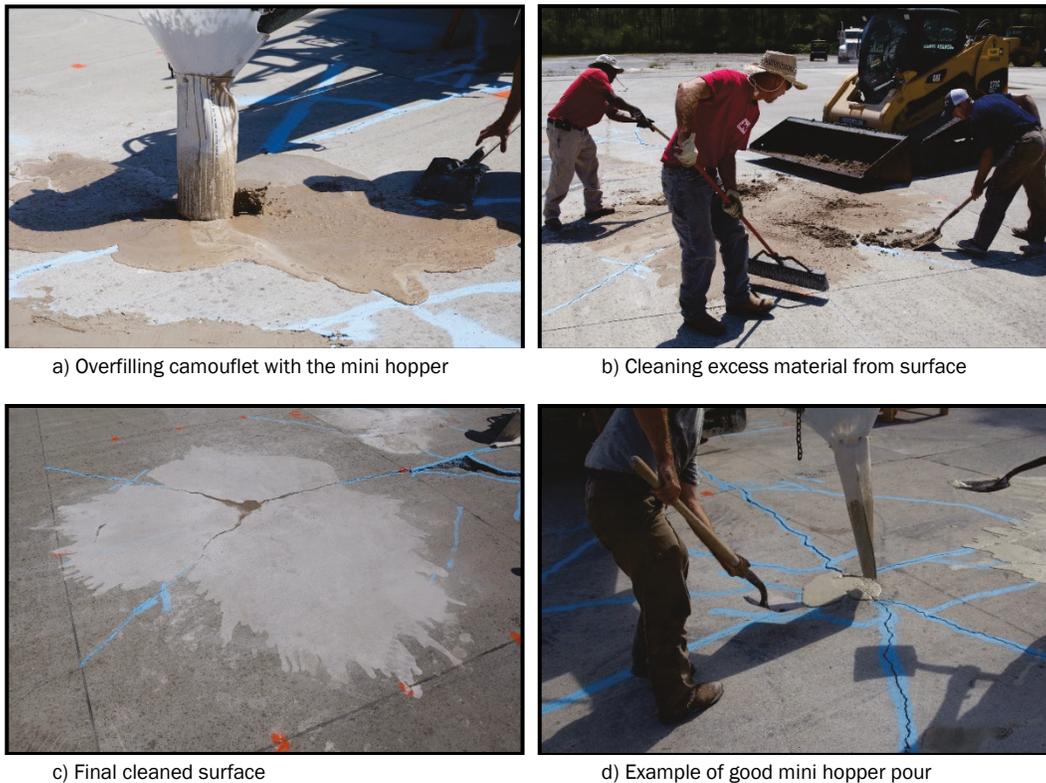
The greatest difficulty during repairs was tracking the fill level of material inside the camouflet and knowing when to stop production of the SVM. If the SVM operator waited to stop the SVM until the camouflet was visibly full (i.e., material at the surface), the camouflet would be overfilled as the remaining material in the SVM auger was discharged, creating a spill as shown in Figure 6.1a. This material was cleaned up to prevent creating a foreign object debris (FOD) issue (feathering of material has been noted as a FOD concern in multiple previous reports (Priddy et al. 2011a; 2011b).

Figure 6.1. Photographs of camouflet pours using the mini hopper.

Figure 6.1b shows the excess material being shoveled and swept into a CTL bucket shortly after it was placed and once it was set enough to shovel. Aside from requiring a few minutes post-pour, this clean-up was not a major burden. It was also fairly effective, leaving sand-sized or smaller particles. It was not the most ideal solution aesthetically (Figure 6.1c), but it did not seem to pose a FOD threat.

Figure 6.1d shows the end of the Camouflet 6 pour (third and final use of the mini hopper). In this case, an adequate amount of material was produced, and a spill was avoided. The key difference between the Camouflet 6 pour and the earlier pours was that one man was dedicated to monitoring the fill level. This required him to insert his arm into the camouflet OPE alongside the mini hopper trunk as material was also being poured. For a long-term solution, this is not practical; during the field work, however, it was the most obtainable solution given the options at hand.

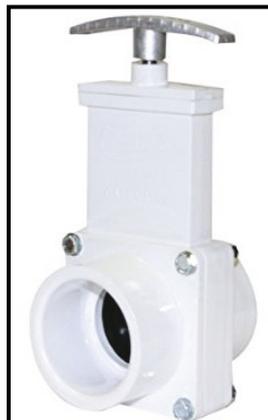
Figure 6.3. Pull-handle gate valve.

Given the testing potentially required to develop a floating level indicator that works properly, using a valve on the tremie funnel would be the most promising solution absent further testing and evaluation. A 4-in.-diameter pull-handle gate valve, such as the one shown in Figure 6.3, could be installed at the outlet of the tremie funnel, providing a quick flow shutoff solution.

The tremie funnel is also large enough that it could serve as a temporary holding reservoir, providing enough buffer to contain the remaining discharge from the SVM once the gate valve is closed and the SVM is stopped. This could also provide a surplus of material in case more is needed after material settles in the camouflet under vibration. A more robust (i.e., steel) tremie funnel stand should be fabricated if the tremie funnel was to be fielded. Some type of lifting mechanism should also be considered for a new stand for moving the tremie funnel to the washout area or to a subsequent camouflet. This could be in the form of handles for lifting by hand or supports or pockets for lifting with a forklift or both.

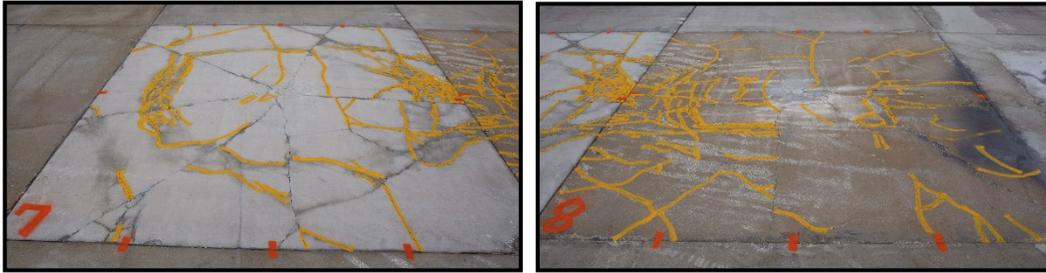
Figure 6.10. Severe load cart damage on Camouflets 7 and 8.

Similarly, Figure 6.10 shows extensive damage to Camouflets 7 and 8 after only 112 passes. In this case, the blue paint used to mark pre-existing cracks was not dry when rain moved into the Silver Flag area, and the paint was washed away. All new cracks that occurred due to trafficking were marked in yellow paint to illustrate the extent of cracking. Despite being as severely cracked as Camouflet 6, Camouflets 7 and 8 did not exhibit noticeable movement under the load cart like Camouflet 6. This supported the idea that a saturated base may have had some influence on Camouflet 6.

Camouflet Series B and C did not perform as well under load cart trafficking. While Camouflet 4 exhibited almost no change after 112 passes, Camouflet 5 developed several medium-severity cracks, and all other camouflet slabs developed such severe cracking that it could not be reasonably represented in a map sketch.

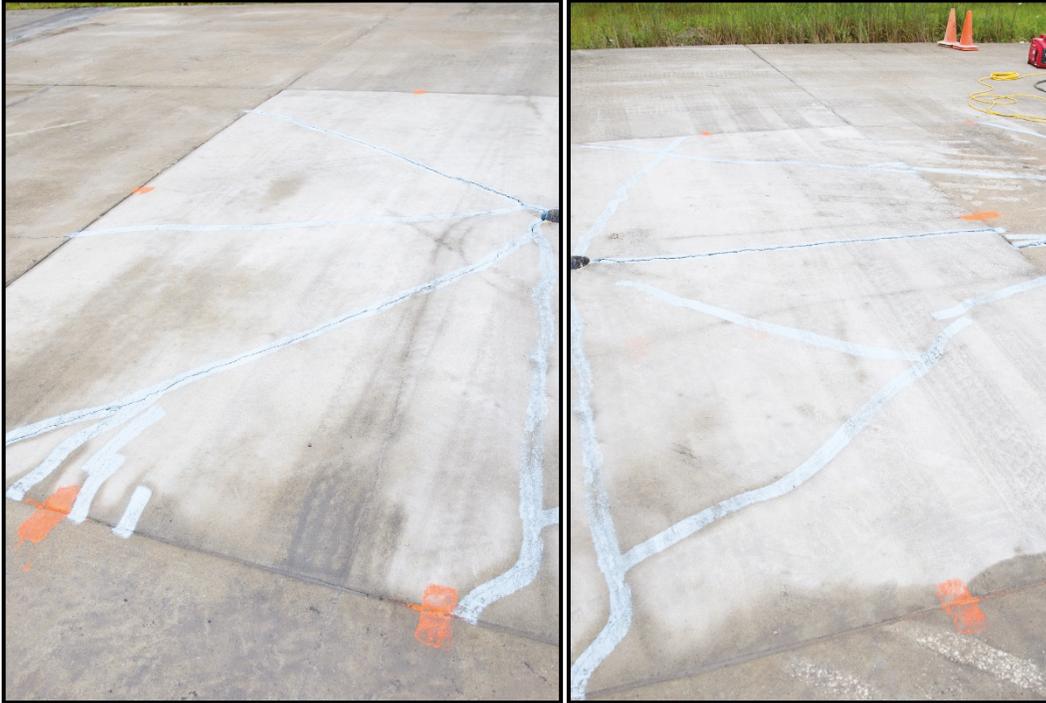
Figure A14. Camouflet 7 after 112 passes of the C-17 load cart.

Blue paint marking pre-existing cracks was relatively fresh when thunderstorm occurred and was washed away.

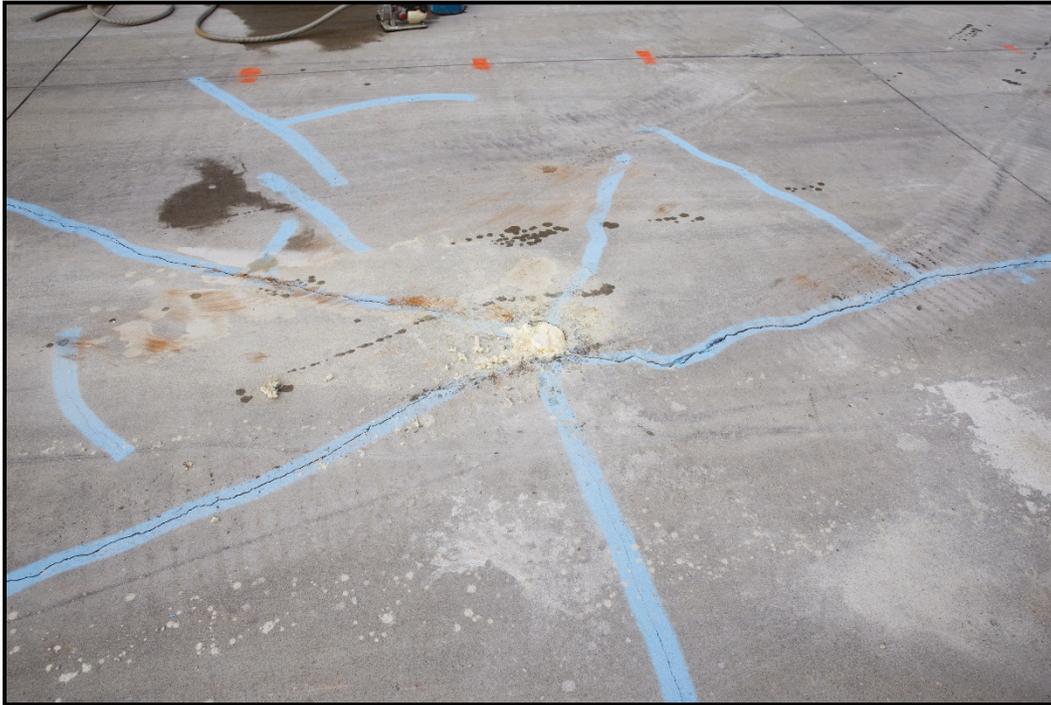
Figure A18. Camouflet 10 after 1,568 passes of the C-17 load cart.

For Camouflet Series A and D, nearly all crack development that occurred as a result of load cart trafficking was classified as low severity. This was an interesting finding considering the extensive cracking that existed before the camouflets were subjected to any traffic. While new cracks did develop and existing cracks grew in length, cracks did not noticeably increase in severity. Trafficking was continued through the end of the Silver Flag work (1,192 and 1,568 passes) at which point all slabs were still fully trafficable despite being shattered from the beginning. Series A and D were considered successful camouflet repairs for emergency situations.
