POTAMOLOGY INVESTIGATIONS

PRELIMINARY DEVELOPMENT

INSTRUMENTS FOR THE MEASUREMENT OF HYDRAULIC FORCES

ACTING IN A TURBULENT STREAM

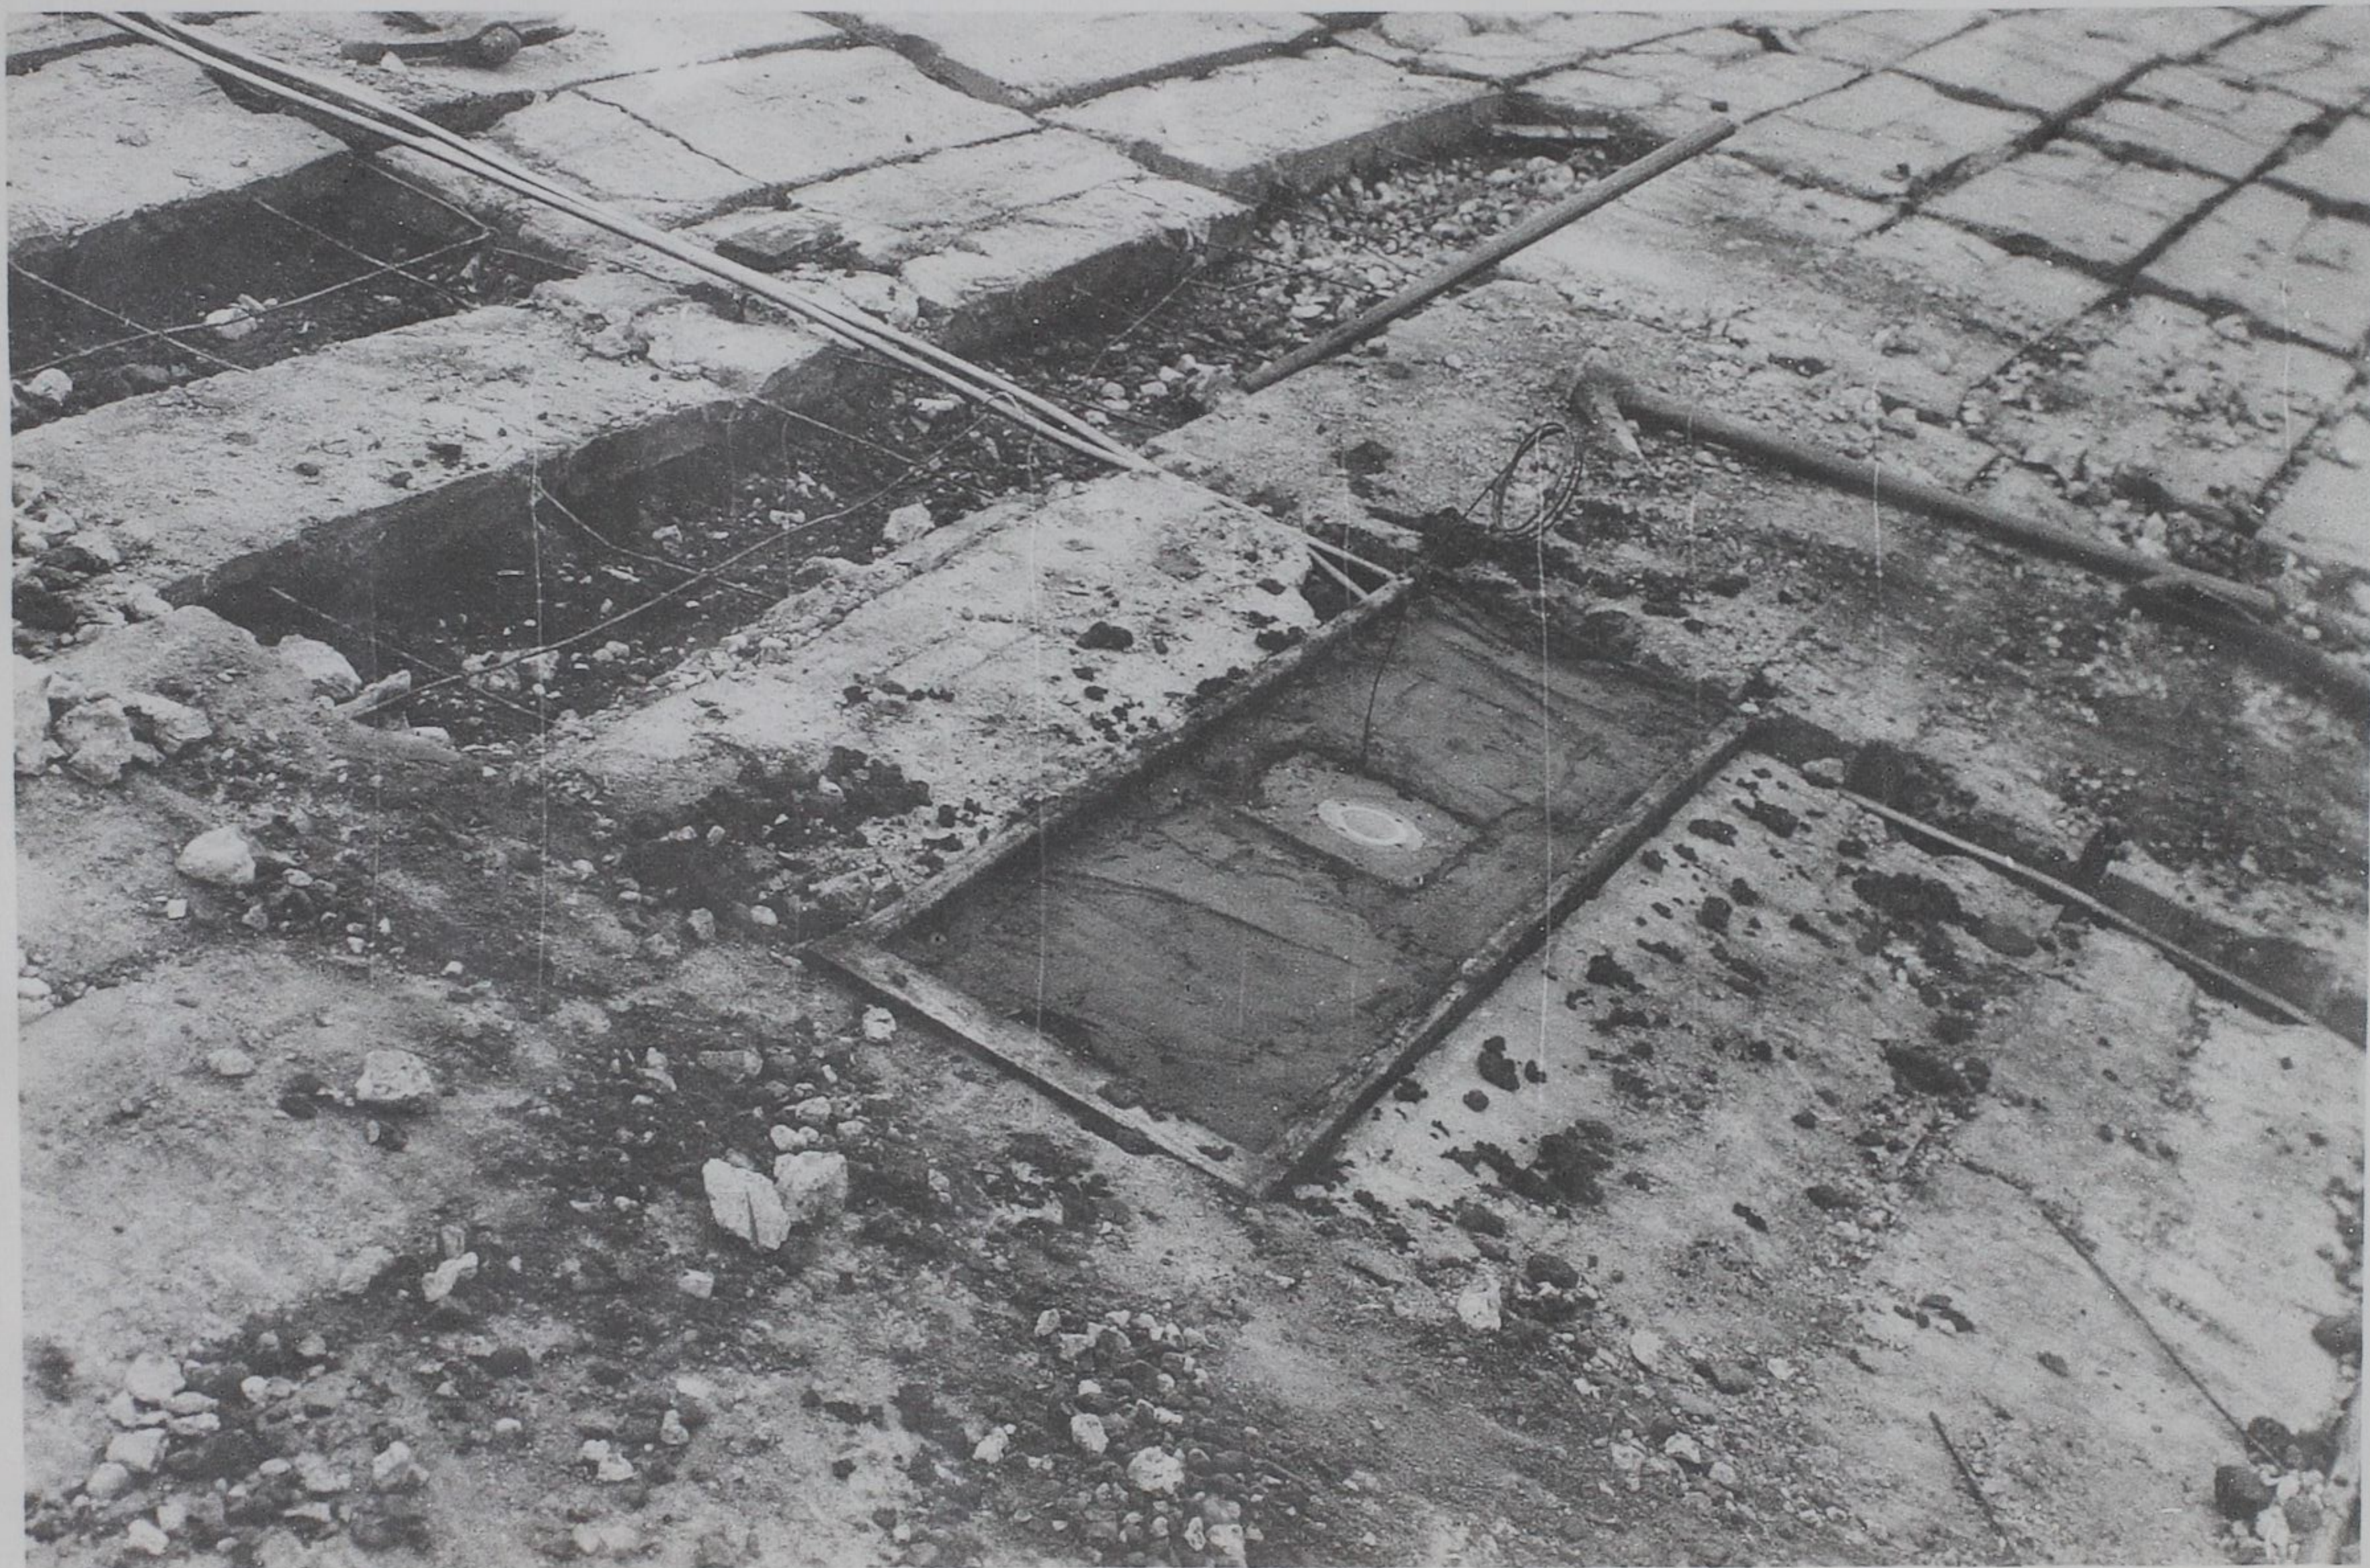
PHOTOGRAPH 6. Differential pressure cell installed in revetment after concrete block is remolded around it

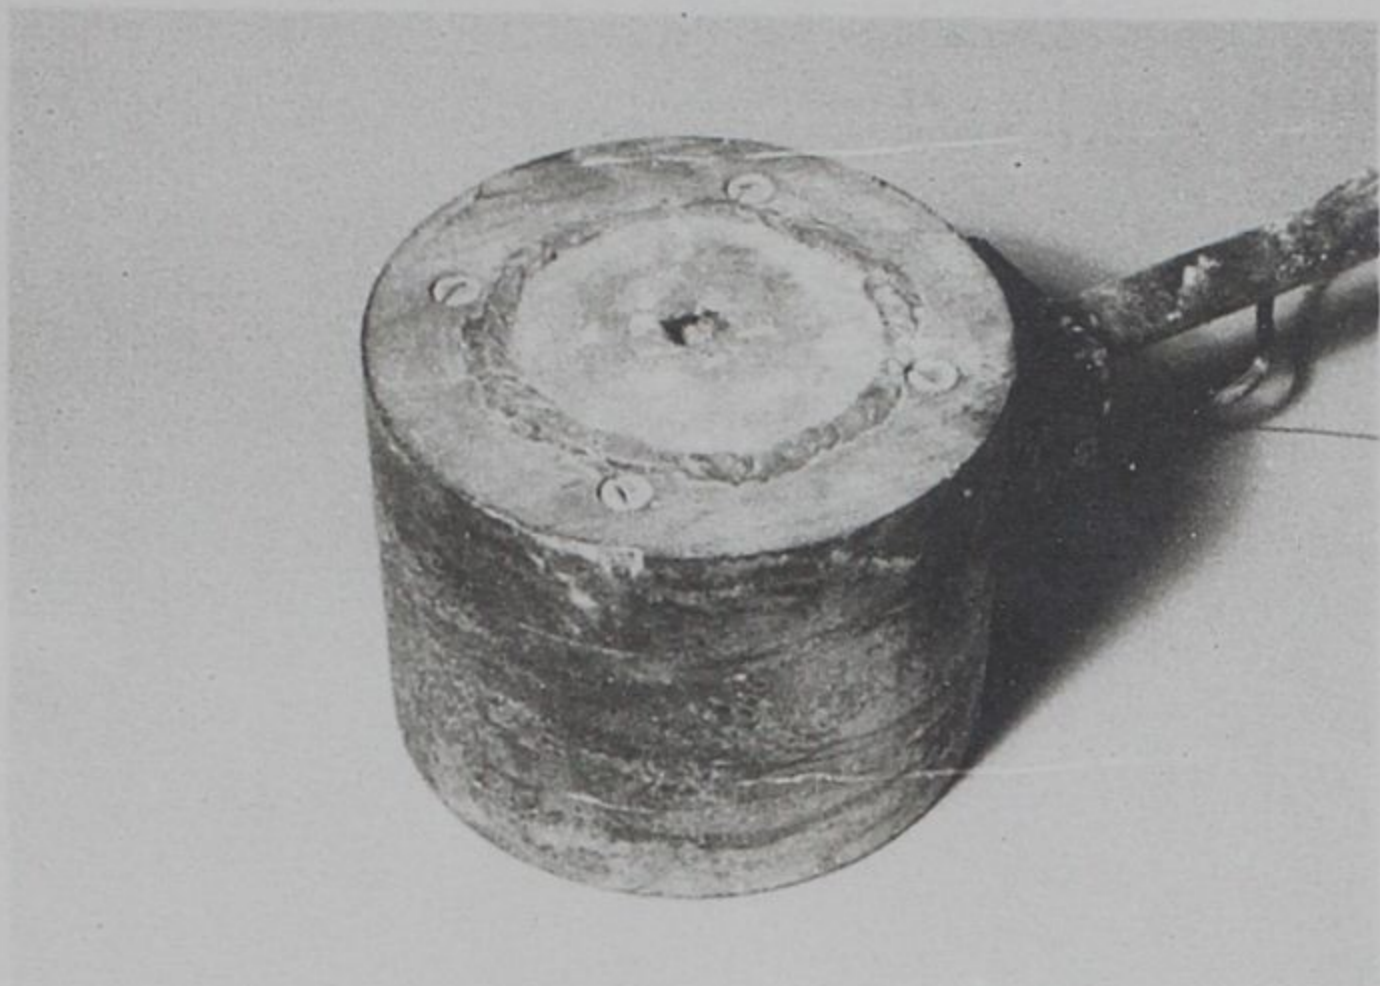
PHOTOGRAPH 9
Differential pressure cell
just removed from
installation

20. Pressure Measuring Instruments. After the water surface had receded below the instruments, the pressure cells were examined to determine the cause of the improper operations. An inspection of the top bellows chamber revealed that despite the 80 mesh per inch screen cover, very fine sand had become packed around the top bellows of the cell. The water again covered the instruments after the sand had been cleaned from around the top bellows of one cell. For several days this instrument was very responsive to waves and tow wash. However, the water surface only reached approximately 30 inches above the cell and then receded below it. Photograph 9 shows a pressure cell just removed from the installation. The hole in the screen was made after the water had receded below the instruments. Photograph 10 shows the same cell with the top cap removed and the sand packed around the bellows. In photograph 11 the same cell is shown with some sand

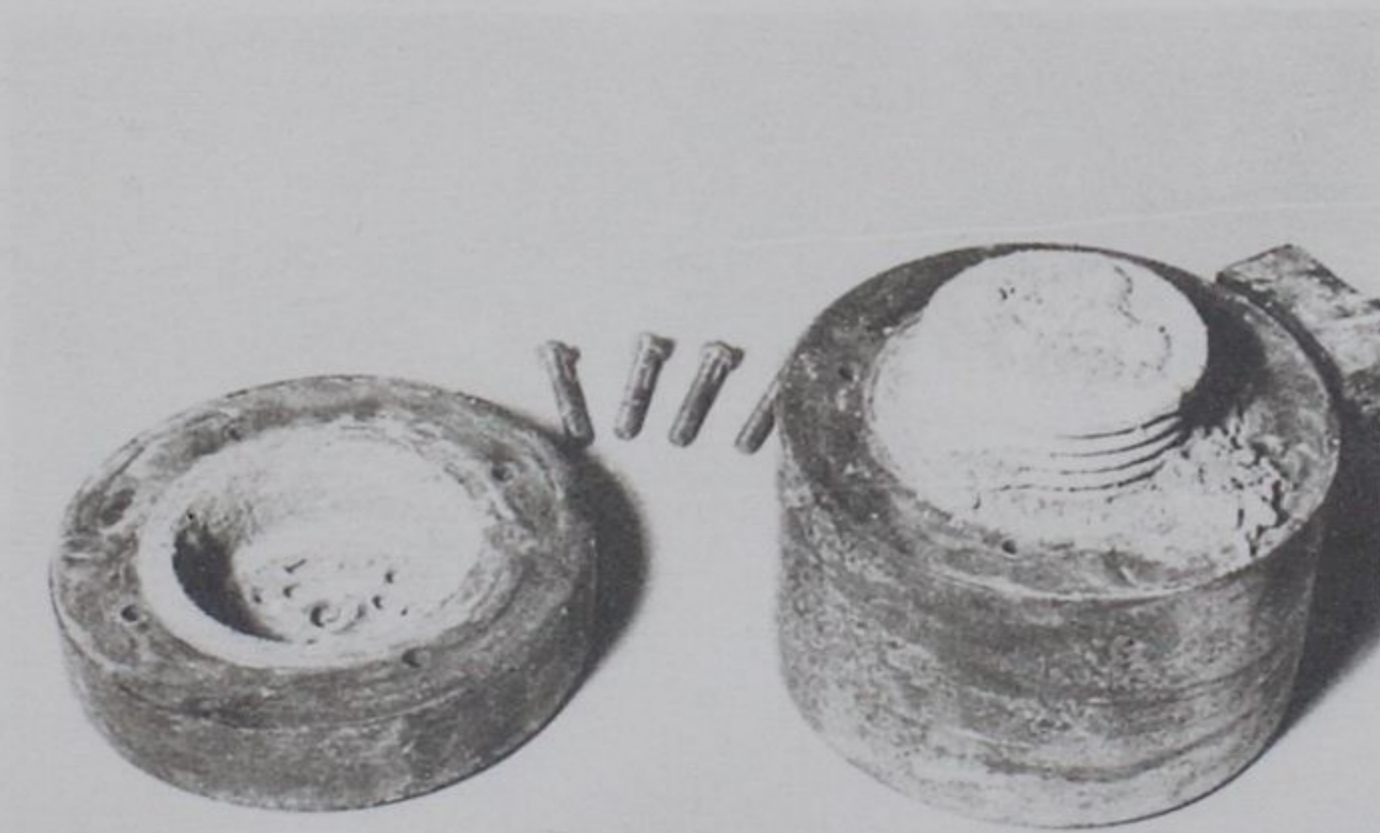
PHOTOGRAPH 11
Differential pressure cell
just removed from instal-
lation with top cover cap
removed and some sand re-
moved from around the
bellows

removed to show the bellows. An analysis of the sand removed from a pressure cell indicated that approximately 53 per cent of it passed a 200 mesh per inch screen. The analysis curve as shown in plate 3 indicates that some of the sand should not have passed the protective screen. No explanation can be offered for this discrepancy.

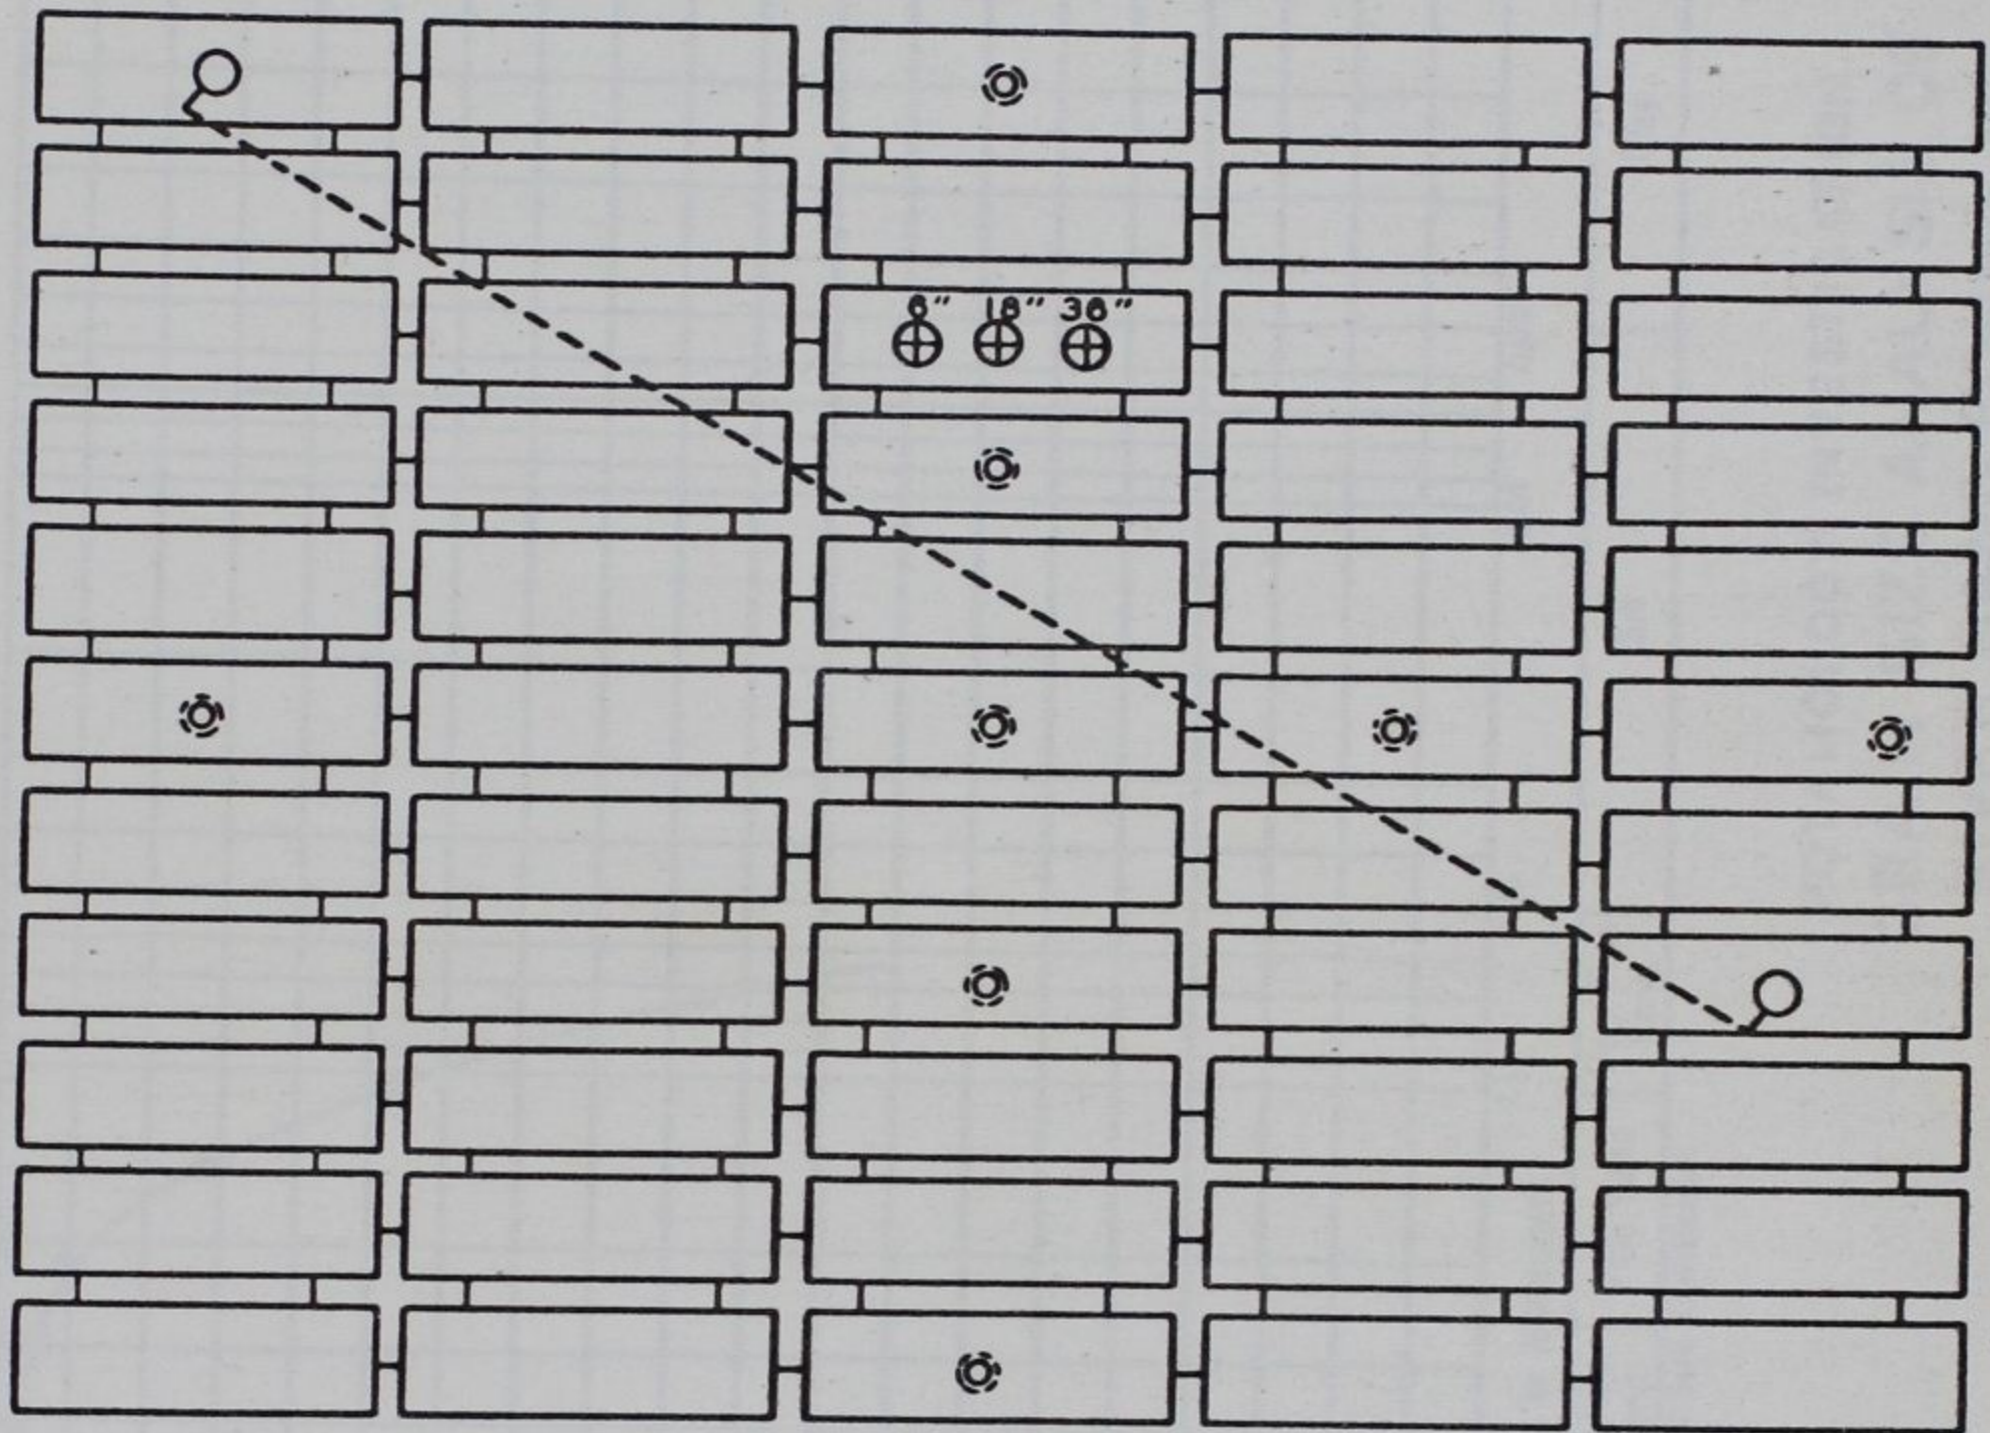
- ⊙ DIFFERENTIAL PRESSURE BETWEEN TOP AND BOTTOM OF BLOCK.
- ⊙---○ DIFFERENTIAL PRESSURE BETWEEN TWO POINTS ON TOP OF BLOCK.
- ⊕ DIFFERENTIAL PRESSURE BETWEEN SOIL SURFACE AND SUB-SURFACE AT DEPTHS INDICATED.

**POTAMOLOGY INVESTIGATION
 INSTRUMENTATION LAYOUT
 REID BEDFORD BEND INSTALLATION**

17. The layout consisted of eight pressure instruments for measuring the differential pressures between the top and bottom of the articulated

concrete blocks, one set of pressure cells for measuring the difference in pressure between the tops of two blocks some distance apart, three pressure instruments for measuring the differential pressures between points at the surface of the soil in the bank and at depths of 6 inches, 18 inches, and 36 inches below the surface, and one mat movement instrument for measuring the vertical movement of a section of mat spanning a hole under the revetment. Photograph 5 shows a differential pressure cell placed in the revetment before the block was remolded around it. The same cell is shown in photograph 6 after the concrete block was remolded. The cells for measuring the differential pressures between points at the surface of the soil in the bank and at 6 inches, 18 inches, and 36 inches below the surface are shown in photograph 7 installed before the concrete block was remolded over them. The mat movement instrument is shown in photograph 8 as installed.
