## **Geophysical Feasibility Study to Identify Signs of Chimney Drain/Drainage Blanket Clogging in Canyon Dam Canyon Lake, Comal County, Texas**

*By Janet Simms and Katie Martin*

**PURPOSE:** To determine the feasibility of using geophysical methods for detecting/identifying areas that may be clogged within the chimney drain and/or drainage blanket.

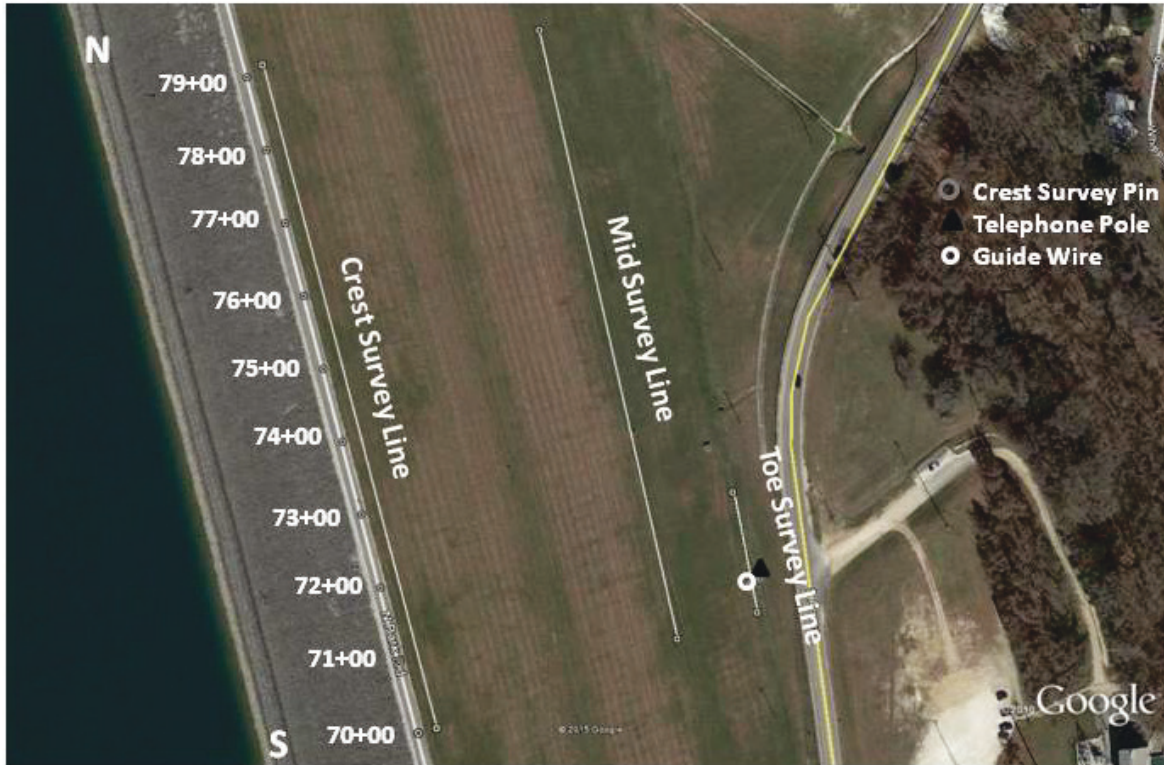
Figure 3. Location of three geophysical survey lines along the downstream embankment. Station 0 of each line aligns with survey pin location 70+00. Google image accessed September 8, 2015.

**SITE DESCRIPTION:** The general geographical coordinates for Canyon Dam are 29.881462°, -98.26746°. Measurements were acquired along three survey lines located on the downstream embankment, i.e., one at the toe, one midway up the embankment, and one near the crest (Figure 3). All lines paralleled the crest of the dam, with station 0 aligned with survey pin station 70+00. The crest survey line was positioned 25 ft (7.6 m) east of the dam centerline, which approximates the center of the chimney drain. Table 1 provides the location of station 0 on each

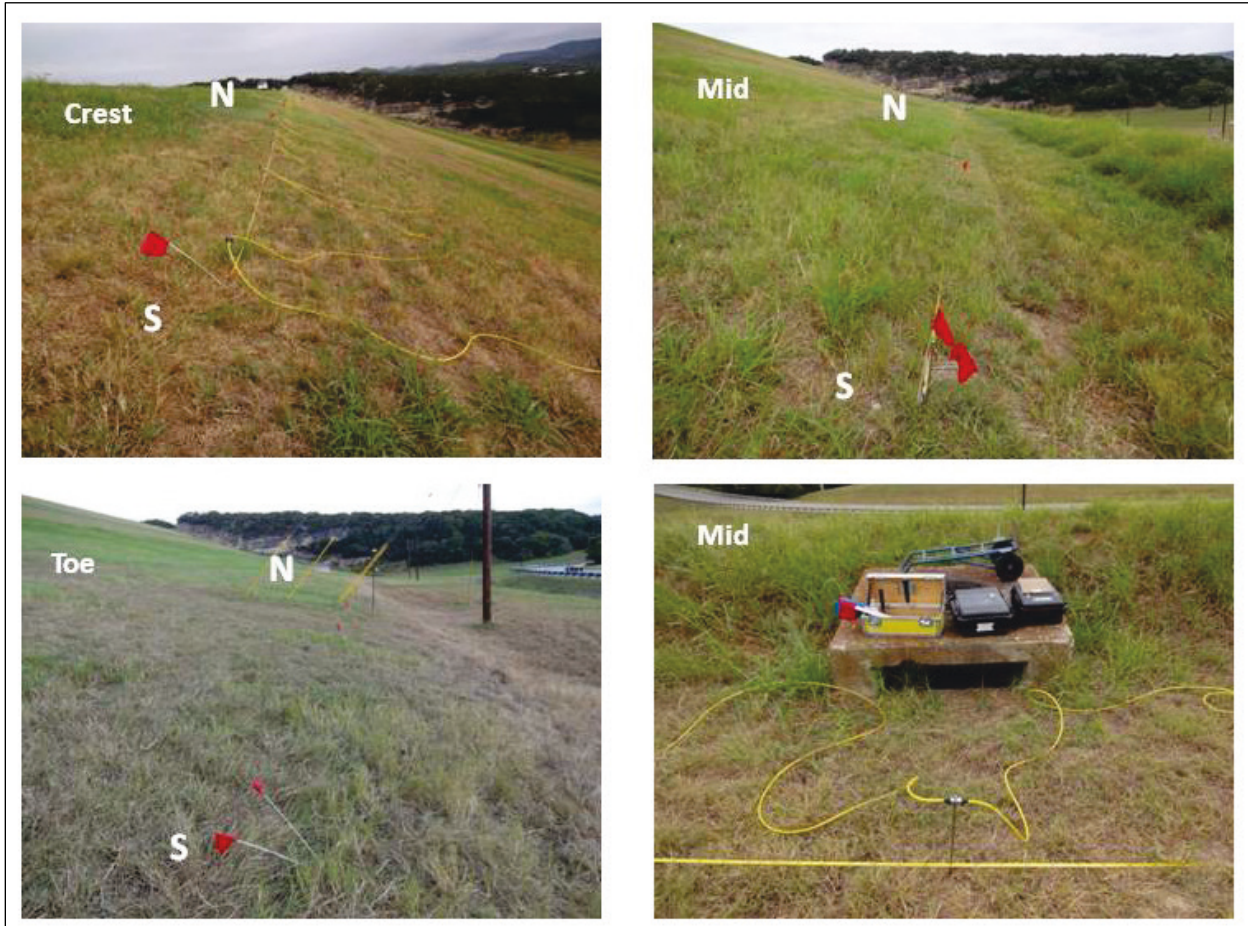
Figure 4. View looking north along each survey line. Note the telephone pole guide wire adjacent to the toe line (bottom left) and drop inlet proximal to the mid line (bottom right).

line and the length of each line. The line length varied depending on the electrode spacing used for the electrical resistivity surveys. Figure 4 shows the view looking north along each survey line. Cultural features proximal to the survey lines that influenced the data include a telephone pole guide wire on the toe line and drop inlet on the mid line.

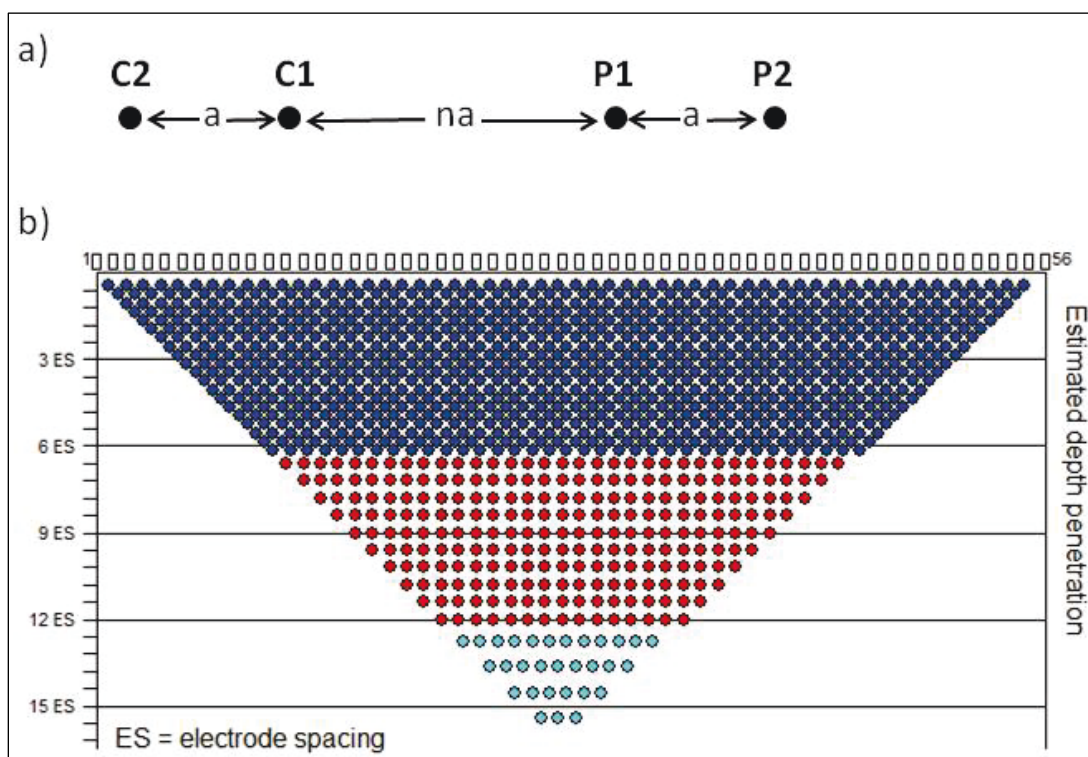
Figure 5. Dipole-dipole electrical resistivity configuration (a). By using different values for “a” and “n,” 2-D coverage of the subsurface is obtained (b). In (b), the rectangles along the surface represent electrodes (in this example 56), and the dots in the subsurface represent the pseudo location of a measurement. For a given number of electrodes, as the electrode spacing increases, the number of measurements at depth decreases.

is possible to obtain a 2-D image of the subsurface. The dots in Figure 5b represent pseudo-depth locations of resistivity measurements for given electrode spacings. Modern ER systems allow initial placement of electrodes and electrode cables and use automatic switching capabilities to measure the multiple electrode combinations. An Advanced Geosciences Inc. (AGI) SuperSting™ R8 earth resistivity system with electrode switch box (Figure 6) was used to acquire the resistivity data. This is an eight-channel system, meaning eight readings, i.e., electrode pairs, are acquired during one measurement. An initial layout of 84 electrodes was used with 6 cables of 14 electrode take-outs. The line length was extended to 112 electrodes by employing two roll-along sequences of one cable (14 electrodes). The electrode spacing, “a,” controls the depth of investigation, with a greater electrode separation providing a greater depth of investigation. An electrode spacing of 8.2 ft (2.5 m) was used for the crest and mid-survey lines, giving a total line length of 910.4 ft (277.5 m). The survey line at the toe had a 1.64 ft (0.5 m) electrode spacing, giving a total line length of 182.1 ft (55.5 m).

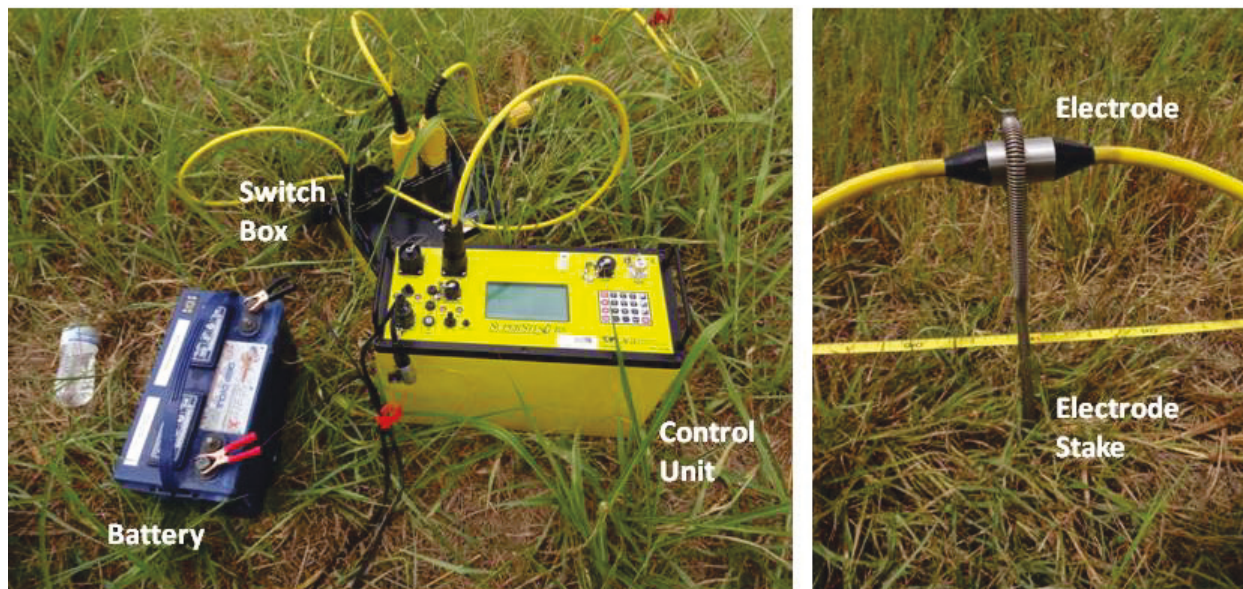
Figure 6. Advanced GeoSciences Inc. SuperSting™ R8 system used to acquire the electrical resistivity data.

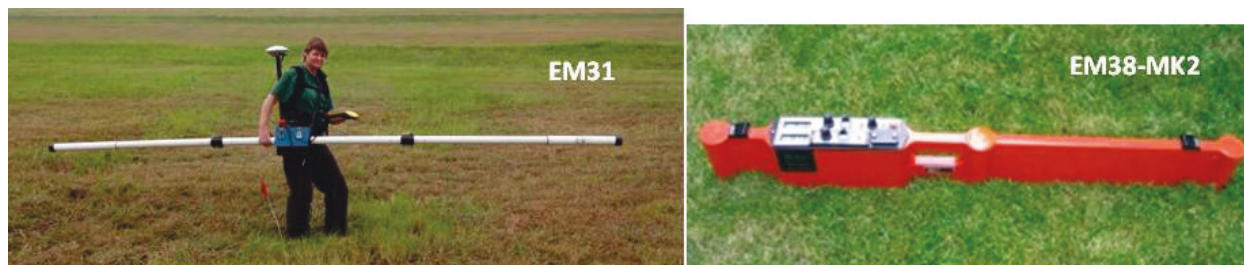
Figure 7. Geonics EM31 (left) and EM38-MK2 (right) electromagnetic induction instruments.

**Electromagnetic (EM) induction.** The Geonics EM31 and EM38-MK2 are frequency-domain EM induction sensors (Figure 7) that measure apparent terrain conductivity and can also detect metallic objects. The conductivity of a material is dependent on the degree of water saturation, types of ions in solution, porosity, chemical constituents of the soil, and the physical nature of the soil. Because of these factors, conductivity values can range over several orders of magnitude. The EM system consists of a transmitter and receiver coil separated by a fixed distance. An alternating current, commonly in the 1 to 20 kilohertz range, is passed through the transmitter coil, thus generating a primary time varying magnetic field. This primary field induces eddy currents in the subsurface conductive materials (where the common phrase EM induction is derived). These eddy currents are the source of a secondary magnetic field that is detected by the receiver coil along with the primary field. Under a fairly wide range of conditions, the measured component that is 90 degrees out of phase (quadrature component) with the primary field is linearly related to the terrain conductivity. Conductivity is measured in units of millisiemen per meter (mS/m).

The EM31 operates at a frequency of 9.8 kHz. It has a transmitter-receiver coil separation of 12 ft (3.7 m) and an effective depth of investigation of approximately 20 ft (6.1 m) when operated in the vertical dipole orientation. The EM38-MK2 operates at 14.6 kHz. It has two receiver coils separated by 3.28 ft (1 m) and 1.64 ft (0.5 m) from the transmitter coil, providing data from effective depth ranges of 4.9 ft (1.5 m) and 2.5 ft (0.75 m), respectively, when operated in the vertical dipole orientation. For both instruments, data were collected at 0.2-sec intervals along the toe survey line and stored in a data logger for later download. The data were processed using Geonics DAT31/DAT38-MK2 software and plotted as a 1-D profile.

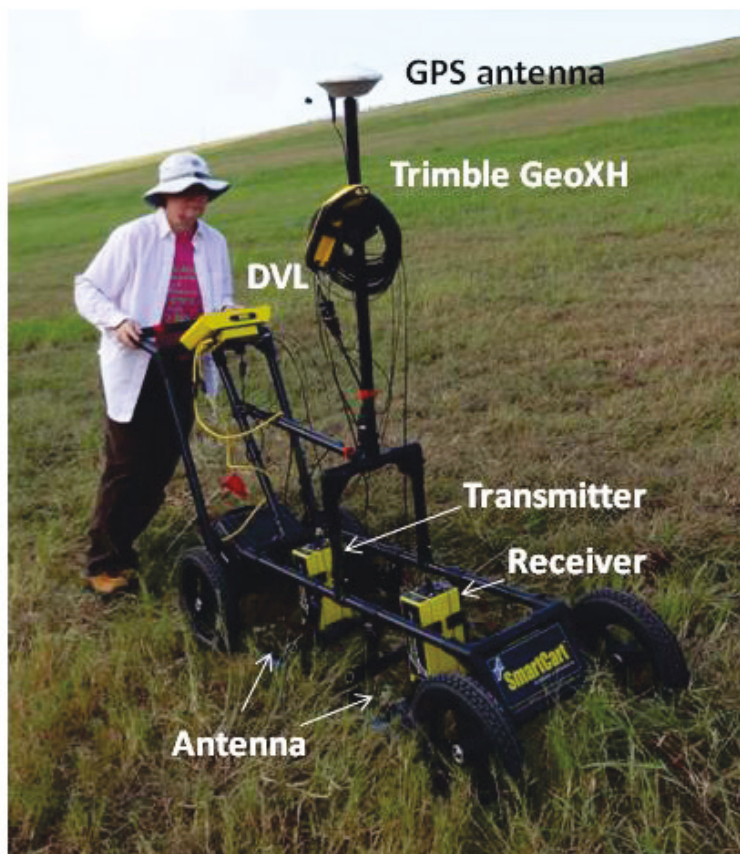
Figure 8. Sensors and Software pulseEKKO PRO GPR system with 200 MHz antenna.

**Ground Penetrating Radar (GPR).** The GPR data were acquired using a Sensors & Software (S&S) pulseEKKO PRO with a 200-MHz antenna. Other antenna frequencies (100 MHz, 50 MHz) were also used; however, the data were lower resolution and did not provide additional information; therefore, these data are not presented. The antenna was mounted on a cart and pushed along the survey line at a slow walking pace (Figure 8). The data were collected at 3.94-in. (10-cm) intervals along the survey line and viewed and stored on a digital video logger (DVL). The data were post-processed using S&S EKKO\_Project 3 software. Basic processing steps included dewow (or signal saturation correction) to remove the low frequency component induced by the transmit signal, an average background subtraction to enhance dipping events, such as hyperbolas from point targets, and a spreading and exponential compensation (SEC) gain to enhance the data. The SEC gain compensates for the spherical spreading losses and exponential ohmic dissipation of energy. The data were then plotted as a gray-scale 2-D profile for interpretation. The depth of investigation achieved was about 4.9 ft (1.5 m).

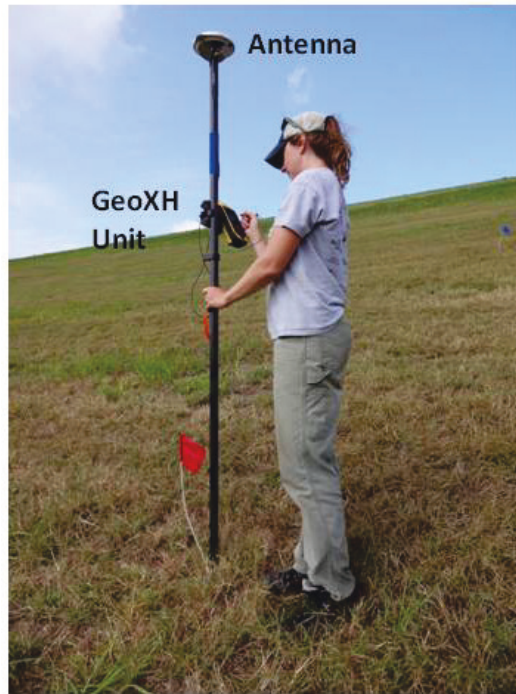
Figure 9. Trimble GeoXH GPS unit used for positioning data.

**Global Positioning System (GPS).** A Trimble GeoXH global positioning system (GPS) was used to collocate the data during acquisition (Figure 9). It was also used to acquire the survey line locations and other features of interest. The GeoXH combines a global (GNSS) receiver with a field computer. It can provide decimeter accuracy after post-processing. In the field, positions were measured within 1.64 ft (0.5 m). Positional data pertaining to the electrical resistivity electrode positions, survey line end points, and general features were post-processed; location data collected while acquiring data were not post-processed.

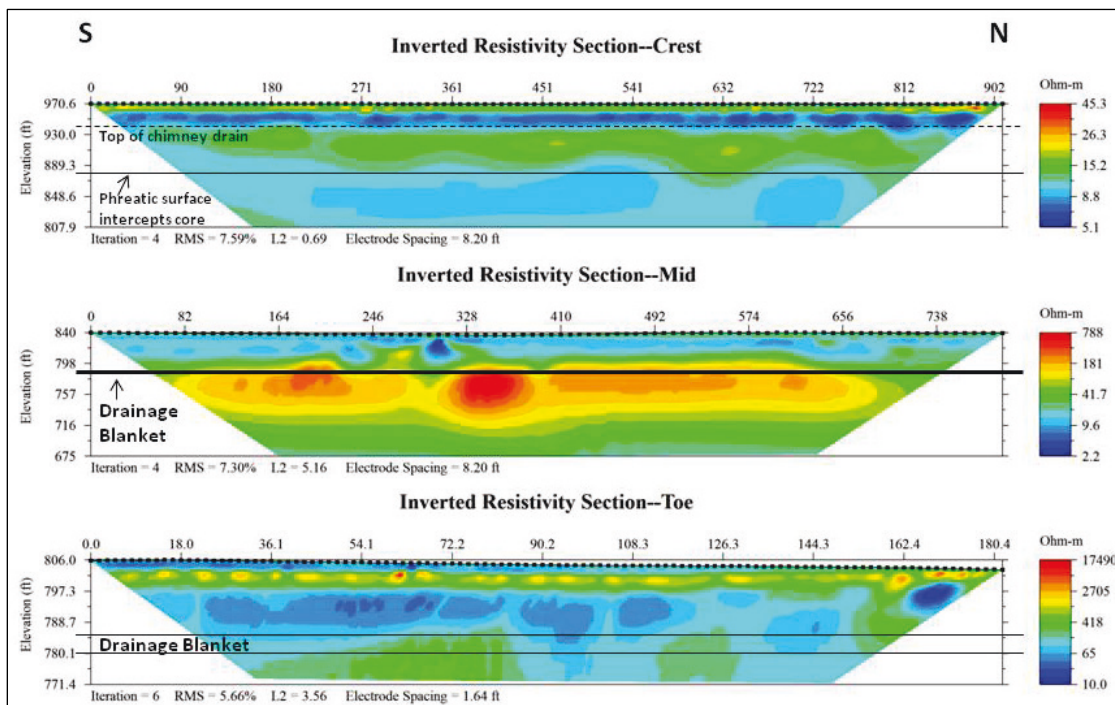
**RESULTS:** The inversion results of the electrical resistivity data for the crest, mid, and toe survey lines are presented in Figure 10. In each plot, the horizontal axis is distance (in feet) along the survey line from south to north. The vertical axis is elevation (in feet) and differs depending on line location. Also, the depth of investigation for the crest and mid sections is greater than the toe section because of the difference in electrode spacing used. The color bar represents apparent electrical resistivity in ohm-m; note that the scales differ for each plot. Table 2 provides information on dam metrics relevant to the discussion that follows.

Figure 10. Results of the inverted electrical resistivity data for the crest (top), mid (middle), and toe (bottom) survey lines. The horizontal axis represents distance (in feet) along the survey line from south to north. Station 0 of each line aligns with station 70+00 on the crest.

**Crest line.** The resistivity survey performed over the chimney drain (crest) achieved a depth of investigation of approximately 163 ft (50 m), thus extending to an elevation of 808 ft (246 m), which is 23 ft (7 m) above the top of the drainage blanket. The inverted resistivity section (Figure 10 top plot) shows that the majority of the volume imaged has an apparent resistivity less than 20 ohm-m, suggesting a moist material. This is unexpected because the filter material is a dry crushed limestone (USCS classification GW), and a typical resistivity value would be greater than 90 ohm-m. A low-resistivity layer (less than 10 ohm-m) is present between elevations 960 and 940 ft. This layer is comprised of the clayey embankment fill material that overlays the top of the chimney drain, which is at elevation 943 ft. It likely has a high moisture content (possibly wet). Within the chimney drain, below an elevation of about 889 ft (271 m), the apparent resistivity is 8 to 10 ohm-m, which also suggests a high-moisture-content material. The inversion results indicate a possible drainage path at the south end of the survey line between the upper and lower low-resistivity regions. It is interesting to note that the elevation of the deeper low-resistivity area approximates that of the 879 ft (268 m) determined in the conservation pool modeling where the phreatic surface intercepts the core. This is probably just a coincidence, because the conservation pool model (Figure 2a top plot) shows that the phreatic surface intercepts the core and deflects downward toward the drainage blanket.

**Mid line.** The mid resistivity survey used the same electrode spacing as the crest and achieved a similar depth of investigation (165 ft/50 m). The inverted resistivity section is the center plot in Figure 10. This line is shorter than the crest line because of an error when moving the last set of electrodes. Relative to the crest line, the bottom 32 ft (9.8 m) of it corresponds to the upper 32 ft of the mid line. Within this depth range, there is agreement between the two sections, i.e., both sections exhibit low resistivity values (< 20 ohm-m). However, because the embankment fill is a clay material, these values are typical for moist clay. The low resistivity anomaly (dark blue circular shape) beneath station 303.4 is caused by a corrugated metal pipe in a drop inlet (pictured in Figure 4). Between the low resistivity layer and drainage blanket (denoted by a heavy black line), there is a moderately resistive (20 to 100 ohm-m) material (green, elevation 805 to 785 ft). This resistivity range likely corresponds to the drier clayey material within the embankment. Beneath the drainage blanket is a high resistivity (> 100 ohm m) layer that is likely associated with limestone; this layer extends to about elevation 736 ft. The moderate resistivity material below could be associated with a shale.

**Toe line.** The inverted resistivity results for the toe line are shown in the bottom plot of Figure 10. Prior to discussing this line, note that the color shading in this plot cannot be directly compared to the color scheme in the crest or mid plots. The resistivity range of the toe section is much greater than that of the other two sections. Use of a smaller electrode spacing (1.64 ft/0.5 m) allowed

imaging of the drainage blanket and below. The upper 2 ft (0.6 m) of material on the south end (station 0-100) has a lower resistivity than the northern end. Below this depth the resistivity is higher, and there is a thin, very high resistivity ( $> 1,000$  ohm-m) layer at approximate elevation 801. Between elevations 797 to 785 ft (top of the drainage blanket), the resistivity is lower, but still moderate to high. On the north end of the section, centered beneath station 169, is a low resistivity anomaly, suggesting a moist material. The location of the drainage blanket is marked by two black lines. The drainage blanket exhibits moderate to high resistivity values, which is expected for a dry, crushed limestone. The material below the drainage blanket has similar resistivity values.

The resistivity inversion results for the survey performed over the chimney drain reveal that the filter material in the drain has resistivity values significantly lower than what was expected for a dry crushed limestone, and that the material may range from moist to wet. There is an approximately 2-ft (6-m) thick layer (elev. 960 to 940 ft) directly above the top of the chimney drain (elev. 943 ft) that has a relatively high moisture content. This layer likely consists of the clayey embankment fill. It is possible that this layer may drain into a region within the chimney drain, at elevation 889 ft. This deeper, high-moisture-content region extends to at least elevation 808 ft (maximum depth imaged at this location).

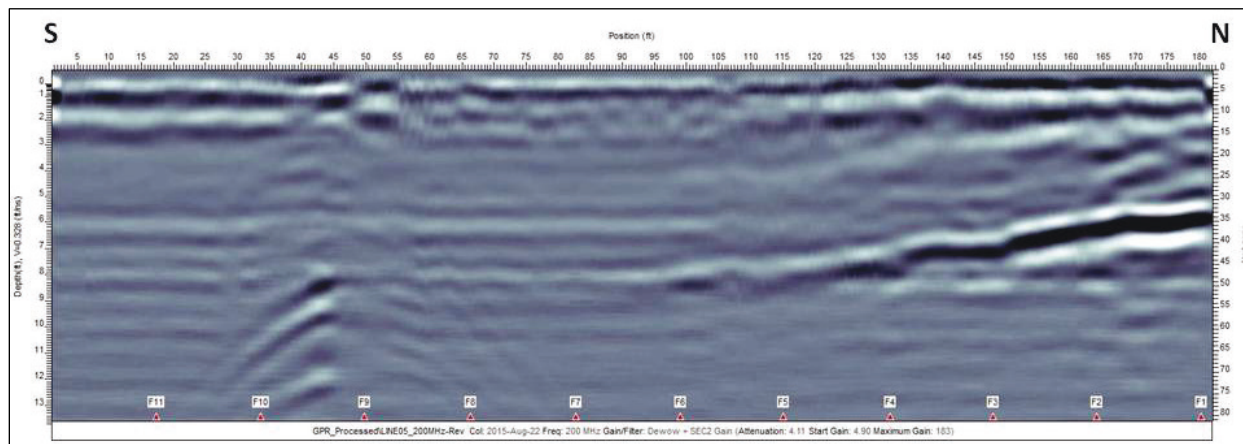
Figure 12. GPR profile acquired using a 200 MHz antenna along the toe survey line.

Figure 12 shows the profile of the GPR data acquired along the toe survey line. The horizontal axis represents distance (in feet) along the survey line; the right vertical axis is two-way signal propagation time (in nanoseconds, ns); and the left vertical axis is depth (in feet) assuming an electromagnetic wave velocity of 0.328 ft/ns (0.1 m/ns). Depth of investigation with the 200 MHz antenna was about 8 ft (2.4 m). Because of the high signal attenuation of the subsurface material, the lower frequency antennas used were unable to achieve a deeper depth of investigation; therefore, those data are not presented. The GPR was unable to image the drainage blanket, which is 21 ft (6.4 m) below ground surface at this location. The large, hyperbolic feature in the data seen at station 40 is a reflection from a surface feature (tie-down cable for a telephone pole). The other prominent feature in the data is the southward-dipping reflector in the northern end of the profile. A polarity reversal of the signal has occurred (white-black-white pattern), which can happen when a dry material overlays a moister material. This reflector could be associated with the low resistivity anomaly observed at the northern end of the apparent resistivity data.

The resistivity survey performed at mid embankment did not find any anomalous conditions that would suggest excess moisture in this area. One isolated location at the north end of the toe survey line (approximate elevation 797 ft) may have high moisture conditions. The GPR imaged a dipping layer at the same location.
