POTAMOLOGY INVESTIGATIONS

Report 300-2

**MAN-MADE CUTOFFS ON THE LOWER MISSISSIPPI  
RIVER, CONCEPTION, CONSTRUCTION,  
AND RIVER RESPONSE**

U. S. ARMY ENGINEER DISTRICT, VICKSBURG

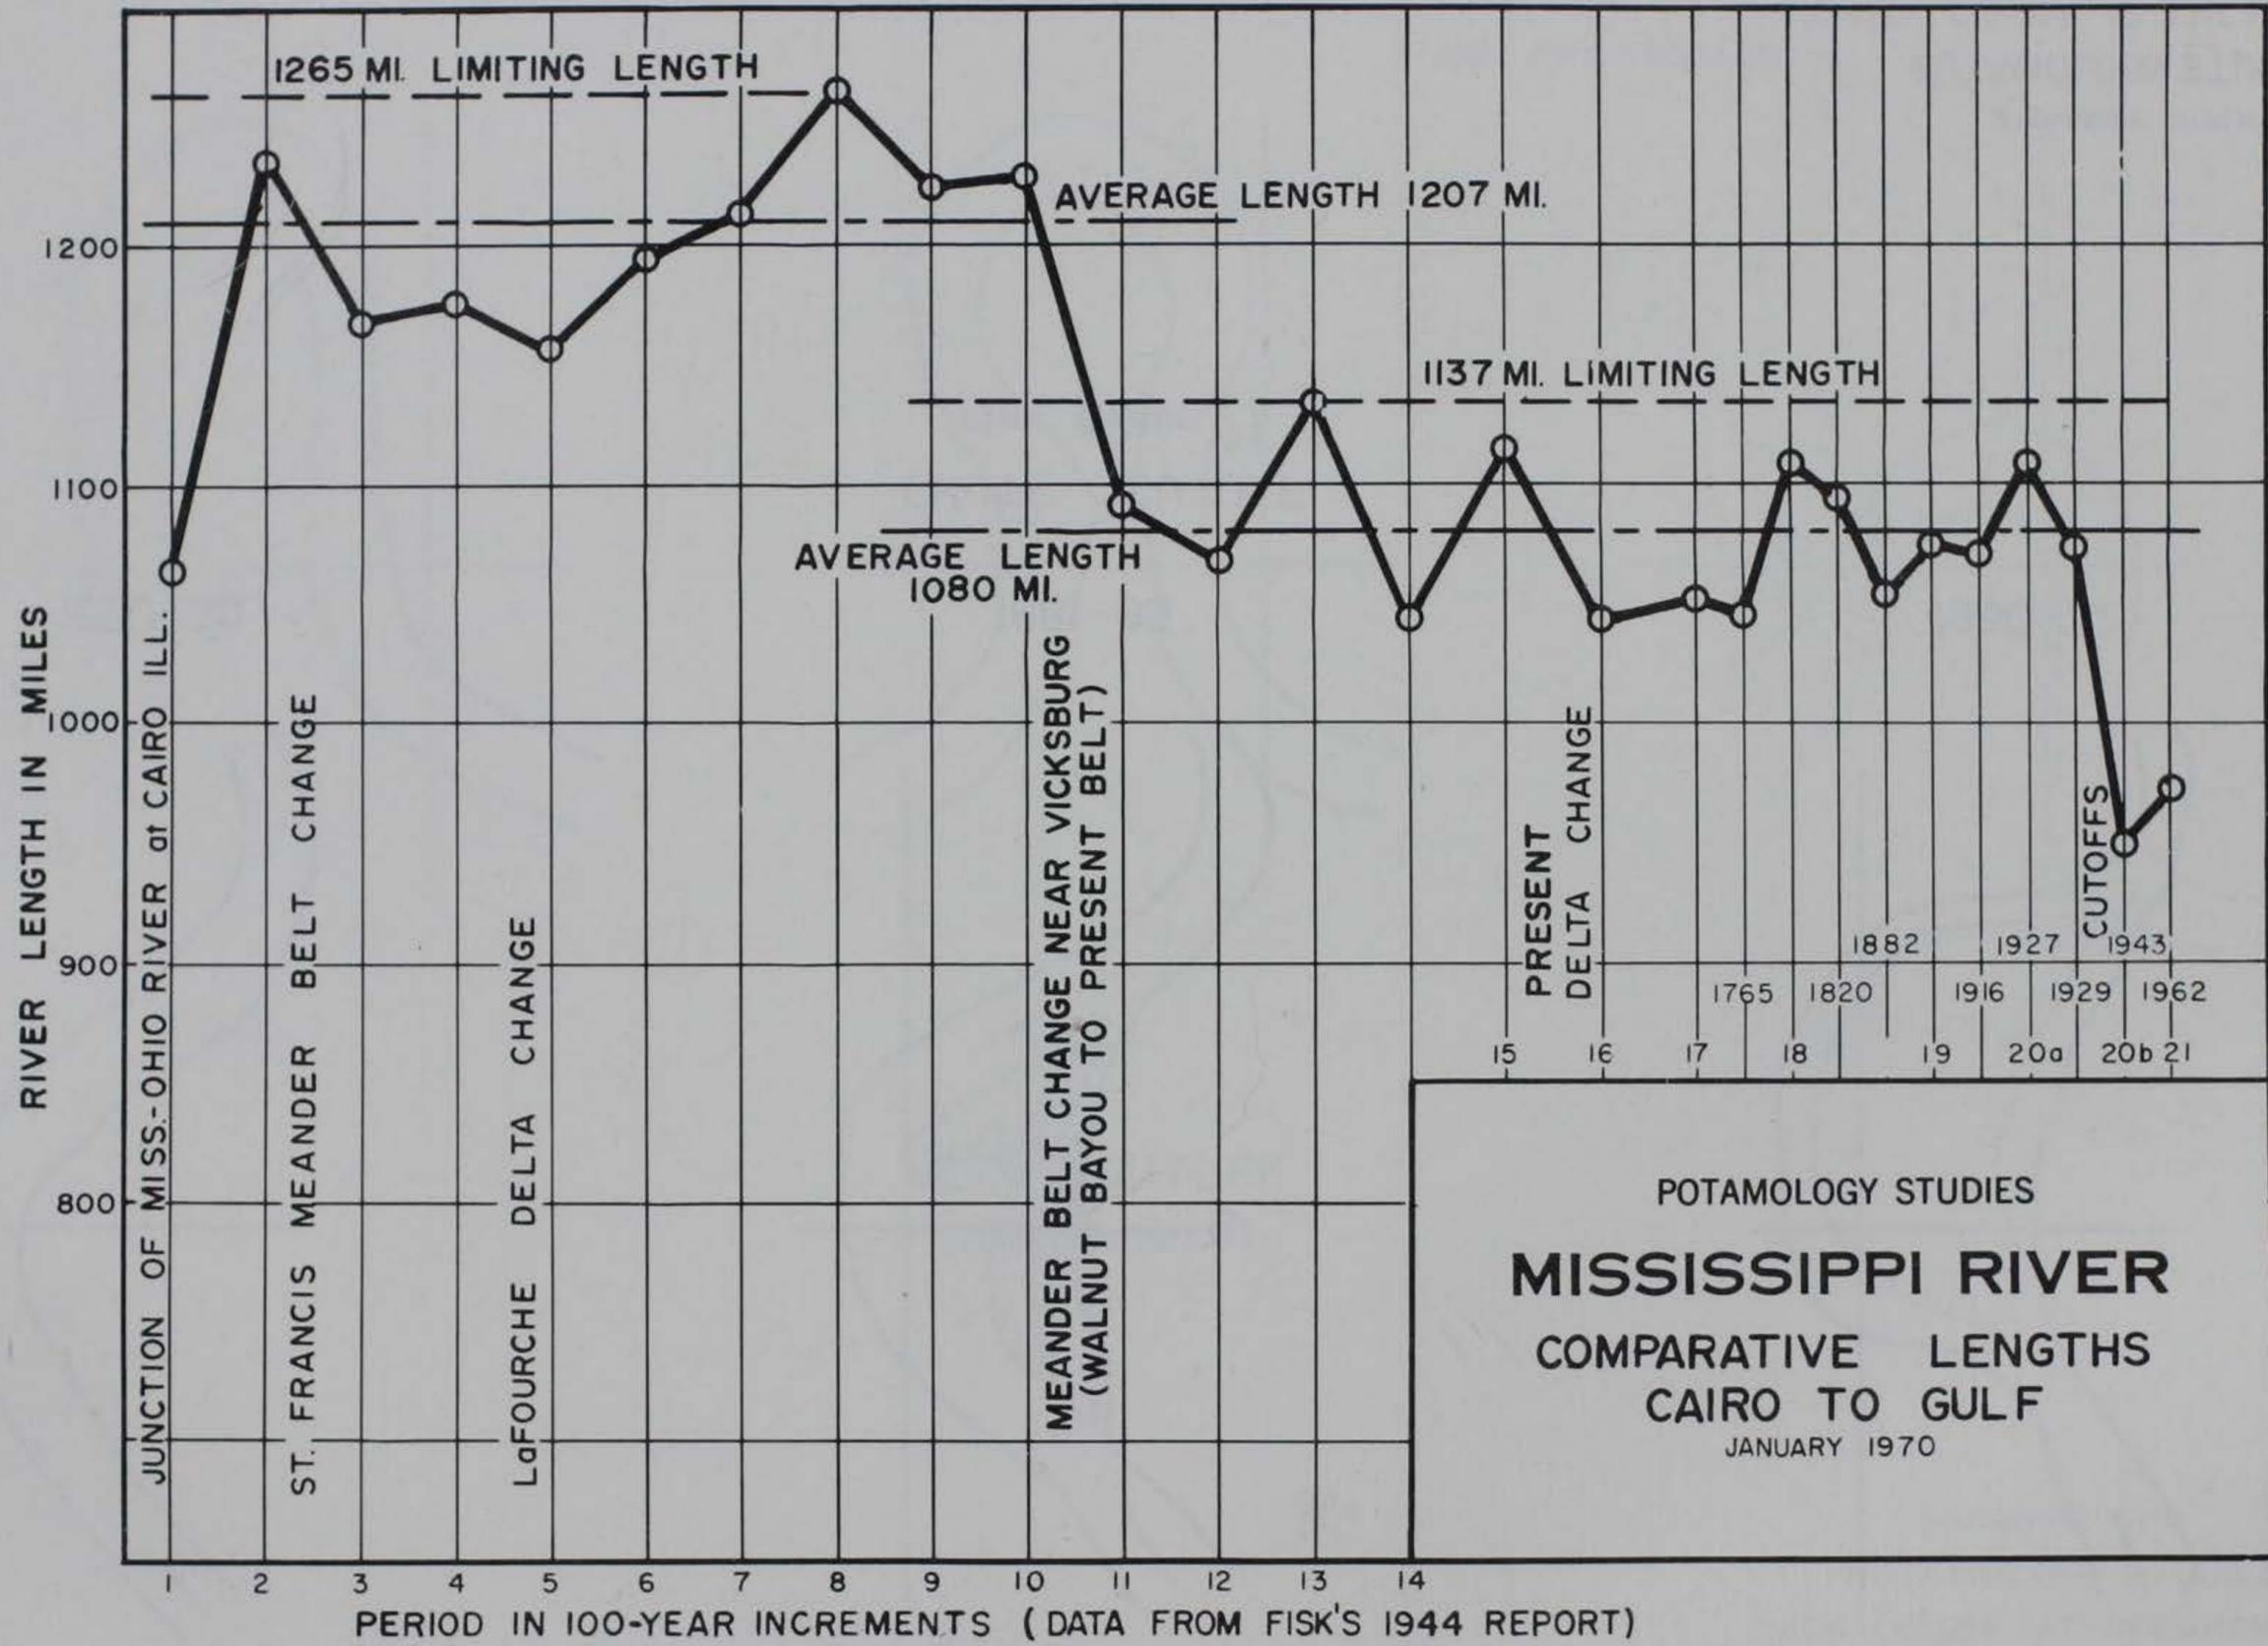
Figure 3

MISSISSIPPI RIVER  
POTAMOLOGY STUDIES  
CHUTE CUTOFF AT LUCAS BEND

Historically, the river has adjusted its length to changes in meander belt and delta outlet (Figure 3) and thus varied about some constant length and slope for a particular set of conditions. The present river is no longer allowed to meander and has had a 50 percent flow increase caused by levees and closure of many natural outlets. In addition, the delta outlet location is now fixed, causing the lower portion of the river to develop a continually flatter slope. This has significantly upset the geometric consistency of the river and the movement of sediments through the system.

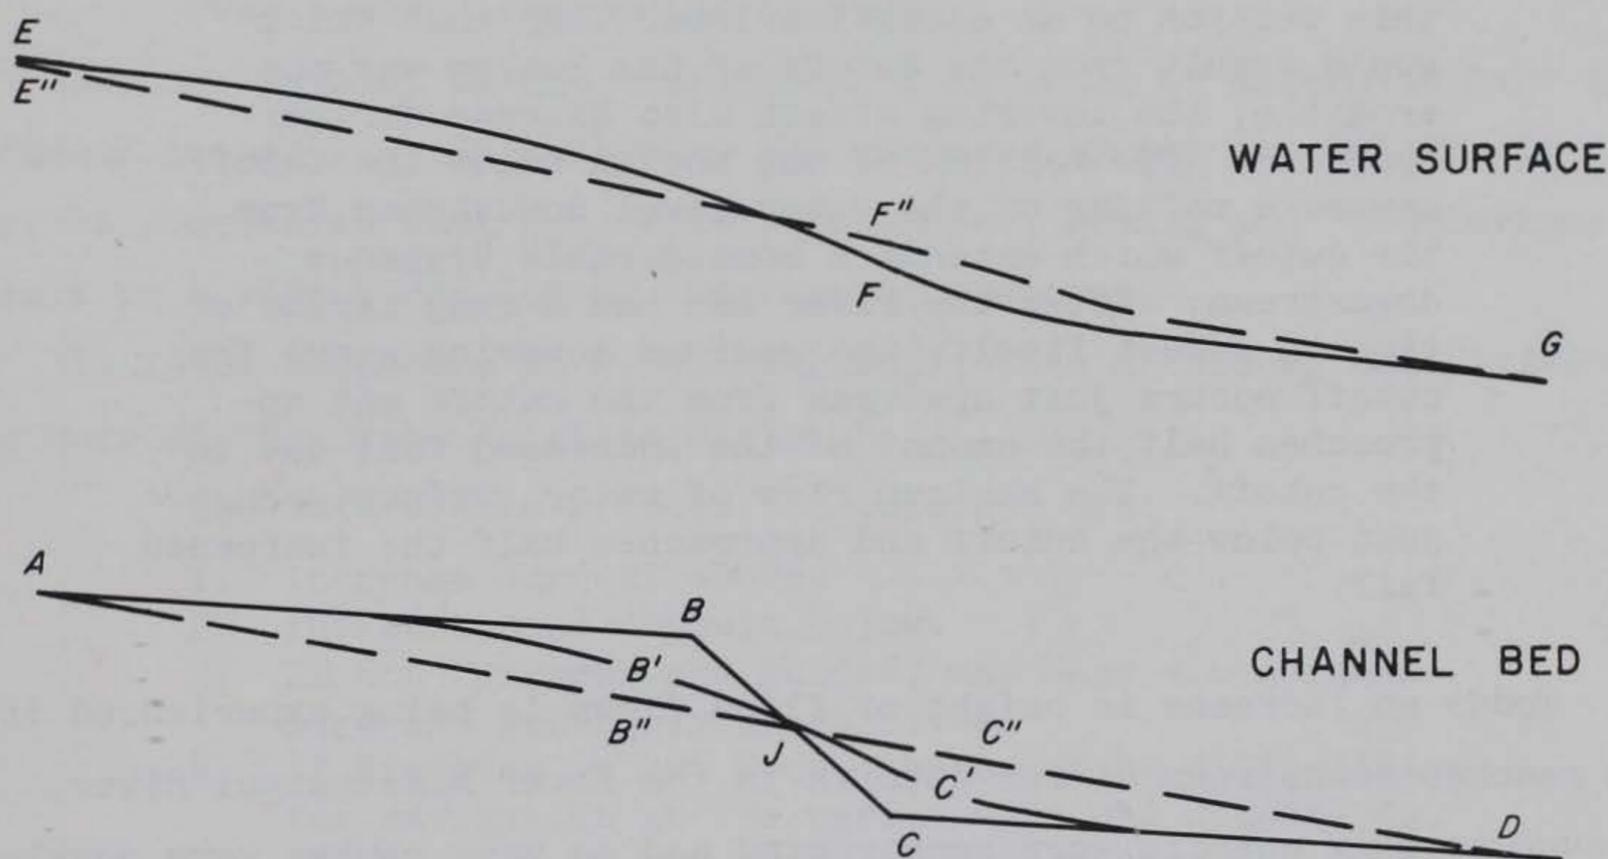
Figure 4. Effect of cutoff in an erodible channel (after Lane<sup>2</sup>)

the water-surface profile EFG. Consider first the reach above the cutoff. The slope and velocity of the water above the cutoff is increased as compared to that existing before the cutoff was made, and the stream can carry a greater load than it was carrying. Because the stream at this point has a capacity to transport material in greater amount than the load brought down to it from above, the water picks up material from the stream bed and carries it downstream. Below the cutoff, however, the slope and velocity of the river is unchanged, and it is able

to carry continuously only the amount carried before the cutoff. The excess over the load carried before the cutoff, which was taken up from the bottom upstream from the cutoff, is, therefore, deposited below the cutoff. This excess is not dropped immediately but is deposited in gradually decreasing quantities downstream from the cutoff. This results in a profile of the bed AB'C'D, which causes some increase in slope downstream from the cutoff and a spreading of the deposits still further downstream. As the movement continues, the bottom downstream from the cutoff continues to be raised, and this effect also extends farther and farther downstream as shown by the profiles AB''C''D and E''F''G. The cutting down of the stream from the cutoff gradually increases in depth and extends farther upstream causing a lowering of the water-surface elevation in this section to an elevation lower than that which would result from the cutoff if the bottom was non-erodible; the lowering effect also extends farther upstream. The raising of the bottom below the cutoff causes a raising of the water level downstream from the cutoff which extends a considerable distance downstream. After the river has had a long period of time to adjust itself, the maximum lowering above the cutoff occurs just upstream from the cutoff and approaches half the amount of the increased fall due to the cutoff. The maximum rise of water surface occurs just below the cutoff and approaches half the increased fall.

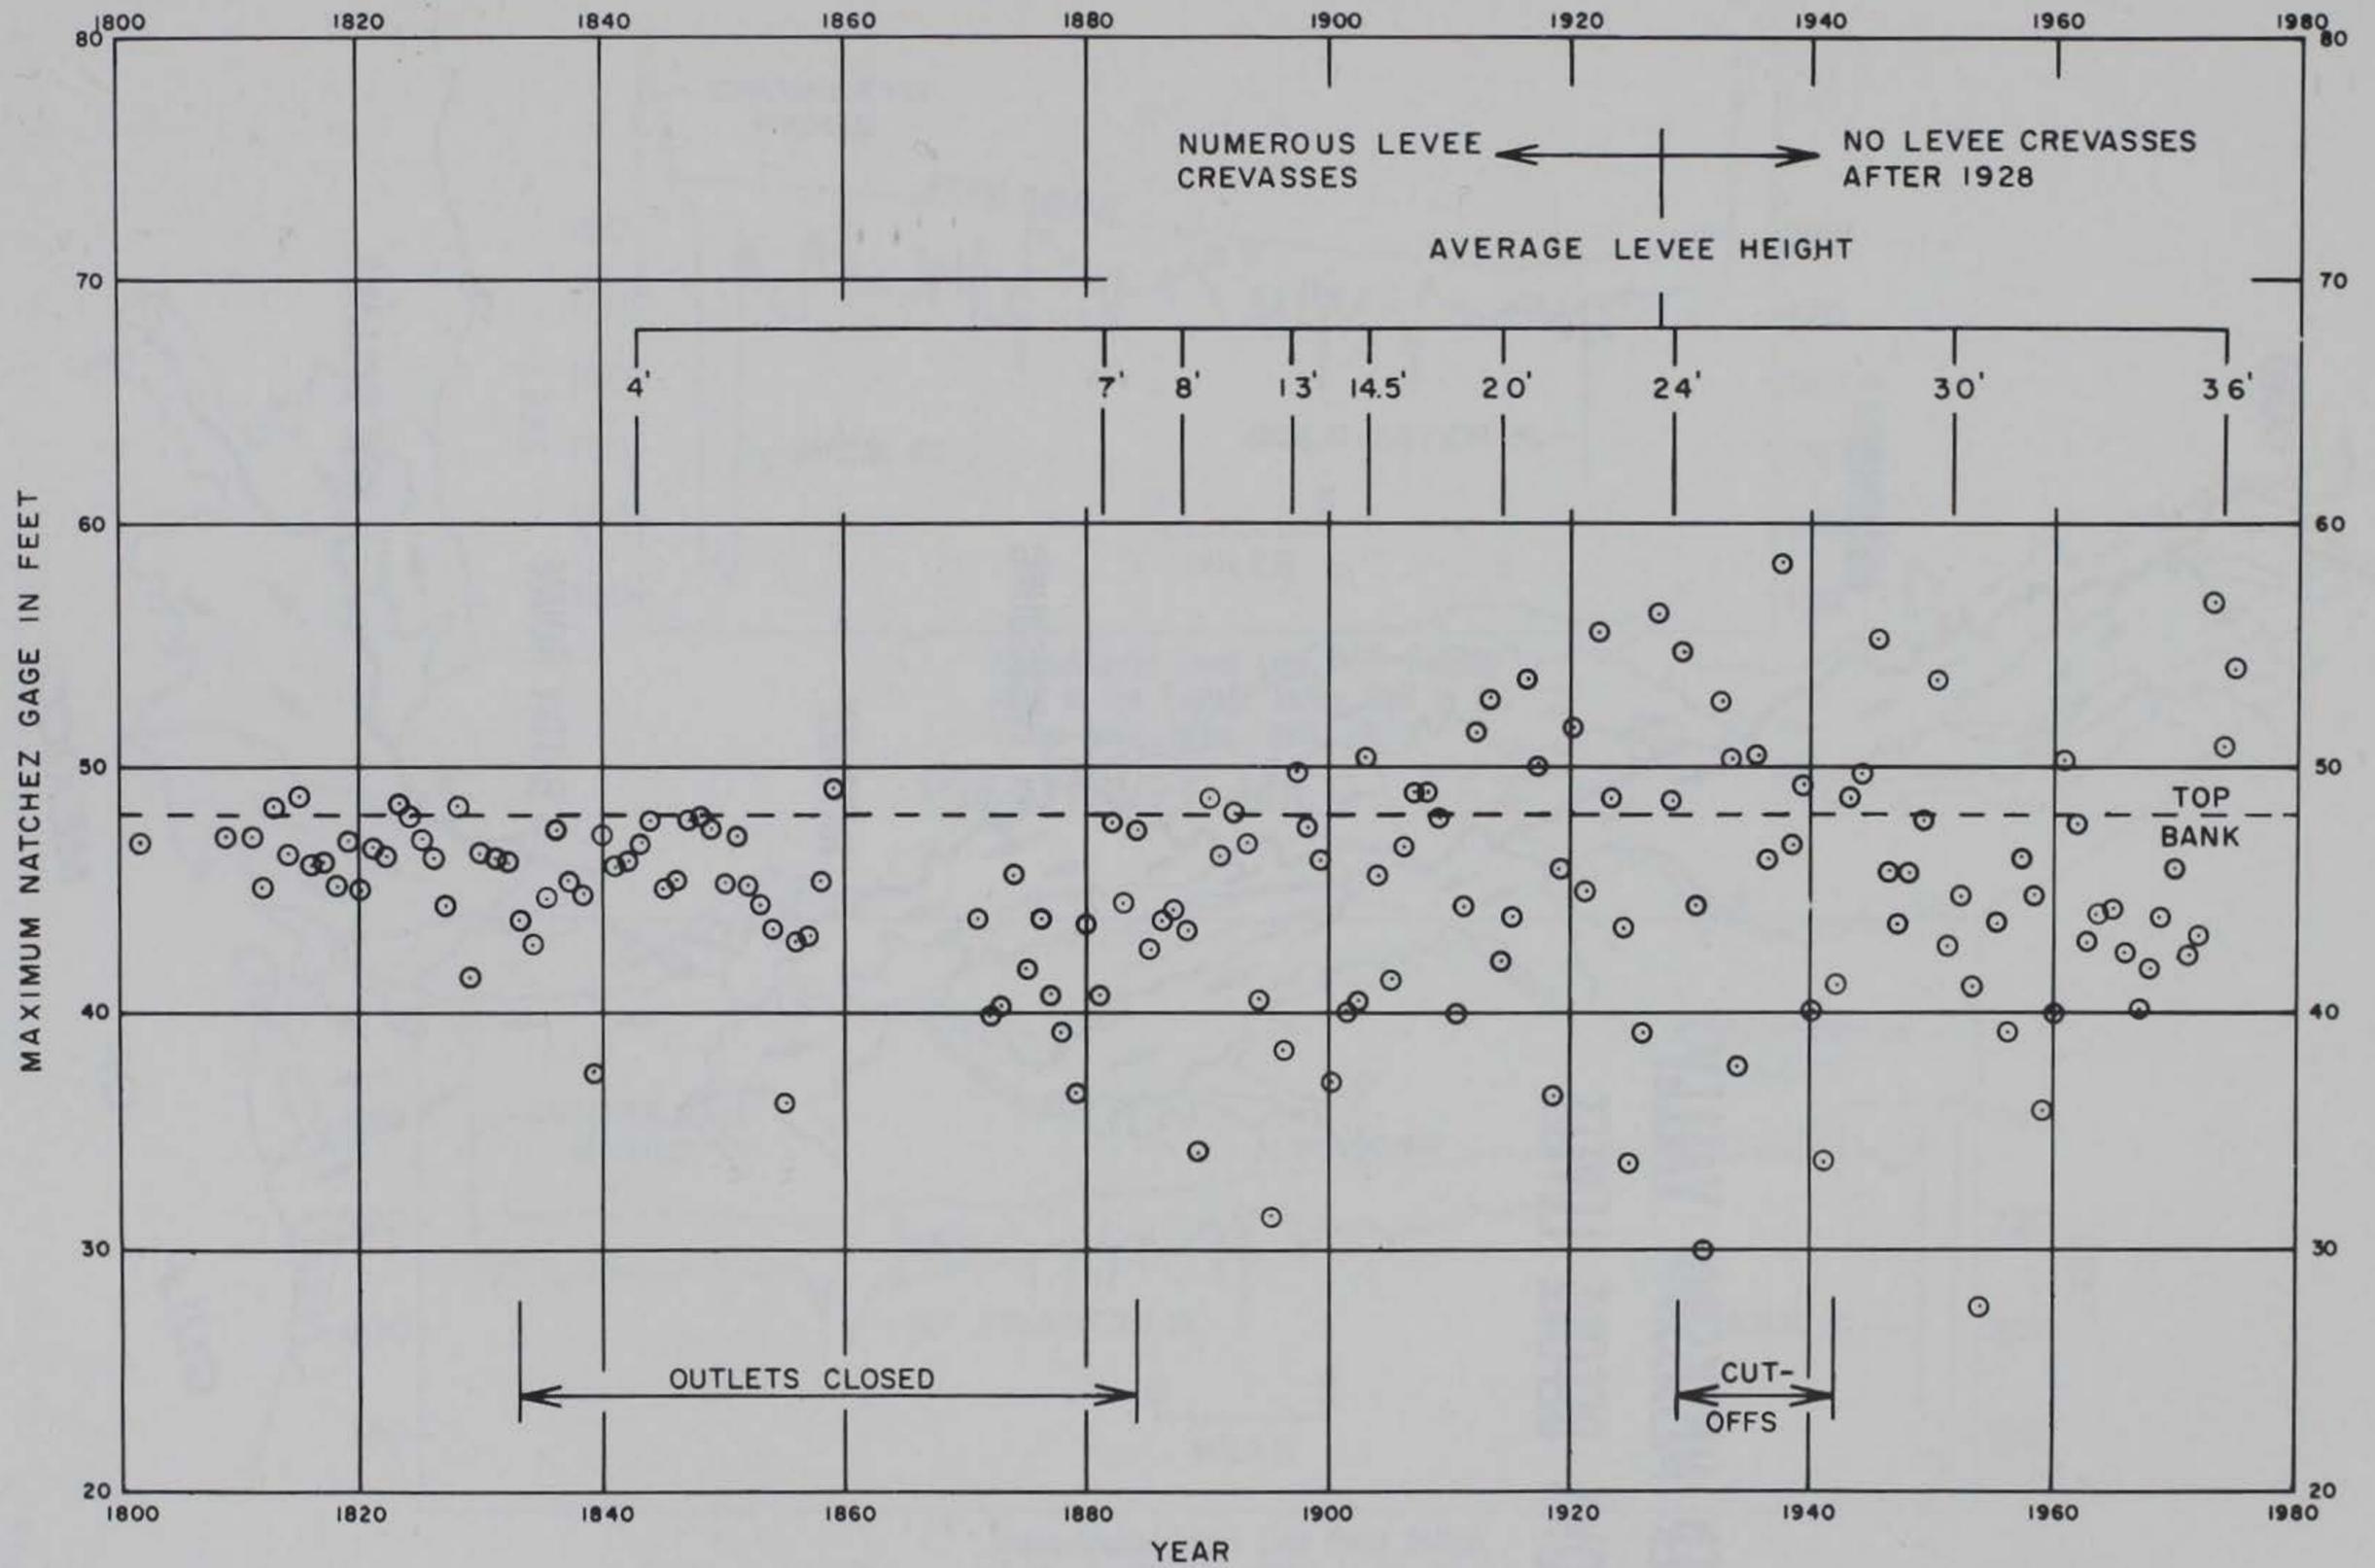
- b. Levee building began in 1719 and was followed by a continual increase in levee length and height; Figure 5 shows this continual increase in levee height and the accompanying increase in stages at the Natchez gage. In Figure 5, a "crevasse" is a levee failure, one or more of which occurred during each major flood prior to 1929. An "outlet" is a diversion channel that drained various size flows from the main channel into the numerous basins on either side of the Mississippi River. During floods, flows through the lower Mississippi valley were similar to those indicated in Figure 6.

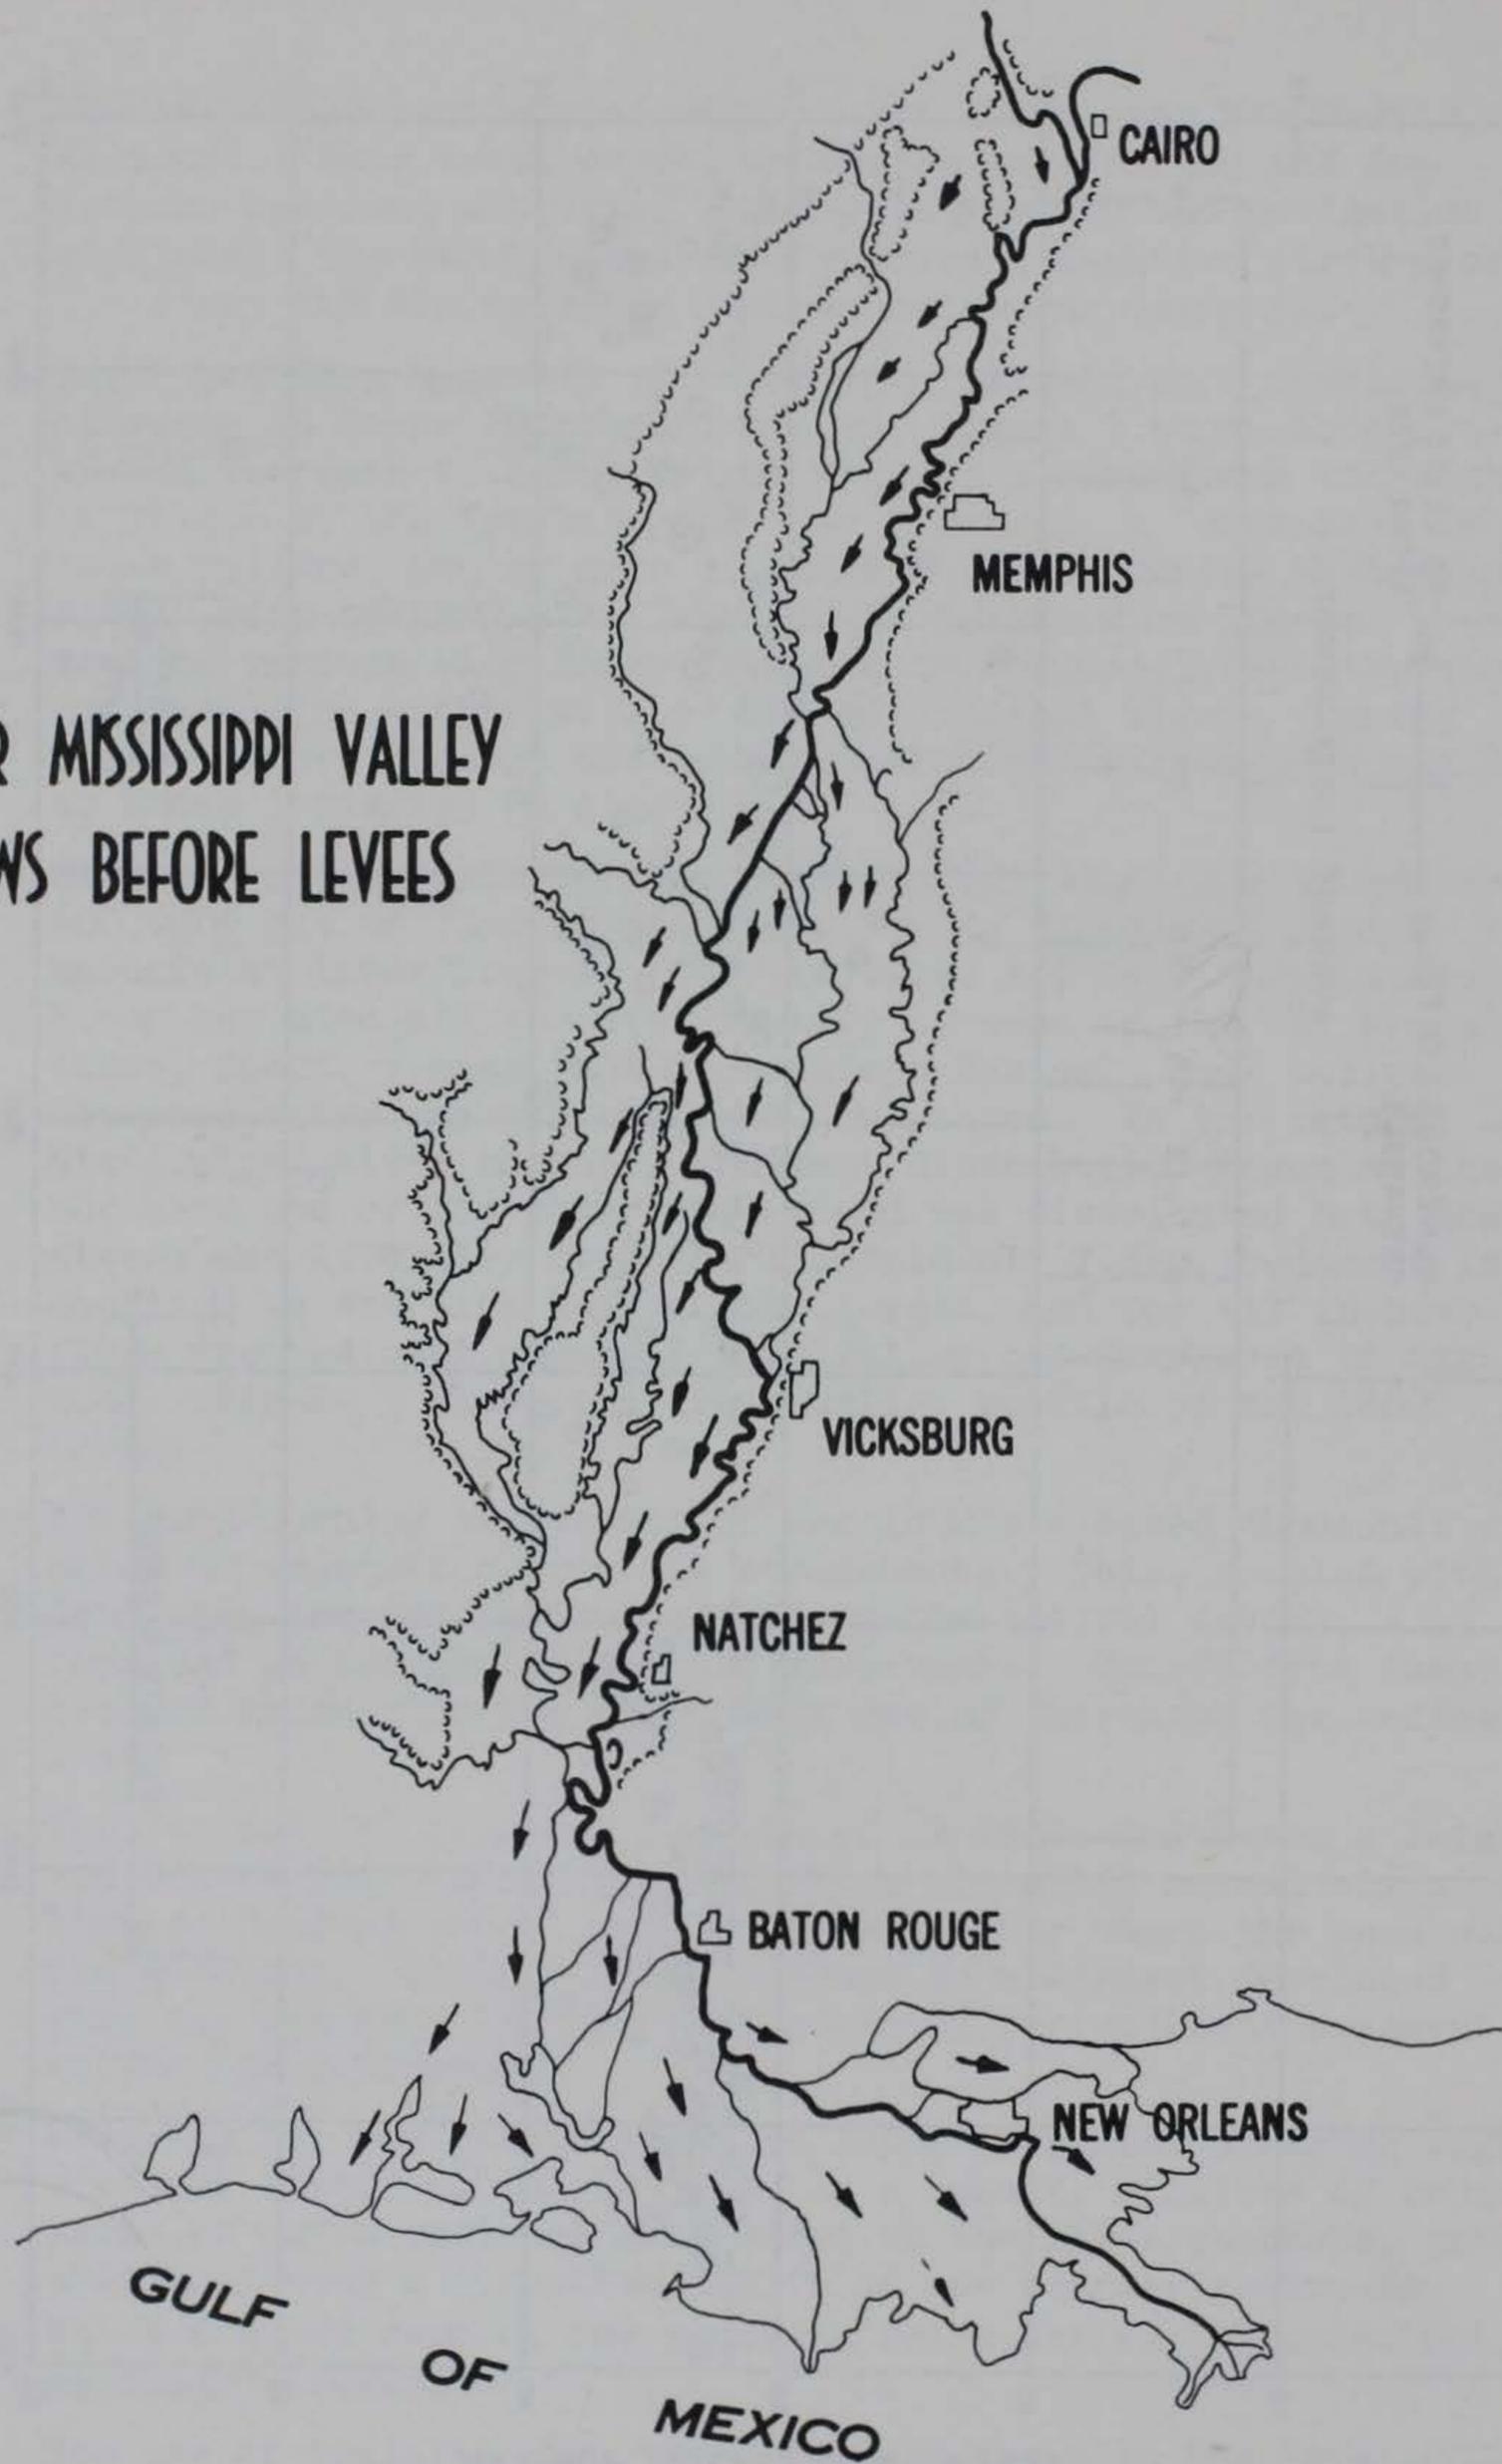
Figure 6

**LOWER MISSISSIPPI VALLEY  
FLOWS BEFORE LEVEES**

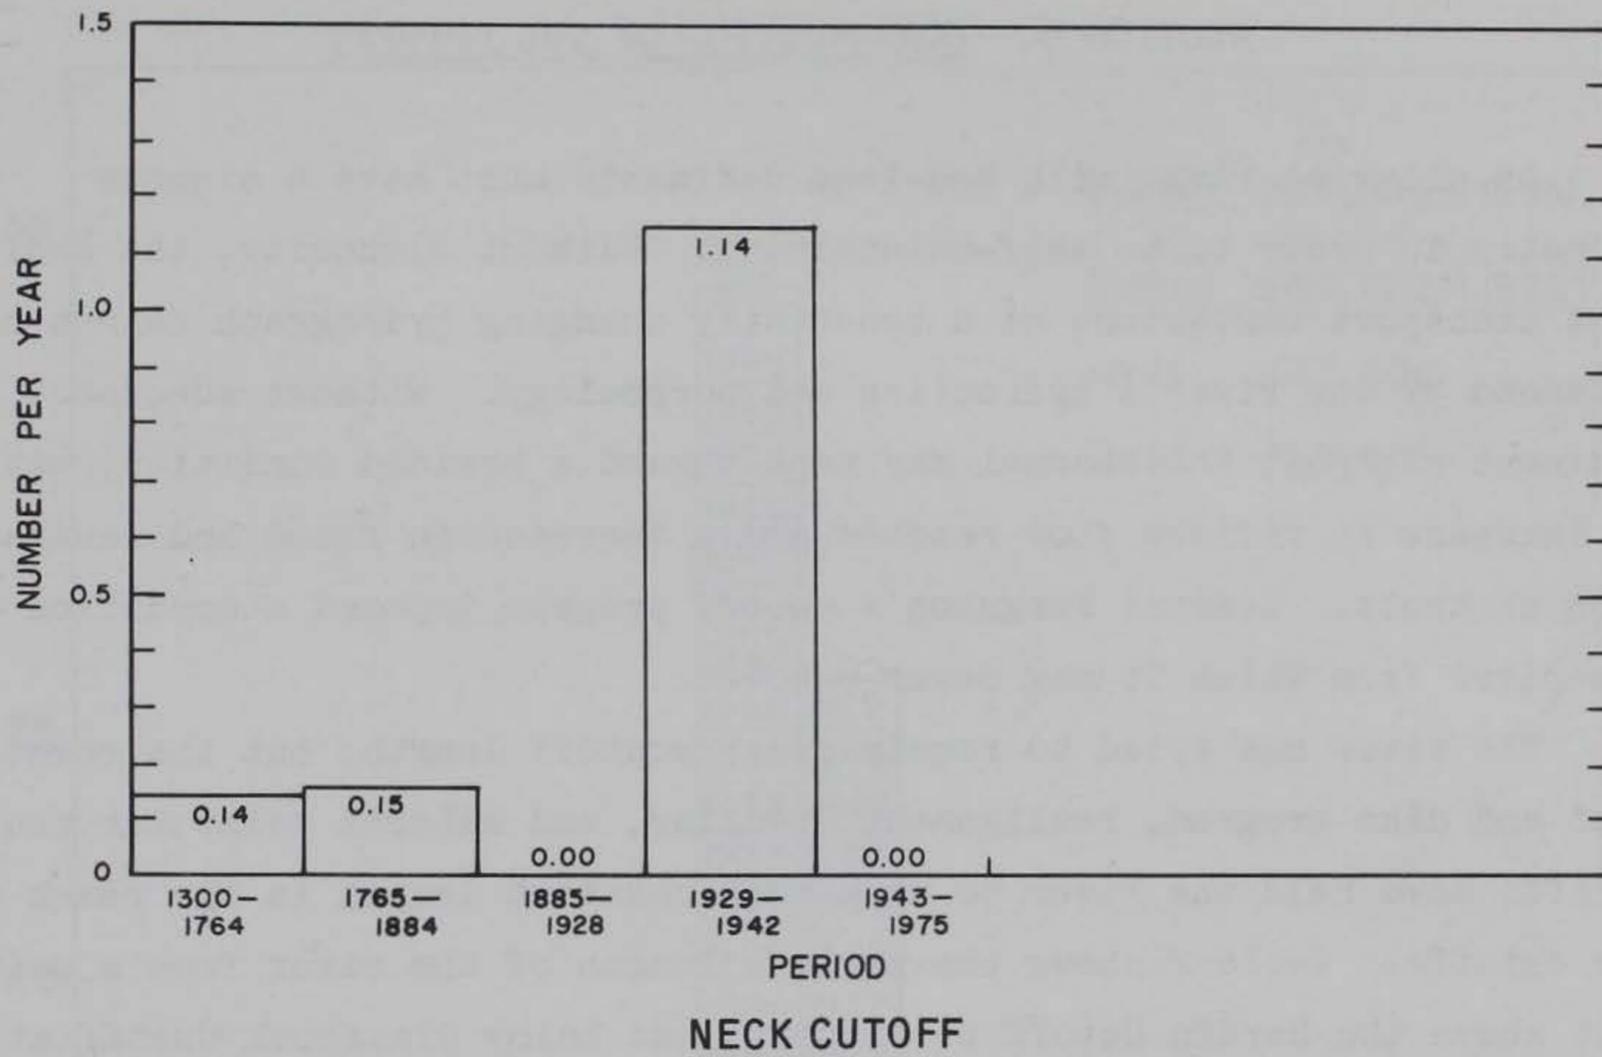
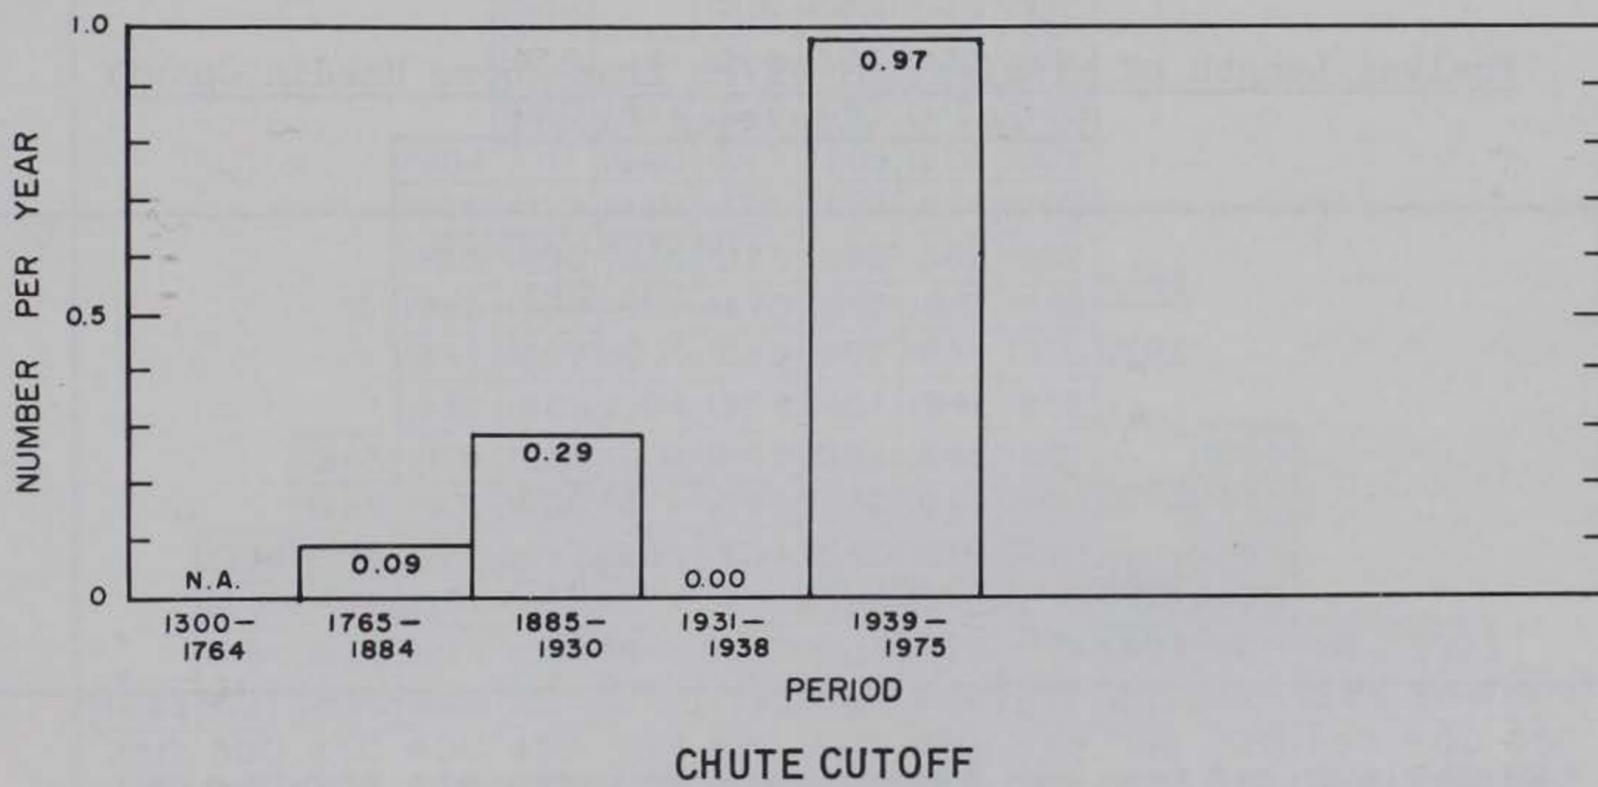
Figure 8

MISSISSIPPI RIVER  
**POTAMOLOGY STUDIES**  
 NUMBER OF CUTOFFS  
 PER YEAR

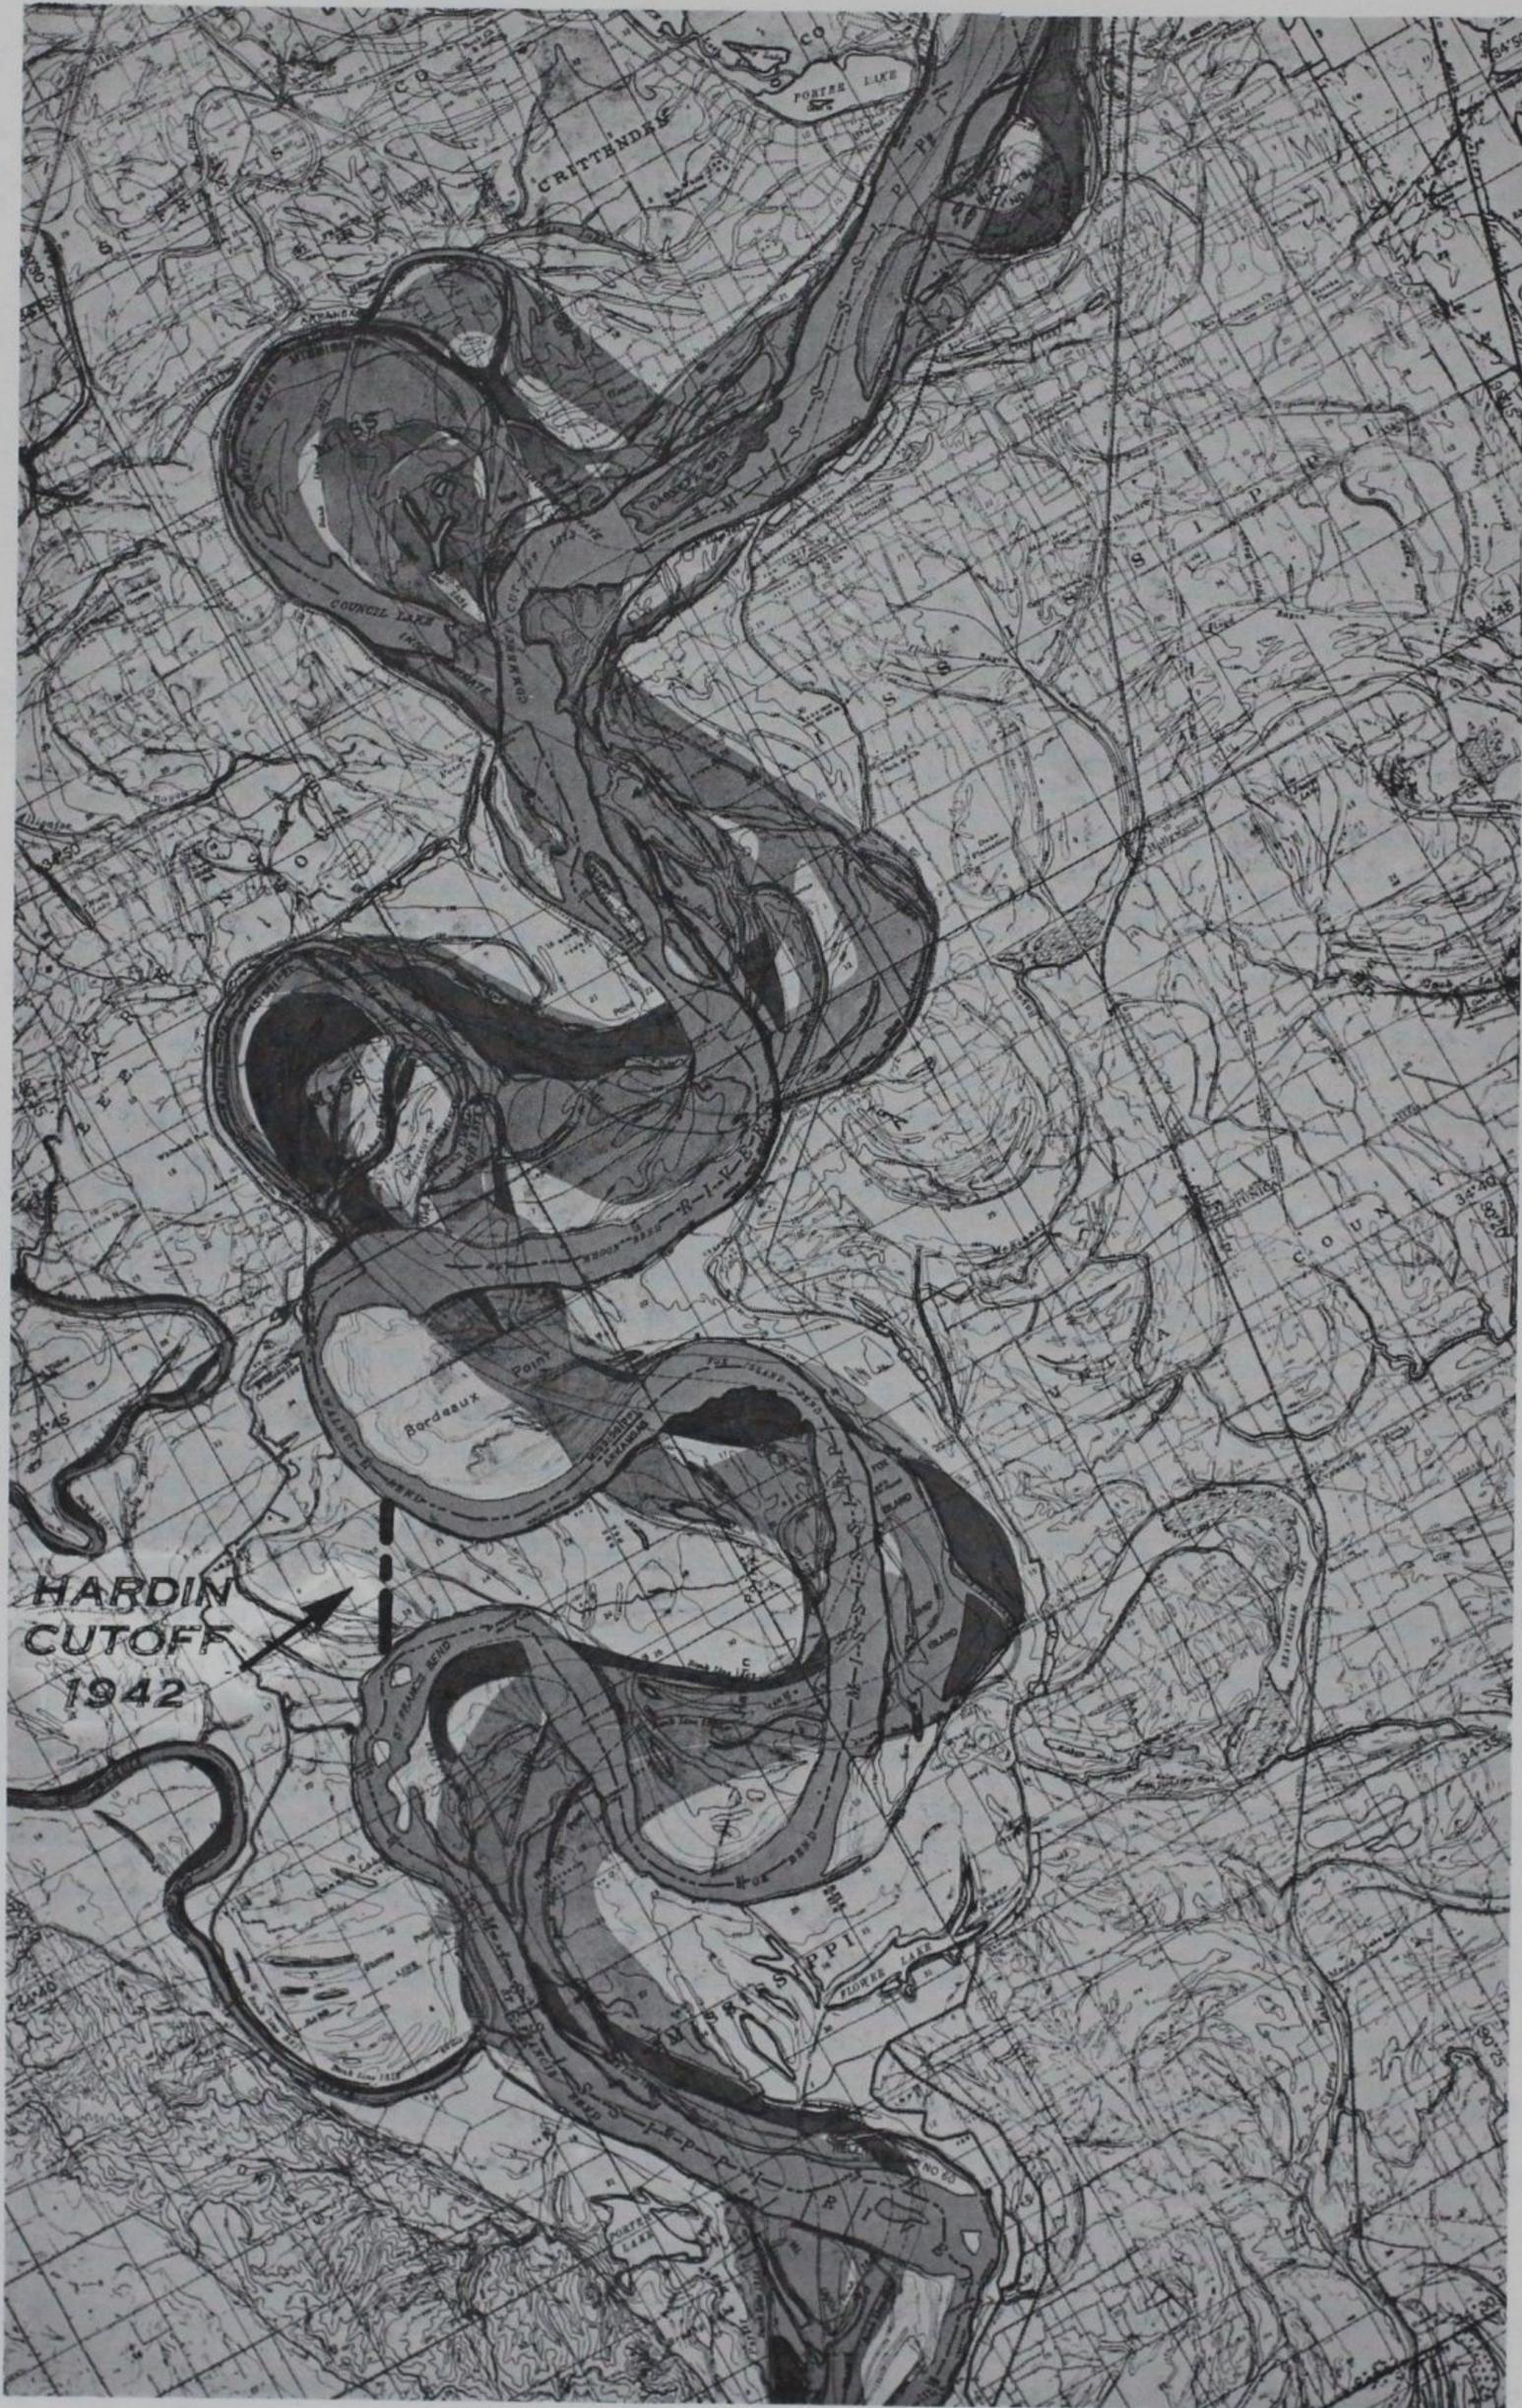
HISTORIC DEVELOPMENT OF THE HARDIN POINT REACH

Figure 12 shows several surveys of the historic river in the vicinity of Hardin Point Cutoff superimposed. Figure 13 presents today's river with the revetment and dike construction. Historically, the river
