POTAMOLOGY INVESTIGATIONS

Report 300-2

**MAN-MADE CUTOFFS ON THE LOWER MISSISSIPPI  
RIVER, CONCEPTION, CONSTRUCTION,  
AND RIVER RESPONSE**

U. S. ARMY ENGINEER DISTRICT, VICKSBURG

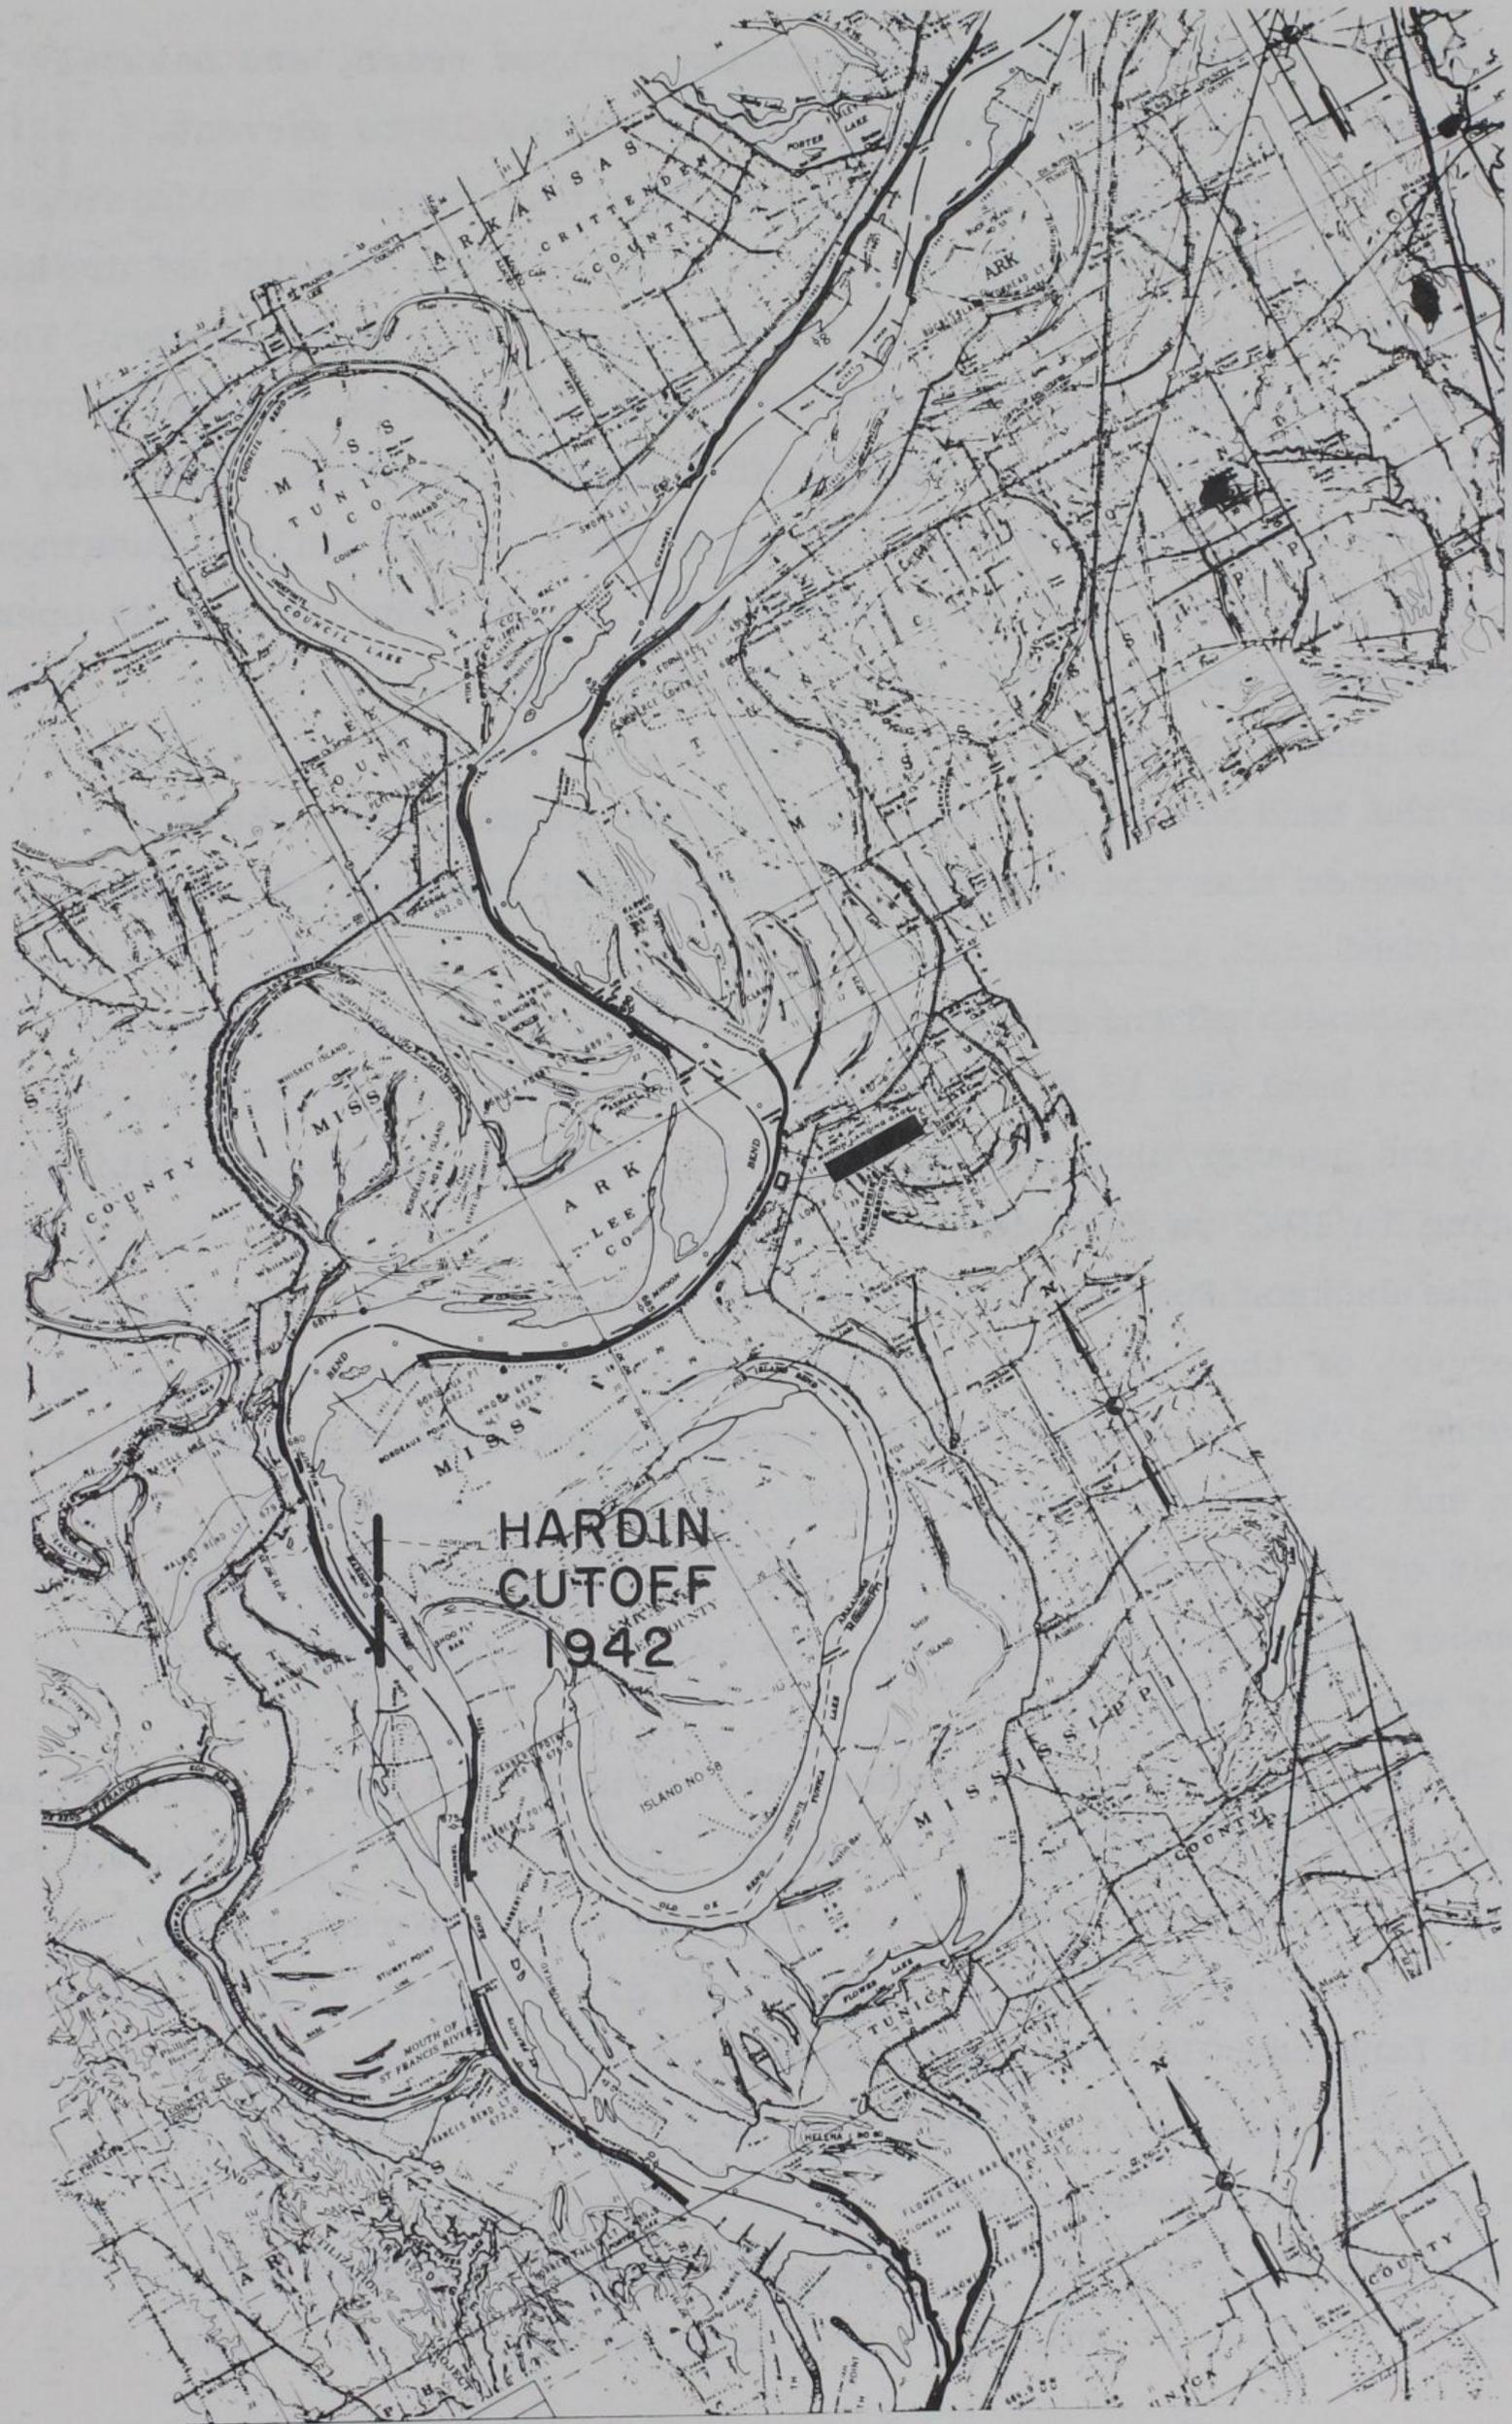
1975 MISSISSIPPI RIVER IN THE HARDIN POINT REACH

Figure 12 shows several surveys of the historic river in the vicinity of Hardin Point Cutoff superimposed. Figure 13 presents today's river with the revetment and dike construction. Historically, the river

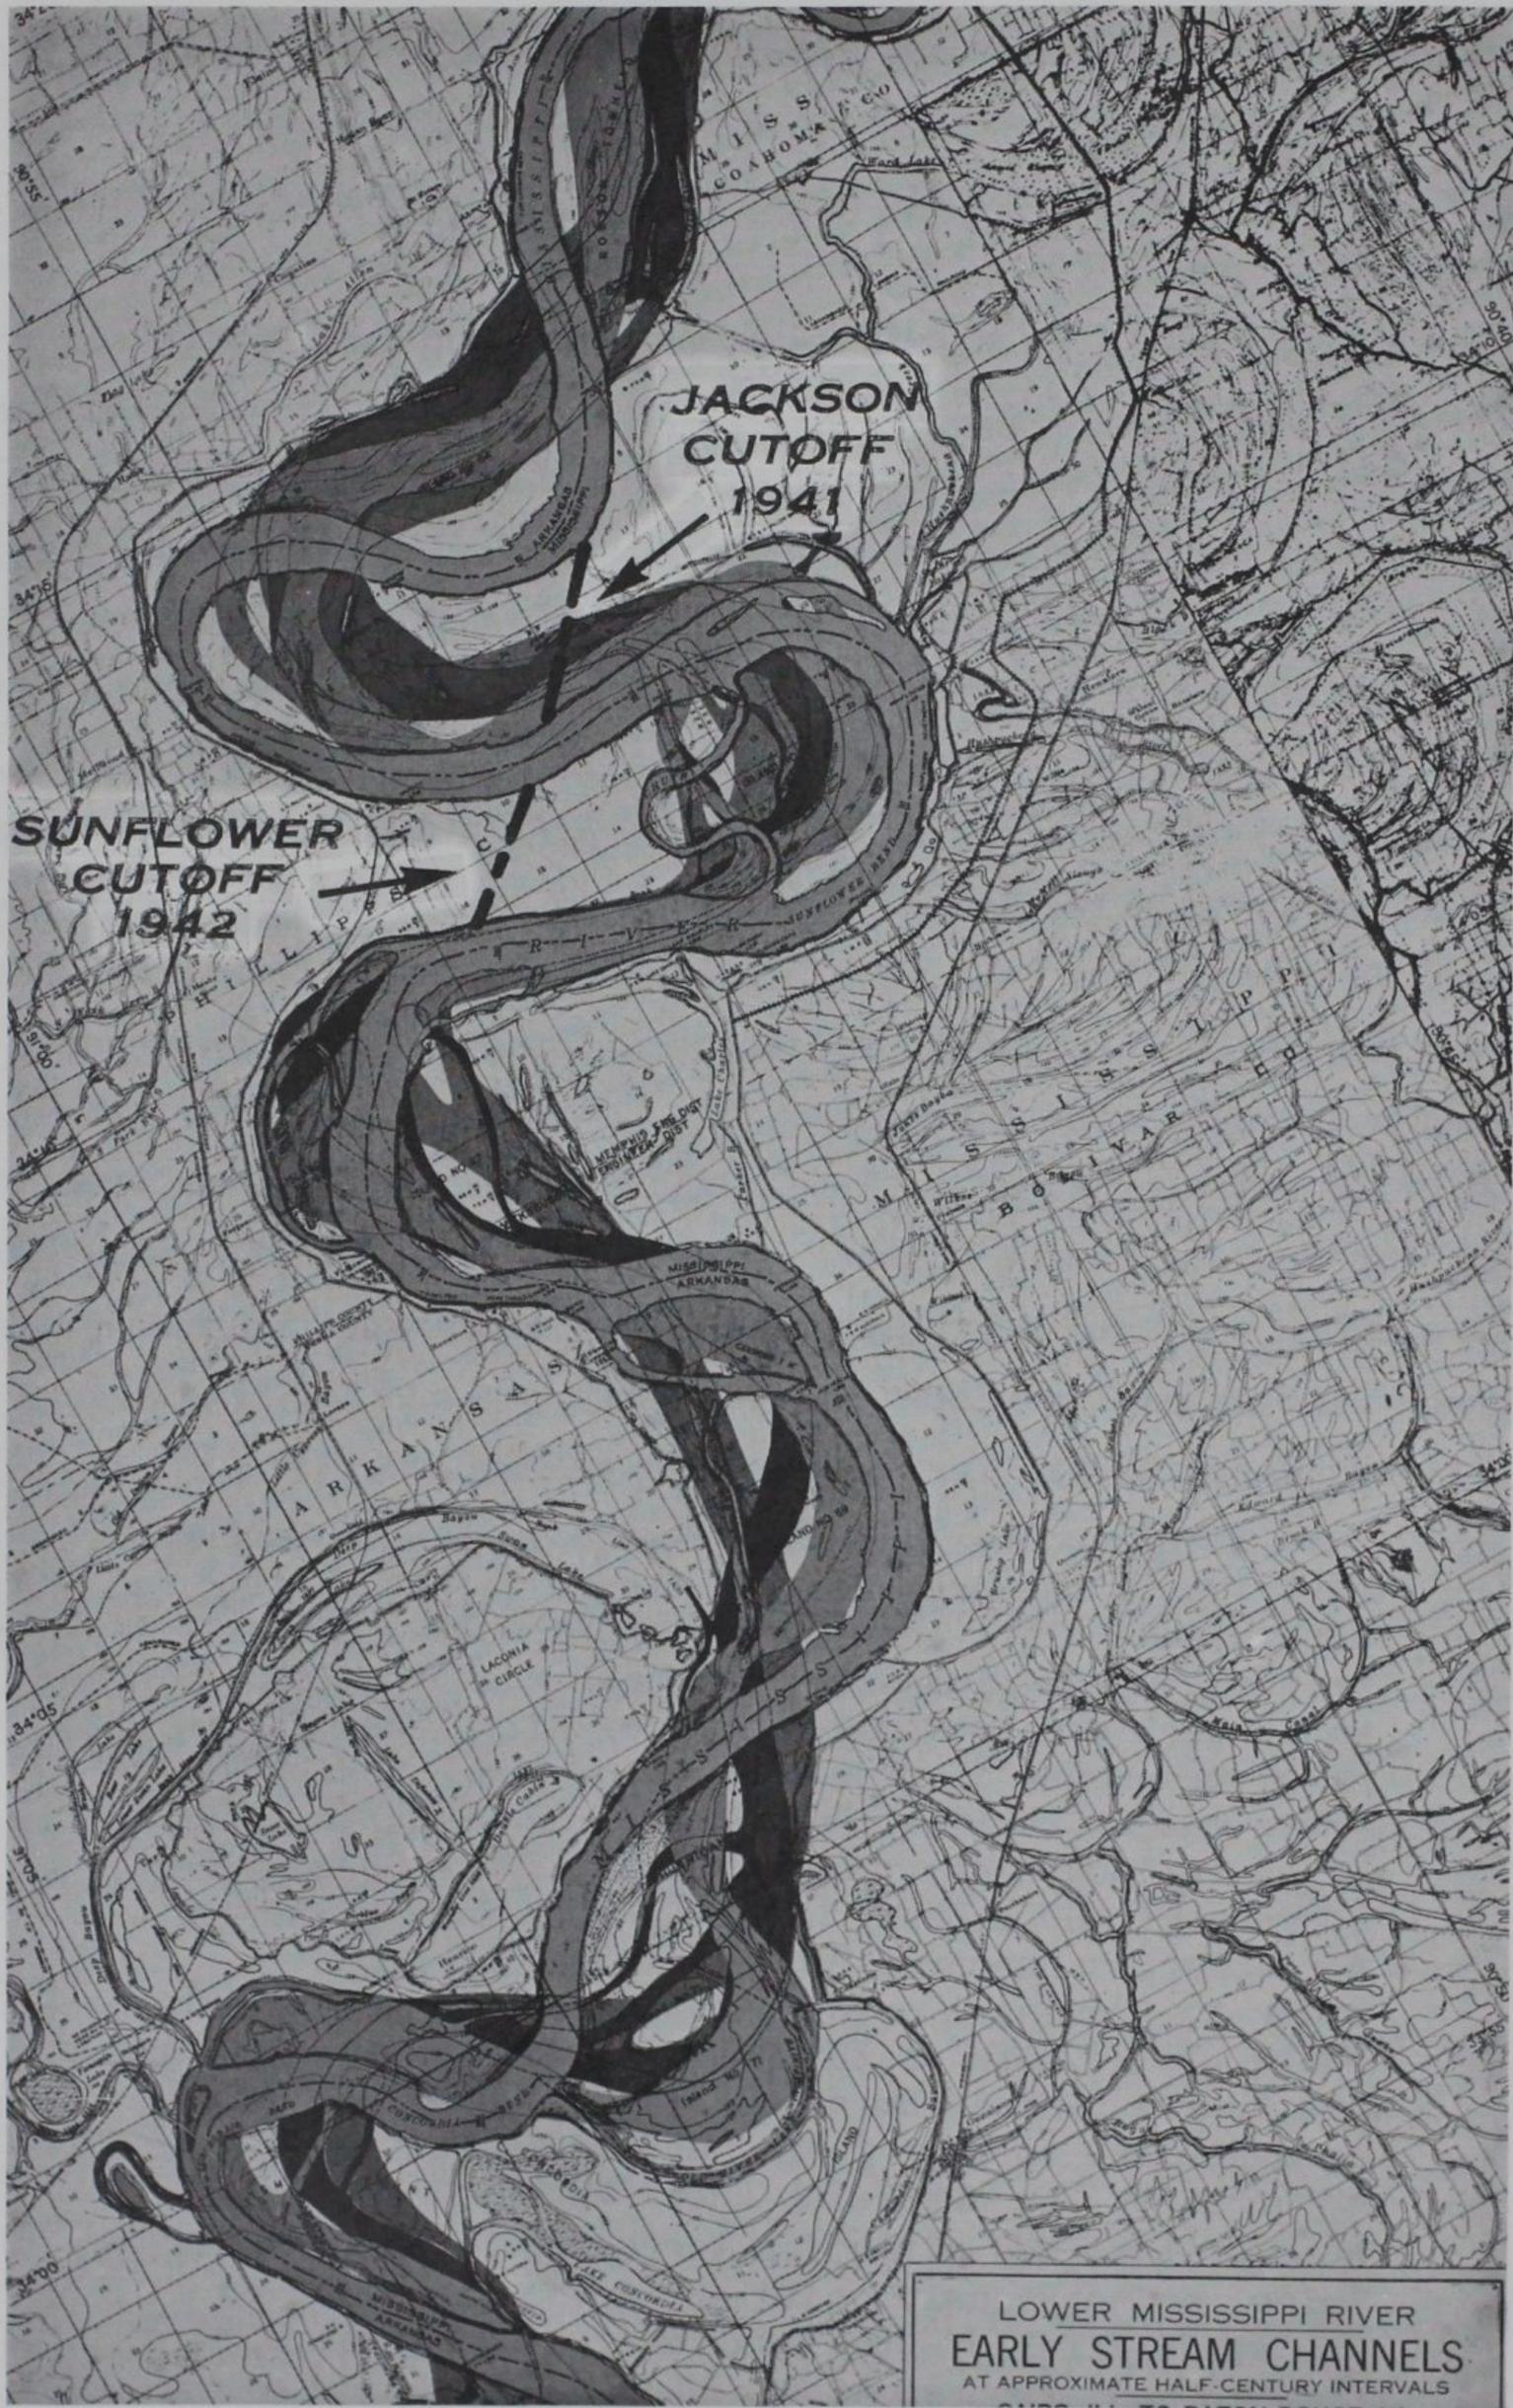
Figure 14 HISTORIC DEVELOPMENT OF THE JACKSON POINT-SUNFLOWER REACH

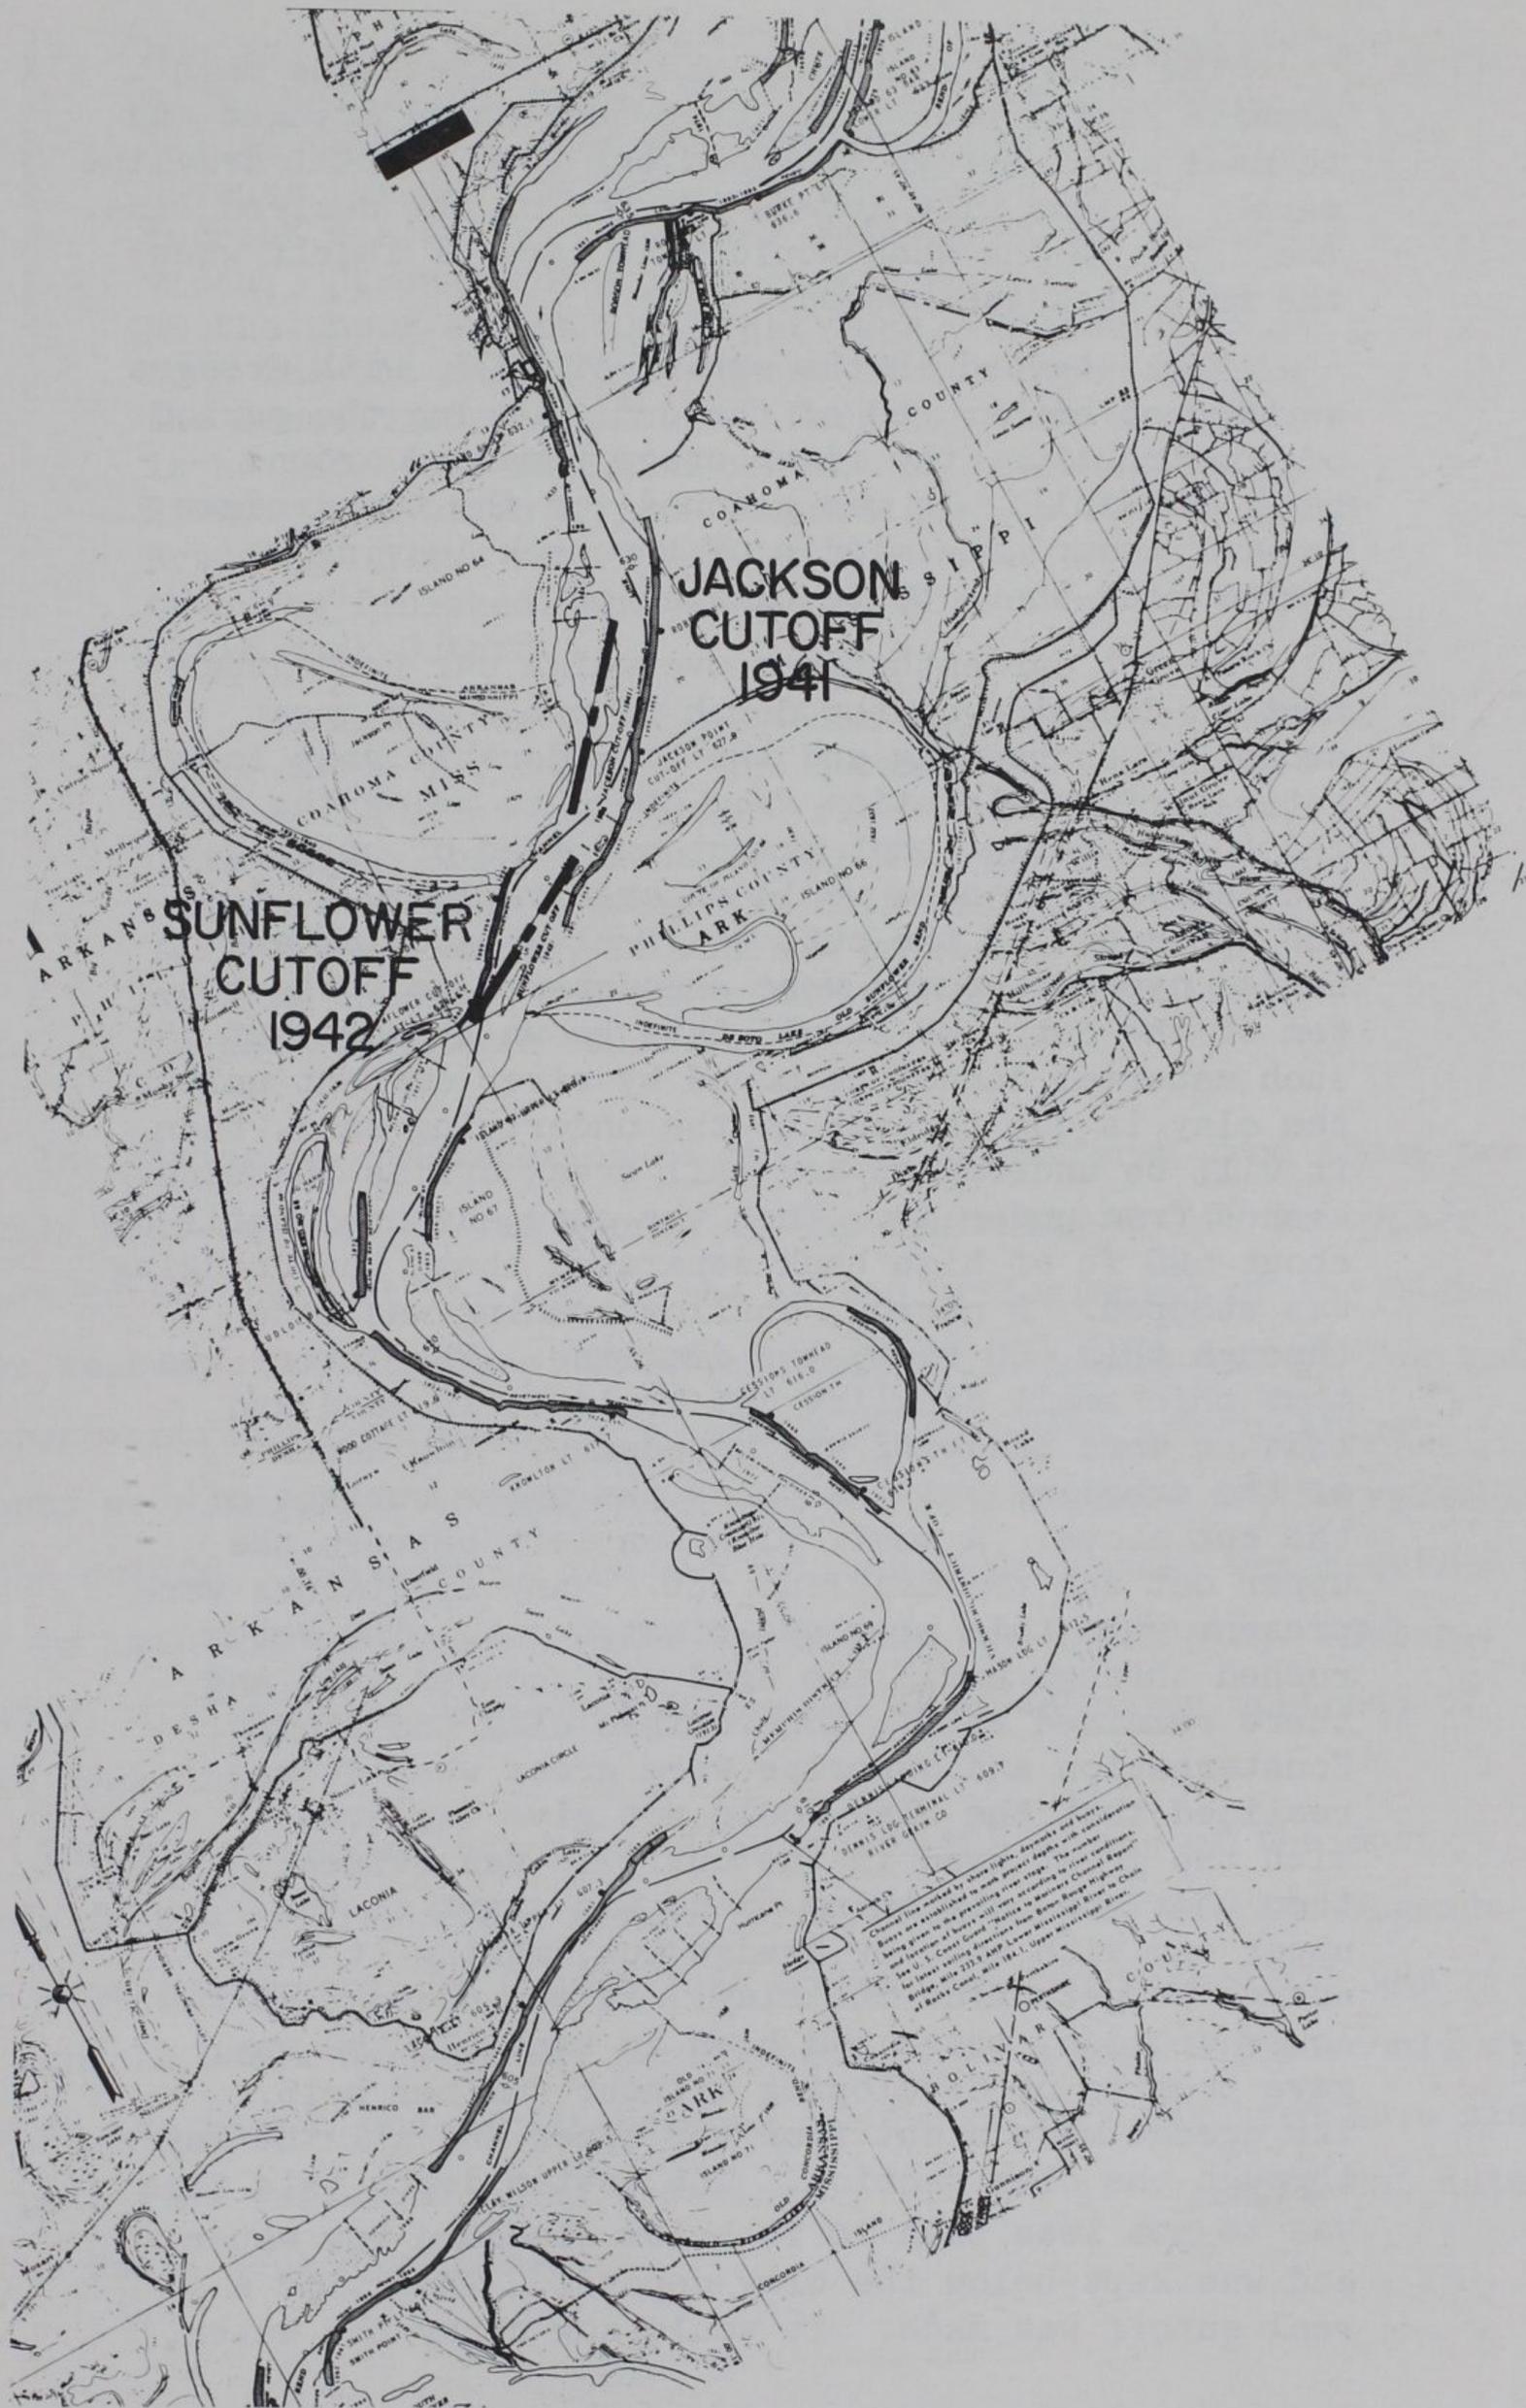
Figure 15

1975 MISSISSIPPI RIVER IN THE JACKSON POINT-SUNFLOWER REACH

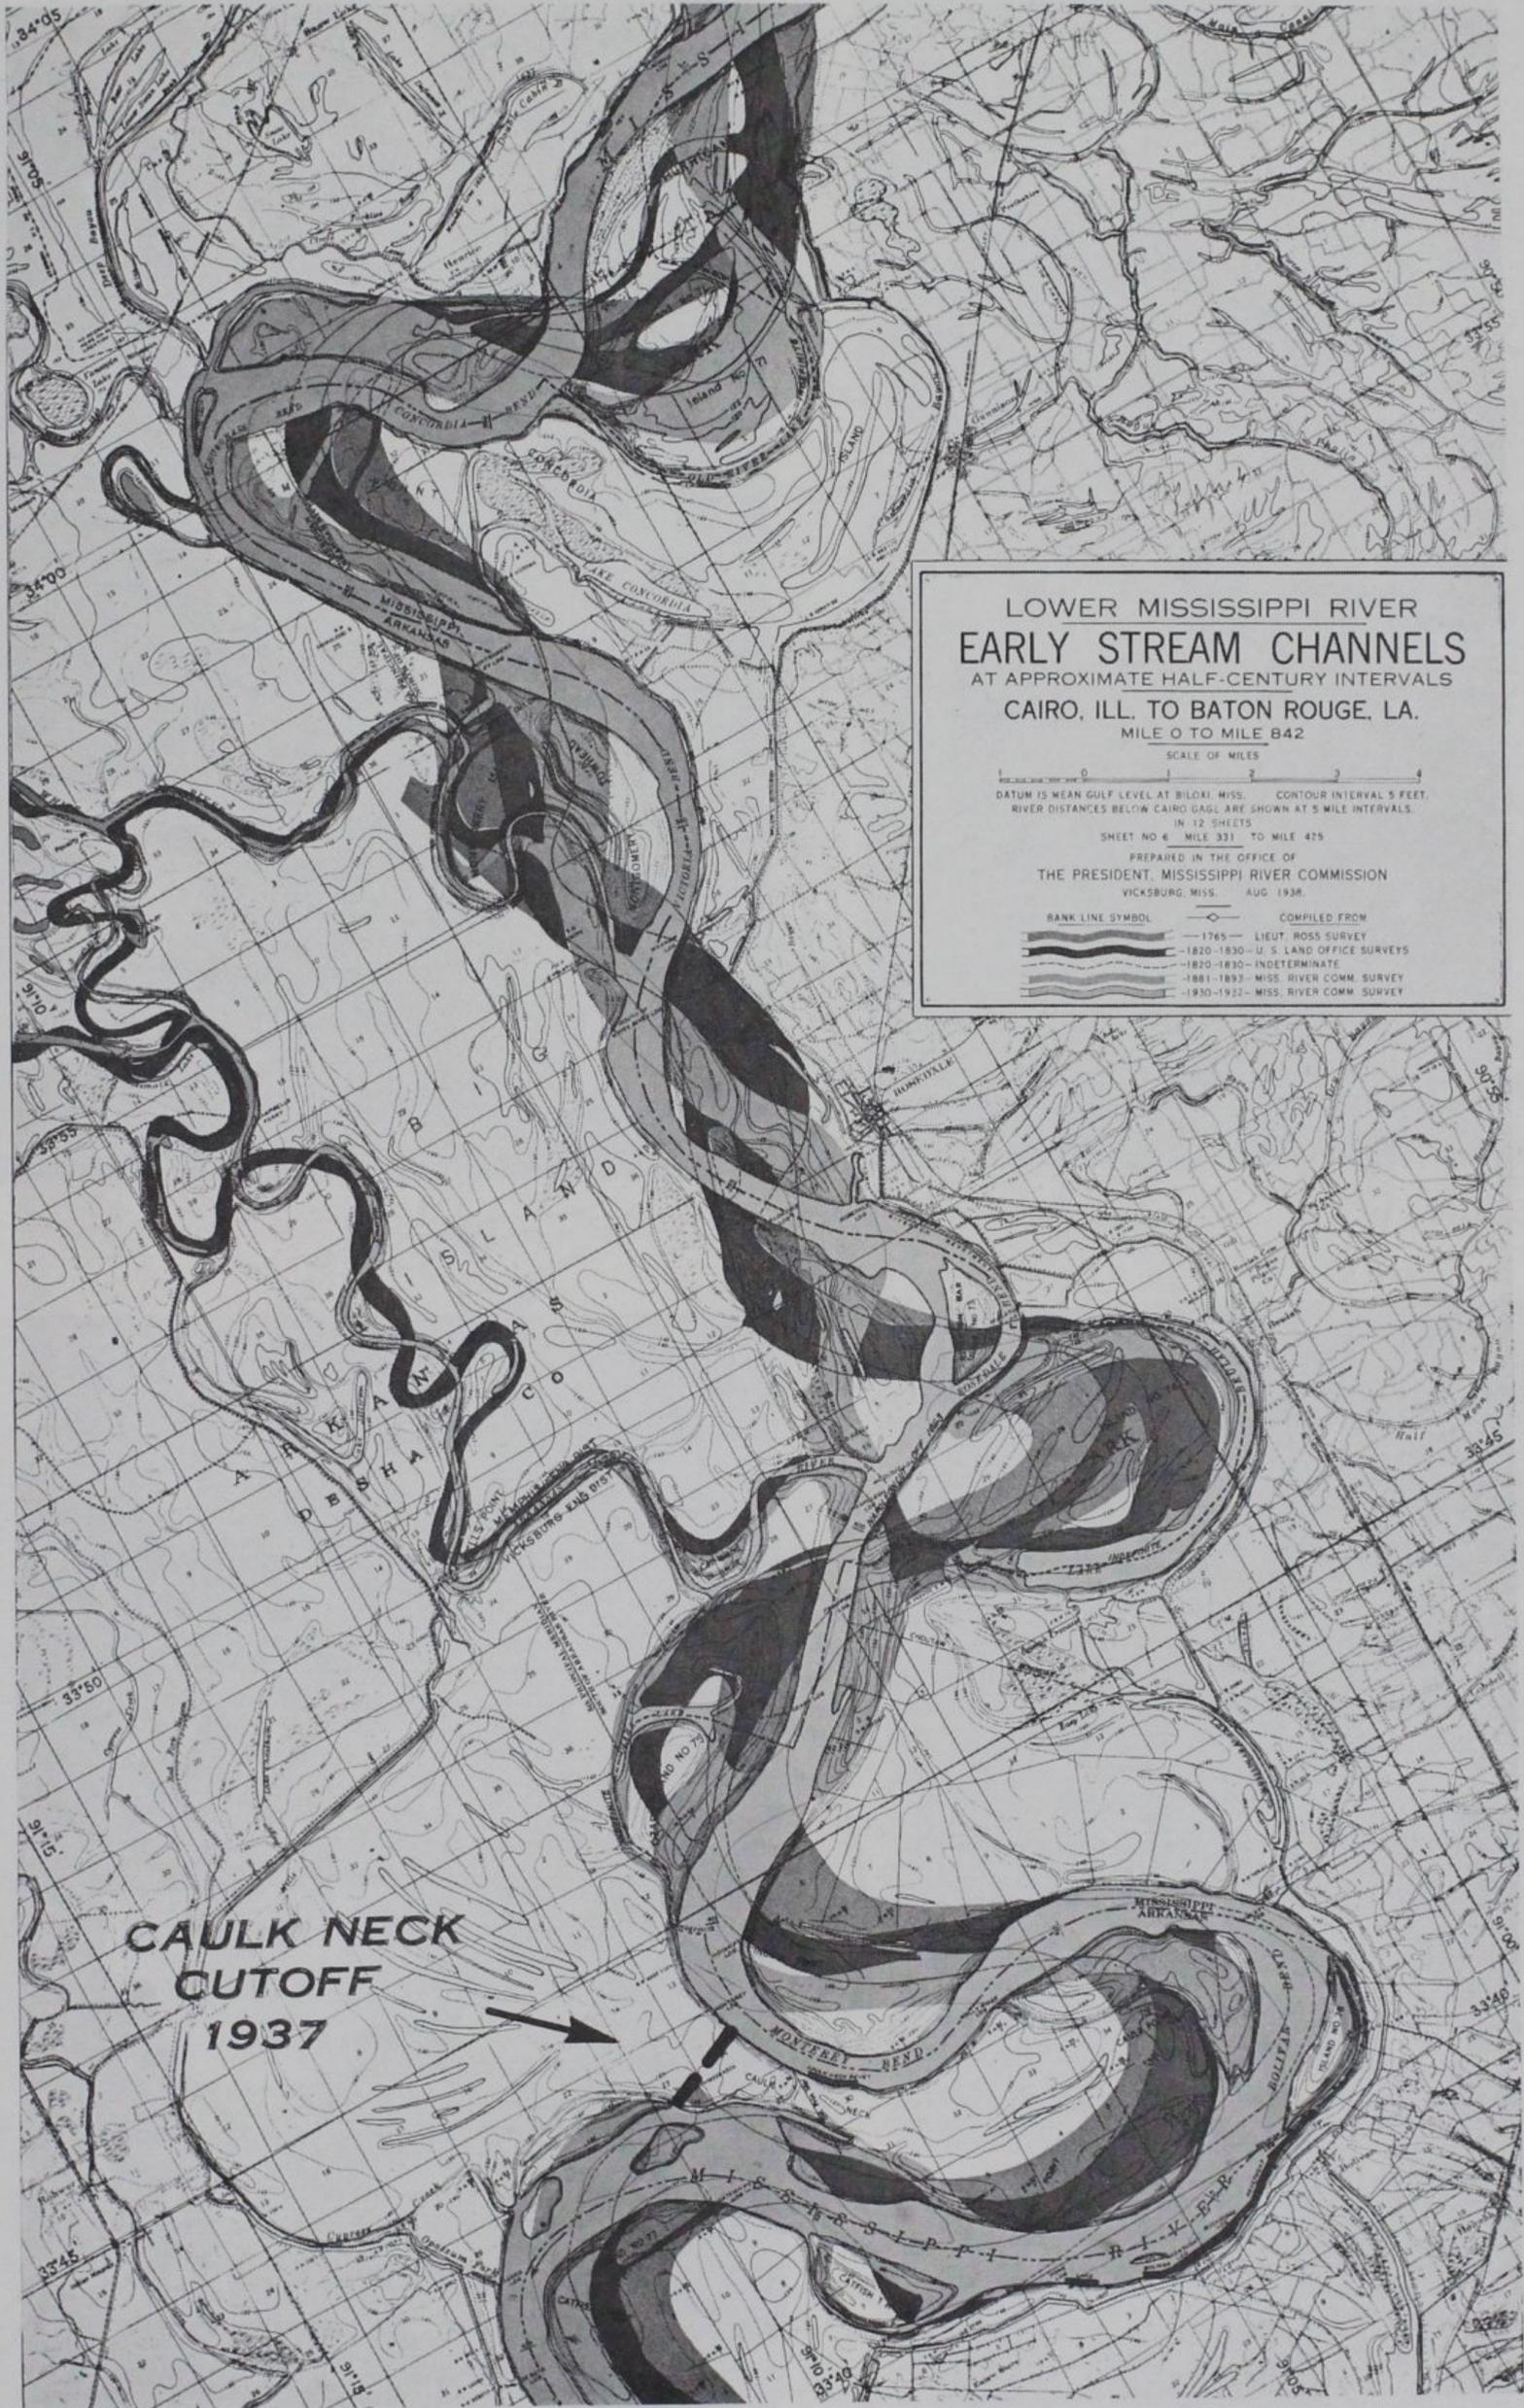
Figure 16

HISTORIC DEVELOPMENT OF THE CAULK NECK REACH

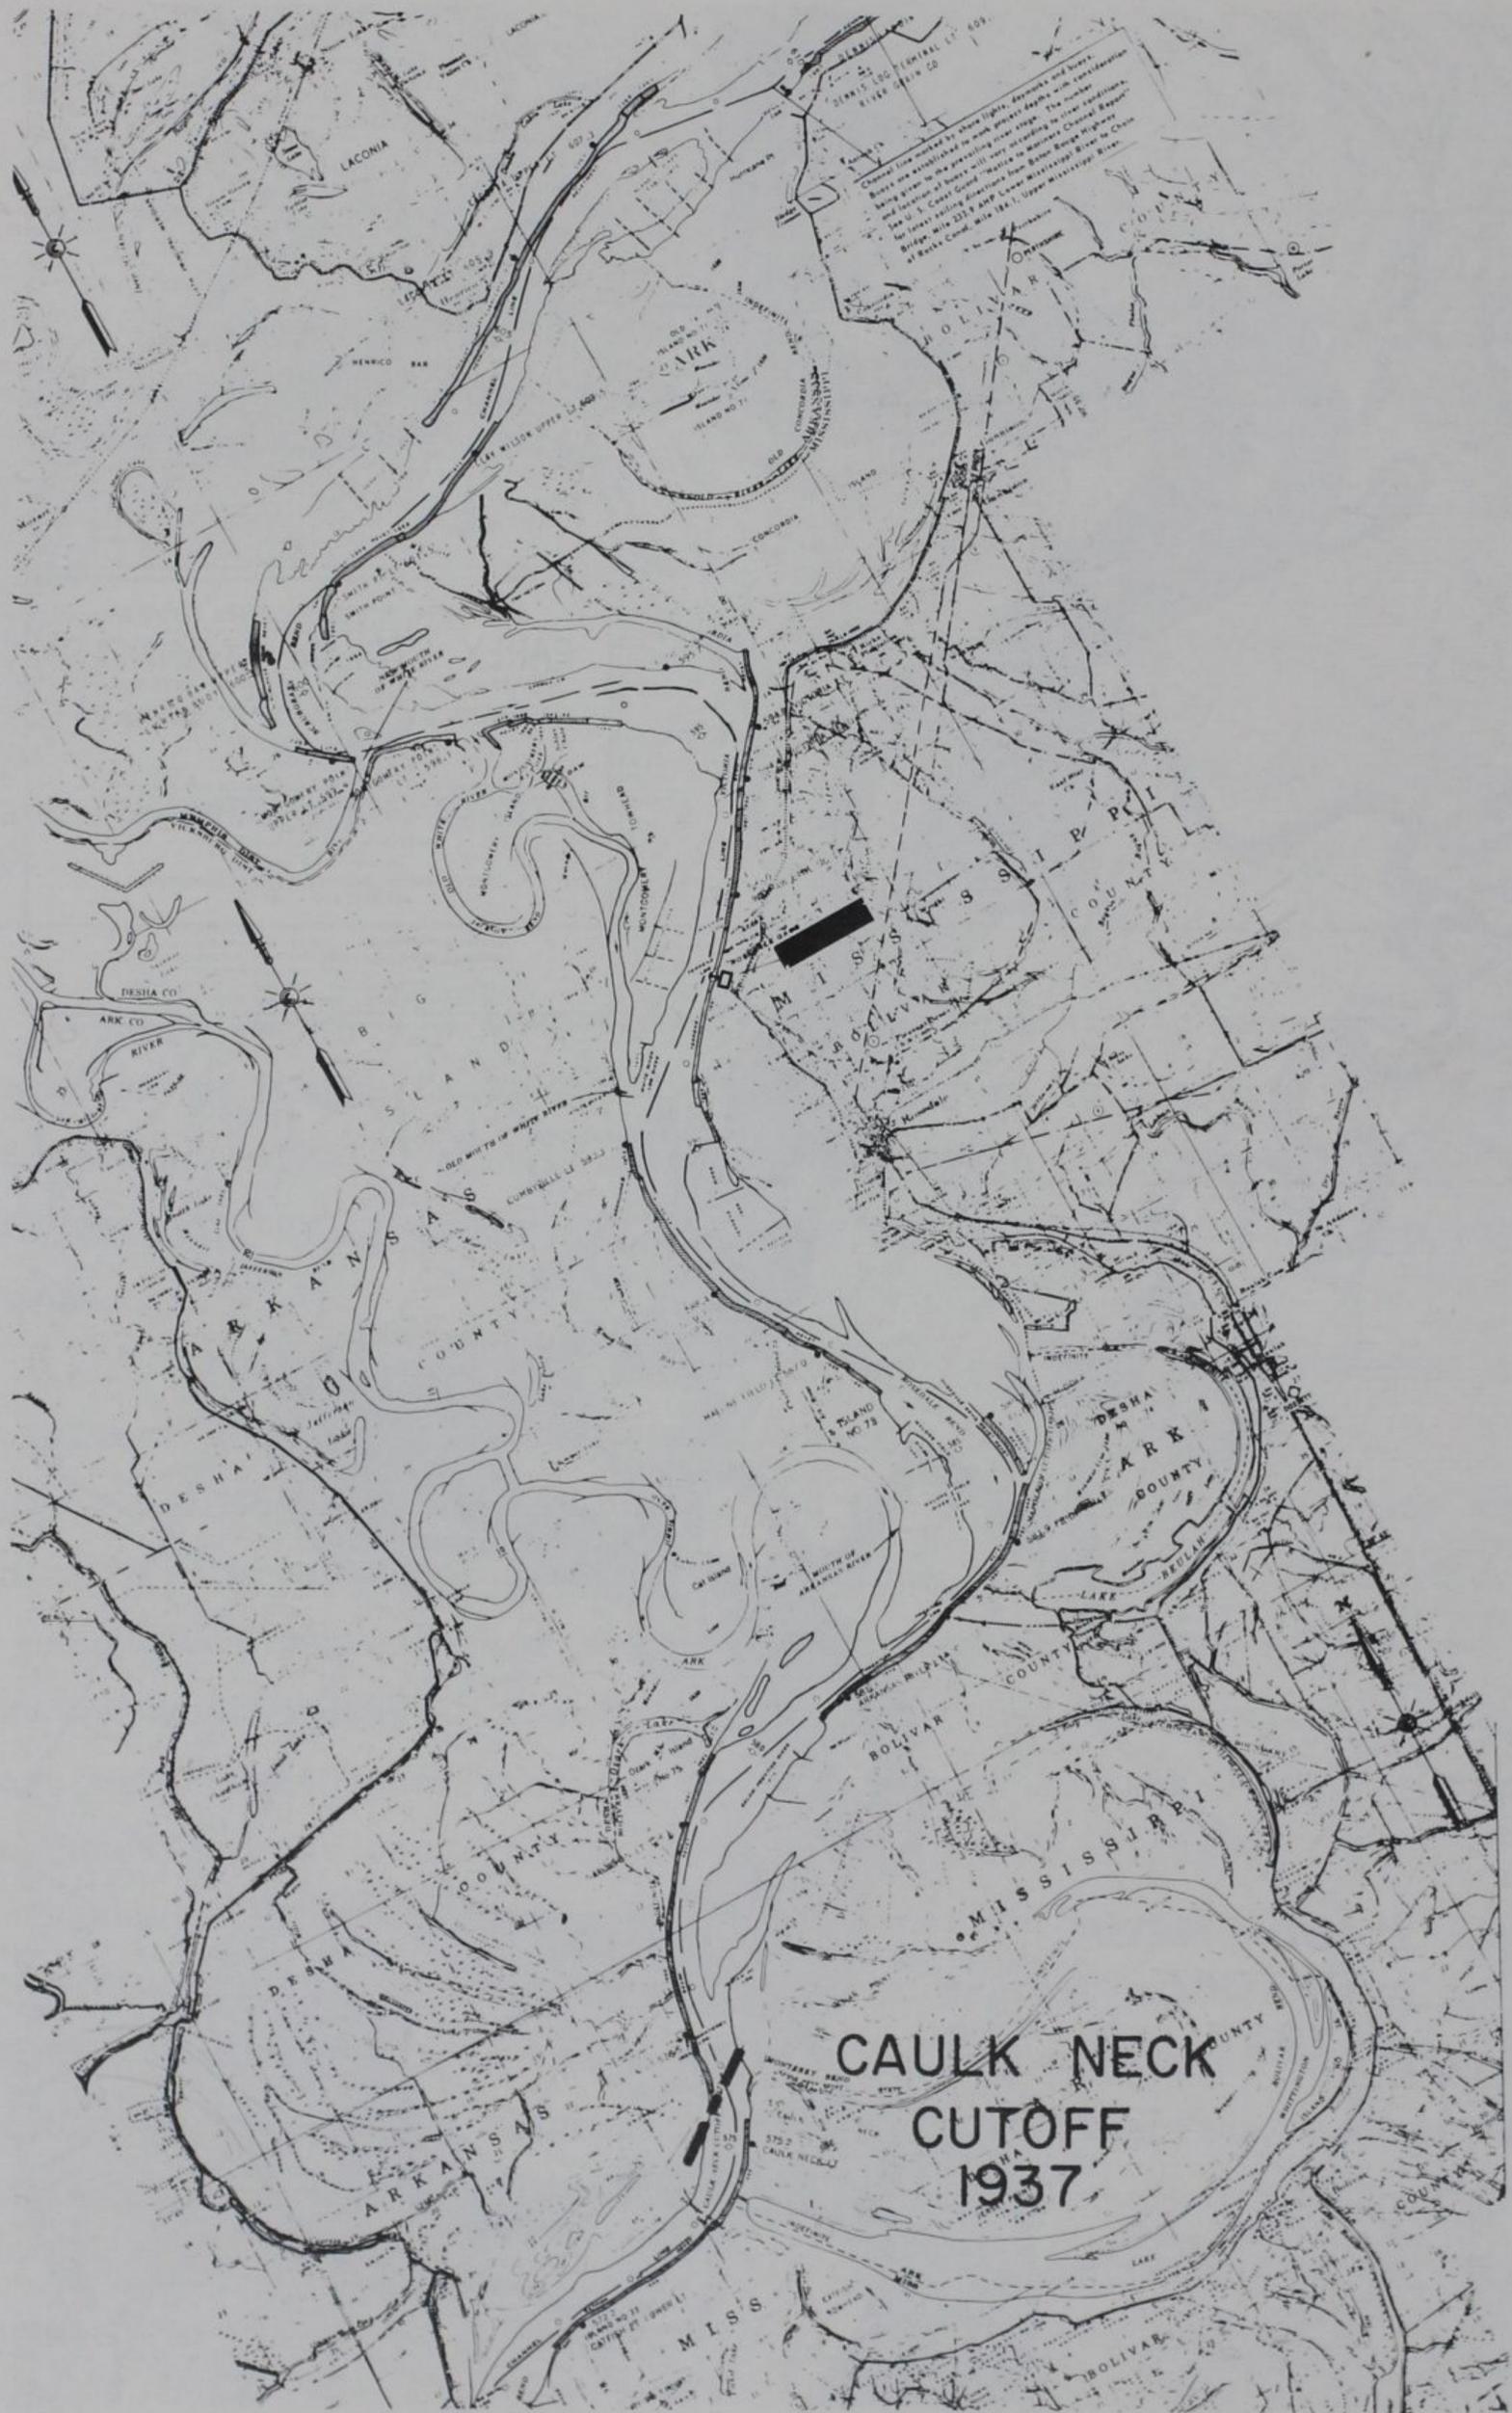
Figure 17

1975 MISSISSIPPI RIVER IN THE CAULK NECK REACH

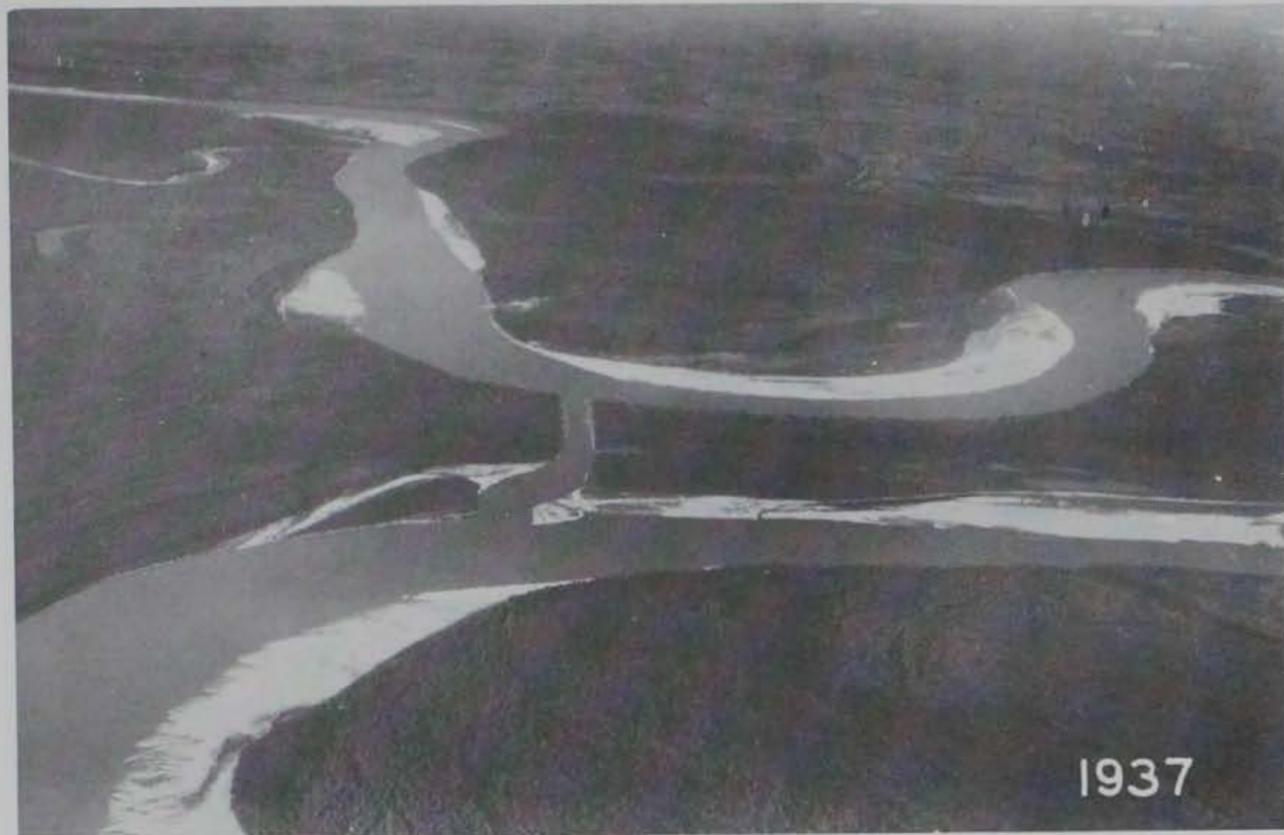
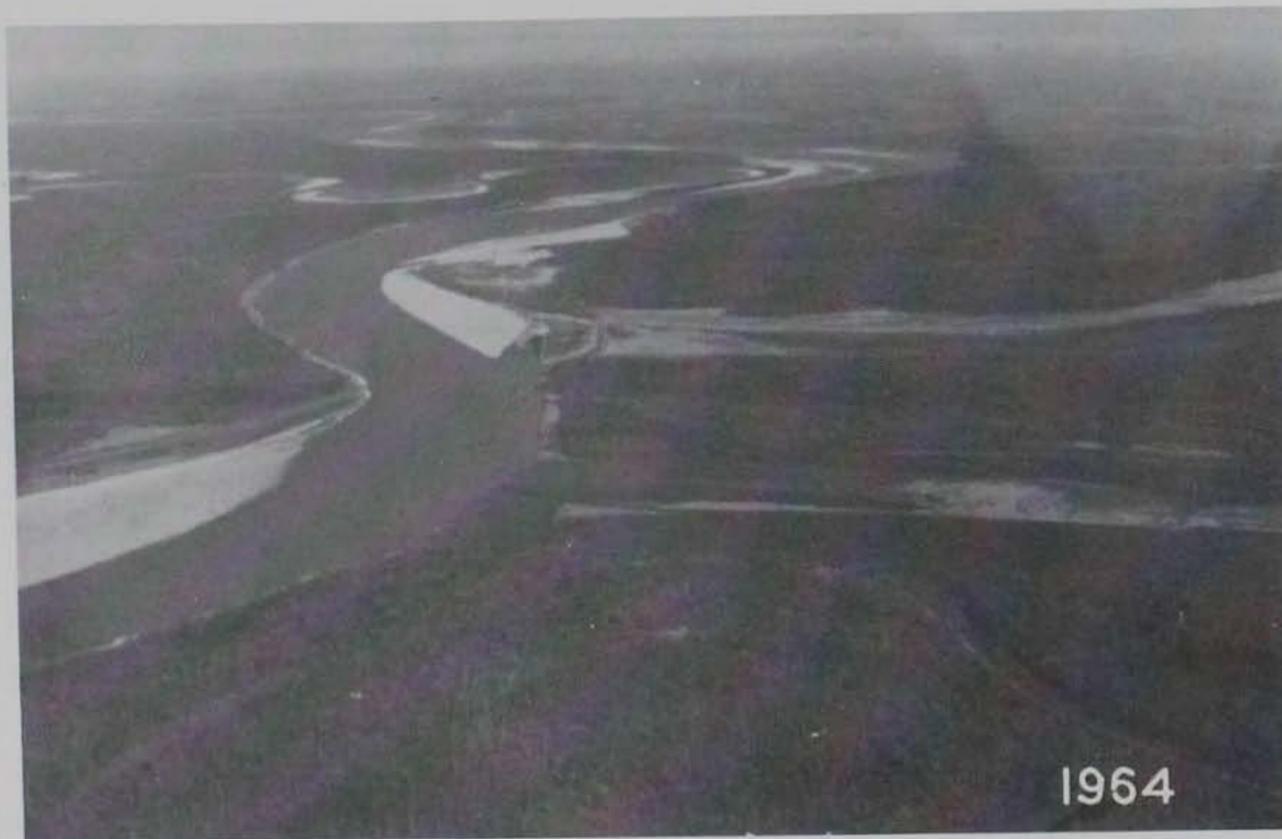
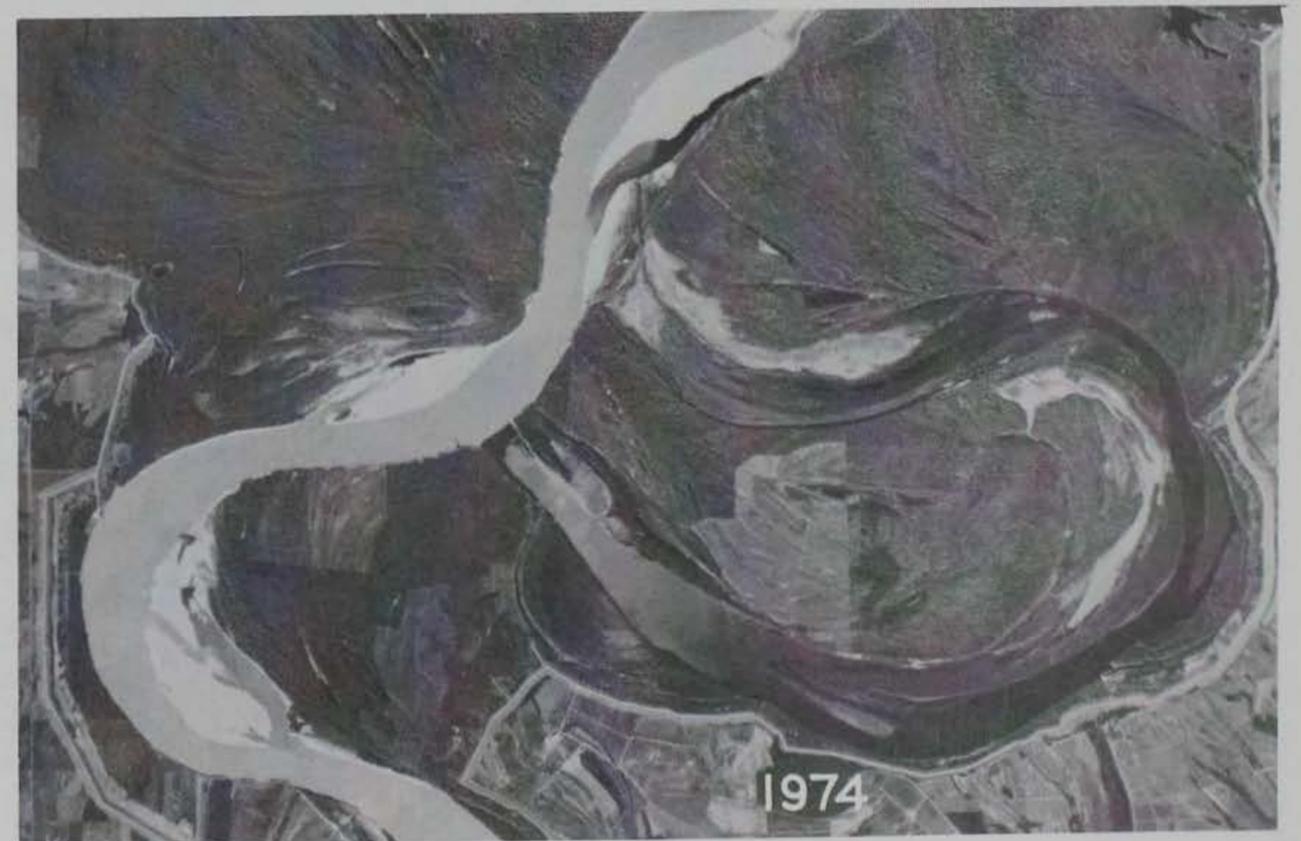
Figures 16 and 17, respectively, show the historic river and the present river in the Caulk Cutoff Reach. Figure 18 presents four aerial photographs (1937-74) of the cutoff. This reach of river below the confluence of the Arkansas and White Rivers has historically been very sinuous.

AERIAL VIEWS OF CAULK NECK CUTOFF
