POTAMOLOGY INVESTIGATIONS

Report 300-2

**MAN-MADE CUTOFFS ON THE LOWER MISSISSIPPI  
RIVER, CONCEPTION, CONSTRUCTION,  
AND RIVER RESPONSE**

U. S. ARMY ENGINEER DISTRICT, VICKSBURG

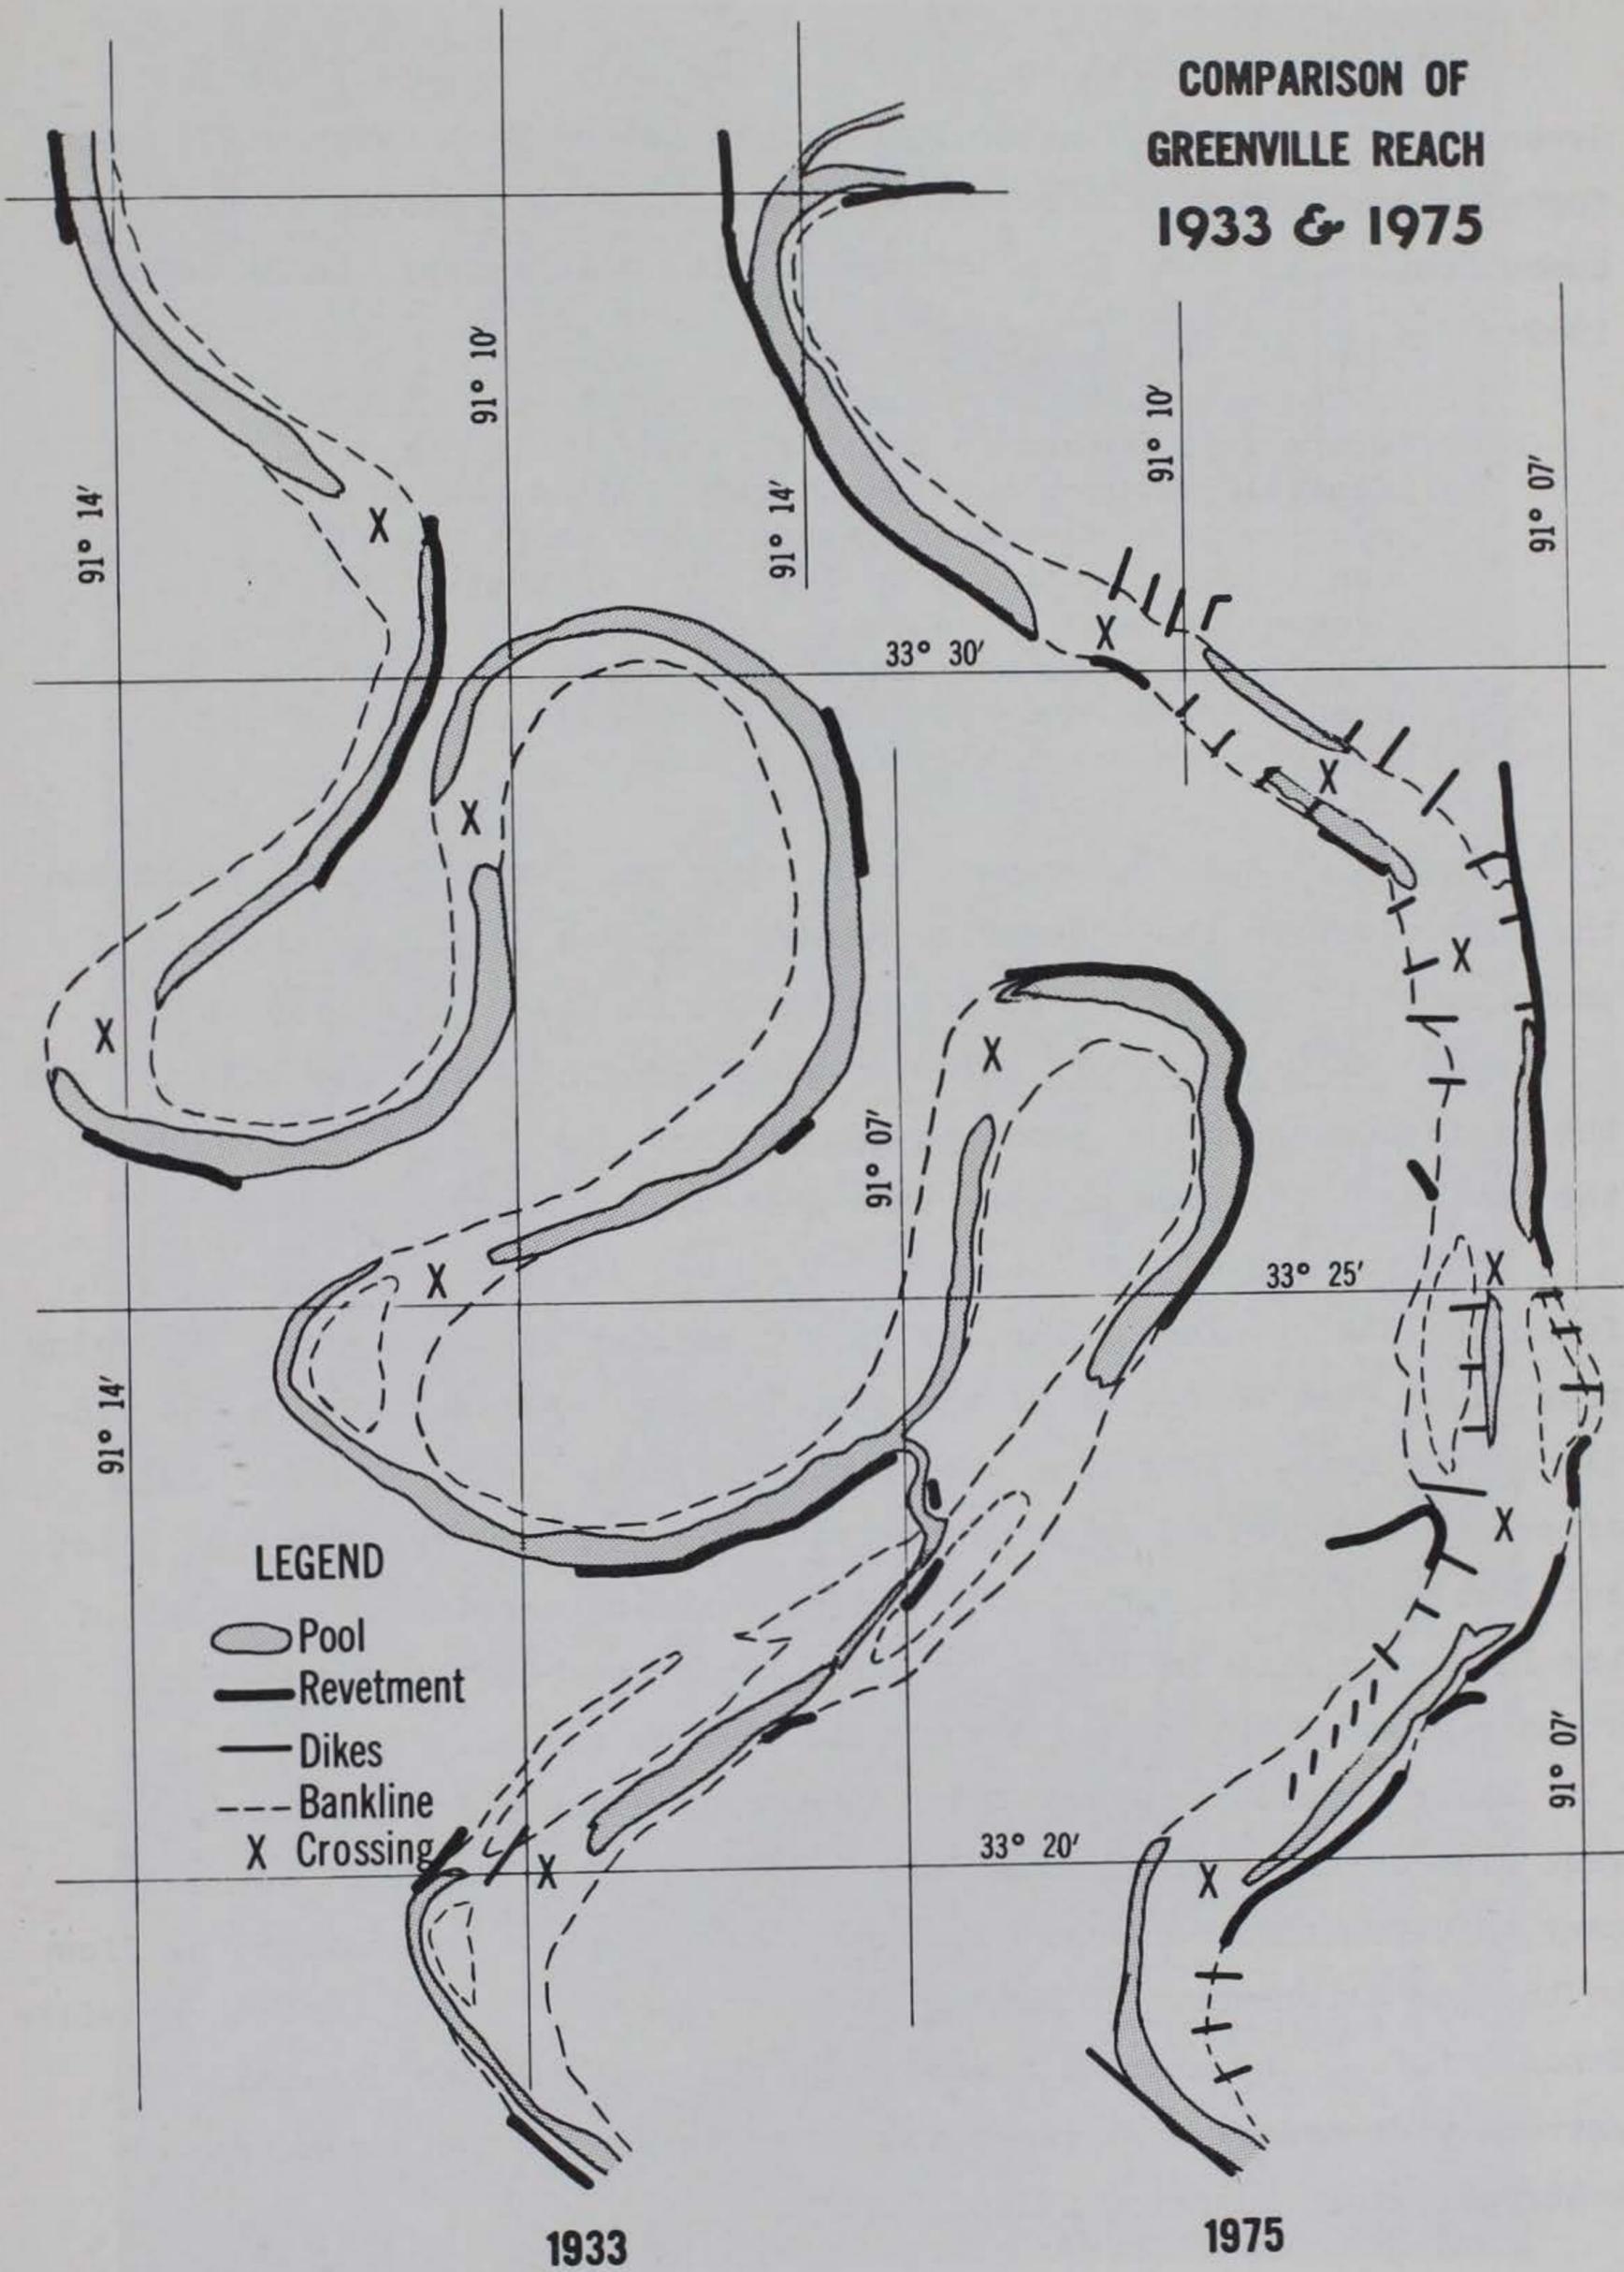
# COMPARISON OF GREENVILLE REACH 1933 & 1975

Figure 20 is a comparison of the Greenville Reach in 1933 with 1975. The structures built in an effort to prevent cutoffs prior to 1932 are shown as well as the structures built recently in an effort to hold the channel in its alignment after cutoffs. The flow in each survey is at a 12-ft stage, which is roughly a 25 percent bank-full flow. The 1975 river is much wider than the 1933 river but is reforming the same sequence and number of pools, bars, and crossings as existed in the 1933 survey.

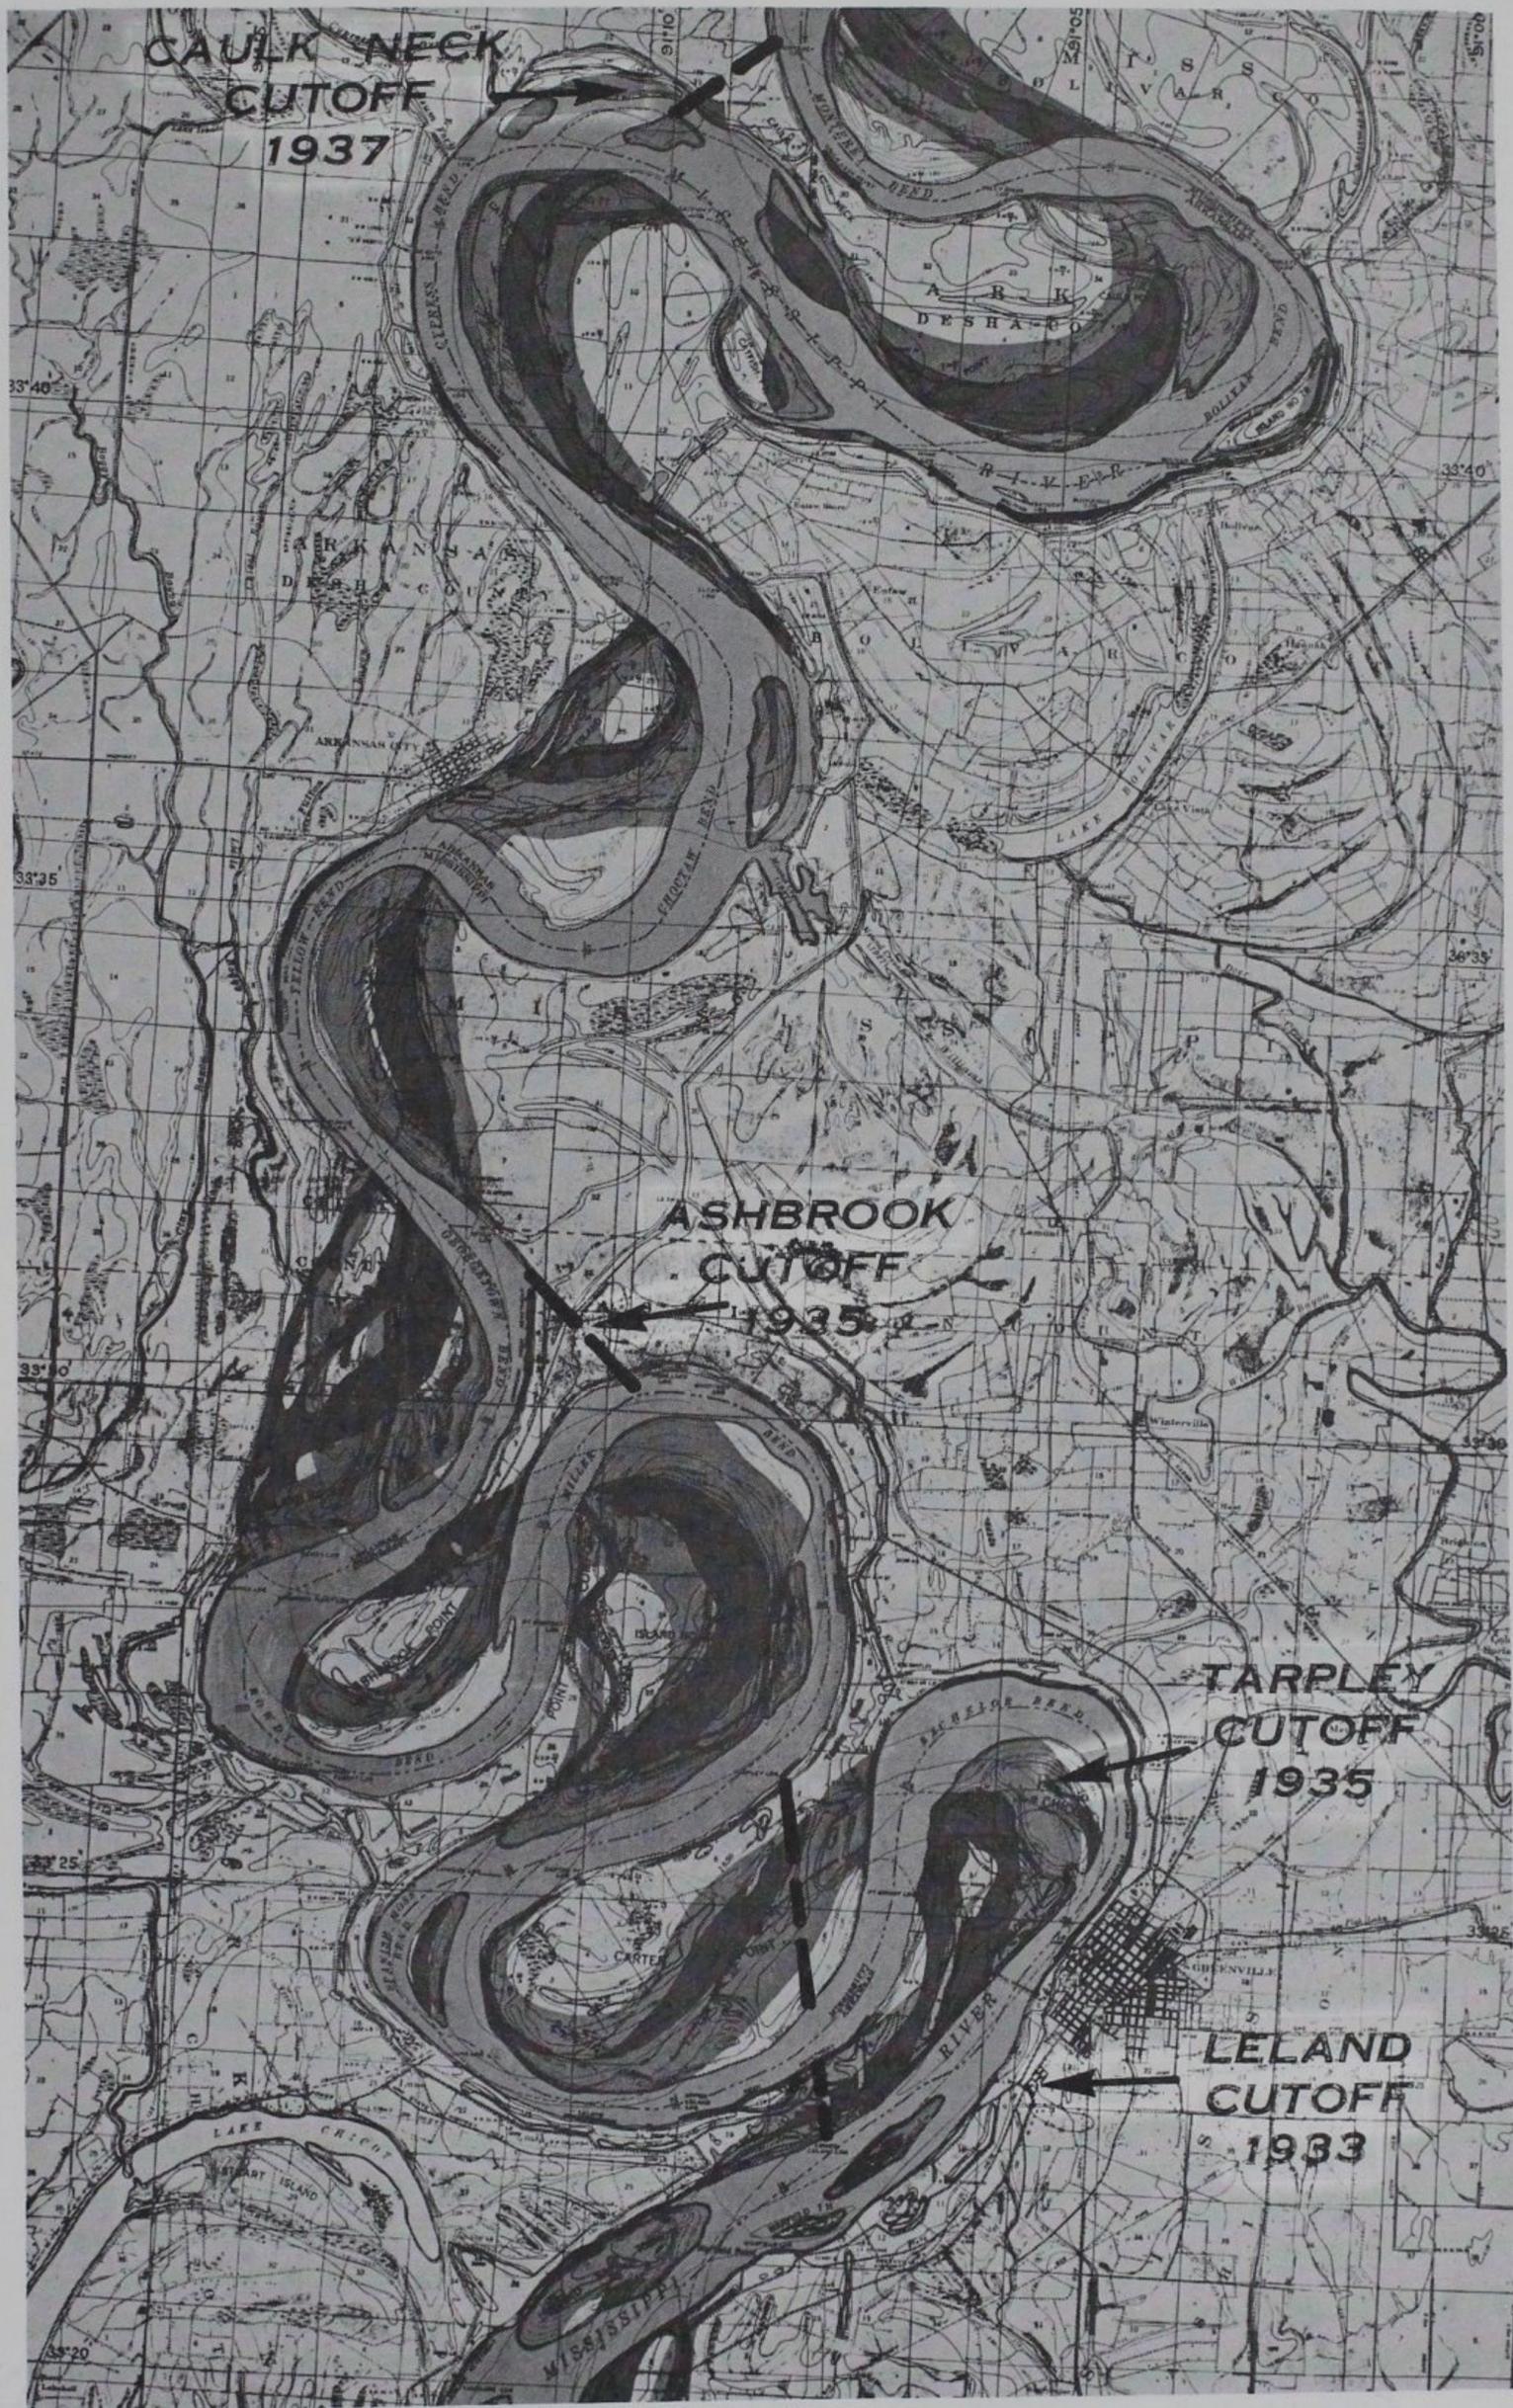
Figure 21

HISTORIC DEVELOPMENT OF THE GREENVILLE REACH

Originally, General Ferguson<sup>3</sup> planned only two cutoffs in the Greenville Reach, but a natural cutoff at Leland Neck (Figure 21) forced a last minute alteration of plans. Matthes<sup>7</sup> states in a communication to W. E. Elam<sup>6</sup> of Greenville, Mississippi, in September 1940:

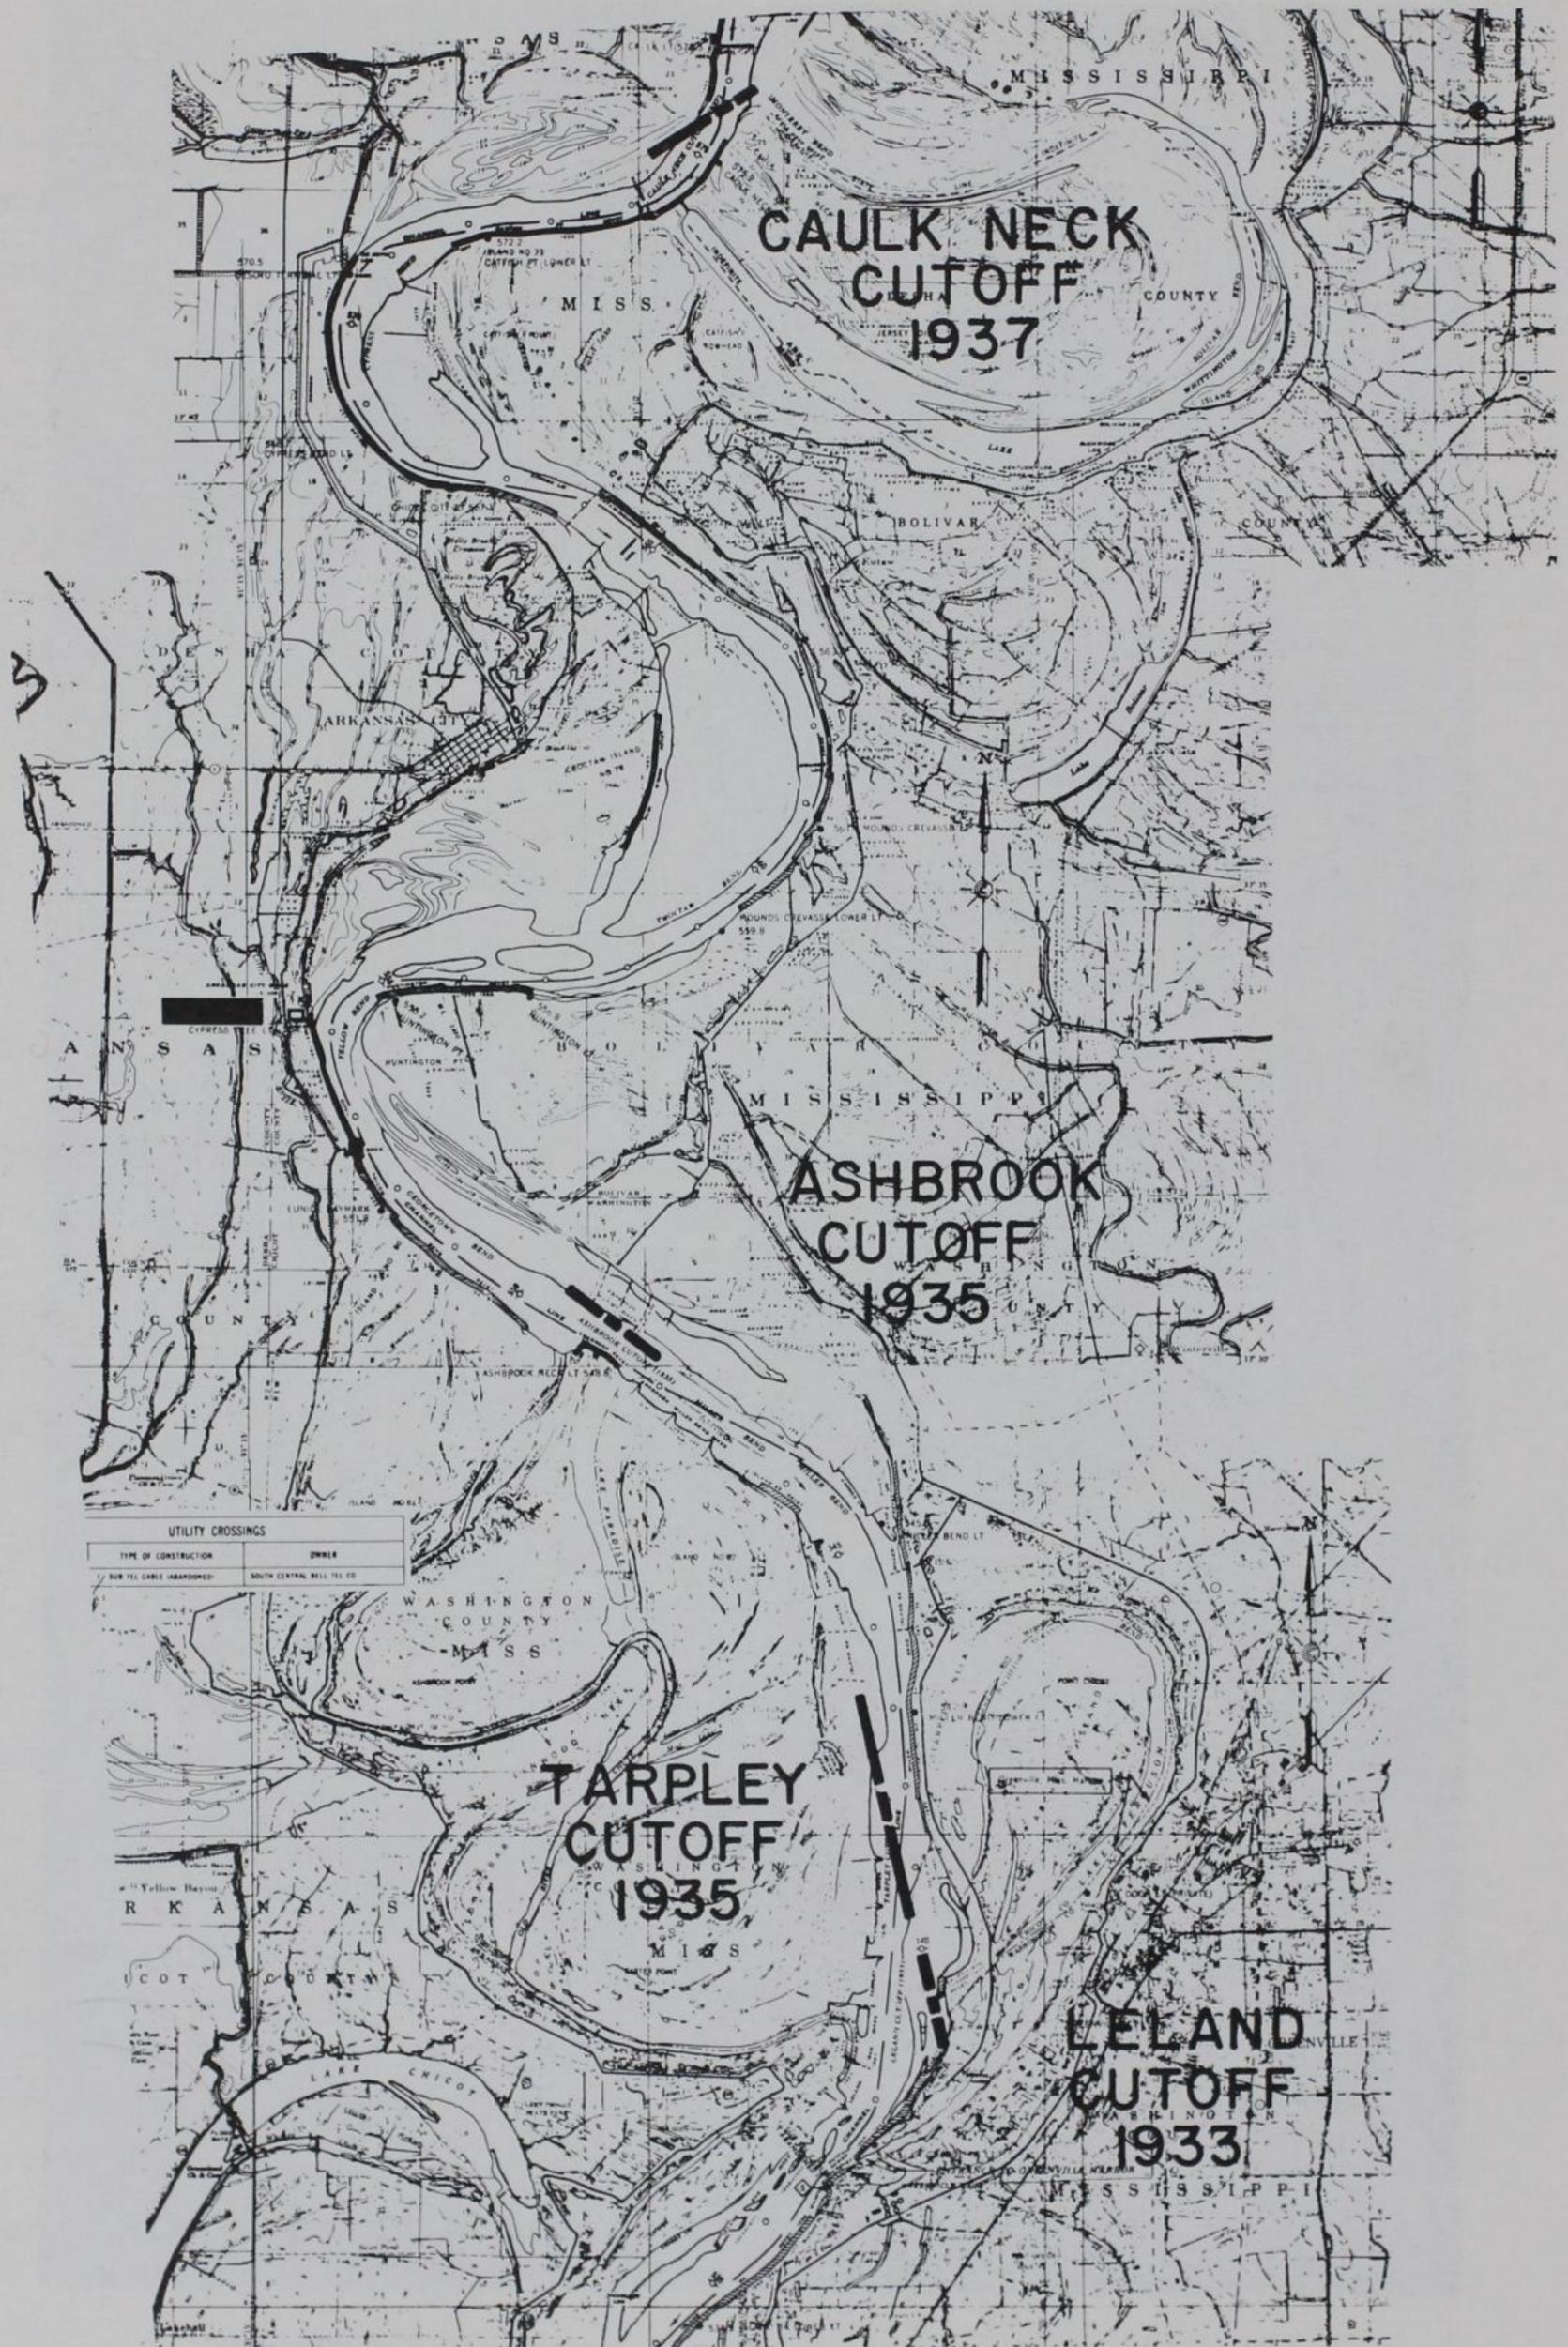
Figure 22

1975 MISSISSIPPI RIVER IN THE GREENVILLE REACH

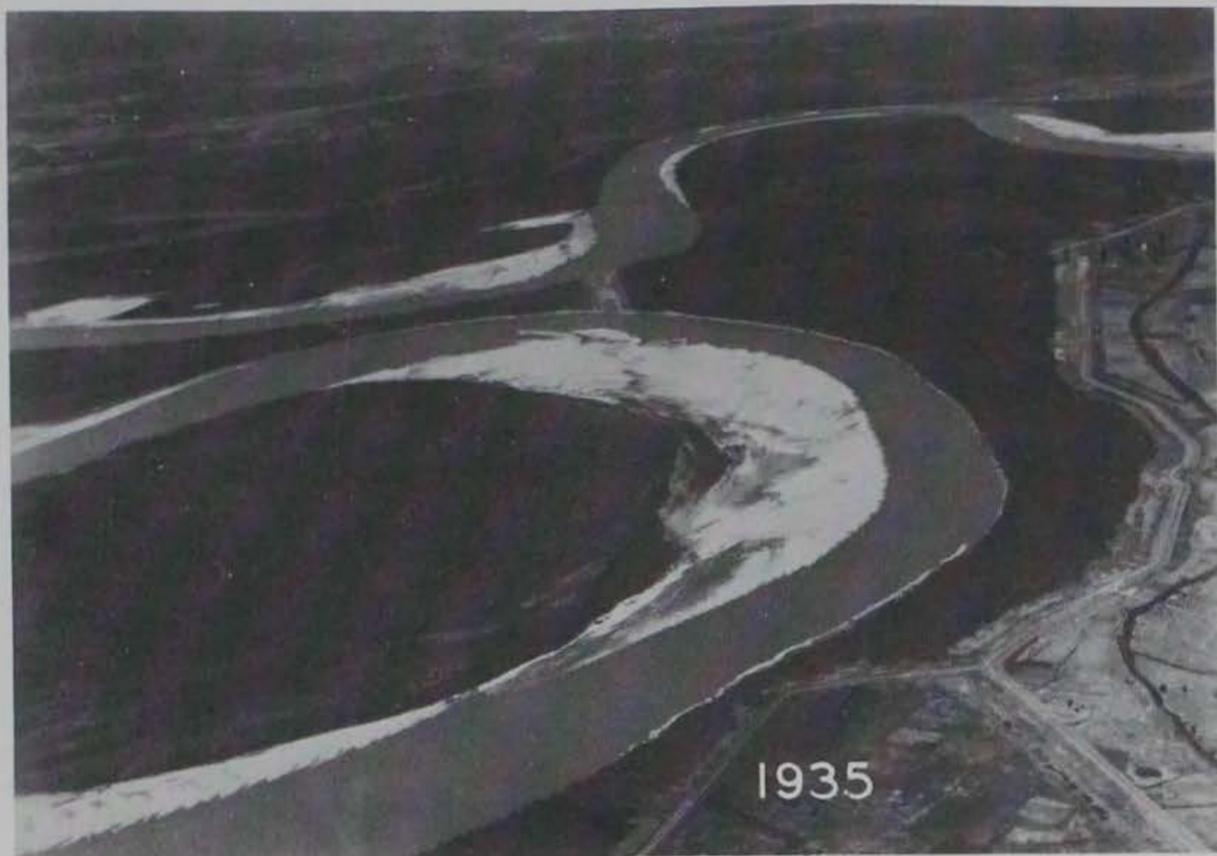
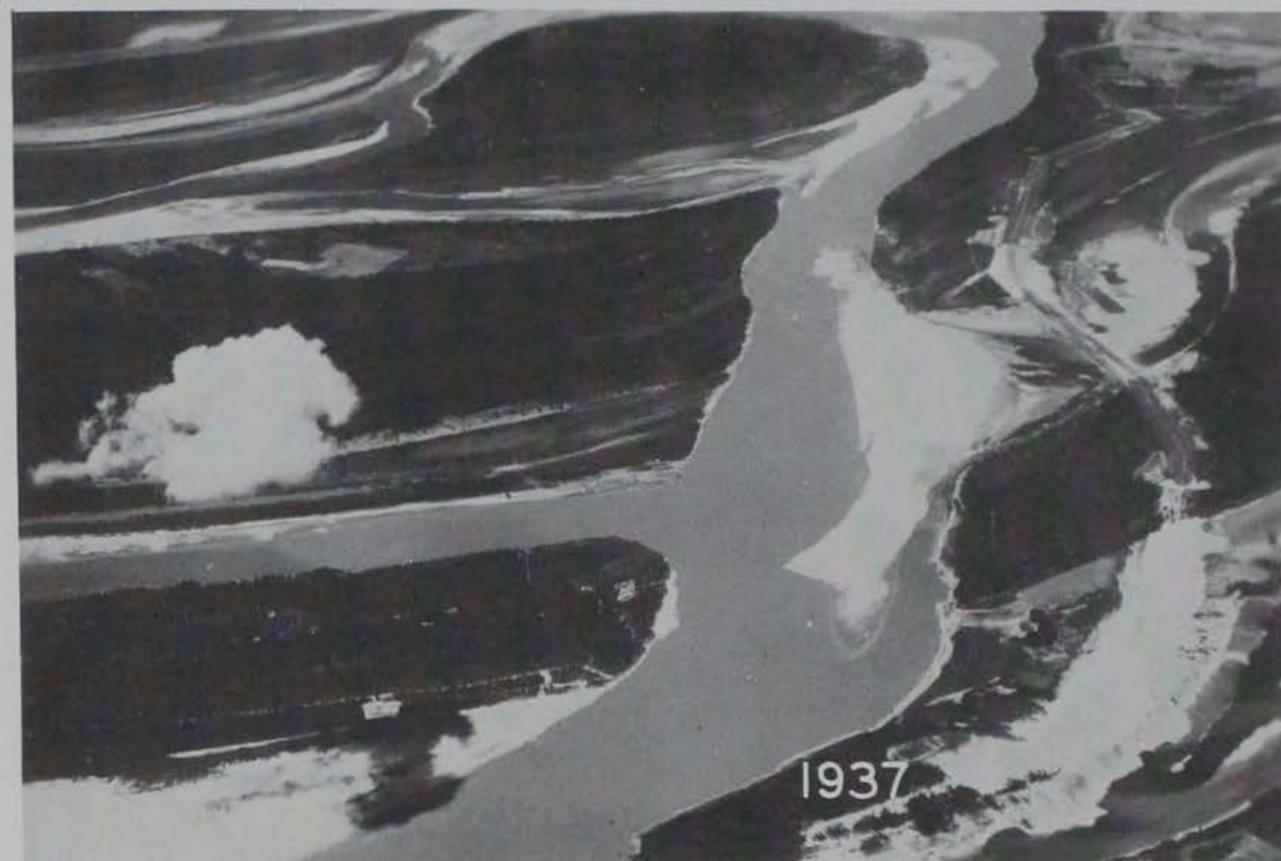
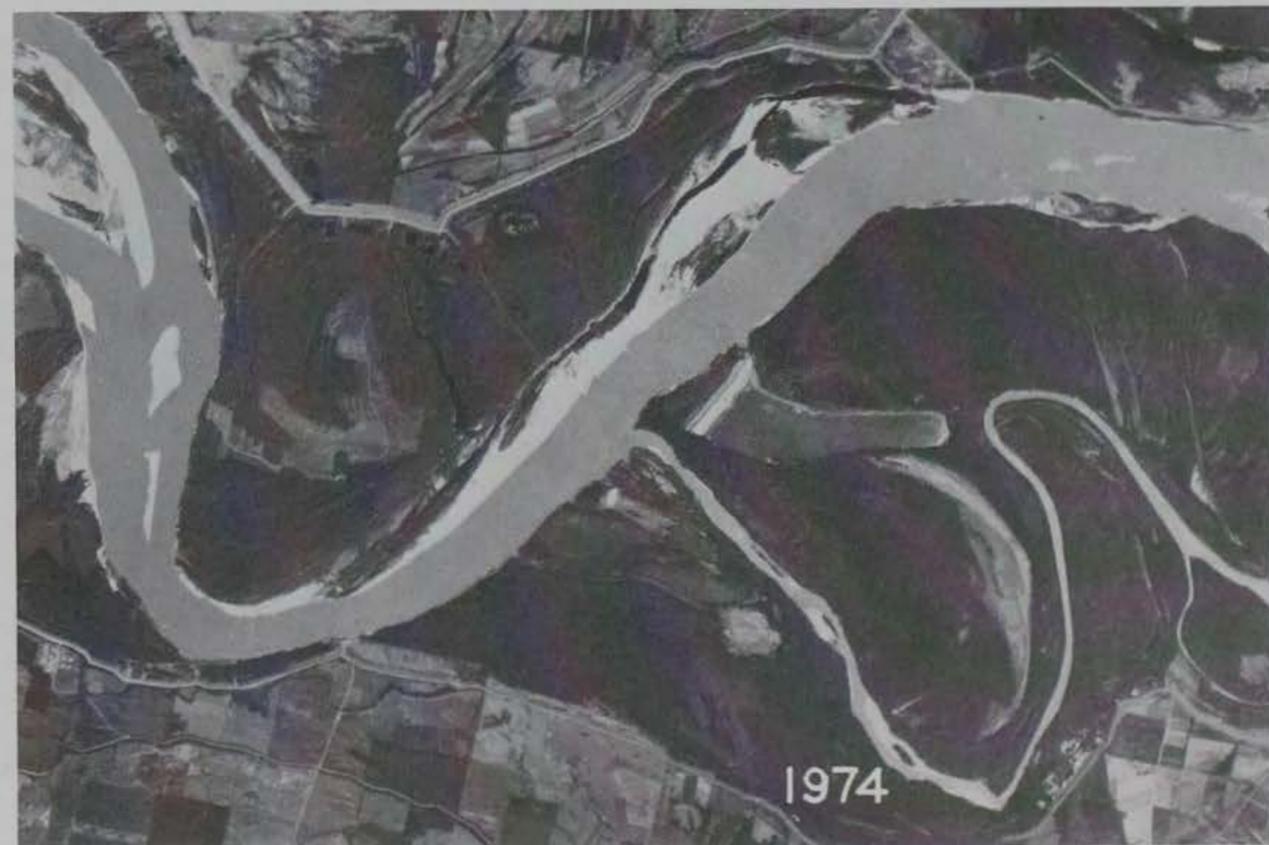
AERIAL VIEWS OF UPPER GREENVILLE REACH (ASHBROOK CUTOFF)

It should be said, though, that by the time construction of Ashbrook Cutoff was to begin, the fears and opposition to it had largely been dissipated. The most interested parties, that is, the residents in the area of potential effect, had noted that Leland and Tarpley Necks in the Greenville Bends had been cut off without untoward results; therefore, little apprehension remained for this last cutoff, which

Dredging was finished the morning of November 19, 1935. Planting of dynamite in the plug started at once. There were many notables present for the opening. The first blast failed to open the plug to depth of water surface. Another charge was planted and blown at 12:05 p.m. This one was successful. Flow immediately started and the plug began to melt away rapidly.... By 1:30 a.m. -- less than an hour and a half after flow started -- the plug was gone and the banks of the dredge cut were caving. The velocity was increasing unbelievably fast....

A few years after the cutoff was made, enormous widening in the river above had taken place. This widening permitted bar building, which extended down into the cutoff itself. This condition did not affect the value of the cutoff to flood control but did interfere with navigation. Dredging with pump barges has been done on two or three occasions to improve the low-water navigation channel.

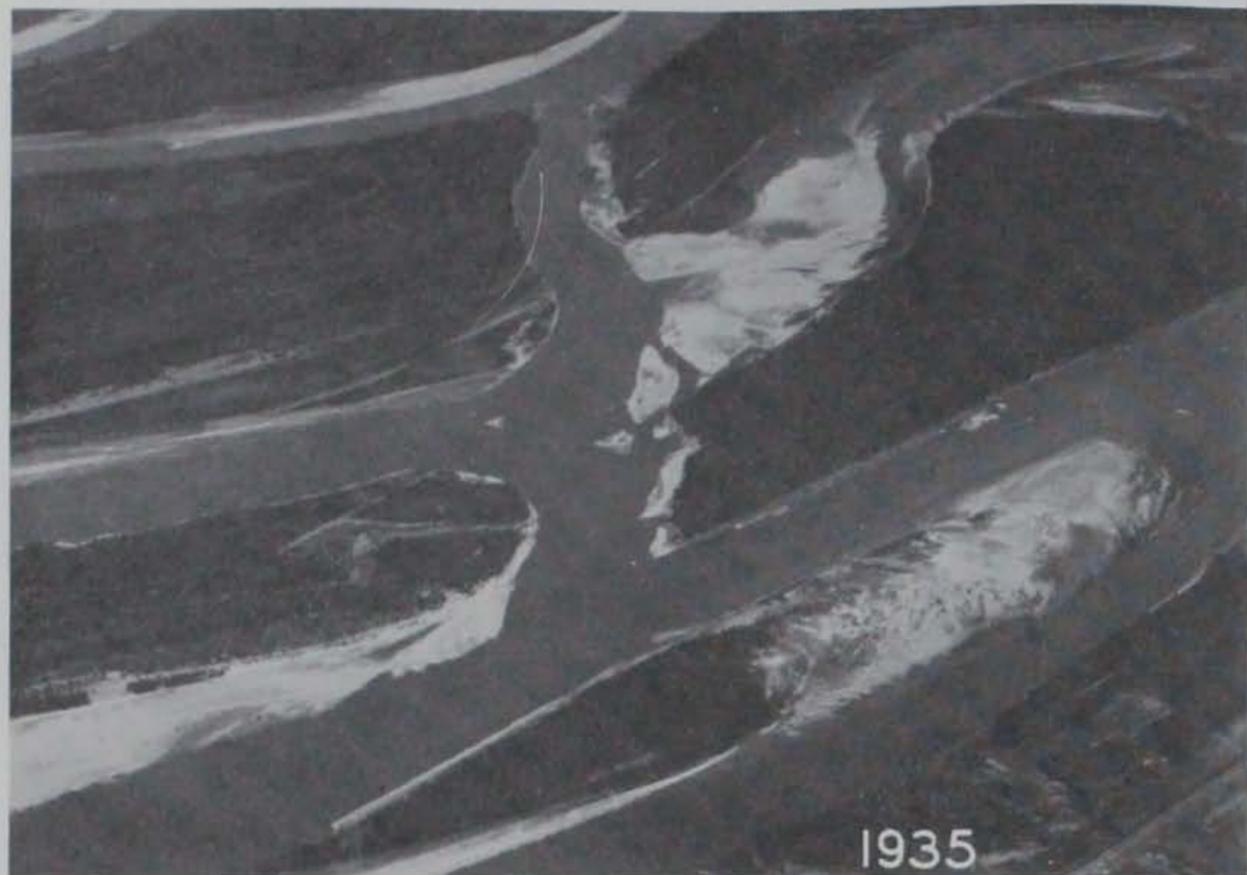
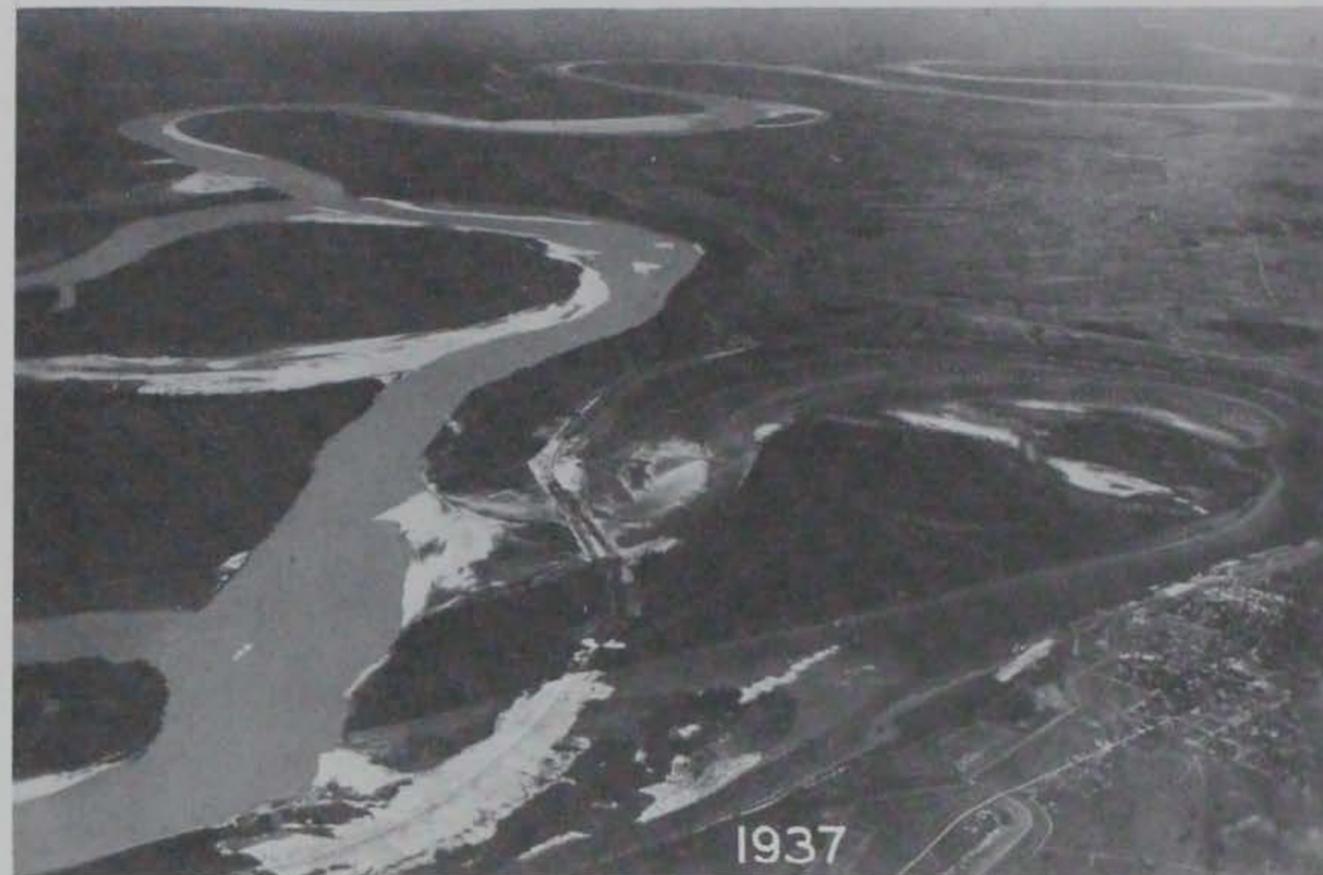
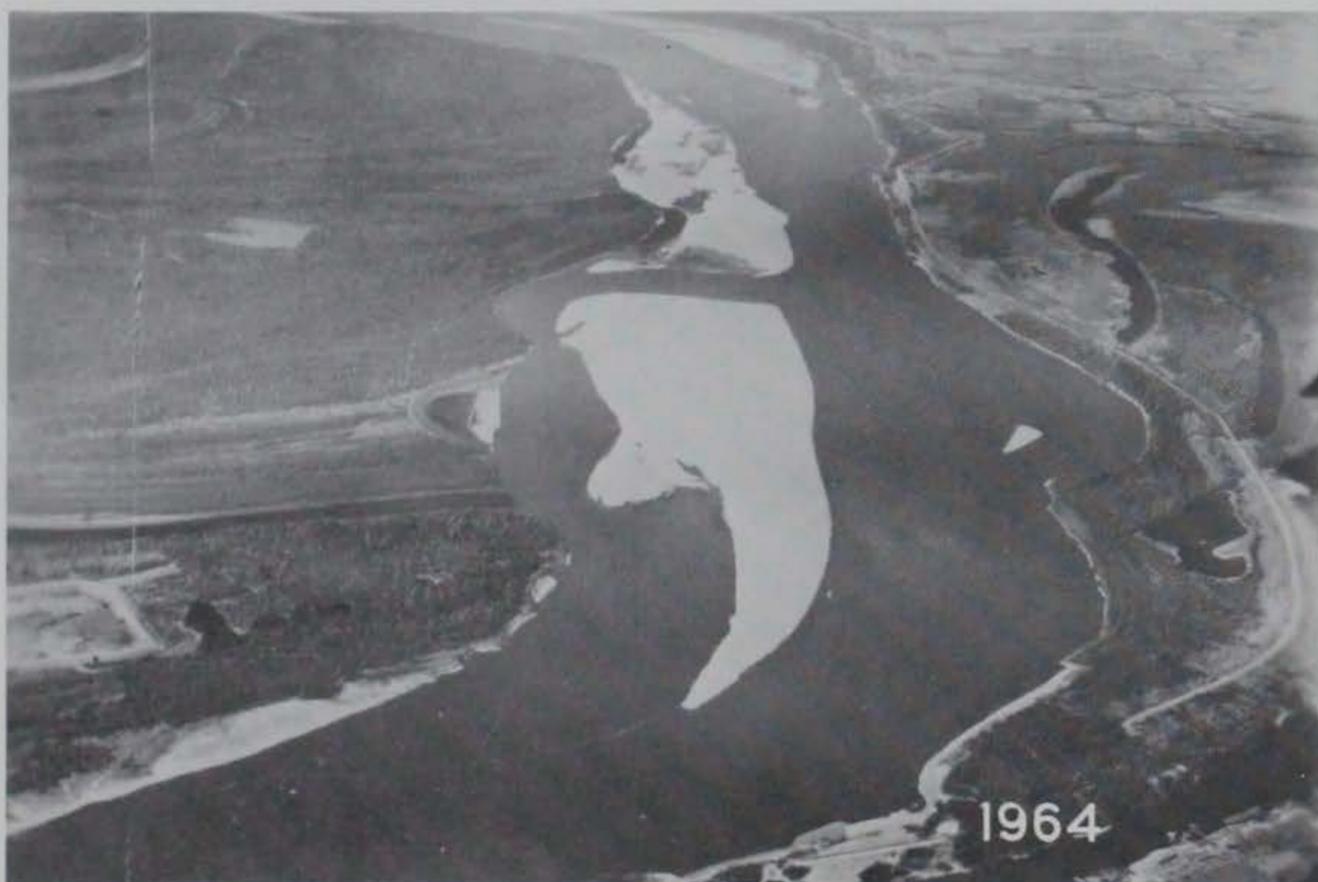
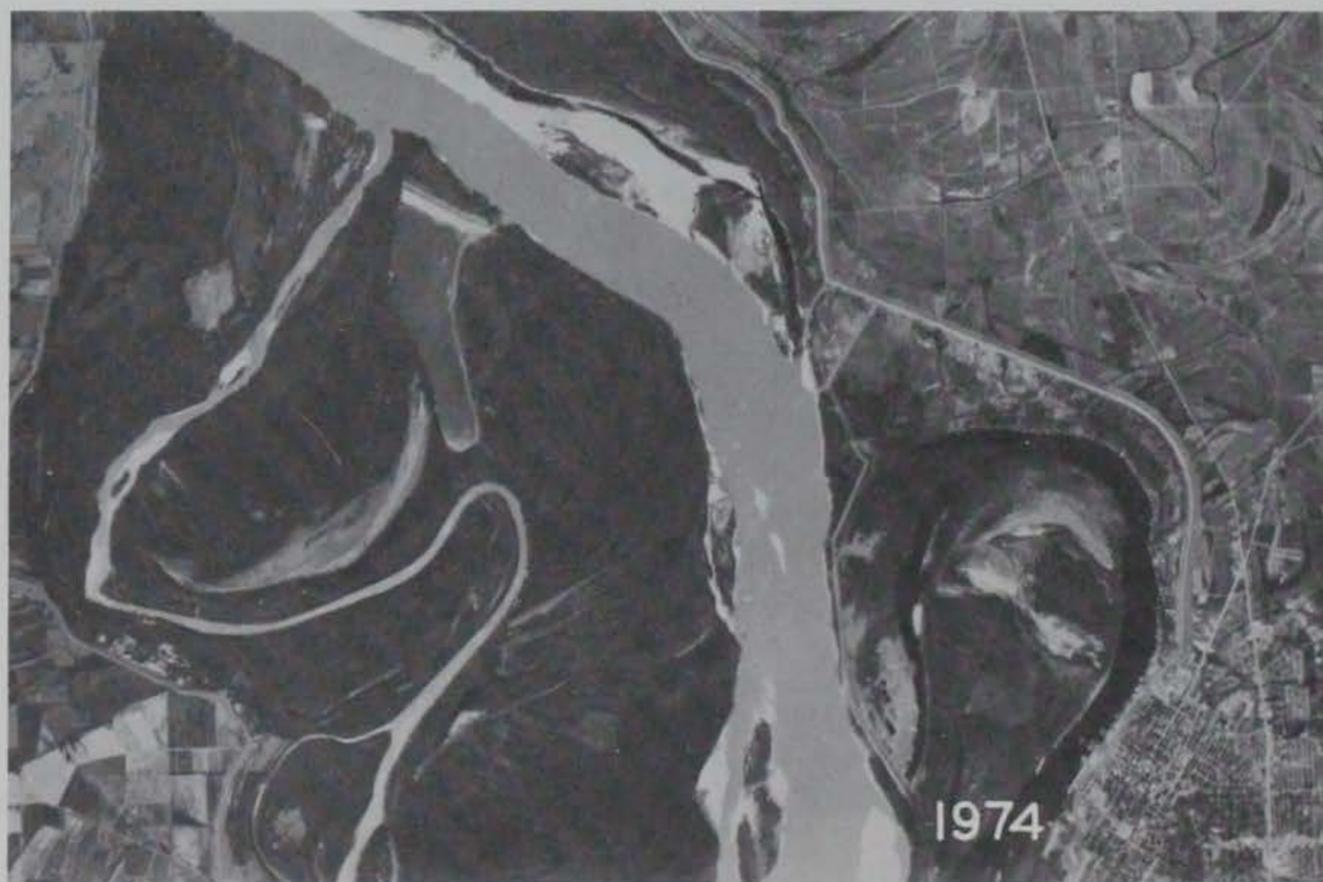
AERIAL VIEWS OF LOWER GREENVILLE REACH (LELAND NECK & TARPLEY CUTOFFS)

At gage readings that somewhat surpassed bank-full, there was flow across the neck prior to the cutoff. This overbank flow had begun to scour "blue holes," which are the result of overbank flow, at high velocities, finding soft, easily erodible spots in the high ground and gouging it out to form a deep lake. These lakes are called "blue holes" because the water has a bluish appearance after the settling out of sediment. They obviously weakened the narrow necks and added to the apprehension of the many who feared so greatly the breaching of any of the peninsulas of the "Greenville Bends." [Figure 19 is a copy of a telegram from General Brown on preventing a cutoff at Tarpley.] This fear led to the filling of the Tarpley "blue holes" with sand dredged from the river in the early part of 1932 to reinforce the neck against a natural cutoff. Also in early 1932, about 1700 linear ft of concrete revetment was placed at the upstream side to protect the bank against caving at what was considered the weakest point. The filling of the "blue holes" with sand is

Construction of the cutoff was begun early in 1935 with a dustpan dredge digging through the sandbar which formed at the lower side of the neck as a result of Leland Cutoff. Immediately after the opening at Leland, the upstream end of the old river bend around Leland Neck began one of the most rapid natural fills ever observed in the district. Due to the fact that Tarpley Cutoff was to be aligned to Leland, the downstream end of Tarpley Cutoff would cross the upper portion of this enormous opening and rapid fill. Inasmuch as this deposit was all sand, a dustpan dredge could advantageously dig this portion of the cutoff channel. The cut extended about 3000 ft until it reached the main high bank of Tarpley Neck. At this point a cutterhead dredge took up the heavy work.
