POTAMOLOGY INVESTIGATIONS

Report 300-2

**MAN-MADE CUTOFFS ON THE LOWER MISSISSIPPI  
RIVER, CONCEPTION, CONSTRUCTION,  
AND RIVER RESPONSE**

U. S. ARMY ENGINEER DISTRICT, VICKSBURG

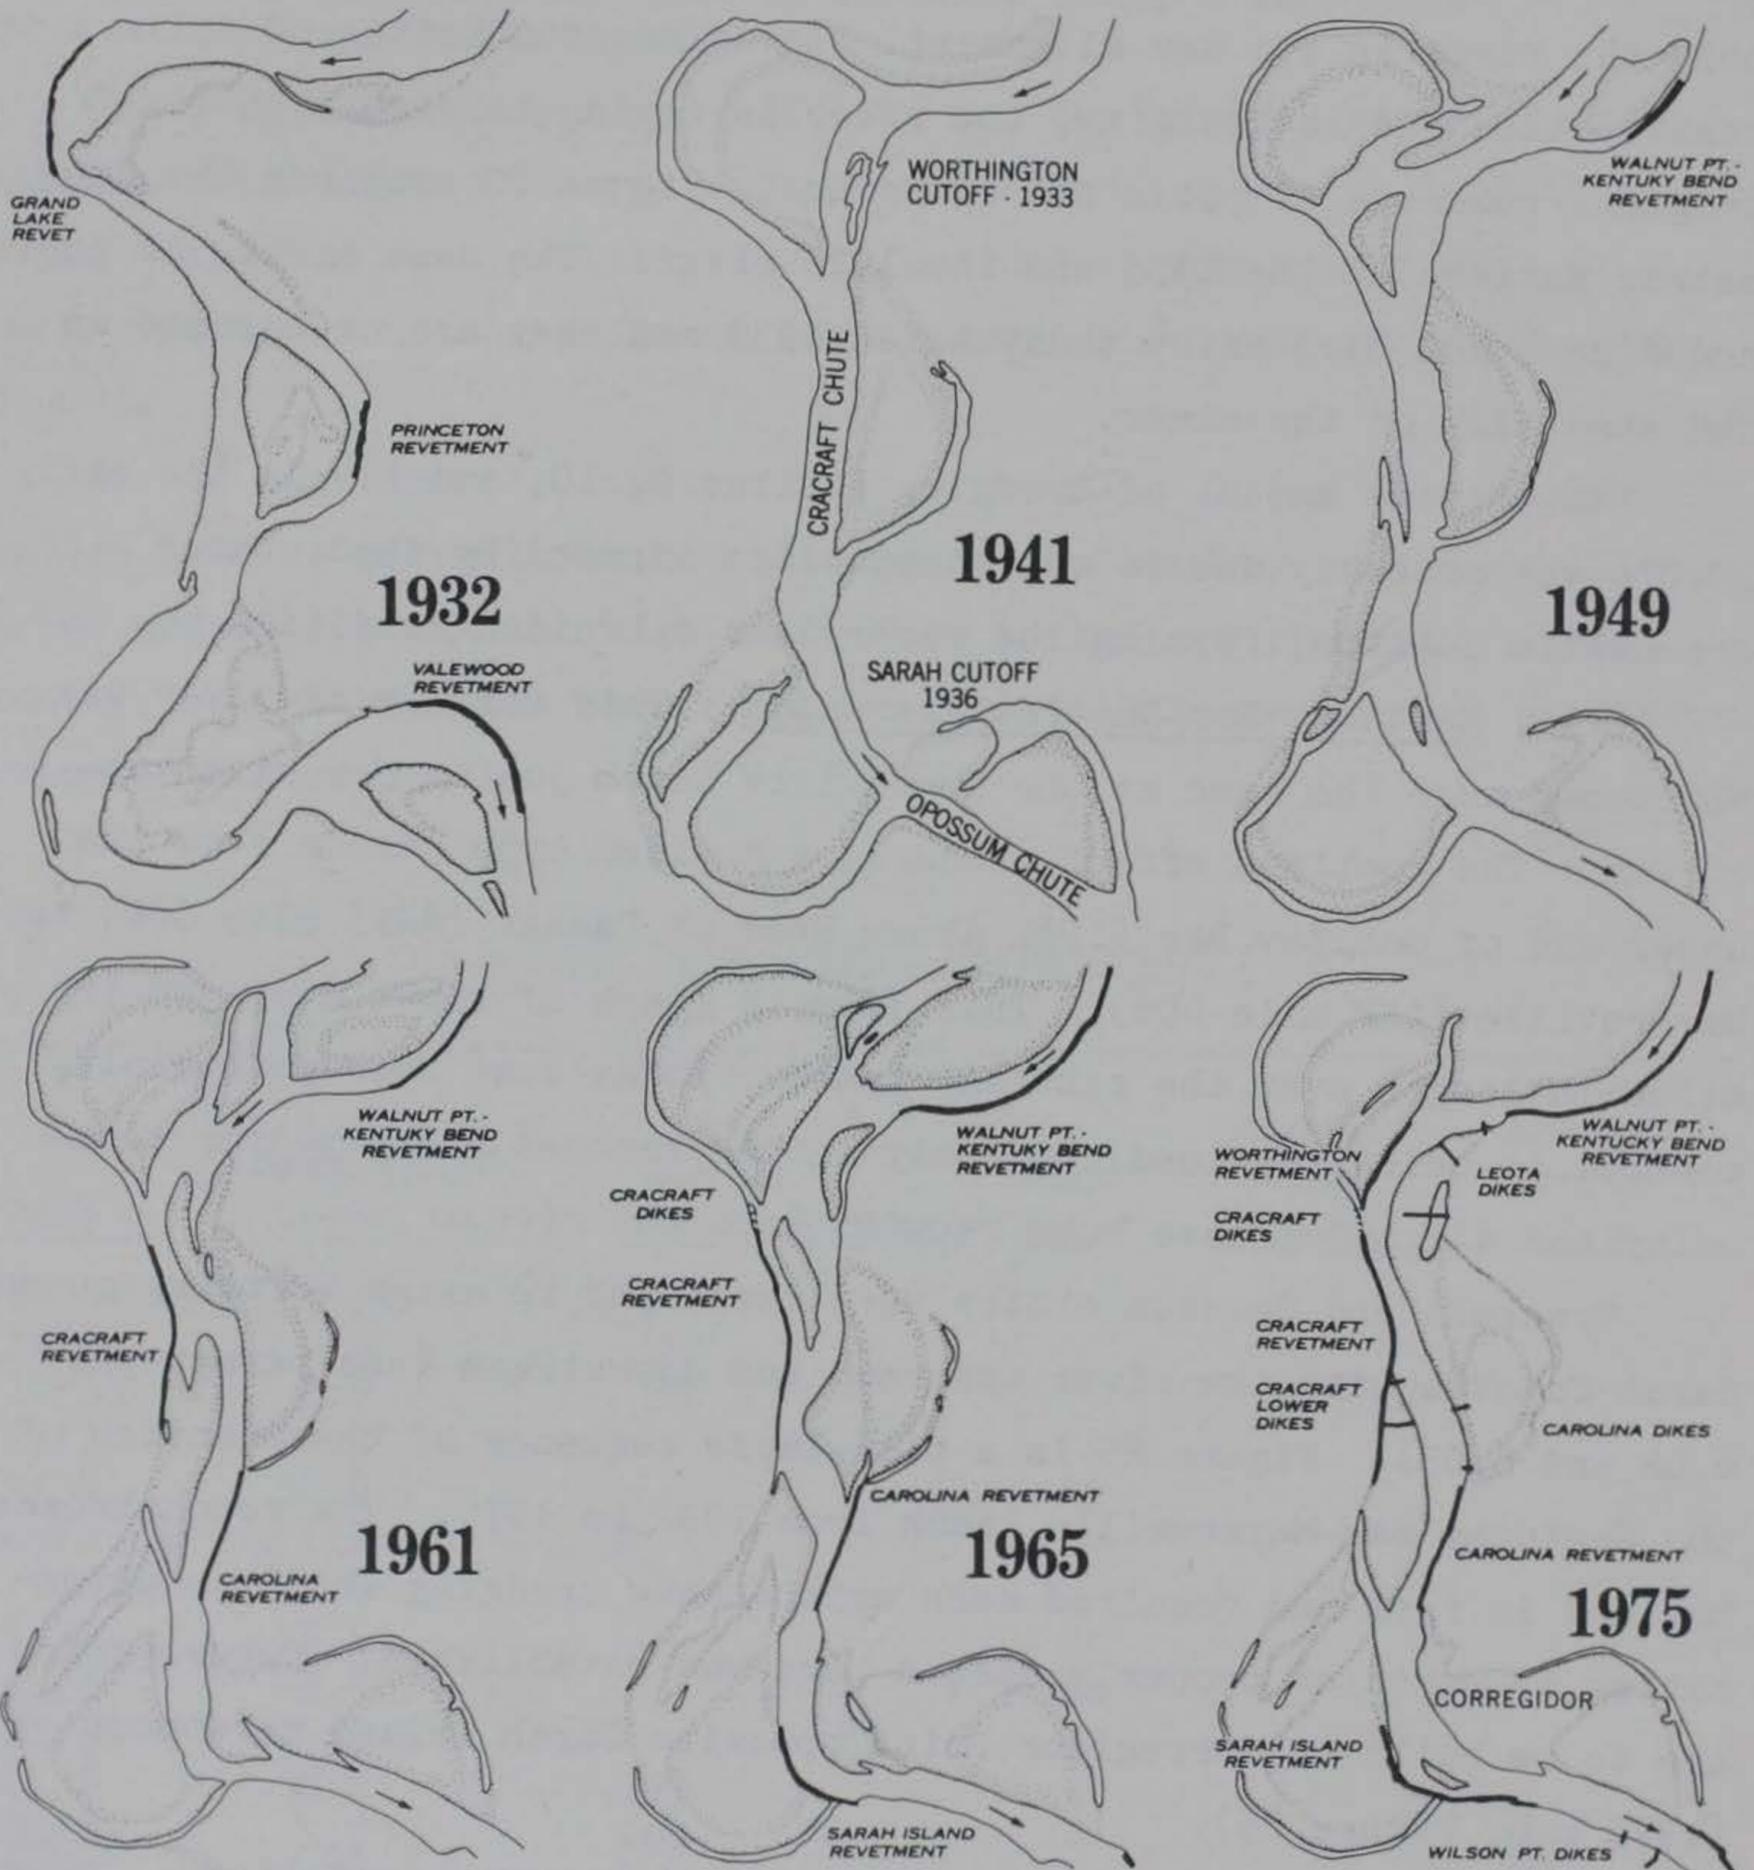
Figure 25

1932-1975 DEVELOPMENT OF THE KENTUCKY BAR - MAYERSVILLE REACH

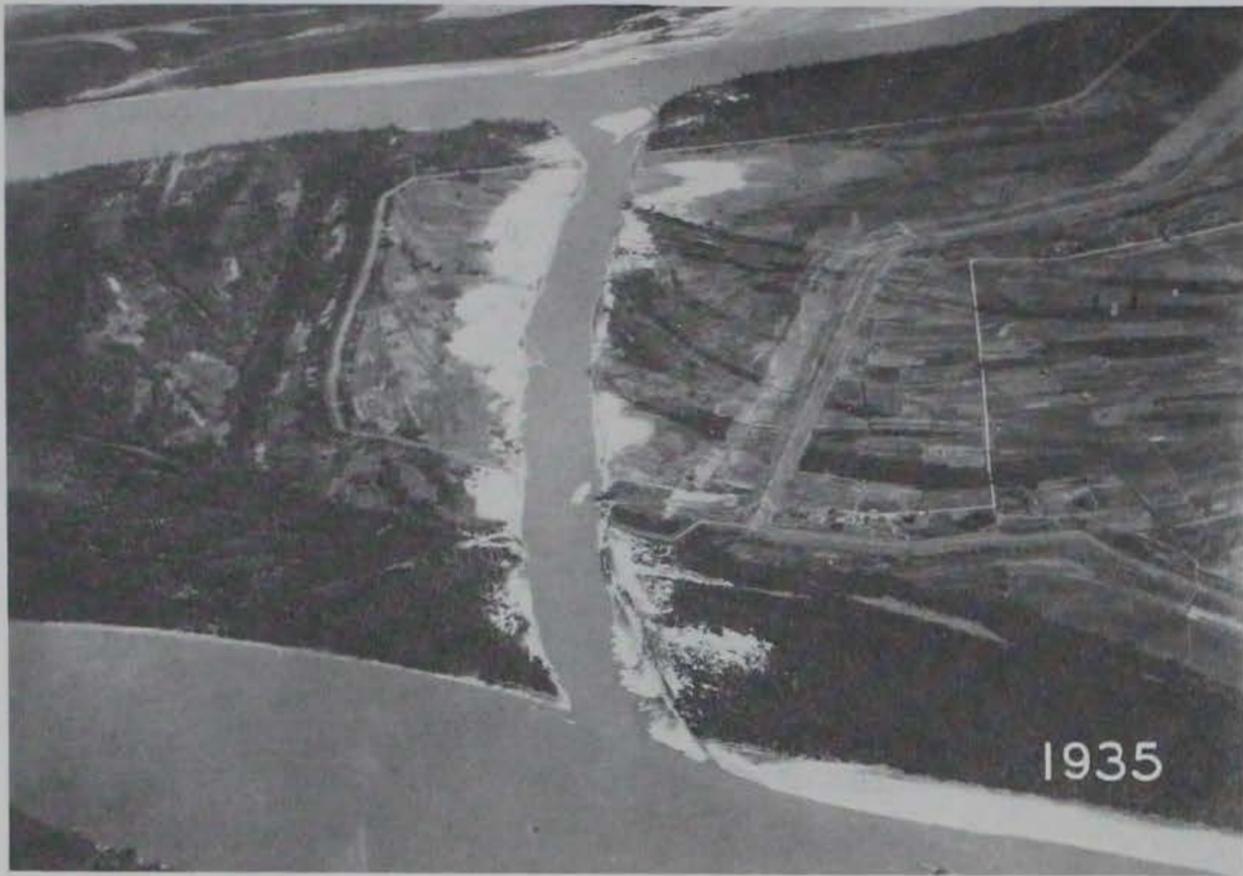
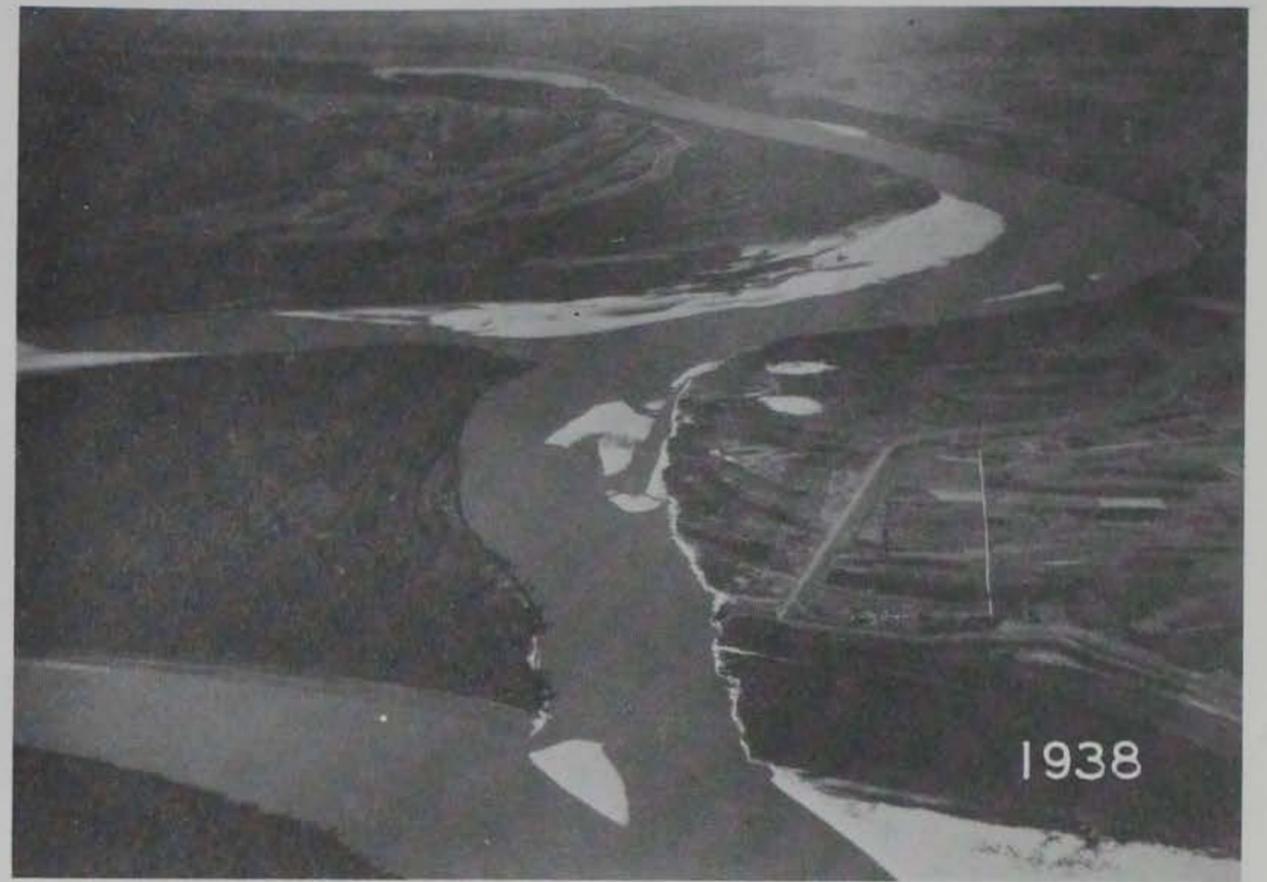
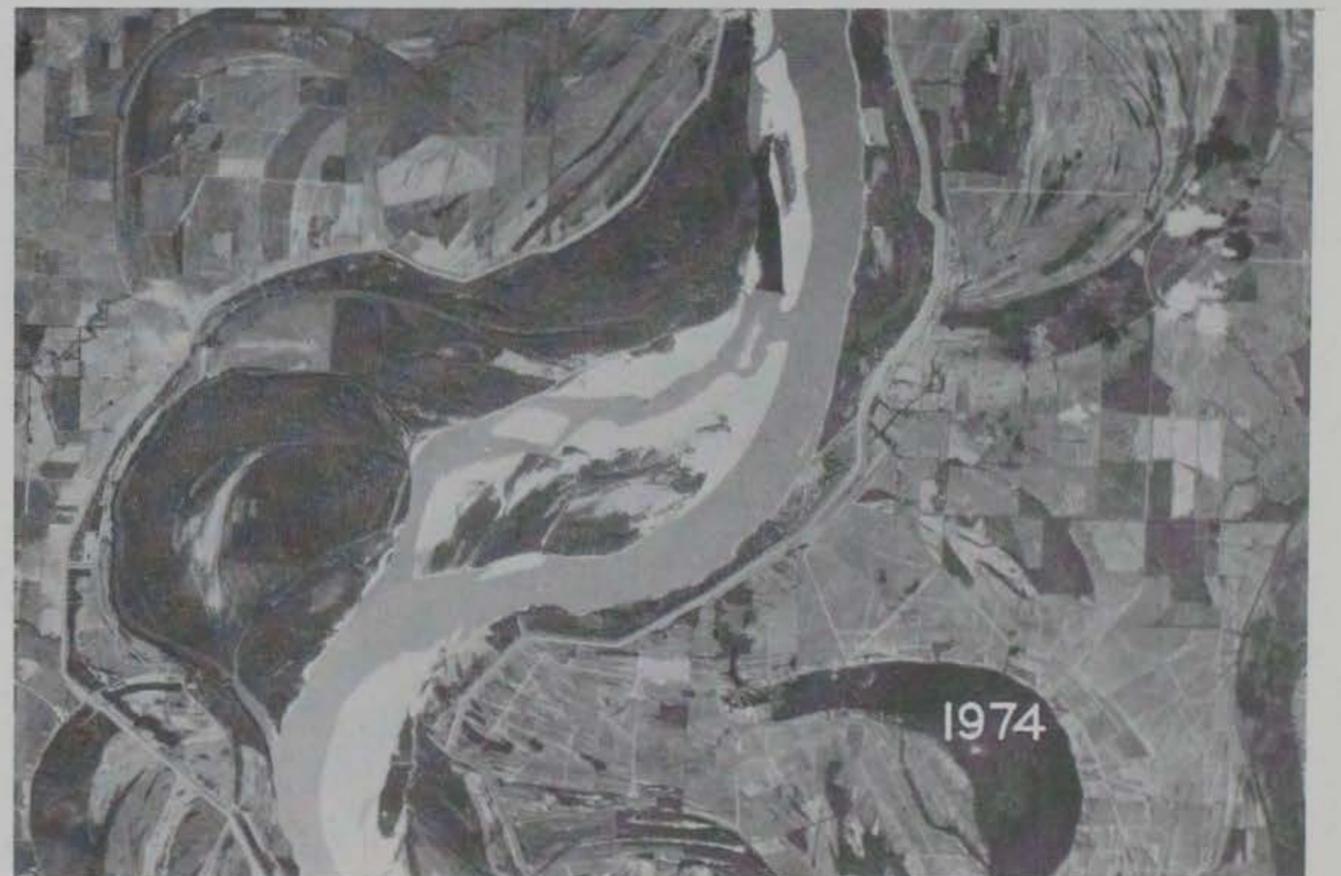
AERIAL VIEWS OF WORTHINGTON POINT CUTOFF

Worthington and Sarah Cutoffs (Figure 25) were only two elements in the plan to "improve" this reach of river. Development of Cracraft and Opossum Chutes (see paragraphs 6.02 and 6.03) completed the realignment. The past history of this reach is at variance with the imposed conditions. The result has been a reach that required much maintenance dredging until recent dike construction. Figure 26 shows the river length over the past 700 years; it should be noted that today's river is less than half the length of the natural river. Figures 27 and 29 are of the historic river development and Figures 28 and 30 of the 1975 river in the upper and lower section of this reach, respectively. Figures 31 and 32 are 1935 to 1974 aerial photographs of this reach.

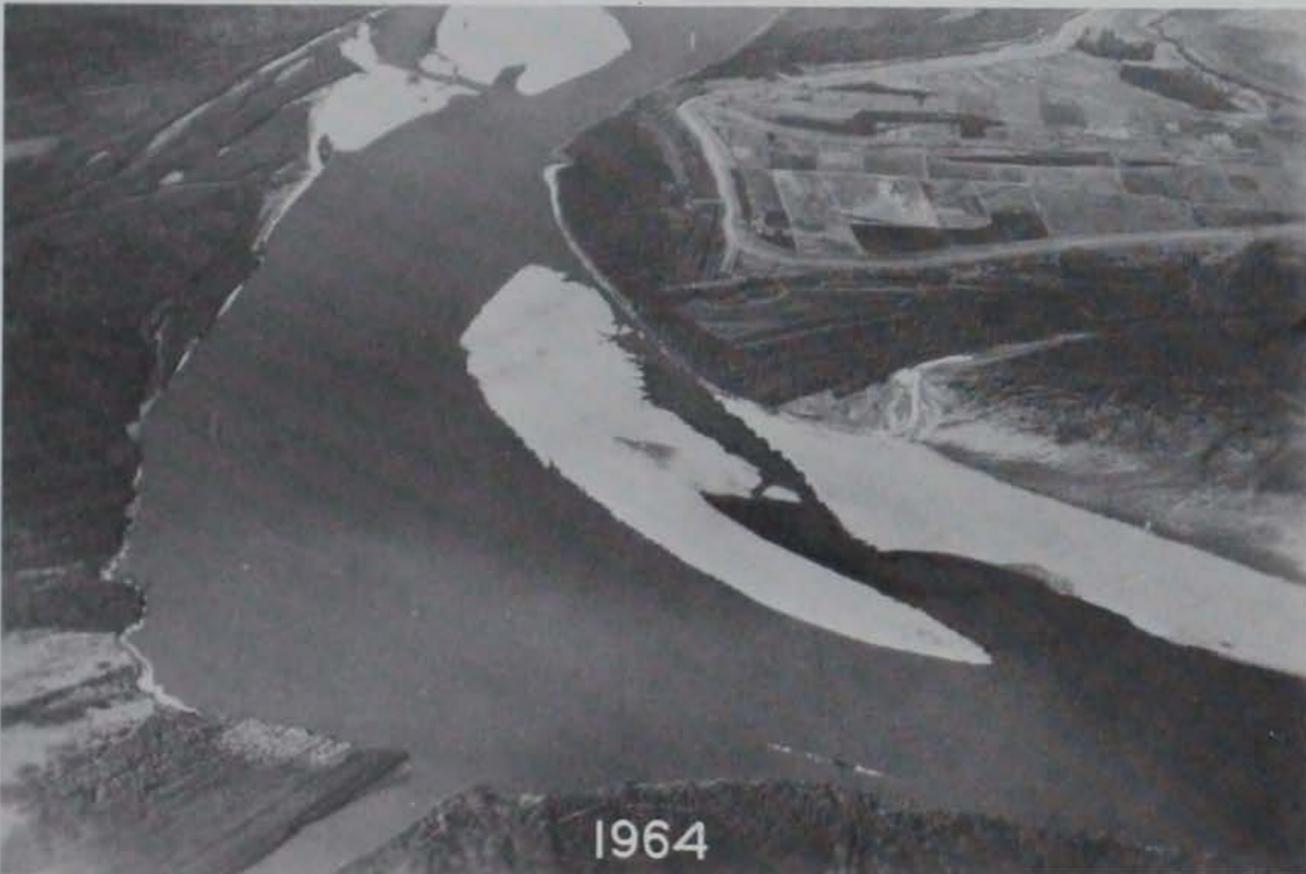
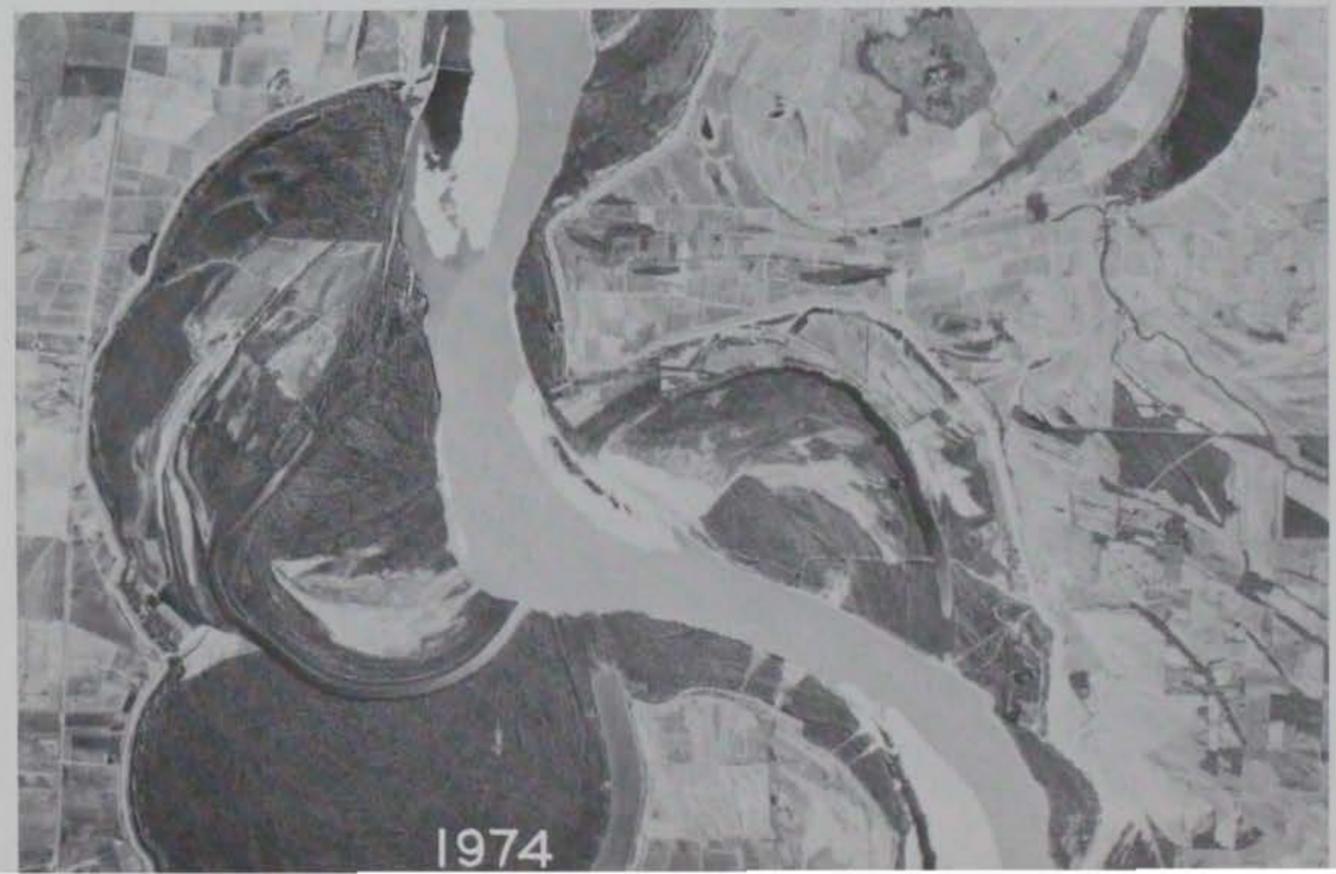
AERIAL VIEWS OF SARAH ISLAND CUTOFF

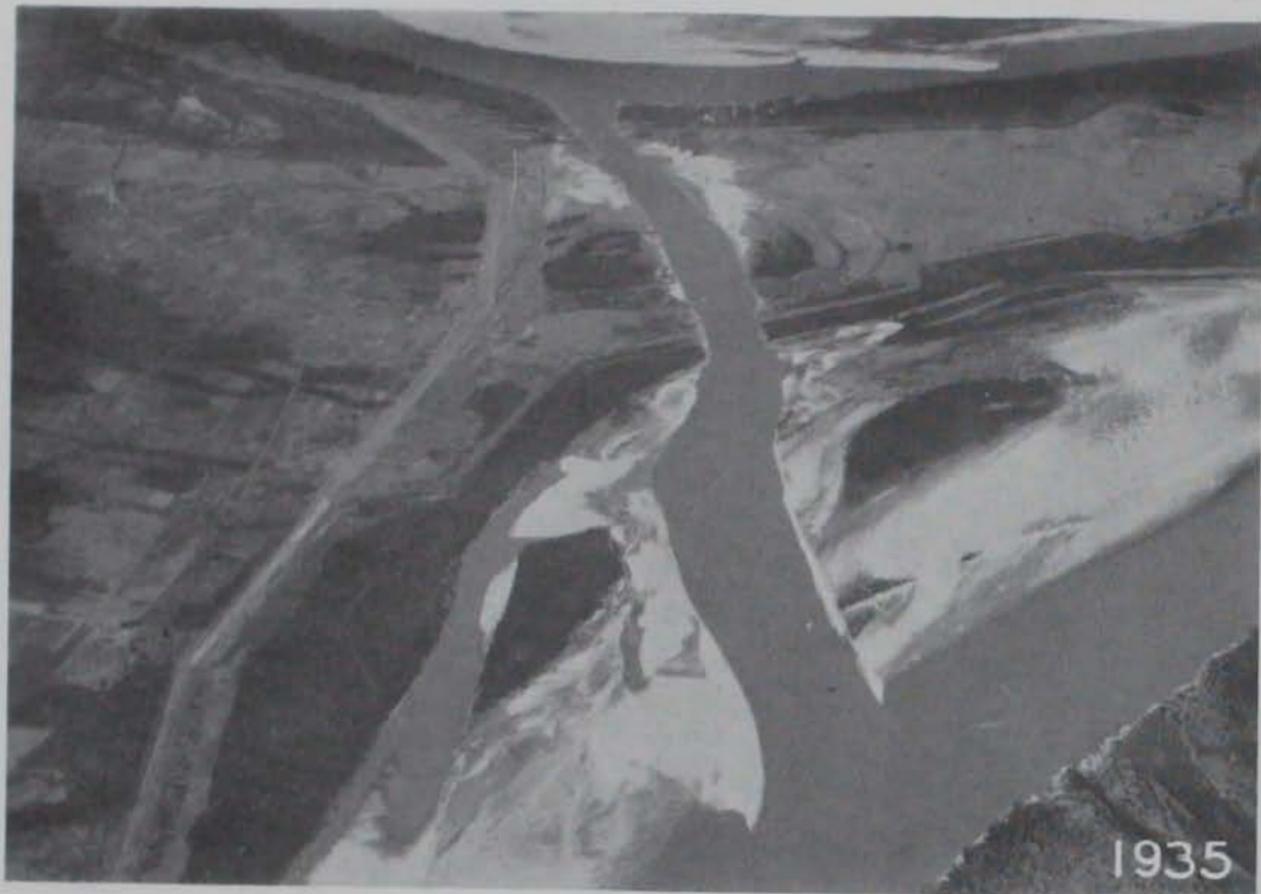
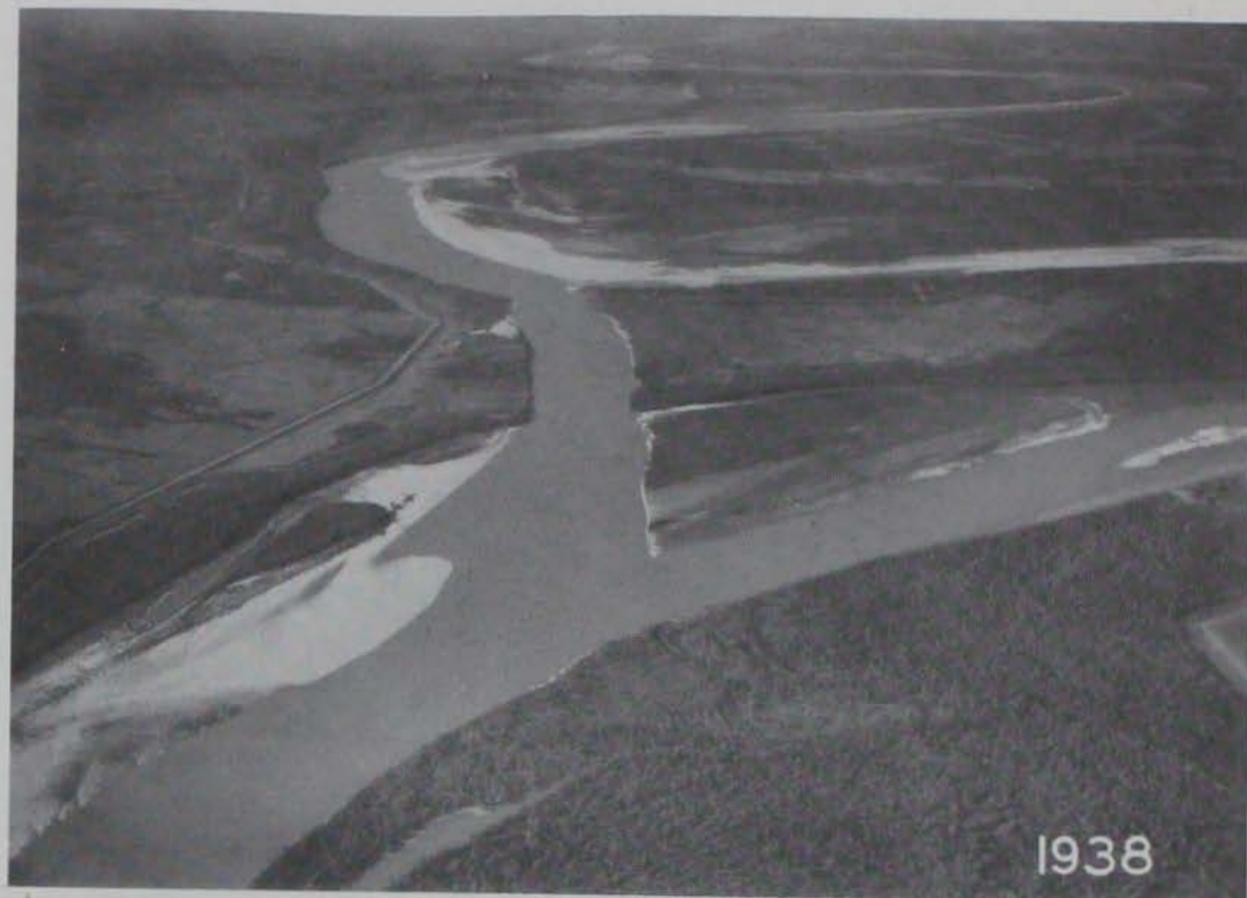
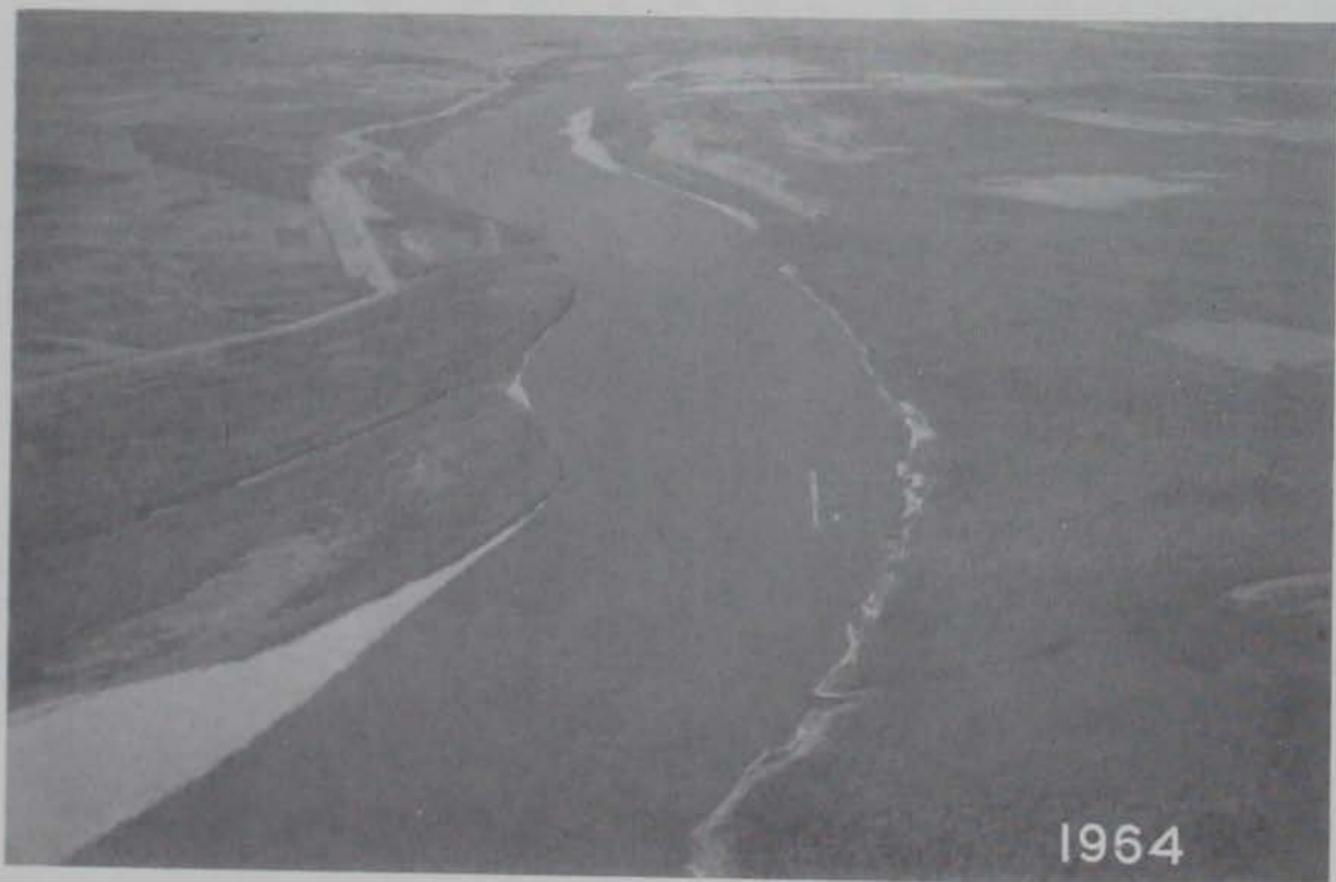
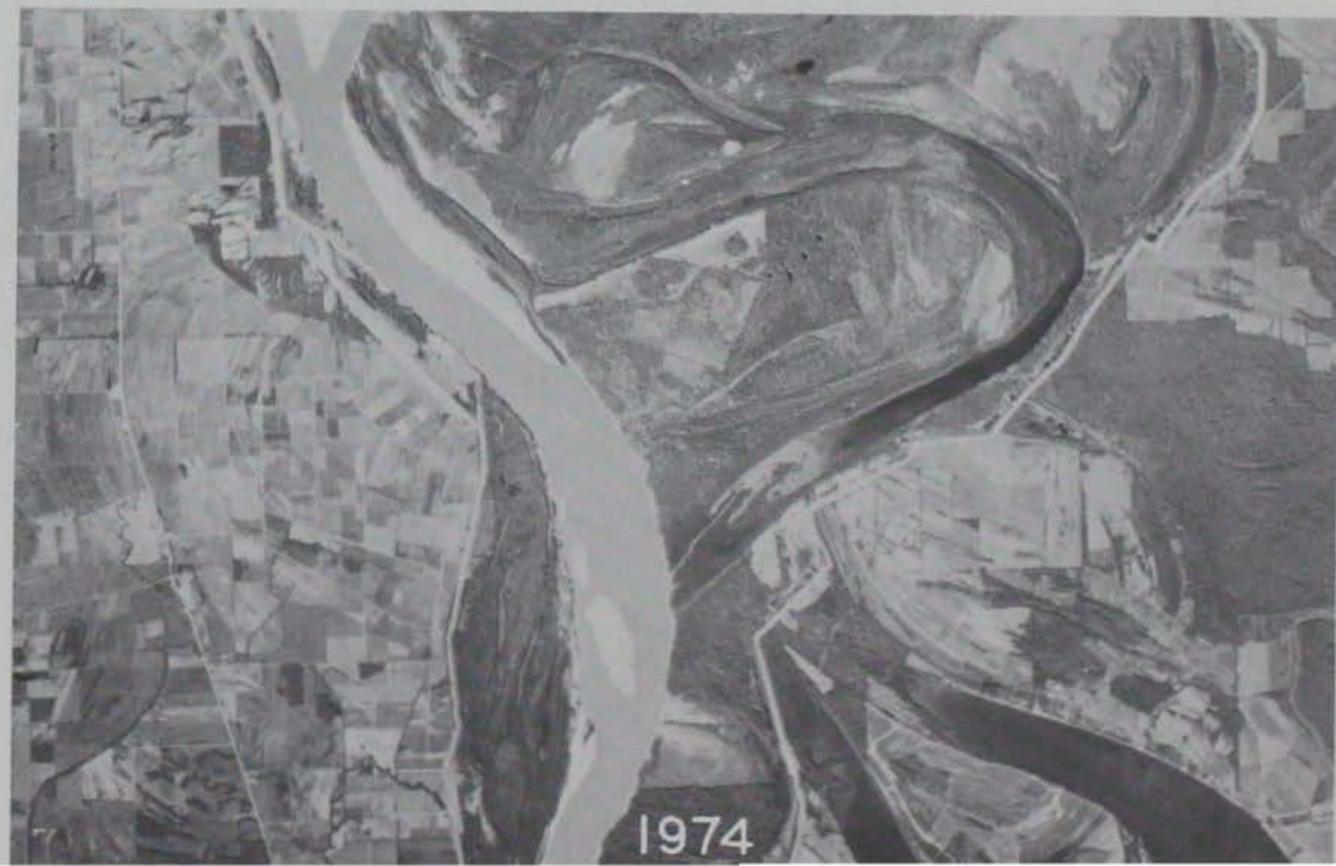
AERIAL VIEWS OF WILLOW POINT CUTOFF

formed on the downstream side of the neck. The plan of operation was to use land machines for the excavation of a pilot ditch across the high main bank and then to allow the flow through the cutoff to find its own channel through the sandbar. Operations with the land machines were commenced in the latter part of November 1933. They progressed to January 1934, at which time the pilot channel through the main section of the neck was completed. Shortly after that time, the river stage rose sufficiently for flow to pass through the pilot channel, but very little development occurred. The retarding factor was determined to be the presence of a heavy formation of very stiff clay close to the upstream end of the cut. It was immediately obvious that dredging would be necessary to open a channel through this clay deposit. Accordingly, the cutterhead dredges were assigned the task of making the cut through the clay. The dustpan dredge Jadwin and the cutterhead dredges Catt, Lake Fithian, and Barnard worked on this cut upon different occasions during the remainder of 1934 [Table 14]. The Lake Fithian and Catt also made cuts in the pilot

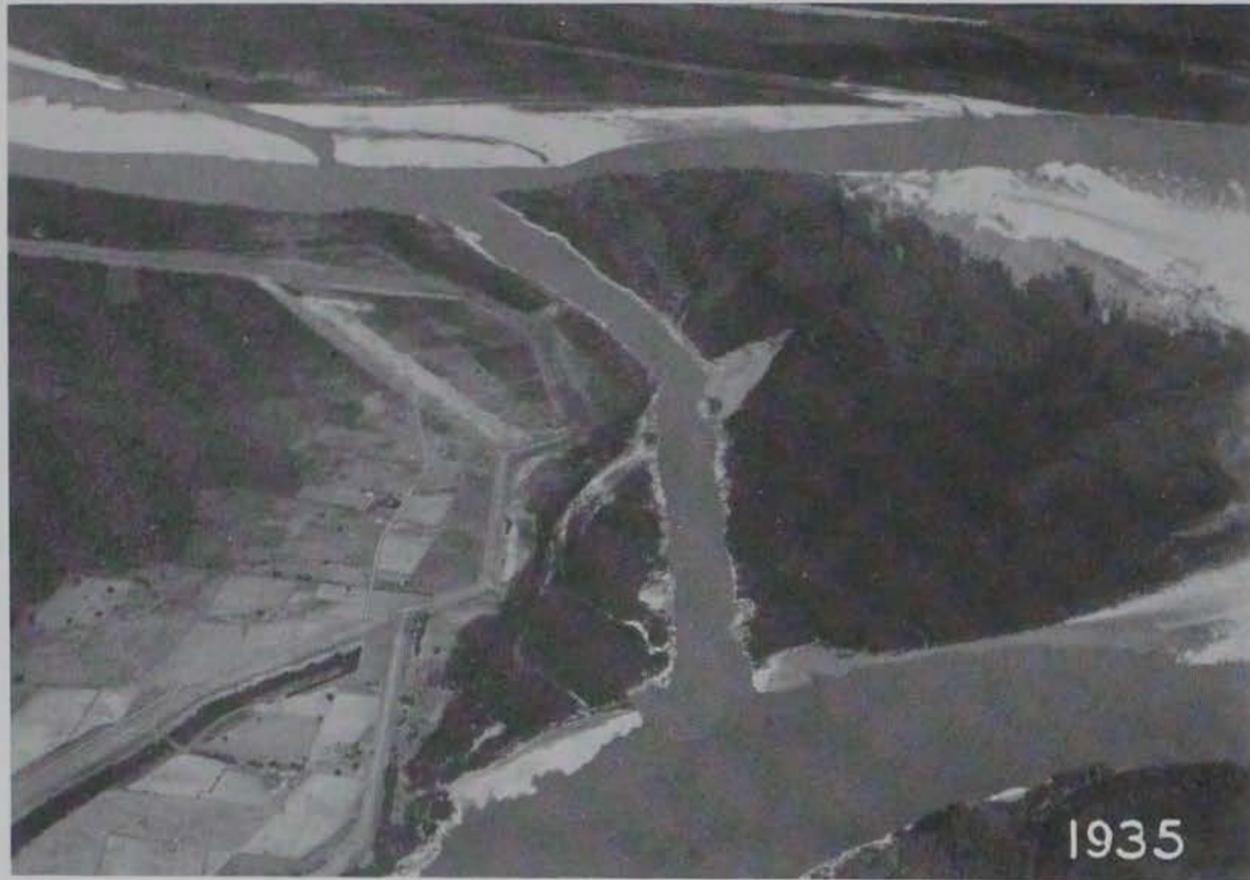
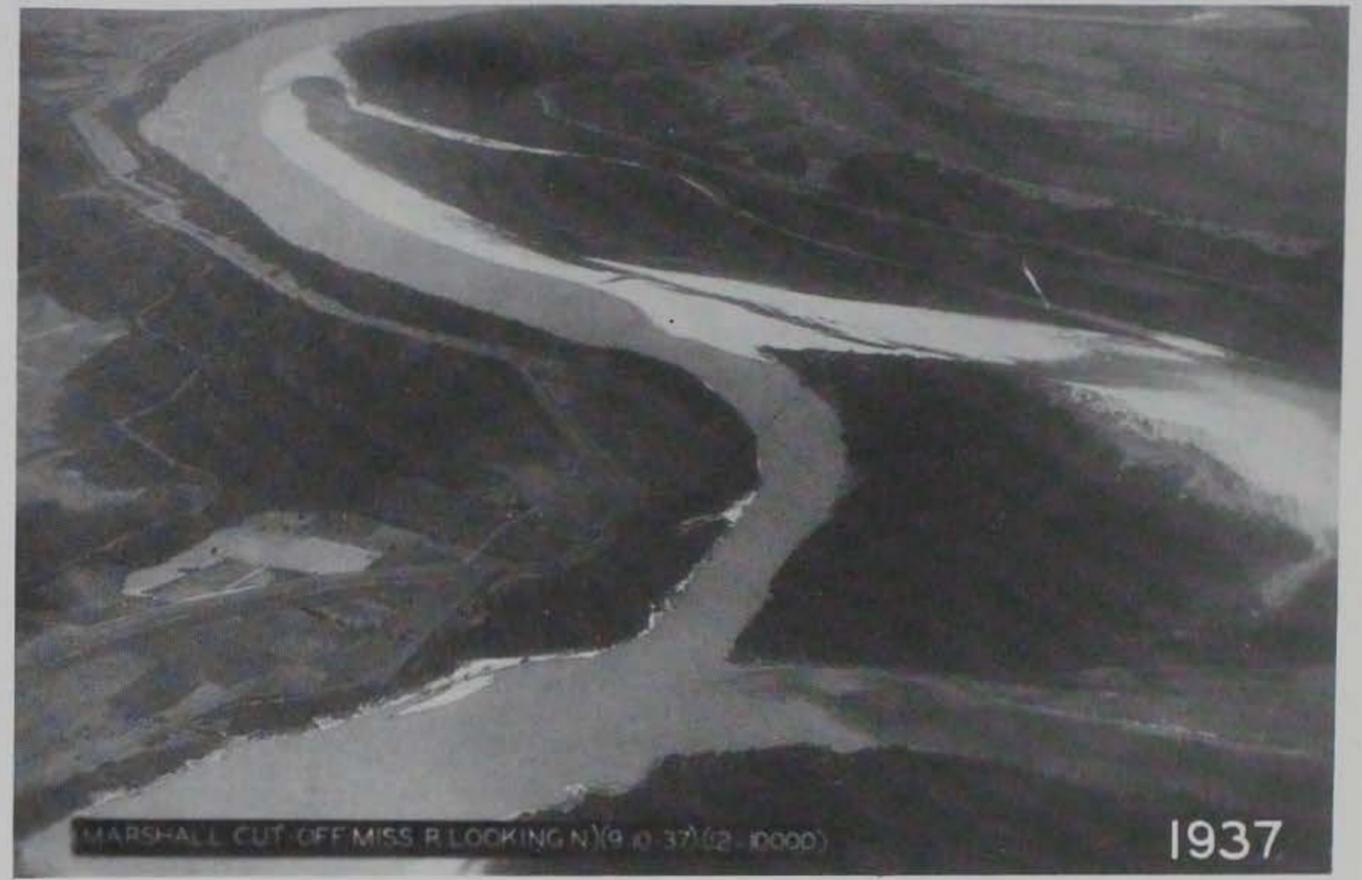
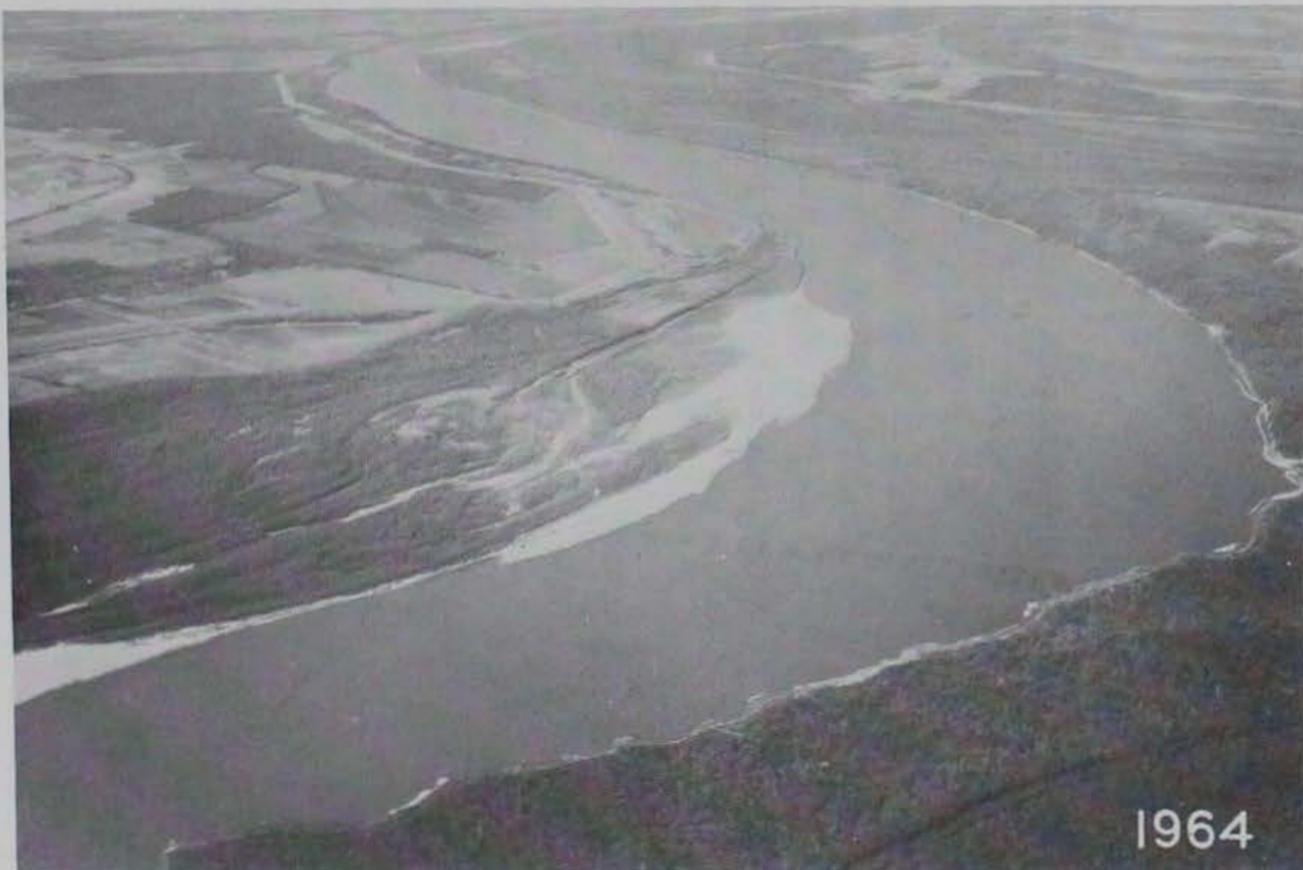
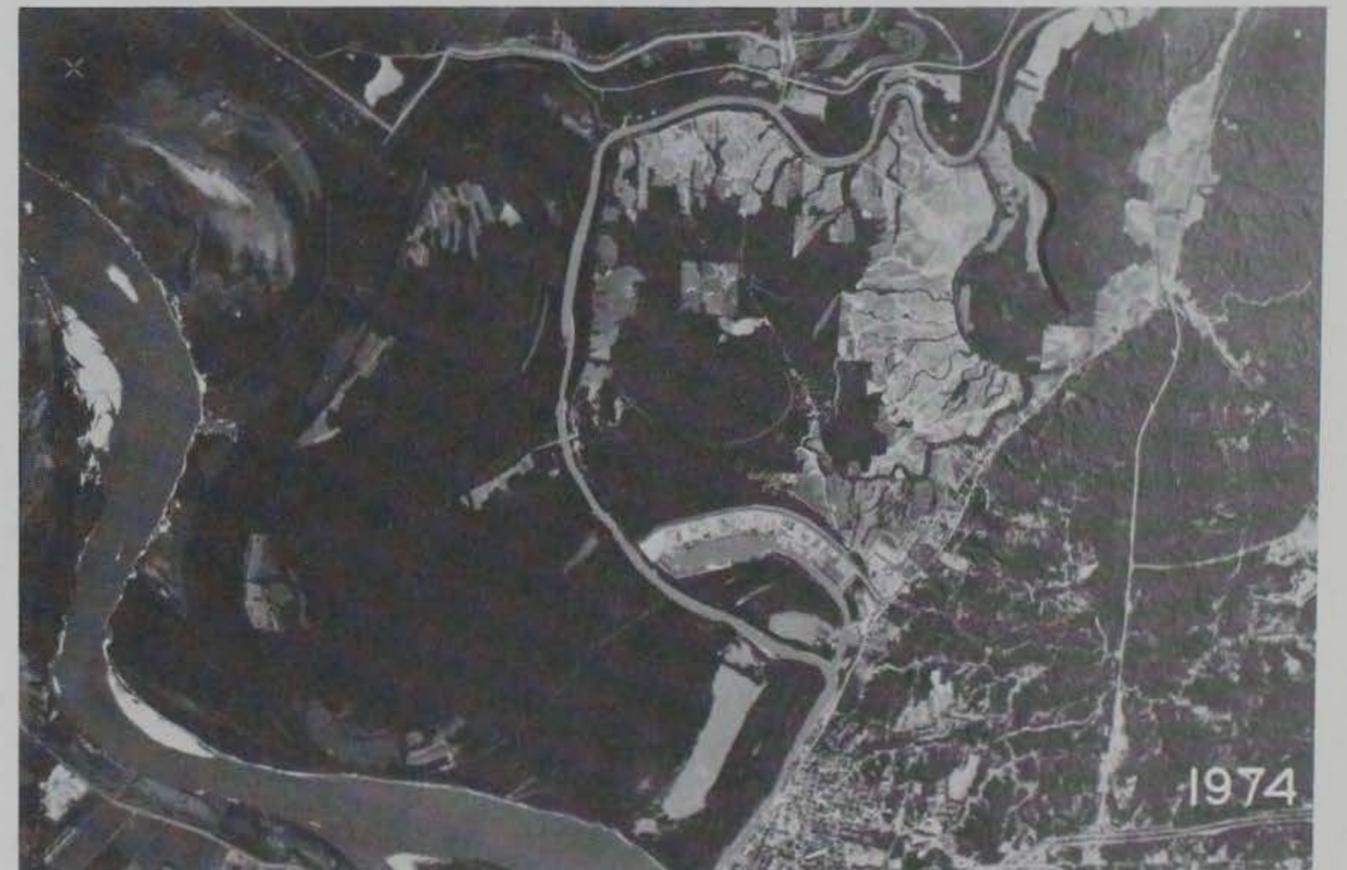
From the lower end of Cottonwood Bar above Willow Point Cutoff to the old mouth of the Yazoo River below Marshall Cutoff is about 26 miles today, but over the past 300 years<sup>1</sup> this reach averaged 56 miles. There were several natural length adjustments prior to man's attempts to control the river, thus a steeper than normal gradient. Figure 36 is a set

AERIAL VIEWS OF MARSHALL POINT CUTOFF

of aerial photographs showing the cutoff from 1935 to 1974.
