POTAMOLOGY INVESTIGATIONS

Report 300-2

**MAN-MADE CUTOFFS ON THE LOWER MISSISSIPPI  
RIVER, CONCEPTION, CONSTRUCTION,  
AND RIVER RESPONSE**

U. S. ARMY ENGINEER DISTRICT, VICKSBURG

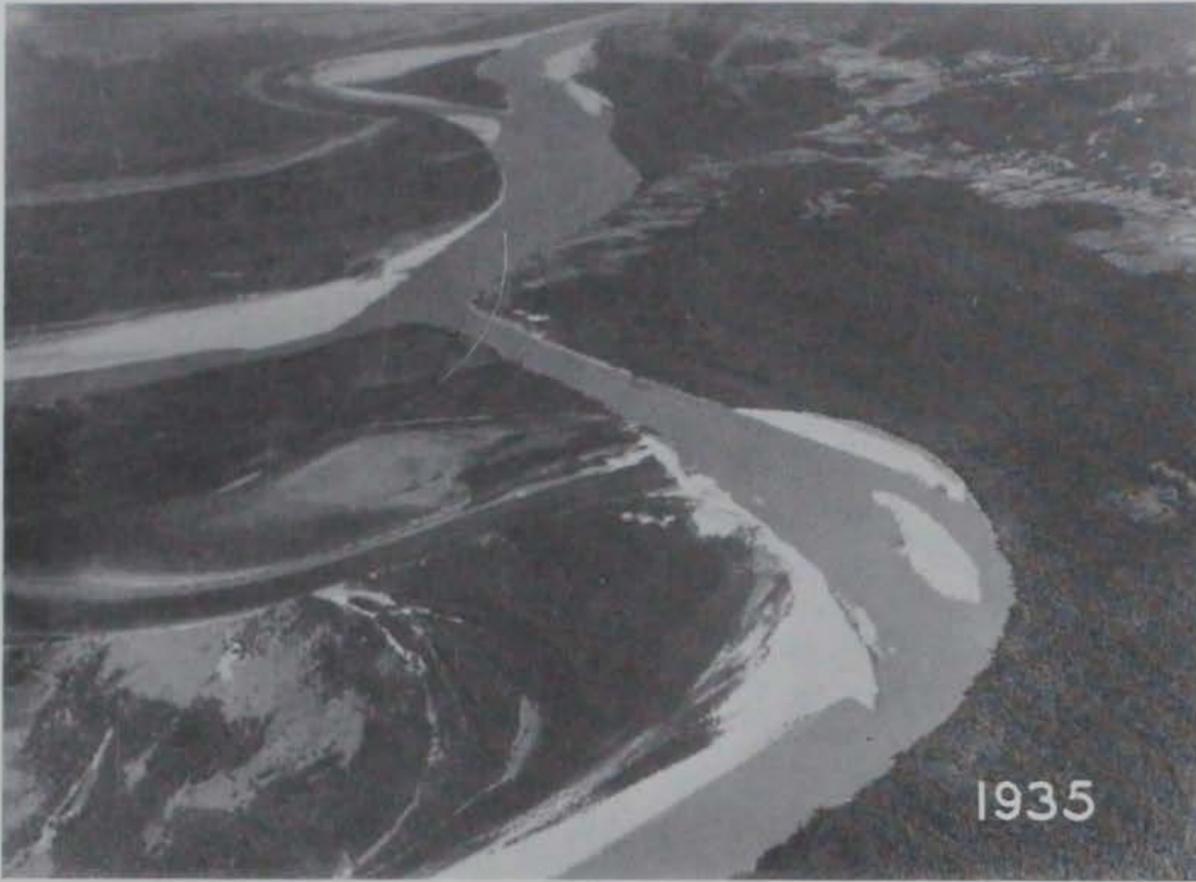
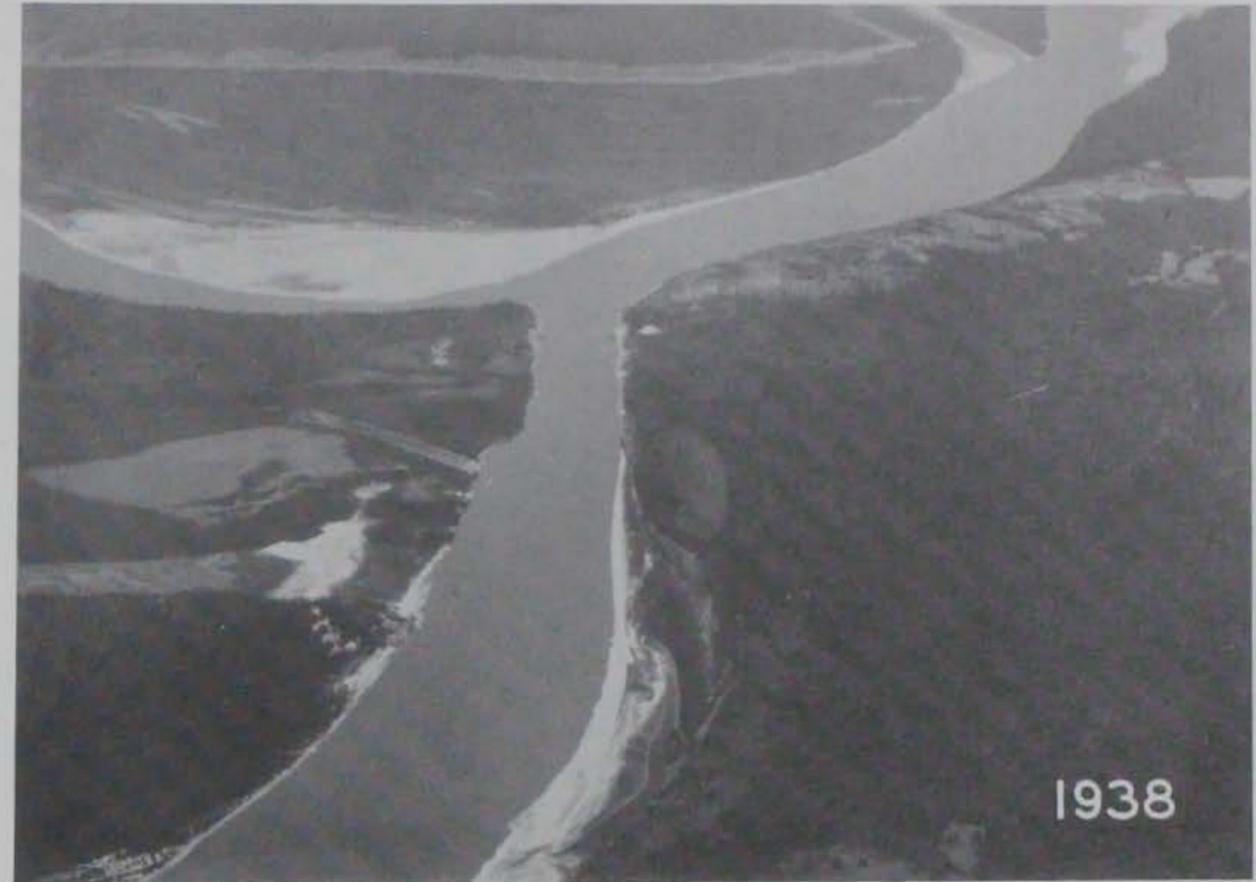
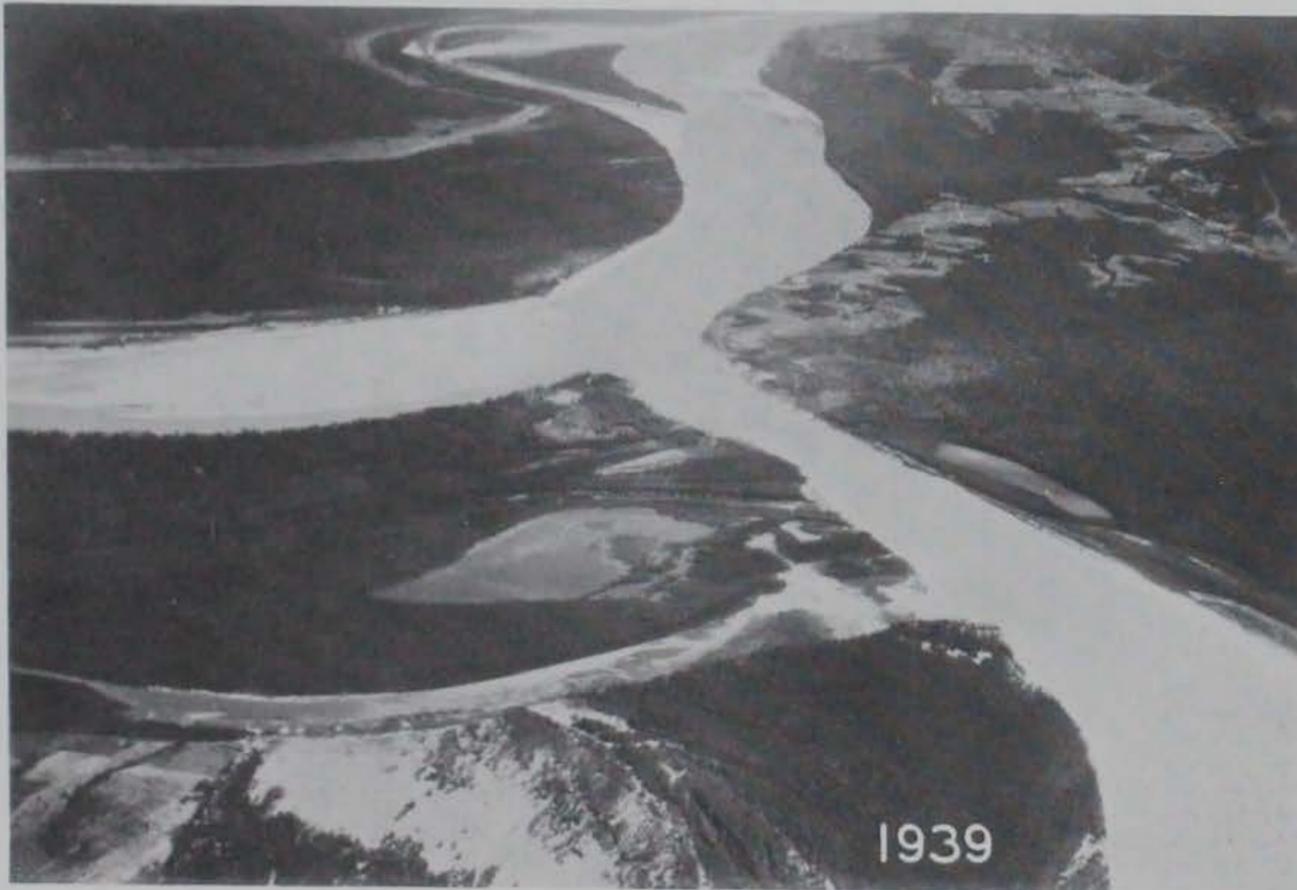
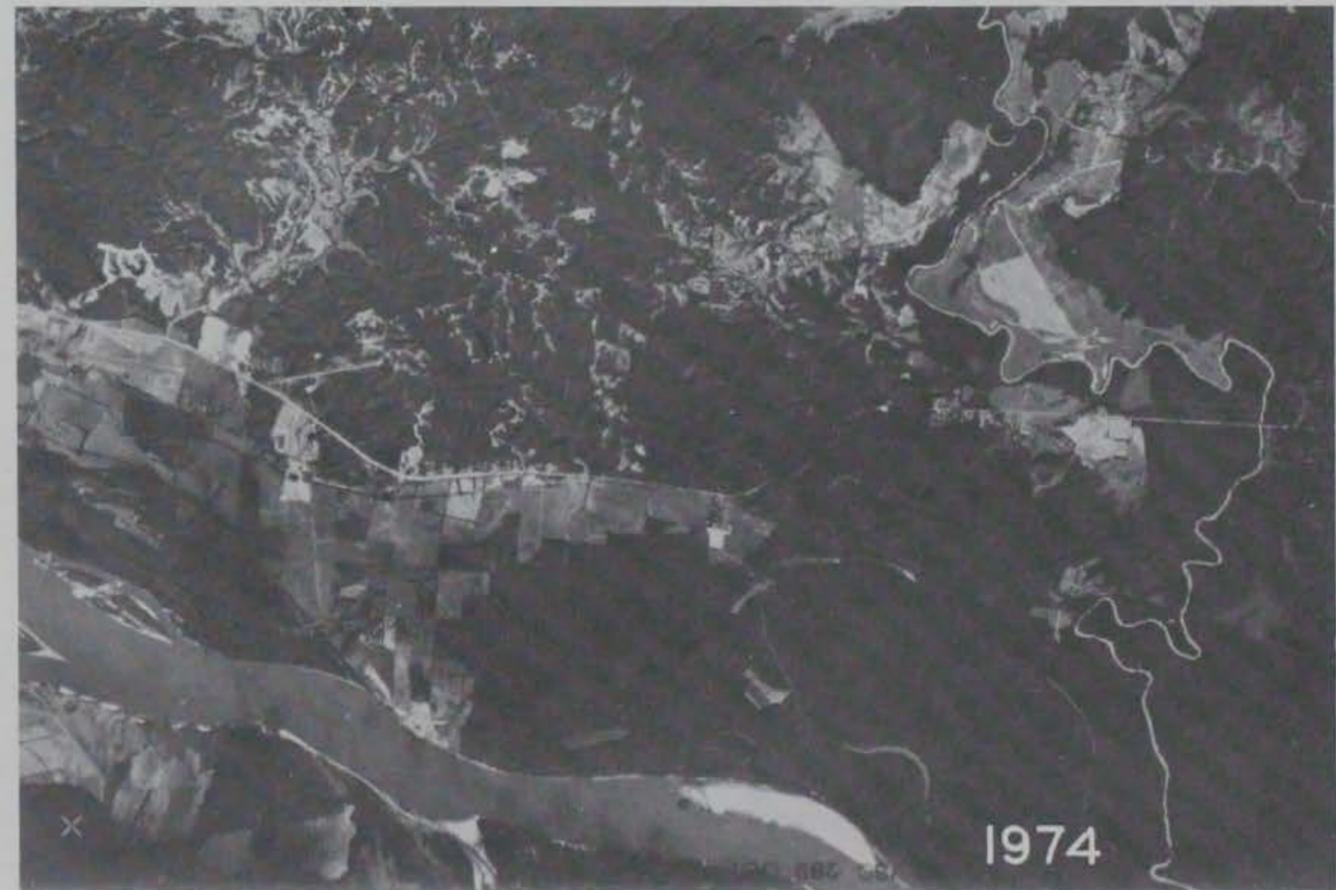
Figure 37 is a set of aerial photographs of the development of this reach for 1937 to 1974. Figures 38 and 39, respectively, show the historic development and the 1975 river in this reach as well as the Yucatan Cutoff Reach.

AERIAL VIEWS OF DIAMOND POINT CUTOFF

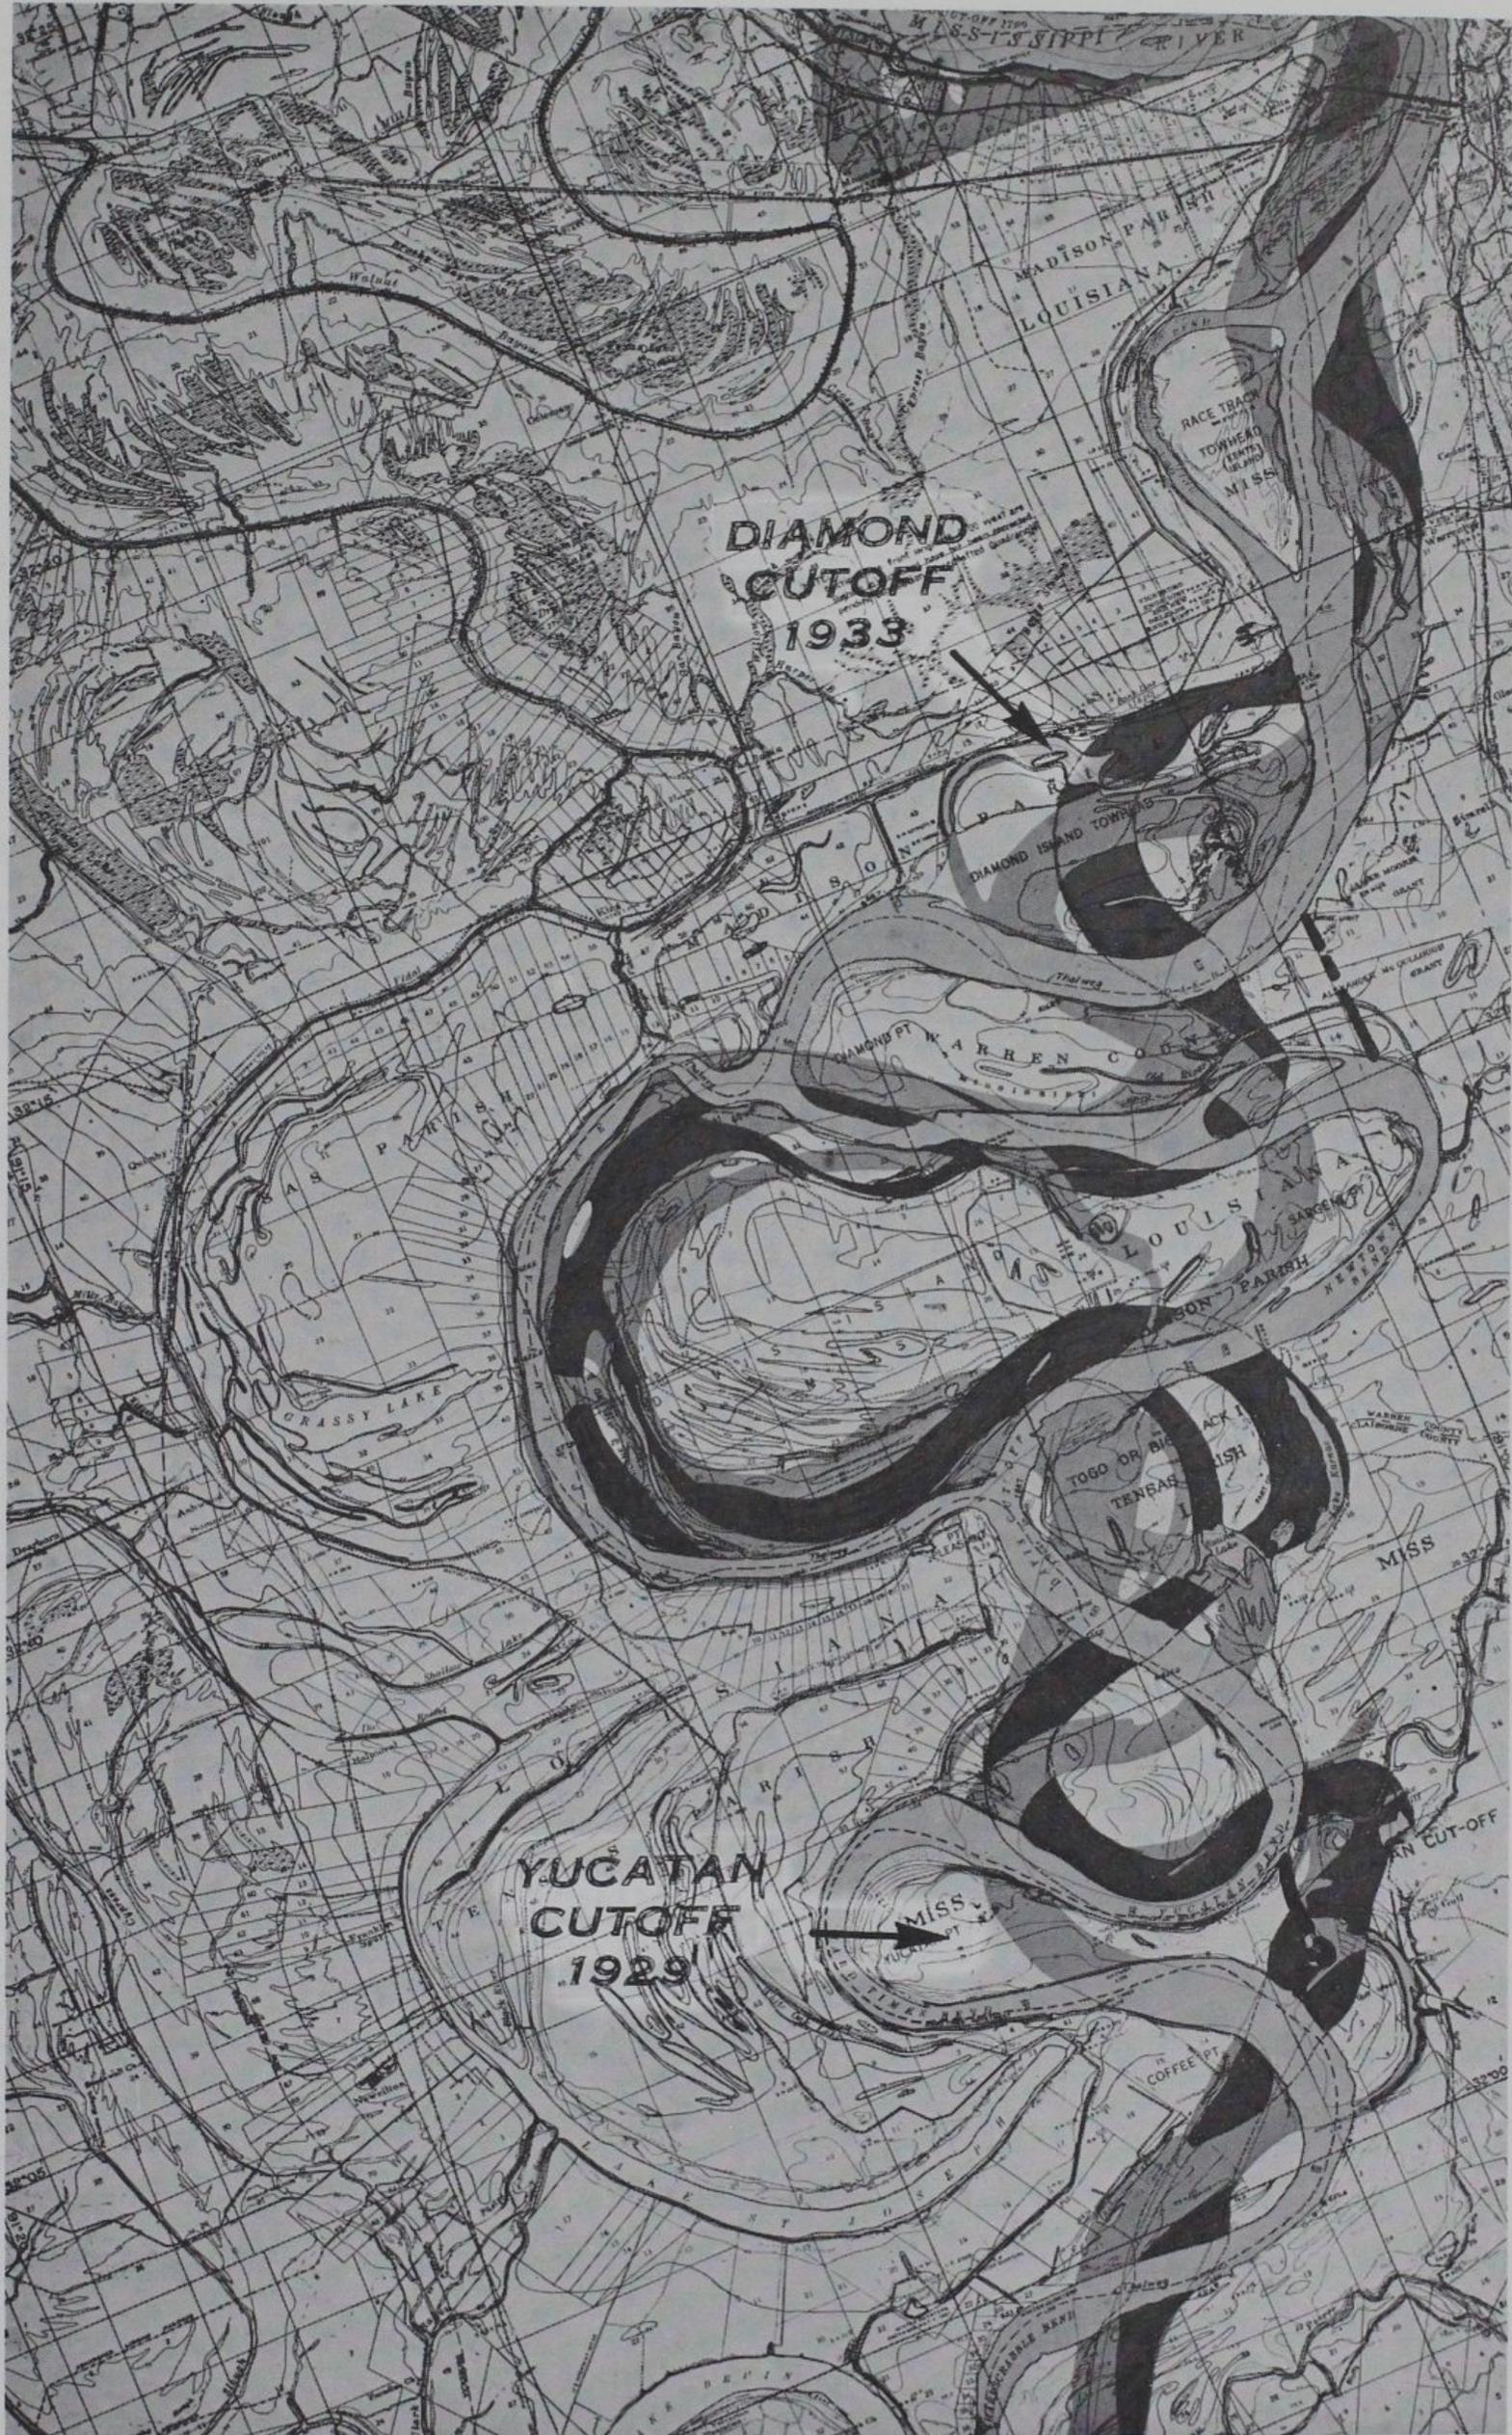
HISTORIC DEVELOPMENT OF THE DIAMOND POINT AND YUCATAN REACHES

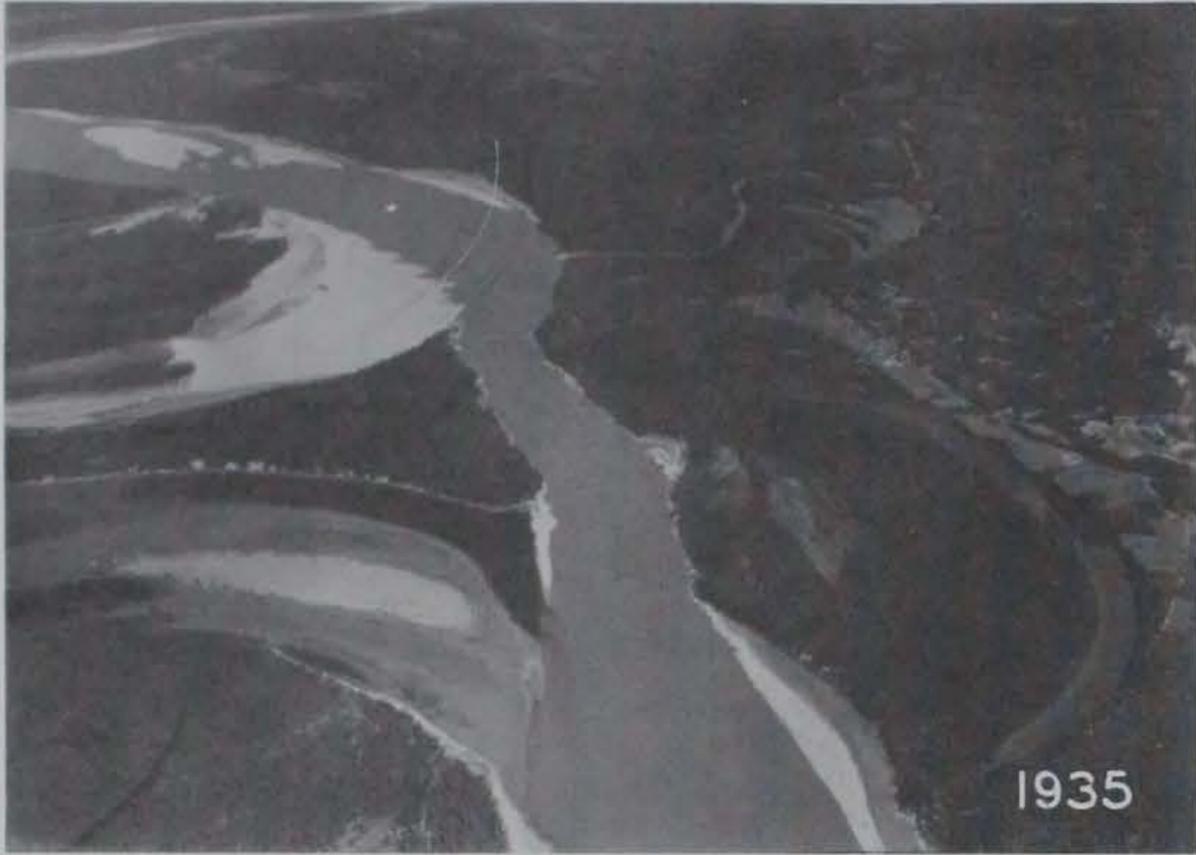
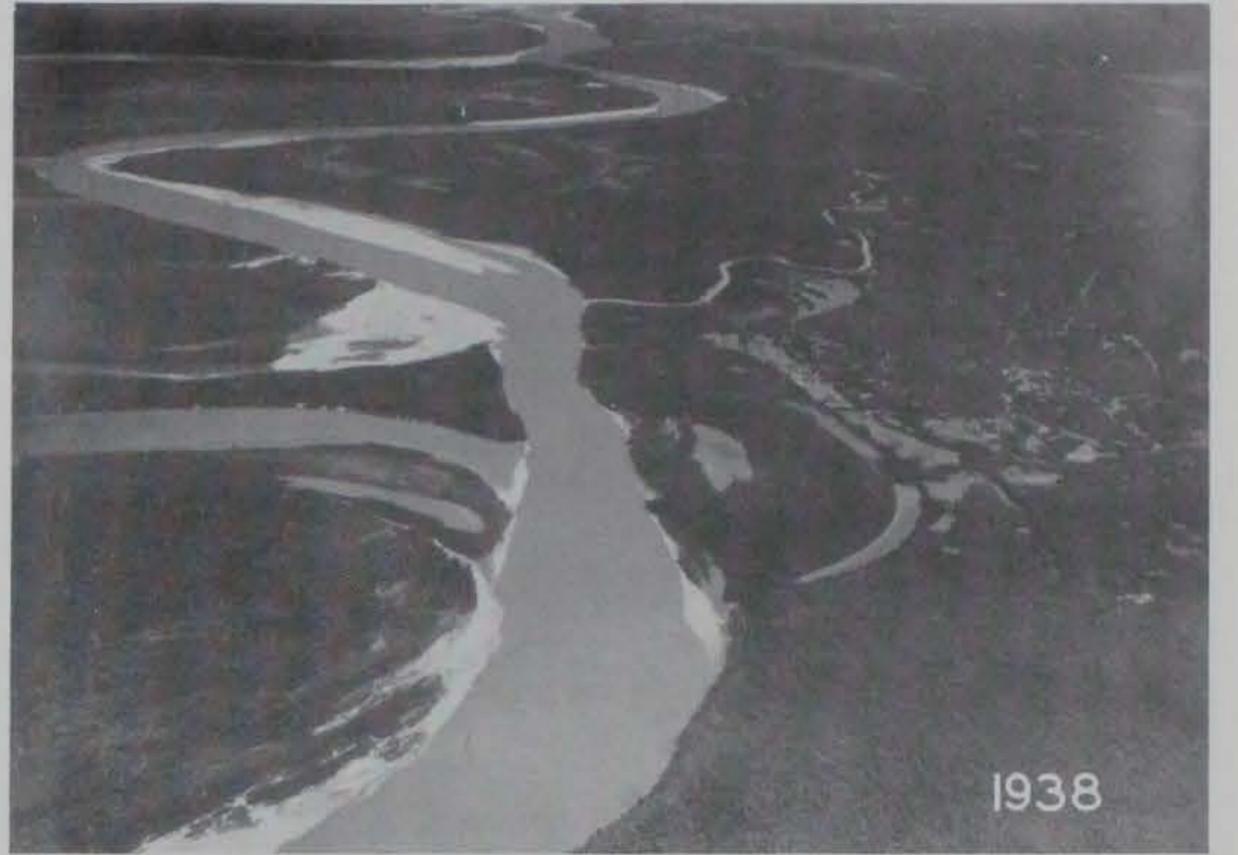
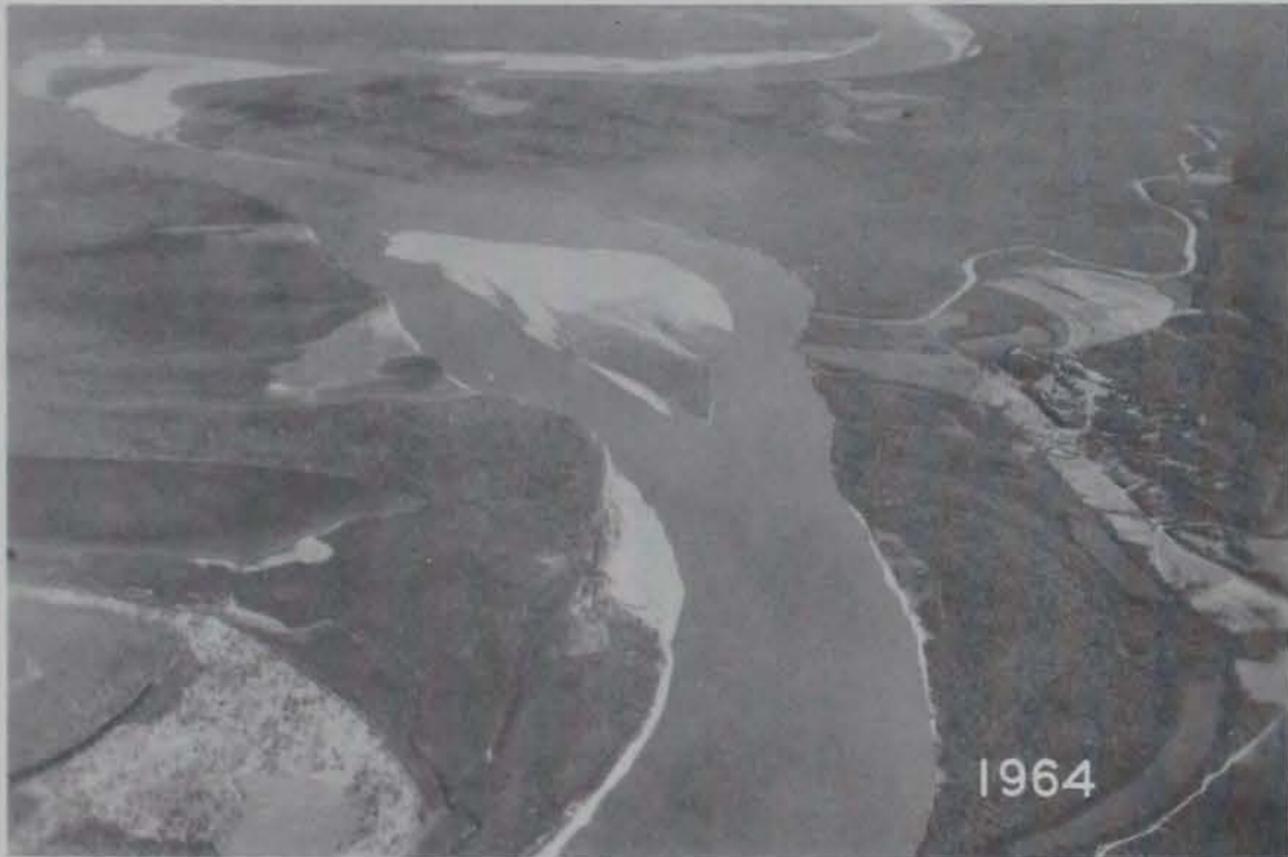
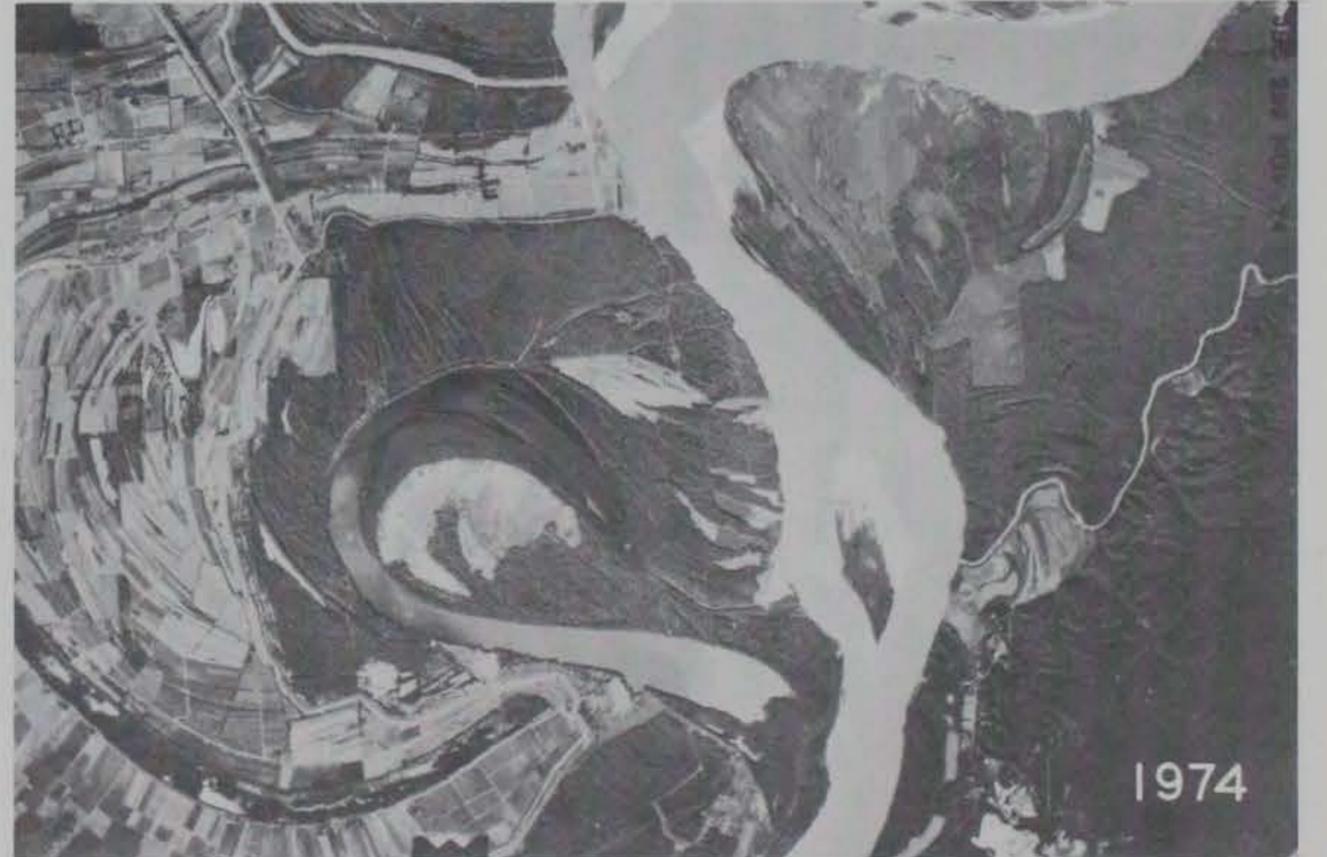
AERIAL VIEWS OF YUCATAN CUTOFF

This cut developed rapidly the first two years, probably because of the readily erodible foundation material and the magnitude and duration of the 1937 flood (Table 18). However, this same easily erodible material allowed the river to develop middle bars with associated navigation problems. Several more years of excessive dredging were necessary in order to maintain navigation through the cut. The alluvium in this reach tends to be very sandy with an unusual amount of coarse sand and gravel, possibly a result of the river migrating along the hill line during the past several hundred years (Figure 41). This section could have swept the coarse sediments from the alluvial fan adjacent to the

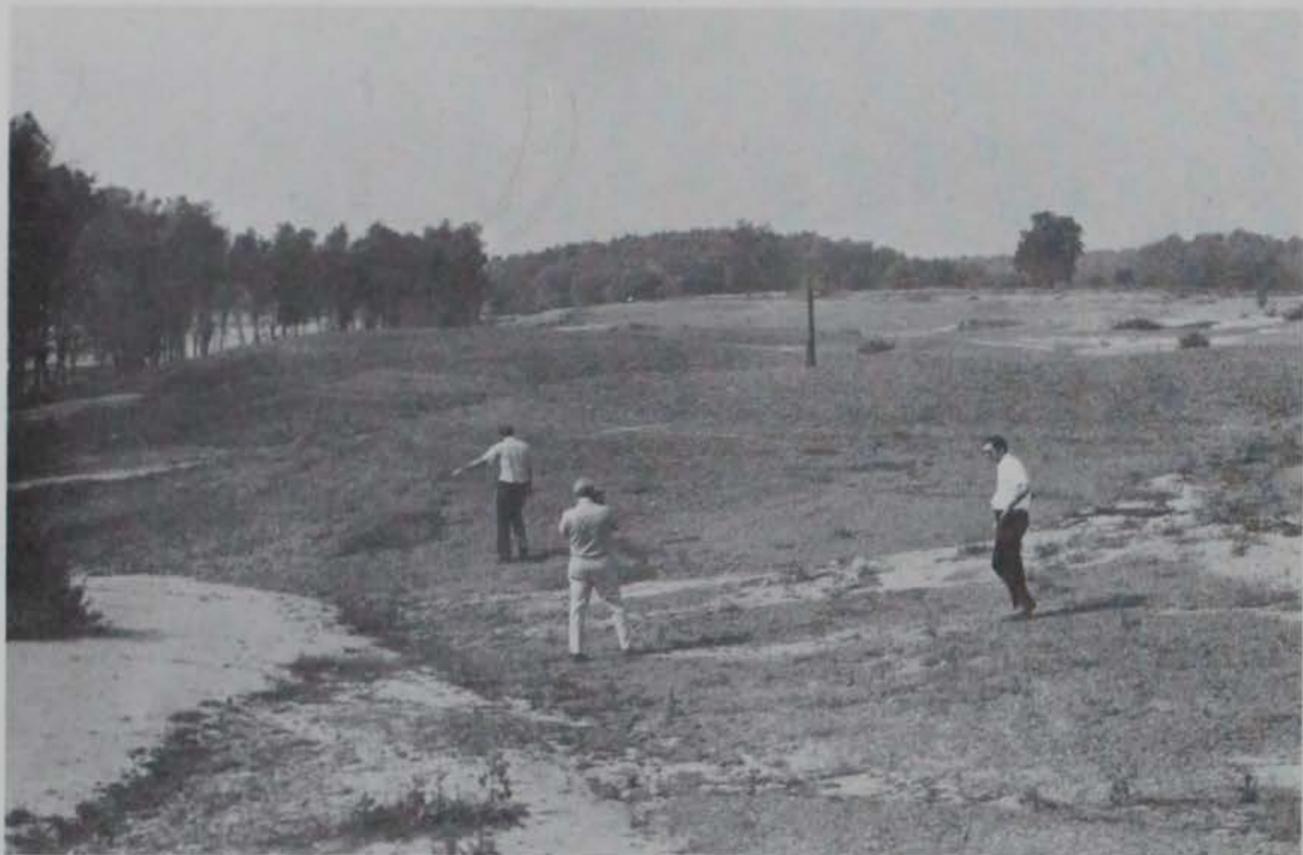
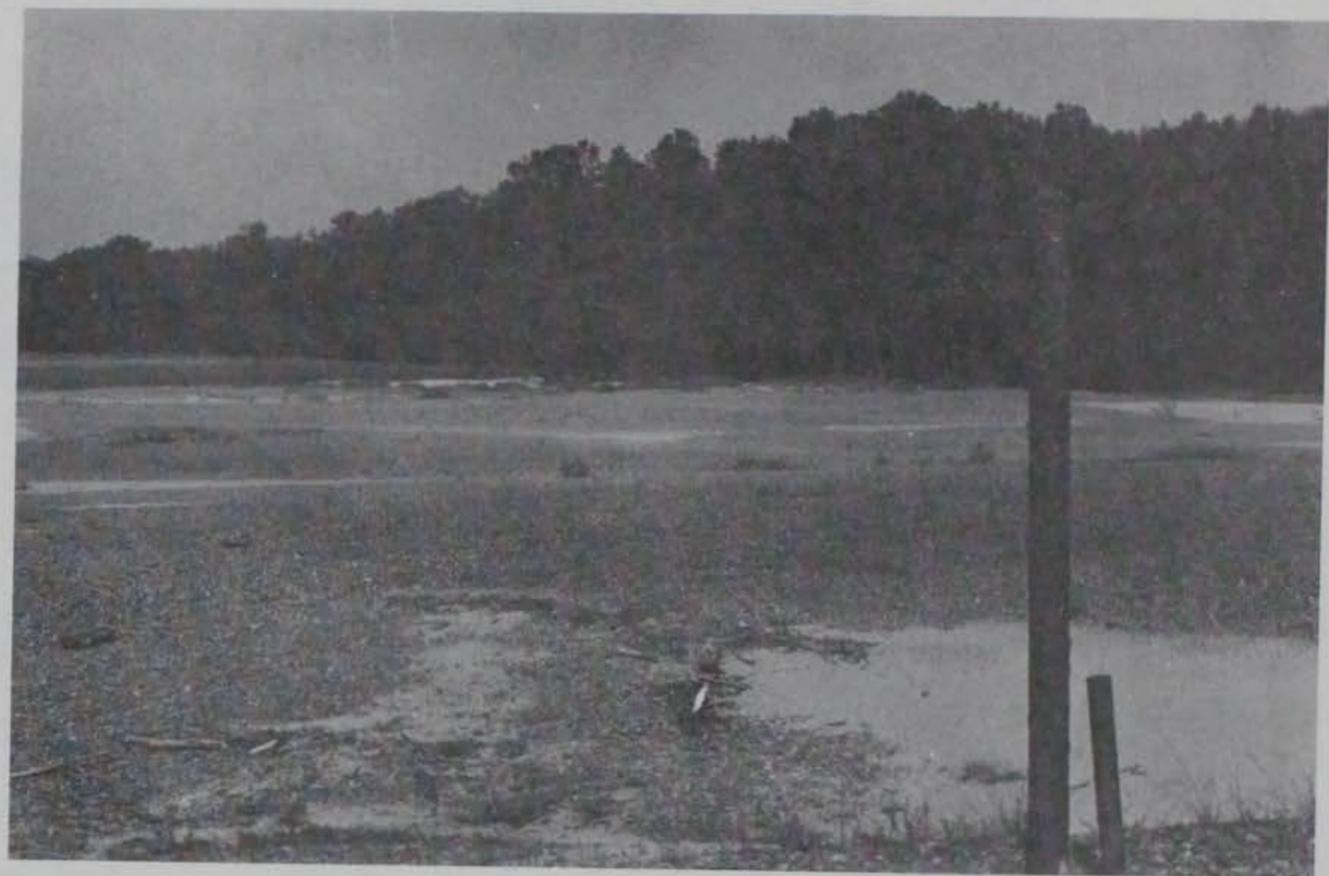
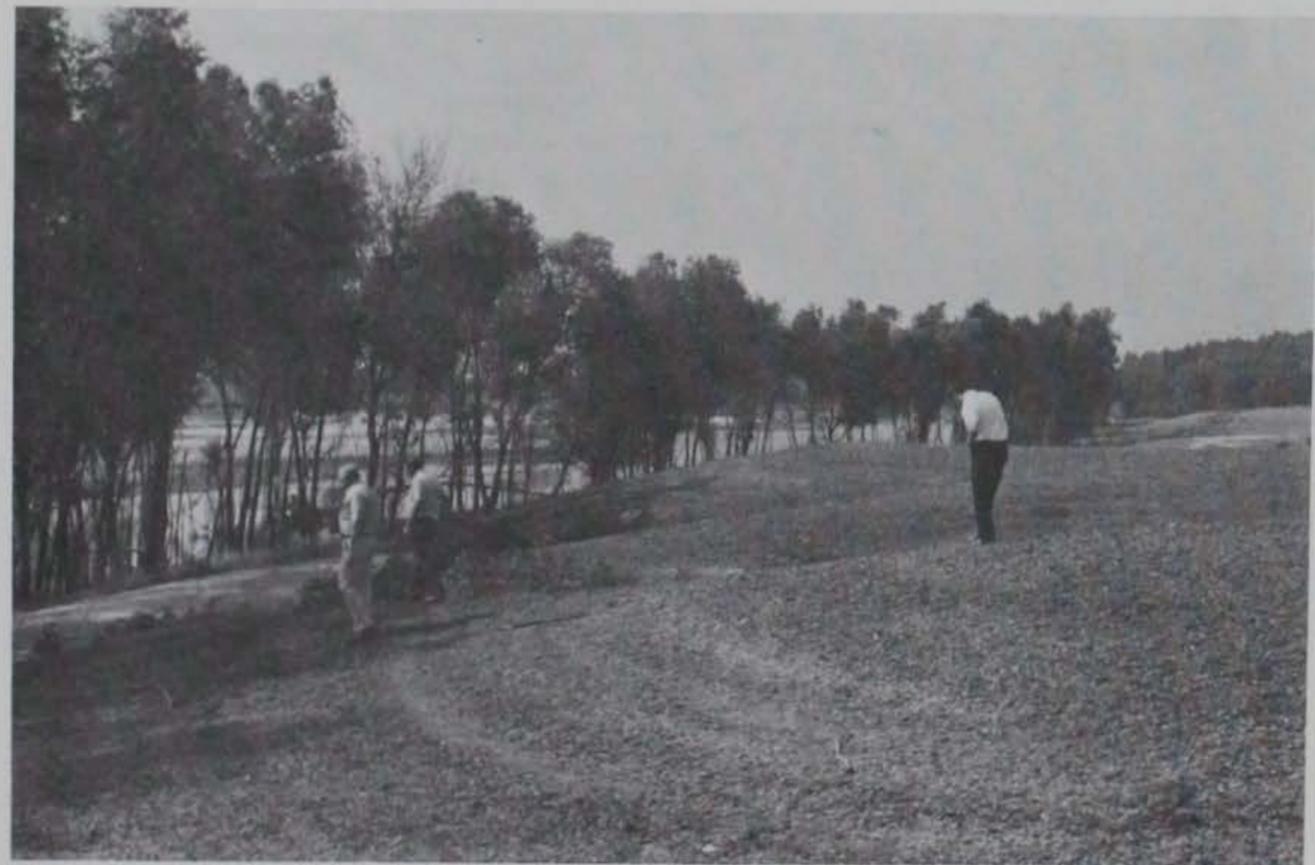
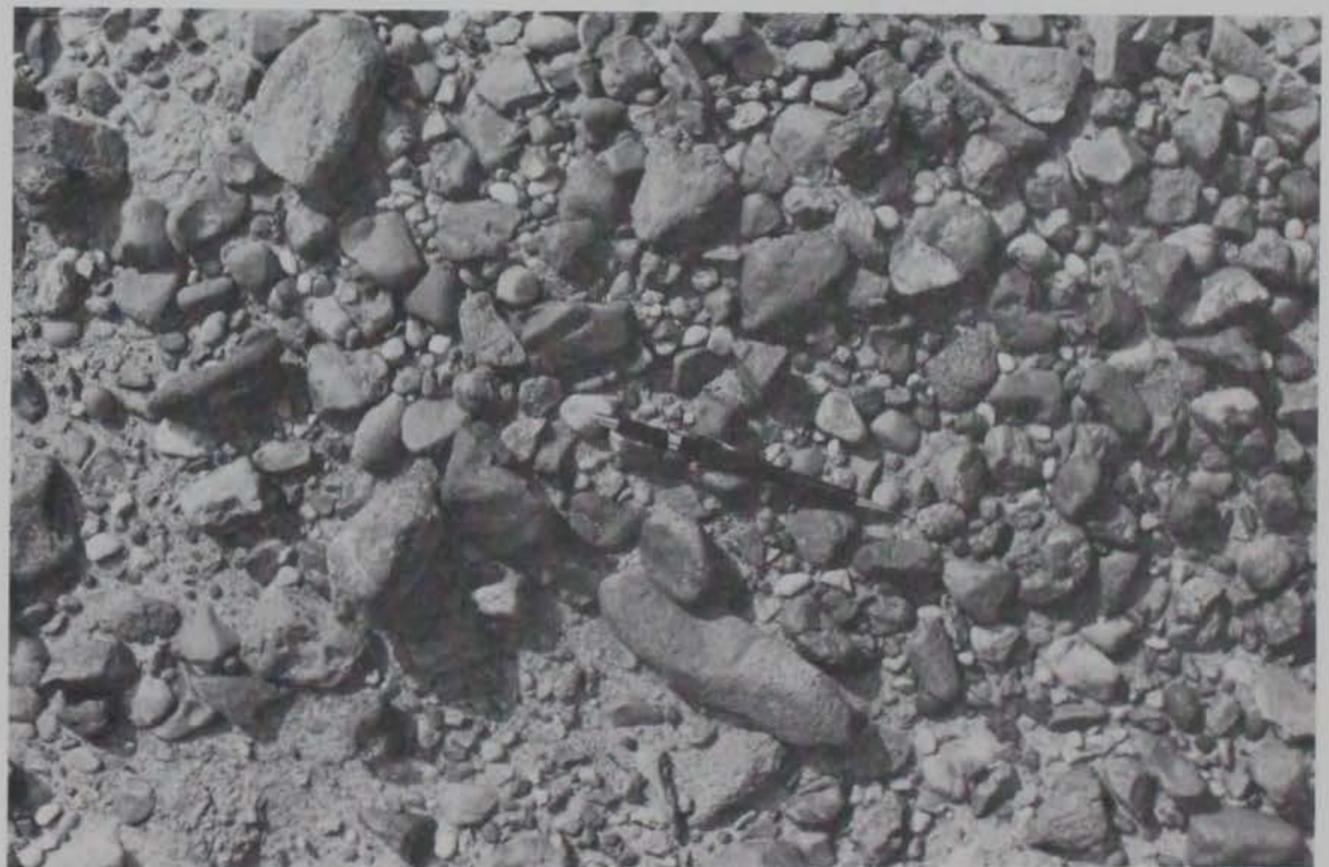
Figures 8 through 12 of L. G. Robbins' report<sup>15</sup> on Mississippi River sediments show gravel and sand formations on the middle bar at Rodney Cutoff. Figure 43 provides a set of photographs of the waves and dunes of gravel in Gilliam Chute just downstream of Rodney in Spithead Towhead (Figure 41). Figure 44 presents aerial views of Rodney Cutoff from 1935 to 1974.

GRAVEL FORMATIONS IN GILLIAM CHUTE

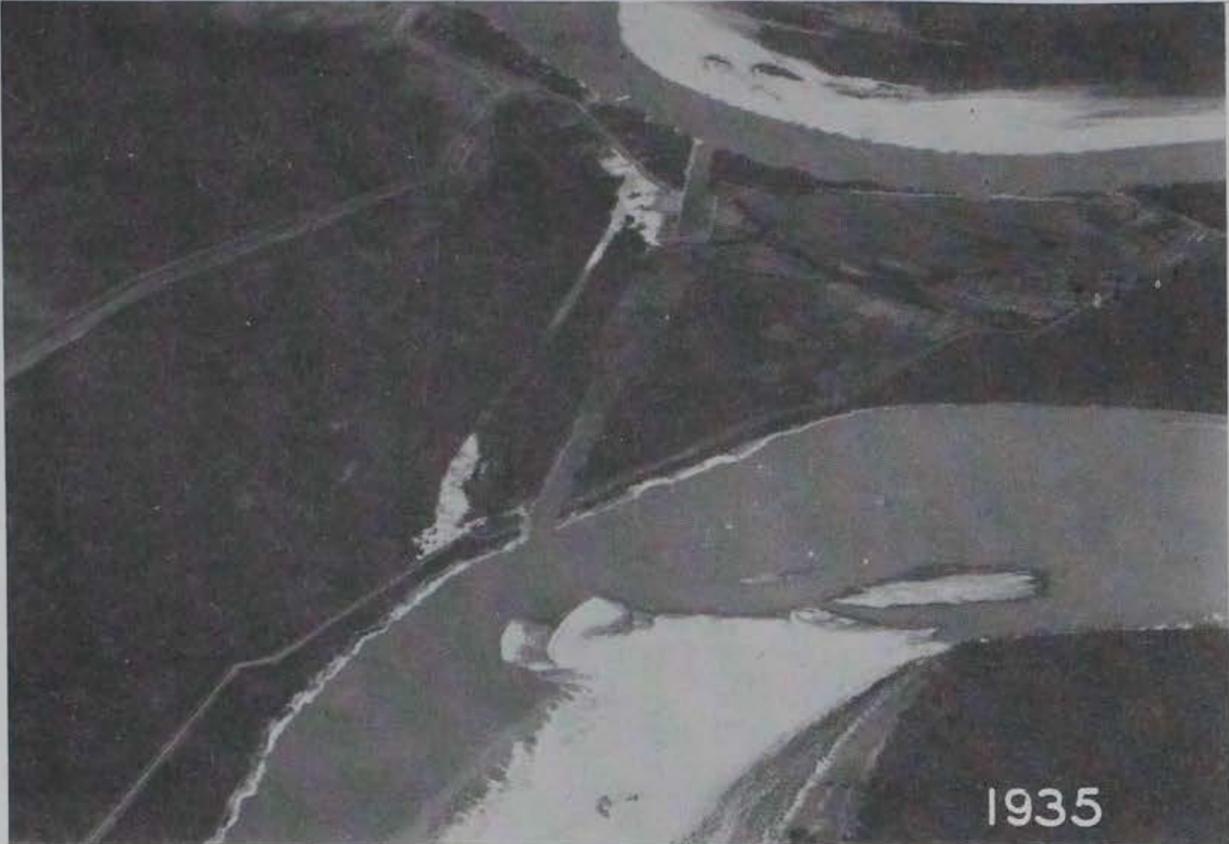
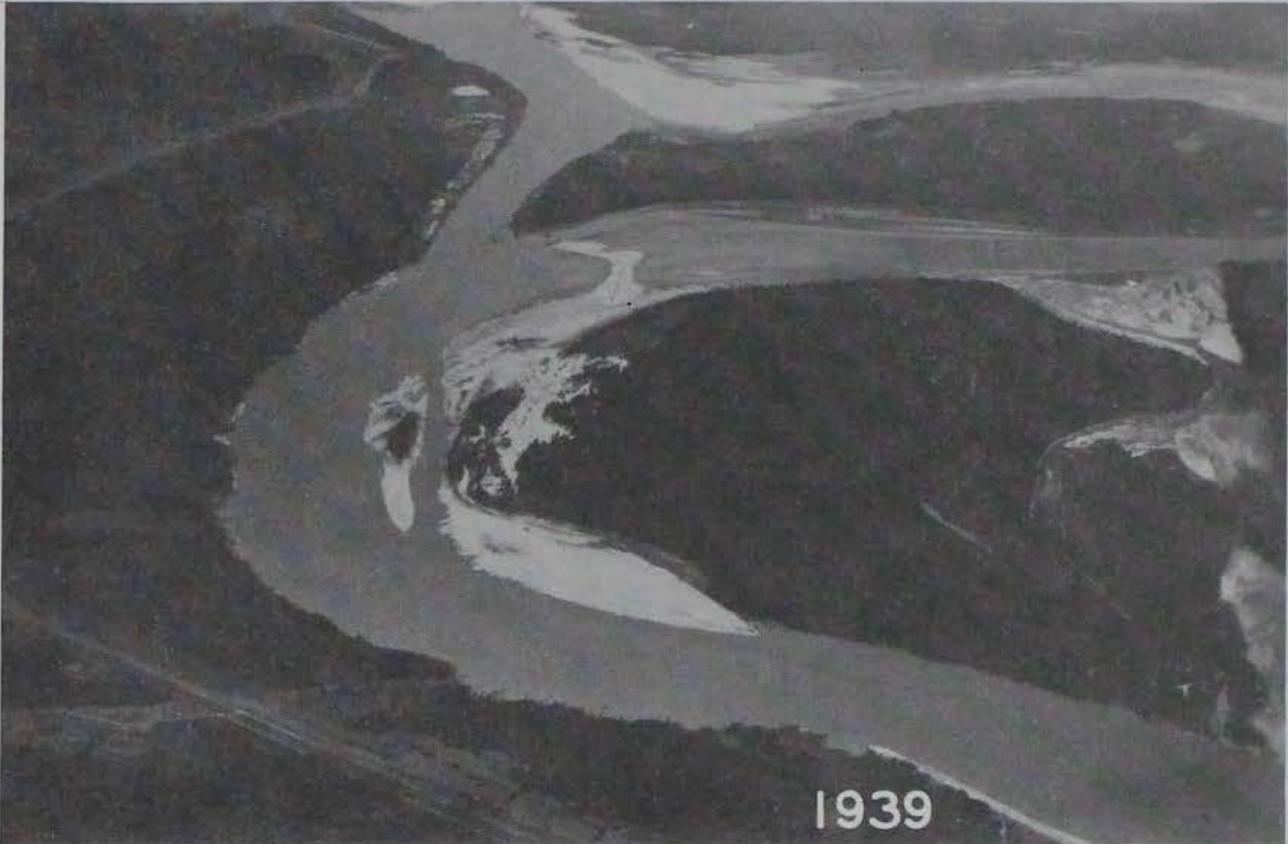
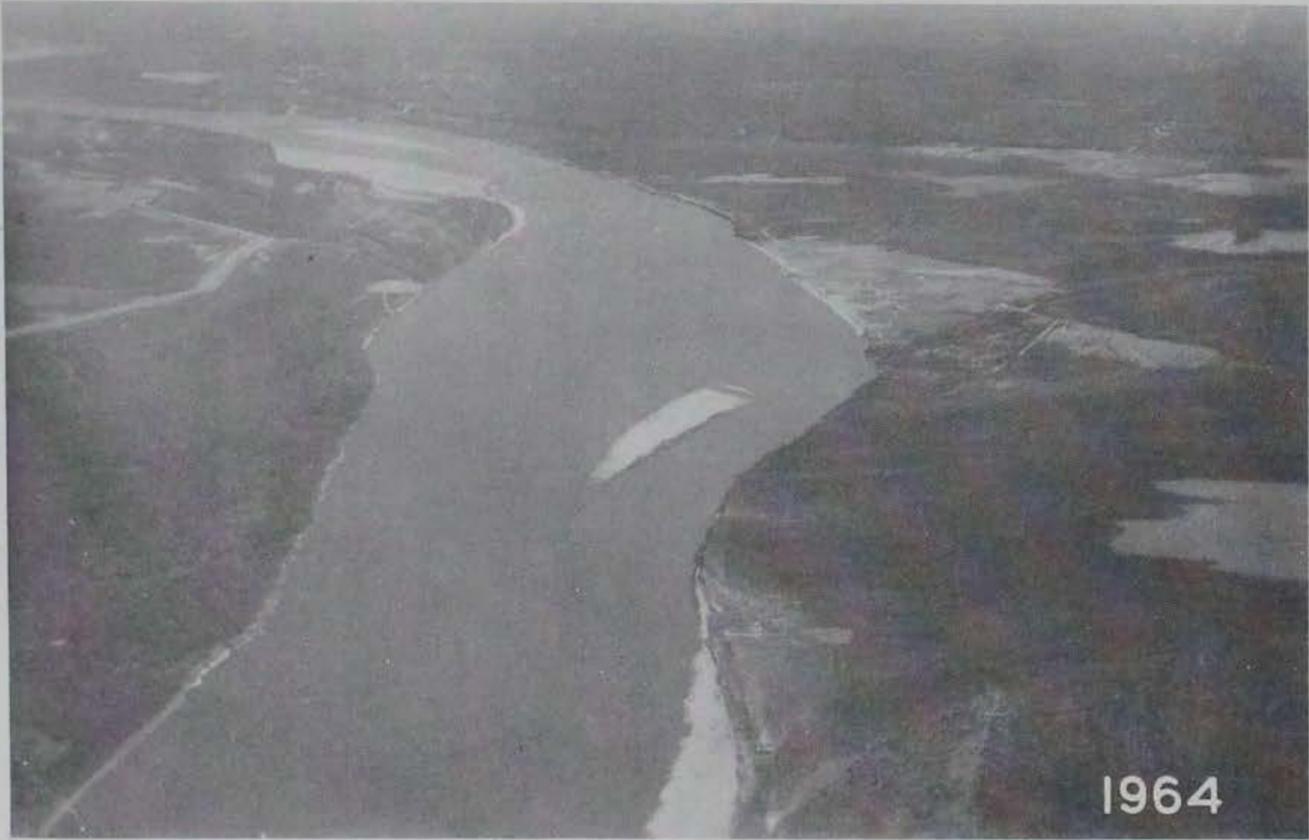
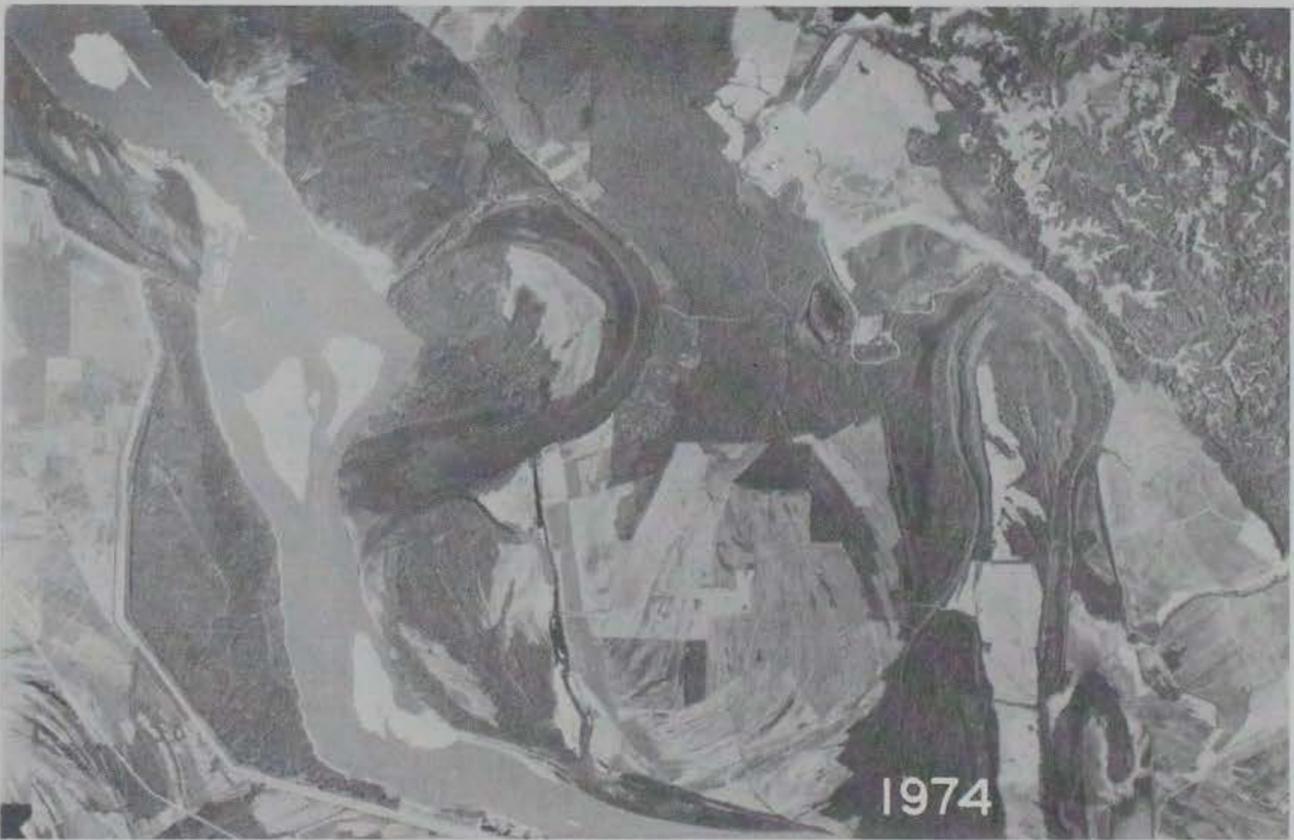
Figure 44

AERIAL VIEWS OF RODNEY CUTOFF
