POTAMOLOGY INVESTIGATIONS

Report 300-2

**MAN-MADE CUTOFFS ON THE LOWER MISSISSIPPI  
RIVER, CONCEPTION, CONSTRUCTION,  
AND RIVER RESPONSE**

U. S. ARMY ENGINEER DISTRICT, VICKSBURG

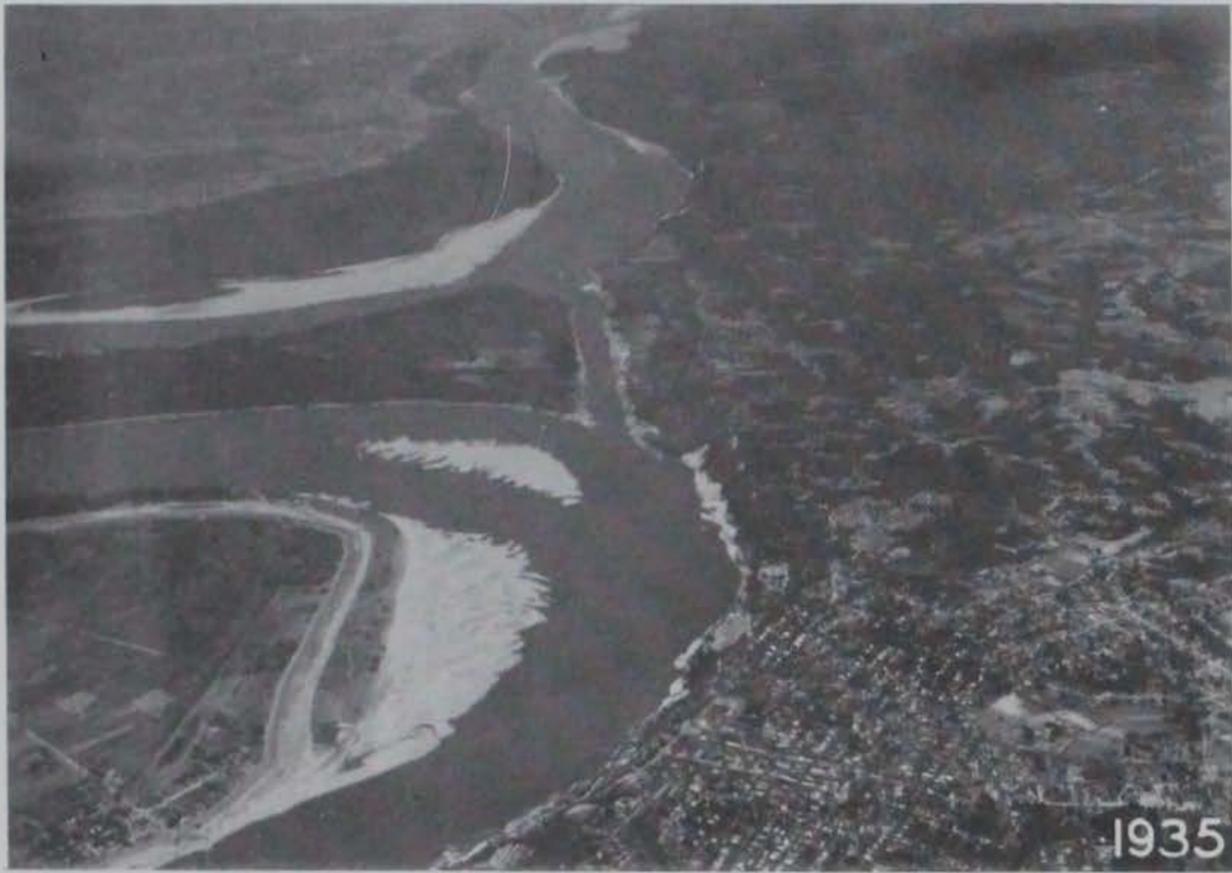
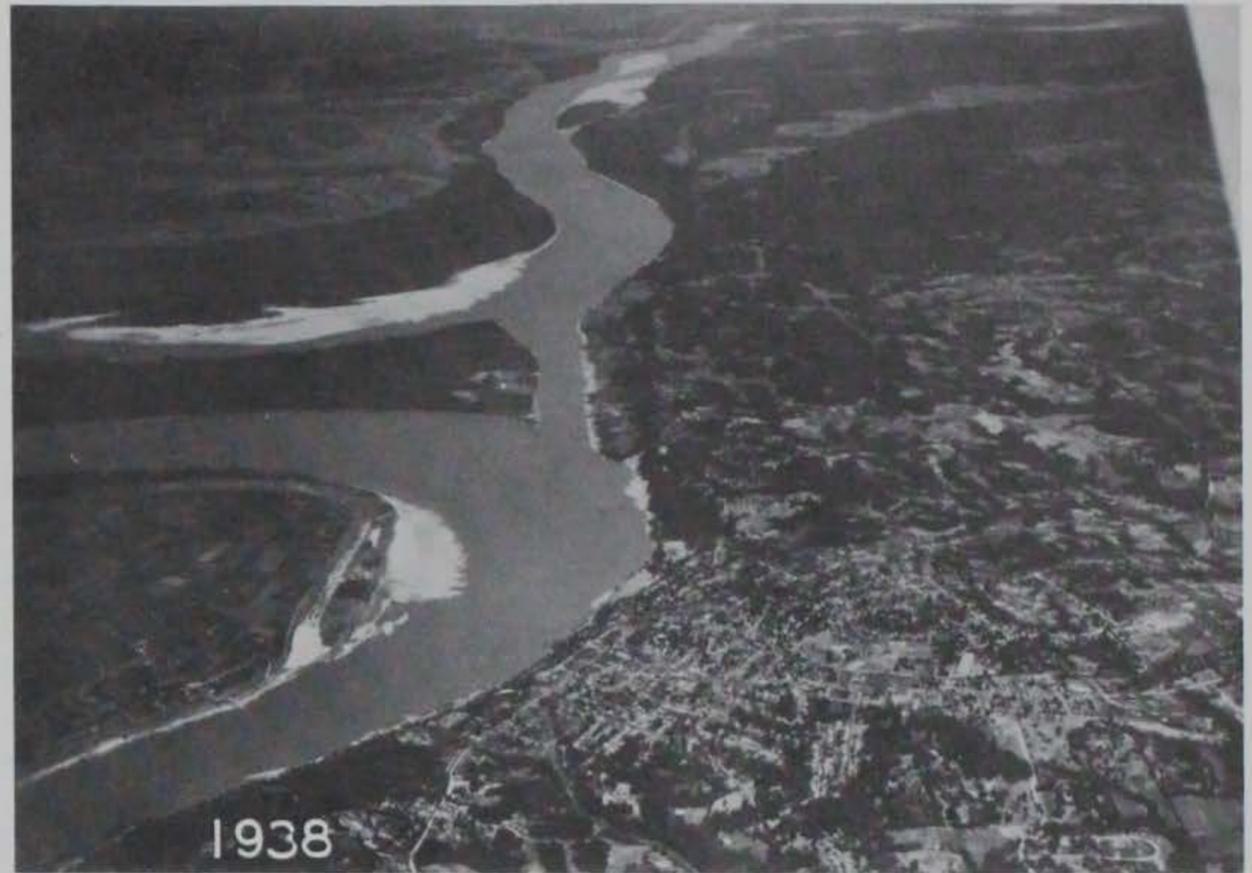
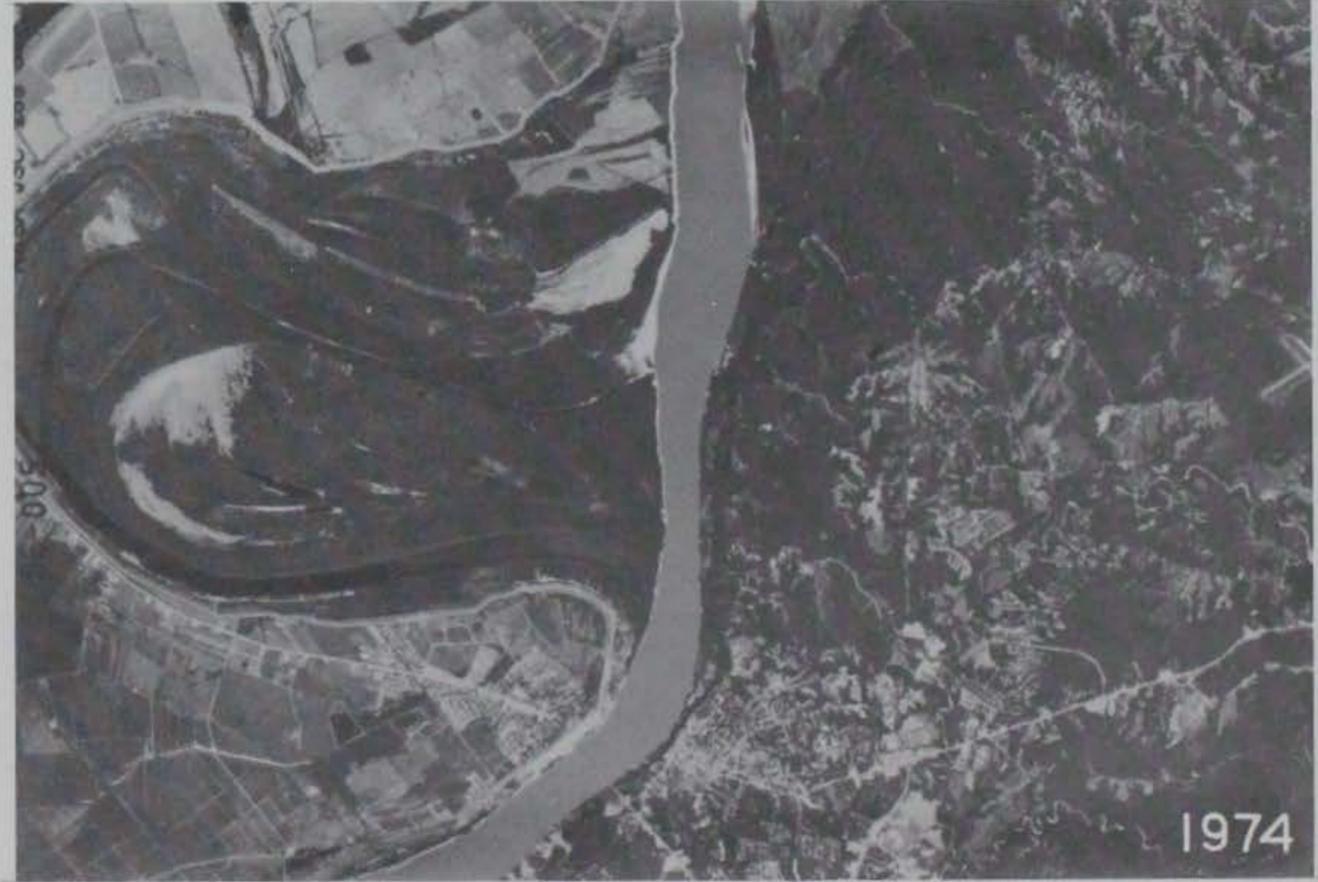
AERIAL VIEWS OF GILES CUTOFF

Figure 45 is a set of aerial photographs of the Giles Cutoff from 1935 to 1974. Figures 46 and 47, respectively, show the historic development and the 1975 river in this reach.

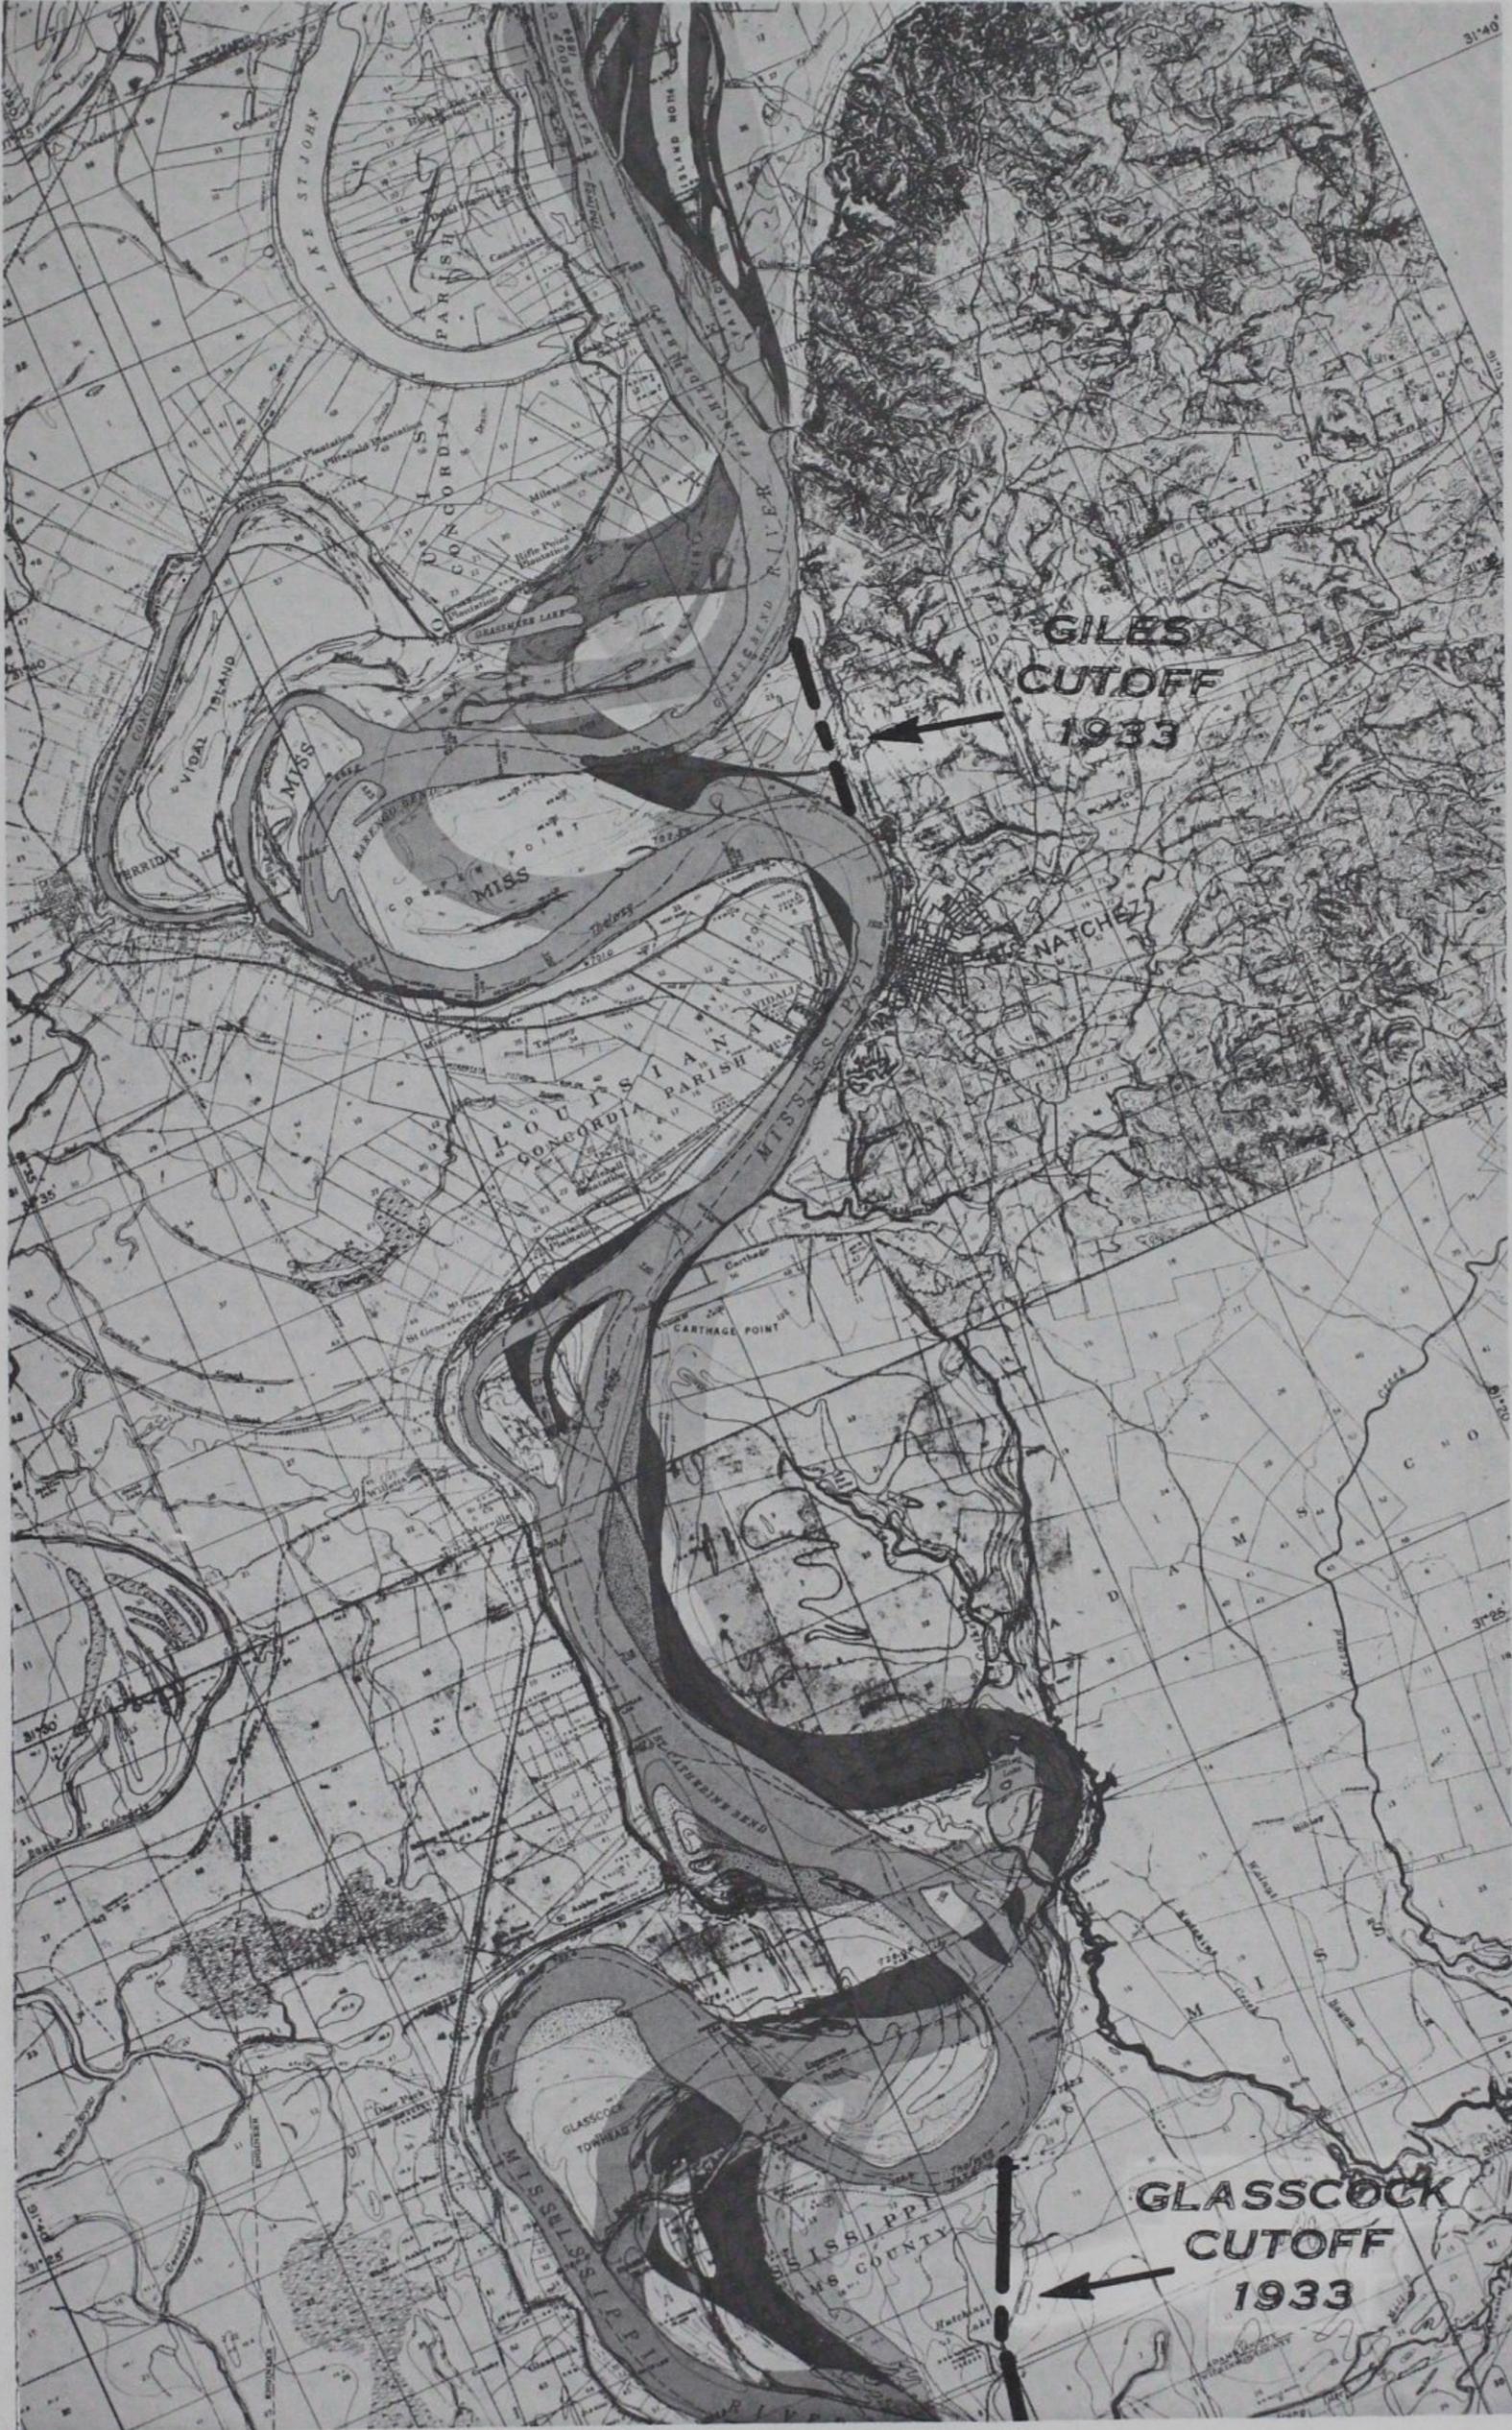
HISTORIC DEVELOPMENT OF THE GILES REACH

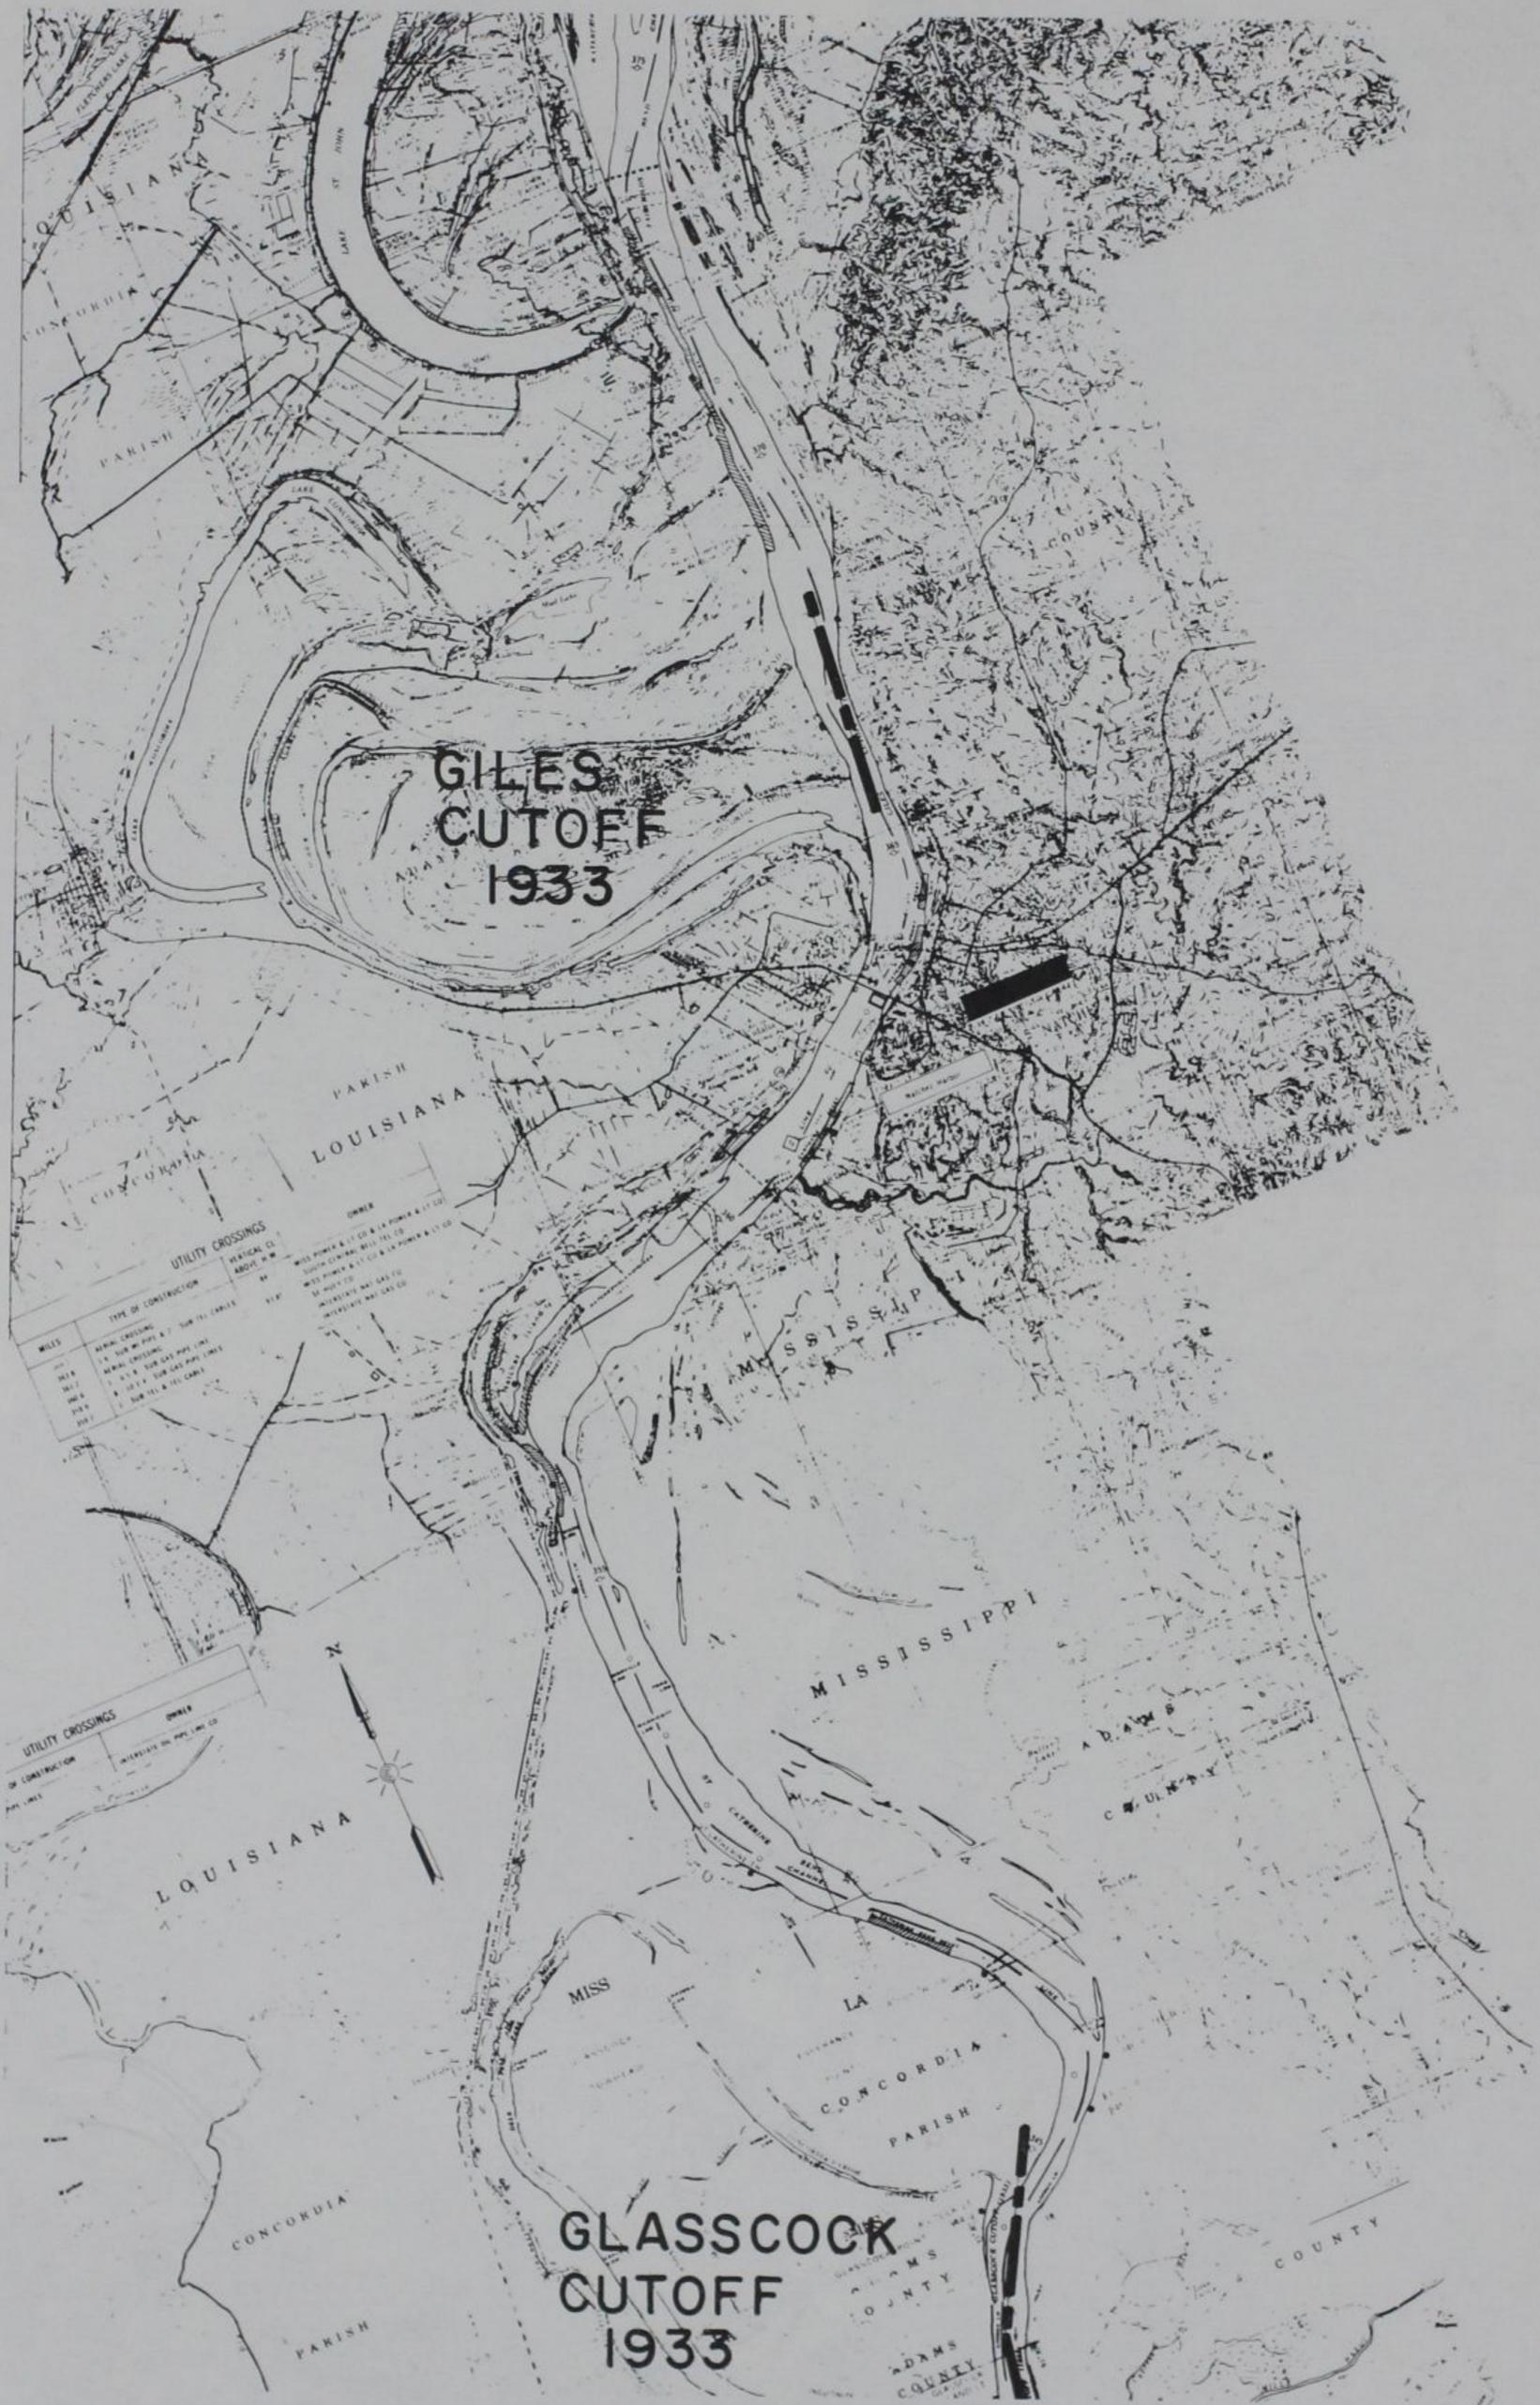
Figure 47

1975 MISSISSIPPI RIVER IN THE GILES REACH

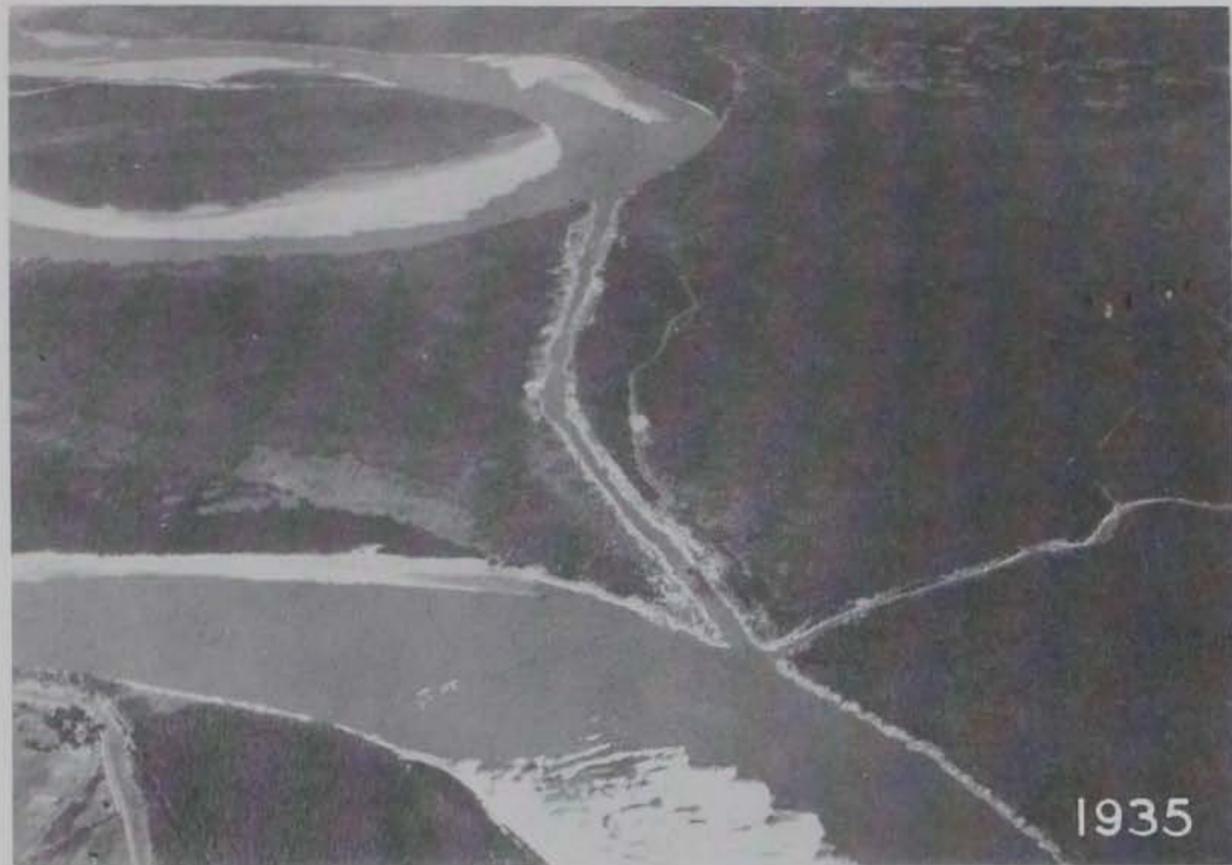
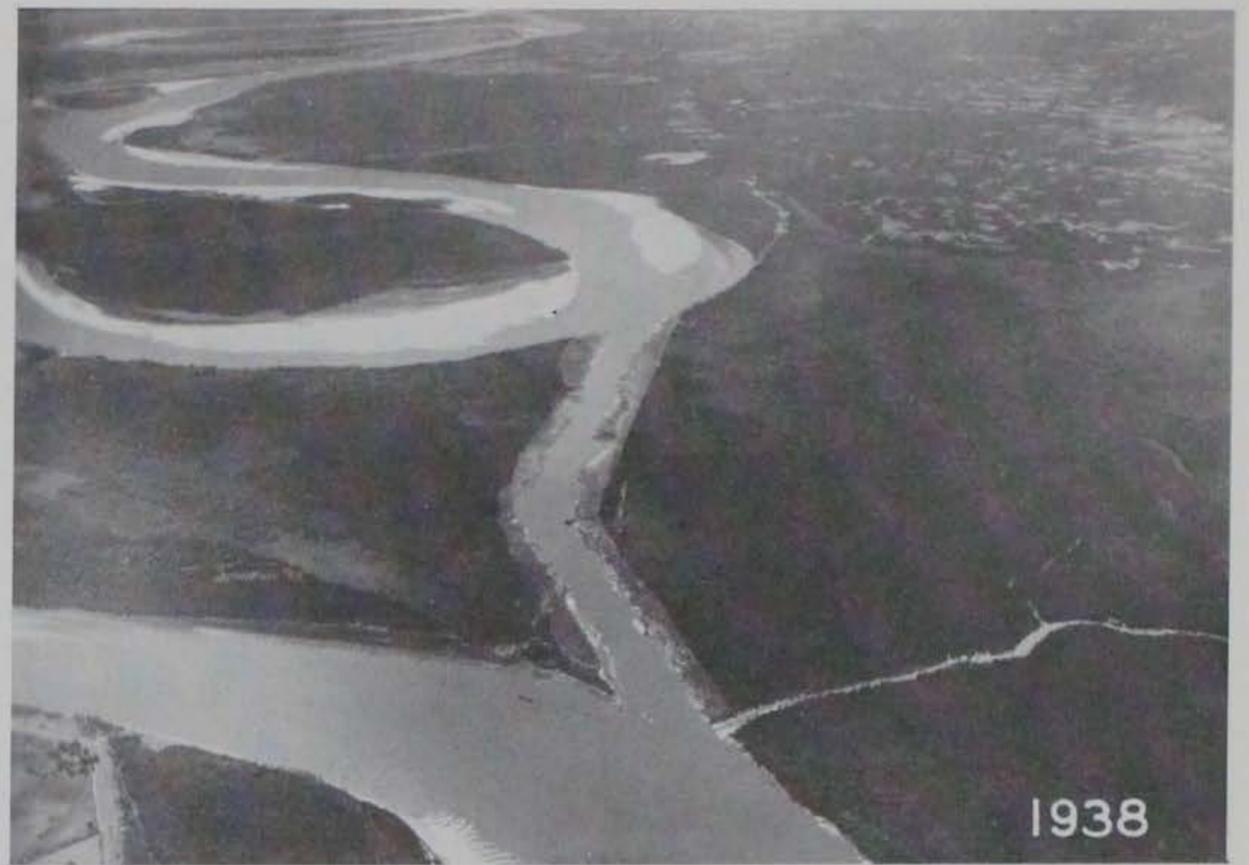
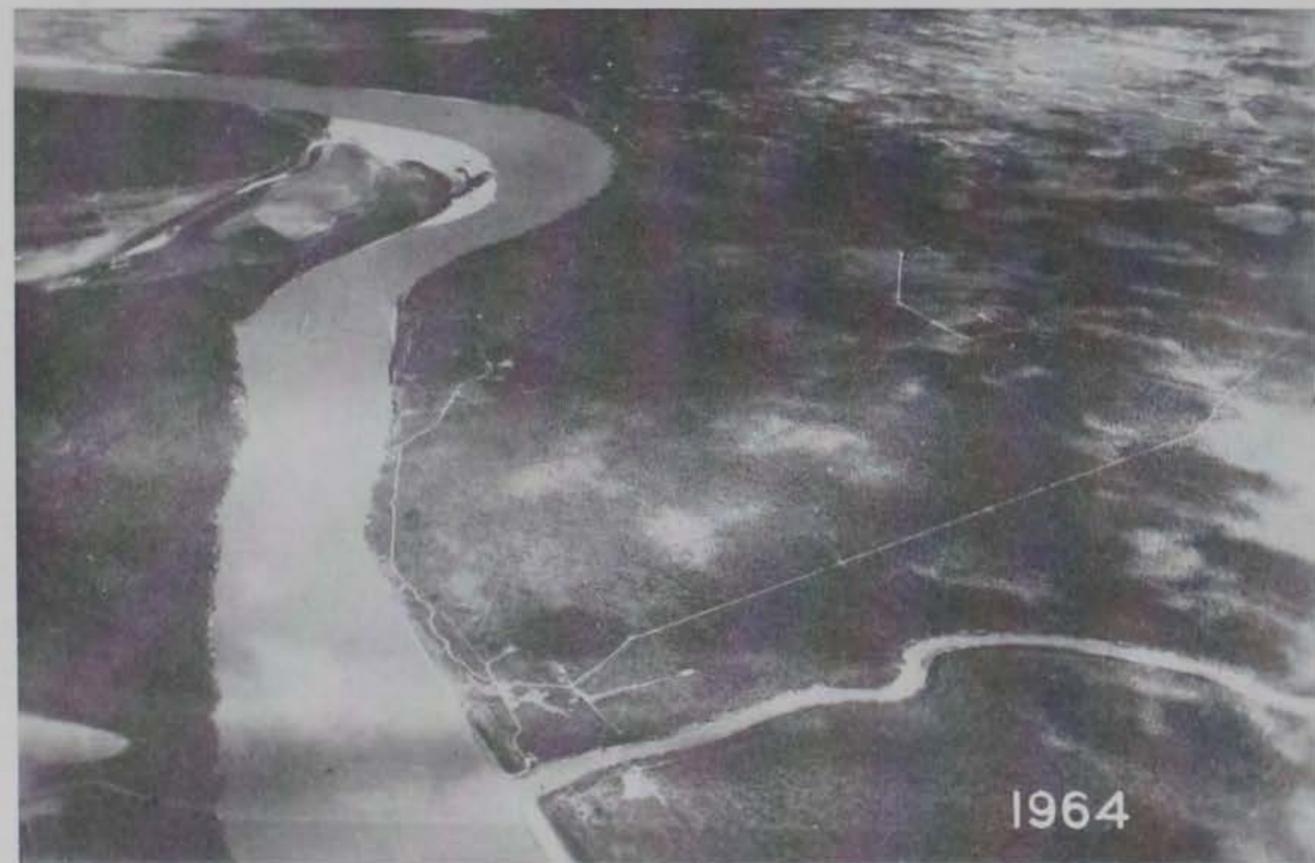
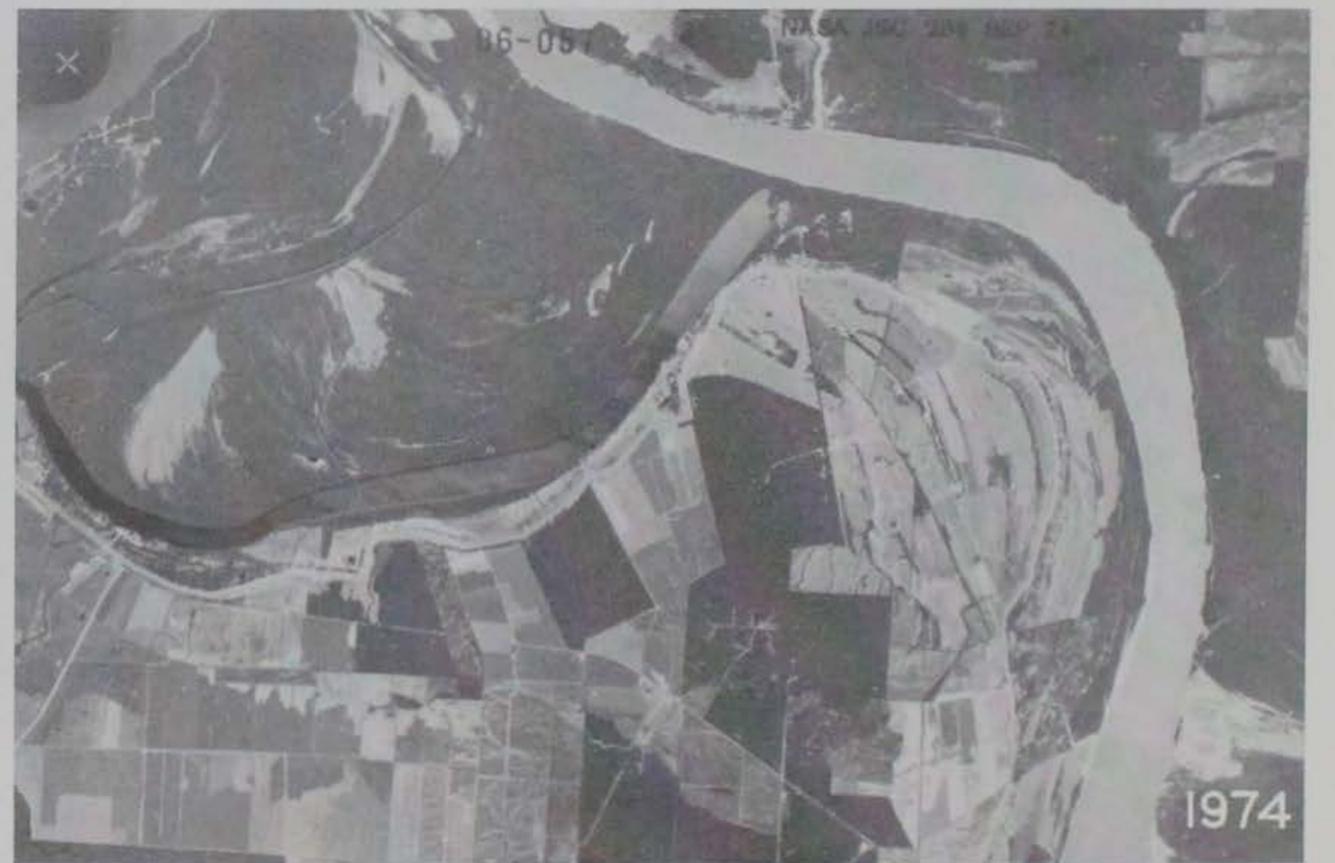
AERIAL VIEWS OF GLASSCOCK CUTOFF

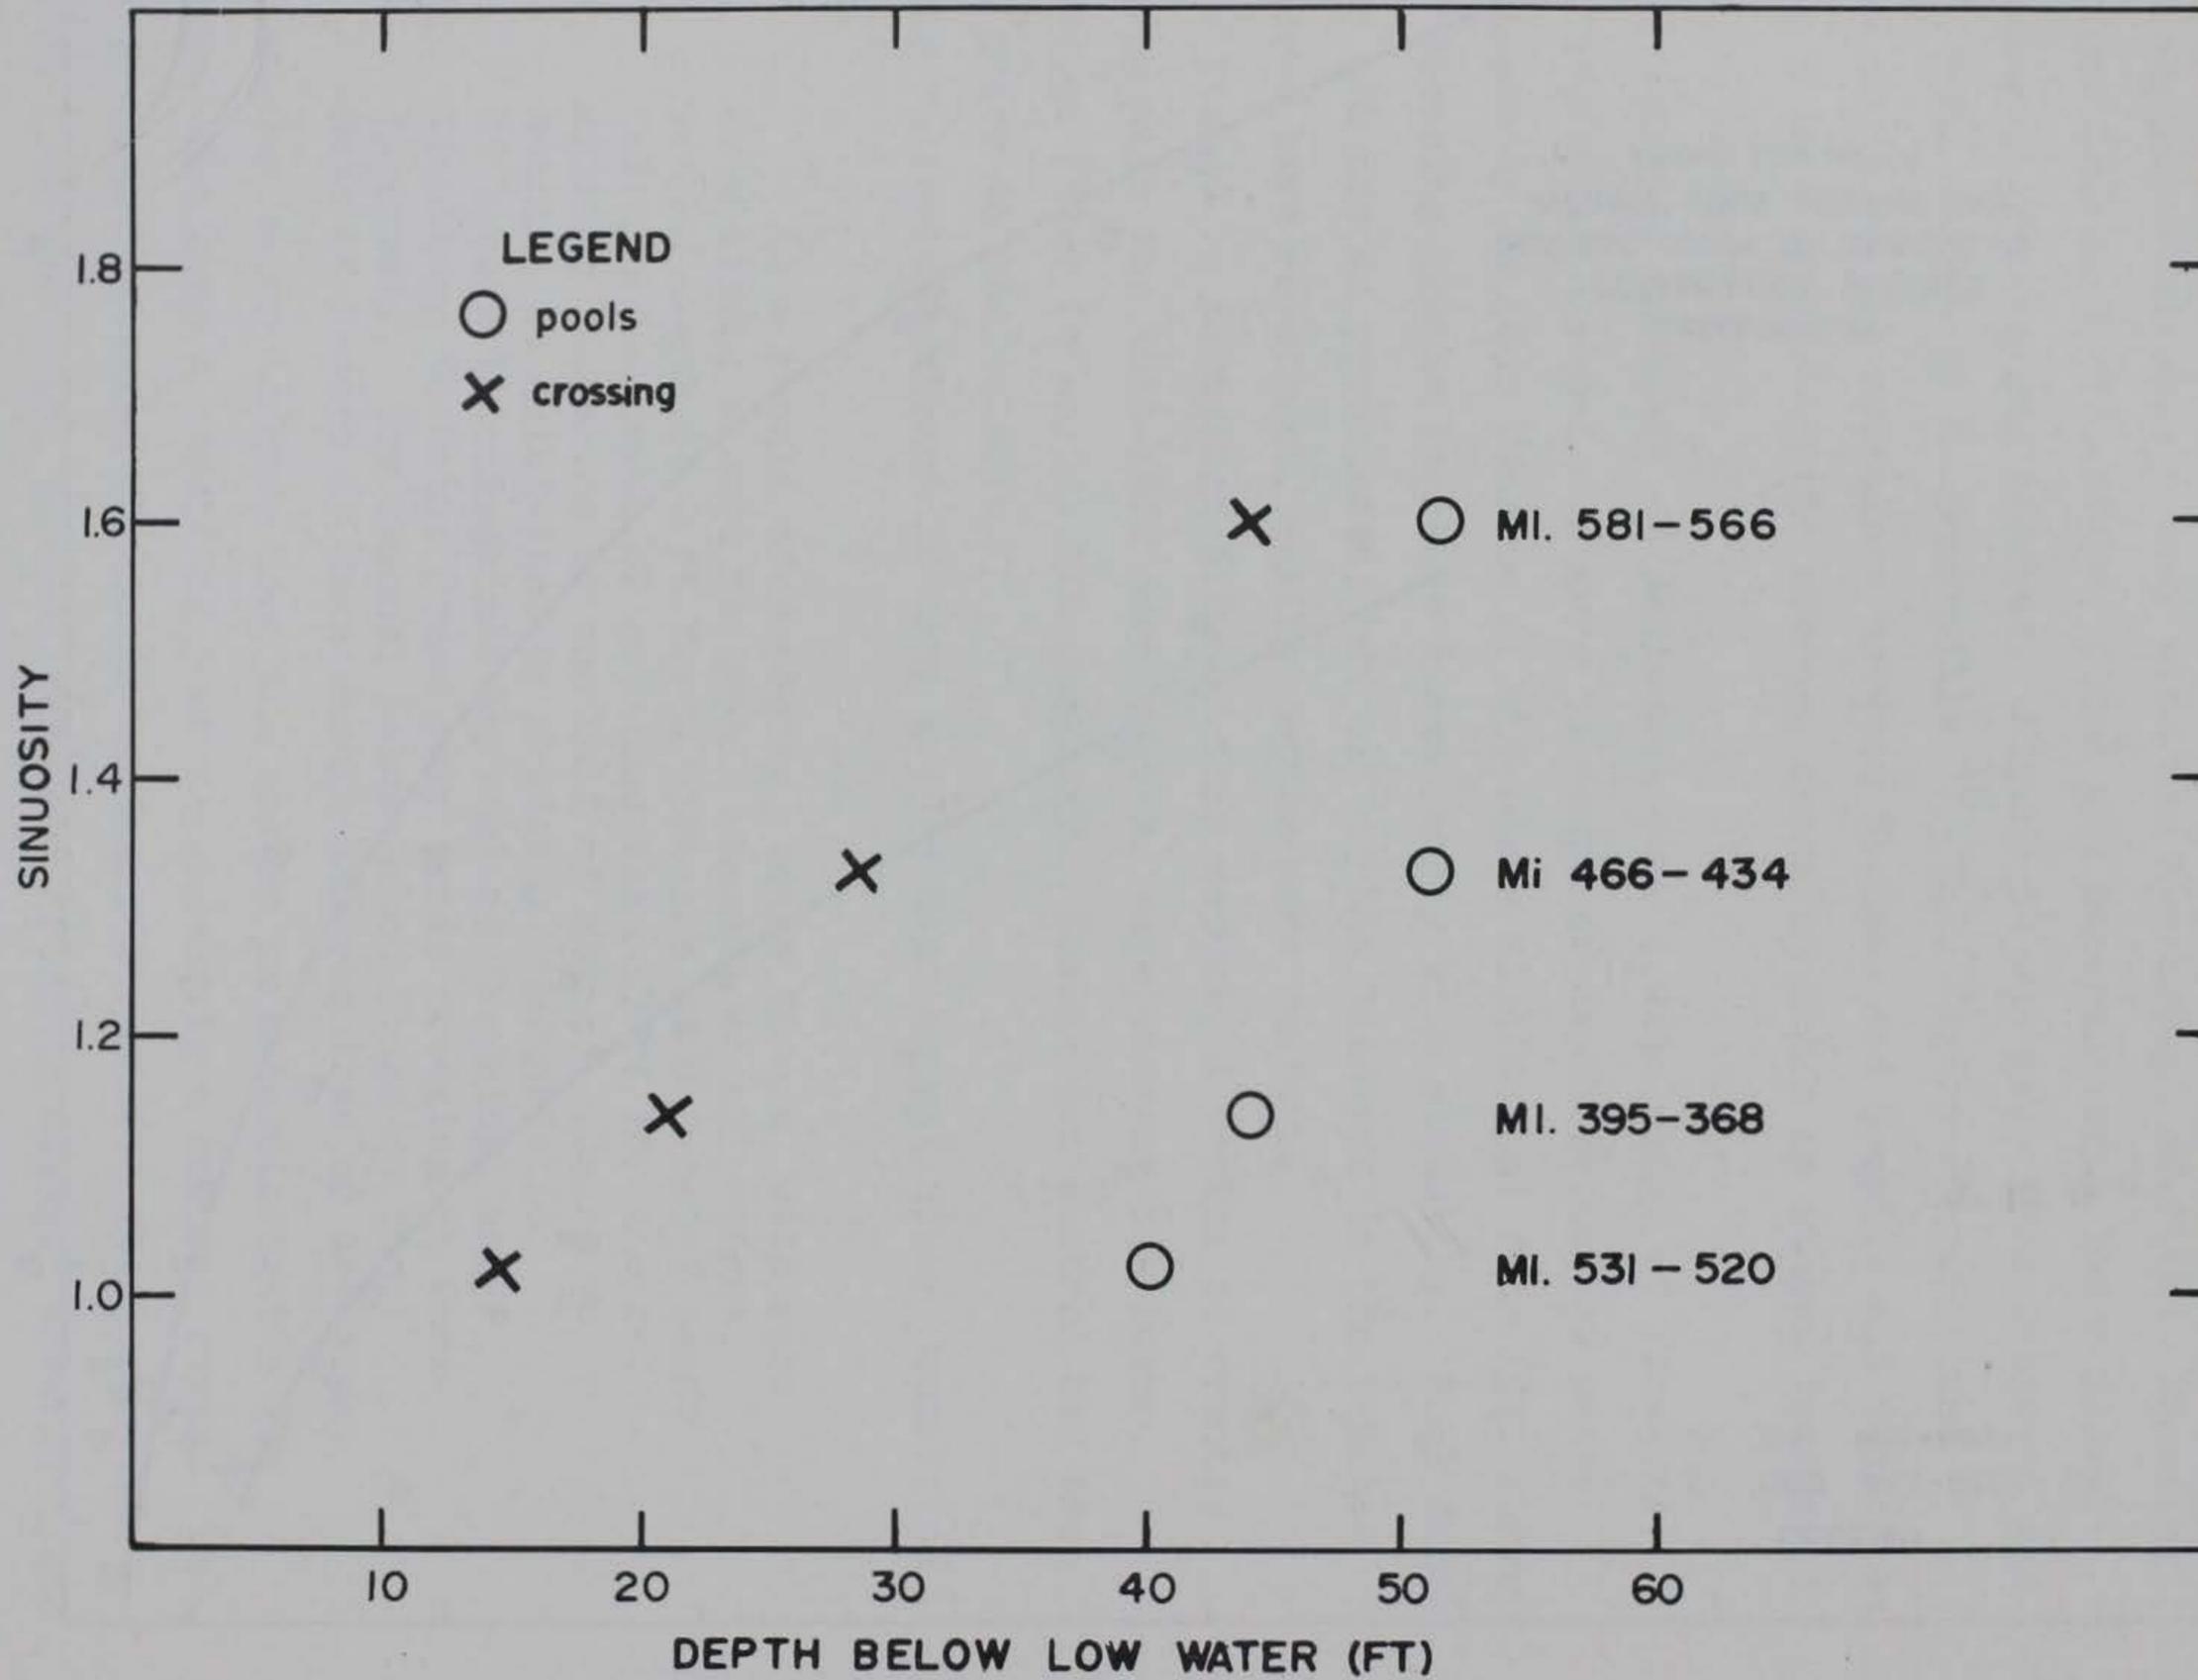
Figure 55

### SINUOSITY VS. DEPTH BELOW LOW WATER 1971 SURVEY

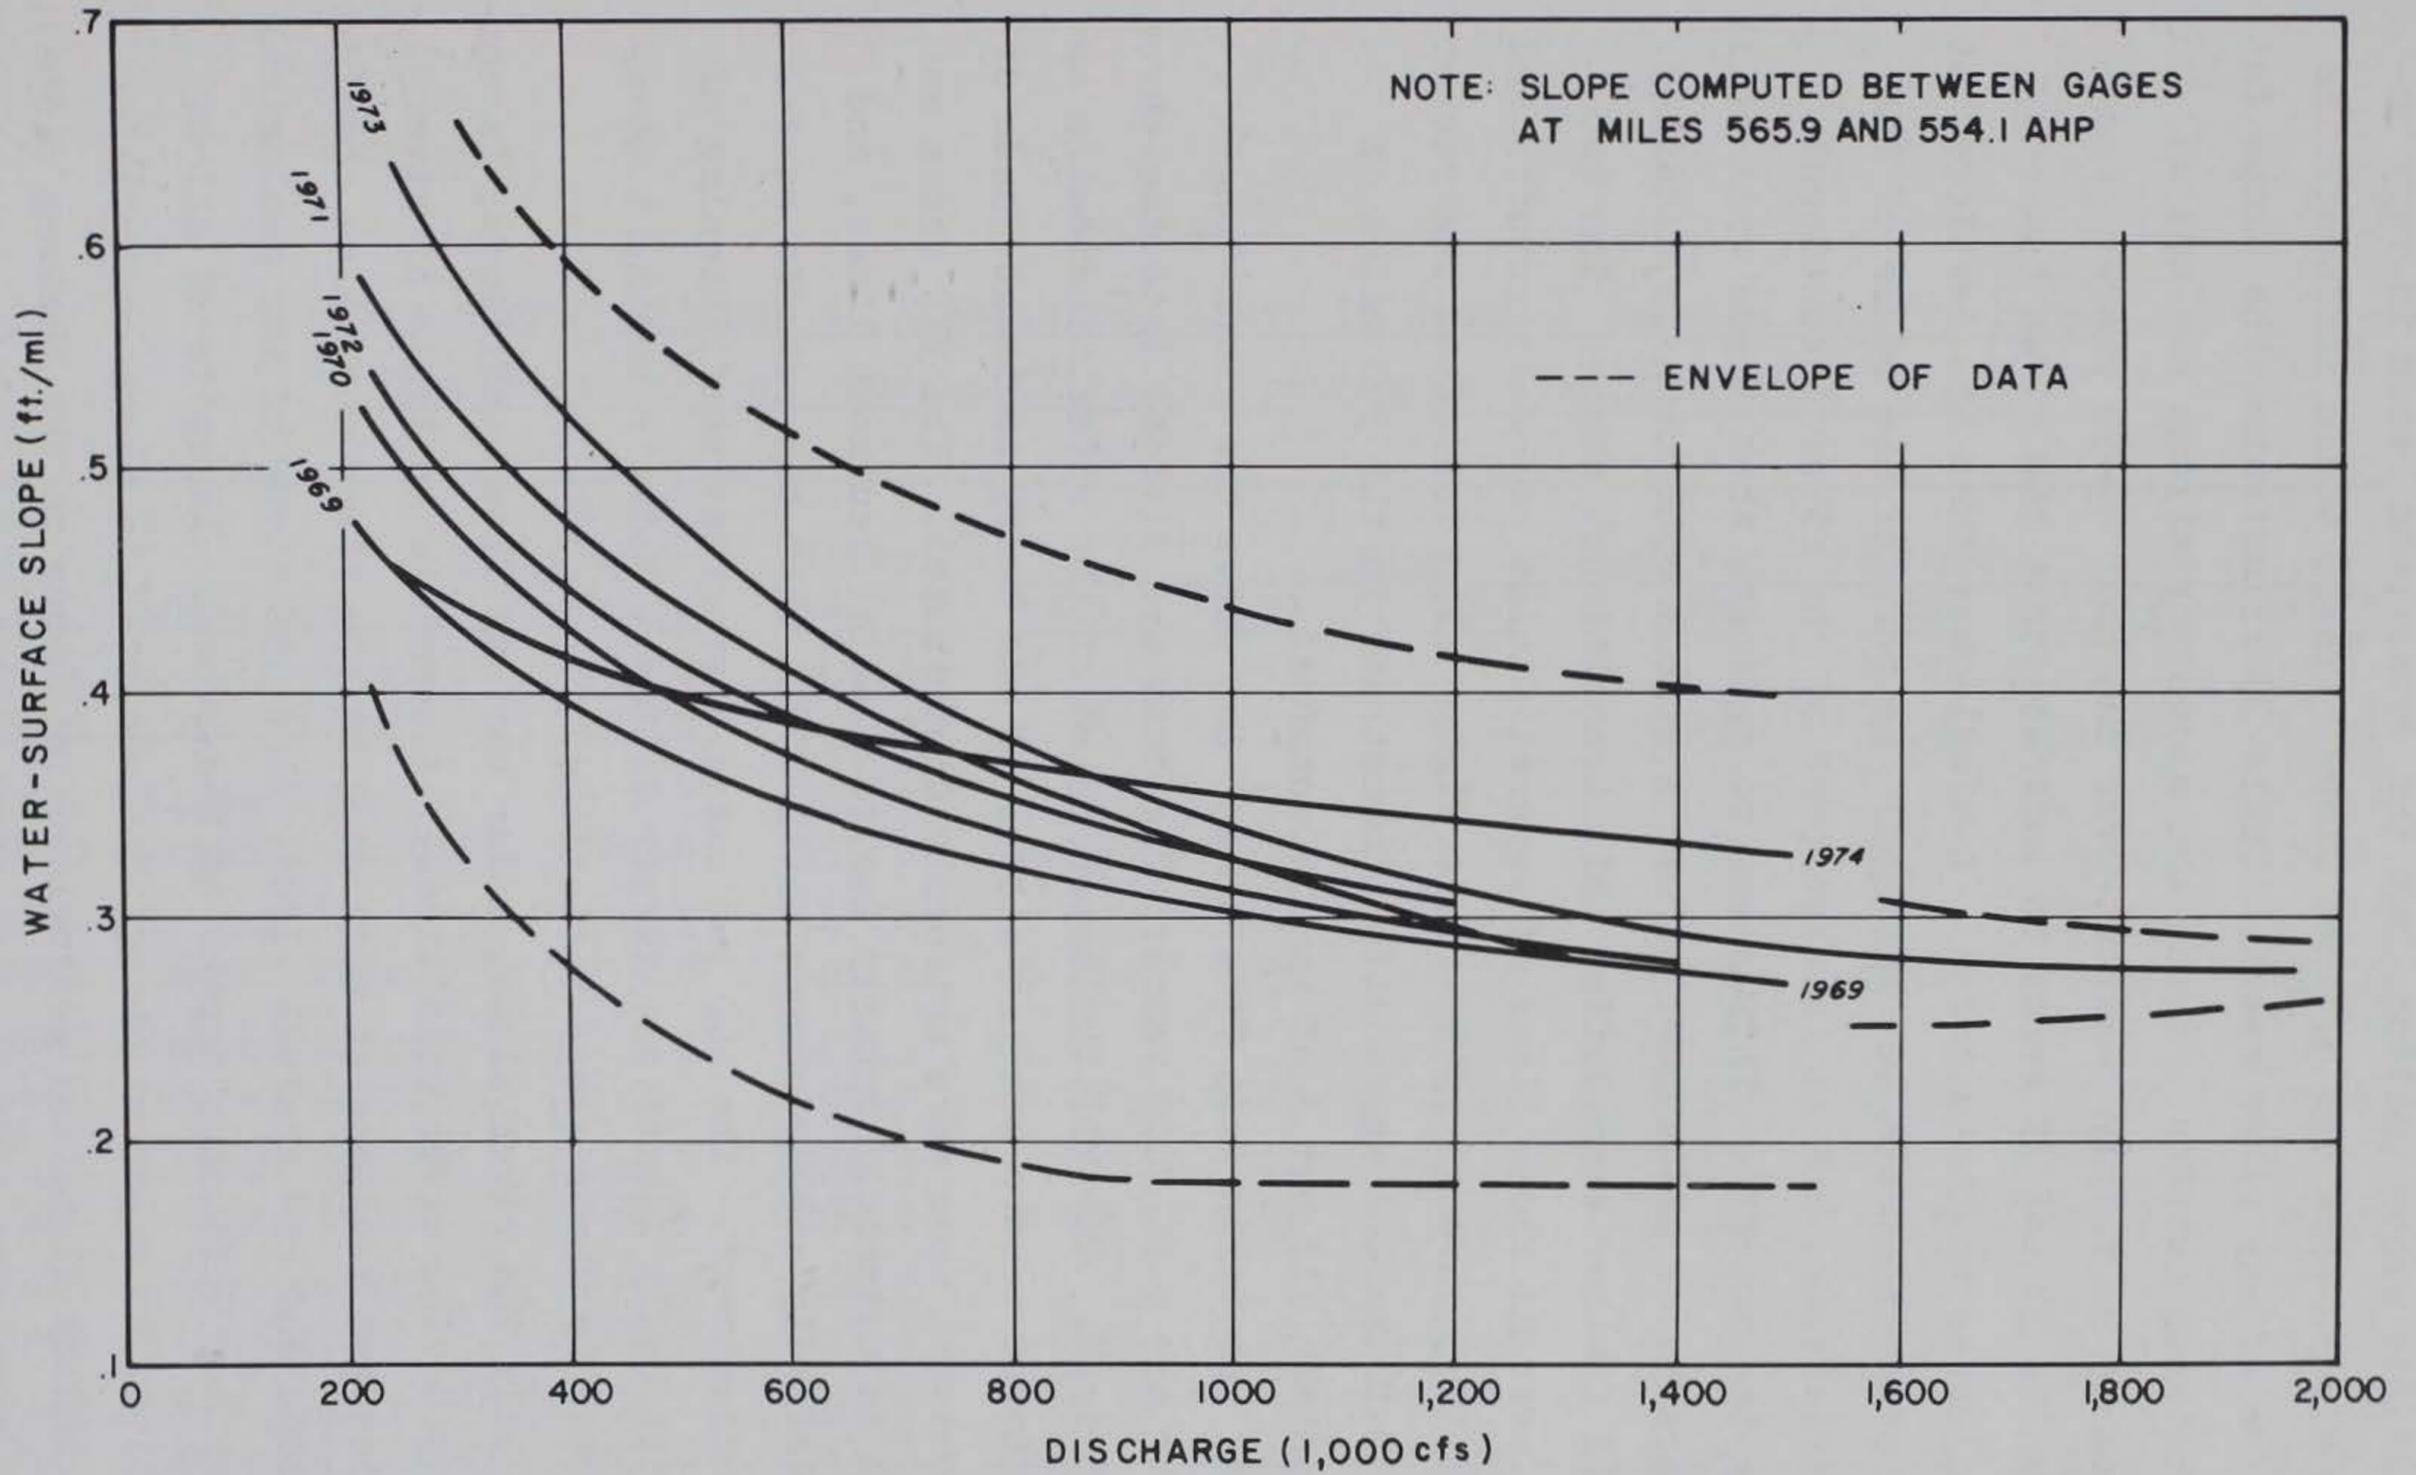
Figure 60

MISSISSIPPI RIVER  
POTAMOLOGY STUDIES  
WATER-SURFACE SLOPE VS. DISCHARGE  
ARKANSAS CITY DISCHARGE RANGE  
MILE 565.9 AHP  
WATER YEAR 1969 - 1974
