POTAMOLOGY INVESTIGATIONS

Report 300-2

**MAN-MADE CUTOFFS ON THE LOWER MISSISSIPPI  
RIVER, CONCEPTION, CONSTRUCTION,  
AND RIVER RESPONSE**

U. S. ARMY ENGINEER DISTRICT, VICKSBURG

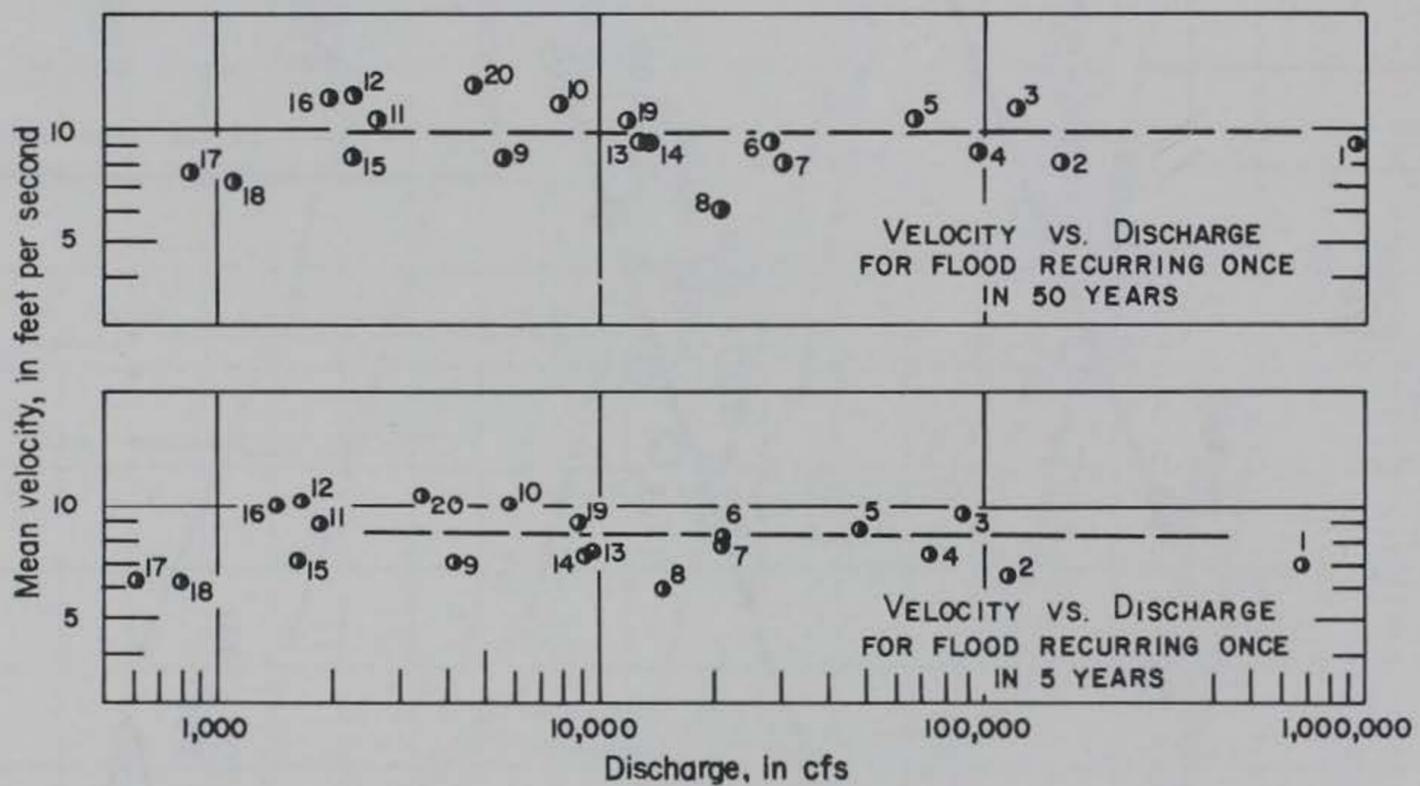
Figure 63. Velocity versus discharge for flood recurring once in 5 and once in 50 years (after Leopold, Wolman, and Miller<sup>26</sup>)

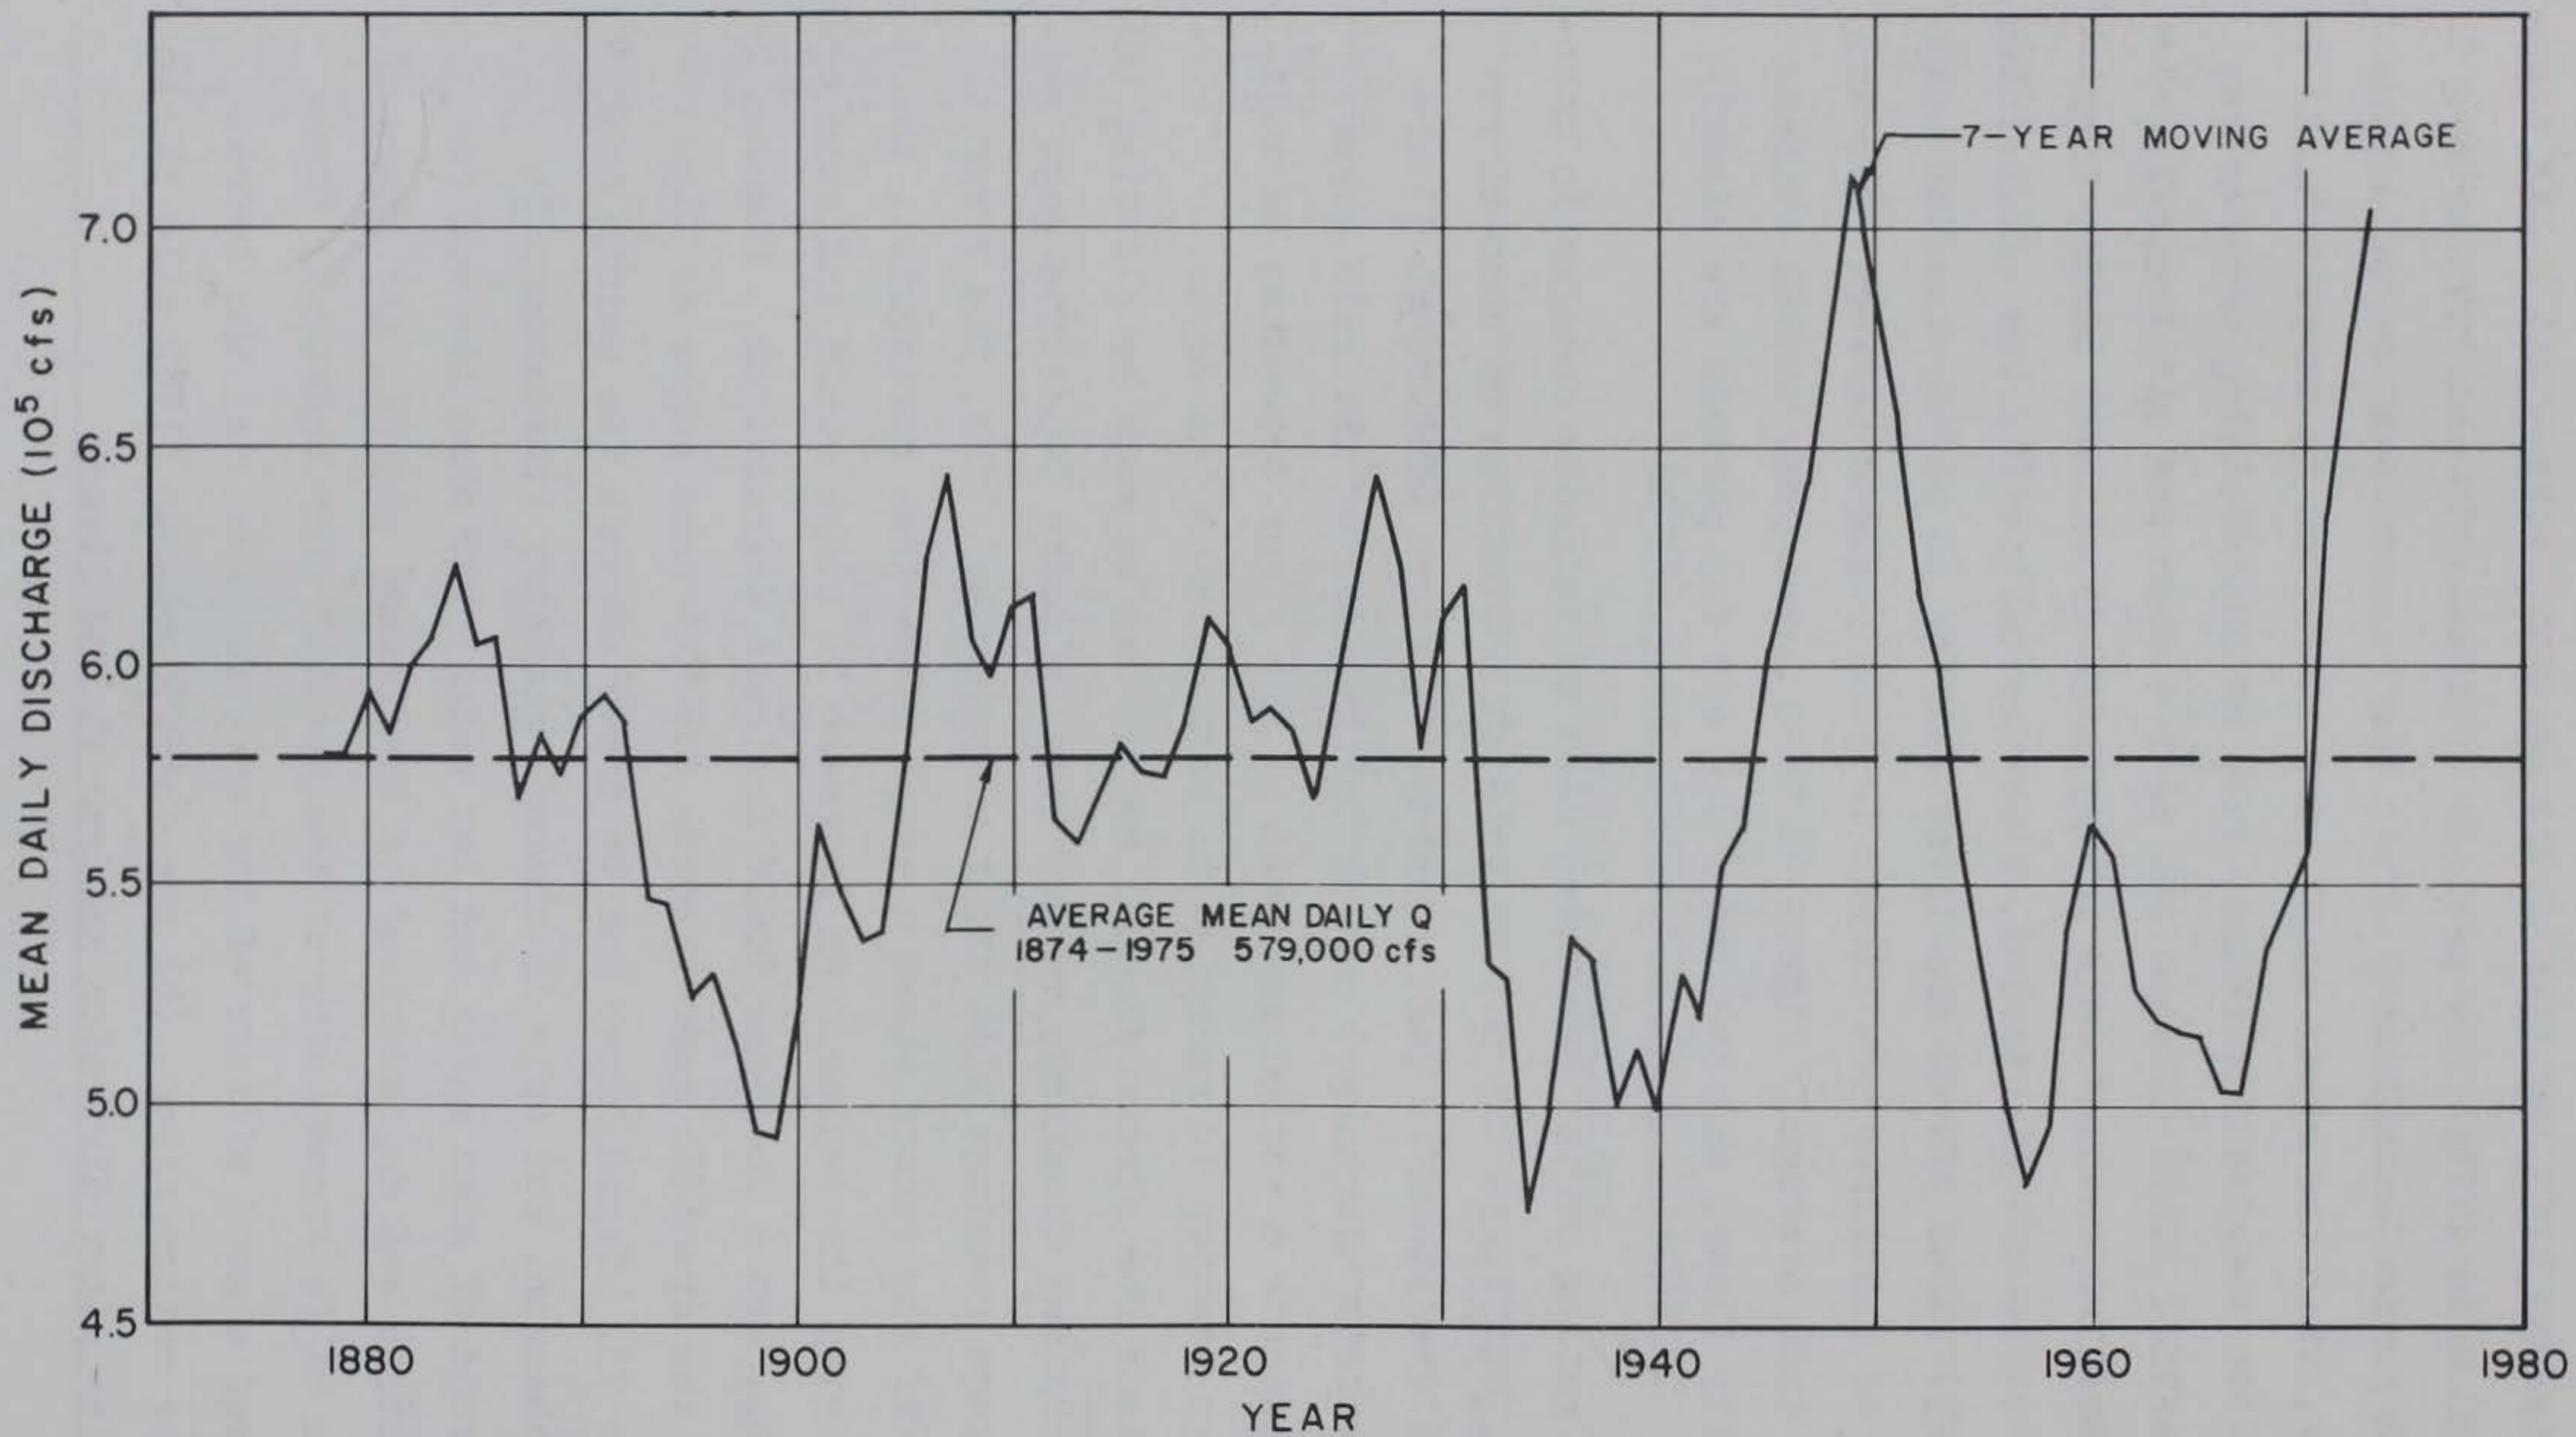
MISSISSIPPI RIVER  
POTAMOLGY STUDIES  
7-YEAR MOVING AVERAGE OF MEAN DAILY  
DISCHARGE FOR CALENDAR YEAR  
AT VICKSBURG

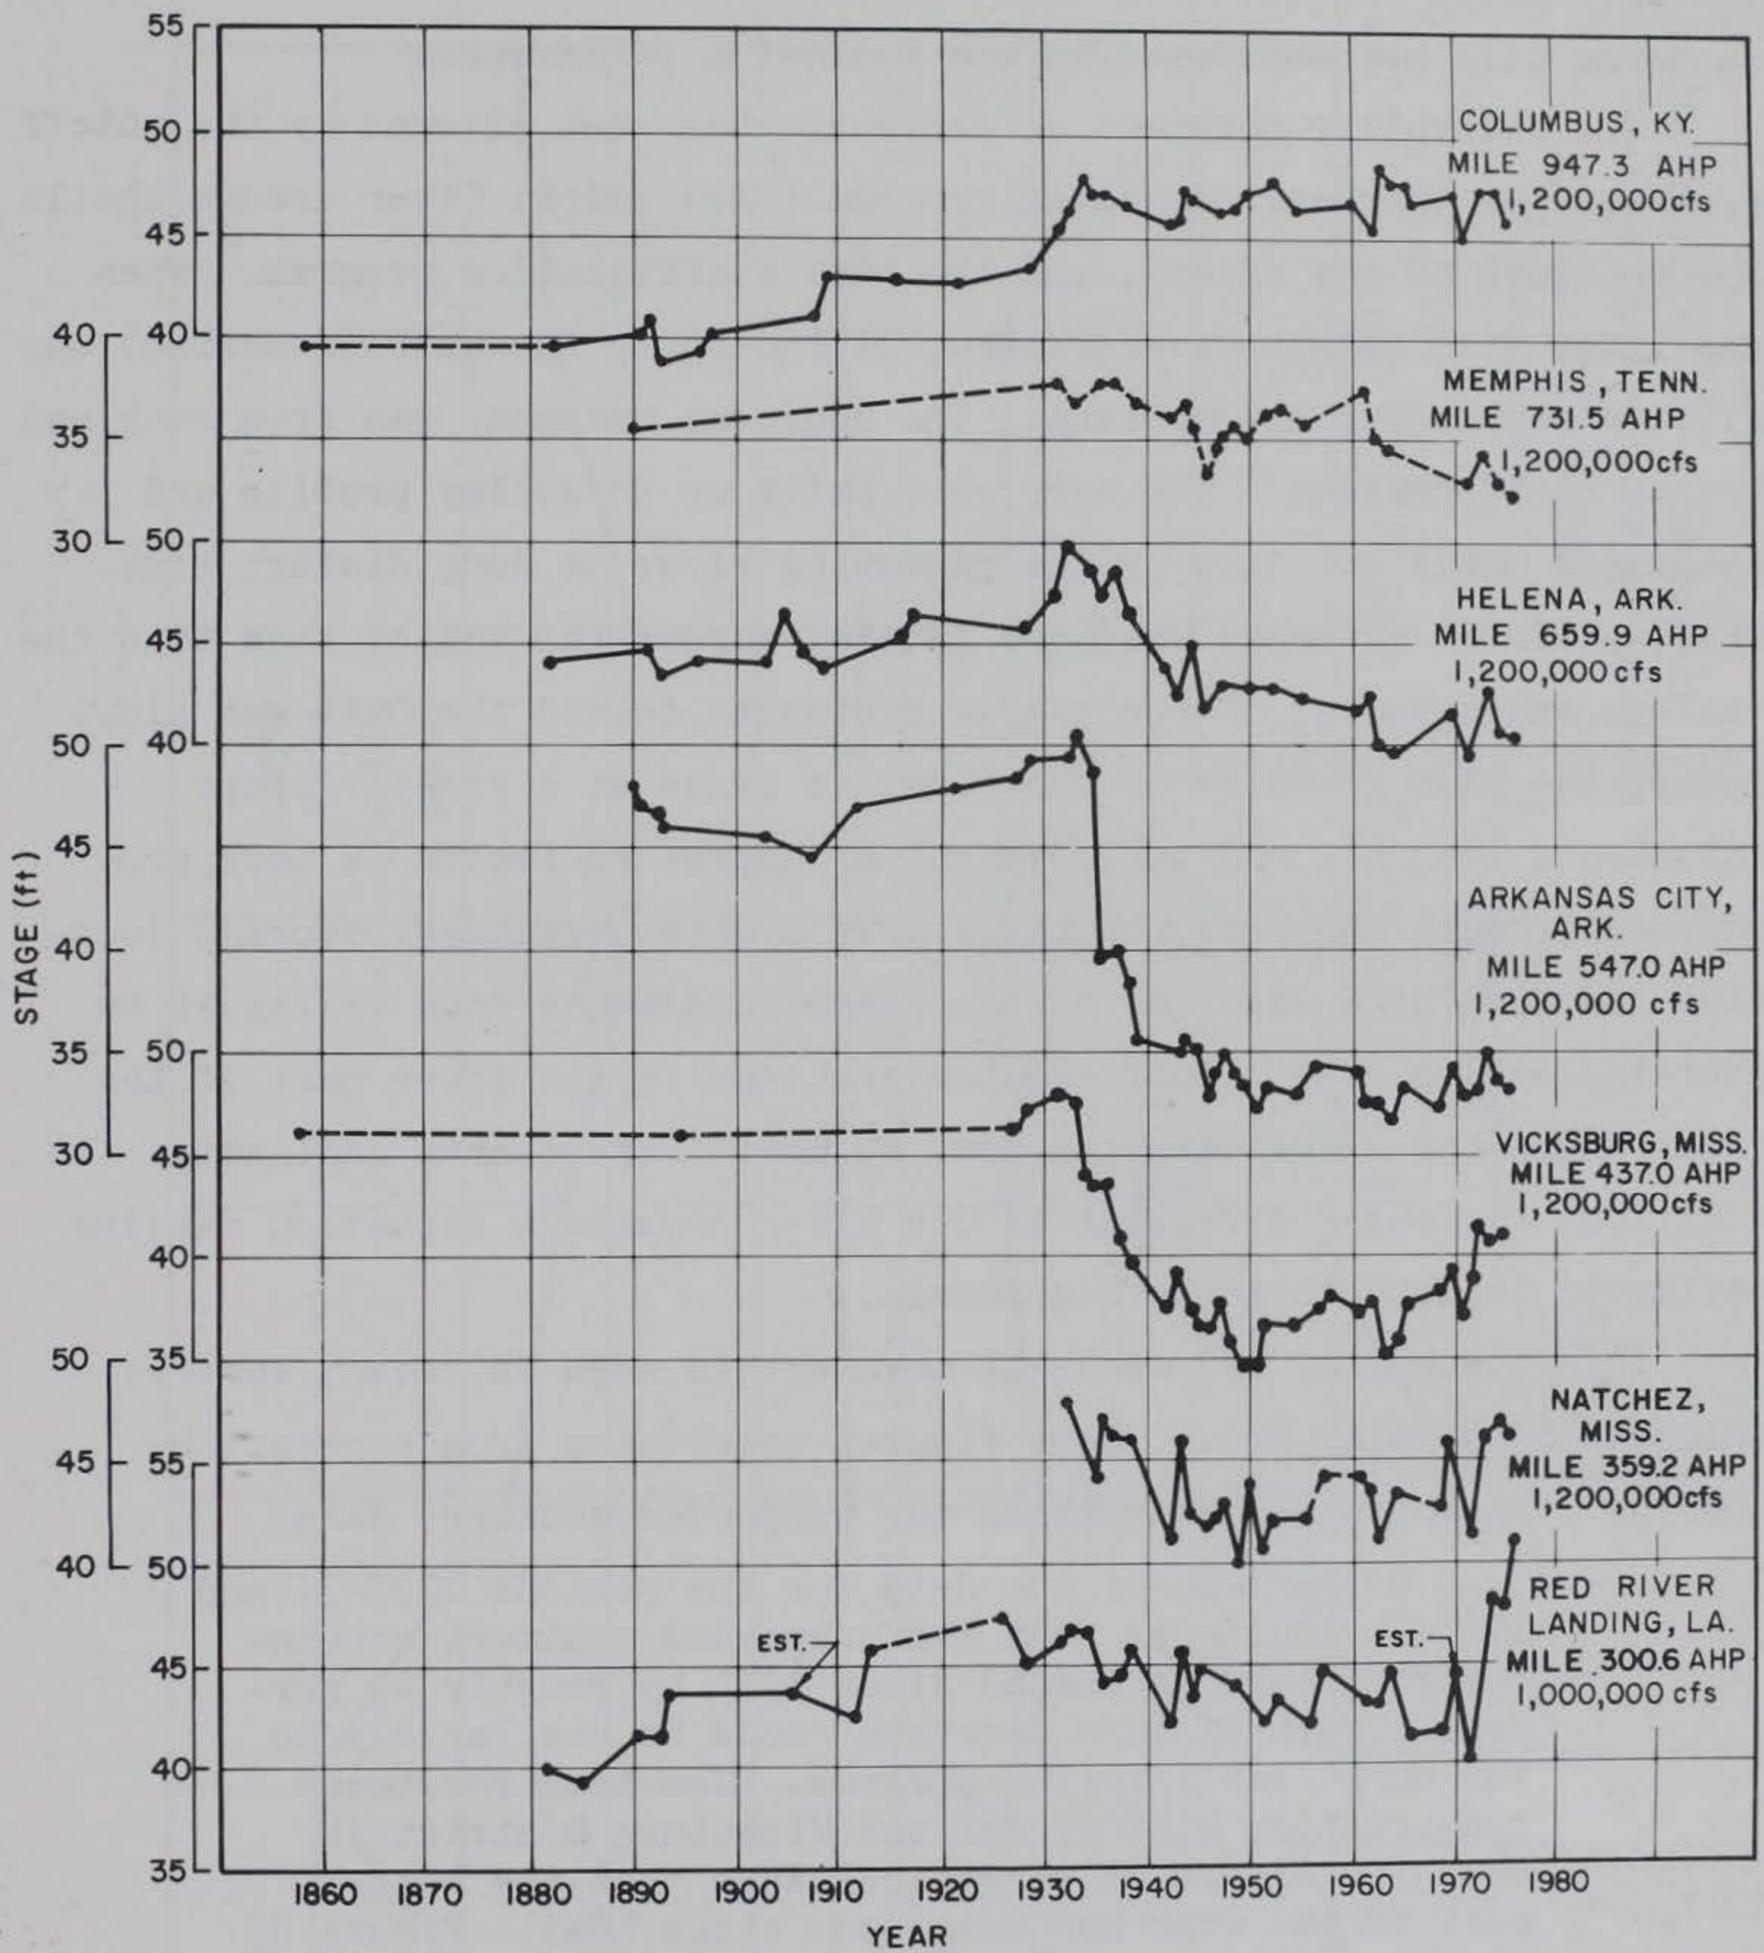
Figure 81

MISSISSIPPI RIVER  
 POTAMOLOGY STUDIES  
 SPECIFIC GAGE RECORDS  
 FOR NEAR NATURAL BANK-  
 FULL STAGES AT VARIOUS GAGES

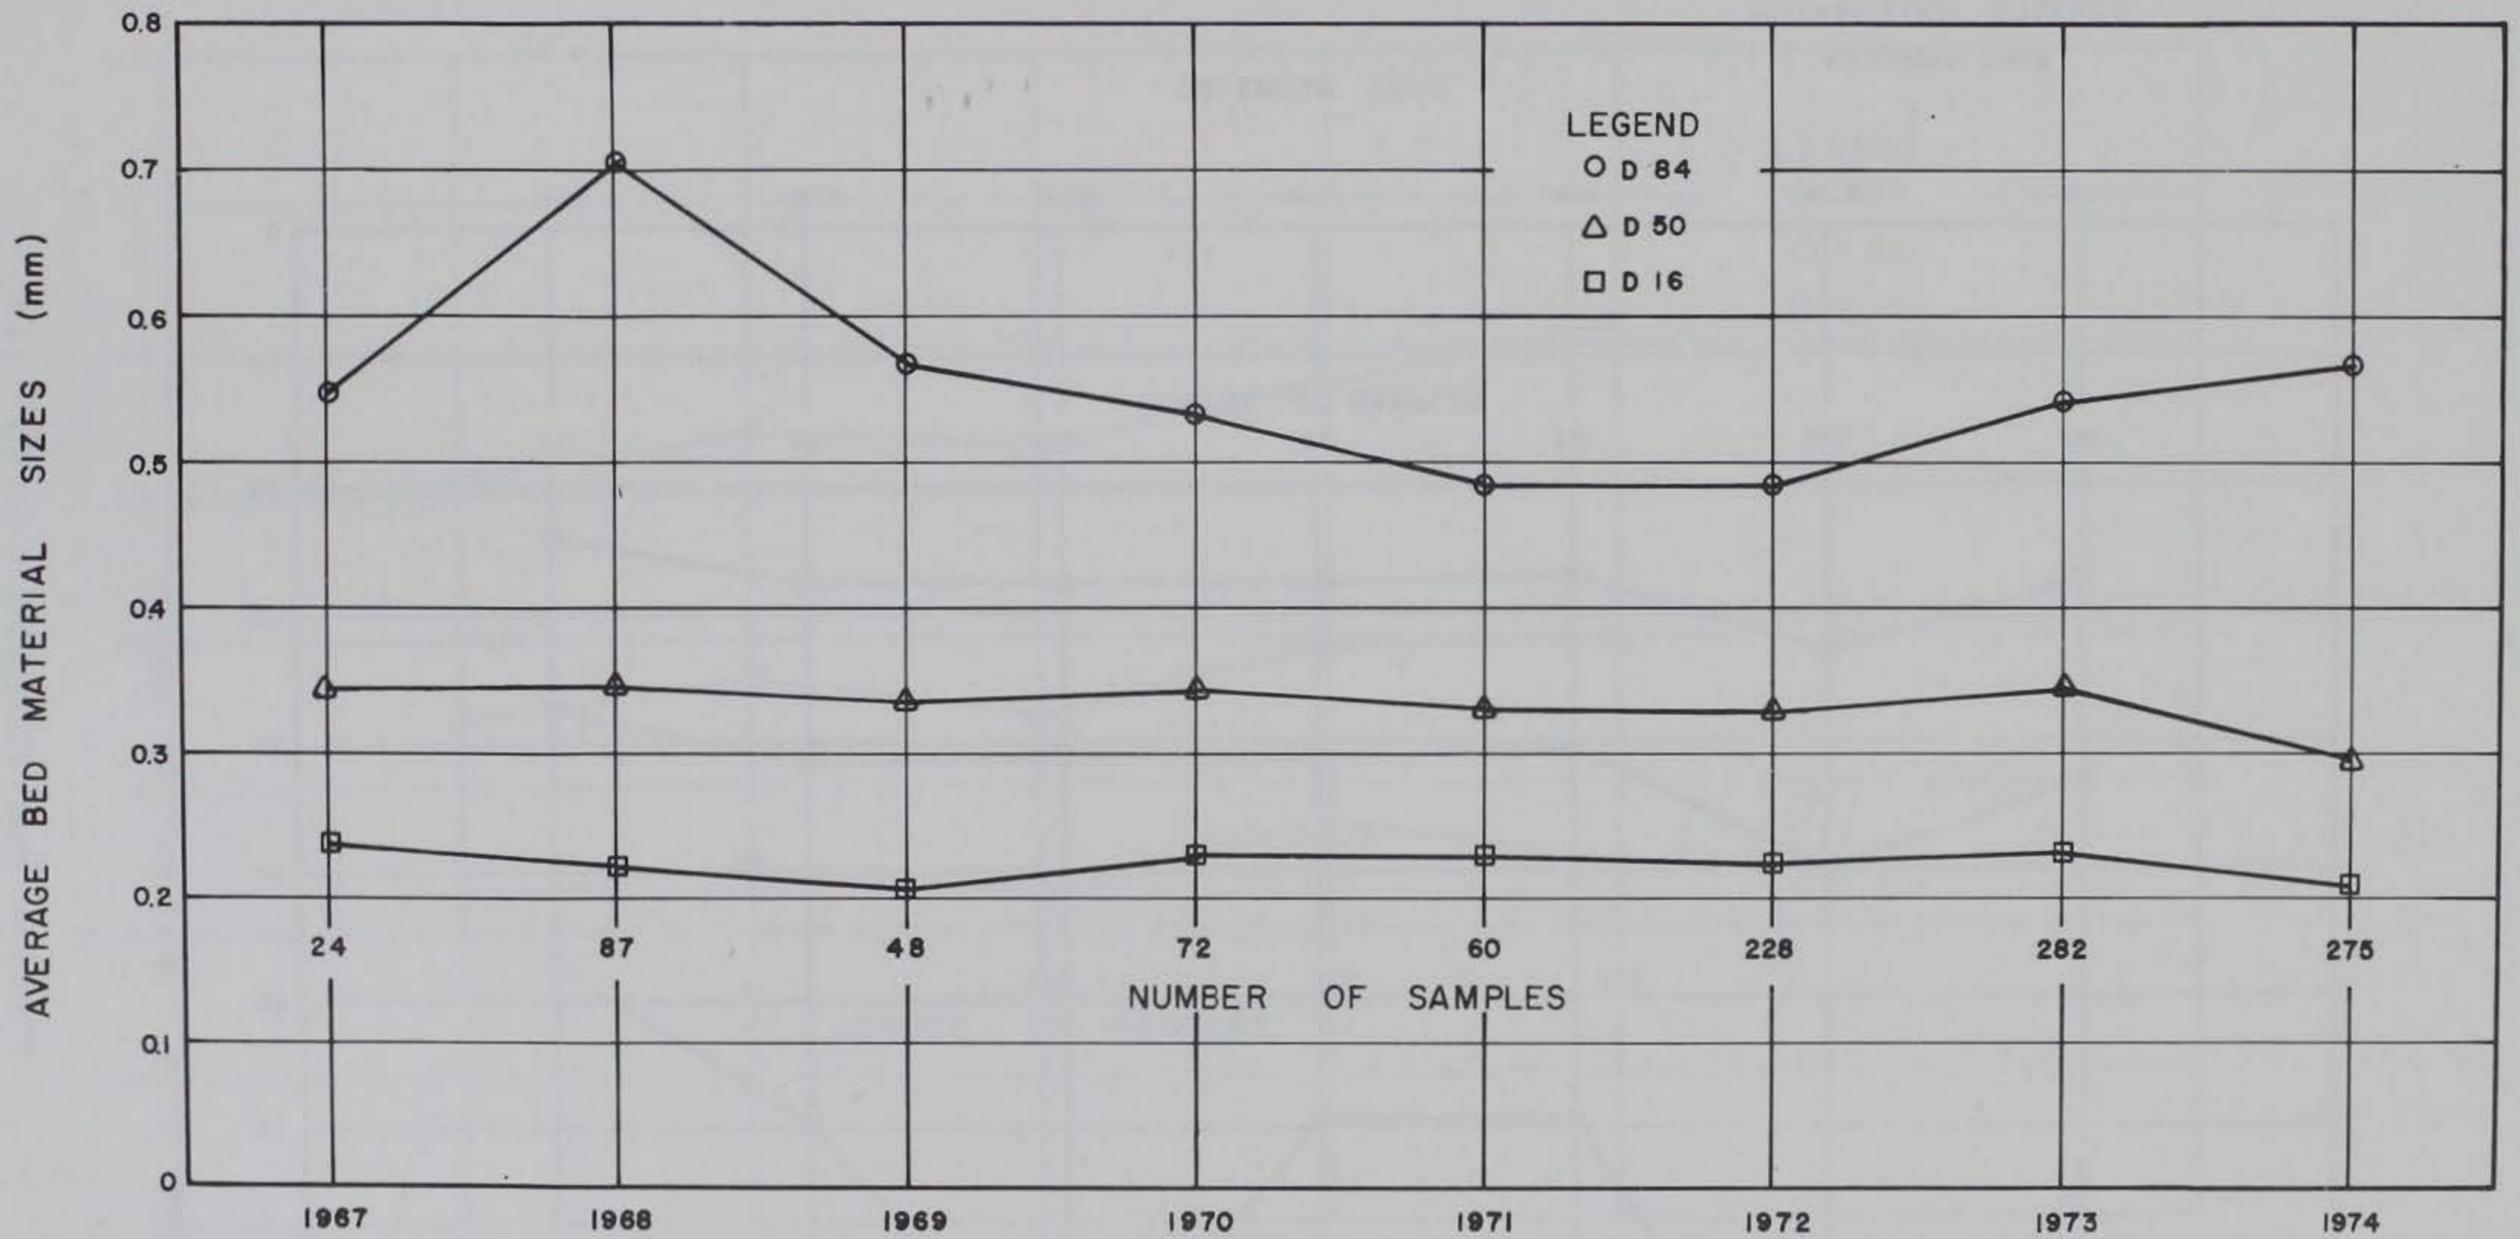
MISSISSIPPI RIVER  
 POTAMOLOGY STUDIES  
 VARIATION IN AVERAGE BED MATERIAL SIZES  
 AT ARKANSAS CITY DISCHARGE RANGE

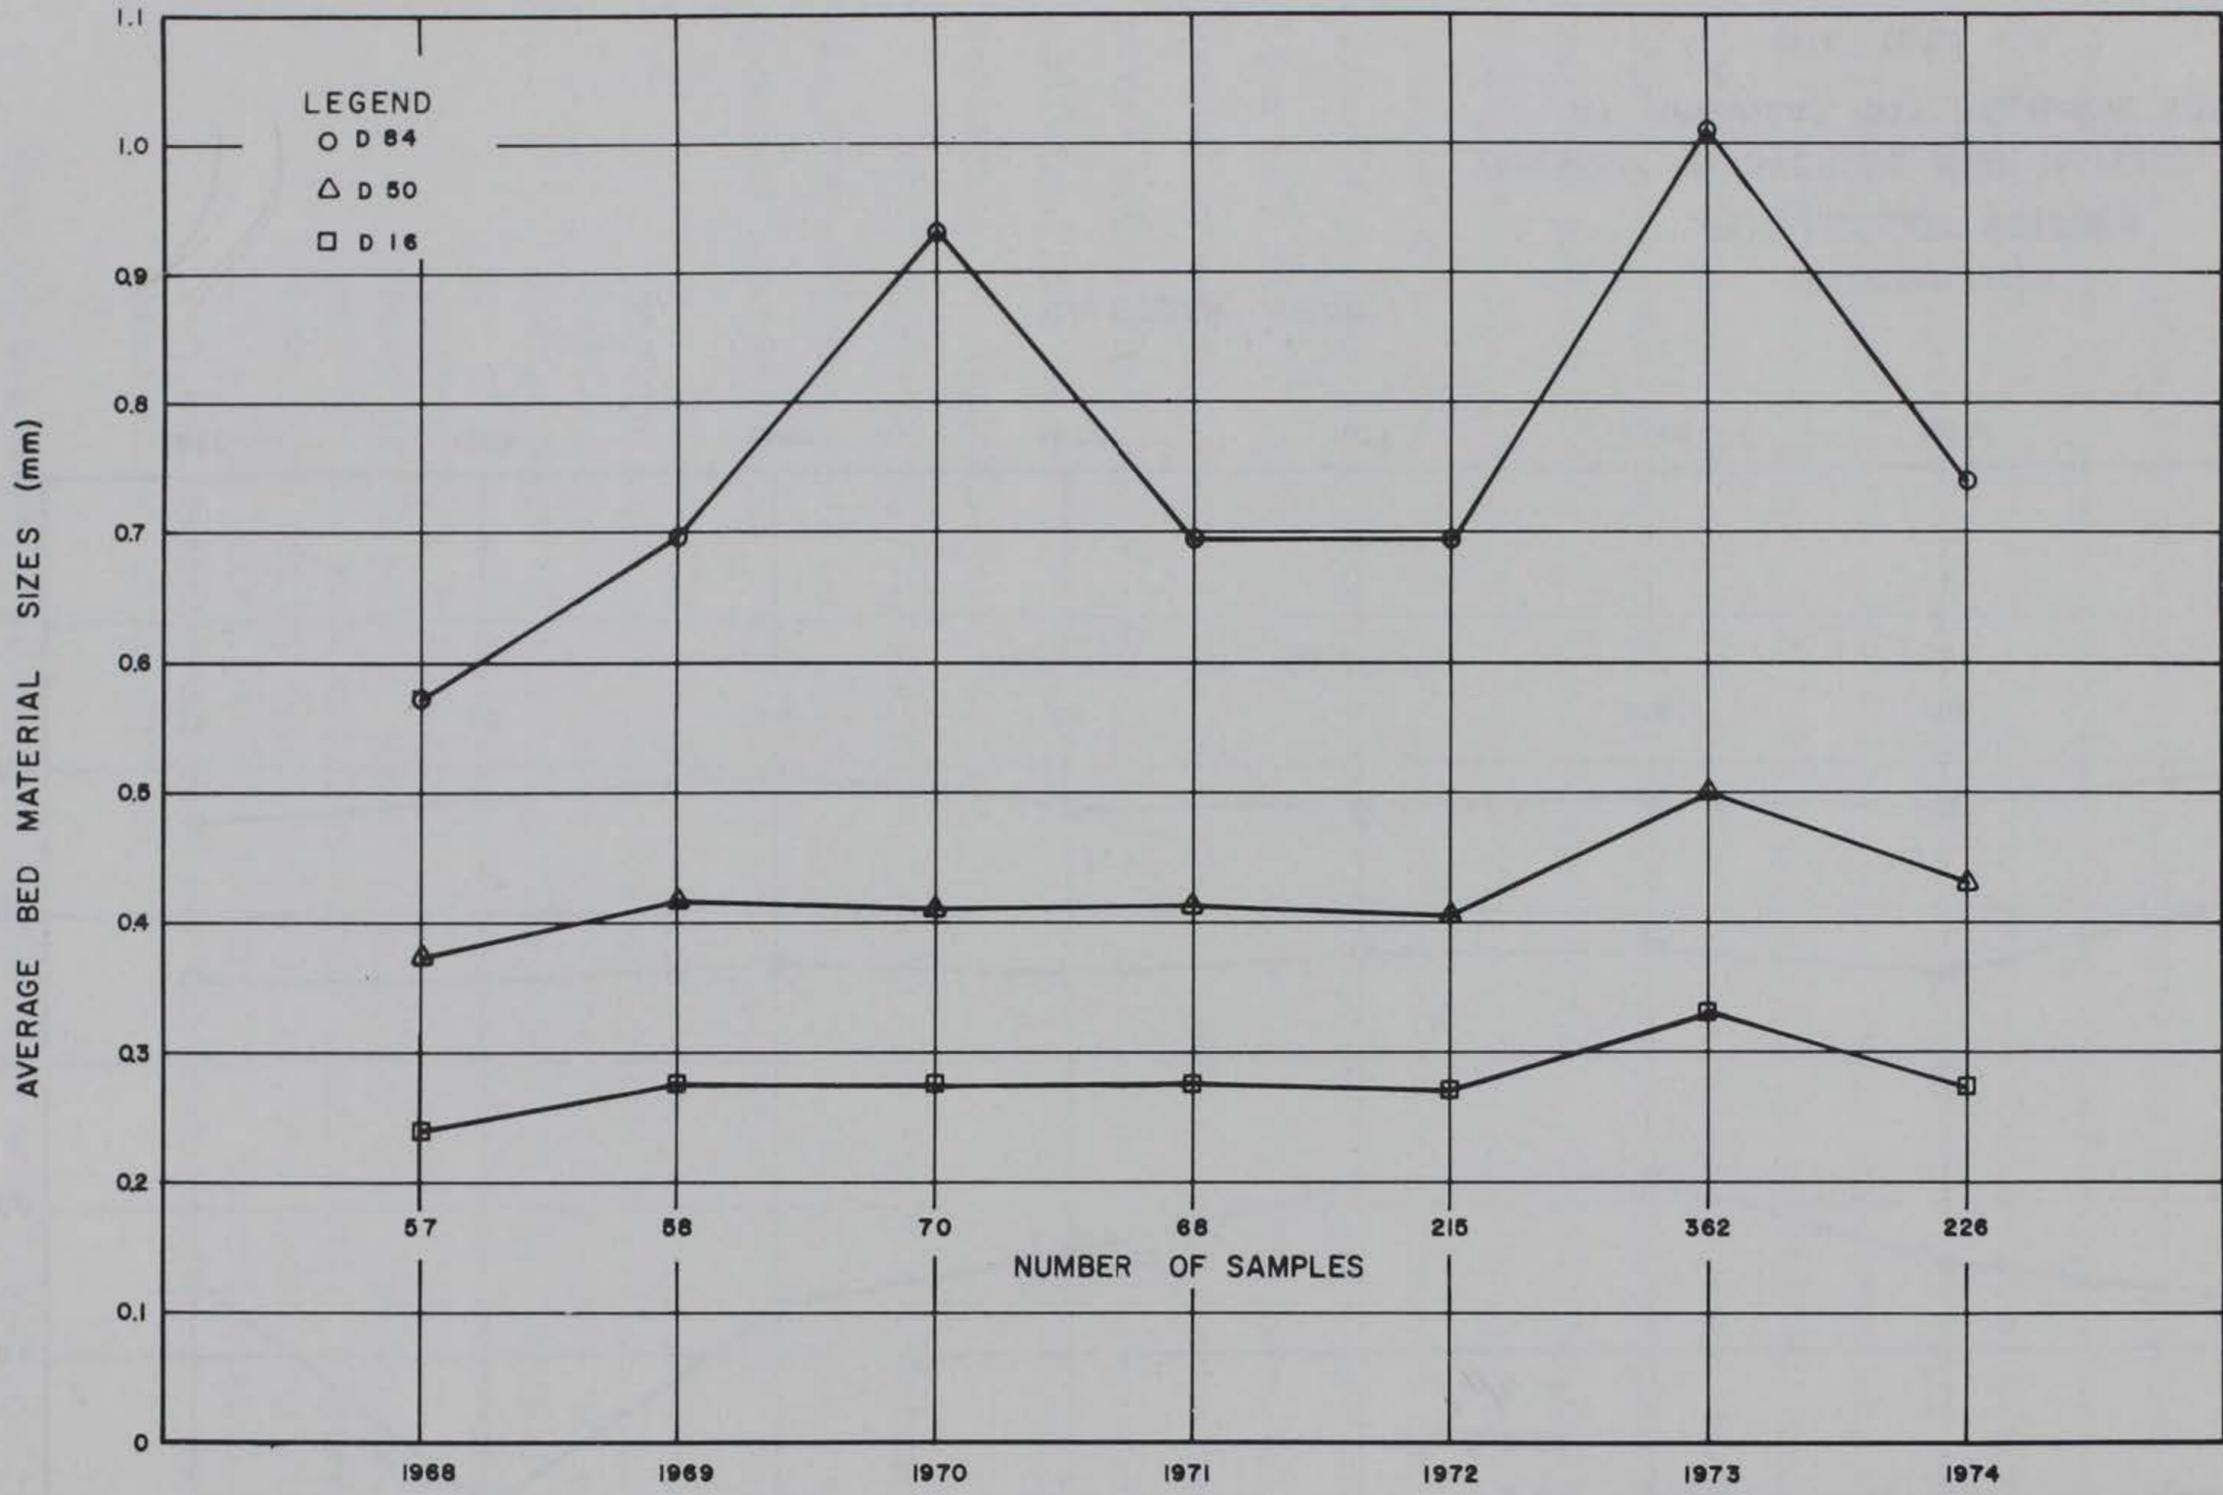
MISSISSIPPI RIVER  
POTAMOLOGY STUDIES  
VARIATION IN AVERAGE BED MATERIAL SIZES  
AT VICKSBURG DISCHARGE RANGE  
MILE 435.41 AHP

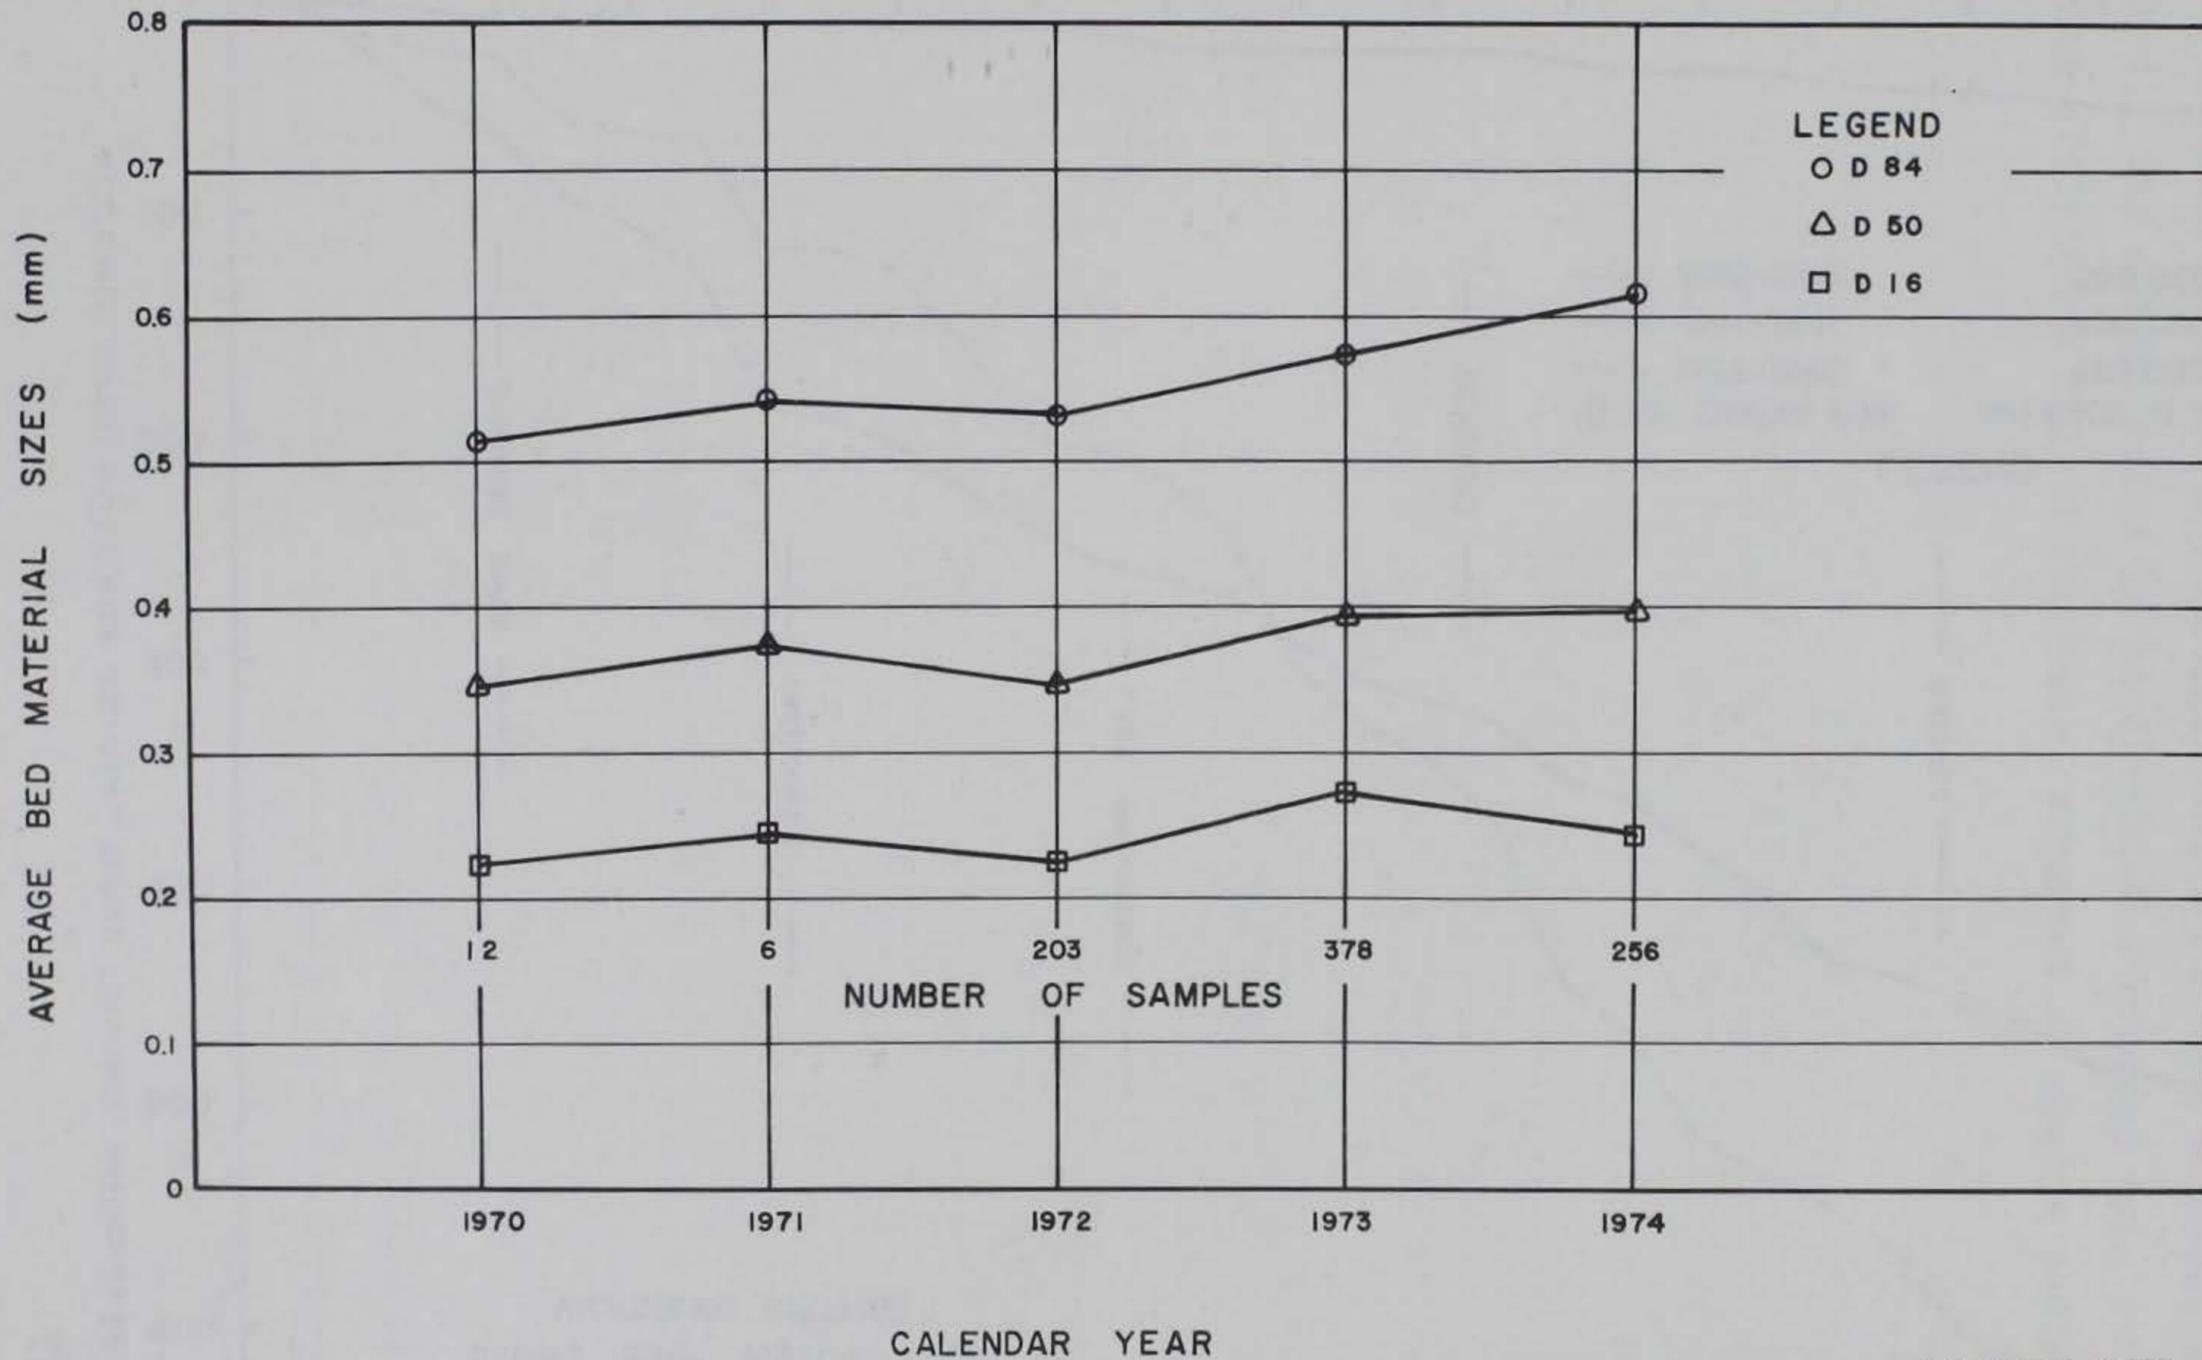
MISSISSIPPI RIVER  
 POTAMOLOGY STUDIES  
 VARIATION IN AVERAGE BED MATERIAL SIZES  
 AT NATCHEZ DISCHARGE RANGE  
 MILE 362.34 AHP
