POTAMOLOGY INVESTIGATIONS

Report 21-3

INVESTIGATION OF EXISTING DIKE SYSTEMS
POTAMOLOGY RESEARCH PROJECT 9

May 1969

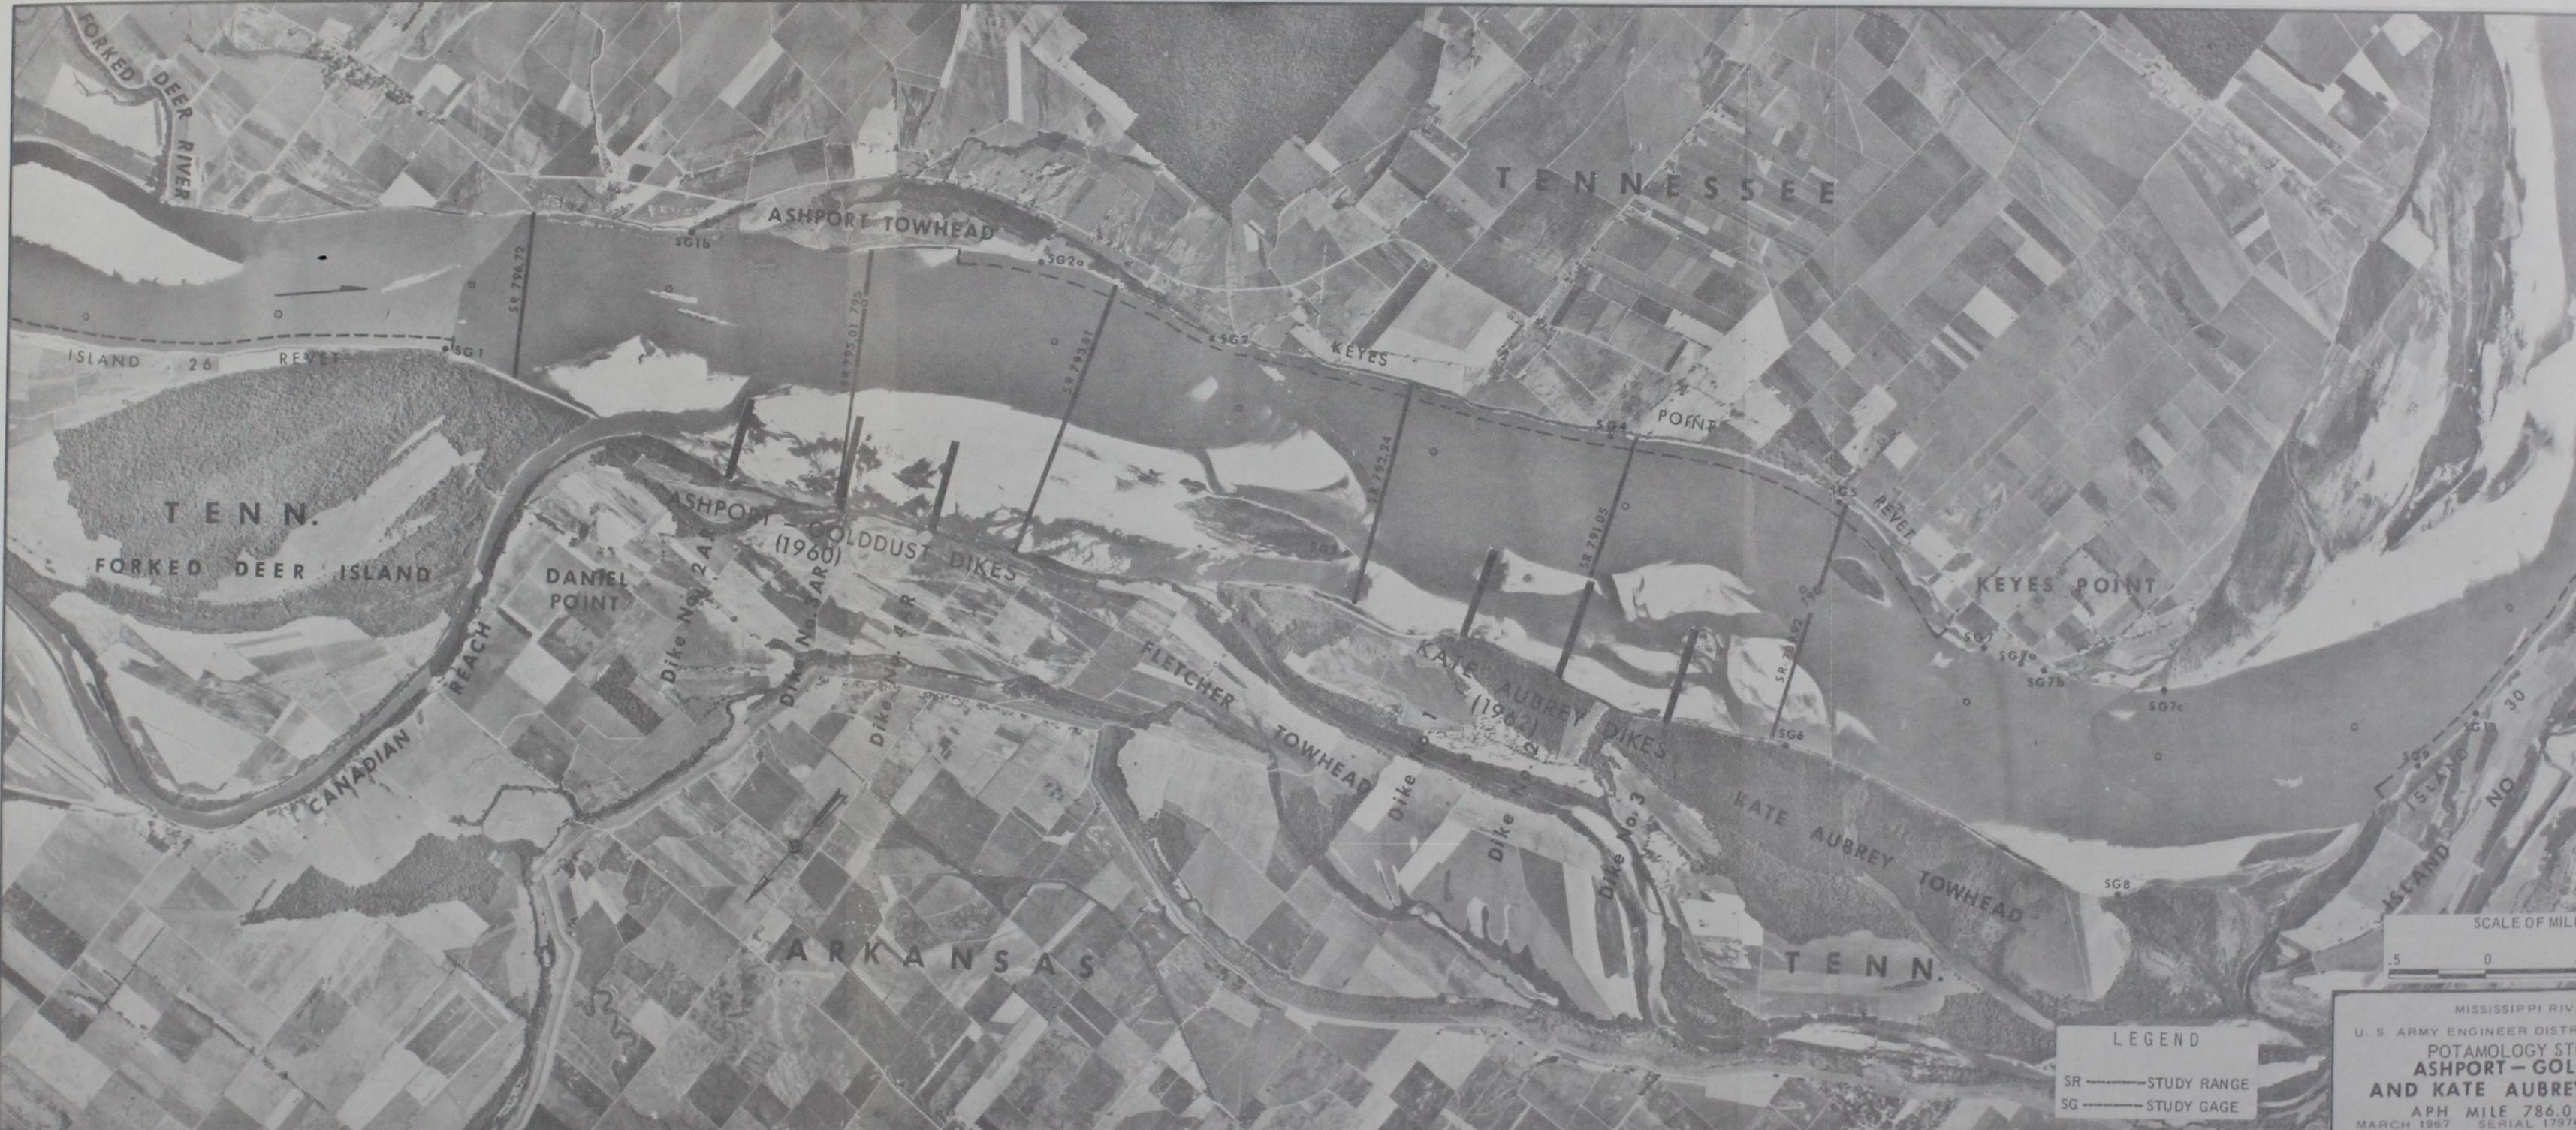
12. Ashport-Golddust and Kate Aubrey is a long and relatively straight section of river located about 55 miles above Memphis (see Plates 1 and 12). The study reach extends from the lower end of Island 26 Revetment to the upstream end of Island 30 Revetment, a length of about 11.0 miles, with limits from Miles 797.0 to 786.0. The excessive riverbed width has caused meandering of the low water navigation channel, resulting in its present unstable condition. Wide shoal crossings have caused insufficient navigation depths at low stages. The main channel follows the left bank through most of the reach, but an undesirable secondary channel has developed down the right bank extending most of the length of the reach and causing deterioration of the main channel. The flow is divided at Fletcher Towhead in the upper portion of the reach and Kate Aubrey Towhead in the lower portion, with a smaller bar opposite Kate Aubrey Towhead which further divides the flow into a main channel and two secondary channels, one along each bank. This division of flow is responsible for many of the adverse conditions existing in this reach. Low water channel widths vary from 2,400 to 4,500 feet and average 3,600 feet. Low and high water slopes through the reach average 0.68 and 0.41 feet per mile, respectively.

MISSISSIPPI RIVER
 U. S. ARMY ENGINEER DISTRICT
 POTAMOLOGY STUDY
**ASHPORT - GOLDDUST
 AND KATE AUBREY**
 APH MILE 786.0 -
 MARCH 1967 SERIAL 17974

17. Six study ranges were established in the Ashport-Golddust and Kate Aubrey Reaches to ascertain any change in channel cross section at critical points (see Plate 12). These study ranges are 796.72, 795.01, 793.81, 792.24, 791.05, and 789.92. The original conditions are shown by a 1960 survey and for comparison a 1965 survey is used to show conditions after the two dike systems had been in place 3-5 years (see Plates 16 through 21). Various surveys made between these dates were included to show the progressive changes. Cross sections are plotted looking downstream. The channel has enlarged and deepened at Range 796.72 while the opposite has occurred farther downstream at Range 795.01. The chute has enlarged at the latter range. At Ranges 793.81 and 792.24, the channel has become narrower and deeper, while the chute has filled slightly at the upper range and enlarged at the lower. The channel has decreased slightly in area but more important is the shifting of the channel from the approximate midpoint of the riverbed to the left bank, as was pointed out in paragraph 16. The channel depth has not changed materially with this realignment, but the chute has enlarged to some degree. Farther downstream at Range 789.92 there is a secondary channel along each bank in addition to the main channel. The chute along the left bank has widened considerably with the rapid caving of the towhead. This caving has caused a fill in the main channel which has practically eliminated divided flow at this point. The right bank channel has shown a sizeable decrease in area since the dikes were built. The main channel has widened but has become much shallower during this time. This section points out the highly unstable nature of the channel within this reach. Stage hydrographs for each survey are shown on Plate 22 to indicate flow conditions. Stage fluctuations during these survey dates were normal except for the July 1965 survey. During this time the stage was rising at a rate of 2.5 feet per day.

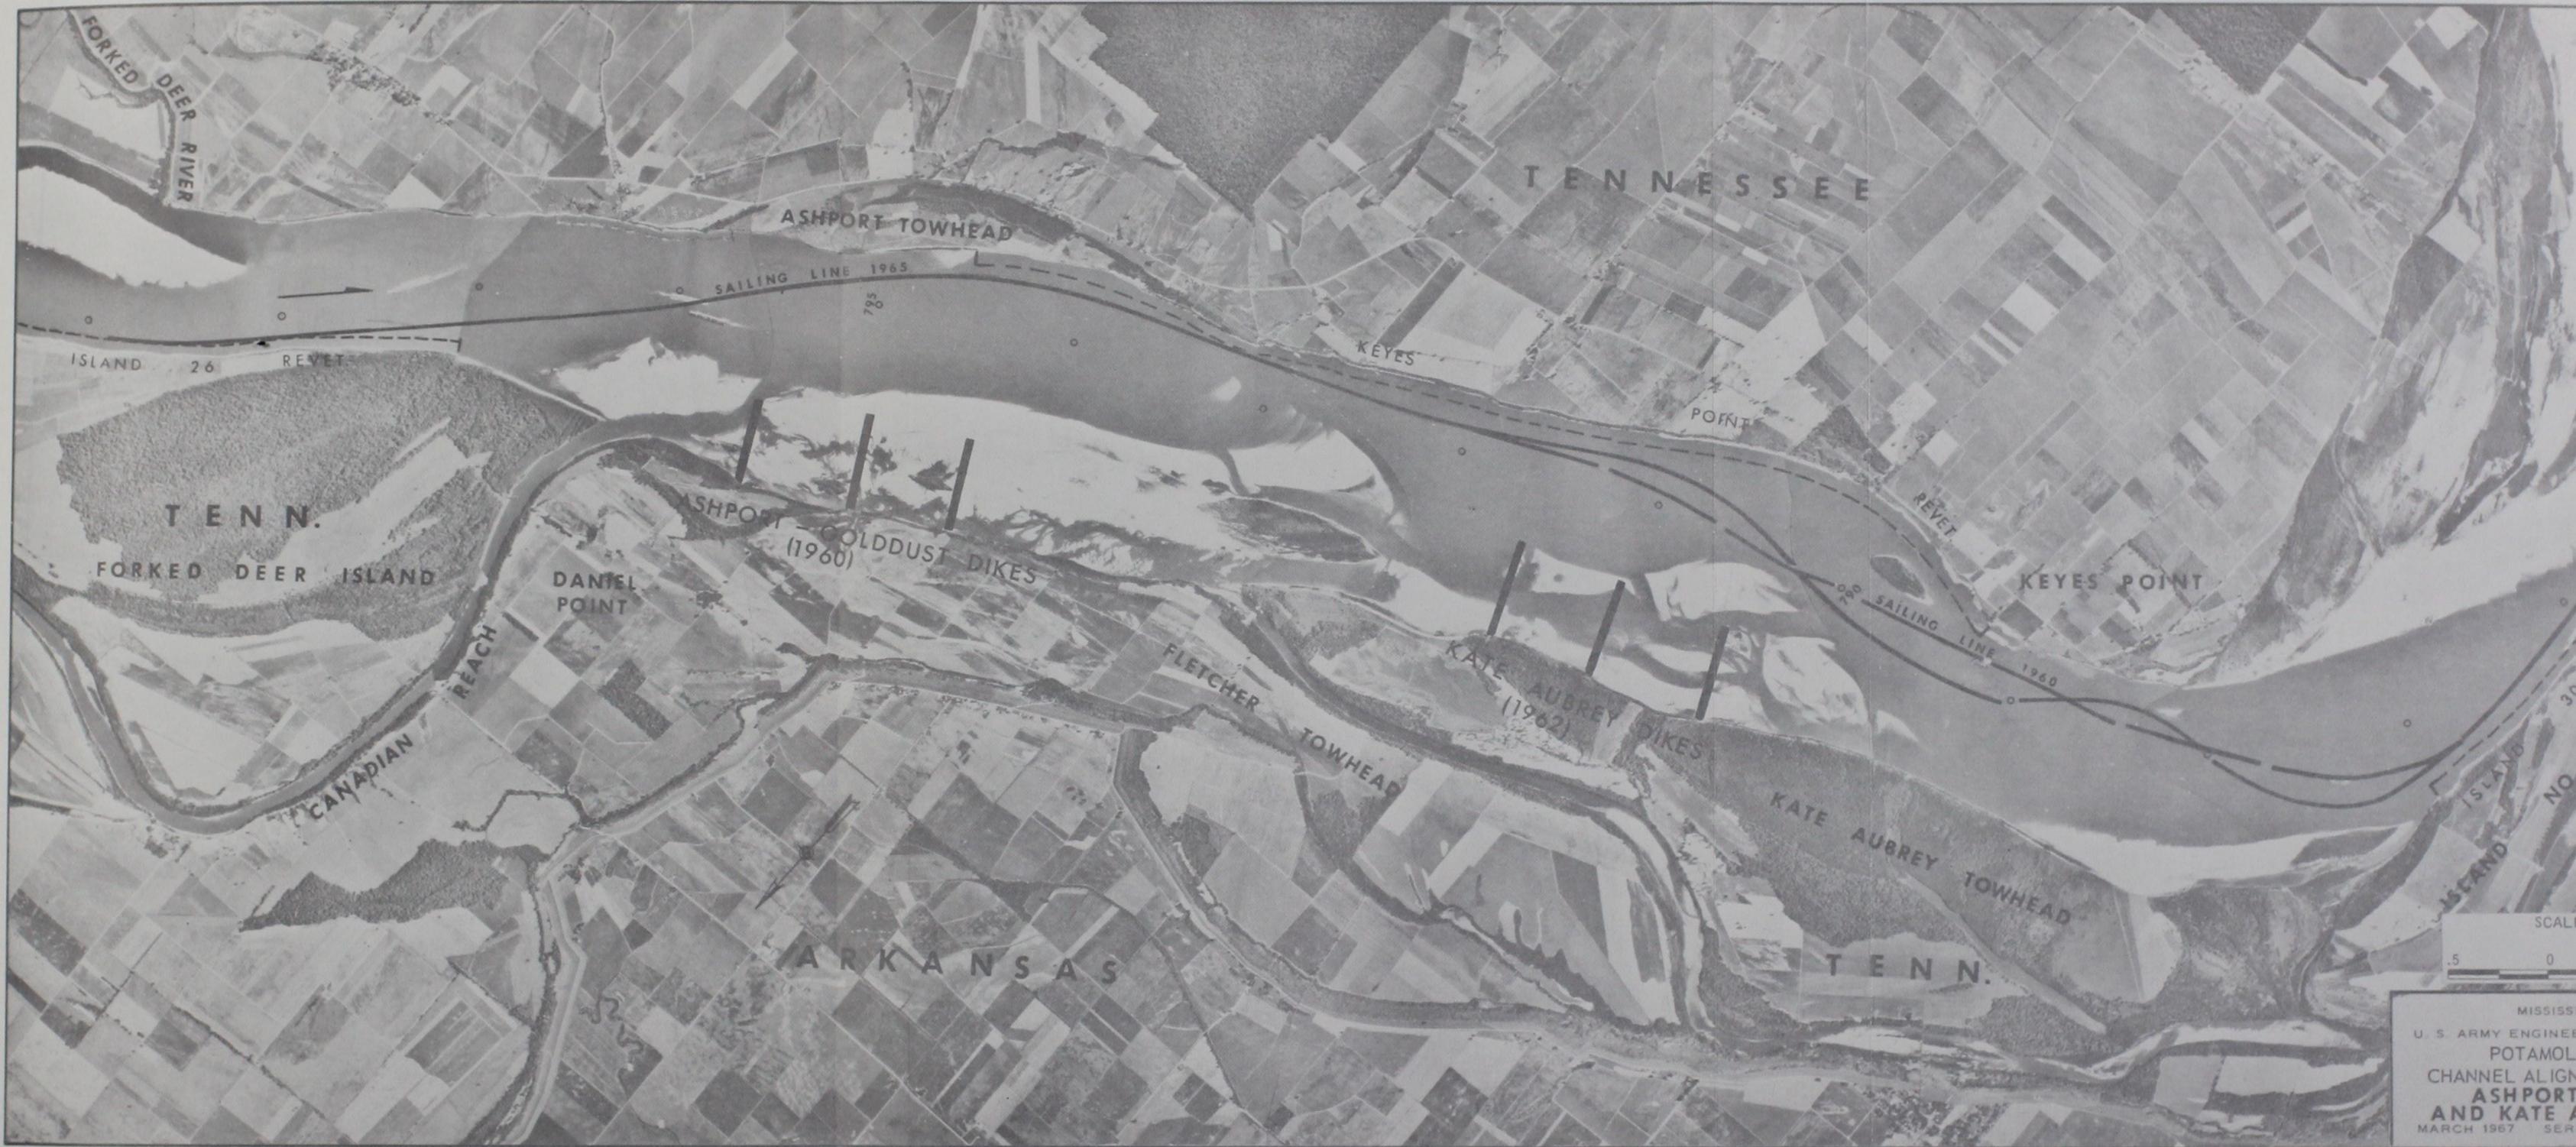
SCALE
 .5 0
 MISSISSIPPI
 U. S. ARMY ENGINEER
 POTOMAC
 CHANNEL ALIGNMENT
 ASHPORT
 AND KATE AUBREY
 MARCH 1967 SER
