# Kikiaola Light Draft Harbor, Island of Kauai; Hawaii: Regional Sediment Management (RSM)

**PURPOSE:** This U.S. Army Corps of Engineers (USACE) Regional Sediment Management Technical Note (RSM-TN) reviews the initial sand bypassing effort conducted by the State of Hawaii, Division of Boating and Ocean Recreation (DOBOR), at Kikiaola Light Draft Harbor (KLDH). DOBOR, as the harbor's non-federal sponsor, implemented a sand bypass project in 2014 to help address the issues of sediment accretion up-drift of the harbor and erosion of the down-drift beaches. This RSM-TN reviews the results of the bypassing effort by performing a shoreline change analysis, reviewing beach profile monitoring reports, and quantifying recent harbor shoaling. The intent is to pave the way for beneficial use of dredged material at KLDH. Recommendations are made with respect to future sand bypass efforts and potential remediation for Kikiaola Gulch, which discharges fine grained terrestrial sediments into the harbor basin. The non-federal sponsor of this RSM study is the State of Hawaii, Department of Land and Natural Resources, Office of Conservation and Coastal Lands.

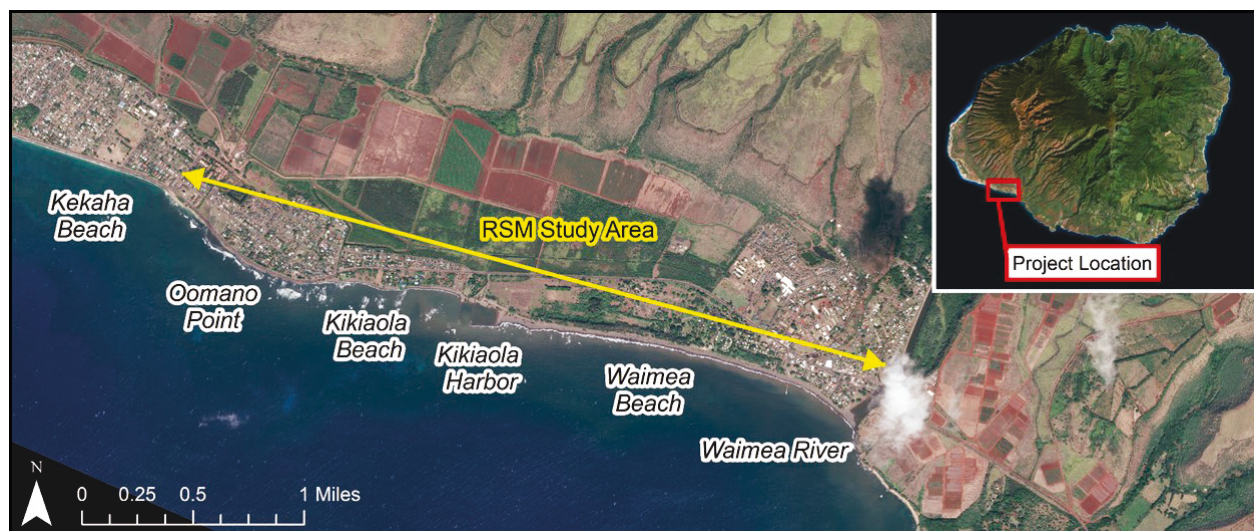
Figure 1. Overview map of the Kikiaola Light Boat Harbor study region.

60,000 cubic yards (cy) of sediment around KLDH in compliance with the non-federal items of cooperation for the federally authorized navigation project implemented in 2005. DOBOR secured the services of The Edge of Kauai (TEOK) Investigations to conduct post-sand bypass monitoring. This study considers trends from the shoreline change analysis, results of sand bypass monitoring investigations, and channel shoaling rates. RSM recommendations are proposed to reduce down-drift erosion and channel shoaling as well as to realize beneficial use of dredged material from KLDH (Figure 1).

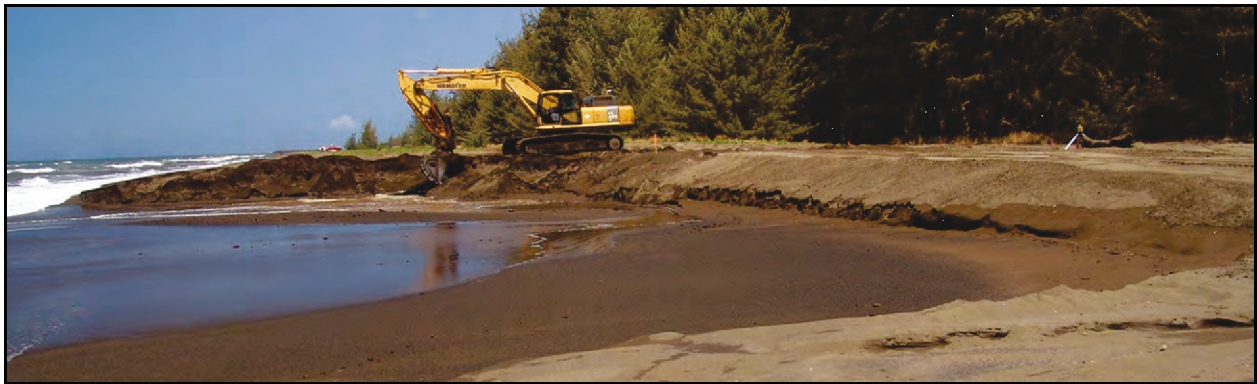
Figure 5. Excavation of the subaerial beach profile at Waimea Cottages during the first increment of the 2014 sand bypass operation. (Location number 2 in Figure 4.)

Figure 5 shows excavation of the beach profile during the initial 2014 sand bypass operation at the Waimea Cottages location. Approximately 43,800 cy of material were removed from the upper portion of the subaerial beach from 9 May–6 June 2014. Beach profile surveys were taken in April 2014 prior to sand bypassing and were followed by monthly post-sand bypassing surveys. Figure 6 is a composite graph of the survey data acquired at this location in June 2014, October 2014, and March 2017. As indicated by the figure, the beach profile has continued to recede landward since sand bypassing from this location. The beach profile has reduced in cross-sectional area equal to 1.54 times the cross-sectional area that was excavated during the sand bypass operation (Figure 6). The beach profile cross-sectional area loss totals approximately 360 square yards (sq yd). The corresponding shoreline recession was approximately 75 ft. This is in contrast to the recovery of the beach profile expected following excavation of sand from this location.

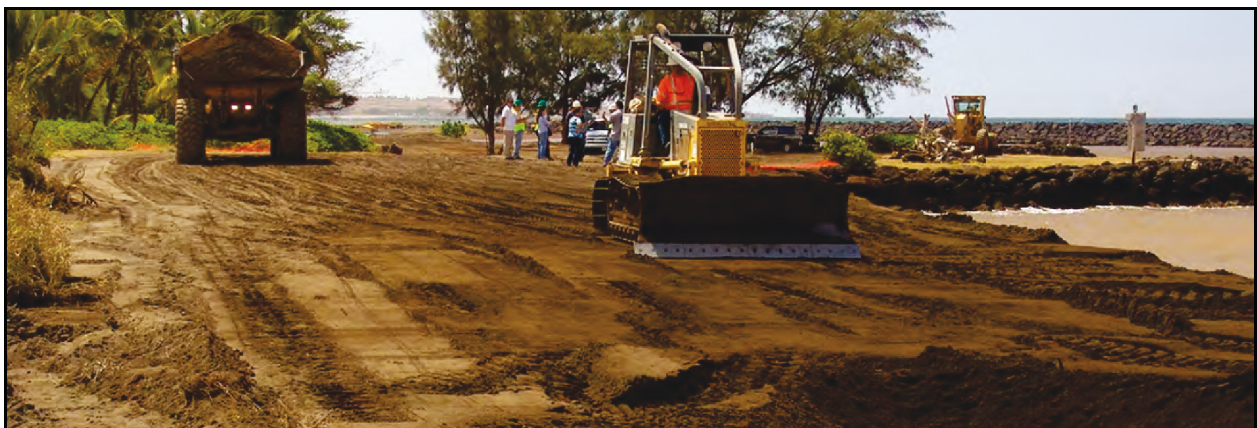
Figure 7. Placement of bypassed sand above the mean high water shoreline at the Kikiaola Harbor location during the second increment of the 2014 sand bypass operation.

Figure 7 shows placement of sand during the second increment of the 2014 bypass operation (24 July–14 August 2014) at the Kikiaola Harbor location. During the first increment, sand was placed below the mean high water shoreline. During the second increment, sand was placed above the mean high water shoreline as displayed in Figure 7. Beach profile surveys were taken in April 2014 prior to sand bypassing, followed by monthly post-sand bypassing surveys. Figure 8 is a composite graph of the survey data acquired at this location in September 2014, January 2015, and March 2017. As indicated by Figure 7, the beach profile has continued to recede landward since sand placement at this location. The total volume of sand bypassed to the down-drift beach was approximately 60,000 cy. This is relative to the beach profile cross-sectional area increase of 158 sq yd at this location. After the first 8 months following completion of the sand bypass operation, 64 sq yd of area were lost from the profile as compared to the subsequent loss of 61 sq yd over the next 26 months. The corresponding shoreline recession was approximately 26 ft. The beach profile cross-sectional area loss rate is therefore approximately 25% of what it was following completion of the sand bypass.

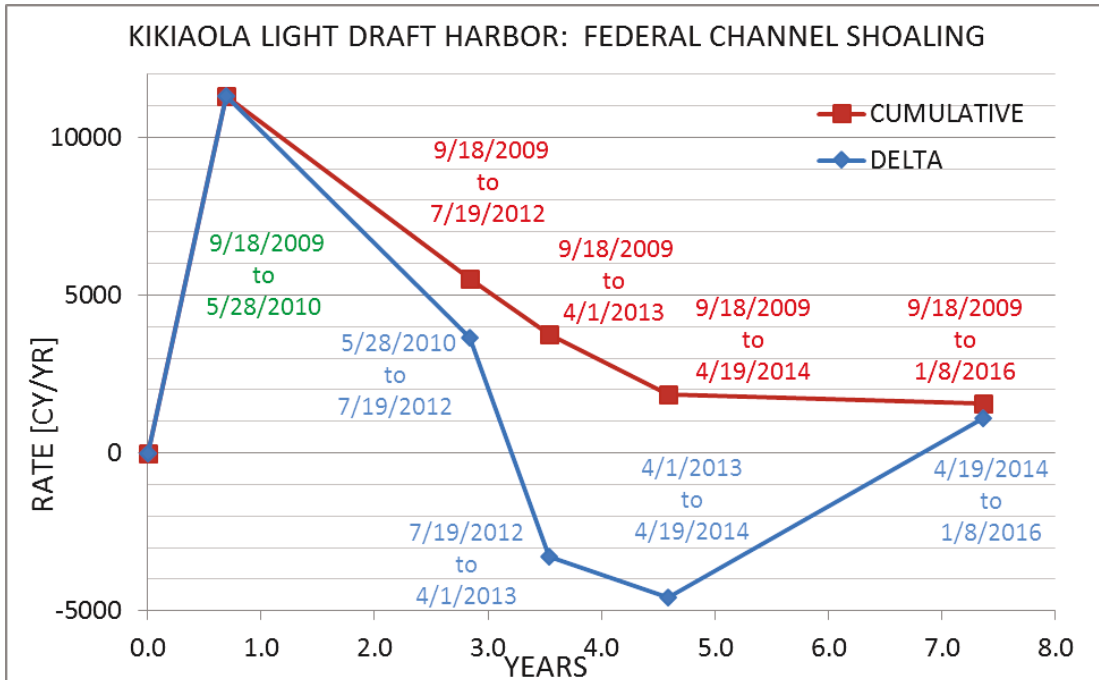
Figure 11. Shoaling rates (cy/year) within the federal project limits at KLDH.

**CHANNEL SHOALING:** Channel shoaling at KLDH has consistently decreased since the first condition hydrographic survey was acquired in 2010. As shown in Figure 11, the initial post-construction channel shoaling rate was approximately 11,000 cy/year based on volume changes calculated for the time period of 18 September 2009 to 28 May 2010. This is mainly attributed to the removal of the east breakwater spur, which had impounded sediment on its up-drift side. Once the spur was demolished, a large quantity of sediment was released and subsequently transported into the harbor channel. It can be seen in the shoaling graph (Figure 11) that both the cumulative and incremental (delta) shoaling rates trended to approximately 1,500 cy/year by the date of the latest condition hydrographic survey in 2016. Negative shoaling rates were calculated in the comparison of the 2010–2013 and 2013–2014 surveys. These anomalies are thought to be a result of propeller dredging within the federal project limits rather than survey error. A contract was awarded in September 2017 to dredge within the federal project limits to authorized depths, an estimated 12,000 cy. It is predicted that channel shoaling will be on the order of 1,000 cy/year following completion of the project and into the near future.

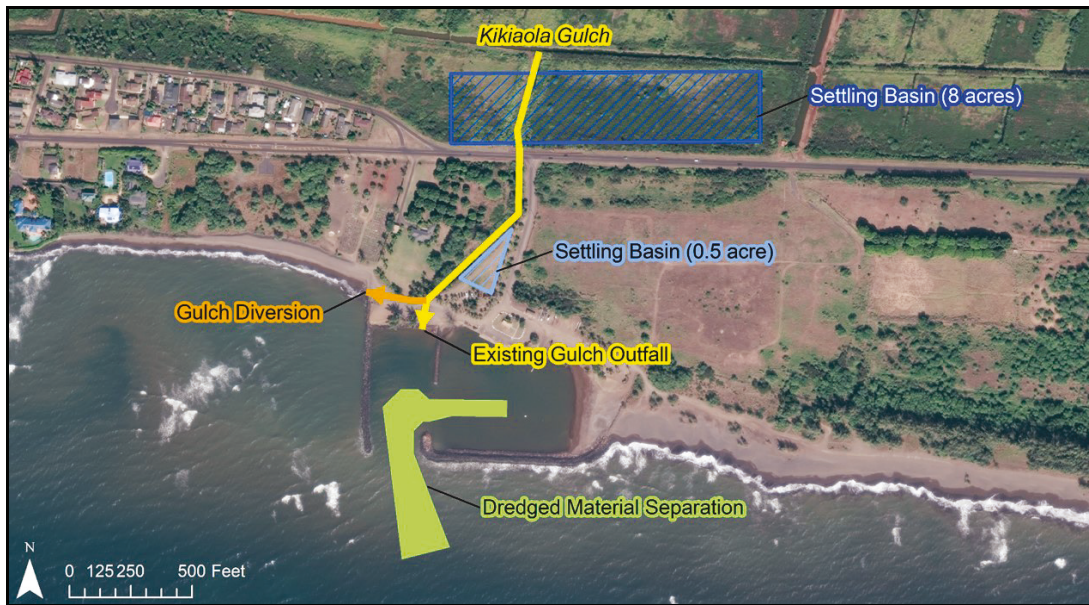
Figure 12. Alternative features considered for mediation of sediment quality within KLDH.

**PAVING THE WAY FOR BENEFICIAL USE OF DREDGED MATERIAL AT KLDH:** Historically, the material dredged from KLDH has not been suitable for beach placement. Silt and clay from the adjoining agriculture land is delivered to the harbor via Kikiaola Gulch (Figure 12).

**Gulch Diversion.** Currently, KLDH serves as an 8-acre settling basin for silt and clay discharged from Kikiaola Gulch (Figure 12). As noted earlier, the input of fine grained terrestrial material renders the littoral sediments transported into the harbor through the entrance channel unsuitable for beach placement. Diversion of the gulch to the west and outside of the harbor (Figure 12) would improve sediment and water quality within the harbor. Environmental impacts and potential mitigation for gulch diversion will need to be quantified to qualify this as a viable alternative. Discharge from Kikiaola Gulch to the west into the Kikiaola Beach nearshore (Figure 1) would dissipate over an extended area as influenced by wave and currents. Impacts to offshore resources can be baselined by existing conditions and compared to future monitoring results. If this alternative is pursued and the Kikiaola Gulch direct discharge to the west (prevented from entering the KLDH) into the nearshore is found to be unacceptable, the present conveyance of gulch discharge into the KLDH can be resumed.
