**US Army Corps
of Engineers®**

Engineer Research and
Development Center

Evaluation of Stone-Monument Repair Materials for Potential Use in Interim Repair of Frost-Damaged Concrete Navigation Structures

September 2007

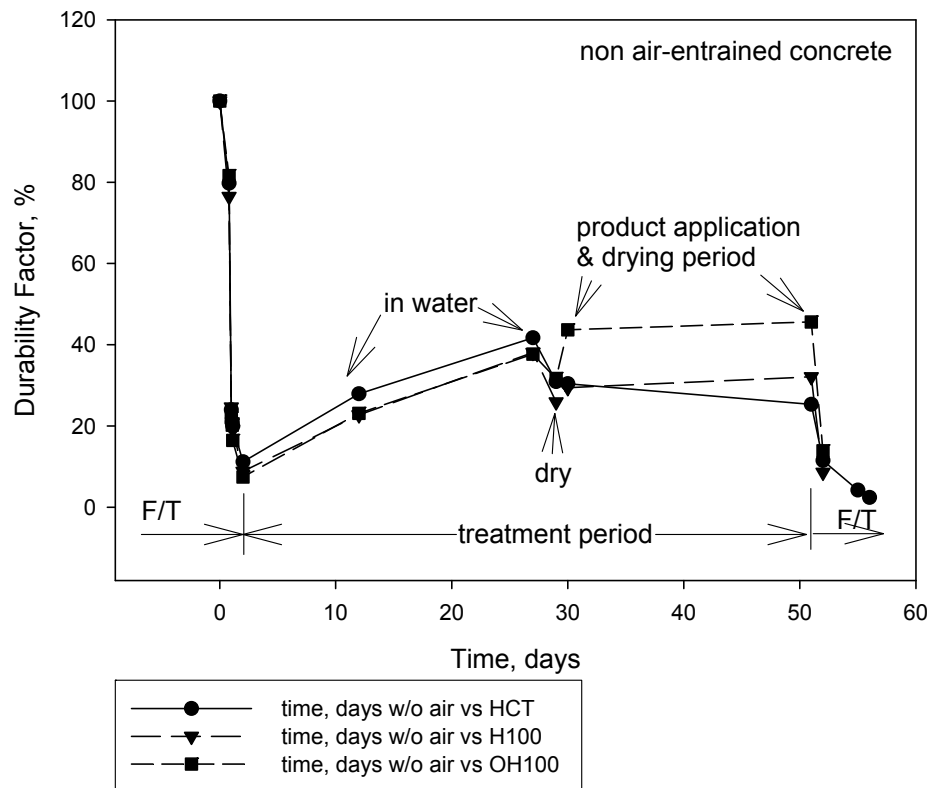
Figure 1. Durability factor (%E) versus treatment time (days) for Prosoco products used on non-air-entrained concrete samples.

Results for the non-air-entrained specimens are shown in Figures 1 and 2. Figure 1 is a plot of Relative E versus time in days. This graph emphasizes the details of the change in Relative E during the treatment period. Figure 2 is a plot of Relative E versus number of cycles of freezing and thawing. This graph emphasizes the before-and-after treatment comparison.

As shown in Figure 1, there was some recovery of modulus following the period of initial freezing and thawing during the period of soaking in water. However, modulus decayed very rapidly upon resumption of freezing and thawing cycles.

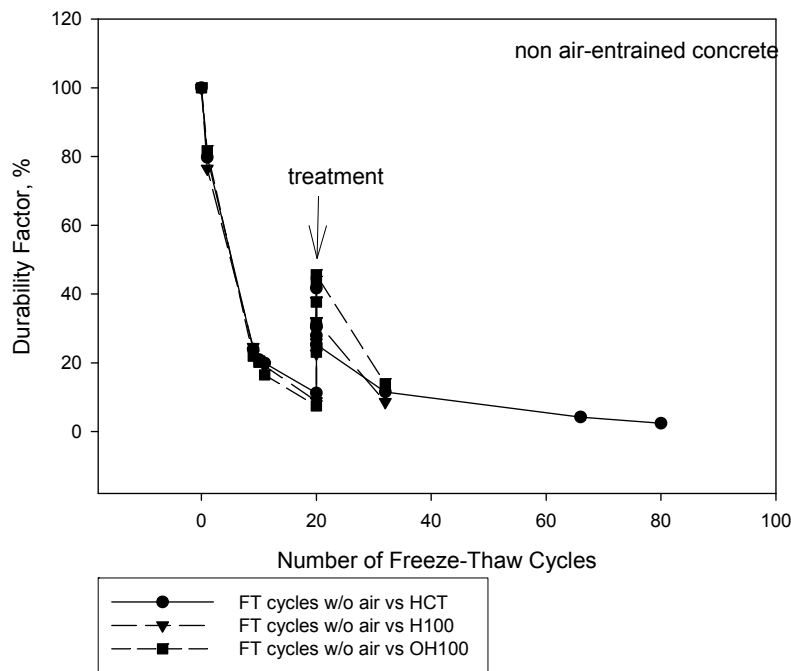
Figure 2. Durability factor (%E) versus number of cycles of freezing and thawing for Prosoco products used on non-air-entrained concrete samples.

Figure 2 puts the rate of decline in durability factor into better perspective. This presentation shows that damage accumulated with increasing cycles of freezing and thawing in a non-linear way. The shape of the decline suggests an exponential decay type function. The application of stone strengthener products seemed only to temporarily interrupt the rate of this process.

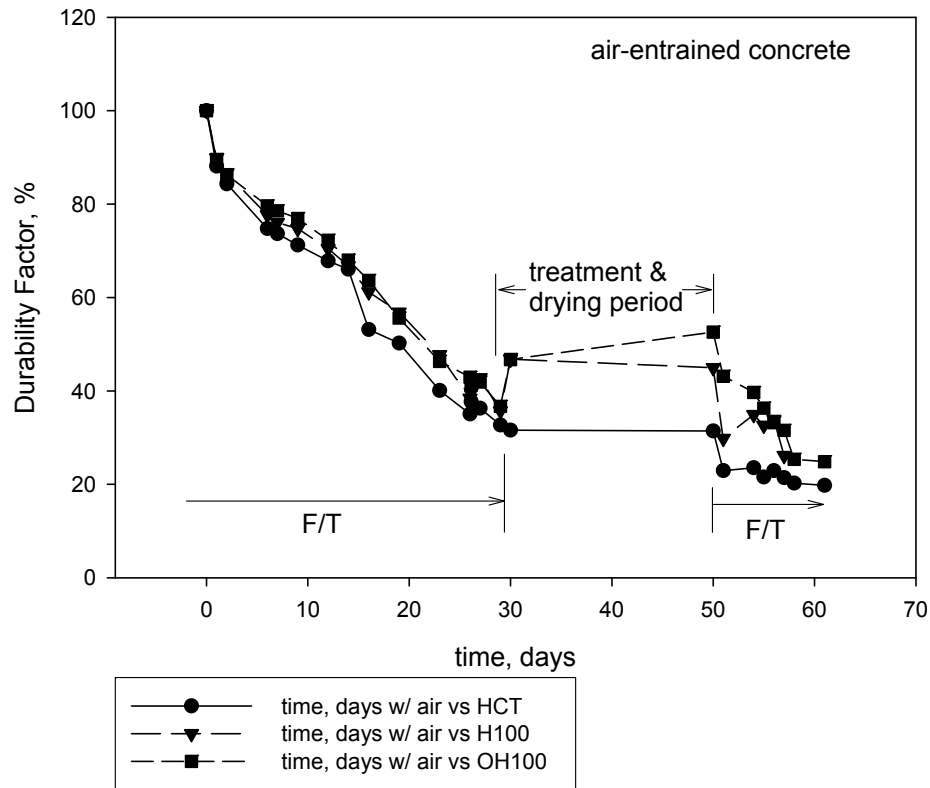
Figure 3. Durability factor (%E) versus treatment time (days) for Prosoco products used on air-entrained concrete samples.

Figures 3 and 4 show the time- and cycle-dependent change in durability factor for treatment of air-entrained specimens. As expected, the pretreatment degradation of durability factor was slower than in the case of non-air-entrained concrete. An increase in %E for product OH100 was seen during the treatment period, but none was observed in use of HCT and H100 products. Degradation of durability factor very quickly returned

to the pre-treatment levels. In the case of the air-entrained concrete, the rate of decay in durability factor appears to be approximately linear with respect to number of cycles of freezing and thawing.

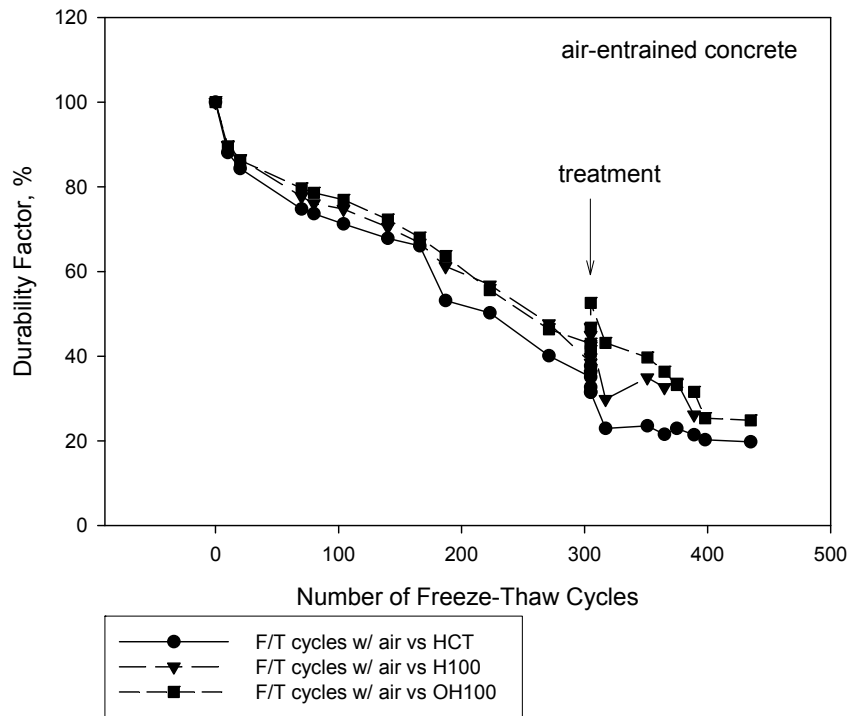
Figure 4. Durability factor (%E) versus number of cycles of freezing and thawing for Prosoco products used on air-entrained concrete samples.

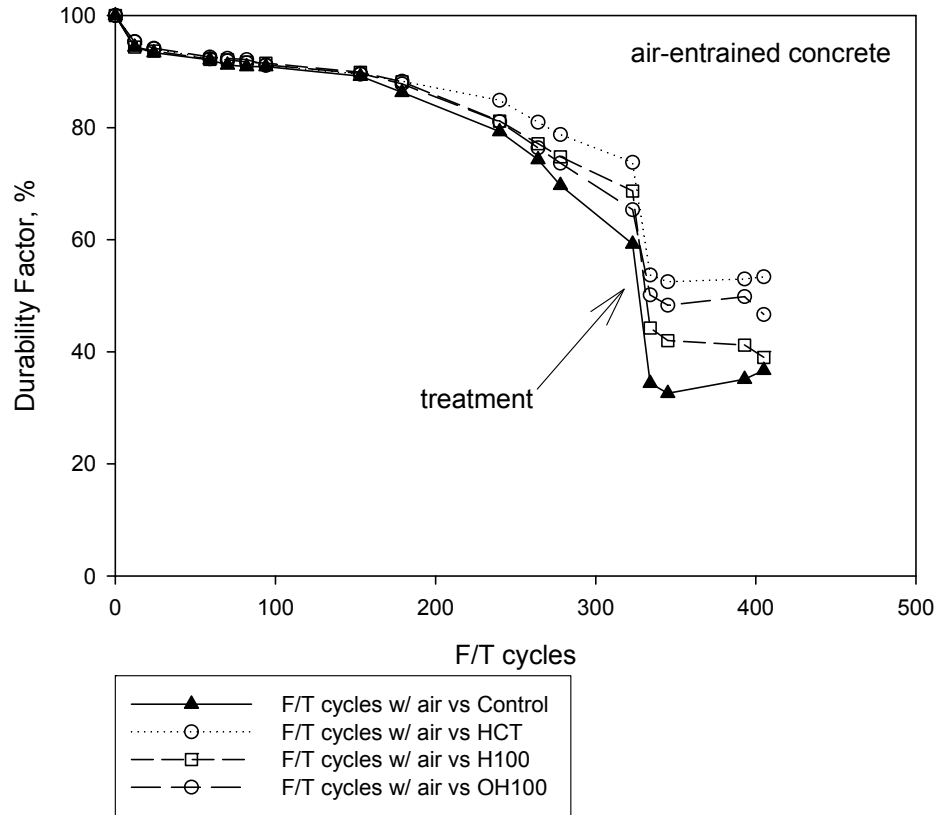
Figure 5. Durability factor (%E) versus number of cycles of freezing and thawing for Prosoco products used on air-entrained concrete samples, Testing Round 2.

Figure 5 shows data from the second round of testing with Prosoco products. In this case the durability factor was reduced to between 60 and 80% before treatment. No data were collected during the treatment period; so, the first post-treatment data point occurred after 11 post-treatment cycles of freezing and thawing. There was significant continued degradation of durability factor at this point. However, damage appeared to cease at this point. This also happened with the control specimen (no stone strengthener applied); therefore, this effect cannot be attributed simply to the stone strengtheners.

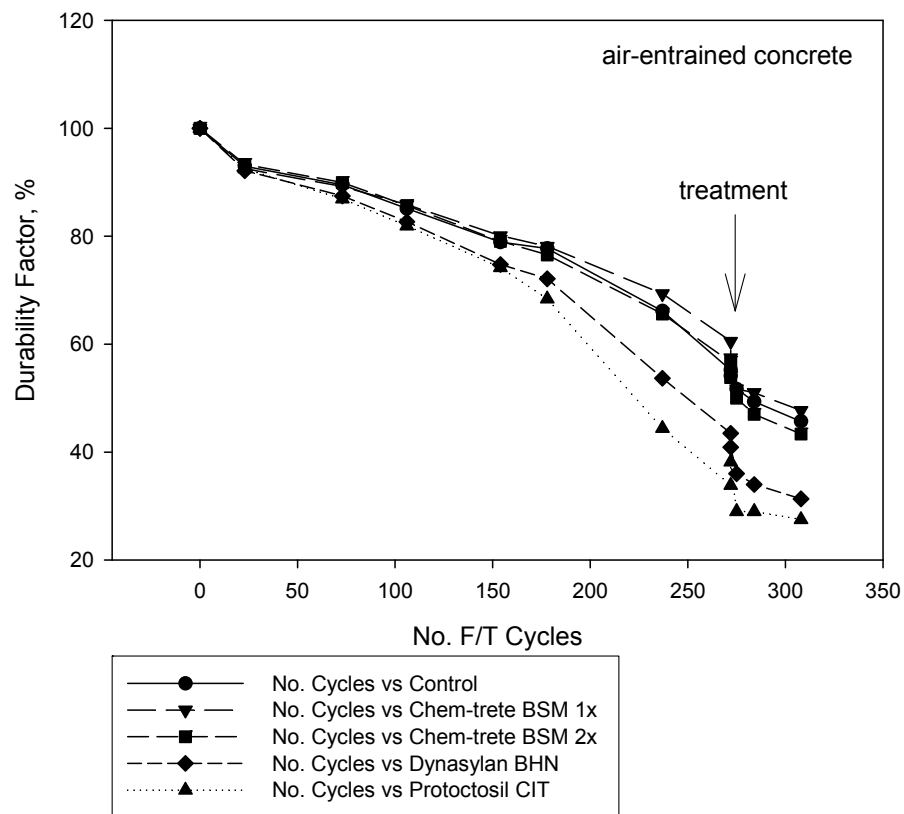
Figure 6. Durability factor (%E) versus number of cycles of freezing and thawing for Degussa products used on air-entrained concrete samples.

None of the Degussa products resulted in a restoration of structural integrity that persisted for even a few cycles of freezing and thawing. All of the specimens, including the control, showed a slight reduction in rate of decay of durability factor (Figure 6), which suggests that this was probably an artifact of the testing and not an attribute of the products.

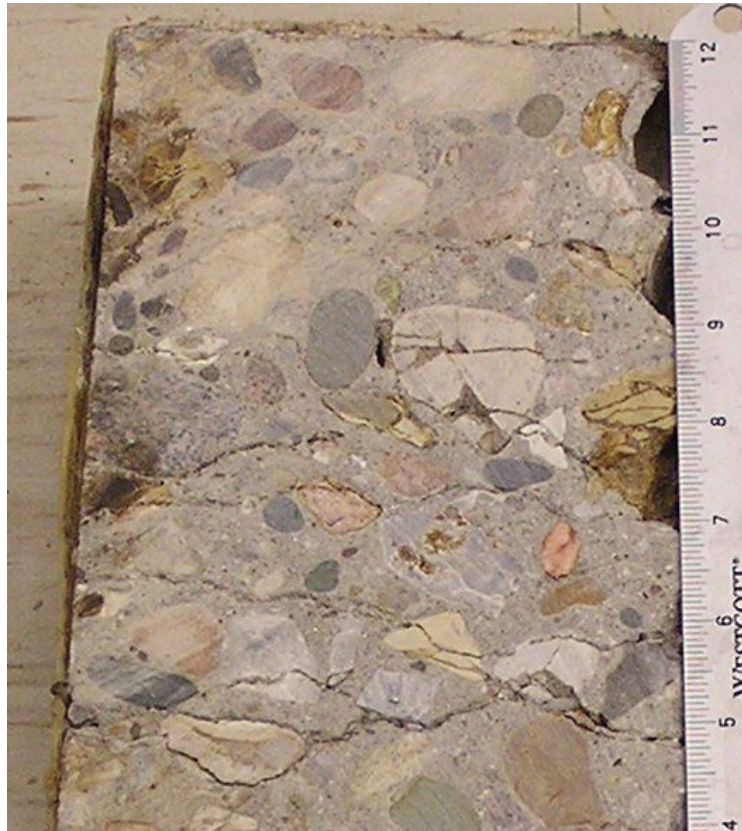
Figure 7. Macroscopic damage from cycles of freezing and thawing in a 1930s-era navigation structure.

The stone consolidation materials are designed to restore strength by restoring the cementing among rock grains. There was no strong evidence that this occurred in frost-damaged concrete. This could be attributable to the way in which damage develops in concrete subjected to cycles of freezing and thawing. Development of macroscopic damage in the form of cracks parallel to the freezing front is common (Figure 7). Microscopic damage also develops. Stone consolidation products may have some

benefit in restoring strength loss as a result of the microscopic damage. However, it is not expected that it would repair macroscopic damage.
