Beneficial Use of Dredged Material with Increased Fine Sediment Content: A Case Study at Egmont Key, Florida

June 2019

Final report

Under Project 456009, "Sand Enhancement from the Dredging Process"

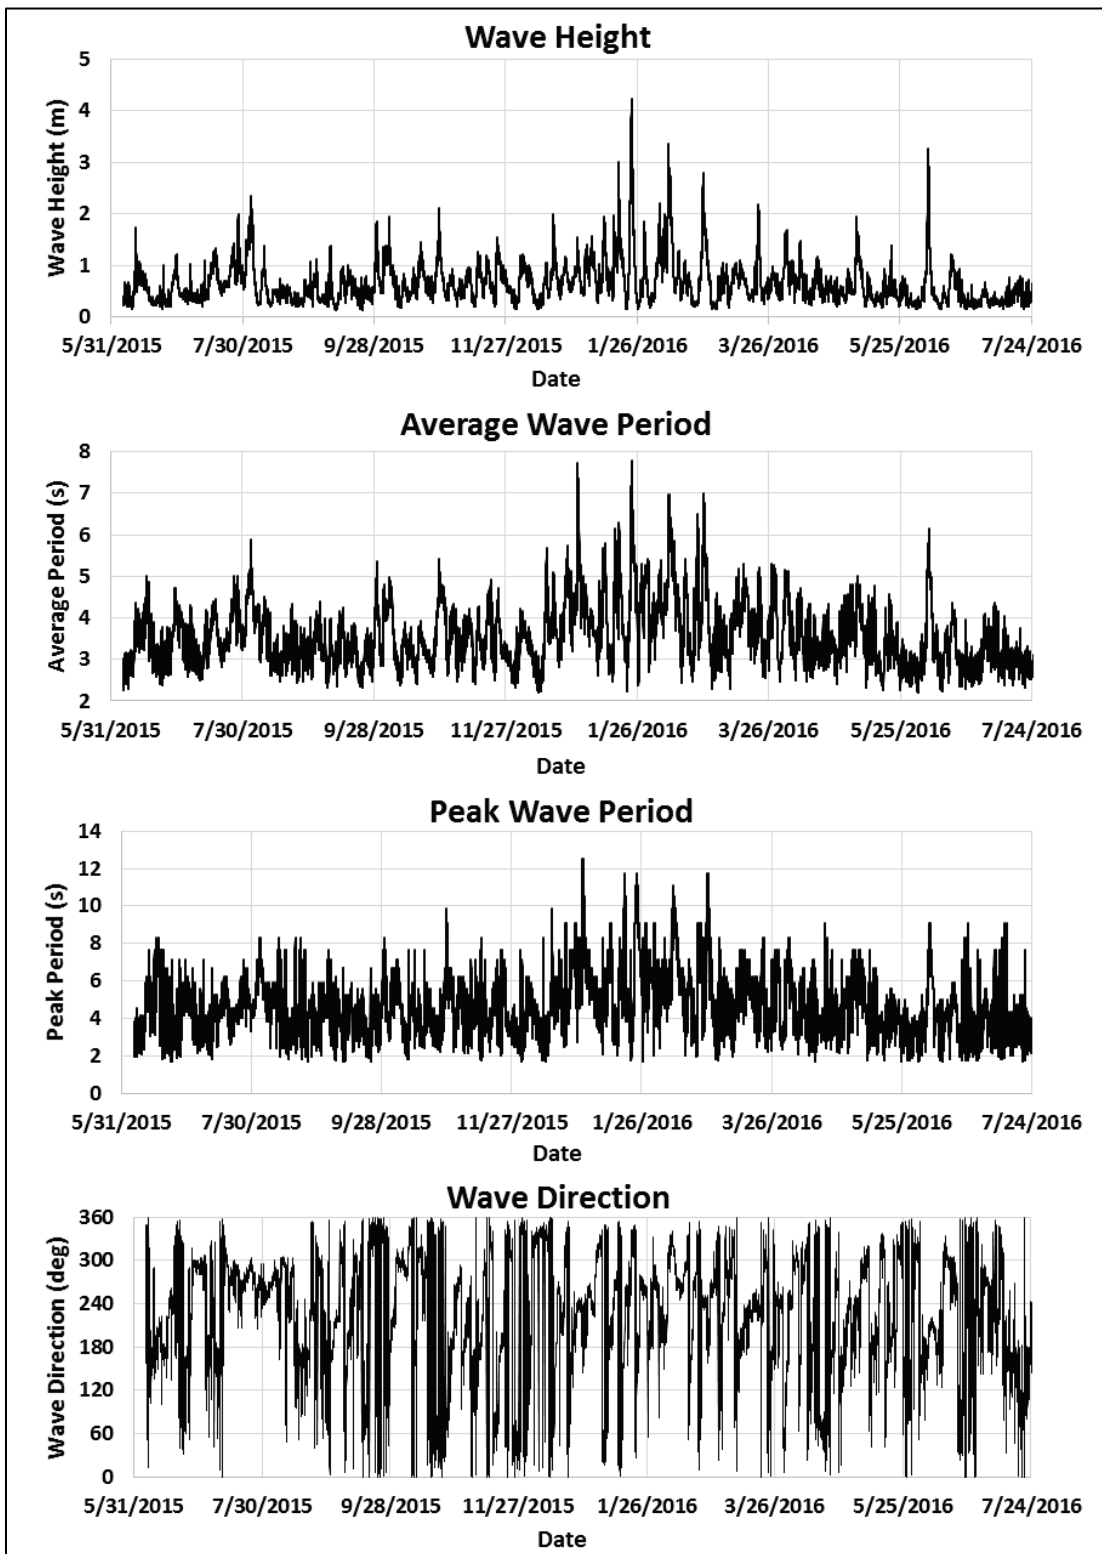
Figure 3. Study area wave height, average period, peak period, and direction as observed from NDBC Station 42098, Egmont Channel.

Wave height, period, and direction are the dominant factors that control nearshore morphodynamics. Wave data for study area were obtained NOAA National Data Buoy Center (NDBC) Station 42098, located 15 km due west of the seaward entrance to Egmont Channel. The wave gauge has been operational since June 2015, and data from June 2015 through July 2016 are presented in Figure 3. A distinct seasonal difference was observed in the wave data. During the summer months, waves are generally less than 2 m in height, with peak periods ≤ 8 seconds (Figure 3). During the winter months, higher energy wave events associated with cold fronts occur approximately every 10 to 14 days. These passing fronts produce wave heights slightly greater than 4 m with average periods slightly less than 8 seconds. The largest waves have recorded peak wave period that exceed 10 seconds.

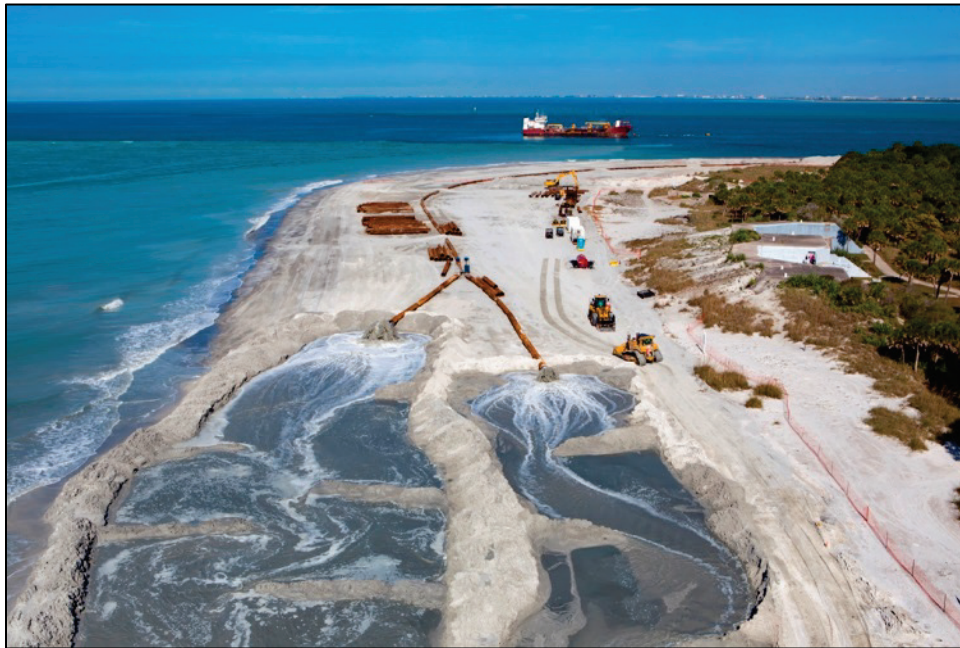
Figure 6. Traditional beach placement at northern end of Egmont Key, Florida, 26 December 2014. (Photo courtesy of GLDD.)

The traditional trapezoidal fill template at the northern end of Egmont Key used a Y-valve and two placement cells with longitudinal dikes with intermediate spurs to increase settlement and minimize material lost to the active swash zone, see Figure 6. The use of this placement design with a Y-valve with two cells allows for one side to be closed down for extending outfall pipes without having to stop discharge. Placement of dredged material occurred at the north end of the island from 19 November to 28 December 2014 and then from 21 January to 5 February 2015. Total volume of this placement was approximately 244,000 m³.

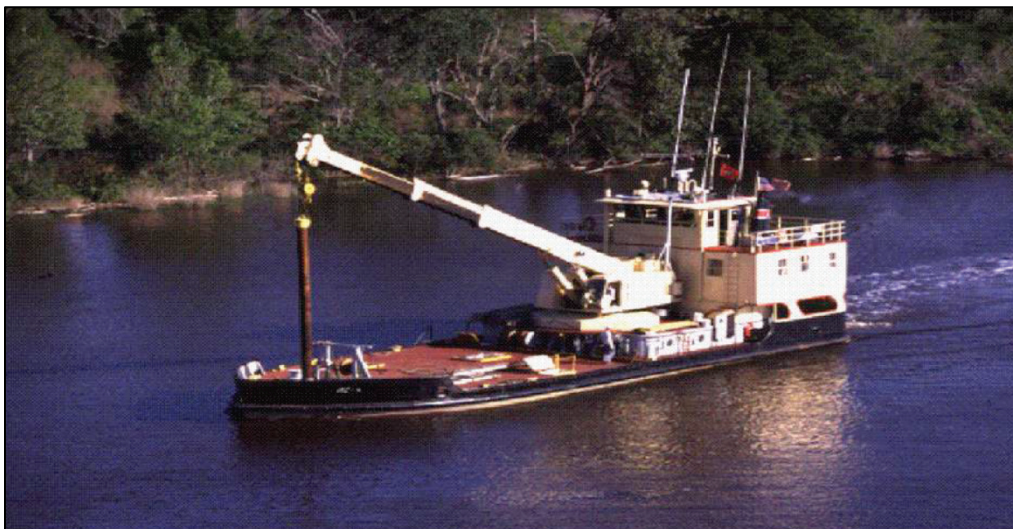
Figure 8. USACE Wilmington District M/V *SNELL*.

Vibracoring was conducted by the USACE multi-purpose vessel (M/V) *SNELL* (Figure 8). The *SNELL* is approximately 32 m × 10 m with a draft of ~2 m. The vessel carries a 35-ton crane that deploys the vibracoring apparatus. During the period of 2–3 April 2014, the *SNELL* obtained 39 cores: 34 cores from Egmont Channel Cut 1, 1 core from Egmont Channel Cut 2, and 4 cores from Mullet Key Channel (Figure 9).

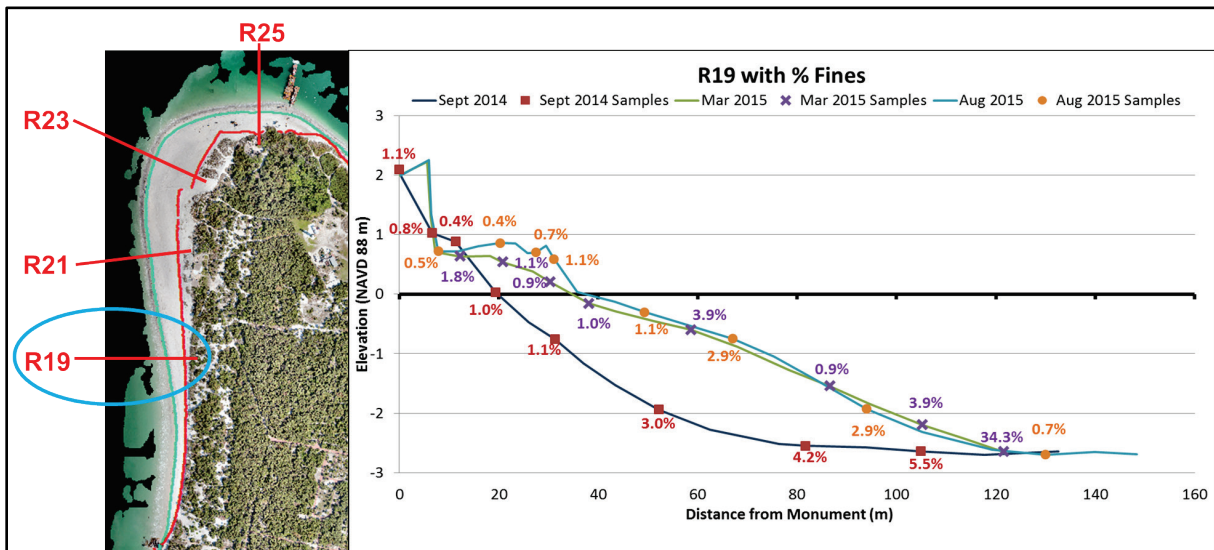
Figure 15. Profile line R-19 across the southern taper area of the traditional fill area on Egmont Key.

The USF CRL collected cross-shore profile surveys along Egmont Key prior to construction in September 2014 and following construction in March and August 2015 (Figure 12–Figure 18). Surface sediment samples were taken along the cross shore profile lines.

Figure 12–Figure 18 indicate the percentage of fines for each of the surface sediment samples taken along the profiles. The pre-construction profiles in the traditional nourishment template contained less than 2% fines on the subaerial beach. Higher percentages of fines were typically found with distance offshore. A maximum fines content of 17.9% was measured at the toe of the foreshore along R21; however, generally the sediment samples contained less than approximately 5% fines. Immediately post-construction in March 2015, samples on the subaerial beach contained 5% or less of fine material. Again, the highest percentage of fines was found at the toe of the foreshore with up to 34.3% at R19 (Figure 15). This is also at the edge of the fill, which may have had an impact on the anomalous concentration of fines seen here.

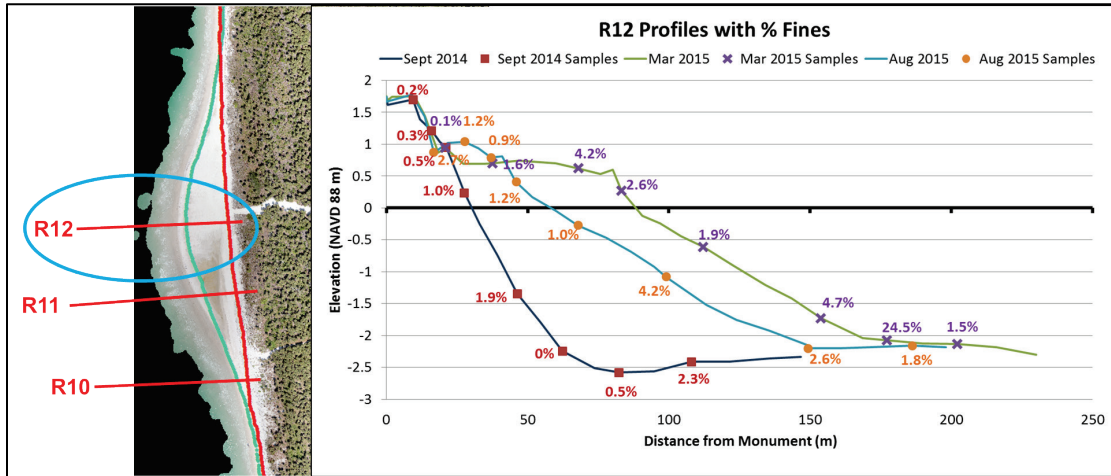
Figure 16. Profile line R-12 across the point of the CSSZ placement on Egmont Key.

Similar to the traditional nourishment site, the highest concentration of fines at the CSSZ placement was found at the farthest offshore extent of the fill (toe of fill). The toe of fill showed higher fines content at the CSSZ transects (24.5%–83.8%) compared to the traditional placement. However, by the next sampling event (5 months later), the fine sediment content had dropped below 5% in these areas. In fact, the August 2015 sampling period showed that all surface samples across the dry beach transect contained less than 5% fine material.
