## **Ice Control to Prevent Flooding in Ship Creek, Alaska**

Steven F. Daly, Joseph S. Rocks, Marina Reilly-Collette,  
and Arthur B. Gelvin

July 2019

Final Report

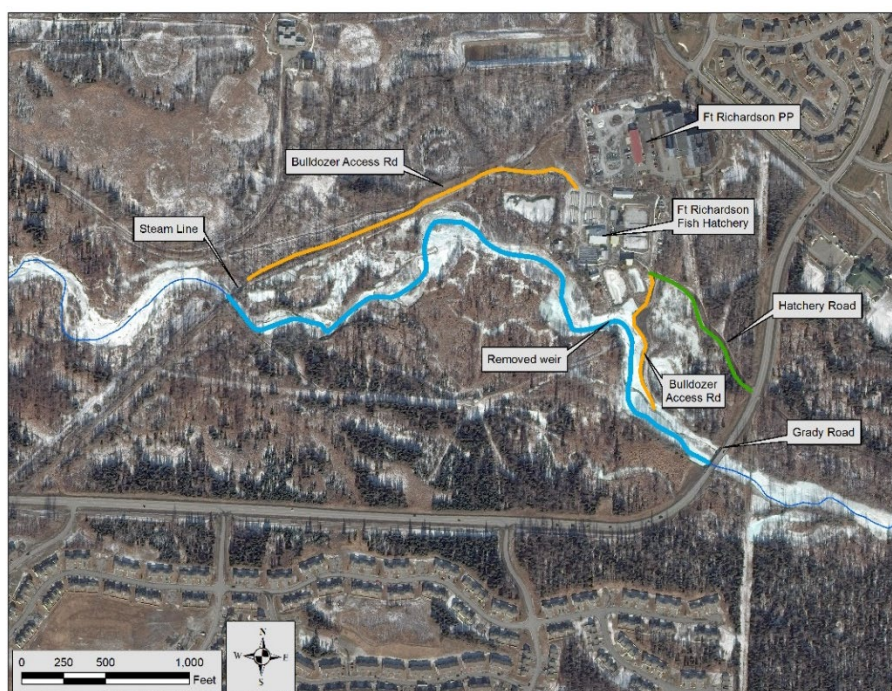
Figure 4. Flood-prone reach (*thick blue*) on Ship Creek.

The rough limits of the *flood-prone reach* of Ship Creek are Grady Road Bridge and the steam-line crossing (see Figure 4). This reach contains the Fort Richardson Fish Hatchery (no longer used), the Fort Richardson Power Plant (decommissioned), and the Fort Richardson Power Plant small dam (now removed). There are also several occupied residences located at the Fort Richardson Fish Hatchery.

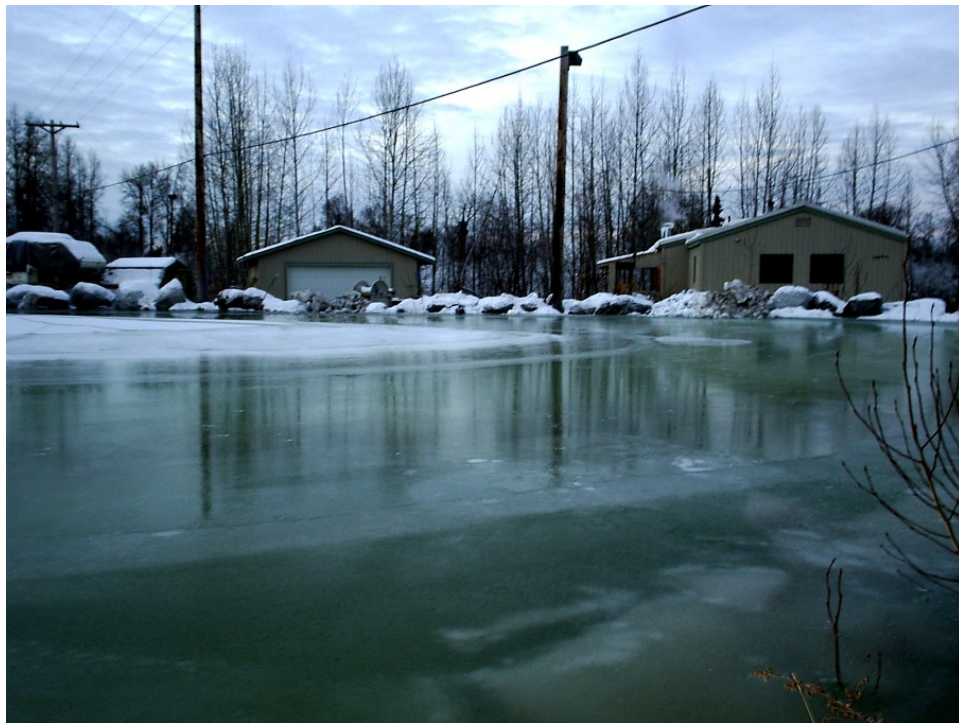
Figure 5. Inundation of buildings at the Fort Richardson Fish Hatchery.  
(Image by Andrea Tesch.)

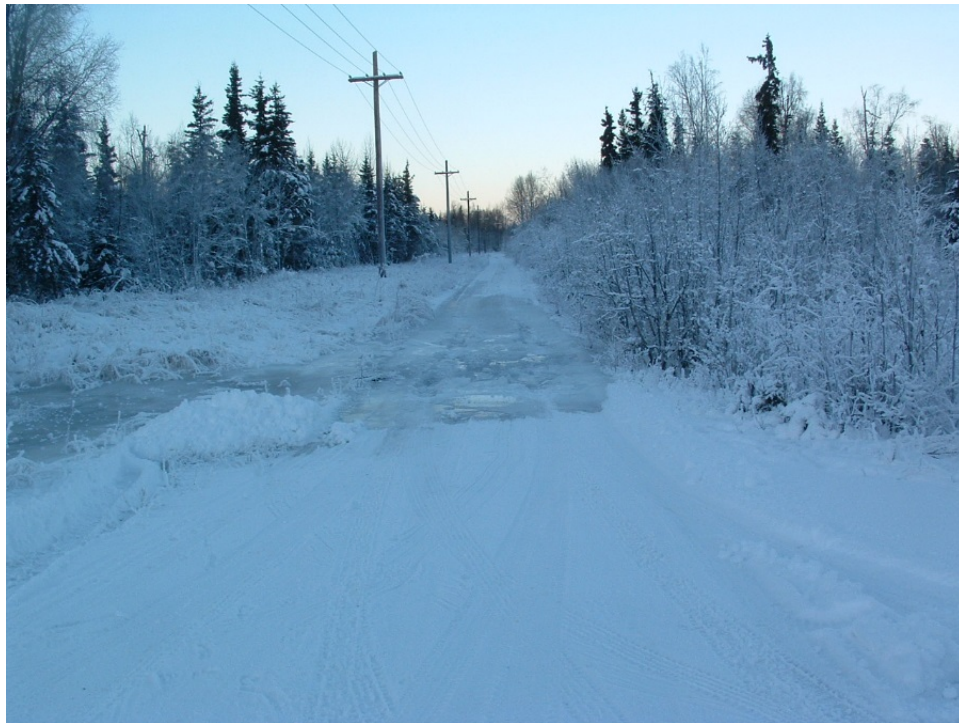
Figure 6. Flooding across the Fort Richardson Fish Hatchery Access Road.  
(Image by Andrea Tesch.)

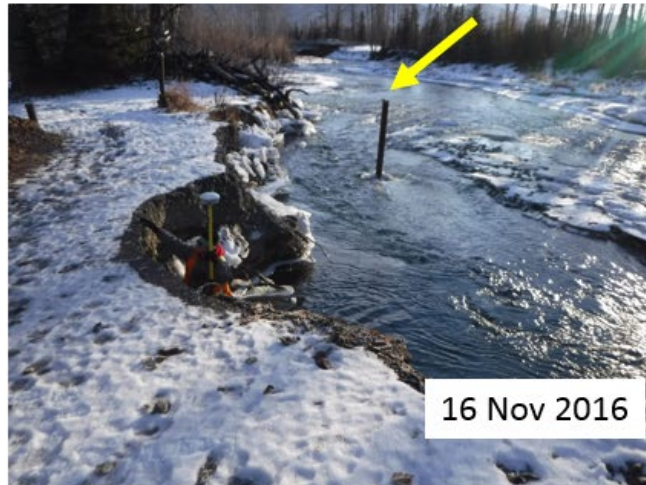
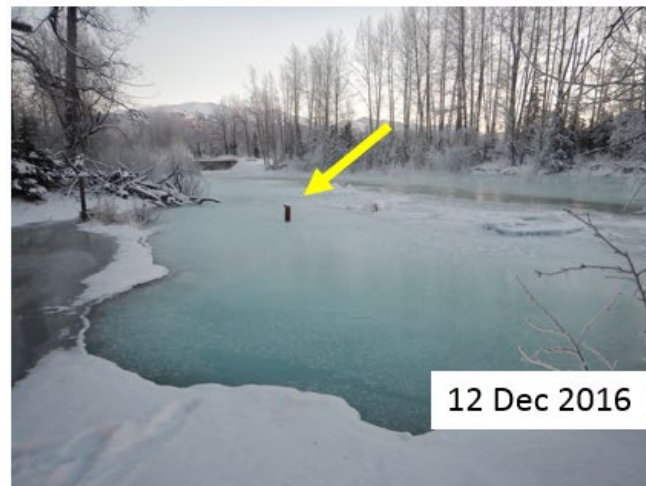
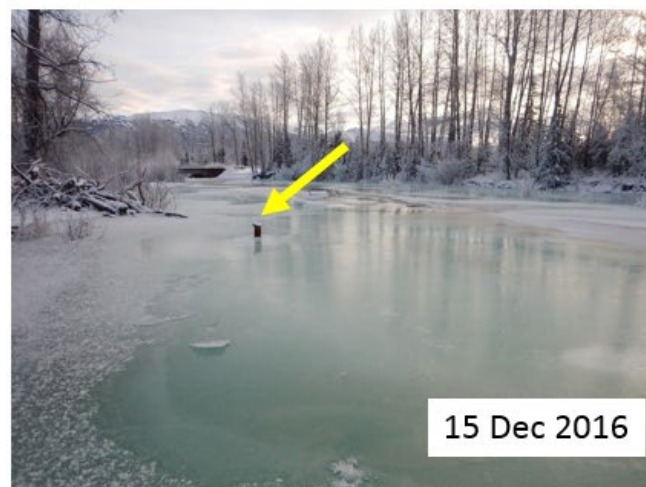
Figure 7. Increase in water level caused by ice formation.

Figure 7 clearly shows the impact of ice on the water levels of Ship Creek. The three images in Figure 7 were taken in November and December of 2016 at the same location on Ship Creek in the flood-prone reach. This location is several hundred feet downstream of Grady Road Bridge (seen in the distance) looking upstream. The location of an old, disused well casing is marked by a yellow arrow in each image. The well casing stands vertically upright and extends approximately 6 ft above the bed of the creek. In the first image, taken on 16 November 2016, there is minimal ice present. Ship Creek is largely open, and the well casing stands in several inches of water. In the second image, taken on 12 December 2016, the creek is largely ice covered. The water level in the creek has risen over 5 ft at this time. Ship Creek is entirely ice covered except for a small open-water channel down the center of the channel. The rise in water level is due entirely to the ice formation in Ship Creek as the flow in the creek has undoubtedly dropped between these dates. The final image was taken on 15 December 2016. Ship Creek had risen several more inches since 12 December.

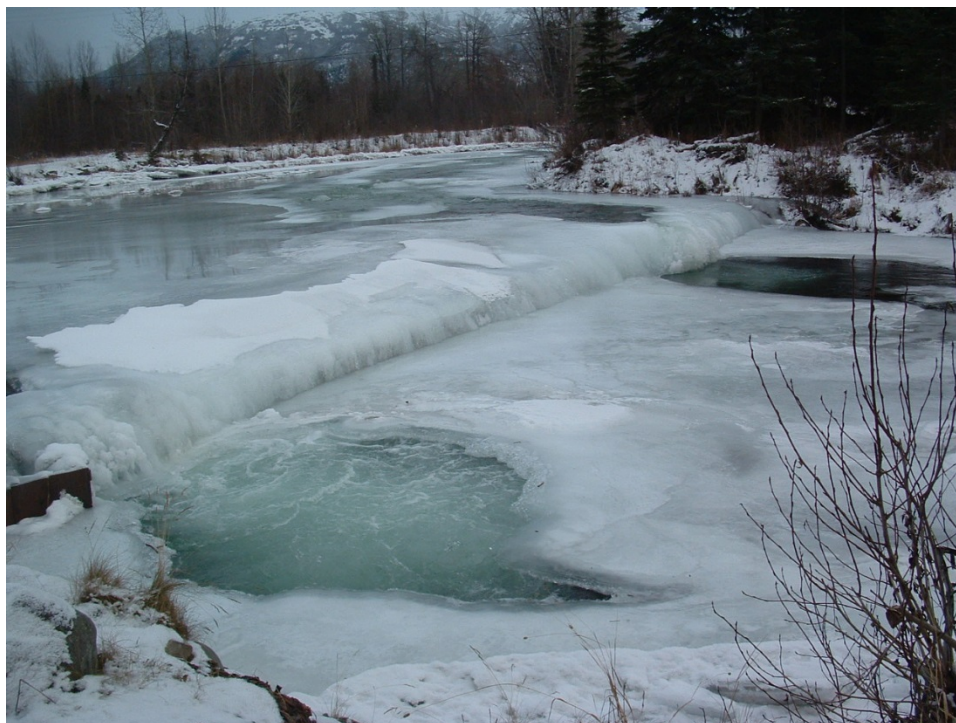
Figure 8. Small dam for Fort Richardson Power Plant (2007–10).  
(Image by Andrea Tesch.)

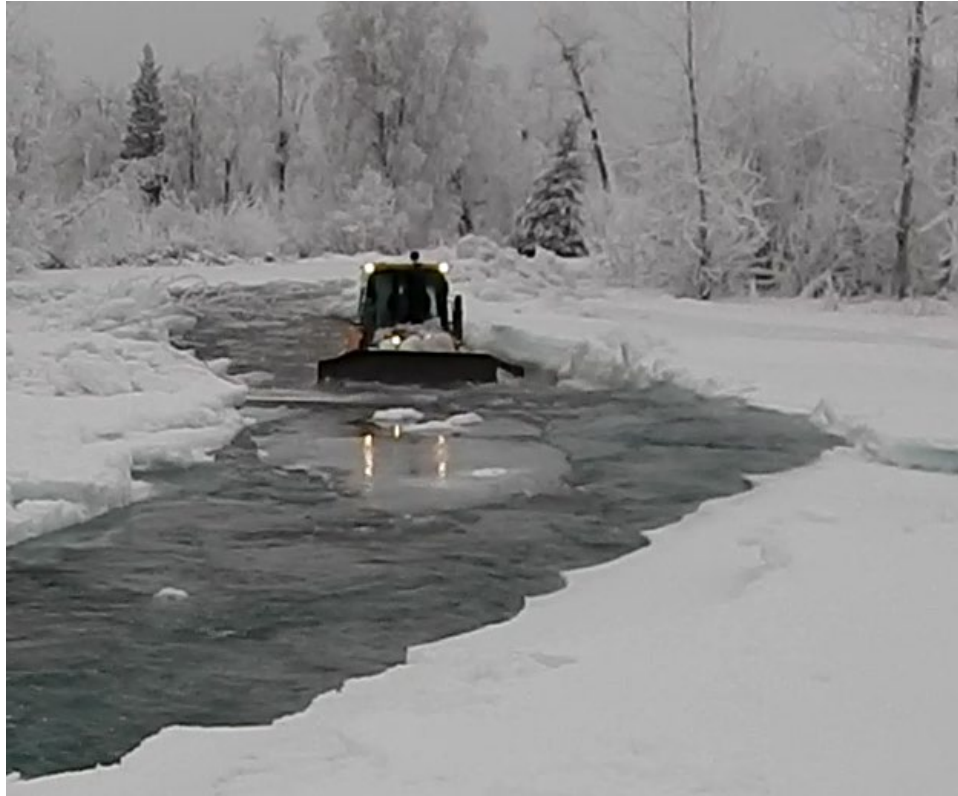
Figure 9. Bulldozer removing ice from the channel bed (January 2017).

a bulldozer in the channel in the upstream direction, with the dozer blade just above the channel bed (Figure 9). This procedure was followed on 13 January 2017 and was very effective in removing ice from the channel bed. The channel flow carried the removed ice downstream. This operation caused the water levels in Ship Creek to drop significantly. The second objective of mechanical removal is to break up and remove the surface-ice cover to provide room for the ice removed from upstream to deposit without raising the creek water levels (Figure 10 and Figure 11). This operation places much more stress on the dozers than simply removing ice from the channel bottom. Figure 12 shows the ice cover of Ship Creek after fracturing.

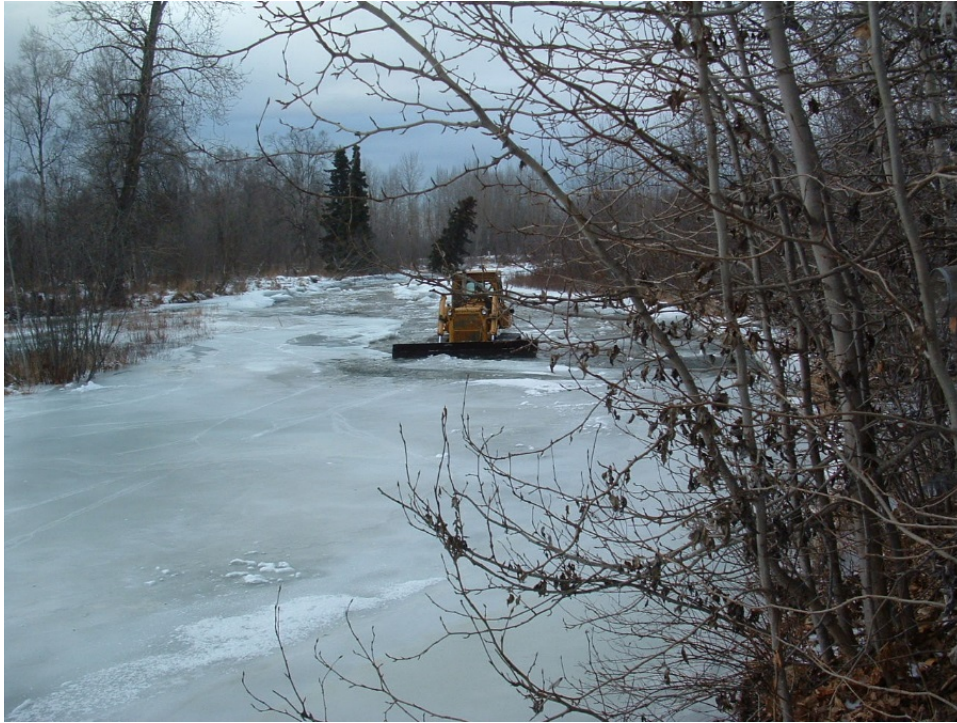
Figure 10. Breaking up the surface-ice cover (2007–10). (Image by Andrea Tesch.)

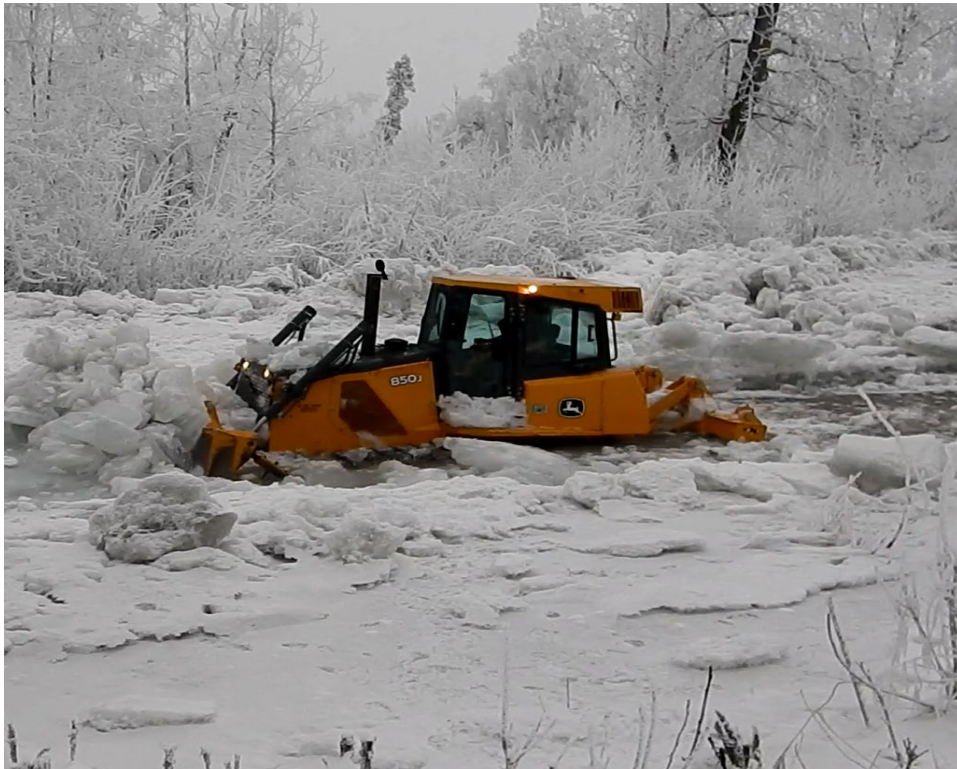
Figure 11. Breaking up the surface-ice cover (January 2017).

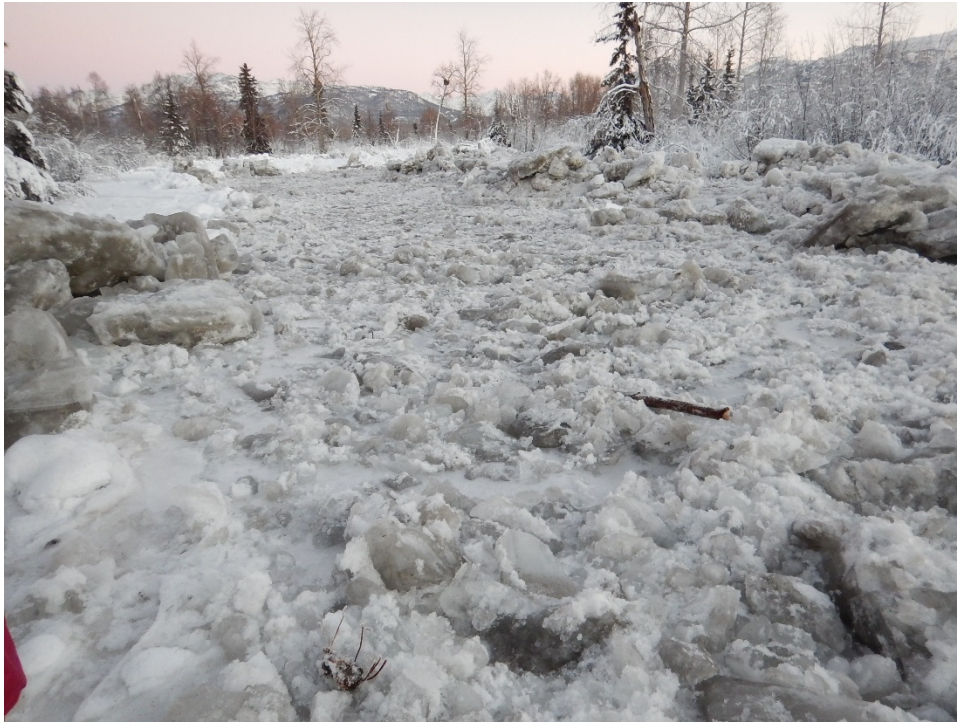
Figure 12. Ship Creek stationary ice cover after fracturing by a bulldozer.

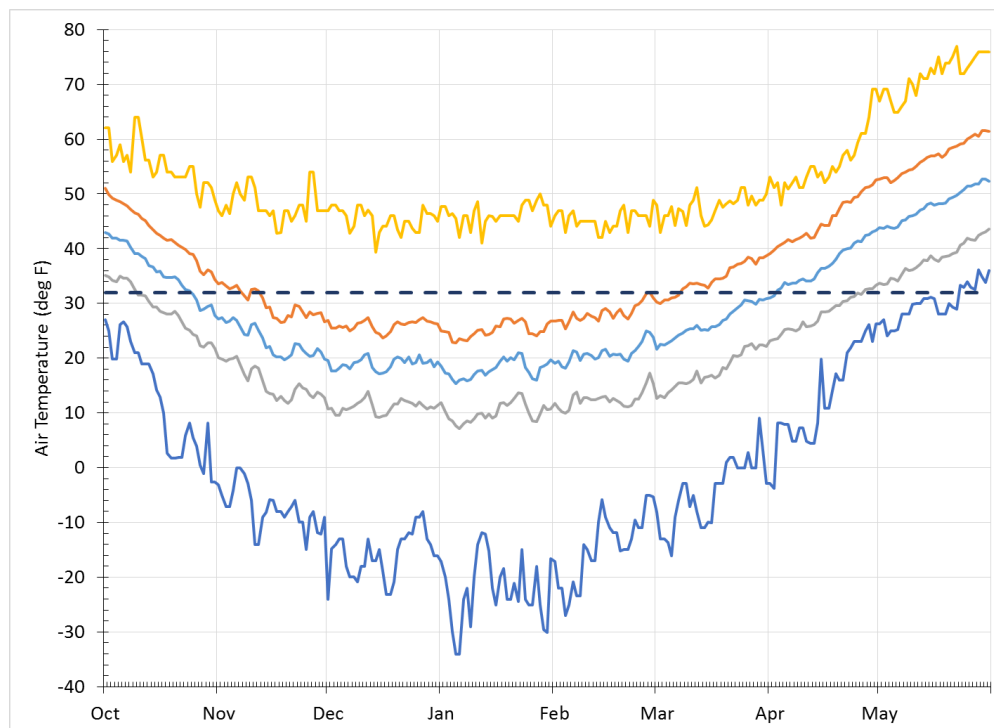
Figure 13. Daily air-temperature statistics for October through May. Shown are the average daily maximum (orange), the daily average (light blue), the average daily minimum (gray), the extreme daily maximum (yellow), and the extreme daily minimum (dark blue) over the period of record. The dotted line indicates the freezing temperature ( $32^{\circ}\text{F}$ ).

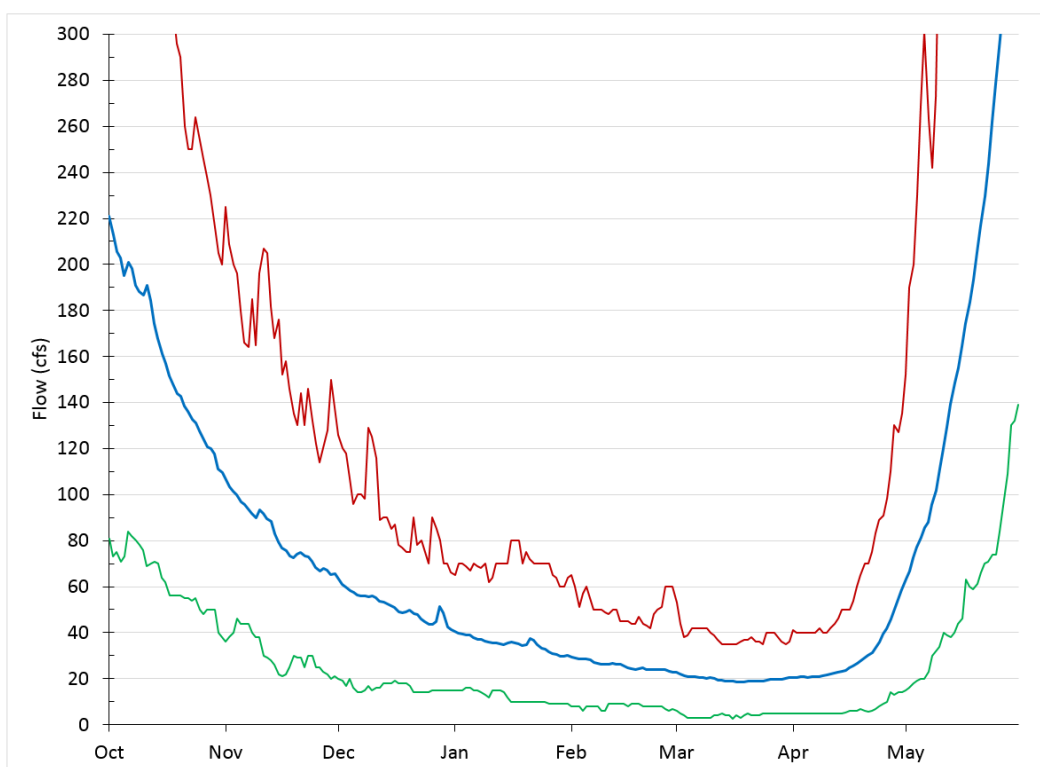
**Figure 14.** Ship Creek flows (the minimum, average, and maximum flows recorded on each day of the winter season, 1 October through 31 May).

the winter months is very consistent, as seen in Figure 14. The short warming periods during the winter associated with the “chinook” winds and other causes generally have little effect on the flow of Ship Creek. This is likely because the warming periods are too brief to cause enough snowmelt and to increase the flow of the Creek. The flow in the Creek starts to increase at the end of March and increases very steadily through April and May until the peak in June. This yearly consistency in the springtime flow increase reflects the consistency in the increase of sunlight that occurs in Alaska during the spring. Sunlight is a major component of the heat transfer causing snowmelt in the Chugach Mountains, leading to the increase in flow.

Recall that the flow in Ship Creek is in recession throughout the winter, as shown in Figure 14. In some way, not clearly understood at this time, the flow rate of the channel influences the MIAWL. Certainly it was observed during winter 2016–17 that the entire flood-prone reach was ice covered by the end of February. Mechanical removal had ended at that time, and the flow was entirely contained within the channel. The ice-formation process had reached Step 6, “Anchor-ice detachment and ice-dam breaching,” throughout the flood-prone reach. The flow was then confined to small passages at the channel bed, and flooding was no longer an issue.

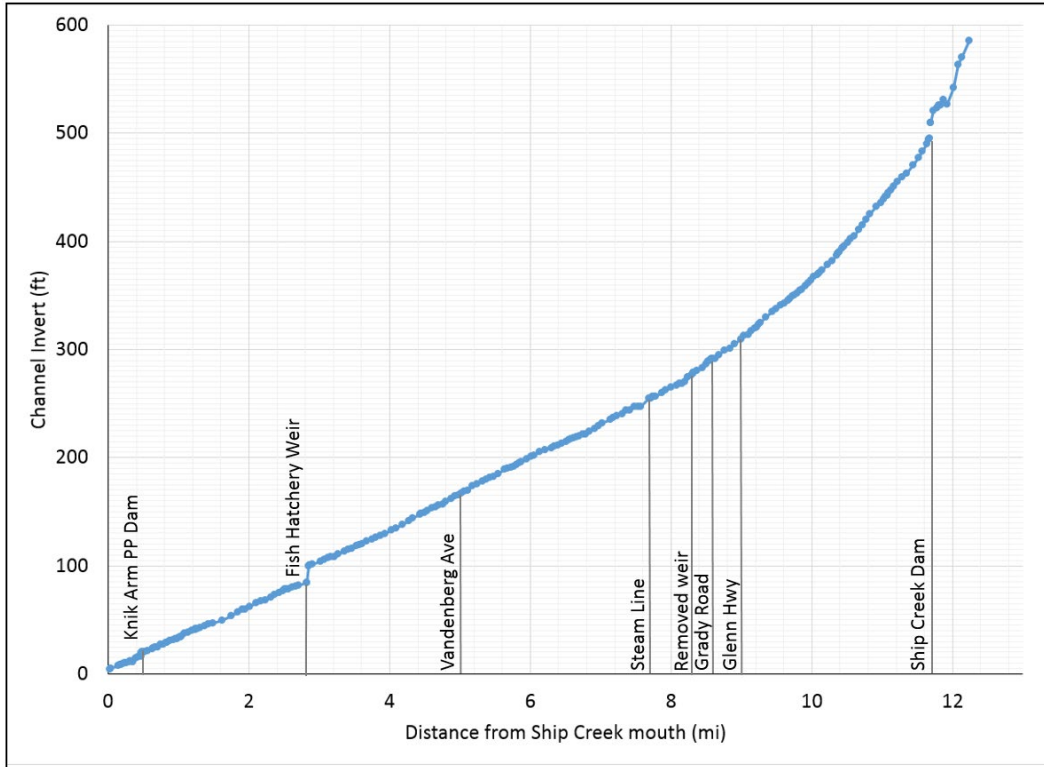
Figure 15. Ship Creek bed profile.

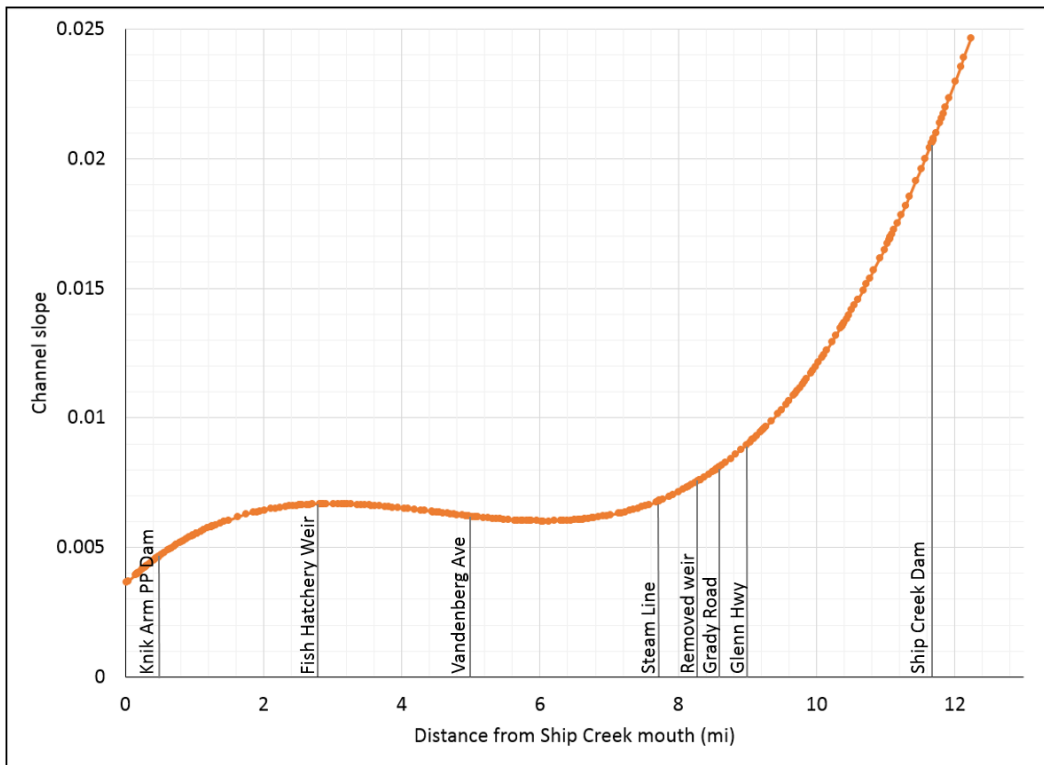
Figure 16. Ship Creek bed slope profile.

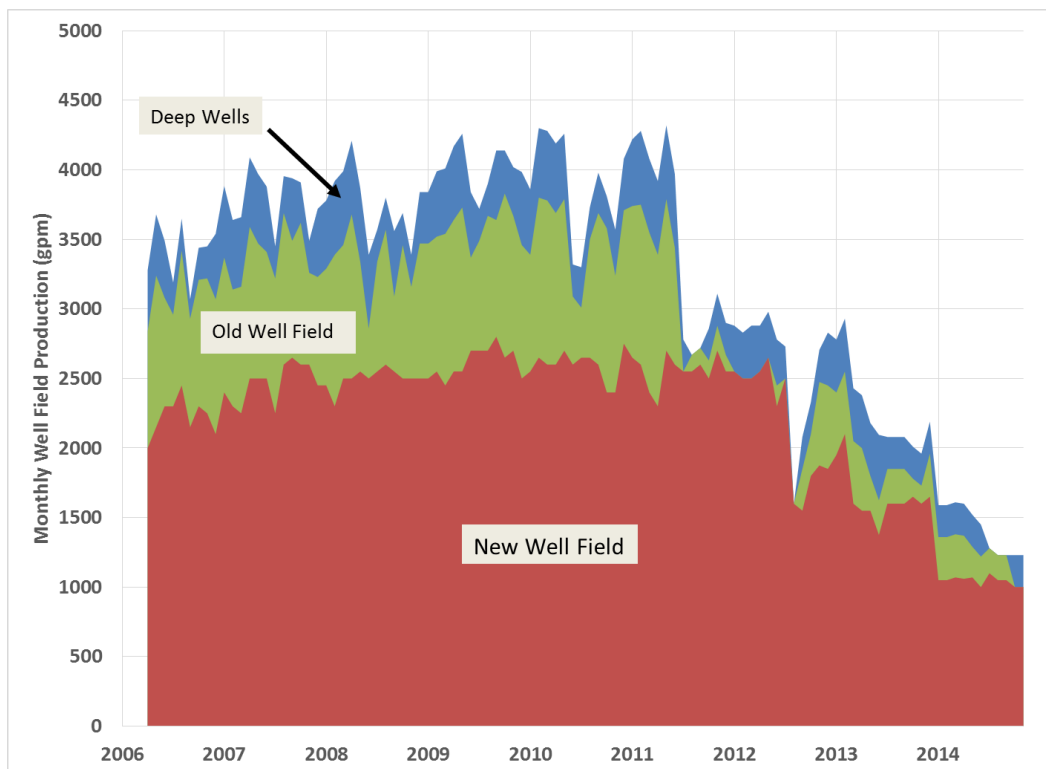
Figure 18. ADF&amp;G well production 2006–14.

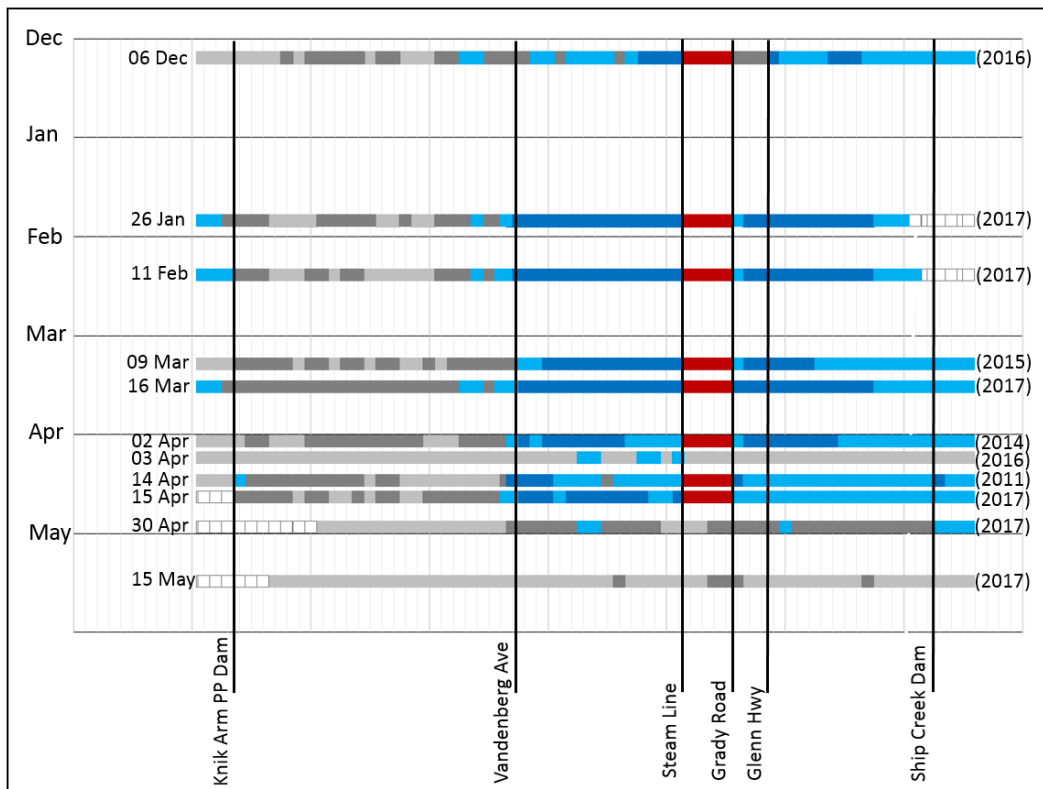
Figure 21. Ice observed in Ship Creek based on satellite imagery.

Figure 21 shows the results of the analysis of the ice distribution in Ship Creek. Each horizontal line is a schematic description of the distribution of ice along Ship Creek that was observed in the satellite imagery on the given date. The vertical order of the schematics corresponds to the day of

winter of the acquisition without regard to the year that the data was acquired. The earliest day of winter that an image was acquired is at the top of the figure (6 December), and the latest day at the bottom (15 May). The downstream limit of Ship Creek at Knik Arm is on the left side of the figure, and the upstream limit at the Ship Creek Dam is on the right side. The vertical lines correspond to landmarks along Ship Creek: Knik Arm Dam, Vandenberg Avenue Bridge, the steam-line crossing, Grady Road Bridge, Glenn Highway Bridge, and the Ship Creek Dam. The imagery provides sufficient resolution to determine if ice is present but cannot provide much detail on the ice process. Table 9 describes the classification system.

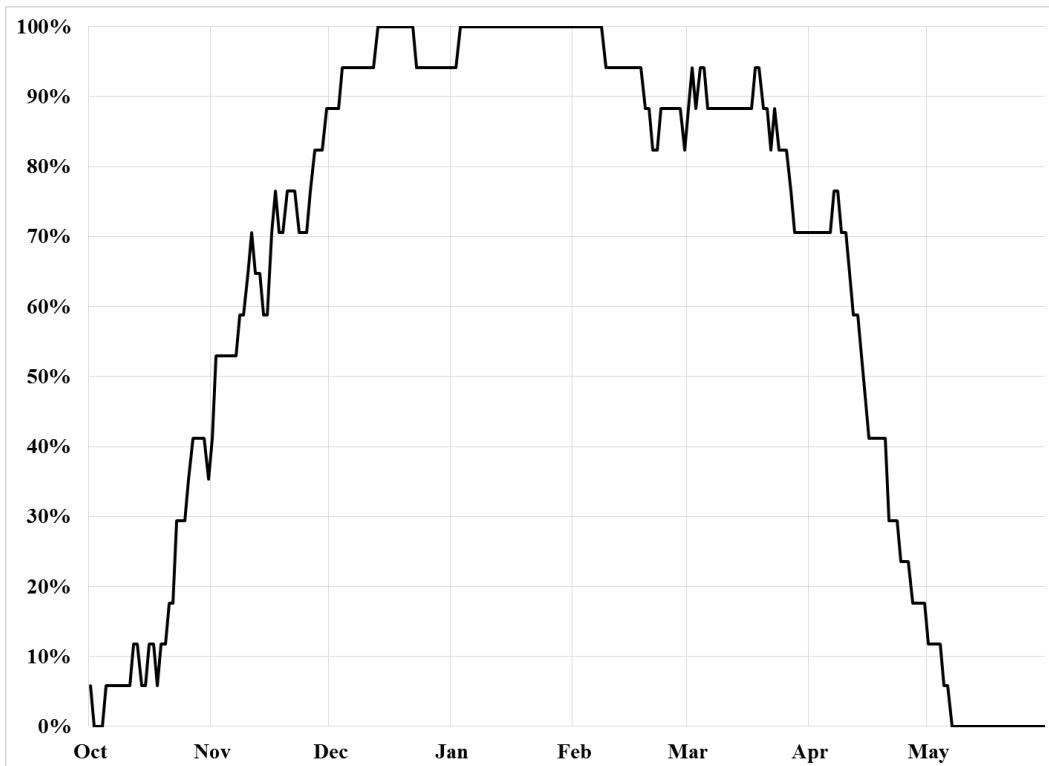
Figure 23. Percentage of winters (2001-17) with ice for each day of winter at the USGS gage.

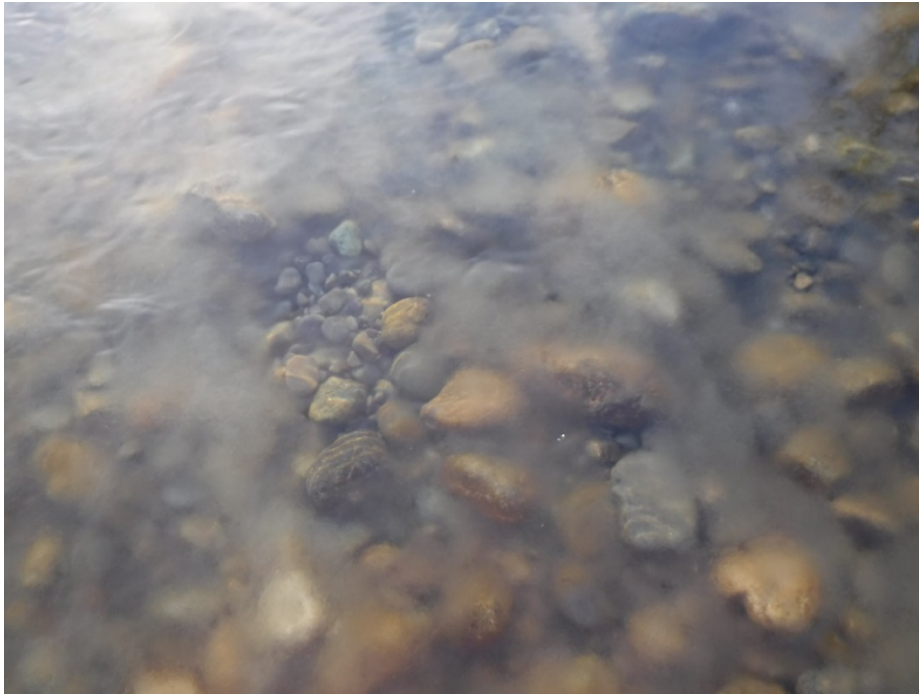
Figure 26. Anchor ice visible underwater (Ship Creek 16 November 2017).

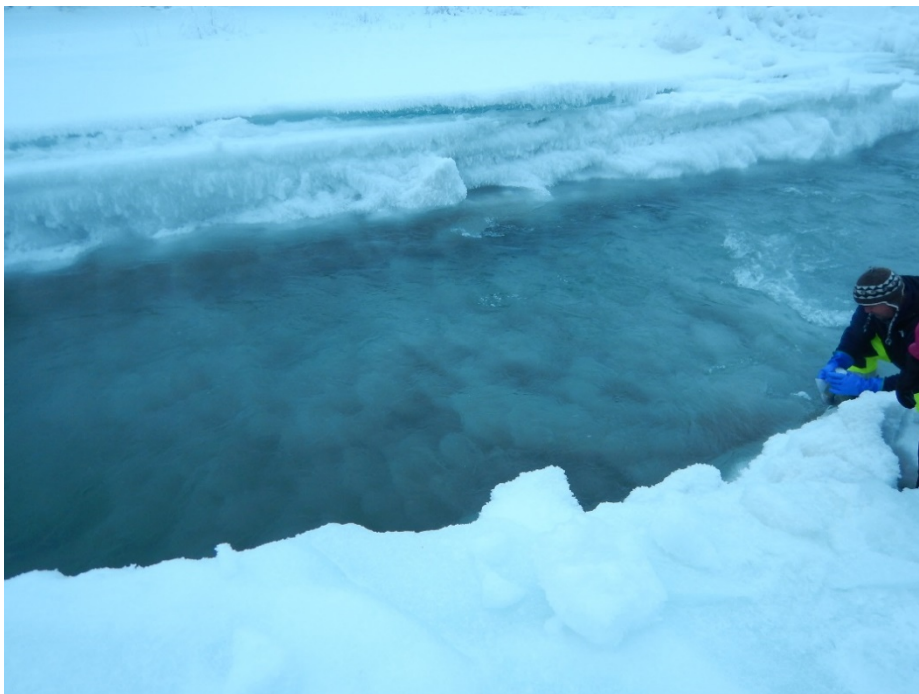
Figure 27. Anchor ice visible underwater (Ship Creek 12 January 2017).

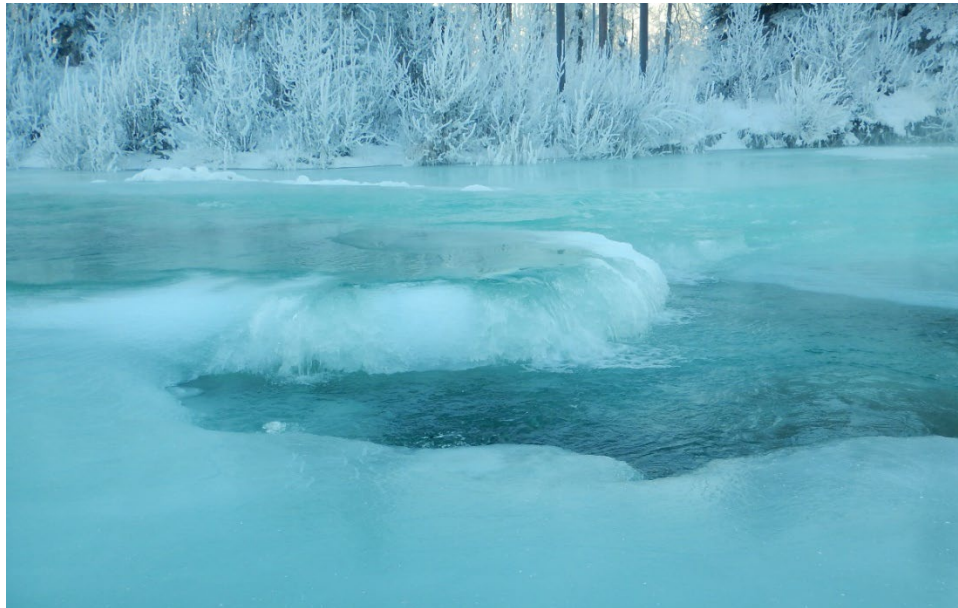
Figure 29. Ice dam and weir (Ship Creek 13 December 2016).

small boulders. In these areas, relatively large depositions occur, leading to the formation of frazil *ice dams* (Dubé et al. 2014) as shown in Figures 28 and 29. Ice dams can have a significant impact on the local flow conditions. They cause increased water levels immediately upstream of their location. The flow often passes over the top of the ice dams in weir-like flow, leading to the formation of *icings*. Icings occur when the water flowing over the ice weir freezes. This leads to continual vertical growth of the ice dams.

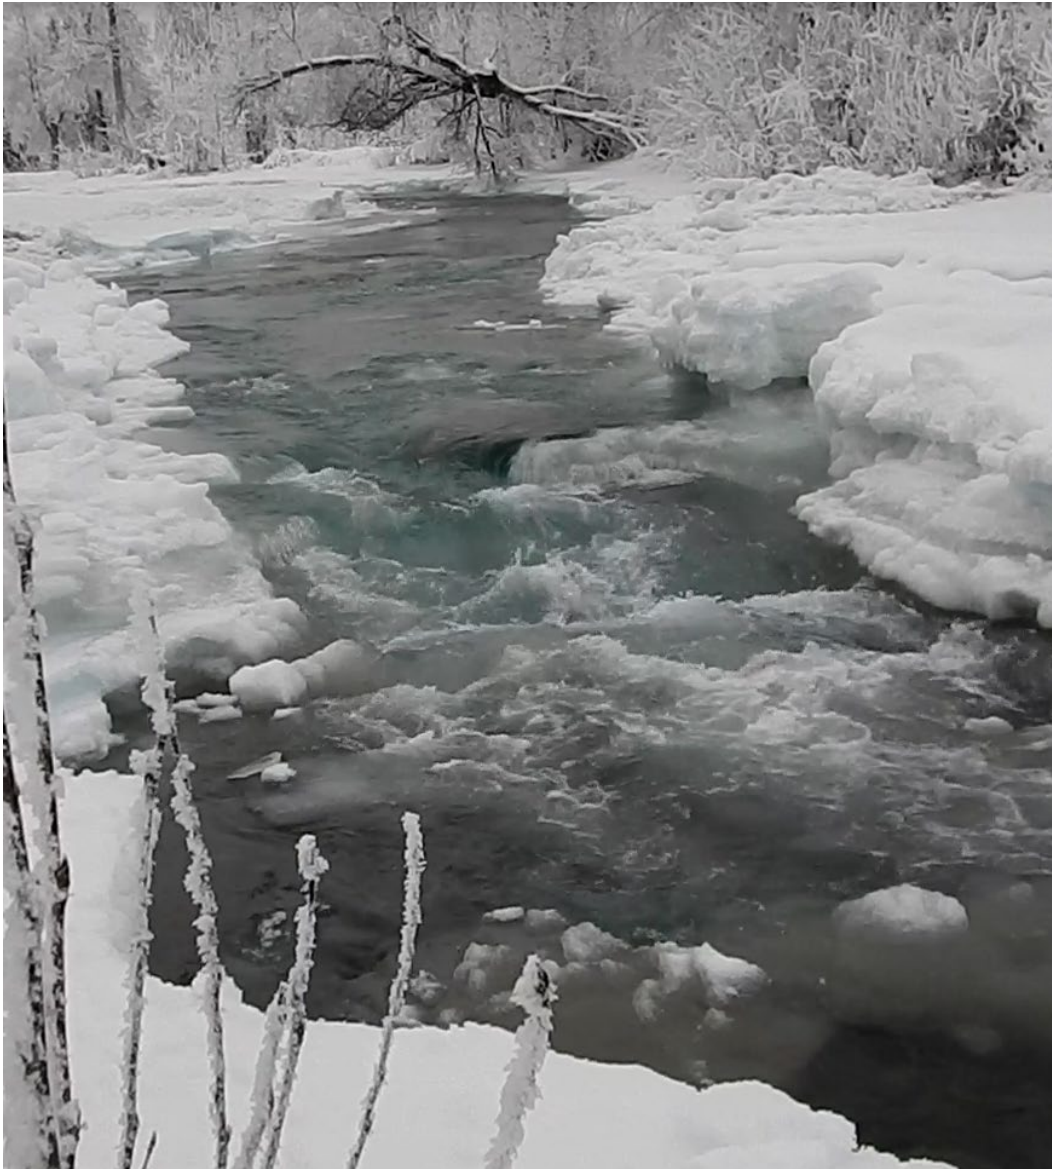
Figure 31. Large ice dam causing stage rise.

The formation of anchor ice, ice dams, ice weirs, and icings causes the water level in Ship Creek to rise (Figures 30 and 31). The rise is mitigated to a small degree by the flow recession—the daily decrease in Ship Creek discharge that occurs each winter. It is important to note that when the initial ice formation occurs, the wintertime discharge is at its maximum. The discharge in Ship Creek declines relatively slowly with time. The decline does not happen fast enough to reduce the water level rise caused by freeze-up to any significant degree.

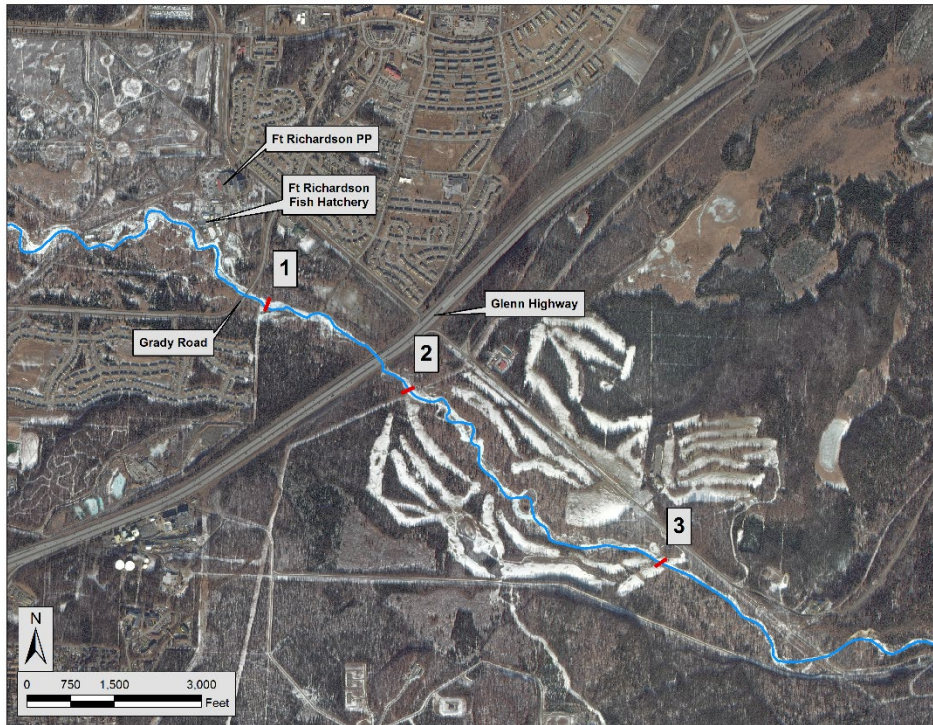
Figure 34. Ice survey cross-section locations.

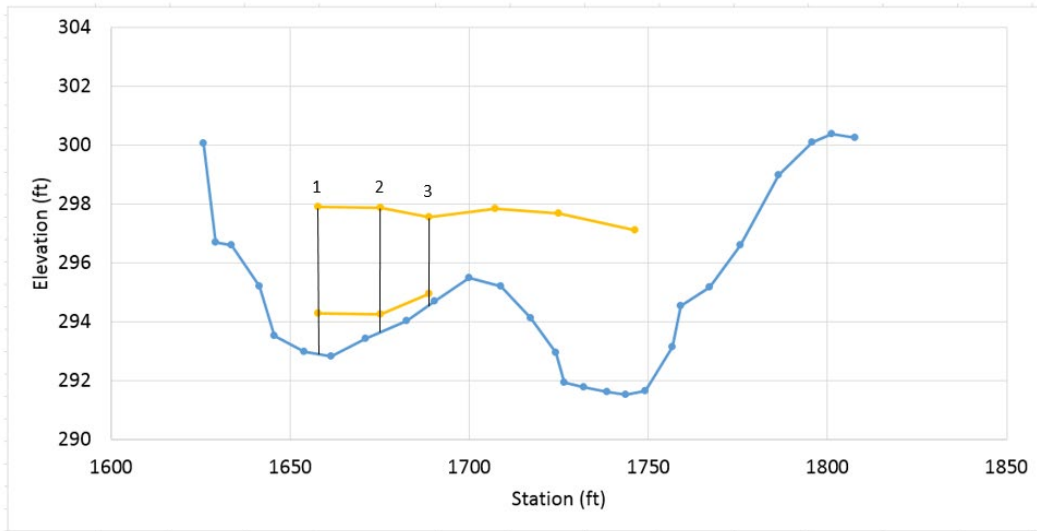
Figure 35. Top and bottom of ice on 14 December 2016 at Section 1.

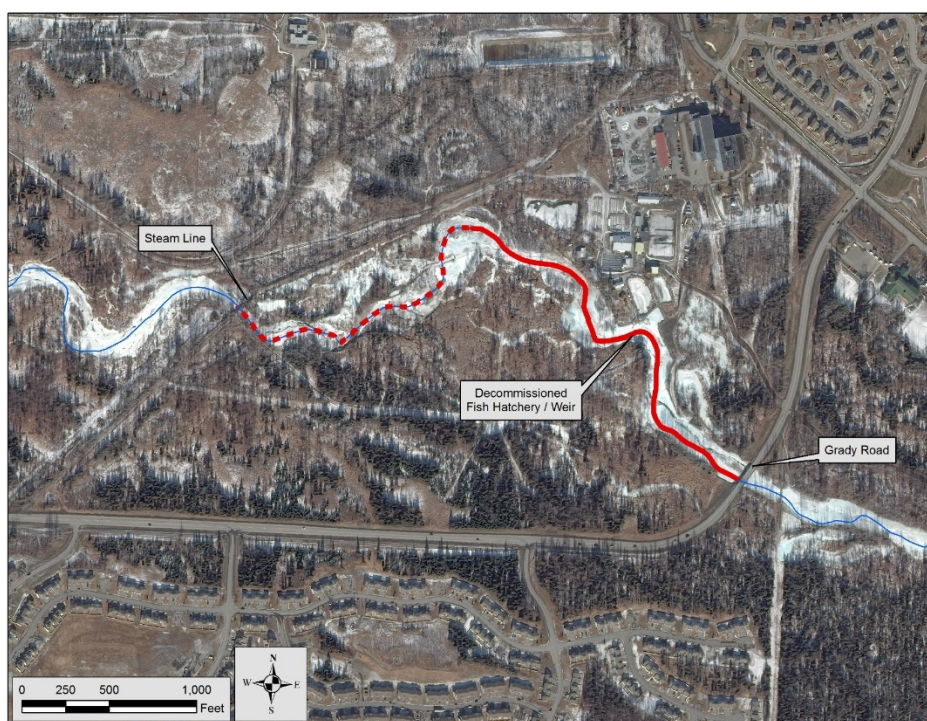
Figure 36. Mechanical removal area of the flood-prone reach (*red line*).

- Closely monitor ice formation in the flood-prone reach of Ship Creek. Anchor ice and ice dams cause the water level of the creek to rise. These ice formations are clearly visible to observers on the banks of the channel. The area to monitor starts at Grady Road Bridge and extends downstream to the section of Ship Creek immediately below the residences in the fish hatchery area. Figure 36 indicates the reach with a solid red line. Most of this area of Ship Creek is visible from the access roads. The formation of anchor ice can begin as early as November. Ice removal was also observed downstream to the steam line bridge, as shown by the dotted red line in Figure 36.

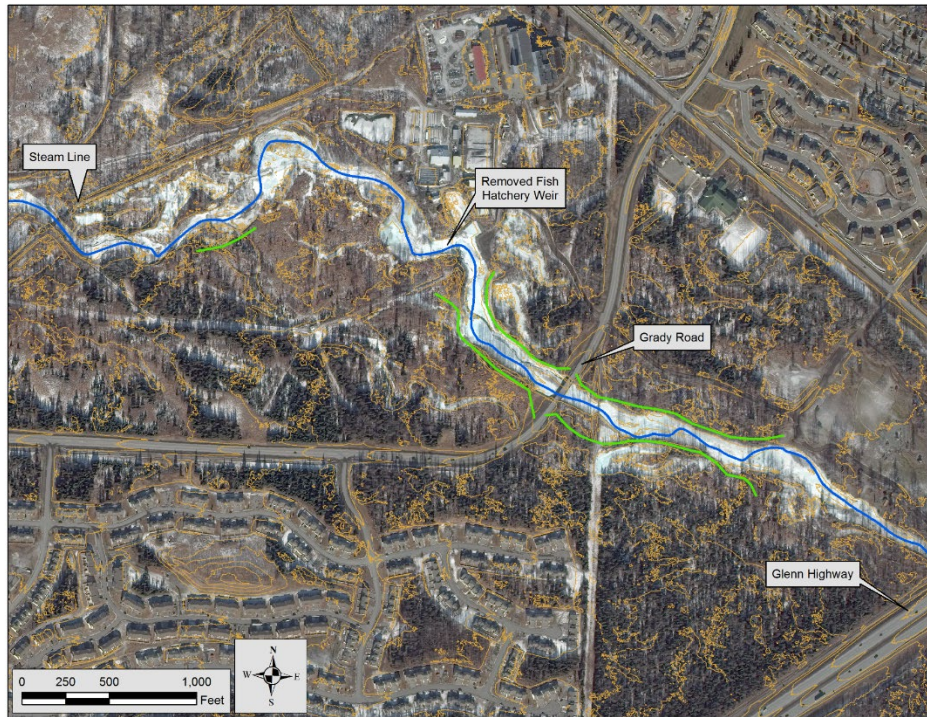
Figure 37. Likely berm locations to contain freeze-up (*green lines*).

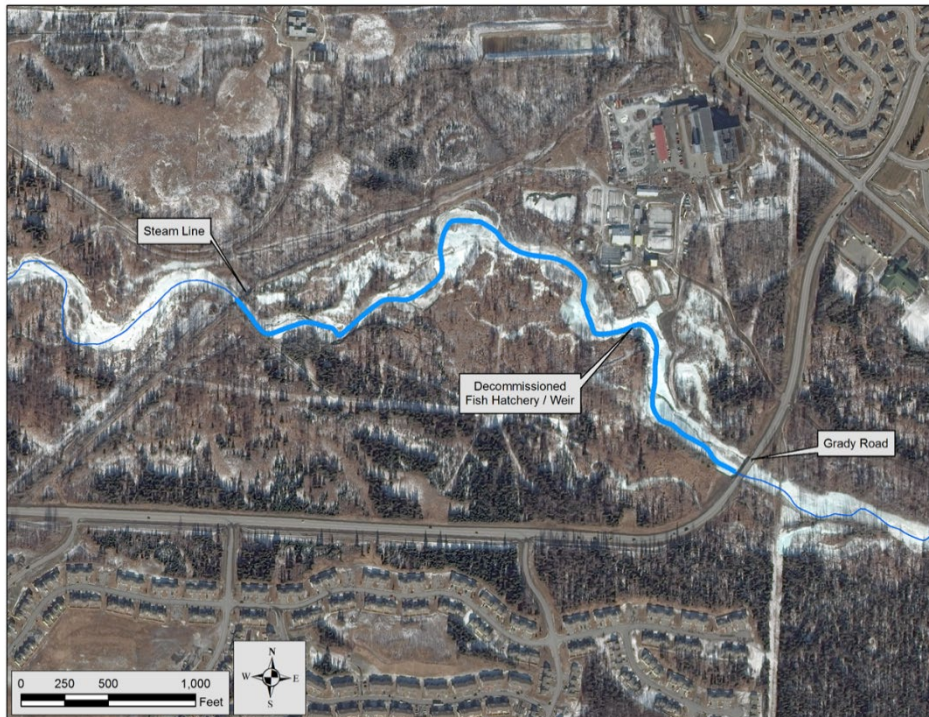
Figure 38. Thermal-suppression Scenario 1, Grady Road Bridge to steam-line crossing.

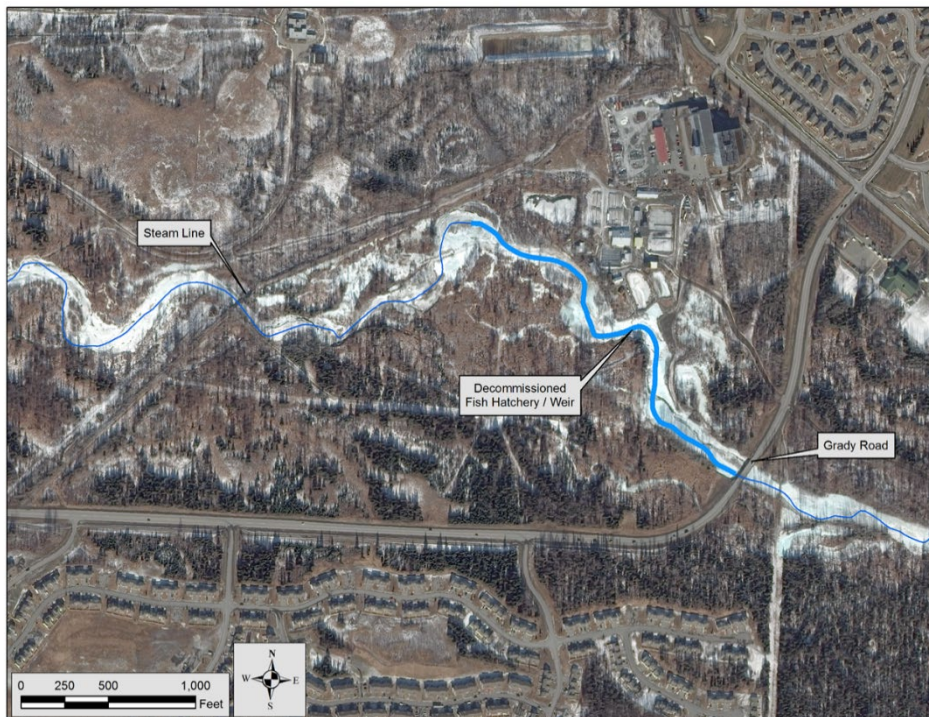
Figure 39. Thermal-suppression Scenario 2, Grady Road Bridge to downstream of the fish hatchery.
