ERDC/EL TR-20-1

Evaluation of Iron Sulfide Soil Formation Following Coastal Marsh Restoration – Observations from Three Case Studies

Jacob F. Berkowitz and Christine M. VanZomeren

January 2020

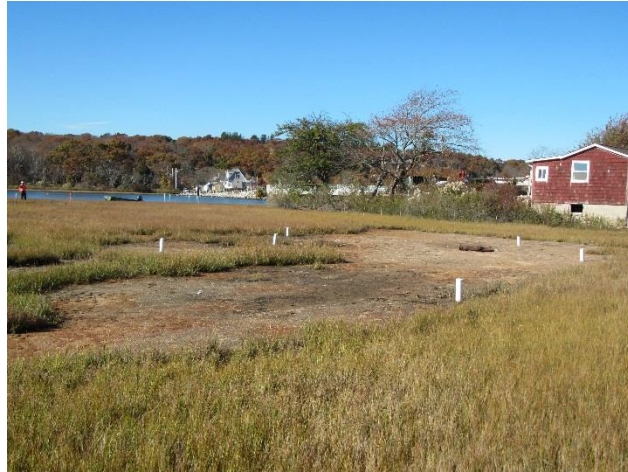
Figure 1. The Narrow River, Rhode Island study site.

The Narrow River restoration site located on the John H. Chafee National Wildlife Refuge is owned and operated by the U.S. Fish and Wildlife Service (USFWS). The USFWS sought to increase marsh elevation in order to improve resiliency in the face of storm surge and relative sea level rise. Prior to initiation of the restoration project, a pilot project was implemented to evaluate the impact of sediment application on marsh vegetation; a local upland sand quarry provided the source material for the pilot project. A layer of sand approximately 10–15 centimeters (cm) thick was placed in two test plots. A year after placement, ERDC was requested to investigate the test plots due to observed dieback of vegetation and the presence of dark red and black soil materials developing on the marsh surface (Figure 1). A navigation channel adjacent to the study location was selected as source material for the full scale restoration effort and sediment from the channel was also evaluated.

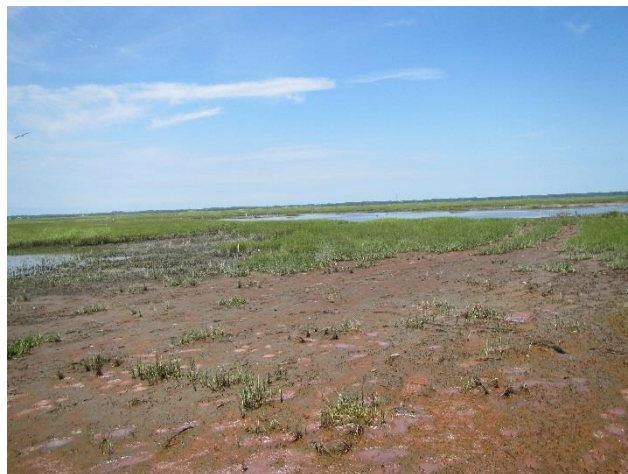
Figure 2. The Avalon, New Jersey study site.

The Avalon restoration site is owned by the state of New Jersey Department of Environmental Protection Division of Fish and Wildlife who, with USACE, including the ERDC and a number of interagency and non-profit partners, sought to increase marsh elevation in order to promote vegetation establishment in recently degraded open water areas and supplement elevation in low-lying vegetated areas. The project utilized dredged sediments from a federal navigation channel funded through post Hurricane Sandy recovery funds. Sediment placement occurred during the winter of 2015–2016. After a year and half, ERDC was requested to investigate the location due to observed dieback of vegetation and the presence of dark red and black soil materials developing on the marsh surface (Figure 2).

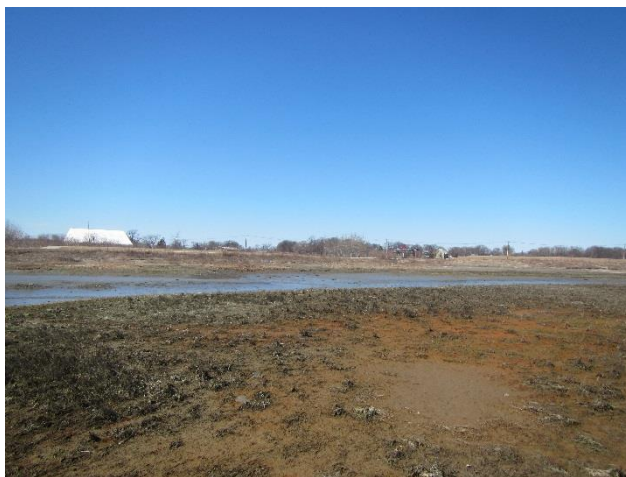
Figure 3. The Broad Meadow, Massachusetts study site.

Owned by the local municipality, the Broad Meadows restoration objective was to reestablish a coastal marsh community in an area that had been utilized as a dredged material disposal area during 1938 and 1956 as part of the Town River Federal Navigation Project. Unlike the other two study sites, the dredged material at Broad Meadows was mounded to supratidal elevations minimizing tidal flushing and maximizing aerobic conditions. In 2011, approximately 35 acres were restored to elevations suitable for the development of low and high marsh vegetation. Dredged material removed from the site was deposited in adjacent areas for the creation of coastal grassland habitat. Following several years of efforts to establish vegetation and preliminary investigation of soil conditions, ERDC staff visited the study location in 2017 to further evaluate site conditions, including the potential presence of FeS (Figure 3).

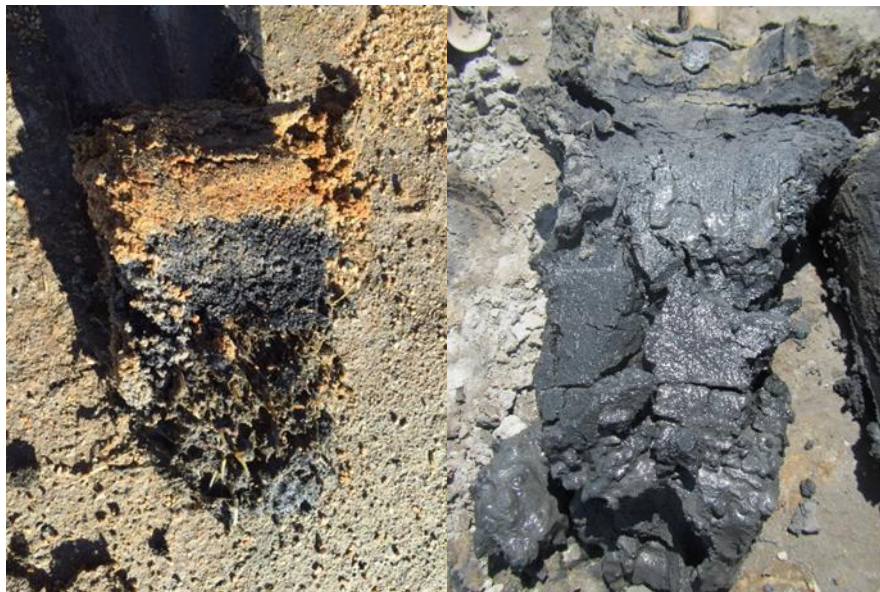
Figure 4. Narrow River (left) soil sample displaying black iron sulfide materials at the contact point between placed upland sands and the underlying marsh soils; Avalon (right) soil sample displaying extensive iron sulfides coating with recently placed dredged materials.

| Parameter | Diagnostic | Example |
|---|---|---|
| Soil Descriptions | FeS forms dark black coatings on soil particles and within soil pores | Figure 4 |

period of approximately one year) resulting in development of a nearly continuous coating of FeS in near surface soils at some sample locations (Figure 4). Additionally, FeS was documented using IRIS tubes, hydrogen peroxide, hydrochloric acid, pore water samples, and α -dipyridyl dye as described in section 1.4.

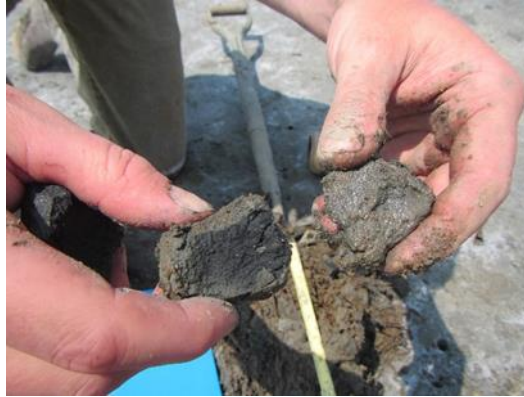
Figure 5. Dark soil coatings (soil on left) from iron sulfide soil materials at Avalon, then oxidized with 3% hydrogen peroxide (soil on right) resulting in removal of dark soil coating and revealing of the underlying grey soil matrix color.

| Parameter | Diagnostic | Example |
|---|---|---|
| Application of hydrogen peroxide (3%) | FeS materials oxidize instantaneously in the presence of strong oxidizing agents, resulting in removal of dark soil coating and revealing the underlying grey soil matrix color | Figure 5 |

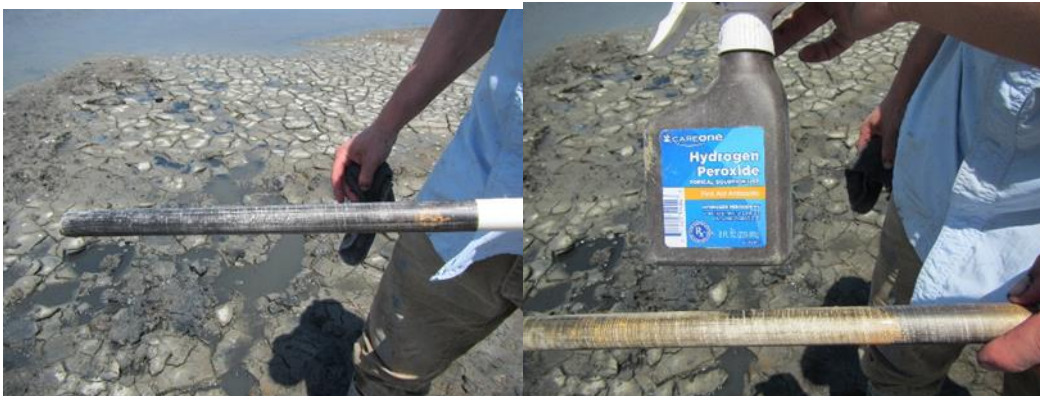
Figure 6. When present, free sulfides precipitate on the surface of Indicator of Reduction in Soils (IRIS) tubes within one hour of installation, resulting in the formation of a black coating (left). Removal of black coating on the IRIS tube by hydrogen peroxide oxidation (right).

| Parameter | Diagnostic | Example |
|---|---|---|
| Installation of indicator of reduction in soils (IRIS) tubes (one hour) | When present, FeS will rapidly precipitate on the surface of IRIS tubes, resulting in the formation of a black coating on the IRIS tube surface | Figure 6 |

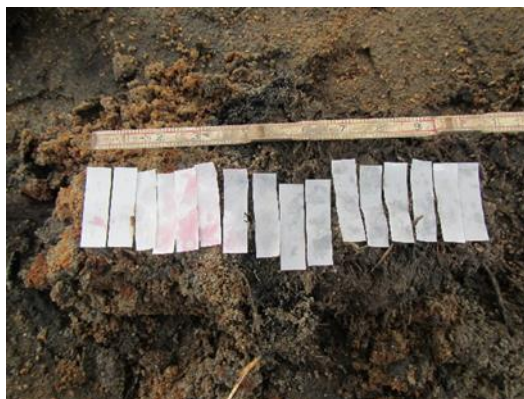
Figure 7. Reaction of reduced iron to α -dipyridyl dye, seen as the development of a pink color, in the upland sands placed at Narrow River.

| Parameter | Diagnostic | Example |
|---|---|---|
| α -dipyridyl dye | Diagnostic test for the presence of ferrous iron, a key component in the formation of FeS; verifies that the soil is chemically reduced with respect to iron. | Figure 7 |

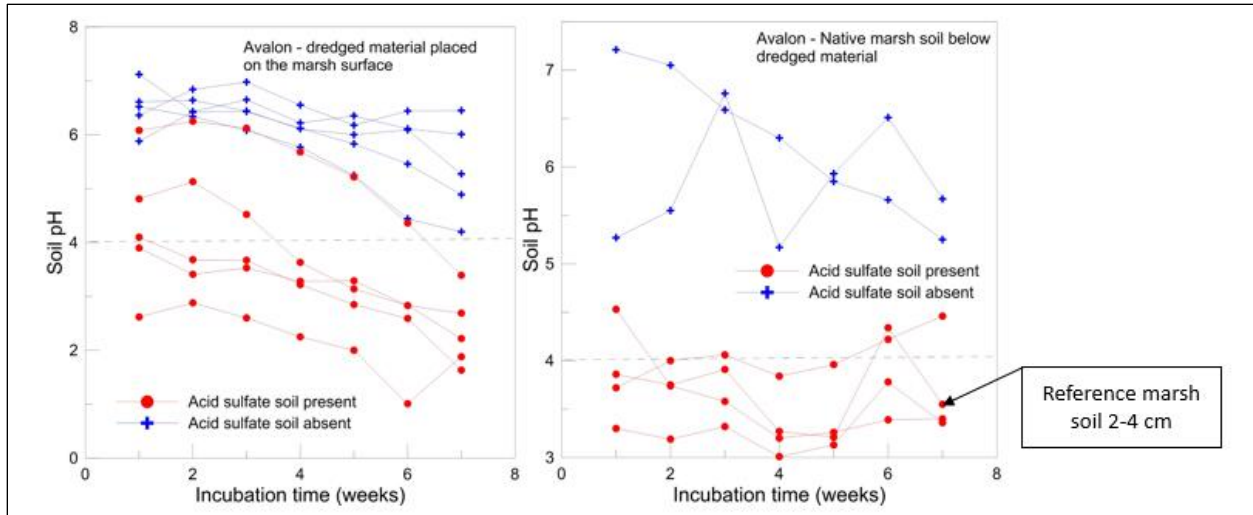
Figure 10. Incubation results demonstrating the presence of FeS within dredged material placed on top of native marsh soils (left) and native marsh soils (right) at Avalon. Note that laboratory incubation results represent a worst case scenario and do not reflect in-situ conditions where tidal flushing, buffering and other factors influence soil pH.

Laboratory incubation further verified the presence of FeS, with pH decreases occurring in a subset of both the placed dredged material and the underlying native marsh soil (Figure 10). Notably, FeS was also observed in native marsh soils (2–4 cm below the surface) in reference areas that received no sediment additions. This demonstrates that FeS naturally occurs in the marsh. However, the rapid formation of FeS within the placement areas could negatively impact restoration outcomes with the potential for acid formation under certain conditions. For example, plant die off was observed at two locations, both of which yielded potential acid generating capacity capable of decreasing soil pH to ~2.0 (Figure 11). Soil pH was not measured in the field so plant die cannot be attributed to soil acid production; however, this may represent a contributing factor operating in combination with climate (i.e., recent drought), increased salinity following sediment placement, alterations in site hydrology caused by remnant containment structure, rafting of vegetation, and other factors. Additional field research is required to link laboratory studies, which may represent a worst case scenario, with in-situ conditions. Many factors other than soil properties influence marsh restoration trajectories including the presence of invasive species, herbivory, inappropriate hydrologic design or species selection, and adverse environmental conditions after construction. As a result, presence of FeS soils alone, or in combination with other factors, can lead to substantial land use limitations if oxidation occurs, potentially adversely impacting marsh restoration outcomes.

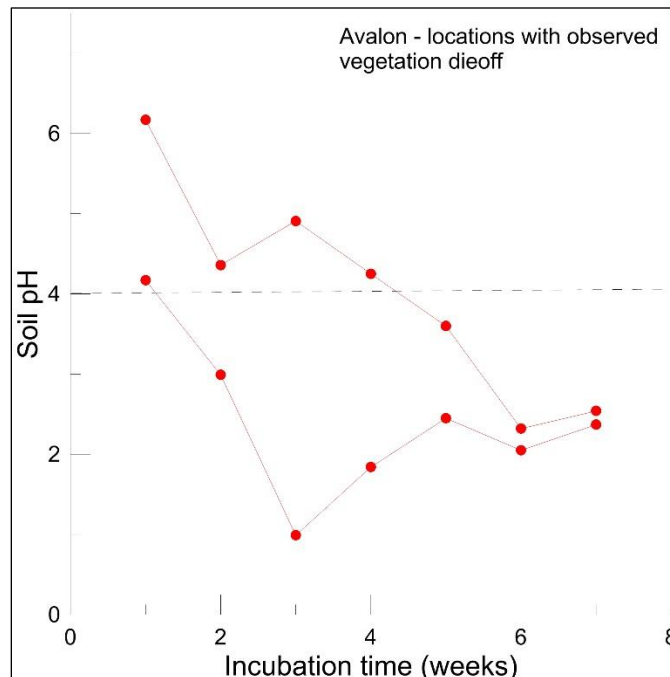
Figure 11. Soil pH decreases in two areas of the Avalon marsh in which vegetative die off was observed. Note that laboratory incubation results represent a worst case scenario and do not reflect in-situ conditions where tidal flushing, buffering and other factors influence soil pH.

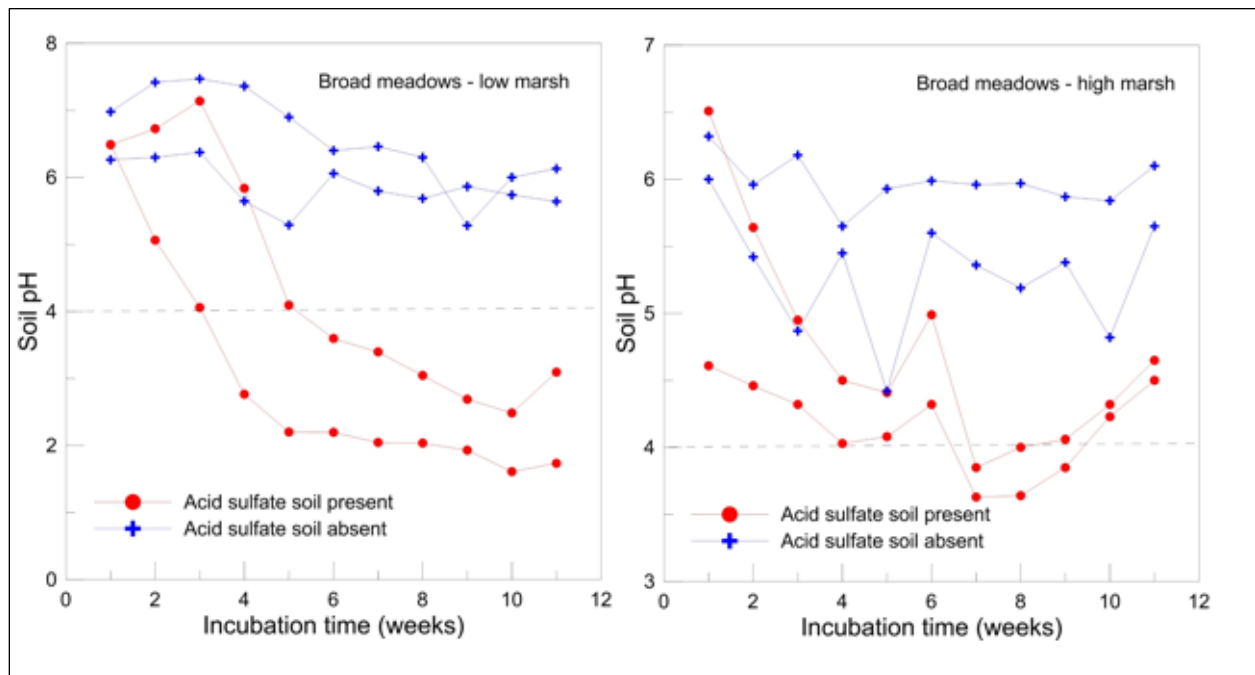
Figure 12. Incubation results demonstrating the presence of FeS within low marsh (left) and high marsh (right) soils at Broad Meadows. Note that laboratory incubation results represent a worst case scenario and do not reflect in-situ conditions where tidal flushing, buffering, and other factors influence soil pH.

Field results documented the presence of FeS at a subset of low marsh, high marsh, and disposal area samples. Black FeS materials coated portions of the soil profile and were documented using the field techniques described above. Laboratory incubation further verified the presence of FeS, with pH decreases occurring in a subset of both high and low marsh soils (Figure 12). Notably, acid sulfate conditions were not observed in reference areas. Acidic soil conditions persisted within unvegetated portions of the dredged material disposal areas adjacent to the marsh, where the soil pH remains <3.8 (Figure 13). Additional monitoring is required to determine how long acidic conditions will persist following the reestablishment of marsh elevations.

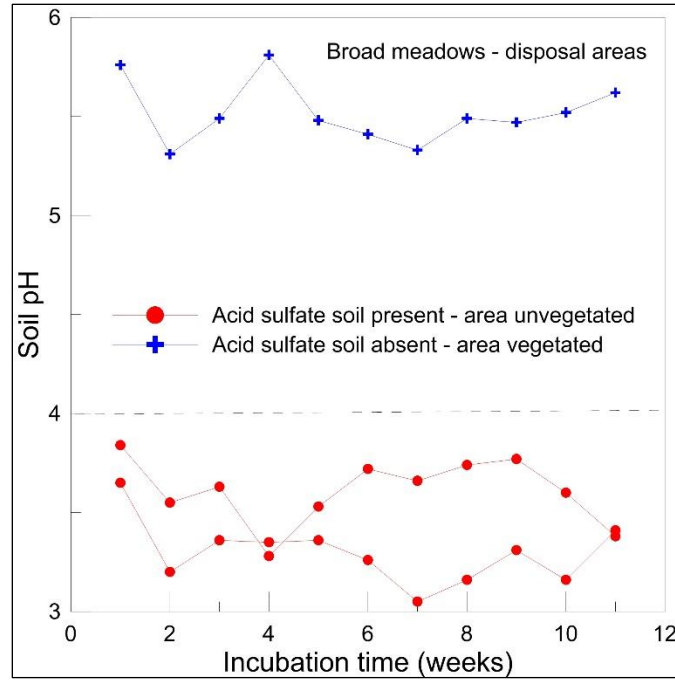
Figure 13. Soil pH conditions remain problematic in unvegetated areas within the dredged material disposal areas at Broad Meadows. Note that laboratory incubation results represent a worst case scenario and do not reflect in-situ conditions where tidal flushing, buffering, and other factors influence soil pH.
