**US Army Corps
of Engineers®**
Engineer Research and
Development Center

Evaluation of Thin Flexible Pavements under Simulated Aircraft Traffic

December 2020

A full-scale airfield pavement test section was constructed and trafficked by the U.S. Army Engineer Research and Development Center (ERDC) to evaluate the performance of relatively thin airfield pavement structures. The test section consisted of 16 test items that included three asphalt pavement thicknesses and two different aggregate base courses. The test items were subjected to simulated aircraft traffic to evaluate their response and performance to realistic aircraft loads and to evaluate the effect of reductions in tire pressure on thin asphalt pavement. Rutting behavior, pavement cracking, instrumentation response, and falling weight deflectometer response were monitored at selected traffic intervals. The results of this study were used to extend existing Department of Defense pavement design and evaluation techniques to include the evaluation of airfield pavement sections that do not meet the current criteria for aggregate base quality and minimum asphalt concrete surface thickness. These performance data were used

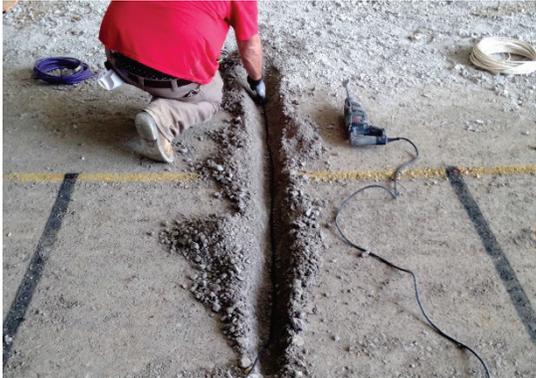
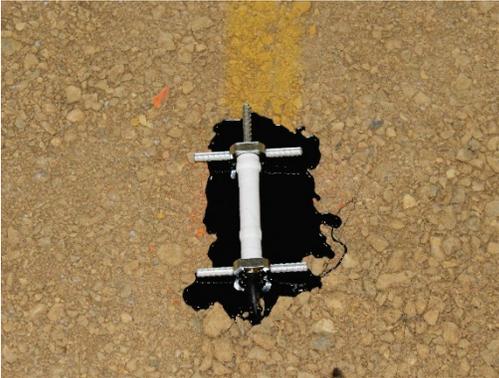
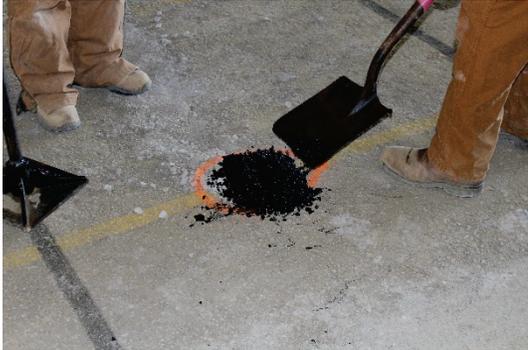
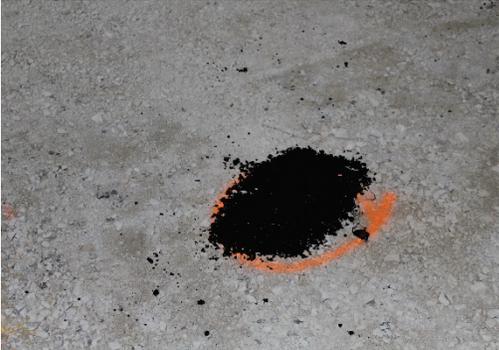
Figure 15. Asphalt strain gauge installation.

(a) Trenching for wire

(b) Adhered to surface

(c) Covering with HMA

(d) Compacted prior to paving

Tensile strain at the bottom of an HMA layer provides a quantitative measure of the pavement response during trafficking. The tensile strain at the bottom of the asphalt is a key response parameter linked to fatigue damage in the HMA layer. For this study, strain at the bottom of the HMA surface was measured by using dynamic asphalt strain gauges (ASGs) in the longitudinal (i.e. with traffic) direction. The ASGs were manufactured by Tokyo Sokki and were capable of measuring a range of $\pm 5,000$ microstrain. The gauges were adhered to the surface of the base course with a heated asphalt binder, and HMA from the asphalt paver was placed as cover over each of the gauges immediately prior to paving the entire test section. This process is shown in Figure 15.

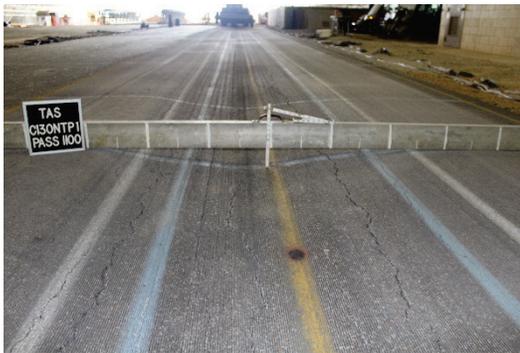
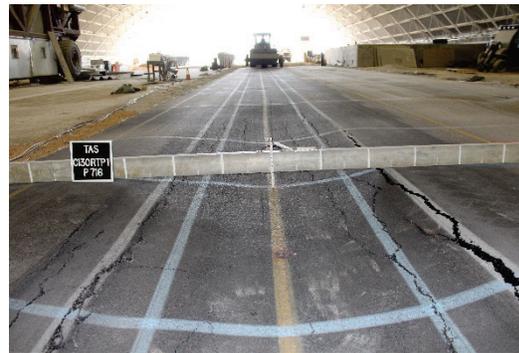
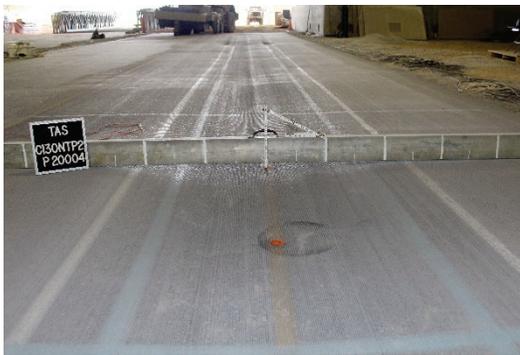
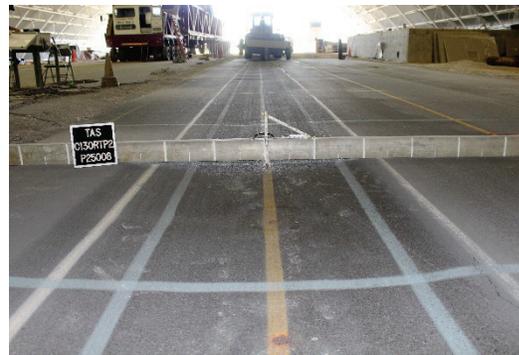
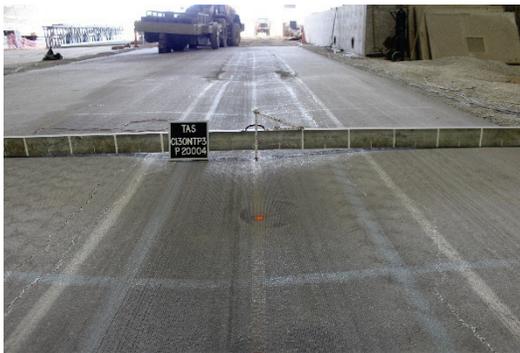
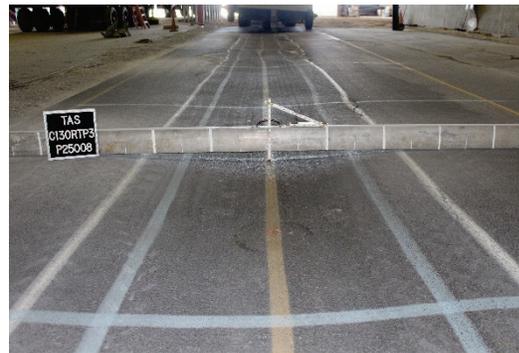
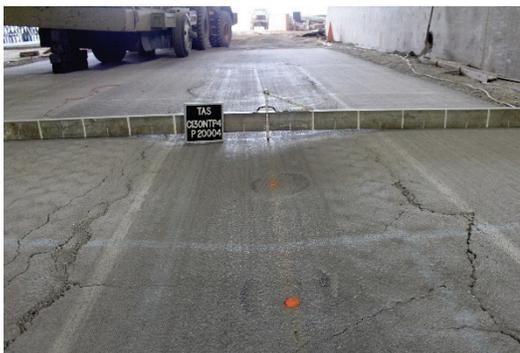
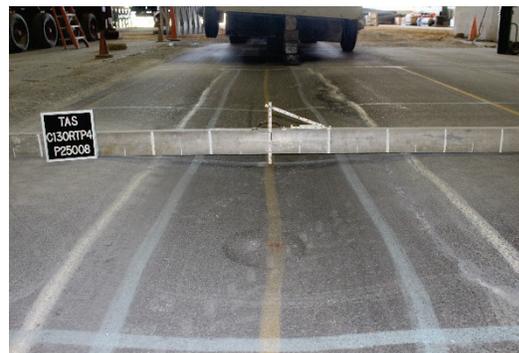
Figure 26. Photographs of rutting in C-130 test items.

(a) C130NTP1 (Pass 1,100)

(b) C130RTP1 (Pass 716)

(c) C130NTP2 (Pass 20,004)

(b) C130RTP2 (Pass 25,008)

(e) C130NTP3 (Pass 20,004)

(b) C130RTP3 (Pass 25,008)

(f) C130NTP4 (Pass 20,004)

(b) C130RTP4 (Pass 25,008)

Photographs showing rutting observed in the C-130 normal and reduced tire test items are presented in Figure 26.

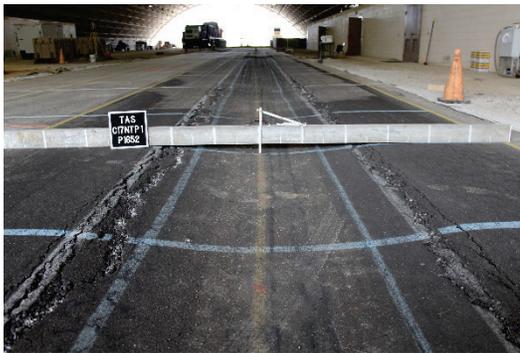
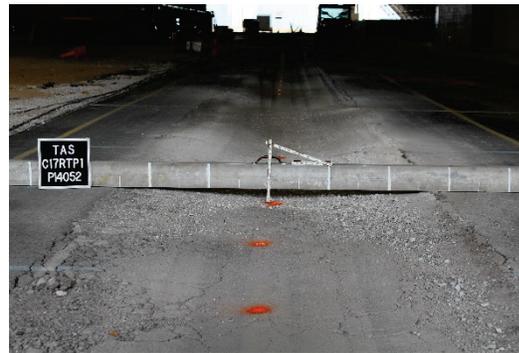
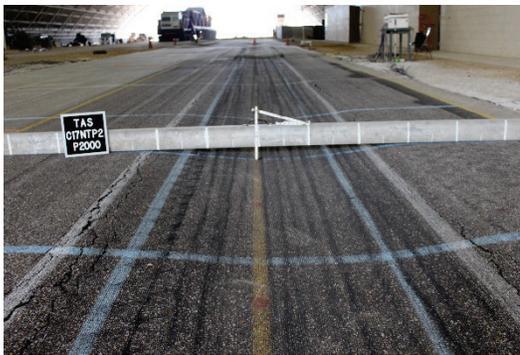
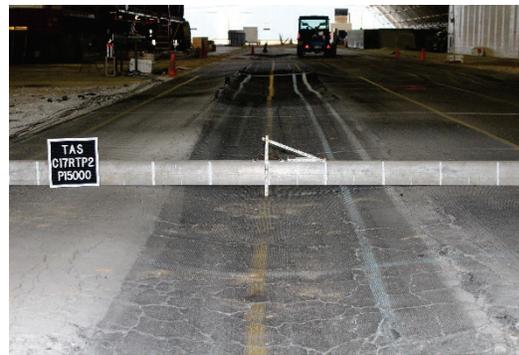
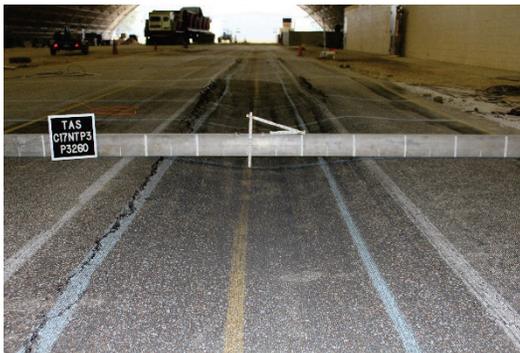
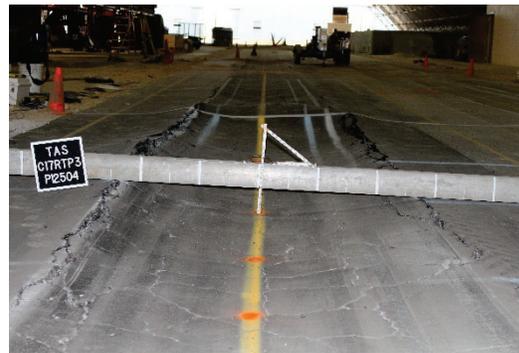
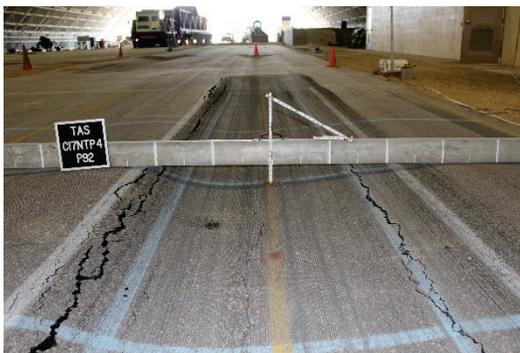
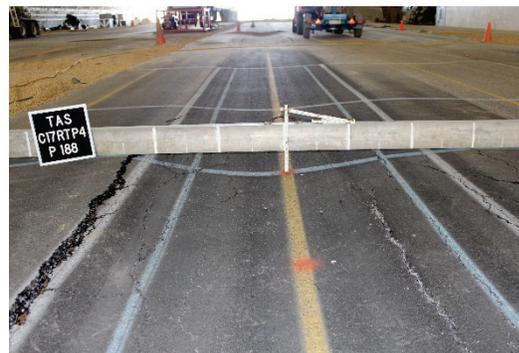
Figure 73. Photographs of rutting in C-17 test items.

(a) C17NTP1 (Pass 1,652)

(b) C17RTP1 (Pass 14,052)

(c) C17NTP2 (Pass 2,000)

(d) C17RTP2 (Pass 15,000)

(e) C17NTP3 (Pass 3,260)

(f) C17RTP3 (Pass 12,504)

(g) C17NTP4 (Pass 92)

(h) C17RTP4 (Pass 188)

Photographs of rutting in the C-17 test items are shown in Figure 73.

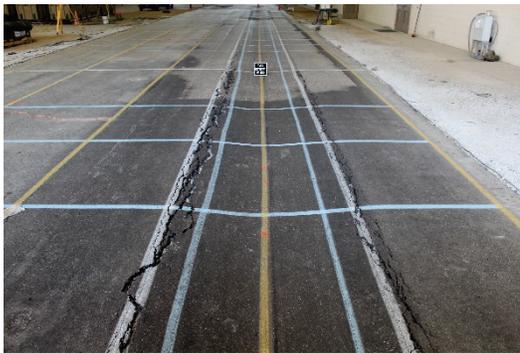
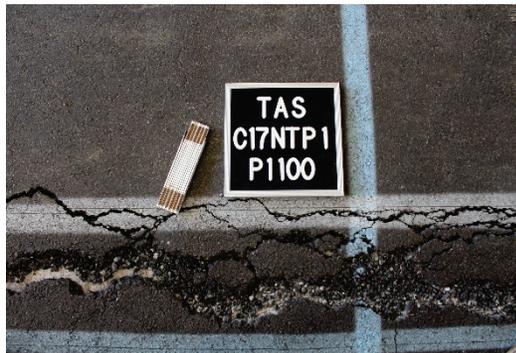
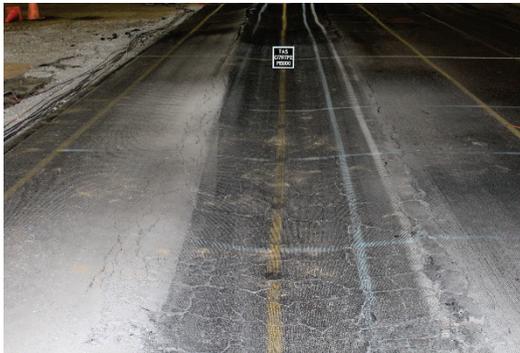
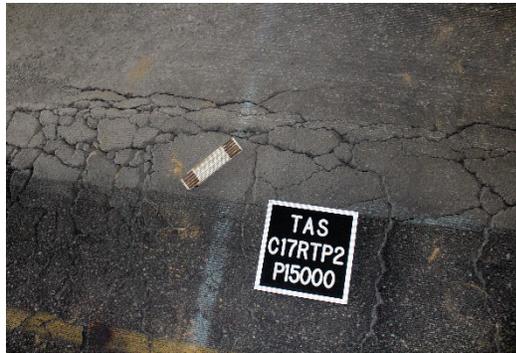
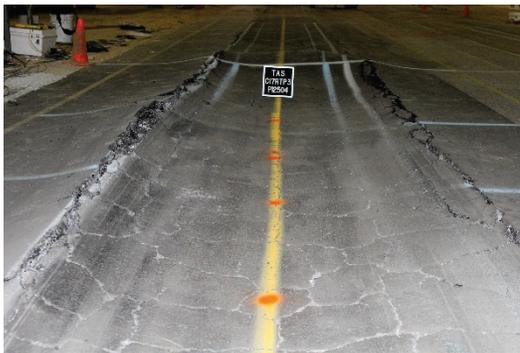
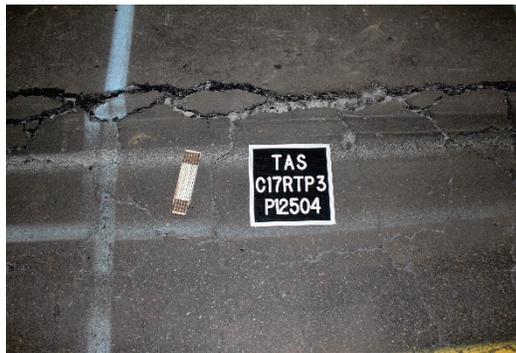
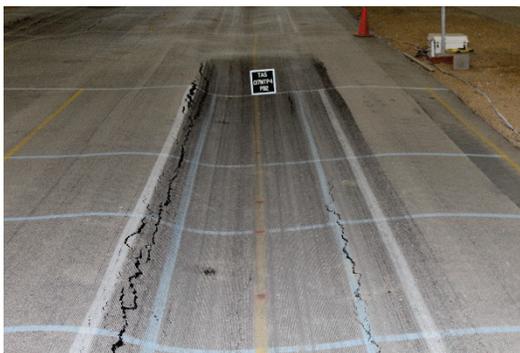
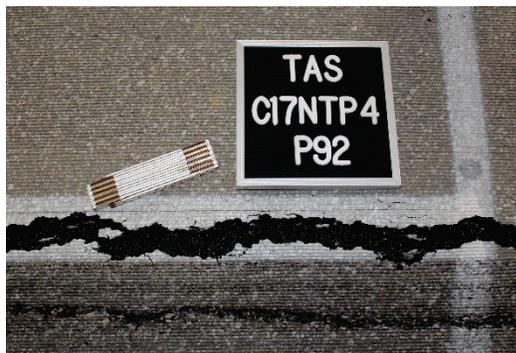
Figure 78. Photographs of cracking in C-17 test items.

(a) C17NTP1 overall cracking

(b) C17NTP1 cracking close-up

(c) C17RTP2 overall cracking

(d) C17RTP2 cracking close-up

(e) C17RTP3 overall cracking

(f) C17RTP3 cracking close-up

(g) C17NTP4 overall cracking

(h) C17NTP4 cracking close-up

Total cracking for the reduced tire pressure test items is shown in Figure 75. C17RTP4 displayed the first visual cracking, as expected. The limestone base test items developed cracking in a logical order (i.e., thinner asphalt to progressively thicker asphalt layer). When compared to the normal tire pressure test items, it was observed that cracking generally occurred later in traffic application in the reduced tire pressure series. Equality plots (Figure 76 and Figure 77) revealed that a 20% improvement in cracking was observed in the 1.0-in. HMA, LMS base, and a 74% improvement in cracking was observed in the 1.5-in. HMA, LMS base items. Insufficient data were available to present equality plots for the 2.5-in. HMA, LMS base and 2.5-in. HMA, GR base items, although it should be noted that crack progression was less in the reduced tire pressure test items. Examples of observed cracking are presented in Figure 78.

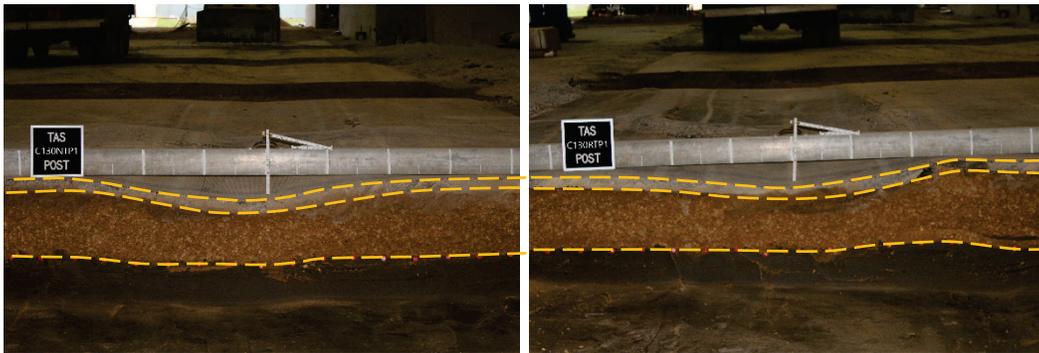
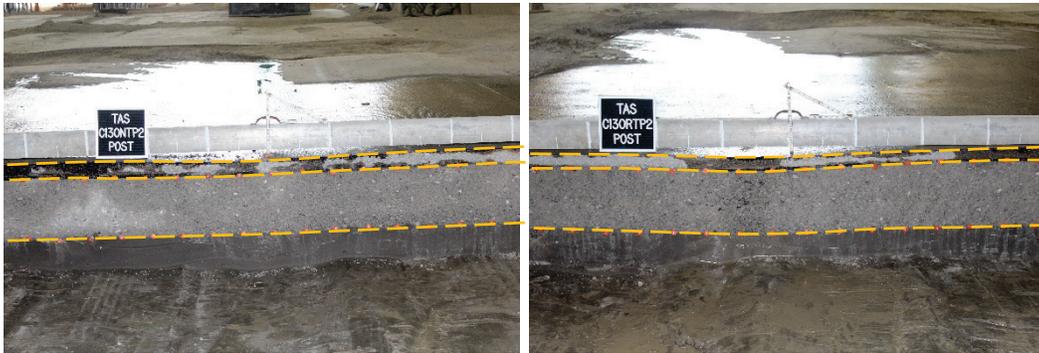
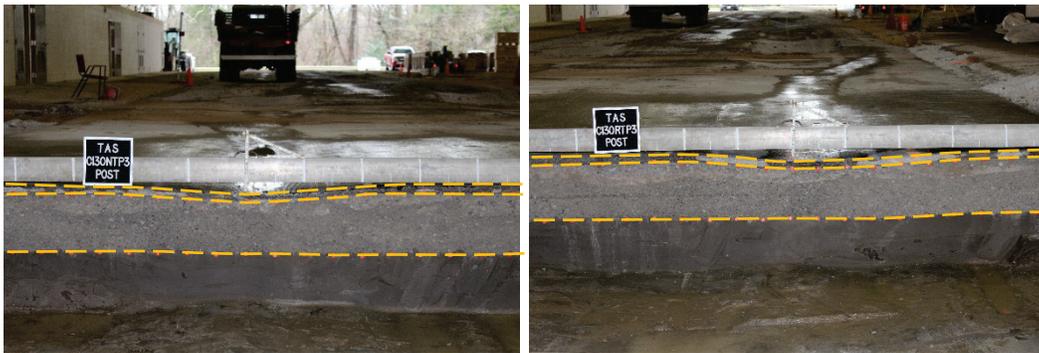
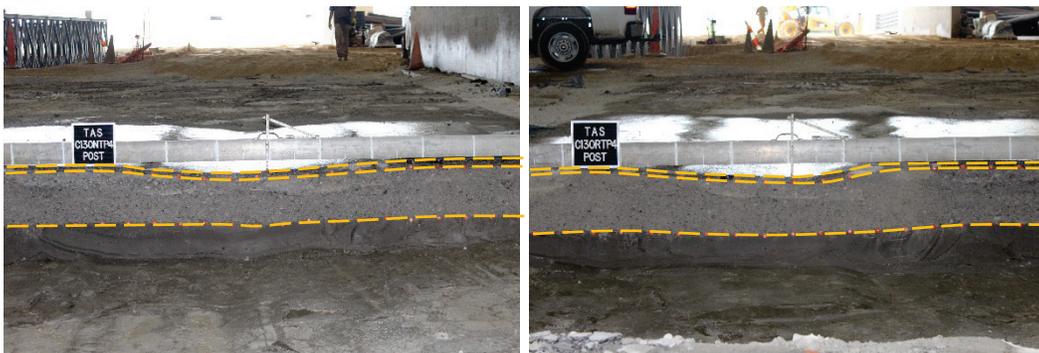
Figure 183. C-130 excavation photographs.

(a) C130NTP1 (2.5-in. HMA, LMS base)

(b) C130RTP1 (2.5-in. HMA, LMS base)

(c) C130NTP2 (2.5 in.-HMA, LMS base)

(d) C130RTP2 (2.5-in. HMS, LMS base)

(e) C130NTP3 (1.5-in. HMA, LMS base)

(f) C130RTP3 (1.5-in. HMA, LMS base)

(g) C130NTP4 (1.0-in. HMA, LMS base)

(h) C130RTP4 (1.0-in. HMA, LMS base)

Photographs of each excavated trench are shown in Figure 183. Layer interfaces are denoted by yellow dashed lines in each photograph.

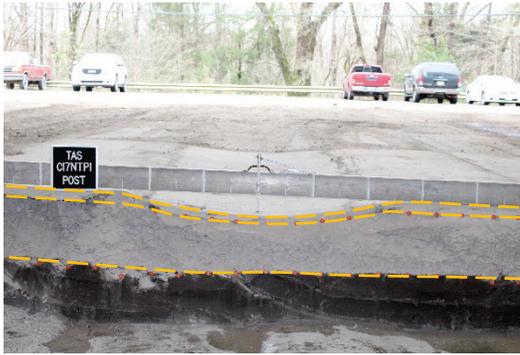
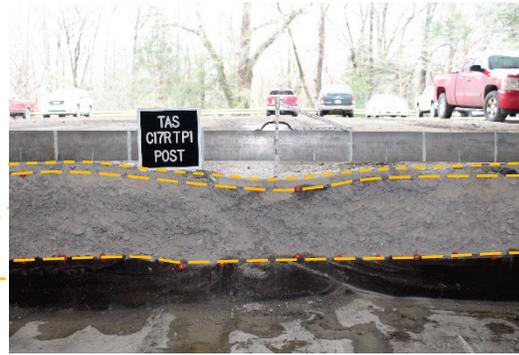
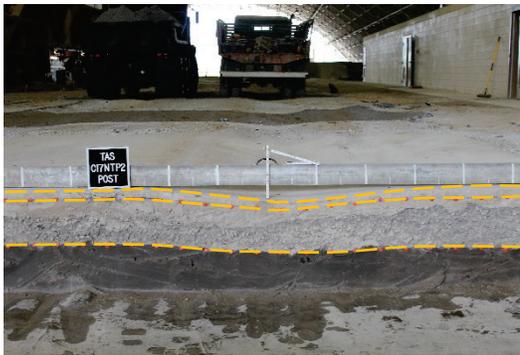
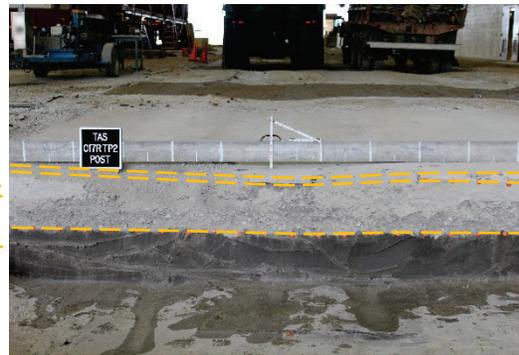
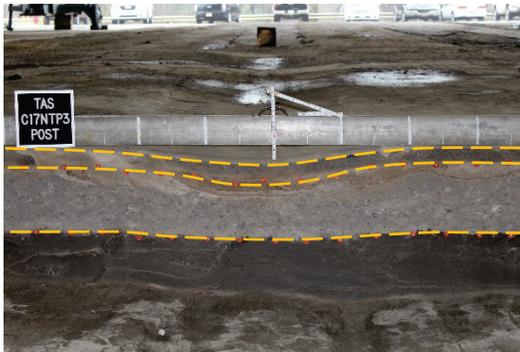
Figure 192. C-17 cross-section photographs.

(a) C17NTP1 (1.0-in. HMA, LMS base)

(b) C17RTP1 (1.0-in. HMA, LMS base)

(c) C17NTP2 (1.5-in. HMA, LMS base)

(d) C17RTP2 (1.5-in. HMA, LMS base)

(e) C17NTP3 (2.5-in. HMA, LMS base)

Photographs of each excavated trench are shown in Figure 192. Layer interfaces are denoted by yellow dashed lines in each photograph.

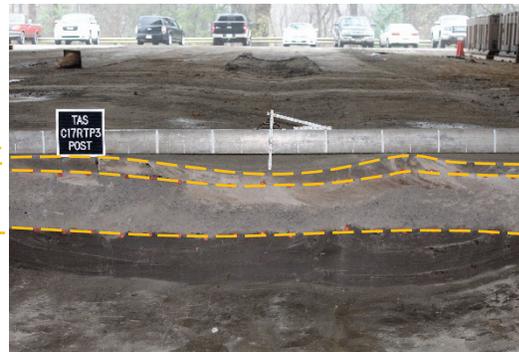
(f) C17RTP3 (2.5-in. HMA, LMS base)

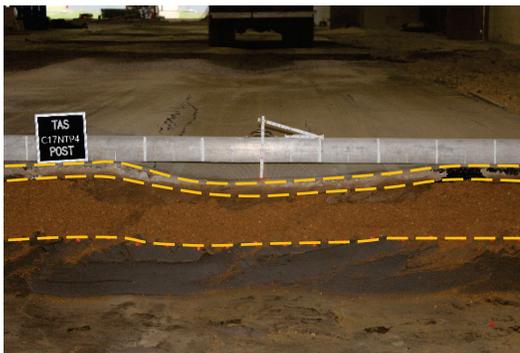
(g) C17NTP4 (2.5-in. HMA, GR base)

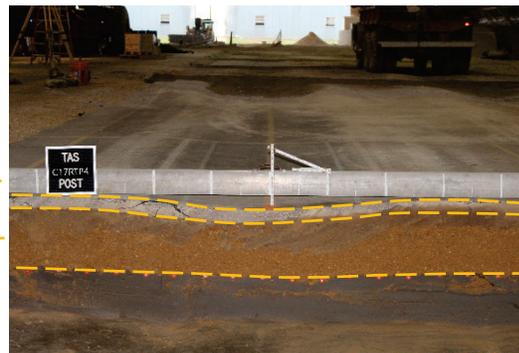
(h) C17RTP4 (2.5-in. HMA, GR base)
