US Army Corps
of Engineers®

Channel Assessment Tools for Rapid Watershed Assessment

by *Chris Haring and David Biedenbarn*

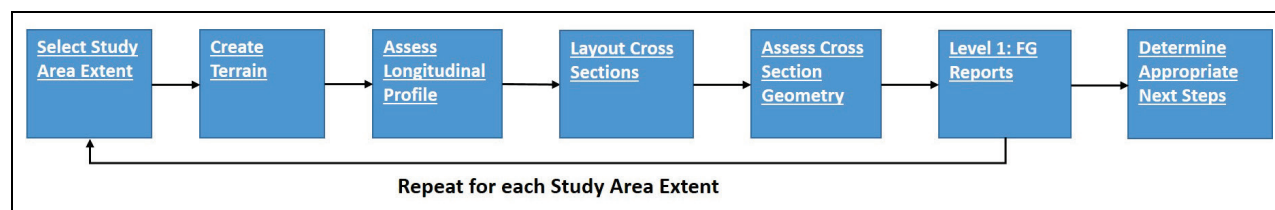
Figure 1. FluvialGeomorph (FG)-Level 1: CSA.

FLUVIALGEOMORPH (FG) APPROACH: The FG-Rapid Geomorphic Assessment (RGA) approach outlined in Haring and Dougherty* is divided into three primary workflows. The first workflow, which is the subject of this paper, defines Level 1-Channel Stability Analysis (CSA) for stream channel reaches within the study watershed (Figure 1). The Level 1 CSA evaluates both LiDAR-based longitudinal water surface profiles and channel cross-sections. This provides a reconnaissance level method to identify potential areas of concern based on LiDAR water surface or dry channel slope profiles and cross-sectional area comparative analysis. The CSA provides a basis for identifying potential areas of interest where channel degradation, aggradation, or widespread channel changes are observed. This approach is used to qualitatively identify sediment sources, pathways, and sinks based on channel stability analysis within the reach or larger stream network.

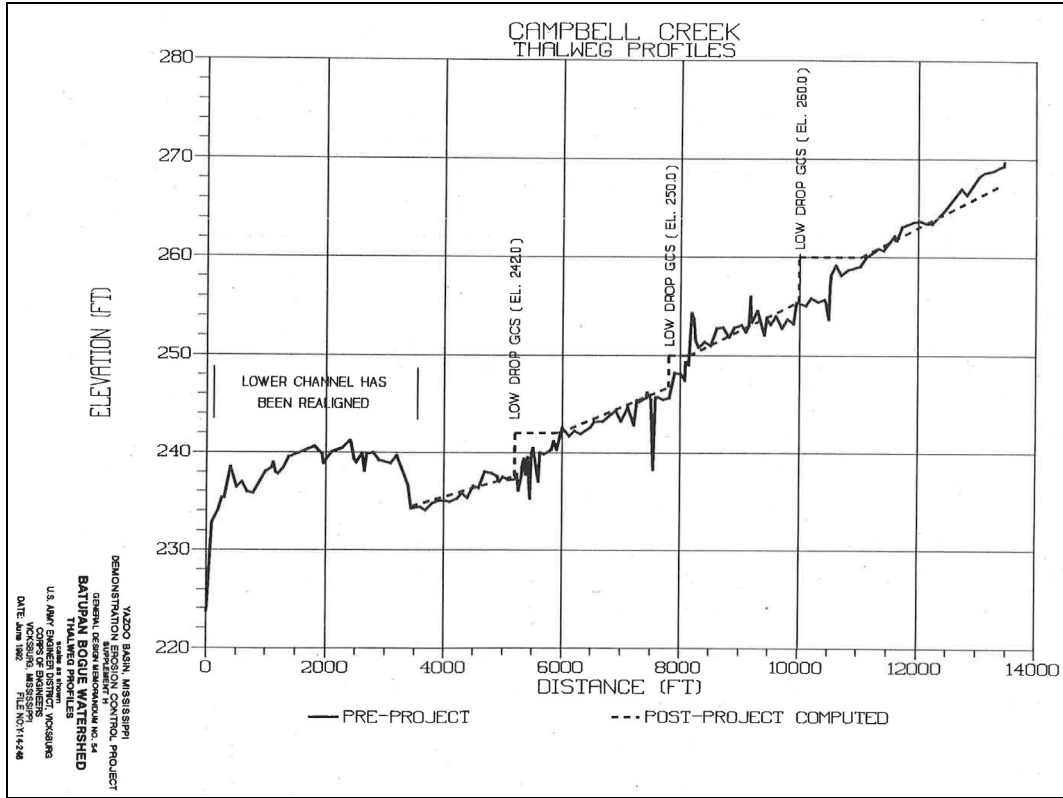
Figure 3. Campbell Creek 1986 channel survey.

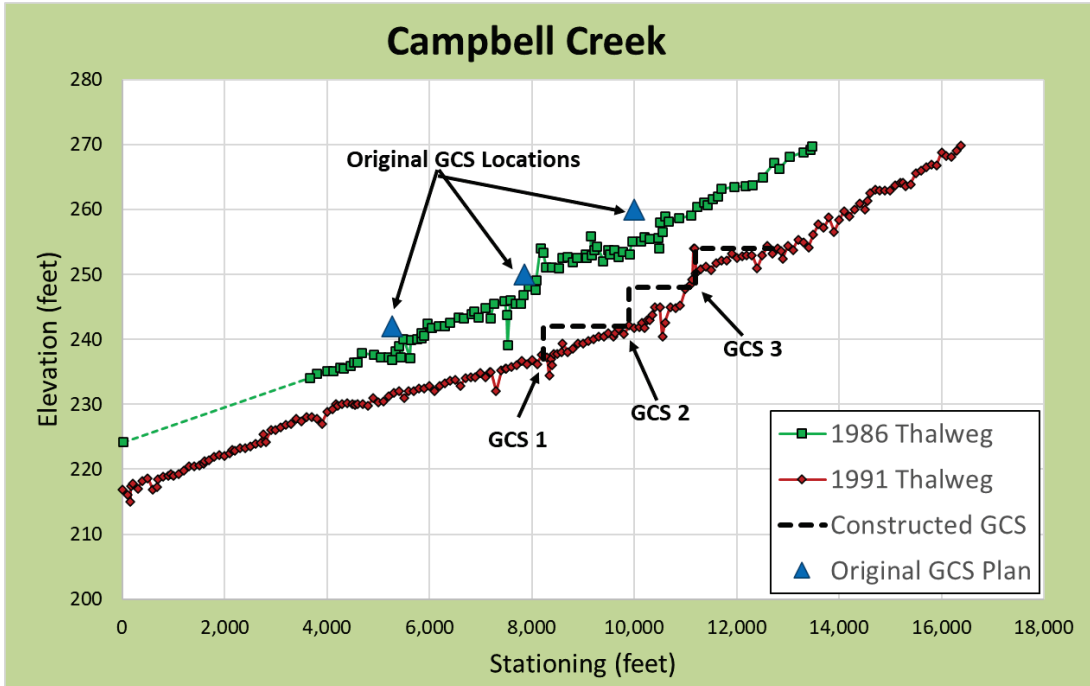
Figure 4. 1986 and 1991 thalweg surveys on Campbell Creek. Note: because of the survey bust in the 1986 survey, the downstream segment was drawn as a straight (dashed) line between approximately Station 3700 and the confluence with Little Bogue, where the elevation was known to be correct.

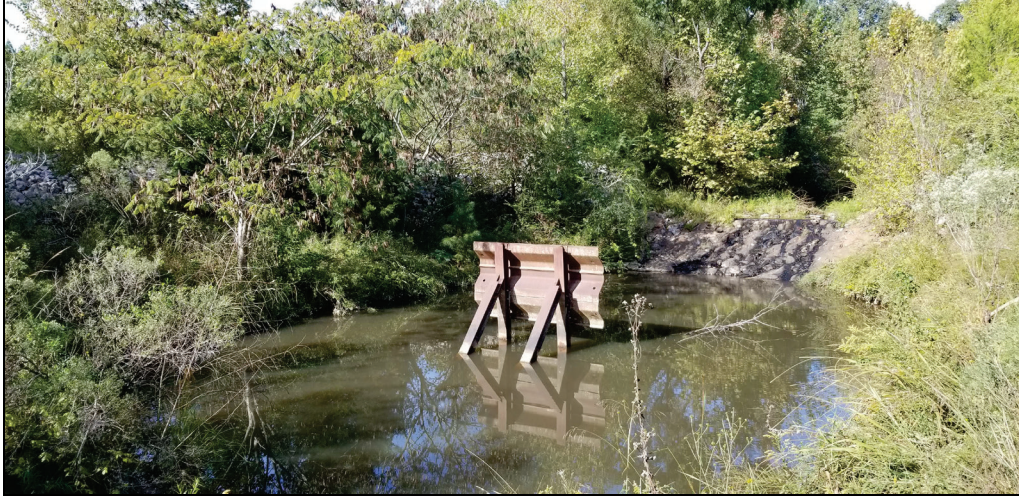
Figure 6. Campbell Creek grade control structure #1.

Photographs of typical channel conditions along Campbell Creek and Campbell Creek Tributary are shown in Figures 6 through 10. These investigations reveal that the channel downstream of the lowermost grade control structure (GCS No. 1; Figure 5) is in a degradational regime, as is most of the entire reach of the Campbell Creek Tributary. In most locations, the bed of the stream had incised into a hard clay material (Figure 10). Although this material is relatively resistant to erosion, there was obvious evidence that the bed was still actively degrading, albeit at a slow rate.

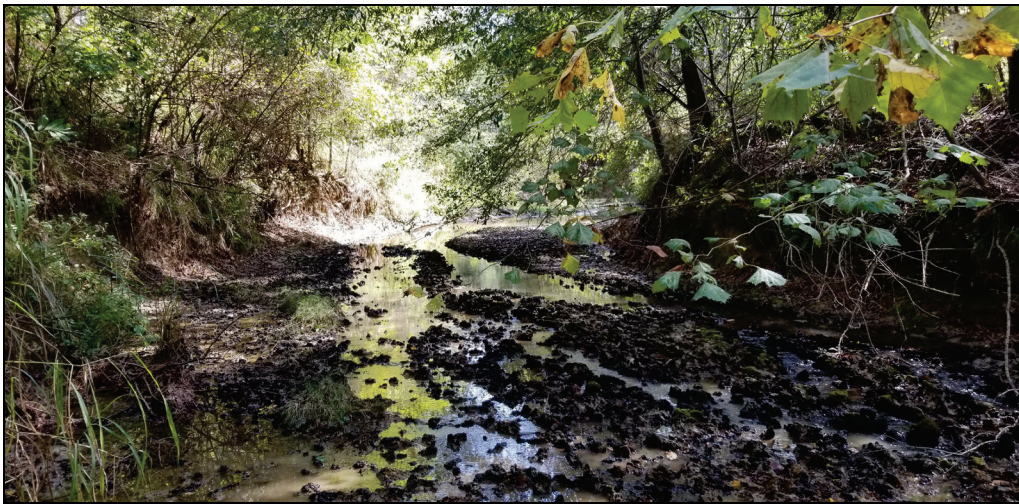
Figure 7. Campbell Creek field identified nick zone in semi-resistant clay bed.

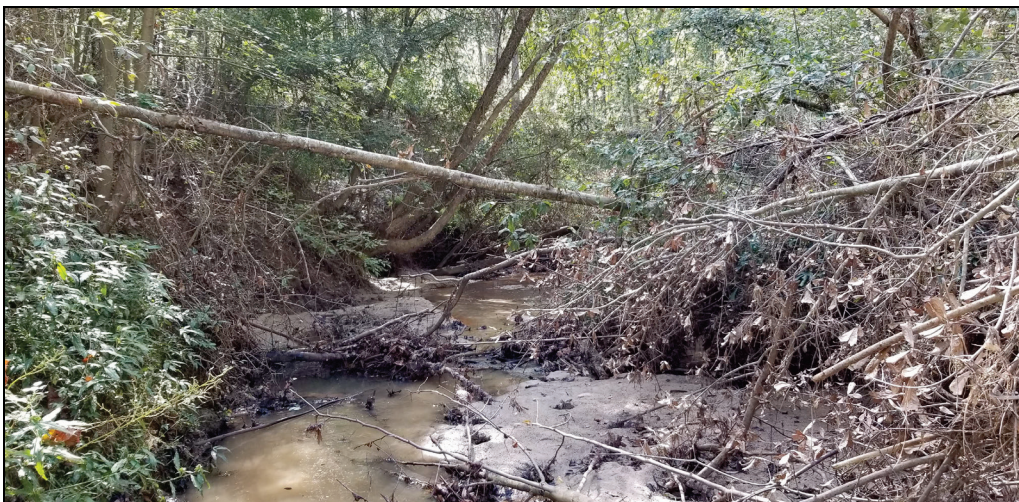
Figure 8. Campbell Creek field identified bed degradation with sloughing bank and vegetation.

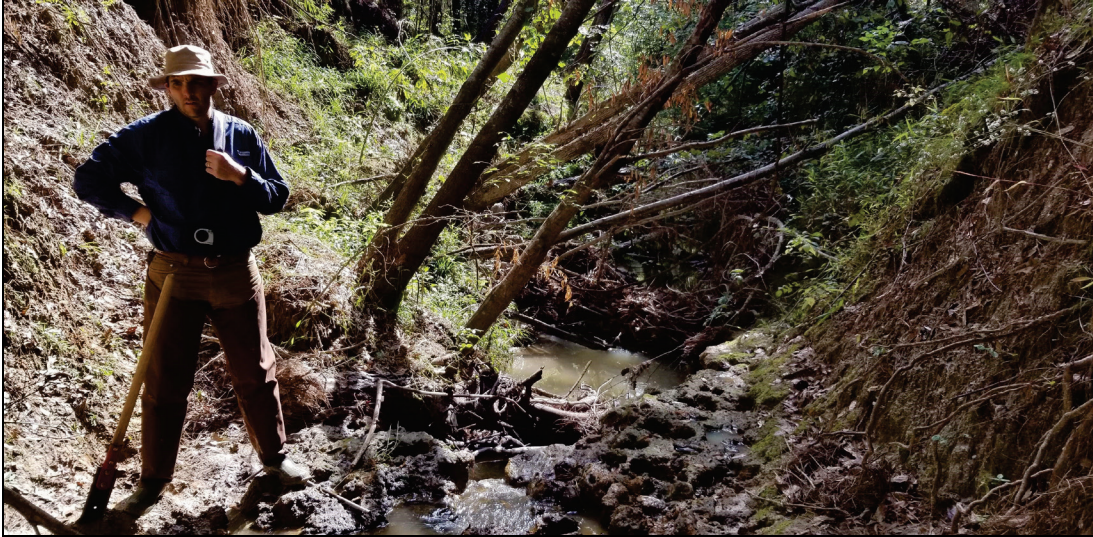
Figure 9. Campbell Creek Tributary nick point with channel widening and sloughing bank and vegetation immediately downstream.

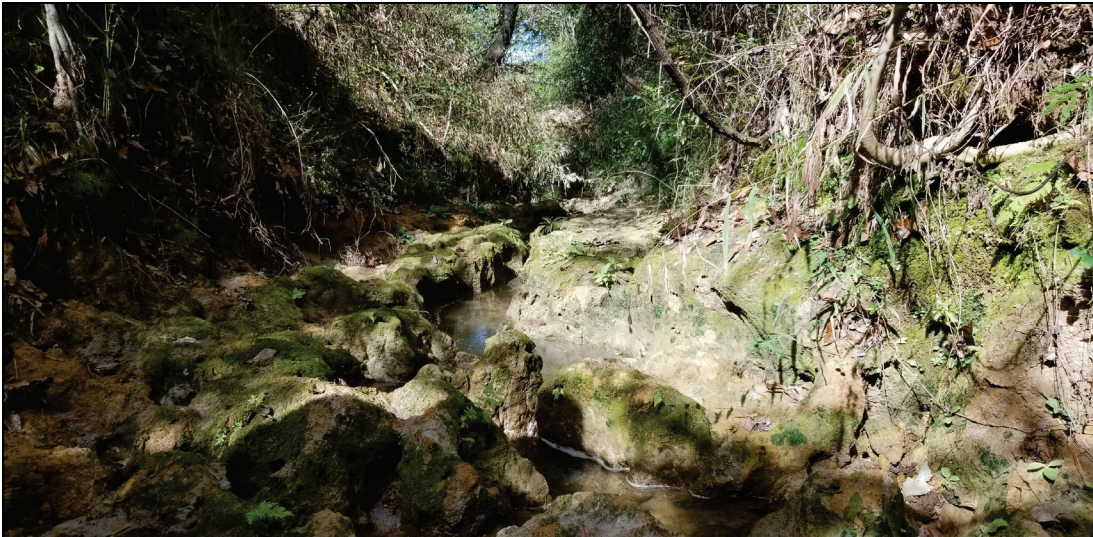
Figure 10. Campbell Creek Tributary nick zone downstream of James H. Bidy Road culverts.

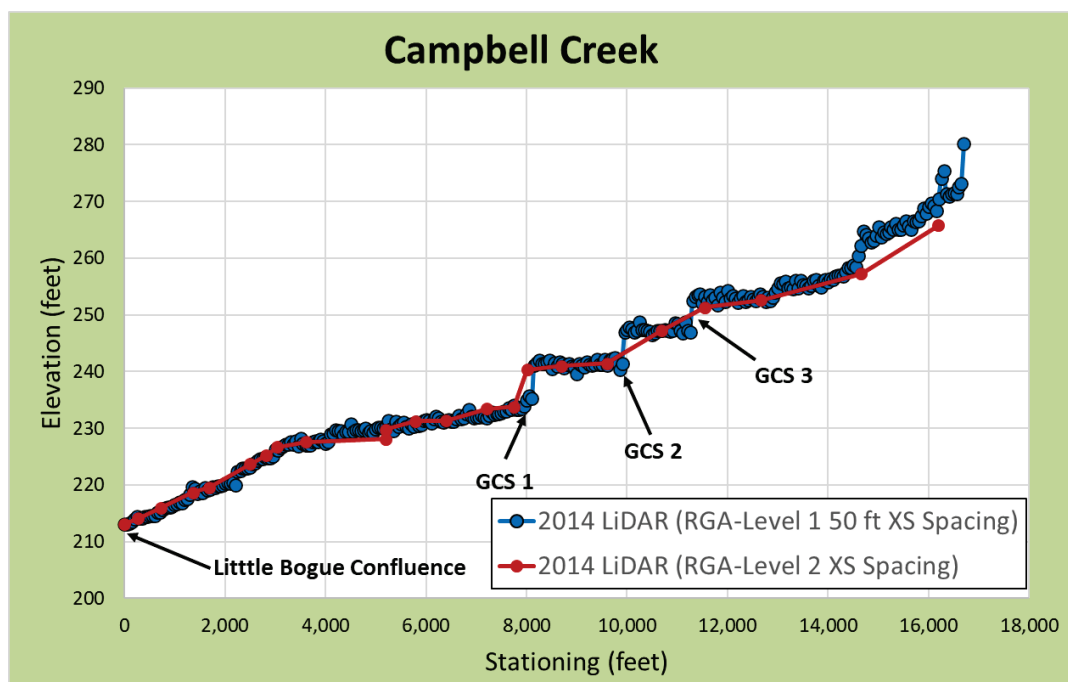
Figure 11. Campbell Creek 2014 LiDAR-RGA Level 1 and 2 profile plot comparison.

Data Analysis. For comparison purposes, the 2014 LiDAR data were initially analyzed using the RGA-Level 2 protocols which located cross sections based on DEM-identified narrow-riffle locations. This profile is shown in Figure 11. This profile appeared to provide a reasonable representation of the overall channel profile. However, several key features such as grade control structures, culverts, and other major breaks in grade were not captured. The RGA-Level 2 approach is focused on the development of hydraulic geometry parameters, and therefore cross-section locations are selected at identified riffle locations, which may be spaced too far apart to capture many of the local breaks in the channel grade. For this reason, the LiDAR data were re-analyzed using the RGA-Level 1 approach, selecting cross sections every 50 ft. As shown in Figure 11, this survey using the 50 ft spacing captured the three grade control structures as well as other significant breaks in grade. Similar profiles were developed for Campbell Creek Tributary (Figure 12). As shown in Figure 12, the profile developed using the 50 ft (RGA-Level 1) cross-section spacing provided a much more detailed view of the channel grade than the RGA-Level 2 approach.

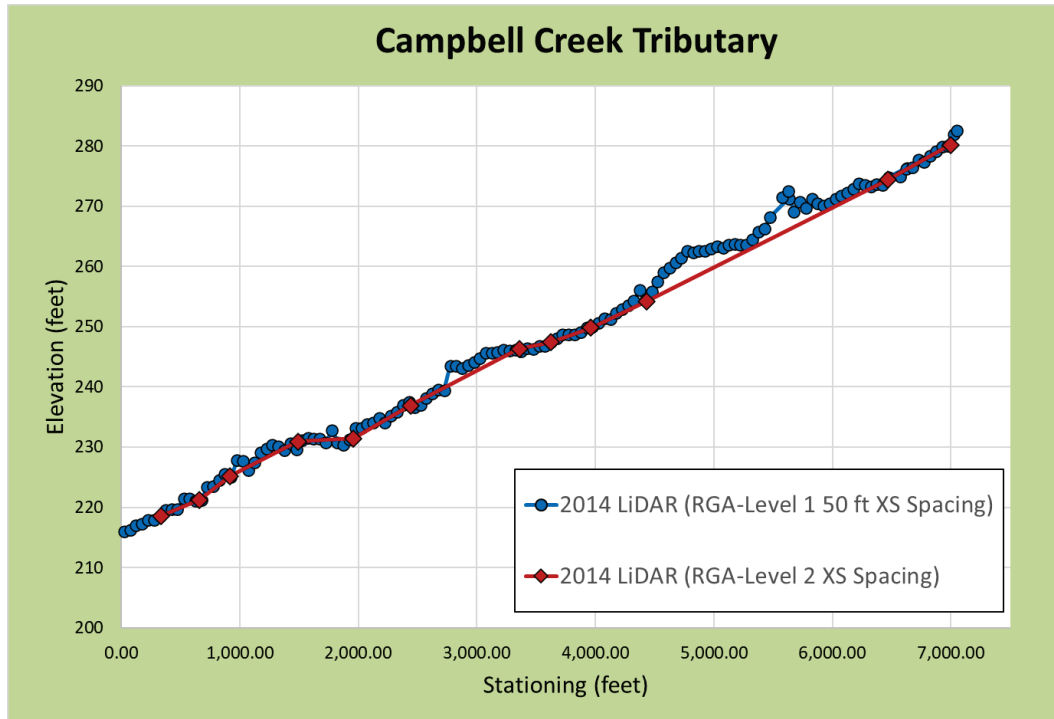
Figure 12. Campbell Creek Tributary 2014 LiDAR-RGA Level 1 and 2 profile plot comparison.

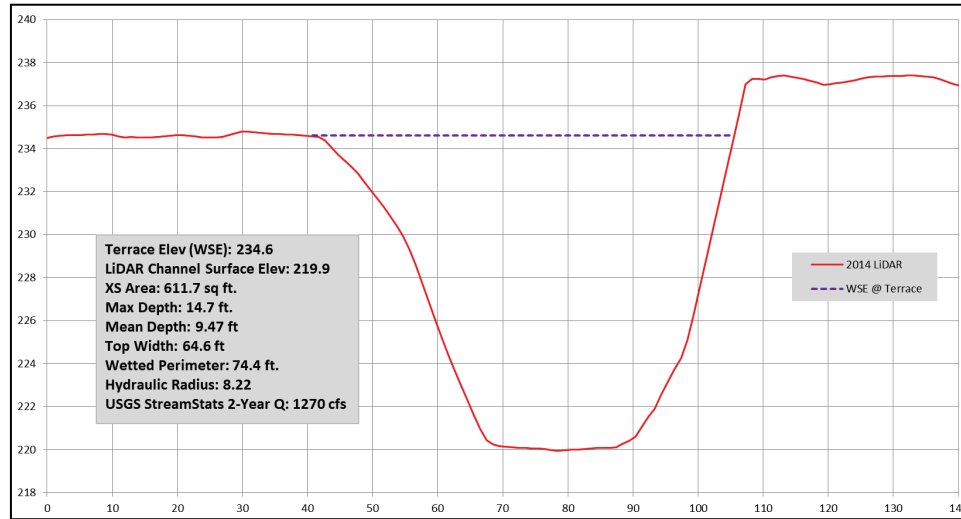
Figure 13. Campbell Creek cross section #40 associated with Figure 8.

As second part of the FG Level-1 CSA analysis, cross-section comparisons from Figures 7 and 8 are analyzed to identify potential channel degradational and aggradation trends within the reach or watershed. During the field site visit, visual field observations were easy to make based on the presence of resistant bed materials and assessing channel dimensions. As an example, Figures 13 and 14 (locations in Figure 5; photos in Figures 7 and 8) illustrate stream channel changes to cross-sectional dimensions and terrace elevation connections. The data in each figure provides the channel dimension comparisons for each cross section. Between the two sites there is an insignificant increase in the watershed size of 0.08 mi² and increase of 10 cfs (USGS StreamStats 2-year discharge increase from 1260 to 1270 cfs), but large increases in all hydraulic channel characteristics such as channel depth, cross-sectional area, and others illustrated in the cross-sectional summary tables. Mapping the cross-sectional area increases and decreases provide locations for identifying potential channel instability and localized nick points or zones. Those locations can then be assessed using detailed survey methods. Geomorphic comparisons of the terrace levels and hydraulic geometry relationships provide further understanding into channel evolution within the watershed. Additional analysis can be completed to compare specific reach relationships such as stream power, shear stress, entrenchment ratios, and other geomorphic indicators in RGA Level 2 and 3.

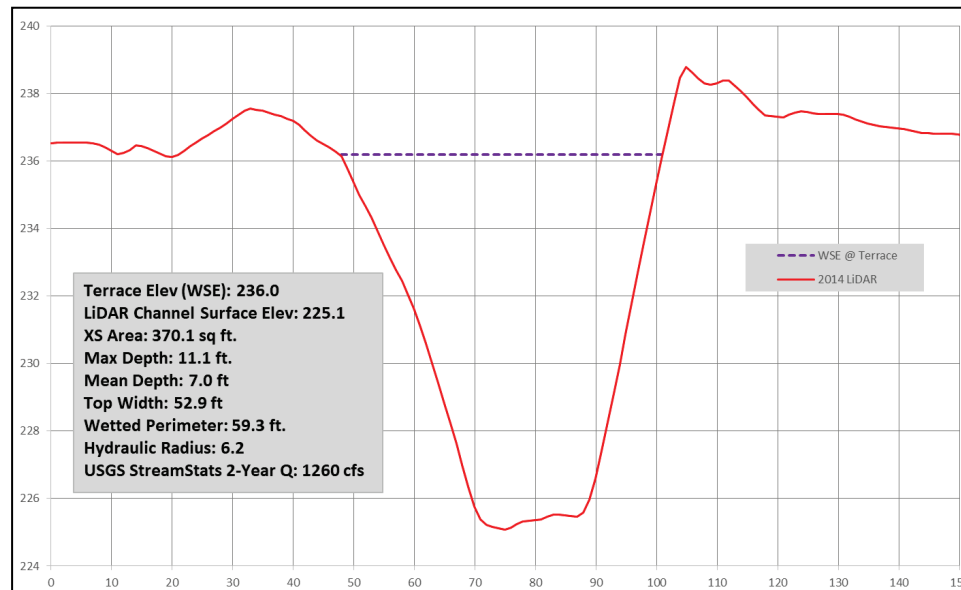
Figure 14. Campbell Creek cross section #60 immediately upstream of Figure 7.

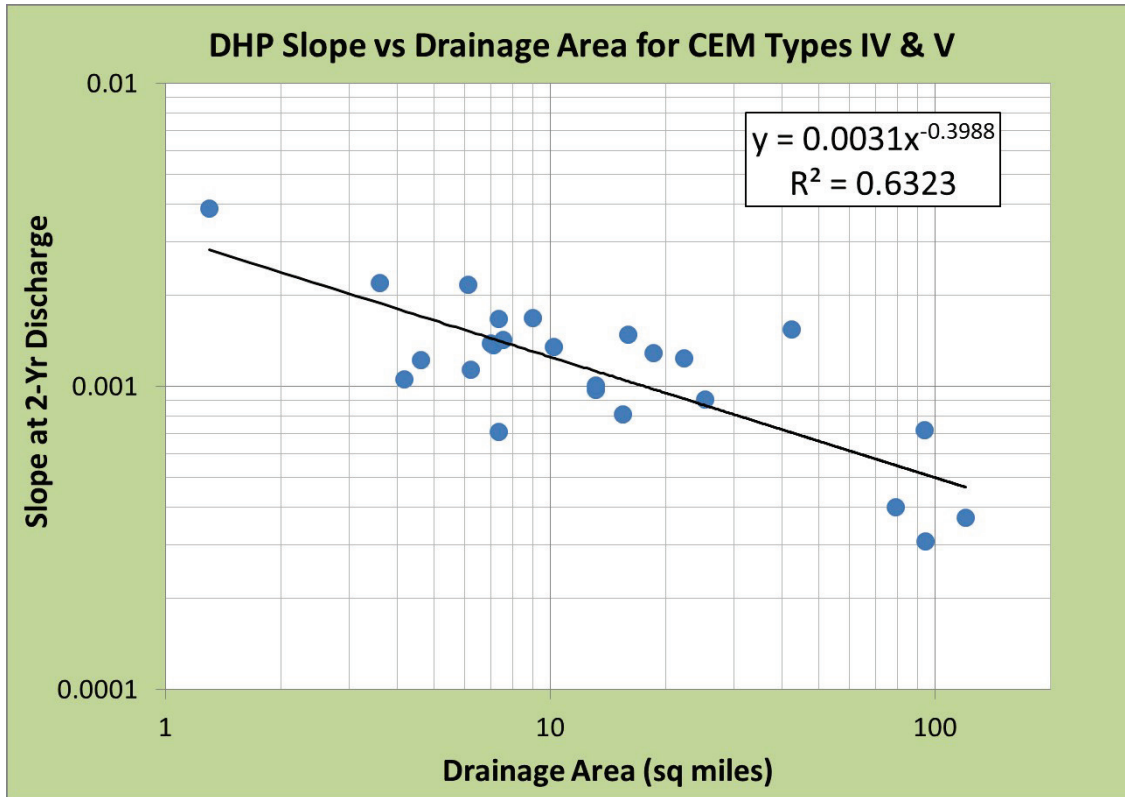
Figure 15. Channel slope vs. drainage area for CEM Types IV and V reaches within the DHP watersheds.

Type IV or V (Schumm et al. 1984). CEM Type IV and V reaches represent reaches that have attained or are approaching dynamic equilibrium. The slope-drainage area relationship for CEM Type IV and V reaches is shown in Figure 15. The Campbell Creek study area, with a drainage area of approximately 3.9 mi², has an equilibrium slope of approximately 0.0019.

The Campbell Creek Tributary only has a drainage area of approximately 0.4 mi², and the equilibrium slope is approximately 0.0047. However, because this drainage area is beyond the lower limits of the data in Figure 15, there is considerable uncertainty with this slope estimate. This tributary is extremely steep with an overall slope of approximately 0.0091, which is twice the calculated equilibrium slope. This slope comparison coupled with the field indicators suggests that the Campbell Creek Tributary is in a degradational regime.

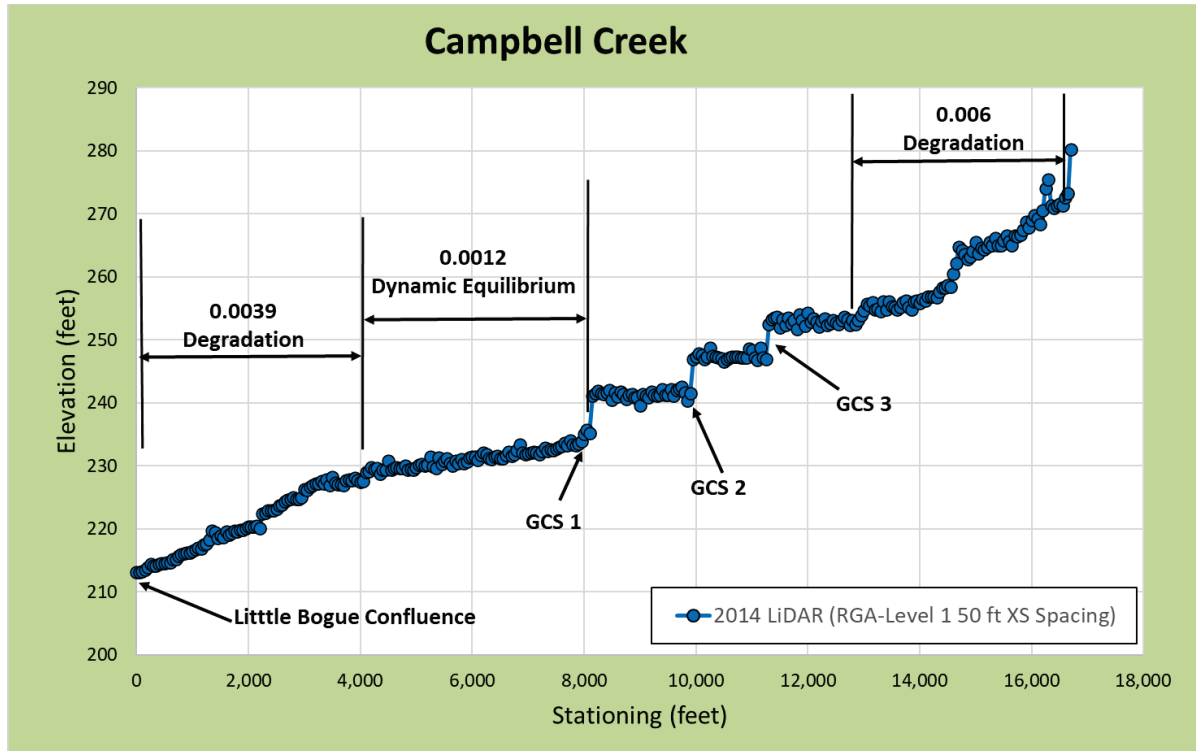
Figure 16. Channel Slope for reaches of Campbell Creek equilibrium slope is approximately 0.0019.

The channel slope based on the 2014 LiDAR was determined for three reaches along Campbell Creek (Figure 16). As shown, the lower and upper reaches have bed slopes that are considerably greater than the equilibrium slope of 0.0019. These two reaches are expected to be degradational based on this comparison. The middle reach, which extends downstream from GCS 1 to approximately Station 4000, had a slope of only approximately 0.0012, which was slightly less than the equilibrium slope. This reach is expected to be in equilibrium or slightly aggradational based on the empirical analysis.

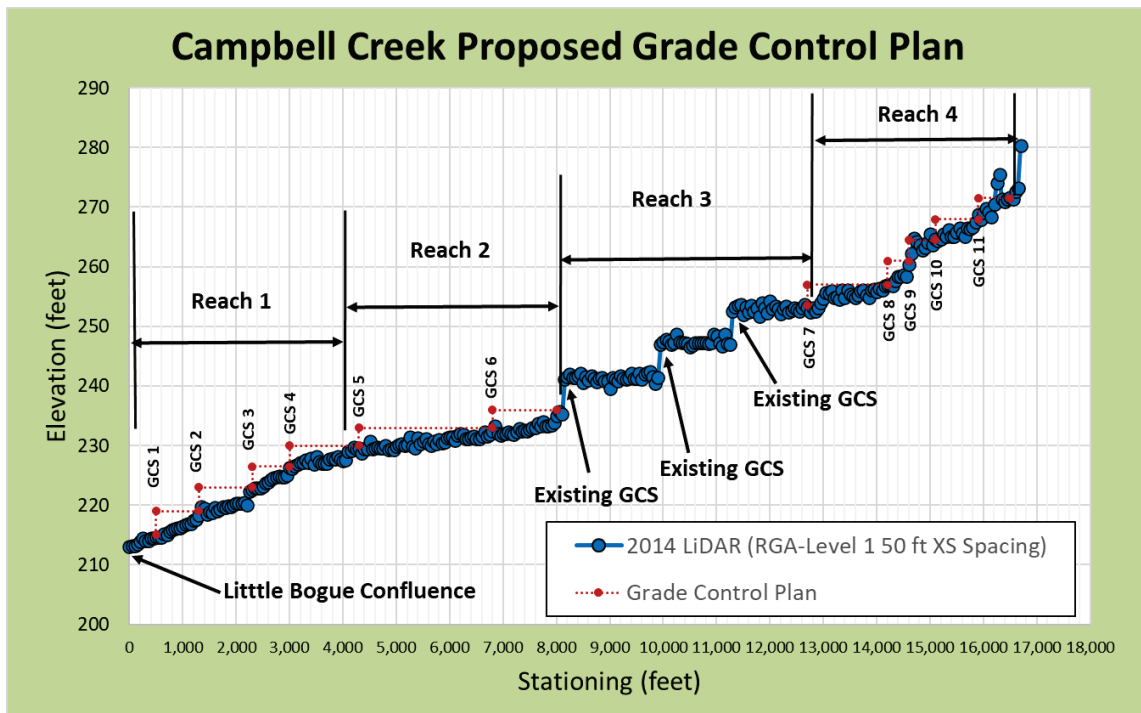
Figure 17. Grade Control Plan for Campbell Creek.

To aid in the development of a grade control plan, Campbell Creek was divided into four reaches as shown in Figure 17. For this effort, all structures are sloping rock riffle type of grade control structures that have drop heights ranging from 3 to 4 ft (Newbury and Gaboury 1993). Reach 1 is

the downstream-most reach, and as discussed previously, was identified as a severely degradational reach. For this reach, four grade control structures are planned (Figure 17). The next upstream reach is Reach 2. The channel slopes in Reach 2 are much less than in Reach 1, but according to the geomorphic assessment, this reach was still considered to be degradational, and therefore grade control are needed. As shown in Figure 17, two grade control structures would be required for this reach. Reach 3 is the reach that is currently stabilized with three existing low drop grade control structures, and analysis of the profile data indicates that no additional grade control is needed in this reach. The most upstream reach is Reach 4, which is a severely degrading. Five grade control structures are planned for this reach. Because of the extremely steep slopes in this reach, several of the structures are spaced very close to each other.
