*Regional Sediment Management and Dredging Operation*

# **Field Measurement and Monitoring of Hydrodynamic and Suspended Sediment within the Seven Mile Island Innovation Laboratory, New Jersey**

Final report

Prepared for US Army Corps of Engineers, Philadelphia District  
Philadelphia, PA 19107

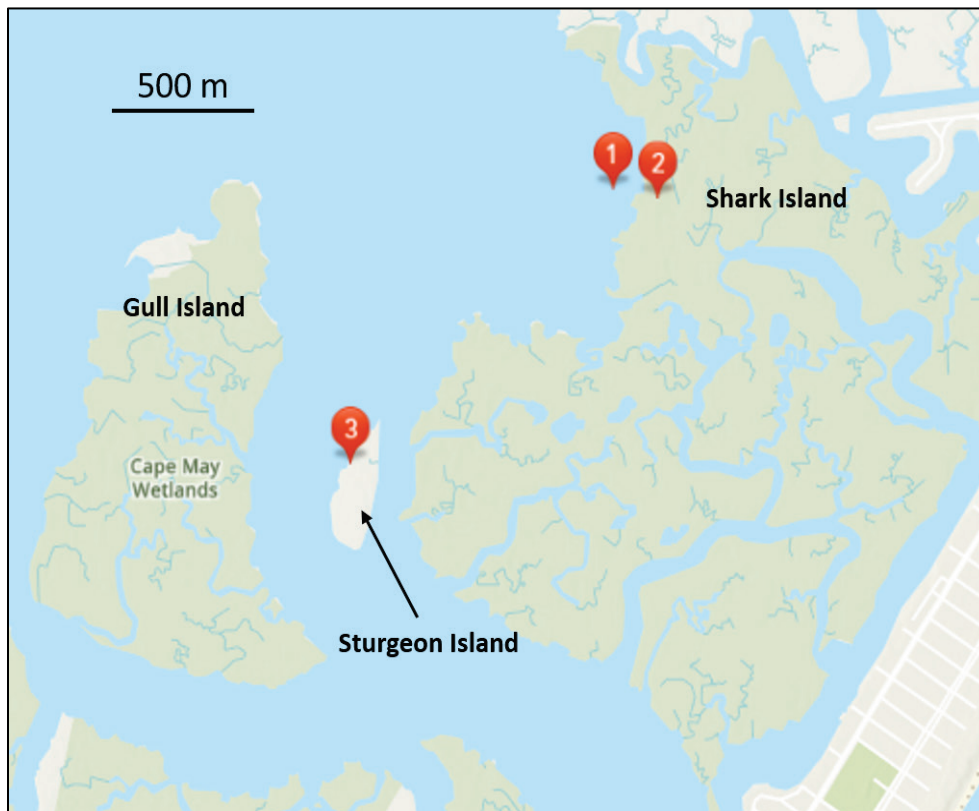
Figure 2. Instrument locations for the Fall, 2019 deployments. Instruments were deployed at (1) Shark Island Embayment, (2) Shark Island Tidal Creek, and (3) Sturgeon Island.

Three data collection sites were established to measure hydrodynamics, turbidity, and SSC within the study area prior to dredged material placement (Figure 2). Instrumentation was deployed at all three stations in October 2019, and monitoring continued through December 2019. Due to limited instrument availability in October, water quality sondes used to measure conductivity, temperature, depth, and turbidity were deployed at each station over different time frames. YSI 600 OMS sondes were deployed in early October; however, concerns over the battery life of these instruments required that In-Situ Aquatroll 600 sondes be deployed when they became available. A brief description of the instrumentation deployed at each site is presented in the following paragraphs and is summarized in Table 1 at the end of this section.
