Field Jet Erosion Tests on Benbrook Dam, Texas

Johannes L. Wibowo and Jamie F. López-Soto

December 2021

Final report

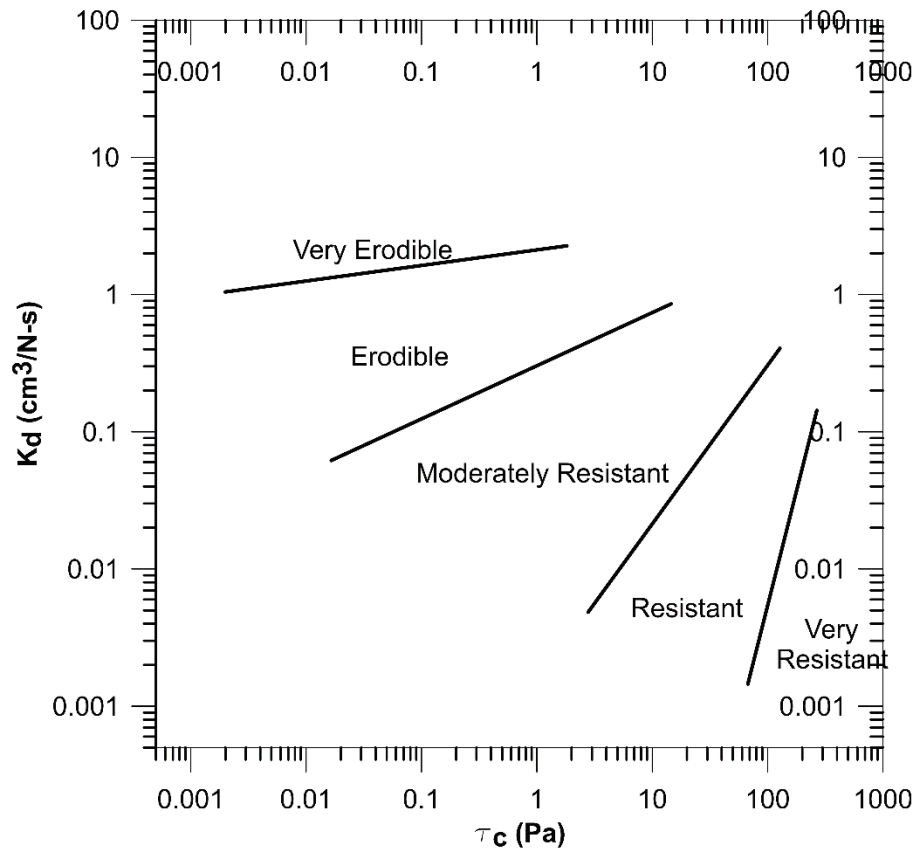
Figure 4. Hanson and Simon (2001) erosion classification.

Hanson and Simon (2001) developed an erosion susceptibility classification for geologic materials based on the measured values of τ_c and k_d . The classification uses five groups with regard to erosion resistance (Figure 4). The five groups are Very Erodible (VE), Erodible (E), Moderately Resistant (MR), Resistant (R), and Very Resistant (VR). The test findings for the Benbrook Dam were plotted and categorized using this erosion classification.

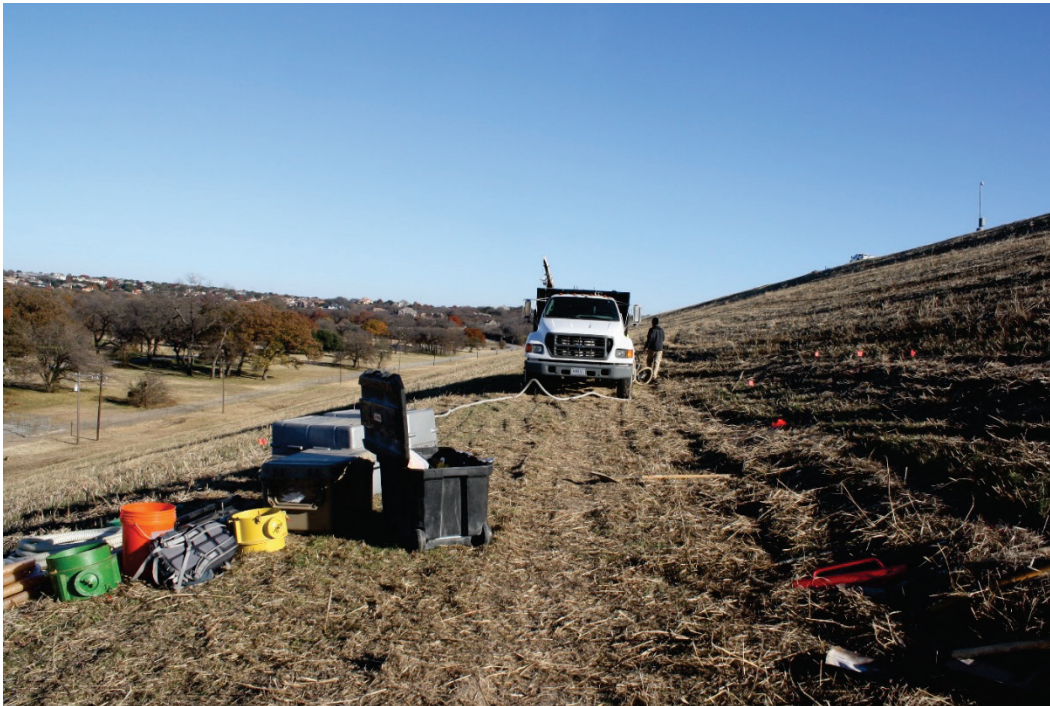
Figure 5. Site preparation for JET.

2. Each test site was cleaned as much as reasonably possible to be free of grass, roots, and any gravelly material. Two smooth surfaces were prepared about 10 ft. apart for the two JET test units, and photographs were taken of the original surface (Figure 5). Exposed material was tested with a pocket penetrometer to characterize the in-situ strength. Penetration tests were conducted on surfaces adjacent to the test sites so as to not influence the test data. Disturbed soil samples were obtained for water content measurements. The JET apparatus was then placed over the prepared surface.

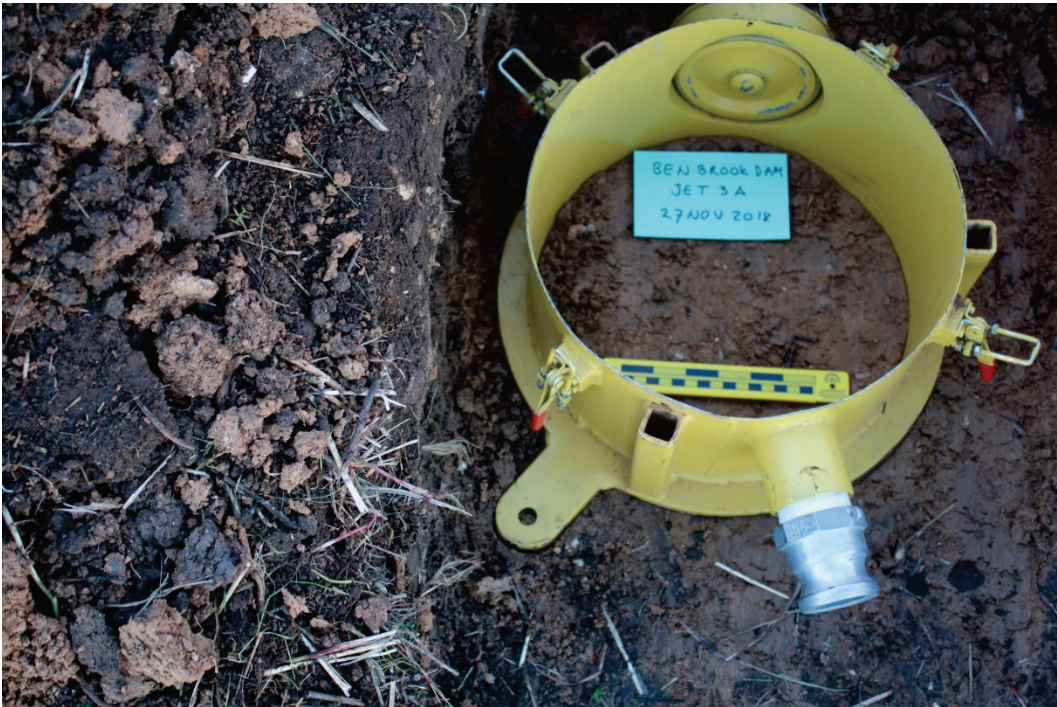
Figure 6. The JET steel chamber driven to the soil surface to keep the soil surface under water during the test.

3. The outer ring of the apparatus was driven about 1 in. into the soil surface using a special driving hammer (Figure 6). The Plexiglas cover composed of a Plexiglas tube frame, jet nozzle unit, manual point gauge unit, and pressure gauge was placed on top of the cylindrical chamber (Figure 6), and the inlet water supply hose was connected (Figure 7).

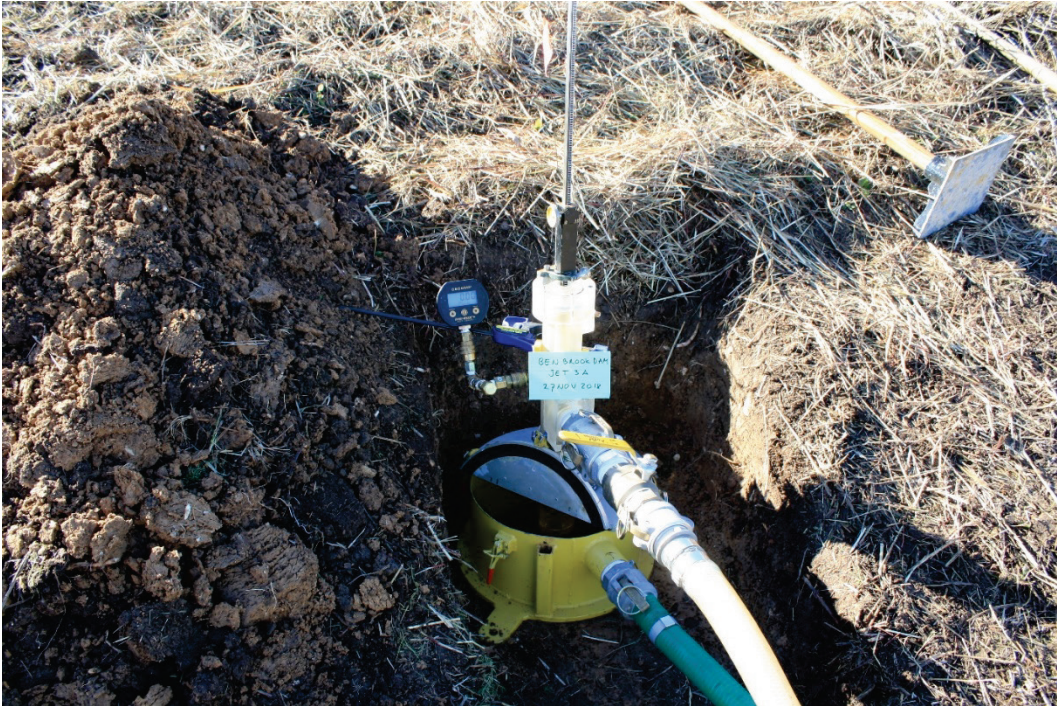
Figure 7. Benbrook JET 3A in progress.

7. After recording the depth/time readings from each of the two units, the water pressure was readjusted to the original value and the above procedures were repeated to obtain about 10 to 12 additional data points for each test. Figure 7 shows the JET in progress, and Figure 8 shows the soil surface after the test.

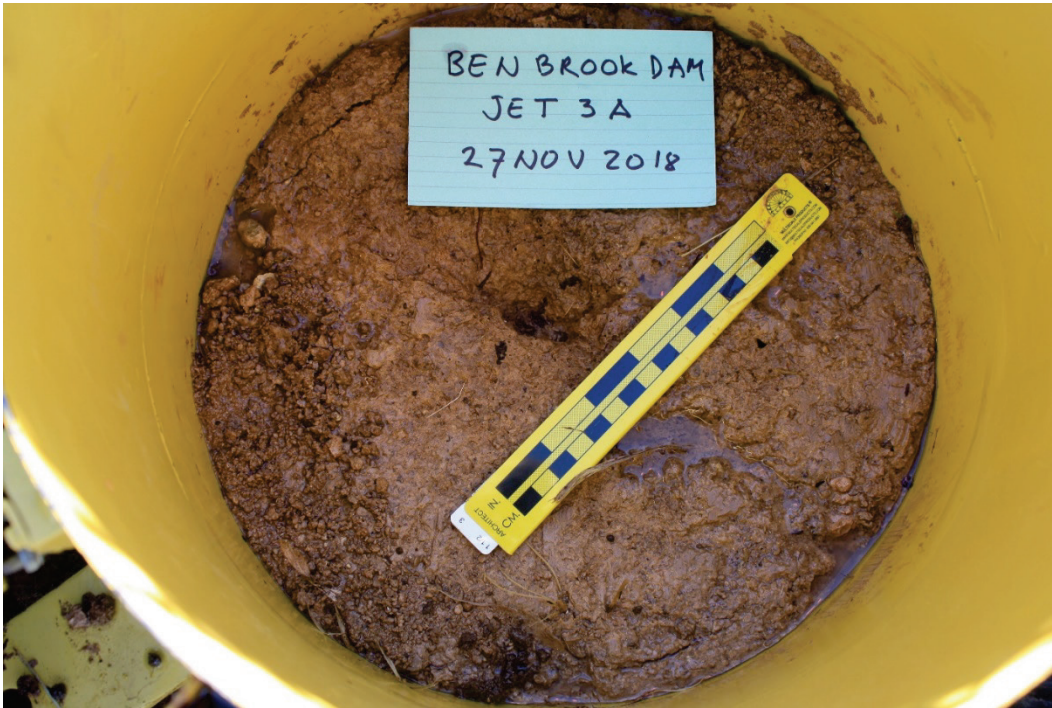
Figure 8. Soil surface after testing.

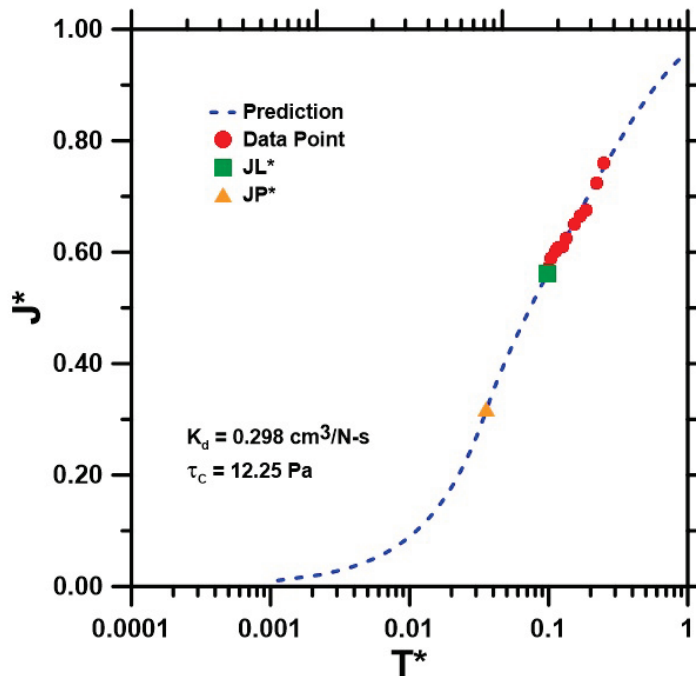
Figure 11. Blaisdell analysis for finding the erosion coefficient of sample from Benbrook Dam JET 3A.

was used to calculate the value of equilibrium erosion depth, J_E , which was then used to calculate the critical stress τ_c using Equation 2. Figure 11 shows the data fit to the dimensionless form of the scour function (Equation 1). The dimensionless time and depth fit were used for calculating the value of the erosion coefficient K_d . Detailed discussion of the theory can be found in Hanson and Cook (2004). For Benbrook JET3A, the value of the erodibility coefficient was $0.298 \text{ cm}^3/\text{N}\cdot\text{s}$, and the value of the critical shear stress was 12.25 Pa . As will be discussed later, this sample was categorized as Moderately Resistant (MR) material.

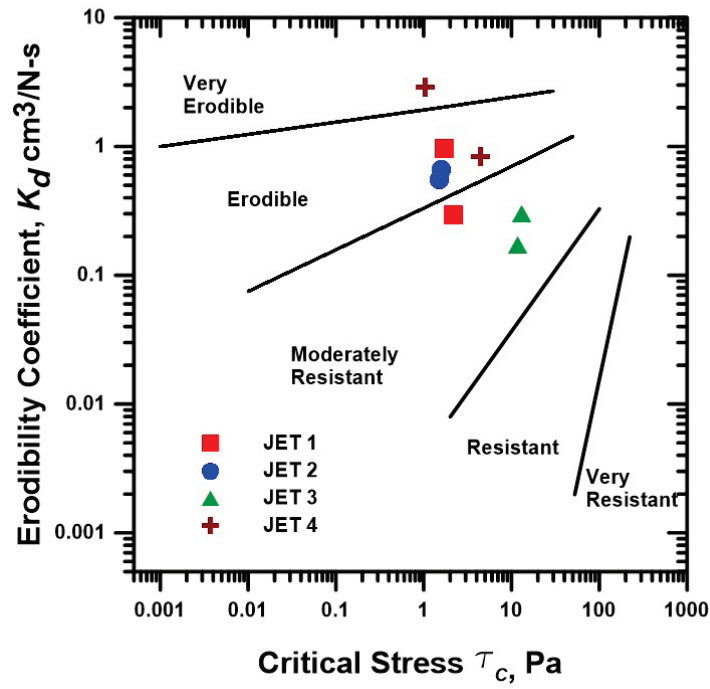
Figure 12. Summary of test data of boring at the Benbrook Dam Jet Erosion Tests.

The summary of JET results for the eight tests is shown in Figure 12, which categorizes the data points as suggested by Hanson and Simon (2001). As shown, the data clusters close to the boundary of Very Erodible (VE) and Moderately Resistant (ME) material. Although considered a homogeneous embankment dam, there are considerable variations in the test results. Tables 2 and 3 document variation in the tested soil's description and classification as well as the cohesion, as estimated using the pocket penetrometer test results. In general, the tested dam embankment material is composed of two soil types, i.e., plastic silty clay and plastic sandy clay, with an average water content of 23.8%. Based on the JET results, the lower-bound values of the erodibility parameters are a critical shear stress of $\tau_c = 1.04 \text{ Pa}$ and an erodibility coefficient of $K_d = 2.865 \text{ cm}^3/\text{N}\cdot\text{s}$, and the upper-bound values are a critical shear of stress $\tau_c = 11.85 \text{ Pa}$ and an erodibility coefficient of $K_d = 0.172 \text{ cm}^3/\text{N}\cdot\text{s}$. During future analysis, it is recommended that both the lower and upper bounds of the erodibility parameters be considered. All erosion data, along with photographs of the soil surface before and after the JETs, are provided in Appendix A.

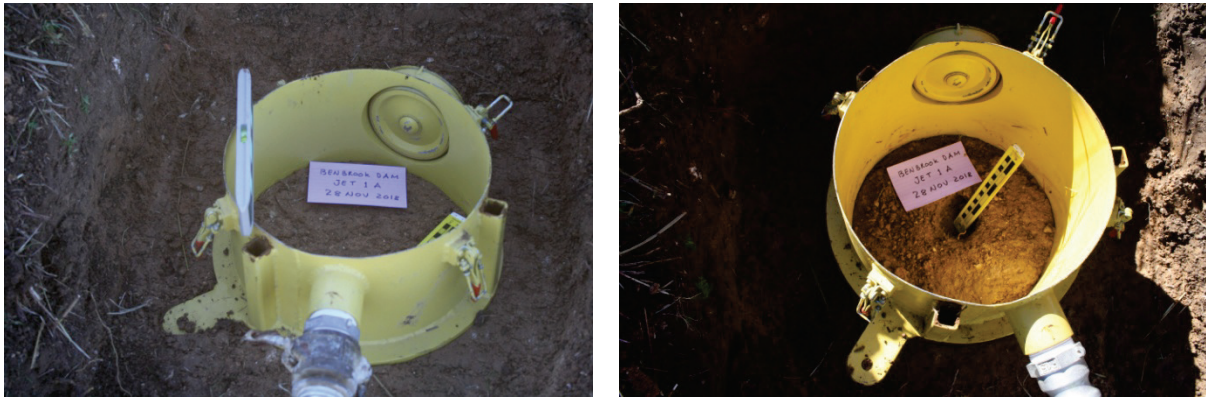
Figure A1. Soil surface before and after JET with erosion data of Benbrook Dam JET 1A.

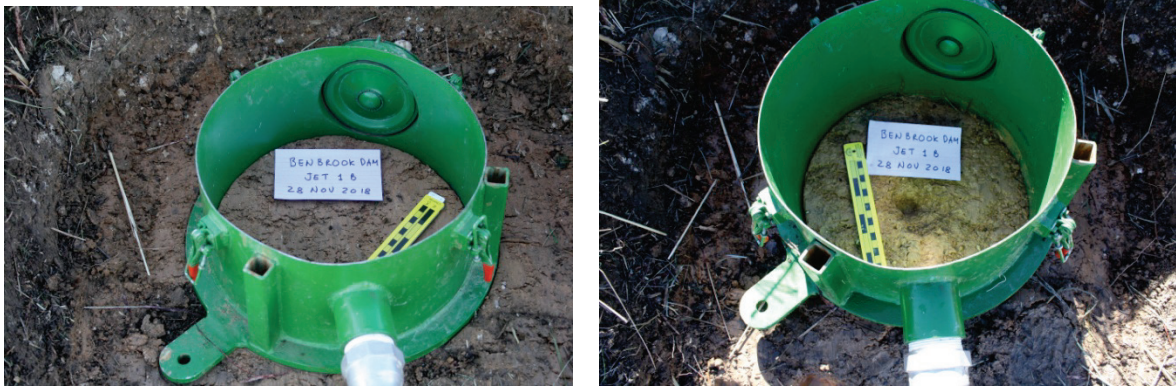
Figure A2. Soil surface before and after JET with erosion data of Benbrook Dam JET 1B.

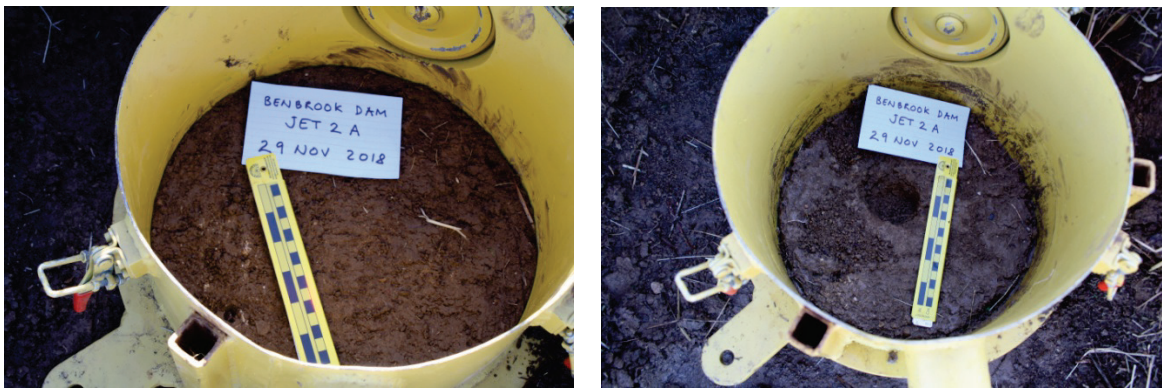
Figure A3. Soil surface before and after JET with erosion data of Benbrook Dam JET 2A.

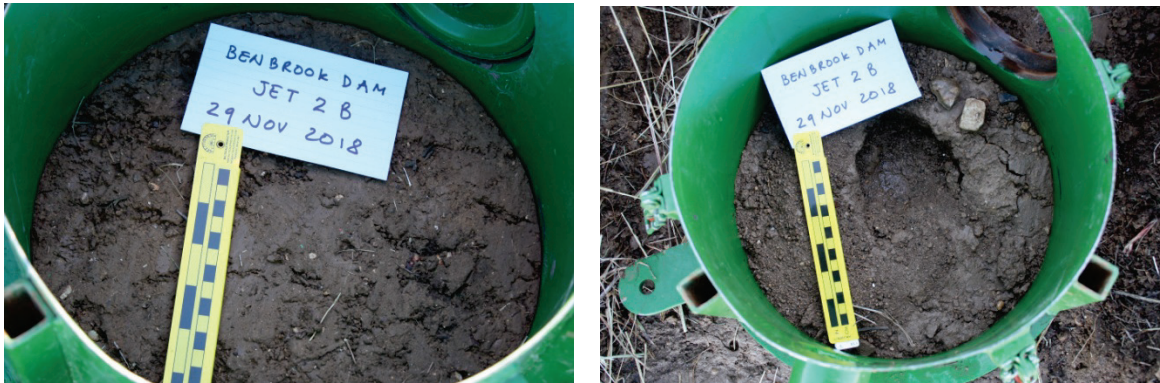
Figure A4. Soil surface before and after JET with erosion data of Benbrook Dam JET 2B.

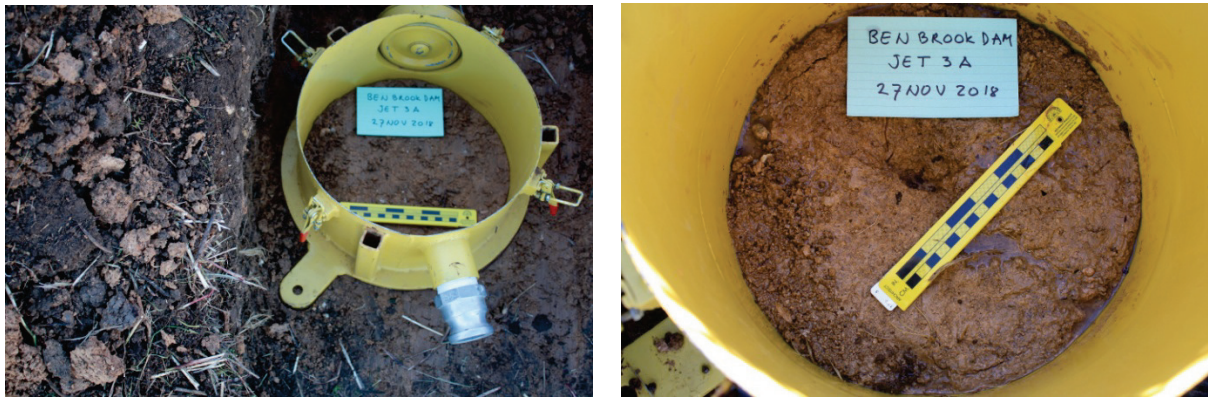
Figure A5. Soil surface before and after JET with erosion data of Benbrook Dam JET 3A.

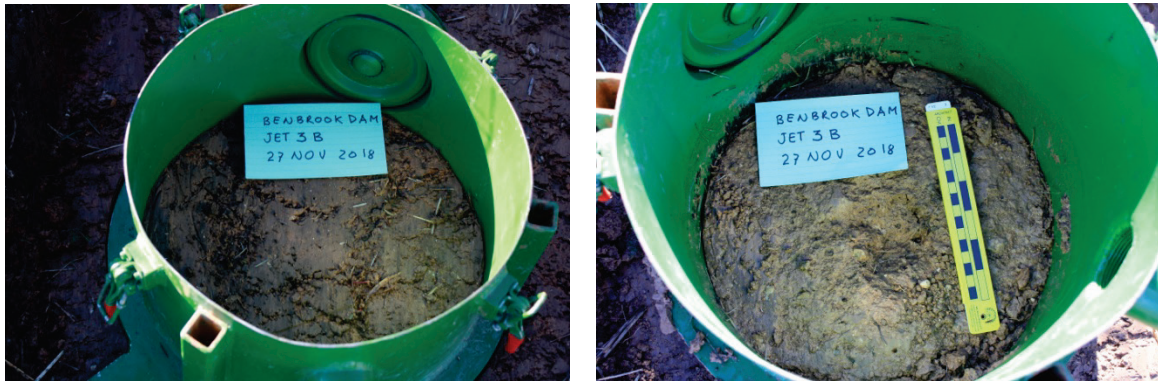
Figure A6. Soil surface before and after JET with erosion data of Benbrook Dam JET 3B.

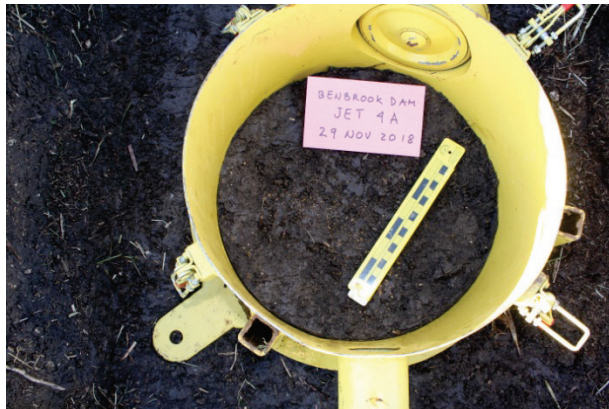
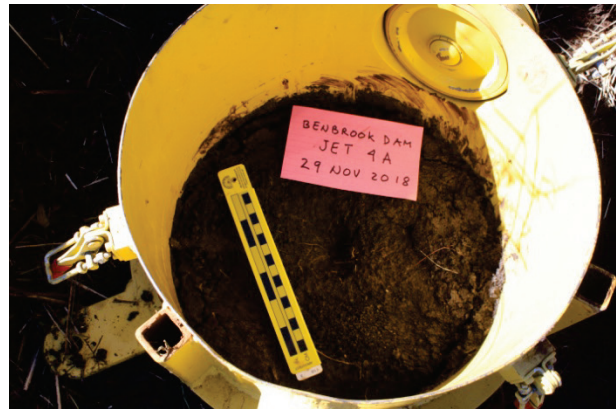
Figure A7. Soil surface before and after JET with erosion data of Benbrook Dam JET 4A.

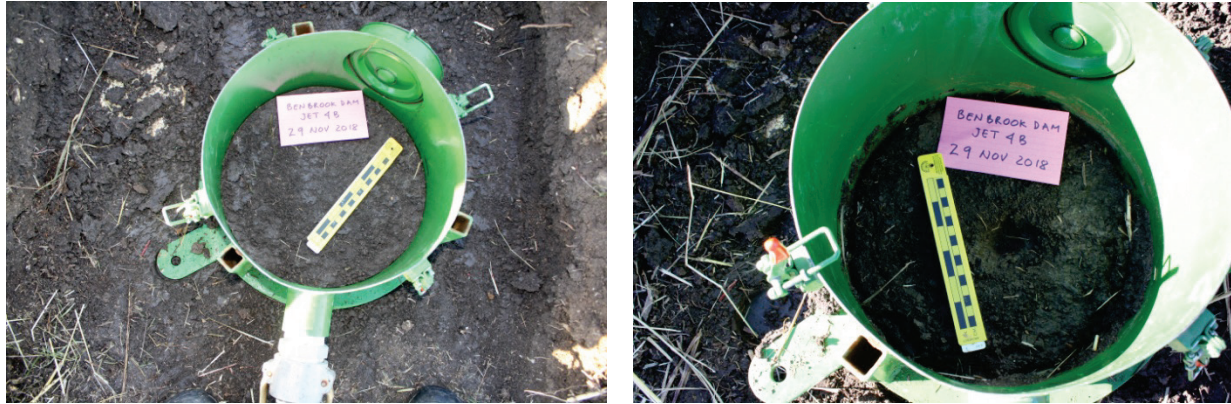
Figure A8. Soil surface before and after JET with erosion data of Benbrook Dam JET 4B.
