US Army Corps  
of Engineers  
Walla Walla District

# Concrete Report

## Willow Creek Dam

World's First All Roller Compacted Concrete Dam

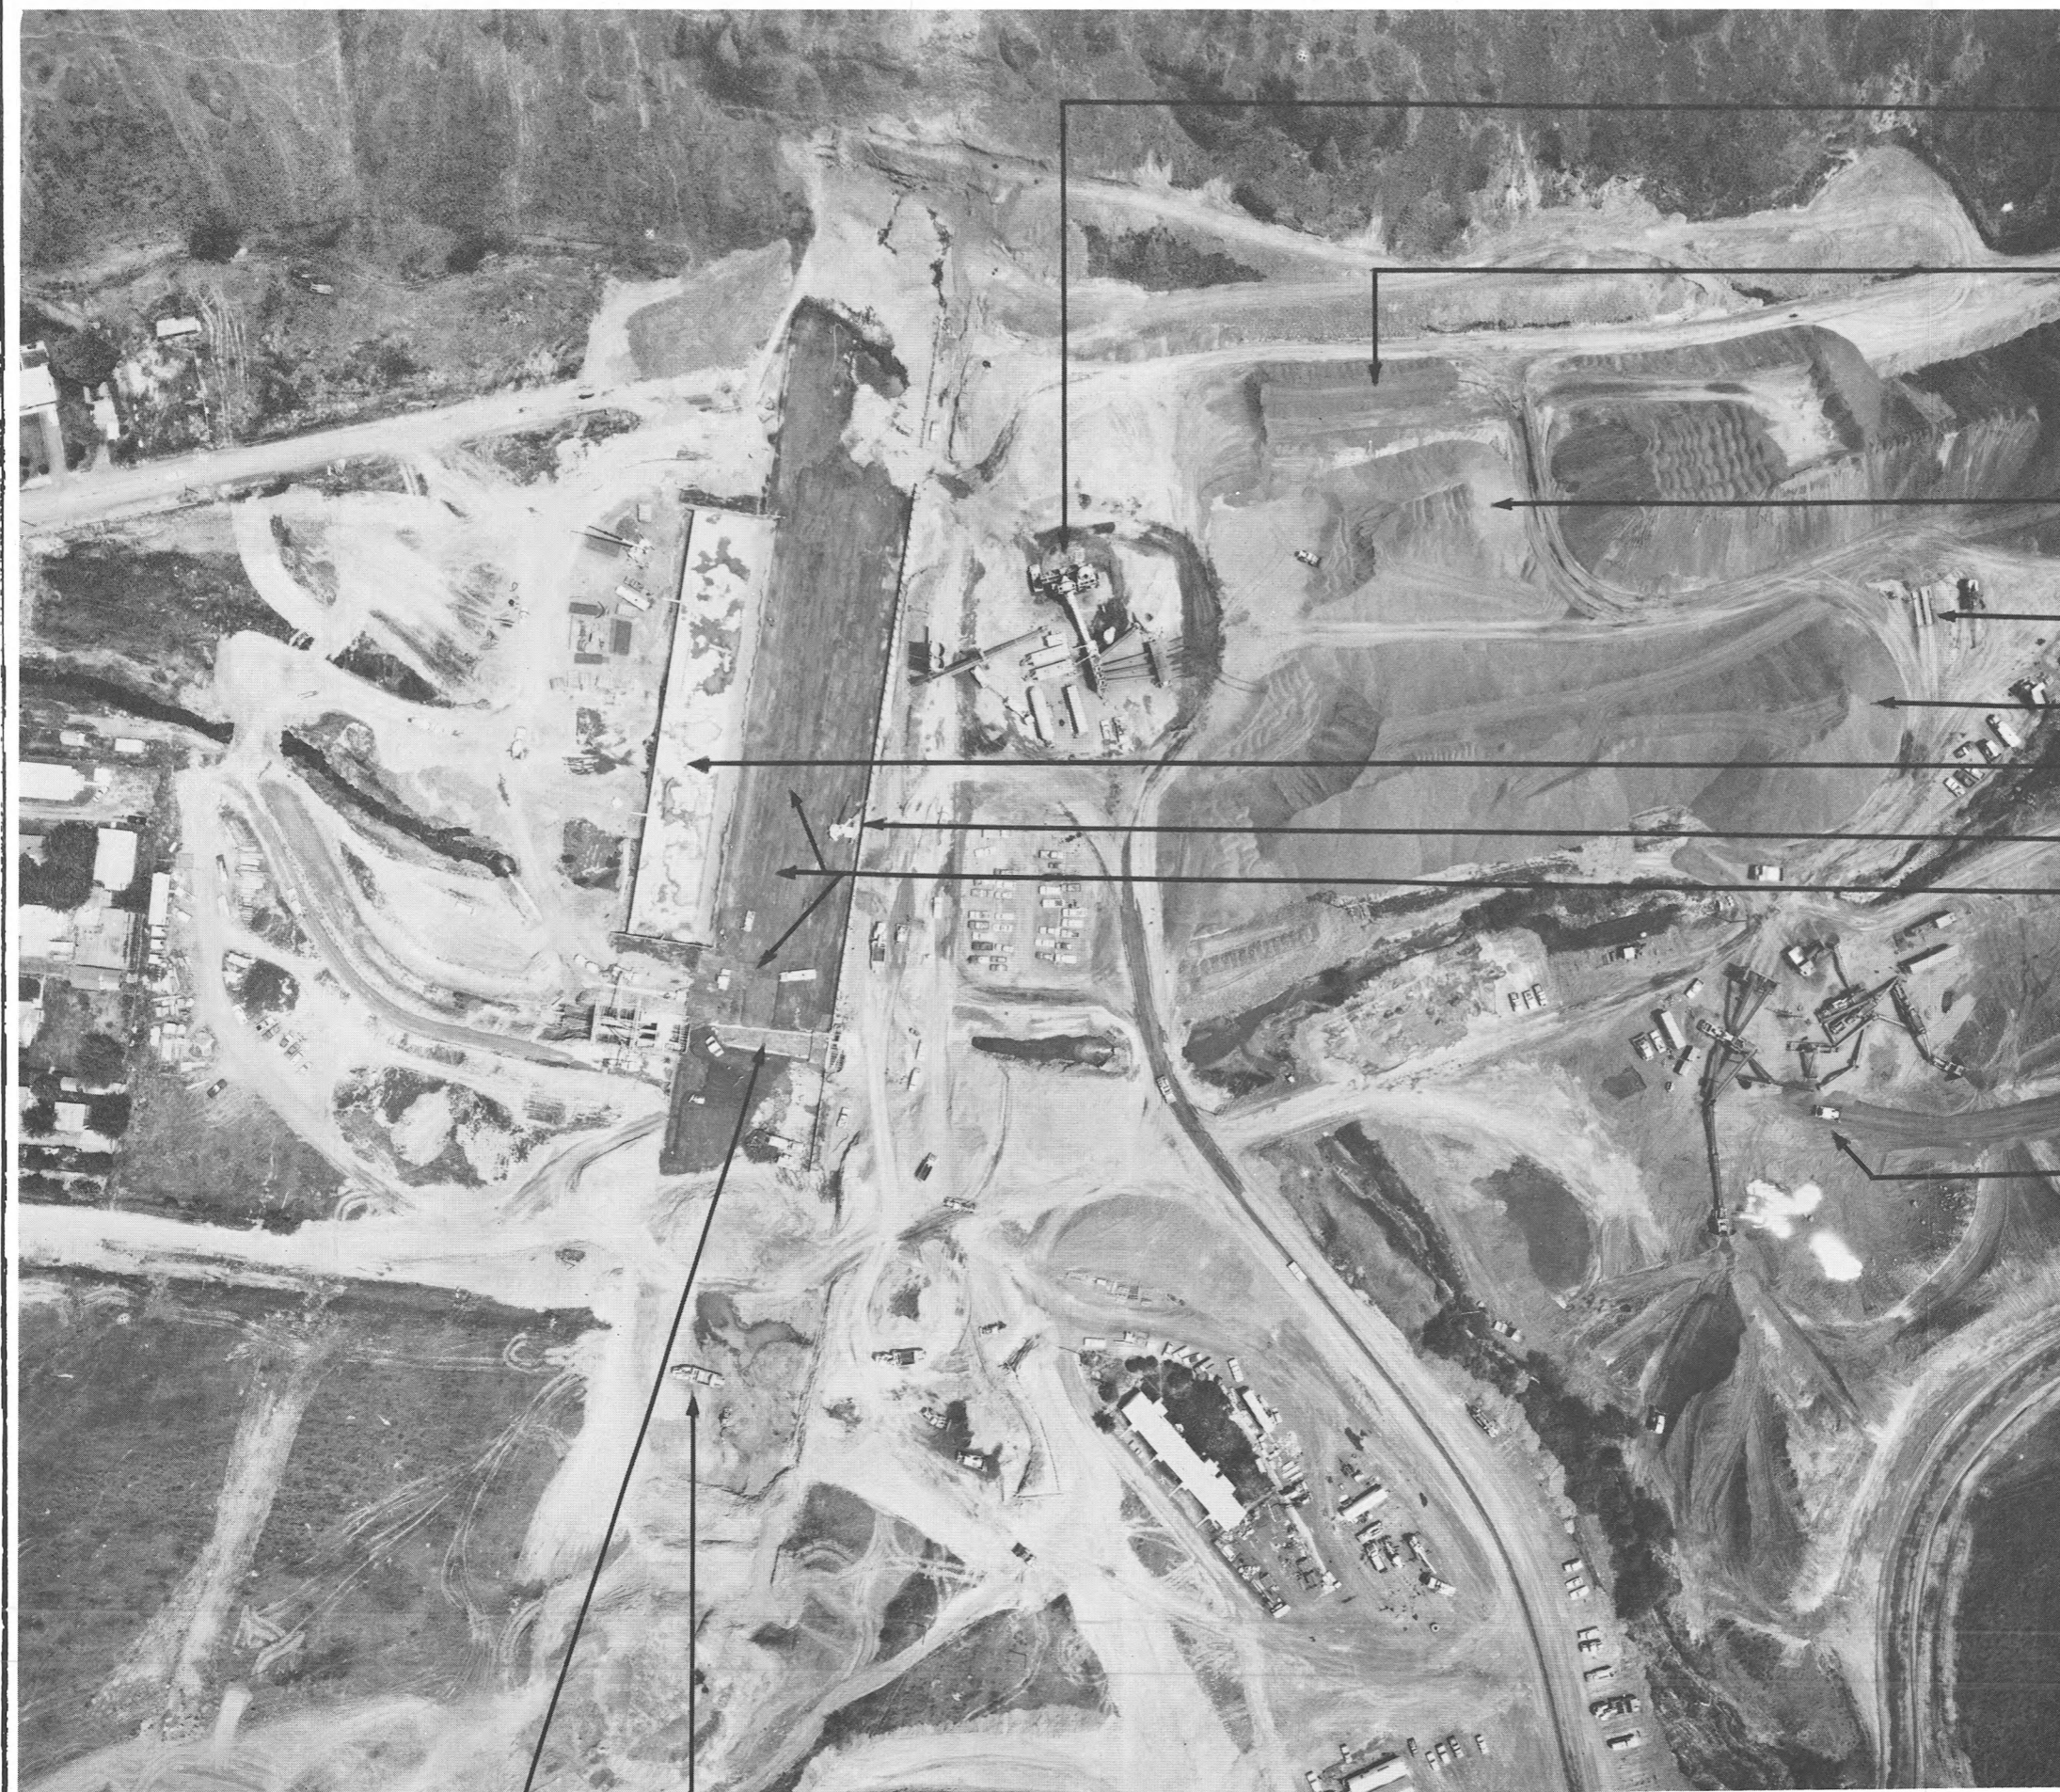
PLATE 1.7

NOTE THE FOLLOWING CONSTRUCTION VIOLATIONS:

1. FOUR LIFT SURFACES SIMULTANEOUSLY EXPOSED.
2. VERTICAL JOINTS DO NOT FOLLOW THE PATTERN ALLOWED IN THE RCC SPEC.
3. TIRE TRACKS LEFT FROM VEHICLE THAT MADE A TIGHT TURN SCARRING THE SURFACE.
4. NONUNIFORM MOISTURE ON THE EXPOSED SURFACE.

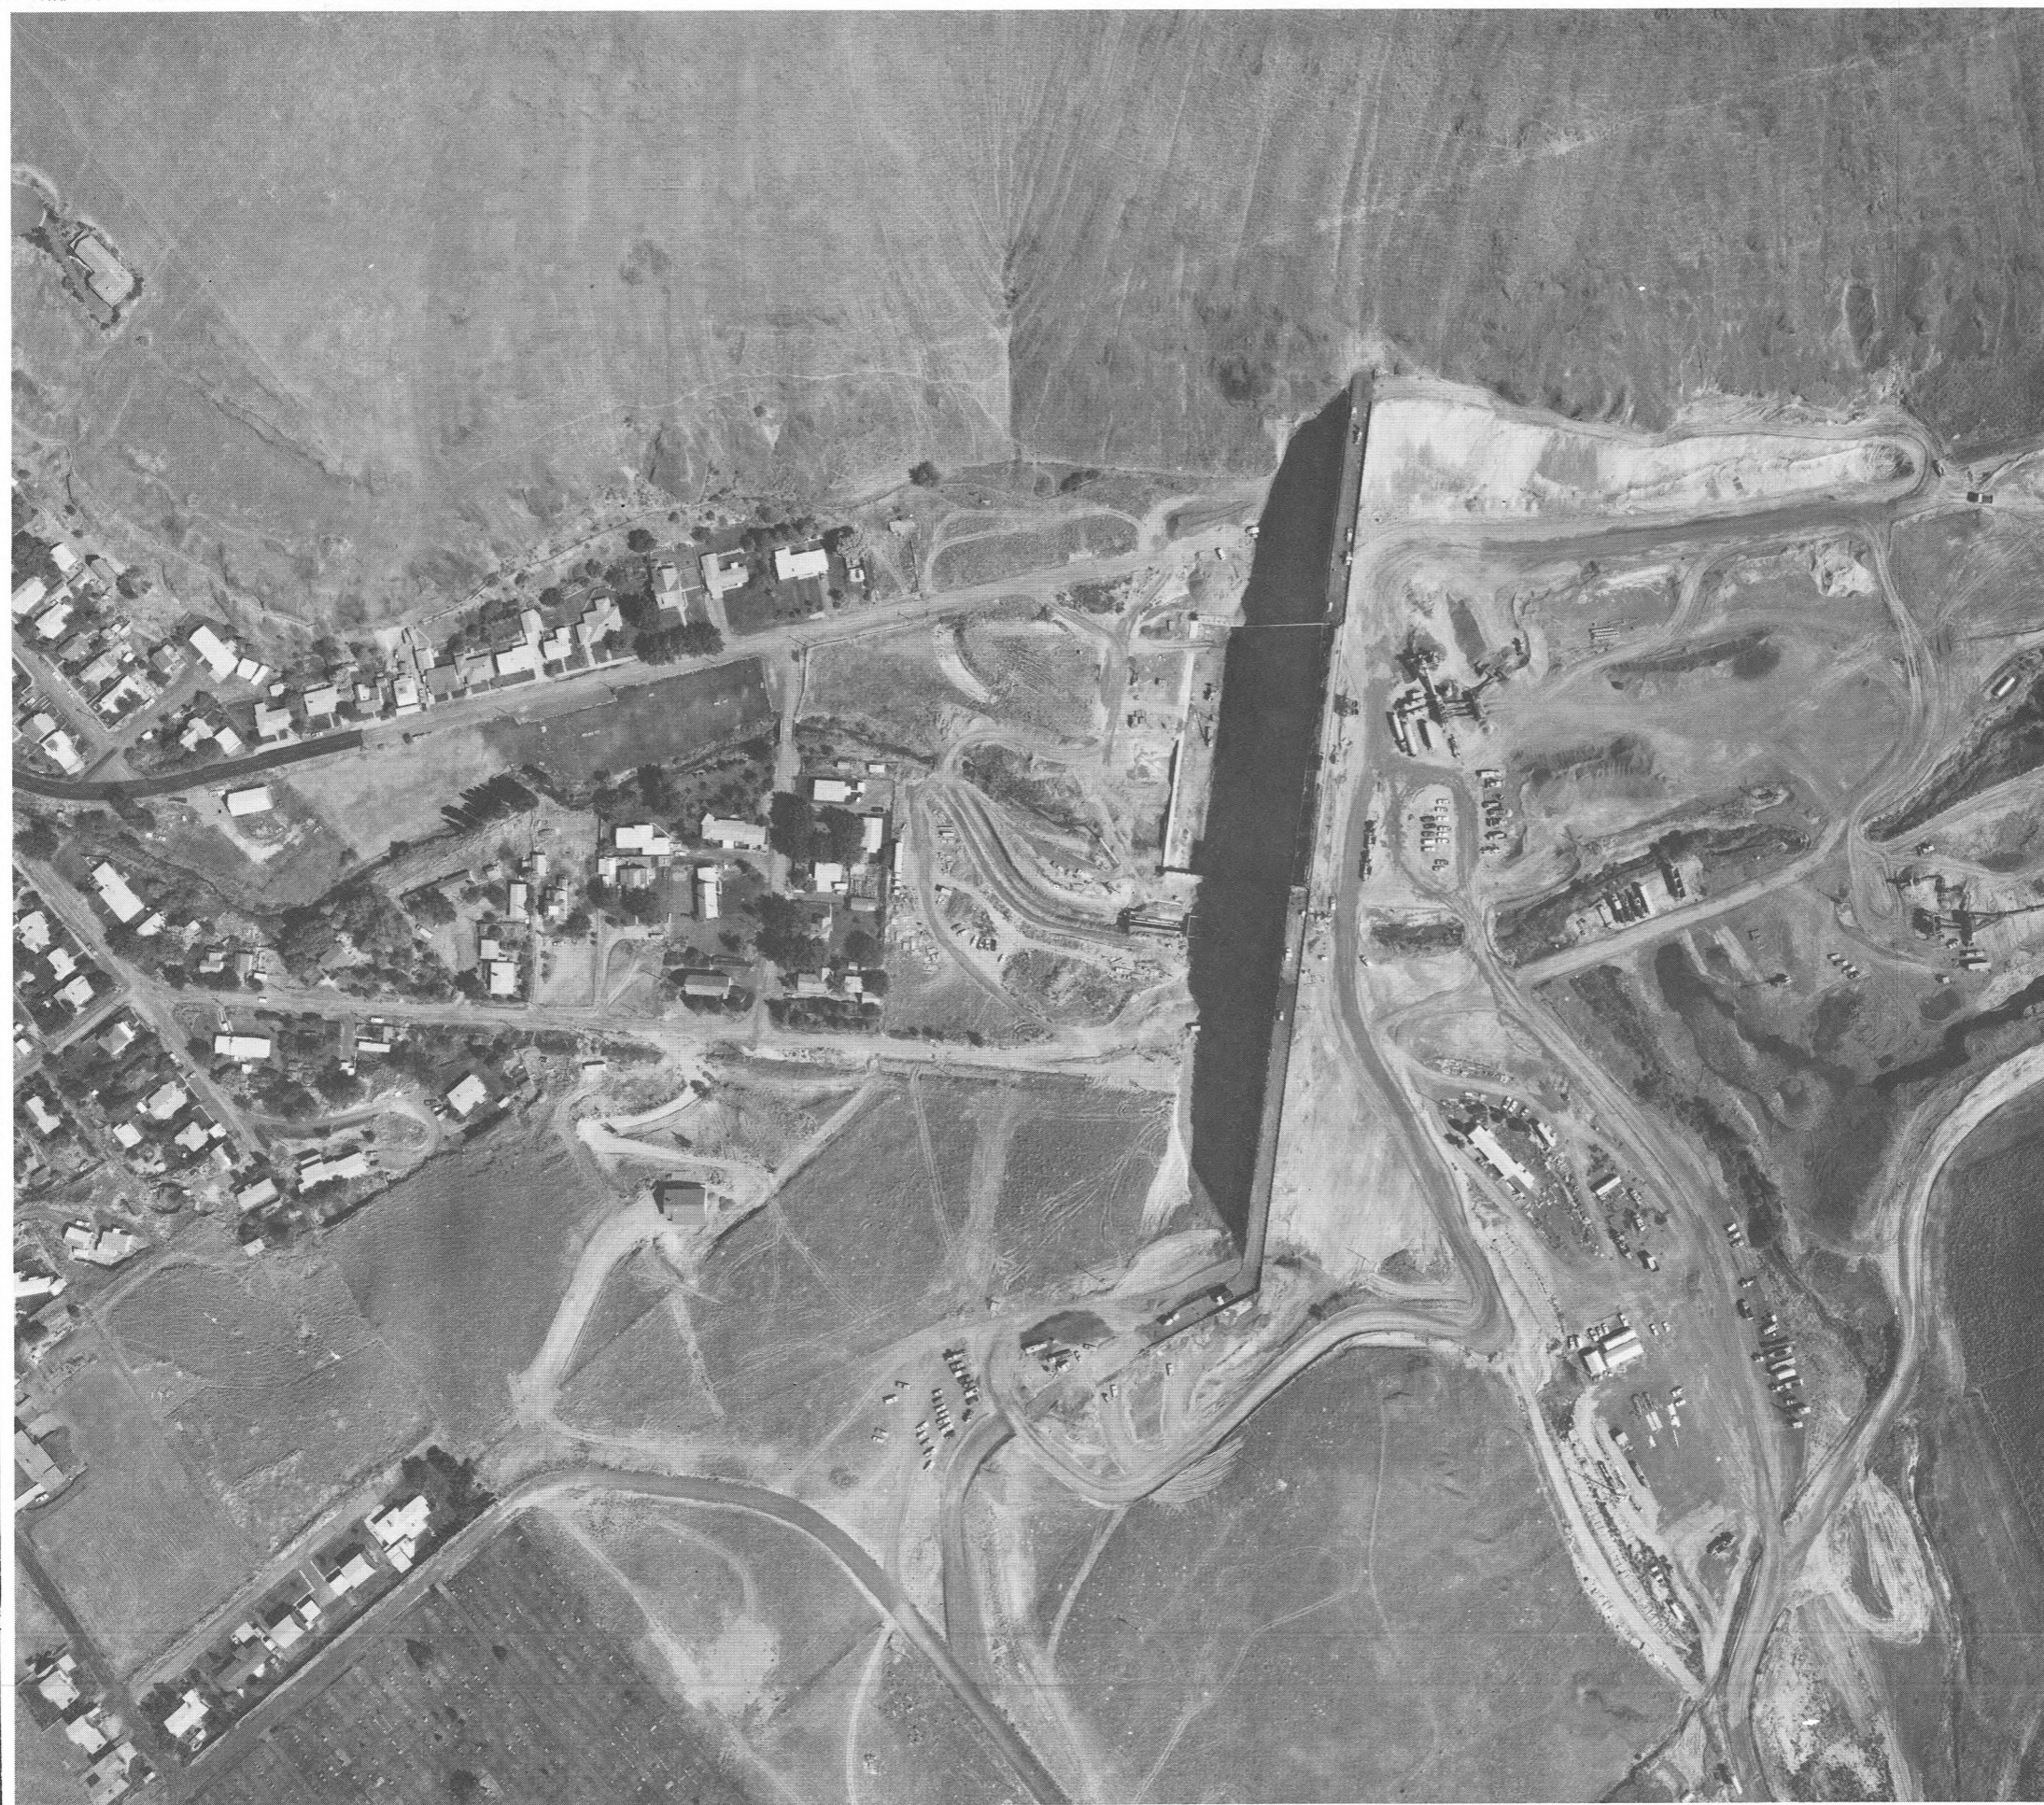
PLATE 1.11

APPROXIMATE ELEVATION 2118.  
EIGHT DAYS AND 11 FEET BEFORE  
COMPLETION OF RCC AT THE TOP  
OF THE DAM.

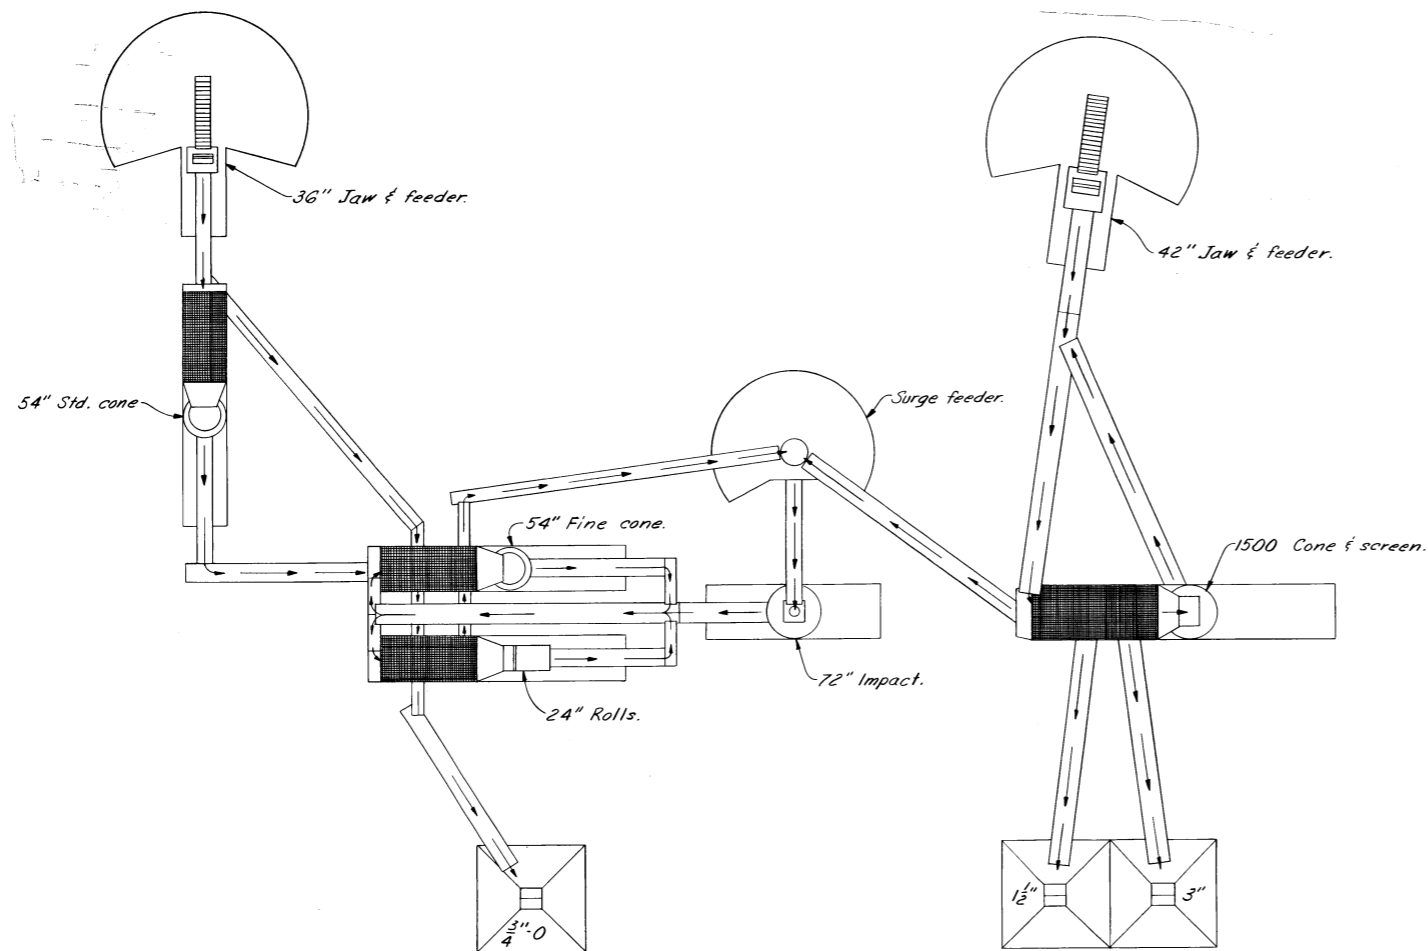
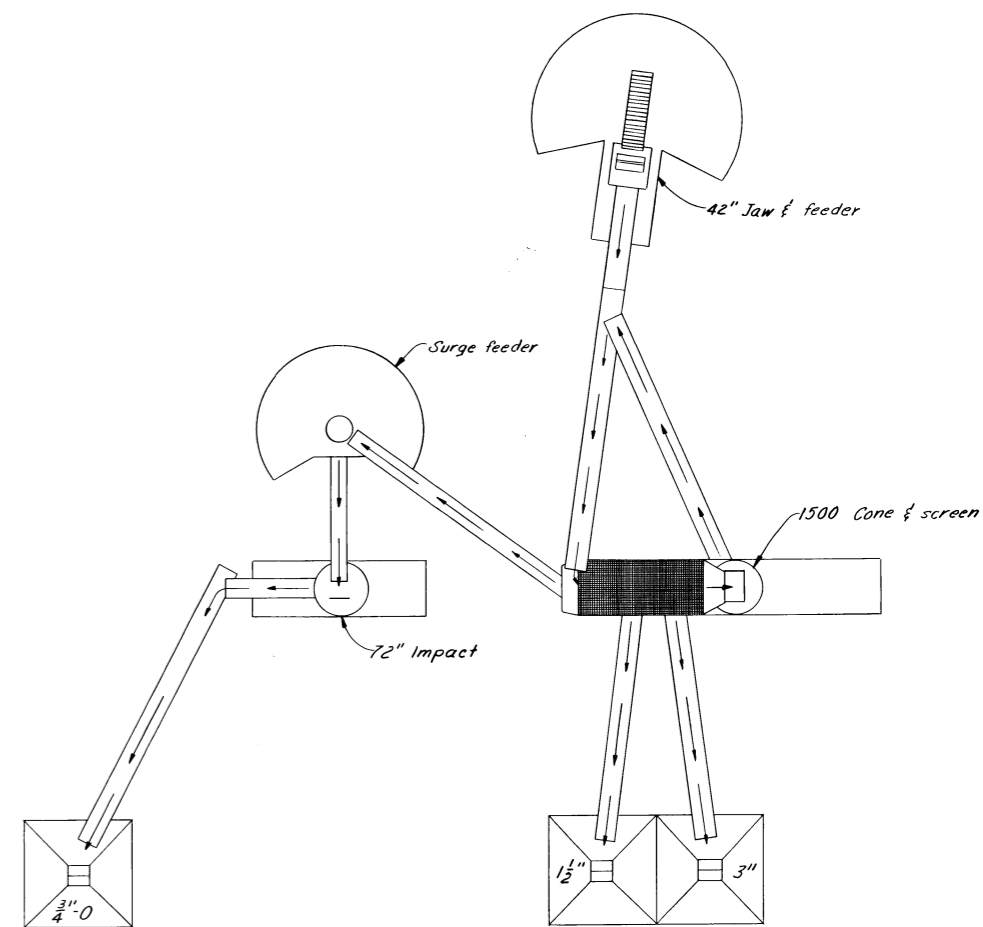
SEVEN UNIT

TWO UNIT

REVISION	DATE	DESCRIPTION	BY
U. S. ARMY ENGINEER DISTRICT WALLA WALLA, WASHINGTON			
<b>WILLOW CREEK LAKE</b> HEPPNER, OREGON			
<b>TWO AND SEVEN UNIT PLANT SET UP</b>			
DESIGNED: <i>Pro Fab</i>			
DRAWN: <i>L. Parsons</i>			
CHECKED: <i>Schrader</i>			
SUPERVISED:			
CHIEF MAT. RES. SECT.			
SUBMITTED:			
CHIEF, FOUNDATION AND MATERIALS BRANCH	SCALE AS SHOWN	INV. NO.	DATE
	SHEET	FILE NO.

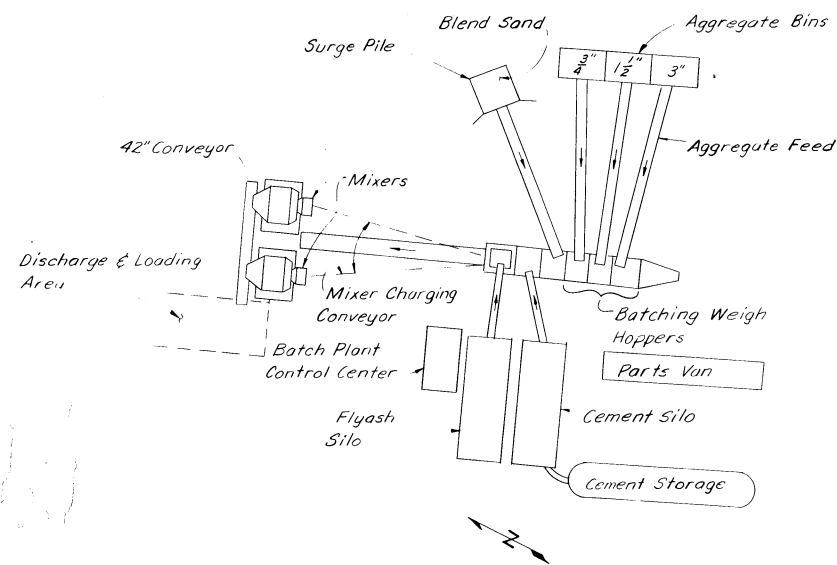
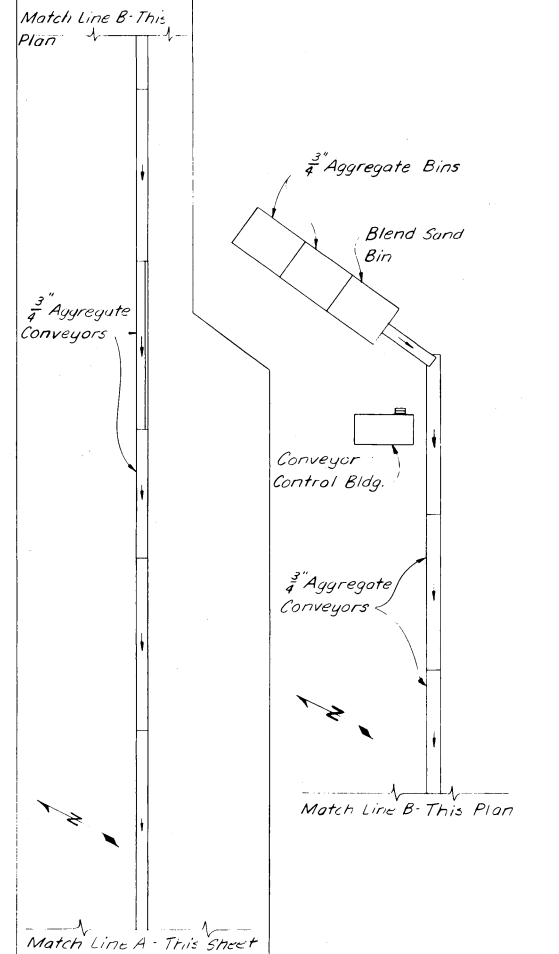
<p><u>BATCH PLANT LAYOUT #1</u> 29 APR 82 - 30 MAY 82</p>	<p><u>BATCH PLANT LAYOUT #3</u> 2 AUG 82 - 26 AUG 82</p>
<p><u>BATCH PLANT LAYOUT #2</u> 1 JUN 82 - 2 AUG 82</p>	<p><u>BATCH PLANT LAYOUT #4</u> 27 AUG 82 - 24 SEPT 82</p>

REVISION	DATE	DESCRIPTION	BY
<p>U. S. ARMY ENGINEER DISTRICT WALLA WALLA, WASHINGTON</p> <p><b>WILLOW CREEK LAKE</b> HEPPENER OREGON <b>ROLLED CONCRETE PLANT LAYOUTS</b></p>			
DESIGNED:	EUCON CORP		
DRAWN:	FAIRLEY		
CHECKED:			
SUPERVISED:			
CHIEF MAT SECT:			
SUBMITTED:			
CHIEF FOUNDATIONS AND MATERIALS:	SCALE AS SHOWN	INV. NO.	FILE NO.

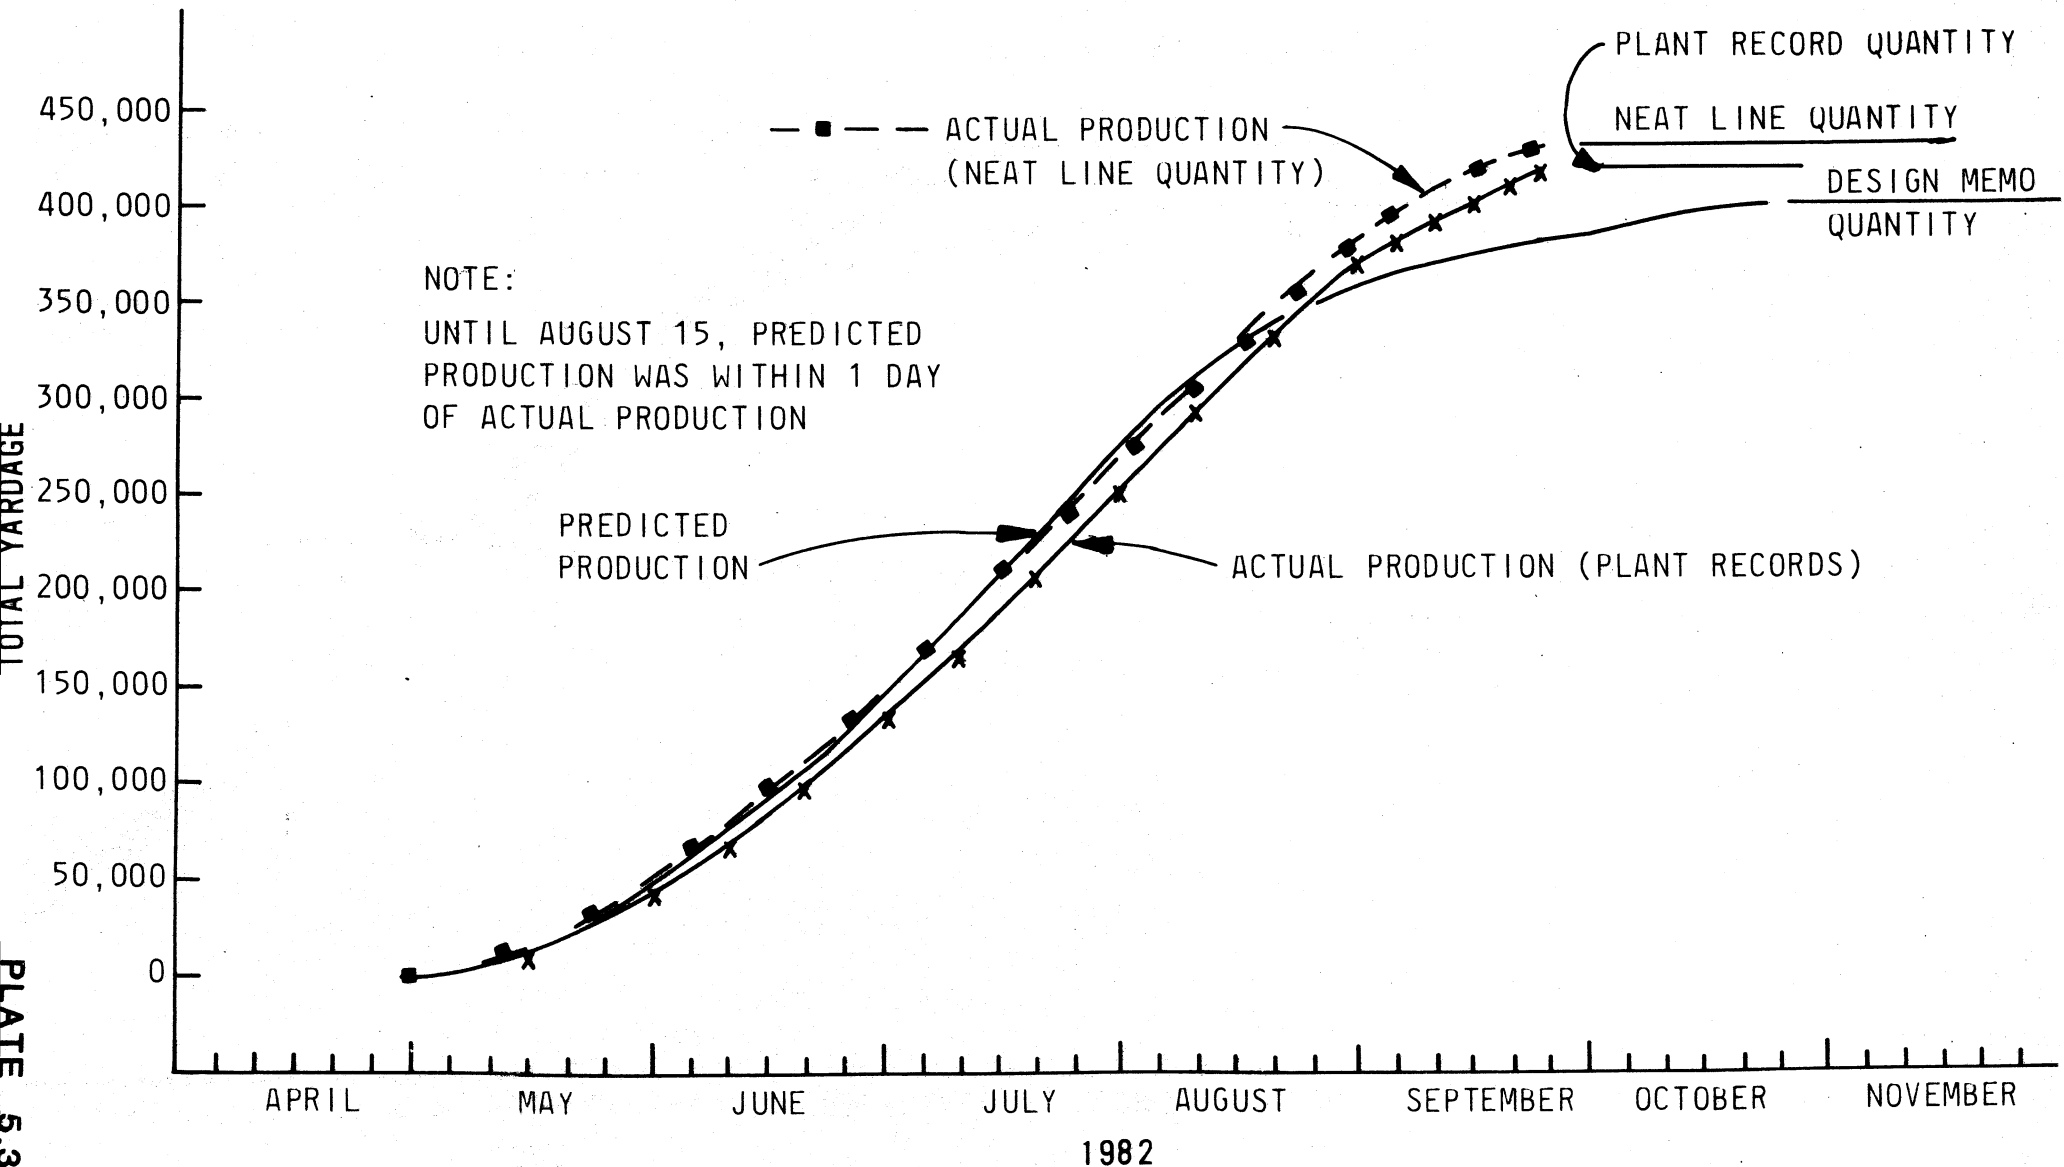
# ACTUAL VS DESIGN PRODUCTION (BY YARDAGE)

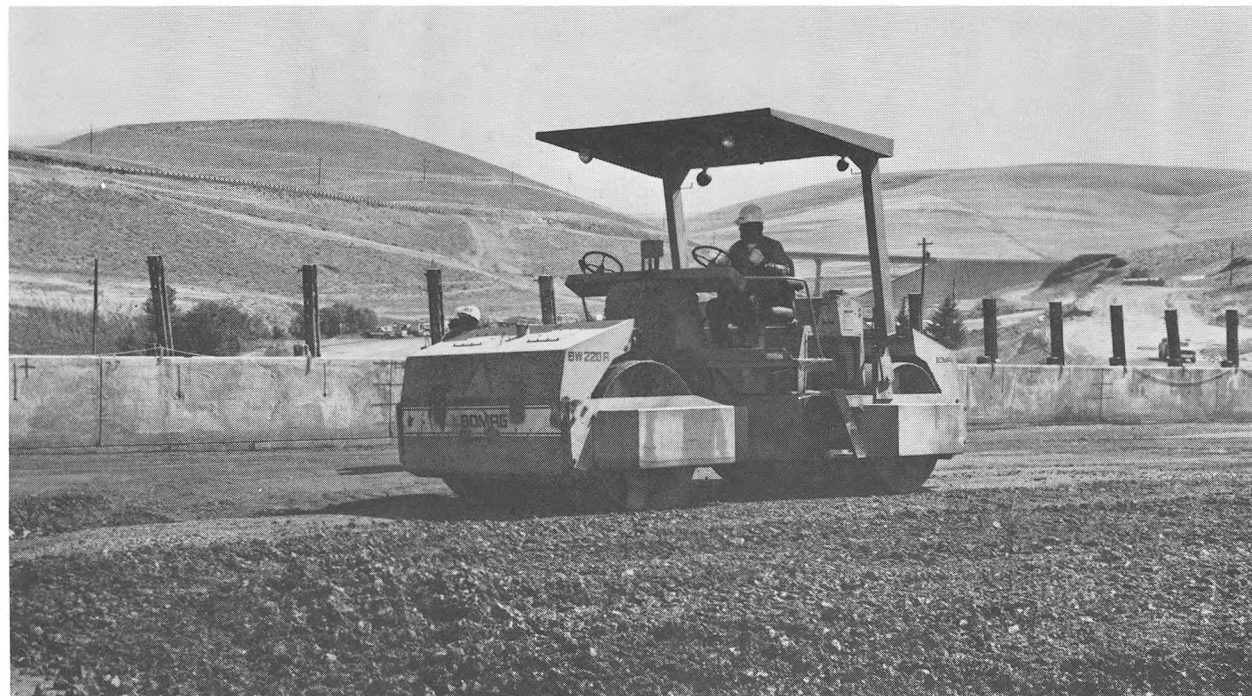
COMPACT WITH A 10 TON BOMAG DUAL DRUM VIBRATORY ROLLER.

Grade control for spreading was achieved through use of a laser beam and movable target. The placing foreman made periodic checks of grade, and with little guidance the operators were able to maintain the lift level within a liberal but tolerable tolerance of about plus or minus 2 inches.

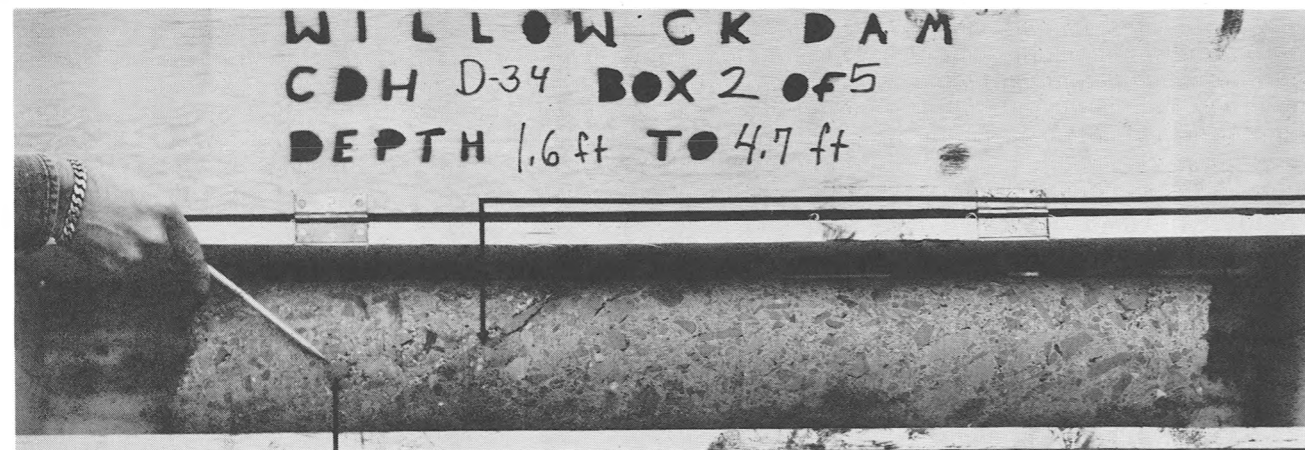
REBAR 2 INCHES ABOVE JOINT.  
- NO BEDDING MIX.

Compressive strengths of the cores are discussed in Chapter 9, "Test Cylinders and Compressive Strength Results." Plates 8.1 through 8.5 show typical core photos including good and bad results. Some of the core, as can obviously be seen in the photos for hole E-16, was distinctly and severely damaged by drill technique and equipment. In this hole the core catcher did not retract. It tore up and broke apart the core. At other times, the drillers were observed removing the core from the barrel with a sledgehammer. Whether all instances of poor core recovery were the result of bad equipment and practice is unknown. There probably also were cases of poorly consolidated material at lift joints, and of segregation which would have resulted in poor core recovery. At any rate, the upcoming core program using 9-inch nominal size barrels will be closely inspected and provide accurate information. As evidenced in the photos, there typically are examples of excellent core recovery. Also, every concrete/foundation rock zone drilled showed excellent contact.

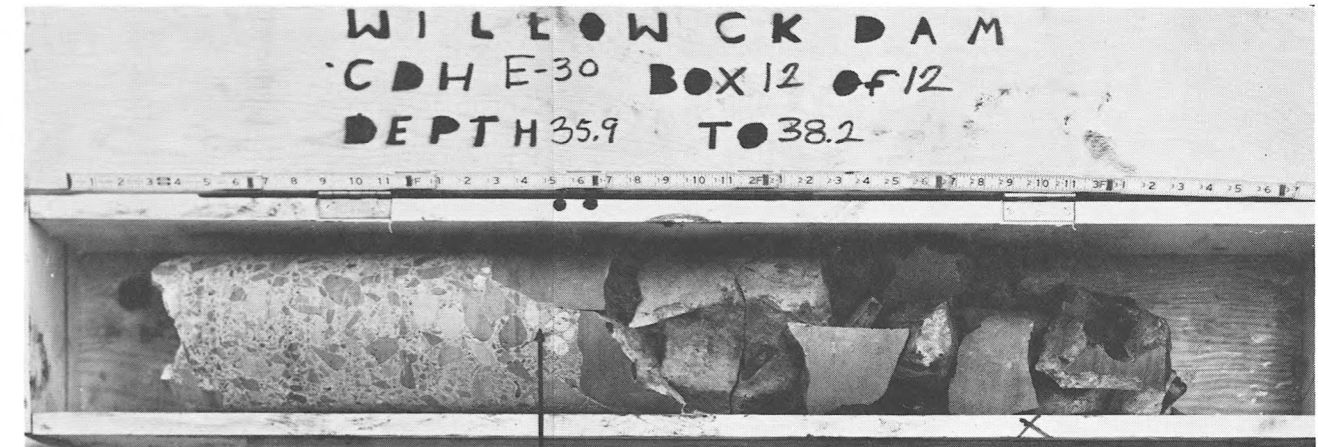
CONVENTIONAL CONCRETE BEDDING BETWEEN FOUNDATION ROCK AND THE FIRST LAYER OF RCC.

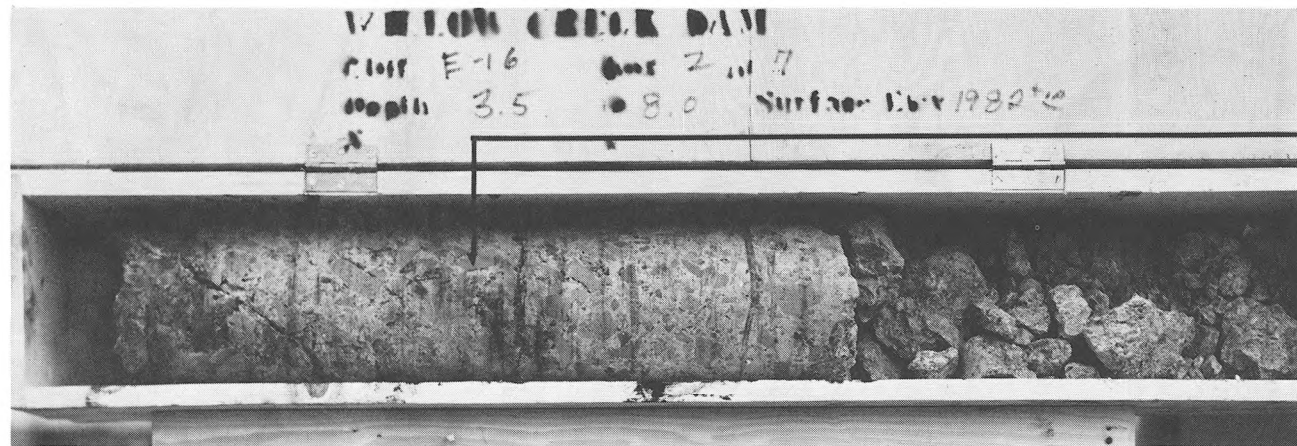
MORE SCORING AND DRILL EQUIPMENT DAMAGE IS EVIDENT.

CORE E-16 WAS DRILLED WHEN THE EQUIPMENT WAS NOT FUNCTIONING PROPERLY AND INSPECTION DID NOT REQUIRE CORRECTION OF THE PROBLEM. THE CORE CATCHER DID NOT RETRACT AND DEBRIS CHURNED AROUND WITHIN THE INNER CORE BARREL. ALSO, SOME CORE WAS REMOVED BY HAMMERING IT OUT OF THE BARREL AND WITH A PRY BAR.

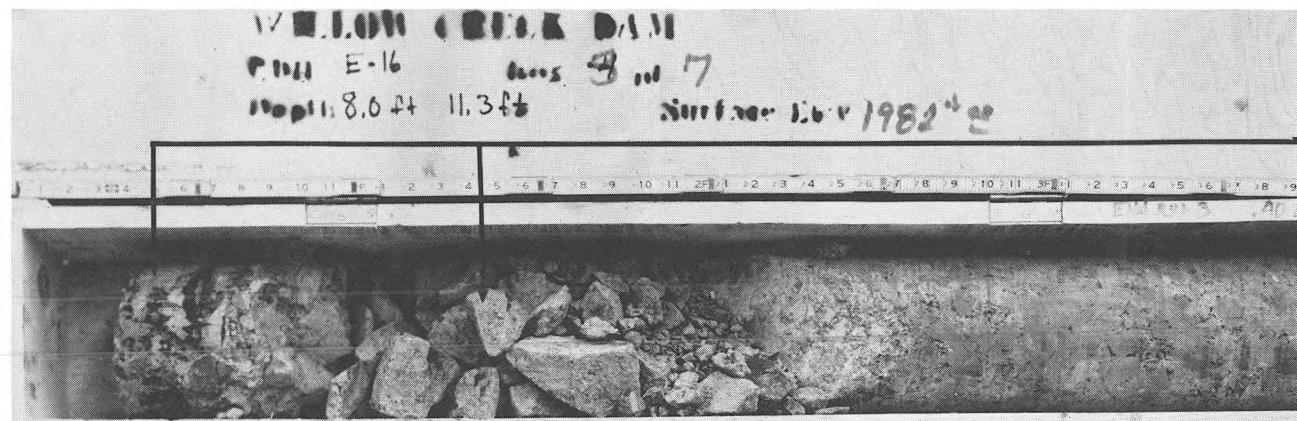
SEGMENT REMOVED BY HAMMER. NOTE SCORING OF UPPER CORE HAD BOUND-UP WITHIN THE BARREL.

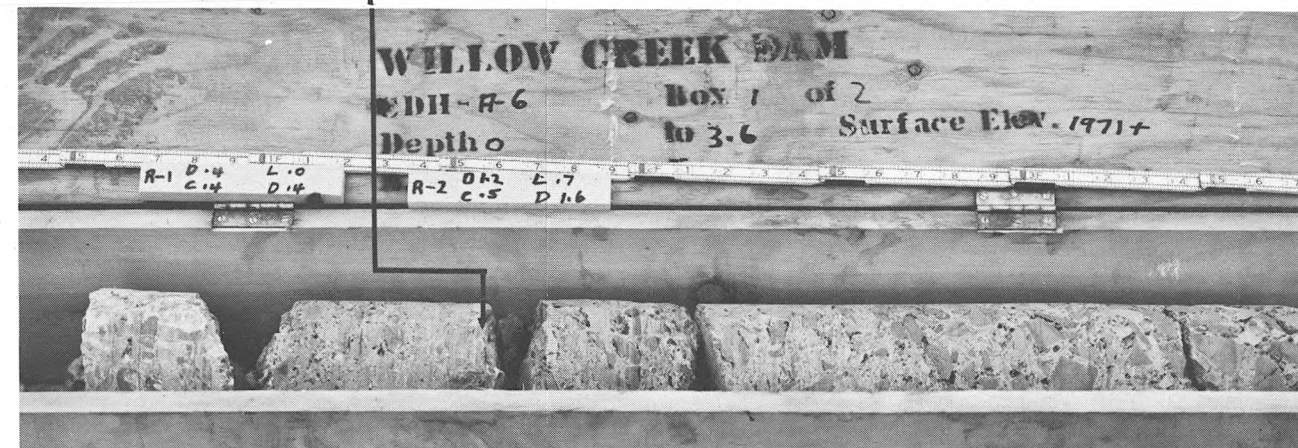
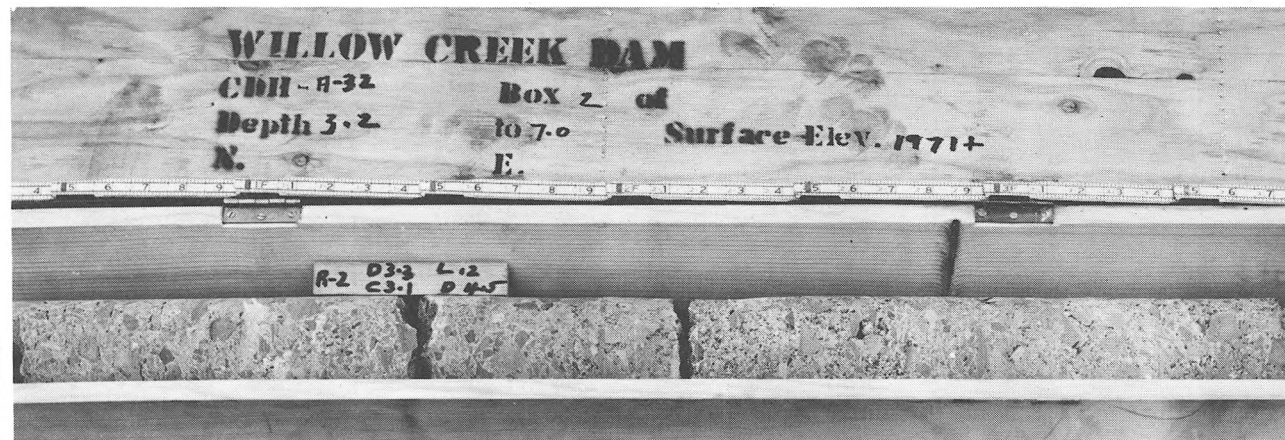
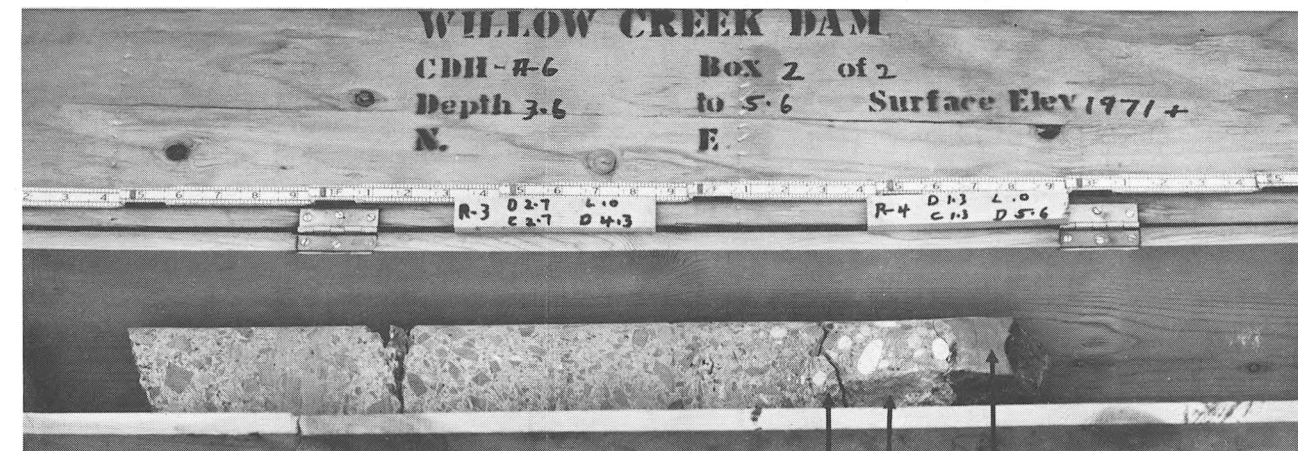
RCC BONDED TO DENTAL CONCRETE BY A THIN LAYER OF CONVENTIONAL CONCRETE BEDDING.

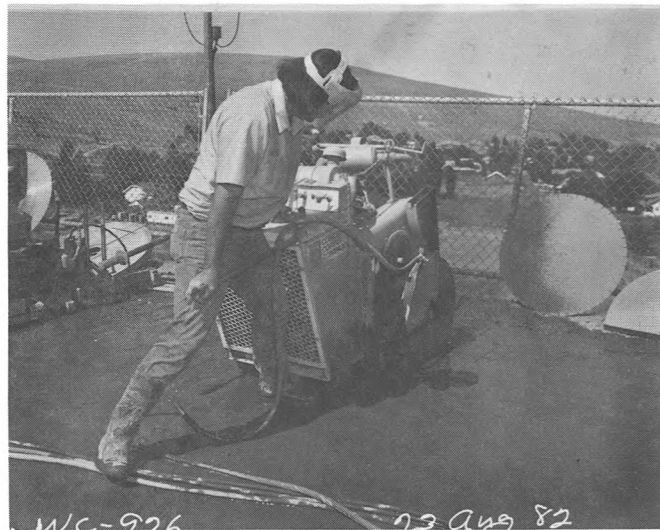
SAWING TEST BLOCK FROM THE DAM.

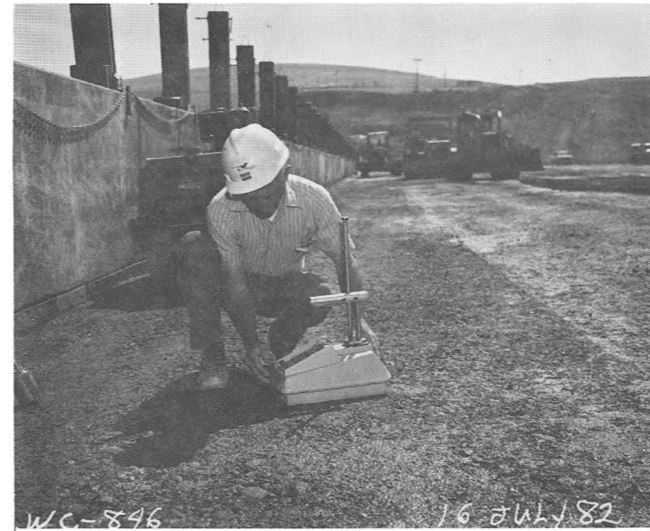
NUCLEAR DENSITY AND MOISTURE.

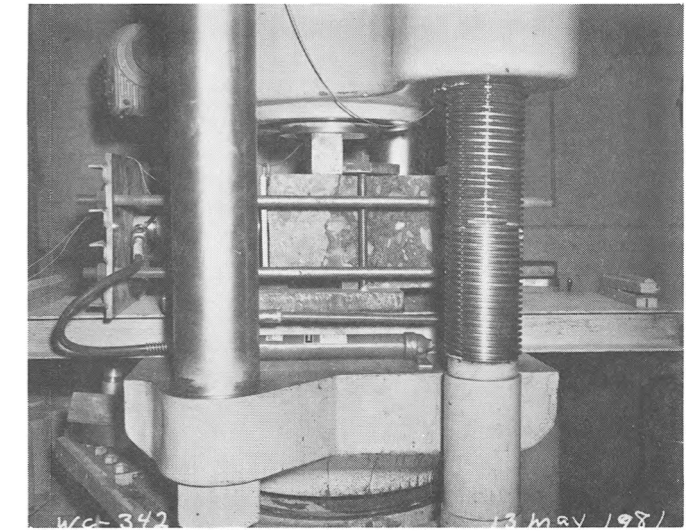
SHEAR TEST ALONG A JOINT UNDER CONFINING PRESSURE.

layer-to-layer joint interface at an angle of about 25 degrees to the core axis. The tests were run at confining loads equivalent to 0 and 55 feet of dead load concrete mass, and at an internal pore pressure representing full hydrostatic uplift of 55 feet of water for the confining load of 55 feet of concrete mass. Testing was done in a stabilized condition of saturation. The resulting shear resistance was extraordinary. At no confining load the average shear resistance was 660 psi. At the confining load of 55 feet of concrete with 55 feet of hydrostatic uplift, the shear resistance averaged 766 psi with values as high as 1,415 psi.

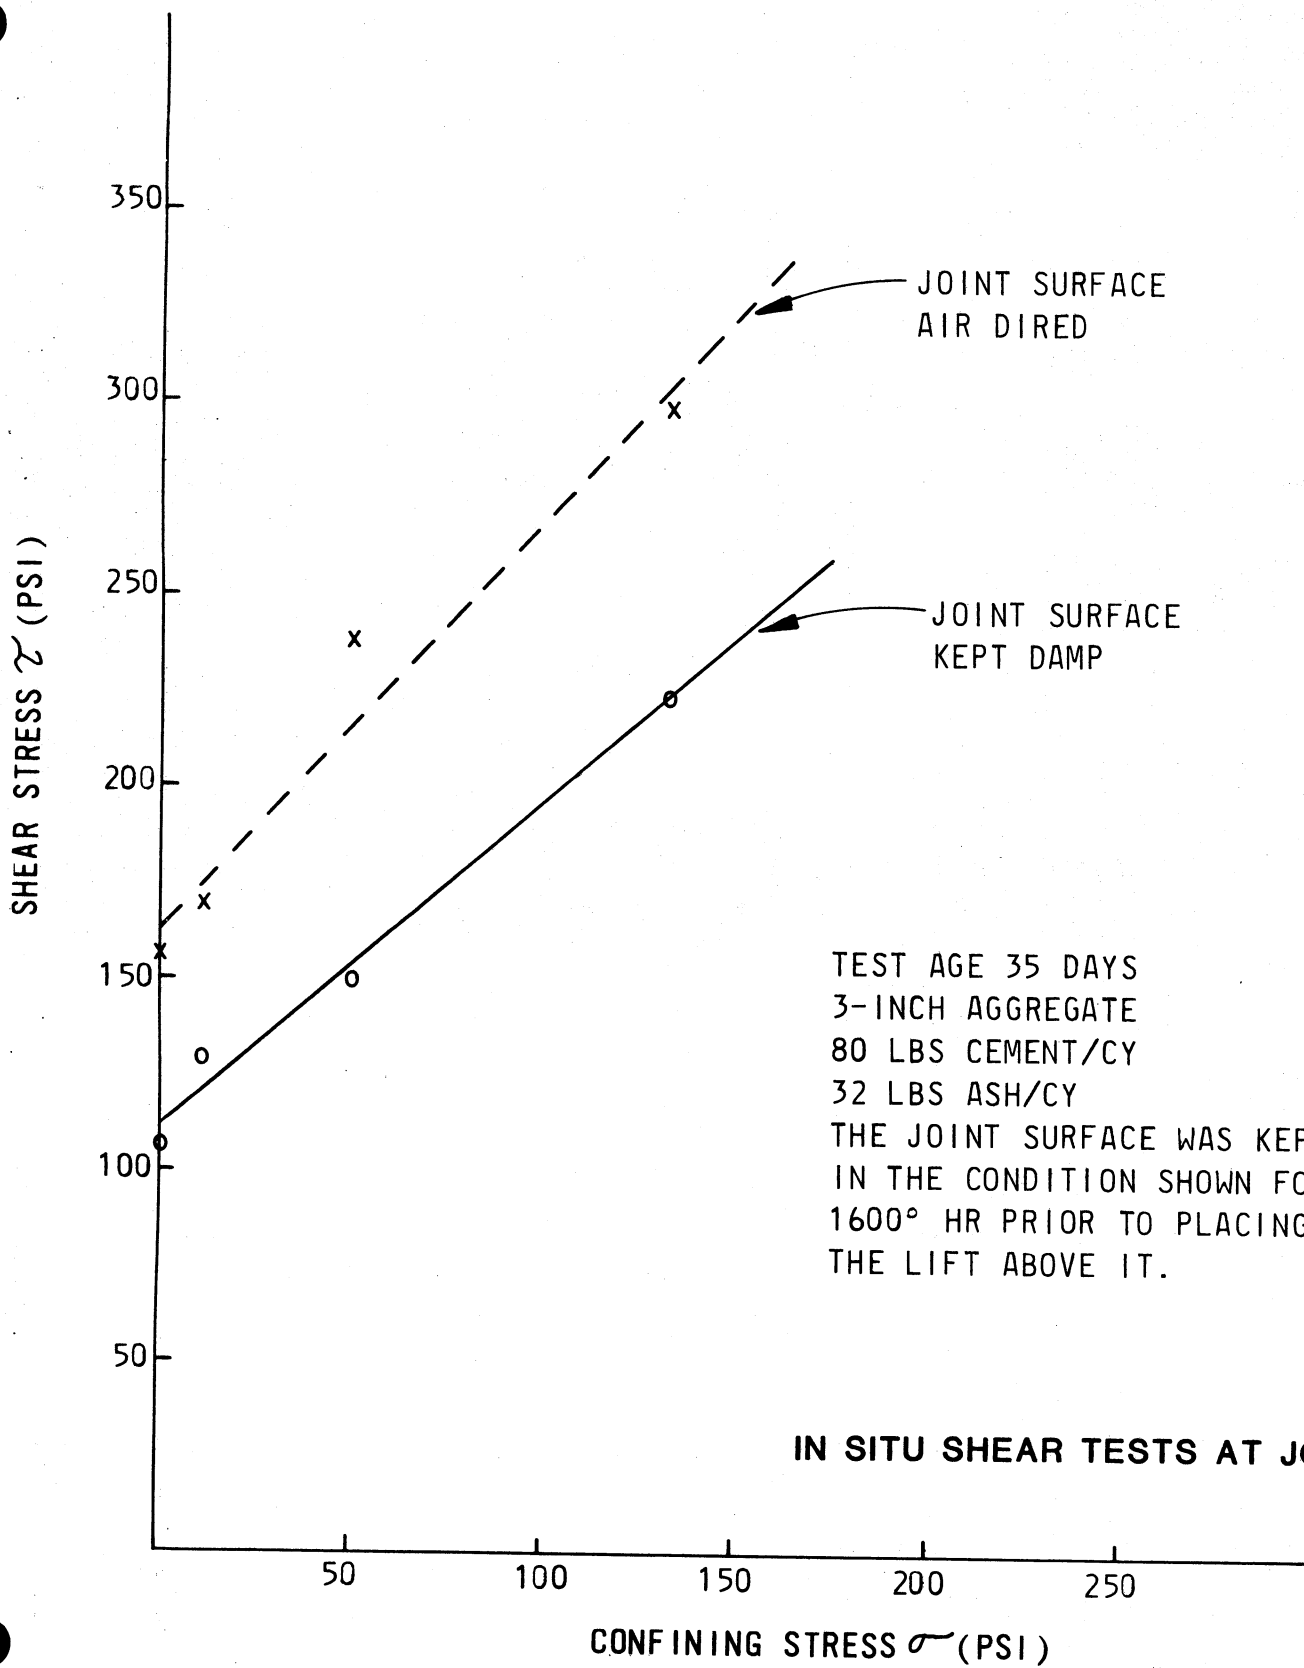
**IN SITU SHEAR TESTS AT JOINTS**

TEST AGE 35 DAYS  
 3-INCH AGGREGATE  
 80 LBS CEMENT/CY  
 32 LBS ASH/CY  
 THE JOINT SURFACE WAS KEPT  
 IN THE CONDITION SHOWN FOR  
 1600° HR PRIOR TO PLACING  
 THE LIFT ABOVE IT.

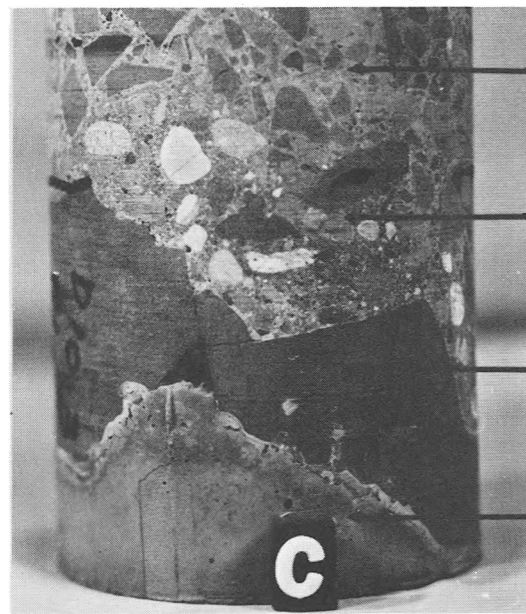
- ROLLER COMPACTED CONCRETE
- CONVENTIONAL BEDDING MIX
- FOUNDATION ROCK
- MORTAR FILLER ADDED FOR SHEAR TESTS

SIX-INCH CORE THROUGH THE RCC AND BEDDING INTO THE FOUNDATION ROCK. SAMPLE PREPARED FOR SHEAR TEST.
