US Army Corps  
of Engineers  
Walla Walla District

# Concrete Report

## Willow Creek Dam

World's First All Roller Compacted Concrete Dam

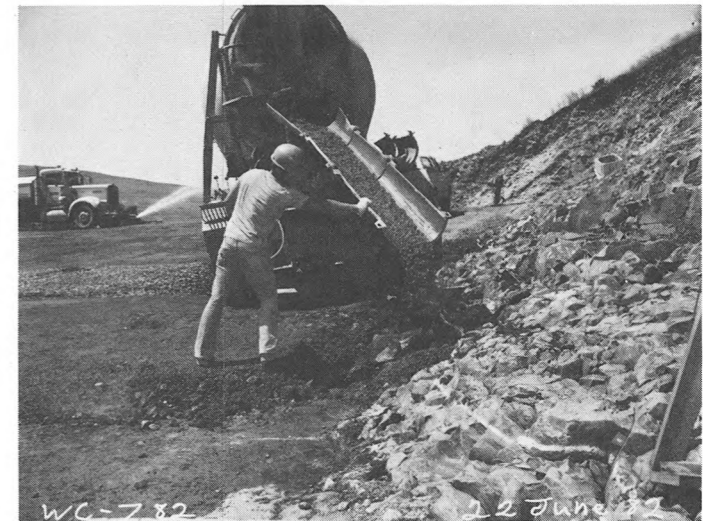
PLACING BEDDING ON THE FOUNDATION PRIOR TO ROLLING RCC INTO IT.

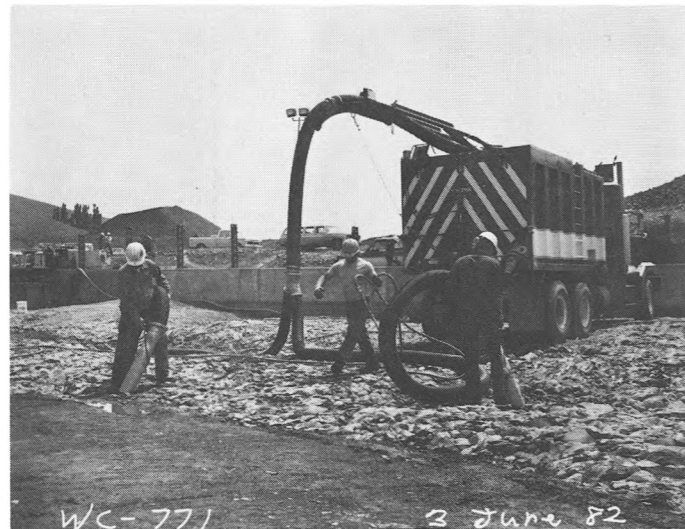
VACUUM CLEANUP OF THE FOUNDATION PRIOR TO PLACING THE BEDDING MIX AND RCC ON IT.

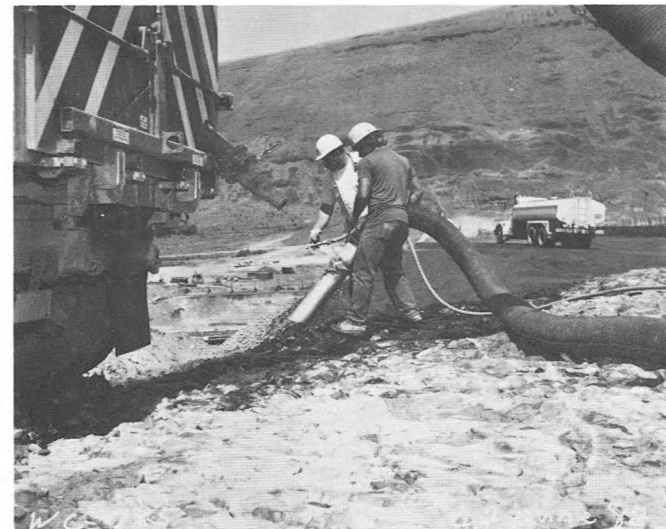
VACUUM CLEANUP OF THE FOUNDATION.

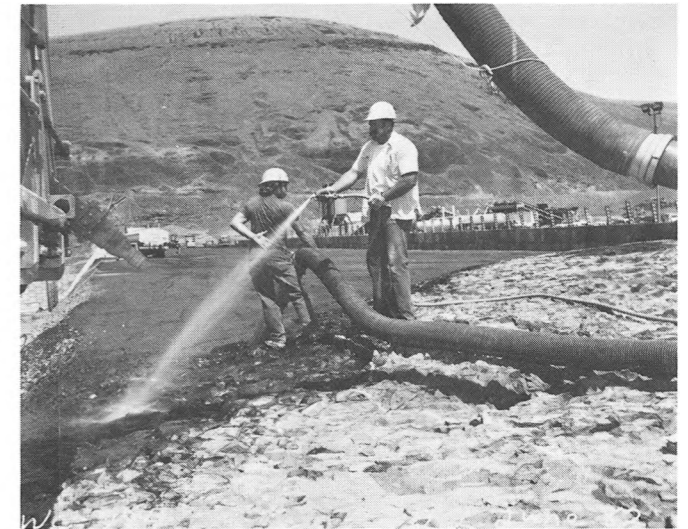
FOUNDATION CLEANUP WITH A STANDARD GARDEN HOSE AND THE VACUUM.

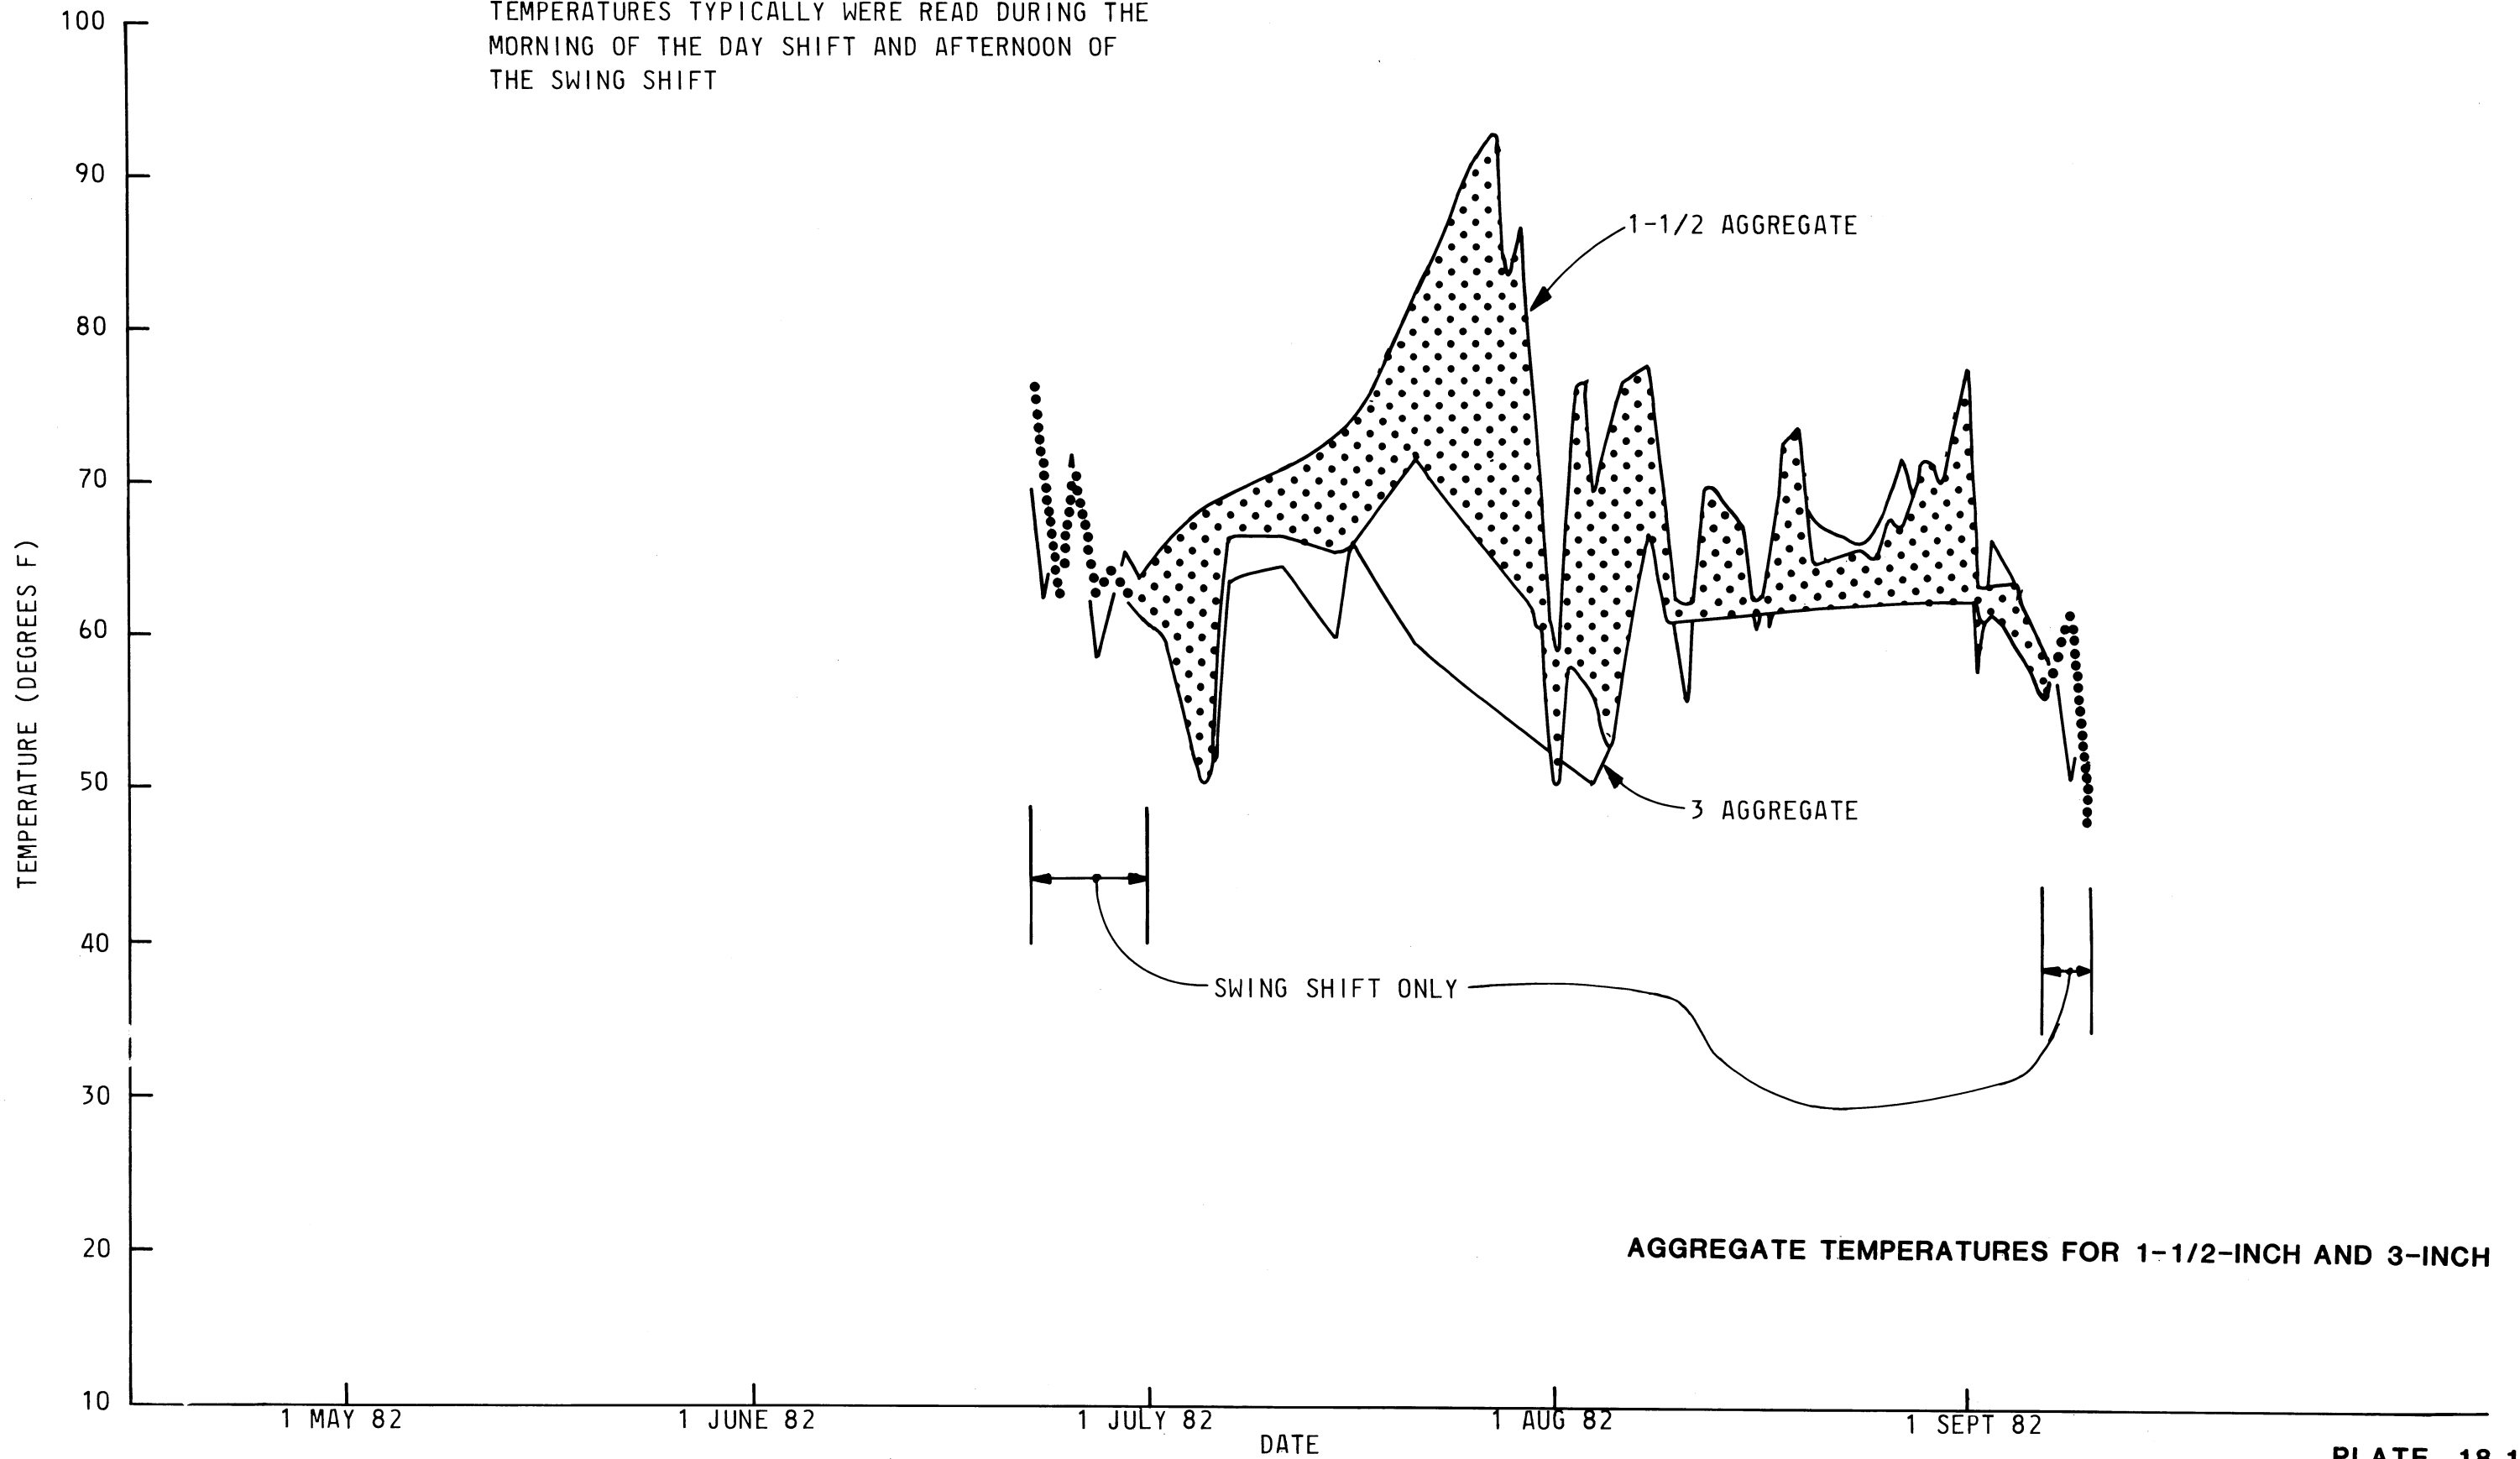
TEMPERATURES TYPICALLY WERE READ DURING THE MORNING OF THE DAY SHIFT AND AFTERNOON OF THE SWING SHIFT

AGGREGATE TEMPERATURES FOR 1-1/2-INCH AND 3-INCH

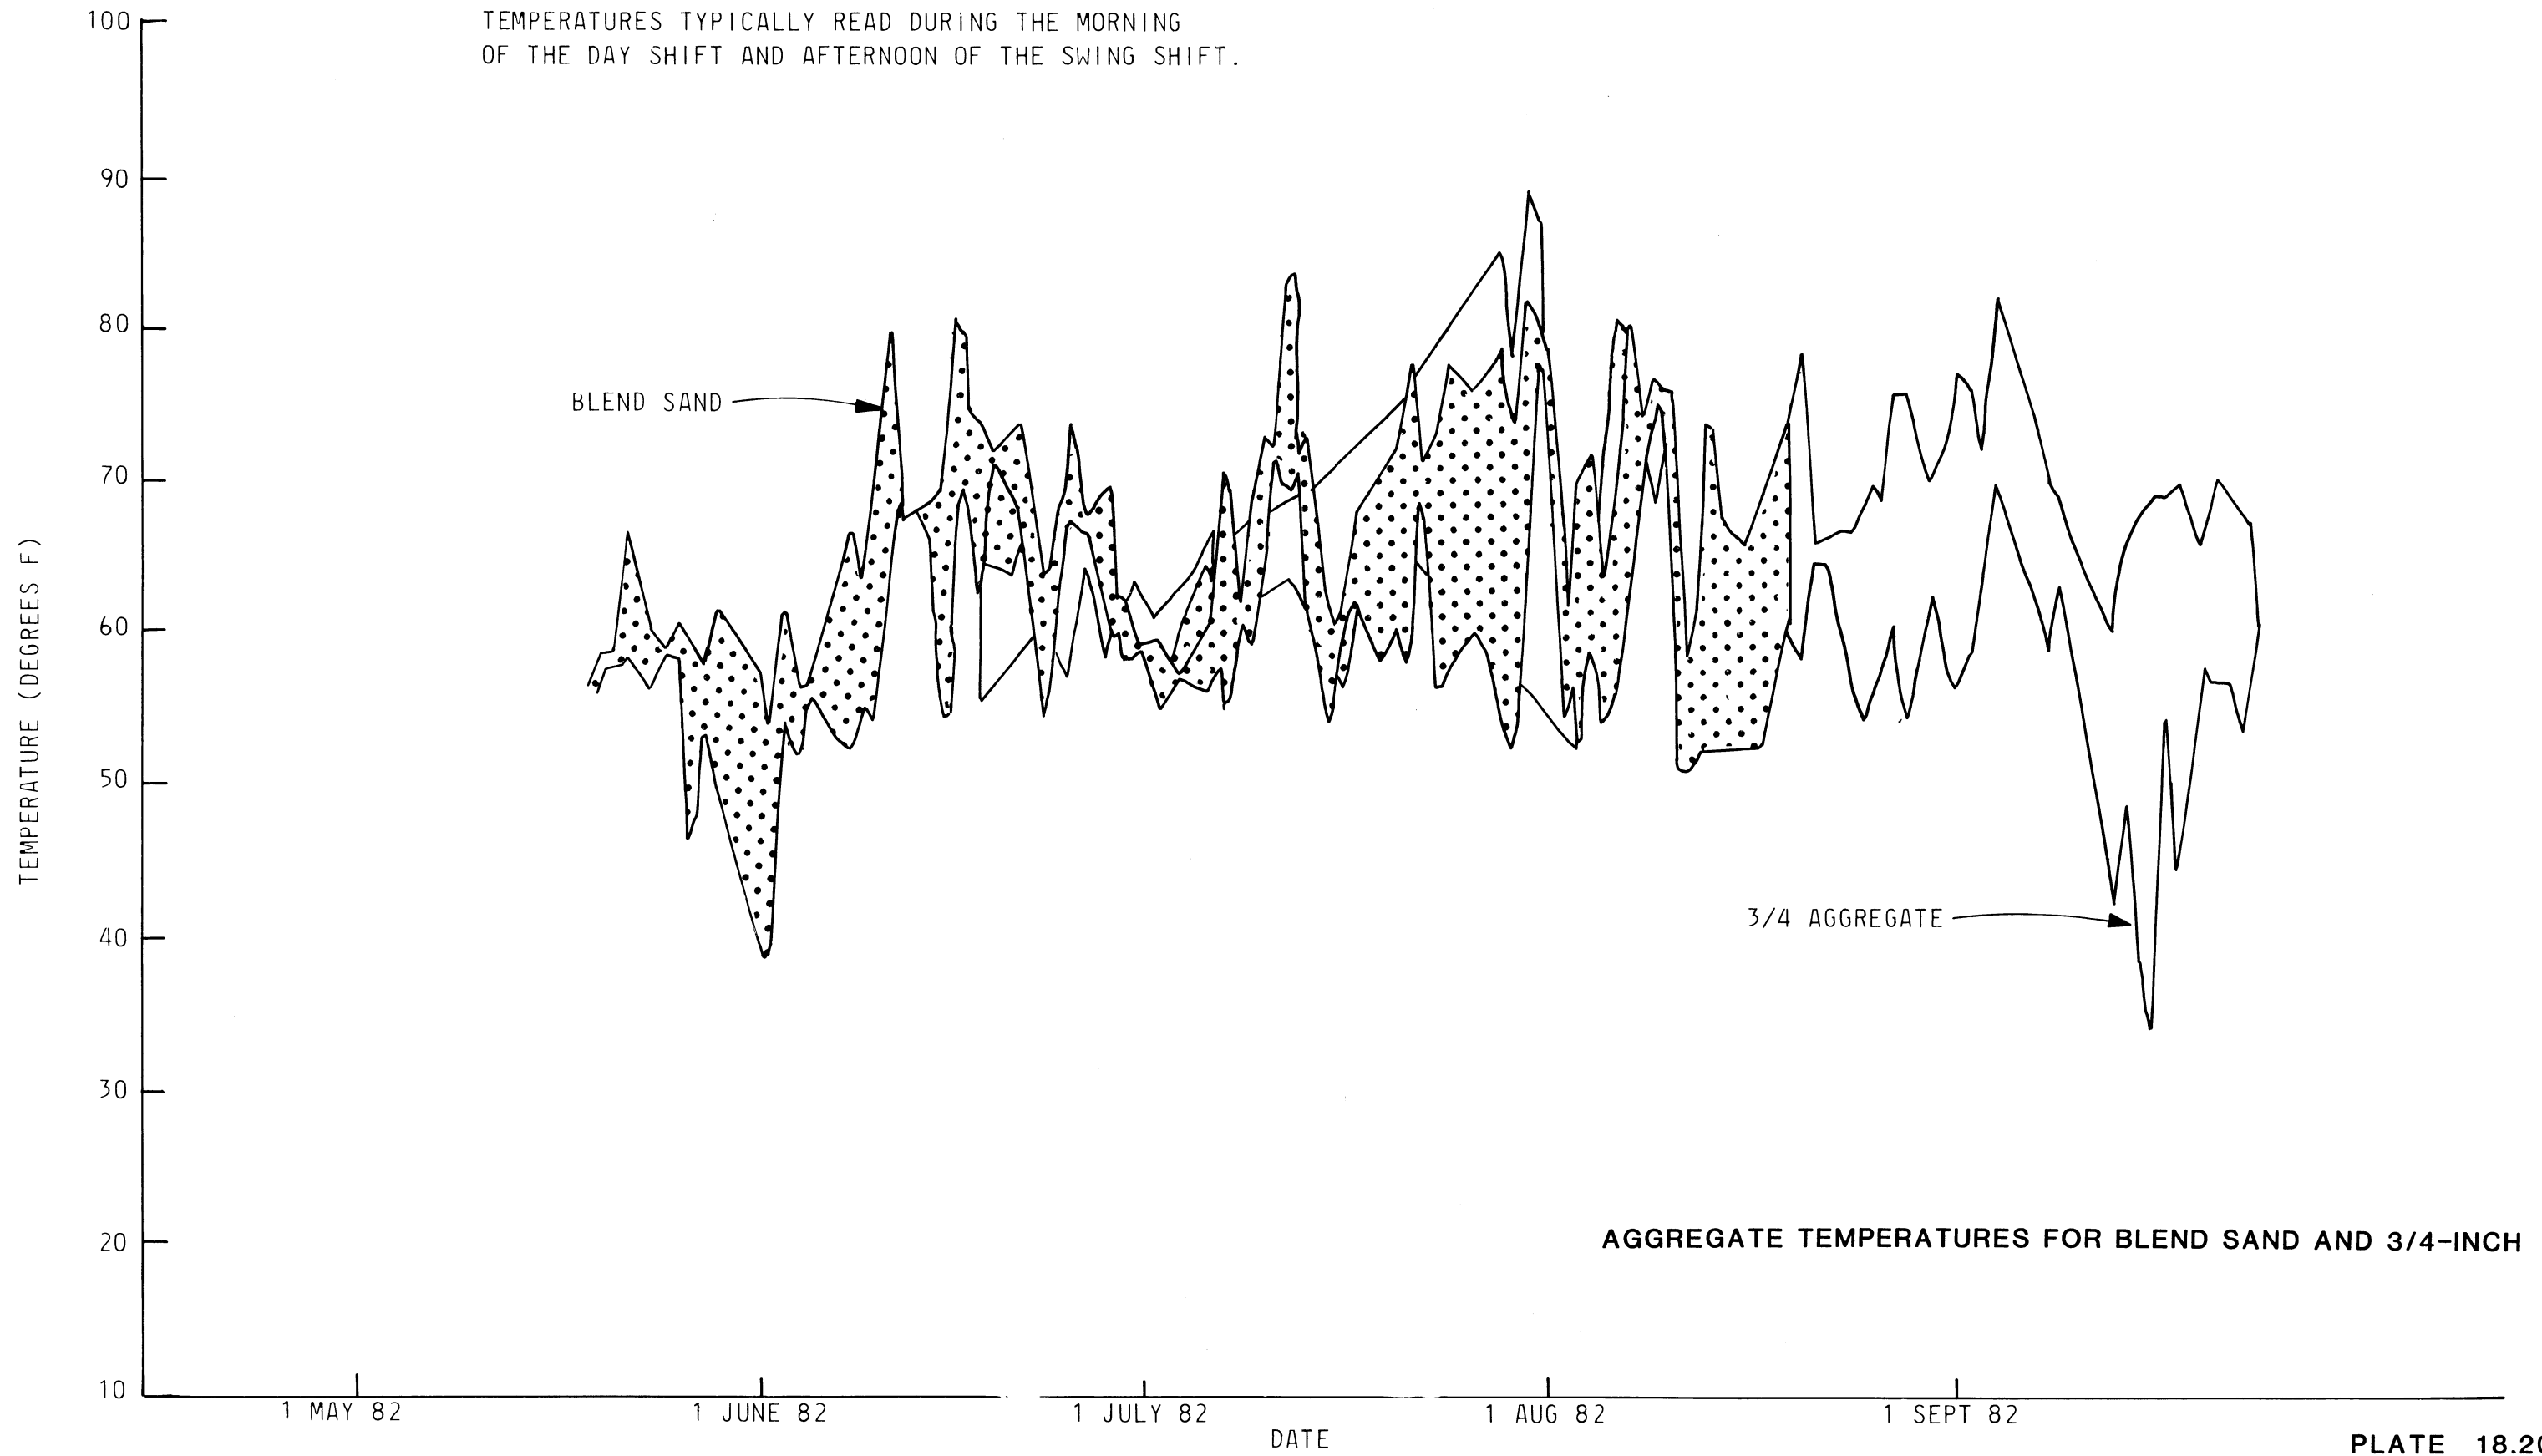
TEMPERATURES TYPICALLY READ DURING THE MORNING  
OF THE DAY SHIFT AND AFTERNOON OF THE SWING SHIFT.

AGGREGATE TEMPERATURES FOR BLEND SAND AND 3/4-INCH

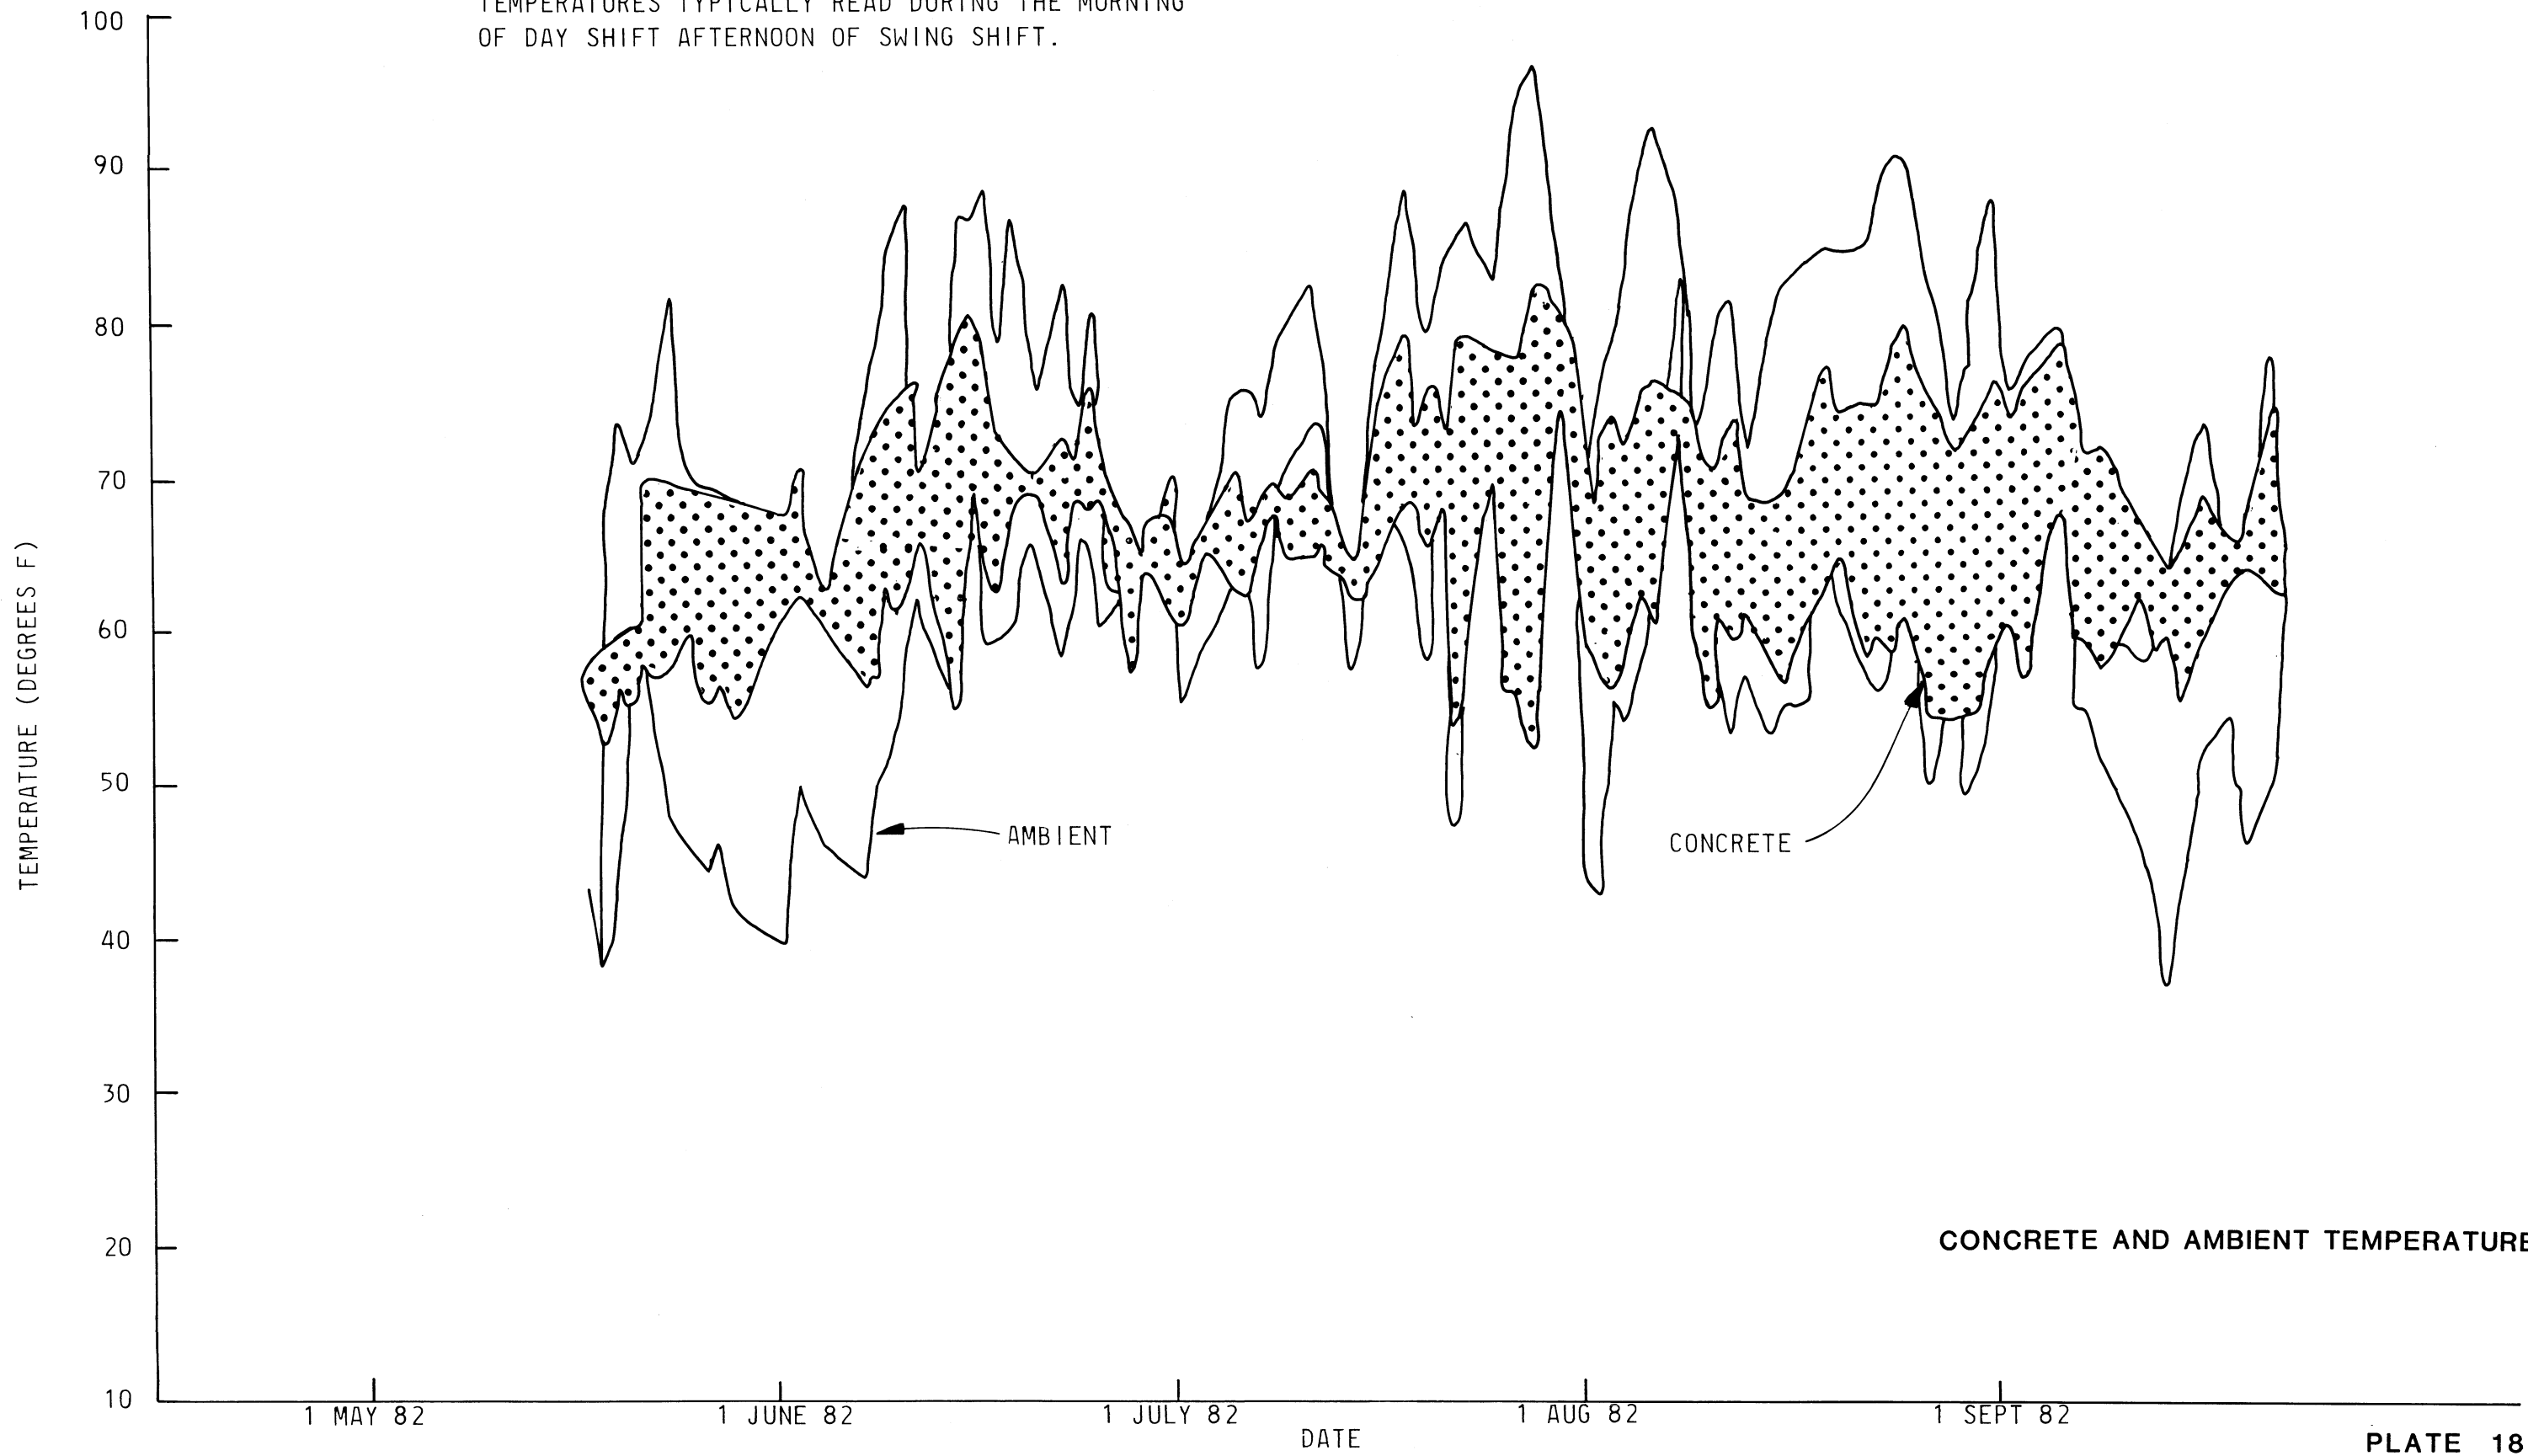
TEMPERATURES TYPICALLY READ DURING THE MORNING  
OF DAY SHIFT AFTERNOON OF SWING SHIFT.

CONCRETE AND AMBIENT TEMPERATURES

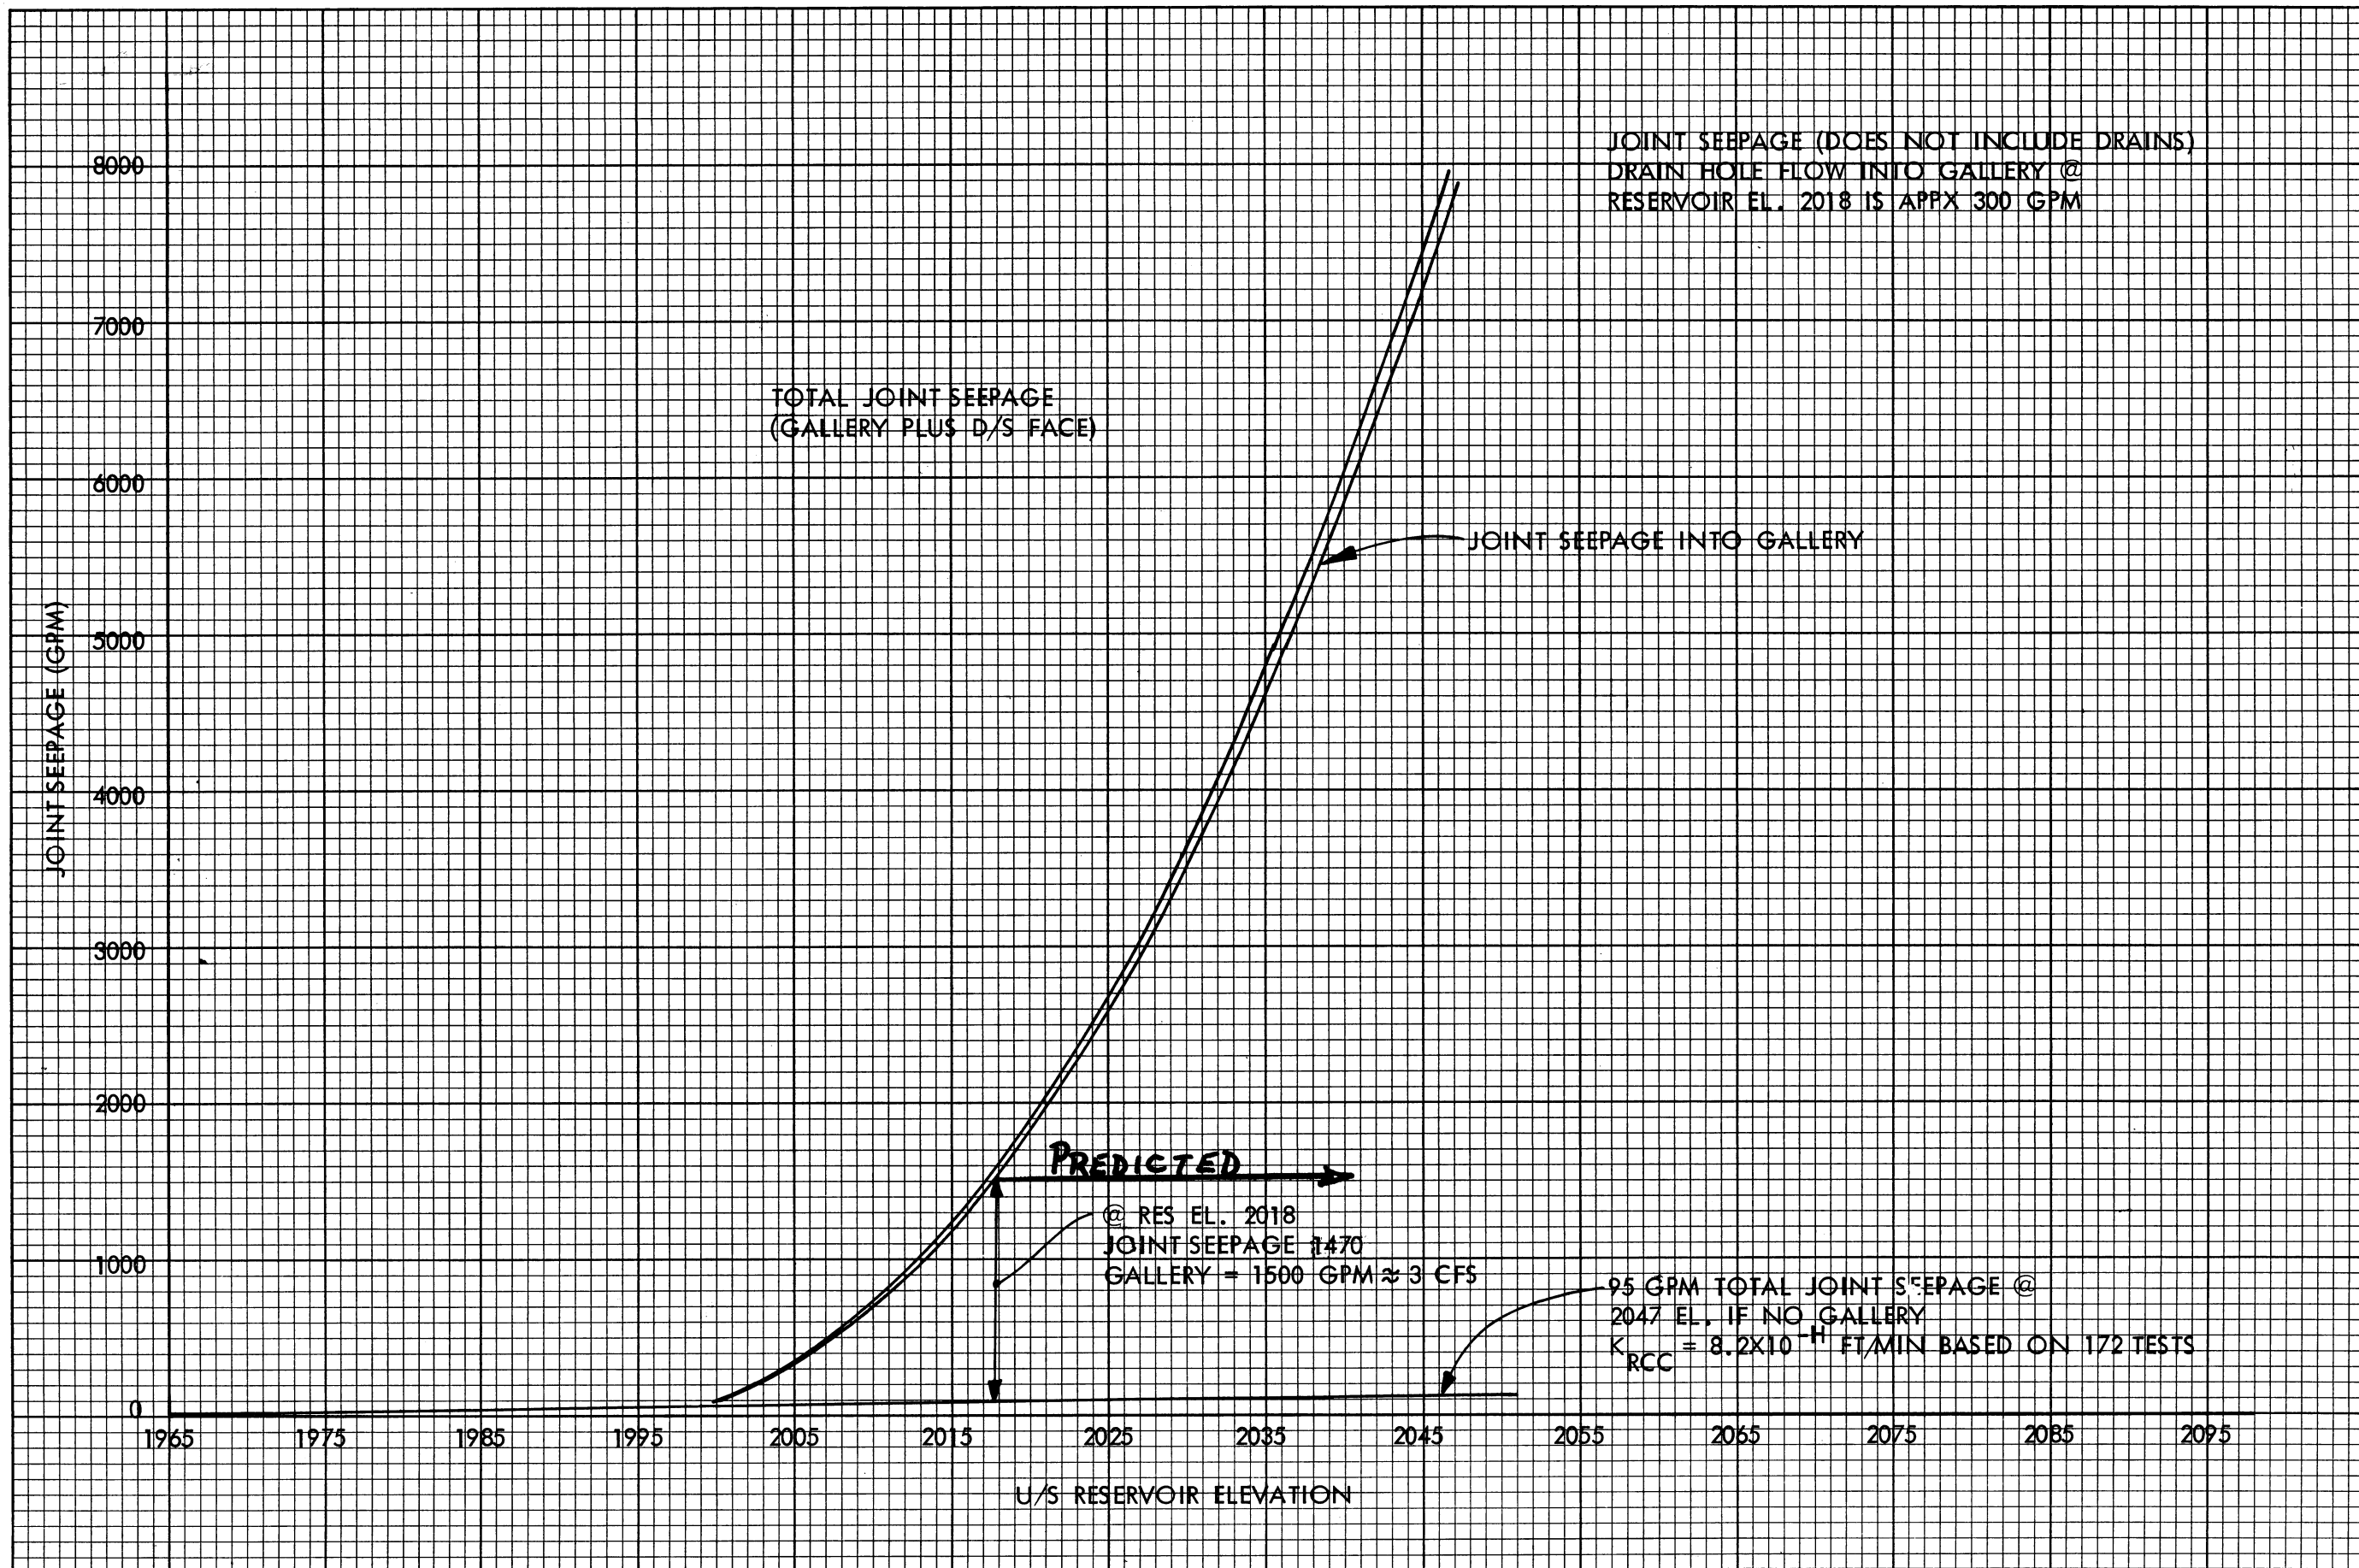
WILLOW CREEK DAM - SEEPAGE RESULTING FROM THE GALLERY

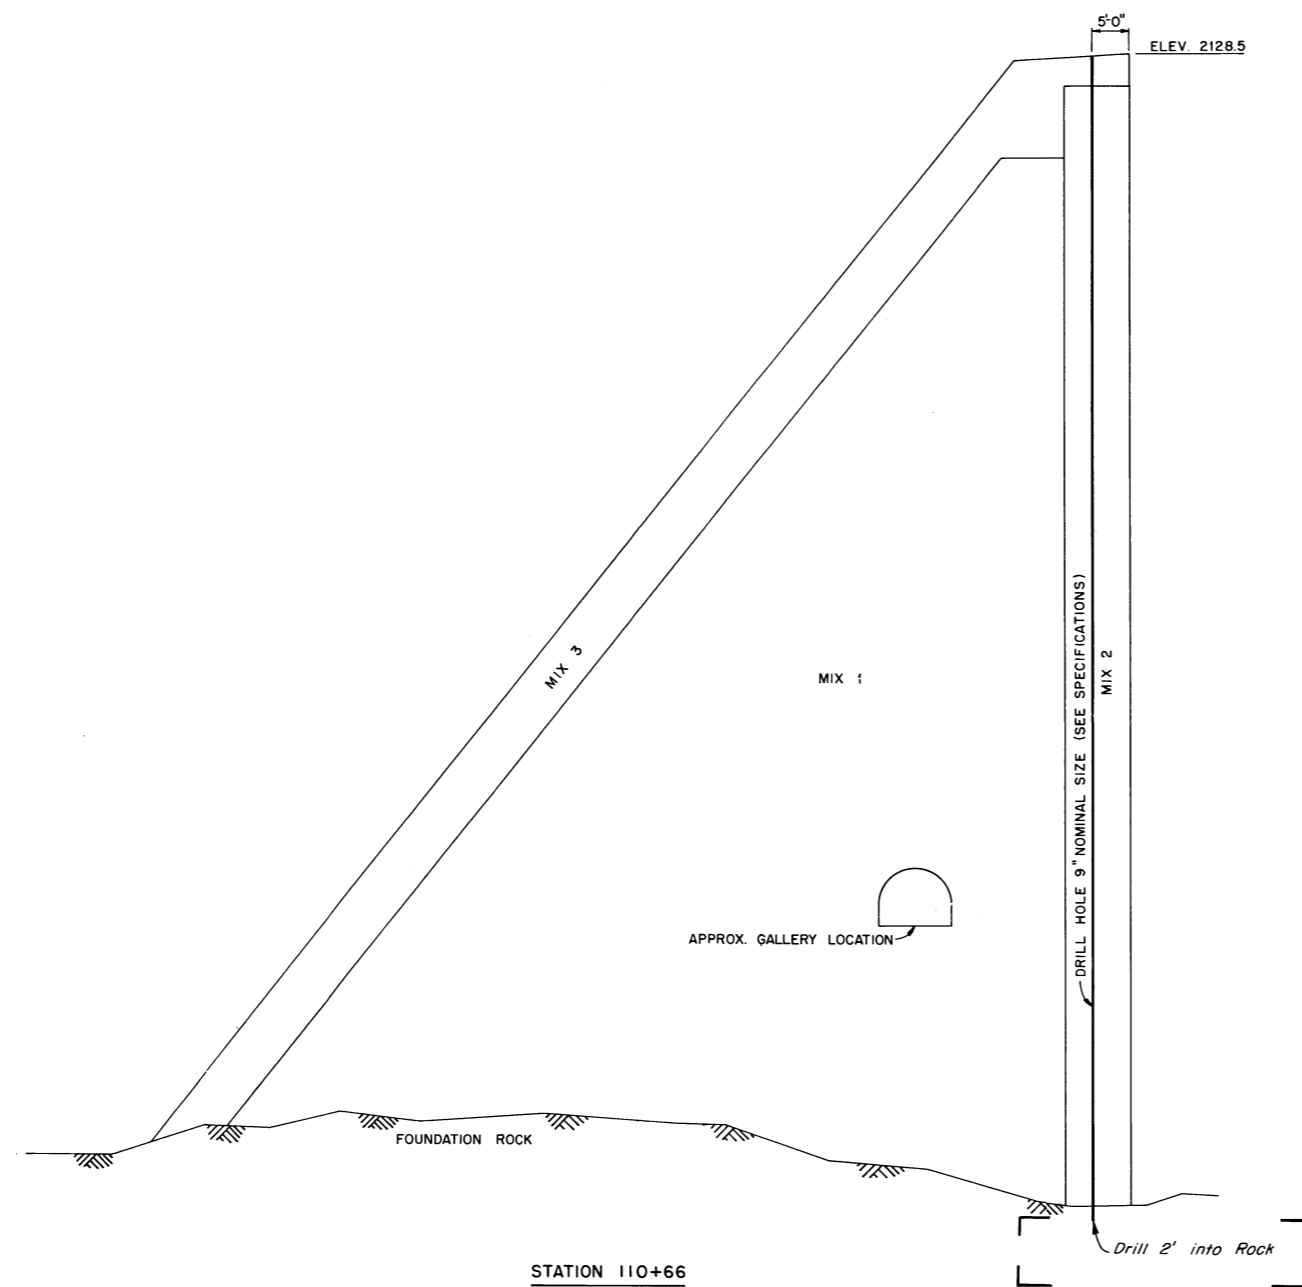
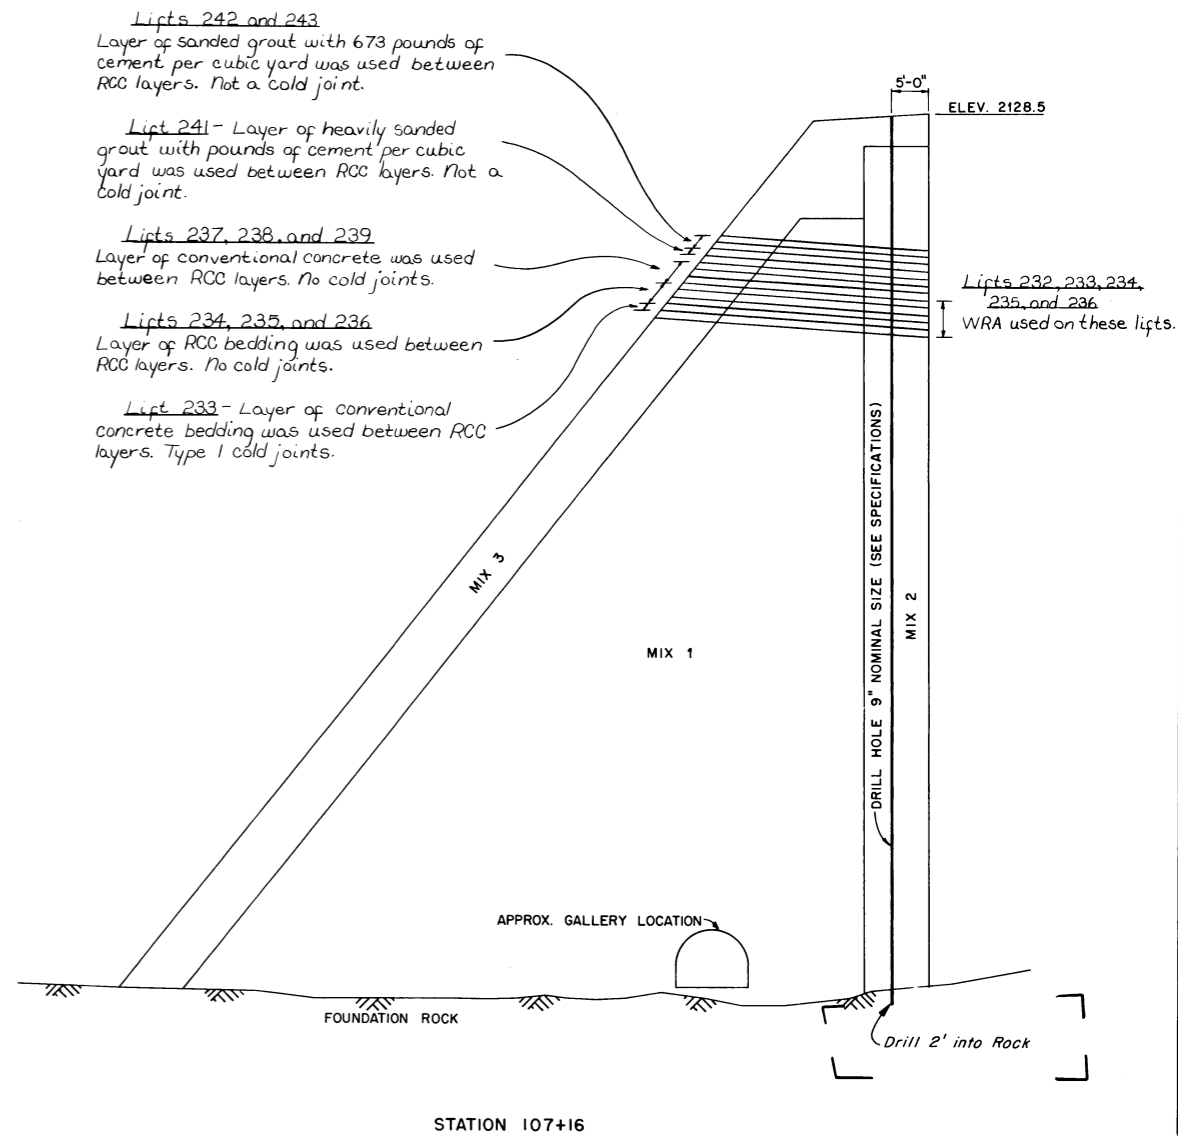
Lifts 242 and 243  
 Layer of sanded grout with 673 pounds of cement per cubic yard was used between RCC layers. Not a cold joint.

Lift 241 - Layer of heavily sanded grout with pounds of cement per cubic yard was used between RCC layers. Not a cold joint.
