**US Army Corps  
of Engineers**  
Kansas City District

# Hydrologic and Geomorphic Changes on the Kansas River

September 2010

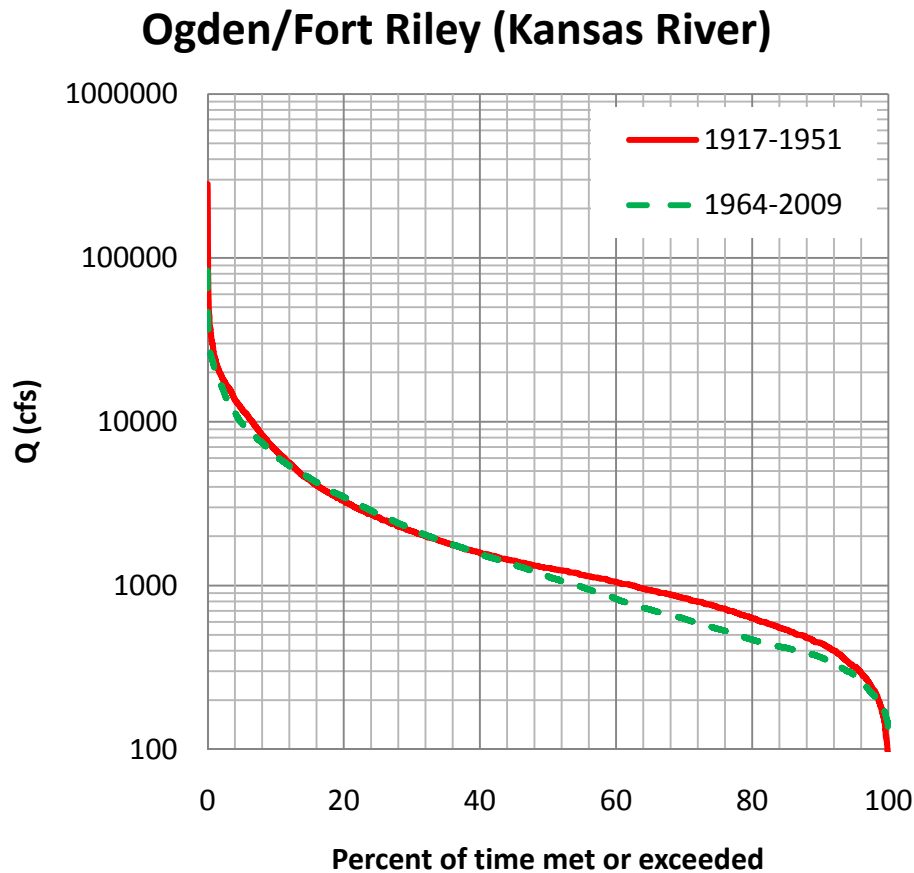
Figure 2. 10. Flow-duration structure for Ogden/Fort Riley

As stated in section 3.1.1, the Fort Riley gage (12/19/1963 – current) and the Ogden gage (6/19/1917 – 9/30/1951) describe the flow record at a similar location. Data from these two gages were combined to derive the flow-duration structure of the Kansas River immediately downstream of the junction of the Republican and Smoky Hill Rivers. The flow-duration curves for the two time periods are plotted in Figure 2. 10. Flow data is not available for 1952 to December 1963.

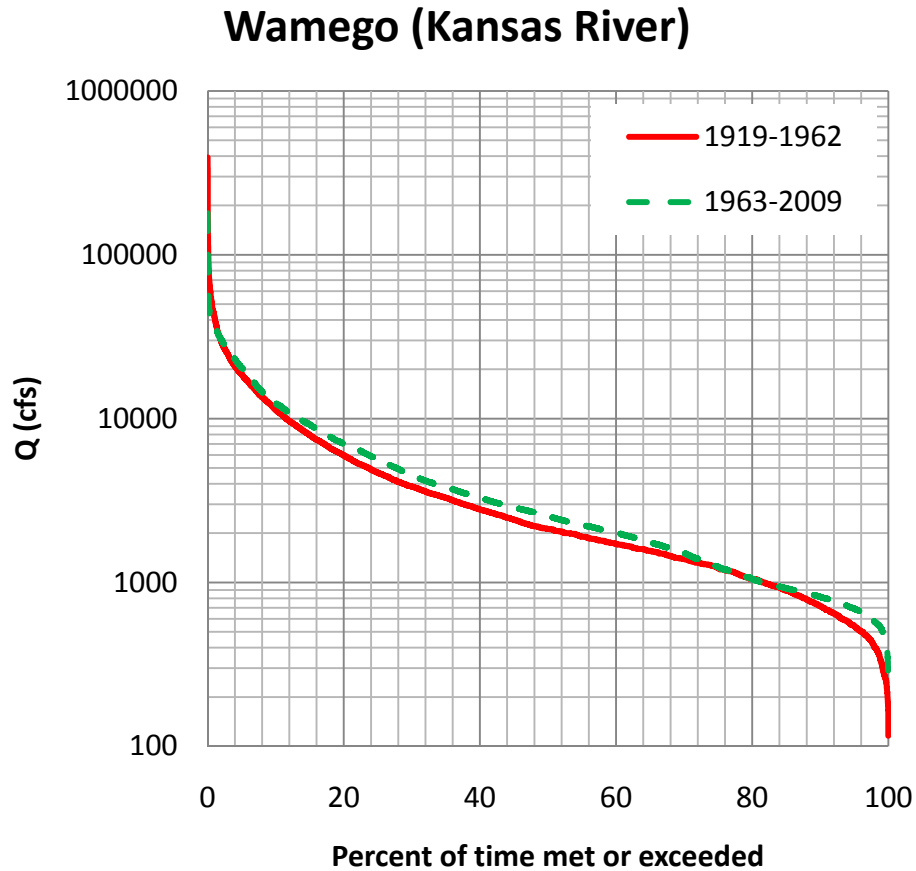
**Figure 2. 11. Flow-duration curve for Wamego (Kansas River) 1919 -1967**

As seen in Figure 2. 11, the Kansas River at Wamego has less severe floods and droughts but increased discharge for intermediate flows in the recent period. Tuttle Creek Lake and Milford Lake are responsible for the attenuation of the floods and the droughts. However, the period from 1919 – 1966 encompassed the dry 1920s and 1930s, which may be the most significant cause of the increase in intermediate flows from 1967 – 2009. This is demonstrated for the Desoto gage (Figure 2. 13 and Figure 2. 14).

Figure 2. 11 presents the flow-duration curves for the Kansas River at Wamego.

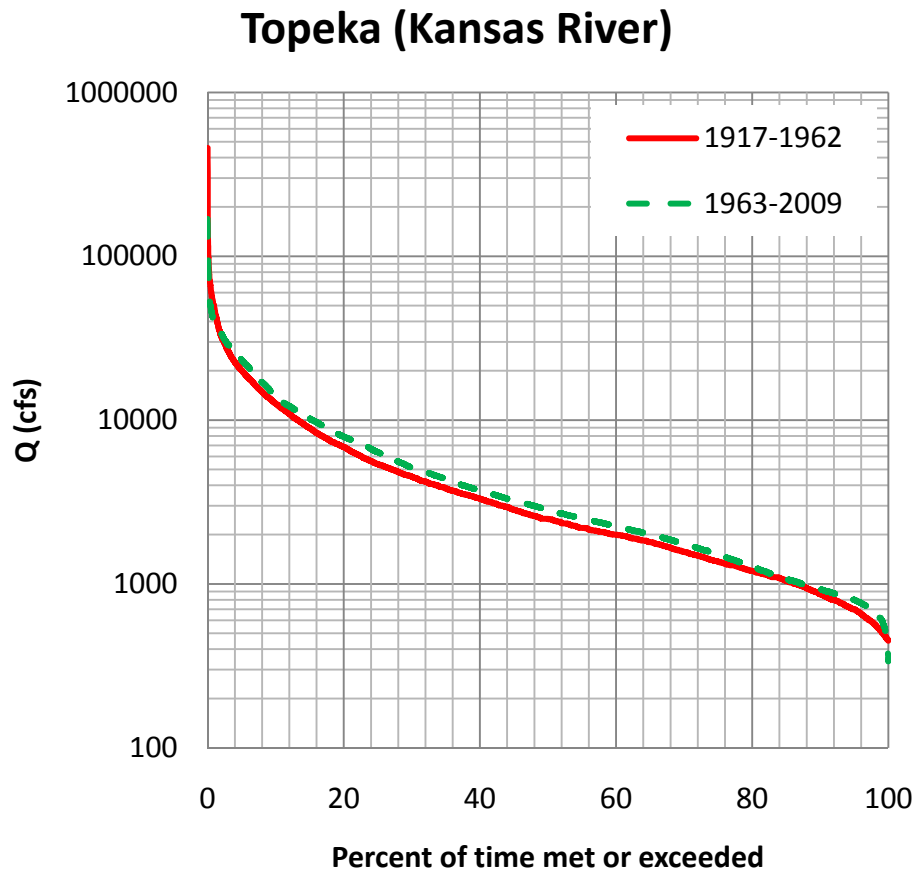
**Figure 2. 12. Flow-duration curve for Topeka (Kansas River) 1917-1967**

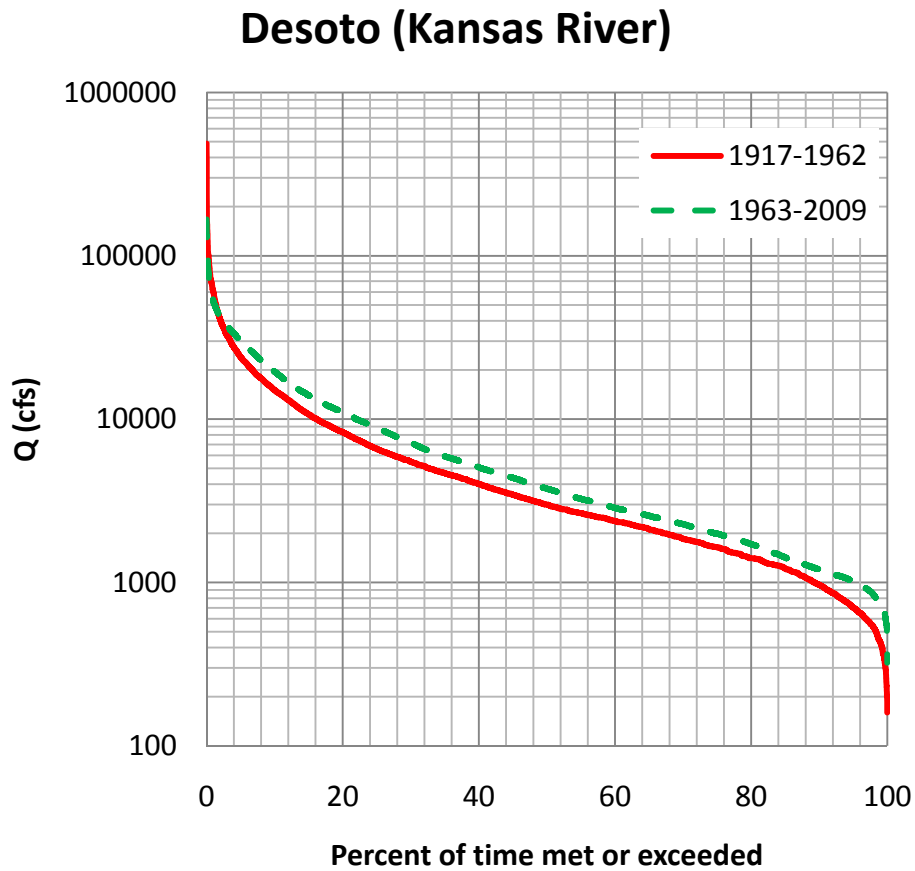
Figure 2. 13 shows a similar result for the Kansas River at Desoto to that seen at Wamego and Topeka. The flood and drought attenuation can be attributed to the action of Tuttle Creek Lake, Milford Lake, Perry Lake, and Clinton Lake.

**Figure 2. 13. Flow-duration curve for Desoto (Kansas River) 1917-1967**

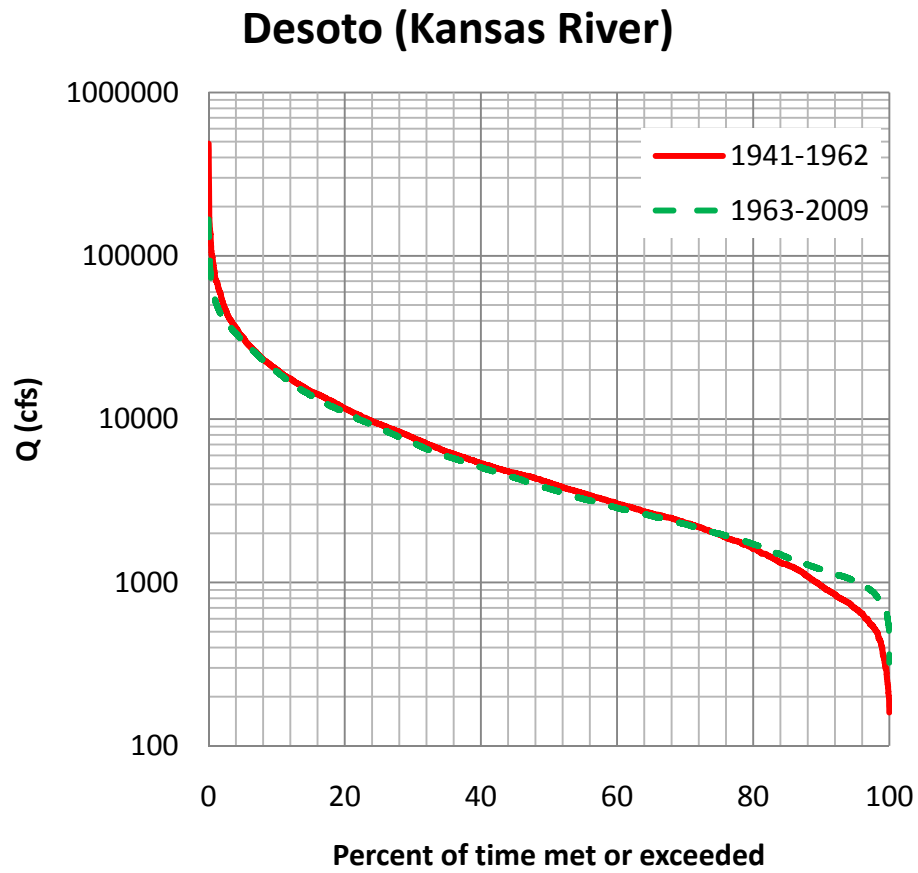
Figure 2. 14. Flow-duration curve for Desoto (Kansas River) 1941-1967

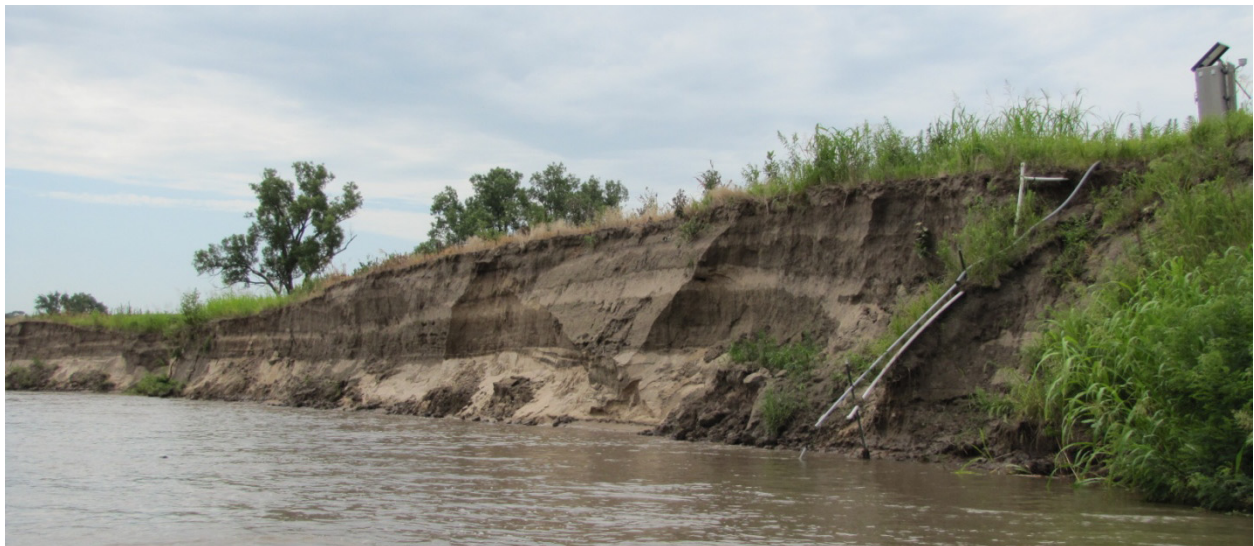
**Figure 3. 2. An eroding, vertical bank. RM 167.8.**

SLA Reach 8 extends from RM 148 to the confluence of the Smoky Hill and Republican Rivers at RM 170.4. Tall, vertical, eroding banks are common in this reach, as seen in Figure 3. 2 and Figure 3. 3. The erosion typically occurs on outside bends—though not every outside bend erodes and not every eroding bank is on the outside of a bend. Often, farmers have planted corn right up to the edge of the bank.

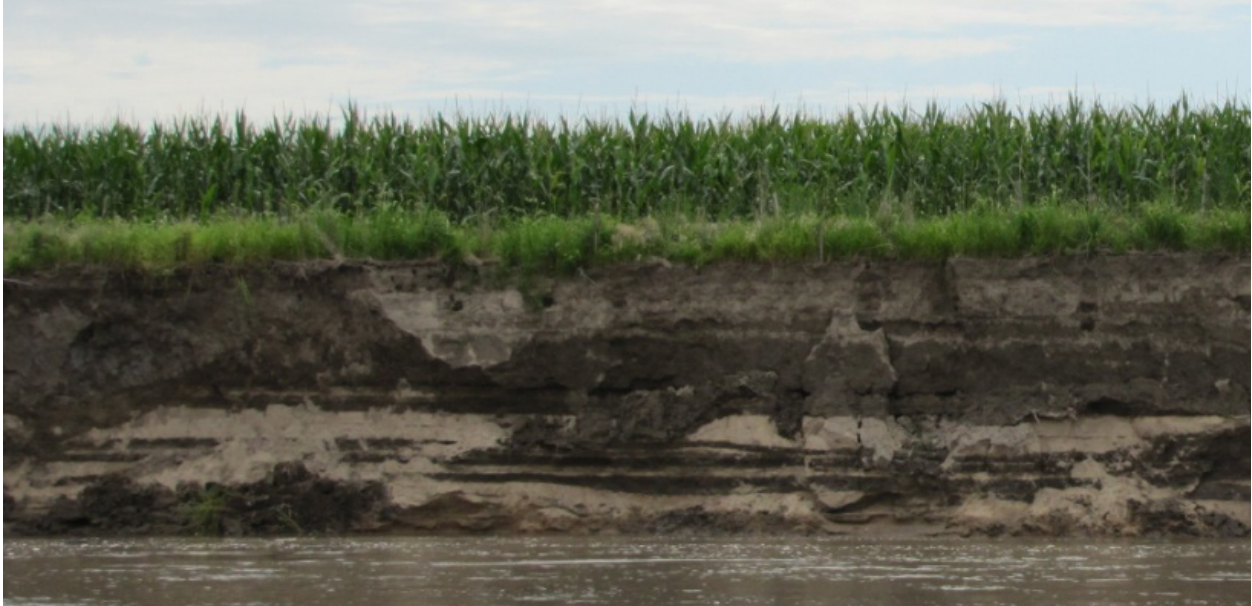
**Figure 3. 3. An eroding, vertical bank. RM 167.5.**

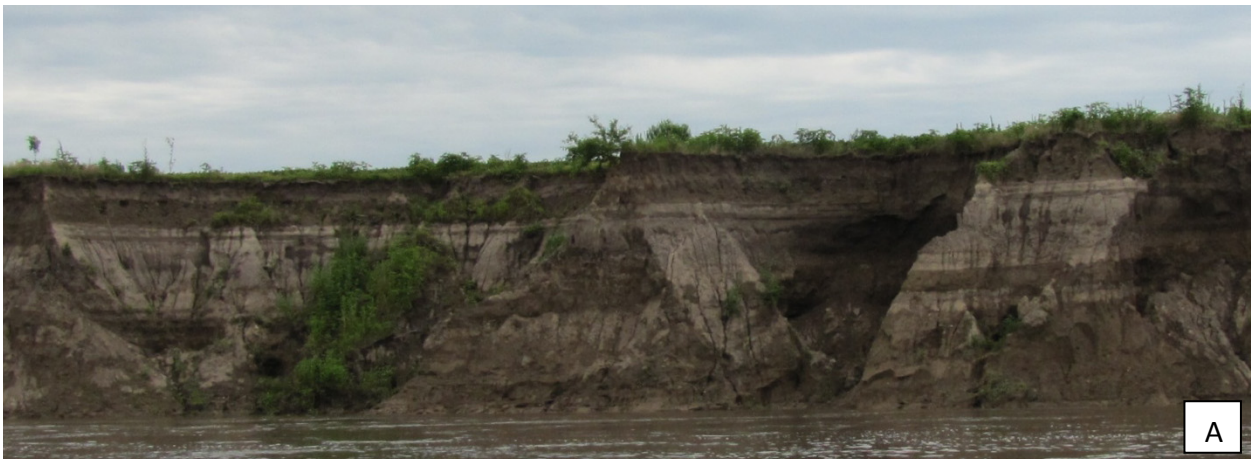
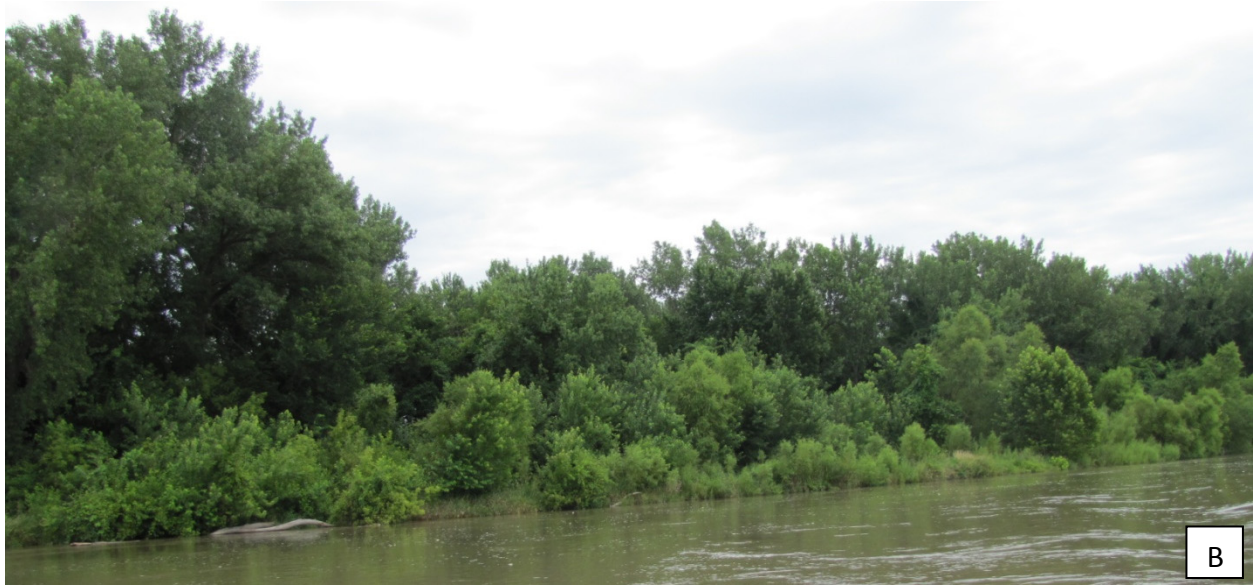
**Figure 3. 4. Bank erosion at the outside bend (A) and accretion on the inside bend (B) at RM 140.4.**

SLA Reach 7 extends from the Willard Bridge at RM 101 to RM 148. Tall, vertical, eroding banks are very common in this reach, as well. While the outside bends tend to erode, the inside bends are depositional, as seen in Figure 3. 4.

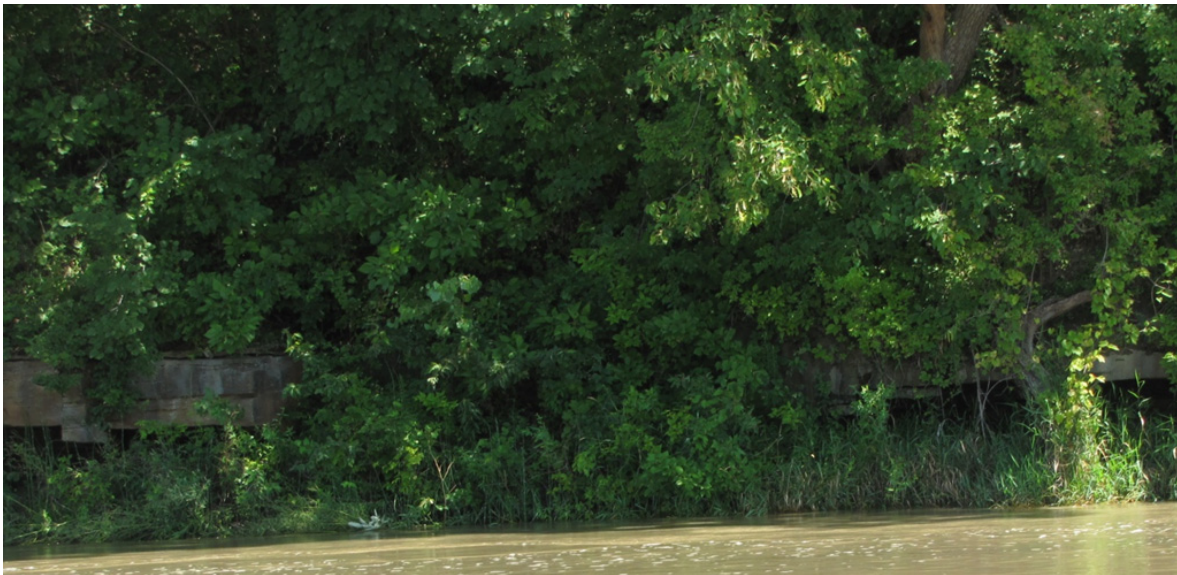
**Figure 3. 5. Bedrock plane at RM 125.6.**

A bedrock outcrop runs parallel to the channel near RM 125.6, as seen in Figure 3. 5. SLA (1984) reports that this bedrock crosses the active channel and forms a vertical control for half the active channel just upstream of Willard Bridge.

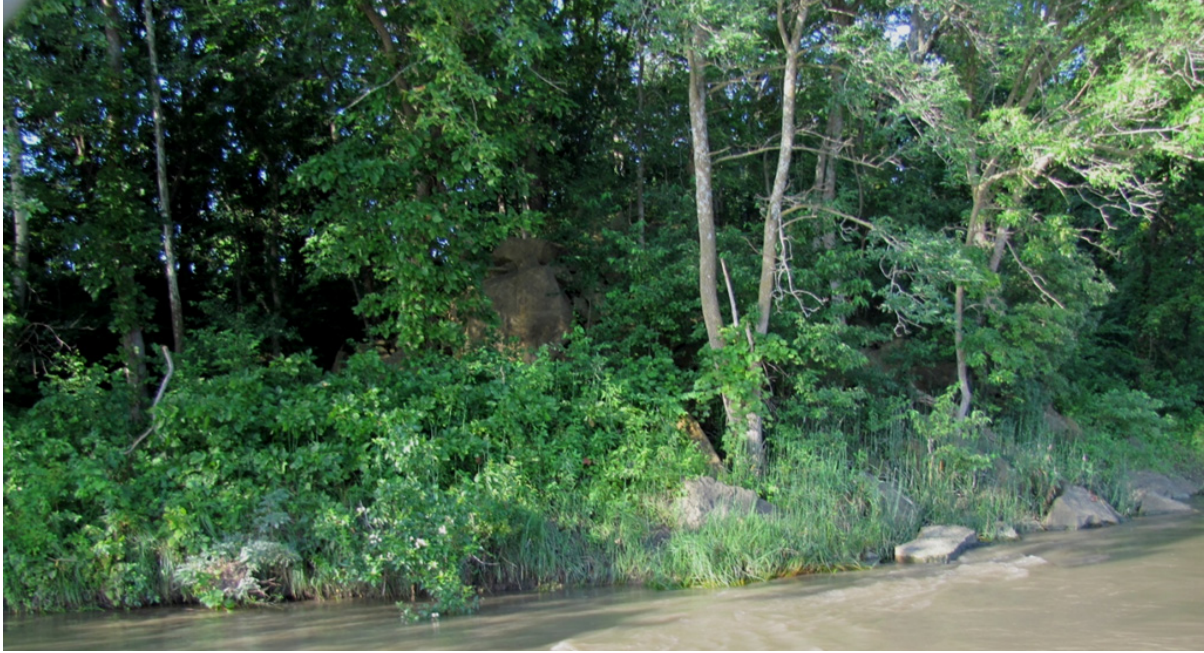
Bank protection measures of many kinds, including hard points, dikes, and stone, slab, and “Detroit” riprap (car bodies) are present in this reach. SLA (1984) reports that most of this bank protection was installed prior to 1958. In most places, the vegetation has grown around and through the riprap, as seen in Figure 3. 6.

**Figure 3. 6. Riprap on banks is overgrown with vegetation. RM 102.2.**

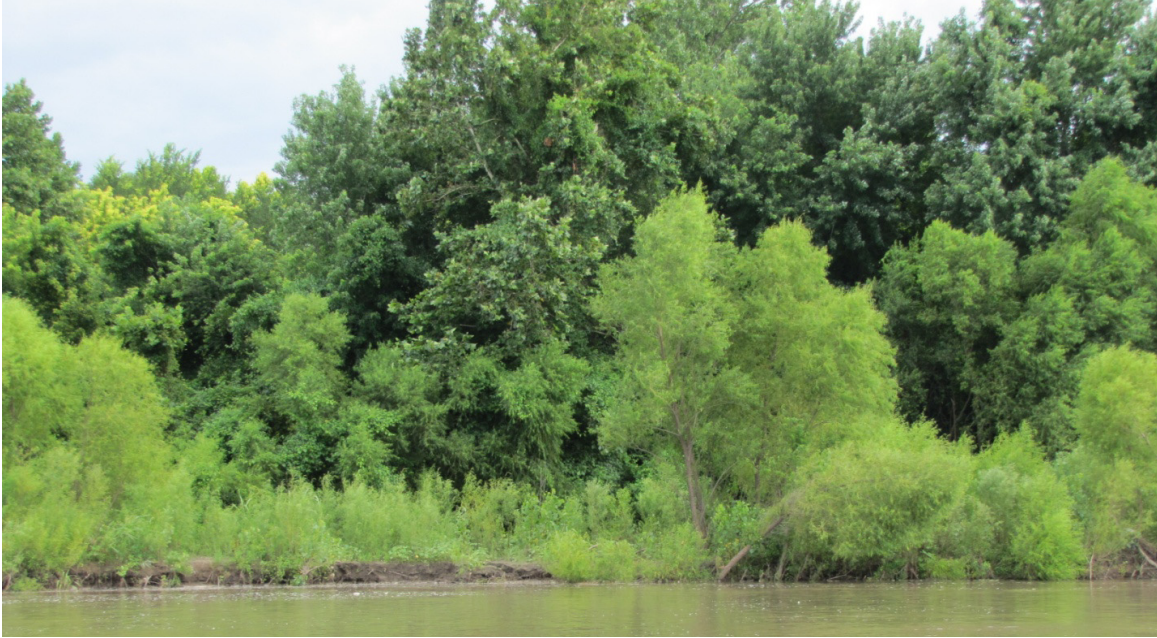
**Figure 3. 8. Accreted Land. RM 94.8.**

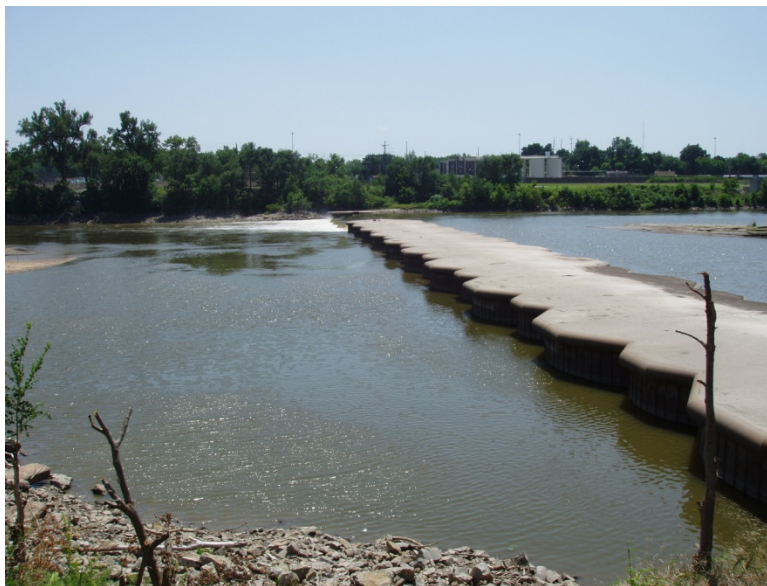
**Figure 3. 9. The weir downstream of the Topeka water intake. Flow = 2,080 cfs.**

The Topeka Weir at RM 87 is a substantial structure on the Kansas River. It provides sufficient depth for the Topeka water intake and serves as a grade control structure. The weir was submerged on the day of the reconnaissance with a flow of approximately 18,400 cfs. Figure 3. 9 shows the weir with a flow of 2,080 cfs.

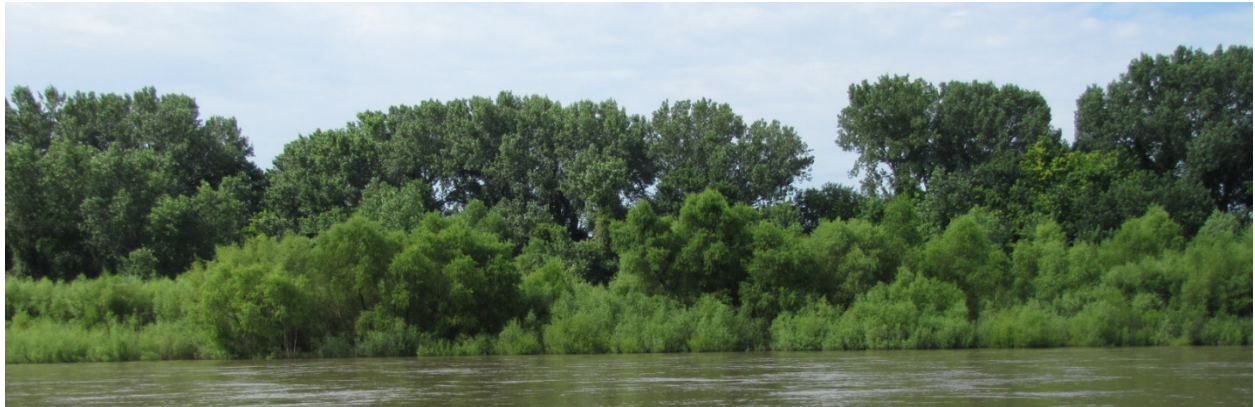
Conventional geomorphic theory would assume that an urban stream downstream from a weir with little to no floodplain and a levee for a bank would be degradational with significant bank failures. Surprisingly, this reach is highly depositional in nature. The channel has narrowed considerably from the side opposite of the levee, as seen in Figure 3. 10.

**Figure 3. 10. Newly accreted land across from a levee. RM 86.3.**

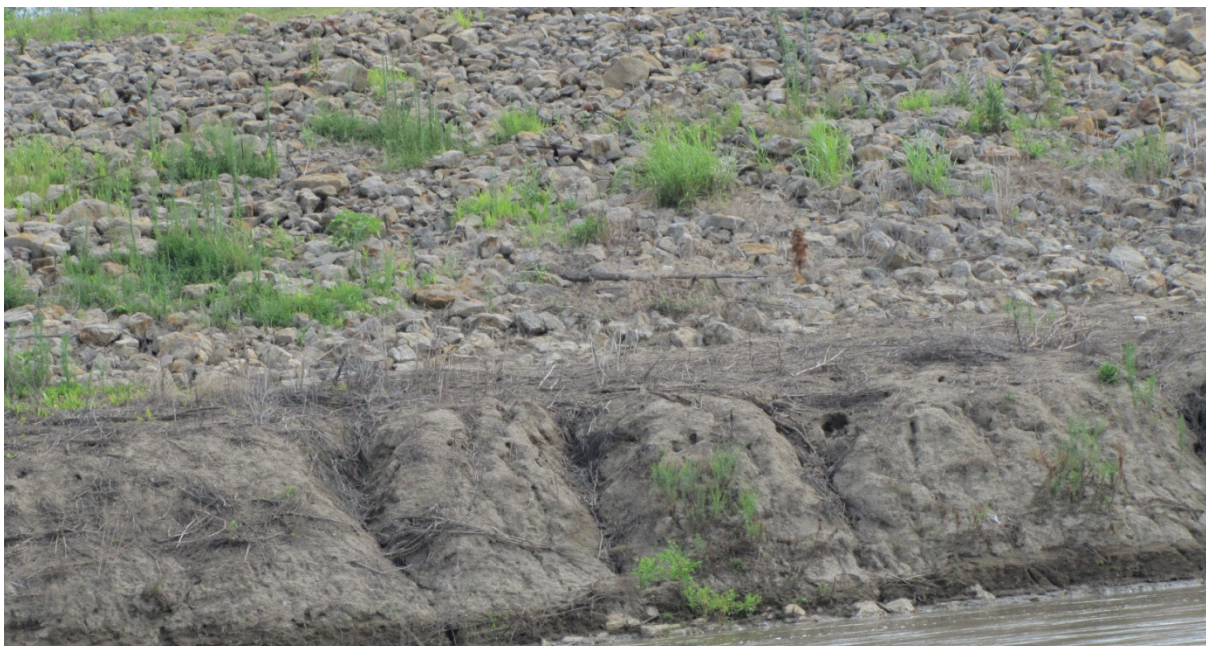
**Figure 3. 11. Deposition and land accretion adjacent to a levee. RM 85.8.**

Shortly downstream, there is significant deposition on the levee (Figure 3. 11). This continues for a several miles.

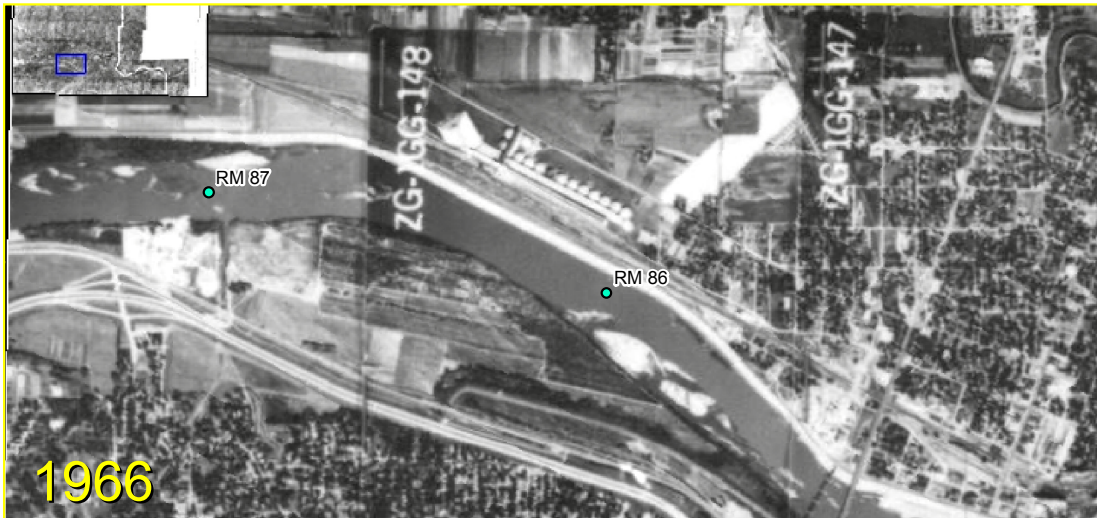
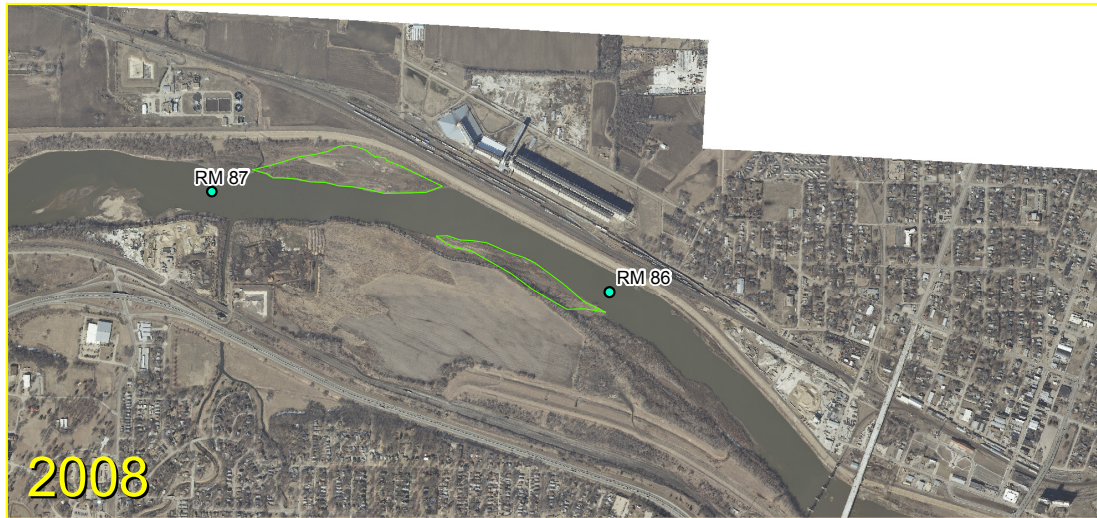
New land since 1966

**Figure 3. 12. Accretion from 1966 to 2009.**

A comparison of aerial photographs from 1966 to 2008 shows overall land accretion in this area (Figure 3. 12).

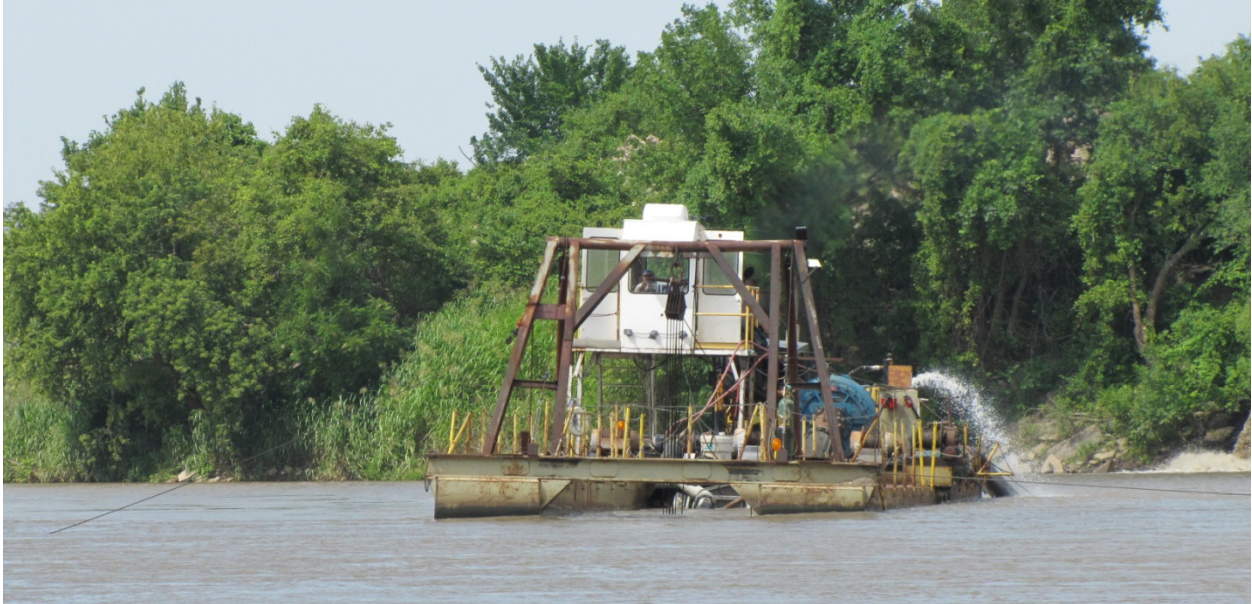
**Figure 3. 13. Active dredging at RM 78.4.**

There have been four authorized dredging reaches in SLA Reach 6 during the years 1999 - 2009. As of 2009 three have been discontinued, leaving only one authorized dredging reach near Topeka. One dredge was present on the day of the reconnaissance (Figure 3. 13). There were no visible differences at the dredging site in terms of height of bank, bank erosion, or land accretion compared to adjacent reaches. Differences in bed form could not be assessed because of the high water level.

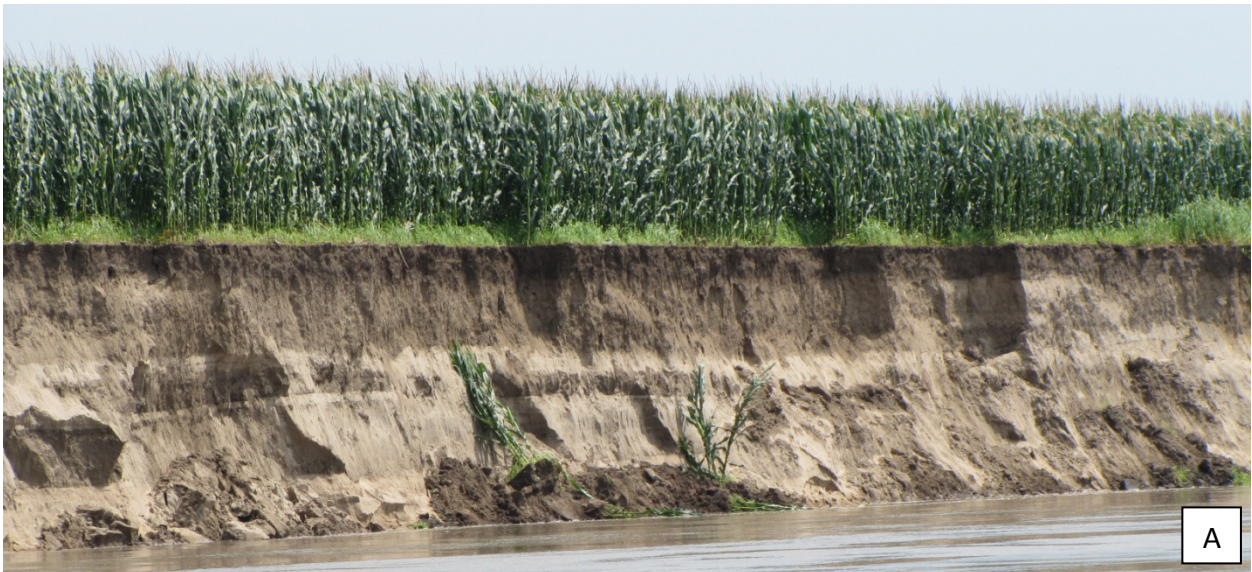
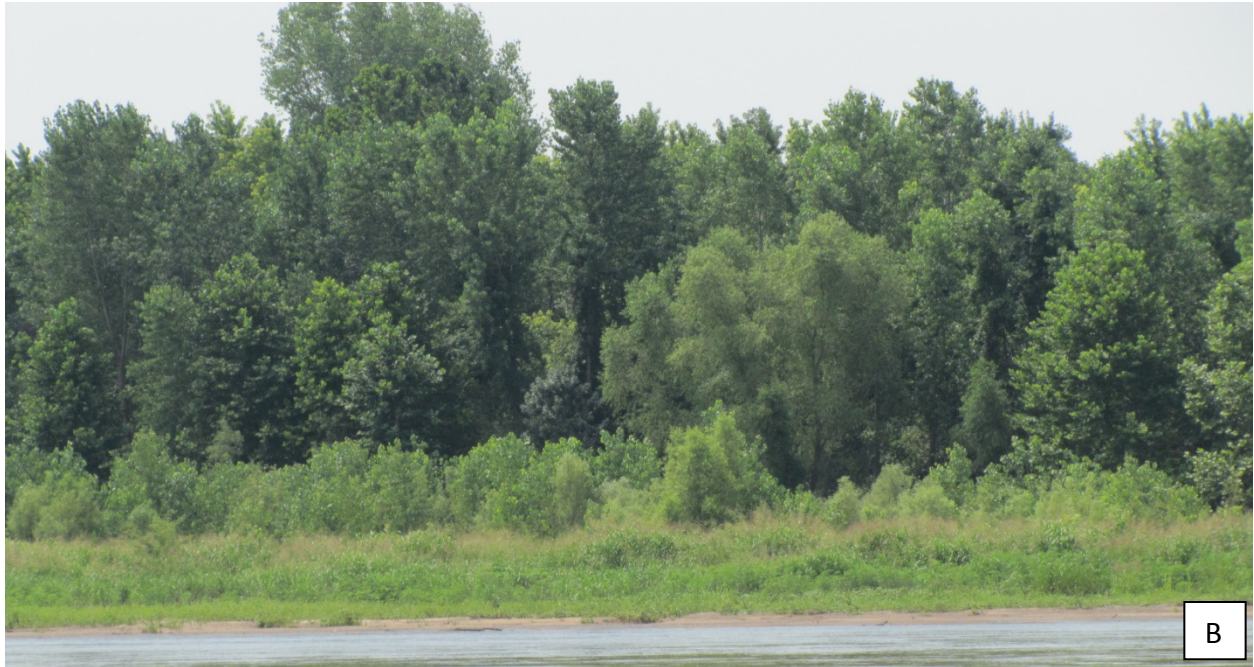
SLA Reach 5 runs from Bowersock Dam at RM 51.7 to RM 76. A small stretch from RM 71 to RM 74 is cutting on the outside banks and depositing on the inside banks (Figure 3. 14). Dort (2009) shows that this cutting and accreting from RM 71 to 74 has caused a slight increase in sinuosity since 1971, as shown in Figure 3. 15.

Figure 3. 14. Cutting outside bank (A) and accreting inside bank (B). RM 74.1.

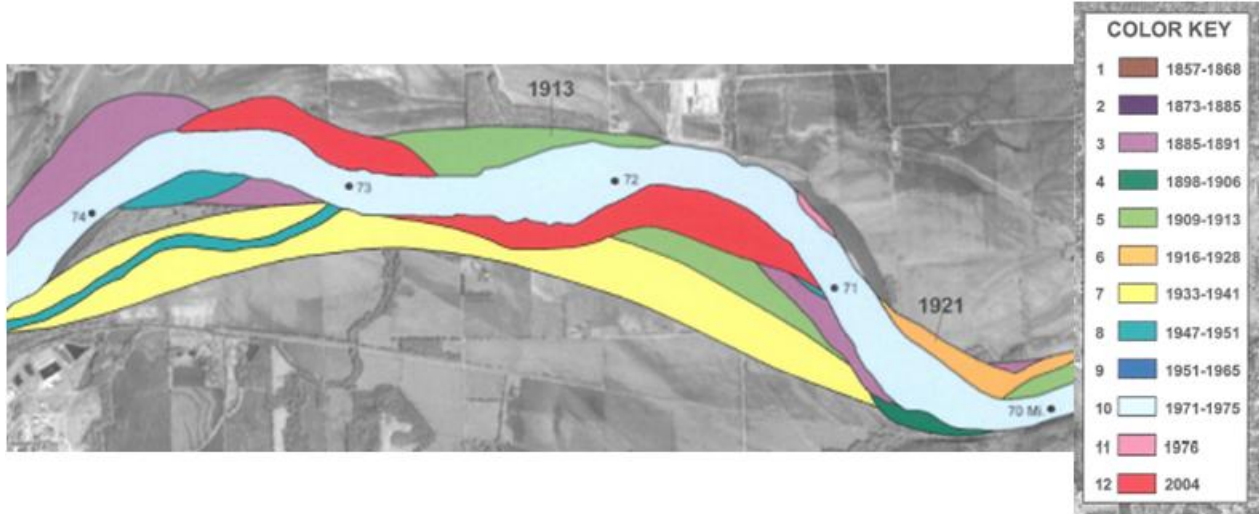
Figure 3. 15. Planform Changes. RM 70-74.

From Dort (2009). Where the dark red is obscured by the light blue, the 2004 channel follows the 1975 channel.

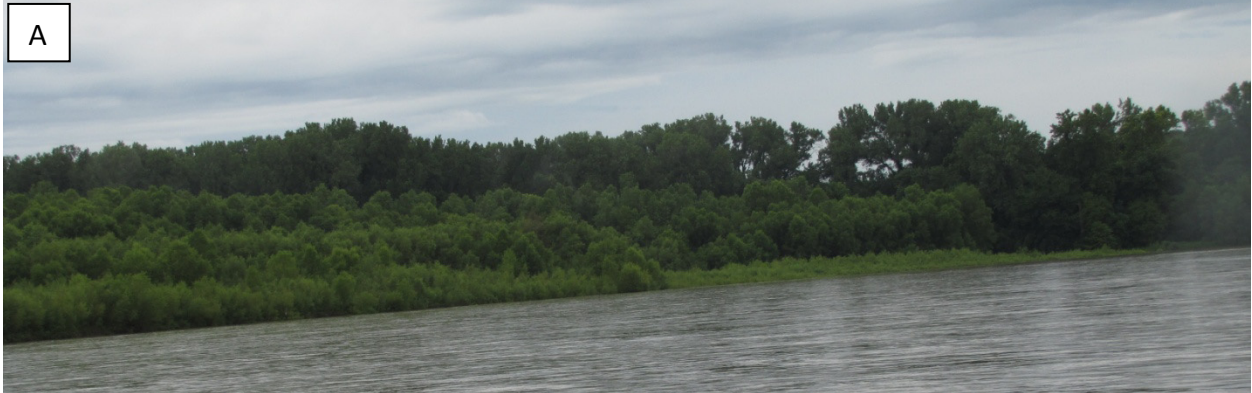
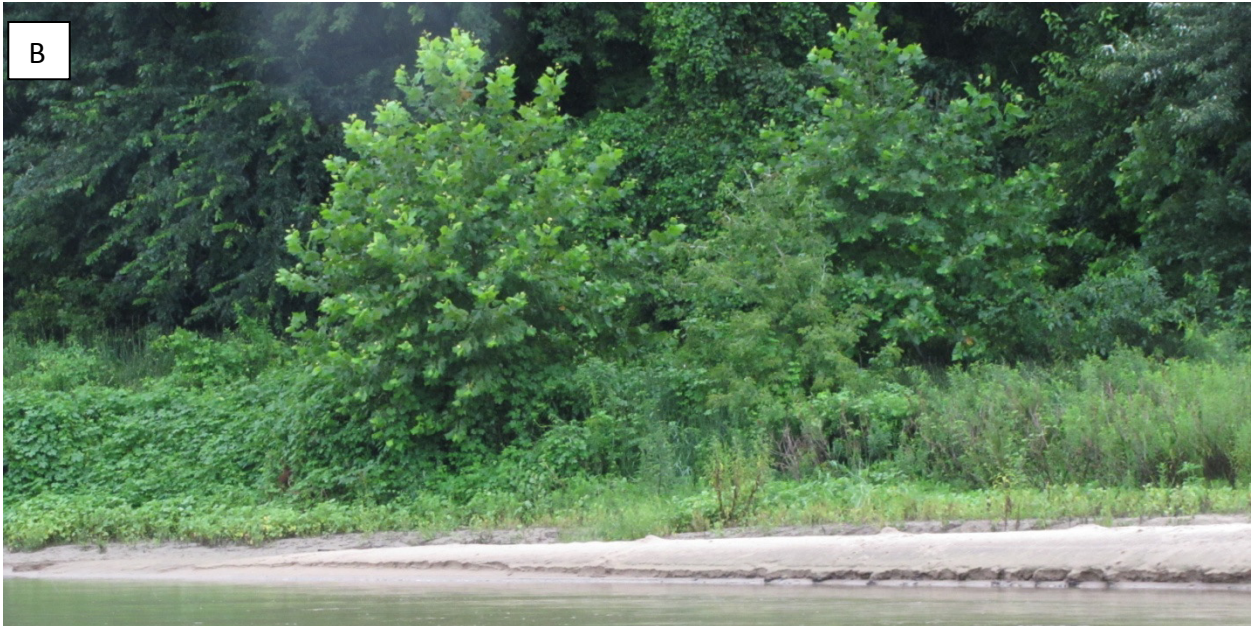
SLA Reach 4 runs from RM 21.5 to RM Bowersock Dam at RM 51.8. Reach 4 includes 8 authorized dredging reaches. While eroding banks do occur in this reach on some outside bends, in most places, the channel is narrowing through accretion, rather than widening through bank failures, as seen in Figure 3. 17.

**Figure 3. 17. Accretion on the left bank (A) and right bank (B). RM 47.6.**

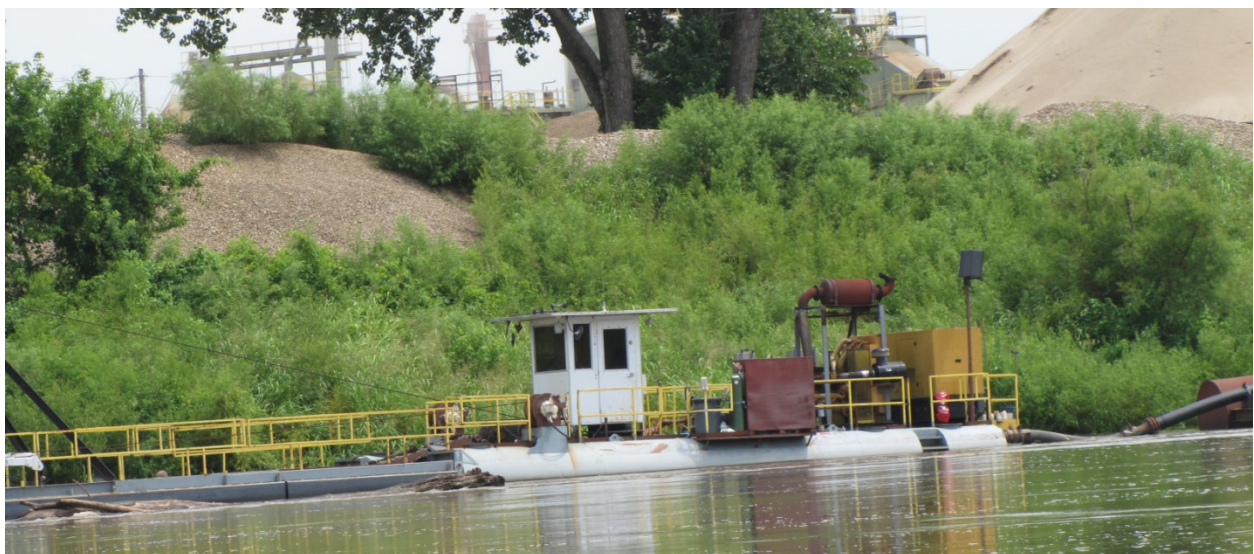
**Figure 3. 19. Dredge. RM 15.9.**

SLA Reach 3 extends from the Johnson County Water One weir at RM 15 to RM 21.5 and includes four authorized dredging reaches. Like SLA Reach 4, this reach is mostly accretional in nature. The bank (not shown) opposite to the dredge shown in Figure 3. 19 was accreting.

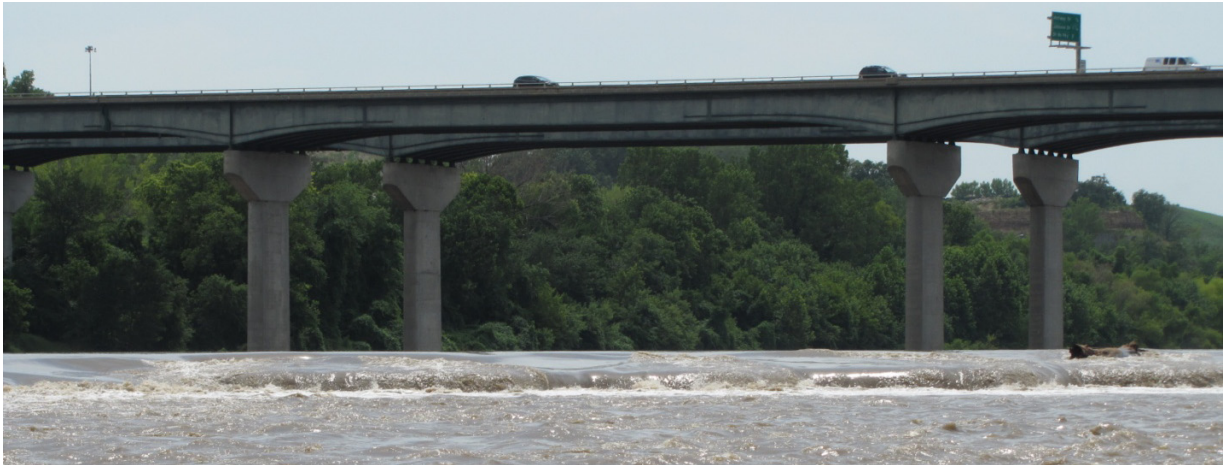
**Figure 3. 20. Johnson County Water One Weir.**

The Johnson County Water One weir was constructed in 1967 to provide sufficient water depth to the Johnson County Water District No. 1 intake. The weir prevents downstream headcuts from migrating upstream. The weir was submerged on the day of the reconnaissance, as seen in Figure 3. 20.

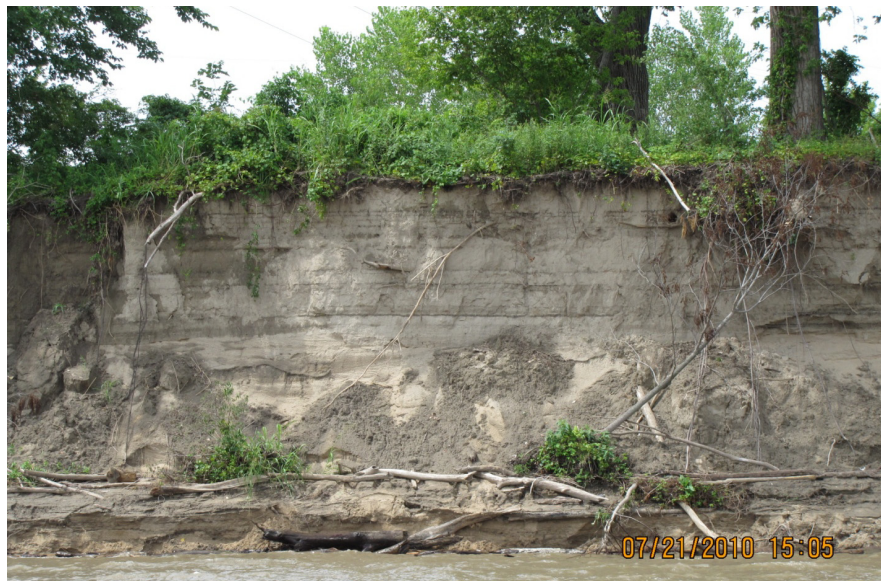
**Figure 3. 21. Vertical eroding bank just downstream of the Johnson County Water One Weir.**

SLA Reach 2 extends from RM 12.2 to the Johnson County Water One weir at RM 15 and includes one authorized dredging reach. Shortly downstream from the Johnson County Water One weir is a very high, vertical, eroding bank (Figure 3. 21). The rest of the reach has more gently sloped, non-eroding banks. The channel downstream of the Johnson County Water One weir is noticeably narrower than upstream of the weir.

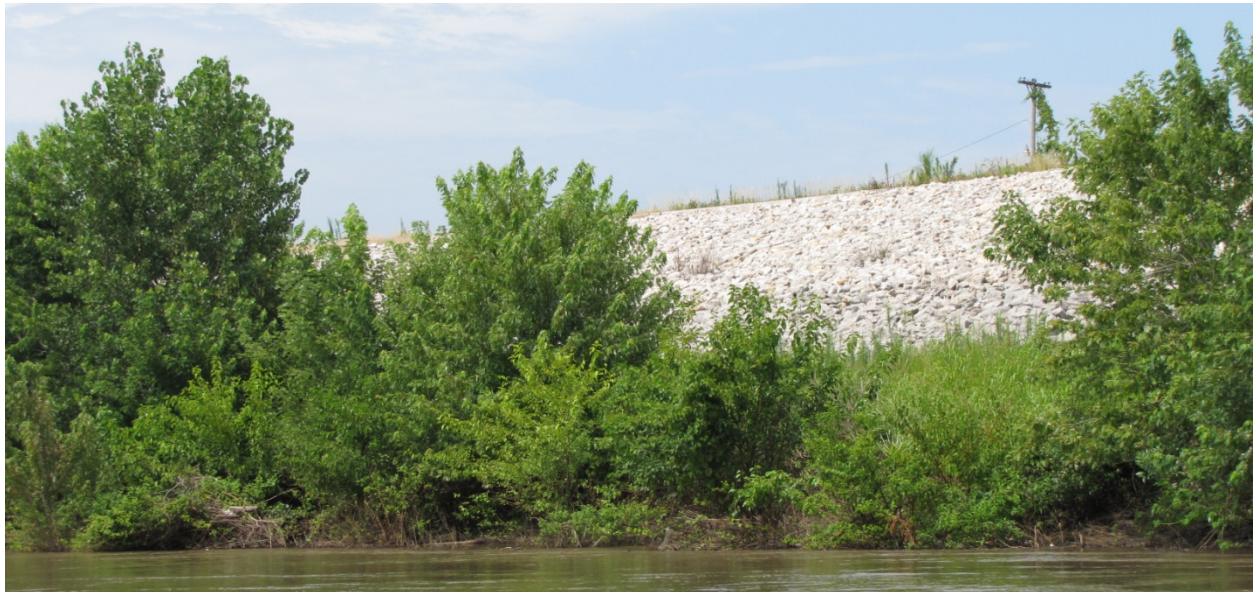
**Figure 3. 22. Land accretion inside of a riprap embankment**

SLA Reach 1 consists of the most downstream 12.2 miles of the Kansas River. The river is very narrow and has no floodplain throughout this reach. In many places, low, vegetated banks have formed on the inside of riprap embankments and floodwalls (Figure 3. 22). Backwater from the Missouri River controls the hydraulics of this reach.

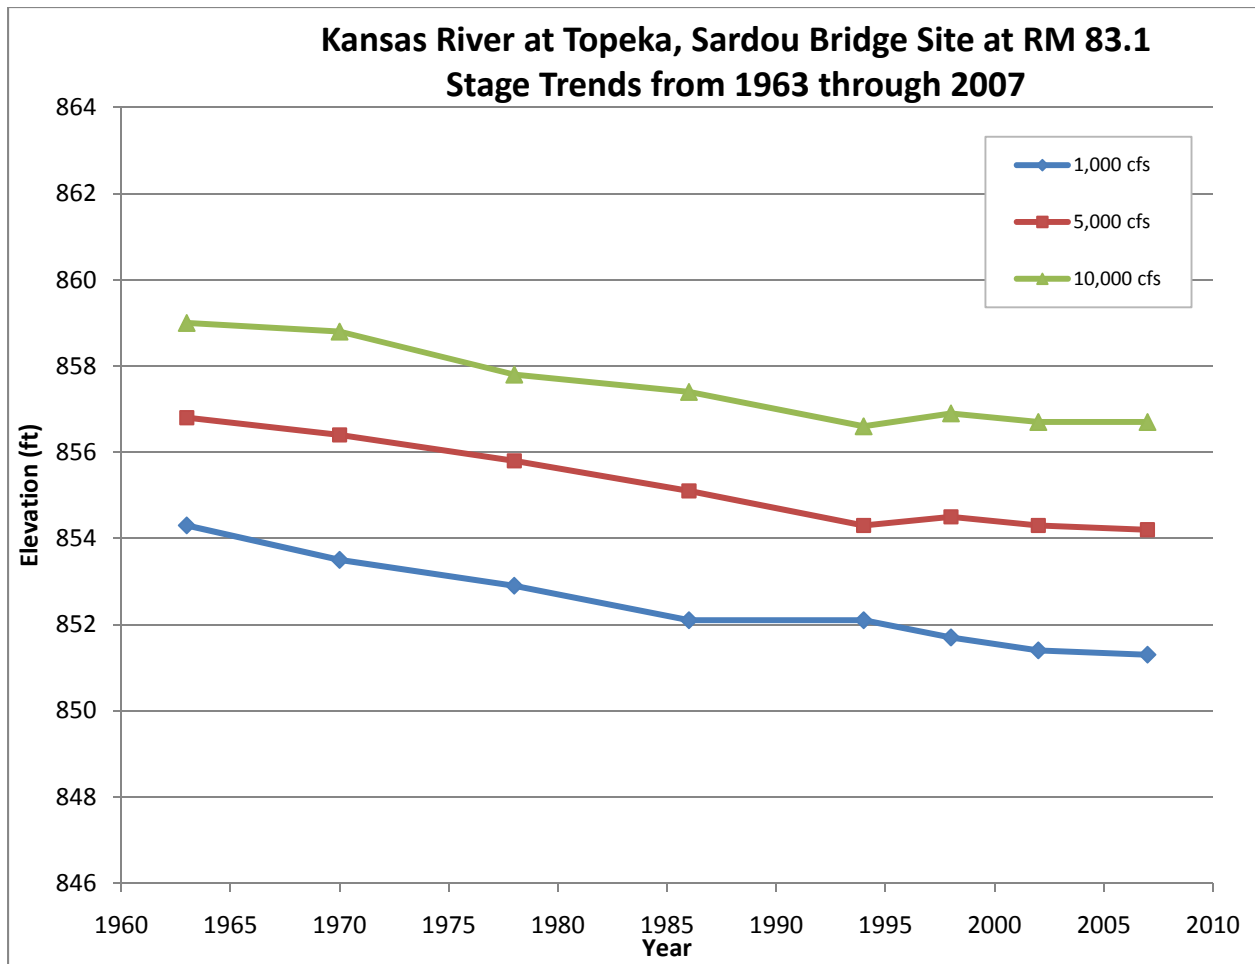
Figure 3. 28 shows the change in stage with time from 1961 to the present. The decrease in stage is gradual, making it difficult to determine whether the stage is still dropping or has stabilized.

**Figure 3. 28. Change in stage with time at Topeka**
