**US Army Corps  
of Engineers**  
Kansas City District

# Hydrologic and Geomorphic Changes on the Kansas River

September 2010

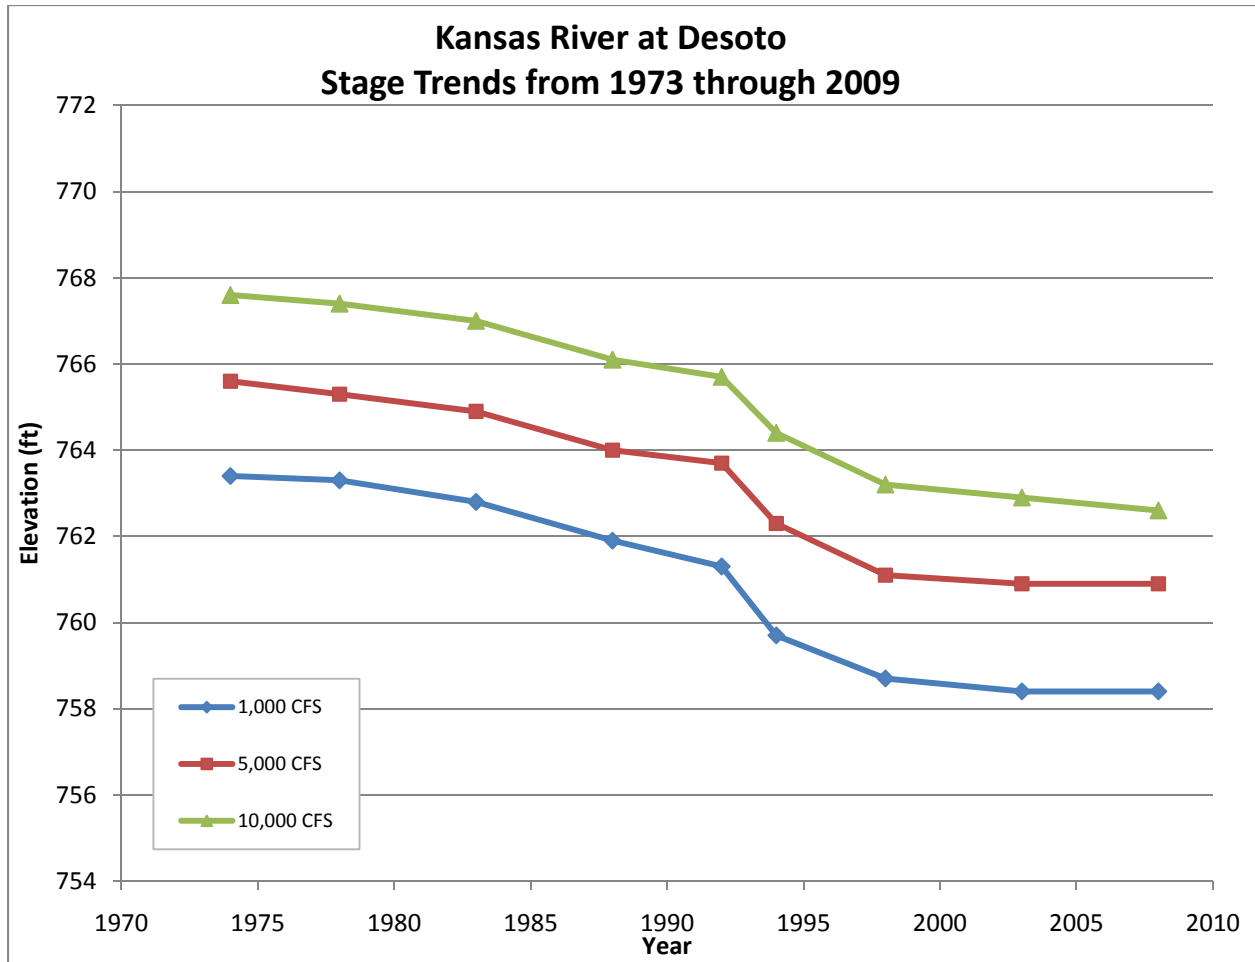
Figure 3.31 presents the stage-discharge measurements for the Kansas River at Desoto. The plot shows a steady decrease in stage from 1972-1993 (pre-flood) totaling 2 ft. The flood of 1993 resulted in a rapid 1 – 1.5 ft drop in stage. An additional 1 ft decrease occurs from 1993 to 2000. There has been no significant change in stage since 2000. Figure 3.32 shows how the stage has changed with time.

**Figure 3. 32. Change in stage with time at Desoto**

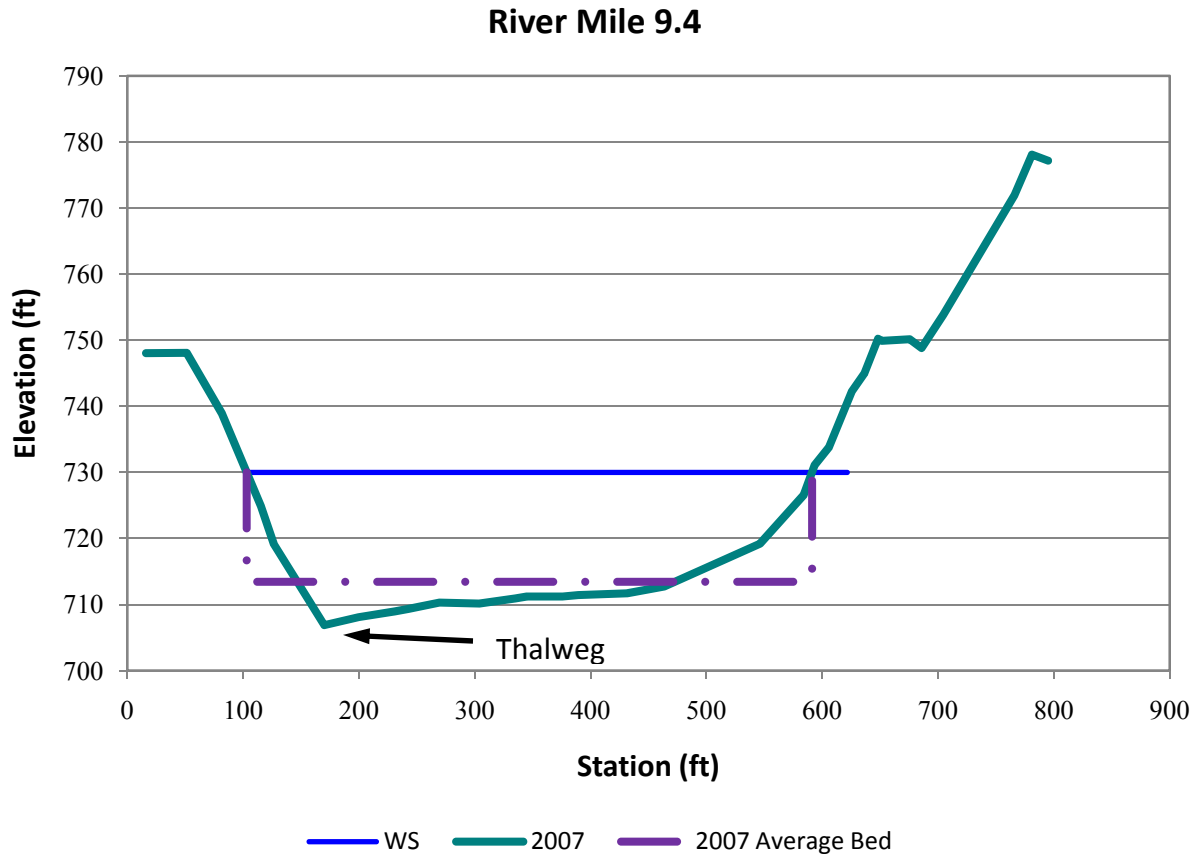
These cross-sections yield two readily available options for channel depth. The first option is based on the average bed elevation, calculated as the baseline elevation minus the hydraulic depth (cross-sectional area / top width). This provides a measure of what the entire bed is doing and is perhaps more appropriate when a limited number of cross-sections are available. The second option is based on the channel thalweg. These measurements reflect the formation of low-flow channels and are usually more variable than average bed measurements. An example of these measurements is shown in Figure 3. 33. In this report, the average bed elevation is used.

**Figure 3. 33. Average bed elevation at river mile 9.4**
