Regional Sediment Management Program

Tombigbee River: River Miles 81.0–76.0 Sediment Management Study

Final report

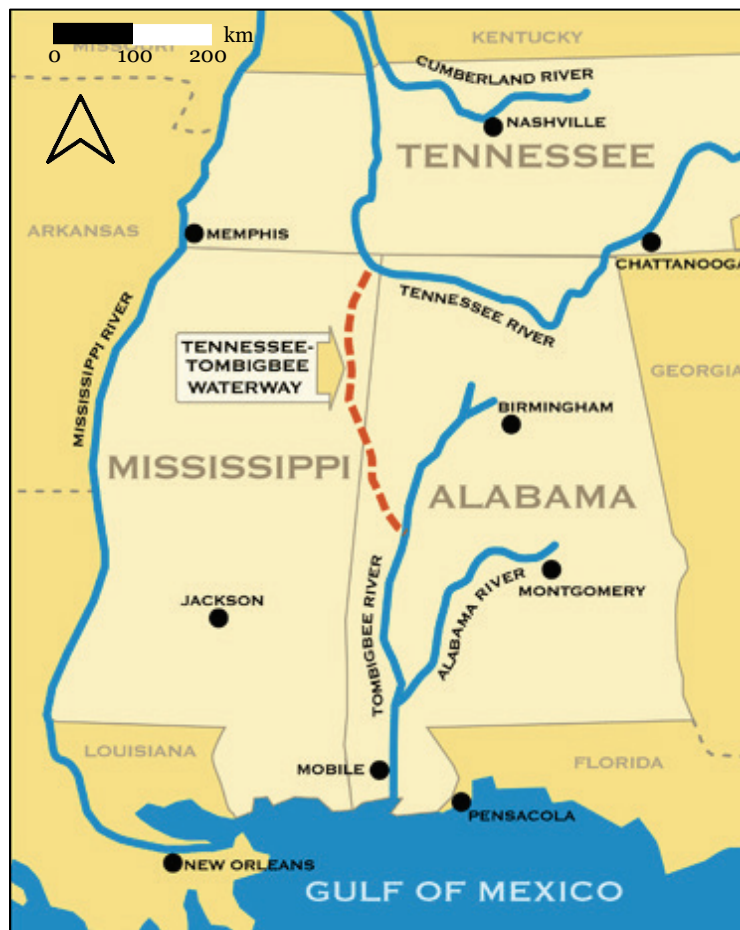
Figure 1. Tombigbee and Tennessee-Tombigbee Waterway system.

The Tombigbee River serves as a key navigation artery of the Inland Marine Transportation System. The river is used to supply coal and other products to communities along the river including the major city of Mobile, AL. Coal is transported from the Ohio and Tennessee River Valleys via the Tennessee-Tombigbee Waterway (Figure 1).

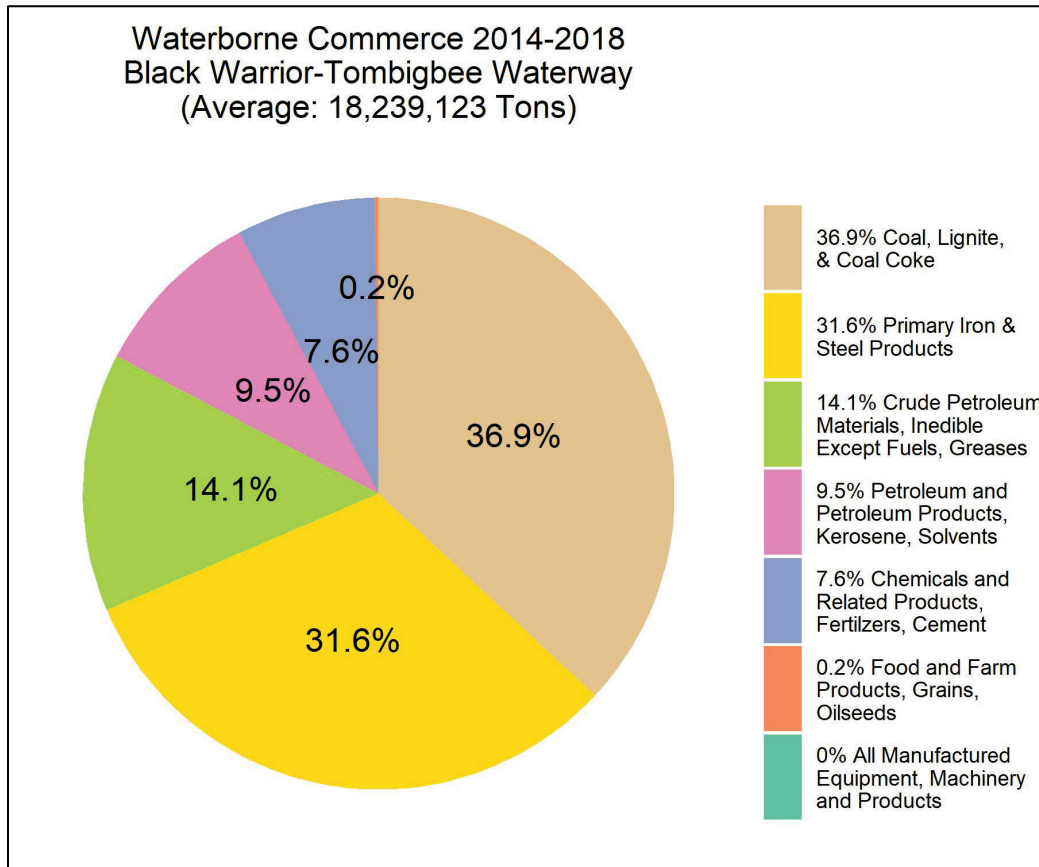
Figure 2. Tonnage on the Black Warrior-Tombigbee Waterway.

Between 2014 and 2018, tonnage on the Black Warrior-Tombigbee Waterway (Black Warrior River is the main tributary to Tombigbee River) ranged from 16.7 to 21.2 million tons per year, with an average of 18.6 million tons per year (USACE WCUS 2021). Steel, coal, petroleum, and chemical products make up the bulk of the commodities moving along the river (Figure 2).

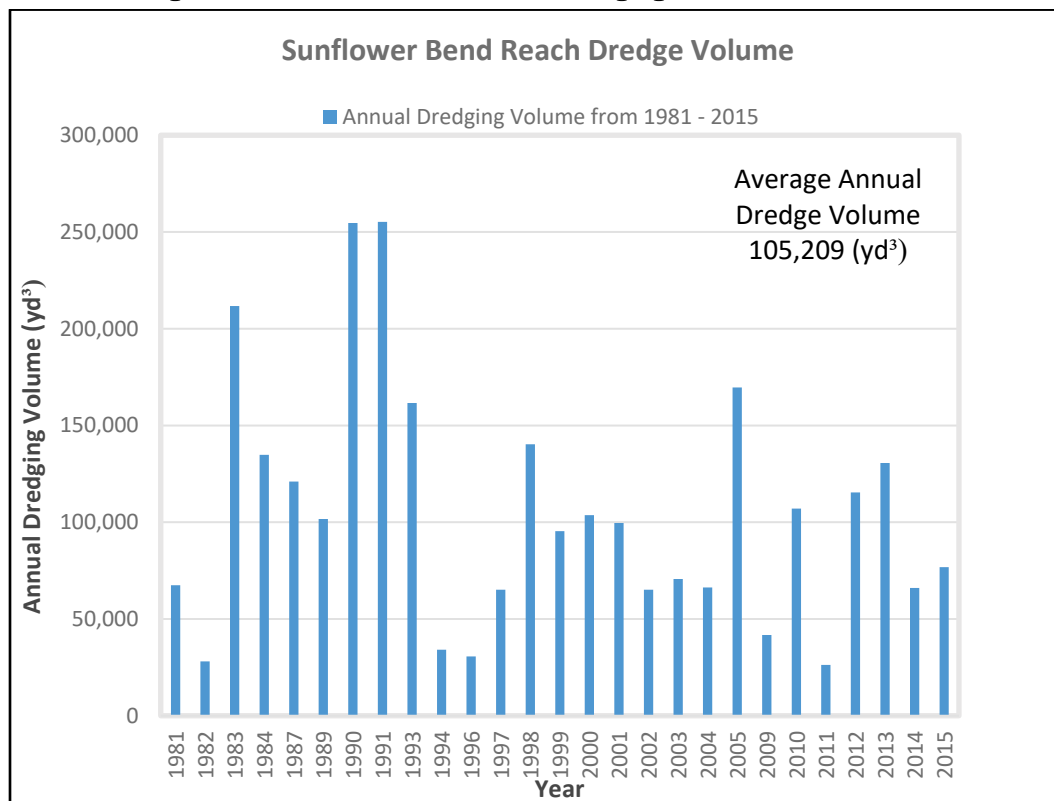
Figure 5. Sunflower Bend annual dredging volume 1981–2015.

The amount of dredging has varied over the years. Between 2011 and 2016, the average amount of material removed from the channel was 83,000 cy/yr, at an average cost of \$4.00/cy, or \$332,000 per year. Since 1981, the average volume has been approximately 105,000 cy, with two events exceeding 250,000 cy (Figure 5).

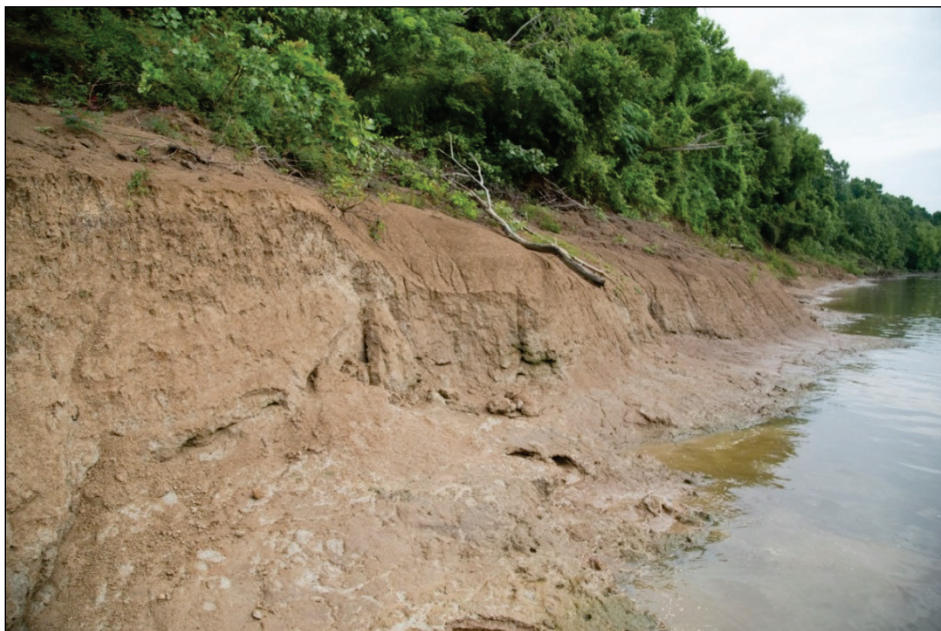
Figure 7. Silty clay banks along the Tombigbee River.

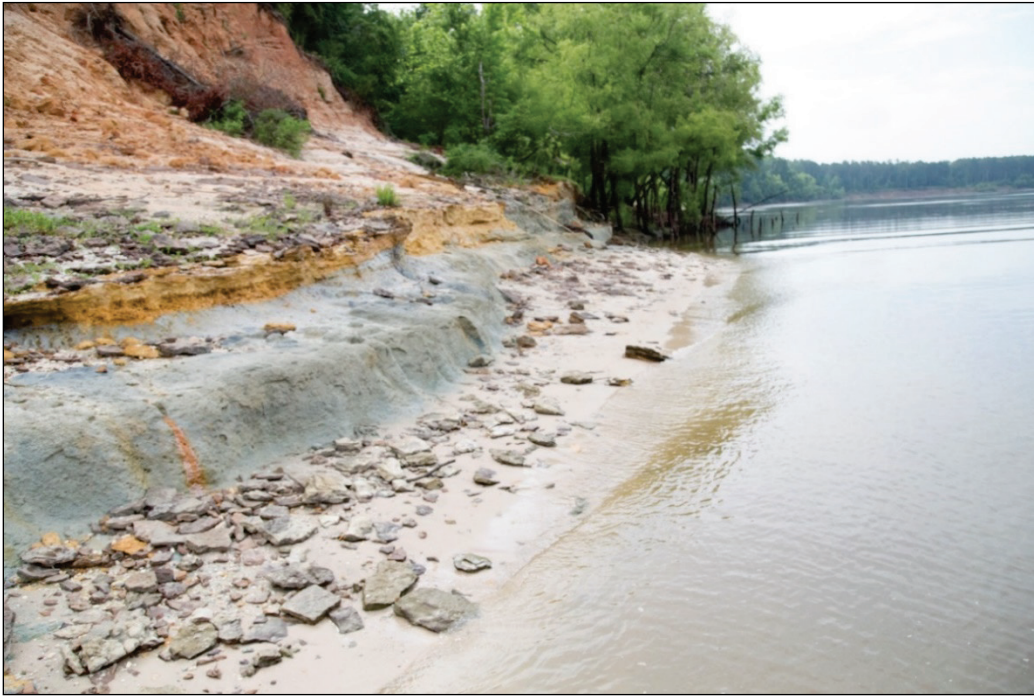
Figure 8. Heavily consolidated silts and clays along the bank of the Tombigbee River.

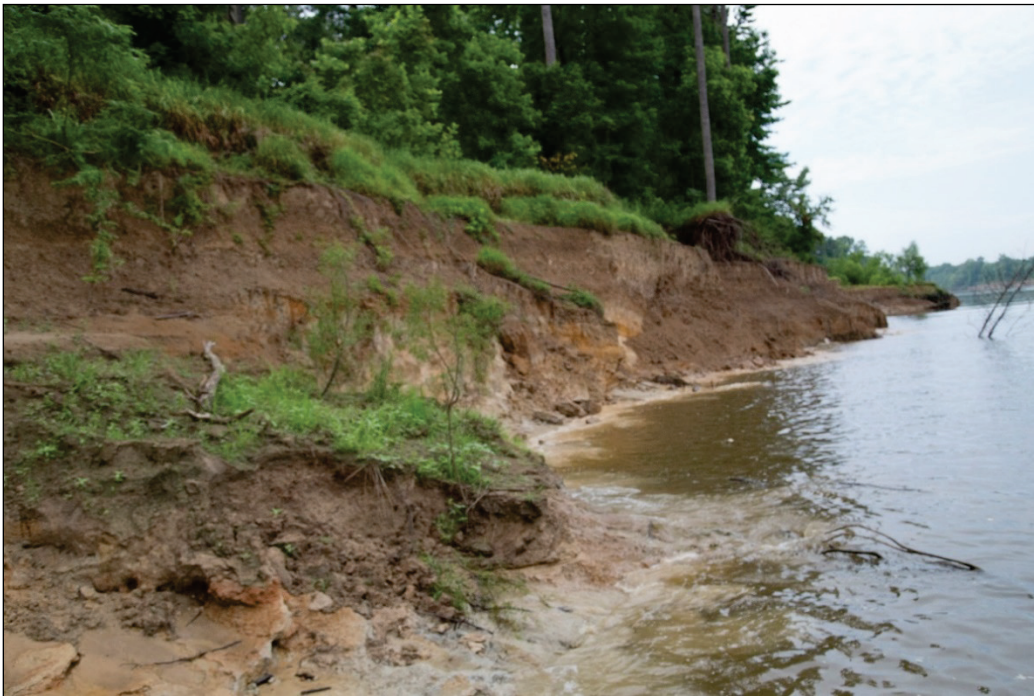
Figure 9. Active bankline erosion

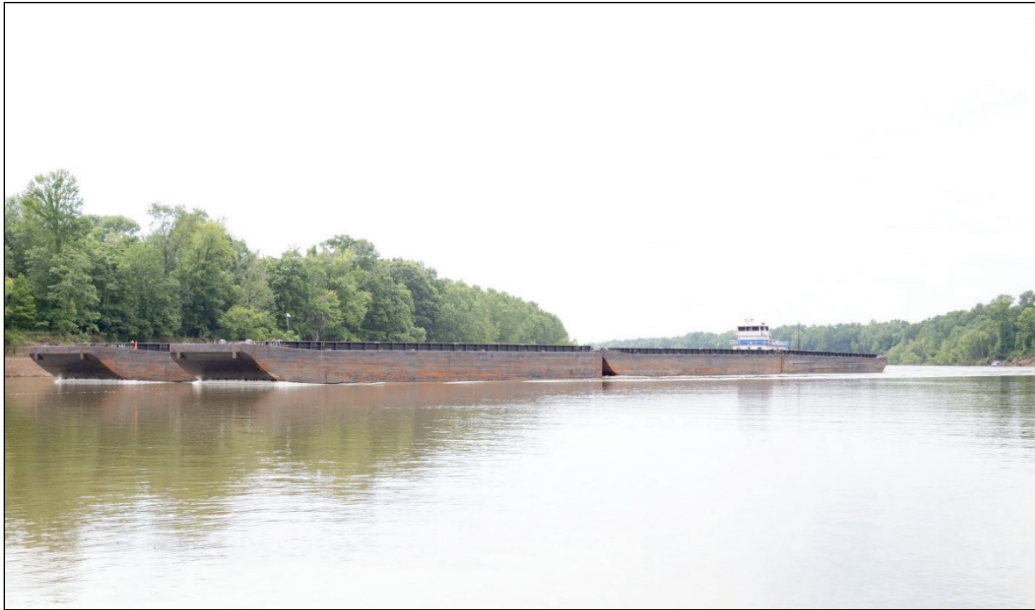
Figure 10. Towboat transporting barges on the Tombigbee River.
