Evaluation of a Permeable Dam as an Erosion Control Structure on Coca River, Ecuador

June 2023

Final Report

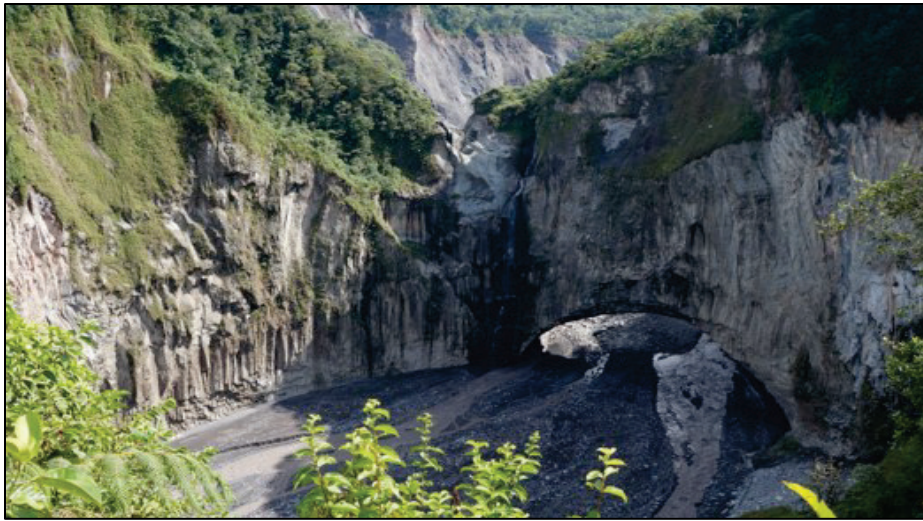
Figure 2. Piping failure conditions at the San Rafael Waterfall location (provided by US Army Corps of Engineers [USACE], Mobile District).

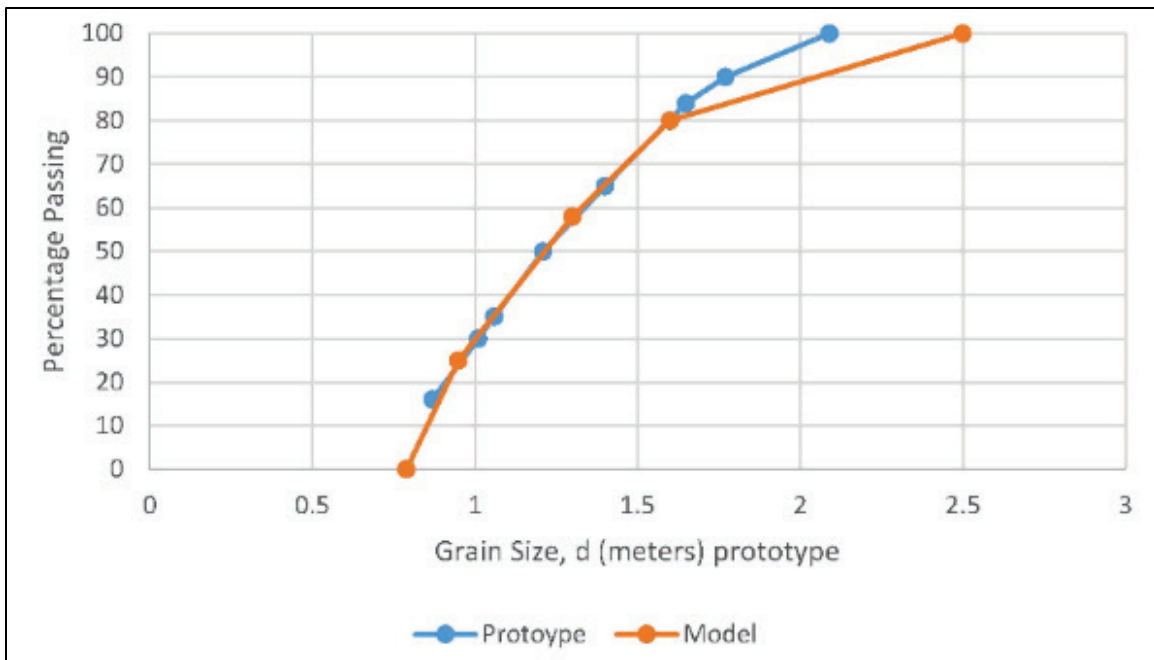
Figure 23. Gradation curves for prototype and model stone structure (prototype data provided by CELEC).

The fourth design change retained the stone structure of alternative 3 with a few modifications (Figure 22). Changes included removing the three longitudinal piles, moving the set of piles downstream of the bridge's center line by 5.65 m (prototype), and using different granulometry for the stone structure. The structure's solid core stone size was reduced from 2.7 m to 2.5 m (prototype) while using a mixture of stone sizes with D100 of 2.09 m (prototype) elsewhere (Figure 23).

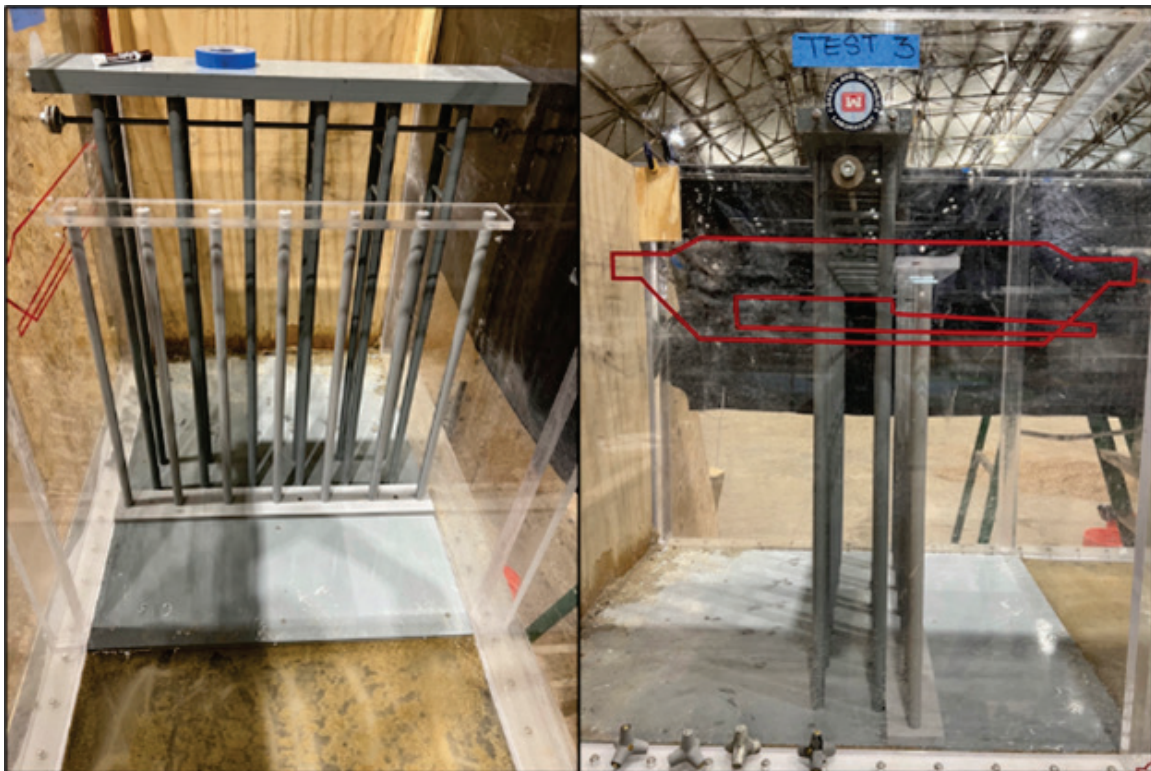
Figure 24. Placement of third row of piles downstream of bridge: front (*left*) and side (*right*) views.

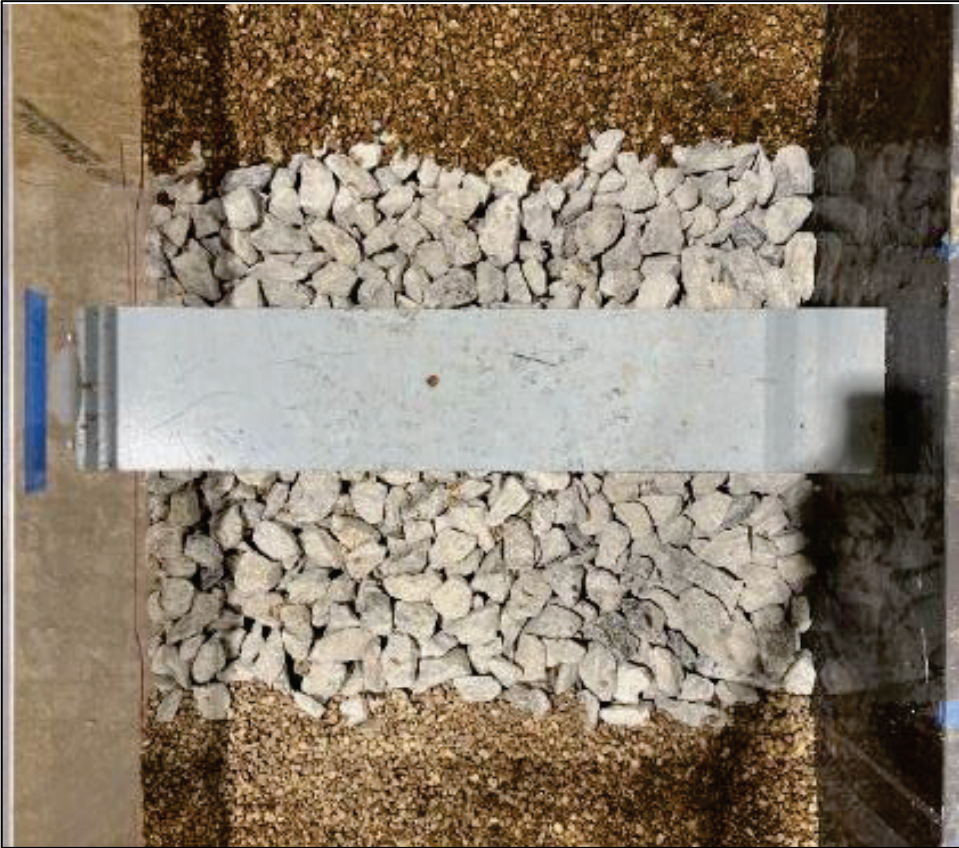
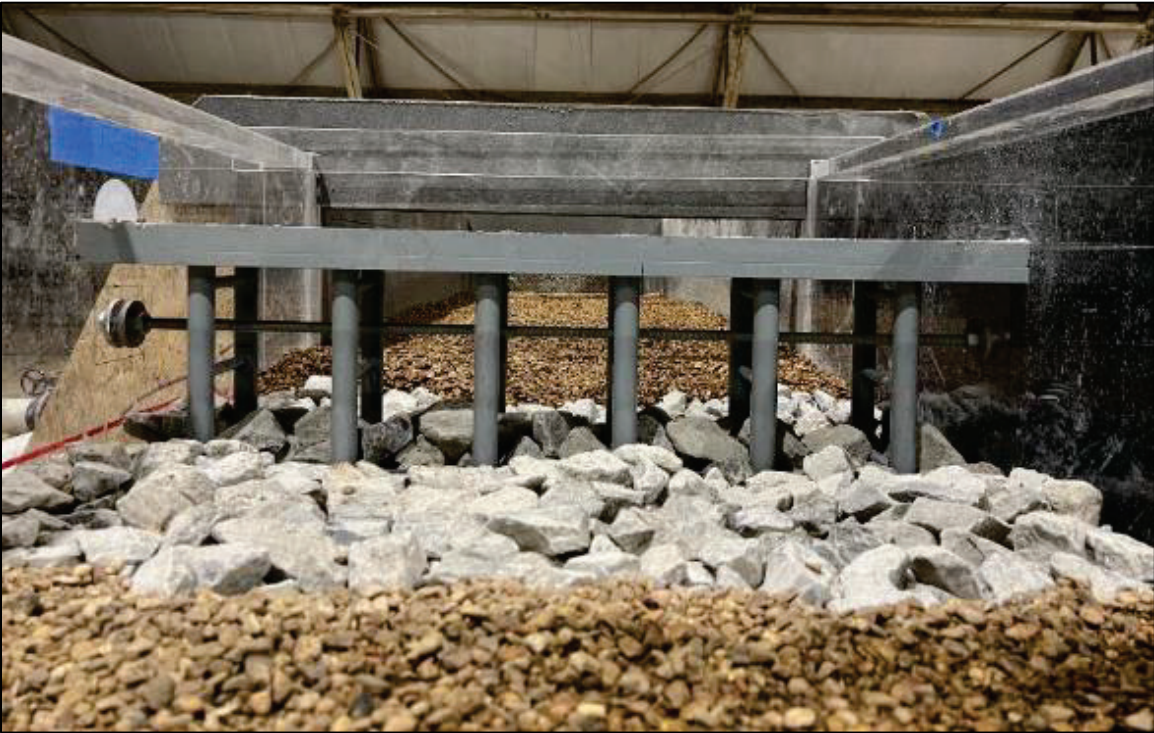
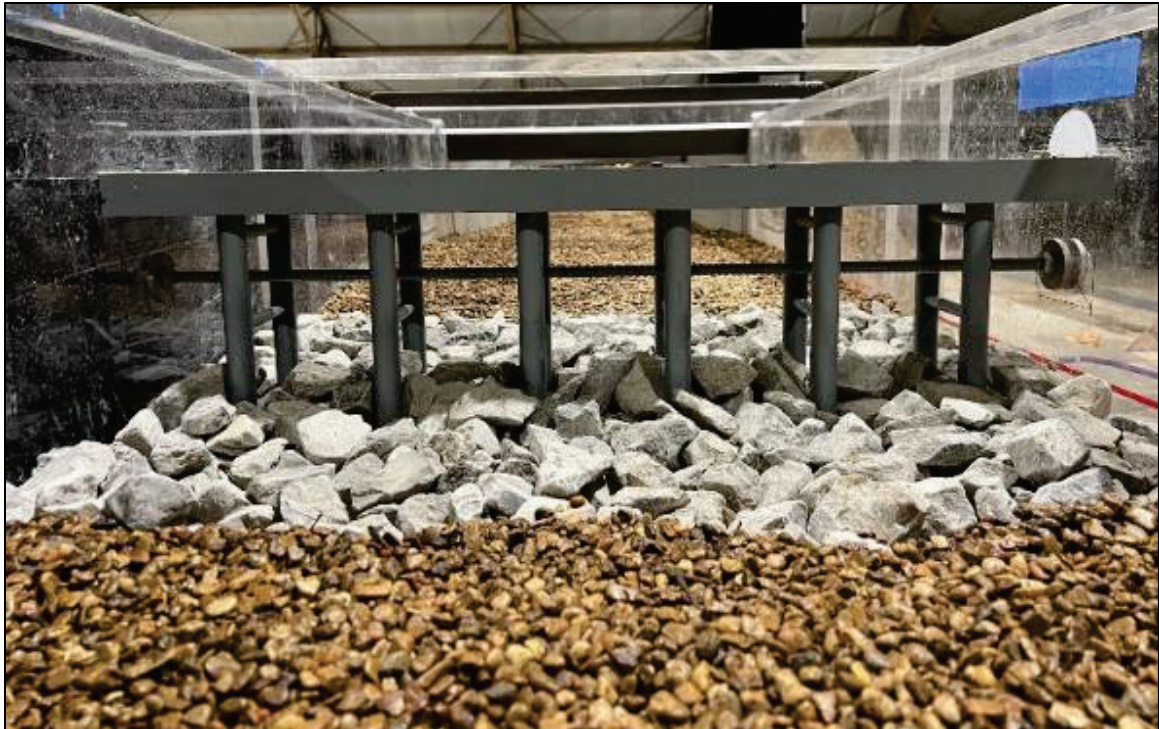
Figure 34. Side view of the model alternative 6.

Figure 35. Top view of model alternative 6.

Figure 36. Front view of model alternative 6.

Figure 37. Rear view of model alternative 6.

The sixth version of the permeable dam modified alternative 5 by (1) removing the downstream set of piles and (2) adding a sheet pile cut-off wall behind the downstream bridge columns. Model alternative 6 simulated the sheet piles with a piece of sheet metal that extended to the flume bottom (Figure 34 to Figure 37).

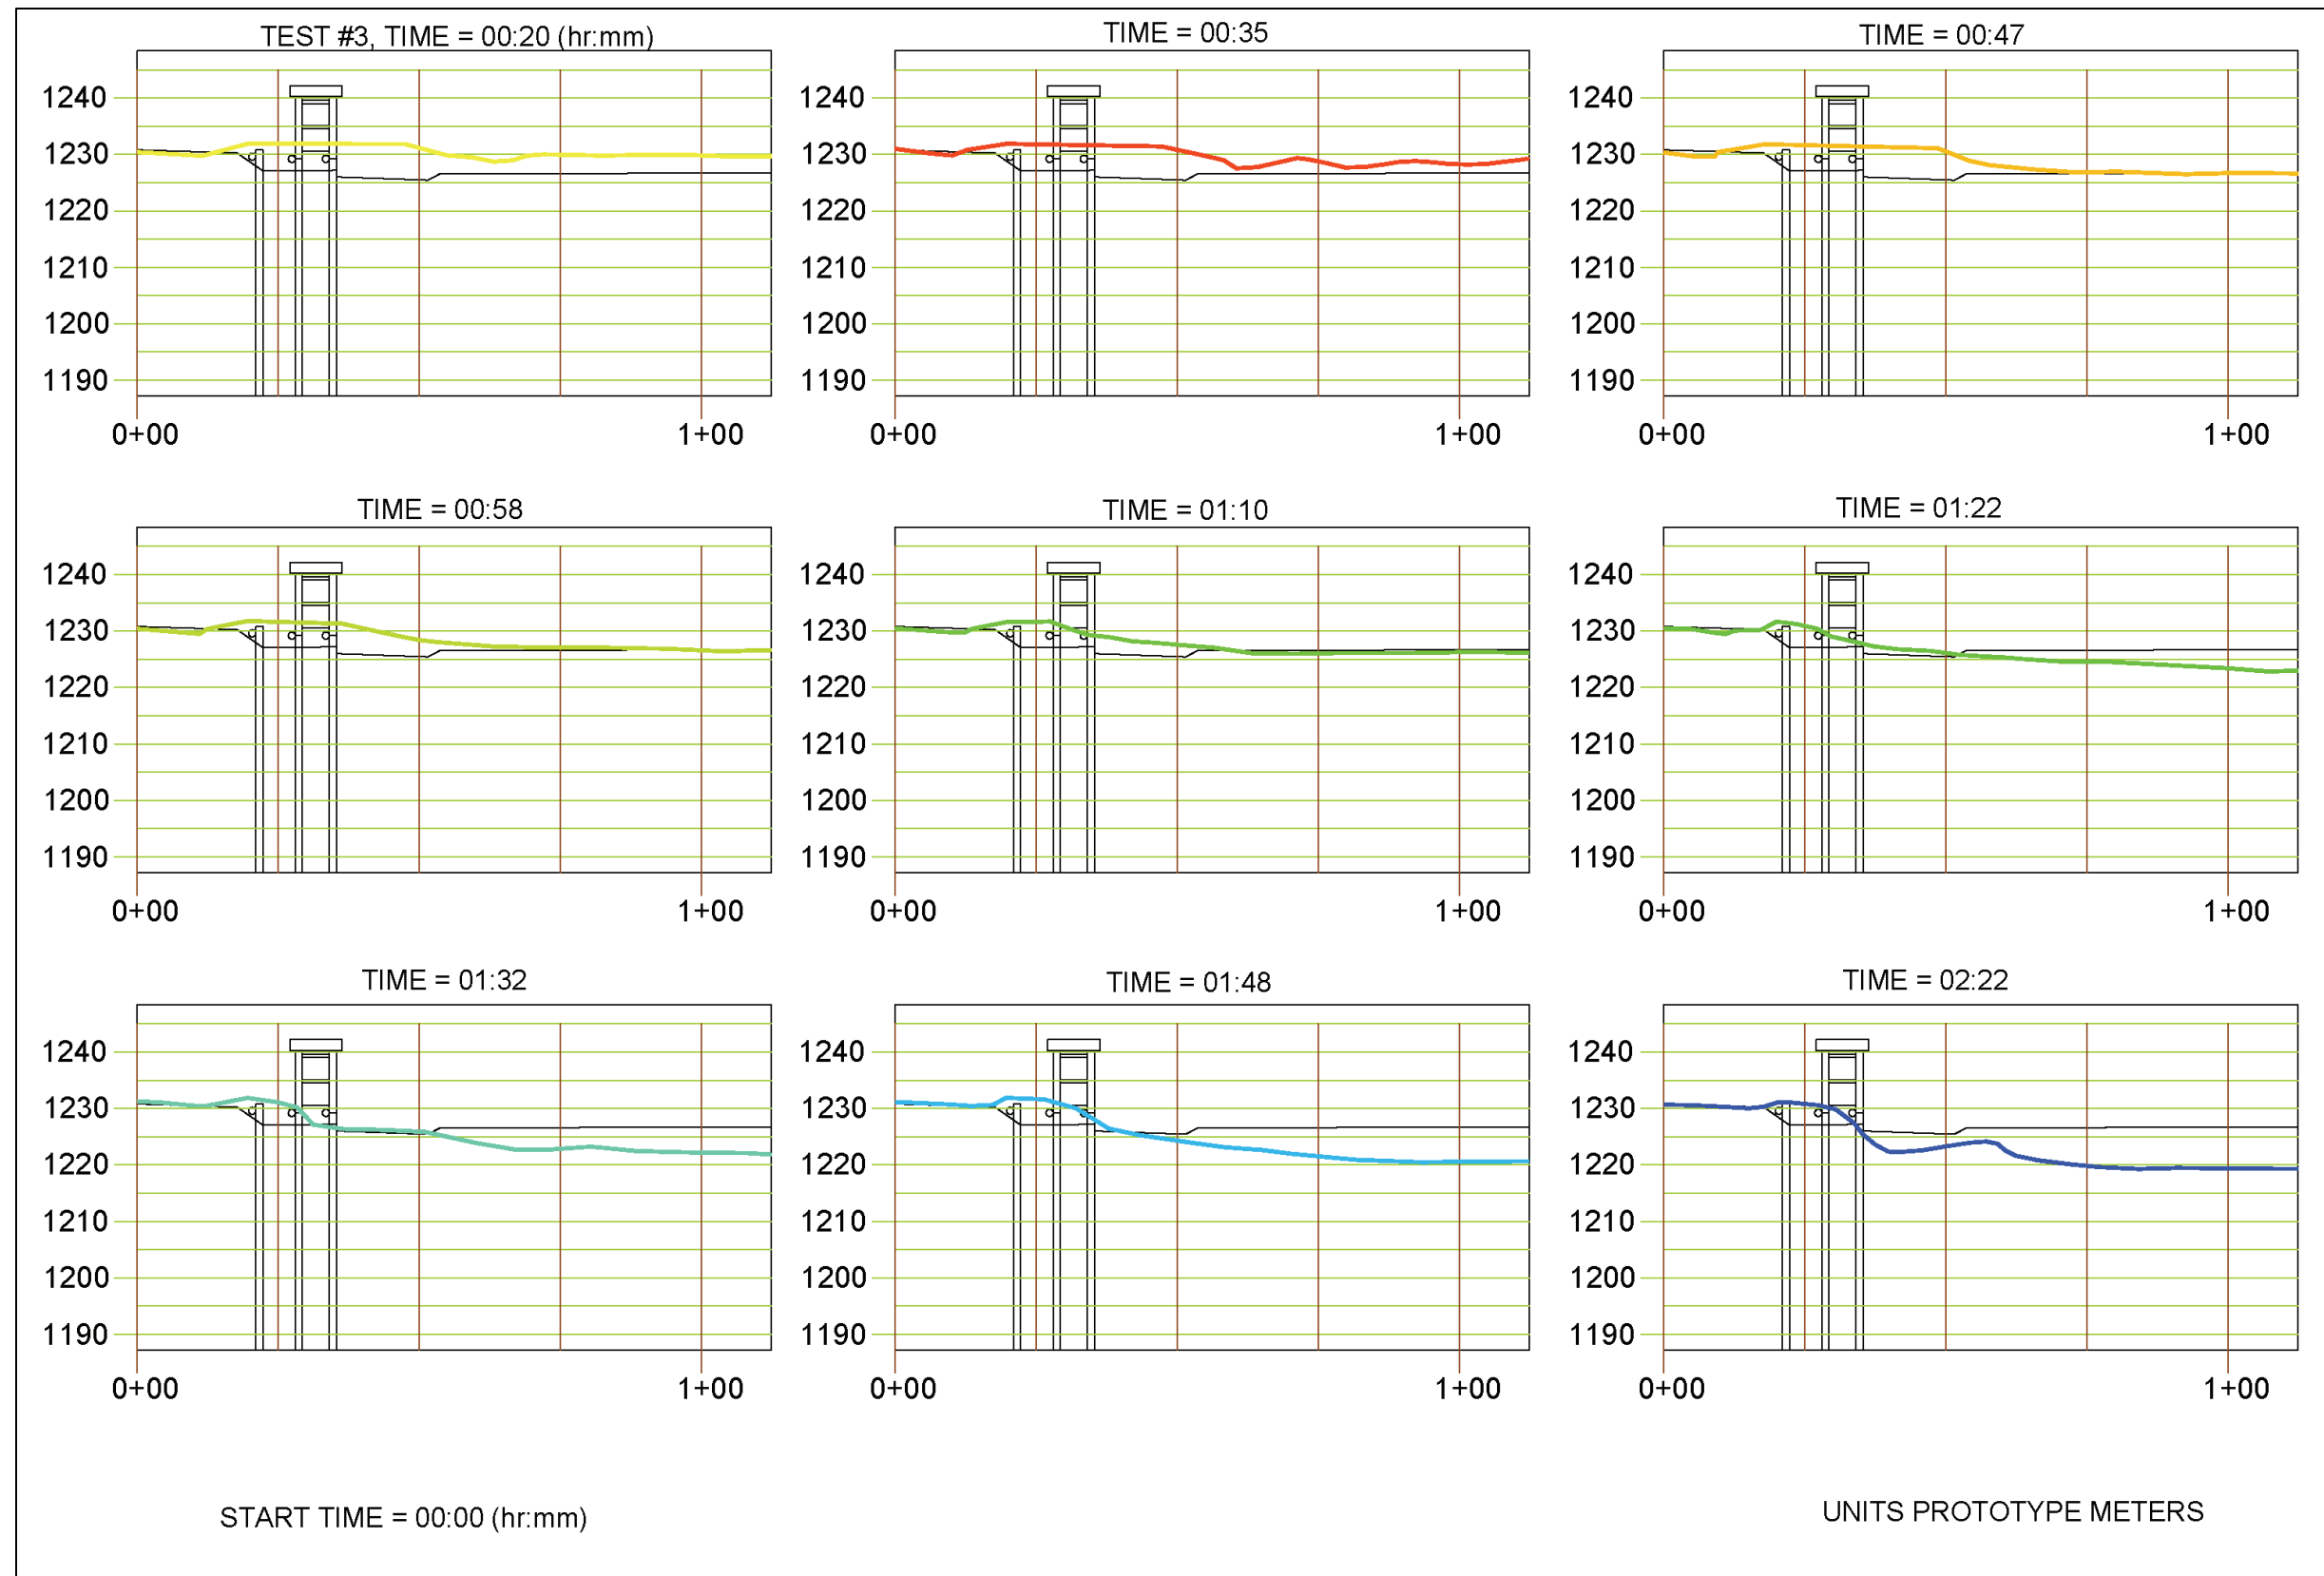
Figure 48. Scour profiles of model alternative 3.

Model alternative 3 allowed the formation of a shallow scour hole at the toe of the stone structure 13 min (model) after achieving peak flow (Figure 48). The tailgate reached the 5 m (prototype) mark 26 min (model) later, although initial rock movement was not observed until 12 min later. Visual inspection at 1.5 hr (model) into the test found most of the downstream alluvial layer eroded while stones of the permeable dam settled. About two-thirds of the stone structure collapsed after 2 hr of testing. Most debris rocks were carried downstream in the flume while some got stuck between the bridge piers. In addition, the upstream alluvial material armored the downstream bed.

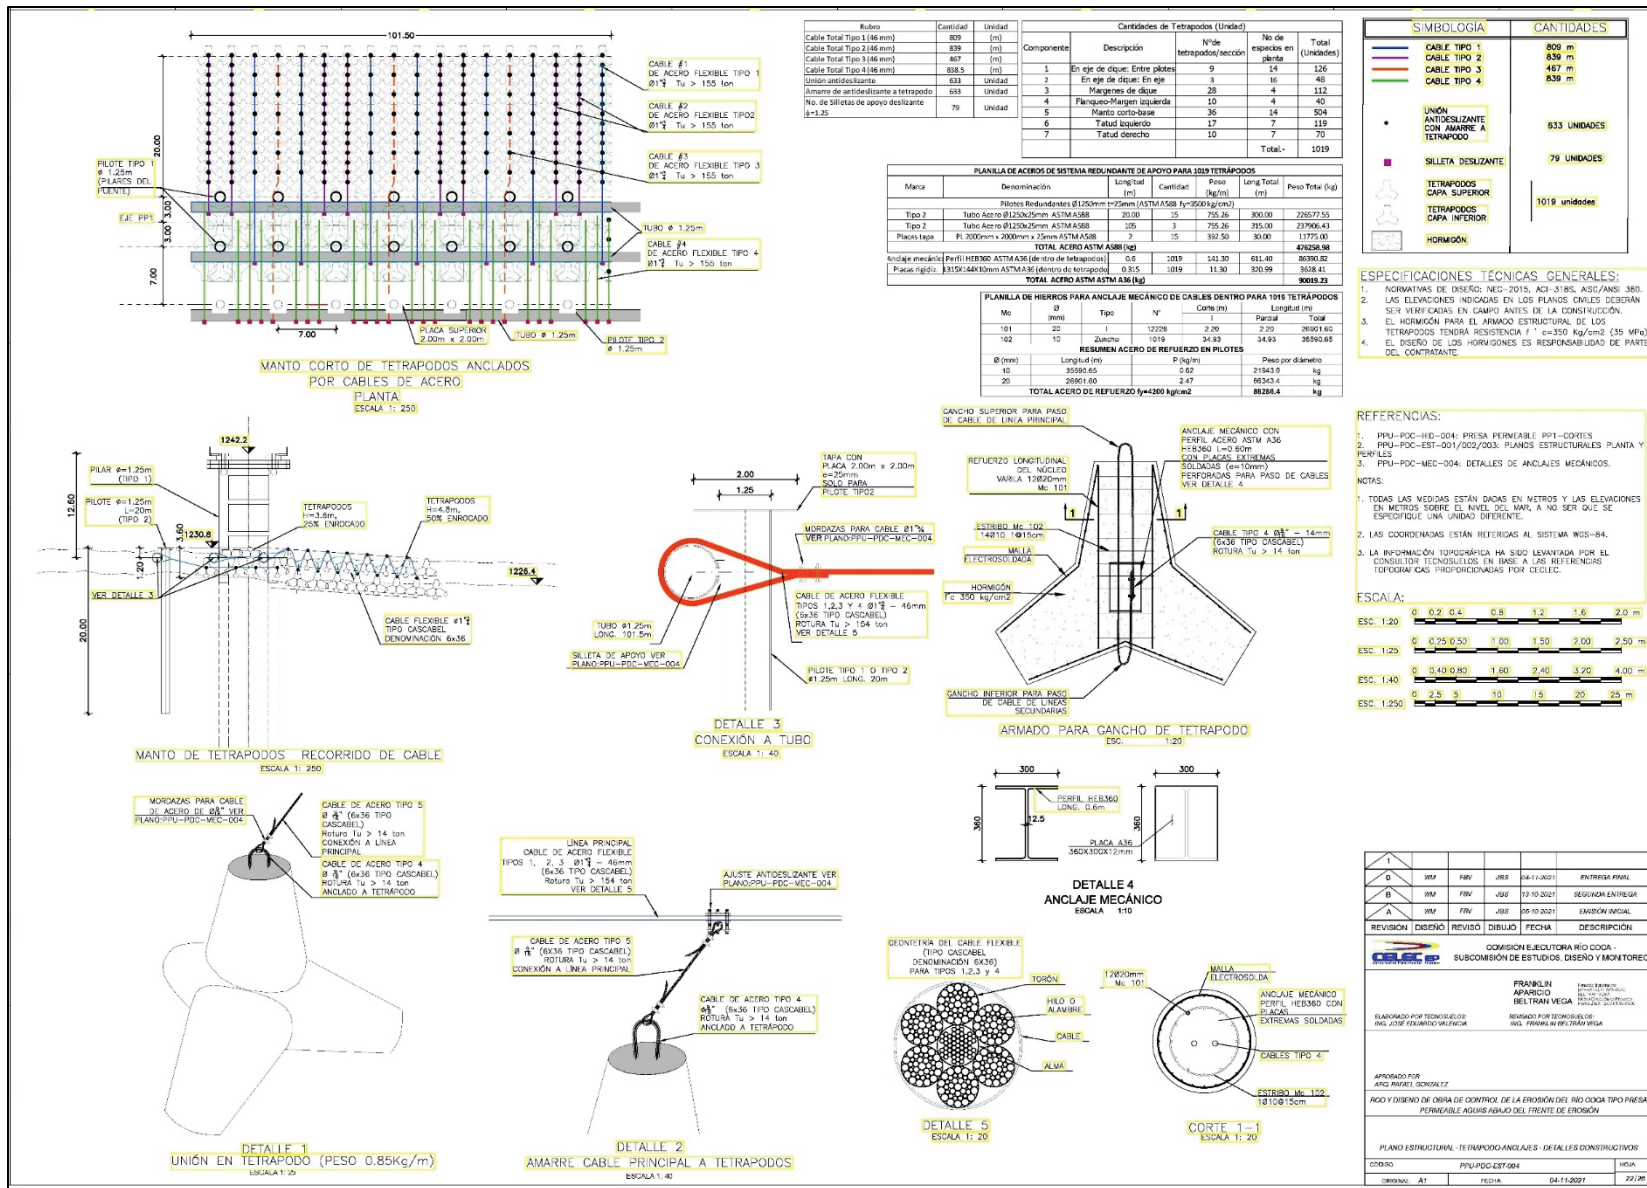
Figure A-3. Initial permeable dam design—details of tetrapods (CELEC, with permission).
