ERDC/CERL SR-05-15

Fort Knox Hammerhead Barracks Architectural Survey

August 2005

Final Report

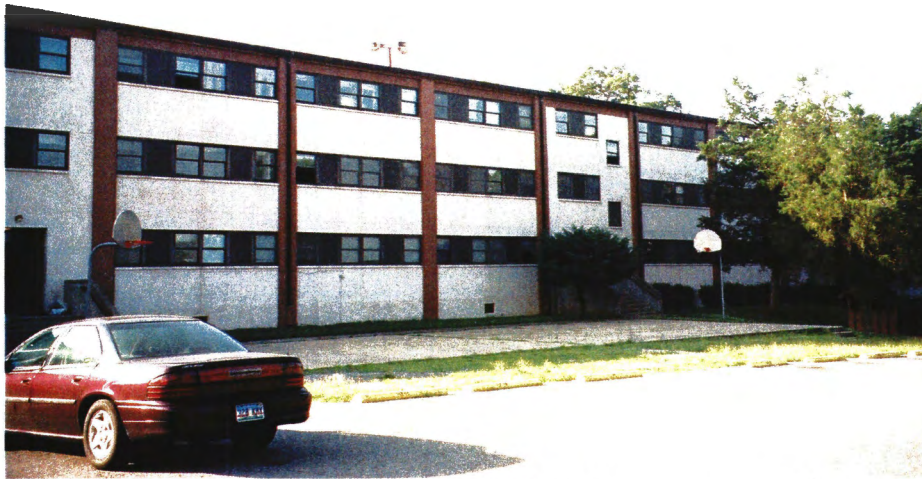
Figure 37: One of the modifications from the VOLAR program resulted in the removal of original steel awning windows being replaced with anodized bronze aluminum windows (ERDC-CERL).

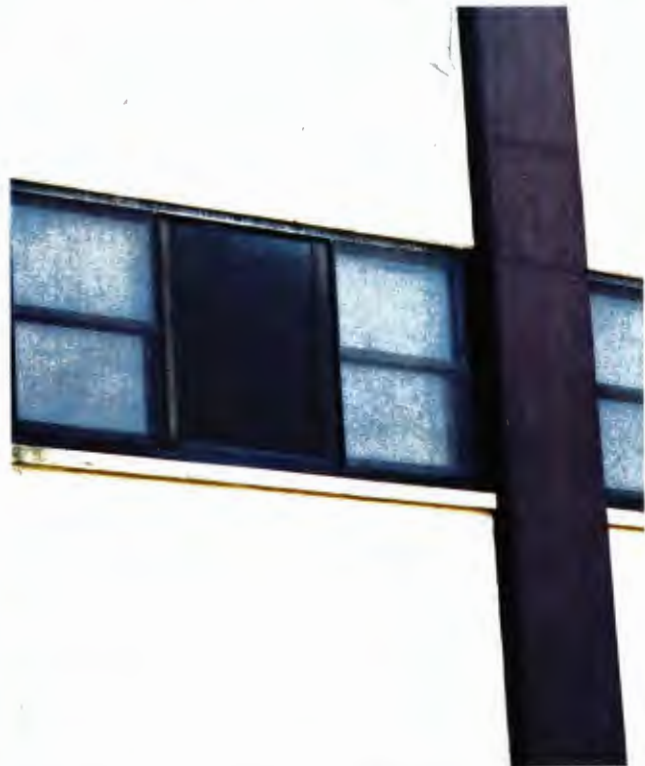
Original unpainted exposed concrete and concrete block with original steel awning windows

Current painted concrete and concrete block with anodized aluminum replacement windows

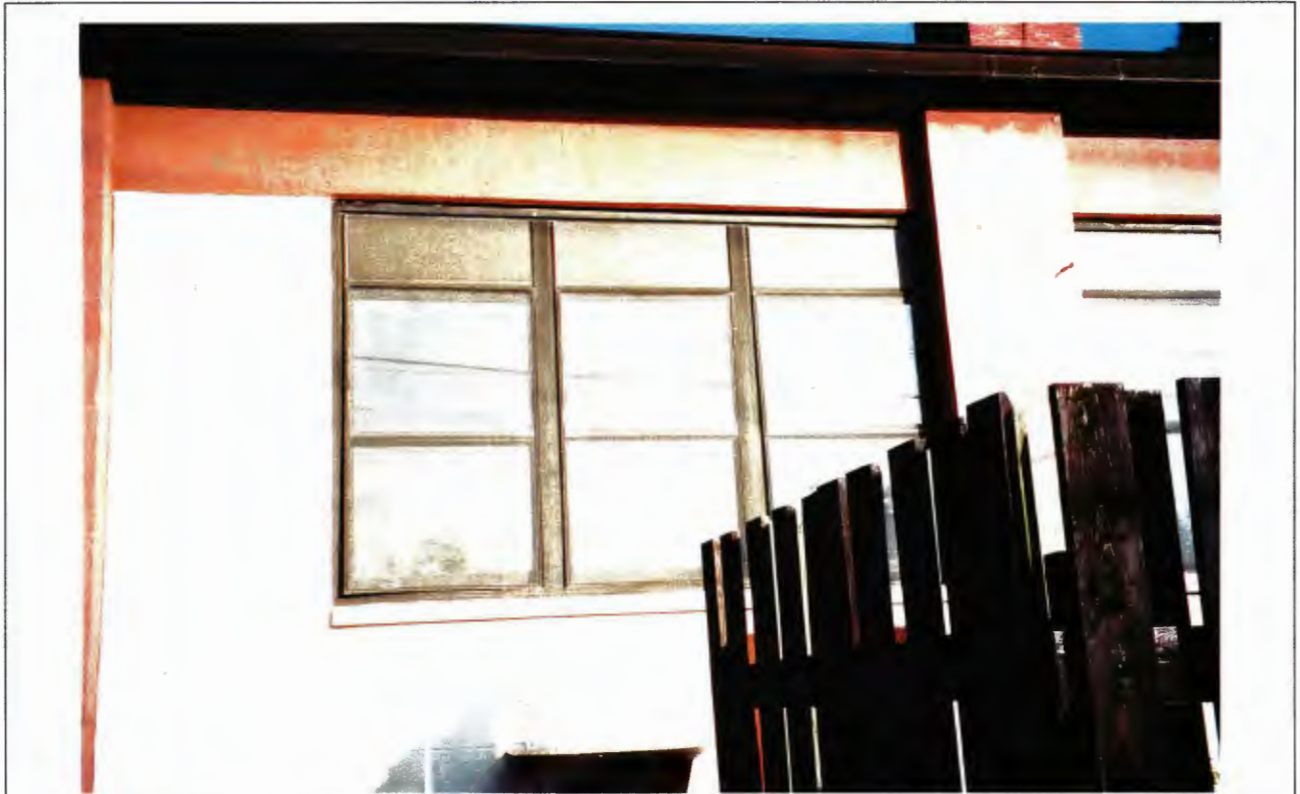
Building 297 – replacement anodized bronze aluminum window located on the *head* portion

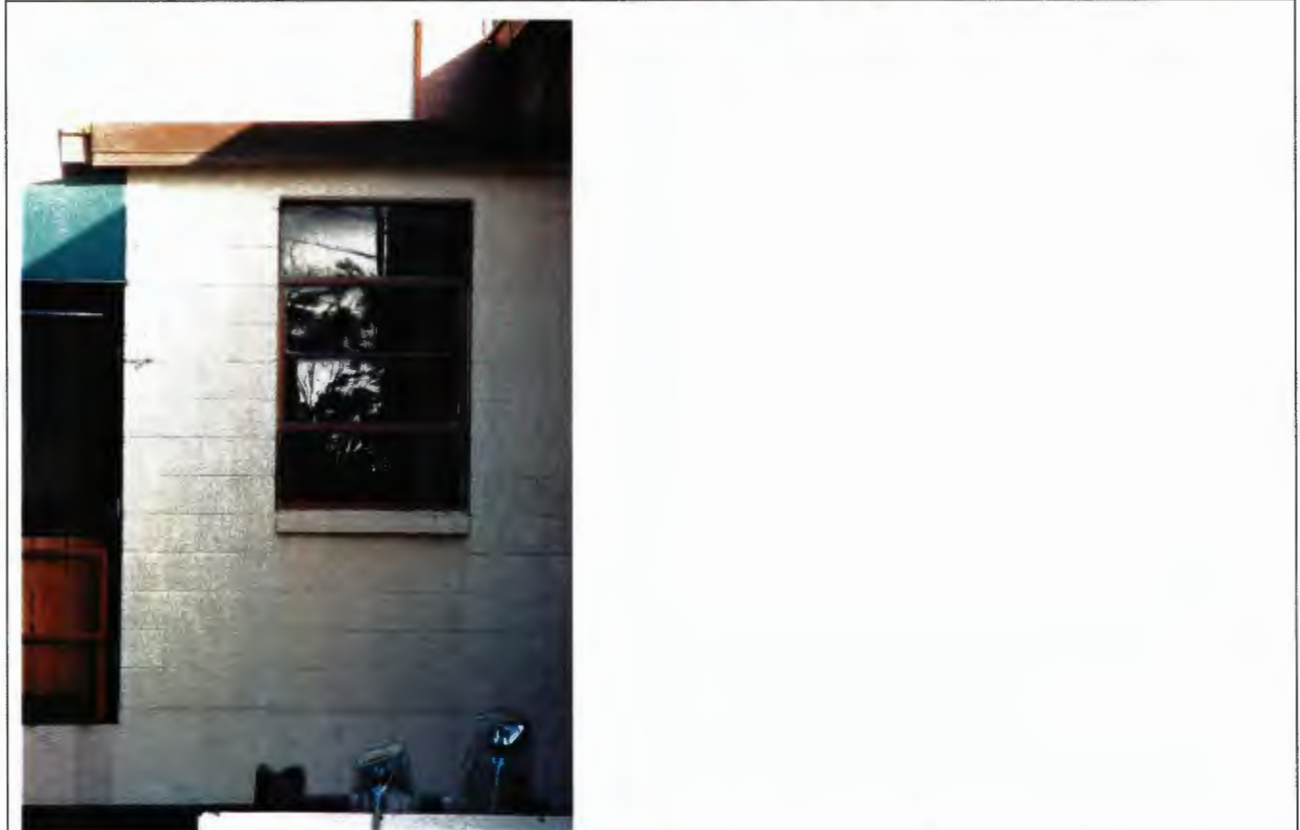
Building 297 – original steel awning window located between the *head* and *handle* on the southeast elevation

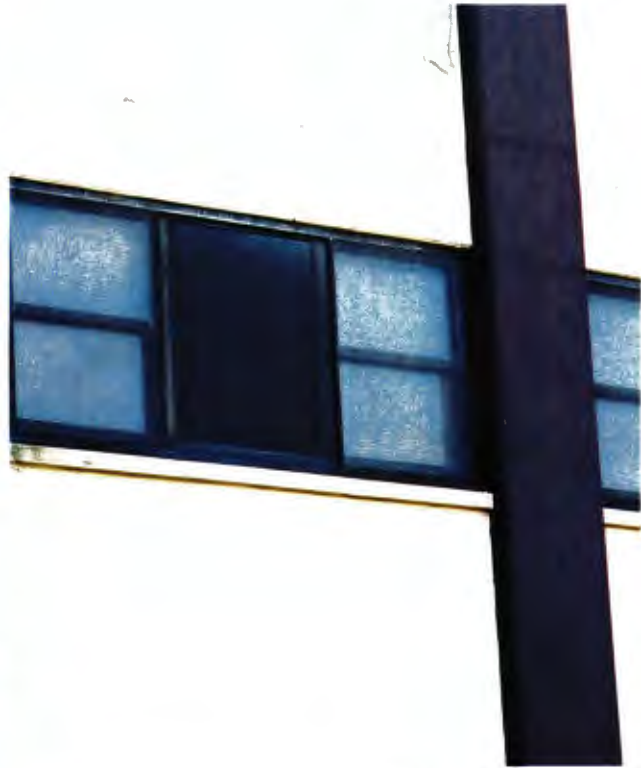
Original unpainted exposed concrete and concrete block with original steel awning windows

Current painted concrete and concrete block with anodized aluminum replacement windows

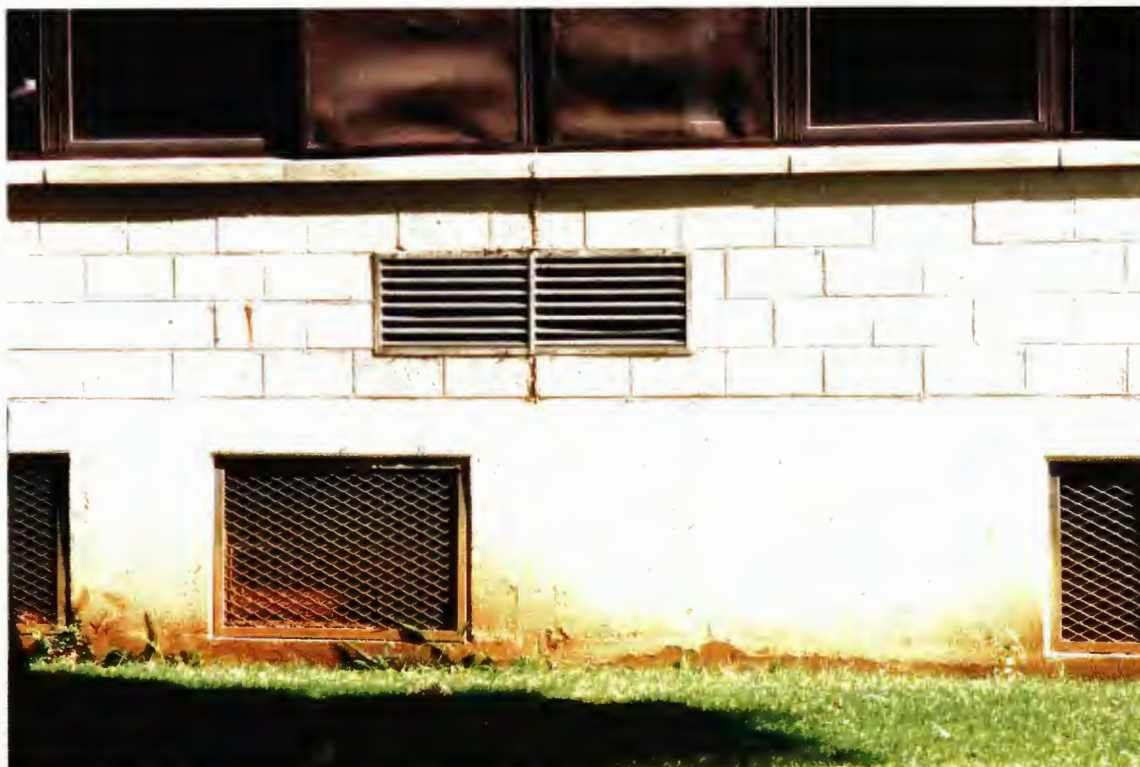
Building 1480 – air conditioning unit installed in the concrete block exterior wall

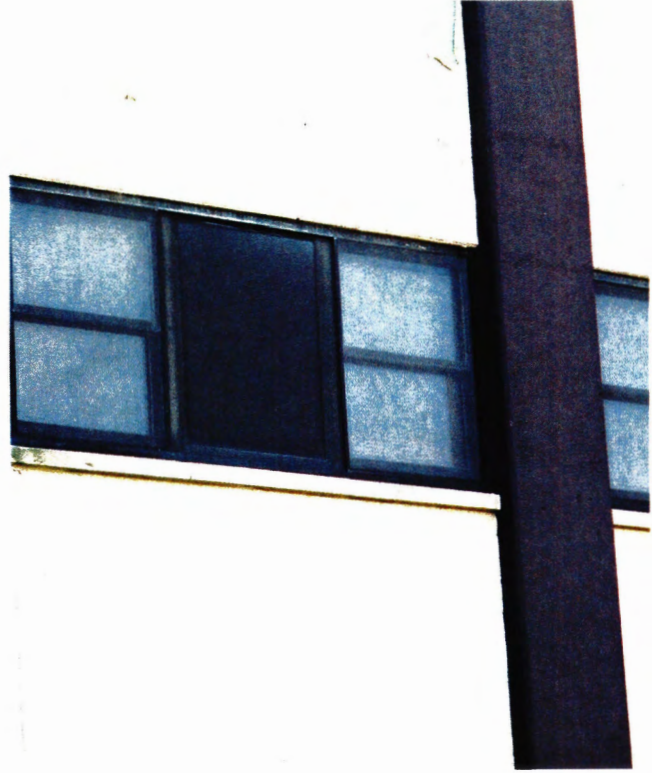
Original unpainted exposed concrete and concrete block with original steel awning windows

Current painted concrete and concrete block with anodized aluminum replacement windows

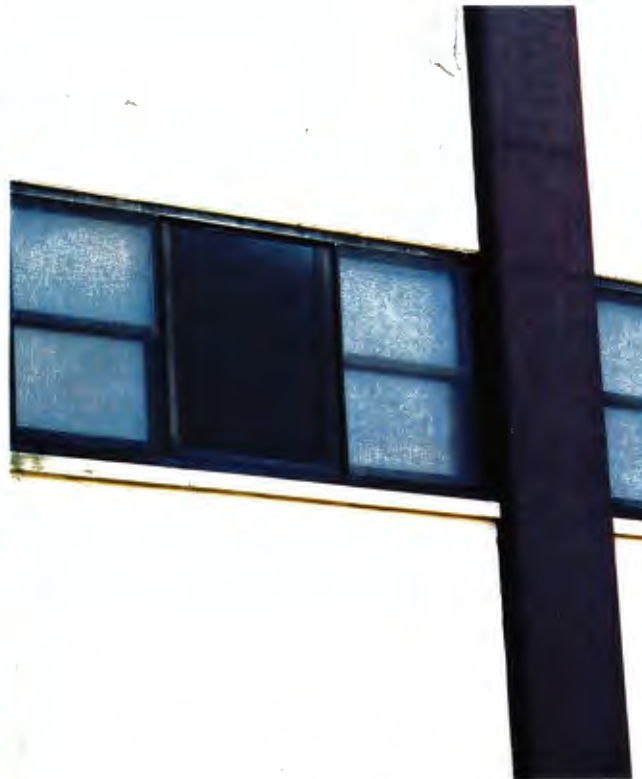
Original unpainted exposed concrete and concrete block with original steel awning windows

Current painted concrete and concrete block with anodized aluminum replacement windows

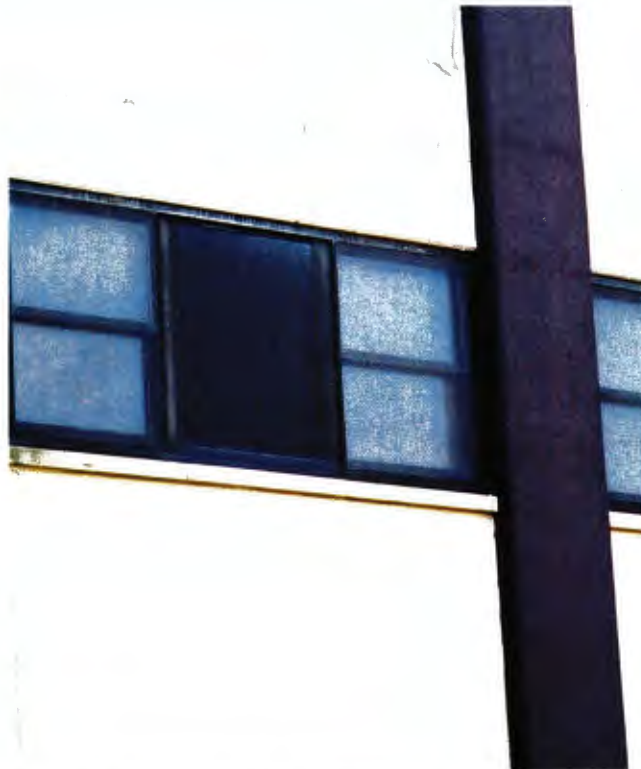
Original unpainted exposed concrete and concrete block with original steel awning windows

Current painted concrete and concrete block with anodized aluminum replacement windows

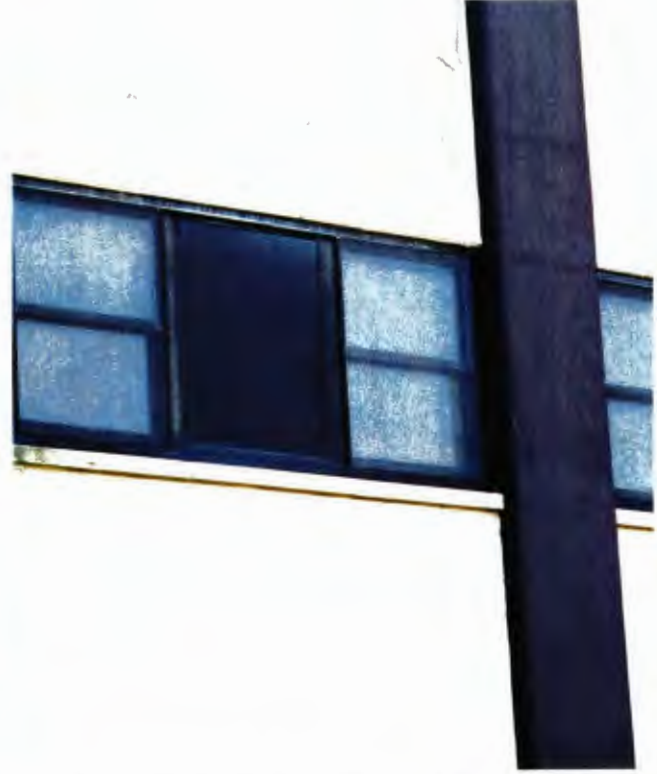
Original unpainted exposed concrete and concrete block with original steel awning windows

Current painted concrete and concrete block with anodized aluminum replacement windows

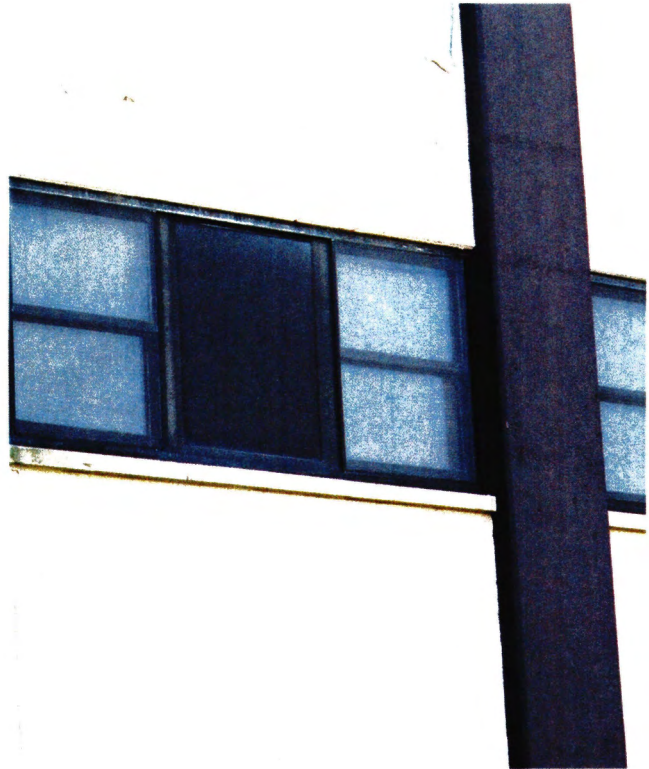
Original unpainted exposed concrete and concrete block with original steel awning windows

Current painted concrete and concrete block with anodized aluminum replacement windows

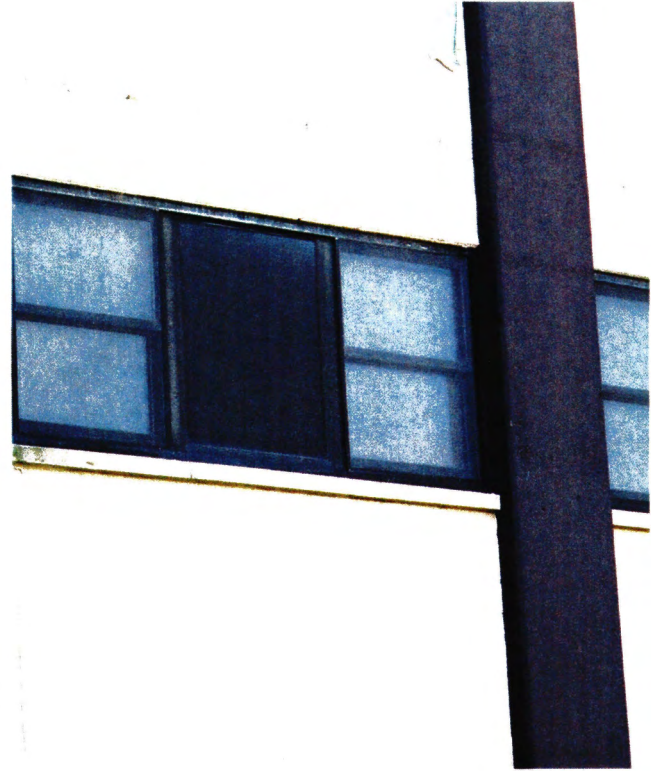
Original unpainted exposed concrete and concrete block with original steel awning windows

Current painted concrete and concrete block with anodized aluminum replacement windows

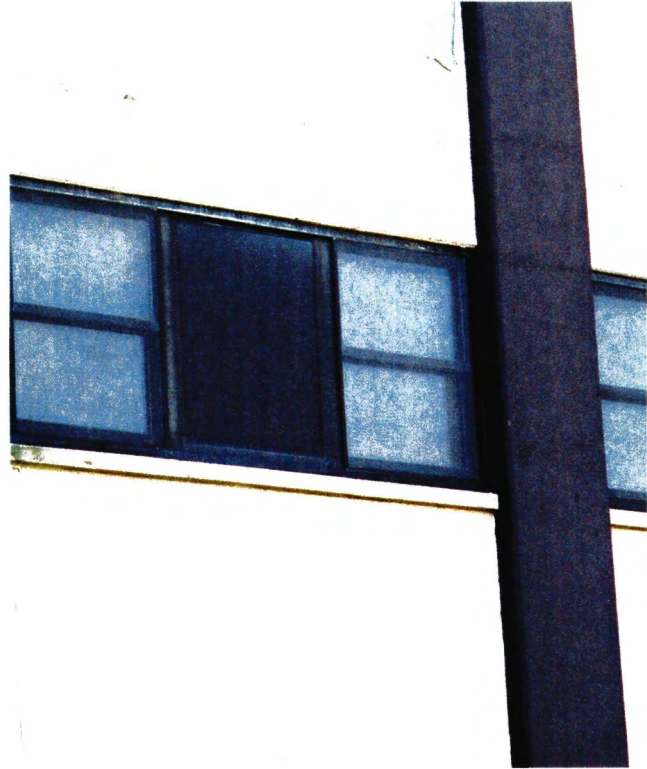
Current painted concrete and concrete block with anodized aluminum replacement windows

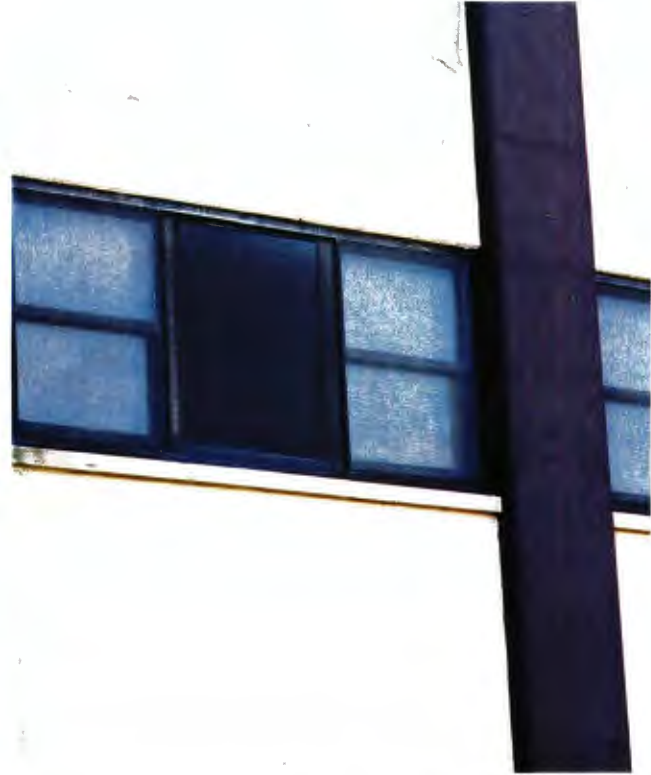
Current painted concrete and concrete block with anodized aluminum replacement windows

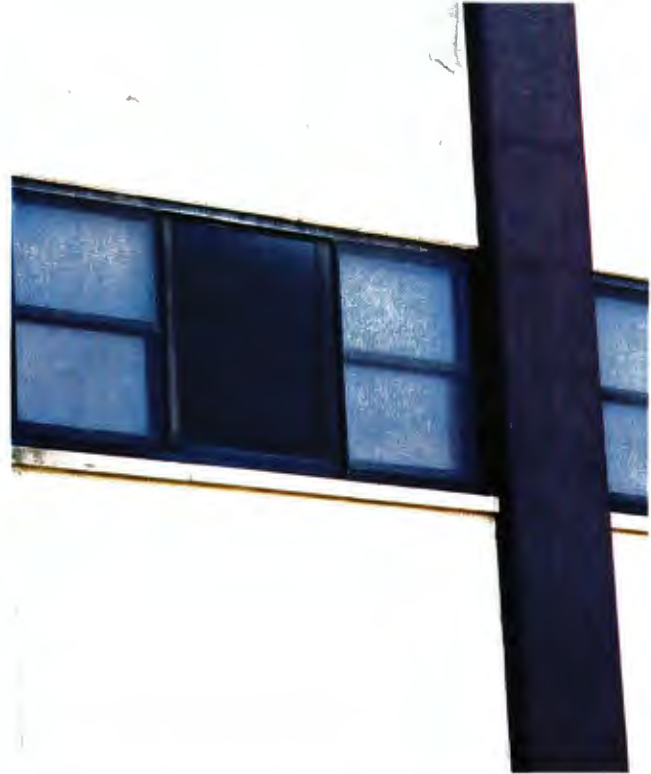
Current painted concrete and concrete block with anodized aluminum replacement windows

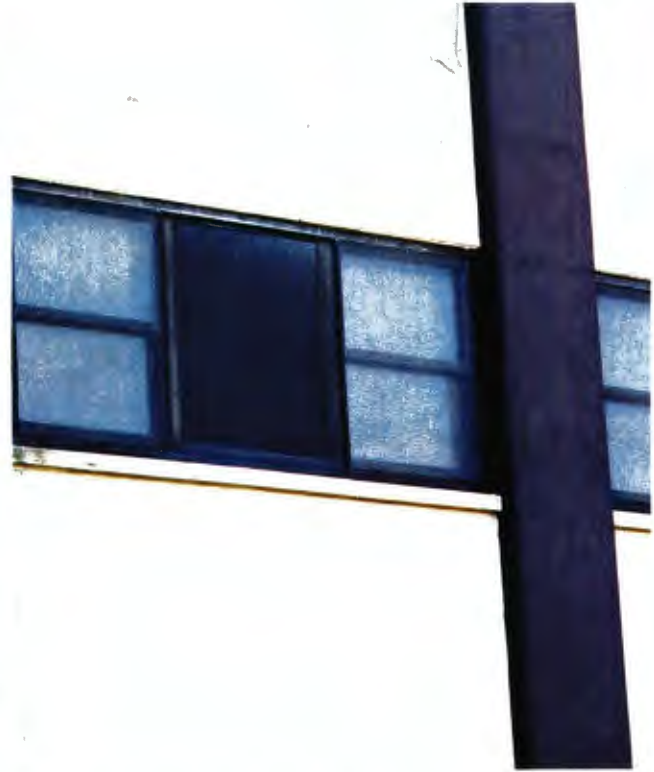
Current painted concrete and concrete block with anodized aluminum replacement windows

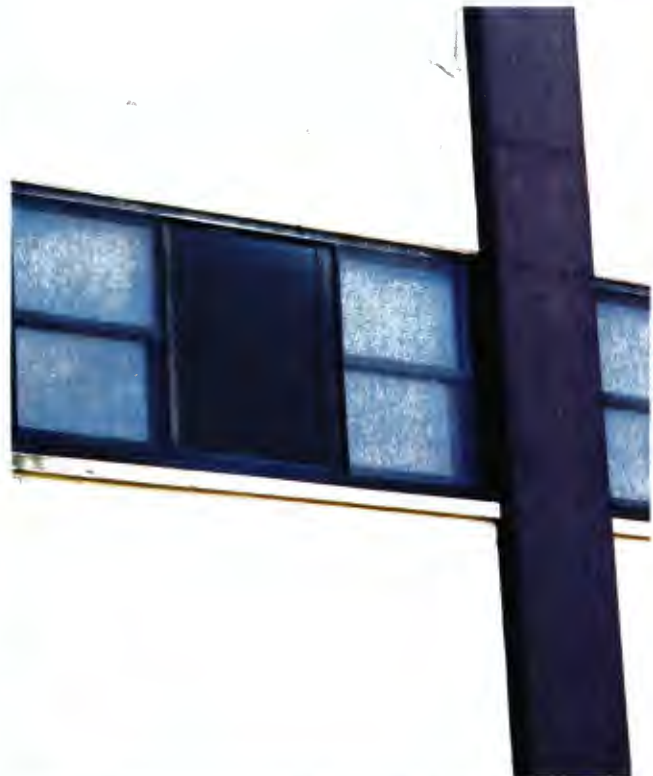
Current painted concrete and concrete block with anodized aluminum replacement windows

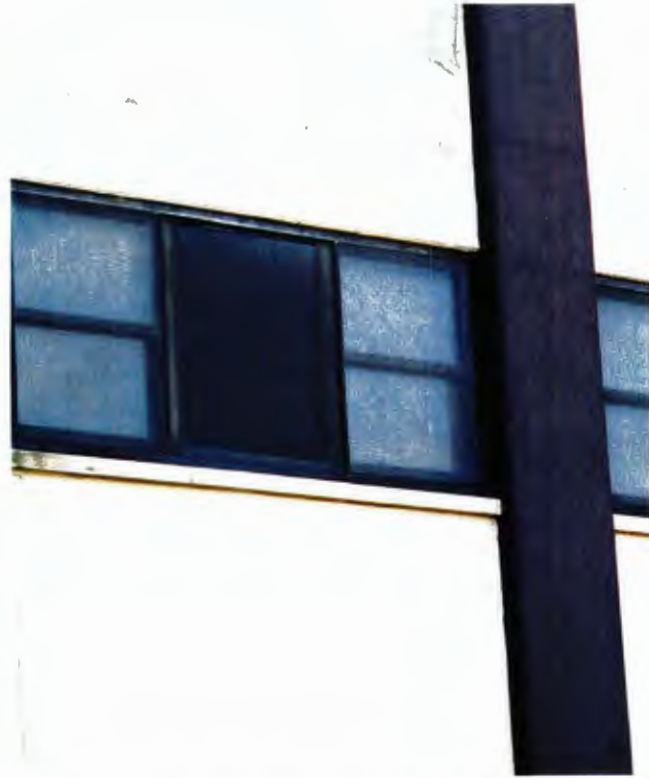
Current painted concrete and concrete block with anodized aluminum replacement windows

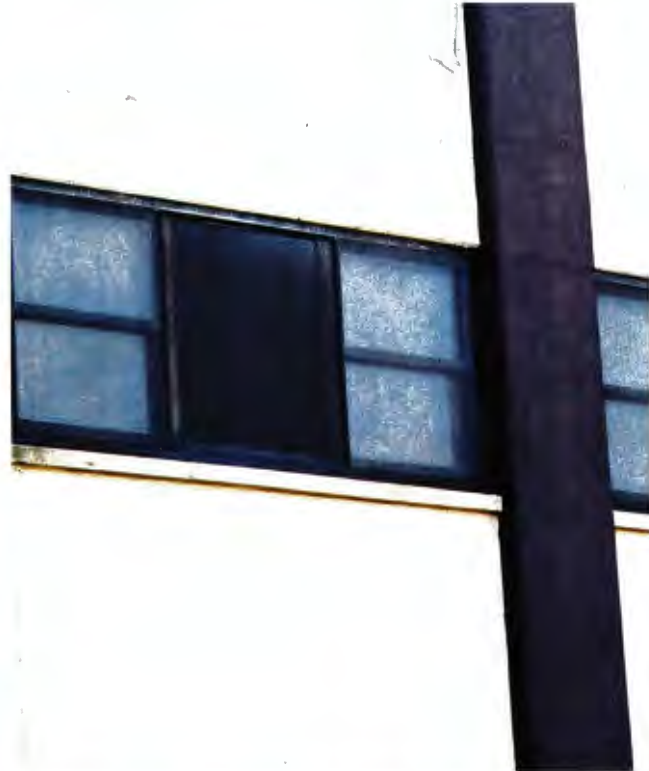
Current painted concrete and concrete block with anodized aluminum replacement windows
