*Installation Technology Transition Program (ITTP)*

## **Initial Data Collection from a Fiber-Optic-Based Dam Seepage Monitoring and Detection System**

October 2023

Final Report

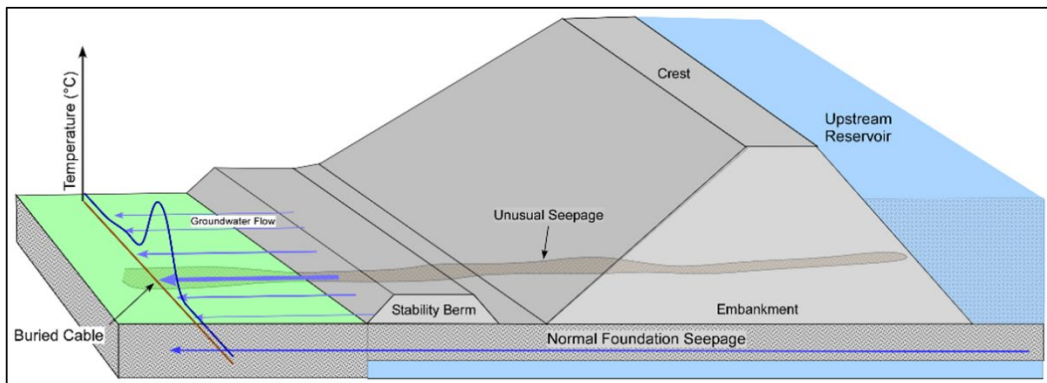
Figure 1. Continuous temperature measurements using a fiber-optic monitoring system at a dam structure.

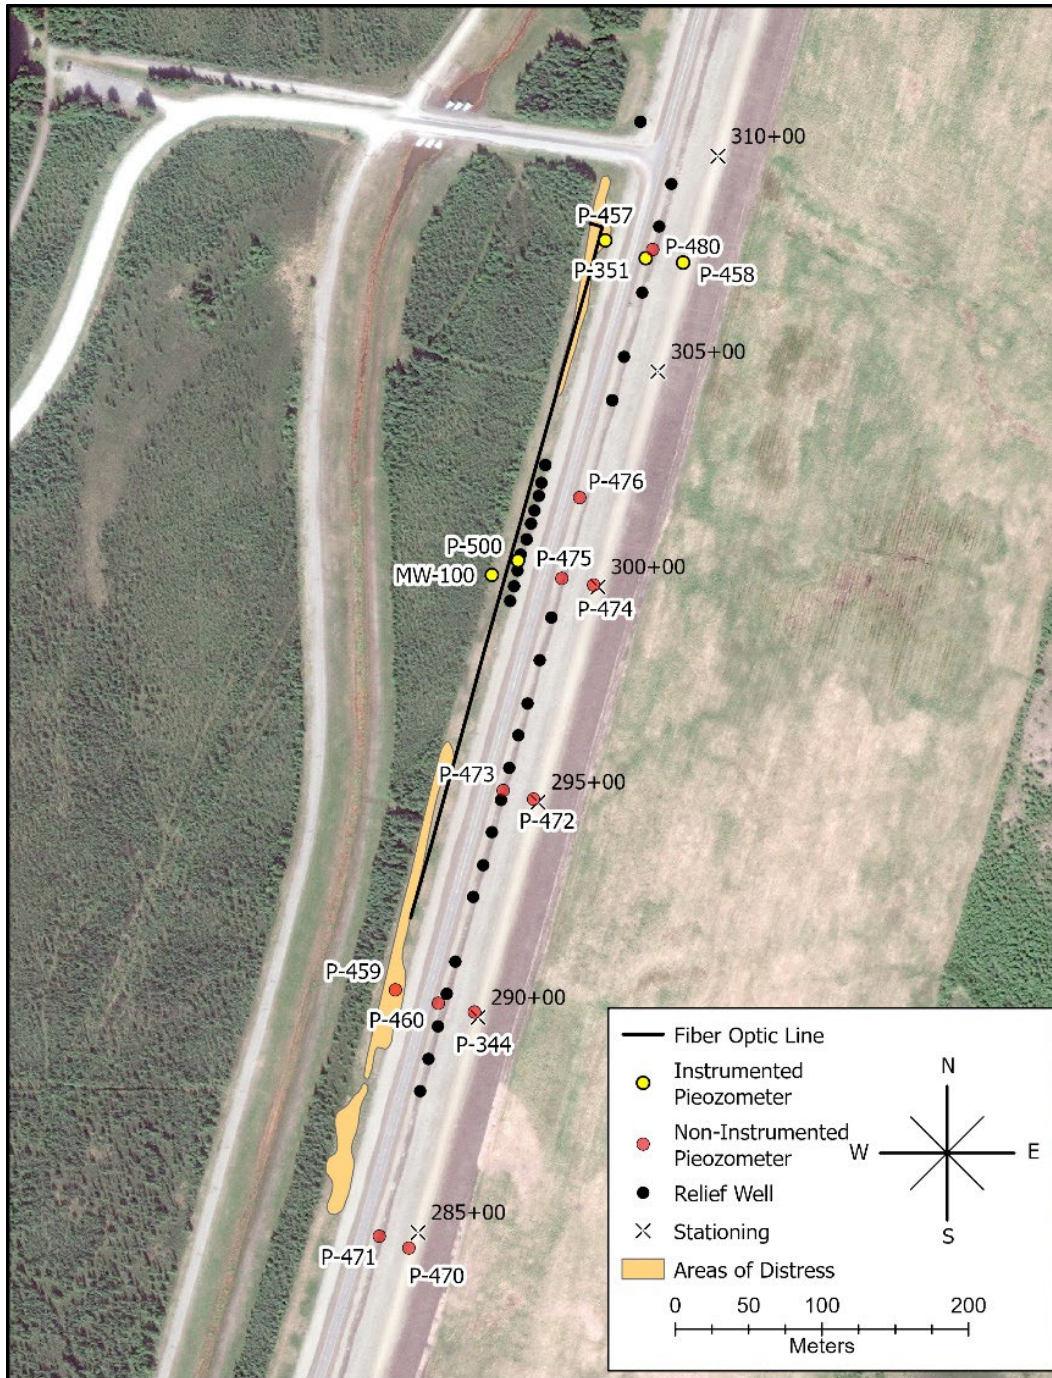
Figure 3. Close-up of the fiber optic line (*black line*) installation and current Moose Creek Dam (MCD) monitoring network. The location of 2014 sand boils are marked as areas of distress (*orange*). (Map reproduced from Maxar®.)

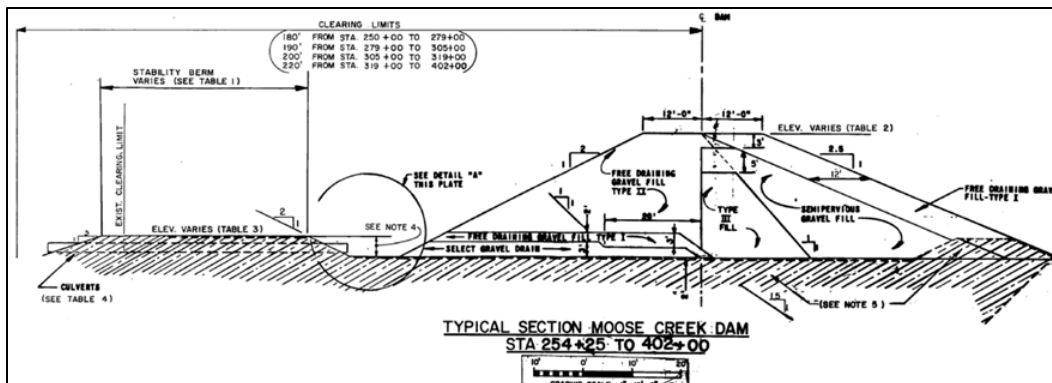
Figure 4. Cross section of the MCD, Station (Sta) 254+25 to 402+00. (Image reproduced from USACE 2016. Public domain.)

This part of the MCD (Sta 254+25 to 402+00) is founded on soil (Figure 4) consisting of various layers with highly permeable material. Drillings in the upper 30 m show mainly layers of sand and gravel. It is a zoned earth embankment, with a sloping core of semipervious (silty) gravel and shells of free-draining gravel. It has also relief to relieve the uplift pressures in the dam foundation during flood events. Relief well depths vary according to the extent of permafrost. There is also a 21 m wide downstream berm and a ditch invert 1.2 m below the berm. Culverts are placed each 2+00 between Sta 290+00 and 310+00 on Elevation +492. They are connected to the ditch invert. No blanket is used along this part of the dam and the dam height is about 7.6 m.

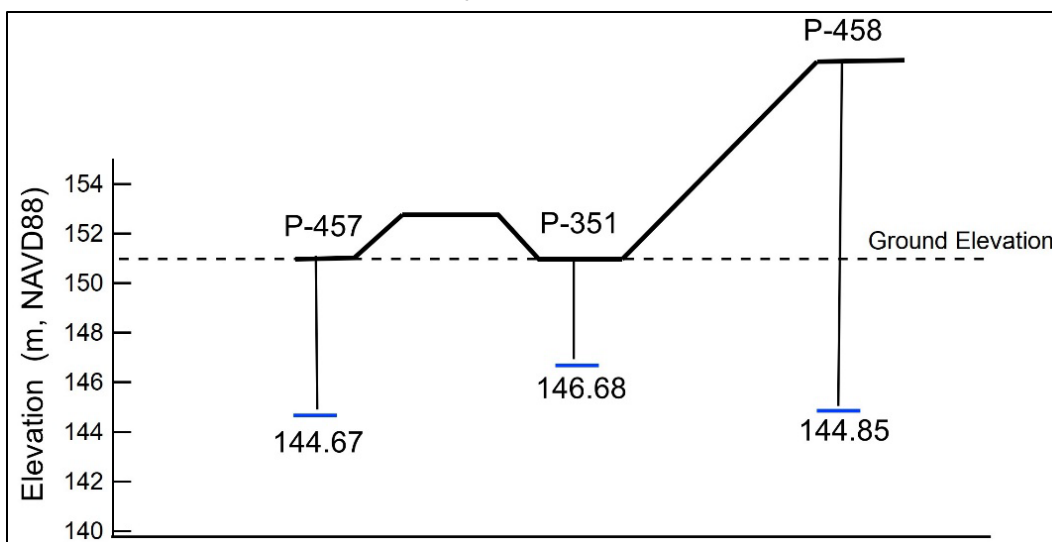
Figure 5. Placement of CS451 sensors in piezometer (P) wells (P-351, P-457, and P-458) at Sta 307+50.

As a part of an on-going effort of the Alaska District to have real time monitoring of all the piezometers, and increasing the chance of identifying potential issues within the dam, Campbell Scientific (CS) electronic sensors (CS451, Campbell Scientific) have been placed in several piezometers along the MCD. From 2018 to 2022, 59 piezometers were equipped with sensors to monitor the liquid pressure of the column of water (the piezometric head) and the groundwater temperatures. Close to our study site, Station (Sta) 307+50 (station distances are in feet), sensors (CS451) were placed in three piezometers (P) wells (P-351, P-457, and P-458; Figure 5).

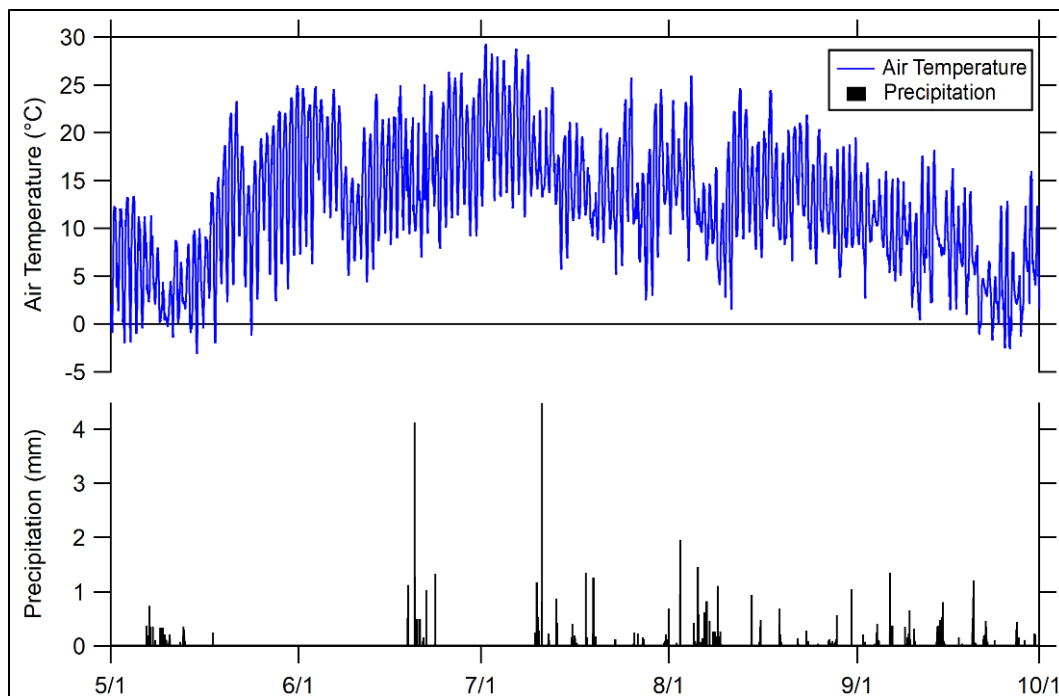
Figure 6. Air temperature (*blue*) and precipitation (*black*) at the MCD meteorological station.

office (latitude 64.76, longitude  $-147.22$ ), about 1,000 m from the study site. Figure 6 shows the air temperature and precipitation for the 2022 summer. About midway, and 5 m west of the fiber optic cable, soil temperatures are continuously measured at every 0.3 m down from the ground surface to about 15 m (Monitoring Well [MW]-100, Figure 3).

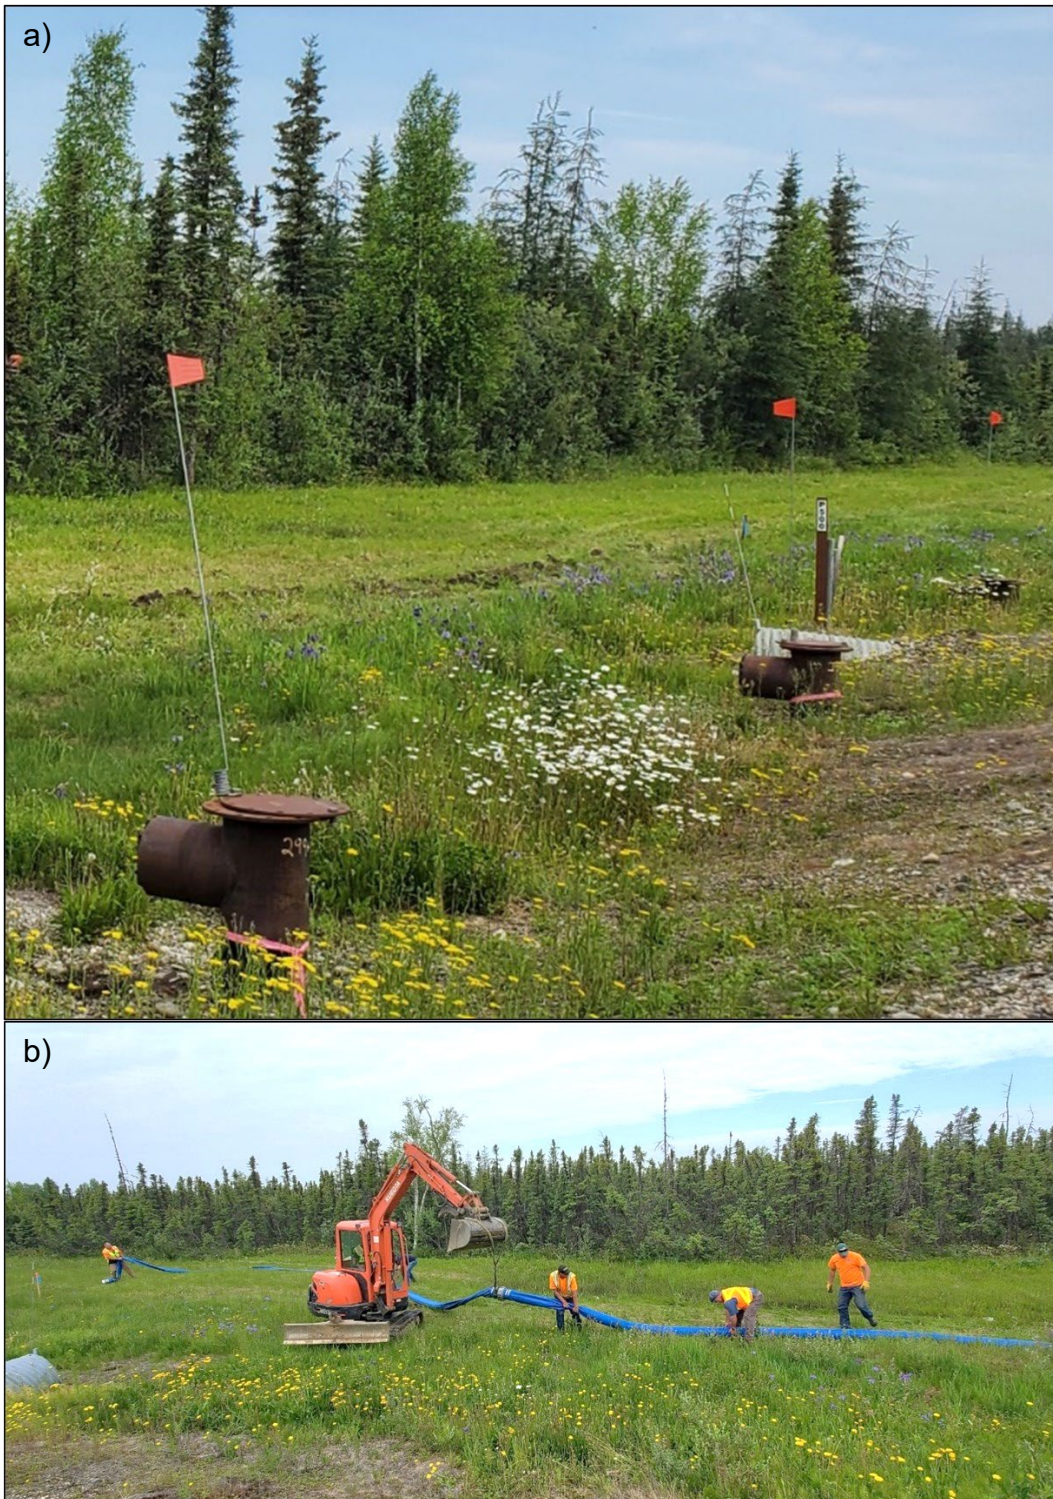
Figure 8. Two relief wells along the fiber optic line (a), and movement of relief well flow conduit prior to installation of fiber optic cable (b).

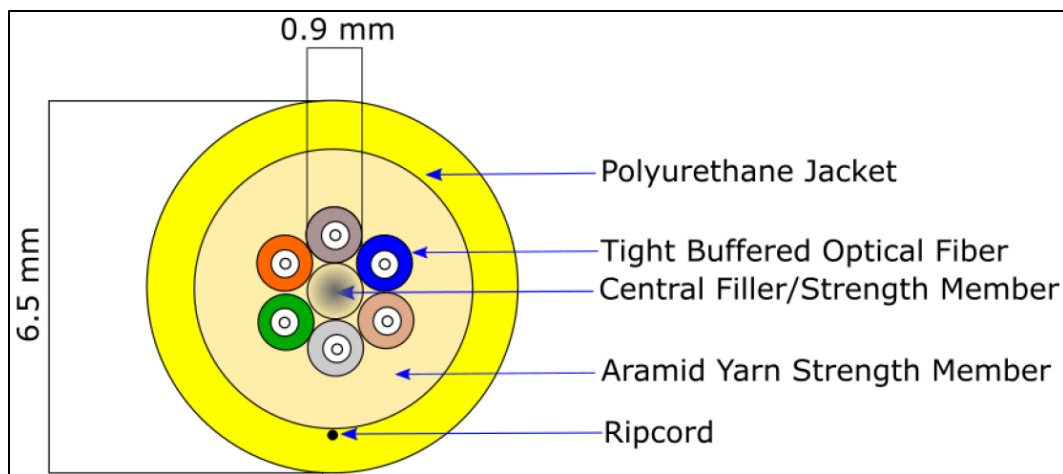
Figure 9. Direct-bury cable with 4 multimode (MM) and 2 single mode (SM) optical fibers.

On 22 June 2022, we installed a 500 m long tight-buffered direct bury fiber optic cable (Figure 3 and Figure 9) at a depth of about 2 m using a cable plow (Figure 10). The cable plow was a Bron 350 series, designed to install underground utilities at a depth of up to 198 cm. Cable plows utilize a slim profile blade to create a collapsing void space underground. As the plow is pulled through the soil, underground utilities are fed into the void space immediately behind the blade by means of a chute attached to the back of the blade. As the void space collapses, the underground utility and associate marking materials are securely held at a controllable depth from the surface. Some of the advantages to this installation method are its low impact to surrounding soils, speed of installation (depending on soil type), and high degree of depth control.

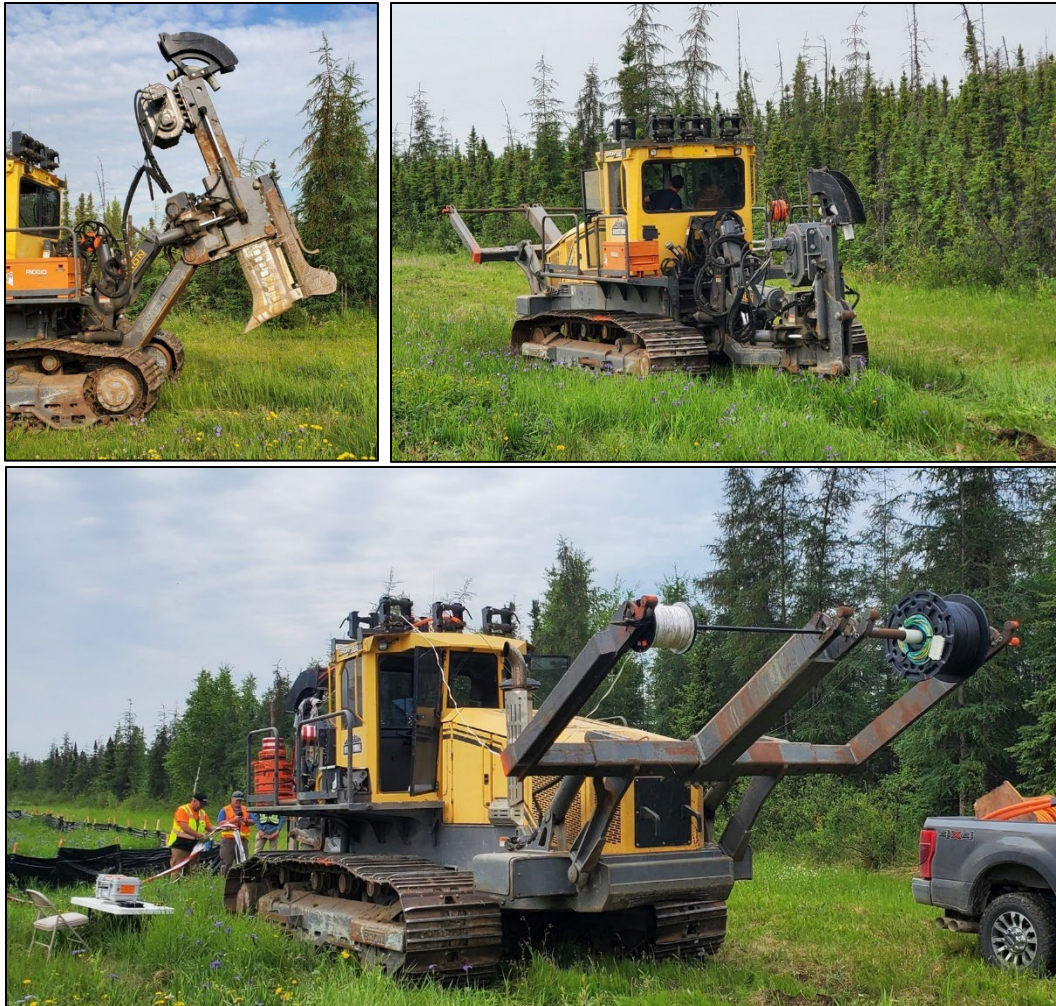
Figure 10. Fiber optic installation with a cable plow.

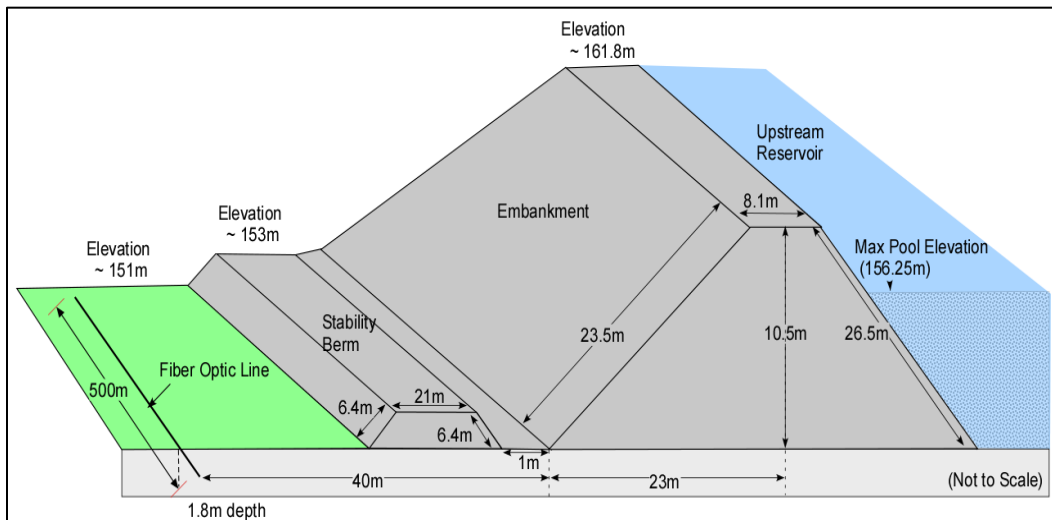
Figure 11. MCD embankment profile.

The fiber optic line paralleled the earthen dam, offset from the toe by 40 m (Figure 11), and it included both a control section, and a section known for the occurrence of sand boils (Figure 3). By installing the cable at depth, we were able to install above groundwater elevations during flood events, this allowed the greatest chance to capture ground temperature fluctuations driven by dam seepage as warmer surface water was drawn into the groundwater table.

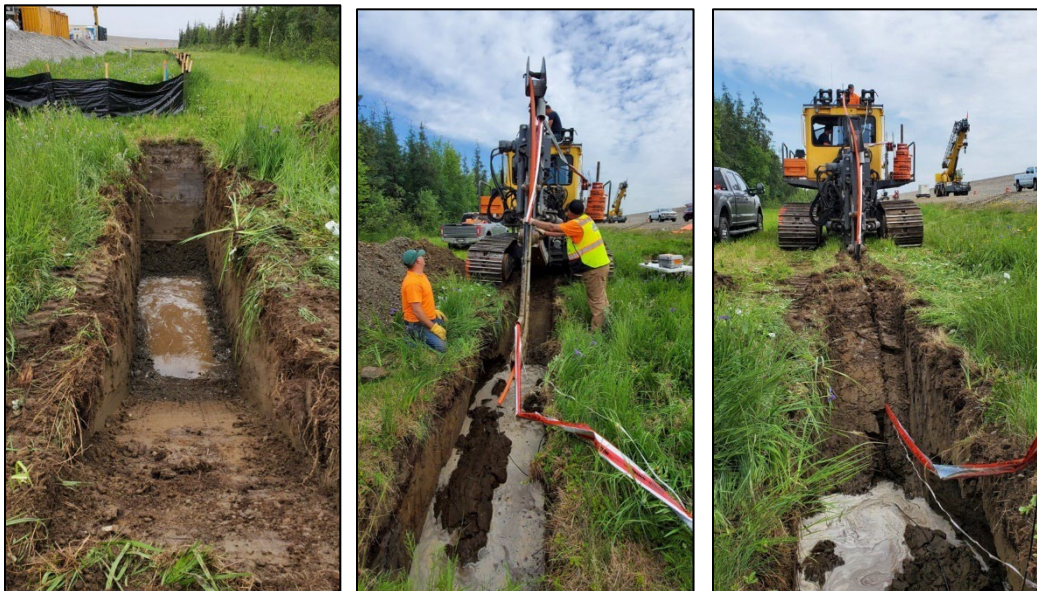
Figure 12. Soil pit at the south end of the fiber optic line.

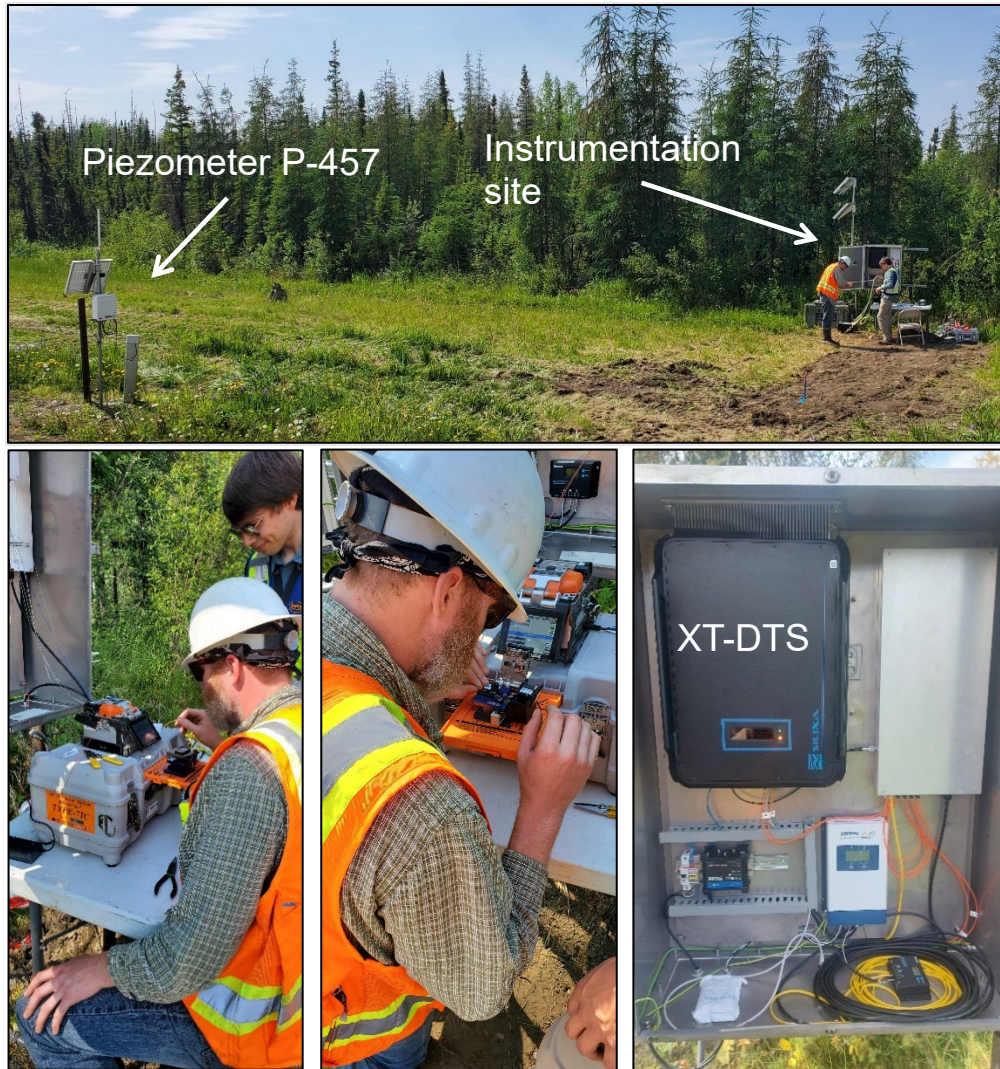
Figure 13. Distributed temperature sensing (DTS) monitoring site and installation.

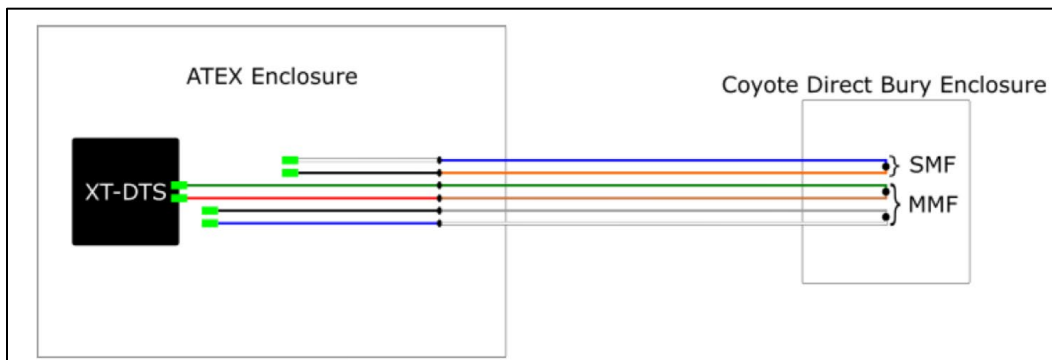
Figure 14. Configuration of optical fibers. *Green rectangles* represent E2000 connectors, *black solid dots* represent splices.

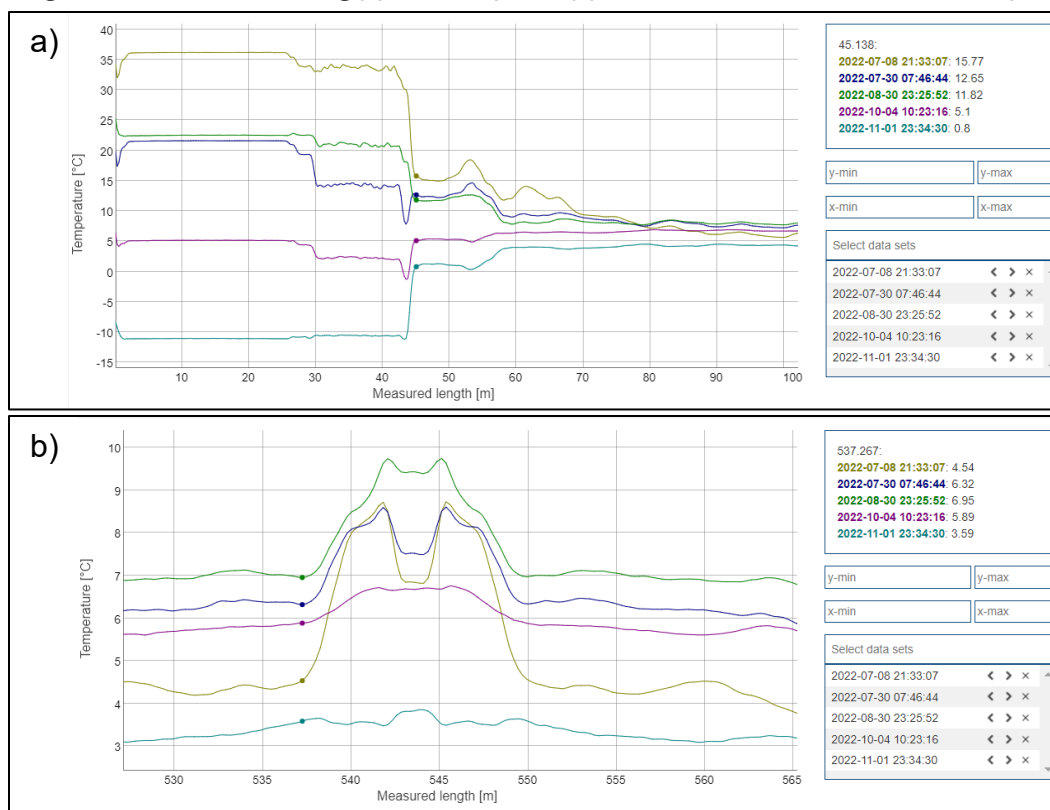
Figure 17. Estimated starting (a) and end points (b) where the cable is at the desired depth.

The temperature measurements indicate the interval where the cable is around its nominal depth. At this depth, temporal temperature variations are minor. Data in Figure 17 suggests 45 m as the interval's starting point and 537 m as the end point. It equals an effective length of 492 m (1614.2 ft). The cable length is slightly shorter. From Figure 17, we can estimate the Station for the starting point to Sta 307+85 and the endpoint to Sta

291+80. This gives a length of 489 m (1,605 ft). The length correction that matches these data is 0.55%, which seems reasonable. However, it should be noted that the estimations from the figure are probably more inaccurate than the corresponding measured data. The given data and the calculations are shown in Table 1.

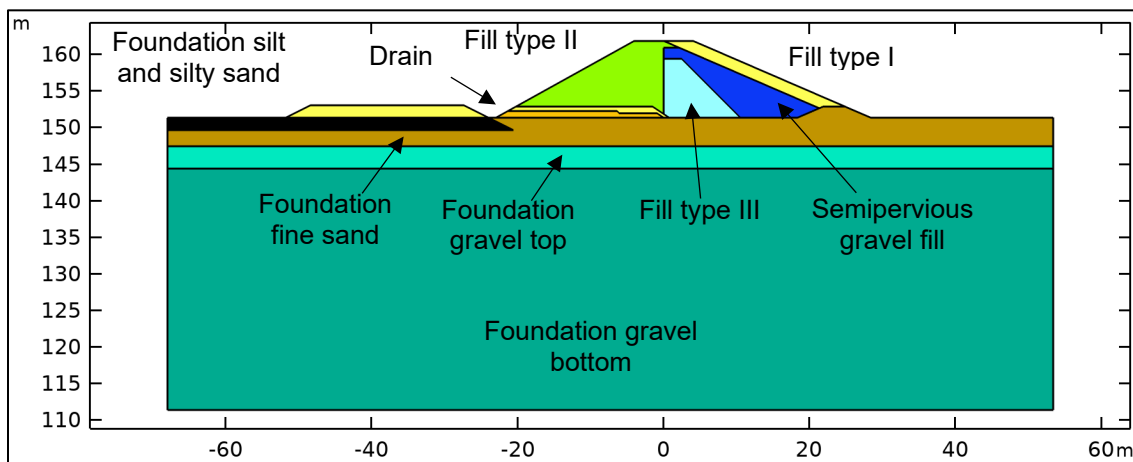
Figure 18. The 2D geometry used in the COMSOL Multiphysics® simulations. The colors correspond to the different materials.

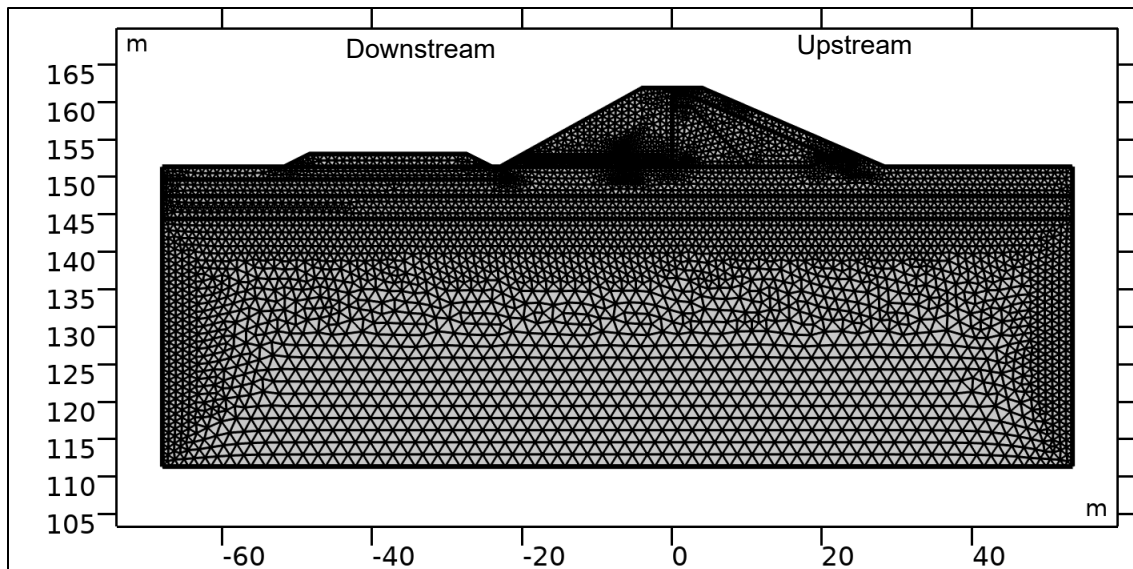
Figure 19. The 2D simulation mesh.

The mesh was constructed from triangular or tetrahedral elements for the 2D (Figure 19) or 3D geometries, respectively. The maximum element size was set to 1 m except in the bottom foundation gravel (and sand) layer. There, the maximum element size was 2 m. The number of elements of the 2D and 3D grids were 12,000 and 680,000, respectively. One simulation scenario was repeated with different grids to show that the results were independent of the mesh to a satisfactory degree (Section 3.3.2).

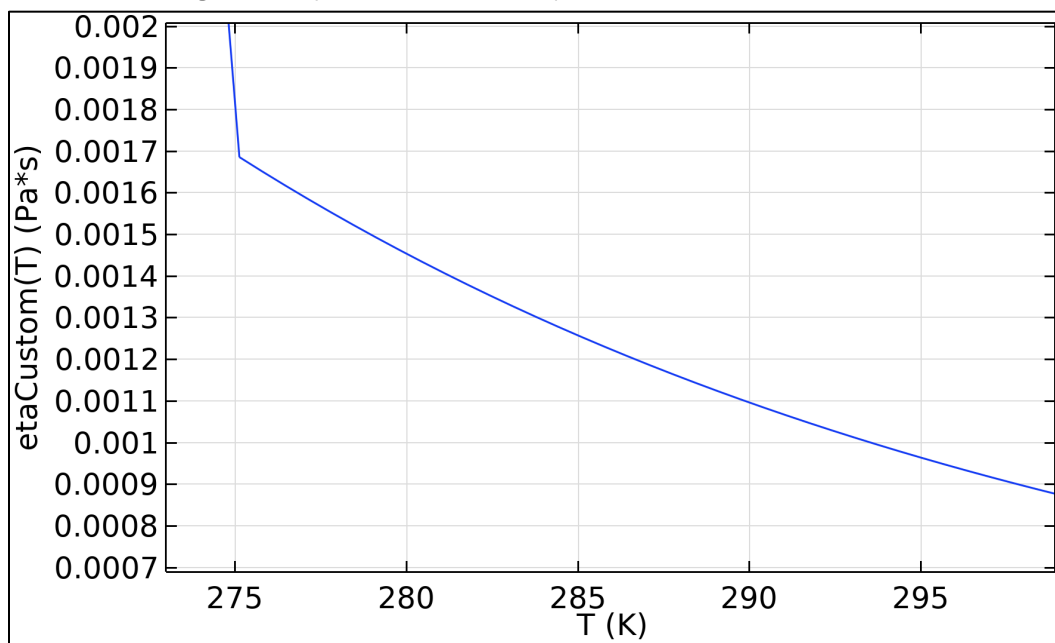
Figure 20. Dynamic water viscosity as a function of temperature.

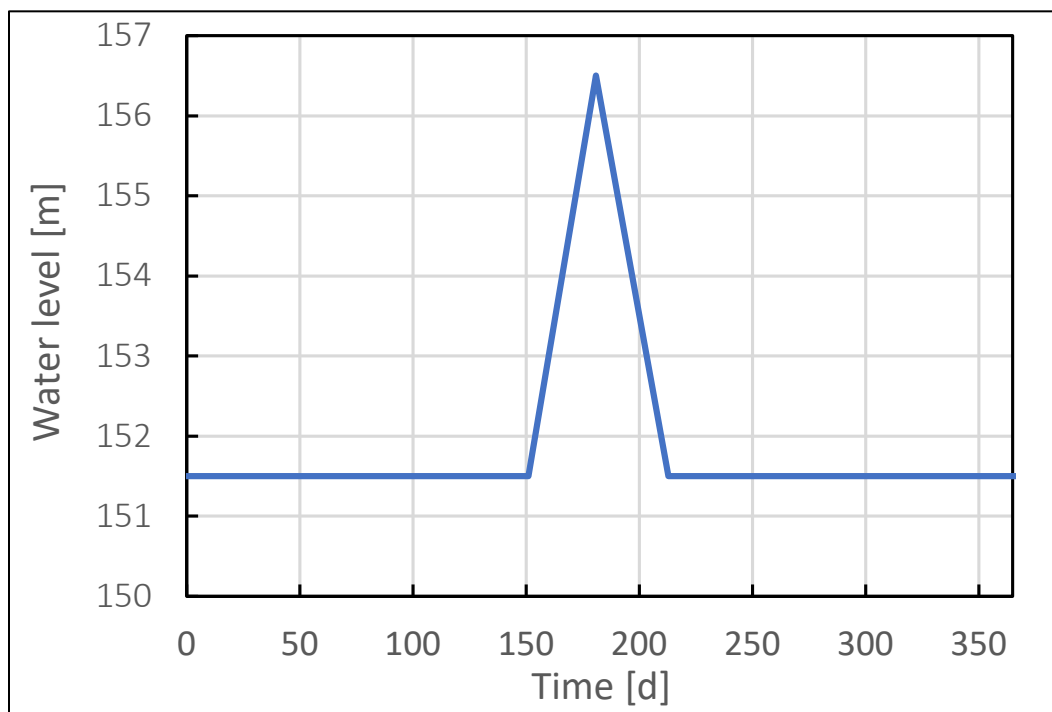
Figure 21. Upstream water table level for one year.

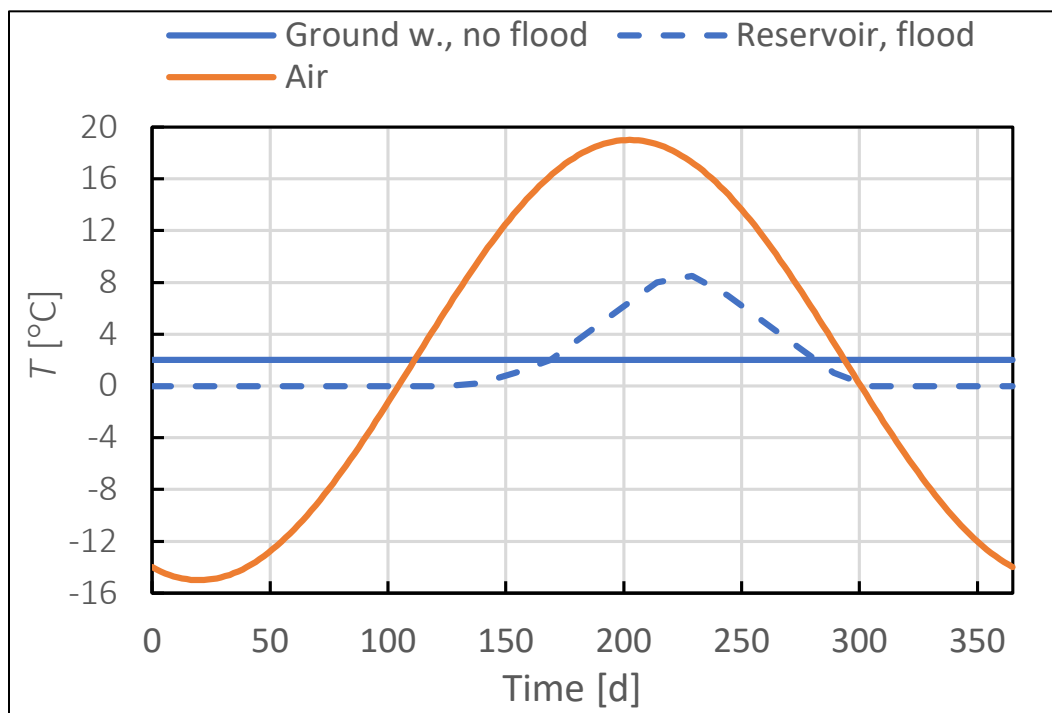
Figure 22. Imposed groundwater or water reservoir temperatures (for no flood event or high reservoir level and flooding, respectively) as well as air temperatures for one year.

above ground. The ground water (for no flooding), reservoir, and air temperatures are shown in Figure 22. Remaining boundaries were thermally insulated.

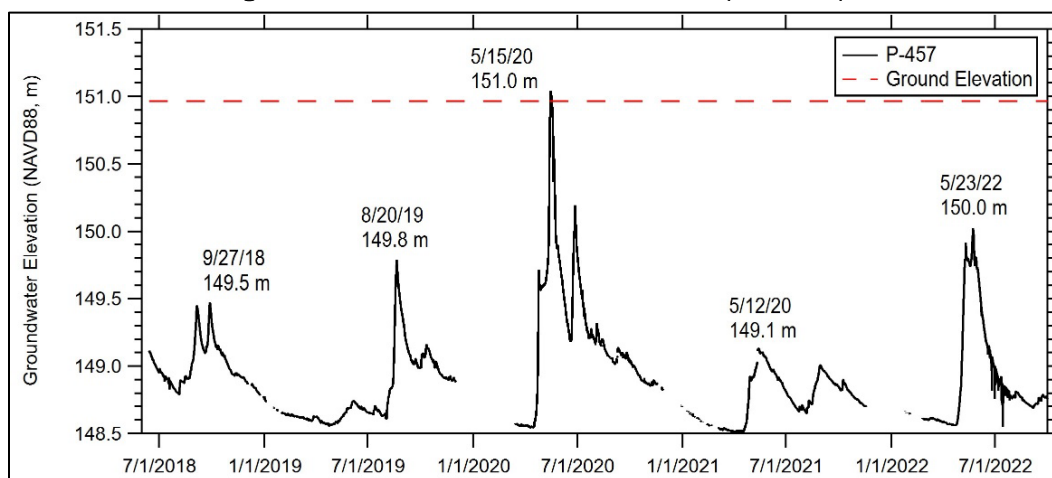
Figure 23. Groundwater elevations at P-457 (*black line*).

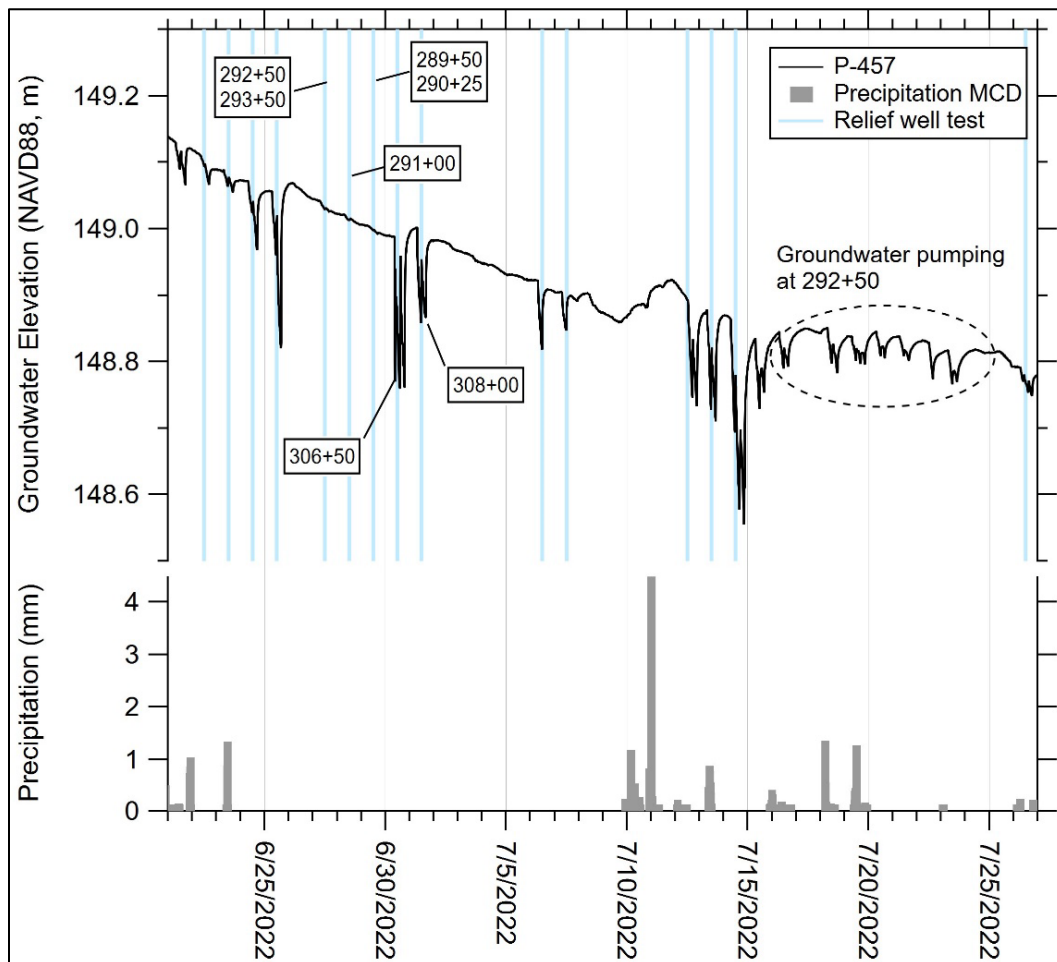
Figure 24. Groundwater elevations at P-457 (*black line*), relief well test dates (*light blue bars*, not all labeled, see Figure 7 for more information about station location and dates for each test), and precipitation (*gray bars*) at the MCD meteorological station.

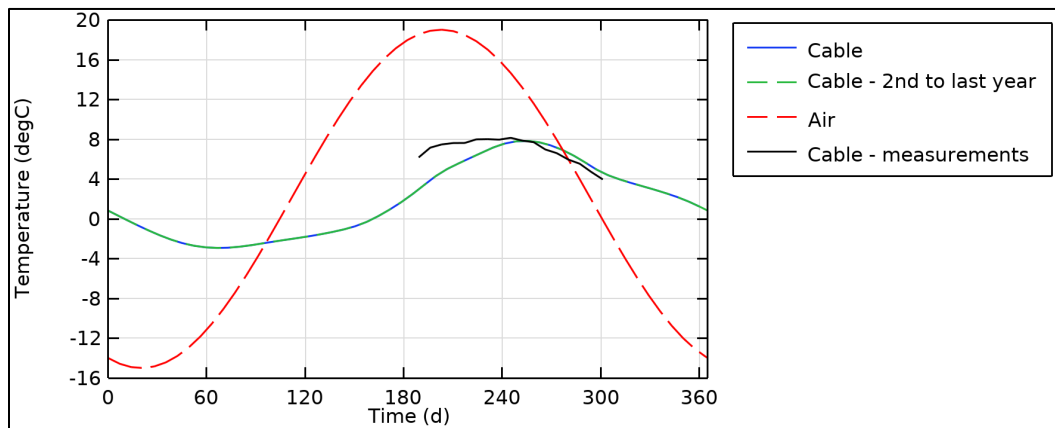
Figure 27. Modeled cable temperature from last year (2022) and second to last year (2021, *solid blue and dashed green lines*, respectively, in excellent agreement). The air temperature input and DTS data from 2022 are also shown.

Assuming no flooding, the modeled temperature at the cable location as well as measured temperatures are shown in Figure 27 (Day 0 = January 1). The measured data is the average of the temperatures at Sta 305+00, 303+00, 302+30, 301+00, 300+00, 299+00, 295+00, 293+00, and 291+75. Both temperatures show a clear peak at the end of summer, even if there is a slight time shift between them. Uncertainties in parameters and boundary conditions contribute to this difference. However, the comparison indicates that the simulation captures the essential features of the heat transport in the dam.

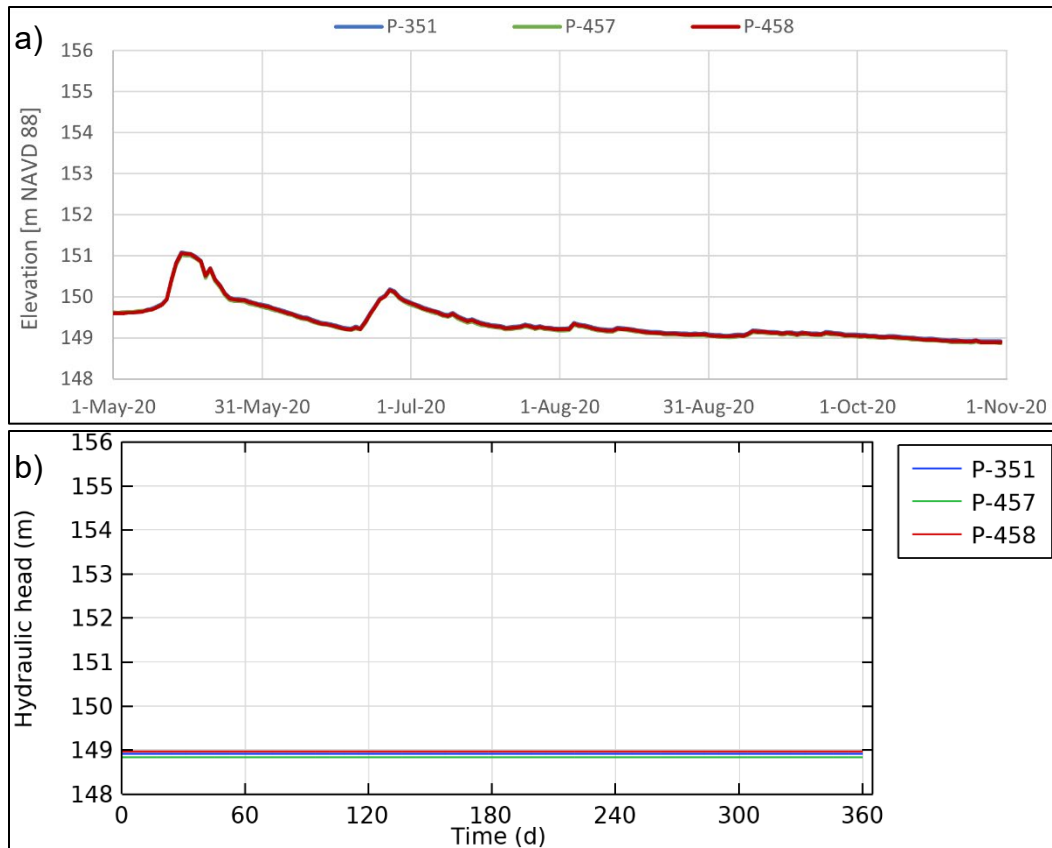
Figure 29. Hydraulic head, computed from piezometric measurements during 2020 (a) (cf. Figure 23) and modeled pressure at no flooding conditions (b).

In general, P-351 has the highest pressure and P-457 the lowest. In the simulation, the most upstream sensor has the highest pressure and the most downstream the lowest (P-458 and P-457, respectively). The recorded data also have variations and higher values during the recorded period because of flooding. Since a constant water table elevation was imposed at the boundary of the model, a steady modeled pressure is expected.

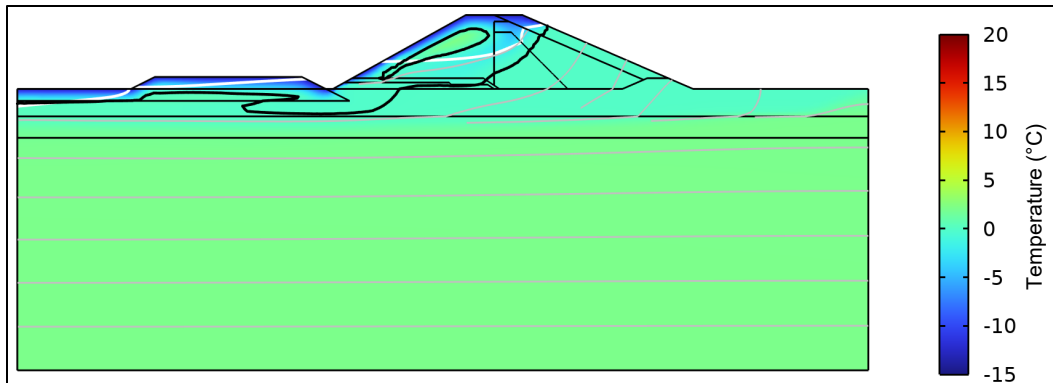
Figure 30. Dam temperature on day 360 (27 December) in the simulation (on the fifth year). The water table, freezing level, and streamlines are also shown (*white*, *black*, and *gray lines*, respectively). The freezing level was assumed to be  $-0.1^{\circ}\text{C}$  (i.e., slightly lower than the imposed reservoir temperature).

The dam temperature at the end of December for a high reservoir level is shown in Figure 30. The figure also includes the water table, freezing level (shown as  $-0.1^{\circ}\text{C}$ ), and streamlines (*white, black, and gray* lines, respectively). At this date, the air temperature is close to its minimum, and the material at the material-air boundary is frozen. The dam surface in contact with the water is close to  $0^{\circ}\text{C}$ . In the dam, a region with temperatures greater than  $0^{\circ}\text{C}$  is reduced as the winter progresses. Below the top foundation gravel layer, the foundation does not freeze.

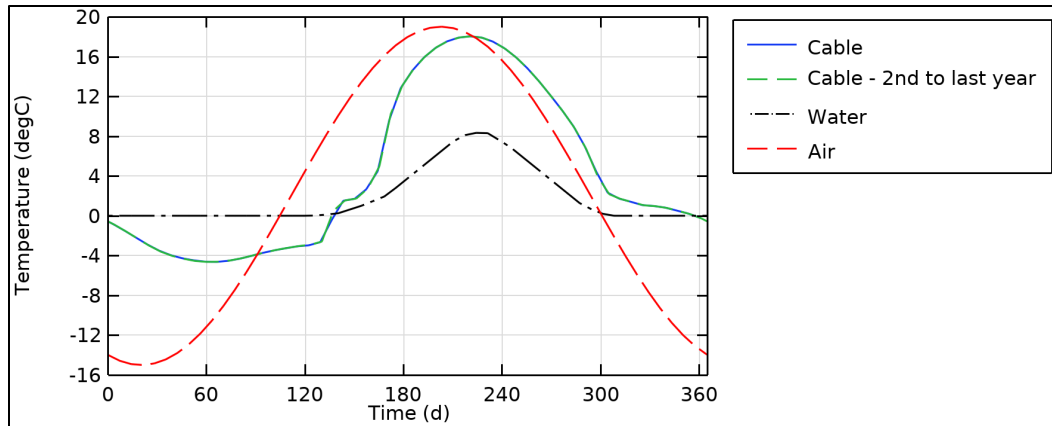
Figure 31. Modeled cable temperature from the last year (2022) and second to last year (2021) at high reservoir level (*solid blue and dashed green lines, respectively, in excellent agreement*). The water and air temperature inputs are also shown.

The modeled cable temperature is shown in Figure 31. Compared to when there is no flooding (Figure 27), the cable temperature is high. The ground is saturated close to the surface, which increases its heat conductivity. A large conductivity enables fast temperature changes of the region around the cable. Correspondingly, the temperature at the cable location is like that of the air. However, there is still approximately a 30 day shift between the air and cable temperature peak.

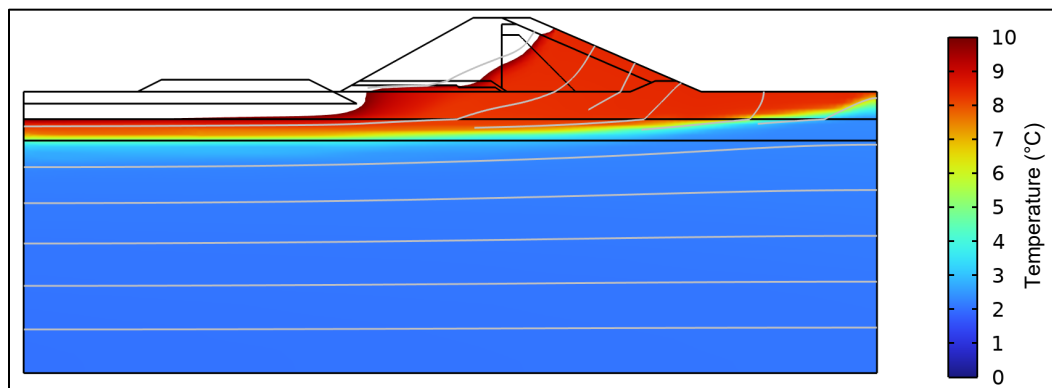
Figure 32. Dam temperature and streamlines (*gray lines*) at day 227 (16 August).

The region influenced directly by the water reservoir temperature is illustrated in Figure 32. Only temperatures between  $0^{\circ}\text{C}$  and  $10^{\circ}\text{C}$  are shown in the middle of August. Air temperatures are above this interval at this date. Therefore, temperatures in regions primarily affected by air temperatures are excluded. Below the top foundation gravel layer, the temperatures are low, indicating that the influence of the water reservoir there is limited.

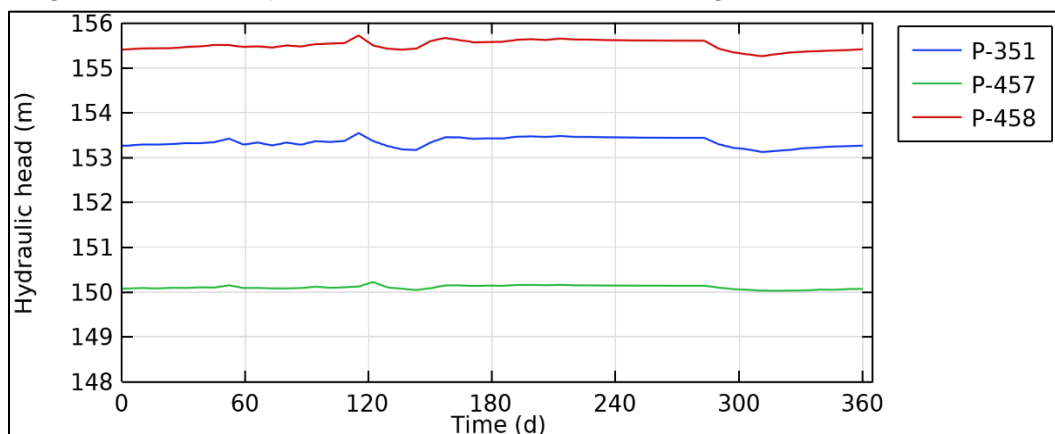
Figure 33. Modeled hydraulic head at positions corresponding to P-351, P-457, and P-458.

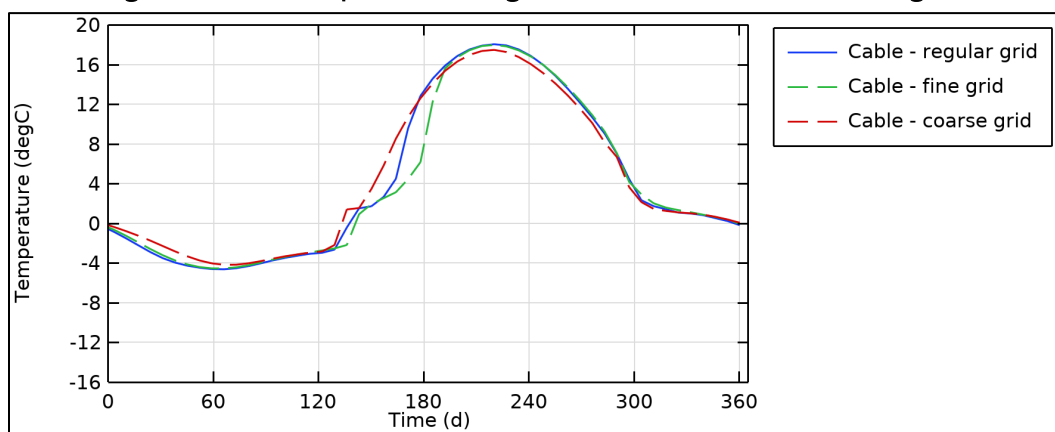
Figure 34. Cable temperatures at high reservoir level for three different grids.

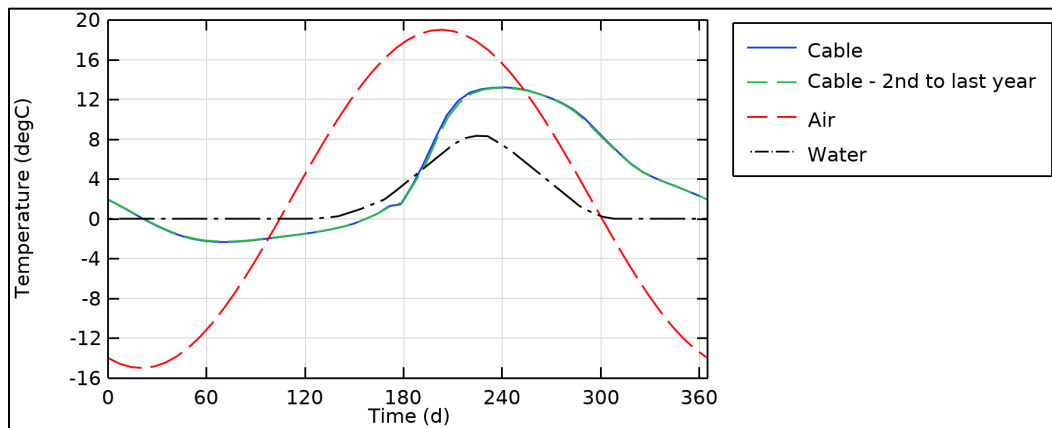
Figure 35. Modeled cable temperature from last year (2022) and second to last year (2021) at flooding (*solid blue and dashed green lines, respectively, in excellent agreement*). The water (*dashed dotted black line*) and air temperature (*dashed red line*) inputs are also shown.

The modeled cable temperature is shown in Figure 35 for a year with flooding. The maximum cable temperature and its phase shift are in between those found for the constant high reservoir and no-flooding simulations. The hydraulic heads at positions corresponding to P-351, P-

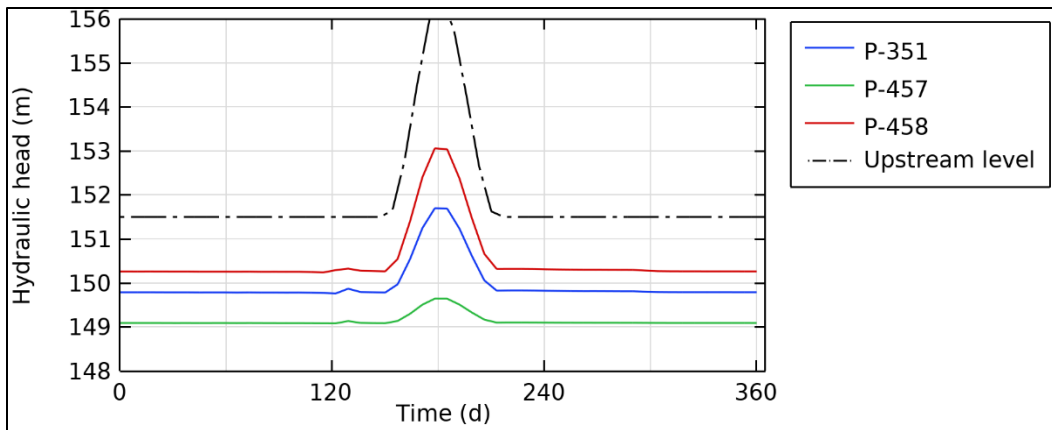
Figure 36. Modeled hydraulic head at positions corresponding to P-351, P-457, and P-458. The upstream water table level is also shown (*black dotted dashed line*).
