*Installation Technology Transition Program (ITTP)*

## **Initial Data Collection from a Fiber-Optic-Based Dam Seepage Monitoring and Detection System**

October 2023

Final Report

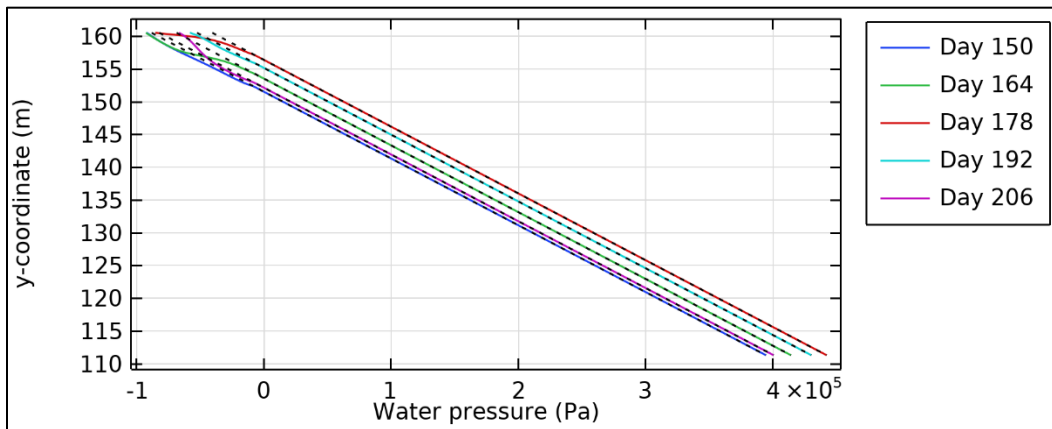
Figure 37. Water pressure on the boundary where the pervious layer boundary condition is applied, shown at five different times (with 14-day difference) during which the upstream water table elevation changed. Imposed water pressure distributions are shown with *black dotted lines*, valid above 0 Pa.

In this simulation, the upstream water pressure was applied with the pervious layer boundary condition. To check that the water pressure was correctly imposed, the measured pressure was compared with the theoretical distribution (Figure 37). There is a satisfactory agreement between the applied and measured pressure from the bottom of the model to the water table (water pressures above 0 Pa).

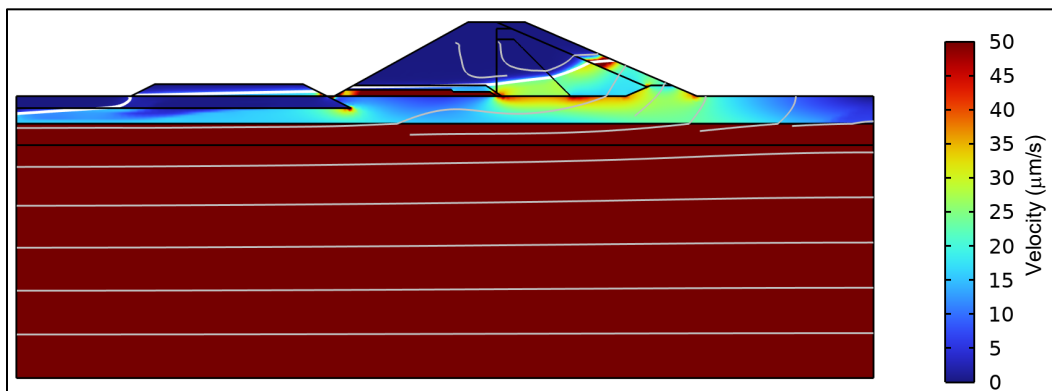
Figure 38. Velocity magnitude ( $\mu\text{m/s}$ ) at day 178 (28 June). The color bar is limited to show 0  $\mu\text{m/s}$ –50  $\mu\text{m/s}$ . The water table is indicated with a *white line* and streamlines with *gray lines*.

The flow velocity magnitude for day 178 (28 June, rising water level) is shown in Figure 38. The velocity above the water table (unsaturated zone) is close to 0  $\mu\text{m/s}$ . The foundation gravel layers, and the drain have a large velocity due to their high permeability.

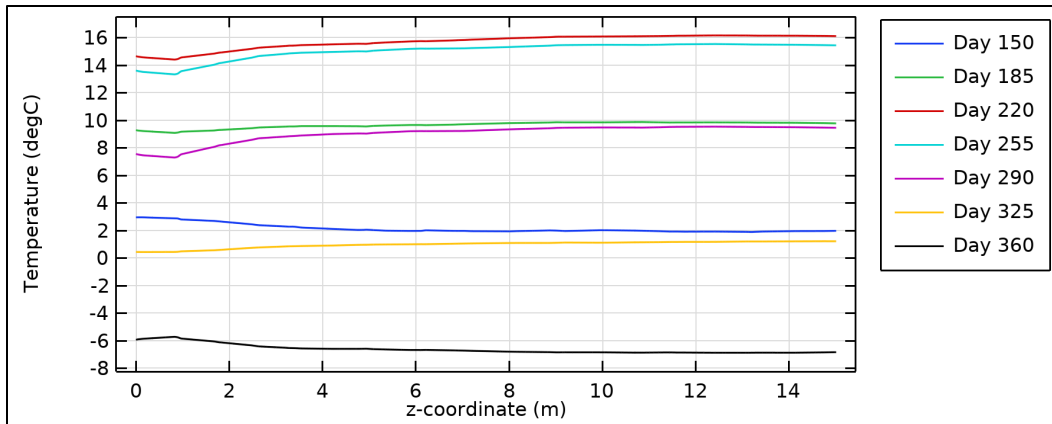
Figure 40. Measured temperature at the high-water level at different dates.  
 (Day 150 = 31 May; Day 185 = 5 July; Day 220 = 9 August; Day 255 = 13 September;  
 Day 290 = 18 October; Day 325 = 22 November; Day 360 = 27 December.)

The temperature measured at the location of the cable at the high-water level is shown in Figure 40. There is around a  $1^{\circ}\text{C}$  temperature difference between the defect region and the other side of the model ( $z = 0$  and  $15$  m, respectively).

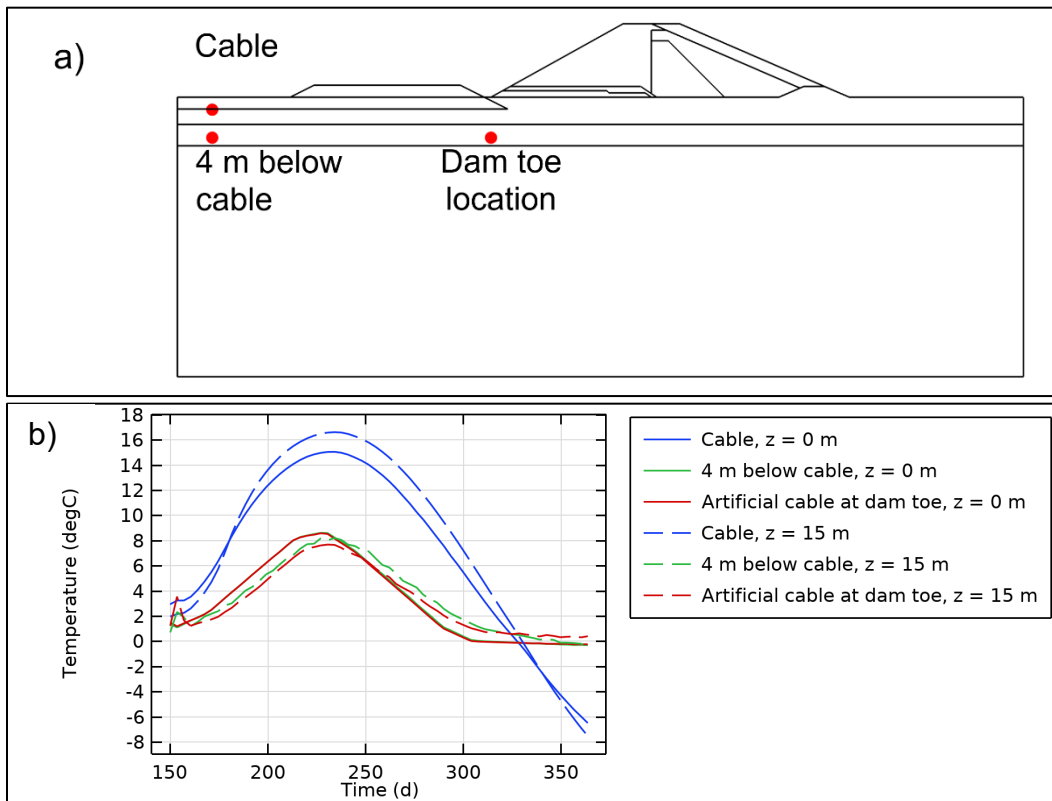
Figure 41. Spatial location of temperature measurements (a) (red dots). These locations include the position of the cable, a line 4 m below the cable, and a location below the dam toe. Temperature for several locations (b) as shown with red dots in (a).

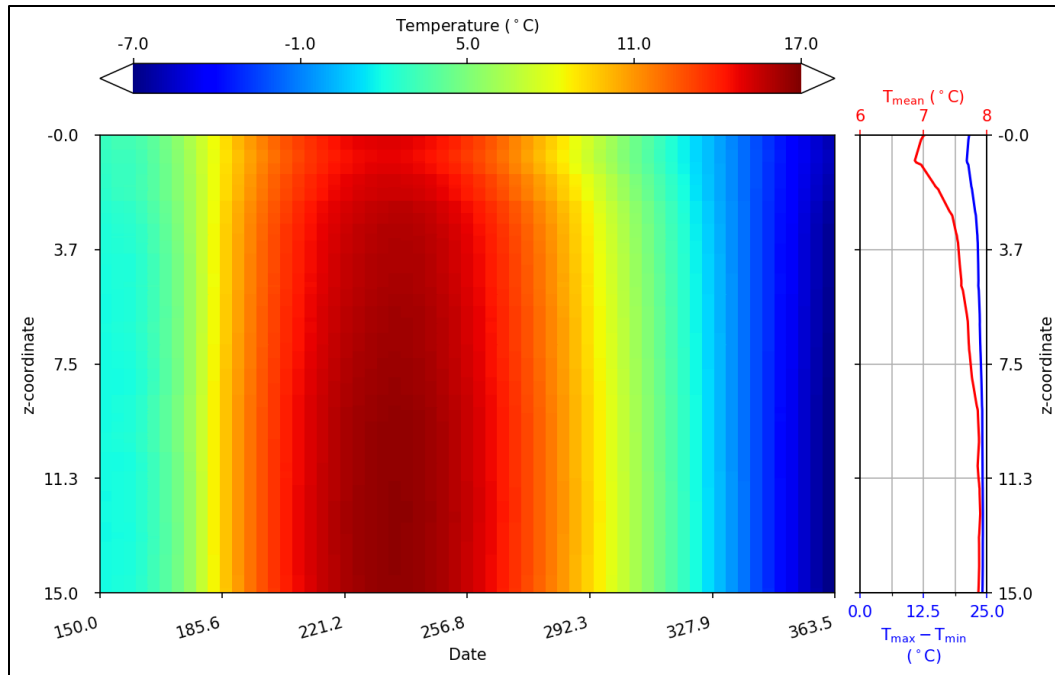
Figure 42. Temperature map from the location of the cable installation at a high-water level.

A temperature waterfall plot is shown in Figure 42, constructed from the temperature at the cable location. The highly permeable region is apparent around  $z = 0$  m by the reduction in temperature it induces. The mean

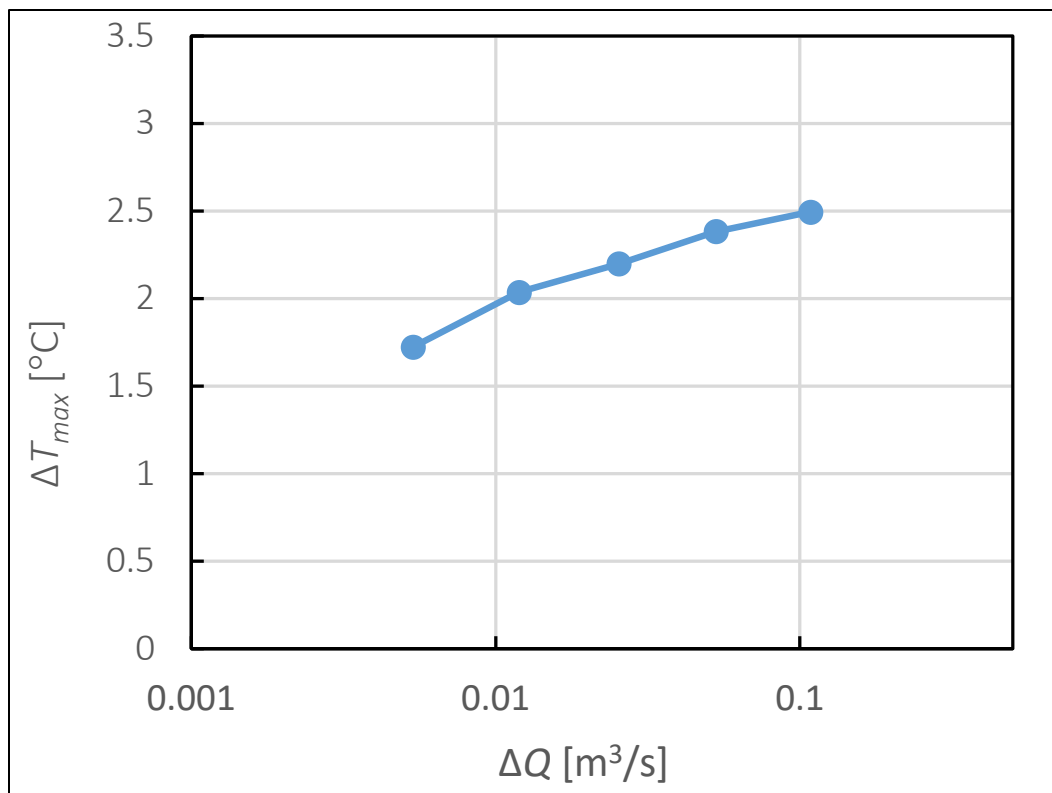
Figure 43. Maximum temperature difference between  $z=0$  and  $15 \text{ m}$  at the location of the fiber optic cable,  $\Delta T_{max}$ , and flow due to a higher permeable region,  $\Delta Q$ .
