NORAD C.O.C.
COLORADO SPRINGS, COLORADO

REPORT OF INVESTIGATION
OF CHEMICAL GROUTS FOR
ROCK BONDING

EVALUATION OF THE EFFECTIVENESS OF EPOXY RESIN
AND POLYESTER RESIN TO STRENGTHEN FRACTURED
GRANITE AT NORAD C.O.C.

U. S. ARMY ENGINEER DISTRICT, OMAHA
CORPS OF ENGINEERS
OMAHA, NEBRASKA
JULY 1963

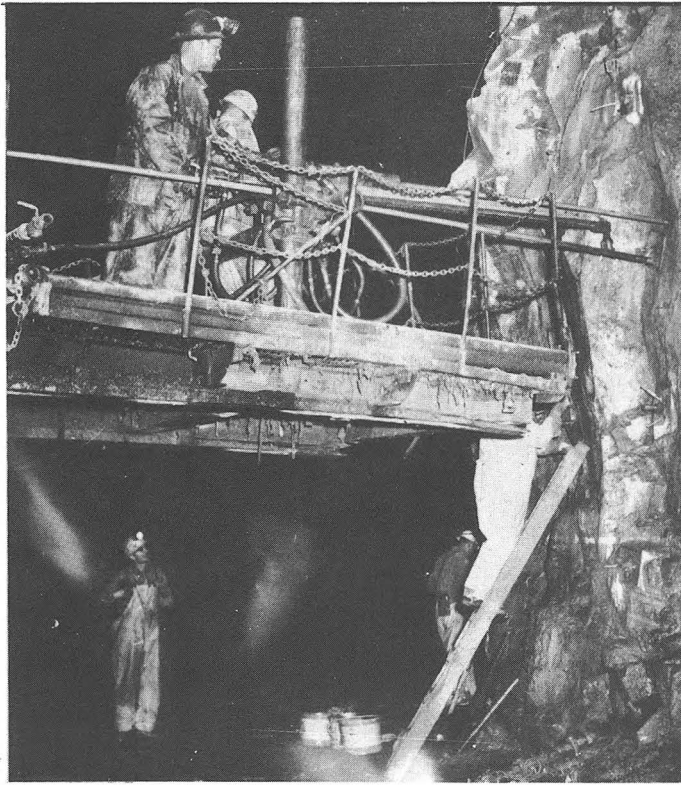
Drilling Injection Holes

When pressure washing was completed, the visible surface cracks were thoroughly grouted with a quick-setting cement mortar which was forced into each crack. The larger cracks were backed with jute packing. The drilling and calking operations are shown in Photographs No. 1 and 2, Plate 1.

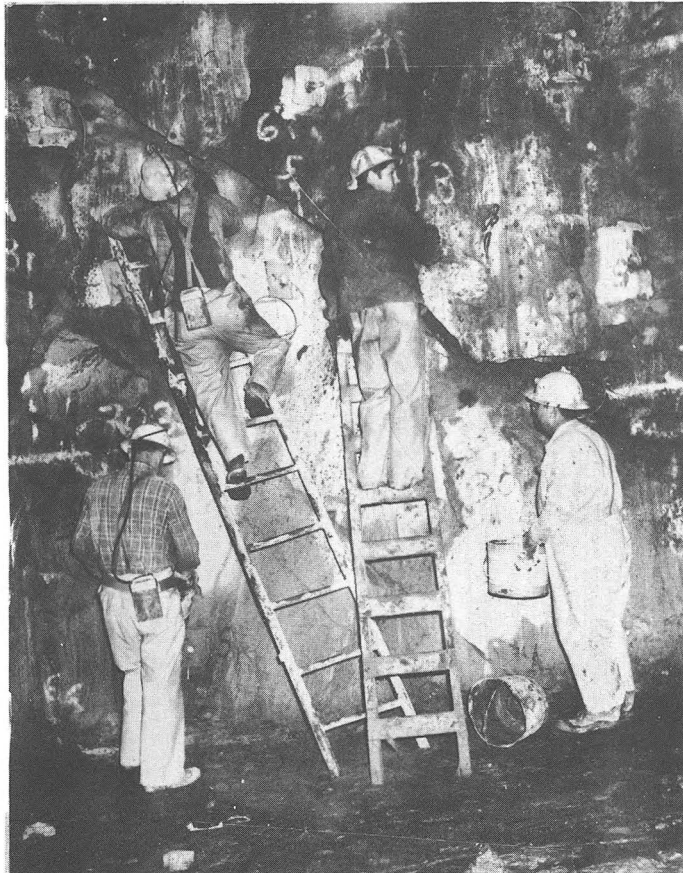
2

Calking Cracks

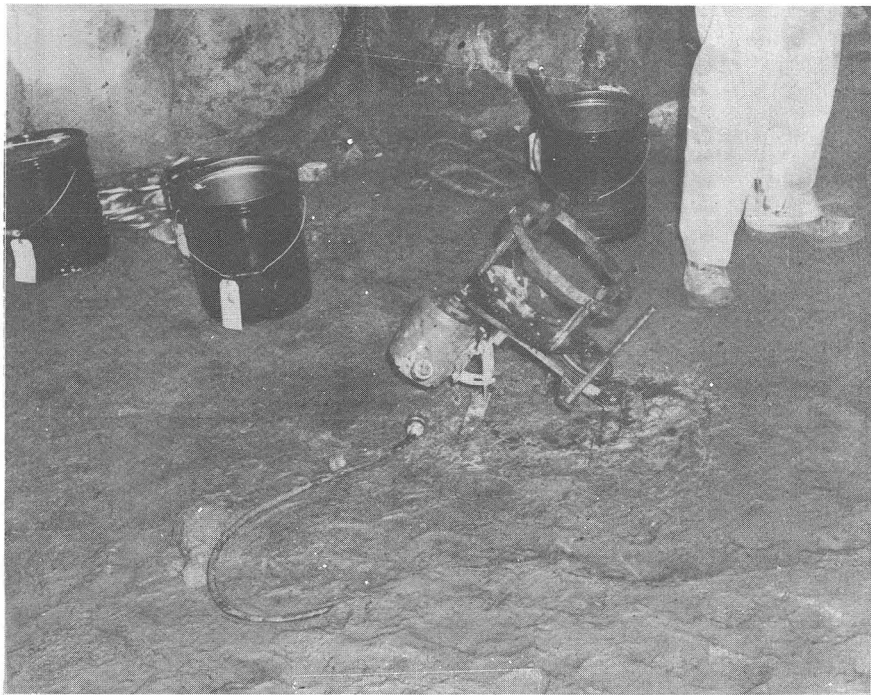
4

Mix-All Type Mixer

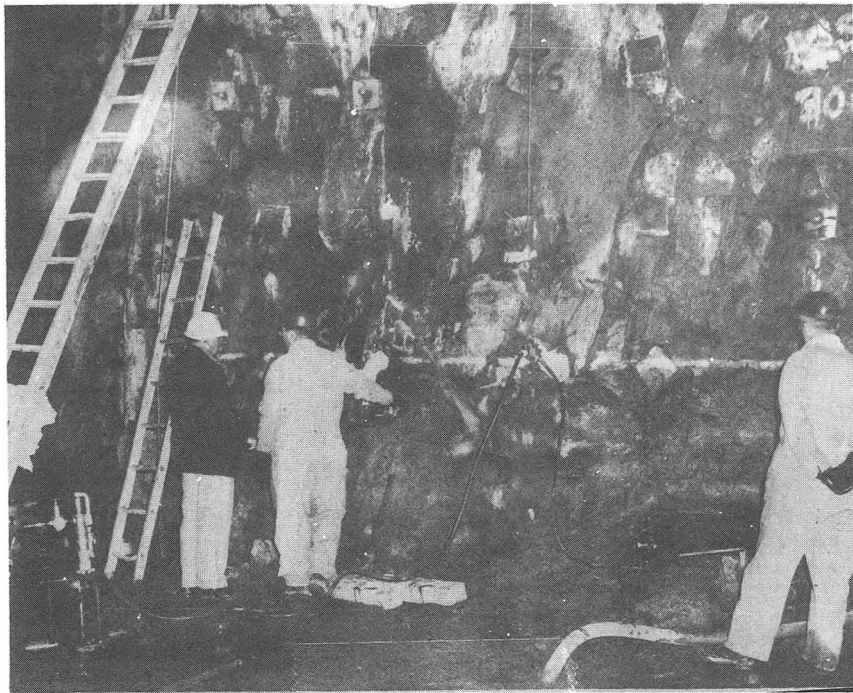
8

Epoxy Resin Injection Operations

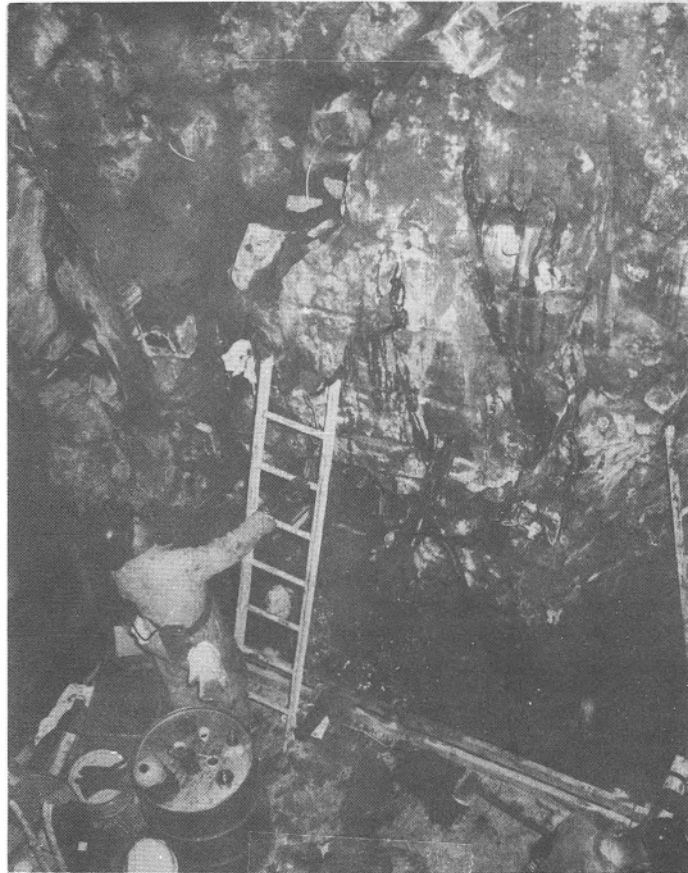
12

Polyester Resin Grout Returns During Injection of Hole T-8

value (estimated at 50 psi at the collar), and the rate was reduced. This was done as an additional precaution against causing further movement. Hole T-8 had a diameter of $1\frac{1}{2}$ inches and a depth of 24 feet. The wide range of surface returns during grouting of this hole are shown in Photographs starting with No. 12, Plate 6 and continuing through No. 14, Plate 7. The injection hole can be identified in each photograph by the location of the injection nozzle. Surface returns were noted from at least four anchor bolt holes as far as 8 feet from the point of injection and from cracks predominately at elevations above the hole. Surface returns were noted from approximately 20 locations around the hole. This hole took approximately 78 gallons of grout during the 227 minutes of injection. It is considered that this hole was extremely well vented and that distribution of the grout was especially good.

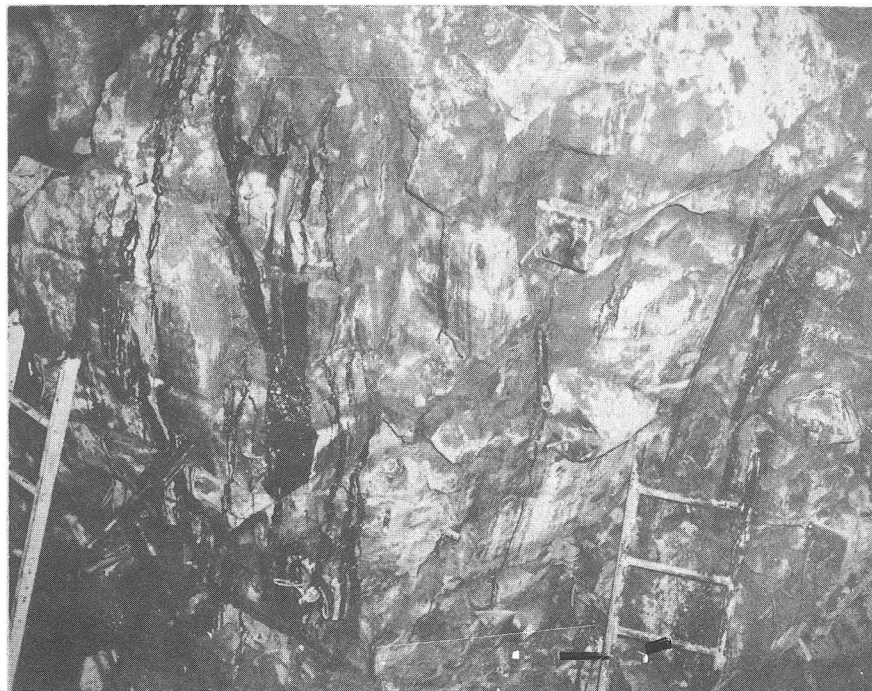
14

Polyester Resin Grout Returns During Injection of Hole T-8

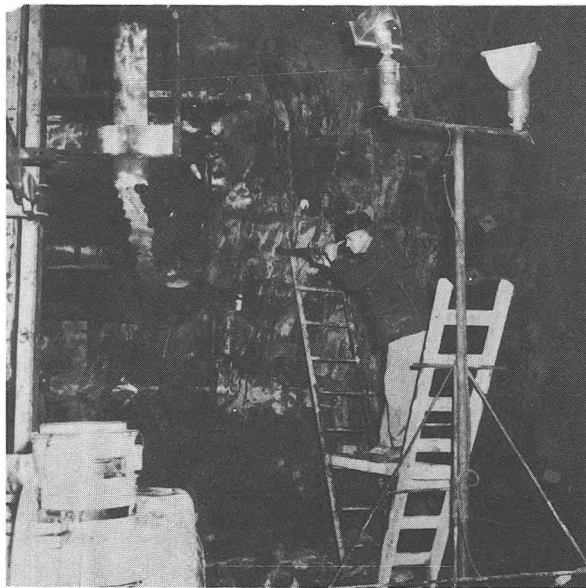
16

Stratascope Operation

b. Core Holes. Examination of the core holes with the U. S. Bureau of Mines' stratascope gave the best information on the location and width of cracks, and it was possible to see roughly how well filled the cracks were. It was not possible to determine the bond by visual observation. Briefly the following are conclusions from examination of the core holes:

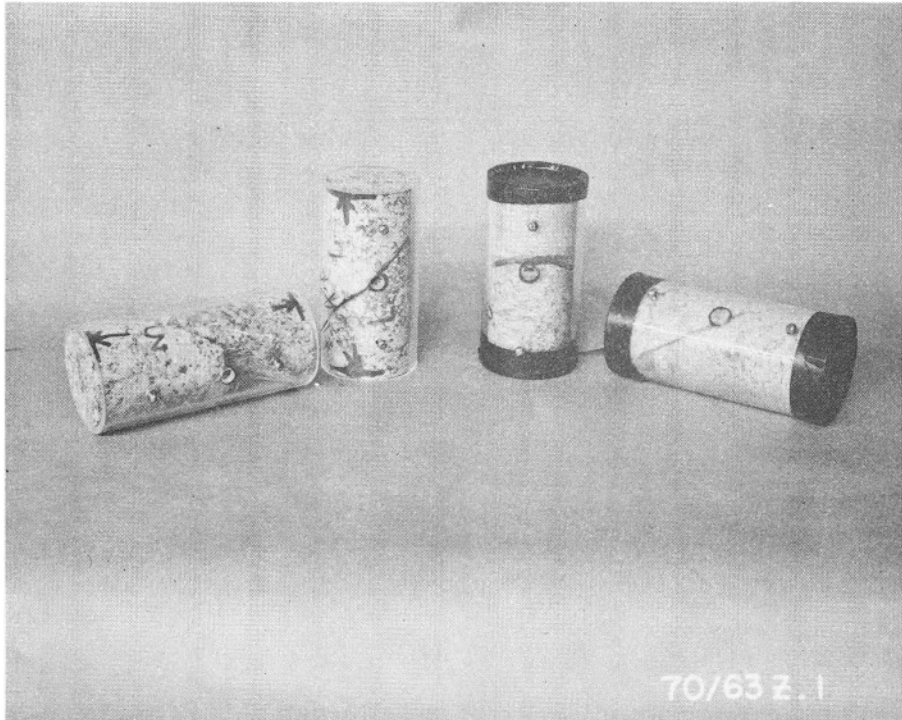
(a) Alignment and spacing of rock cores in lucite tubing, and showing end closure by neoprene tape to prevent leakage of grout.

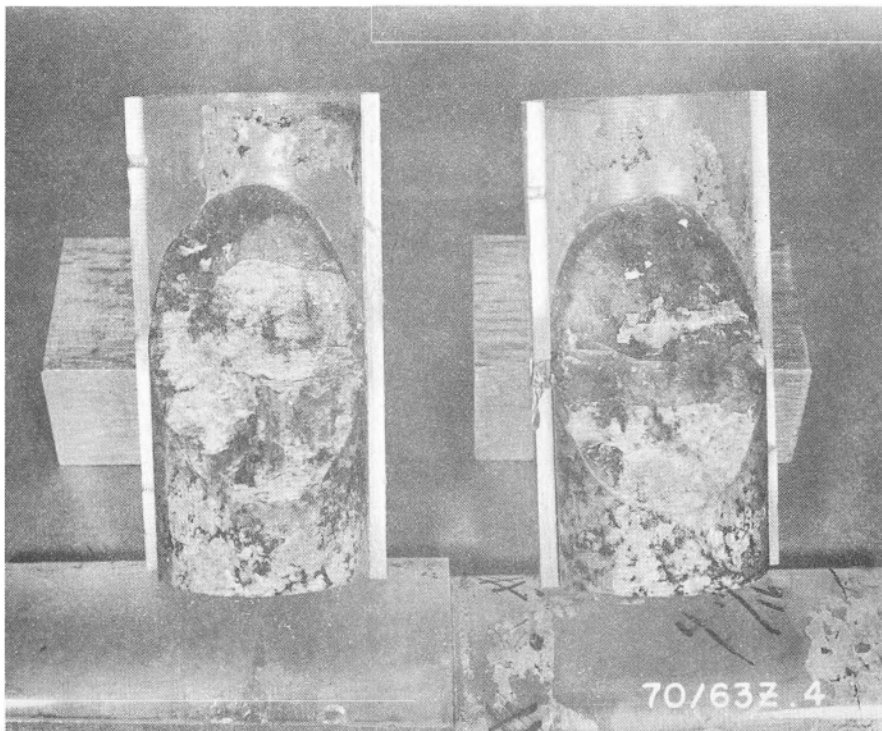
(a) Sawed halves of lucite tubing to remove bonded cores. Also shows Core No. 12 bonded with polyester resin which separated during sawing.
