Deadmans Run Lincoln, Nebraska

Section 205 -Flood Risk Management

Final Integrated Feasibility Report and Environmental Assessment

August 2018

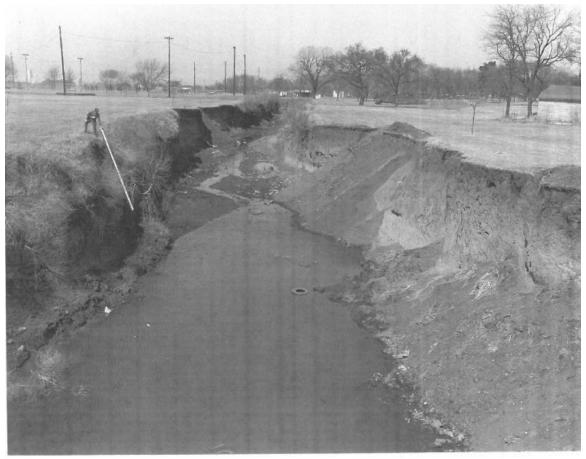
impervious area throughout the watershed, storm events yielded larger amounts of runoff. With less sediment from the surrounding area, the channel began down cutting and head cutting upstream. By the middle of the 20th Century, many of the channels within the watershed were deeply incised as noted in Figure 6, which is a picture of the Deadmans Run channel northwest of 52nd and Francis Streets in 1967. In response to the increasing erosion problem, a large portion of the Deadmans Run channel bed and banks were covered with fabric-formed concrete mats and gabion cages, installed by the LPSNRD and City of Lincoln over many years (Figure 7). Since installation of the erosion control measures, the channel and banks have remained relatively stable during the past few decades. No signs of erosion were found where erosion protection measures are in place.

Figure 6. Channel Erosion Northwest of 52nd and Francis Streets in 1967

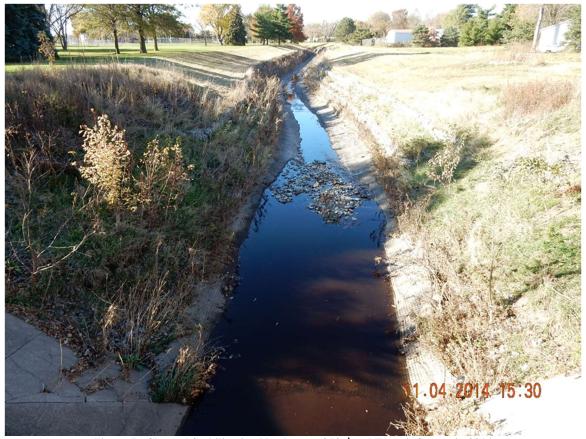
Figure 7. Channel Stabilization Northwest of 52nd and Francis Streets in 2014

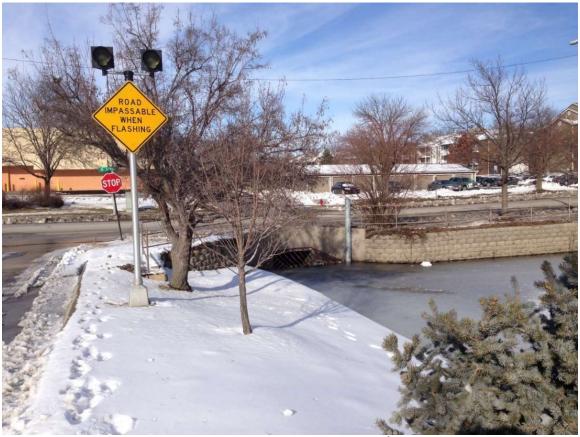
first floor elevations of buildings, relocation of buildings and buy-outs. These measures result in physical modifications to buildings in flood hazard areas that make them less vulnerable to flood damages or removal of the buildings from the flood hazard area entirely. Nonstructural measures can be implemented for public and private structures. Relocation or acquisition is the only acceptable nonstructural measure for structures located in the FEMA regulatory floodway. Implementation of nonstructural measures requires the permission and active participation of the property owners. Non-physical measures such as automated flood warning systems, which supplement National Weather Service flood warnings, can also reduce the threat to life and give warning to remove some property from flood prone areas ahead of a flood. Figure 13 shows an example of a flood warning device found in Lincoln, Nebraska.

Figure 13. Stage Activated Traffic Flood Warning Device near 50th and R Streets, Lincoln, NE

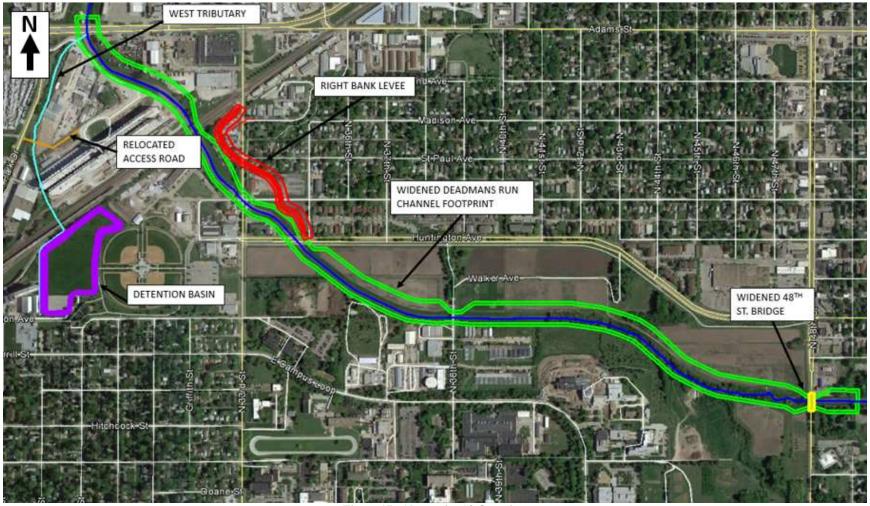
Similar to Alternative #1, the initial version of Alternative #2 only included structural measures along the main Deadmans Run channel. However, the HEC-RAS models for Alternative #2 also showed that backwater effects were produced with the implementation of the structural measures due to coincident hydrographs on the main channel and the West Tributary. Therefore, the detention basin and relocated access road were incorporated as pieces of Alternative #2 as well.

Figure 17. Alternative #2 Overview

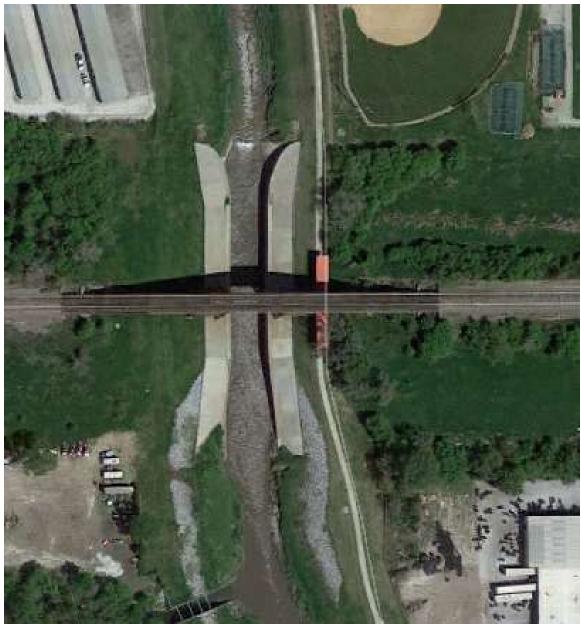
The two railroad bridges that span the Deadmans Run channel were identified as constraints when modeling the 1% ACE event. However, it was determined to be cost prohibitive to remove and replace the existing structures. Rather, the TSP proposes to construct a concrete flume that would run beneath both railroad structures. This flume would increase the hydraulic efficiency, allowing the channel to pass the flows from the 1% ACE event while retaining the existing railroad structures in place. To prevent erosion around the concrete flume and gradually contract and expand flows entering and exiting the flume, the flume will be gradually widened up and downstream from the bridges until the width of the flume matches the width of the proposed channel. A detailed cross-section of the proposed flume can be found in Appendix J. Figure 22 shows an example of a similar flume designed and constructed by the USACE Omaha District in the 1990s on the Big Papillion Creek in Omaha, Nebraska.

Figure 22. Concrete Flume under Railroad Bridge (Southeast of 84th St. & I-80, Omaha, NE)

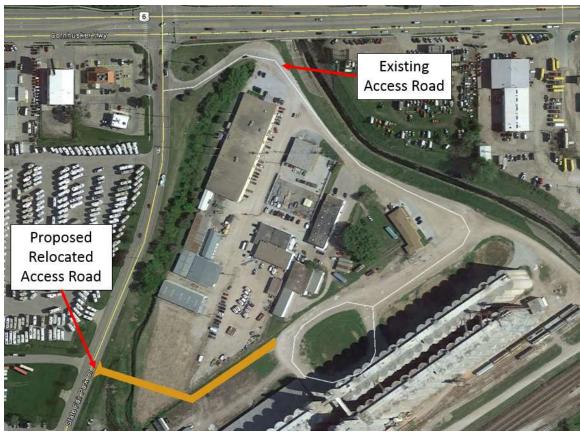
An additional benefit that could be realized by relocating this access road is the improved safety of the intersection that would allow for a safer and more efficient intersection. It should be noted that the relocation of this access road would necessitate the relocation of some of the existing facilities associated with the grain elevator, shown in the bottom right portion of Figure 23, such as the weigh station, as the flow of traffic would be reversed from its existing direction.

Figure 23. Existing & Proposed Relocated Access Road along the West Tributary

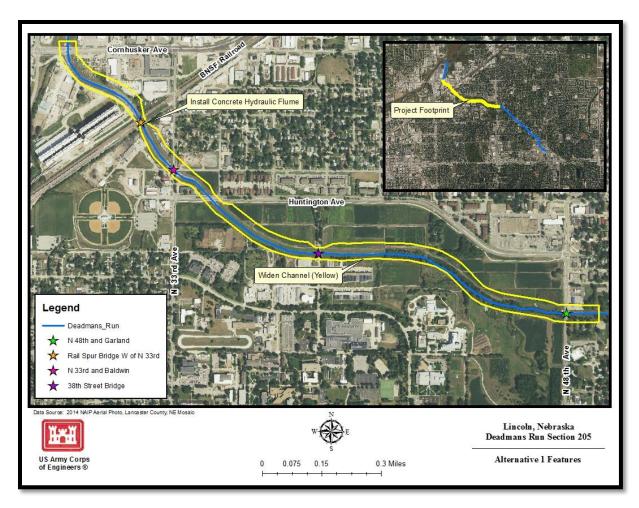
As described in the Section 205 Feasibility Report and Integrated EA, the Corps proposes to implement the Recommended Plan- Updated Alternative 1. The Recommended Plan would consist of widening and improving Deadmans Run from Cornhusker Avenue upstream to just east of 48th Street, installation of a concrete flume under the BNSF Bridge and rail spur to improve conveyance, and removal and replacement of an existing concrete mattress with 44,672 tons of rock riprap extending 7,196 linear feet of the project area. The concrete flume will require 18,677 tons of riprap for the spall filter, resulting in a net total 63,349 tons of riprap utilized within the channel.

Figure 2. Proposed project components of the Preferred Alternative

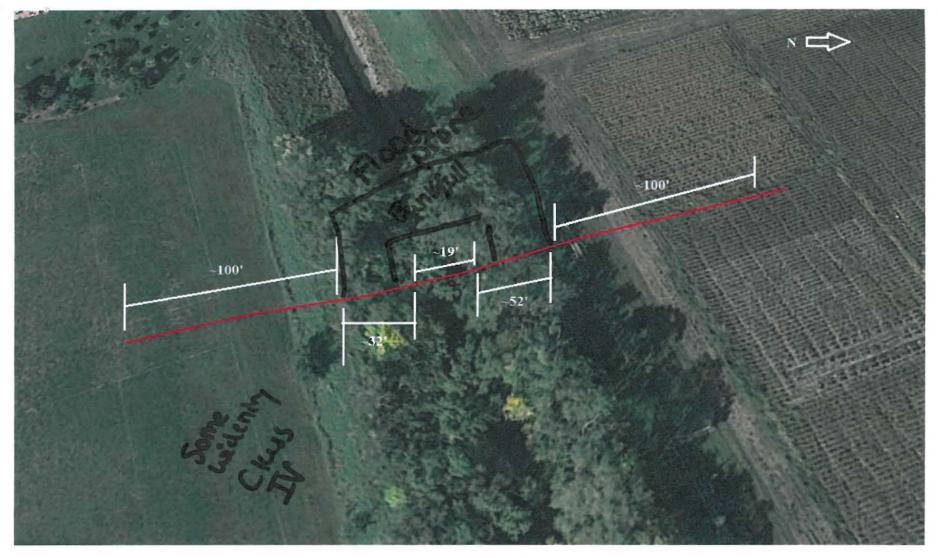
Approximate cross section of DP5. Imagery from GoogleEarth® 2016.

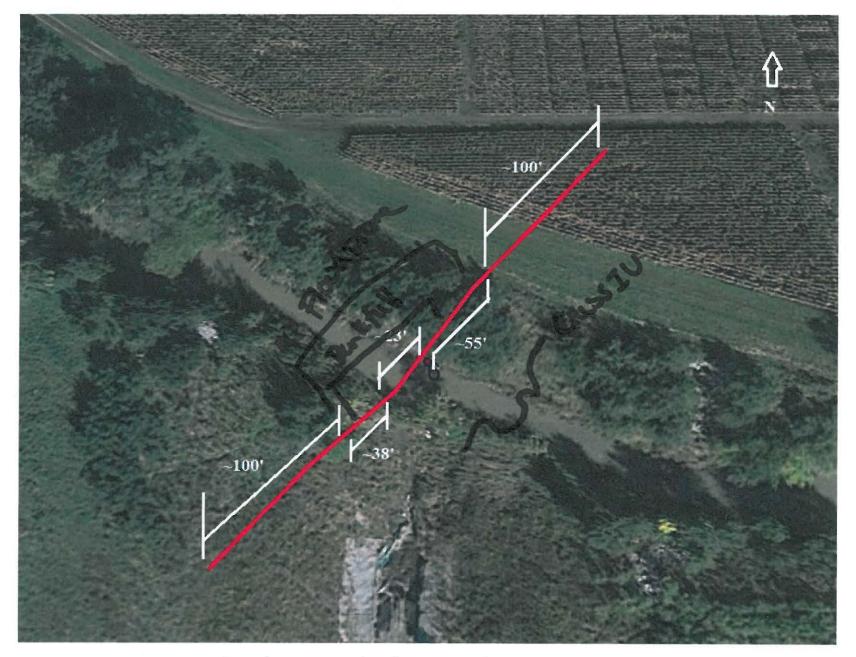
Approximate cross section of DP6. Imagery from GoogleEarth® 2016.

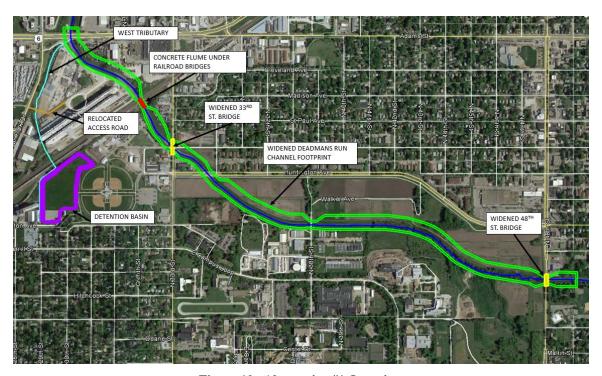
Figure 10. Alternative #1 Overview

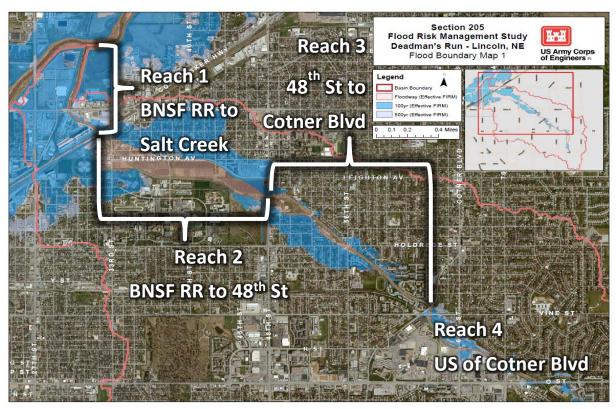
Figure 2. 2007 Effective Floodplain map

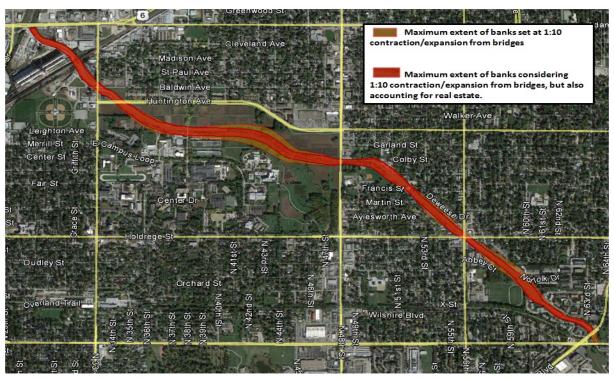
Figure 10. Contraction and Expansion at bridges being optimized to increase flow. Maximum channel extents vs realistic extents based on real estate.
