Engineering for Polar Operations, Logistics, and Research (EPOLAR)

Remediation of Old South Pole Station Using Autonomous Data Collection and Remote Assessment of Ground-Penetrating Radar

July 2015

Final Report

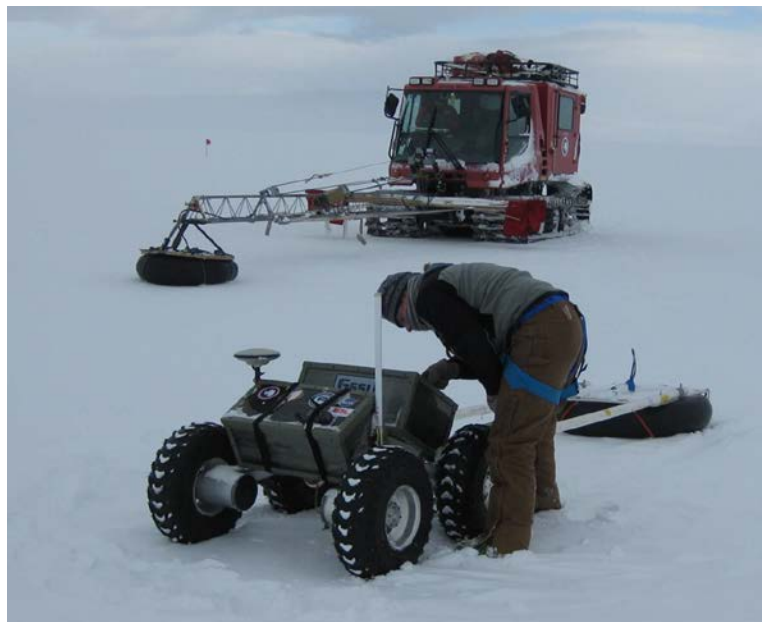
Figure 3. The Yeti rover deployed to the McMurdo shear zone crossing to support the South Pole Traverse (October 2010). In the background is a tracked over-snow vehicle, one type of vehicle used to conduct manual GPR surveys, equipped with identical instrumentation as the rover.

The autonomous rover, Yeti, was specifically designed to conduct GPR surveys in challenging polar environments and was developed through a partnership between Dartmouth College and the U.S. Army Cold Regions Research and Engineering Laboratory (CRREL). Yeti has been used successfully in the harsh Arctic and Antarctic environments to detect crevasses for overland traverses, withstanding air temperatures of -22°F . Figure 3 is a photograph of Yeti supporting the South Pole traverse during a GPR survey in the McMurdo shear zone crossing. With its smaller footprint and tighter turning radius, the robot is capable of collecting high quality GPR data at closer spacing compared to the more conventional approach of a small-tracked, over-snow vehicle outfitted with a forward-extending boom containing the radar antenna.

Yeti is battery powered, weighs approximately 160 lb, and exerts a low ground pressure at approximately 2 psi through 20 in. pneumatic ATV tires. It has a small footprint, 12 in. of ground clearance, and a central chassis pivot to maintain four-wheel contact over rough terrain. With 4-

wheel drive, it has displayed excellent mobility over polar snow during three deployments in Antarctica and two in Greenland. Autonomous navigation is via Global Positioning System (GPS) waypoints following a pre-defined survey grid loaded into the robot, or manual control is through a 2.4 GHz radio link. A 400 MHz GPR antenna is towed behind the robot in an air cushion and is the same equipment commonly used to conduct manual GPR surveys (Figure 4). A Geophysical Survey Systems, Inc. (GSSI), SIR3000 radar controller is on board the rover. The forward compartment on the rover houses the control electronics while the lithium-ion batteries and radar controller are located in an insulated rear compartment to keep the batteries warm for sufficient run time.

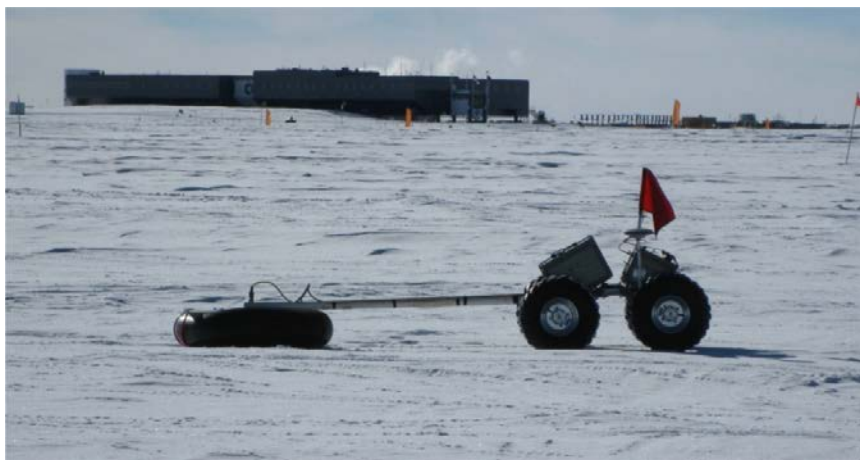
Figure 4. The Yeti rover conducting an autonomous GPR survey at the Old Pole site. To maintain close contact between the radar antenna unit and the snow surface and to protect the unit from severe vibration, the GPR 400 MHz transducer is mounted within an inflated inner tube and towed behind the rover. The GPR control unit is contained in the left compartment on the rover, between the wheels. In the background is the Amundsen-Scott South Pole Station in close proximity to the geographic South Pole.

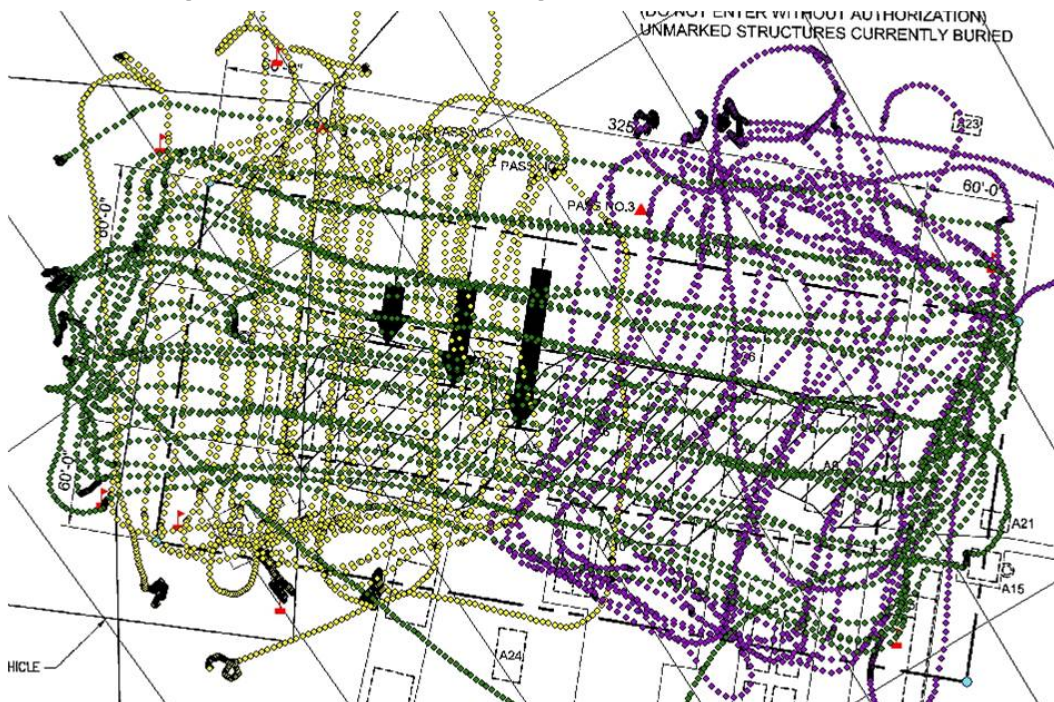
Figure 7. Yeti's position as indicated by 1 sec GPS tracking during three autonomous surveys over Old South Pole. *Yellow* indicates the survey conducted on 6 December 2011, *purple* designates 7 December 2011, and *green* indicates 8 December 2011.

The GPS tracks from the autonomous surveys were overlaid onto a map of Old South Pole. Figure 7 indicates the path of the rover during the surveys and verifies the complete survey coverage. The wide turns at the beginning

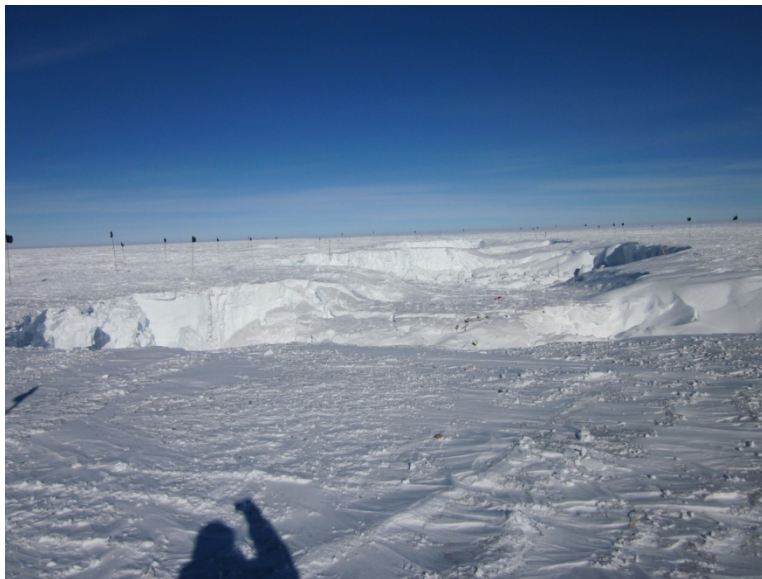
The displaced material from each blast collected in a mound along the crater's central horizontal axis (Figure 8). The drift snow filled the crater after blasting and created localized cornices on the crater's windward side, creating hazardous conditions, particularly at the vertical interface where drift snow often does not adhere well to the crater wall. Snow conditions within the crater were expected to be highly variable with some locations being more densely compacted as a result of the displaced debris.

Figure 8. A view looking west of the cratered area of Old South Pole after blasting was completed. Taken 10 December 2011, this illustrates the debris mounds along the center of the crater.

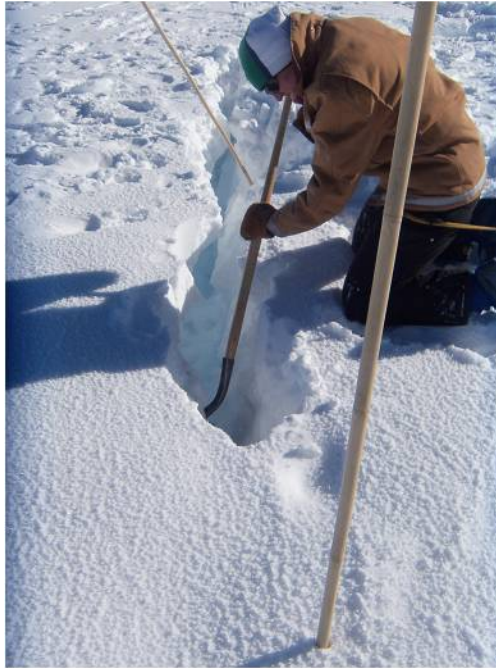
Following safety protocols, including using harnesses and ropes, RPSC personnel conducted a subsurface investigation along the crater's perimeter and interior. They used hand tools and poles (Figure 9) to probe the upper 6–8 ft below the snow surface and determined the presence of small, shallow subsurface voids along the interface between the crater wall and the drift snow, which they then exposed. Additionally, at two locations they collected cores using a 4 in. diameter fiberglass coring auger to obtain a snow density profile with depth.

Figure 9. RPSC personnel used hand tools to determine the depth and extent of small subsurface voids. (Photo by RPSC.)

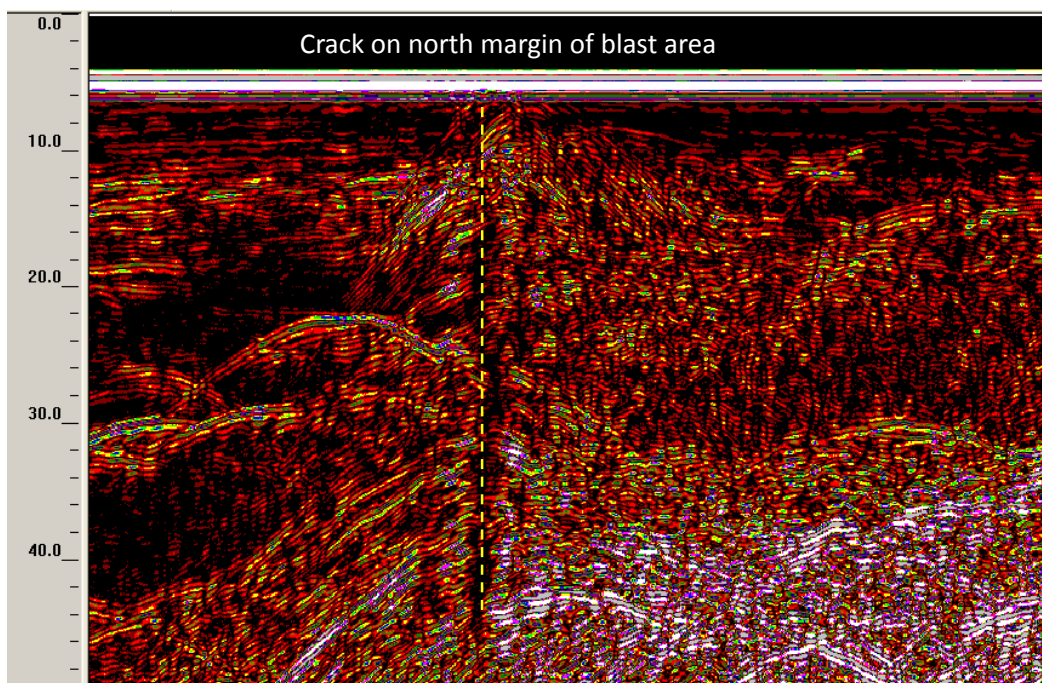
- The GPR data revealed cracks, or vertical gaps, in the drifted-in snow along the northern (windward) wall of the crater (Figure 12). This posed a hazard to pedestrian foot traffic; however, we believed the gap was too narrow to threaten vehicle operations, which we communicat-

Figure 12. A radar sequence revealing a vertical crack along the northern margin of the blast crater, likely the result of imperfect infilling by blowing snow, predominately from the windward direction. The vertical axis shows the depth below snow grade (ft), and the horizontal axis is a linear distance.

ed to station personnel prior to our departure. Soon after, following safety precautions, such as ropes and harnesses, station personnel used hand tools to probe these gaps, confirming what was observed in the radar data and determining the extent and depth of the vertical gaps (RPSC, pers. comm., 2011). Using heavy equipment to backfill the site as planned closed the cracks to sufficient depth to eliminate their hazard to personnel.

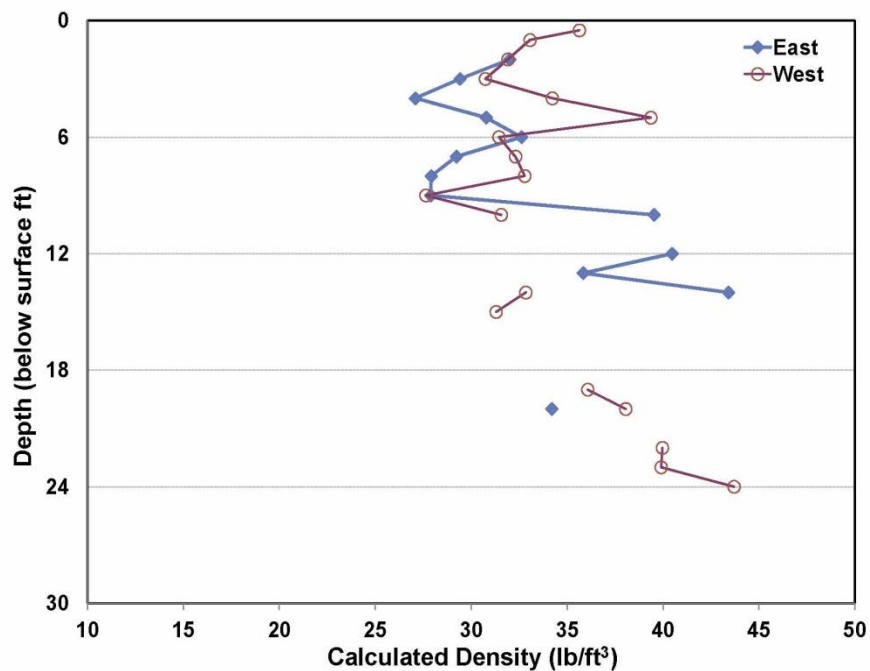
Two cores were collected by RPSC to depths of approximately 25 ft below snow grade to determine the profile of the snow density with depth (Figure 15). Within the upper 10 ft from the surface, the density averaged 31.8 lb/ft³. While coring, RPSC visually observed that sections of the core samples varied with some sections containing voids or bits of blast debris. Several samples also contained large snow crystals. On the east side below a

Figure 15. The profile of density with depth calculated from cores collected from within the crater area.

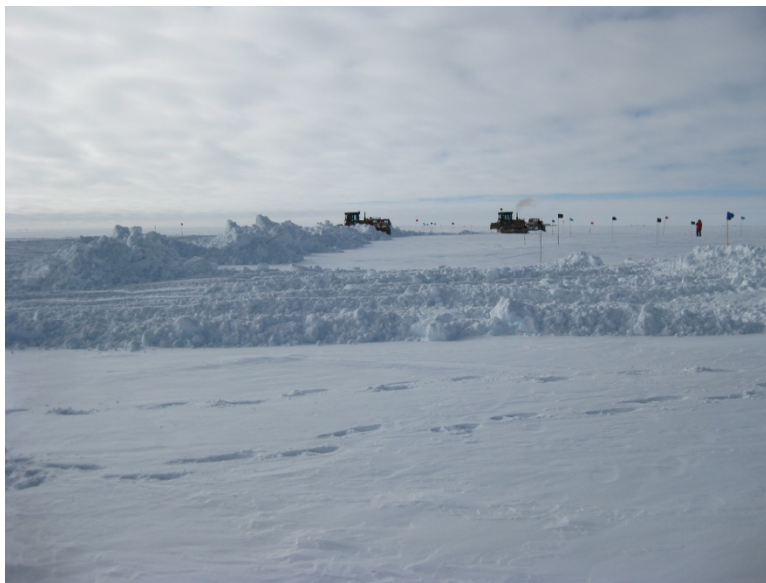
Figure 17. Backfilling Area 1 by pushing snow in a 3-pass progression using bulldozers. The view looks toward the east.

Backfilling the primary drifted-in crater area was completed in January 2012, in approximately a day, by using two D6 bulldozers (Figure 17). Bulldozers pushed snow in a 3-pass progression (indicated by the arrows in Figure 16), beginning on the northern side of the crater and working around the perimeter. Pass one was a short pass just outside the crater boundary to break through the vertical shear wall created from the blasting. This also broke up any small near-surface voids created from the drift snow, such as the ones identified along the northern boundary of the crater. The second and third passes of the dozers began further away from the center of the crater. Once backfilled, personnel leveled the surface by using a drag. Figure 18 shows Area 1 several days after backfilling was completed. In Figure 18, the flagging on the left side defines the locations of the fuel arches, the area including Building 10, and the Tunnel/Ramp (Figure 16). Concurrent with backfilling Area 1, personnel backfilled the location on the west side of the test area where the D-8 dozer sank into a shallow depression in early 2010.

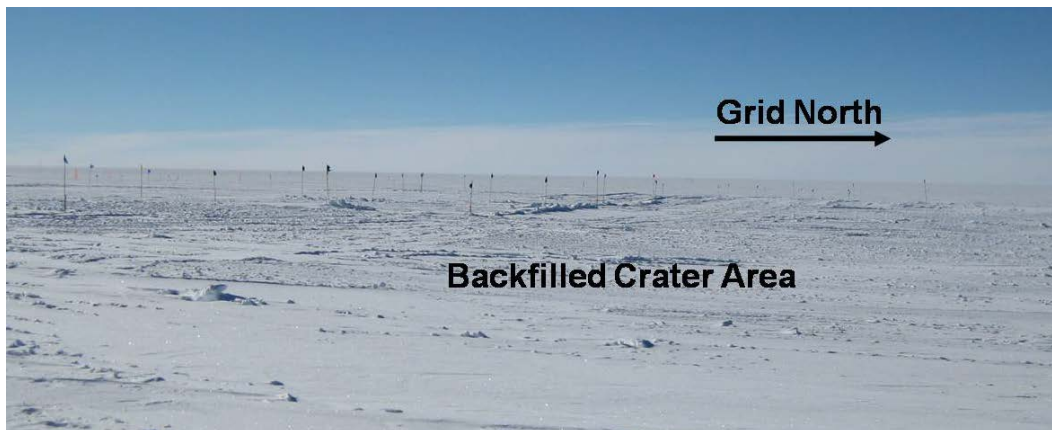
Figure 18. The view looking to the west of the completed Area 1. The flagging on the left side of the photograph identifies the locations of the subsurface fuel arches, the area near Building 10, and the Tunnel/Ramp.

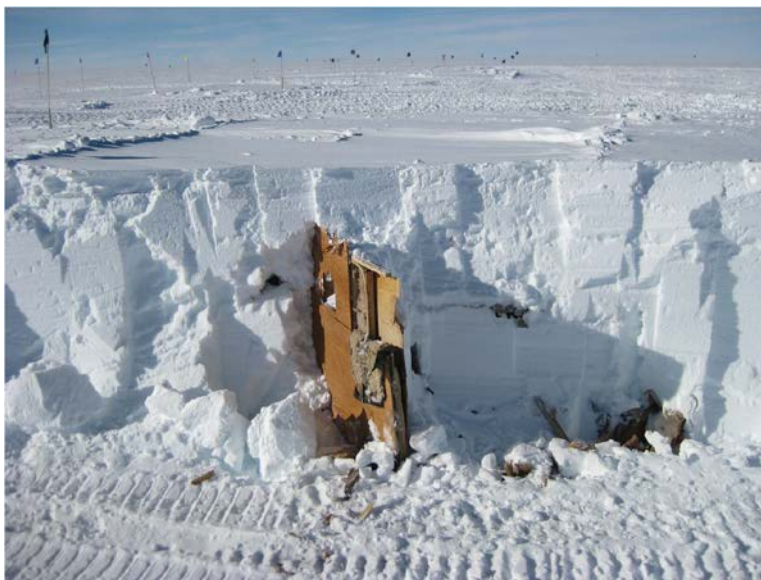
Excavating below the surface, essentially ground truthing a segment of the GPR data, provided a valuable opportunity. Within 2–3 ft of the surface, we encountered a wooden structure (Figure 20), confirming the interpretation of the radar reflections. As shown in Figure 20, the first feature uncovered was a section of an insulated wall. We believe that the wall section was part of a windscreen positioned on the rooftop of Building A15 facing toward the predominant wind direction.

Figure 20. The excavation of a near-surface structure (Building A15) in Area 2 (17 January 2012).

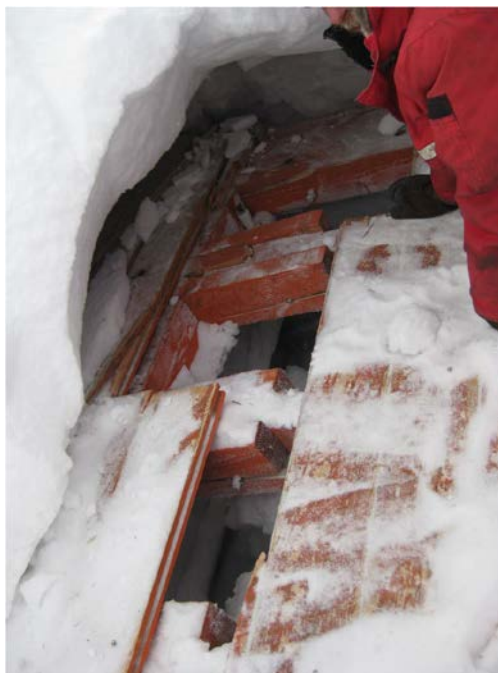
The excavation continued; and at roughly 20 ft below the snow grade, RPSC uncovered the supporting members of an aluminum-framed square structure, about 20 × 20 ft (Figure 21). We believe, given the depth at which we encountered the main section of this building, that this elevation of the structure served the level between the second and third floors. If so, the floor of the first level might be an additional 16 ft down. The interior of the second floor was mostly filled with snow, suggesting that snow also filled the first level, minimizing the risk of a large void at a depth of 33–41 ft below the snow surface. The excavator was used to remove as much of the exposed ceiling material as possible and to backfill and compact snow into the open cavity to an estimated depth of 30 ft below grade.

Figure 21. In Area 2, excavation exposed the supporting members of Building A15, an aluminum-framed square structure. The structural members in the photo are believed to be the ceiling-floor between the second and third floor levels.

the depth of snow cover and the smaller size of the building's footprint, the building was no longer a risk to equipment or to personnel. After examining the condition of Building A21 and the backfilling of Building A15, RPSC backfilled the trench, thus completing the remediation of Area 2.

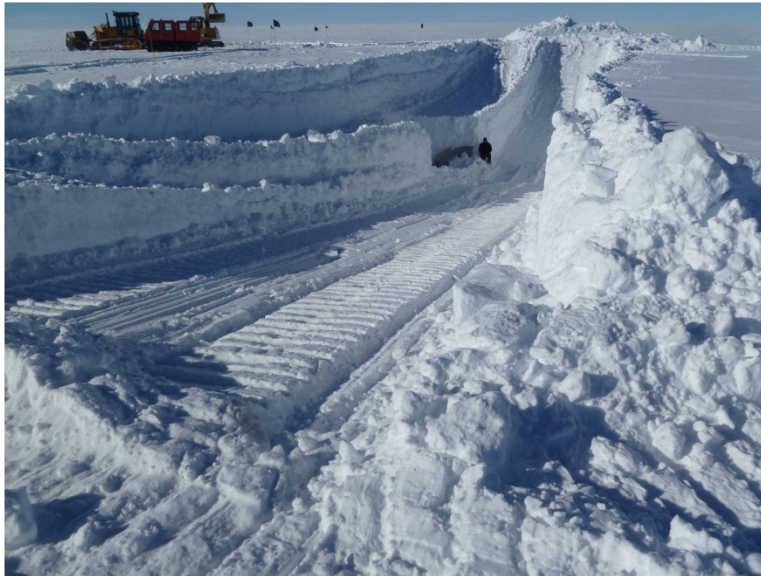
Figure 22. The trench cut in Area 3 to expose the buried A10 building and to gain access to view the interior.

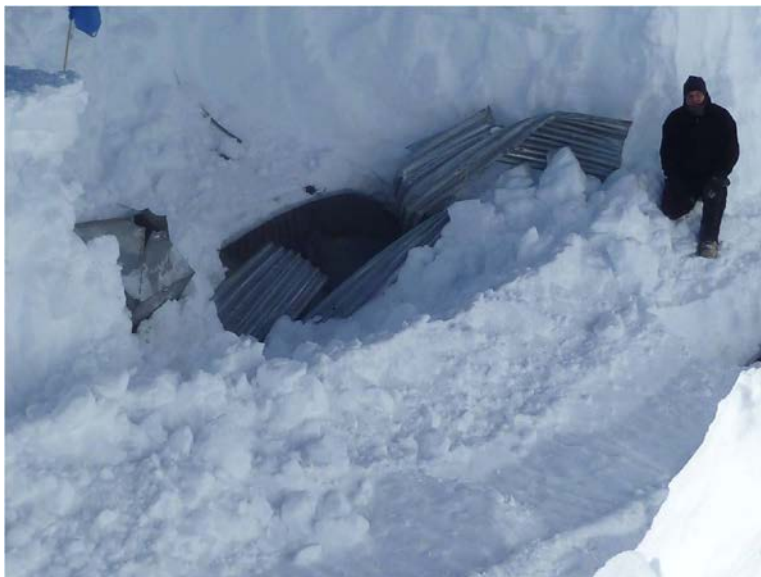
Figure 23. Corrugated metal roofing material. To the left of the metal roof is the cap on a vent stack for a chimney.

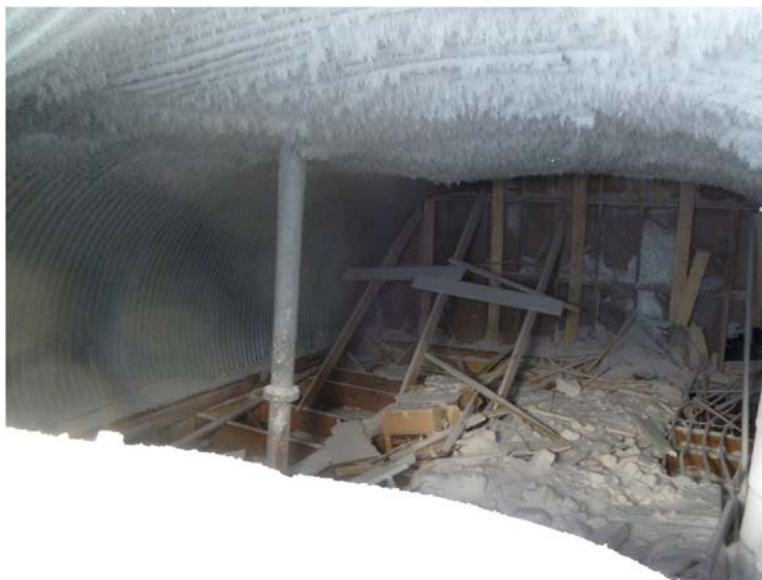
The view inside the metal roof (Figure 24) revealed an intact interior building with a support post between the top of the interior building and the metal roof. Roof joists were visible below the support post, and several electrical conduits ran over the tops of the roof joists. Toward the back of the structure was a bulkhead wall constructed out of framing material. Ac-

Figure 24. An interior view of the corrugated metal-roofed building. We believe that the metal roofing covered an interior building. Joists are visible on the bottom of the photo. On the back wall is a bulkhead constructed of lumber. No access to view the dimensions of the interior building was visible.

cess into the interior building was not readily visible, preventing us from judging the elevation and span of the interior building and what its function was. Given the complexity of this structure, the primary contractor used blasting to implode the building in December 2013 (Figures 25 and 26). Figure 27 shows the extent of the blasted area. Natural drift snow has now filled the resulting crater.

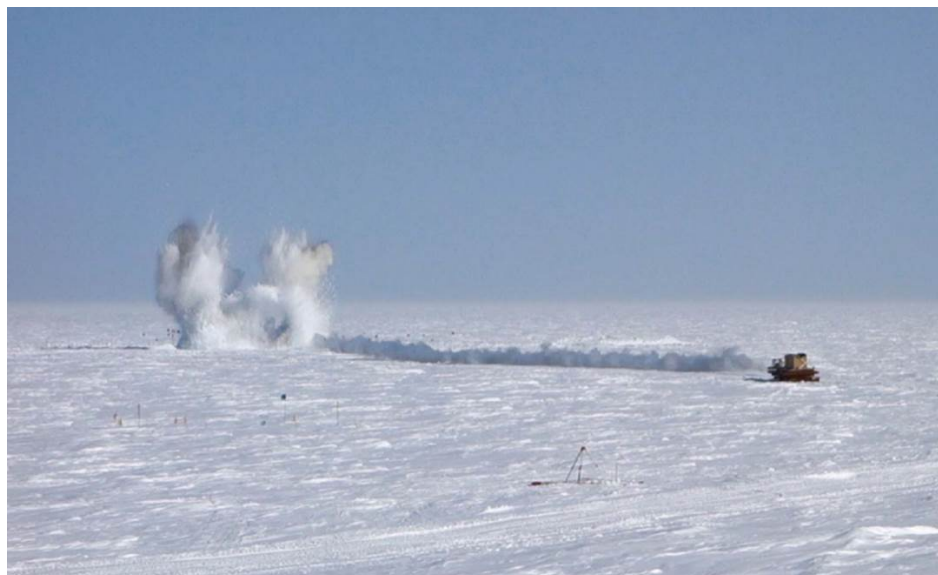
Figure 25. Explosives placed below the snow surface to implode the buried metal-covered building. (Photo by Antarctic Support Contract [ASC].)

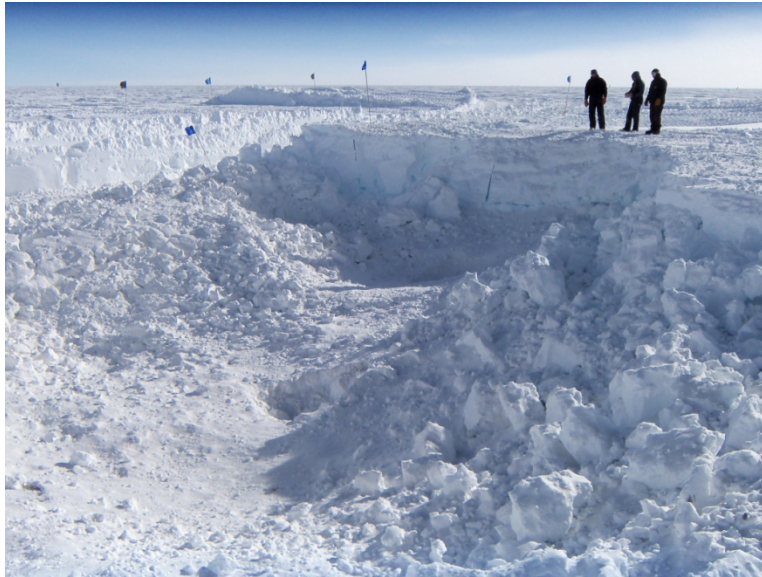
Figure 26. Mounded debris in the blast crater. (Photo by ASC.)
