Naval Arctic Research Laboratory (NARL) Subsurface Containment Berm Investigation

Kevin Bjella

October 2015

Final Report

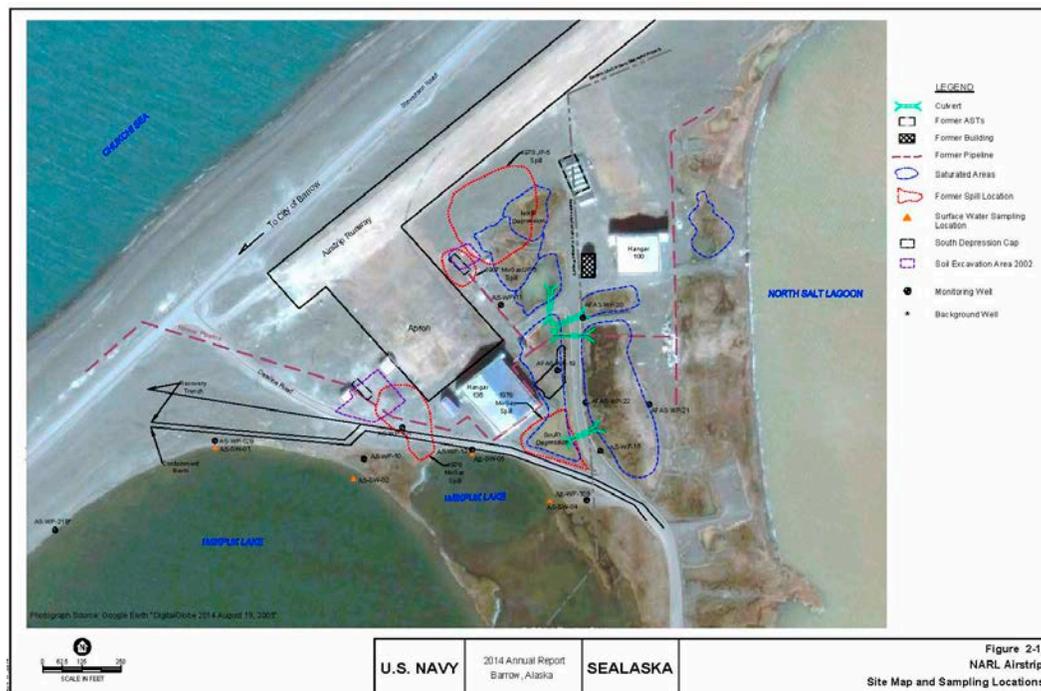
Figure 1. A plan view of the airstrip area, detailing the locations of the containment berm and recovery trenches (Naval Facilities Engineering Command Northwest [NAVFAC] 2014).

Over its history, NARL has cleaned up on-site fuel spills to various degrees and with various methods. One effort in particular, the installation of a subsurface containment berm and associated recovery trenches, was designed to exploit the cold conditions of Barrow and to create a raised permafrost feature that effectively prevents free product on the airfield from migrating into Imikpuk Lake (Figure 1).

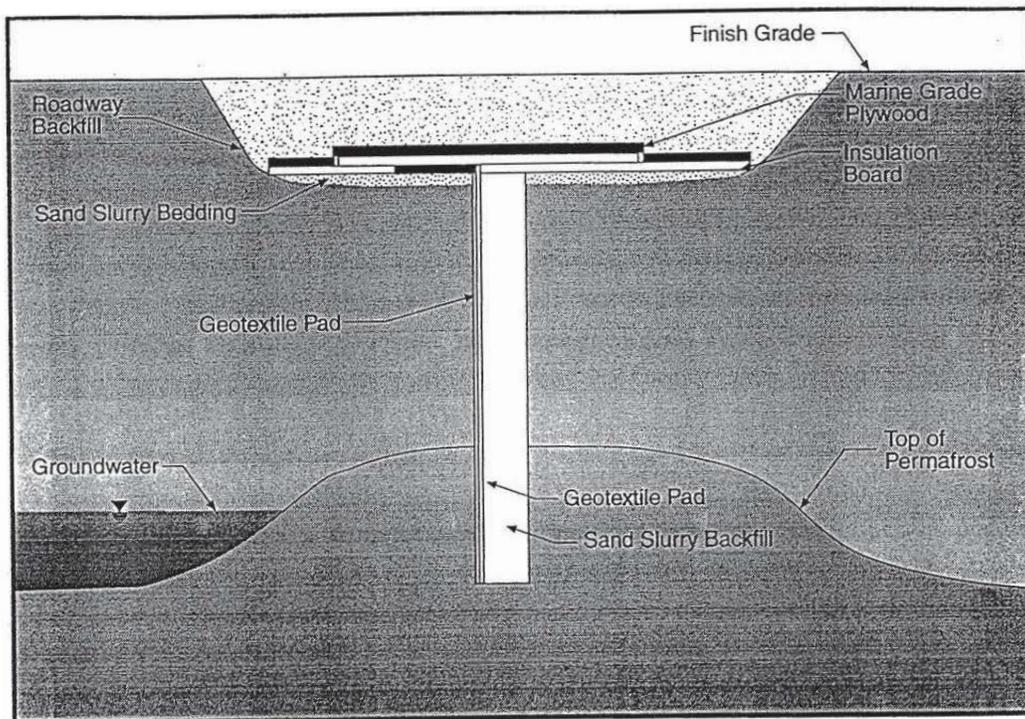
Figure 2. The design cross section of the containment berm (NAVFAC 1998).

In the case of the berm, this was accomplished by installing two, 5 cm thick and 3.7 m wide layers of extruded polystyrene (XPS) board insulation at approximately 1.0 m below the ground surface for the length of the berm. The XPS was covered with 2.0 cm thick marine-grade plywood and a 0.6 m layer of gravel for protection. Figure 2 provides a schematic of the containment-berm cross section. In addition to the containment berm, product recovery trenches were installed upstream and parallel to the berm. These trenches were designed to collect free product from past spills upstream of the berm as it flows towards the lake. FWENC deactivated the recovery trenches in 2002 after free-product quantities recovered by the system diminished to a levels where it was no longer practicable to continue operating the system; characterizing performance of these trenches was not a part of the scope of this study.

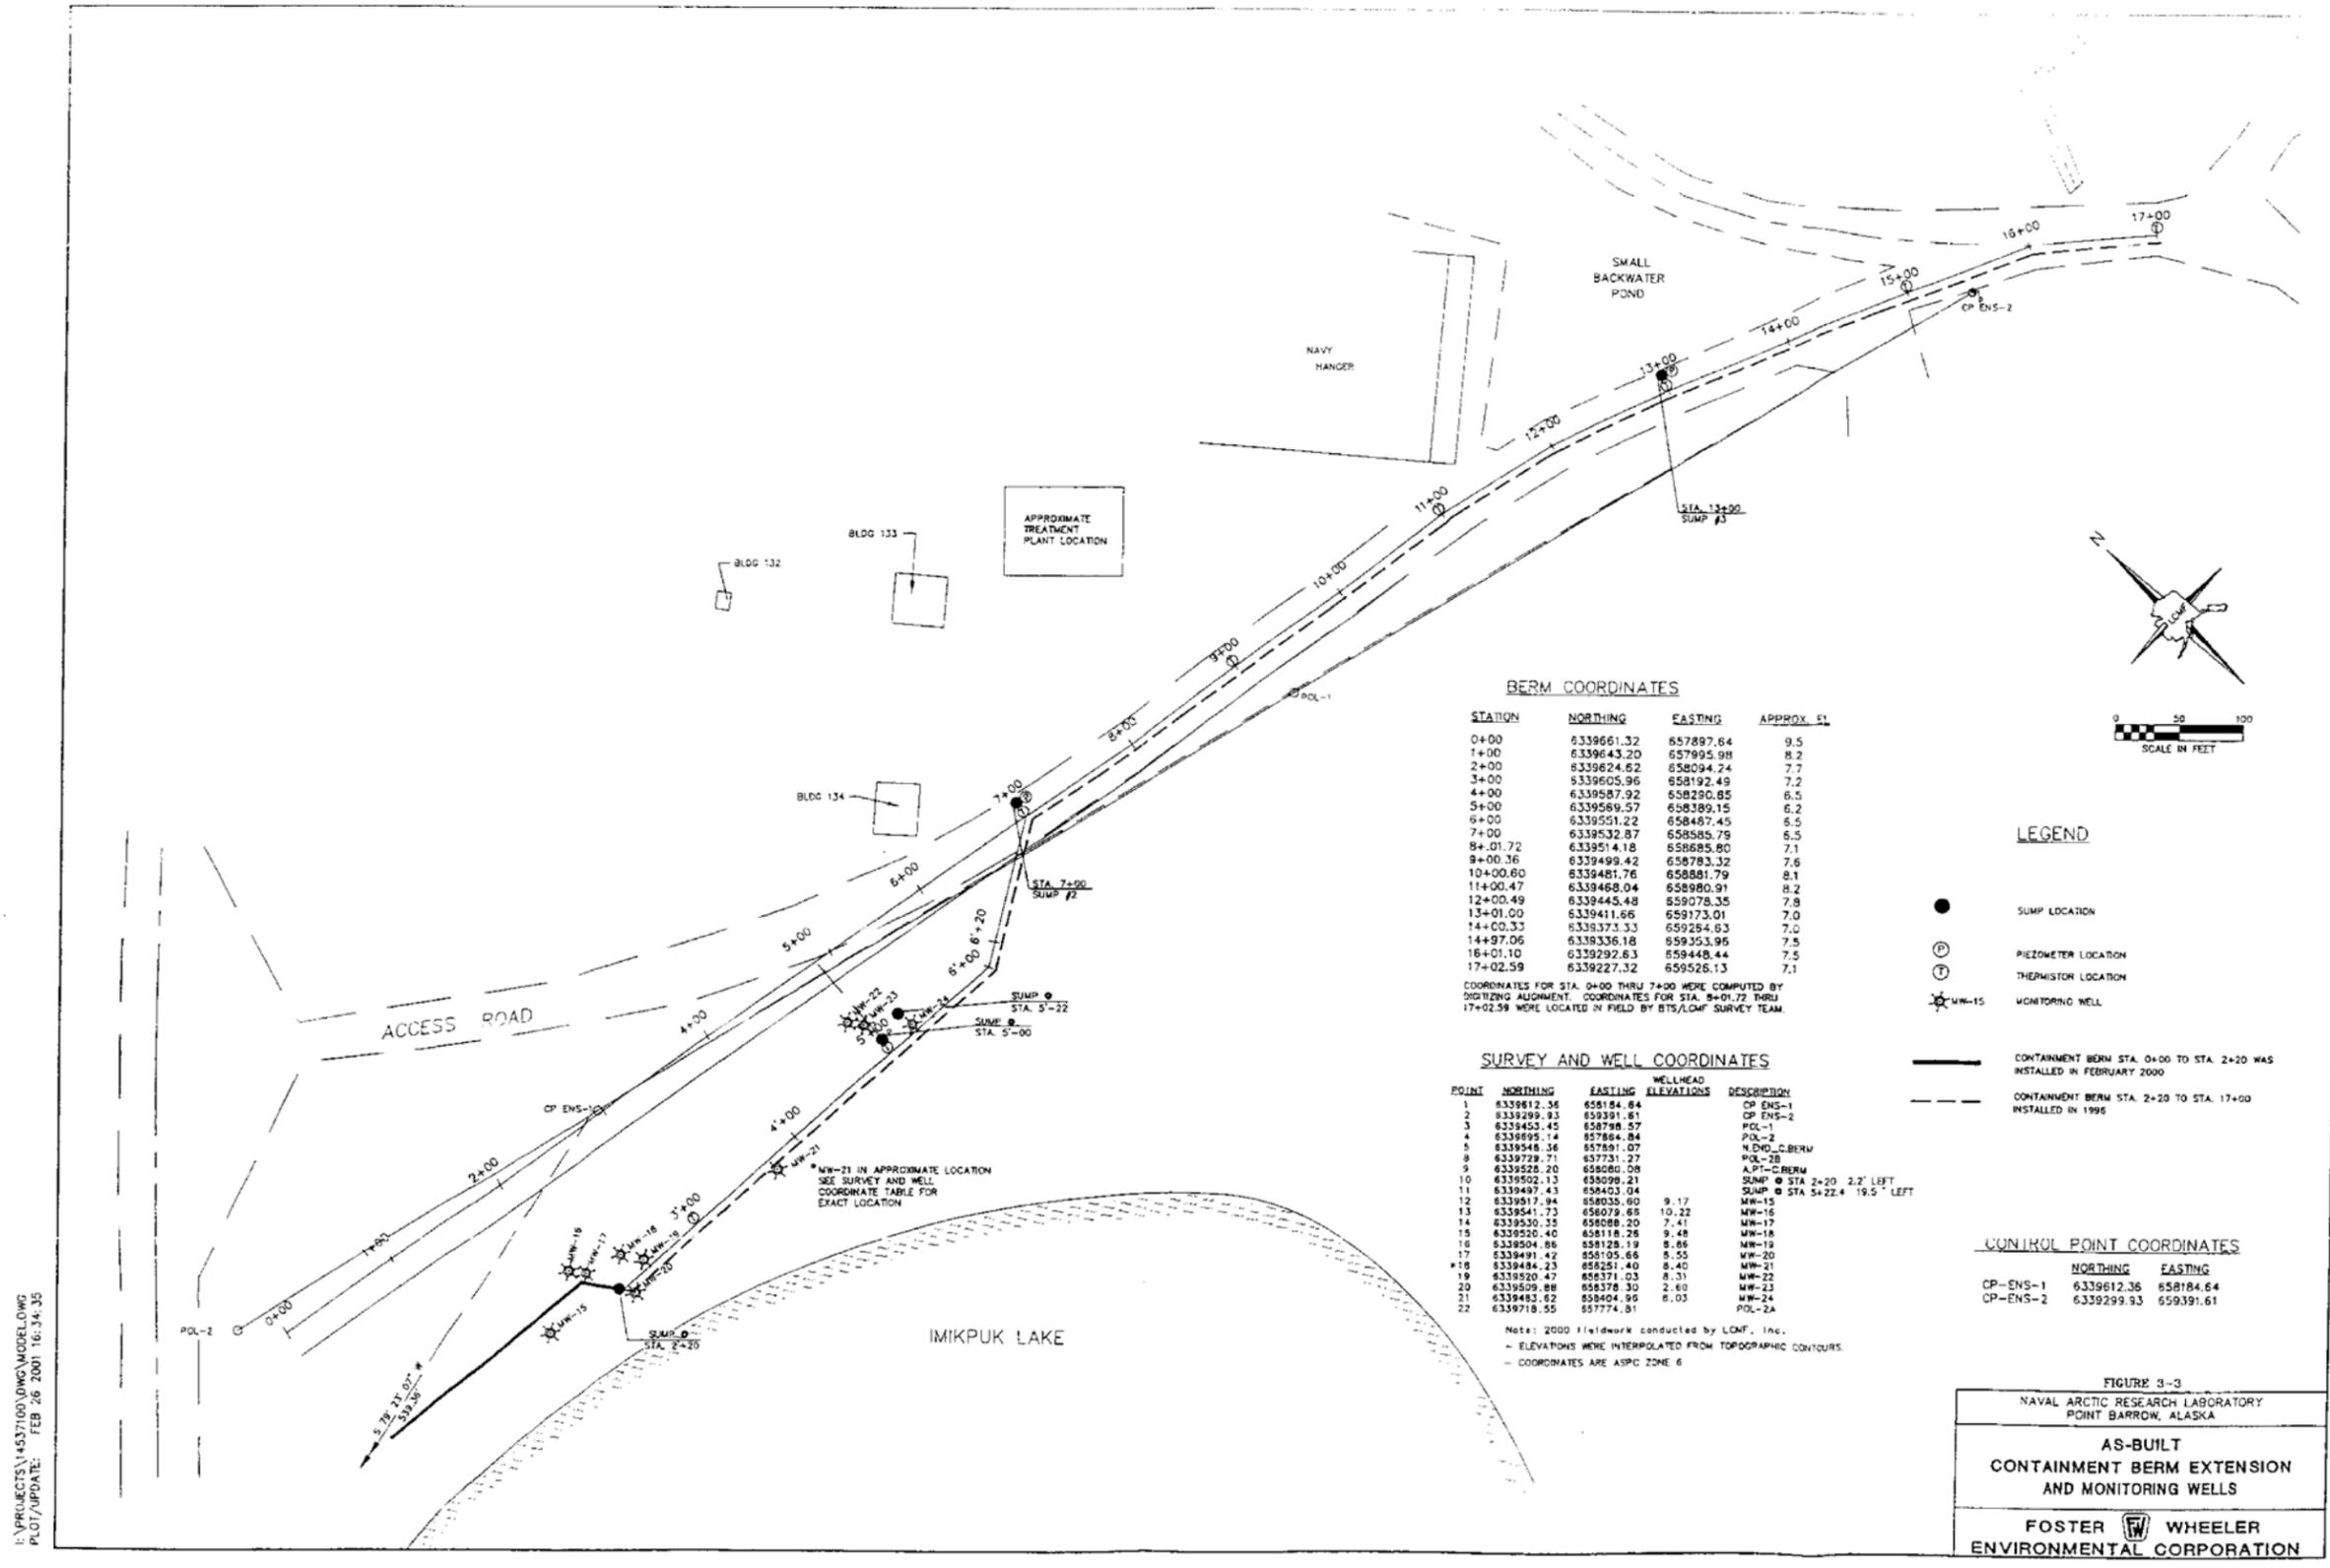
Figure 3. The 2001 as-built containment berm extension and monitoring wells.

The planned location and alignment of the berm ran east to west and extended for 515 m between station 0+00 and station 17+00 (Figure 3). The area between stations 7+00 and 17+00 contained no free product, so this section was constructed as originally planned. Free product was present between the planned alignment and the lake from station 3+00 to station 6+00. As such, the as-built location of the berm was moved 53 m toward the lake to prevent subsurface product migration into the lake (NAVFAC 1998). In 2000, under contract with the Navy, FWENC extended the berm 67 m to provide increased protection to the lake and groundwater (NAVFAC 2001). Figure 3 shows both the as-built location of the original berm and the later extension in 2000.

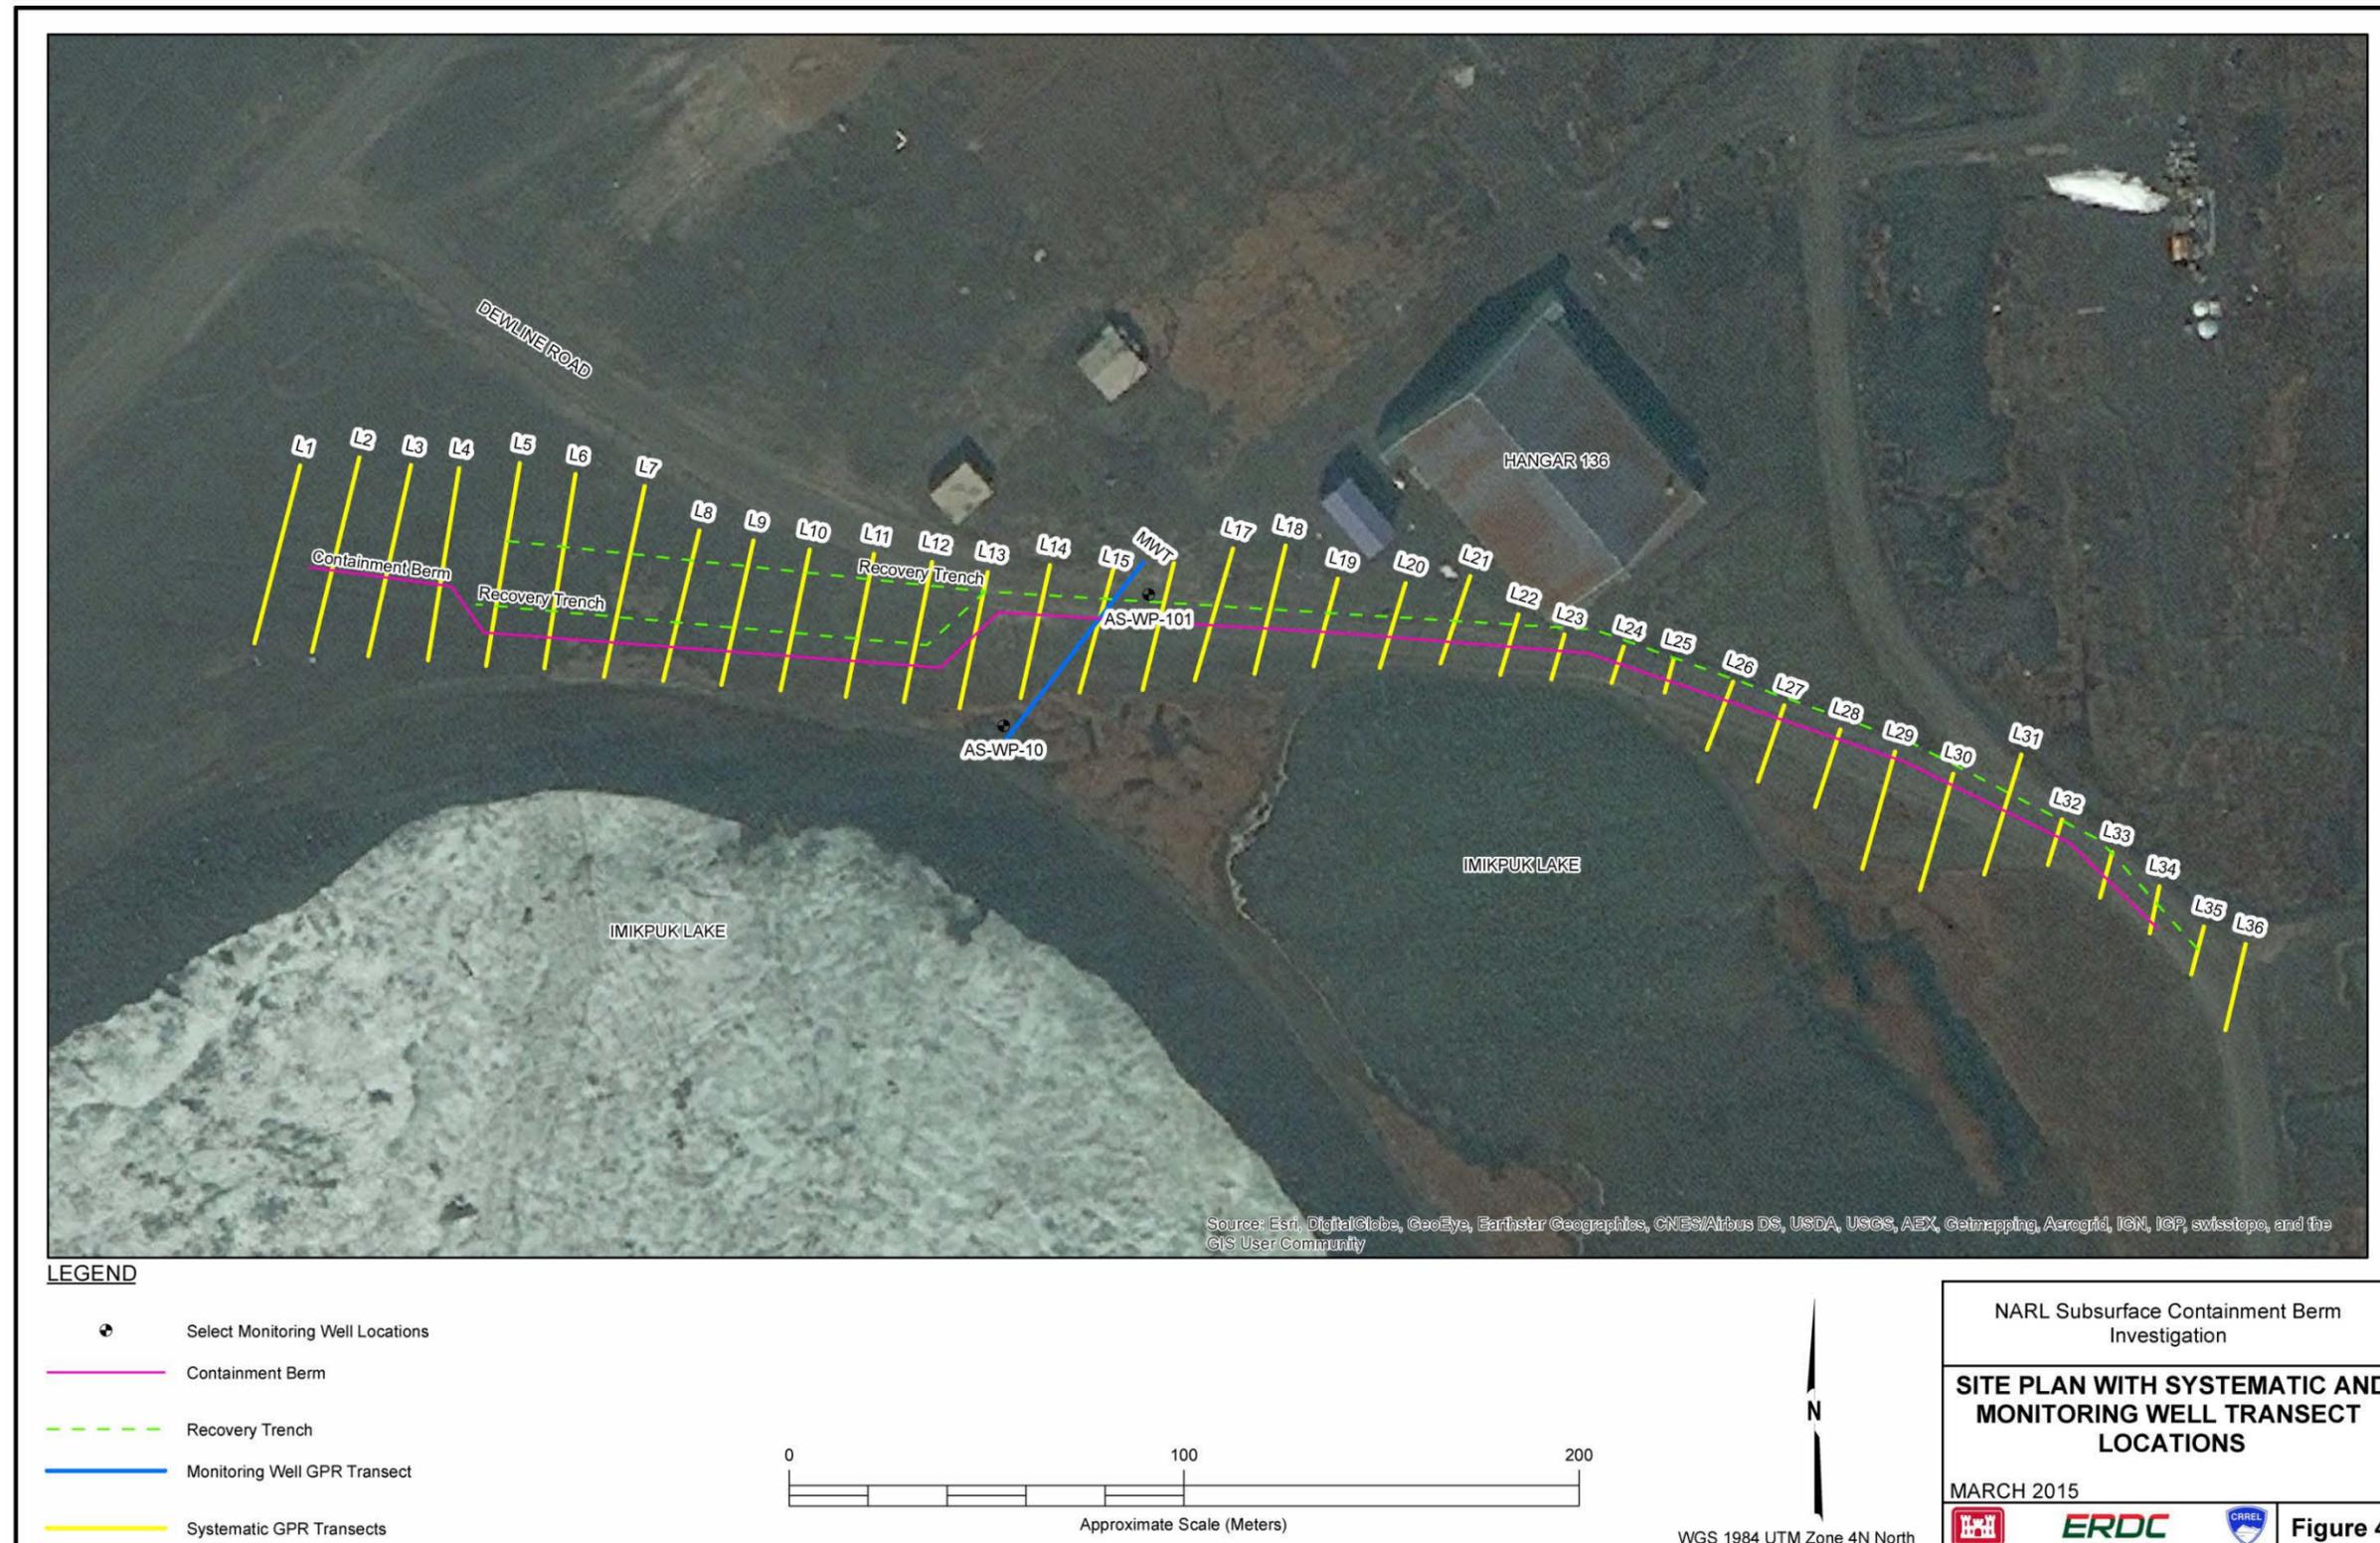
Figure 4. A site plan with systematic and Monitoring Well Transect (MWT) locations. The systematic transect locations are in yellow; the MWT is in blue.

We performed two longitudinal surveys in opposite directions directly over the axis of the berm for the full length and extending approximately 15 m beyond the ends of the berm. We compared the responses as a quality check of data and methods, and the responses correlated well. We completed one additional transect (Monitoring Well Transect—MWT) running in a straight line from 10 m north of monitoring well AS-WP-101 adjacent to the blue treatment building and then across the road to a point 10 m past monitoring well AS-WP-10 in the tundra and to the sands of Imikpuk Lake. The ice depth was measured in AS-WP-101 at 1.4 m, and frost depth was measured adjacent to AS-WP-10 at 0.8 m. Figure 4 shows a site plan with systematic transects and the MWT.

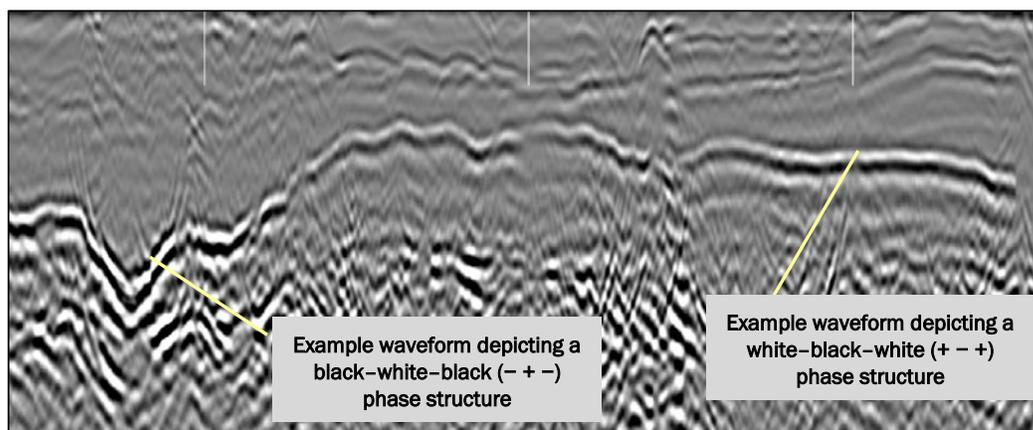
Figure 5. An example GPR reflection showing waveform signature.

Because of the dielectric permittivity contrast between ice, moist thawed sediment, and water, it is possible to make qualitative assessments on the type of material the radar energy encountered (Figure 5). When the waves propagate from a region of lower dielectric permittivity to higher, such as from moist sediments to a water layer, the reflection will have a waveform of (+ - +), or white–black–white (viewed in grayscale). When the waves propagate from a region of higher dielectric permittivity to lower, such as when moving from moist sediments to substantial ice layer(s), the reflections will have a waveform of (- + -), or black–white–black (viewed in grayscale). This study found that the areas upstream of the containment berm generally exhibited the (- + -) waveform, indicating the possibility of ice below the bottom of the active layer. When viewing transects close to Imikpuk Lake, it found that on approaching the lake, a strong reflector with (+- +) would emerge, suggesting water on the top of the permafrost.

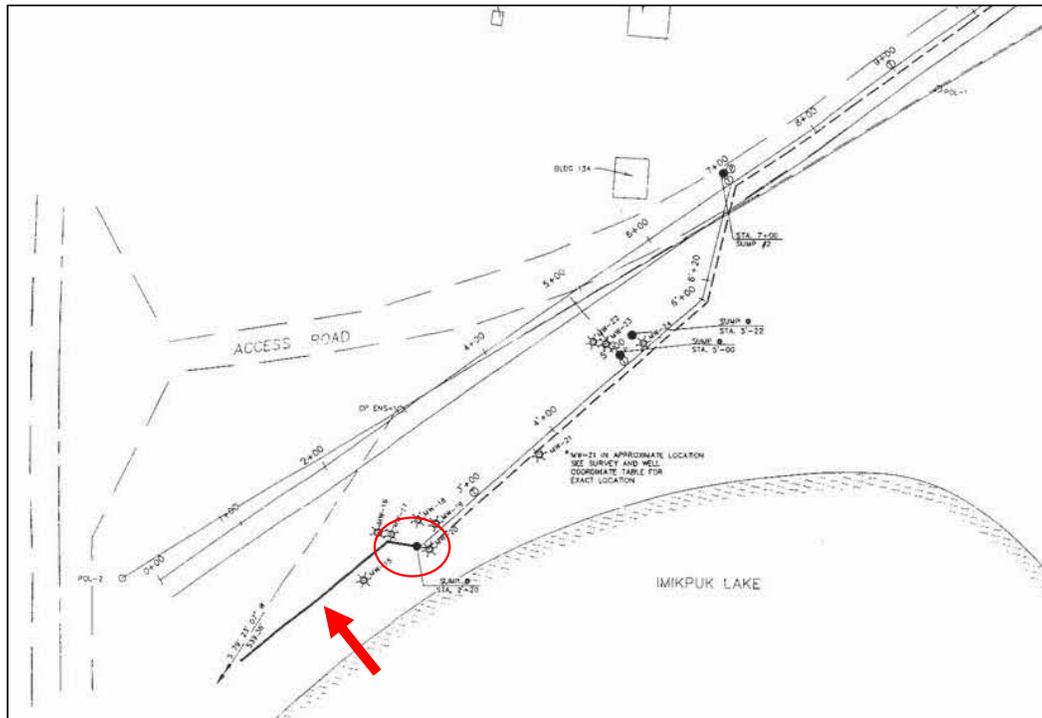
The long transect conducted above the axis of the containment structure was successful in imaging the insulation/plywood layer for the entire length of the containment structure. However, the area between L4 and L5 had no visible insulation/plywood in the GPR images (Figure 15). This area was intensely frost probed, and no insulation or plywood was found for a length of approximately 4 m though insulation/plywood was visible in both the L4 and L5 transects, which we confirmed with frost probing. The mineral sand and gravel surface in this area appeared reworked and disturbed and was also locally depressed compared to the adjacent ground. As noted earlier, the containment berm was extended in 2000; and a short angle connecting the old alignment with the new alignment was constructed (Figure 4). This angle was known during the investigation, and the frost probing was conducted in a wide swath to ensure insulation/plywood was encountered if it existed. The plans show this was the former location of a sump on the adjacent recovery trench. The disturbed ground and locally depressed area suggest this sump was removed and is therefore the reason for the missing insulation/plywood. Figure 6 shows the area of missing insulation/plywood. During all the probing conducted in that area, no product odor was noticed.

Figure 6. A plan map of the 67 m berm extension (red arrow), constructed in 2000, shown as an angle at the location where the GPR survey found insulation/plywood missing (red oval) (NAVFAC 2001).

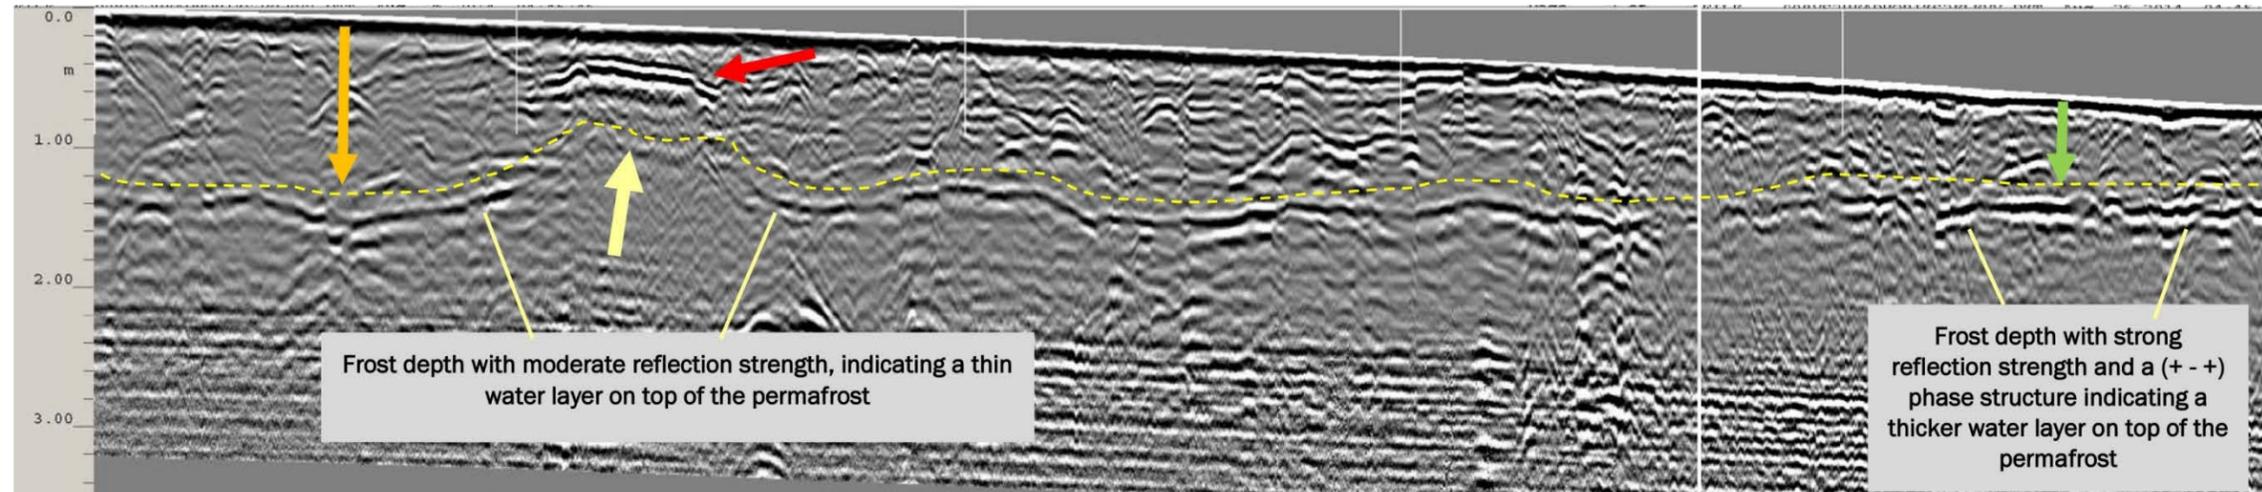
Figure 7. A GPR image interpretation of the MWT. The MWT from AS-WP-101 to AS-WP-10 ended at the beginning of the sands of Imikpuk Lake shoreline. The length is approximately 50 m. This transect was not part of the systematic transects. The surface has been normalized to simulate the drop in surface elevation (approximated). The short, vertical *white lines* mark 10 m intervals. Frost depth probing was 1.4 m at AS-WP-101 (*orange arrow*) and 0.8 m at AS-WP-10 (*green arrow*). The thin, dashed yellow line traces the inferred frost depth reflector; and this yellow line has been raised a small amount to prevent masking of that reflection. The red arrow is pointing to the containment berm insulation/plywood layer, and the two-tiered structure is clearly visible (Fig. 2). A definitive frost depth reflector is dimly visible under the insulation/plywood (*yellow arrow*). However the rise in the frost depth upstream and downstream of the structure is clearly evident. This image is vertically exaggerated; and the full-length, vertical *white line* is a match line for assembling the image.

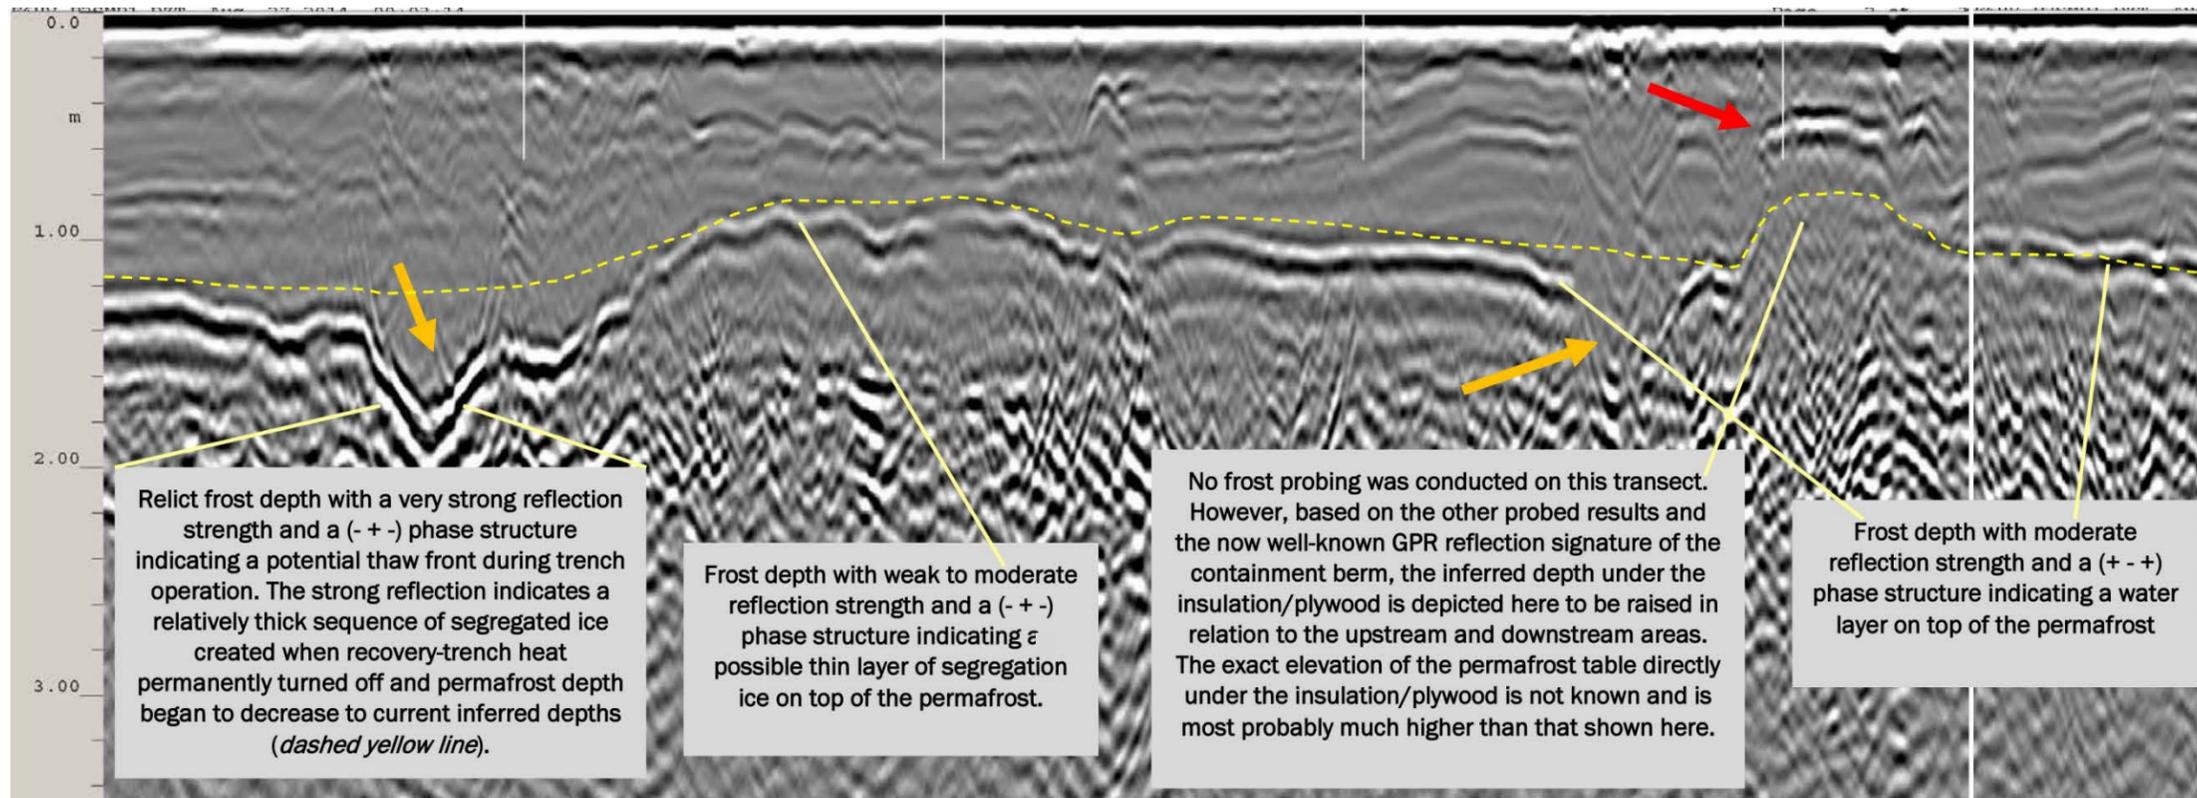
Figure 8. A GPR image interpretation of systematic transect L6. The *left* is near Dew Line Road, and the *right* stops short of the shoreline of Imikpuk Lake. The length is 50 m. This image has not been corrected for surface elevation changes, and no frost probing was conducted along this transect. The thin, dashed *yellow line* traces the inferred frost depth line; this line has been raised a small amount to prevent masking of the reflection used for interpretation. The *red arrow* is the insulation/plywood layer for the containment structure. The *orange arrows* indicate the locations of the recovery trenches. The short, vertical *white lines* mark 10 m intervals.

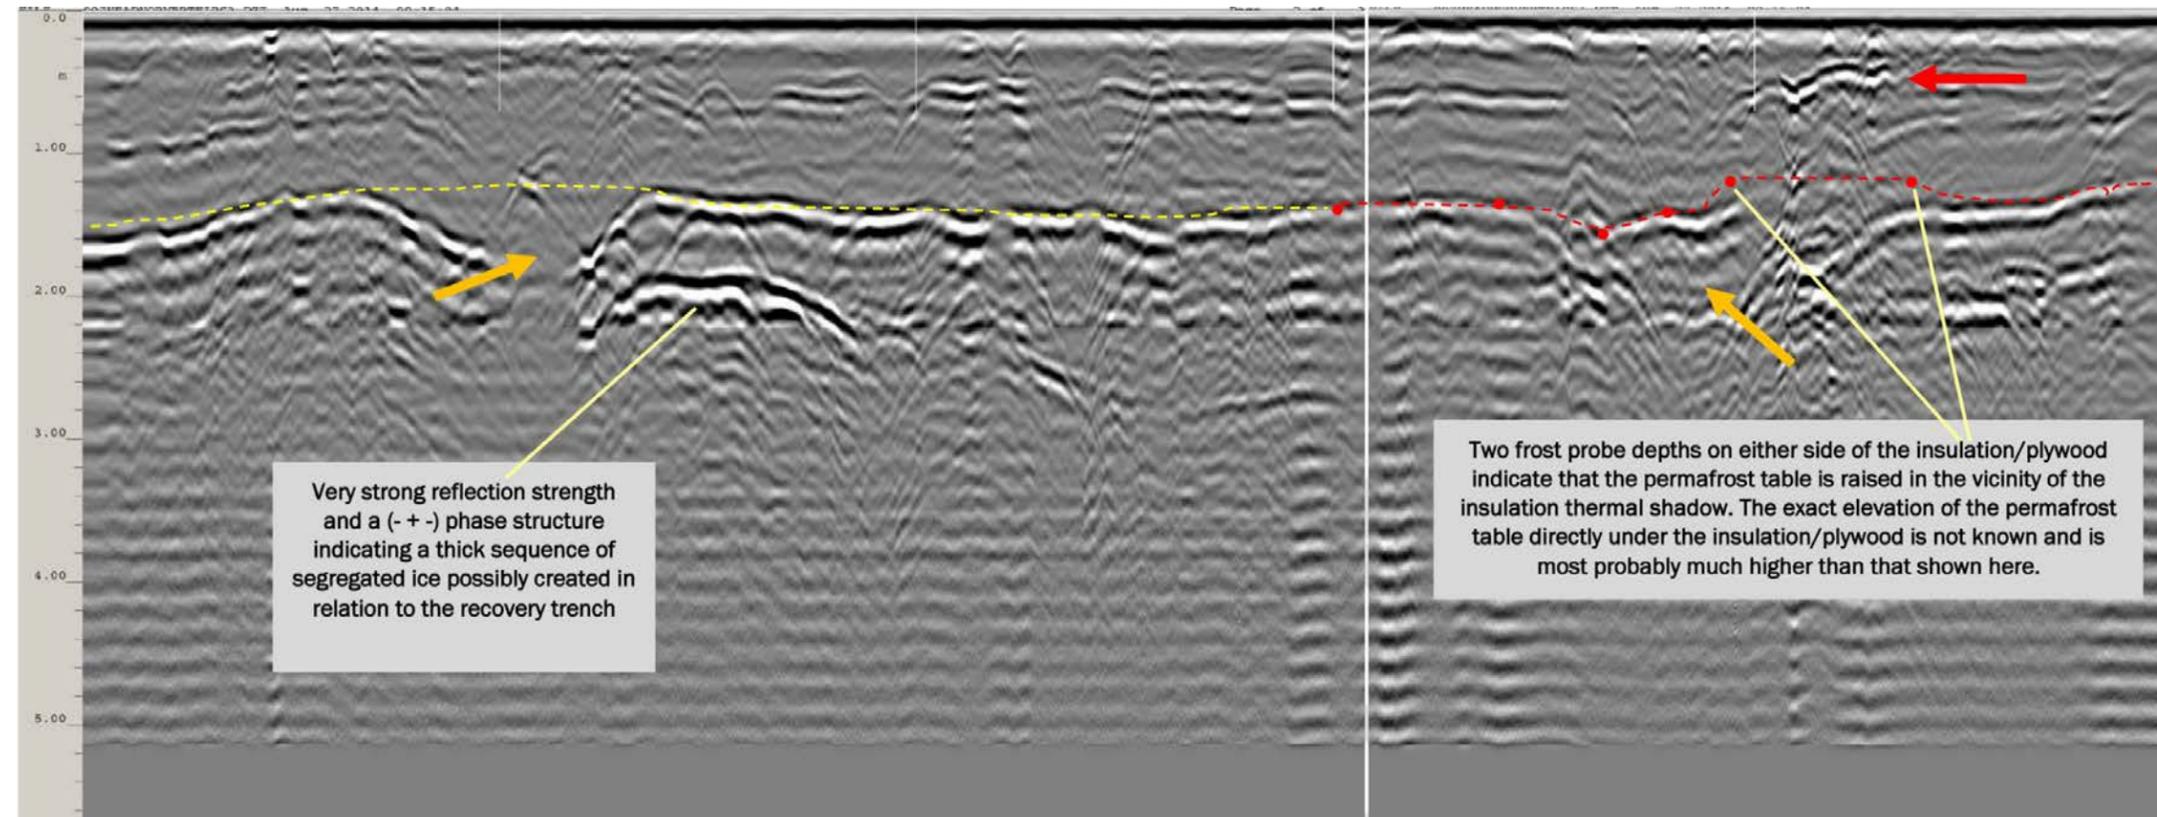
Figure 9. A GPR image interpretation of systematic transect L7. The *left* is near Dew Line Road, and the *right* stops short of the shoreline of Imikpuk Lake. The length is 50 m. This image has not been corrected for surface elevation changes. Frost probing was conducted along this transect, and the probe depths are marked with *red dots*. The thin, dashed *yellow line* traces the inferred frost depth line; and the thin, dashed *red line* represents the thaw depth based on the frost probing. The *red arrow* is the insulation/plywood layer for the containment structure. The *orange arrows* indicate the locations of the recovery trenches. The short, vertical *white lines* mark 10 m intervals.

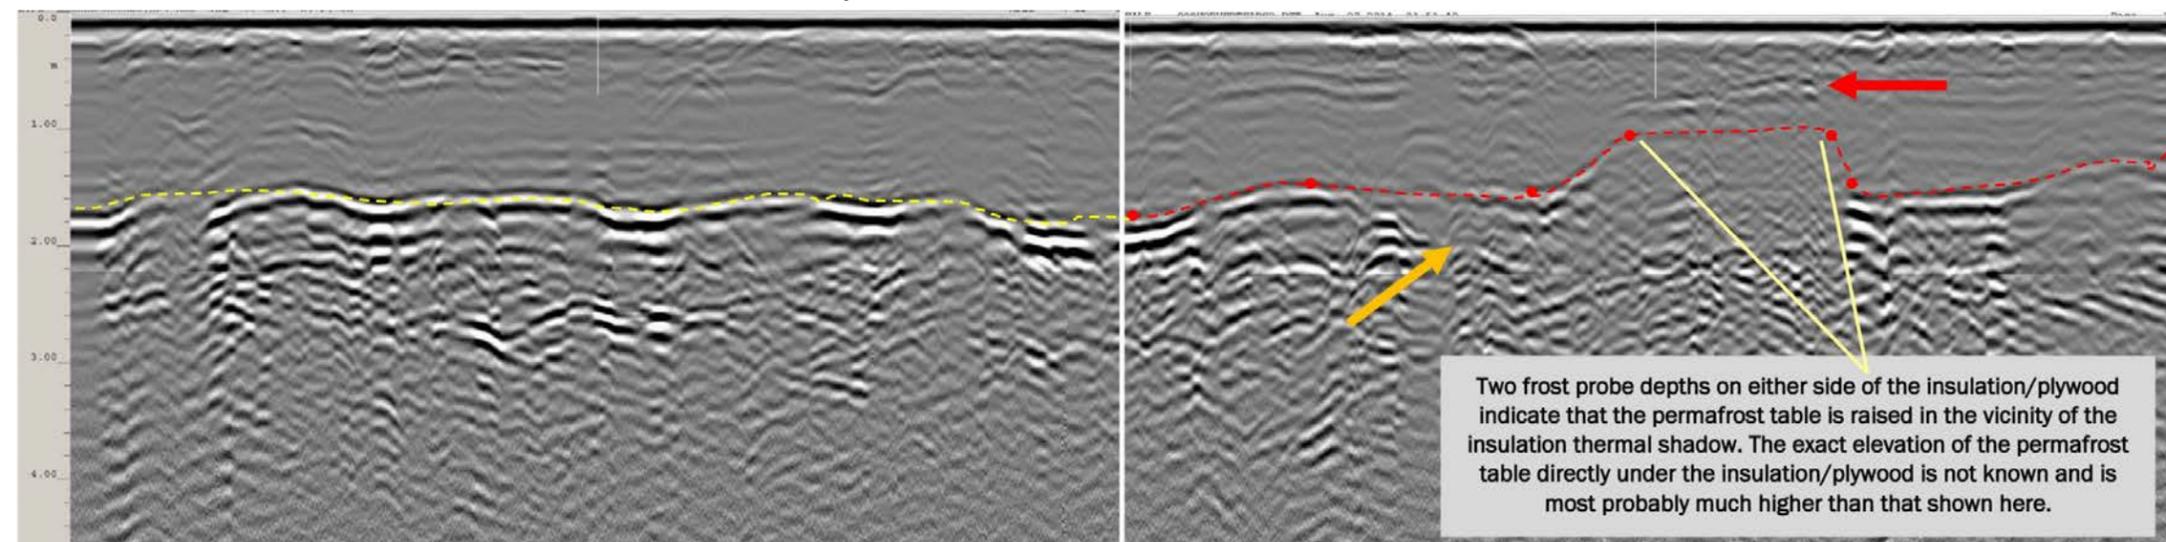
Figure 10. A GPR image interpretation of systematic transect L8. The *left* is near Dew Line Road, and the *right* stops short of the shoreline of Imikpuk Lake. The length is 40 m. This image has not been corrected for surface elevation changes. Frost probing was conducted along this transect, and the probe depths are marked with *red dots*. The thin, dashed *yellow line* traces the inferred frost depth line; and the thin, dashed *red line* represents the thaw depth based on the frost probing. The *red arrow* is the insulation/plywood layer for the containment structure. The *orange arrow* indicates the locations of the recovery trench. The short, vertical *white lines* mark 10 m intervals.

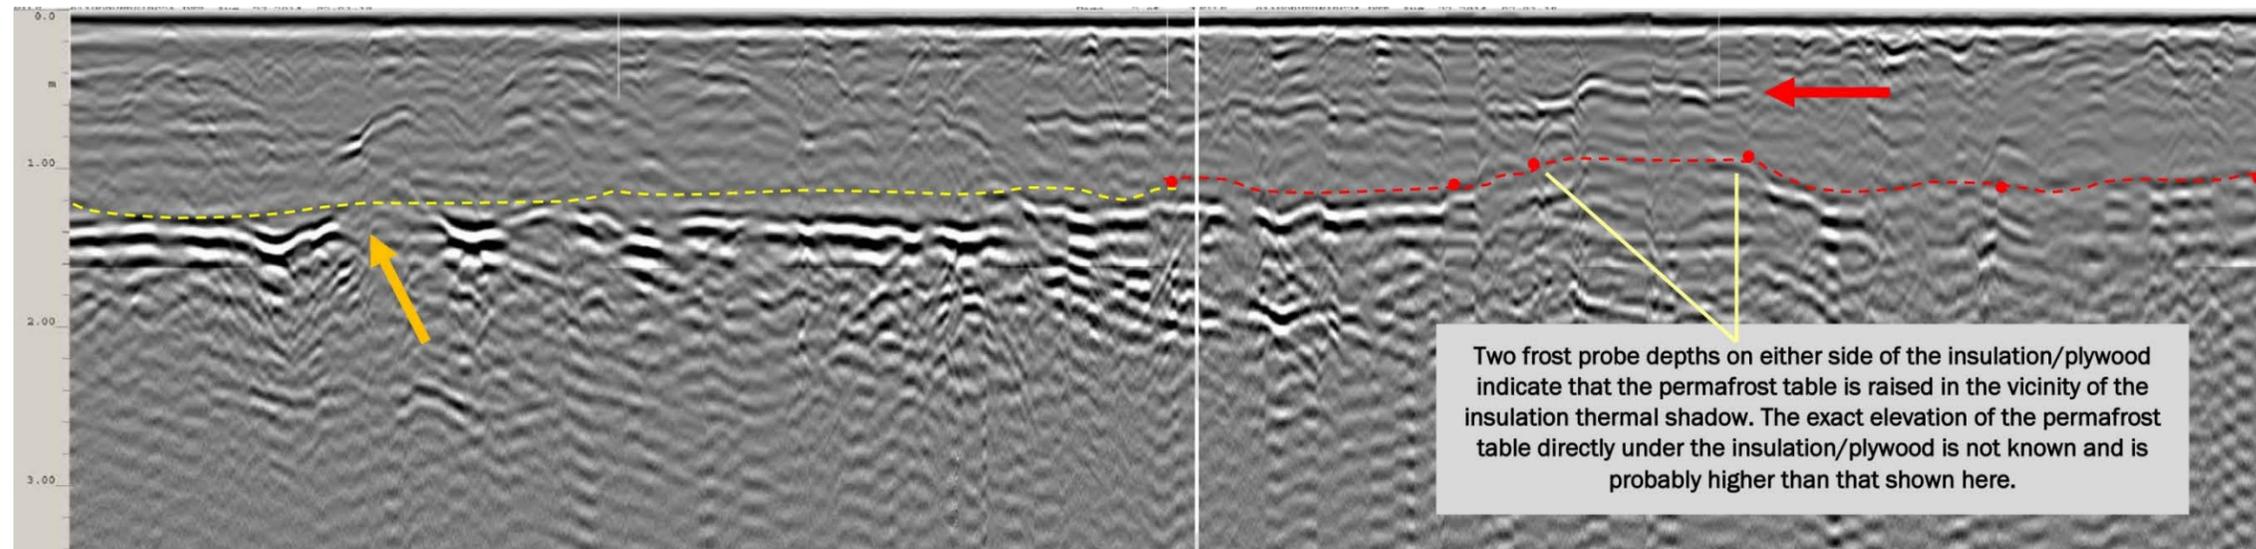
Figure 11. A GPR image interpretation of systematic transect L11. The *left* is just north of Dew Line Road, and the *right* stops short of the shoreline of Imikpuk Lake. The length is 40 m. This image has not been corrected for surface elevation changes. Frost probing was conducted along this transect, and the probe depths are marked with *red dots*. The thin, dashed *yellow line* traces the inferred frost depth line; and the thin, dashed *red line* represents the thaw depth based on the frost probing. The *red arrow* is the insulation/plywood layer for the containment structure. The *orange arrow* indicates a location where reflections are abruptly softened or muted. The short, vertical *white lines* mark 10 m intervals.

Some areas in the radar grams were visibly devoid of any reflection signature. They had a softened or muted texture and appeared and ended rather abruptly. One example is in Figure 11 where the area is noted with an orange arrow. These regions indicate the GPR signal was attenuated due to some property of the sediment at that location where water and high percentages of mineralogical clays or silts are good attenuators of radar energy. However, it is possible that the momentary lifting of the radar antenna from the surface when encountering rough terrain, as experienced at the NARL facility, can cause this effect.

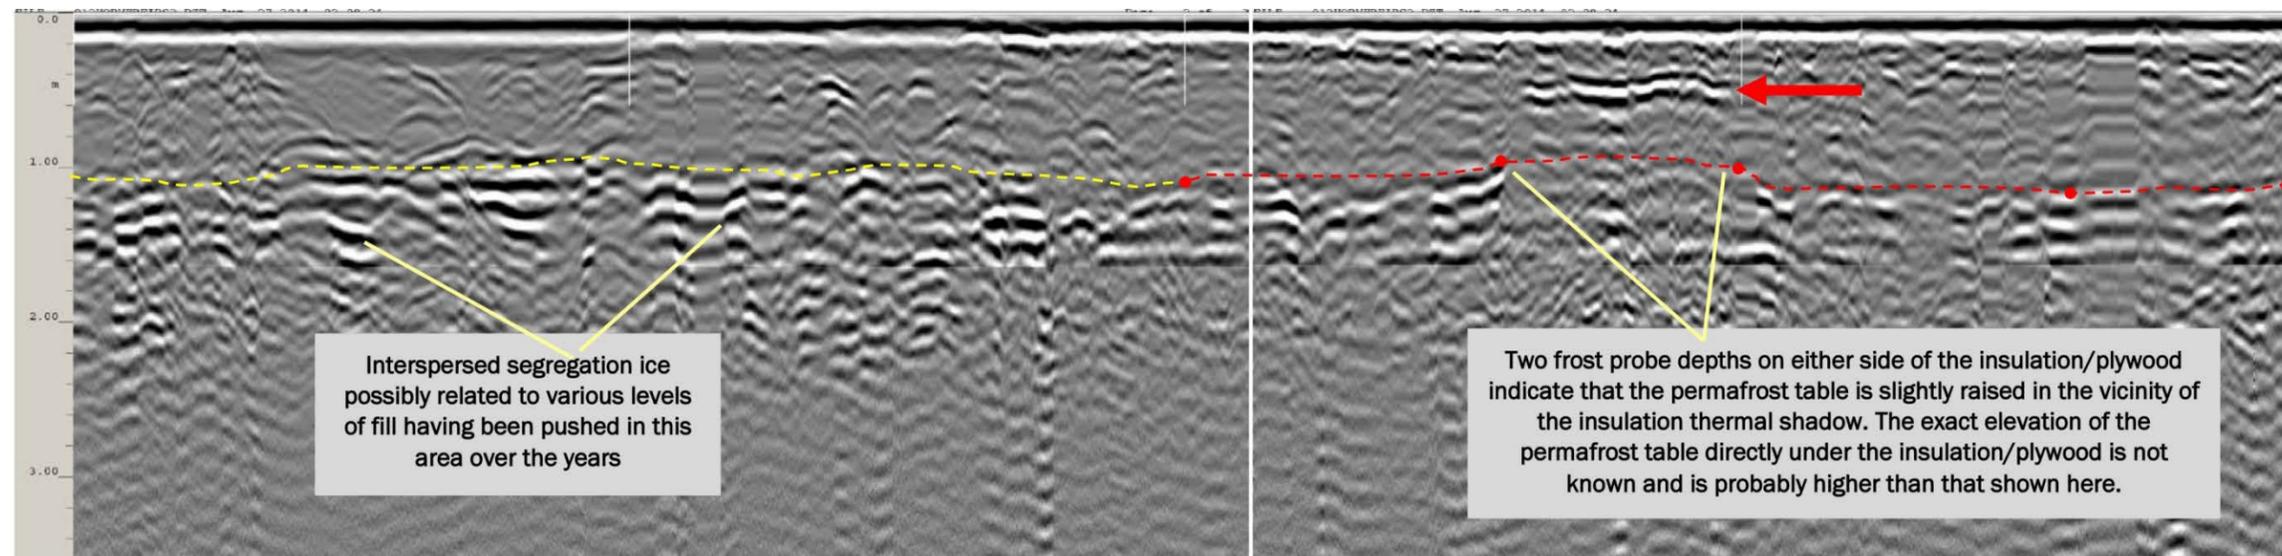
Figure 12. A GPR image interpretation of systematic transect L12. The *left* is just north of Dew Line Road, and the *right* stops short of the shoreline of Imikpuk Lake. The length is 40 m. This image has not been corrected for surface elevation changes. Frost probing was conducted along this transect, and the probe depths are marked with *red dots*. The thin, dashed *yellow line* traces the inferred frost depth line; and the thin, dashed *red line* represents the thaw depth based on the frost probing. The *red arrow* is the insulation/plywood layer for the containment structure. The short, vertical *white lines* mark 10 m intervals.

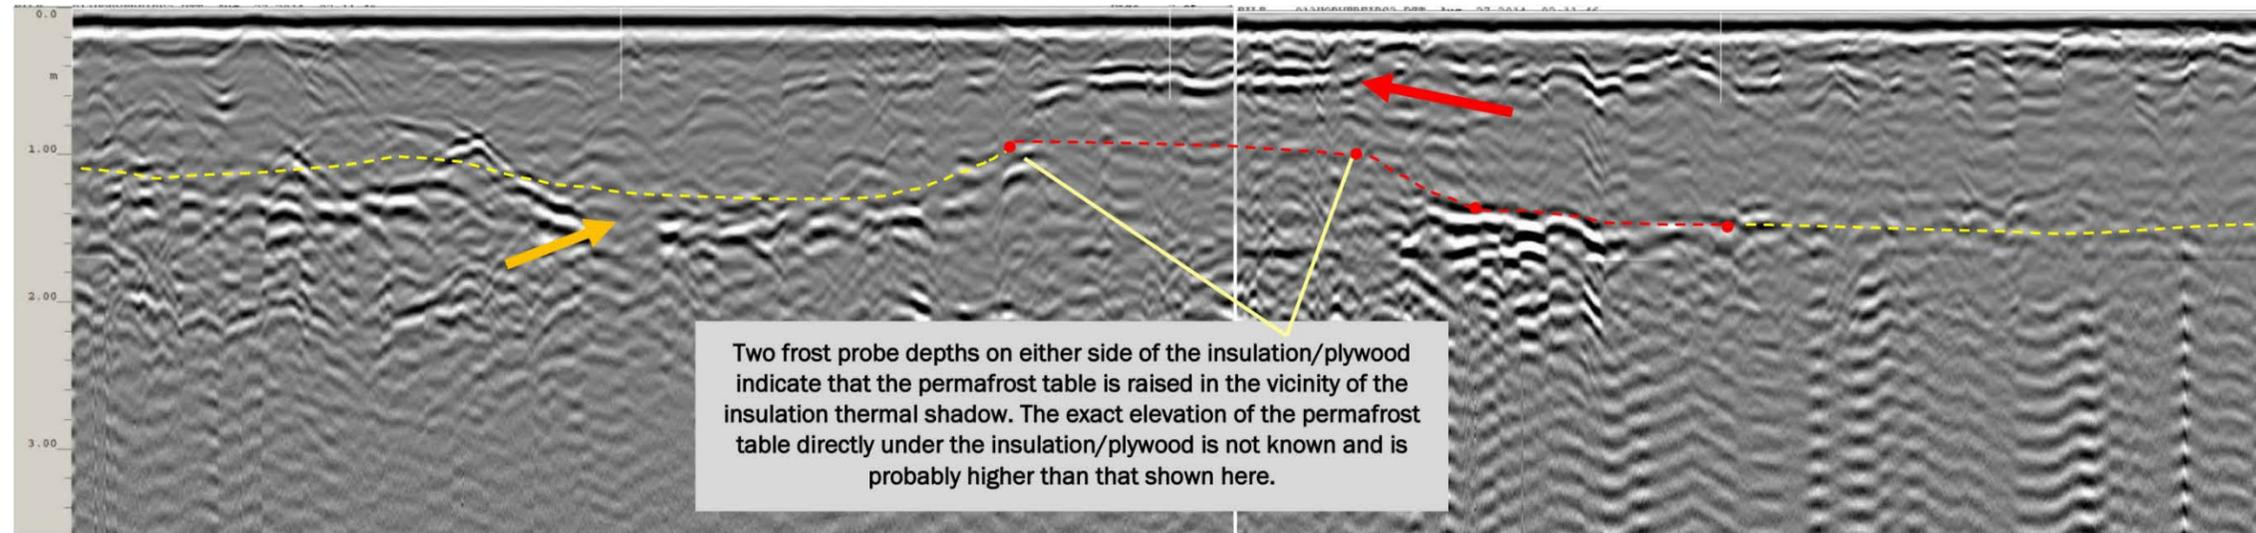
Figure 13. A GPR image interpretation of systematic transect L13. The *left* is just north of Dew Line Road, and the *right* stops short of the shoreline of Imikpuk Lake. The length is 40 m. This image has not been corrected for surface elevation changes. Frost probing was conducted along this transect, and the probe depths are marked with *red dots*. The thin, dashed *yellow lines* trace the inferred frost depth line; and the thin, dashed *red line* represents the thaw depth based on the frost probing. The *red arrow* is the insulation/plywood layer for the containment structure. The *orange arrow* indicates the location of the recovery trench. The short, vertical *white lines* mark 10 m intervals.
