Naval Arctic Research Laboratory (NARL) Subsurface Containment Berm Investigation

Kevin Bjella

October 2015

Final Report

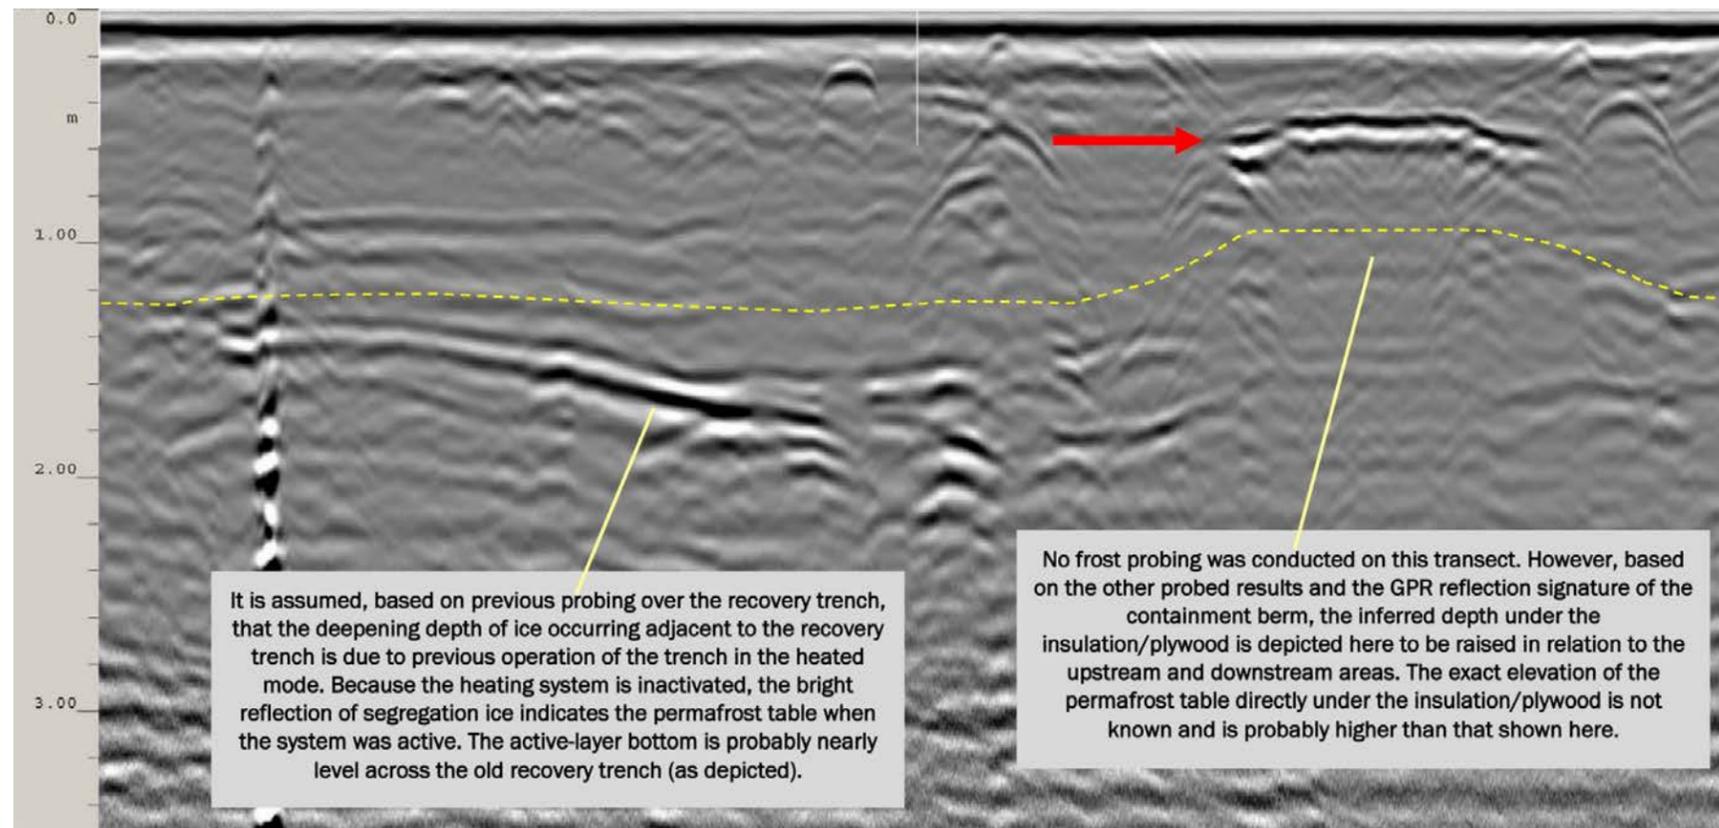
Figure 14. A GPR image interpretation of systematic transect L22. The *left* is just north of Dew Line Road and near the southwest corner of the Navy Hangar, and the *right* stops at the edge of the road embankment. The length is 20 m. This image has not been corrected for surface elevation changes. Frost probing was not conducted along this transect due to the hard compacted soils of the road and near the hangar. The thin dashed *yellow line* traces the inferred frost depth line. The *red arrow* is the insulation/plywood layer for the containment structure. The short, vertical *white lines* mark 10 m intervals.

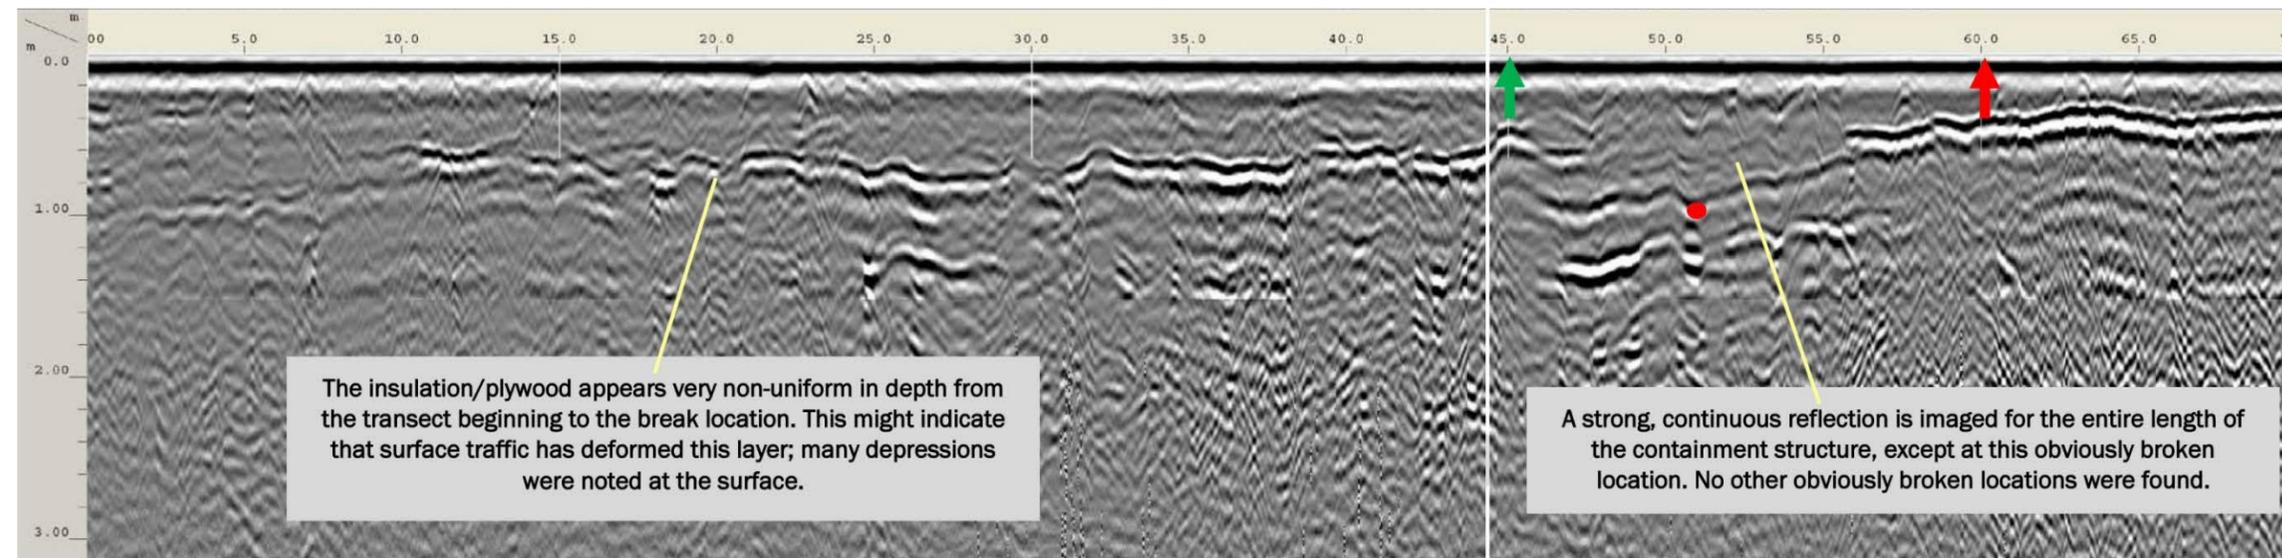
Figure 15. A GPR image interpretation of transect L01 along the axis of the containment berm. The left starts at L1 with the insulation/plywood beginning at approximately 10 m. A break in the insulation/plywood is clearly visible starting at about 46 m and ending at about 55 m. L4 is located at 45 m (*green arrow*), and L5 is located at 60 m (*red arrow*). Frost probing was conducted in the break area at a depth of 1.2 m (*red dot*). No other obvious broken locations were found along the entire length of the structure. The short, vertical *white lines* mark 10 m intervals.

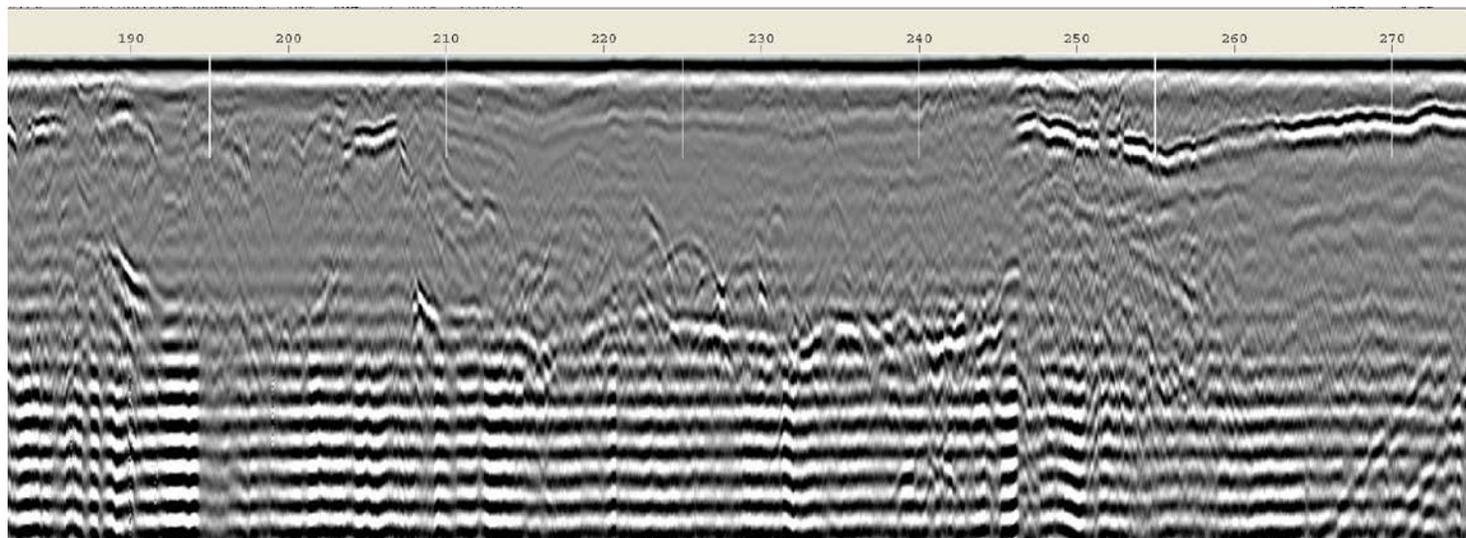
Figure B39. The transect along the top of the containment berm. Line 15 through Line 20. The discontinuous nature of the insulation/plywood layer is due to misalignment of the GPR transect over the centerline of the containment berm. The insulation/plywood was readily imaged in Lines 15 through 20.
