Engineering for Polar Operations, Logistics, and Research (EPOLAR)

Maintenance and Drainage Guidance for the Scott Base Transition, Antarctica

October 2014

Final Report

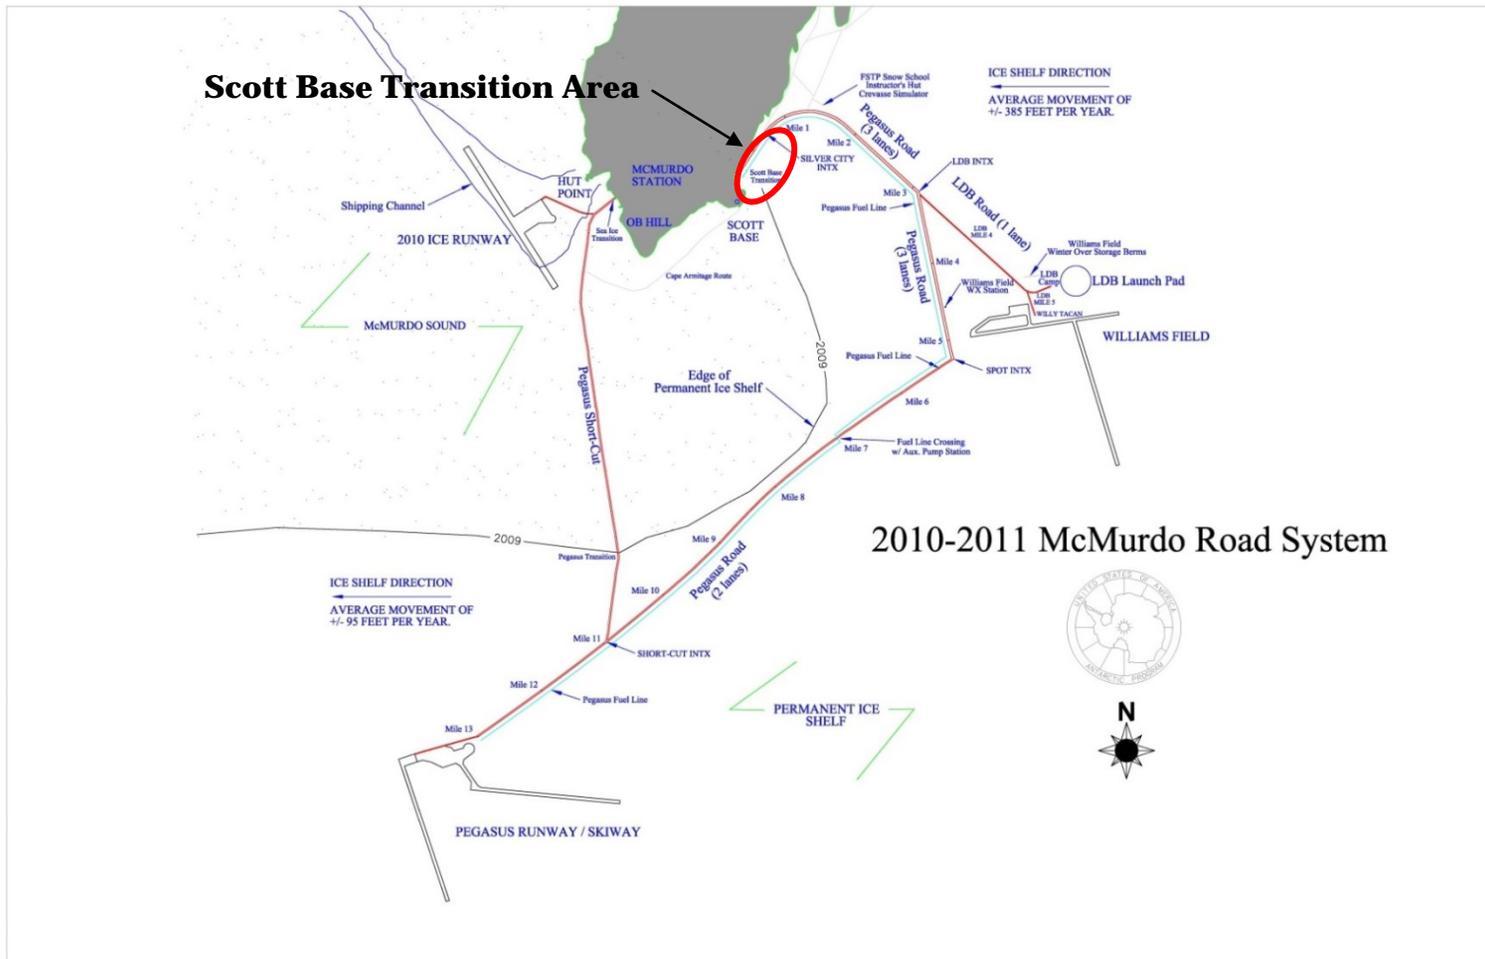
Figure 1. McMurdo road system map.

The snow roads at McMurdo Station, Antarctica, shown in Figure 1, are the primary transportation corridors for moving personnel and material to and from the airfields servicing intra- and intercontinental air traffic. The majority of the road system is made of snow overlying a snow and ice subsurface. However, at the Scott Base Transition (SBT), the aggregate and soil road leading from Scott Base transitions from the permafrost, soil, and rock subbase of Ross Island on to the ice shelf and becomes a full depth snow road (Figure 1). Because of the transition between materials, the topography of the area, and extensive use during the summer, the SBT is prone to problems unique to that portion of the McMurdo road system and requires specific maintenance activities to remain passable during periods of higher temperatures. This document provides a baseline guide for construction, maintenance, and repairs of the two distinctly different segments of the SBT. This report serves as an accompaniment to Antarctic Support Contract (ASC) Manuals for construction and maintenance of the Scott Base Transition and the snow-road system in general (ASC 2014, forthcoming).

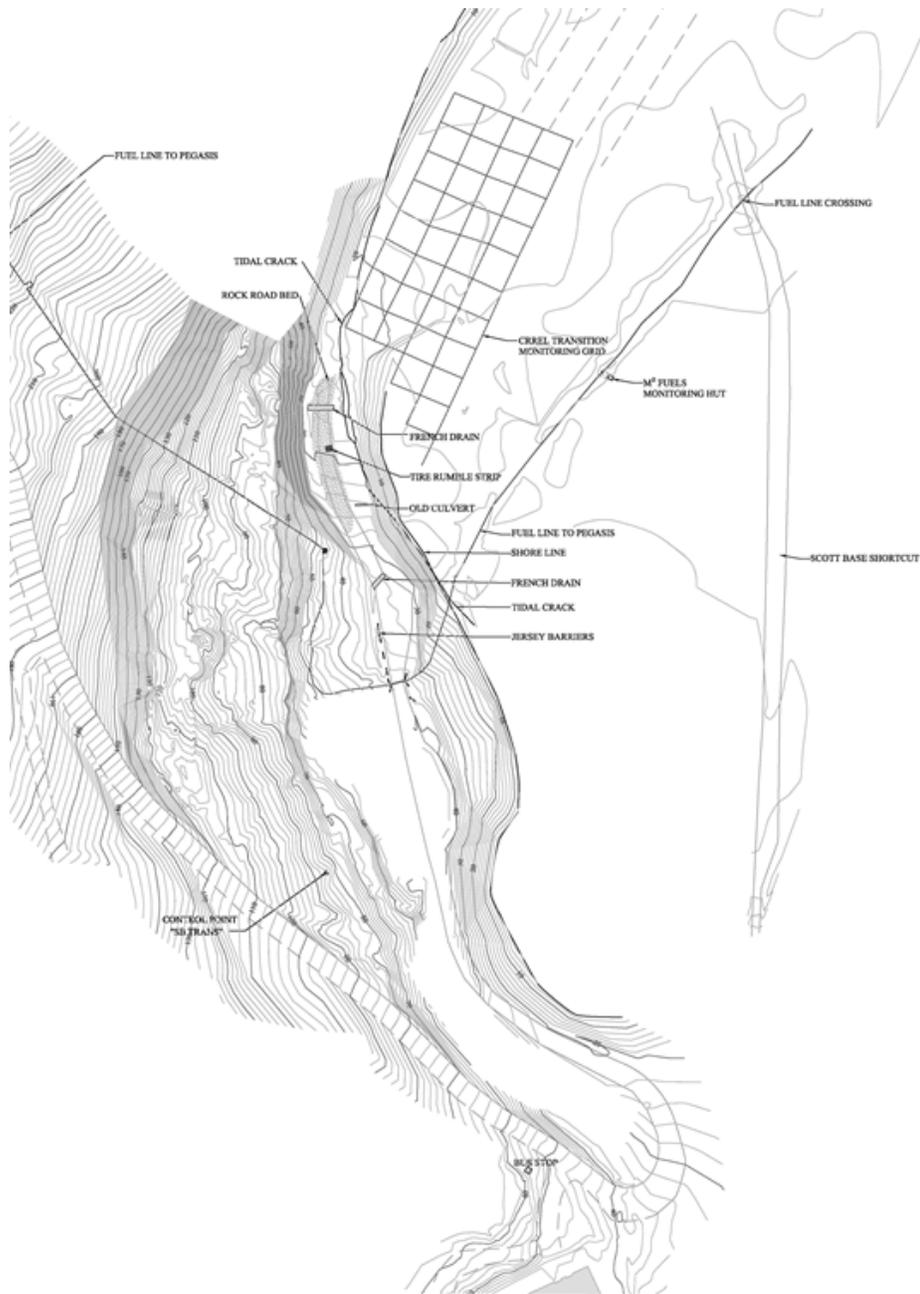
Figure 2. Map of the Scott Base Transition, showing the 2010–2011 placement of maintenance structures.

Vigilance and regular maintenance are critical to providing the SBT the best chance of remaining fully operational through the difficult last portion of Main Body. Year-to-year variances in ambient temperature, cloud cover, winter snow deposition, and melt impact the transition areas greatly. Issues that affect the Land Transition section are water runoff, subsurface melting, traffic load (vehicle count and weight), and working tidal cracks through the permafrost on the “land” side and the “snow” side of the SBT. For reference, Figure 2 provides a map showing the features of the SBT and the locations of mitigation structures used during 2010–2011.

3. Approximately 100 ft (30.5 m) of 3–4 in. (7.6–10.2 cm) clean-off rock placed in a 6–8 in (15.2–20.3 cm) deep layer forms a clean road surface just prior to entering the ice shelf (see area of placement in Figures 2 and 12).

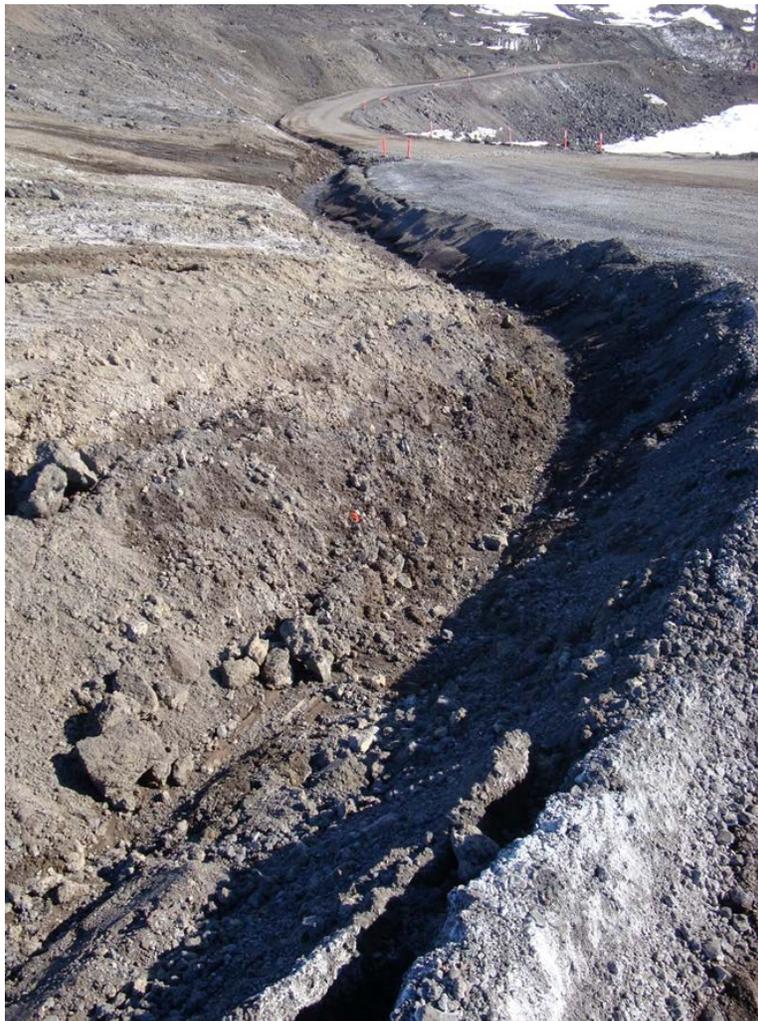
Figure 3. Upslope drainage ditches along the Land Transition of the SBT.

Installing and maintaining drainage structures can mitigate this problem by controlling the flow of water. One type of drainage structure is roadside ditches. Adequately sized and bermed ditches (Figure 3) will prevent water from flowing onto the roadway.

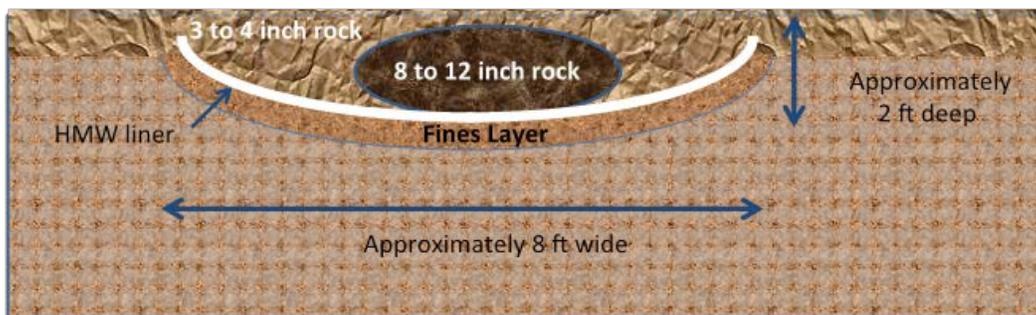
Figure 4. Schematic of the Antarctic French Drain.

Further down slope toward the ice shelf requires an Antarctic French Drain (AFD) like the one shown schematically in Figure 4. An AFD consists of a ditch approximately 8 ft (2.4 m) wide and 2 ft (0.6 m) deep and is installed from the base of the rock cliff, across the road to the downslope outflow to allow water to flow from the cliff to the ice without causing erosion or wetting of the road surface. After initial excavation, lining the ditch with 3–4 in. (7.6–10.2 cm) of (gray) fines seals off the water from penetrating deeper into the road subgrade. Placing an impermeable liner on top of the fines-lined ditch will further channel the water. In 2010, 25 ft by 8 ft (7.6 m by 2.4 m) pieces of high molecular weight (HMW) plastic were used for the AFDs.

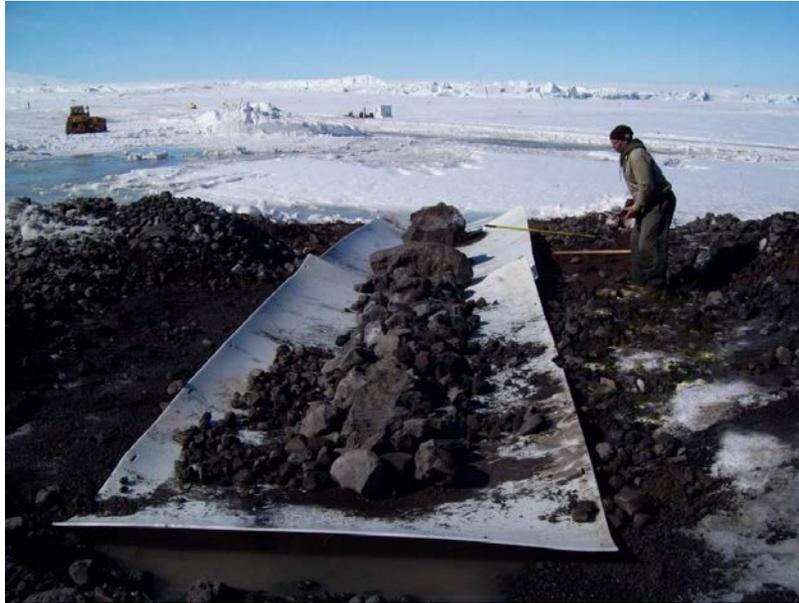
Figure 5. The fines and plastic are installed, and the large rock is placed along the center of the drain.

Figure 5 illustrates how laying 8–12 in. (20.3–30.5 cm) rock on the plastic allows for non-erosive water drainage. The larger rock increases the drain’s lifespan and flow capacity over the 3–4 in. (7.6–10.2 cm) clean-off rock, which easily plugs with silt. Finally, clean-off rock (3–4 in. [7.6–10.2 cm] rock) should cover the plastic and the larger 8–12 in. (20.3–30.5 cm) rock to bring the ditch back to the normal road surface grade.

This AFD successfully drains the water and prevents future subsidence and surface or subterranean erosion that is caused when inferior materials are used. Figures 5 and 6 show the 2010 construction, and Figure 7 shows close-up views of the inflow and outflow sides of a fully constructed, successful AFD.

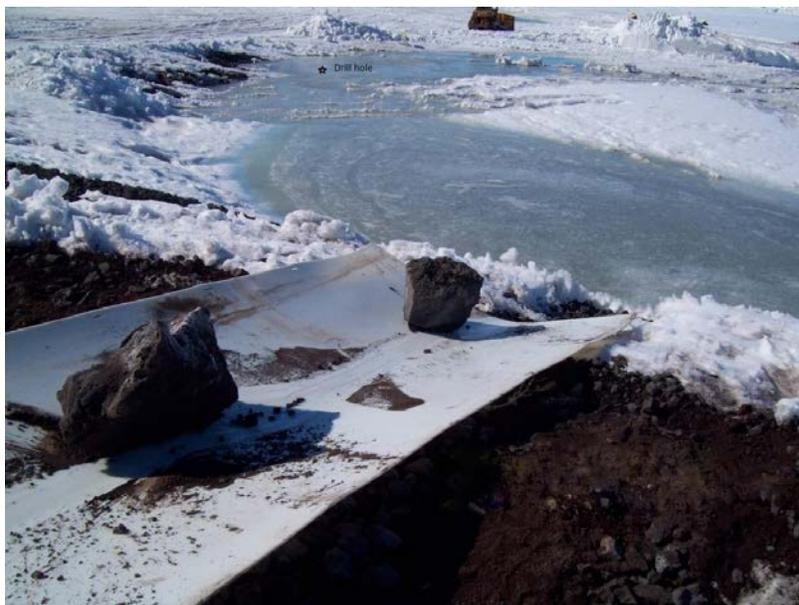
Figure 6. The plastic sheet forms an outlet to protect the Land Transition's side slope from settlement and erosion.

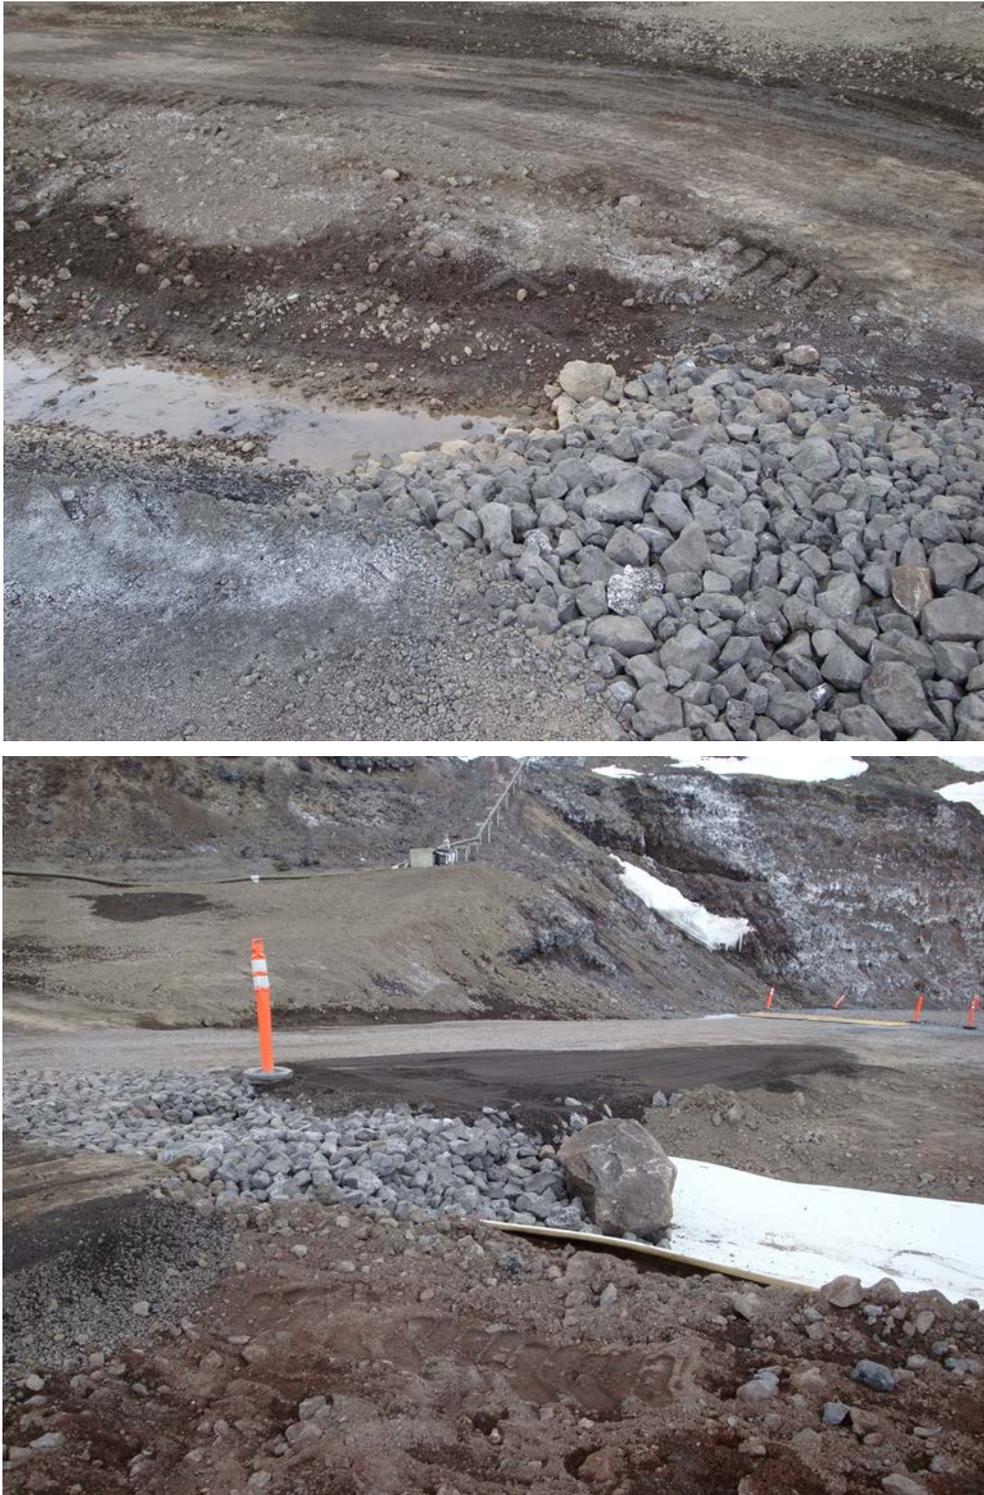
Figure 7. The finished Antarctic drain inflow (top) and outflow (bottom).

The plastic HMW liner should extend beyond the Land Transition road travel lanes on the downslope side to provide erosion protection for the roadside slope at the drain outlet (Figure 7). The side slope tends to crack and settle, and water runoff exacerbates the problem. Whether using a culvert or an AFD, it is imperative to ensure that the outflow is well past the road bed prism or unacceptable erosion and loss of roadway can occur. Two large rocks hold down the plastic for the outlet; the plastic does not need to be covered with smaller rock at the outlet as it is not part of the roadway.

Occasionally, plastic can be used at the roadside slope as a drain outlet to provide erosion control if necessary (as in Figure 7, bottom). In this case, the outlet should be cut deeper than the road trench, sealed with fines, and then laid over with plastic. The fines help prevent it from undercutting. Topping the plastic with large rocks as needed will help keep it in place. The location of these smaller drains should be determined by the location of heaviest flow across the road, which may change from year to year.

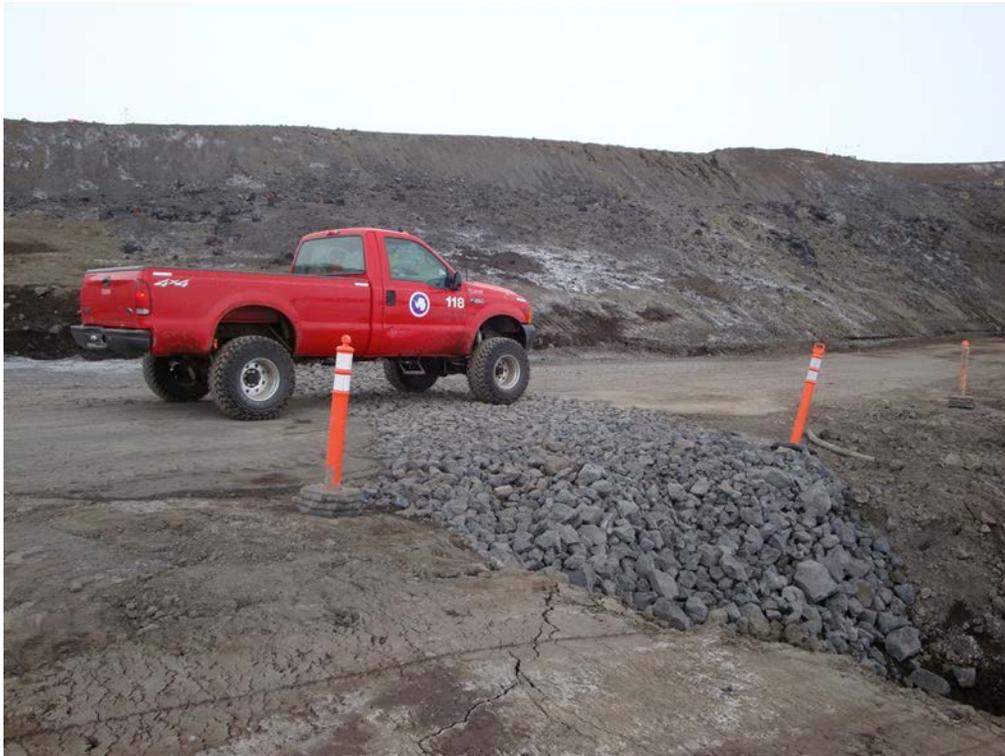
Figure 8. Unlined french drain crossing built with clean-off rock only.

small drainage ditches were cut across the Land Transition road. Traffic crossing these small ditches picked up mud. To fix this problem, transverse trenches 6–8 in. (15.2–20.3 cm) deep and 4 ft (1.2 m) wide were cut with a backhoe and then filled with 3–4 in. (7.6–10.2 cm) clean-off rock (Figures 8 and 9). Fines and HMW plastic are not needed here because the road subbase is solid, impermeable vesicular basalt with no permafrost and is not aggregate and soil over ice as previously discussed with the AFD construction.

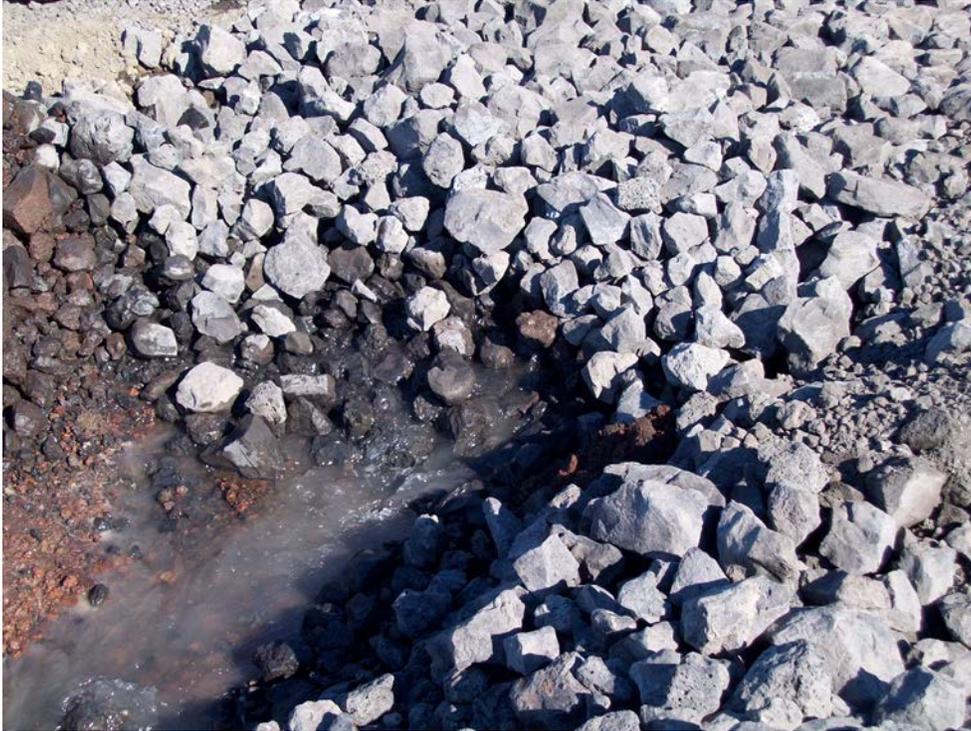
Figure 9. Clean-off rock drain outflow without HWM plastic.

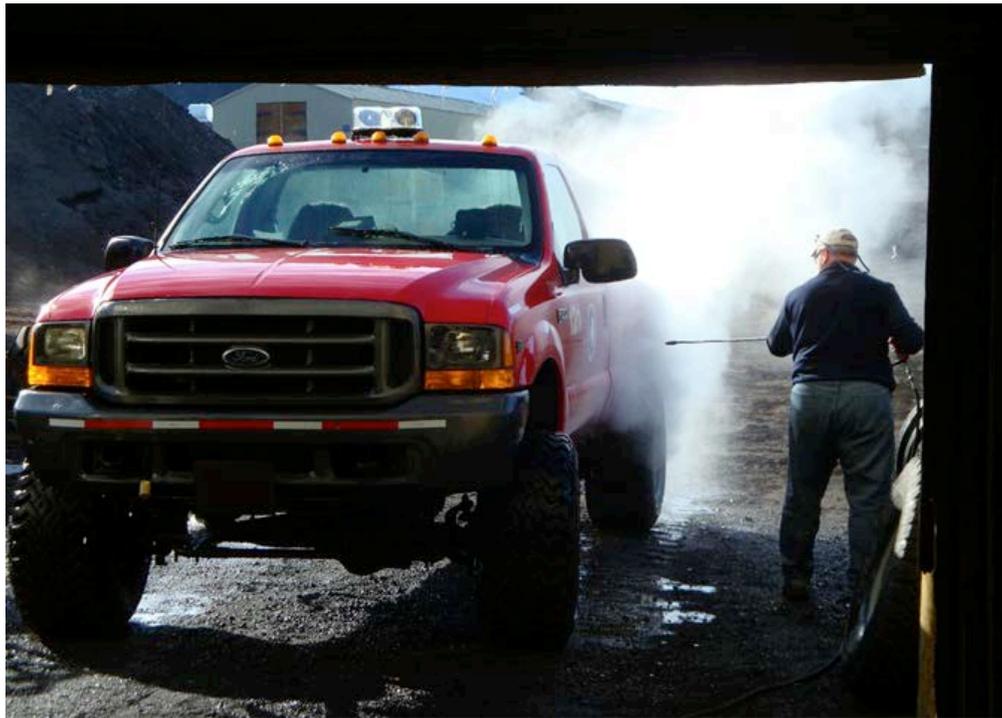
Figure 10. Using a vehicle wash station to keep vehicles clean and well maintained.

1. Any vehicles using the ice shelf should be kept clean at one of the vehicle wash stations in McMurdo (Figure 10). This reduces the wear and tear on the vehicle and keeps dirt off the snow roads.
2. Dust and mud accumulated while driving the McMurdo–SBT Road should be removed at the pull-off vehicle cleaning station before driving onto the ice shelf (Figure 11). Cleaning stations should be maintained and stocked with appropriate tools for vehicle cleaning.

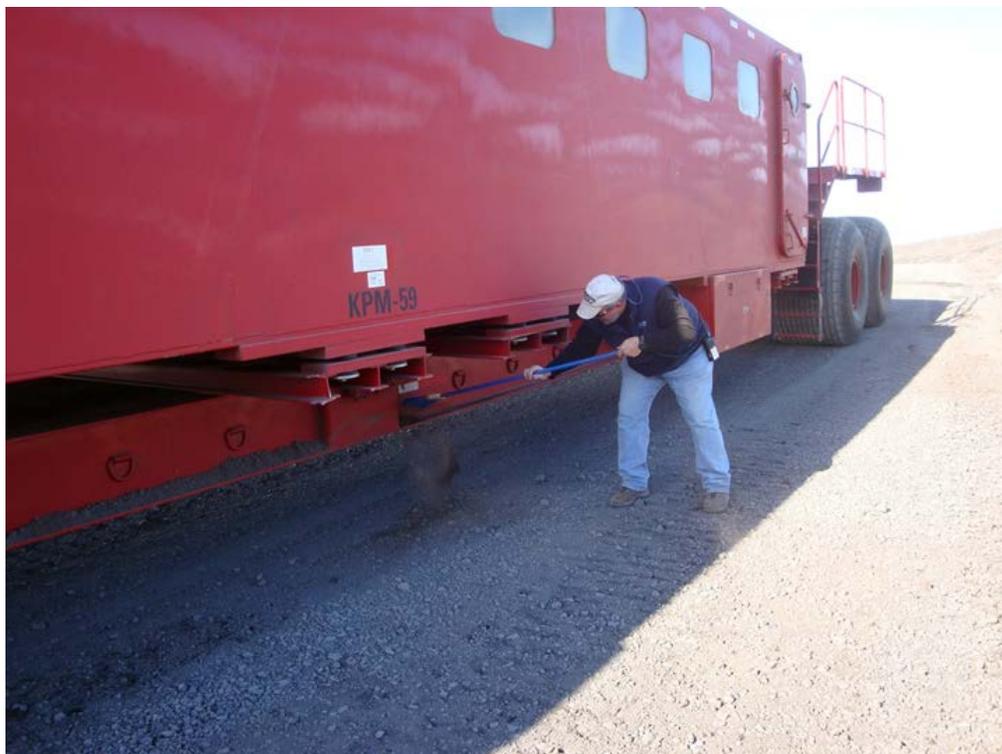
Figure 11. Vehicle cleaning station.

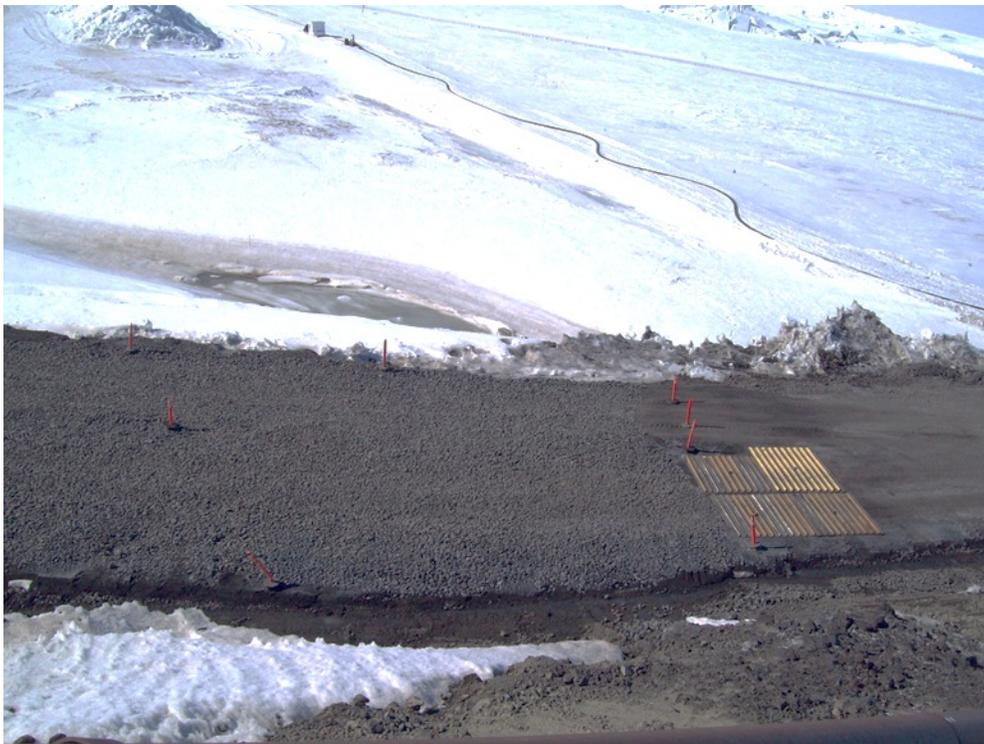
Figure 12. Shake plates and clean off rock help shake dust and mud off vehicles and keep them clean prior to entering the ice shelf.

4. Shake plates provide additional vehicle cleaning. We recommend that 40 ft (12.2 m) of shake plate be used along the road (Figures 12 and 13). These plates are 8 ft by 10 ft (2.4 m by 3.0 m) and were originally made of 10 ft by 3 in. (3.0 m by 7.6 cm) angle iron welded in a pleated or corrugated shape. Light wheeled vehicles are required to cross the shake plates before going out onto the ice. Placing the plates near the start of the 100 ft (30.5 m) clean-off rock area but far enough to the right to allow Deltas and tracked vehicles to bypass around the plates (to avoid damage to the tracks or suspension of over-snow vehicles) greatly reduces the amount of dirt tracked onto the Ice Transition.

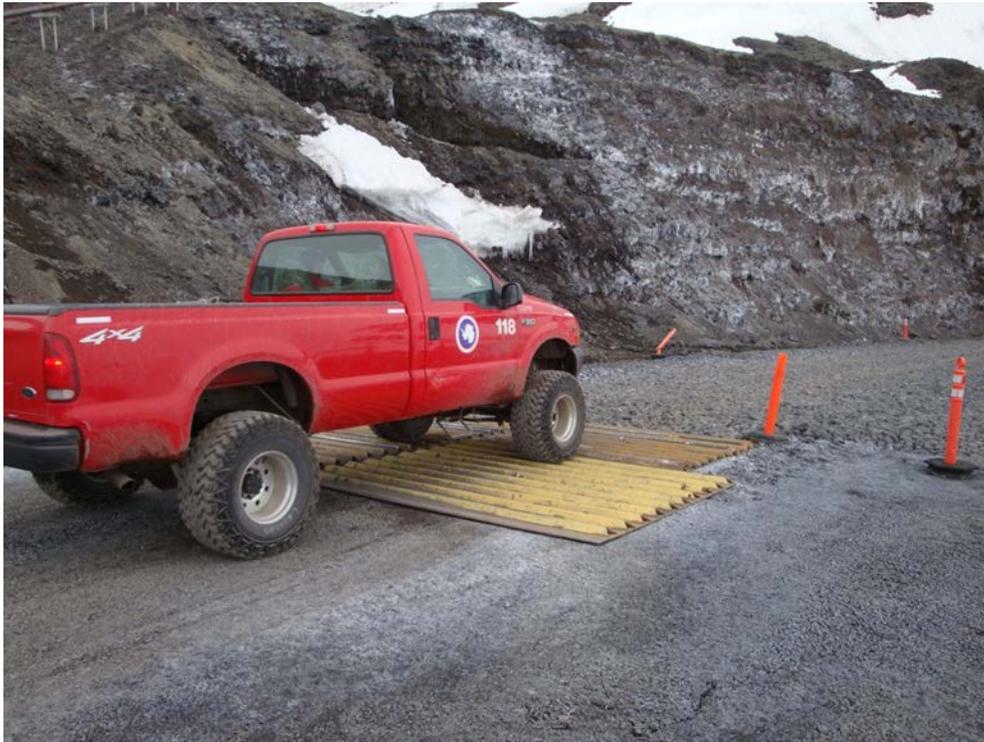
Figure 13. A U.S. Antarctic Program truck crosses the shake plates to clean off debris from the tires and body.

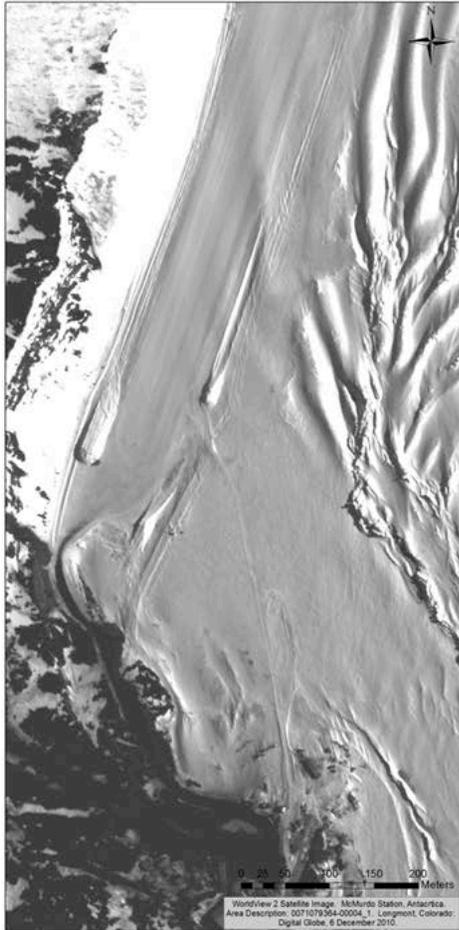
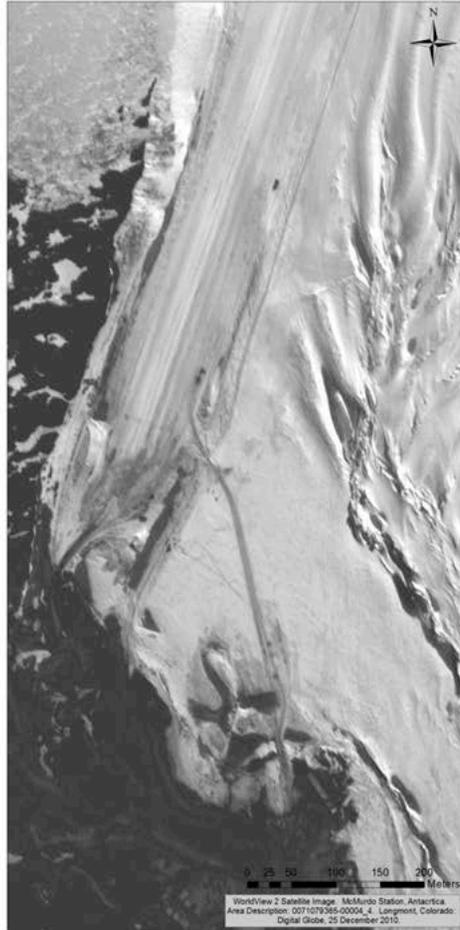
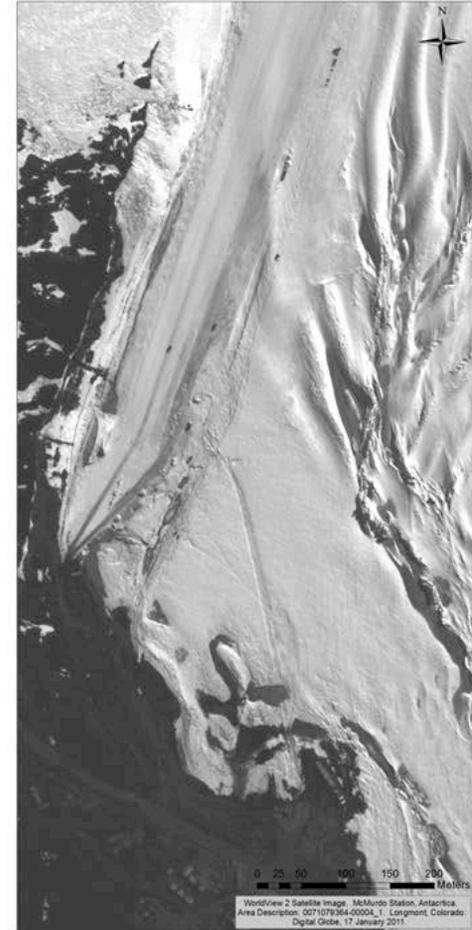
Figure 14. Images showing the SBT Ice Shelf through the progression of the melt season. The dark areas on the ice shelf are meltwater pools and wet snow (6 December 2010 to 17 January 2011).

4. Figure 14 shows the rollers and snow stockpiles.
5. Goose or drag snow once per month to keep the area level and smooth.
6. After storms, goose or drag and compact snow to build smooth, level layers (lifts) of compacted snow. This will help the transition last through the melt season.

Figure 14 shows images of the progression of the SBT during the melt season from December 2010 to January 2011. The image on the left shows the stockpiled snow and all four lanes of the snow road in excellent condition (at the opening of the snow roads to Pegasus). The center image was taken on 25 December 2010 and clearly shows the dark color and decreased albedo of the melt pools. The image on the right, taken on 17 January 2011, shows the decreased stockpiles of snow, the water collected in the drains near the cliff face (left side of the image), the decreased size of the melt pools (through drainage holes), and the repaired lanes beginning to heal although melt is still visible.

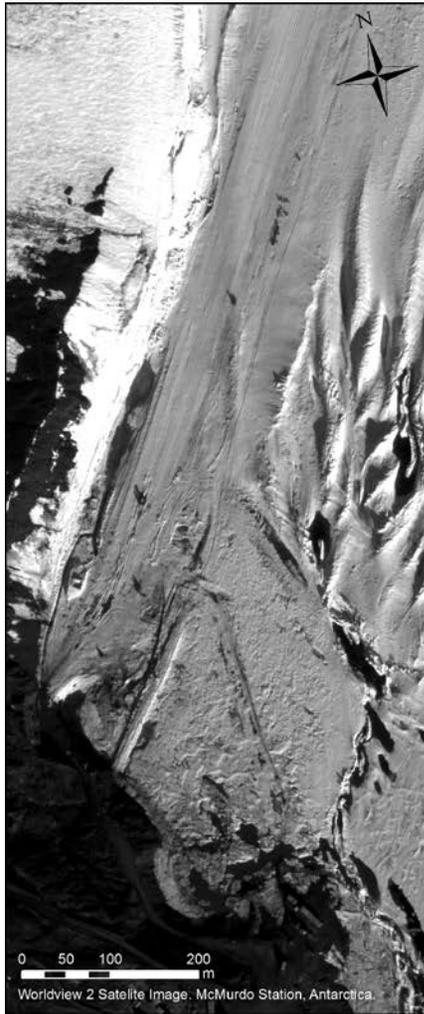
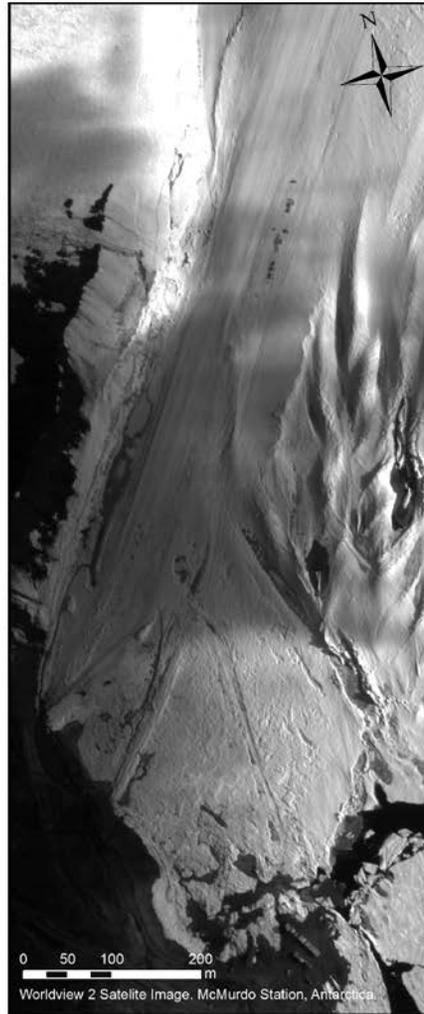
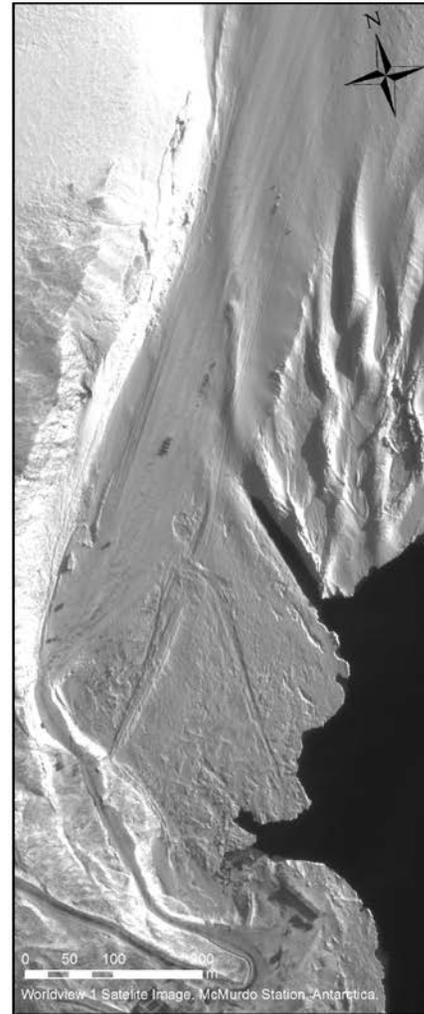
Figure 15. Images showing the SBT Ice Shelf through the progression of the melt season and ice shelf breakout. The dark areas on the ice shelf are meltwater pools, with open water shown on the right-hand side by the end of the season (8 January to 28 February 2014).

For comparison, Figure 15 shows the same area from 8 January to 28 February 2014. The conditions were clearly quite different between the two years. During 2014, the ice shelf broke out in front of Scott Base and close to the snow road at the transition area. The differences in Figures 14 and 15 illustrate how widely varied the conditions can be.

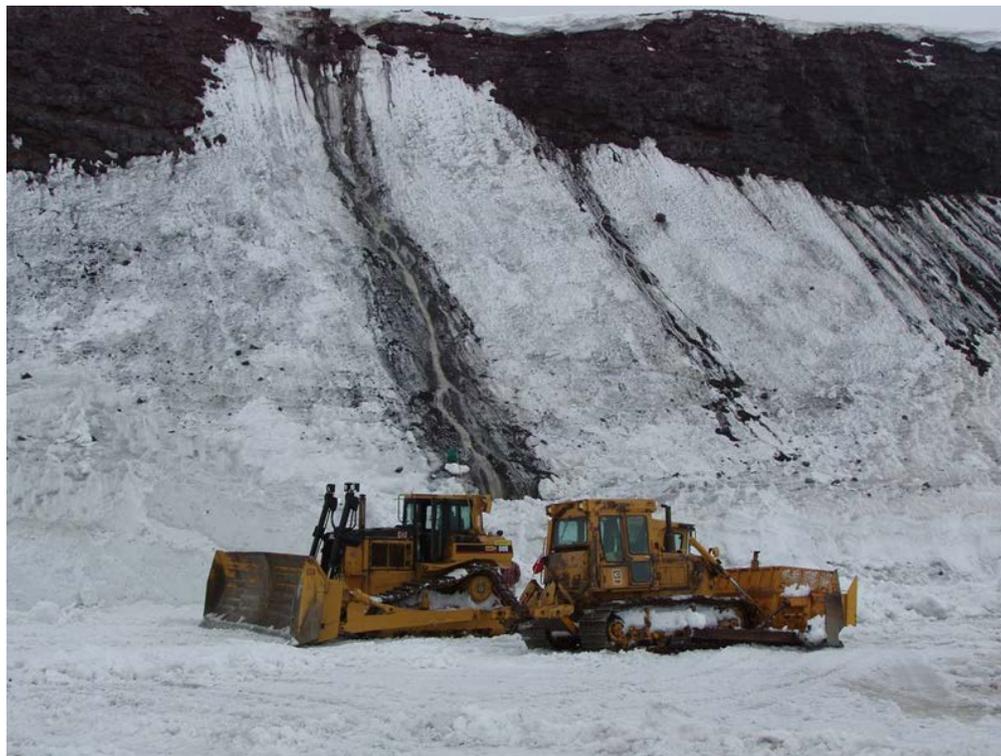
Figure 16. Water runoff down the cliff face.

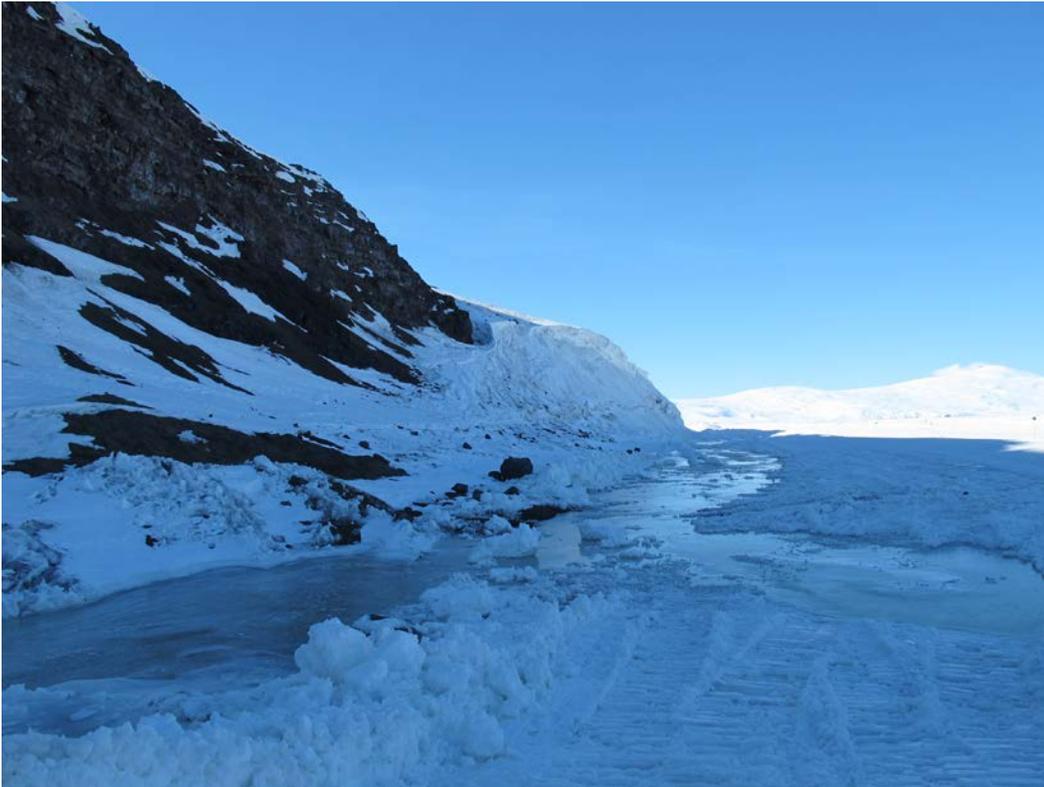
Figure 17. Drainage ditch to catch cliff meltwater.

The water runoff from snow melting on top of the cliff (Figures 15 and 17) is another aspect of water mitigation. In some past seasons, a ditch was cut along the bottom of the cliff; and it flowed to a runoff catch basin or retention pond. This drainage kept water from flowing onto the Ice Transition area. Cutting the ditches deeper may entail digging the catch basin deeper. A laser level or the survey department should determine the slope line and the depth of the ditch's excavation. This ditch could be cut with a D4 (a small bulldozer) or a backhoe. An excavator would be best suited for this project, if available.

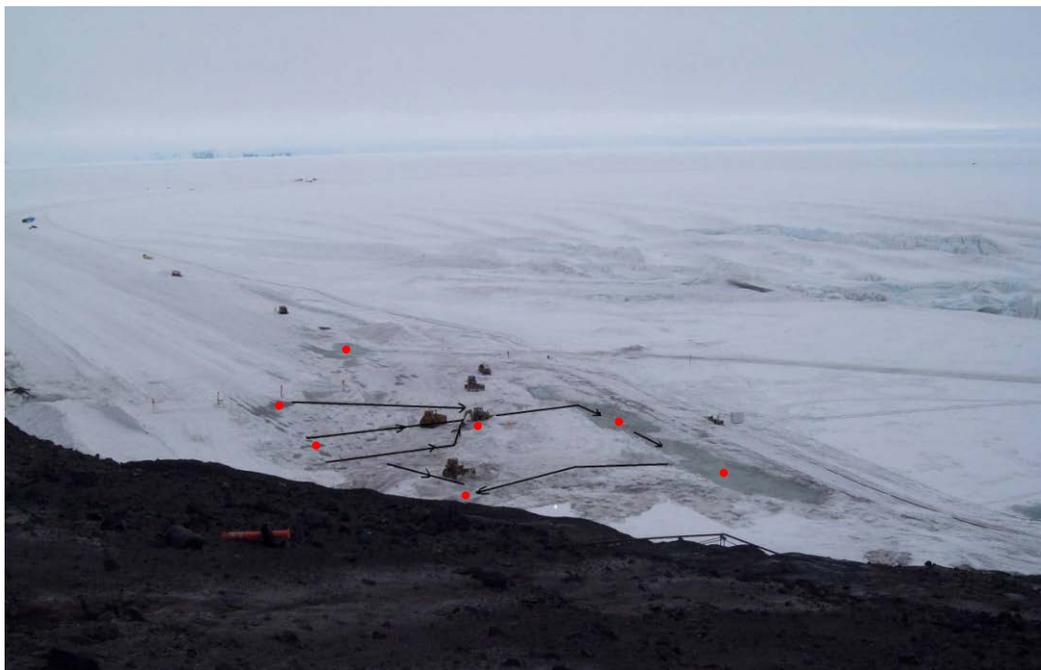
Figure 18. An Ice Transition photo from the cliff. The water flow lines are in black, showing the direction with arrows, and the drainage points are red dots.

Once the Ice Transition starts to deteriorate, a dewatering scheme should commence. Because the dewatering plan can change drastically from year to year, it can be helpful to take photos from the adjacent cliff to sketch out the water flow pathways and where the drainage holes should be located. In the 2010–2011 example in Figure 18, the water flow lines are in black, showing the direction with arrows; and the drainage points are red dots.

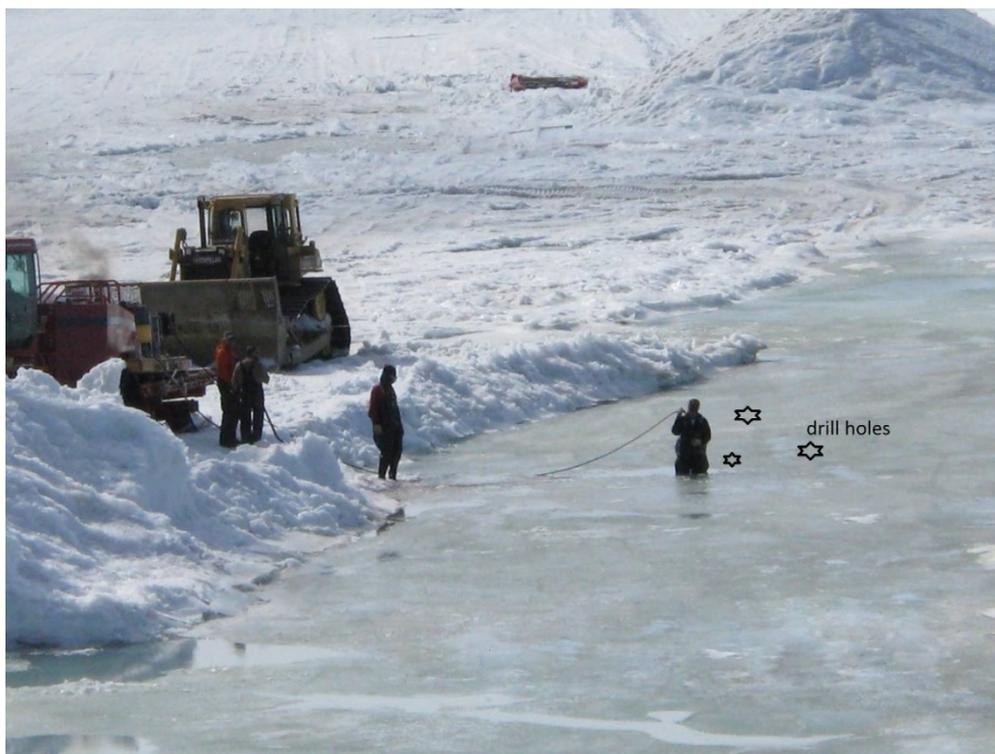
Figure 19. Hot water drilling to drain the retention ponds.

In 2010–2011, two large ponds formed between the Ice Transition and Scott Base. A ditch was trenched from the big ponds to the low area by the Land Transition, forming a single new retention and infiltration pond. During that season, in the new pond that formed at this low point near the fuel line side of the transition, nine holes were drilled 28–30 ft (8.5–9.1 m) deep with a hot water drill (Figure 19). In this case, most of the holes took 15 minutes to drill. After punching through the ice, hitting a crack or void, the water began to drain quickly. It took about a day and a half for the big pond to drain to approximately 20% of its original capacity. Any drill holes and ditches should be located and recorded with GPS and kept on file with the McMurdo survey office. Recording the drill-hole locations and depths over the years provides insight into the structure and behavior of the ice shelf in this area.

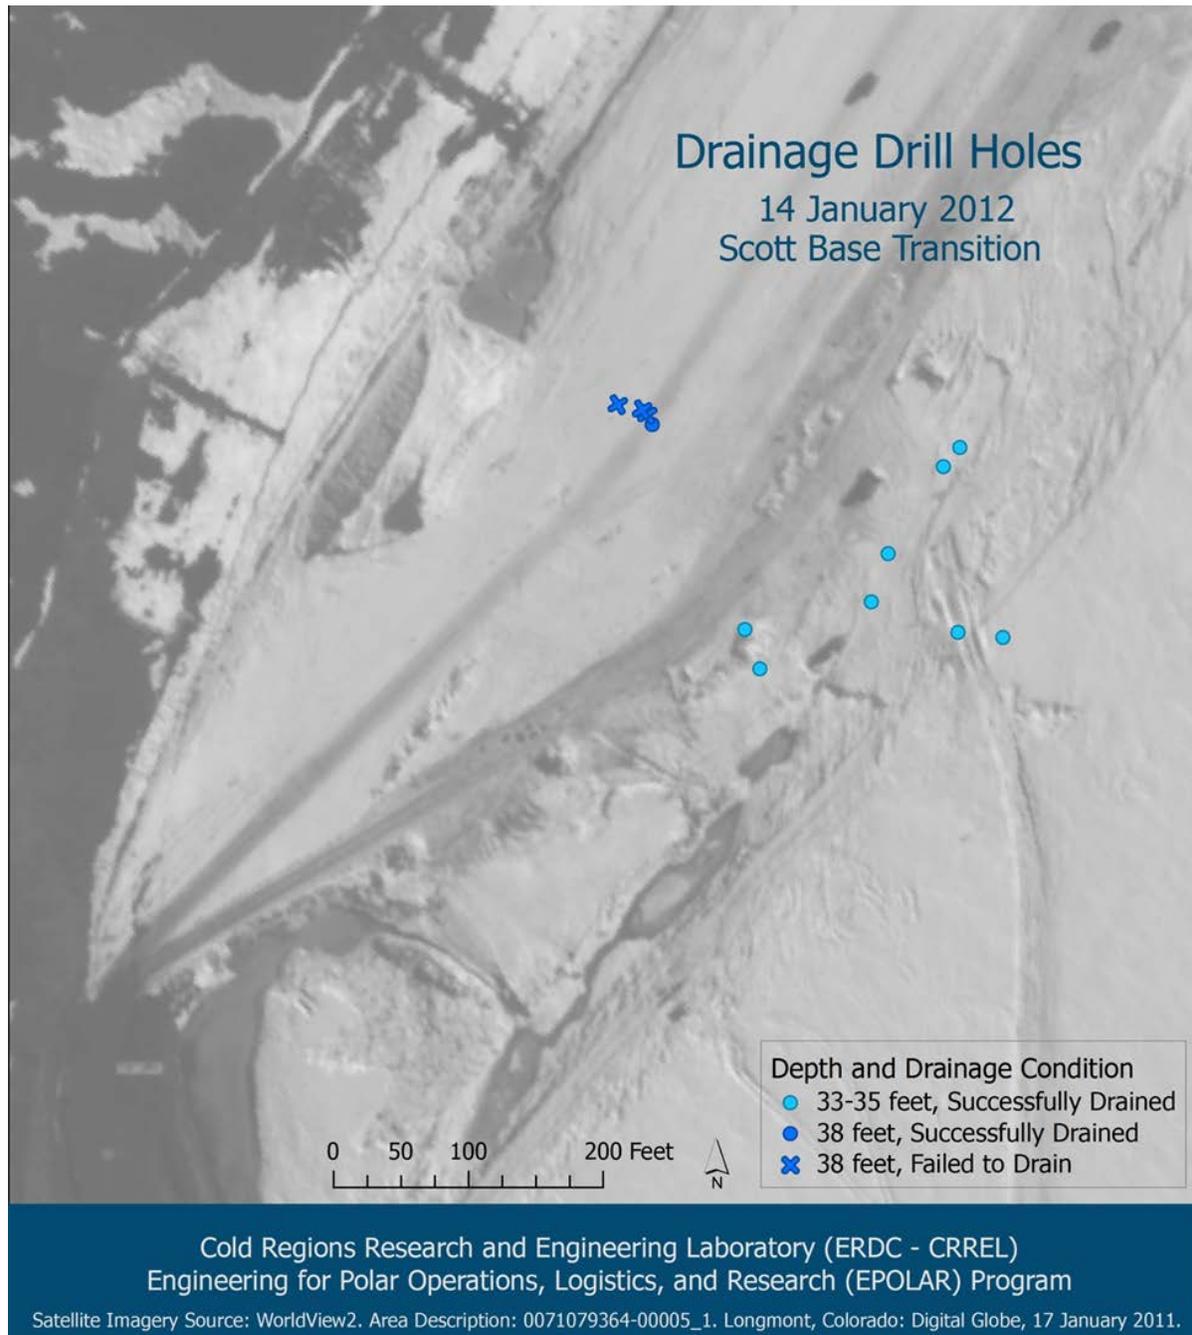
Figure 20. Drill sites for drainage holes from January 2012.

Figure 20 shows the location of the drill holes from January 2012 (33–38 ft deep [10.1–11.6 m]) overlain onto earlier imagery. The uniformity in the depth of successfully drained holes (33–35 ft [10.1–10.7 m]) suggests that drainage may have been into the seawater below the ice shelf instead of into a fracture system. The grouping of holes closest to the cliff was 38 ft (11.6 m) deep, and all but the furthest seaward hole encountered sediment (presumably the sea floor or the under-ice continuation of the cliff). At this time, the exact mechanism and subsurface drainage pathways on the Ice Transition are unknown.

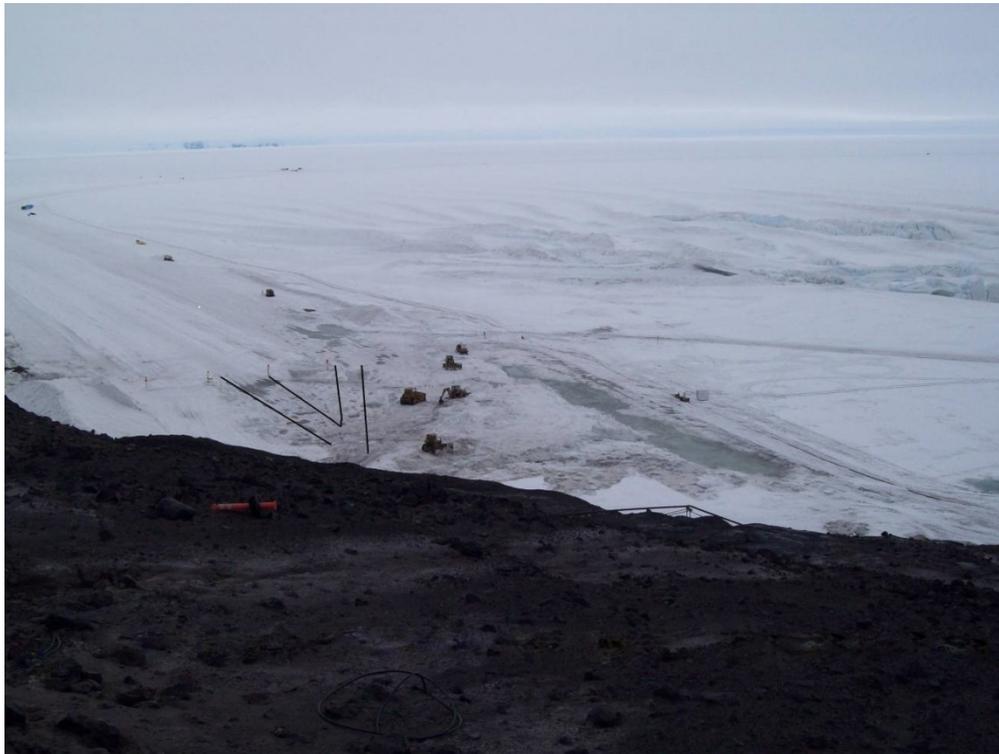
Figure 21. First lanes to be rebuilt and reopened to traffic during the 2010–2011 season.

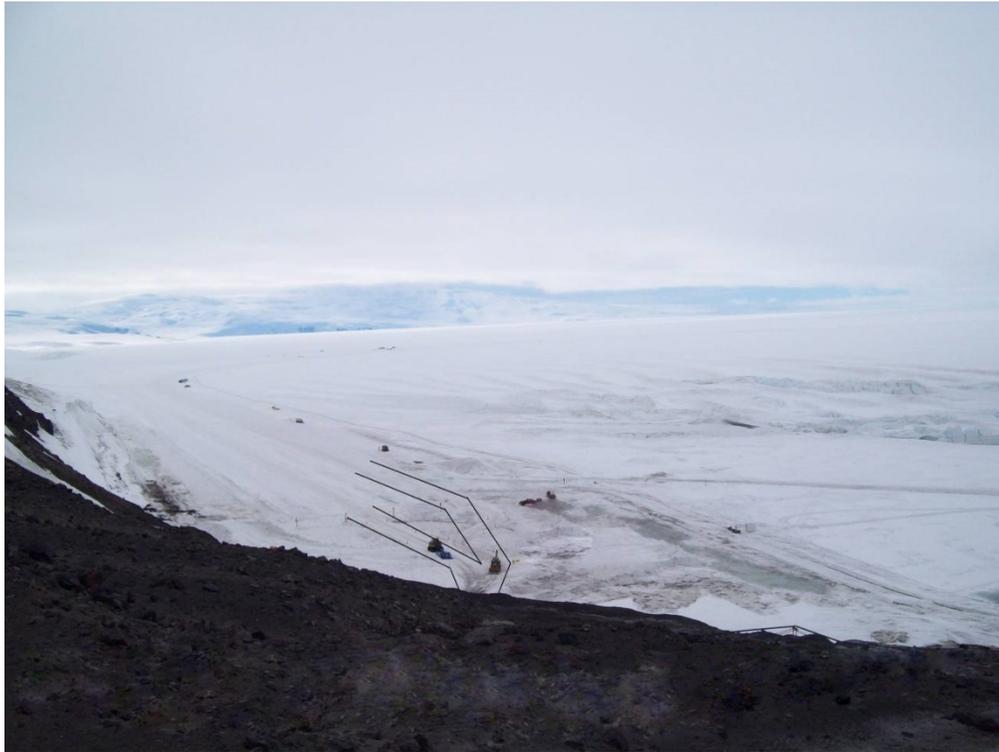
Figure 22. Continued construction during the 2010–2011 season.

Figure 22 shows the reconstruction of the Ice Transition as the first two lanes were worked and the rest of the area was being dewatered. Once these lanes were 100% completed, the rest of the transition was rebuilt.
