Engineering for Polar Operations, Logistics, and Research (EPOLAR)

Maintenance and Drainage Guidance for the Scott Base Transition, Antarctica

October 2014

Final Report

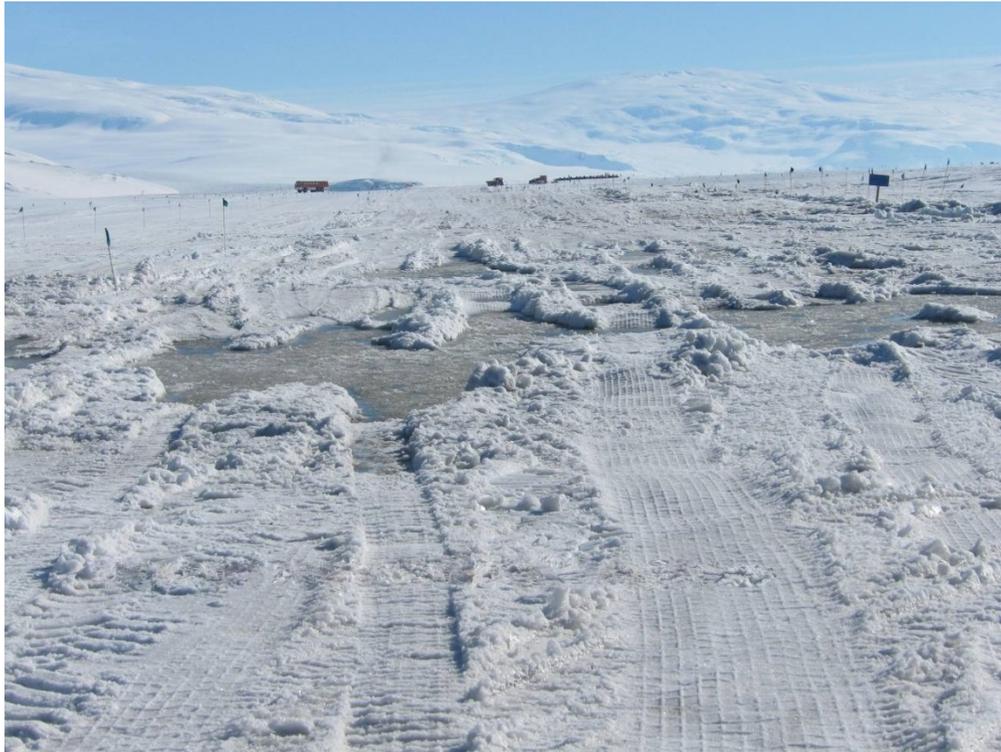
Figure 23. General conditions in the Ice Transition prior to maintenance.

Once the first two lanes are established, the remaining Ice Transition area may need to be scraped to the ice to remove the saturated snow and to fix melt pools. Figure 23 shows the general conditions of the Ice Transition from dirty vehicles, solar impact, and migrating water while Figure 24 shows melt pools and potholes prior to the Ice Transition being dozed. The excavated material is stockpiled outside of the travel area to allow it to drain. After draining the frozen slush, this material is mixed with clean snow and provides good patching material for holes on the Ice Transition surface, much the same way as repairing asphalt on a highway. This mixture may be used for filling in the large areas that have been dewatered, for filling in the dewatering ditches after draining, and as a subbase for the new lanes.

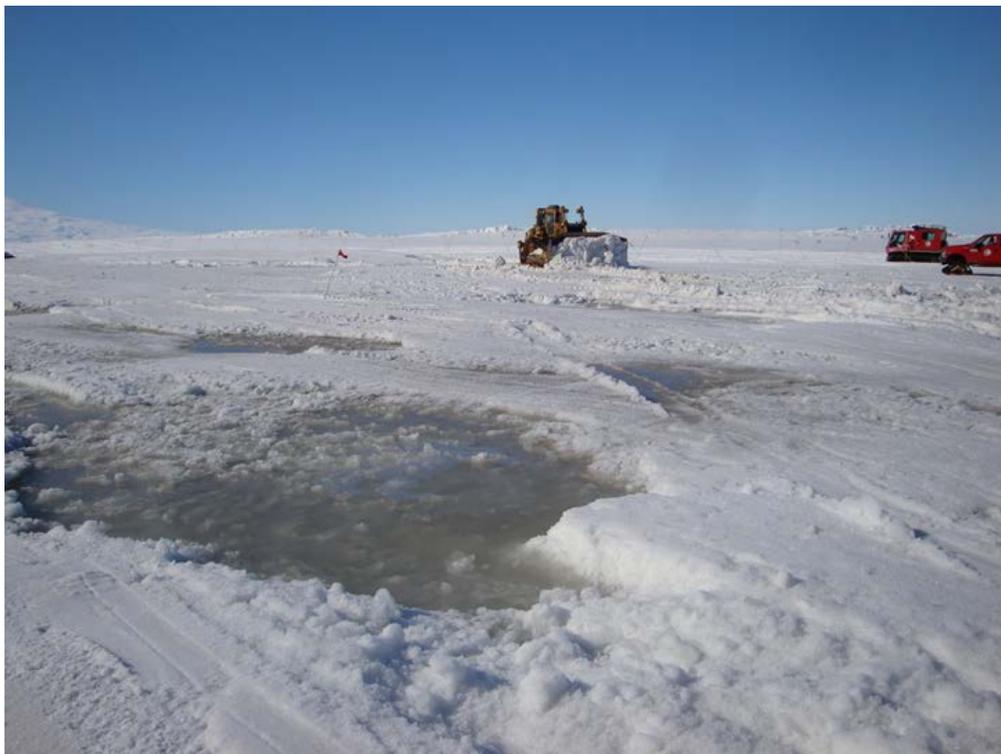
Figure 24. Melt pools requiring maintenance on the Ice Transition.

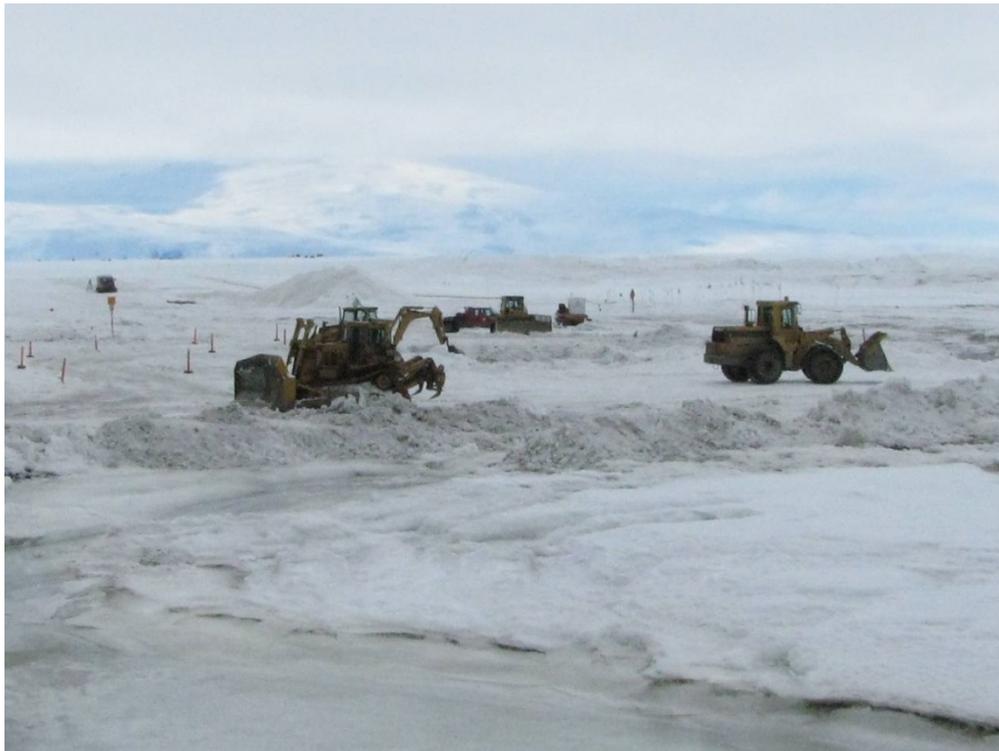
Figure 25. Scraping, ripping, and patching the rest of the Ice Transition after stabilizing the primary lanes.

During this time of clearing and filling melt pools, a ripper helps to break up any ice layers that have formed below the road bed as a result of repeated freeze–thaw (Figure 25). This layer is particularly common on the track vehicle lane where the heavy cargo vehicles compact the snow. These ice layers block the melting snow from percolating downward into the firm. Once the ice layer is broken, mixed, and compacted, additional clean, stockpiled snow can be used to increase the height of the patch. It is ideal to create a patch that is a mix of the colder ice from below and the warmer surface snow, with the patch being above grade by 1–2 ft (0.3–0.6 m). The patch will solidify during the Antarctic summer “nights” when the temperatures drop slightly, and it can be graded level after a couple of days.

Any new holes that appear may require digging out, ripping, and patching with the snow and slush slurry mixture as needed (Figure 25). The new lanes and patched areas can be covered and rolled with new or stockpiled clean snow as available. As discussed by Shoop et al. (2013, 2014), in 2011 and 2012, the clean snow was laid down on the lanes by a Challenger pulling a snow milling machine (the Keweenaw Research Center SnowPaver), which mixed and compacted the road (Figure 26).

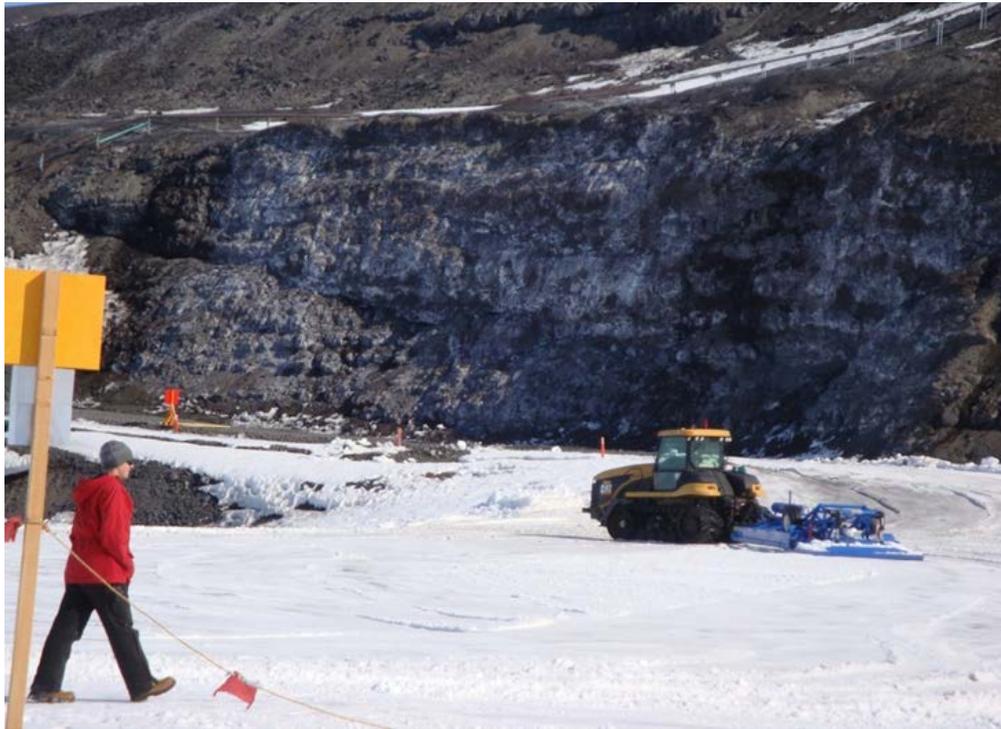
Figure 26. The Keweenaw Research Center SnowPaver mixes and compacts the wet snow at the SBT (January 2012).

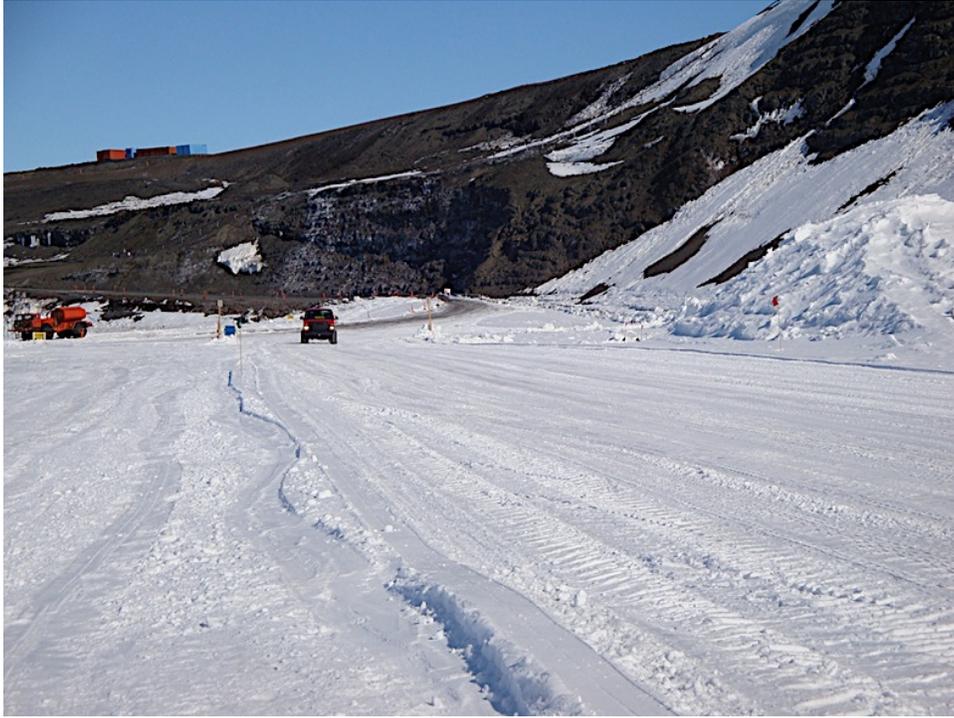
Figure 30. Final results—a nice dry and passable Ice Transition.

Keeping the dirt and debris off the ice is essential for having a solid, well-built Ice Transition roadway section. A properly maintained Land Transition is key to ensuring a clean ice shelf to minimize melting. The final result is a well maintained SBT area that is passable through the melt season (Figures 27 through 30). The melt pools are under control and lanes are open.
