CORPS OF ENGINEERS, U. S. ARMY

AIRPHOTO PATTERN RECONNAISSANCE OF NORTHWESTERN CANADA

TECHNICAL REPORT NO. 41

Volume 2

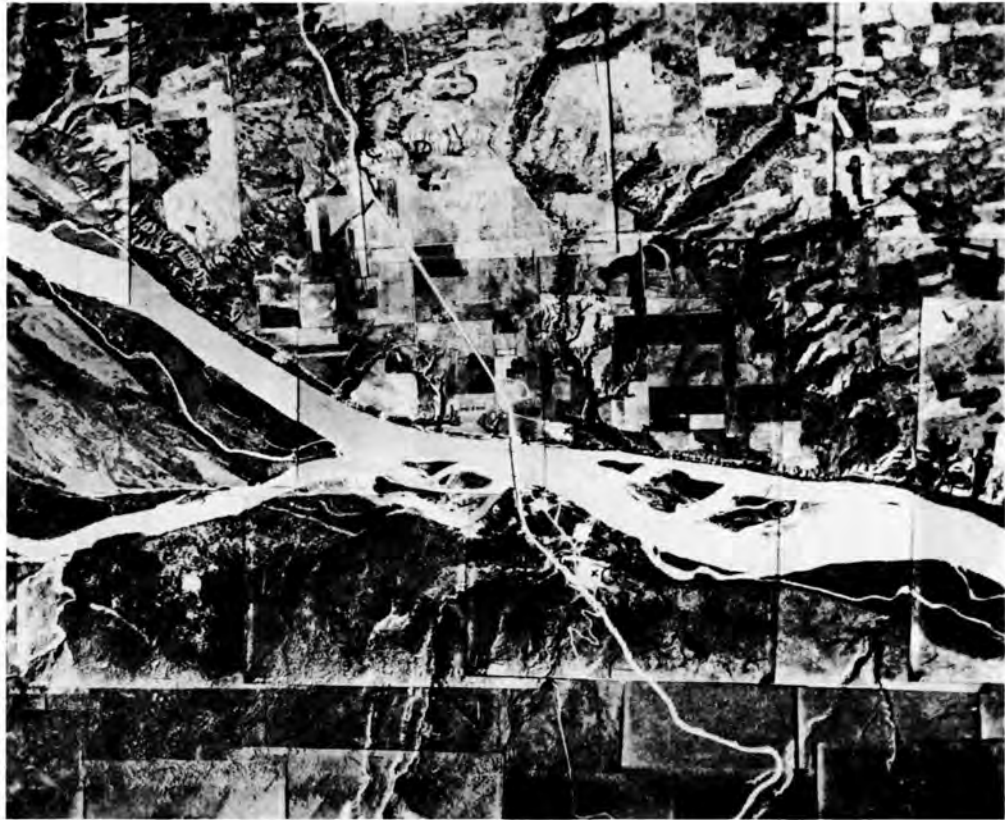
Fig. 1. Mosaic of the Peace River area.

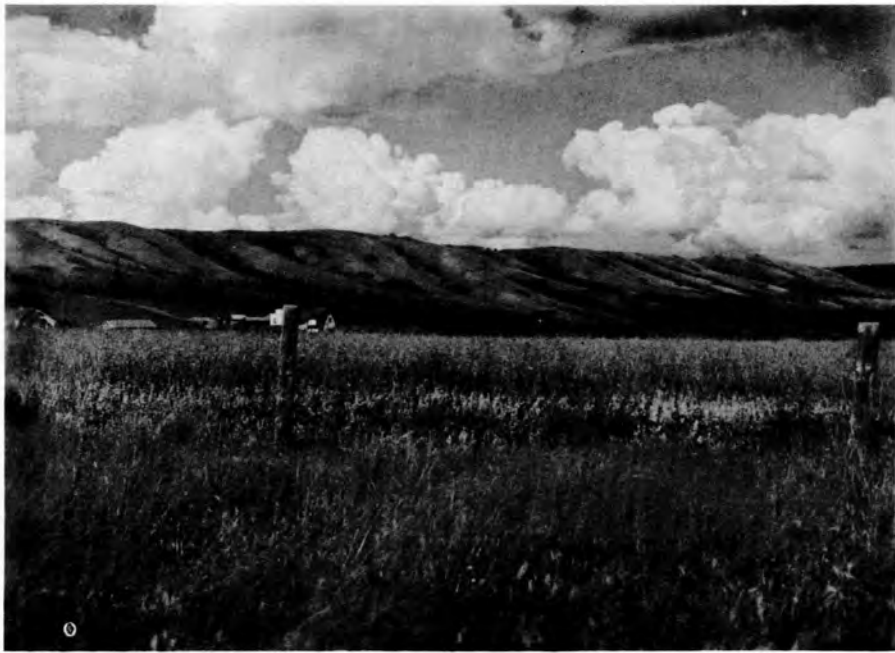
Fig. 2. "Scalloped" face of the escarpment of drift on shale, Peace River area.

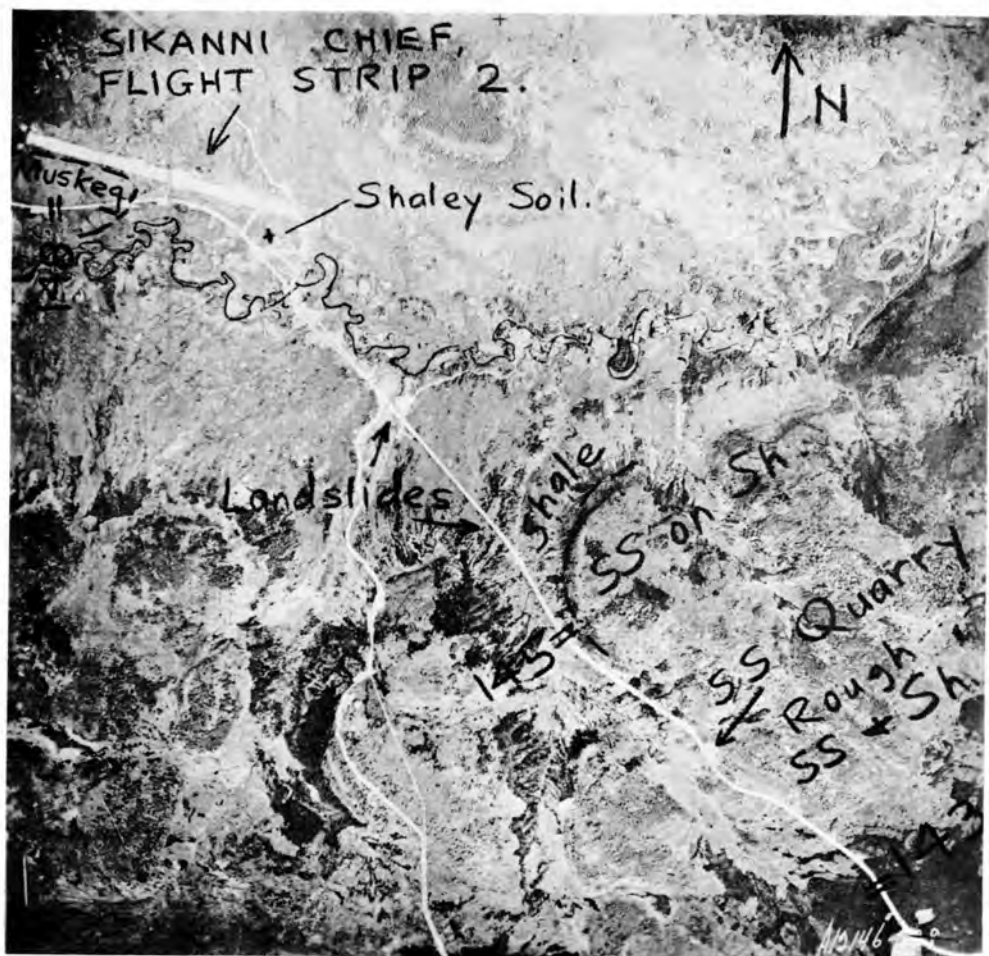
Fig. 4. Vertical airphoto of Sikanni Chief Airstrip.

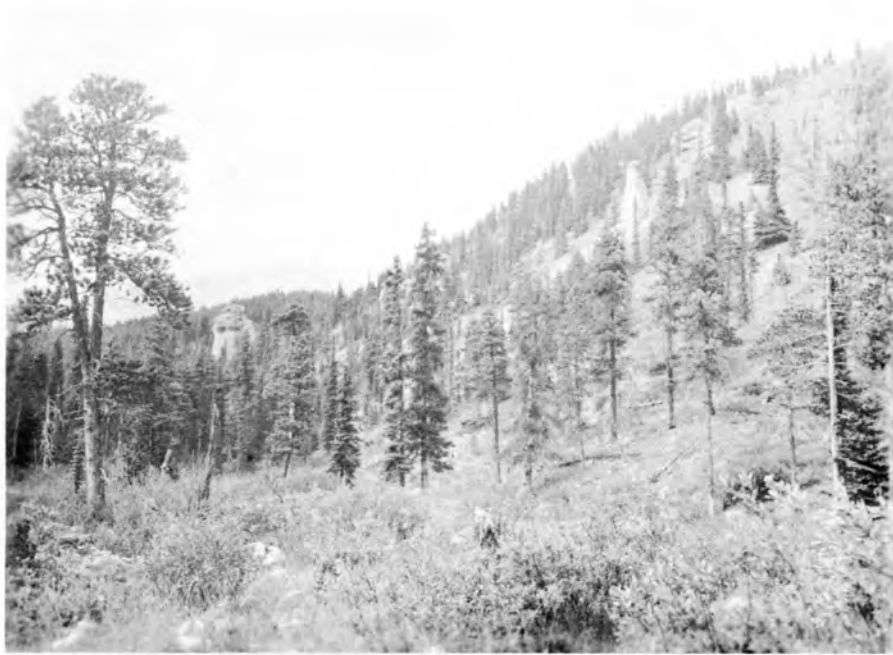
Fig. 5. Hoodoos at Mile 394.

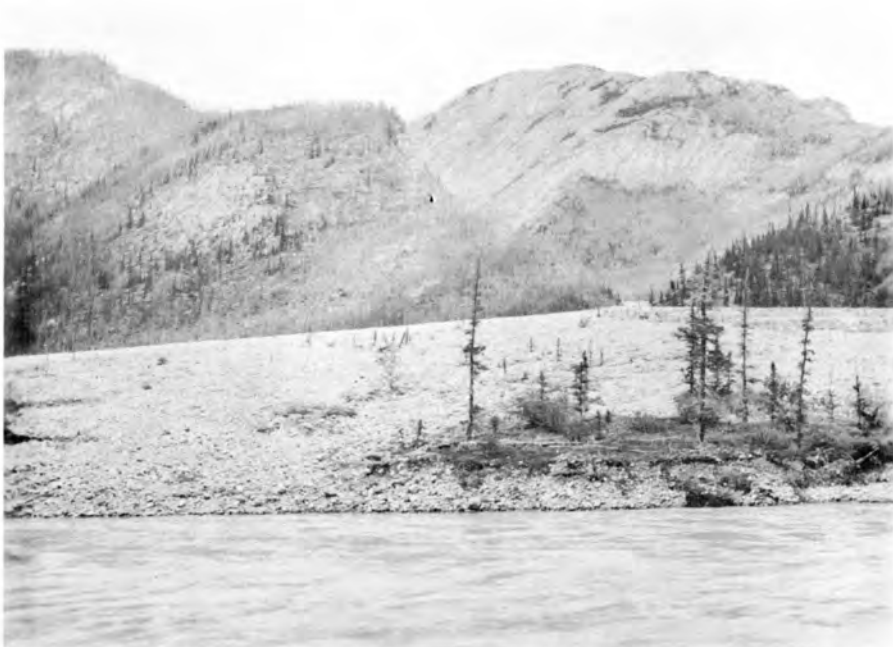
Fig. 6. Alluvial fan at edge of Toad River at Mile 436.

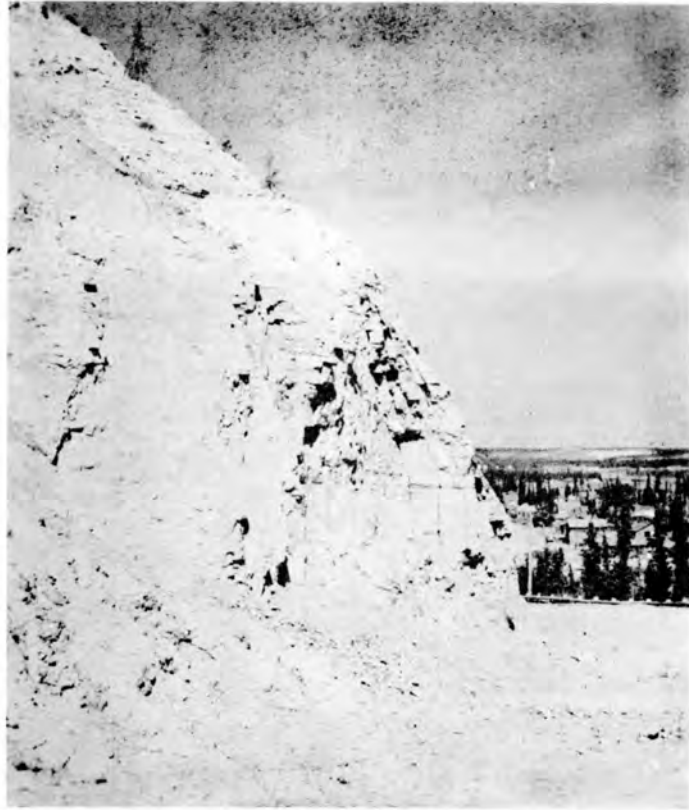
Fig. 8. Stratification of the silts near Whitehorse.

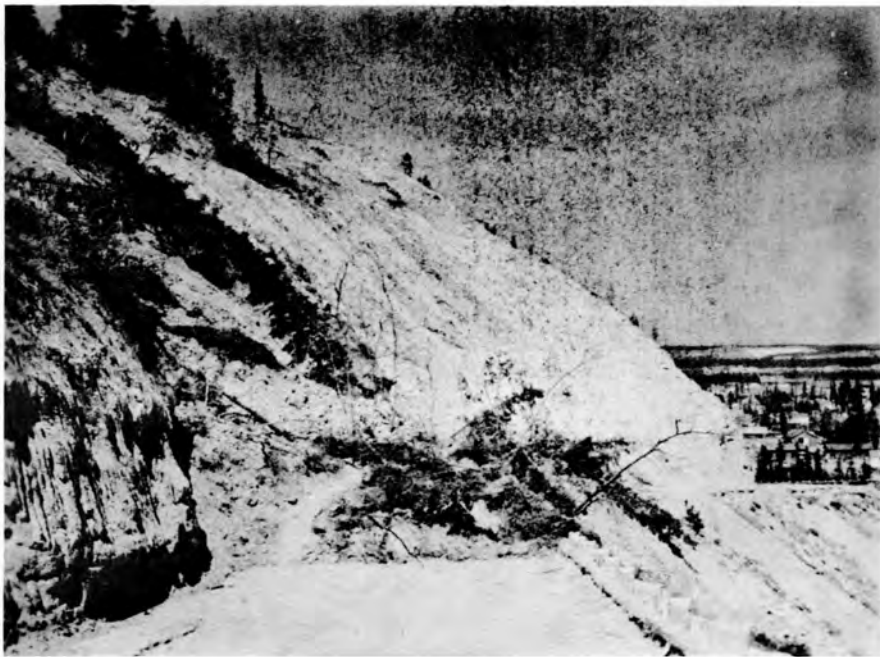
Fig. 9. A landslide caused by the silts becoming saturated and flowing during wet weather.

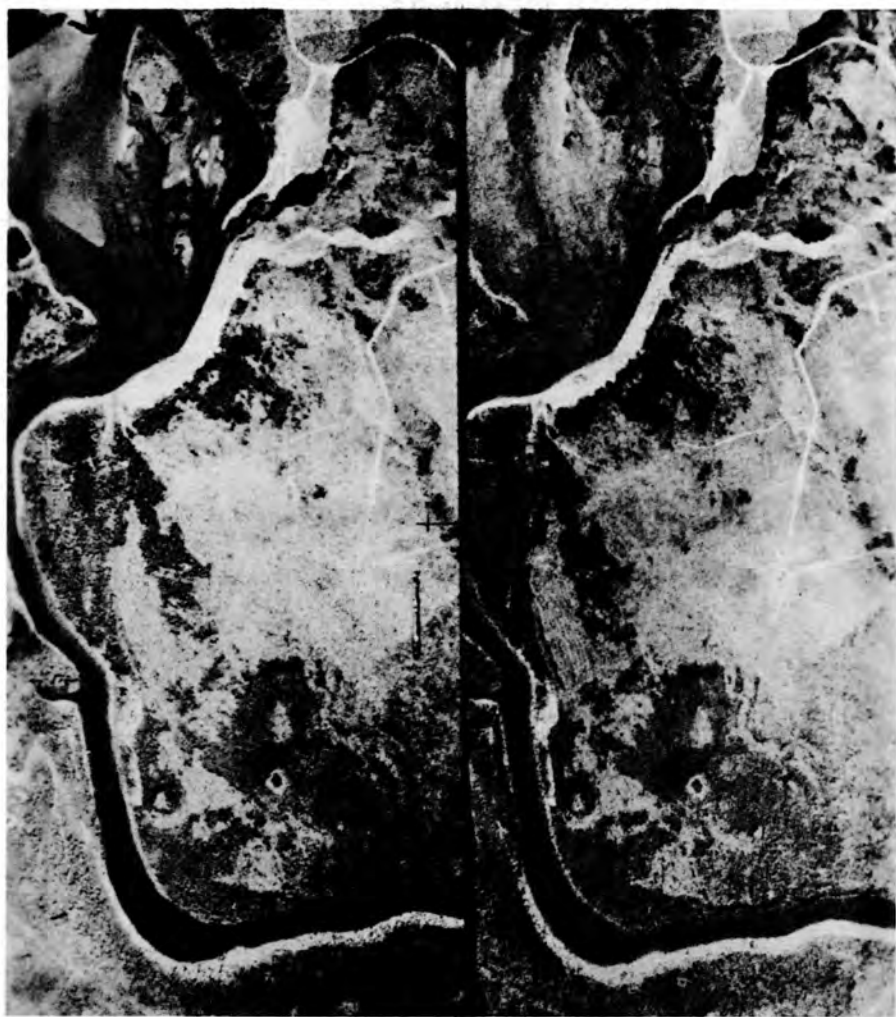
Fig. 10. Stereopair of the silts a few miles north
of Whitehorse.

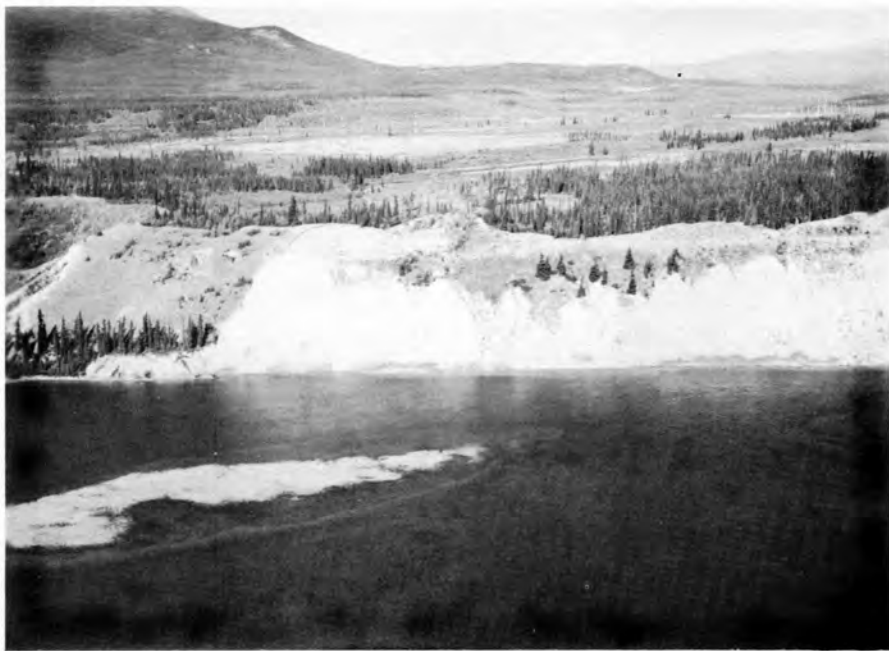
Fig. 11. Low-altitude oblique view of exposure of the silts adjacent to the Yukon River a few miles downstream from Whitehorse.

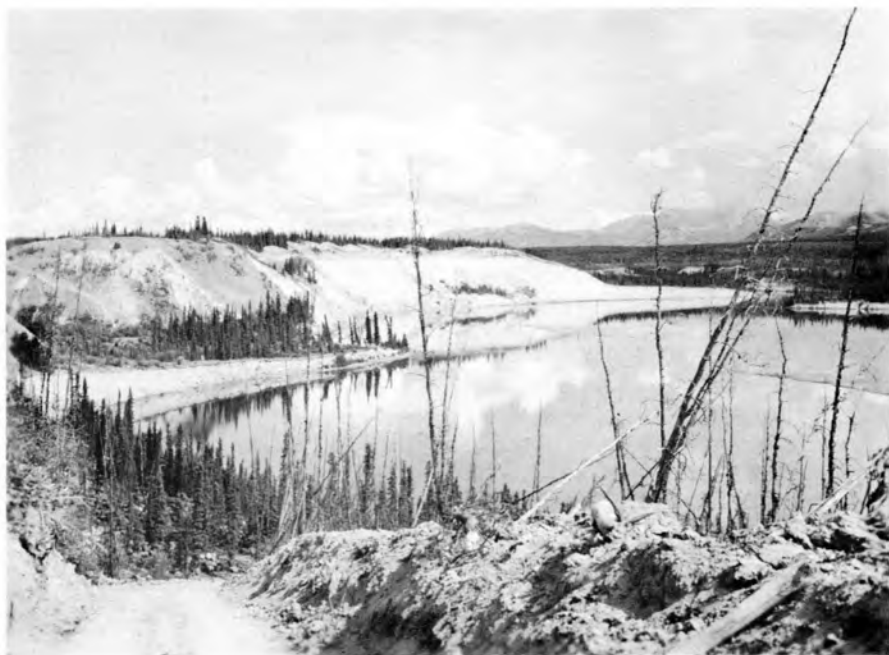
Fig. 12. Ground photo of area in fig. 11.

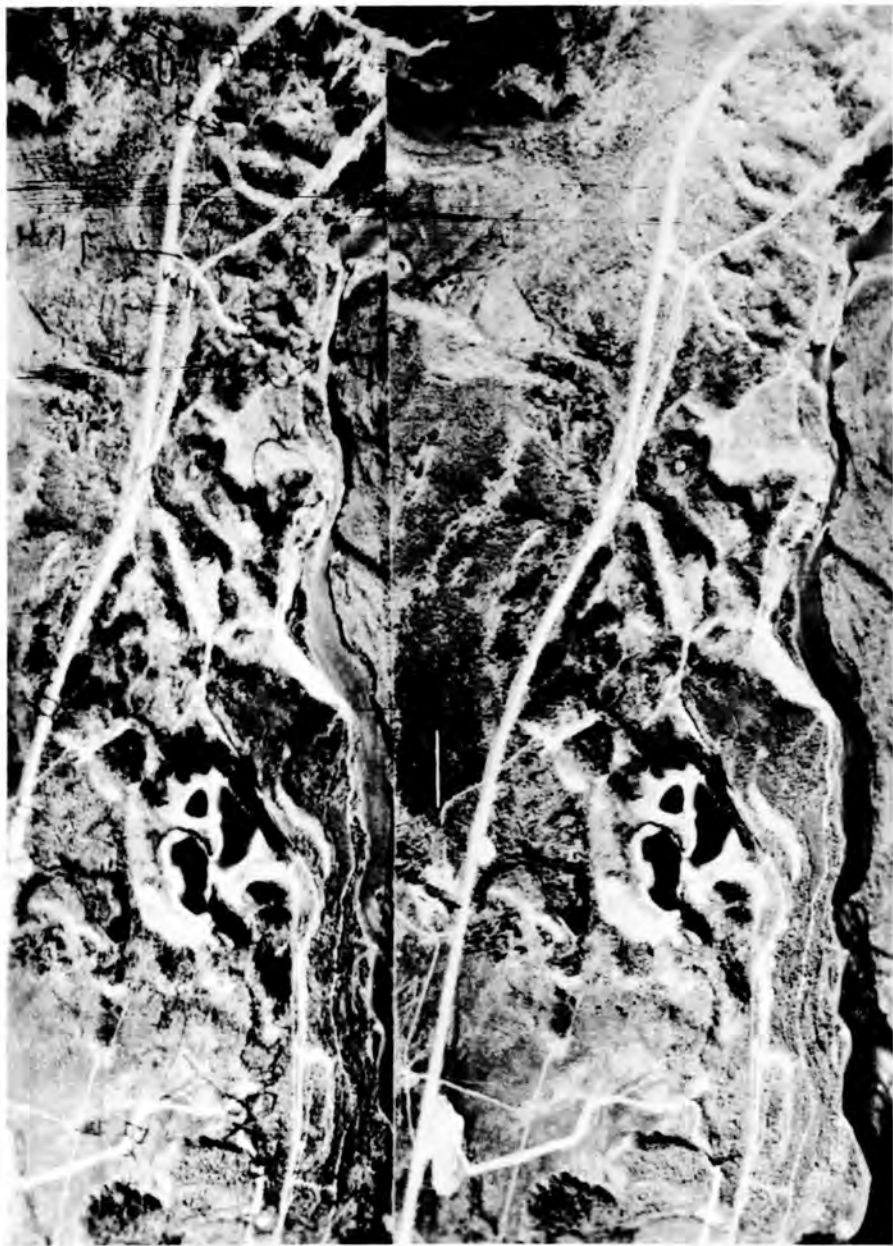
Fig. 13. Stereopair of the gravel deposits near Miles Canyon. The canyon can be seen at the left margin in the lower third of the stereopair.

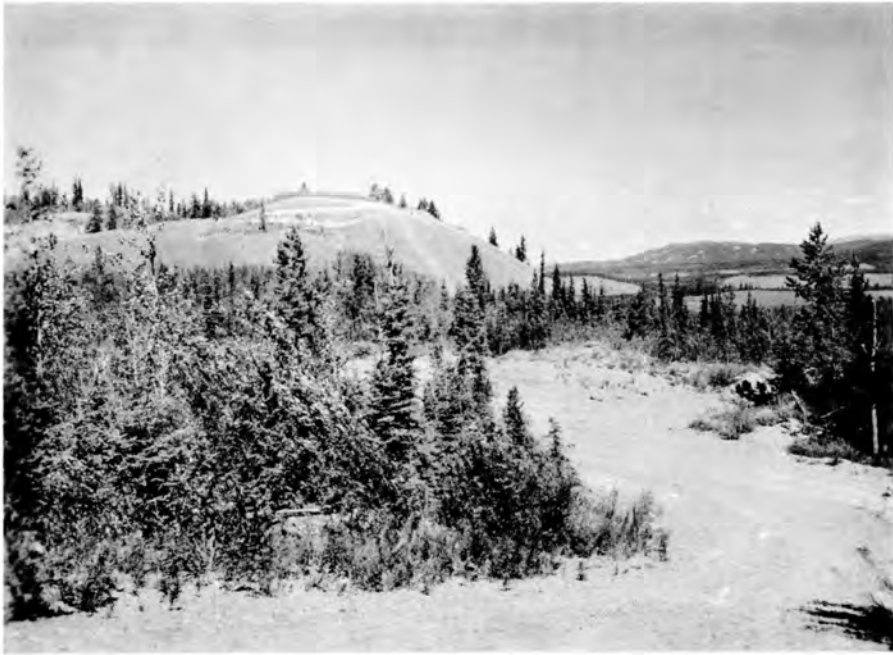
Fig. 14. Topography in the kettle-kame area on the air-photo shown in fig. 13.

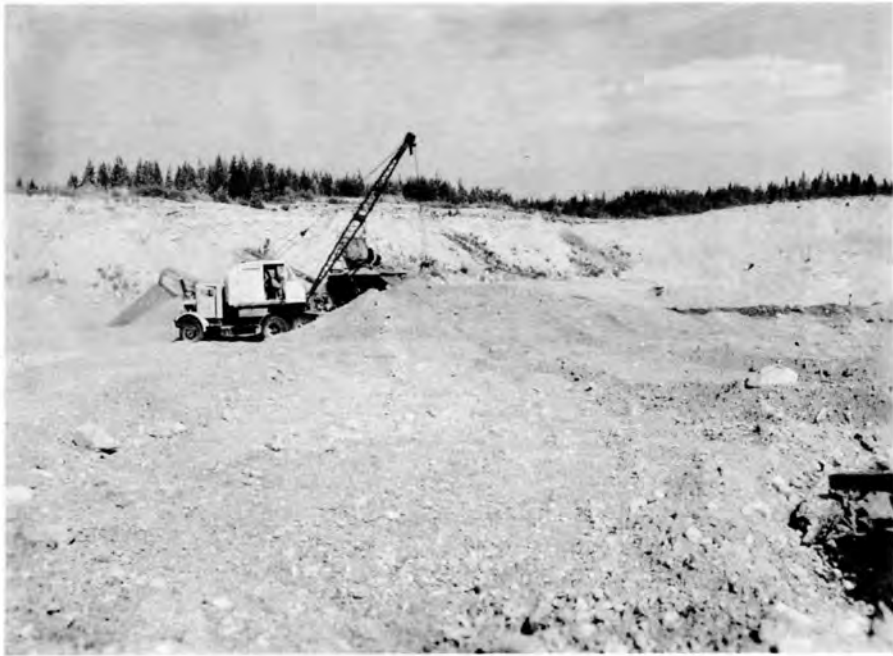
Fig. 15. Gravel pit adjacent to the Alaska Highway near Whitehorse.

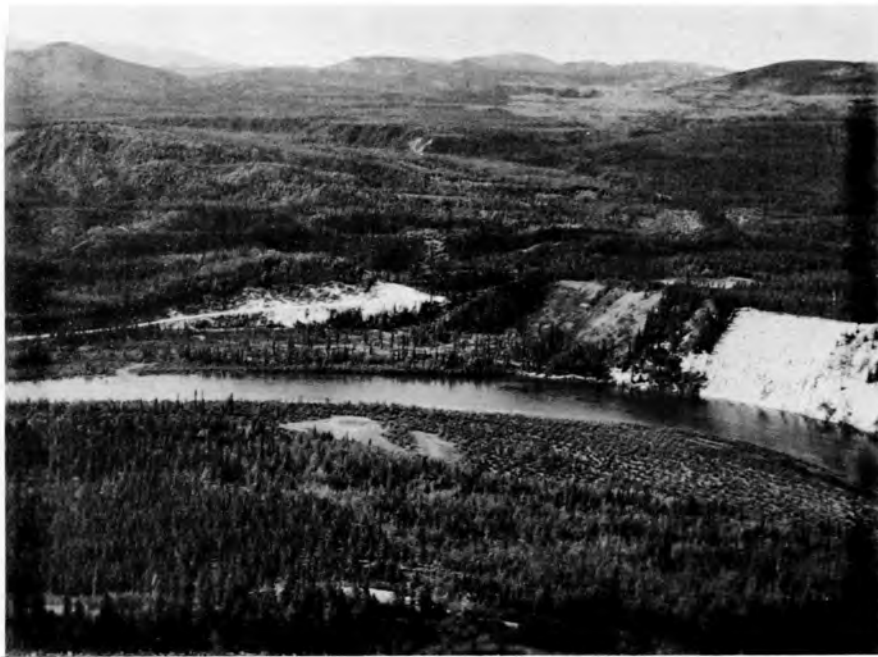
Fig. 17. Exposures of sand along the Yukon River. The Yukon Dam is out of the picture to the left. In the background are kames, eskers, and several terraces.

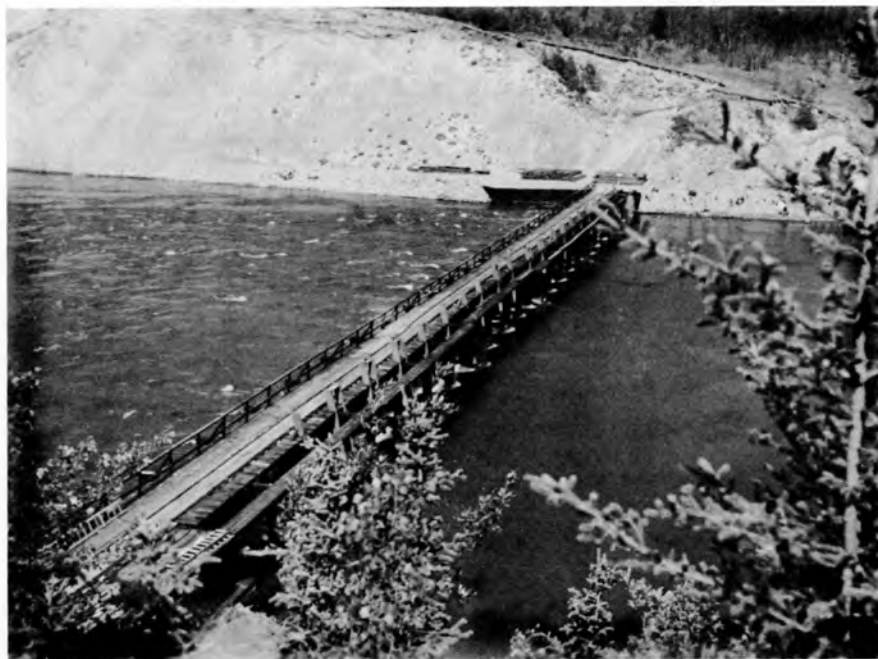
Fig. 18. The Yukon Navigation Dam. Notice the deep sands on the east side of the river.

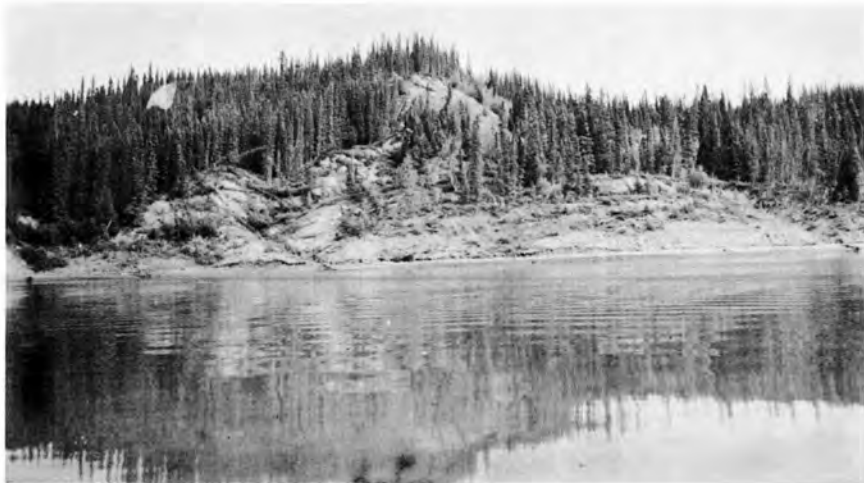
a. Landslide in cutbank about 10 mi upstream from East Mountain.

Fig. 22. Exposed banks along Mackenzie River and tributaries.

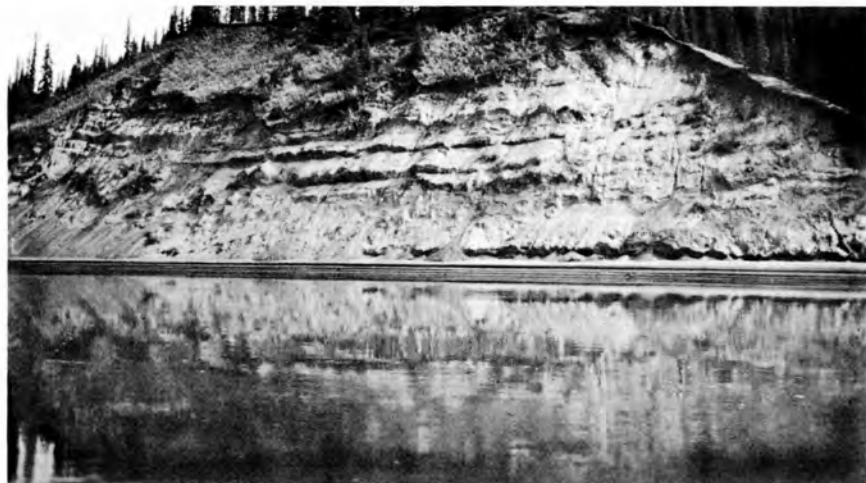
b. Stratified sands about 8 mi upstream from East Mountain.

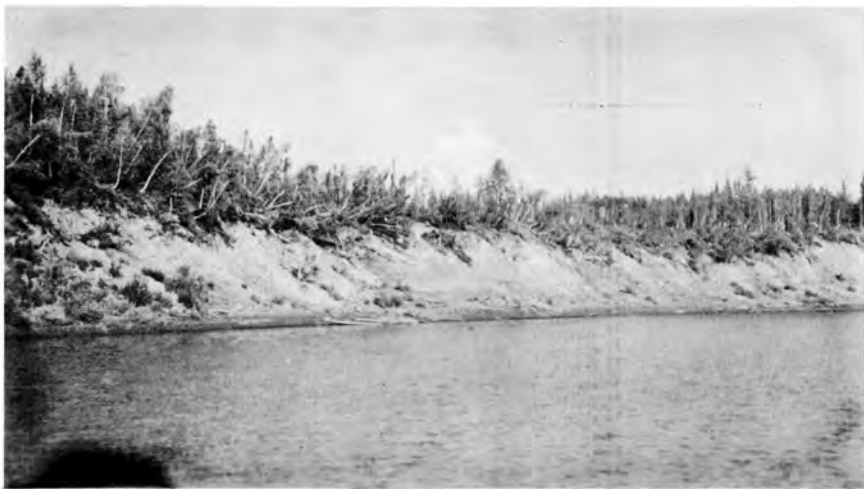
c. Cutbank of drift along Hume River.

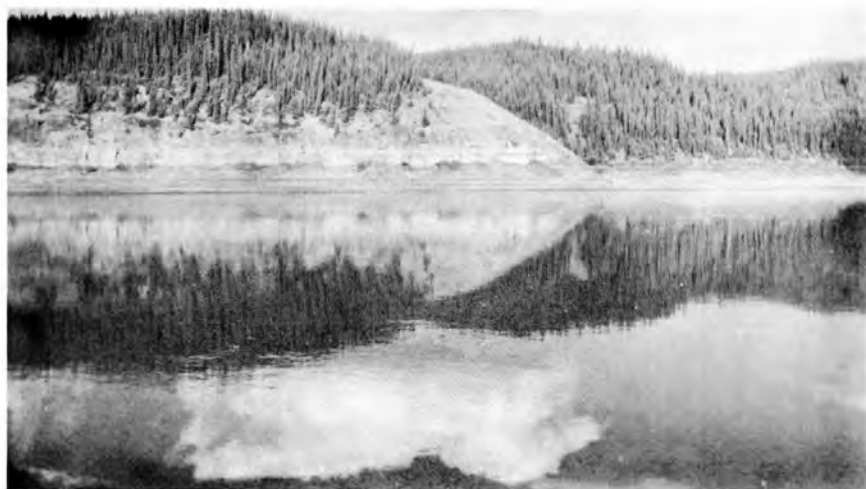
d. Drift on bedrock near mouth of Thunder River.

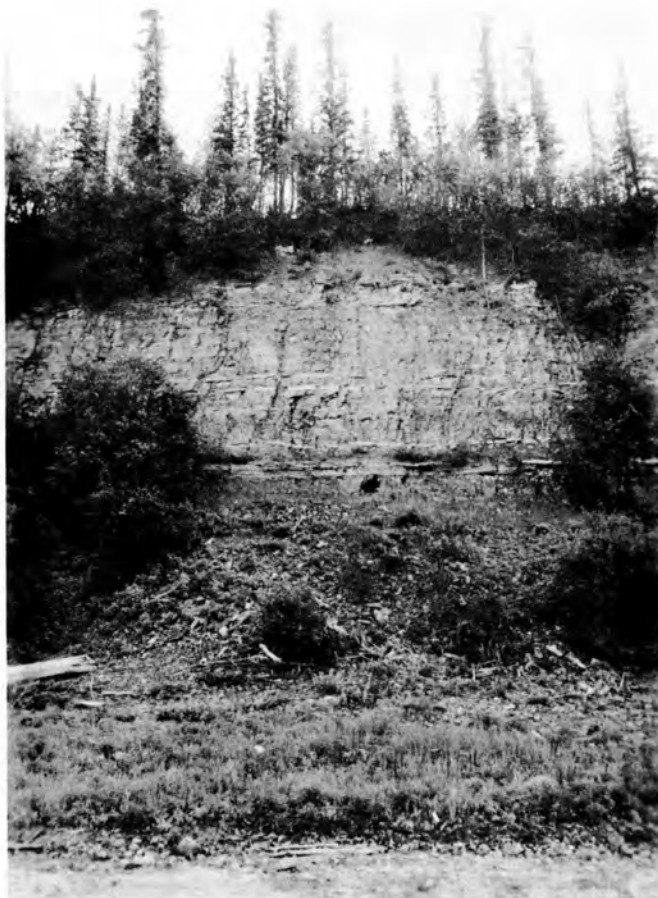
a. Bedded shales with some sandstone
downstream from Carcajou Ridge.

Fig. 23. Exposed banks along Mackenzie River.

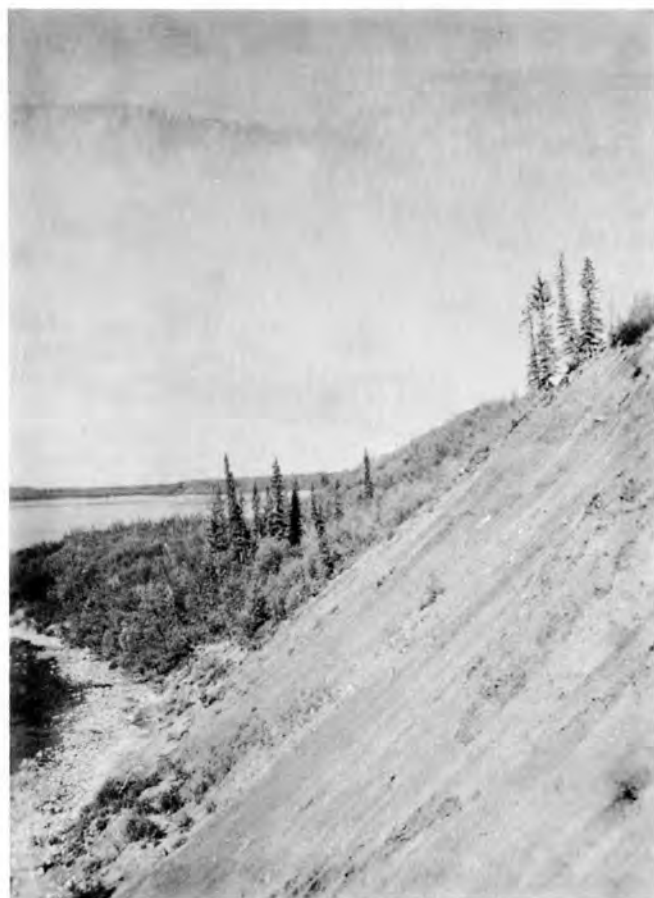
b. Thinly bedded shales at mouth of
Tainter River.

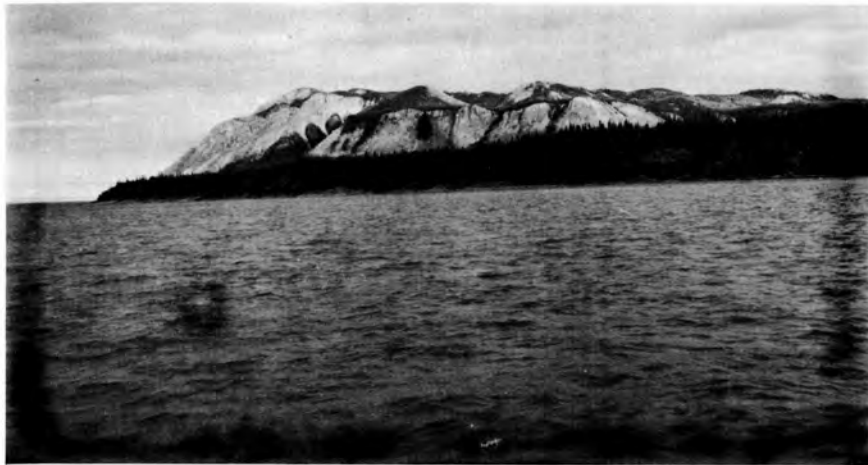
a. Great Bear Rock north of mouth of Great Bear River on Mackenzie River.

Fig. 24. Topography and terrain views along Mackenzie River.

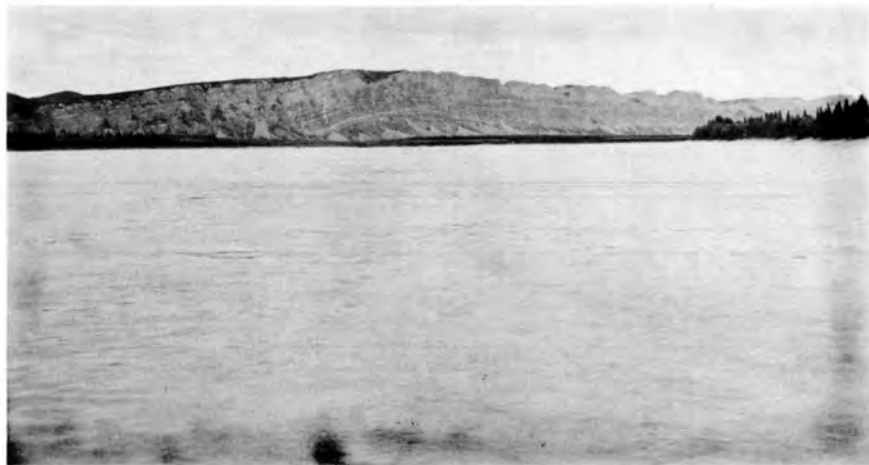
b. Camsell Bend. Limestone scarp in background is part of Mackenzie Mountains. Note anticlinal bending of the strata.

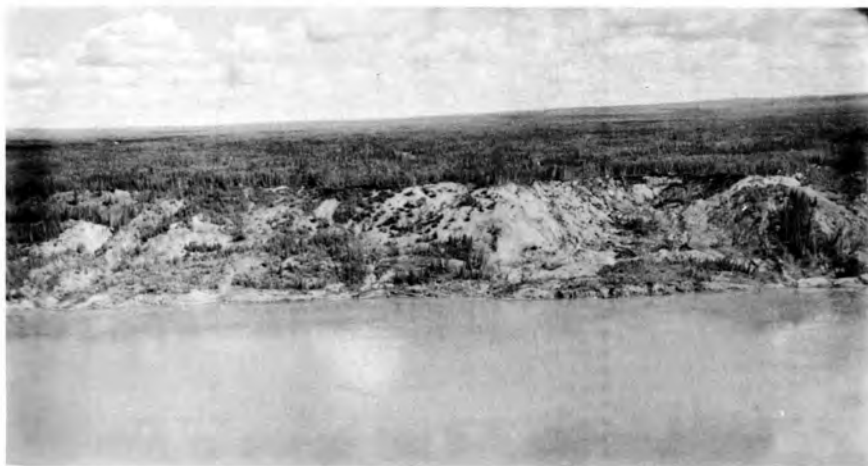
c. Landslide in drift deposits near Old Fort Point. Notice flat to gently rolling terrain.

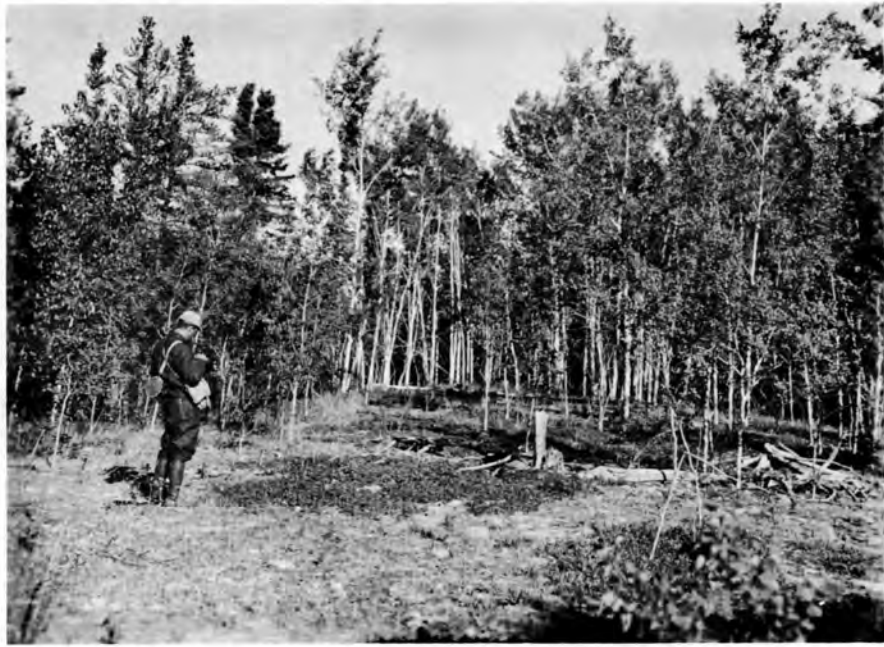
Fig. 27. Sand beach ridge with aspen, jack pine, and spruce vegetation on south shore of Great Slave Lake. This ridge may be seen in fig. 25.

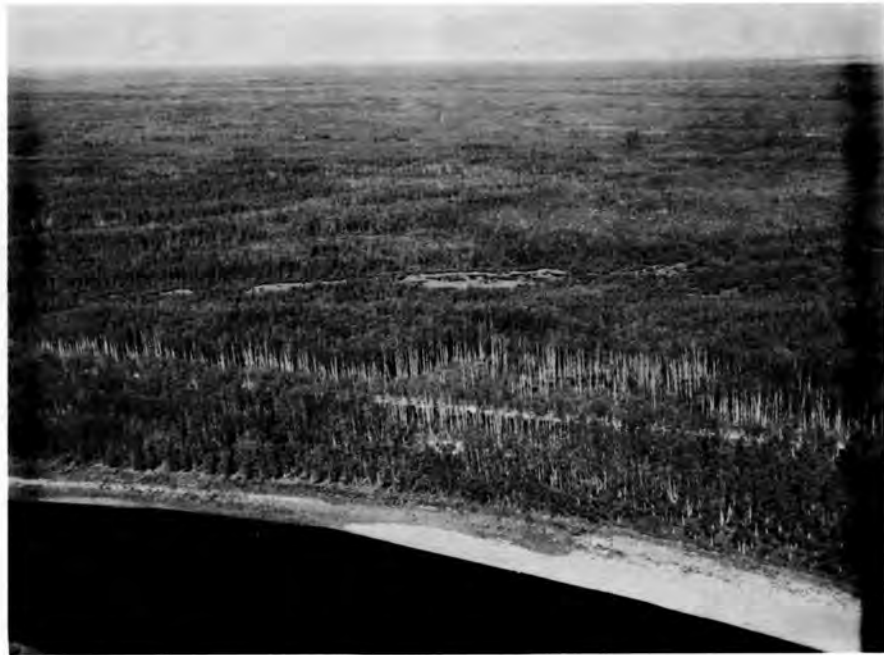
Fig. 28. Low-altitude oblique view of muskeg between beach ridges along Hay-Grimshaw Highway about 10 mi south of Hay River. Some beach ridges are in background; the Hay River appears in foreground.

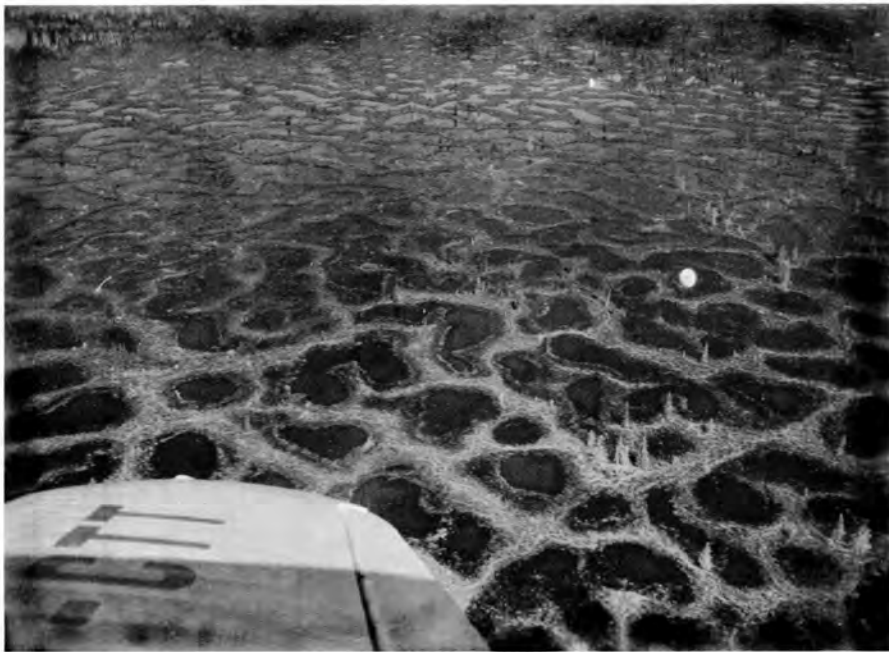
a. Depressed-center polygons in lake bed. Such patterns are found between beach ridges.

Fig. 29. Oblique views of polygons and beach ridges of Great Slave Lake west of Hay River.

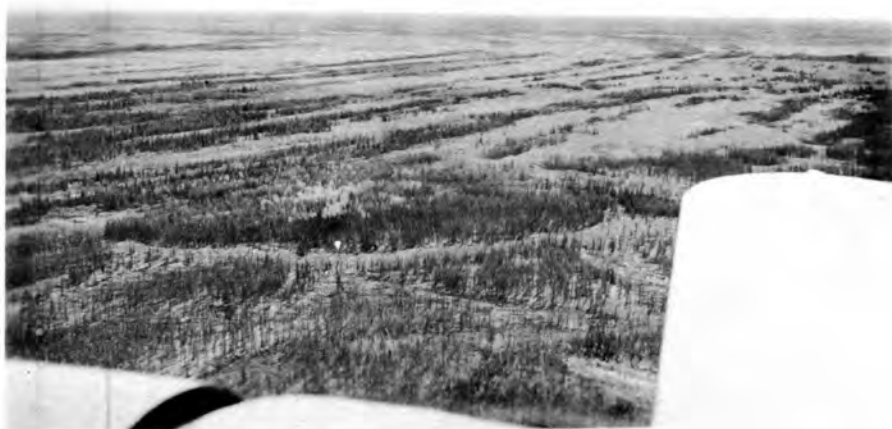
b. Great Slave Lake beach ridges mantled with spruce, aspen, and jack pine, and separated by troughs with polygonal ground south of Hay River.

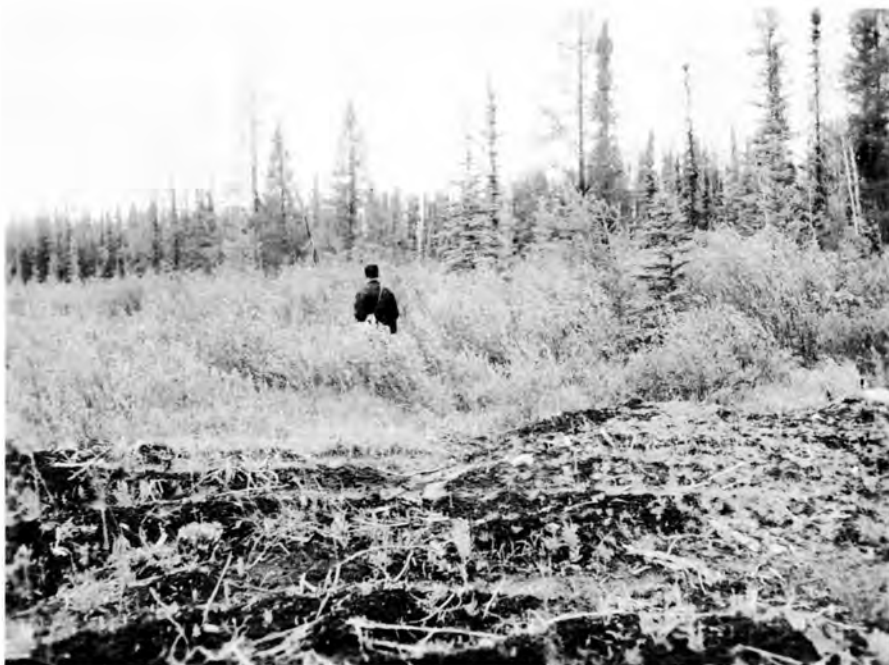
Fig. 30. Changes in vegetation in muskeg south of Hay River. Peat in foreground, willow in center, and jack pine and spruce in background.

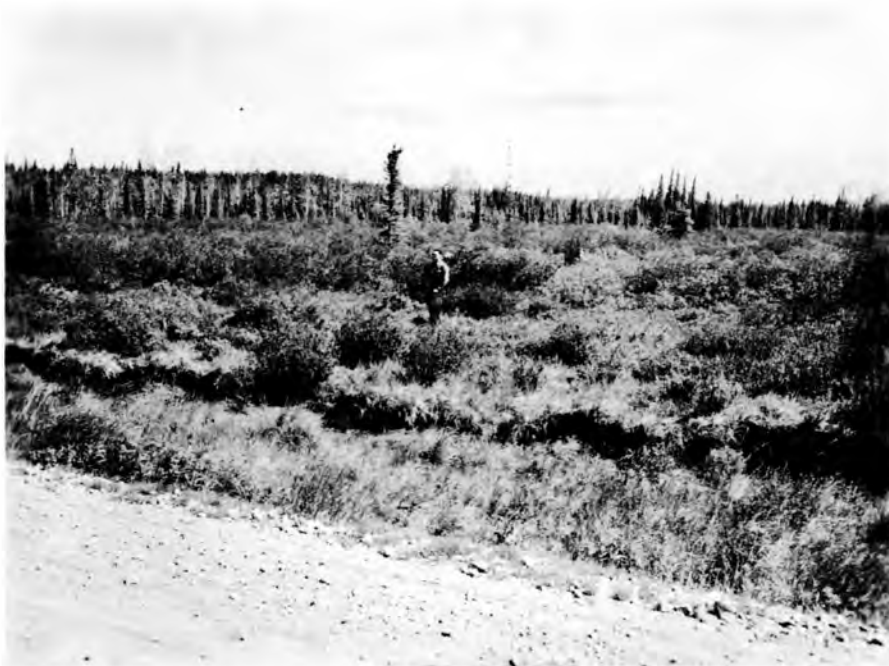
Fig. 31. Dwarf birch bog along Hay-Grimshaw Highway south of Hay River.

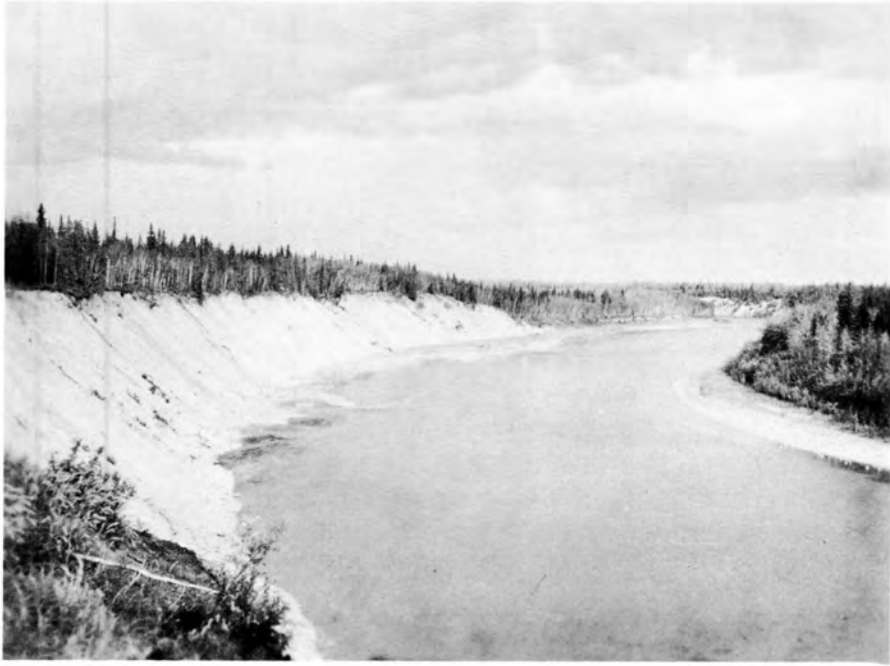
Fig. 32. Cutbank of the Hay River.

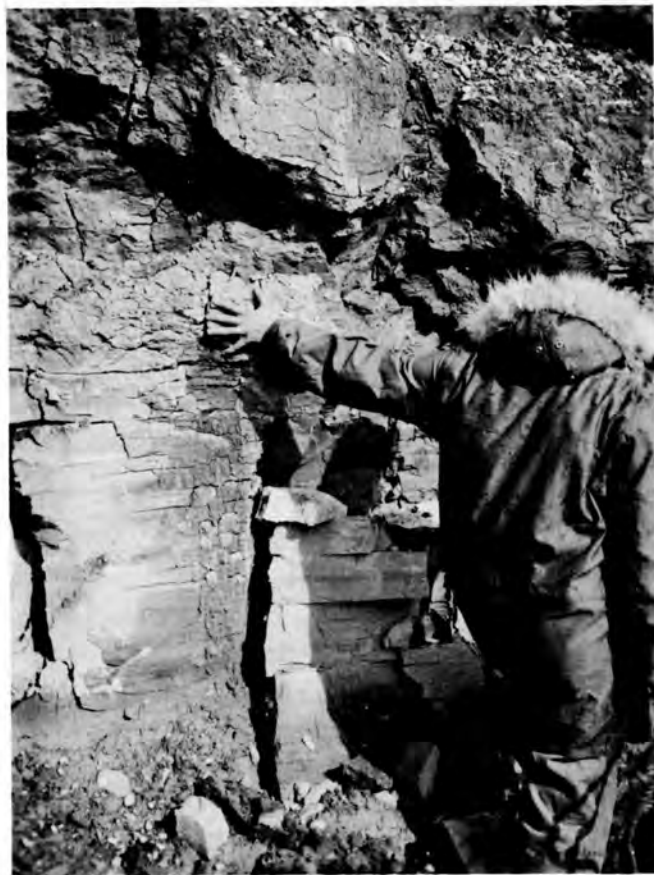
a. Lake-bed clays. Note gravel layer at top of section.

Fig. 33. Profile views about 3 mi up the Trout River from the Mackenzie River. The Trout empties into the Mackenzie downstream from Fort Providence.

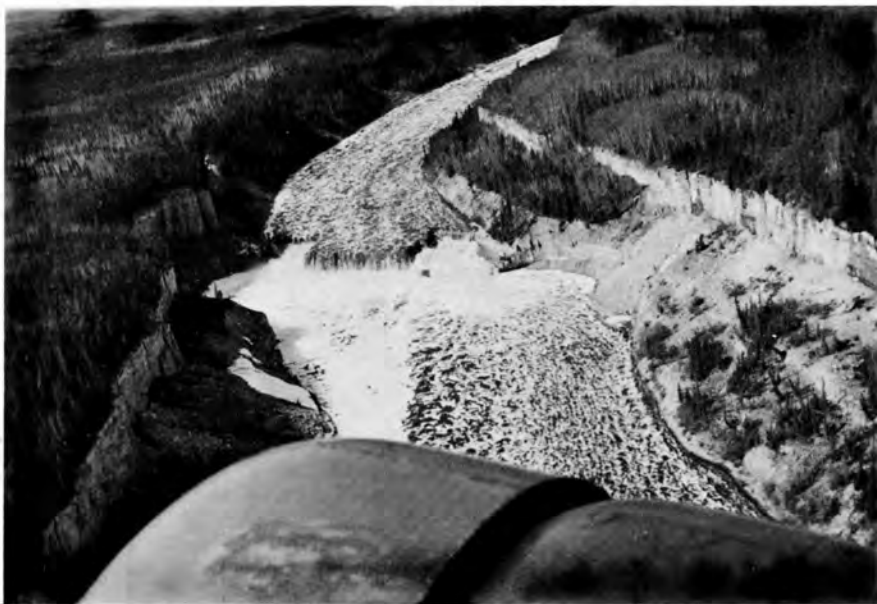
Fig. 34. Beach ridges of Great Slave Lake superimposed on limestone. Louisa Falls about 35 mi south of Hay River. This falls marks the scarp boundary between the Peace River Plains and the Mackenzie Lowland.

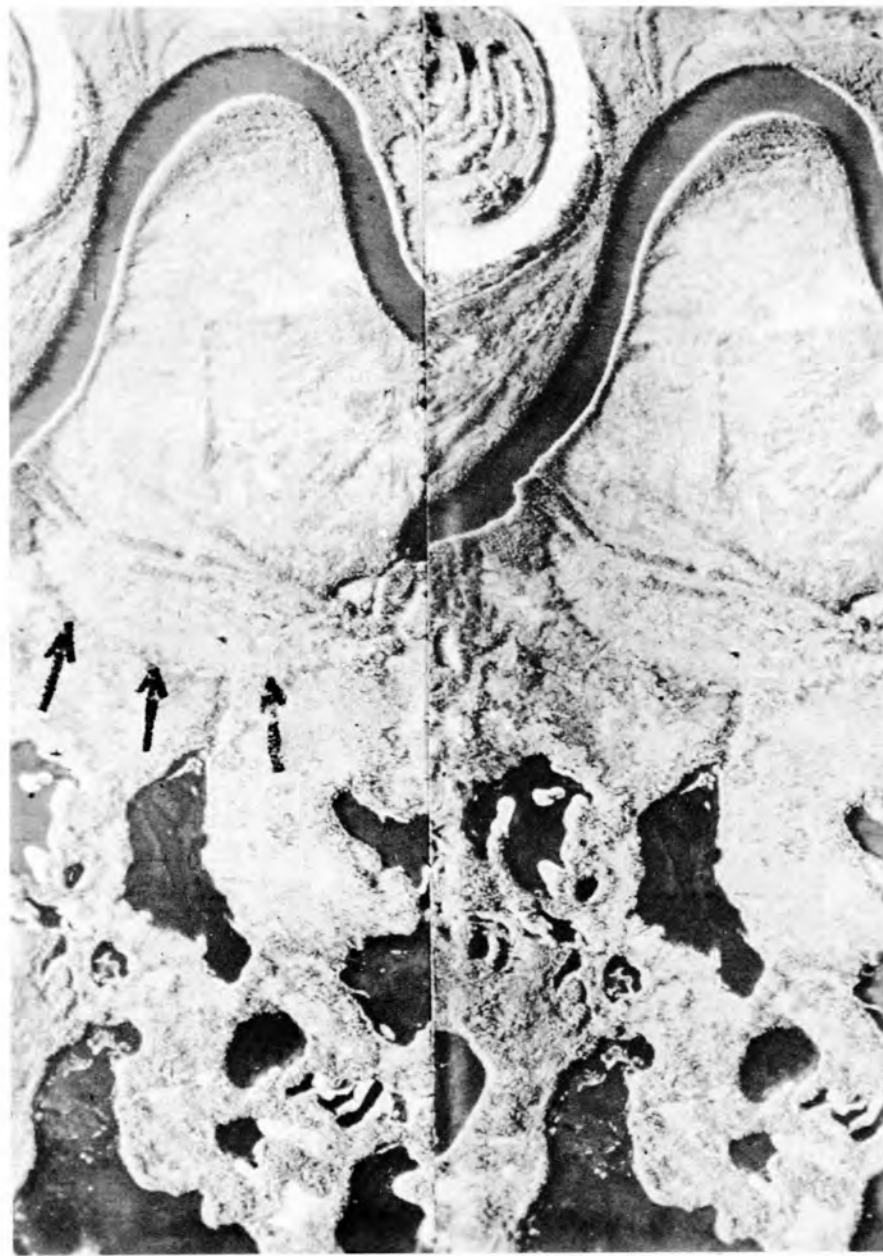
Fig. 36. Stereopair of thermokarst lakes in upland. Notice low topographic break indicated by arrows. Ramparts River alluvium does not have this type of lake.

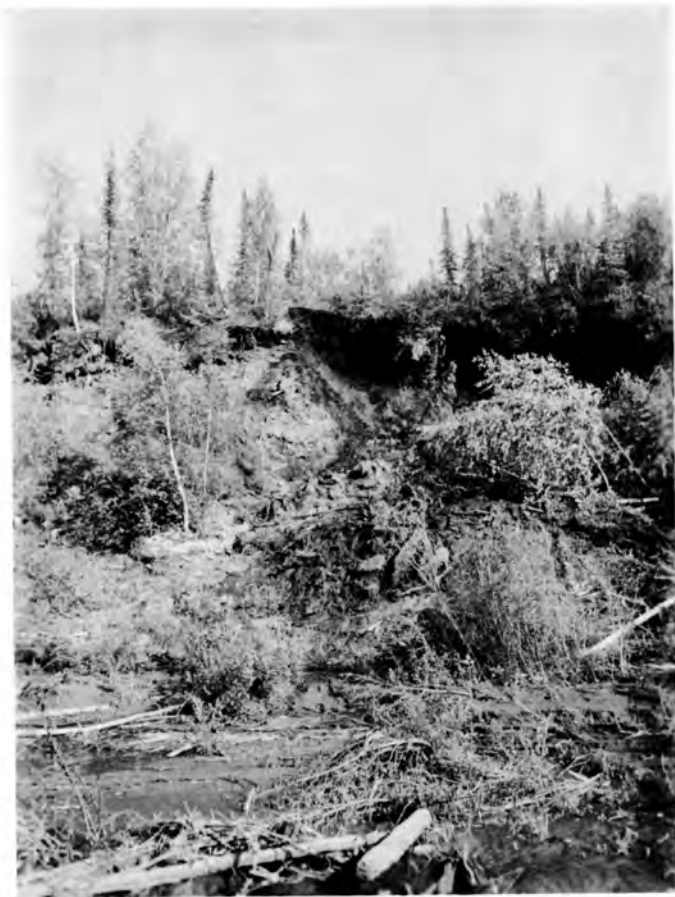
a. Small landslide with thick overhang of peat.

Fig. 39. Permafrost exposed in cutbank landslide of Hume River.

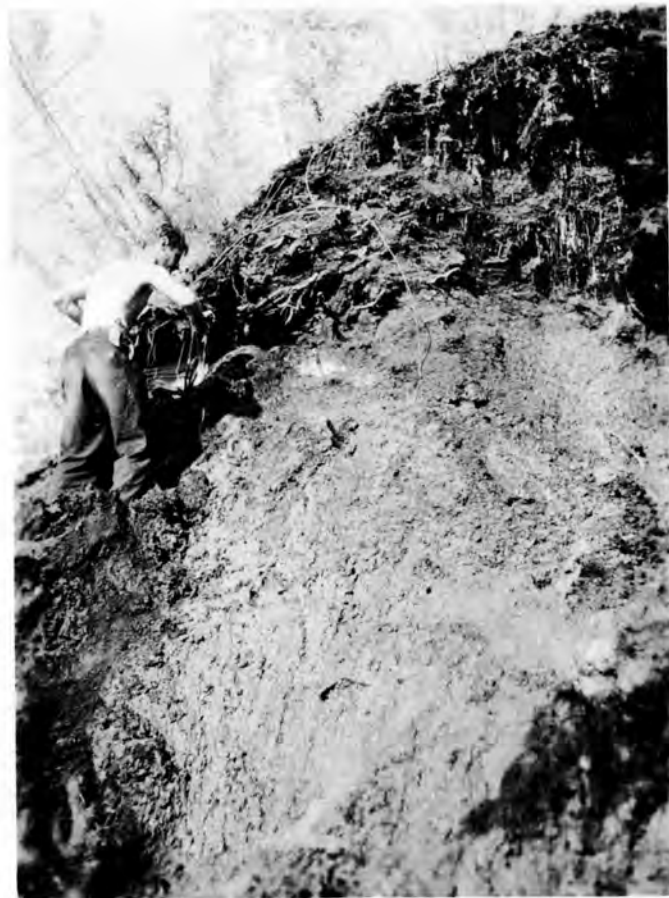
b. Permafrost exposure. Notice very thick peat layer.

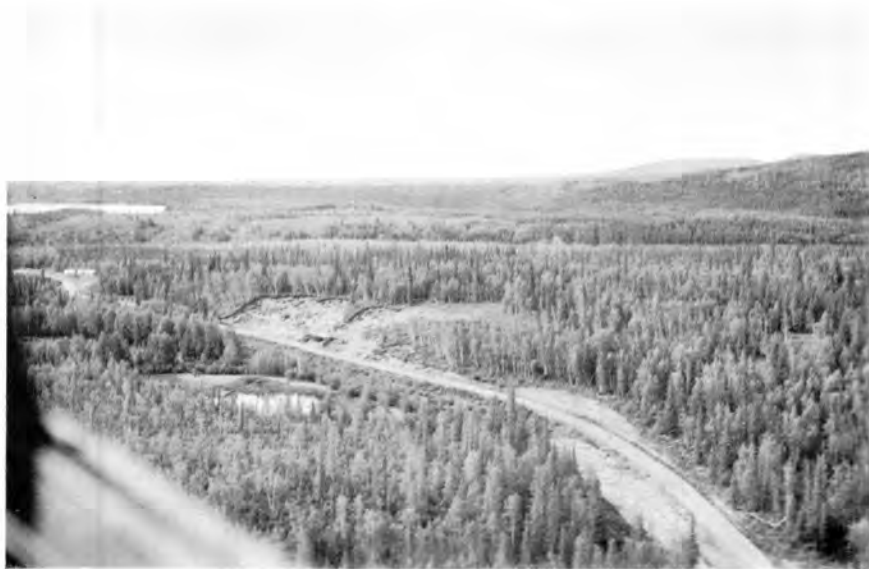
Fig. 40. Low-altitude oblique view of sand ridge near portage at St. Charles Rapids on Great Bear River.

Fig. 41. Ground view of exposure shown in fig. 40.
