CORPS OF ENGINEERS, U. S. ARMY

AIRPHOTO PATTERN RECONNAISSANCE OF NORTHWESTERN CANADA

TECHNICAL REPORT NO. 41

Volume 2

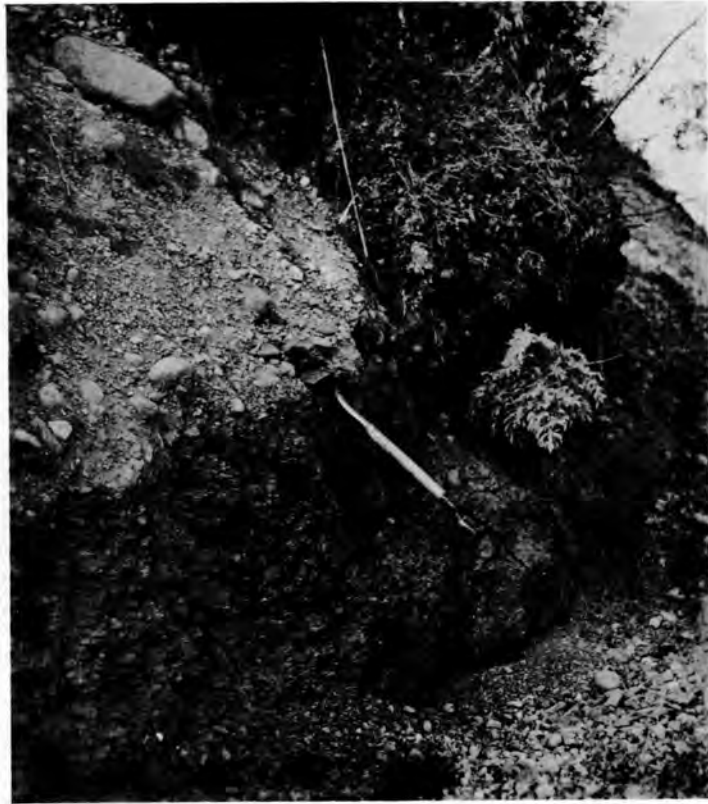
Fig. 42. Gravel on shale exposed at portage road near St. Charles Rapids.

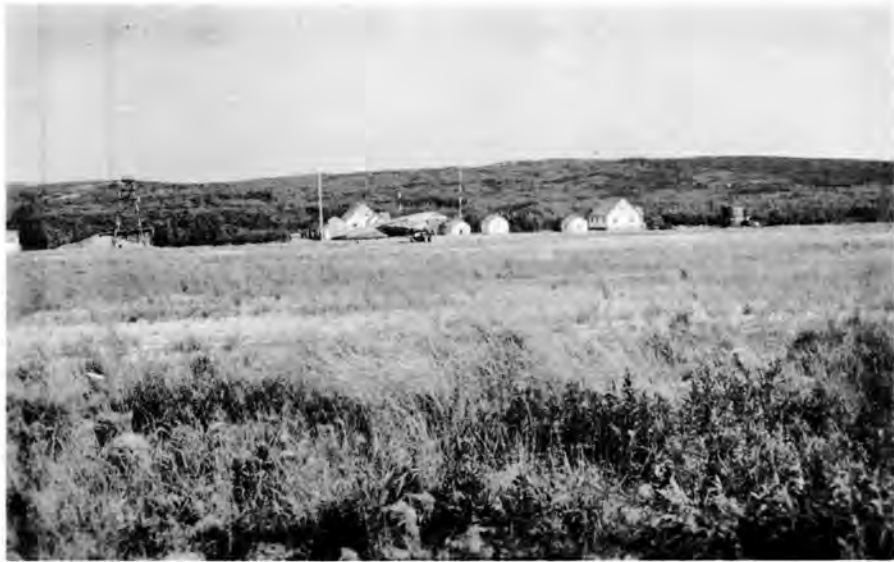
Fig. 44. Outwash terrace with Wrigley runway in foreground. Background is a low slack-water area between terrace and Franklin Mountains.

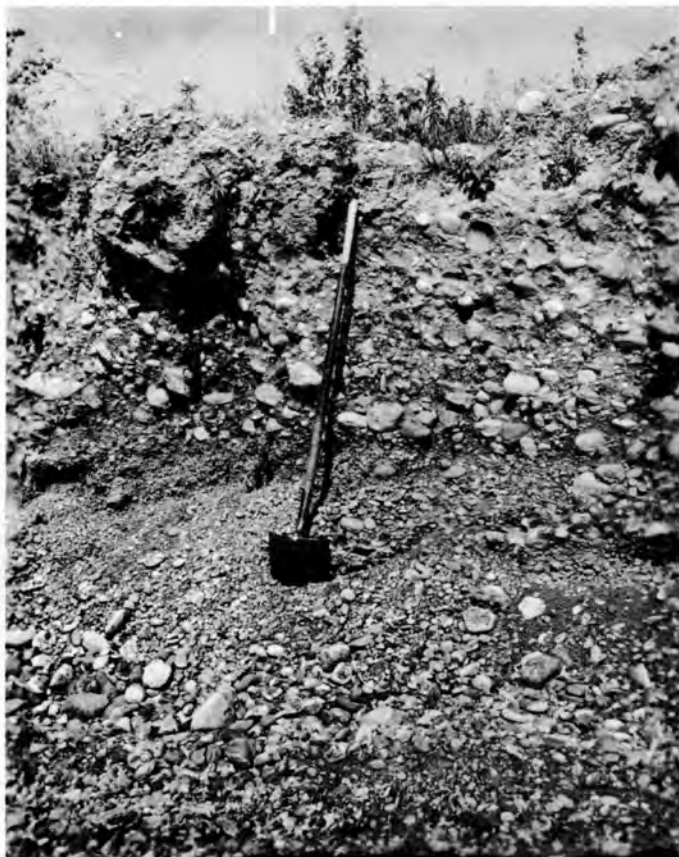
Fig. 45. Exposed face of gravel at Wrigley airfield.

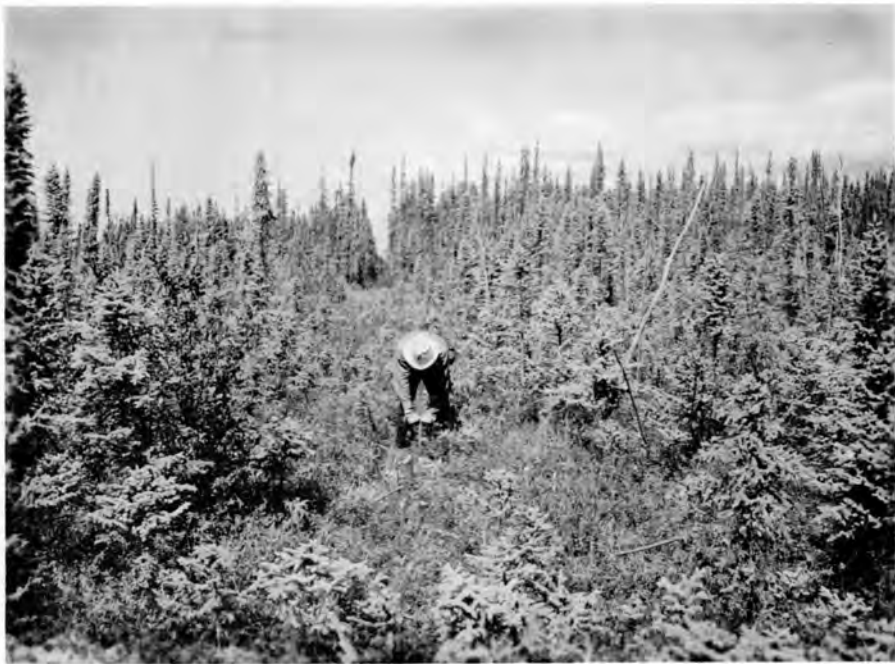
Fig. 46. Spruce vegetation in burned areas, Wrigley survey trail line. This depression area has a higher moisture content.

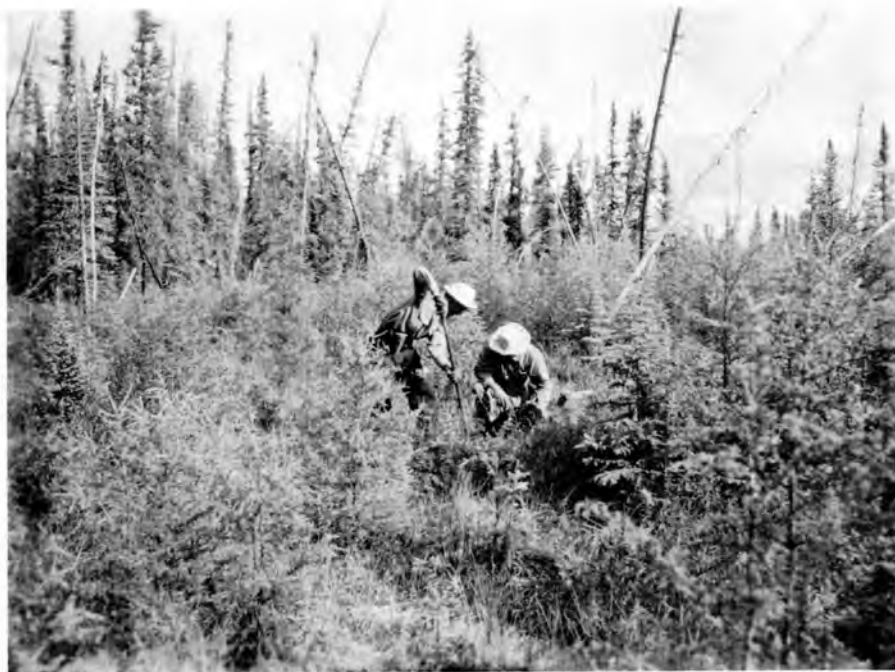
Fig. 47. Second growth vegetation in burned-over area along Wrigley survey trail.

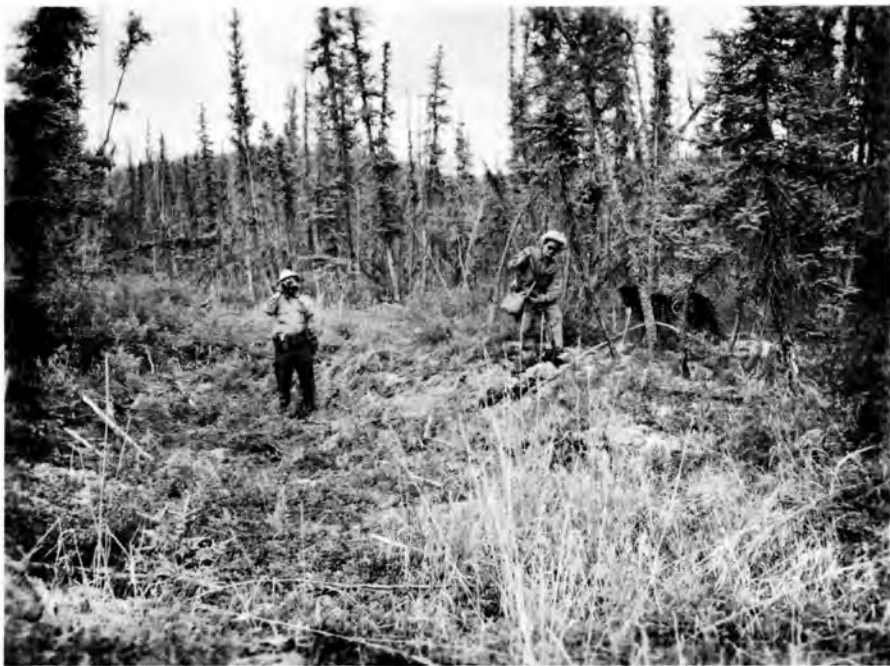
Fig. 48. Leaning trees along survey trail produced by removing vegetation and subsequent thawing; Wrigley.

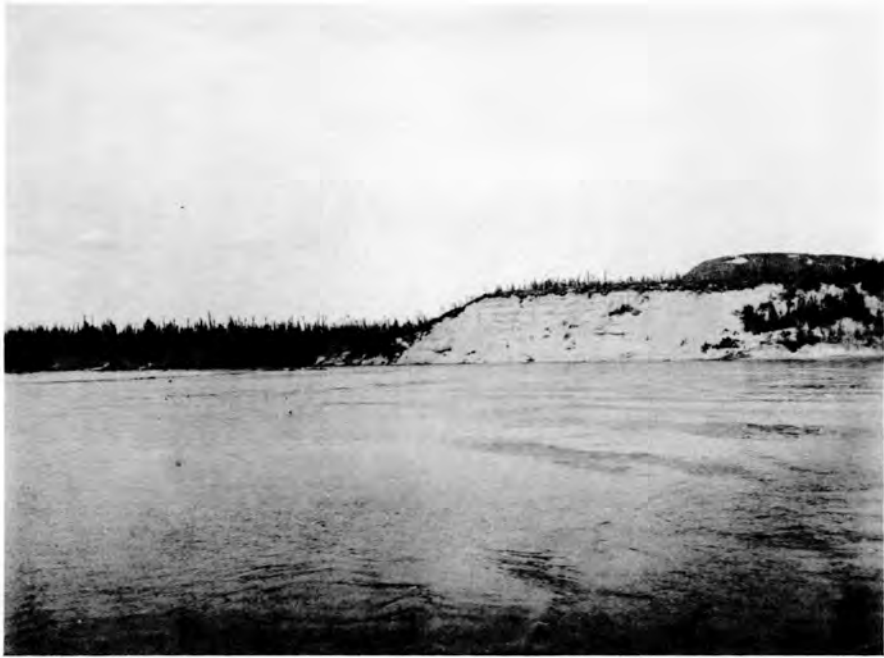
Fig. 49. Two terrace levels of Mountain River about one mile from Mackenzie River; 30-ft terrace is on left, 100-ft terrace on right.

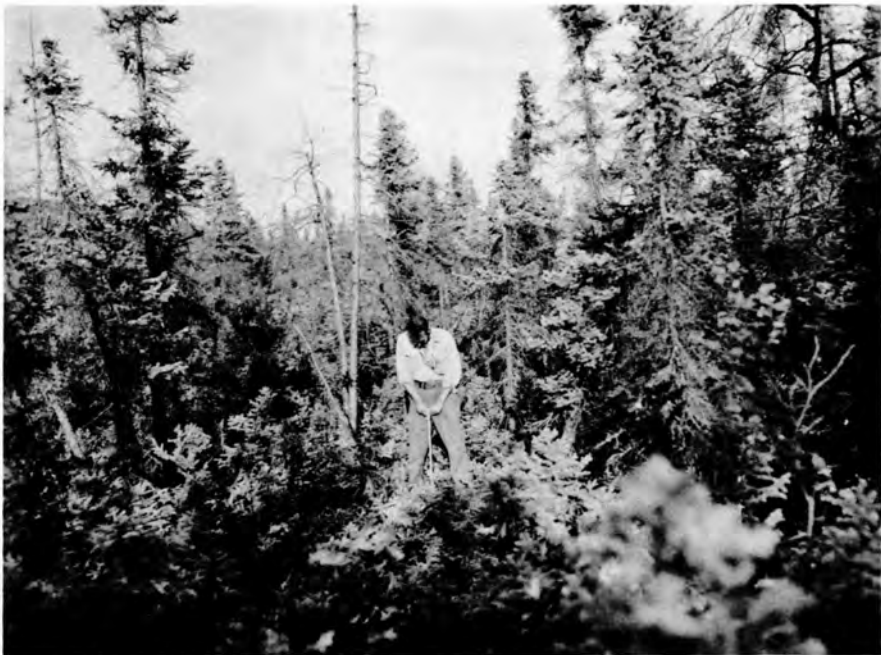
Fig. 50. Dense vegetation on 100-ft granular terrace shown in fig. 51 on the right.

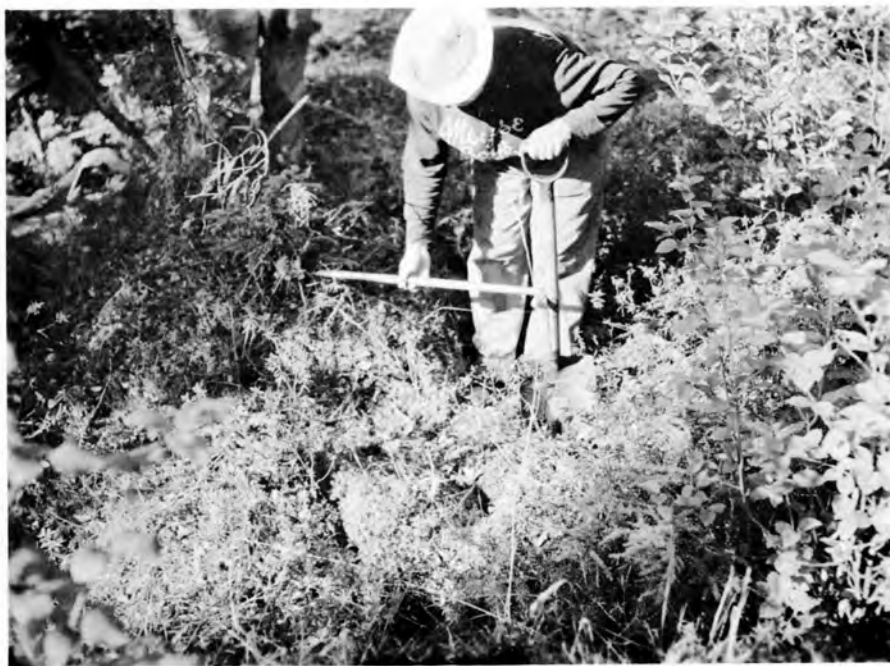
a. Elevated frost hummock with depressed rim on the upland about 1-1/2 mi up the Ontaratue River

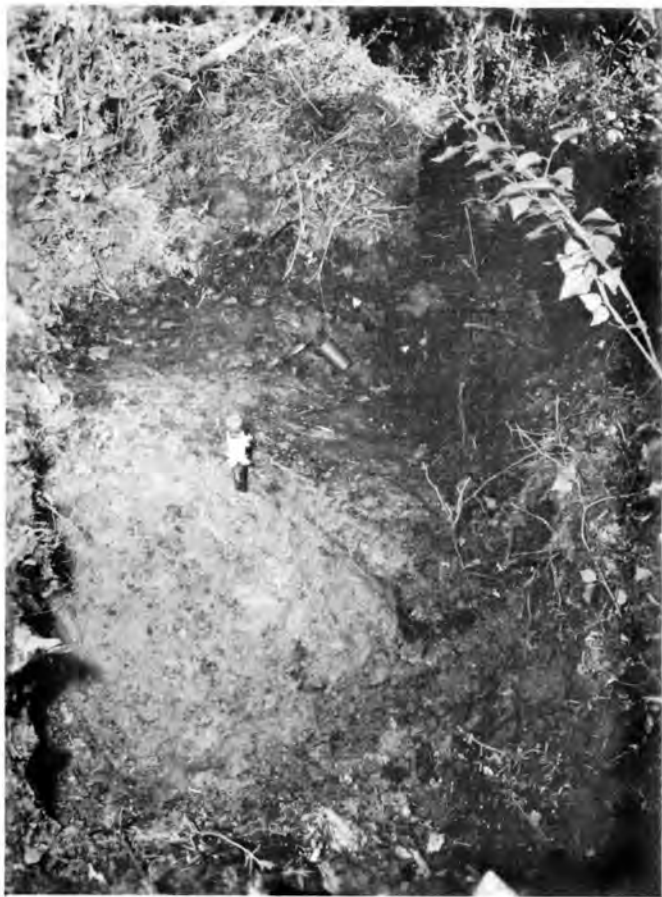
a. Frozen ground and ice layer;
knife marks frozen soil.

Fig. 53. Views of area investigated in hummocky topography on Ontaratue River.

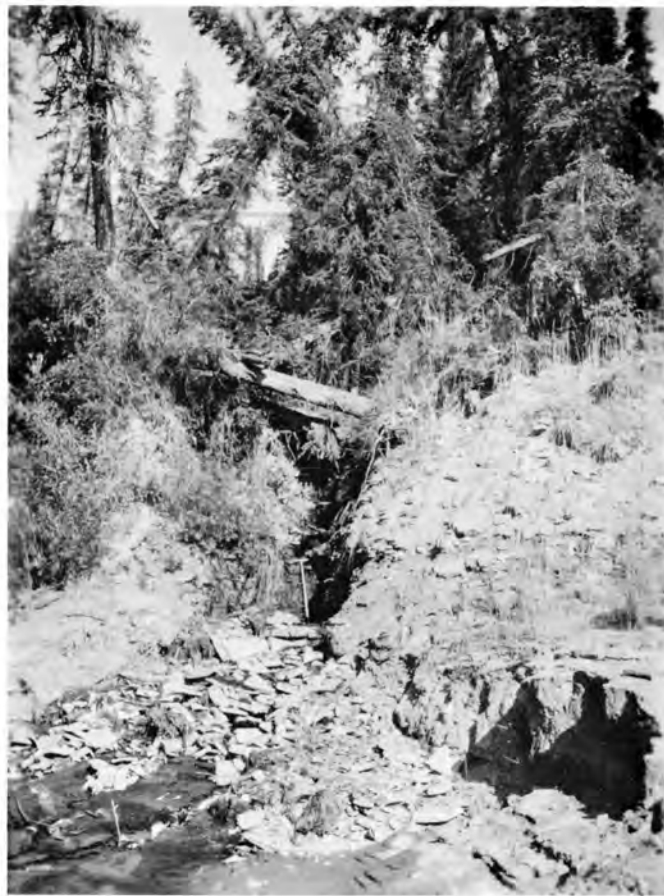
b. Figs. 52a and 53a were taken at site which is
about 100 ft from this gully. Notice alluvial
materials overlying shales.

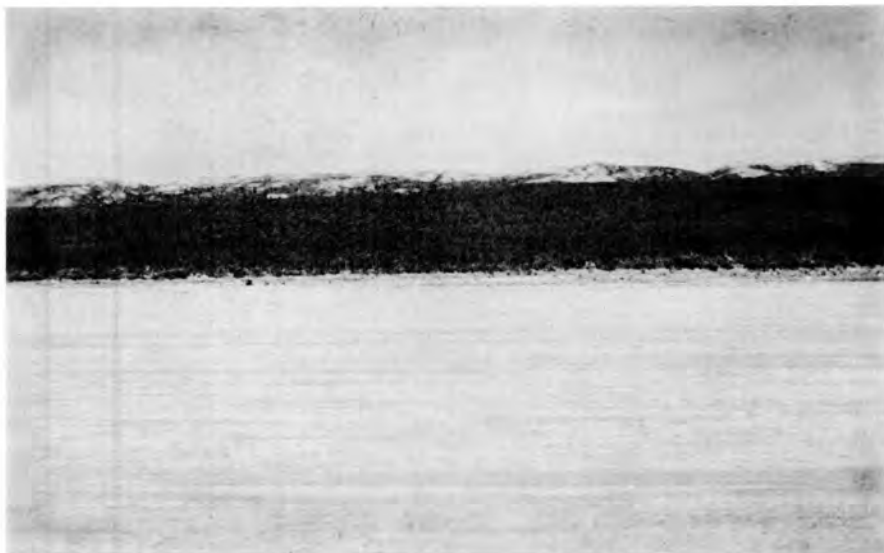
Fig. 55. Norman Wells runway on granular terrace with Franklin Mountains in background. Depressed area beyond terrace is old channel.

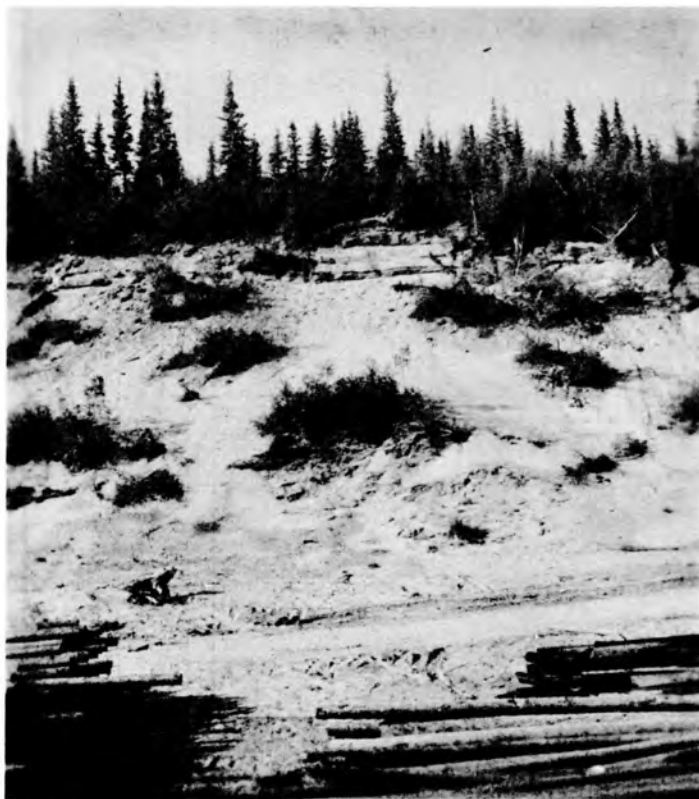
Fig. 56. West bank of Mackenzie River at Norman Wells showing stratified sands and gravels. The Canol Road landing on Mackenzie River is located at this point.

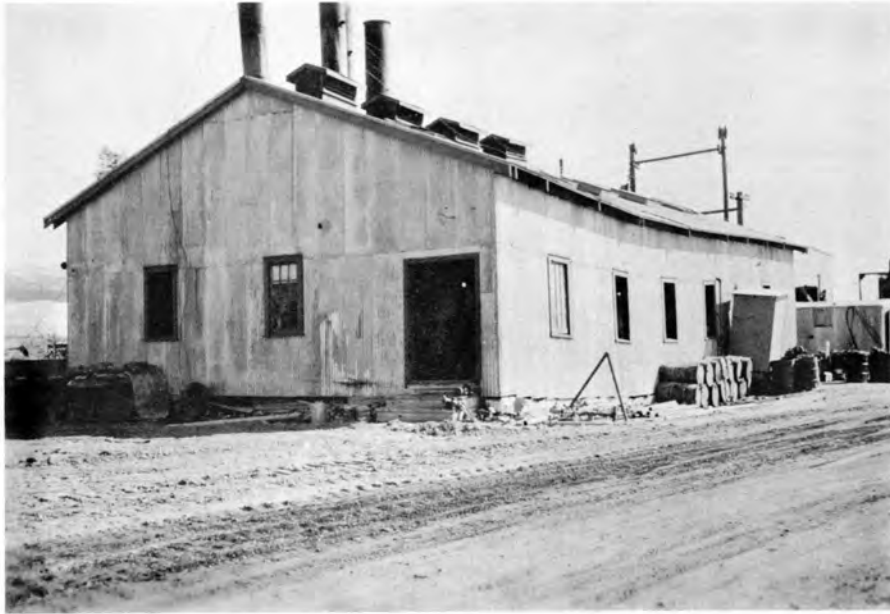
Fig. 57. Settlement of boiler plant at Norman Wells, built on short piles embedded in permafrost. New building being constructed at rear is supported on 30-ft piles that extend to shale bedrock.

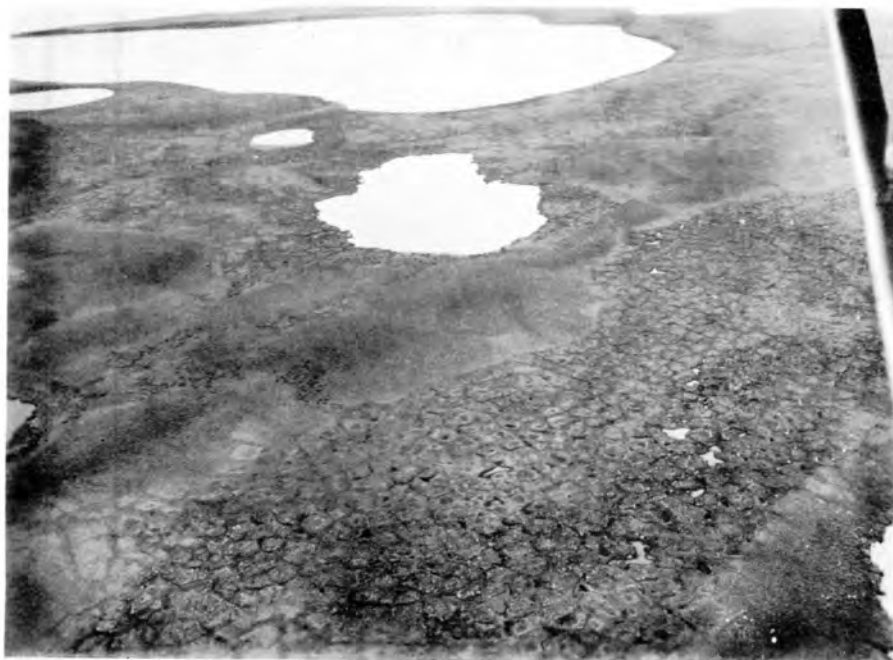
Fig. 61. Sand ridges of coastal regions of Mackenzie Lowland surrounded by raised-center polygonal forms.

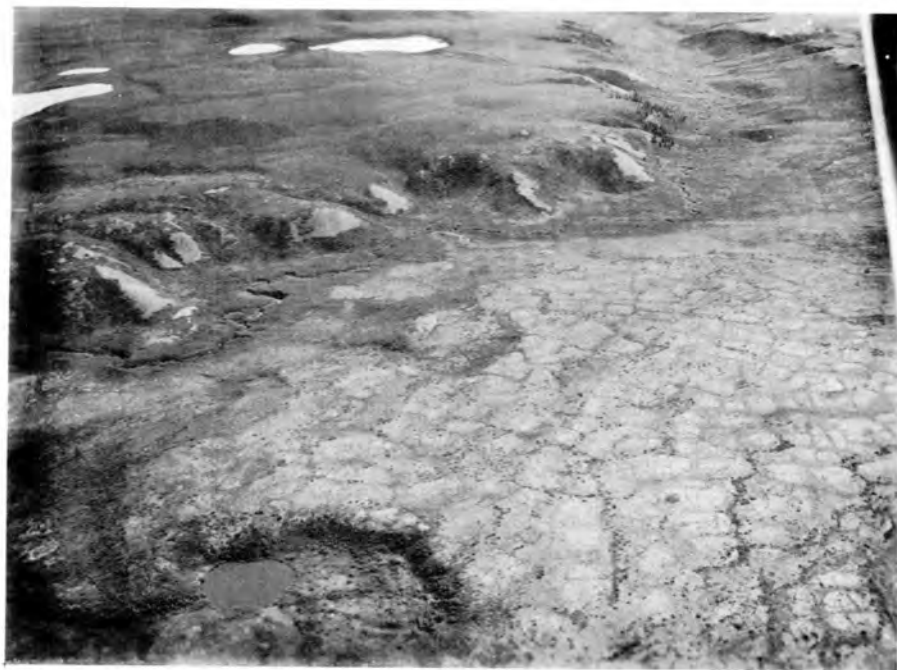
Fig. 62. Raised-center polygons on terrace near Caribou Hills on Coastal Plain

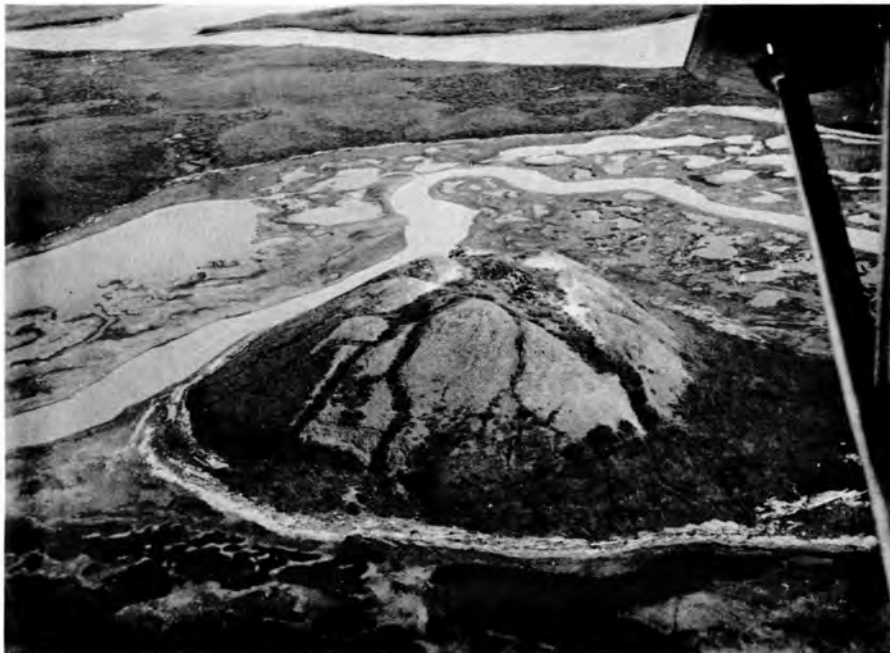
Fig. 64. Oblique view of pingo in vicinity of Port Brabant.

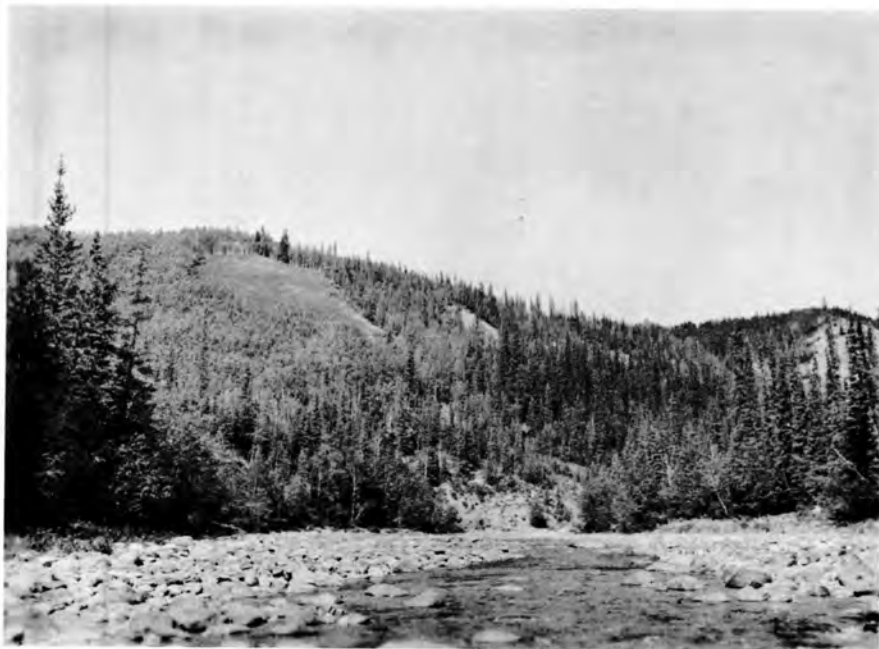
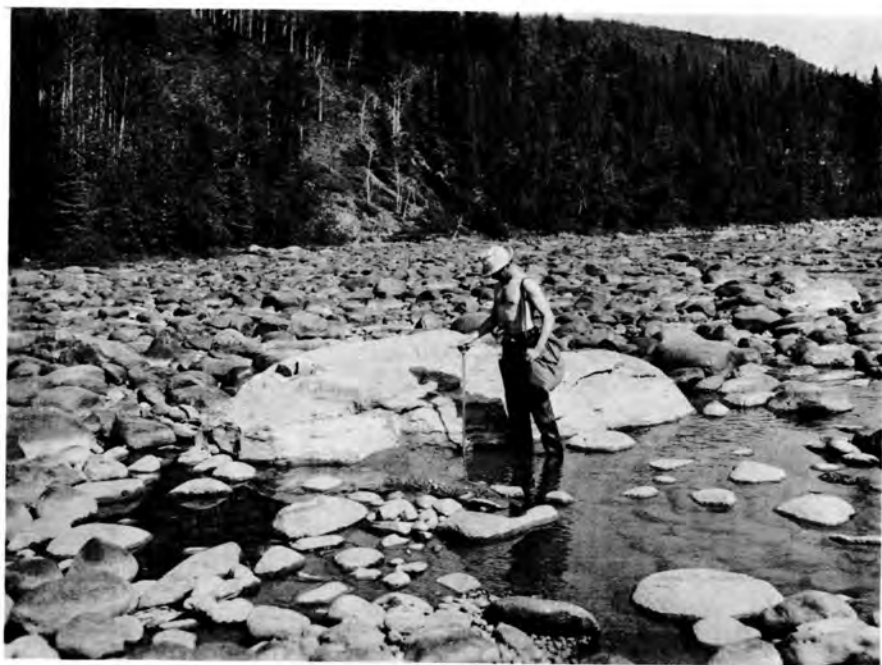
Fig. 65. Terrain features along Ochre Creek north of Wrigley.

a. Windblown silt ridge in background. Shallow, rocky riverbed.

b. Large limestone boulder in riverbed.

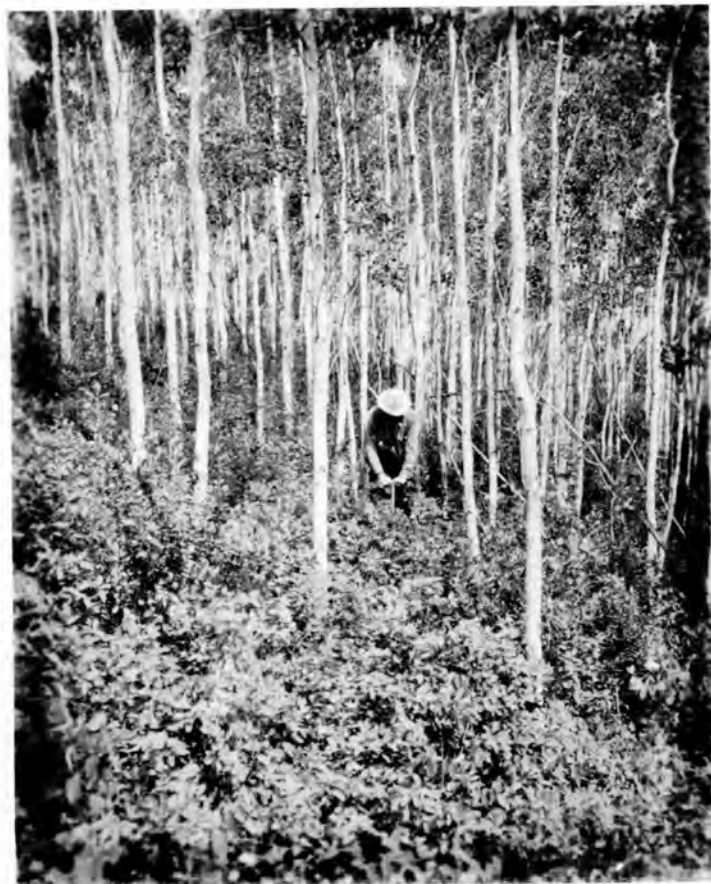
Fig. 66. Thick aspen growth on windblown silt ridge. Test pit indicated 0 to 3 in. of forest litter, 4 to 18 in. of brown powdery silt, and 18 to 36 in. of fine sandy silt. No frost was encountered in this dry, well-drained topographic position.

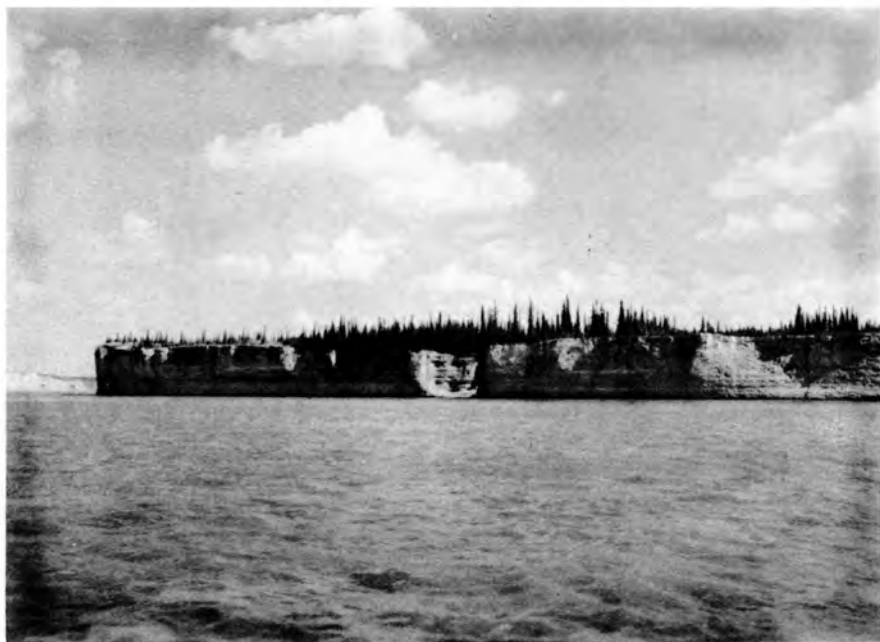
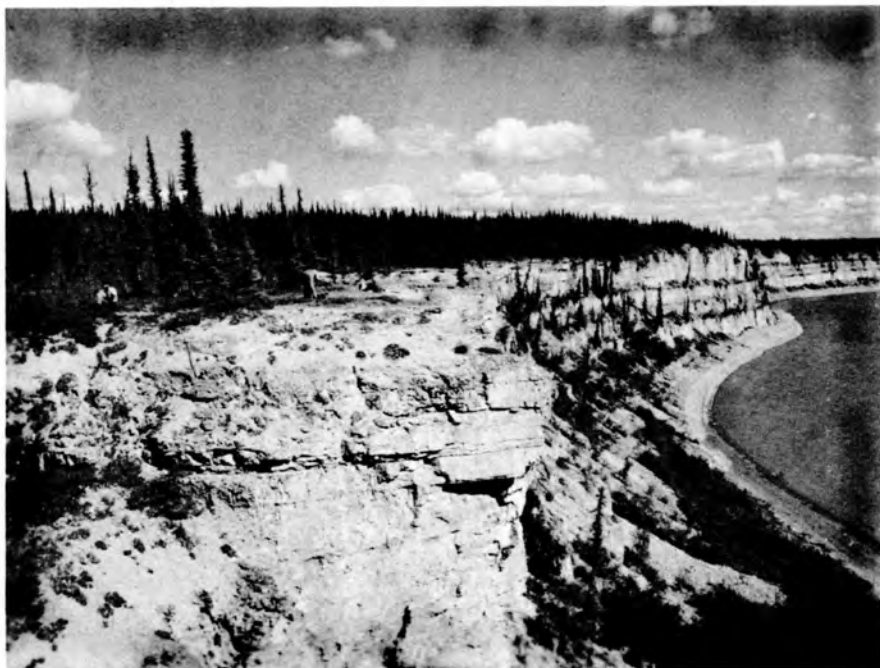
Fig. 68. Views of limestone cliffs at Ramparts south of Fort Good Hope.

a. Cliffs as viewed from river.

b. Stratification as viewed from top of cliffs.

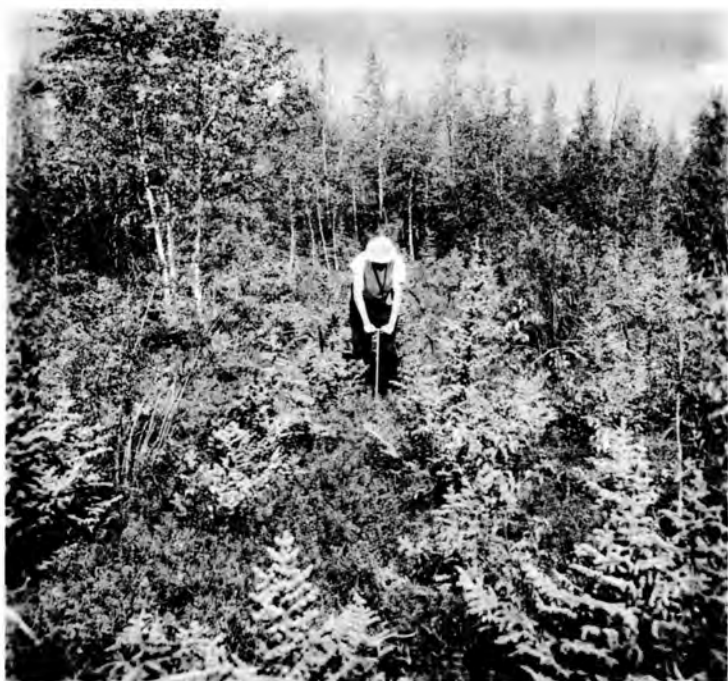
Fig. 69. Vegetation on materials that overlie Ramparts limestone. Opposite the mouth of the Ramparts River.

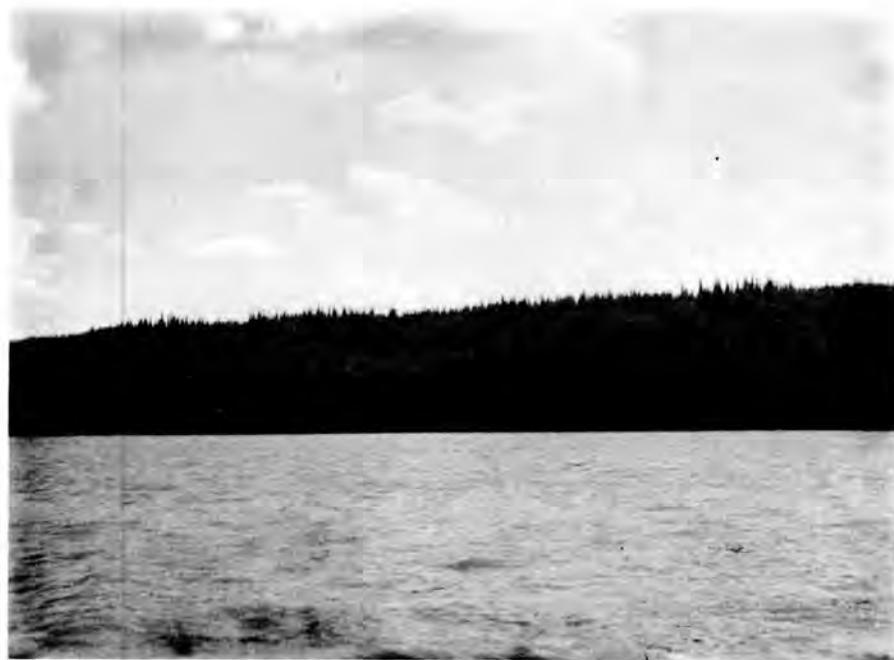
Fig. 70. Beginning of limestone outcrop upstream from the Ramparts. Shale and possibly some drift overlie limestone.

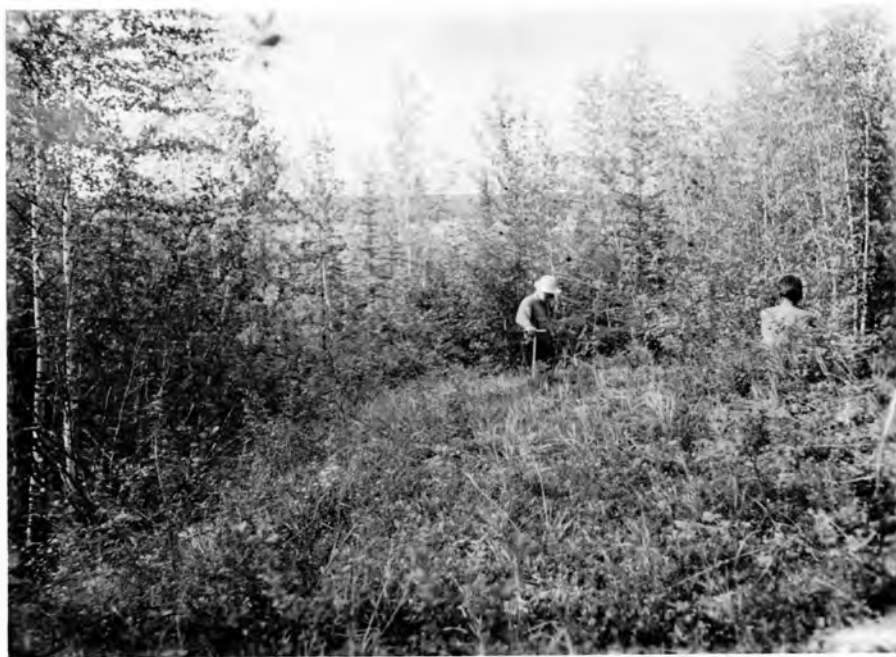
Fig. 71. Test site on granular ridge about 2 mi north of Fort Good Hope.

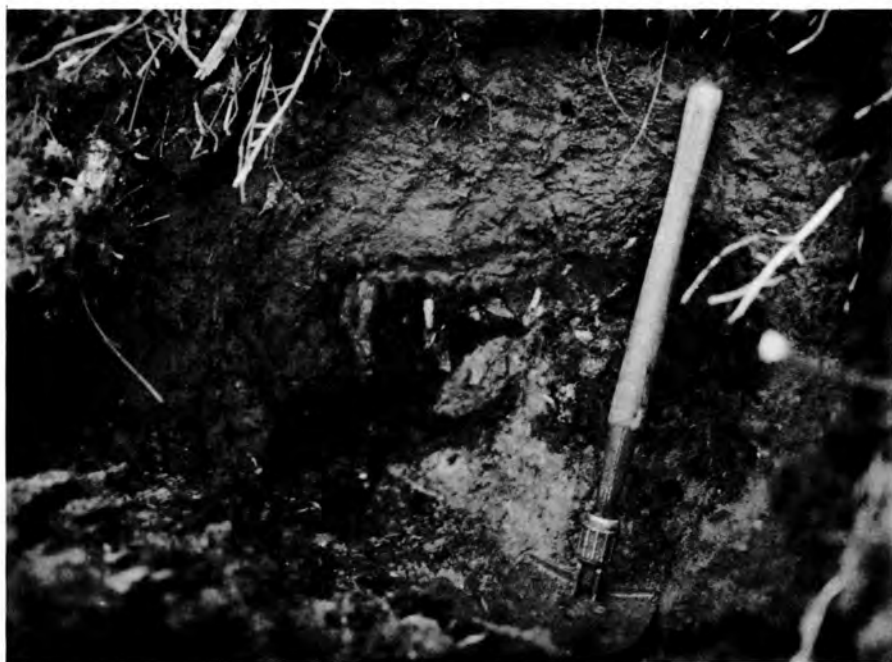
Fig. 74. Exposure of ice in winter tractor trail near Fort Norman. Site located about 300 ft from Great Bear River.

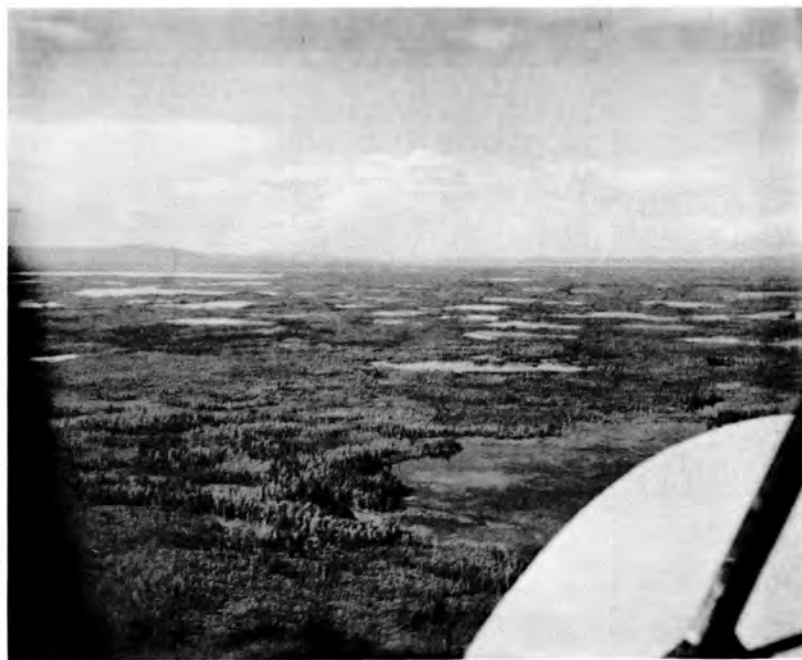
Fig. 75. Drift plains dotted with lakes and muskegs in vicinity of Great Bear River.

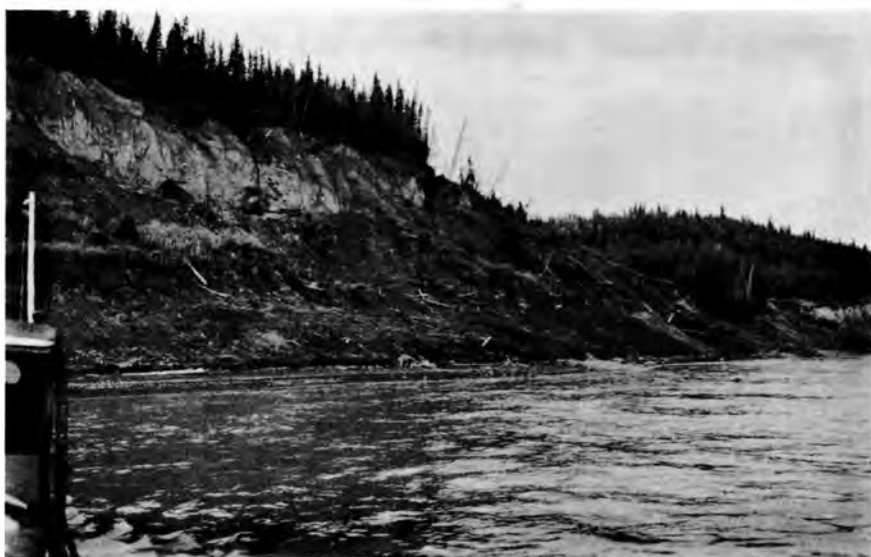
Fig. 76. Lignite beds and semiconsolidated sandstone near Fort Norman.

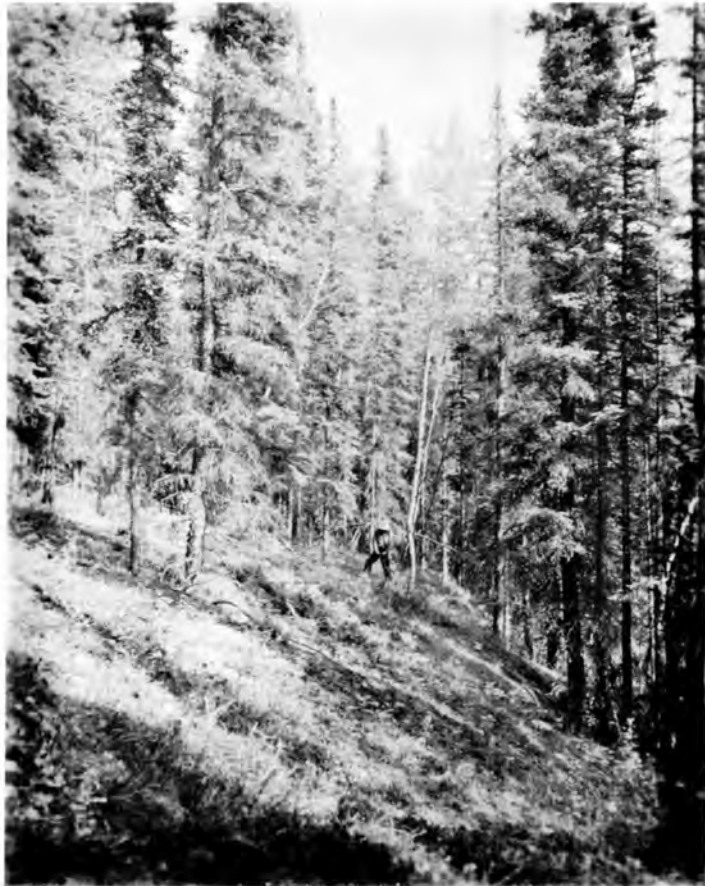
Fig. 79. Rock ridge near foot of Carcajou Ridge.

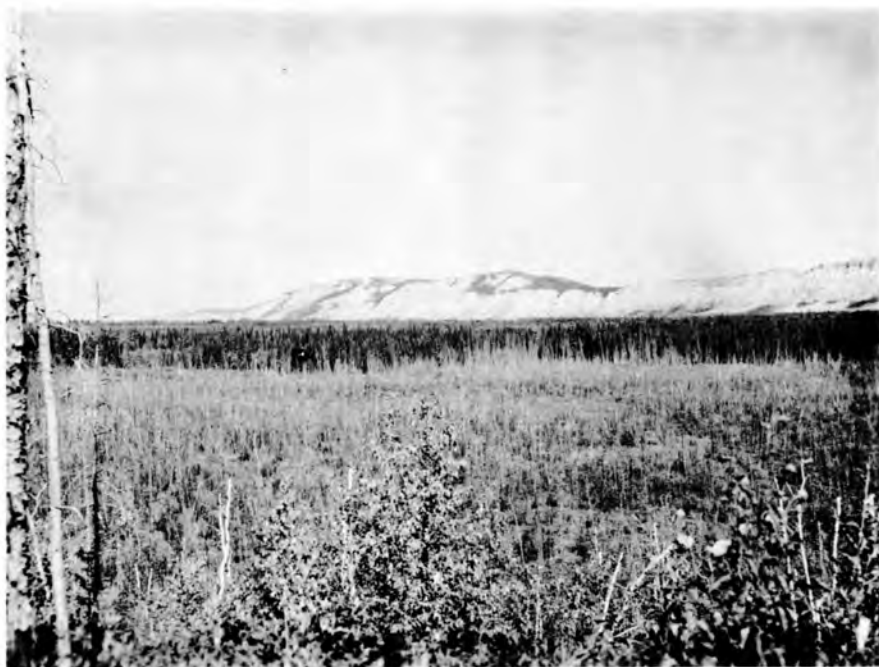
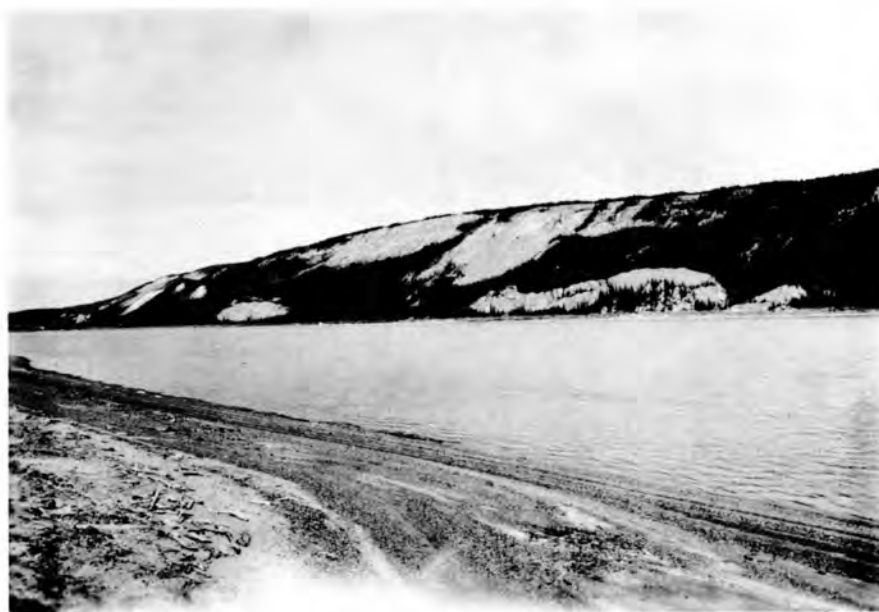
Fig. 80. Terrain views of Carcajou Ridge along Mackenzie River.

a. Carcajou Ridge in background and burned area in foreground.

b. Carcajou Ridge where it is cut by Mackenzie River.

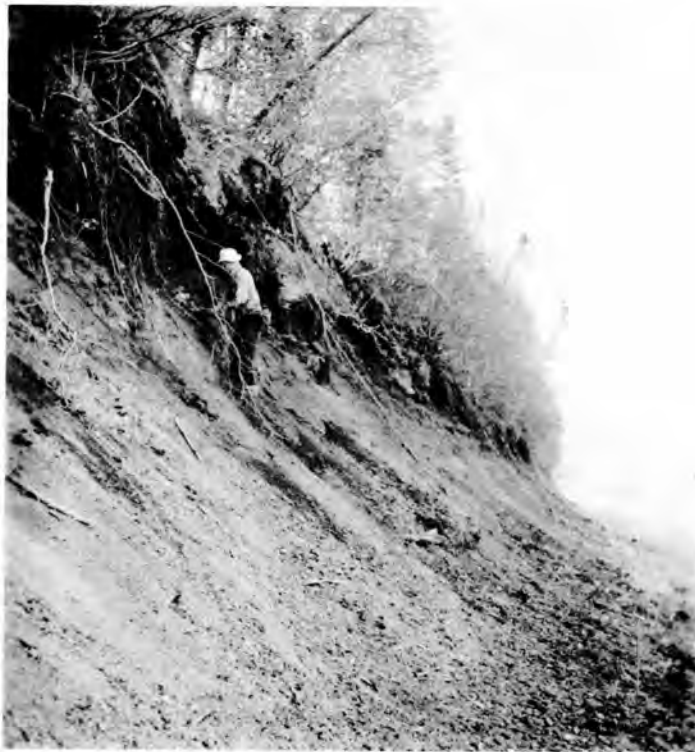
Fig. 82. Stratified silts and sands overlain by 2 ft of peat. Permafrost is exposed under peat overhang. On the surface frost was encountered in peat at 10 to 14 in. or at 14 to 36 in. in sandy silt. This exposure is on opposite bank of Mackenzie River from Carcajou Ridge.

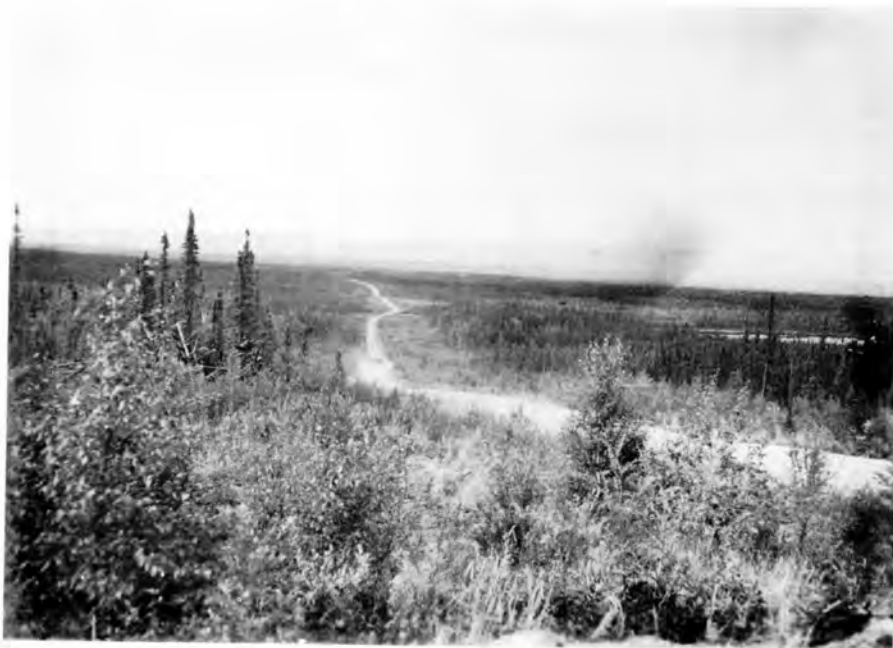
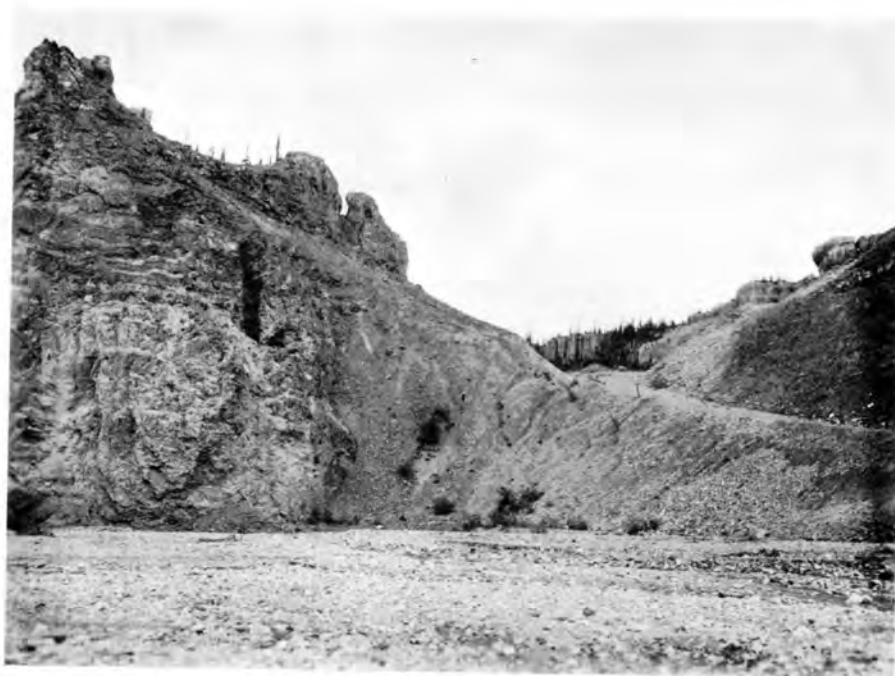
Fig. 84. Terrain along Canol Road at Norman Wells.

a. Mackenzie River terraces along Canol Road.
River in background.

b. Dodo Canyon with Canol Road on right.

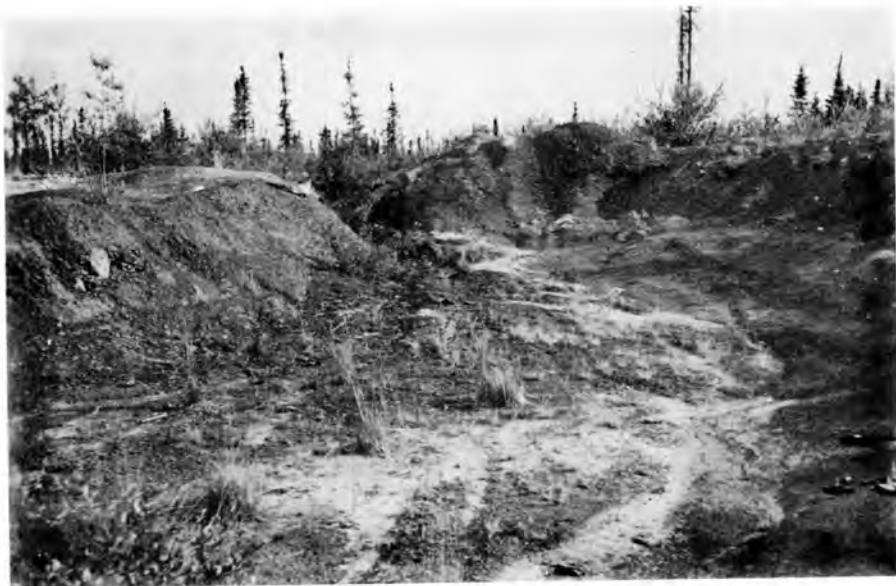
Fig. 85. Exposure of shale on upper terrace seen in fig. 83.

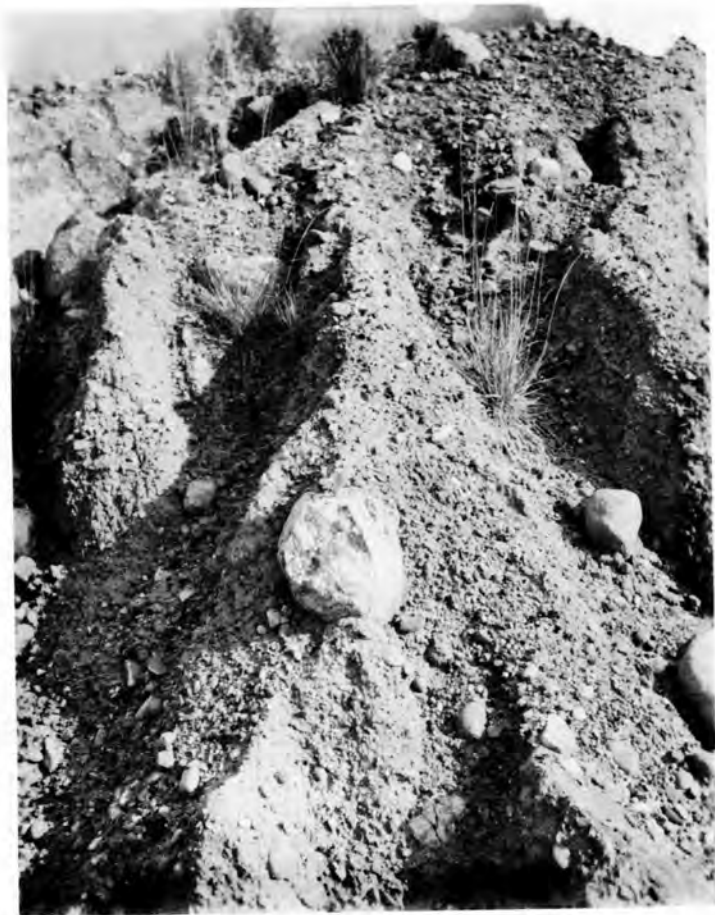
Fig. 86. Sand and gravel exposure in ridge at mile post 18-1/2, Canol Road.

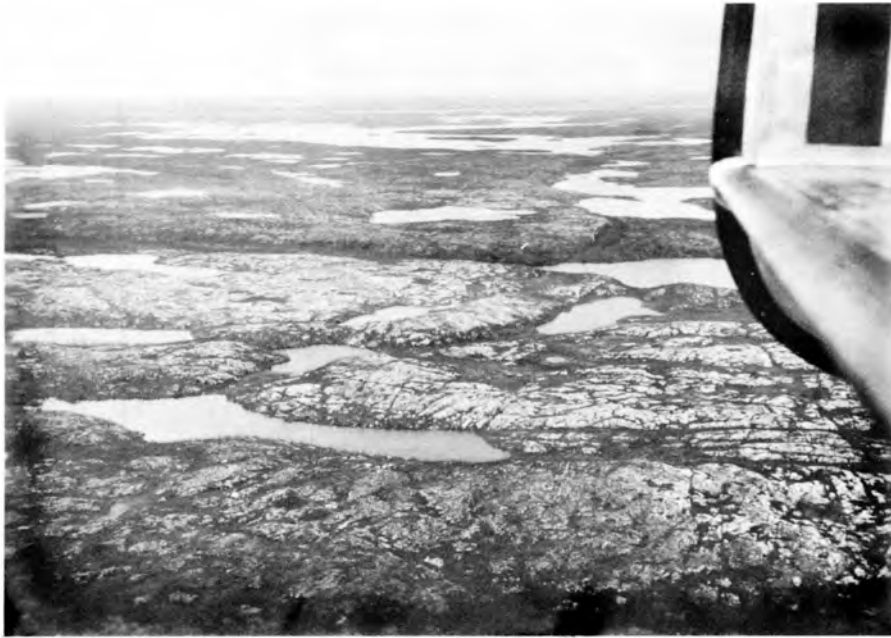
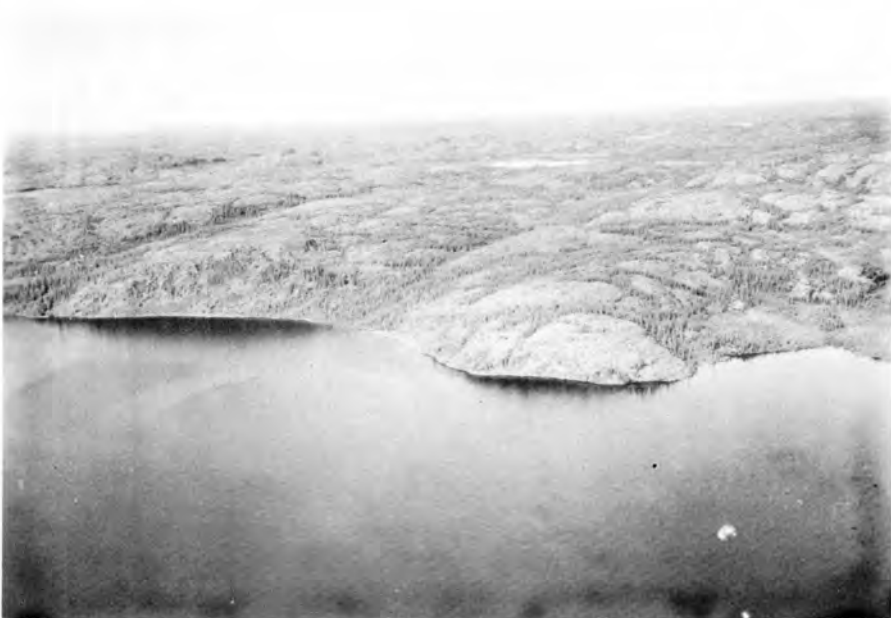
Fig. 87. Topographic features of Keewatin section of Canadian Shield.

a. Lakes and bare rock ridges east of Yellowknife.

b. Bare rock knobs with thin glacial valley fill east of Great Bear Lake.
