CORPS OF ENGINEERS, U. S. ARMY

AIRPHOTO PATTERN RECONNAISSANCE OF NORTHWESTERN CANADA

TECHNICAL REPORT NO. 41

Volume 2

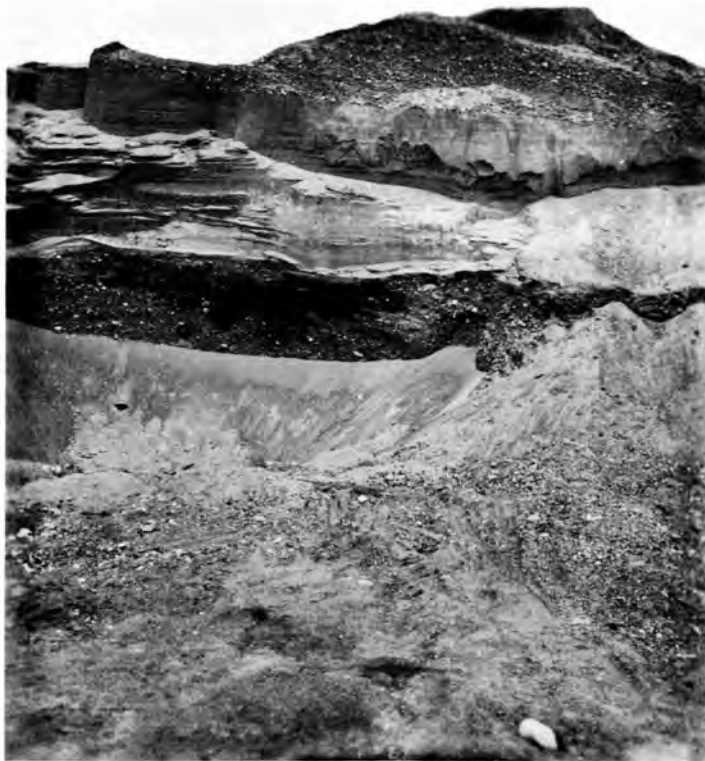
Fig. 92. Ground view of stratified gravels, sands, and silts exposed by borrow pit operation of the outwash shown in fig. 91.

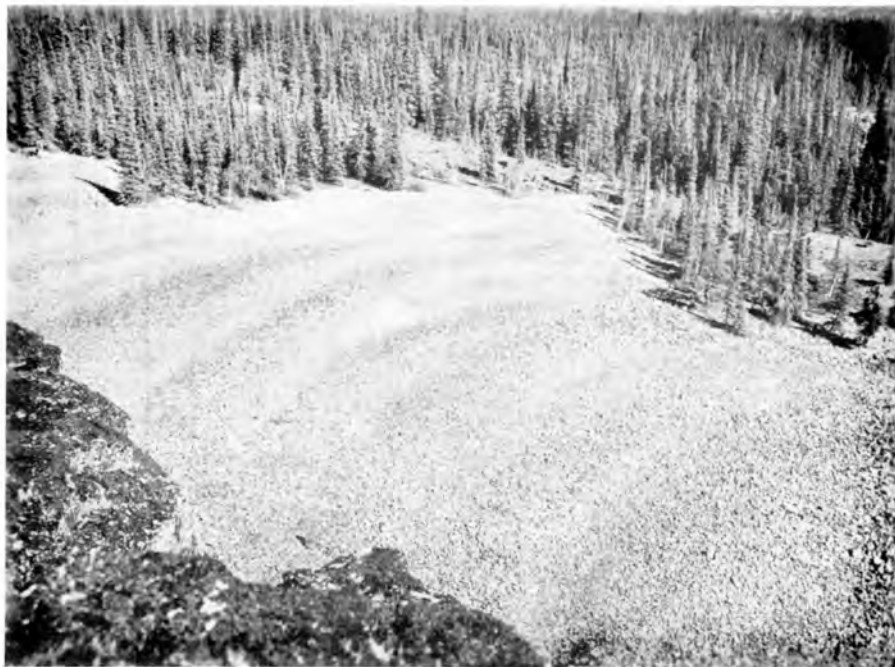
Fig. 95. Coarse granular beach ridges below diabase outcrop on Et-Then Island in Great Slave Lake.

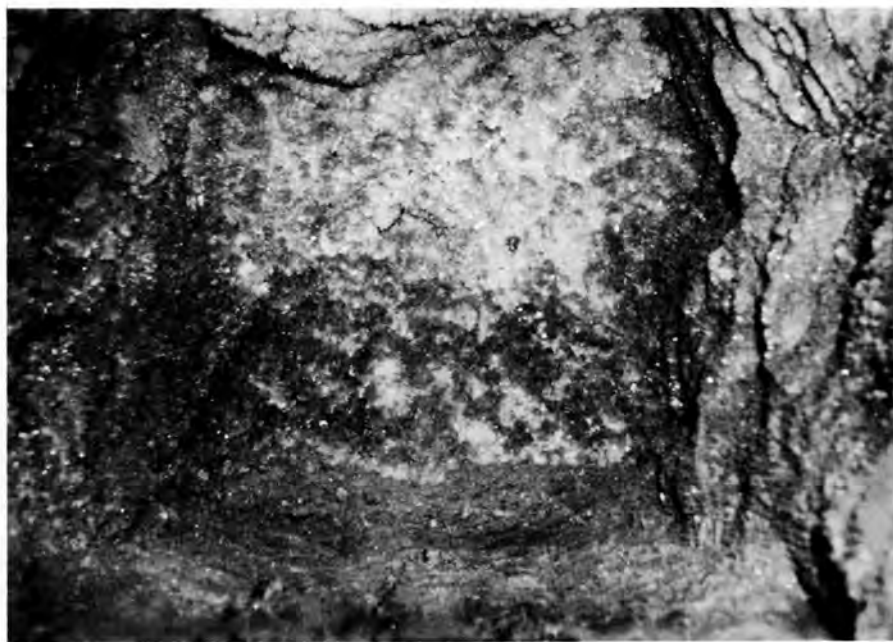
Fig. 97. Ice crystals formed in unventilated tunnel at 115-ft level of Giant Gold Mine No. 2 at Yellowknife.

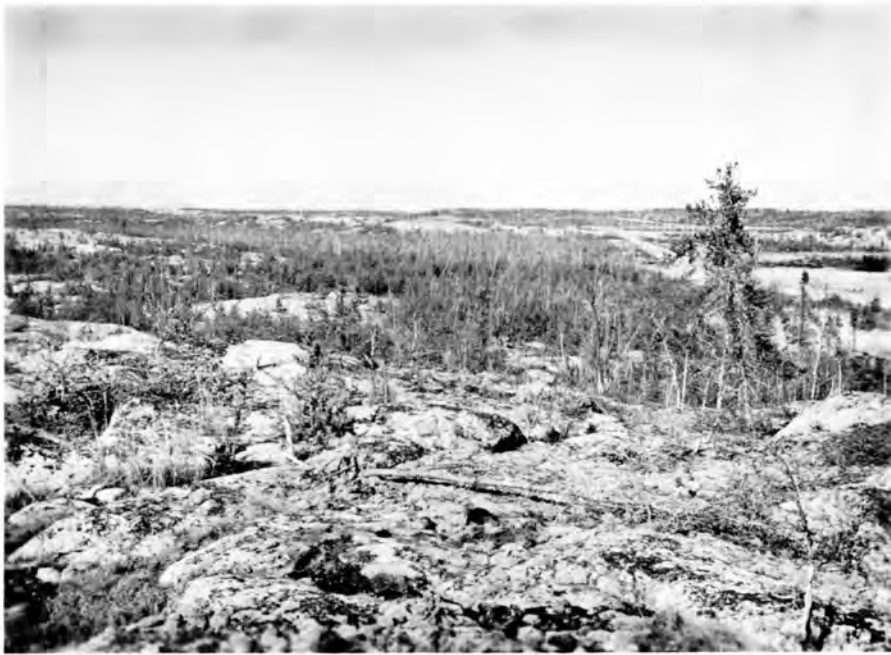
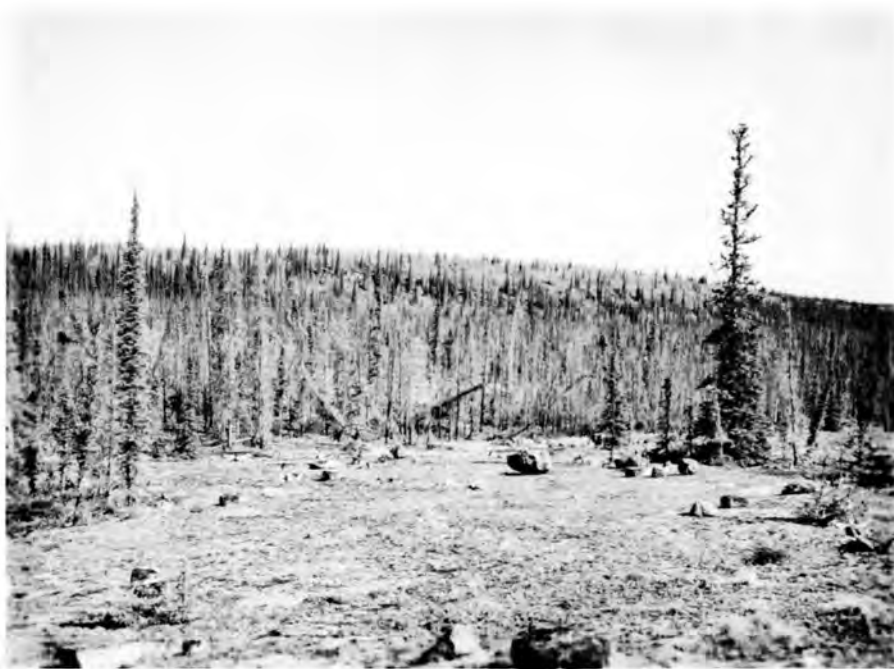
Fig. 98. Topography in the Yellowknife area.

a. Irregular erosional forms of igneous intrusives with many fissures and crevices.

b. Regular erosional forms of slate (graywacke) forming smooth rounded knobs. Surface rocks are glacial-deposited or frost-thrusted.

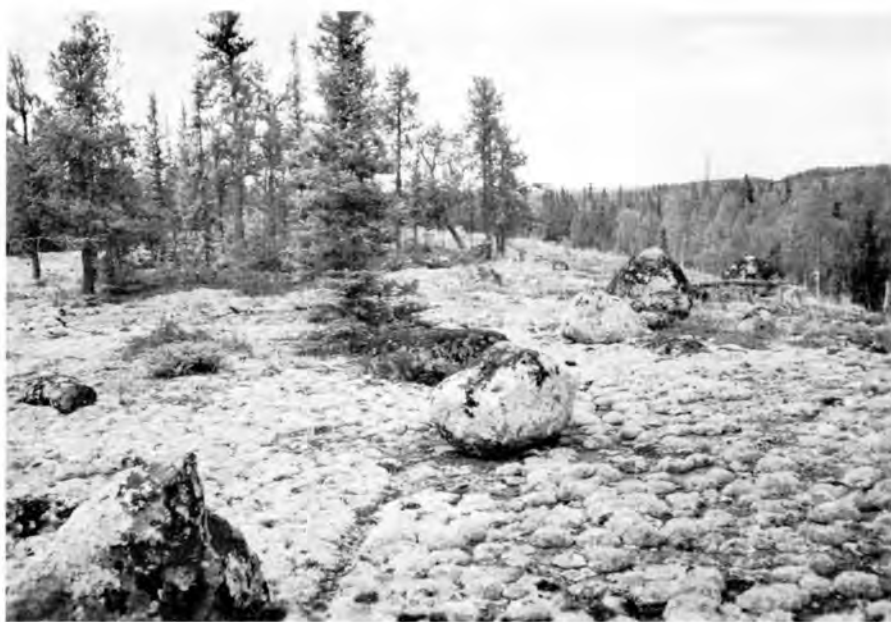
Fig. 99. Glacial erratics frequently found in Keewatin section and also in Barren Lands. The boulders above are granites left on graywacke (slate) knolls.

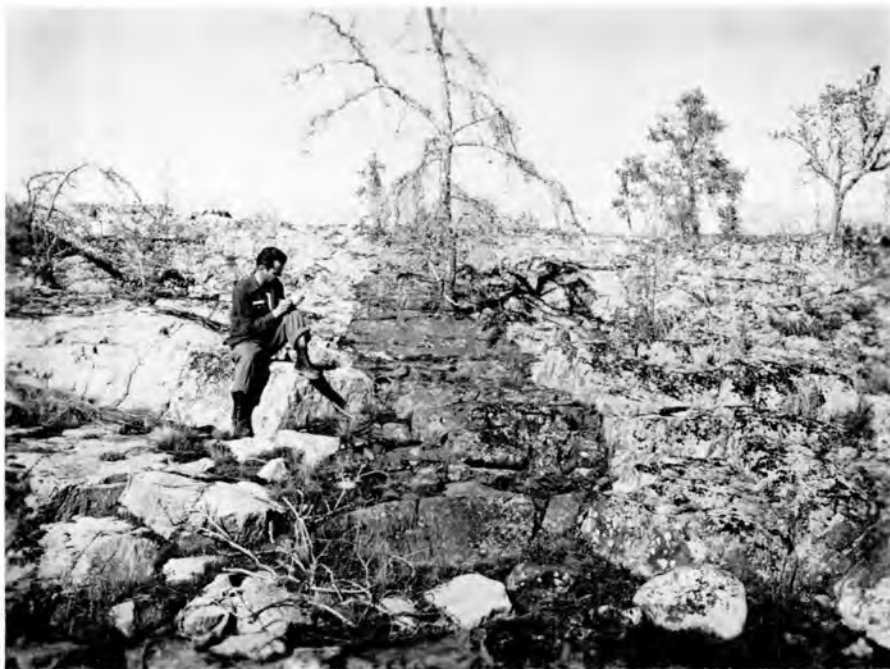
Fig. 101. Narrow intrusive dike crossing intrusive granite.
Notice absence of any soil development.

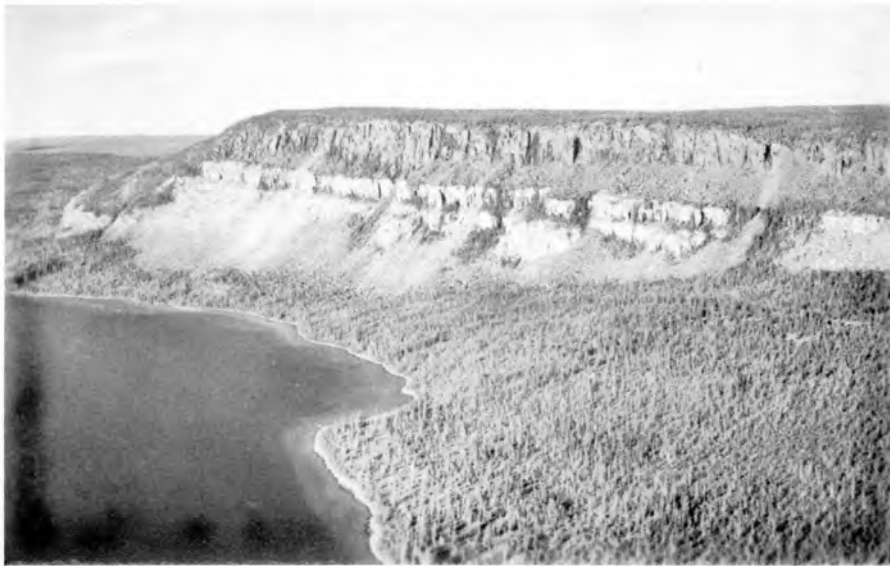
Fig. 104. Diabase sill with columnar structure overlying pre-Cambrian limestones. Horizontal stratification is indicated in the underlying limestone scarp.

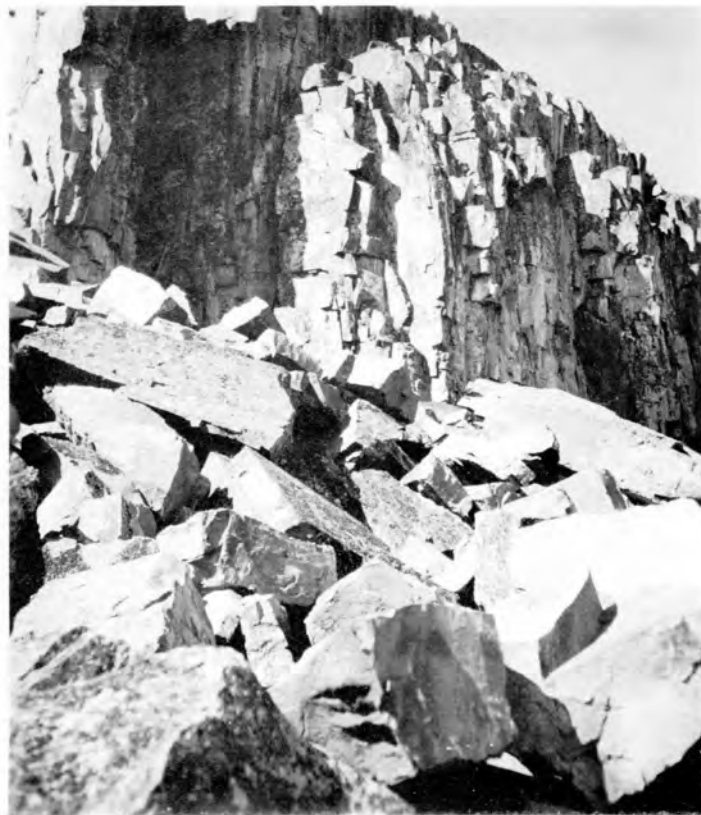
Fig. 105. Columnar jointing in an exposed intrusive sill.

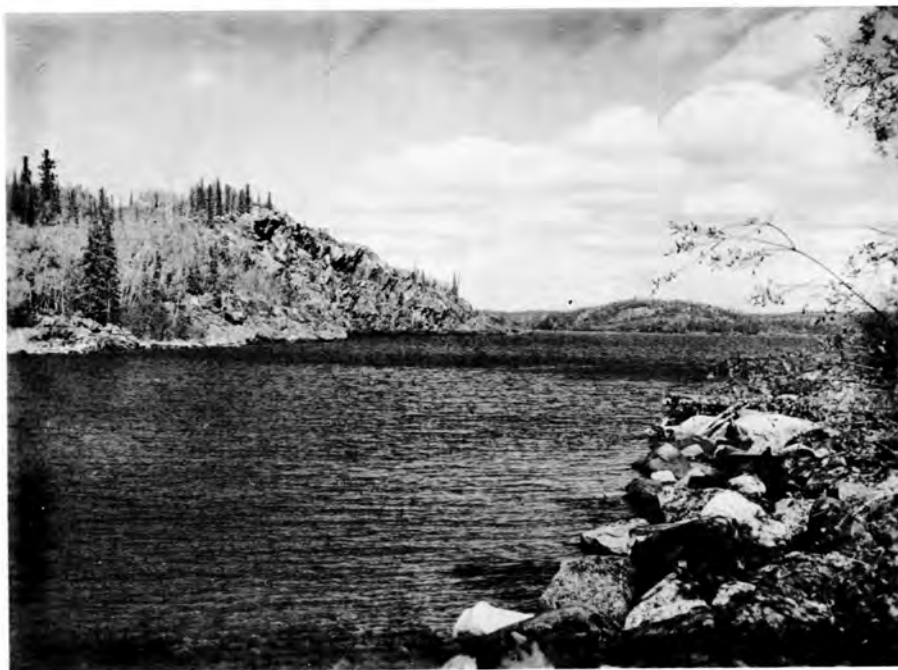
Fig. 107. To the right of the power-line tower on opposite shore columnar structure of flow is evident.

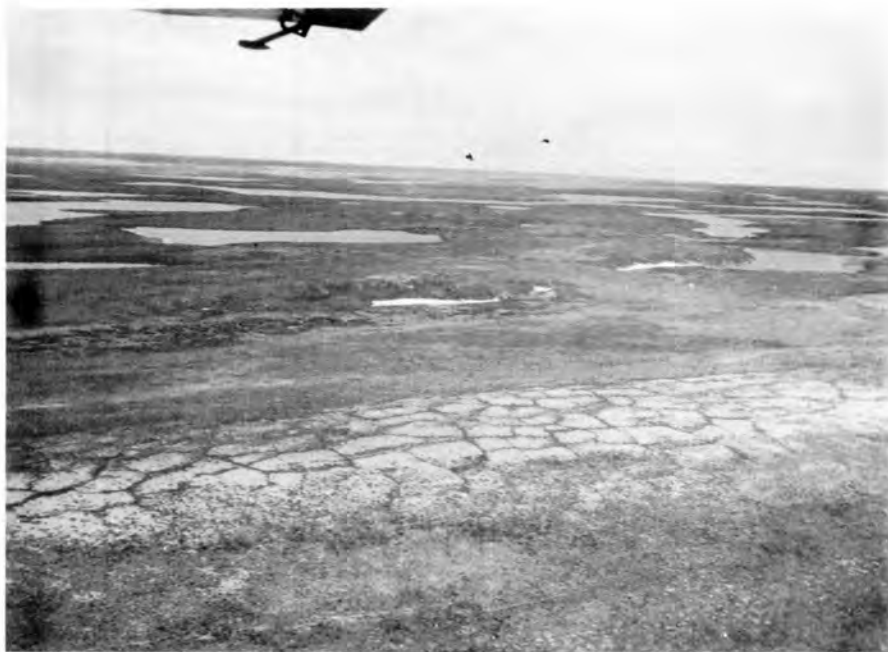
Fig. 112. Oblique view of polygons on ridge similar to that of previous illustration. Notice also the polygons in filled valley beyond ridge.

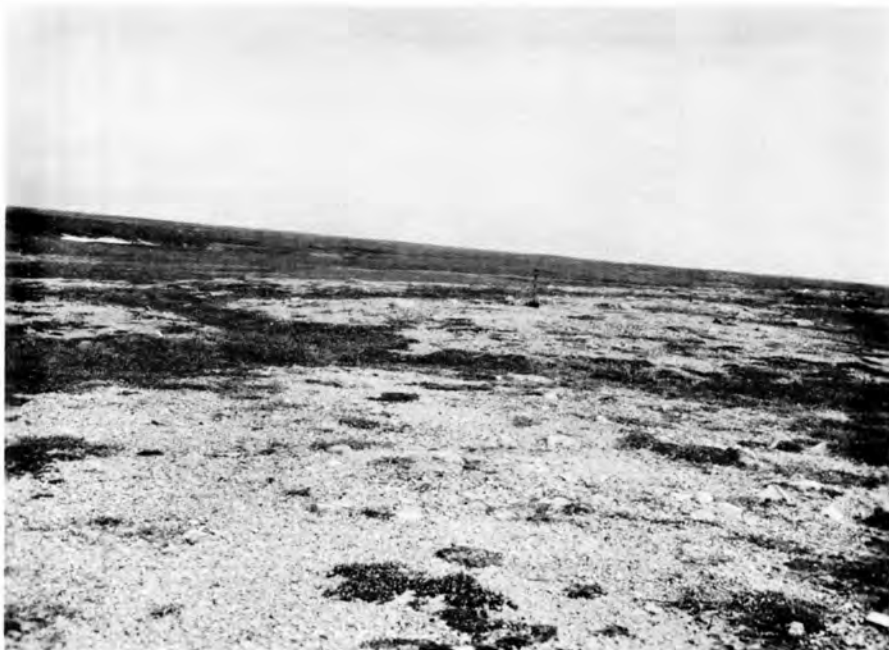
Fig. 113. Vegetation in polygon rims on granular ridge. Notice size and roundness of granular particles. Shovel in mid-distance gives scale.

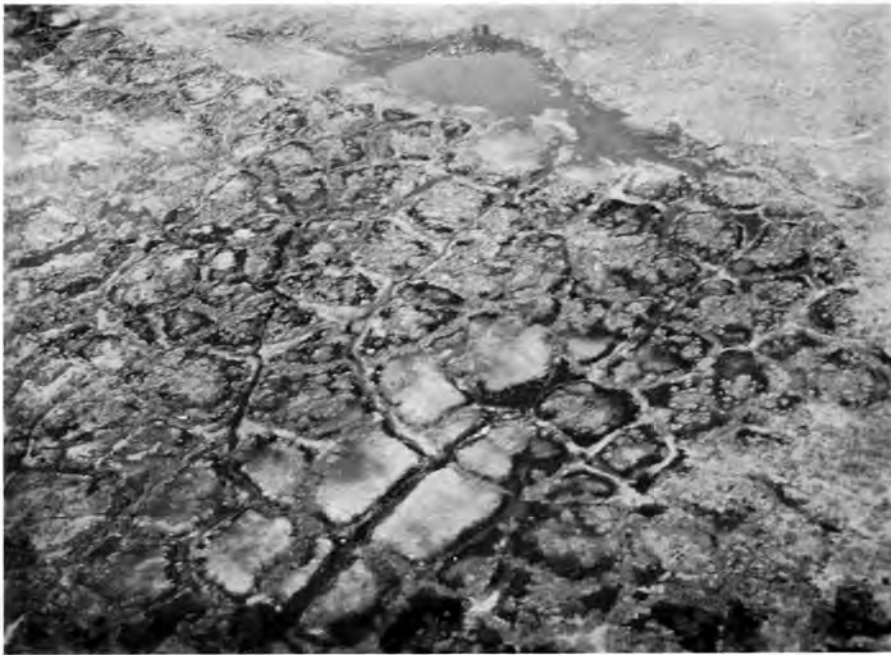
Fig. 114. Raised-center type polygons in valley filling beyond ridge shown in fig. 112. There is deep peat development in the low depressions, and these polygons are the result of the growth of ice lenses from high amounts of groundwater in the thick peat.

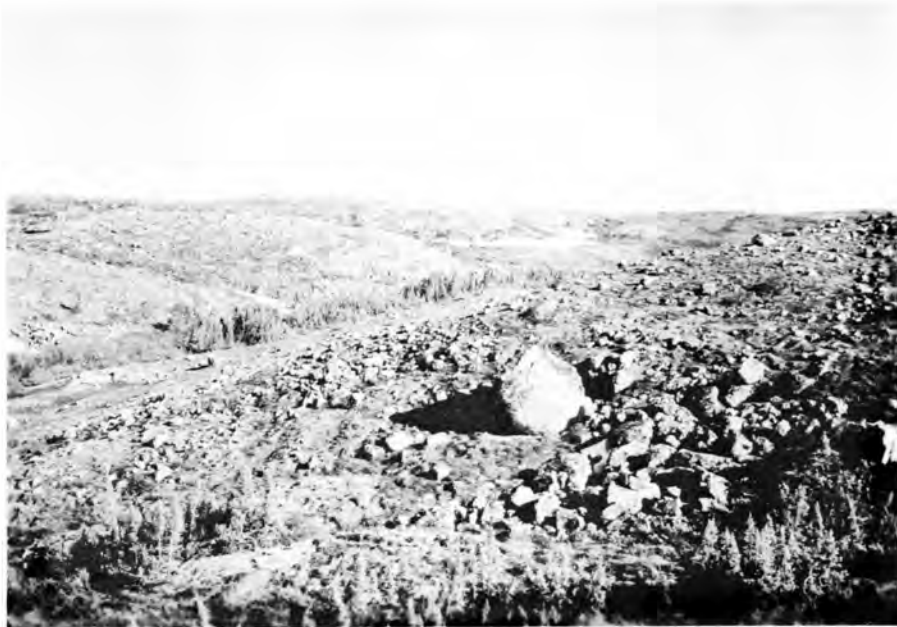
Fig. 117. Rock field resulting from glacier activity and frost thrust on bedrock. Bedrock is angular and much fractured. Thin glacial mantle will give smooth effect to slopes as in background. Notice enormous boulder in foreground. Spruce trees are about 15 to 20 ft high.

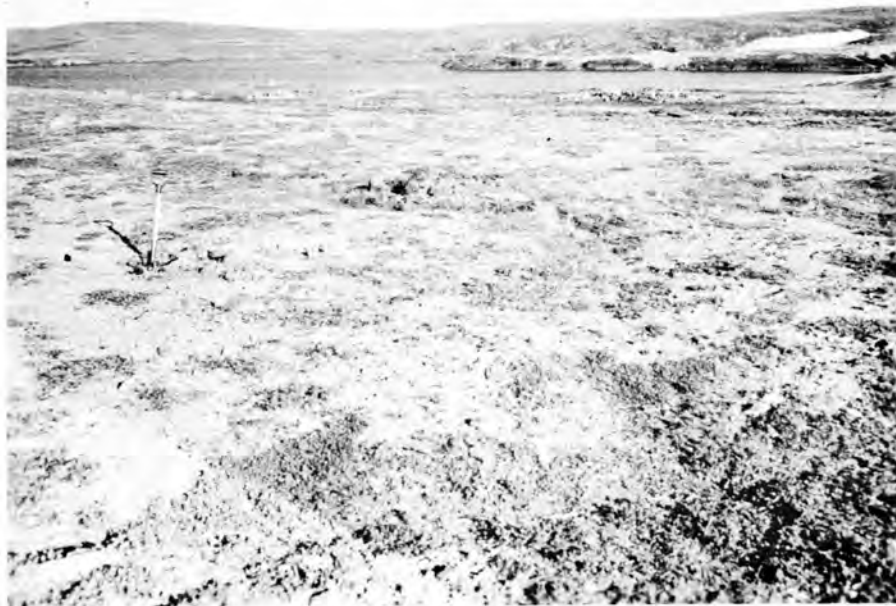
Fig. 118. View from a drift ridge in fig. 116 showing esker jutting into lake. Note boulders on rock in middle distance.

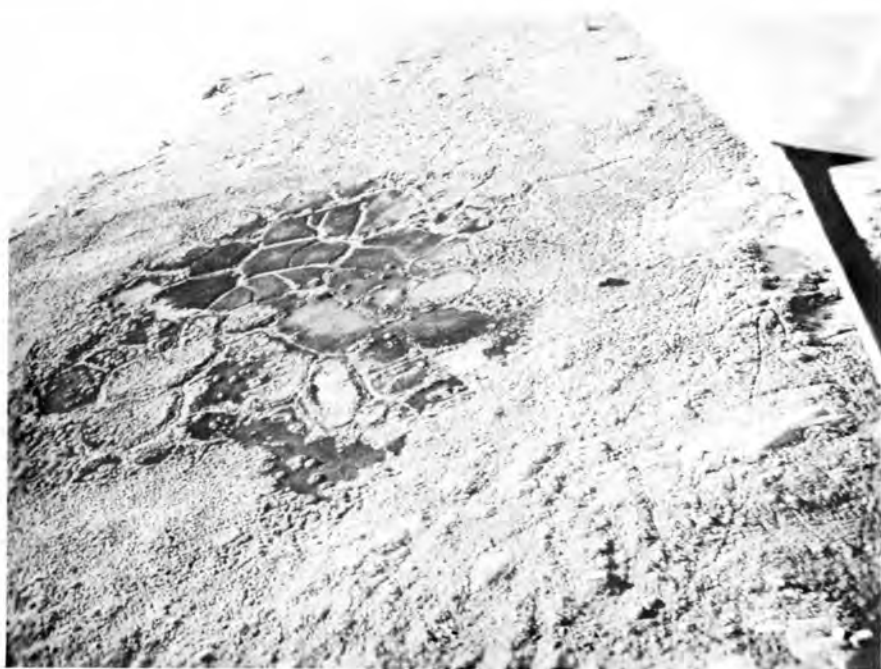
Fig. 119. Peat polygons on shore of Artillery Lake. Notice rock outcrops along beach and in lower right-hand corner.

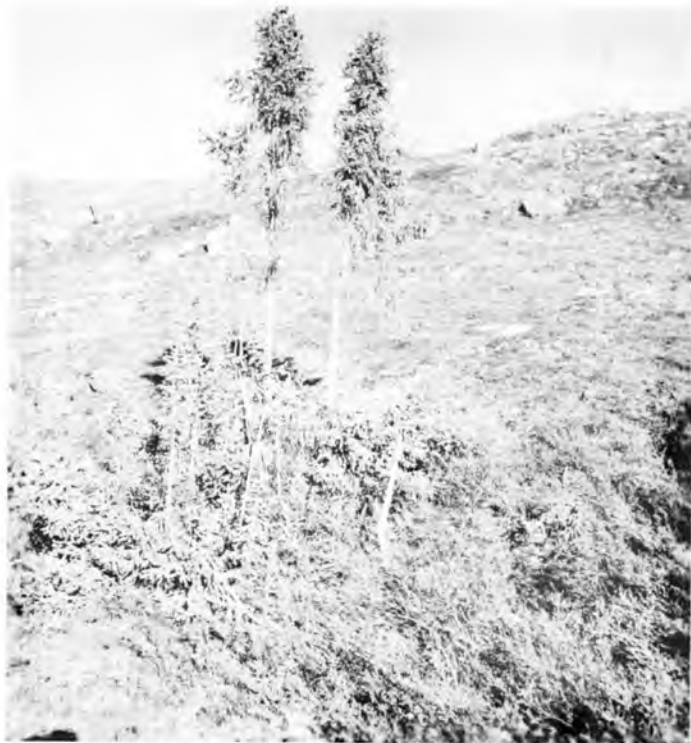
Fig. 120. Stunted spruce on rocky slope in Barren Lands section. These are about 10 ft tall.

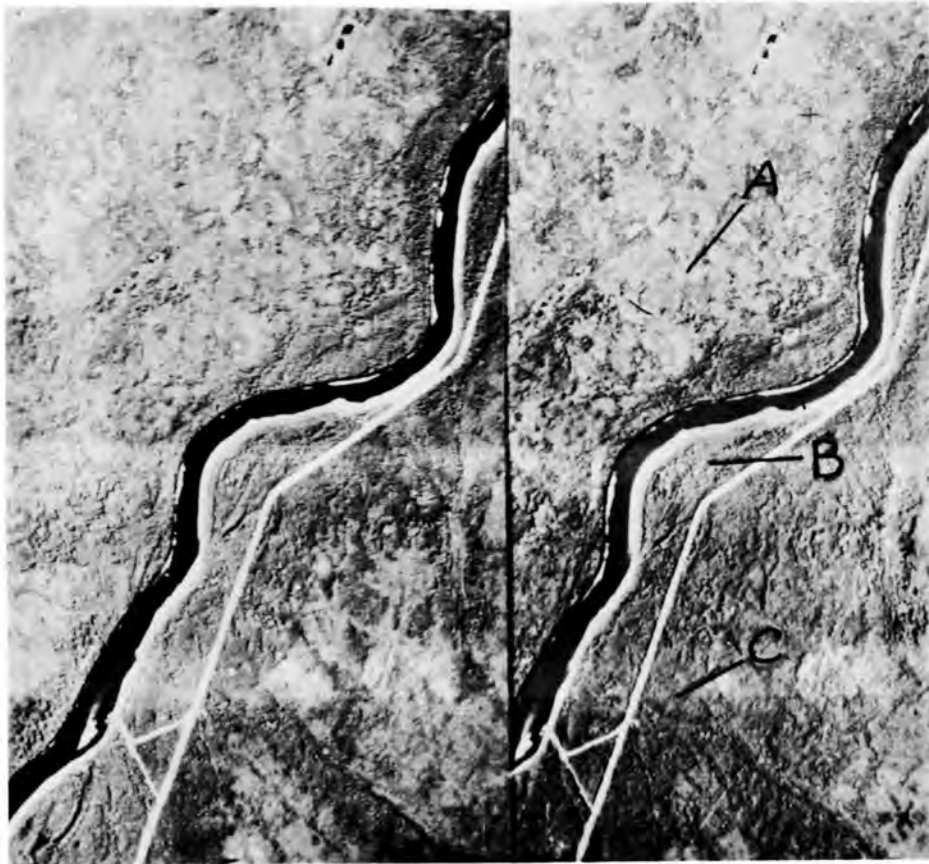
Fig. 121. Stereopair of a typical mixed forest along the Grimshaw Highway. The cover type is aspen with an admixture of white spruce and jack pine. Where aspen is the dominant tree (C), the photo texture is relatively smooth and uniform. The open stand (B) is about one-half spruce and one-half aspen. The stippled pattern on the left side of the road between B and C is produced by a stand composed principally of white spruce with a few jack pine and aspen. The sandy soil is fairly well drained under the forested areas and very poorly drained in the peat-filled bogs (A). Permafrost is found at an average depth of 2 ft in the depressions, and is absent or at depth of 5 ft or more beneath the mixed forest.

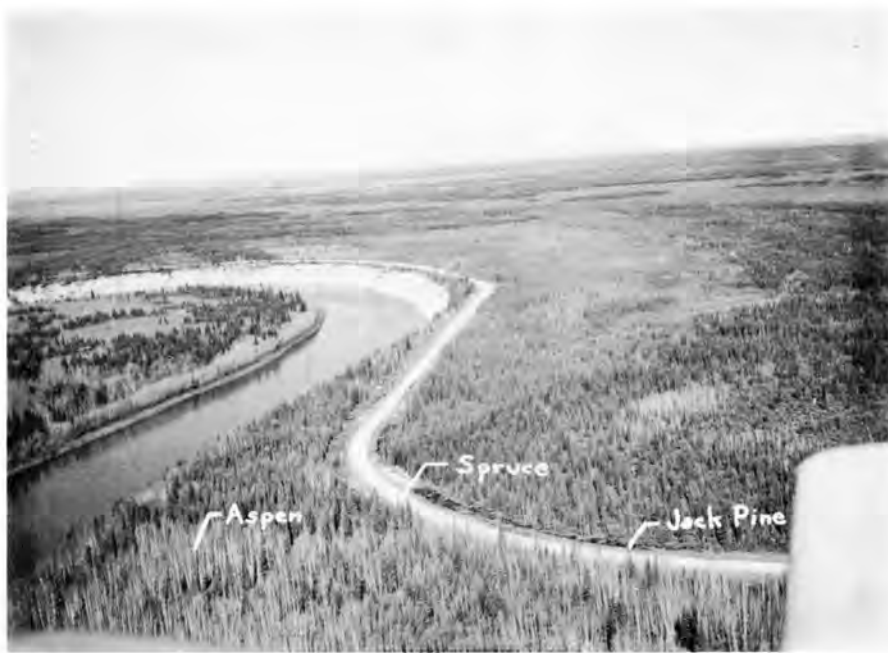
Fig. 122. A white spruce-aspen-jack pine stand on a dry granular plain along the Grimshaw Highway south of Great Slave Lake. The shaggy, rounded crowns of jack pines are readily distinguished from the uniform, narrow spires of spruces. The aspens were just beginning to leaf when this photo was taken.

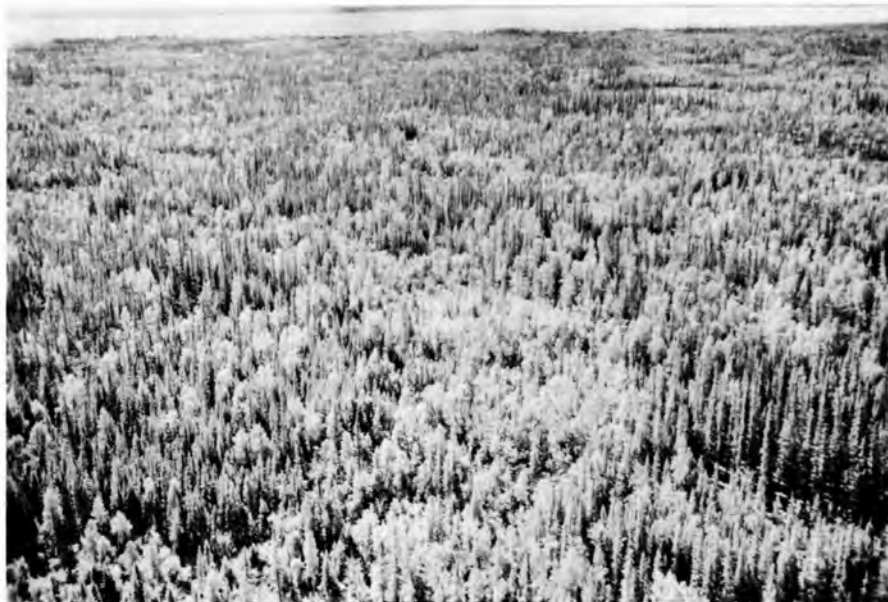
Fig. 123. A mixed forest composed of white spruce, balsam poplar, and aspen on the moist, fine-grained alluvium in the Mackenzie bottomlands near Mills Lake. During the early part of the growing season, the aerial observer can distinguish balsam poplars from other hardwoods by their shiny leaves, regular pyramidal form, and pointed crowns.

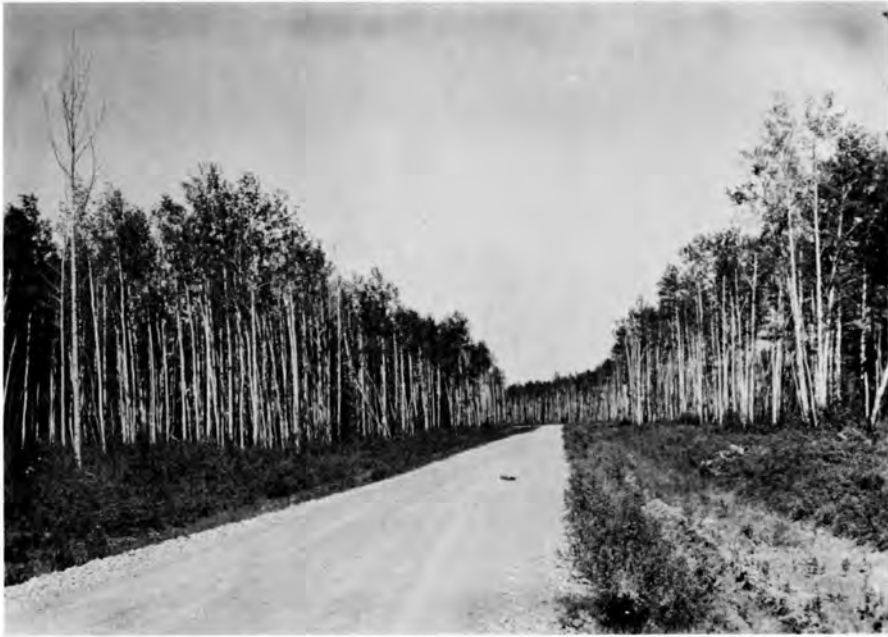
Fig. 126. A dense 60-ft aspen stand on a fairly dry, sandy silt bench near Hay River. The straight, slender boles are branchless two-thirds of the total height. Unlike the sharp-pointed crowns of mature balsam poplar and birch, aspen has a rounded crown.

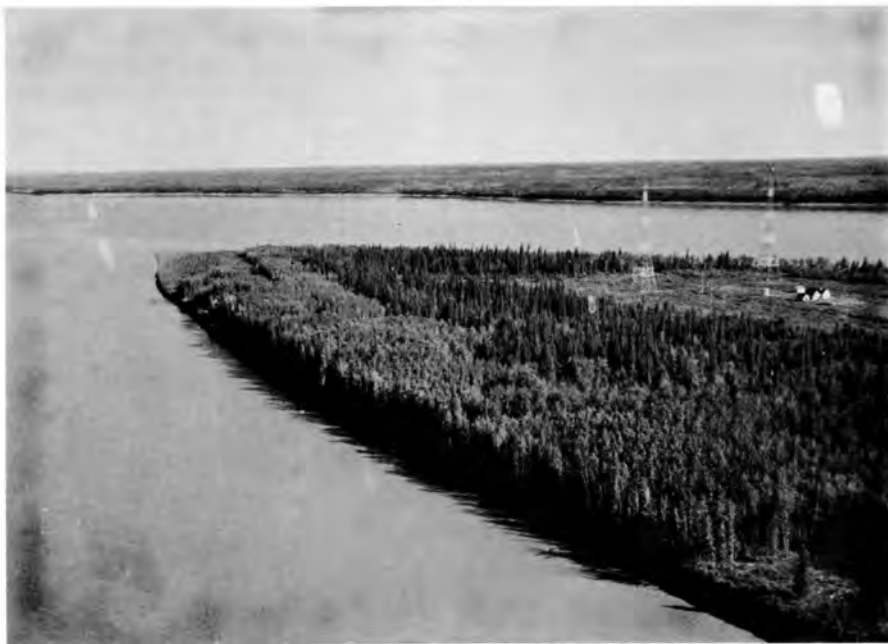
Fig. 127. Balsam poplar stand on moist fine-grained alluvium near Simpson in the Mackenzie bottomlands. Note the open, feathery, pointed shadow cast by this species. Branches persist on the trunk over two-thirds of the total height. Compare the general appearance of this tree with aspen shown in fig. 126. Note white spruce zone between poplar stand and central cleared area.

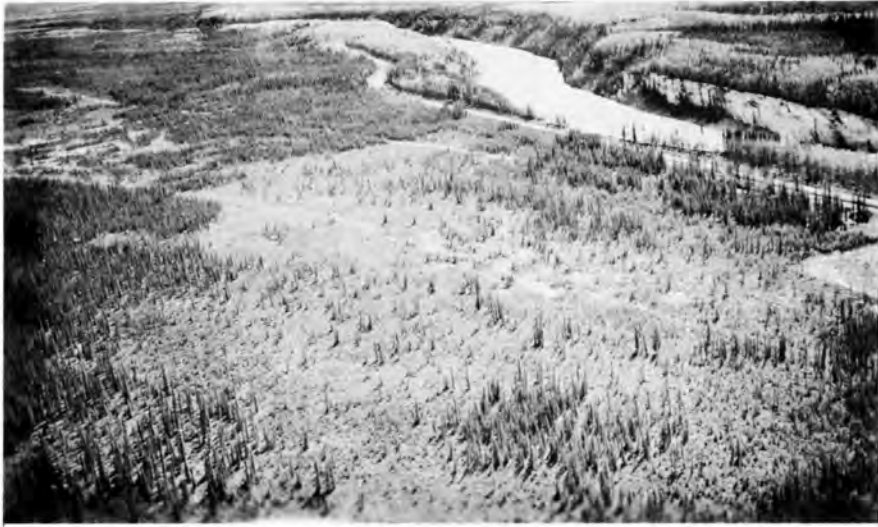
Fig. 128. Typical open black spruce-tamarack bog along the Grimshaw Highway south of Hay River. The active layer in the peat-filled depression is about 2 ft in this vicinity. In the better-drained surrounding sites which support a white spruce-aspens-jack pine forest, permafrost is either absent or at relatively great depths.

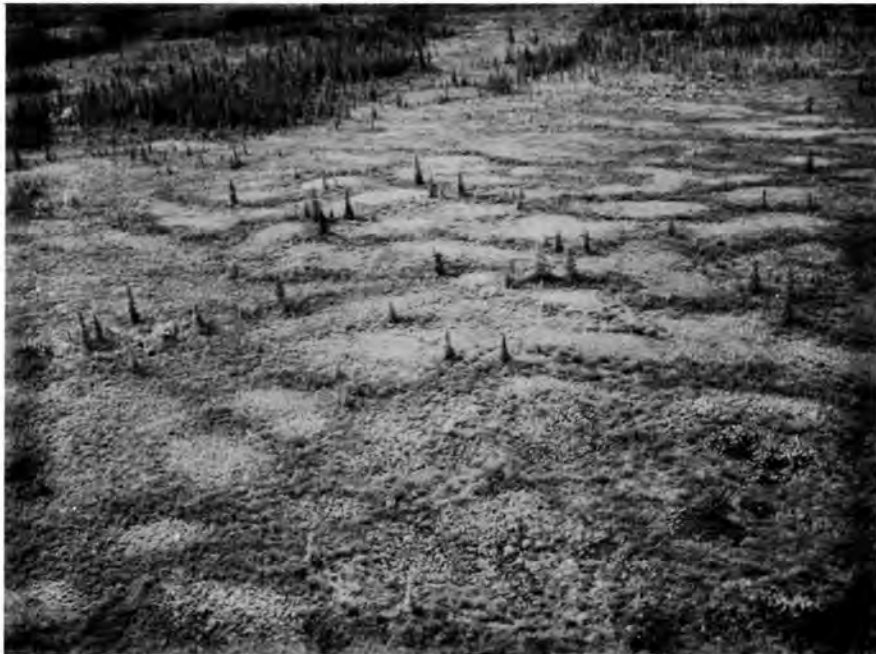
Fig. 129. Scattered tamarack and black spruce on perimeters of depressed-center polygons near Hay River. The sedge-covered paddies are very wet. Willows and other woody plants occur only on the locally better-drained ridges.

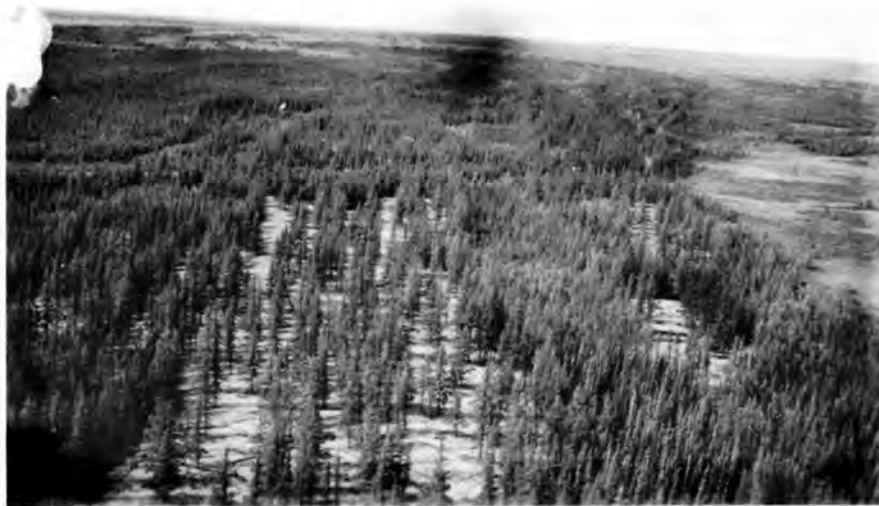
Fig. 130. An open 50-ft jack pine stand on a dry granular beach ridge in the southern Great Slave area. The interspaces between trees are partially covered with lichens and low-lying shrubs which photograph snowy white.

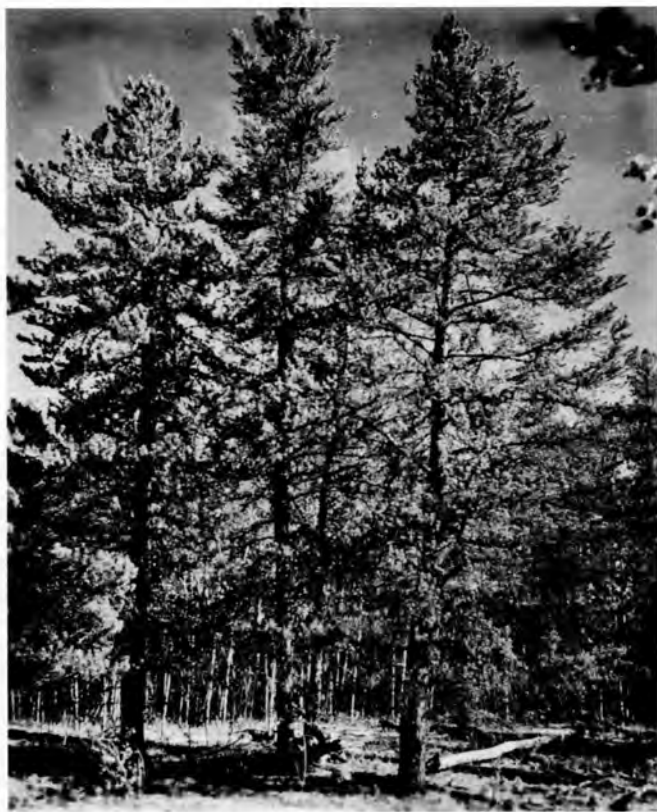
Fig. 131. A ground view of the open jack pine stand shown in fig. 130. In open stands, branches persist on jack pine nearly to the ground, but in closed forests the trunk is free of branches three-quarters of its height. The white-barked trees in the background are aspen.

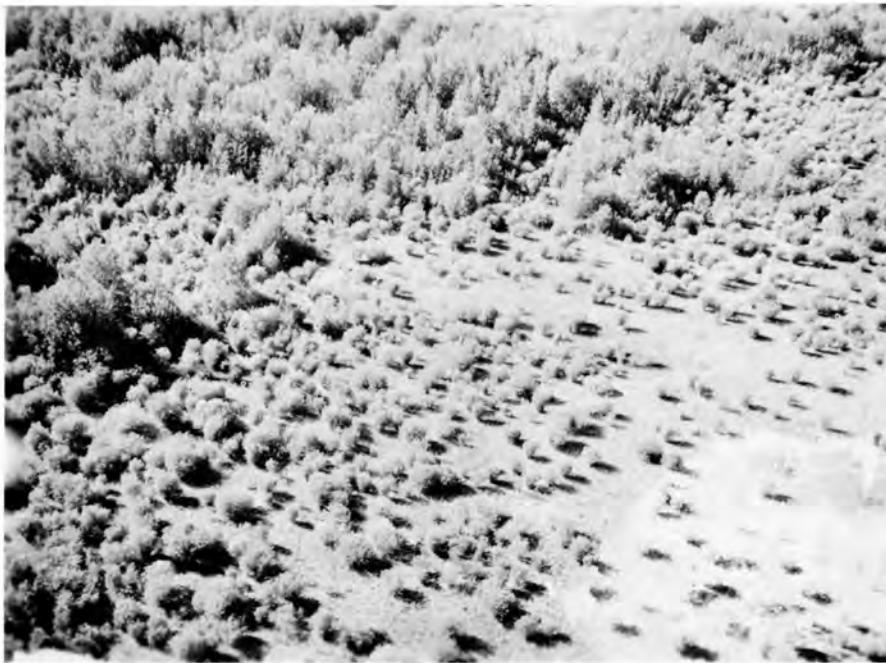
Fig. 132. A low oblique airphoto of globular willow clumps on wet fine-grained alluvium near Mills Lake. The open areas between clumps are covered with a dense sedge cover. Insulating moss mantle is thin or nonexistent. The trees located on better-drained sites are balsam poplar.

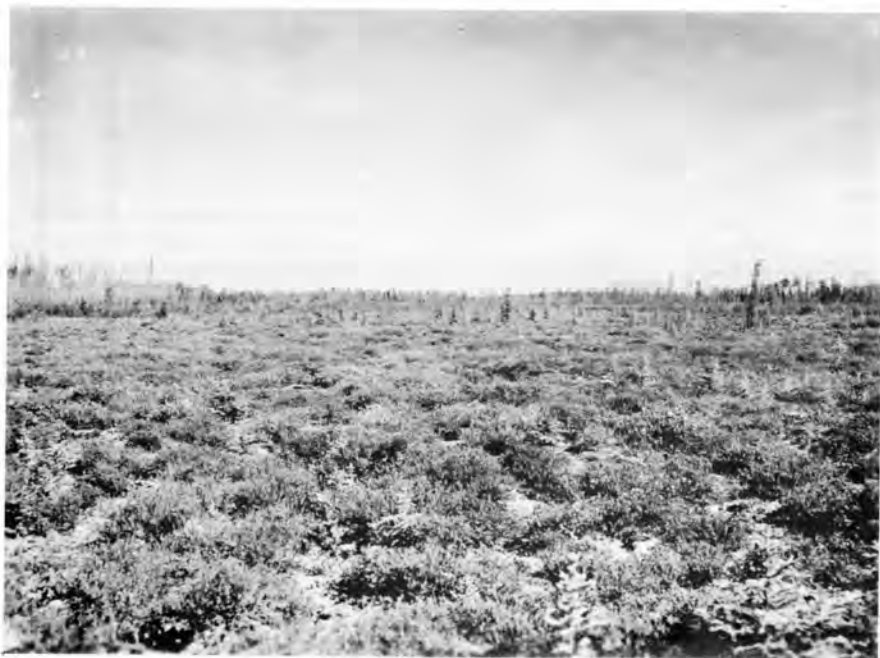
Fig. 136. Ground view of the heath cover shown in the interspaces between trees in the above illustration. In the early part of July, the relatively dry, brown, fibrous peat was frozen at a depth of 17 in. Vegetation consists of ledum, blueberries, ground birch, some sedge, and fruticose lichens.

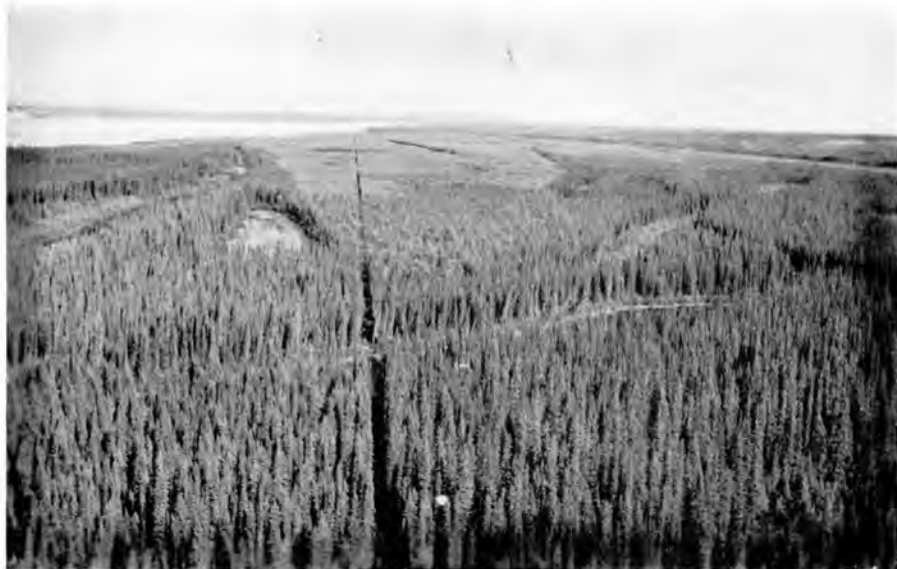
Fig. 138. White spruce stand on alluvial silt near Fort Norman in spruce-birch area. Average height of spruce is 65 ft, with the maximum about 80 ft. The mature stand in foreground is practically pure white spruce; the hardwoods in center background have established themselves following fire.

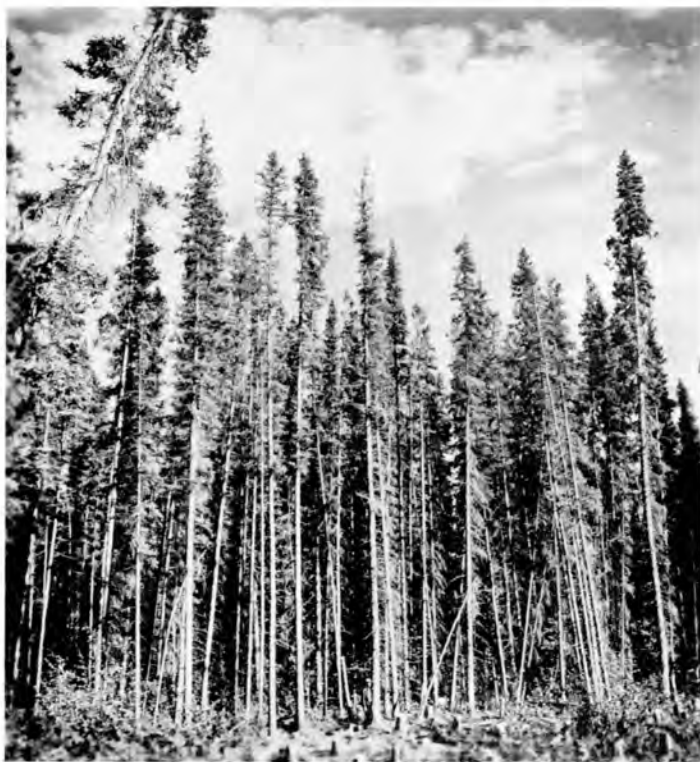
Fig. 139. Ground view of the same white spruce stand shown in fig. 138. The center tree with the man at its base is 75 ft tall, which is a few feet taller than the average. Frost level in this stand on July 21 was 31 in.

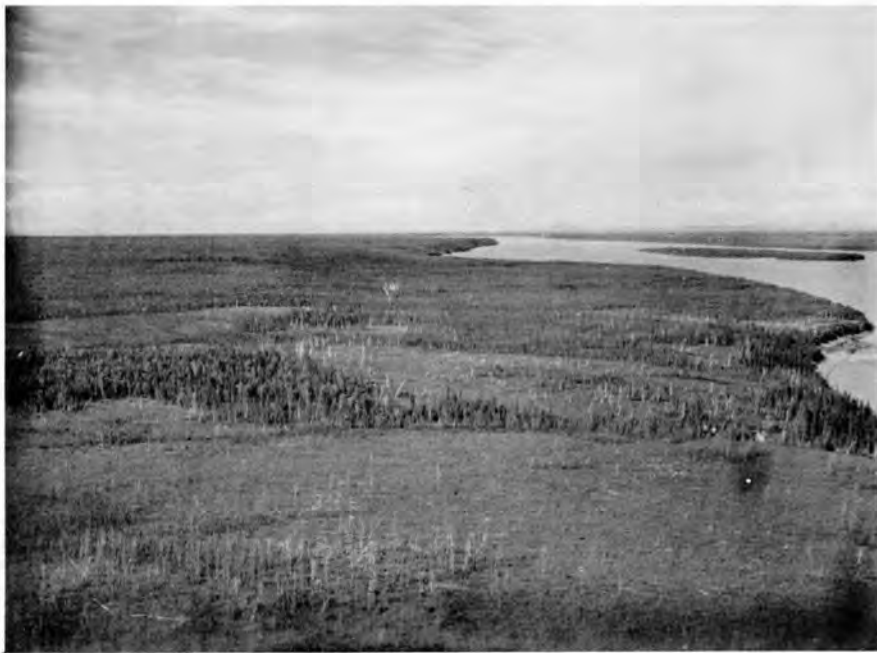
Fig. 140. Recently burned white spruce-birch forest near Fort Norman. Birch trunks break high forming conspicuous tall, white-barked (-boled) snags. The color tone on very recent burns is dark on airphotos.

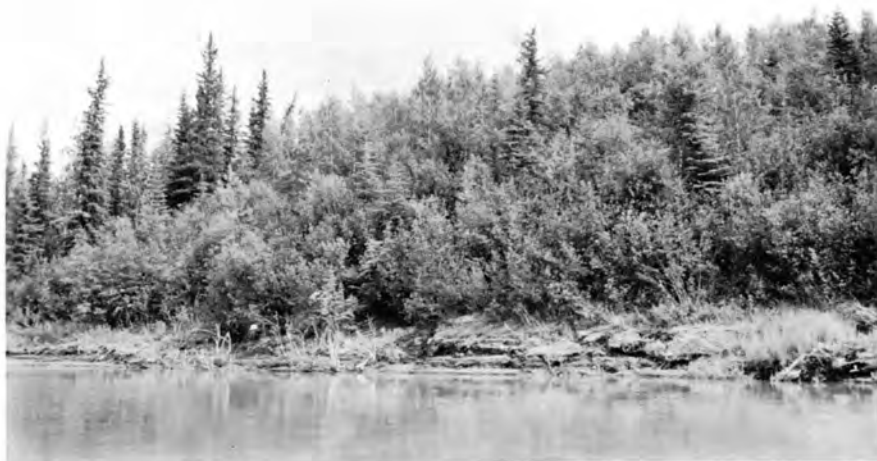
Fig. 141. Second-growth birch-spruce-tamarack forest established following old burn along the Root River. The taller spruces survived the fire. This secondary or temporary role of paper birch following disturbance is typical of the tree.

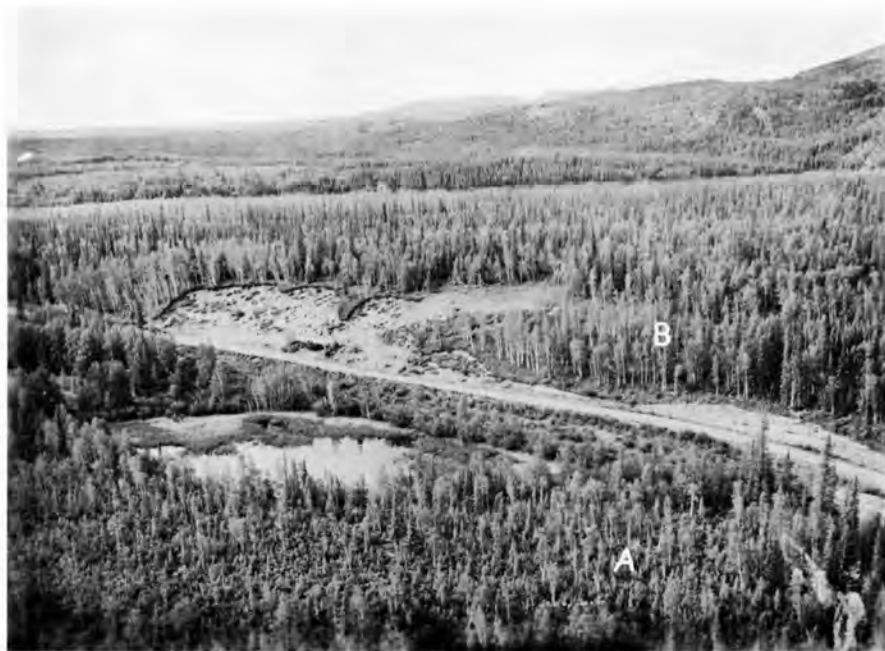
Fig. 142. White spruce-birch type in kettle-kame terrain along Great Bear River. Paper birch (A) is distinguished from aspen (B) on such photos by its proportionately longer crown, less conspicuous white trunk, and sharper top.

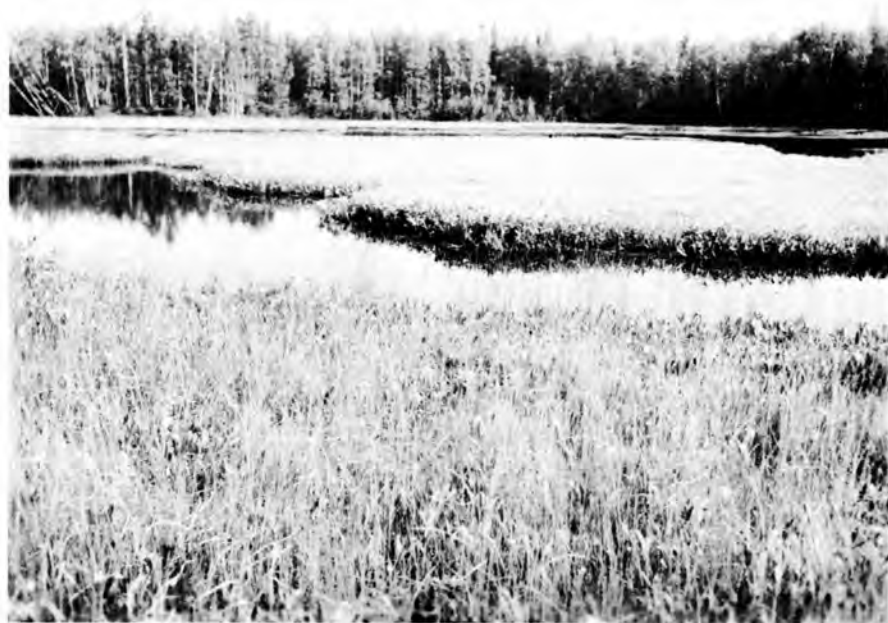
Fig. 143. Floating mat of sedge and buckbean in bog of the white spruce-birch region near mouth of Hume River. The mat in the foreground will not support a man's weight.

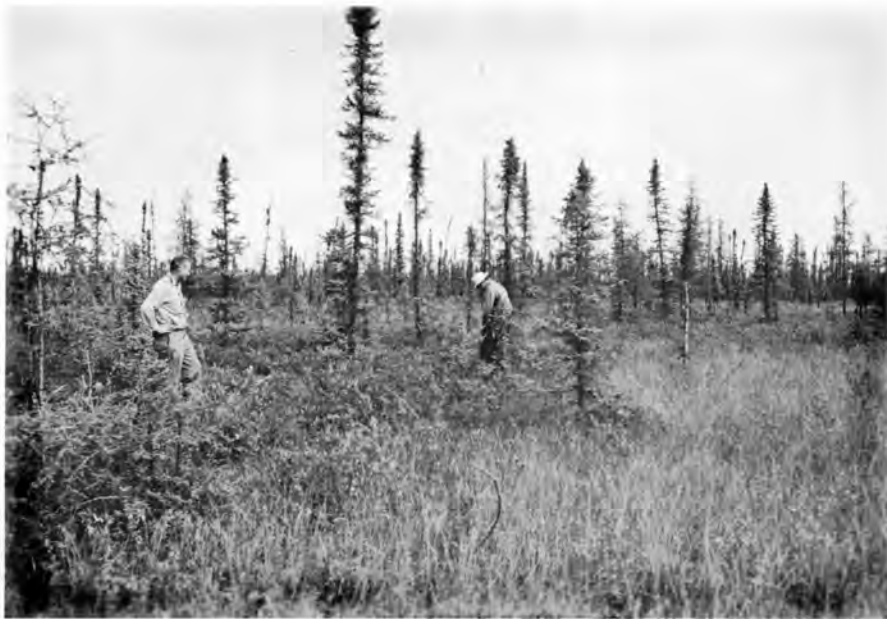
Fig. 144. Black spruce-tamarack bog in the white-spruce-birch forest near Loon River. The trees and mat of heath shrubs occupy raised perimeters of depressed-center polygons, where the frost line on 9 August was encountered at a depth of 12 to 18 in. Shallow basins 2 ft below the ridges support sedge tussocks standing in a few inches of water, beneath which the deep peat deposit is frozen at a depth of 15 in.

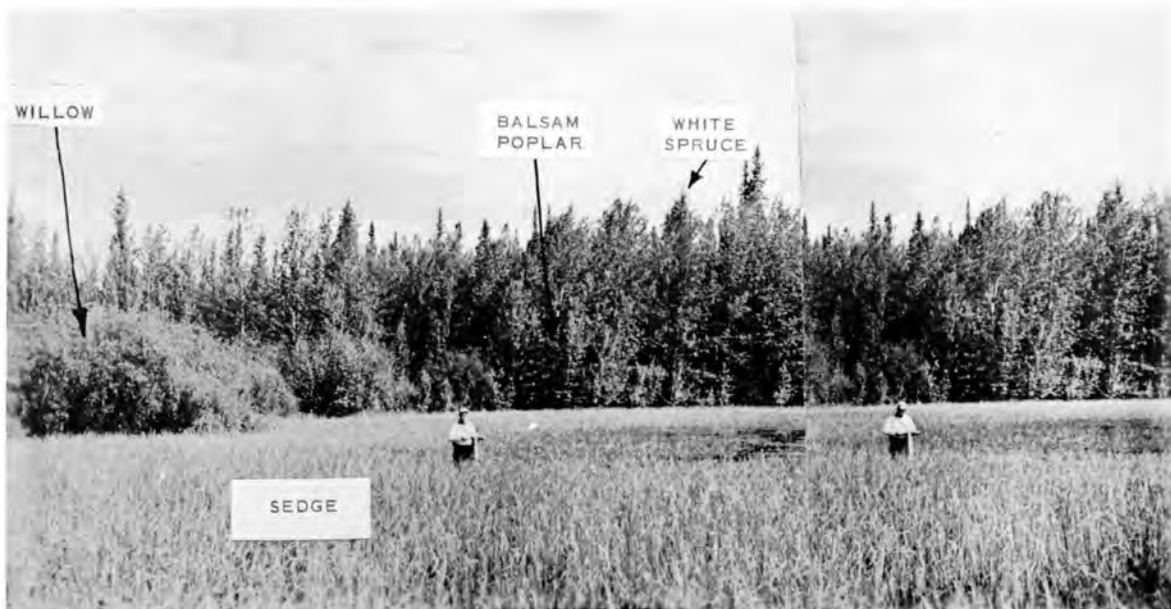
Fig. 145. Stereopair of sedge-horsetail marsh near Wrigley. Water-sedge (foreground) produces a very light tone on airphotos. It is underlain by 1 ft of peat over silt. Horsetail rush surrounds the open water, occupying most of the marsh. The rounded willow clumps bordering the marsh occupy soil made up of alternating layers of peat and silt.
