CORPS OF ENGINEERS, U. S. ARMY

AIRPHOTO PATTERN RECONNAISSANCE OF NORTHWESTERN CANADA

TECHNICAL REPORT NO. 41

Volume 2

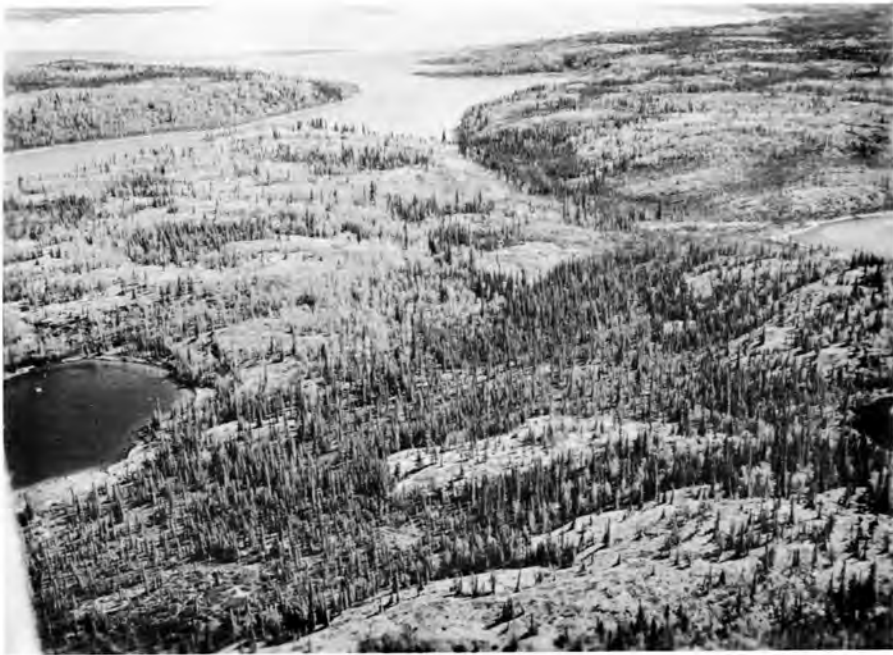
Fig. 147. Closed cover of conifers, paper birch, and aspen on glacial drift near Yellowknife. White spruce occupy the more moist slopes, jack pine and hardwoods the dry ridges where fire eliminated much of the spruce. Jack pines, shown at lower right, are readily identified by their broad, rounded crowns.

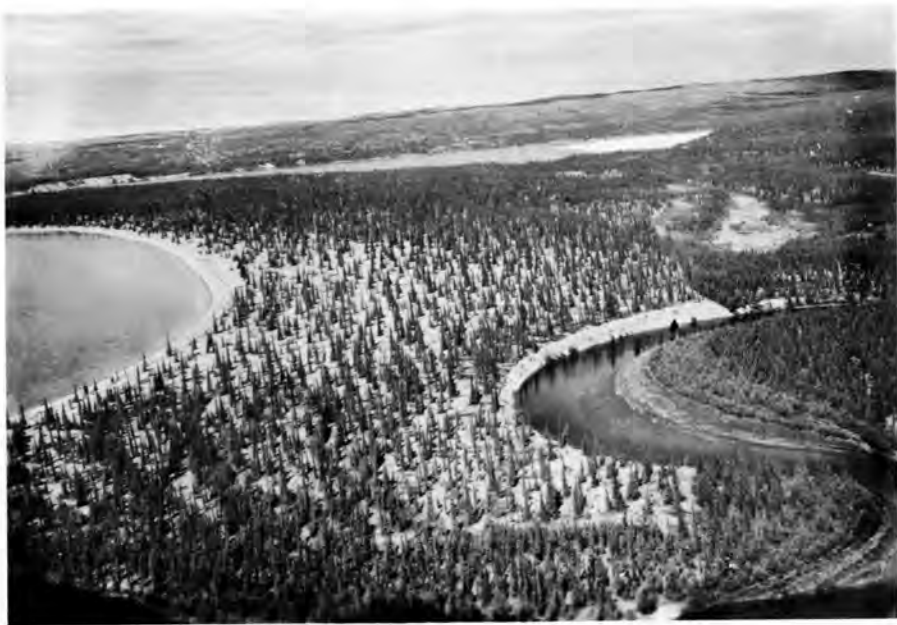
Fig. 148. Open white spruce parkland on a dry gravel bench near Reliance. Average height is about 50 ft. Inner bends of meanders show bands of low willows, balsam poplar, and denser white spruce. The steep cutbanks are typical of coarse granular materials.

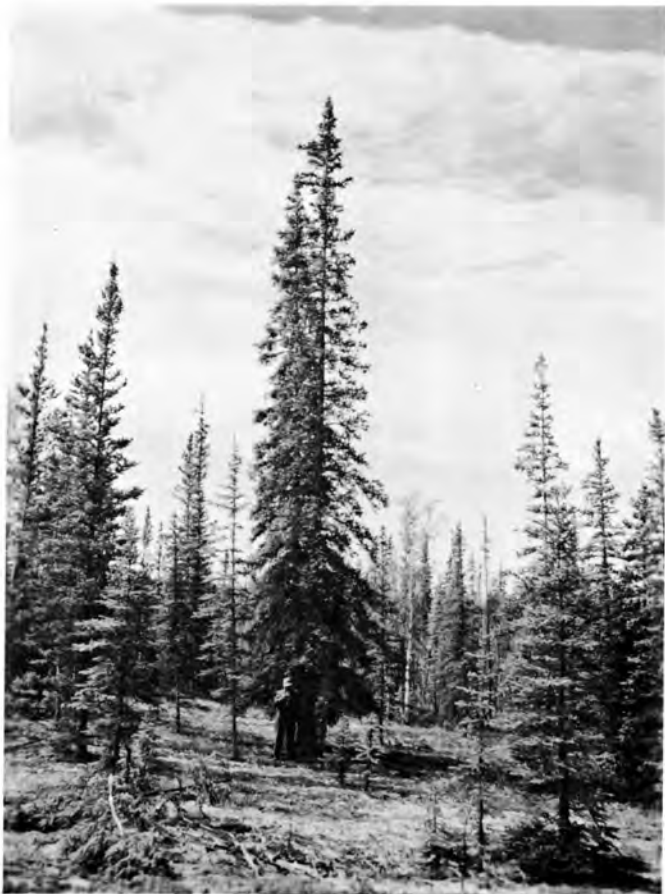
Fig. 149. Open white spruce stand on sandy gravel north of central Great Slave Lake. Paucity of undergrowth and wide spacing of trees indicate a dry, coarse substrate. On silty soils willow and alder undergrowth is usually dense.

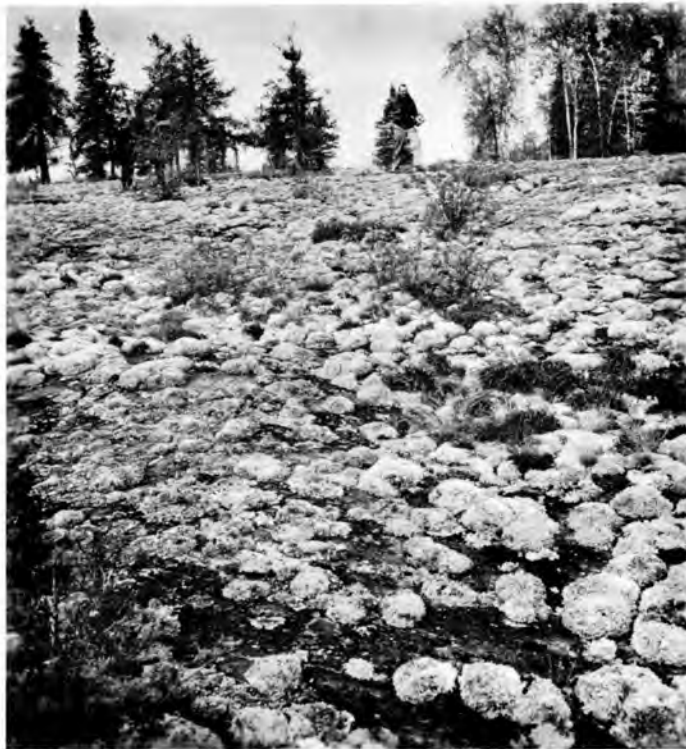
Fig. 151. Dry granite ridge with thick, dome-shaped masses of reindeer lichens. These produce a uniform light tone on airphotos. Scattered jack pines occur in crevices. Dense white spruce stands are found in nearby moist valleys.

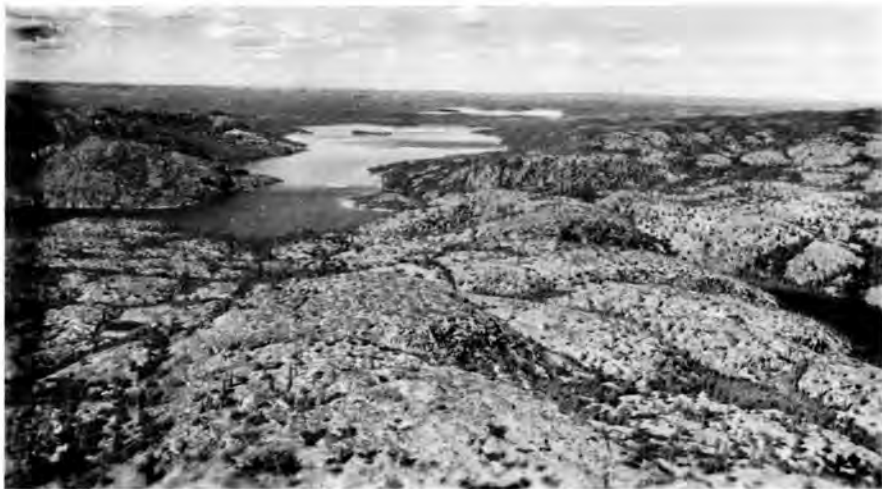
Fig. 152. A typical view of open vegetational "mosaic" on granitic bedrock east of Great Bear Lake. Severity of climate here approaches timberline condition. Small white spruce stands, with some dwarfed paper birch, are confined to gullies and depressions where some soil has collected. Lichens dominate the dry exposed rock domes.

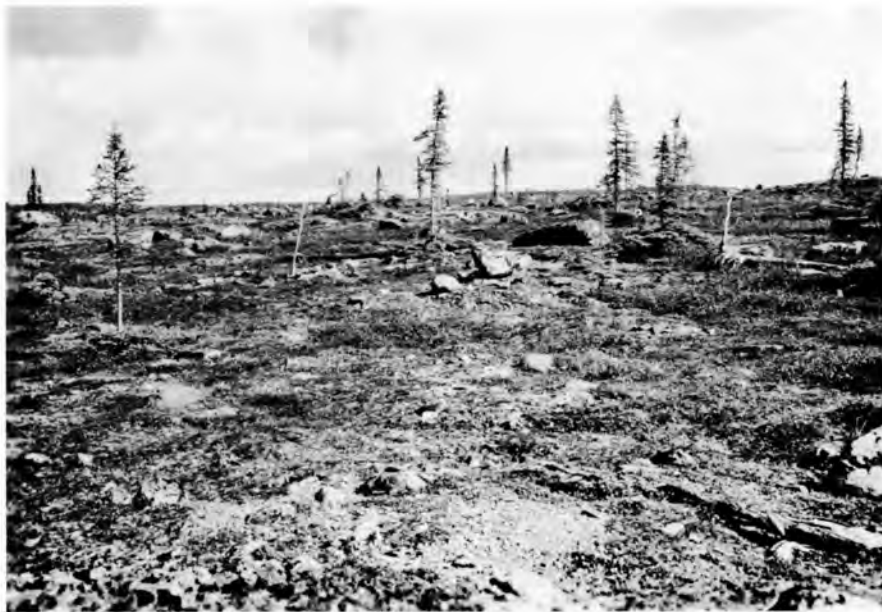
Fig. 153. Open white spruce-paper birch vegetation with scattered jack pine on bare rocks near Yellowknife. Trees become established in joints and crevices of the greenstone bedrock. Low juniper mats are typical. Aspen is uncommon on rock sites like this, but common on sand and gravelly drift.

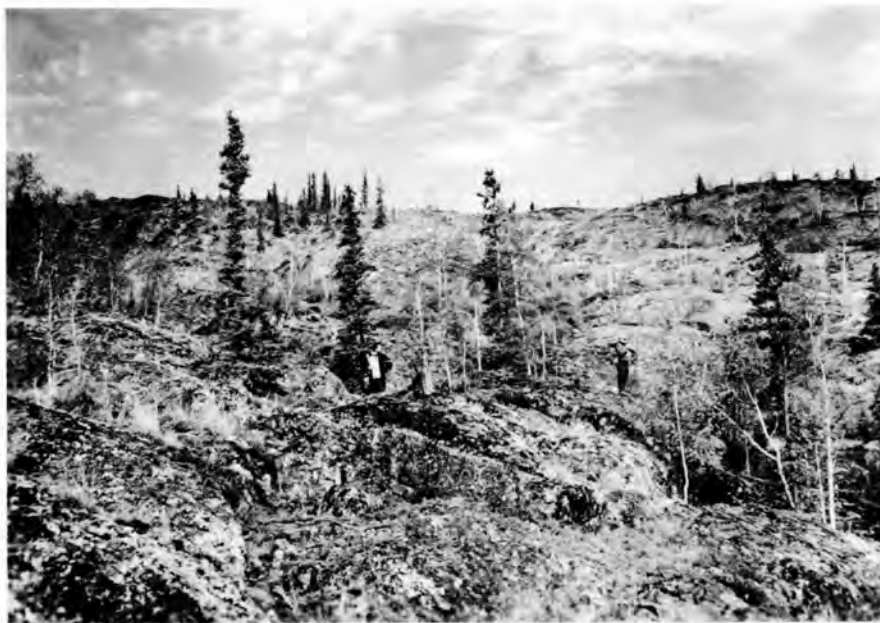
Fig. 154. Very scattered small white spruces at timberline near Hornby Bay, Great Bear Lake. Igneous bedrock surface has occasional glacial boulders. No other tree but white spruce occurs here. Ground birch and crowberry form the dominant shrubby cover.

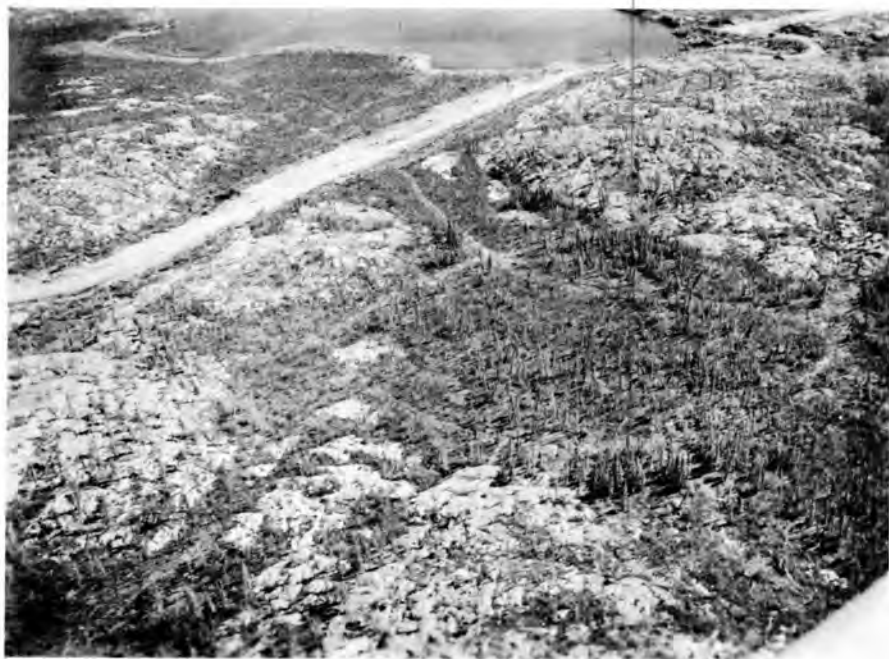
Fig. 155. A southern transition forest bog near Yellowknife, with black and white spruce 10 to 35 ft high. Jack pine and a few white spruce occupy the exposed rock sites.

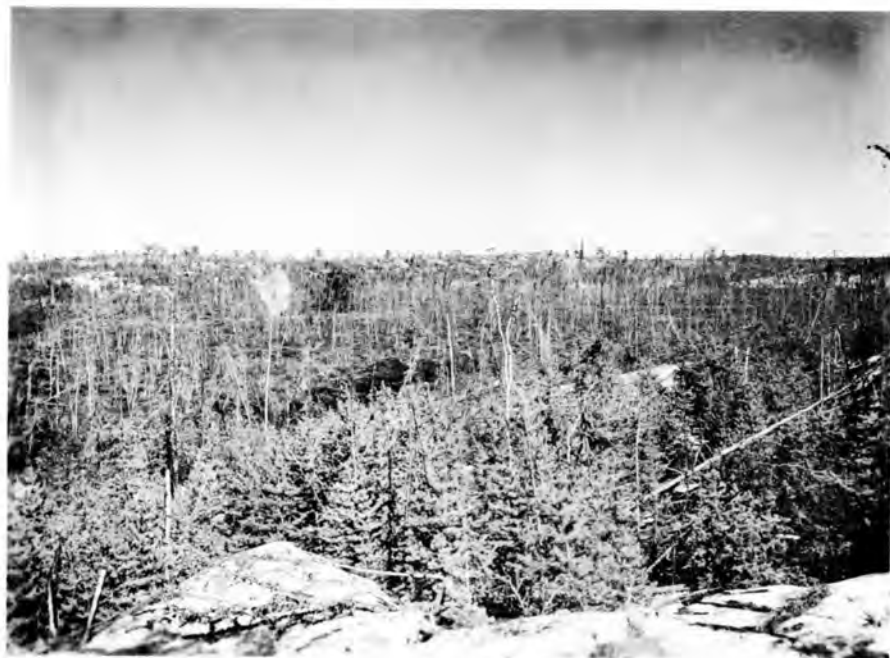
Fig. 156. A burned area near Yellowknife with 13-year jack pine established on granitic rocks. The bog in the center was covered, prior to the fire, by a dense 15-ft stand of black spruce and tamarack.

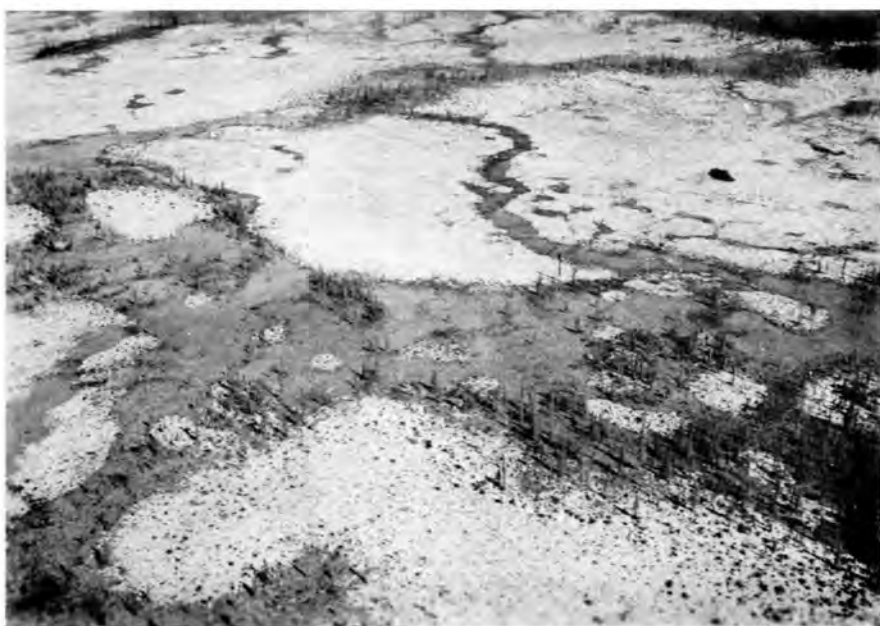
Fig. 157. A bog in a granular lacustrine plain near Fort Franklin, Great Bear Lake; 30-ft black spruce and larch occur on the peat. There is less than 5 ft difference in relief between the bog, occupying obliterated lakes and meanders, and the light-toned mat of reindeer lichens on the flat treeless benches.

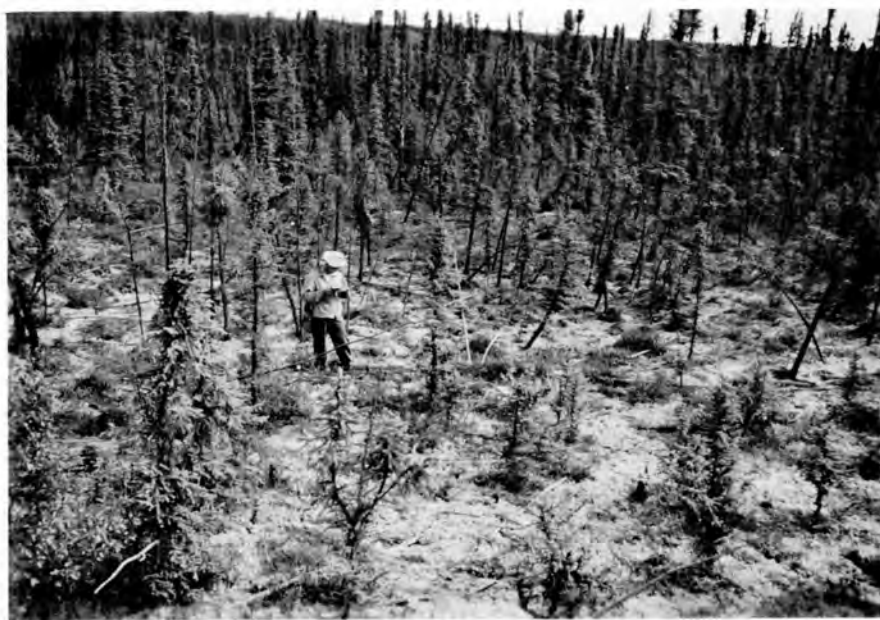
Fig. 158. Bog over clayey silt valley fill along Great Bear River. Black spruce are less than 15 ft tall. The frost line was 15 in. deep on 23 July. Reindeer lichens produce the light tone on the higher parts of the bog between trees.

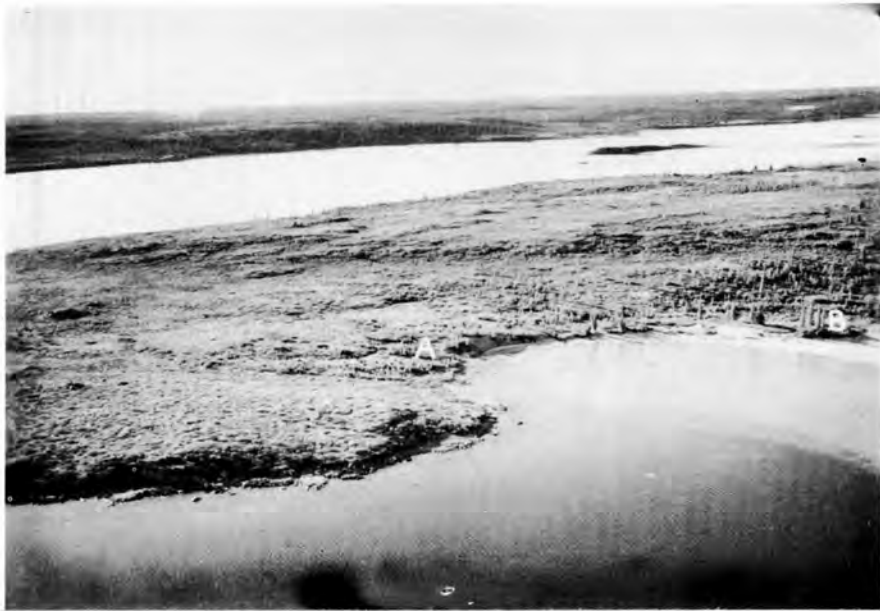
Fig. 159. Timberline white spruce stands in Artillery Lake region. Trees occur in sheltered drainageways and along the lakeshore. Maximum height of trees growing on organic soils (A) is 10 to 15 ft, while individuals reach a height of 25 ft on sandy soils (B).

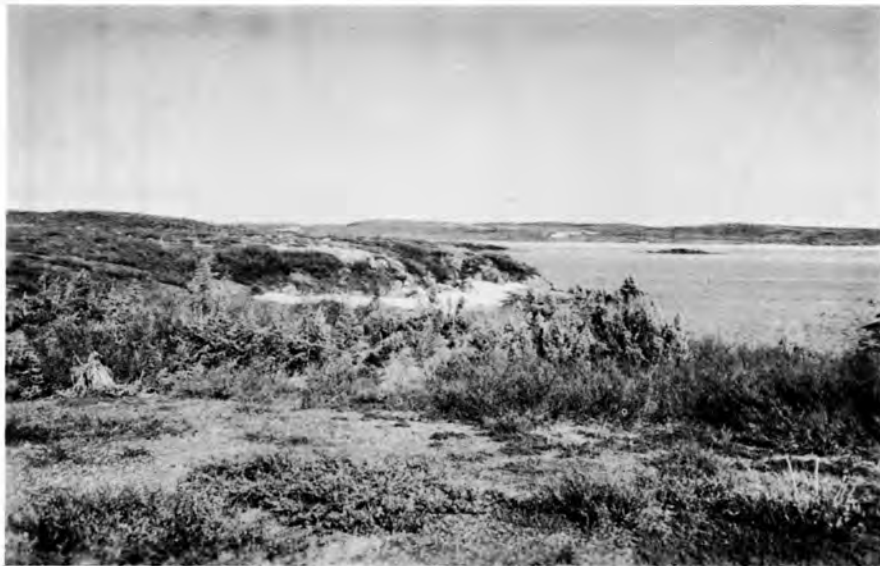
Fig. 160. Timberline white spruce in a protected drainageway at Artillery Lake. Soil is 1 ft of peat underlain by sand. Maximum height of spruce is 13 ft, and maximum diameter is 3.5 in. although stumps were observed that ranged up to 10 in. in diameter in this vicinity. Clumped shrubs at the right are ground birch.

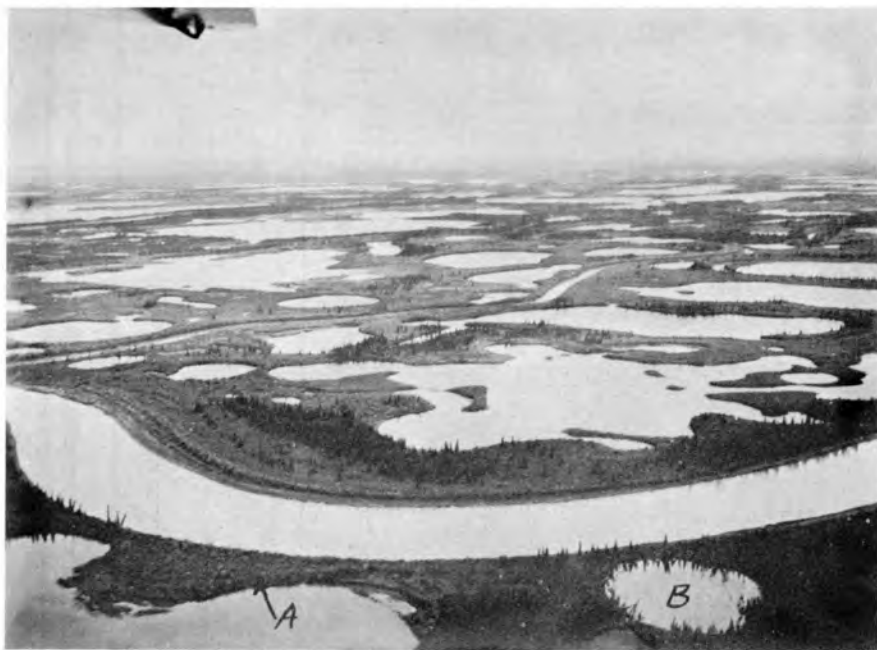
Fig. 162. The Mackenzie Delta transition forest north of Aklavik. The spruce cover is sparse and trees small compared with the stands south of Aklavik. Only fine-grained alluvial soils occur in the delta. At A is shown a dense alder-willow thicket 10 to 15 ft tall. Note "drunken forest" bordering the pond at B.

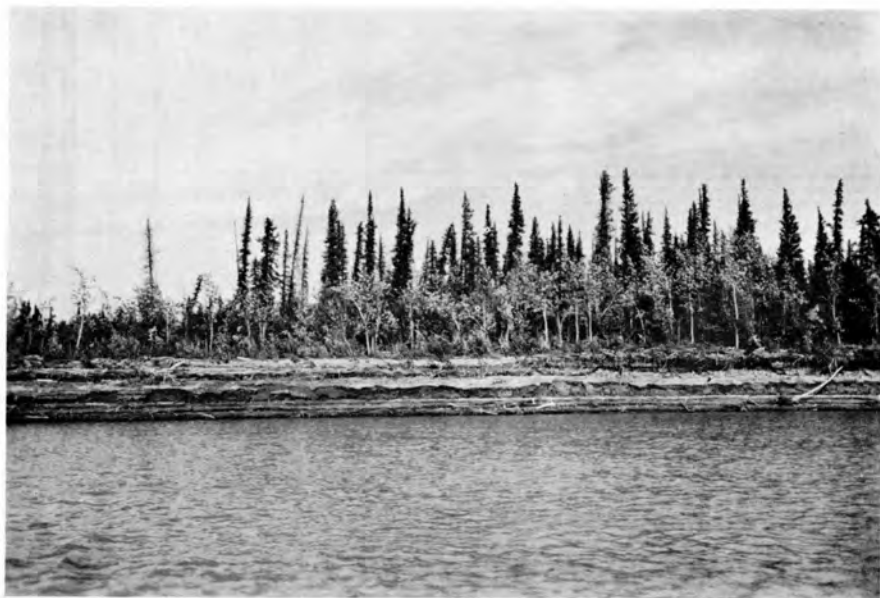
Fig. 163. Typically poor spruce stand in the northern half of the Mackenzie Delta on a low alluvial island. Spruce averages about 40 ft tall. The balsam poplar on the bank top is stunted in size and typical in form, being near its northern limit.

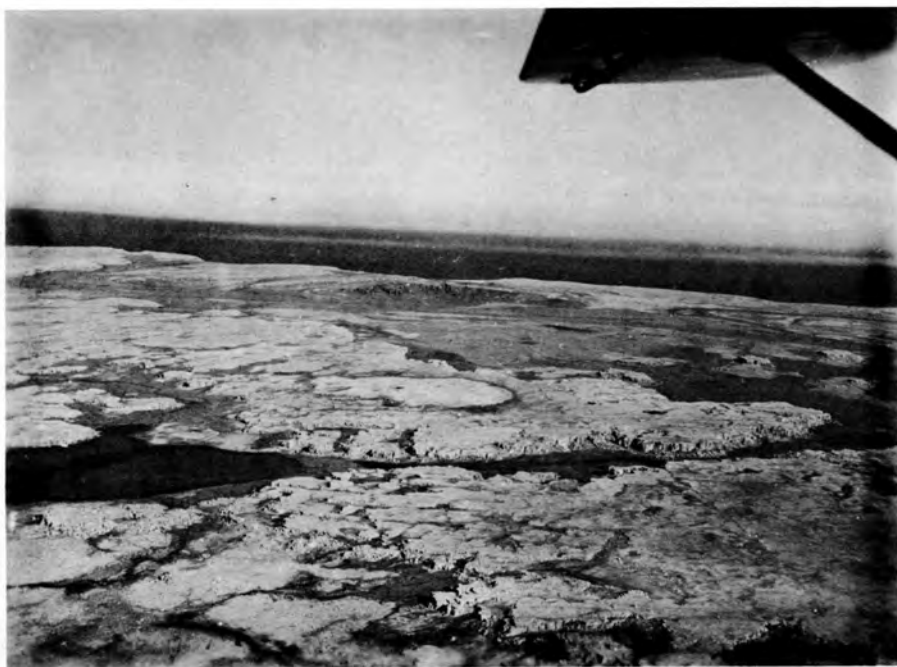
Fig. 164. Dry tundra ("rock deserts") on south shore of Amundsen Gulf. Plant cover is extremely sparse, affecting the photo pattern only in depressions. Note absence of patterned ground on the bare rock bench.

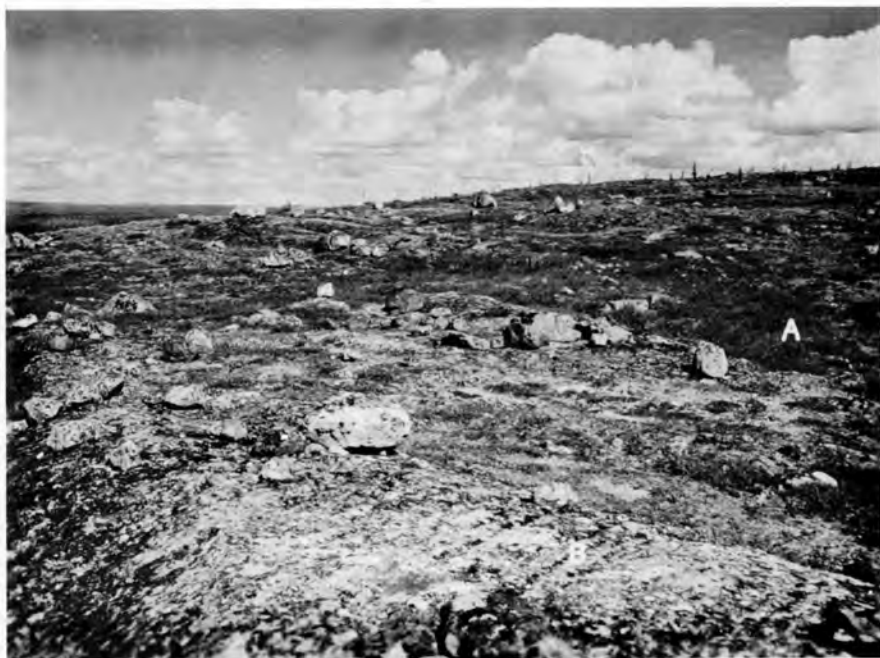
Fig. 167. Rocky dry tundra site north of Hornby Bay, Great Bear Lake. Dominant plants are the woody shrubs ground birch (A) and crowberry. Crustose and foliose lichens cover the rock at (B).

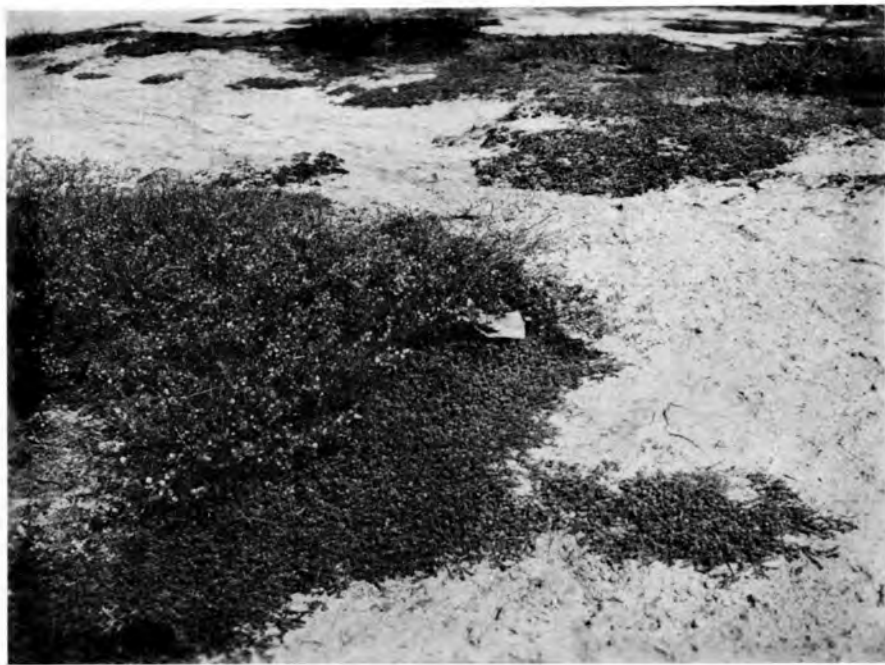
Fig. 168. Dry tundra vegetation on top of a dry sandy gravel esker. Plant at left center is ground birch; the low plant bordering it is crowberry. The glove at center indicates scale.

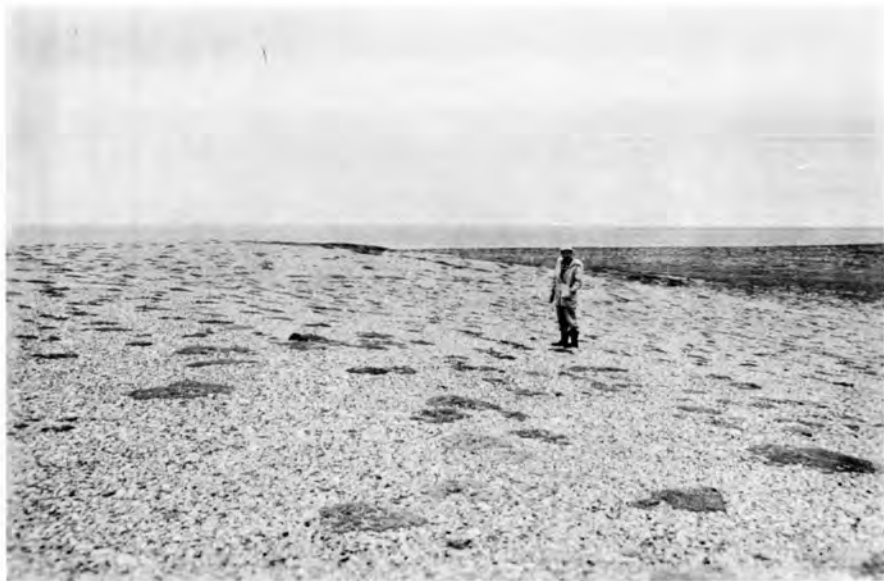
Fig. 169. Dry tundra vegetation on windswept gravel bench 40 ft above the sandy plain adjacent to the Arctic Ocean. Prostrate mats of dryas sparsely occupy the dry coarse-gravel substrate.

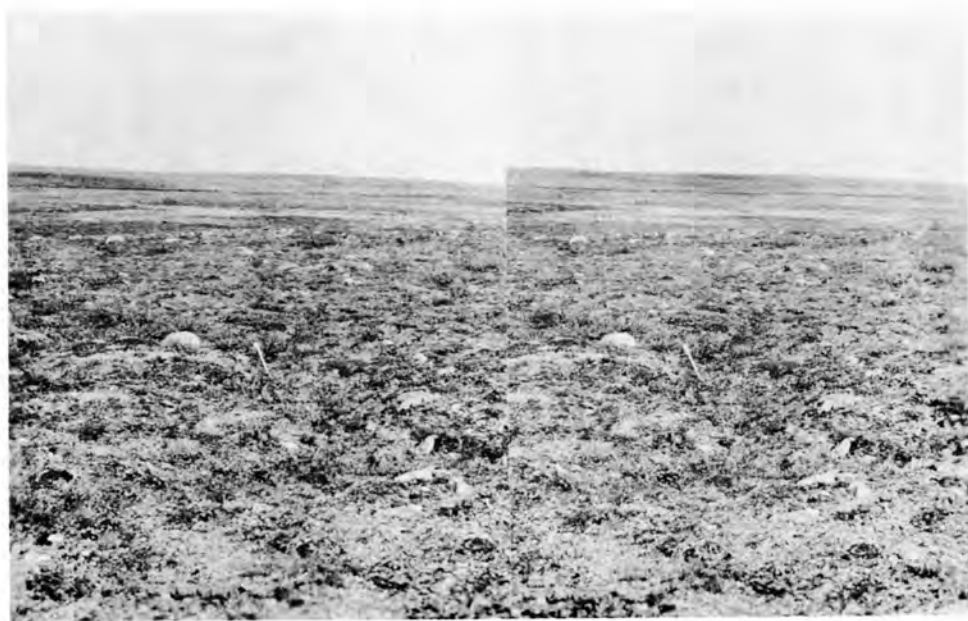
Fig. 170. Stereoview of fissure polygons on dry tundra of a coarse drift ridge. This shows denser vegetation than typical dry tundra habitats. From the air, the 30-ft polygons are very distinct, but in a ground photo, stereovision is needed to trace the channels. The axe indicates a channel. Channels are 3 ft wide and as much as 8 in. deep, and support denser ground birch and ledum than the centers, which support in addition heath, sedge, and lichens.

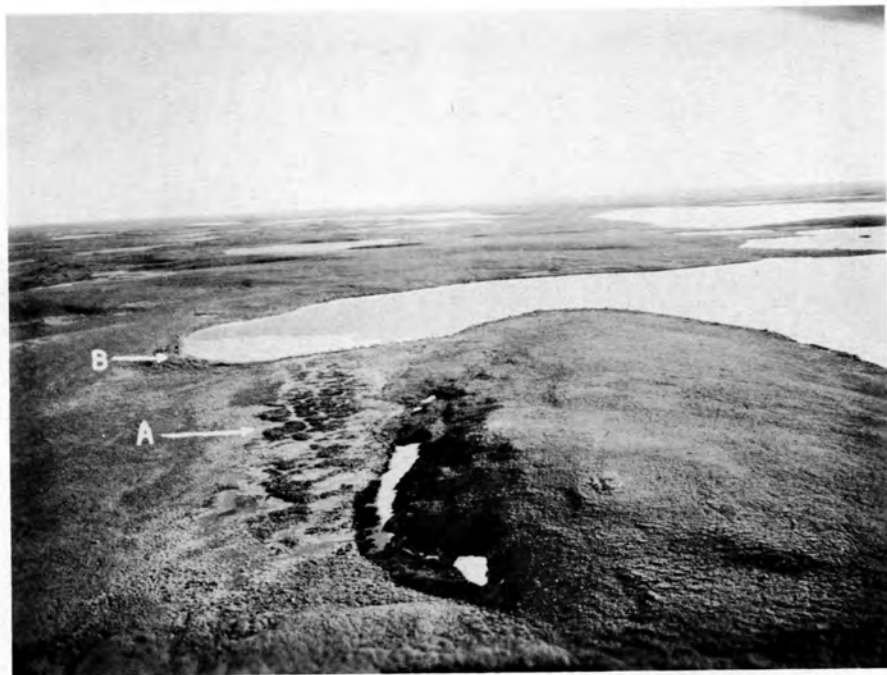
Fig. 172. Moist tundra on thick mantle of glacial drift in the Canadian Shield. Polygons are absent in the uplands, but soil slips are common on slopes (lower right). Wet tundra occurs in a strip at A, where the dark tone is caused by peat polygons. Although definitely a tundra habitat, and so indicated on maps, a small grove of dwarf white spruce is seen at B.

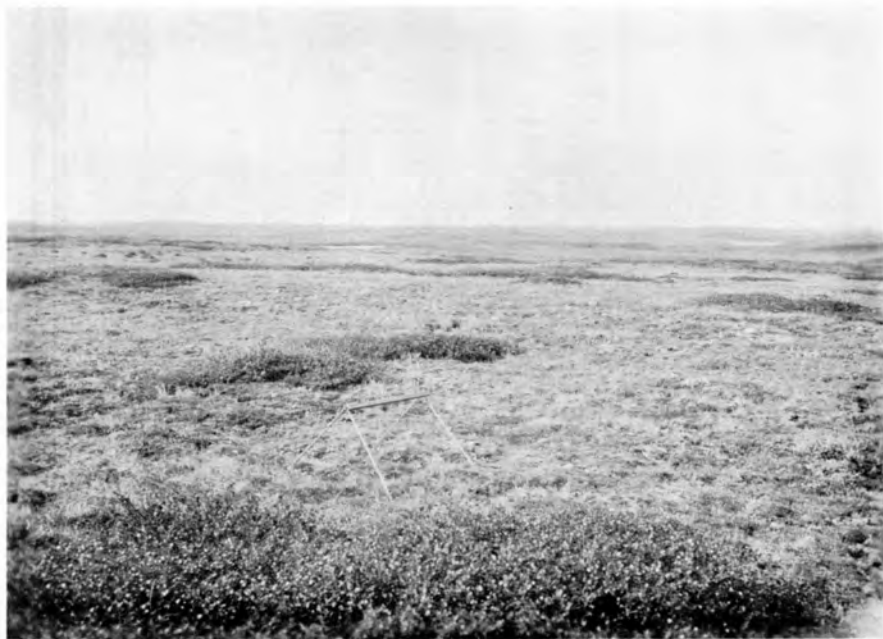
Fig. 173. Typical moist tundra on sand along Arctic Coast east of Mackenzie Delta. The quadrat frame stands 18 in. high. Principal shrubs are ground birch, alder, ledum, mountain cranberry, and dwarf blueberry.

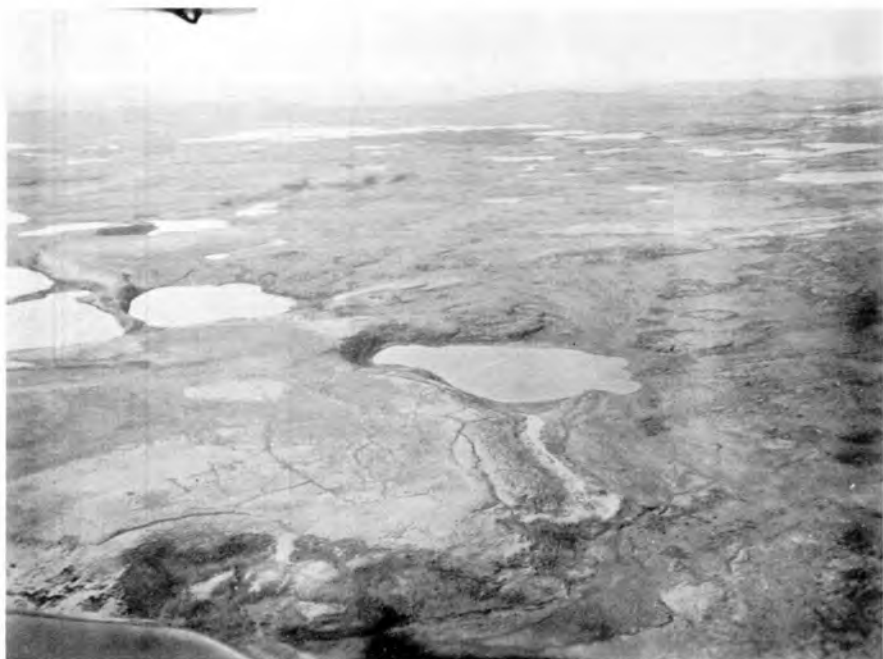
Fig. 174. Moist tundra surrounding a local dry tundra site north of Great Bear Lake. An open stand of ground birch occurs on an elevated windswept granular terrace in the foreground. Elsewhere the vegetation cover is continuous.

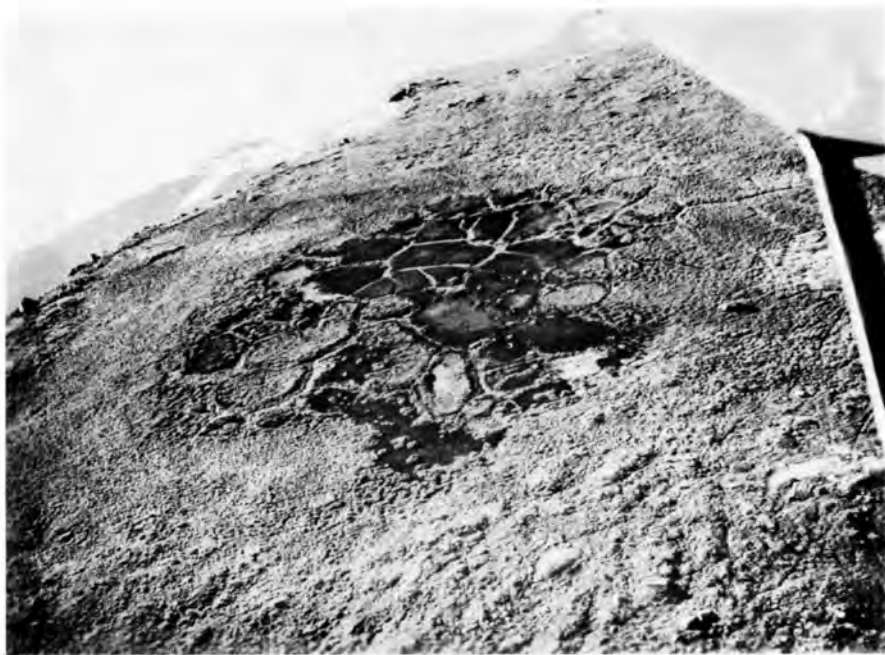
Fig. 176. Peat-filled depressions on shore of Artillery Lake with fissure polygons. The centers are free of vegetation, due to violent frost action, and appear deep chocolate brown to black from the air.

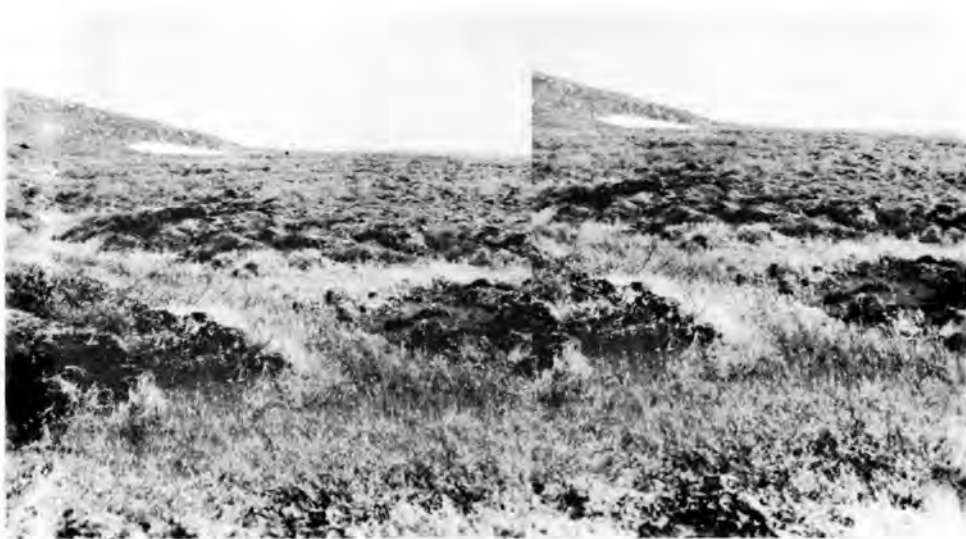
Fig. 177. Stereopair of fissure polygons in wet tundra occupying a peat-filled, hummocky depression between dry drift hills. Polygon centers, 20 to 90 ft across, display peat hummocks up to 3 ft high by 4 ft wide, sparsely covered with ground birch, ledum, blueberry, moss, and reindeer lichens. By late June, the peat was thawed to a depth of 4 to 10 in. The water-filled channels, 7 to 15 ft wide and containing dense cotton sedge, were thawed to a 14-in. depth.

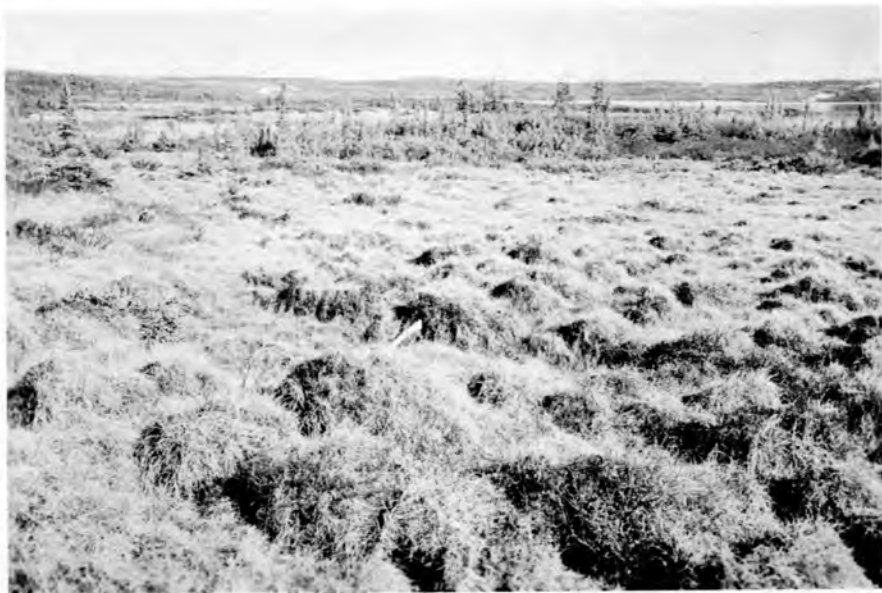
Fig. 178. Wet tundra habitat at timberline on Artillery Lake. Peat hummocks range from 1 to 4 ft high and from 1 to 8 ft in diameter. Vegetation consists of moss, ground birch, ledum, sedges, blueberry, and lichens. The peaty soil in late June was thawed twice as deep (9 in.) on the hummocks as in the depressions. Hand axe furnishes a scale.

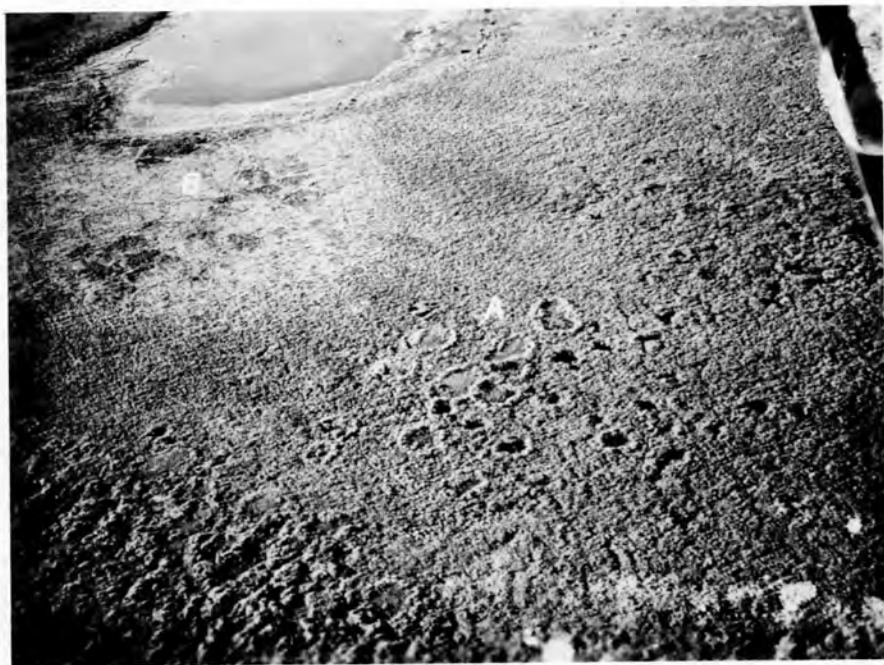
Fig. 179. Vegetation rings (A) on a poorly drained gentle slope and irregular polygons in a wetter site (B). The rings range in size from 10 to 30 ft in diameter.

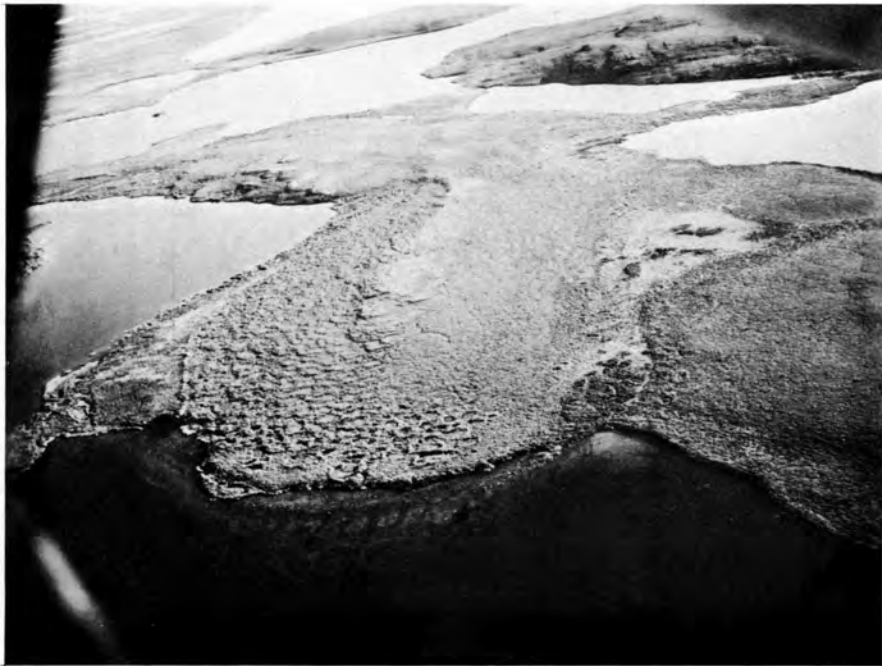
Fig. 180. Vegetation rings or rock rings in wet tundra in the Canadian Shield. On small-scale airphotos such patterned ground appears pitted. The rock rings submerged offshore appear to consist of 2-ft boulders. Note faint polygonal markings on low, level bench on the right.
