MISCELLANEOUS PAPER N-71-3

DYNAMIC TESTS OF A MODEL FLEXIBLE-ARCH-TYPE PROTECTIVE SHELTER

T. E. Kennedy

April 1971

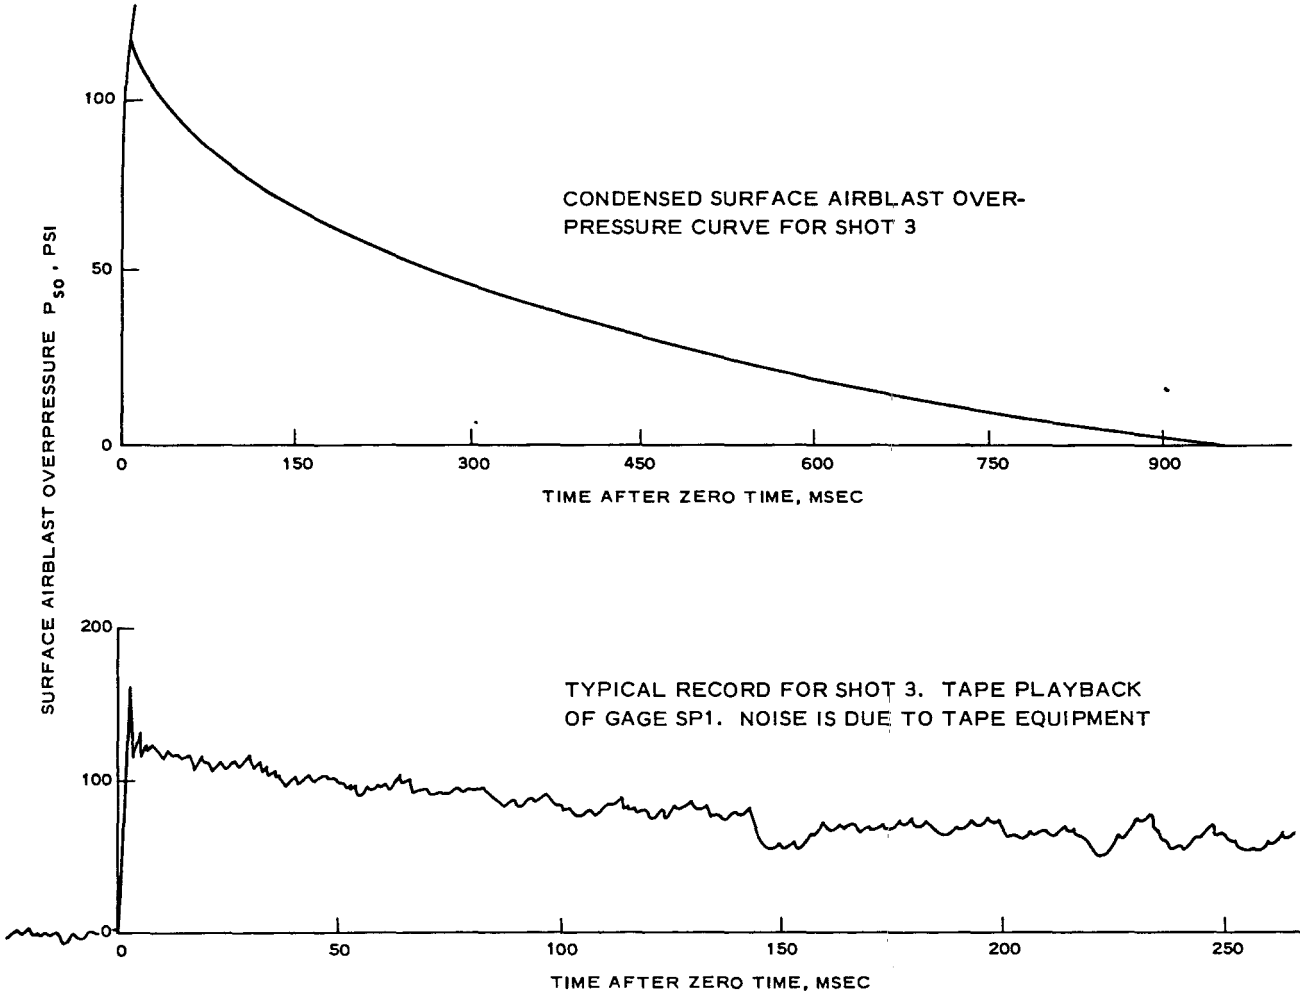
Figure 3.3 Typical airblast data.

A portion of the tape playback for Gage SP1, Shot 3, is shown in Figure 3.3 along with the condensed composite record for Shot 3. The only sets of pressure records indicating duration were obtained for Shots 3 and 4. Generally, the high temperature at the soil surface causes the pressure gages to begin drifting after about 400 msec, and eventually to register a negative pressure. On Shot 3 this did not occur and some confidence can be attached to the duration observed. A duration was observed in Shot 4 without negative pressure registration, but the poor impulse correlation raises some doubt as to the validity of this duration time. Tabulated in Table 3.1 are the surface airblast overpressure parameters as measured for each shot.
