MISCELLANEOUS PAPER N-75-6

# EVALUATION OF EXPEDIENT TECHNIQUES FOR STRENGTHENING FLOOR JOIST SYSTEMS IN RESIDENTIAL DWELLINGS

Weapons Effects Laboratory  
U. S. Army Engineer Waterways Experiment Station  
P. O. Box 631, Vicksburg, Miss. 39180

July 1975

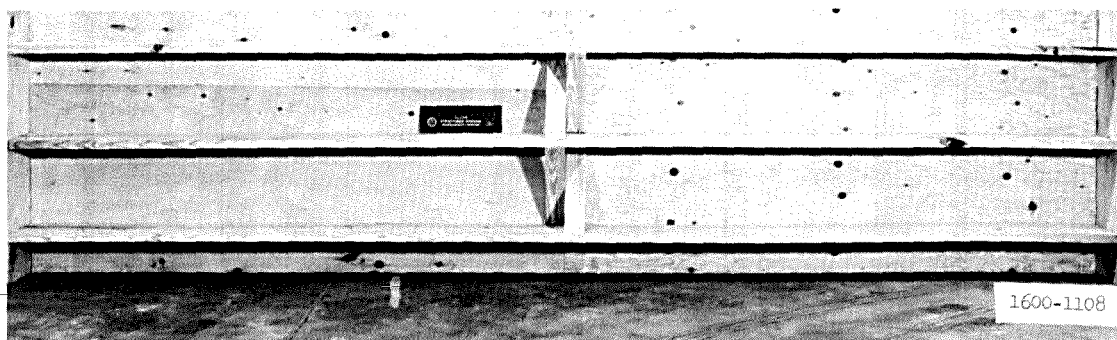
b. Bottom view of unreinforced test specimen (I).

Each of the floor specimens was loaded until two of the three wood joists ruptured. Posttest photographs of all the test specimens are shown in Figures 2.9-2.23.

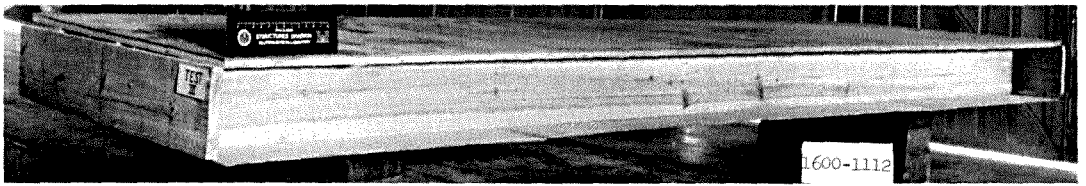
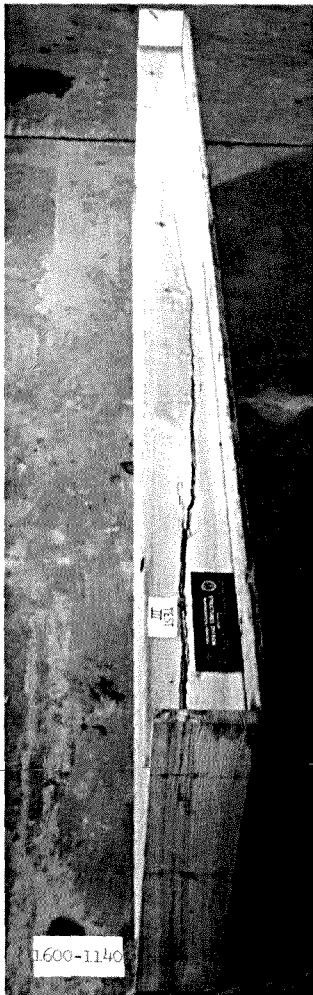
a. Overall view.

b. Top joist failure (bottom plywood removed).

c. Bottom view showing failure of top two joists (bottom plywood removed).

Figure 2.11 Posttest views of Specimen III.

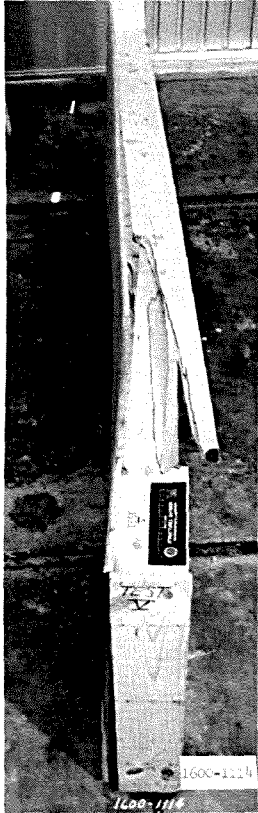
a. Joist failure (note plywood nail pullout).

b. Bottom view showing failure of top two joists.

c. Close-up of joist failures.

Figure 2.13 Posttest views of Specimen V.

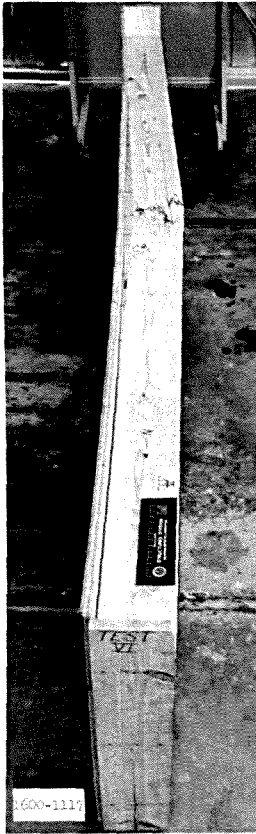
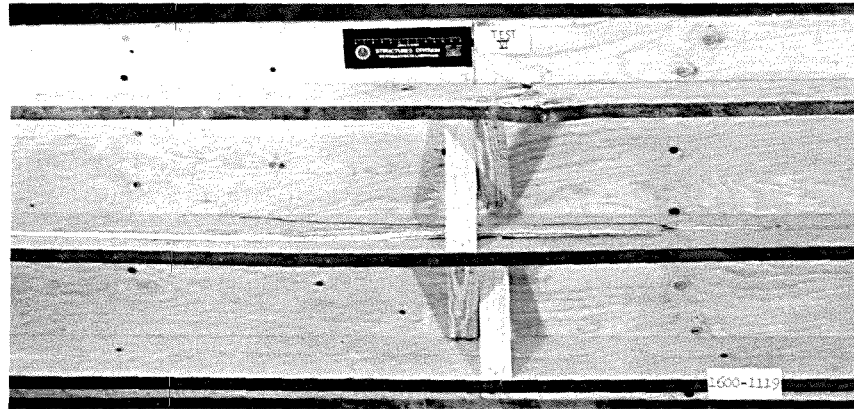
a. Joist failure (note plywood nail pullout).

b. Bottom view.

c. Close-up of joist failures

Figure 2.14 Posttest views of Specimen VI.

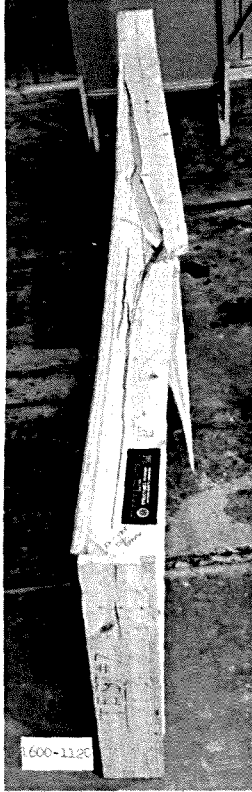
a. Joist failure.

b. Bottom view.

c. Close-up of joist failures.

Figure 2.15 Posttest views of Specimen VII.

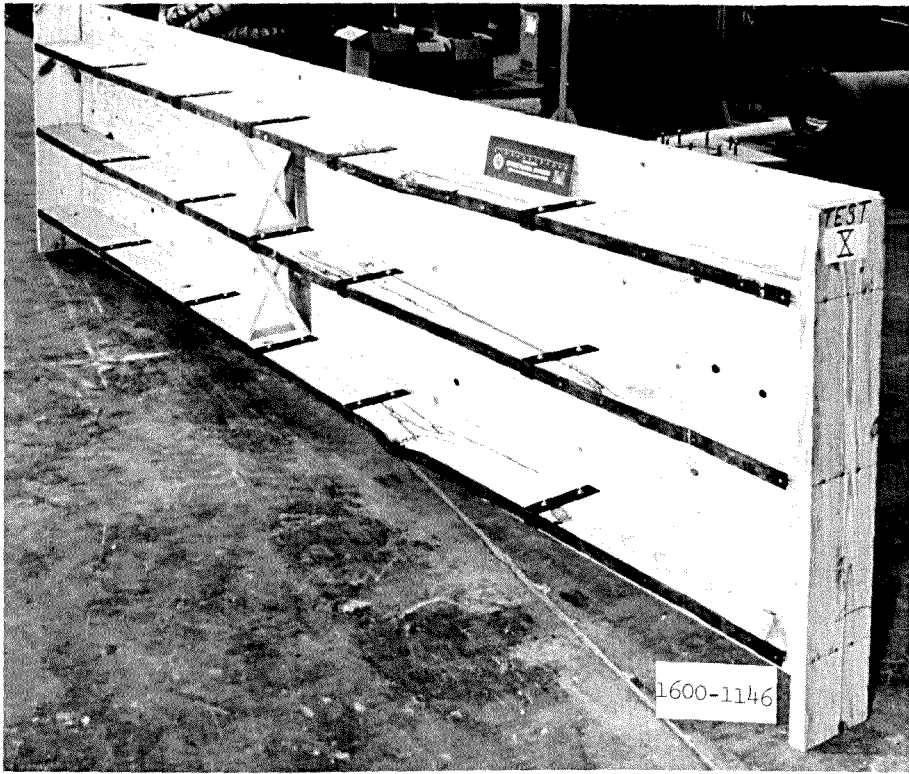
a. Overall view (note that all three joists failed).

b. Close-up of joist failures.

Figure 2.18 Posttest views of Specimen X.

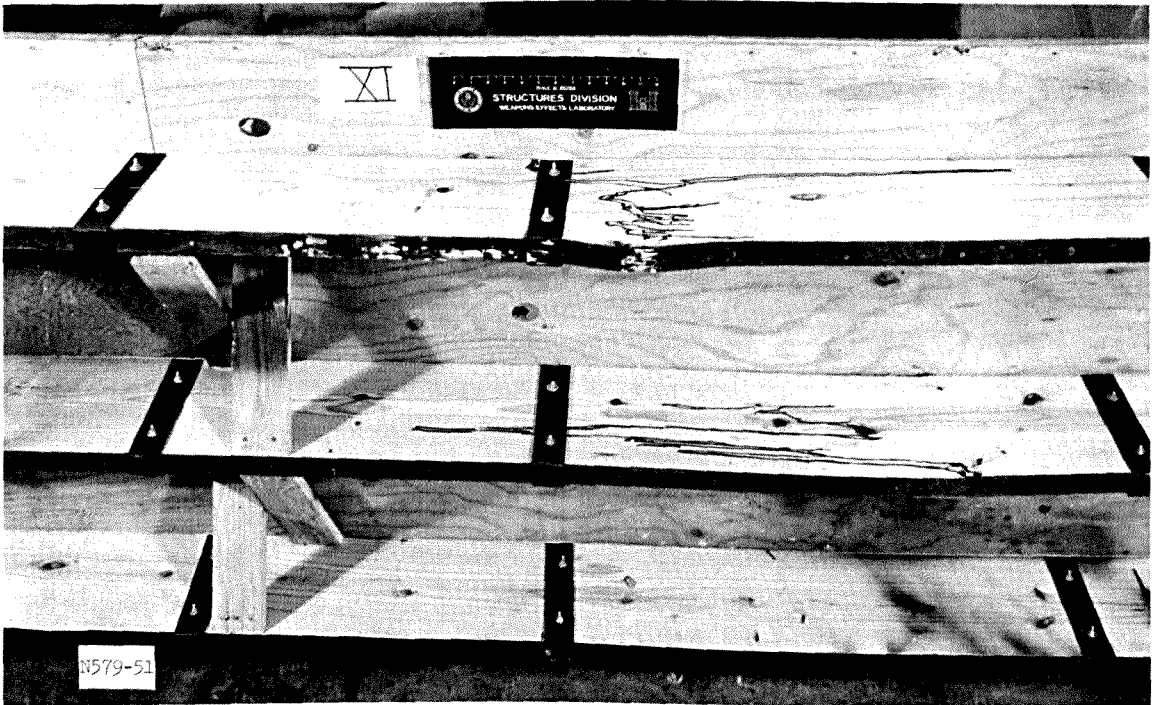
a. Overall view.

b. Close-up of joist failures.

Figure 2.19 Posttest views of Specimen XI.

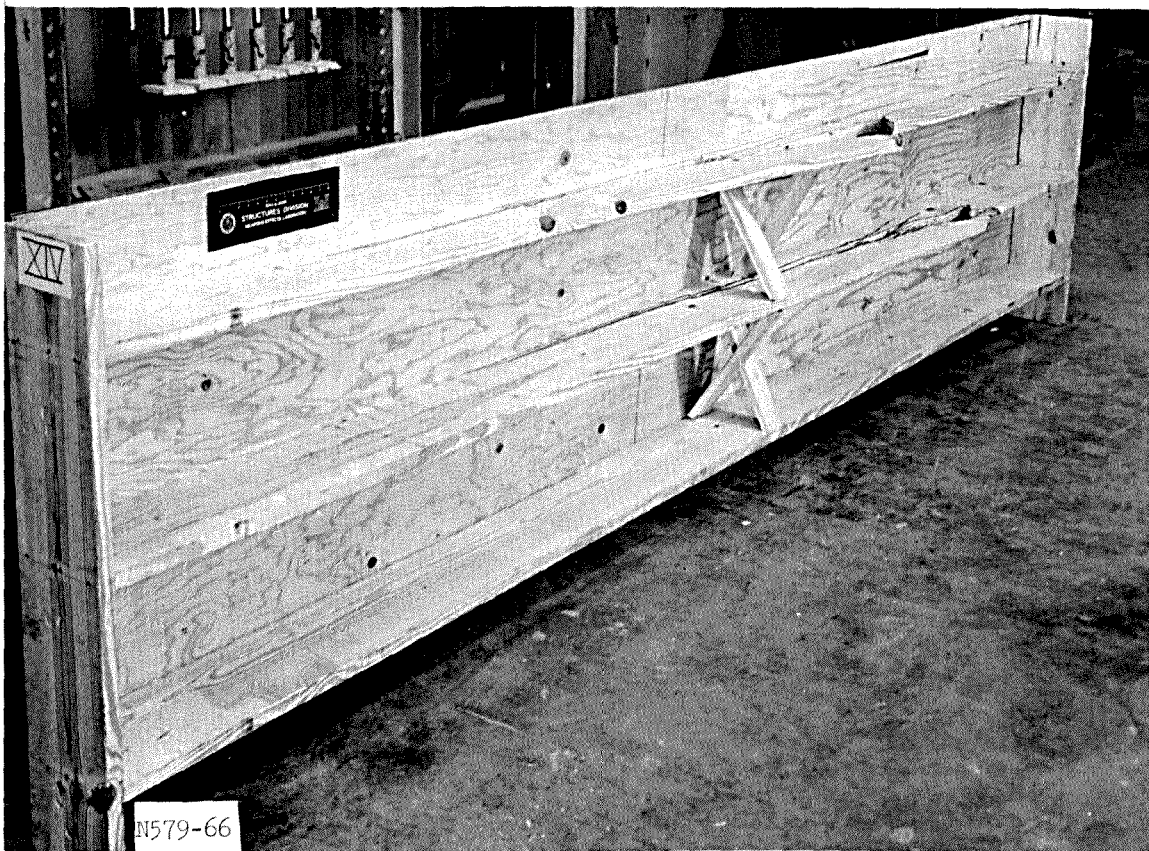
a. Overall view.

b. Close-up of joist failures.

Figure 2.22 Posttest views of Specimen XIV.

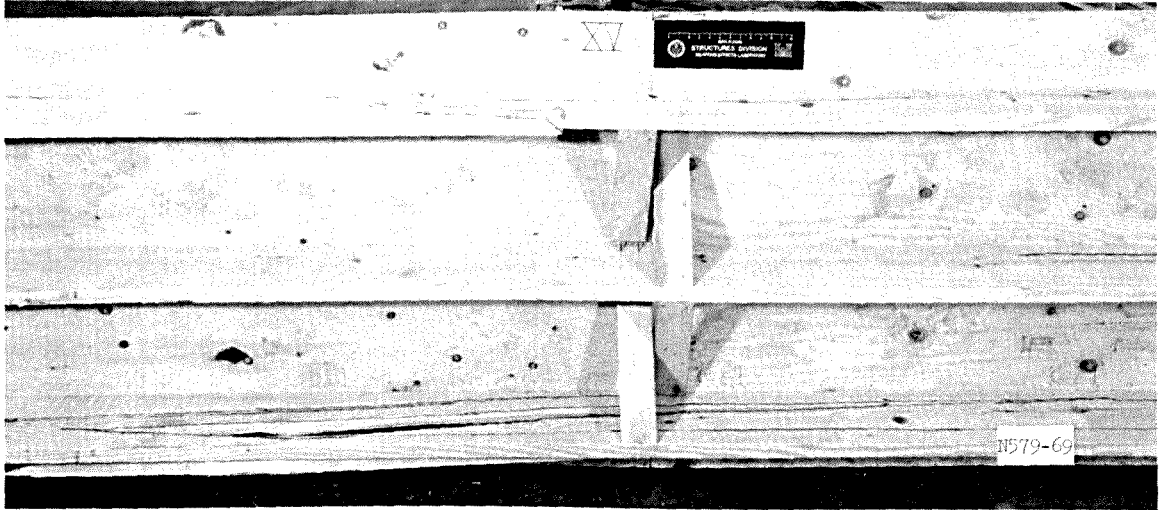
a. Overall view.

b. Close-up of joist failures.

Figure 2.23 Posttest views of Specimen XV.
